1. Report No. FHWA/TX-07 / 0-1774-4		2. Government Accession No.		3. Recipient's Catalog No.	
4. Title and Subtitle Performance of Fiber Composite Wrapped Columns and Beams in a Corrosive Environment			5. Report Date October 2006

Performance of Fiber Composite Wrapped Columns and Beams in a Corrosive Environment

CTR Technical Report:	0-1774-4
Report Date:	October 2006
Project:	0-1774
Project Title:	Effect of Wrapping Chloride Contaminated Structural Concrete with Multiple Layers of Glass Fiber/Composites and Resin
Sponsoring Agency:	Texas Department of Transportation
Performing Agency:	Center for Transportation Research at The University of Texas at Austin

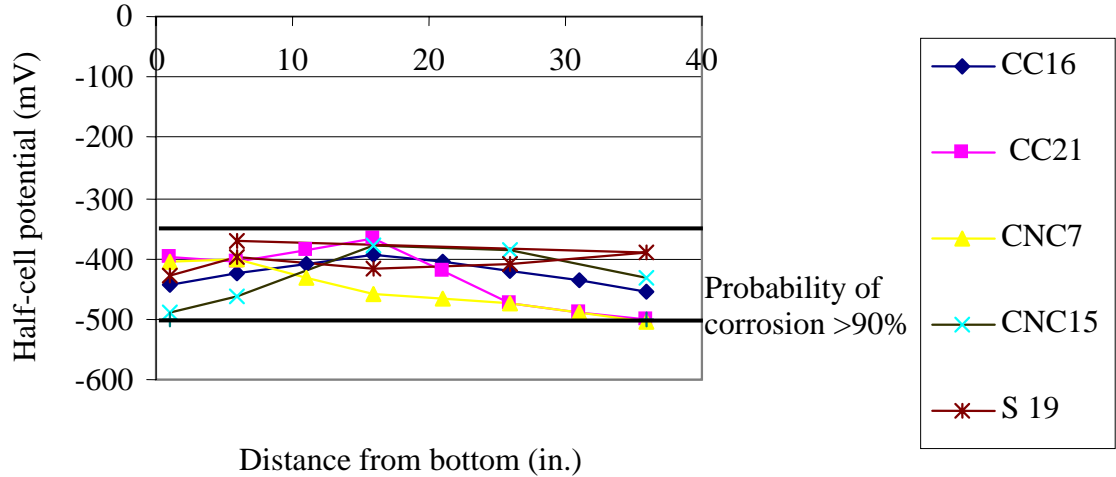
Figure 3.1 Half-cell potentials for unwrapped columns

Figure 3.1 shows half-cell profiles for unwrapped column specimens and Figure 3.2 shows the half-cell profiles for some of the fully wrapped specimens. For the unwrapped columns, the potentials lie primarily between -350 mV and -500 mV, indicating a very high probability of corrosion. For the fully wrapped specimens, the potentials range from -200 mV to -500 mV, indicating that after many cycles in the corrosion tank, it becomes increasingly difficult to predict the level of corrosion based only on half-cell readings. The half-cell readings, though, are very effective in indicating whether the probability of corrosion is very high or low. The half-cell potential profiles also provide a strong indication that the addition of FRP wrap reduces the likelihood of corrosion.

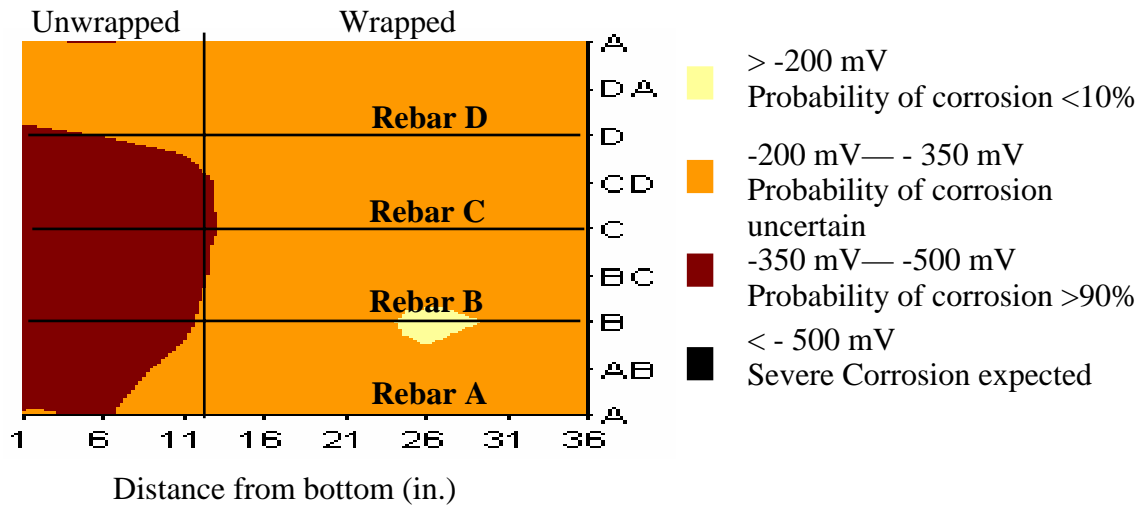
Figure 3.3 Half-cell potential contour for specimen CNC3

Figure 3.3 shows the half-cell potential contour of a specimen CNC3, that was wrapped over the top 24 in. The half-cell readings clearly indicate that the FRP wrapping has reduced the likelihood of corrosion. Similar conclusions can also be drawn by looking at half-cell contour maps of other specimens such as CC1, CC8, CC9, CC19, CNC4, CNC18, S3, S5, S7, S11, S13 and S14. The details are given in Appendix A.

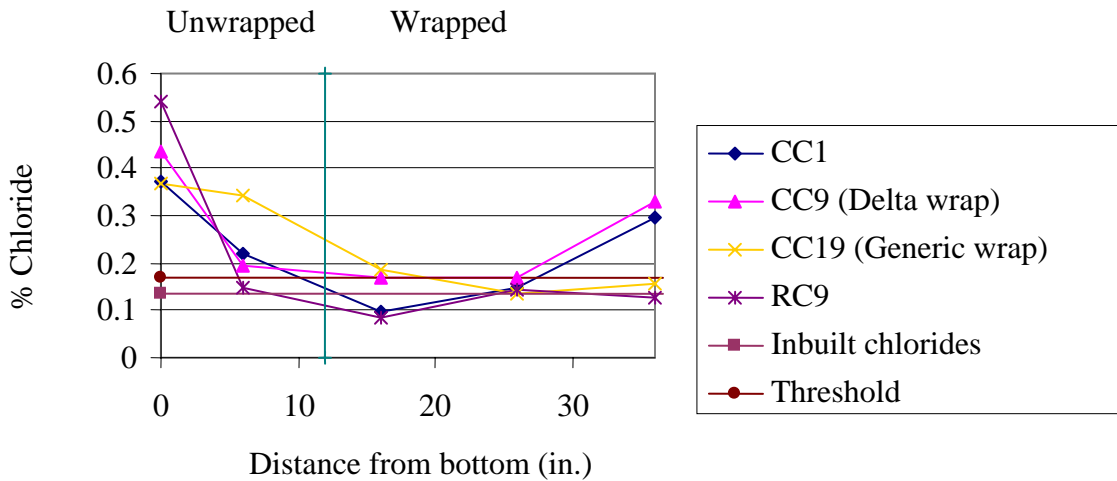
Figure 3.5 Chloride content profiles of specimens wrapped over top 24 in.

A threshold value of 0.03% chloride content as a percentage of weight of concrete is indicated in the figures. For the specimens containing inbuilt (added to the fresh concrete) chlorides (0.137% by weight of concrete), the threshold is considered as an additional 0.03% of migrating chlorides. For the unwrapped specimens, the chloride contents are much higher than the threshold value (Figure 3.4). For the partially wrapped columns, the chloride contents are high in the unwrapped portion but below the threshold in the wrapped portion (Figure 3.5). High chloride contents were found in the exposed upper end of the columns.

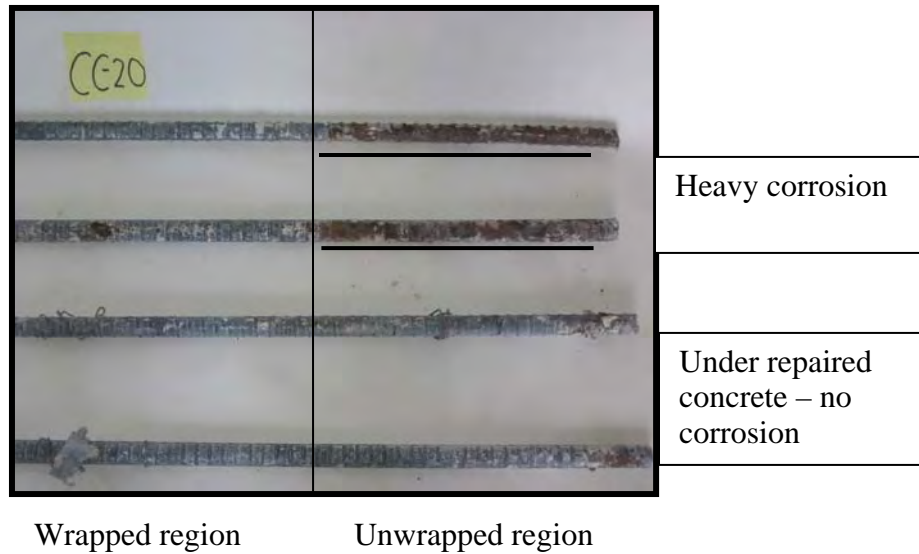
Figure 3.10 Corrosion of bar under repair material

All the repaired specimens that were autopsied had been repaired using Latex-Modified Concrete. LMC repair material is less permeable than ordinary concrete, and it was observed that the chloride content levels below the repair material were very low. After removal of the reinforcing bars, it was observed that no corrosion had taken place below the repair material even in unwrapped regions. The LMC also acted as a barrier for the ingress of chlorides. Figure 3.9 shows the difference in the chloride contents below LMC repaired concrete and areas that were not repaired for specimen CNC9. Figure 3.10 shows the corrosion on reinforcing bars below the repair material. Similar results were observed in specimens CC2, CC4, CNC9 and CNC18.

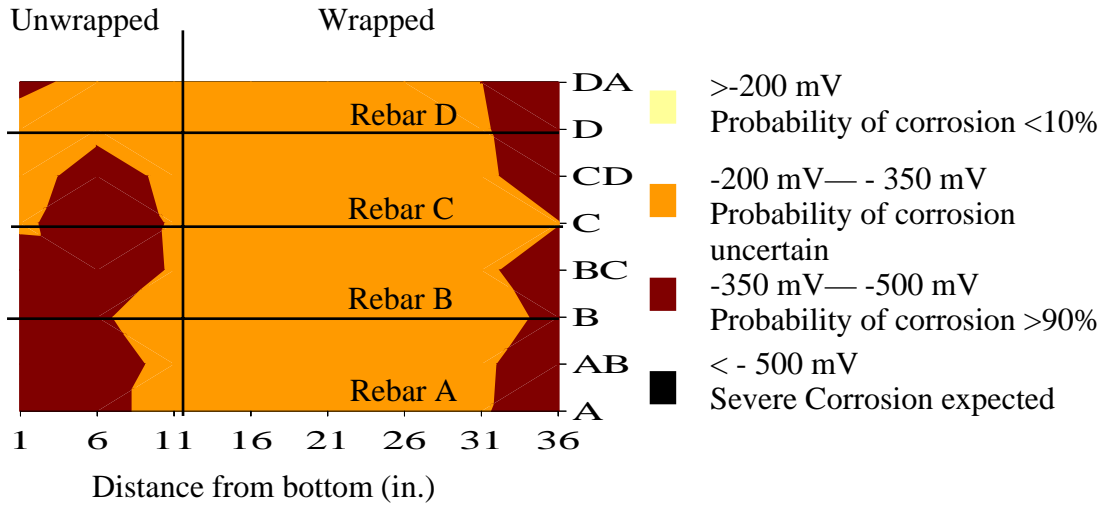
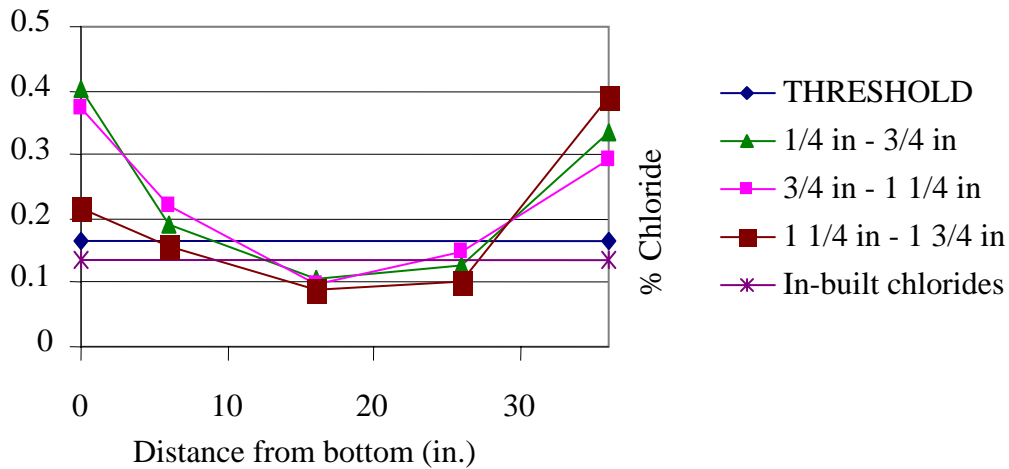
- 1) No corrosion was observed except on the bottom few inches of rebars C and D.
- 2) Though the bottom 12 in. was not wrapped, there was hardly any corrosion in those areas. This is in contrast to other specimens where heavy rusting was observed in unwrapped areas. This could be due to the presence of corrosion inhibitor Ferrogard.

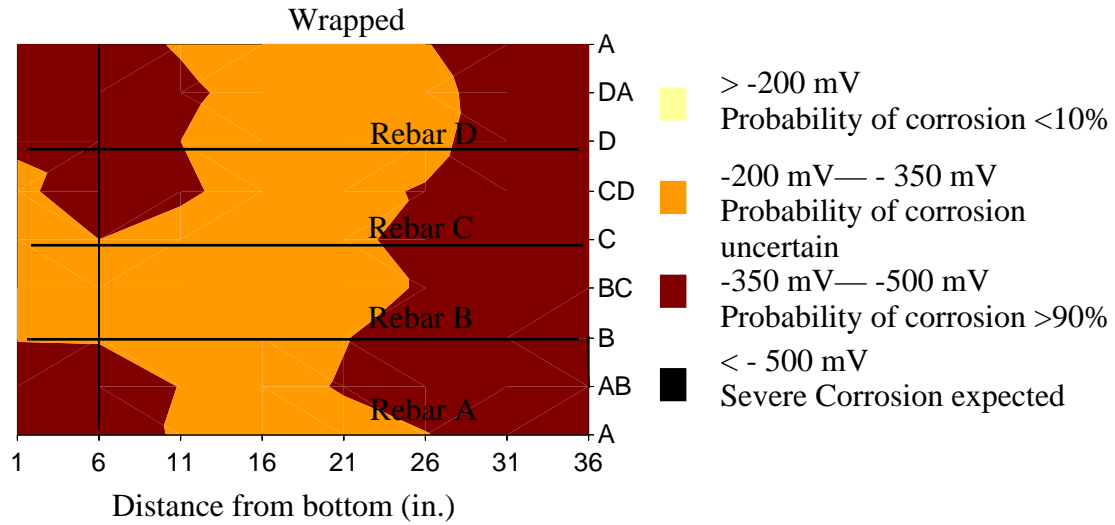
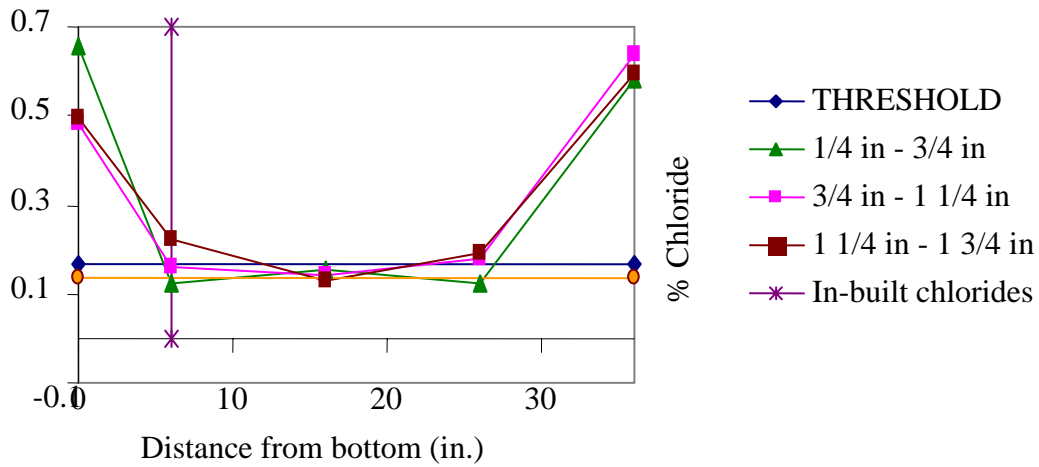
- 1) The cylinder was wrapped over top 30 in.
- 2) The wrap was intact at all places.
- 3) A vertical crack of width 0.016 in. was observed over 0 in- 2 in. over rebar D.
- 4) A rust spot (3 in. × 2 in.) was found over rebar A.
- 5) A vertical crack of width 0.08 in. was observed over 0 in- 3 in. over rebar B.
- 6) After removal of wrap, repair patch was visible over bottom 18 in. at area DC-C-B and till 8 in. at areas BA-A-D-DC.

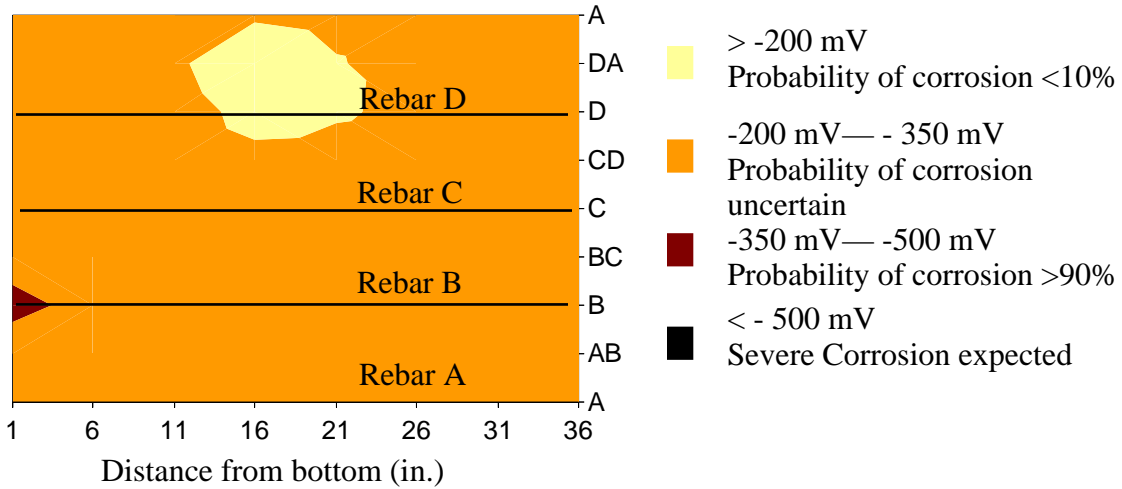
- 1) Rebars in cylinder CC8 were not corroded. The chloride content is below the threshold level. The wrap has been effective in inhibiting corrosion.

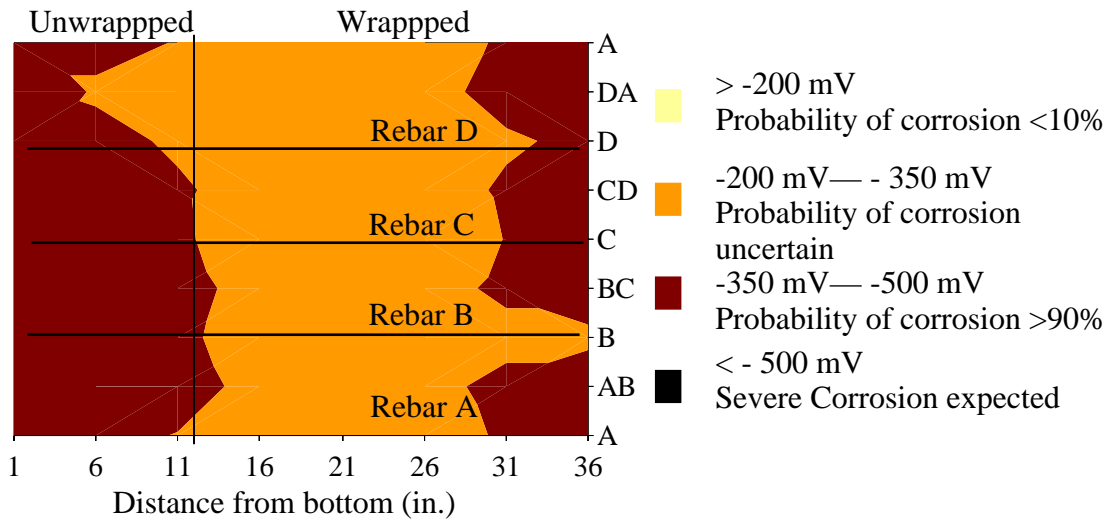
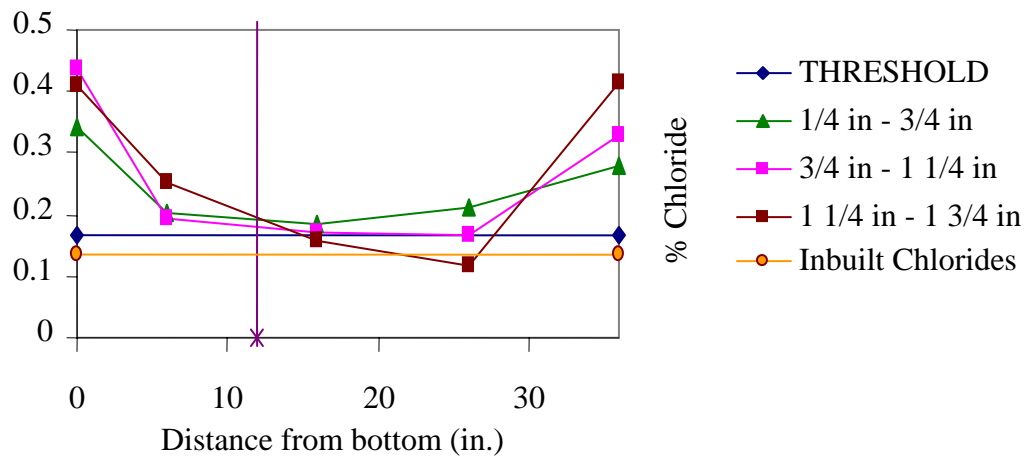
- 1) The cylinder was wrapped over top 24 in.
- 2) The wrap was intact at all places.
- 3) Concrete had spalled-off in the bottom region over rebar A. Rust stains were visible underneath.
- 4) A horizontal crack of width 0.03 in. was observed 2 in. above bottom over area CD-B-BA.

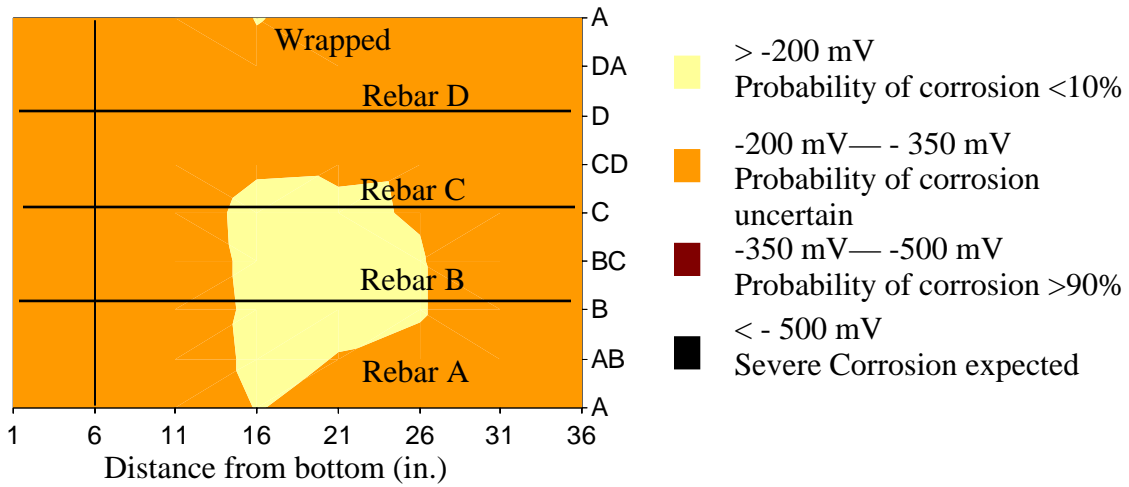
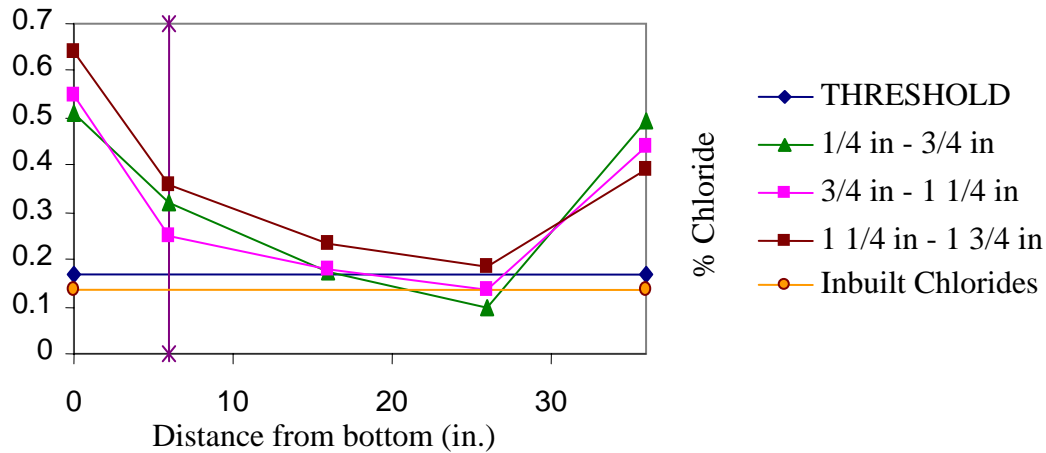
- 1) The specimen was covered with wrap over top 30 in.
- 2) The wrap was intact at all places.
- 3) A horizontal crack of width 0.04 in. was observed over area D-A-B at 2 in. above bottom.
- 4) Concrete over bottom 2 in. over rebar A was spalled.

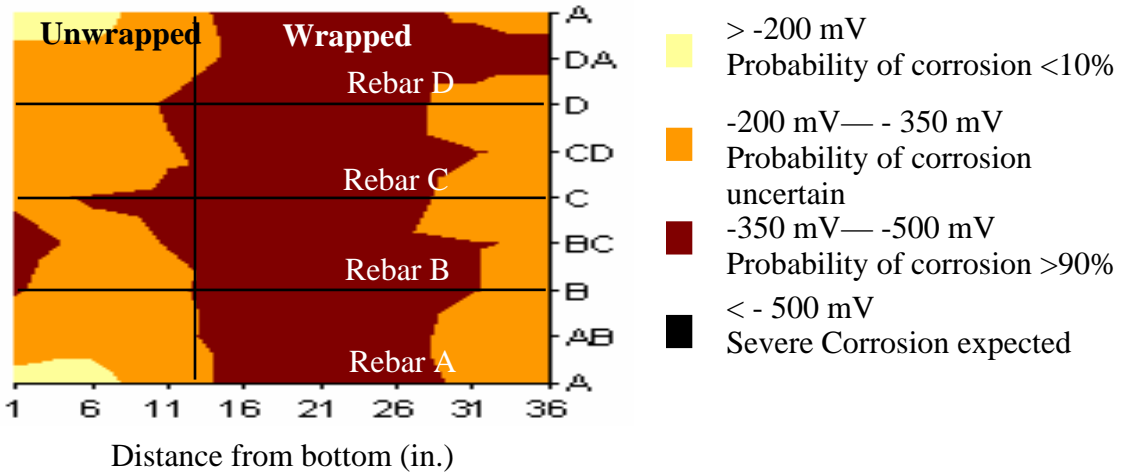
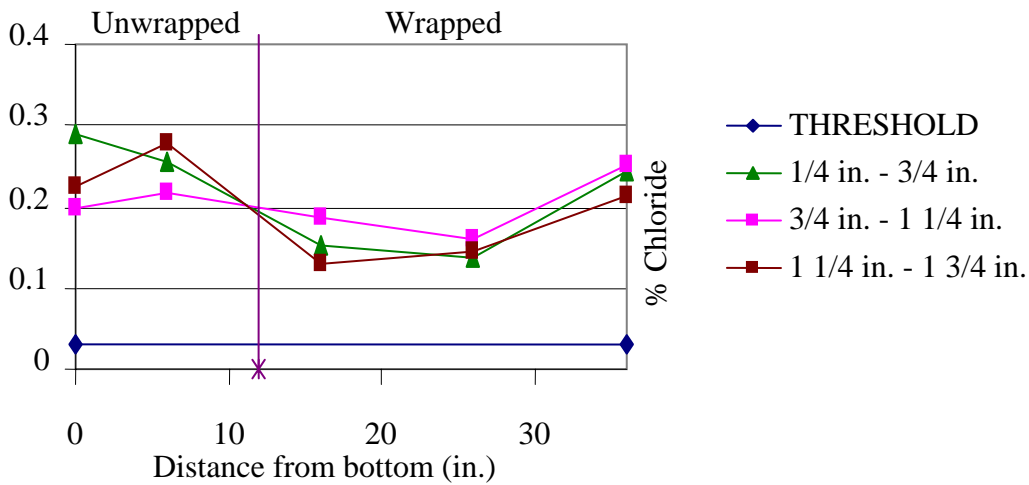
2) In rebar A, the unwrapped area (0 in. to 12 in.) was heavily corroded while the wrapped area (12 in. to 36 in.) was not corroded at all.

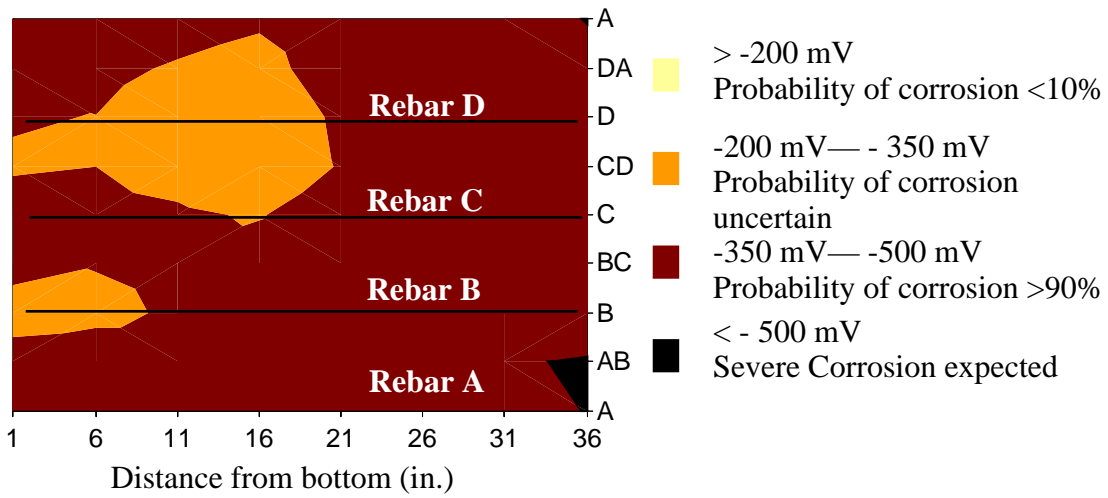
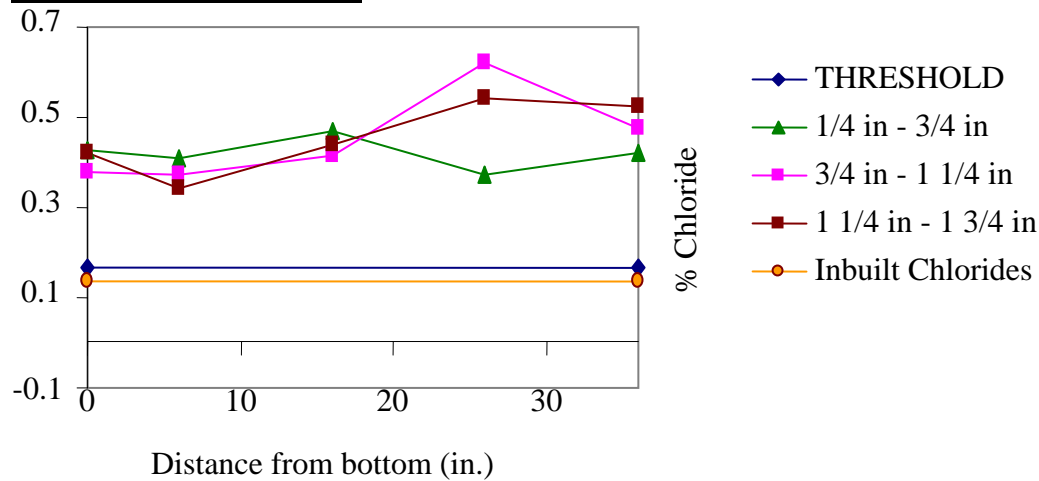
- 1) Though it was not wrapped, corrosion was not as extensive as other unwrapped specimens (for example, CC16). This could be due to the presence of inhibitor Ferrogard. The inhibitor, though, is not very effective in the “splash zone” i.e. 0 in. – 12 in. from bottom.

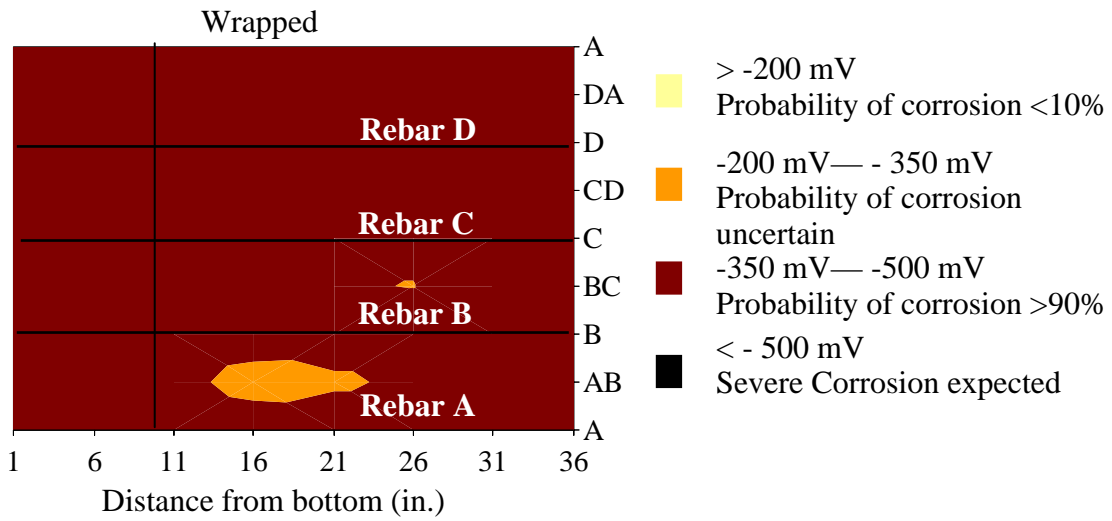
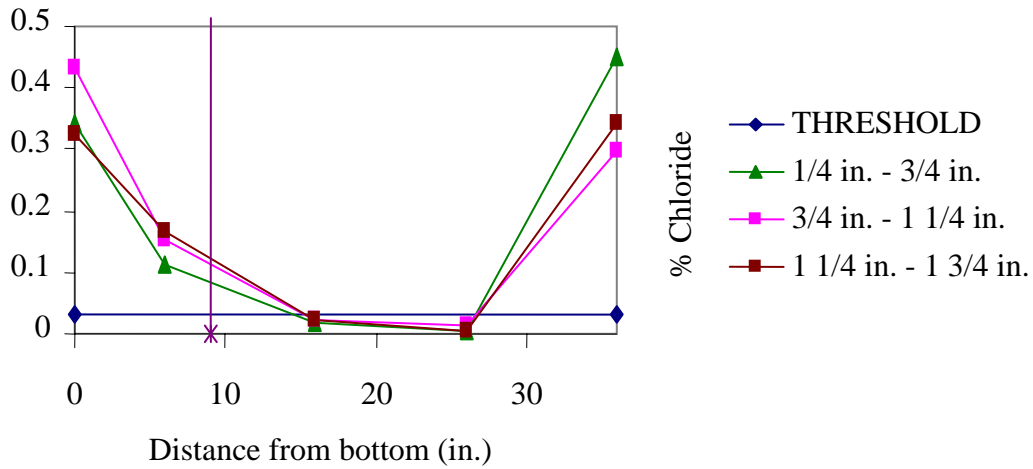
- 1) Though the bottom 9 in. were not wrapped heavy corrosion was not observed on the rebars.
- 2) No corrosion was observed under the wrapped region.
- 3) Heavy corrosion was observed over bottom 8 in. of rebar B

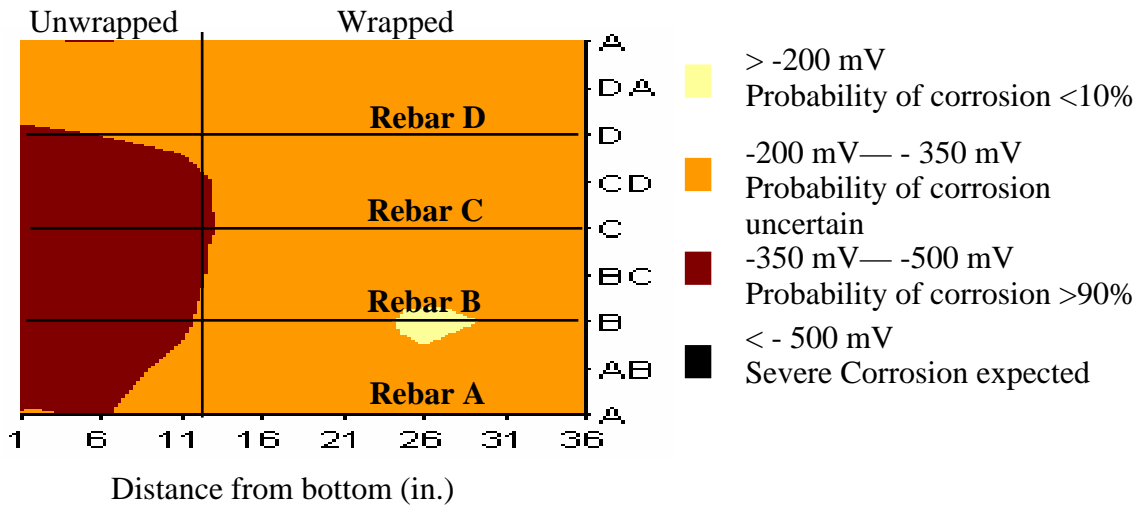
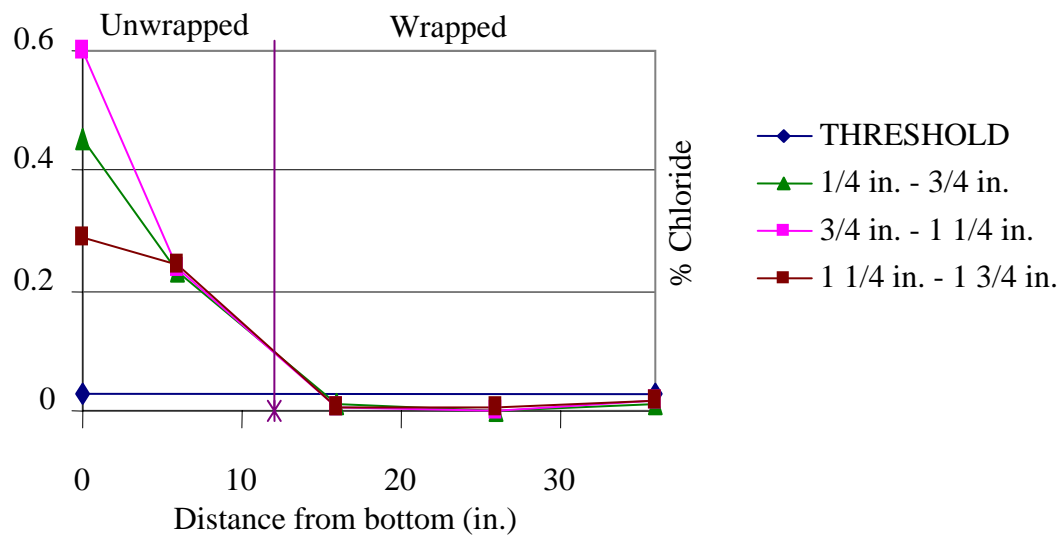
- 1) Bottom 12 in. of rebars A, C and D was heavily corroded while rebar B was not corroded.
- 2) Wrapped areas were not corroded at all.

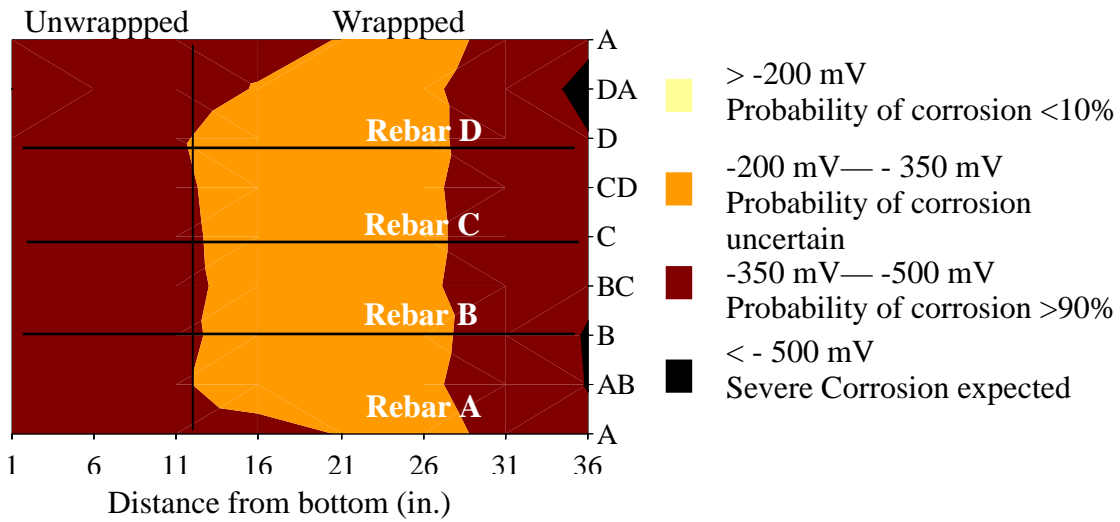
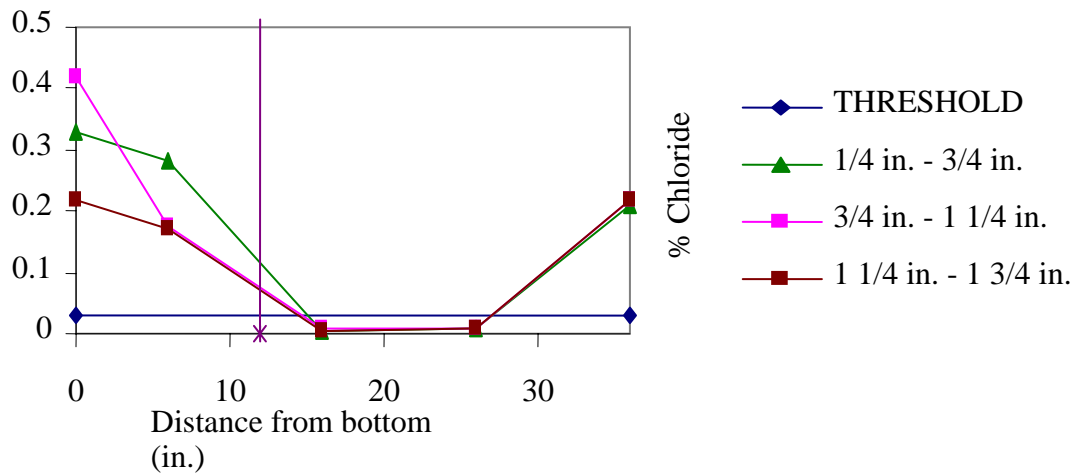
- 1) The cylinder is wrapped over top 24 in.
- 2) The wrap is intact at all places.
- 3) Rust stains were observed over the bottom unwrapped region.
- 4) When the wrap was removed, chunks of concrete came off with it, exposing rust stains lying underneath the surface.

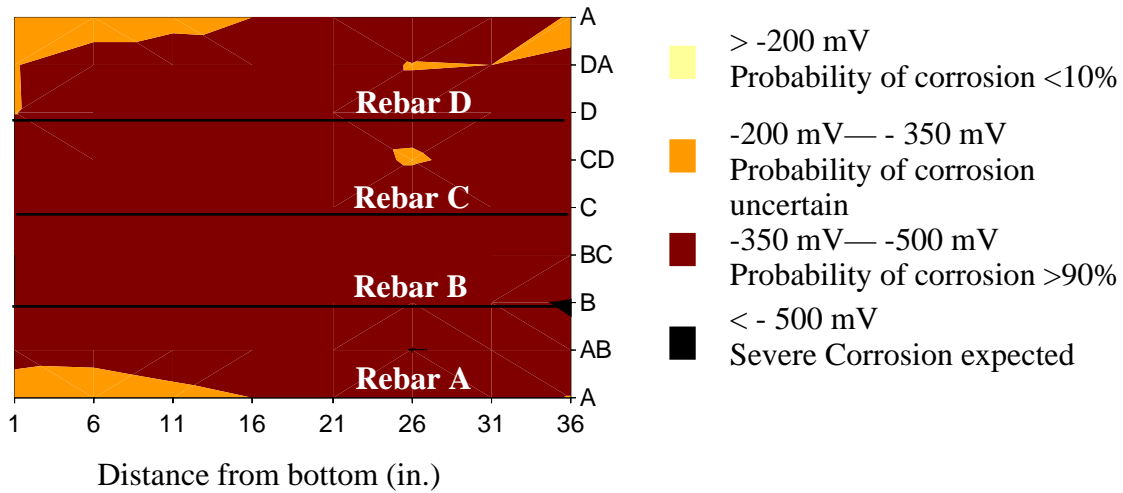
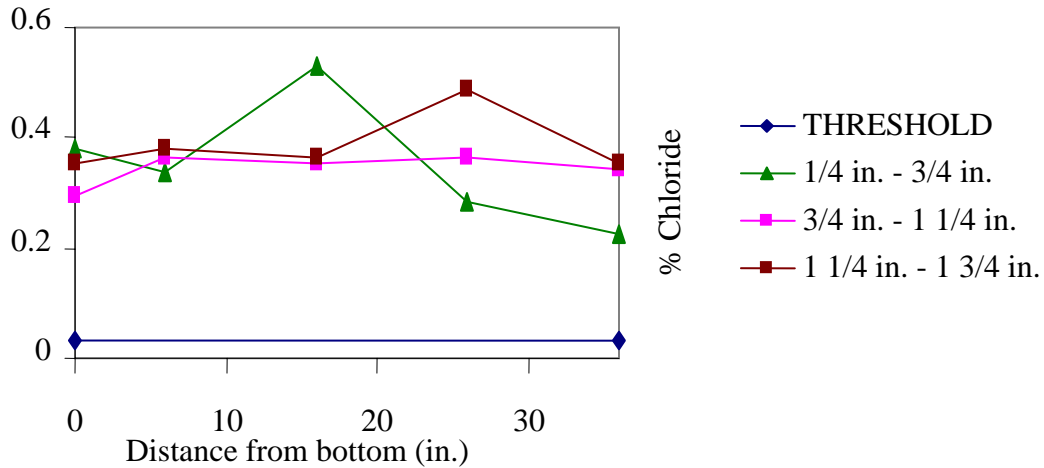
- 1) The specimen was not wrapped.
- 2) A vertical crack of width 0.04 in. was observed over rebar A extending the complete height of the cylinder.
- 3) A vertical crack of width 0.02 in. was observed over rebar B extending the complete height of the cylinder.
- 4) A vertical crack of width 0.03 in. was observed over rebar C extending from 16 in. to 31 in.
- 5) A vertical crack of width 0.016 in. was observed over rebar D extending from 7 in. to 36 in.
- 6) Large rust stains were observed all over the specimen.

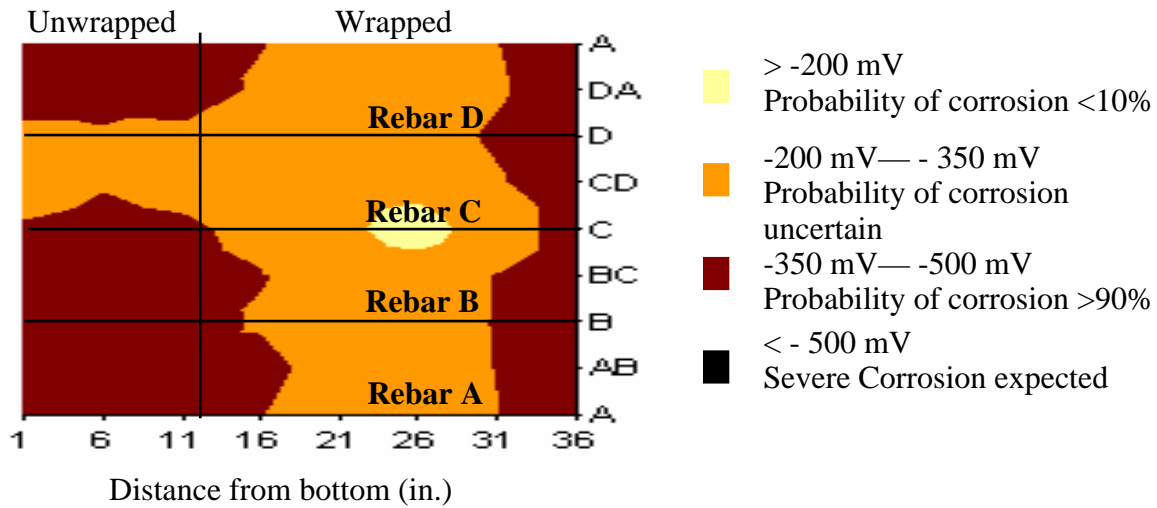
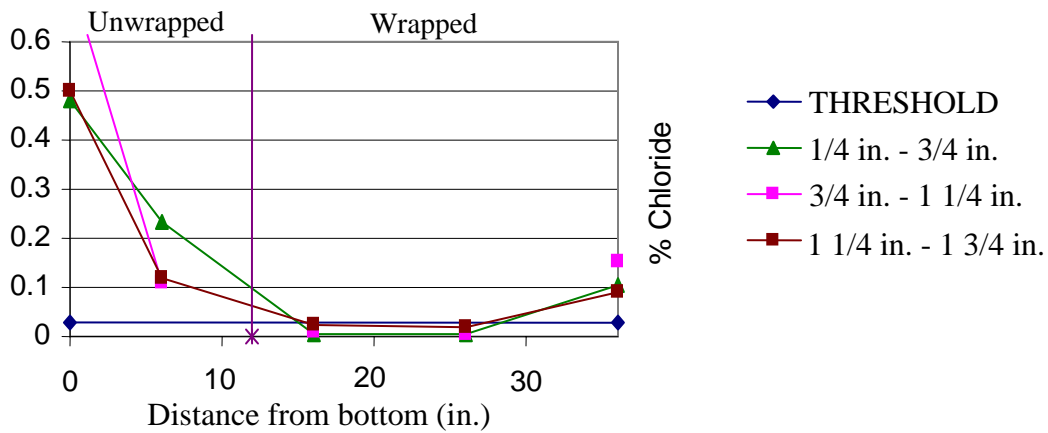
- 1) Unwrapped portions of rebar A and B were corroded while those of rebars C and D were not. This was likely due to the presence of repair material over rebars C and D.
- 2) No corrosion was observed in the wrapped regions.

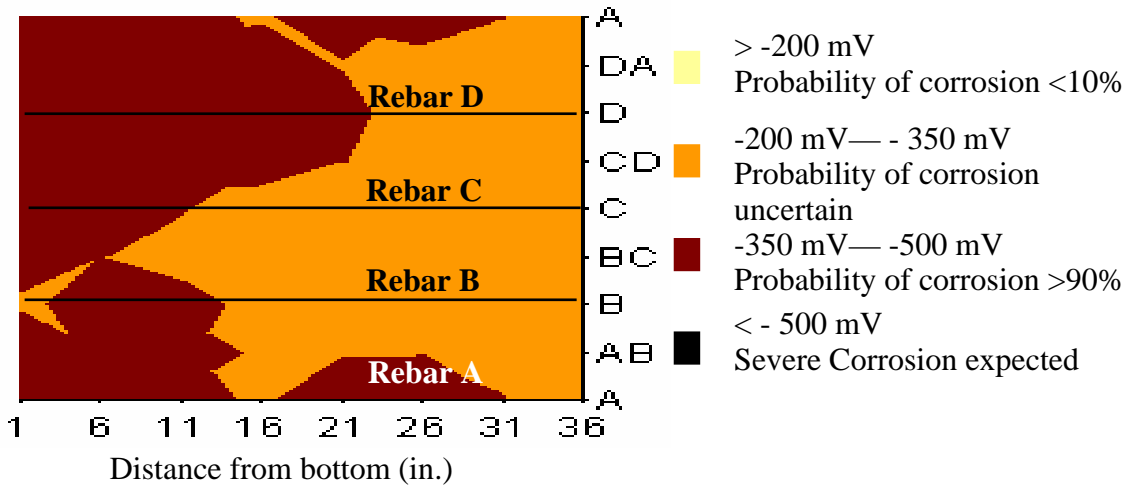
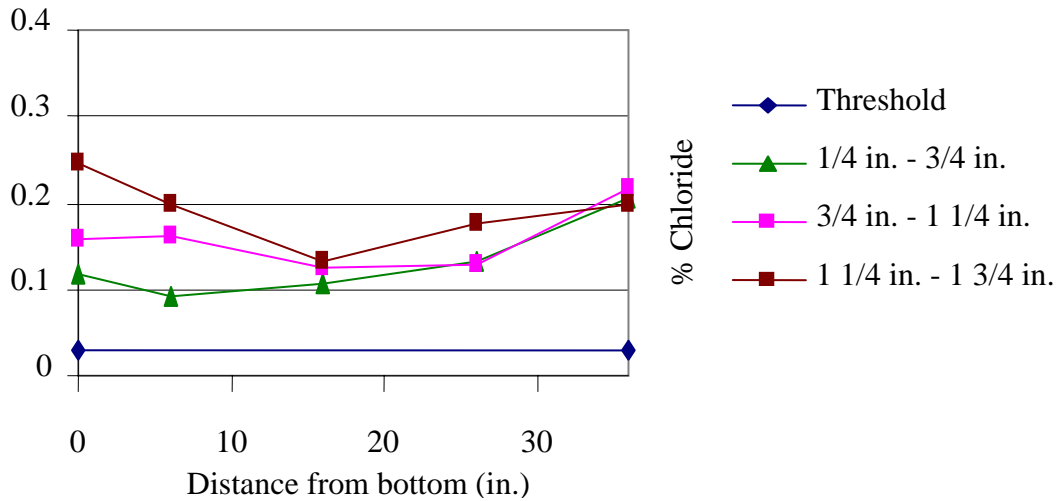
- 1) Though the column was fully wrapped, heavy corrosion was observed in certain areas and light corrosion in some, as marked.
- 2) The inhibitor used, Cortec, does not seem to be beneficial in preventing corrosion.
