1. Report No. FHWA/TX-93+1265-1		2. Government Accession No.		3. Recipient's Catalog No.	
4. Title and Subtitle Studies on Damage and Corrosion Performance of Fabricated Epoxy-coated Reinforcement				5. Report Date January 1993

**STUDIES ON DAMAGE AND CORROSION PERFORMANCE OF  
FABRICATED EPOXY-COATED REINFORCEMENT**

This is the first report on a project to evaluate the structural integrity of epoxy-coated reinforcing bars used in transportation structures in the state of Texas. The report describes an investigation aimed to evaluate some inspection techniques such as holiday detection and to determine damage to epoxy-coated reinforcement during fabrication and concrete vibration. The relative corrosion performance of bent bars damaged to various degrees and subjected to a corrosive environment was also studied. The research was conducted at the Phil M. Ferguson Structural Engineering Laboratory as part of the research program of the Center for Transportation Research at The University of Texas at Austin. The work was sponsored jointly by the Texas Department of Transportation and the Federal Highway Administration.

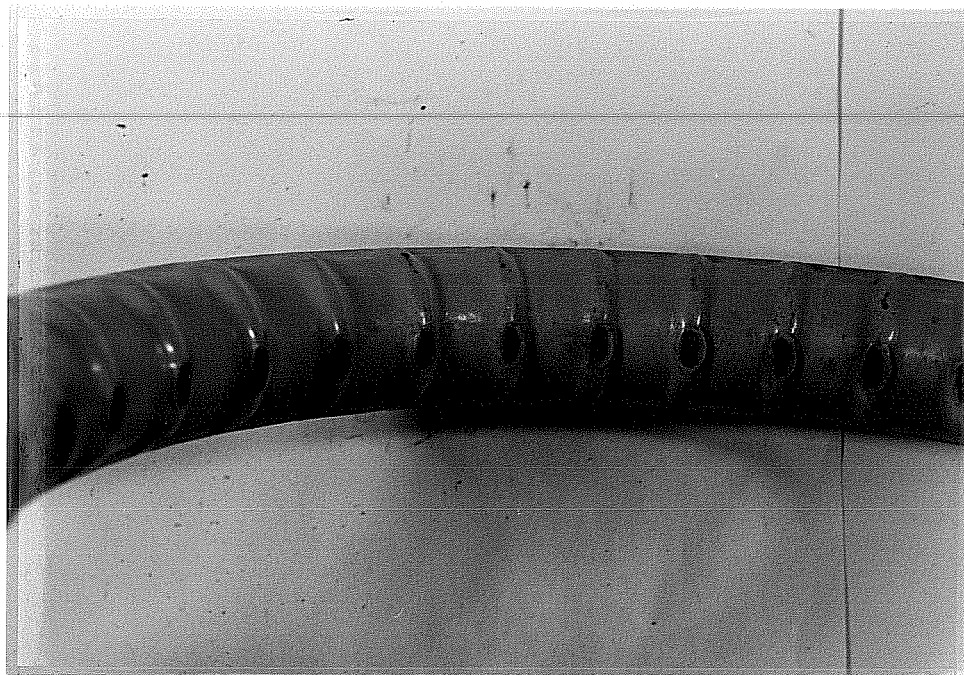
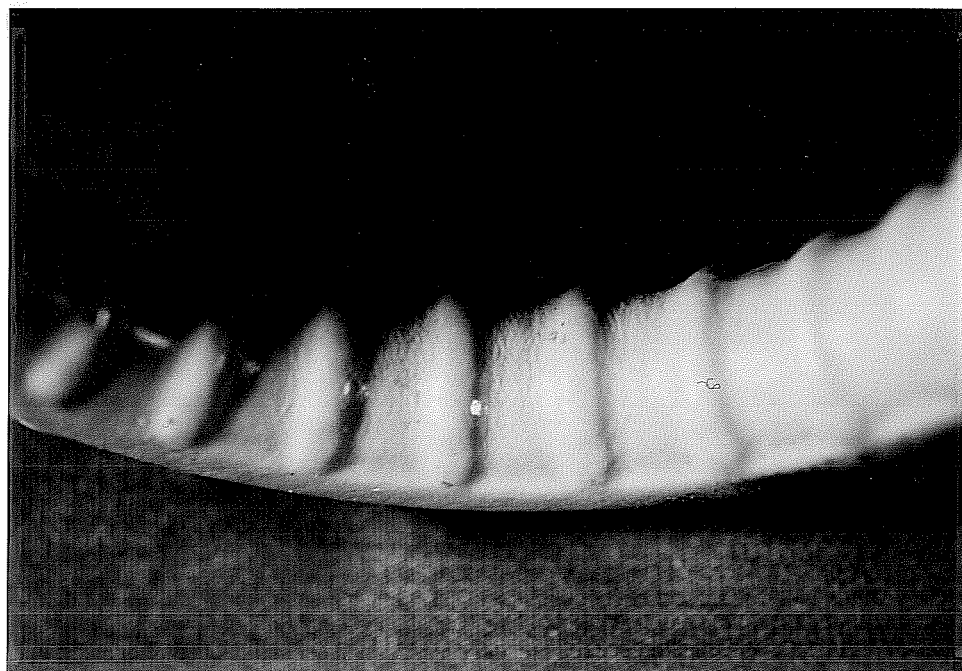
(a) A bar bent at the coating plant

(b) A bar bent in the laboratory

**Figure 3.3 Comparison of damage induced by different bending operations.**

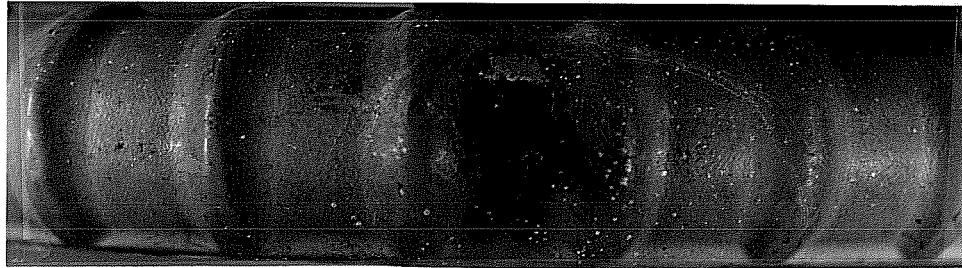
(b) After five months

(c) After eight months

**Figure 3.6 Progression of corrosion in the patched area of a bar in Group B2**

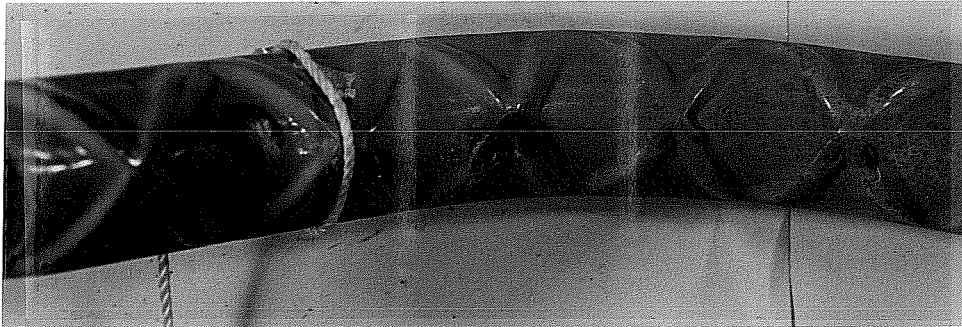
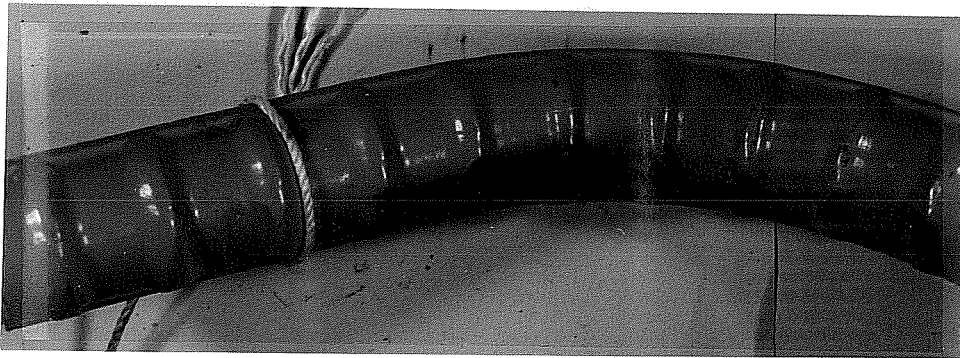
(a) A bar with cross deformations

(b) A bar with parallel deformations

**Figure 3.8 Corrosion in the damaged areas on the inside portions of bends**

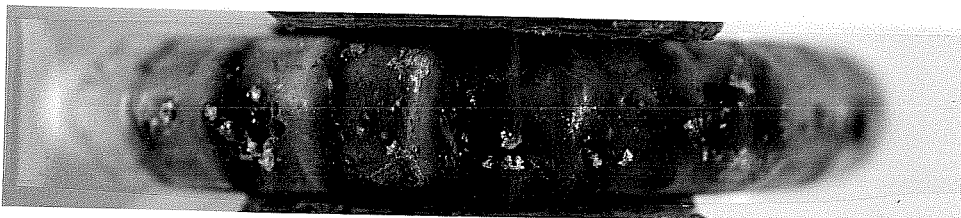
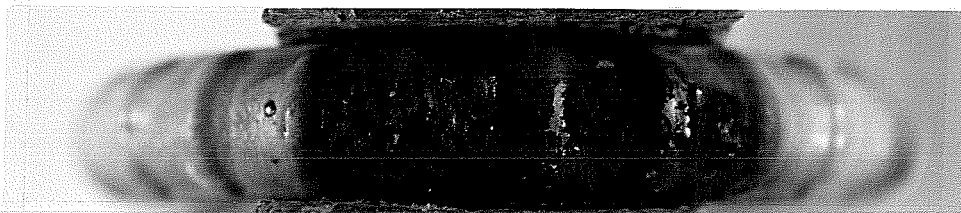
(a) Corrosion in patched areas

(b) Corrosion in exposed areas

**Figure 3.9 Typical corrosion observations of bars in series C and D.**

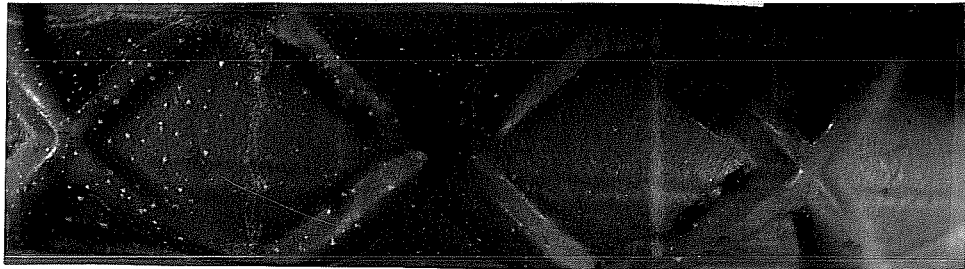
(b) #8 bar (B9 group)

Figure 3.10 Corrosion on holidays (small pinholes)

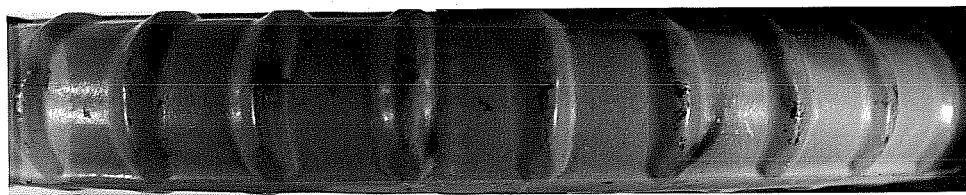
(b) #8 bar (B6 group)

Figure 3.12 Corrosion on hairline cracks on bars with parallel deformations.

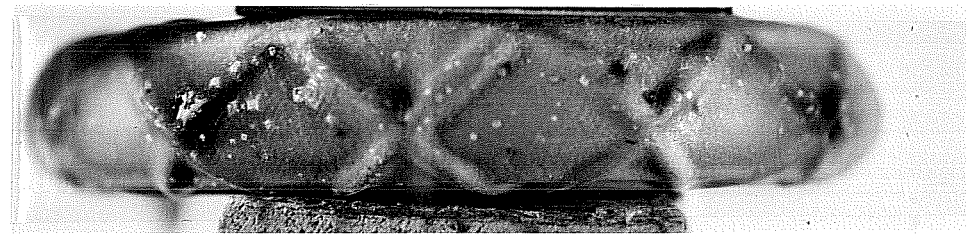
(a) #4 bar with parallel deformations (A3 group)

(b) #4 bar with cross deformations (A11 group)

Figure 3.13 Comparison of corrosion on hairline cracks on bars with different deformations.

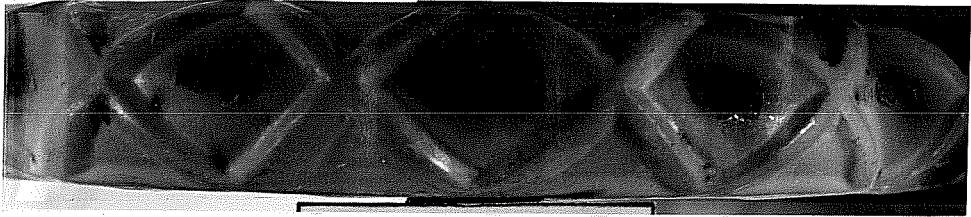
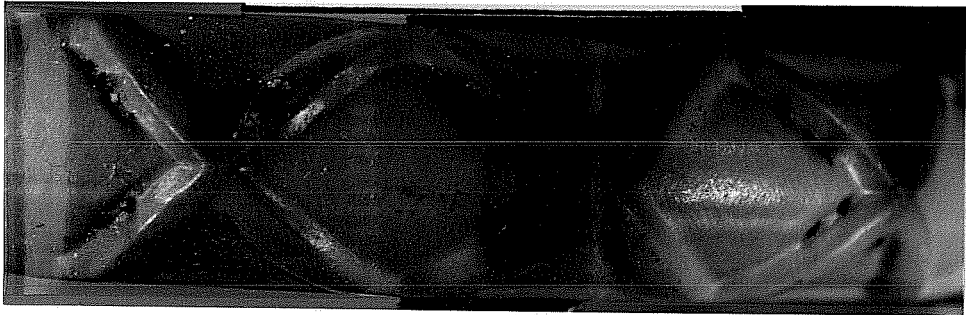
(a) Damage area > 2% (B10 group)

(b) Damage area < 2% (B11 group)

Figure 3.14 Comparison of corrosion on holidays for different damage levels

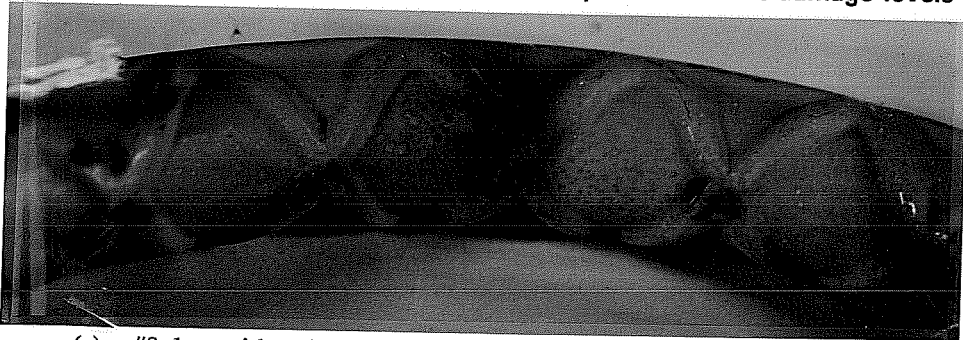
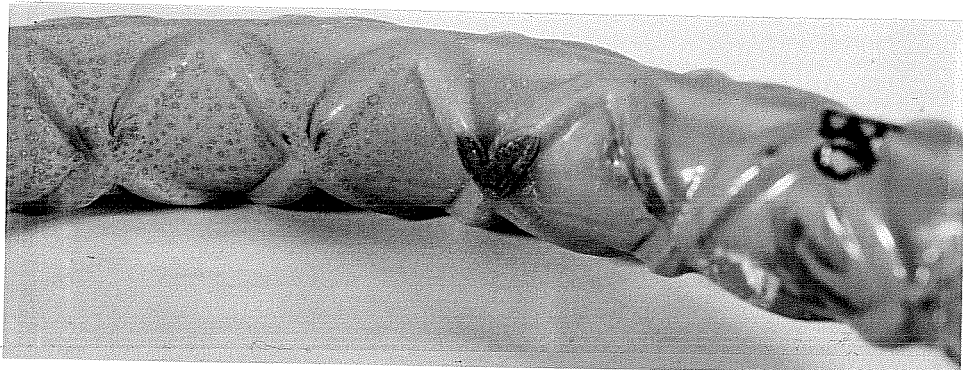
Figure 3.15

(a) #8 bar with a damage spot > 1/4 in. x 1/4 in. which is < 2%

(b) #8 bar with damage area > 2%

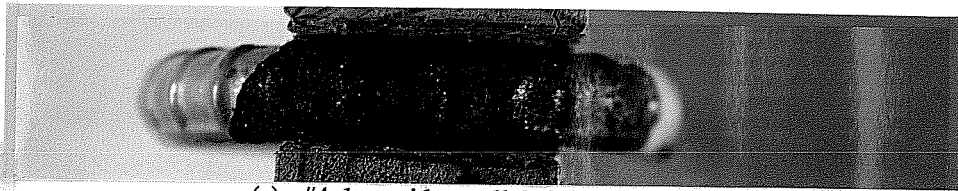
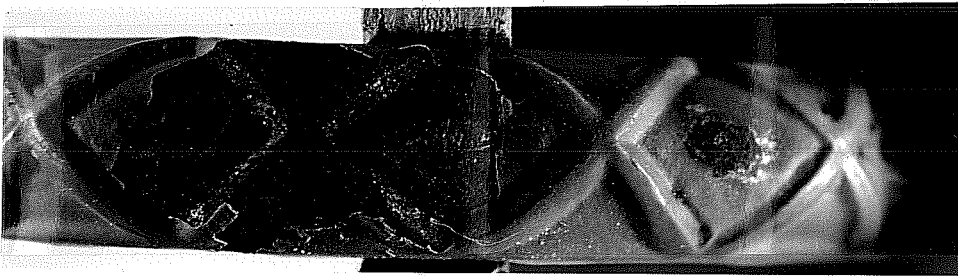
(a) #4 bar with parallel deformations

(c) #8 bar with cross deformations

**Figure 3.16 Corrosion propagation under the coating**

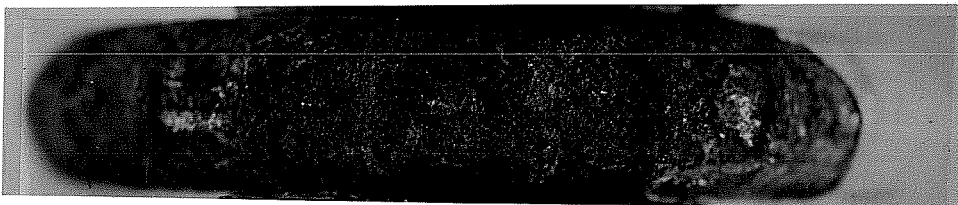
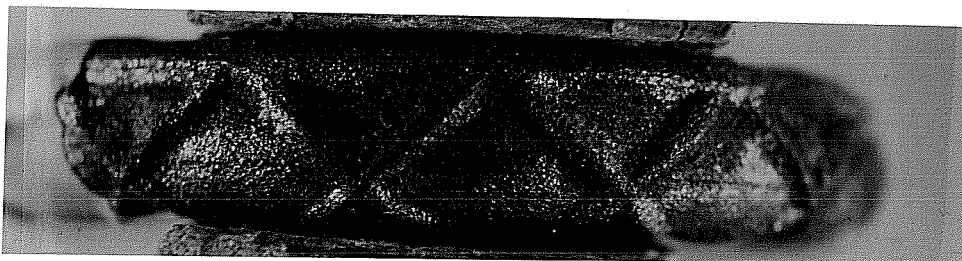
(a) #4 bar with damage area  $> 2\%$  (A7 group)

(b) #4 bar with damage area  $< 2\%$  (A11 group)

**Figure 3.17 Corrosion spots under damaged or disbanded coating.**

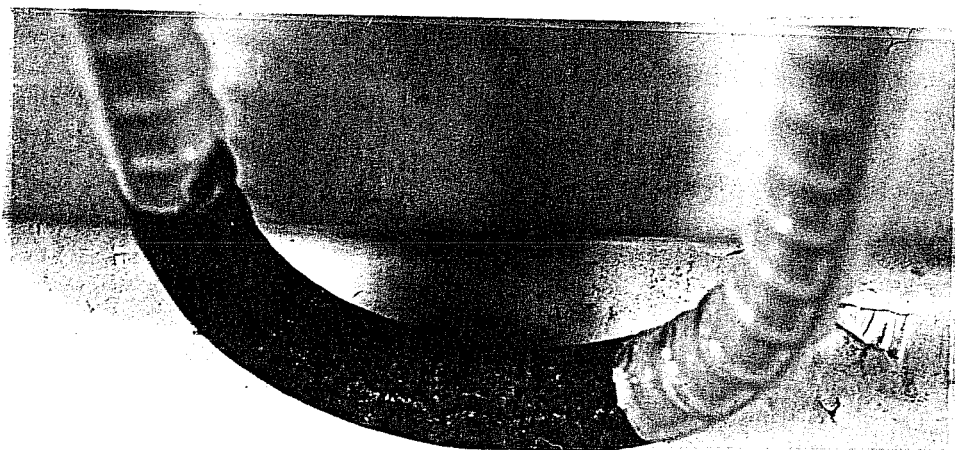
(a) The inside of bend of the bar shown in Figure 3.16(a)

(b) The inside of bend of the bar shown in Figure 3.16(b)

Figure 3.18 Corrosion progression on the inside of bends.

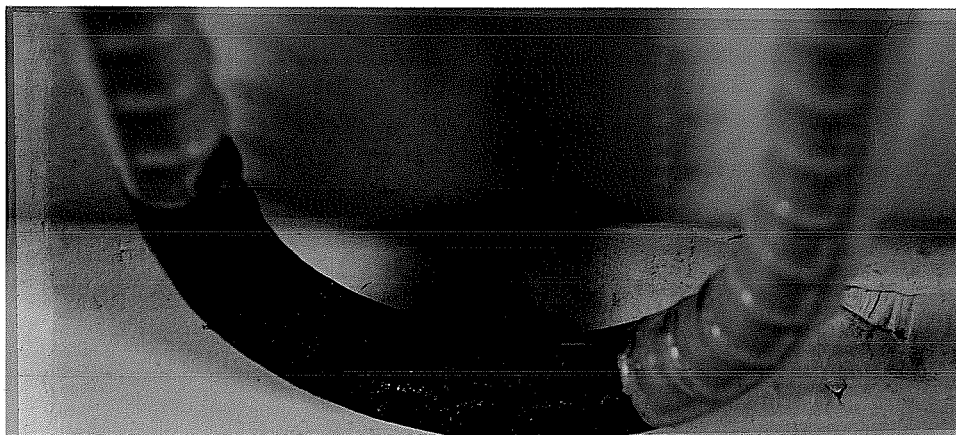
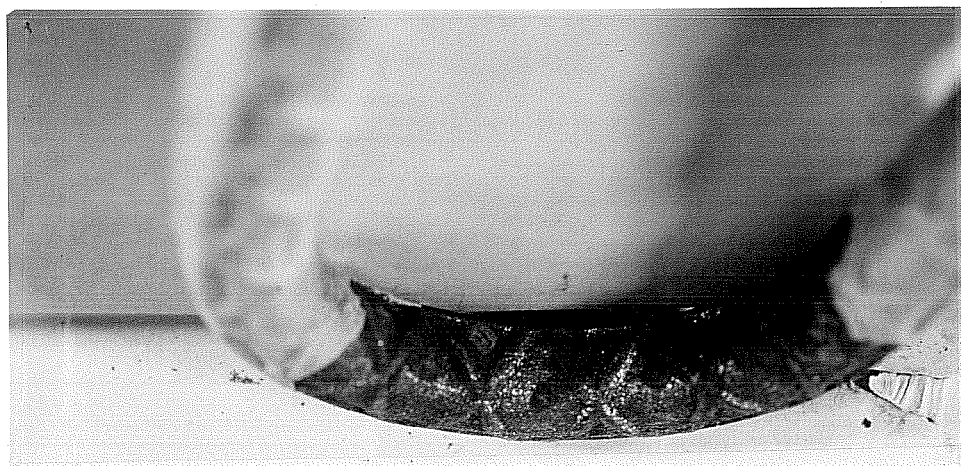
(a) The inside of bend of the bar shown in Figure 3.16(a)

(b) The inside of bend of the bar shown in Figure 3.16(b)

**Figure 3.18** Corrosion progression on the inside of bends.

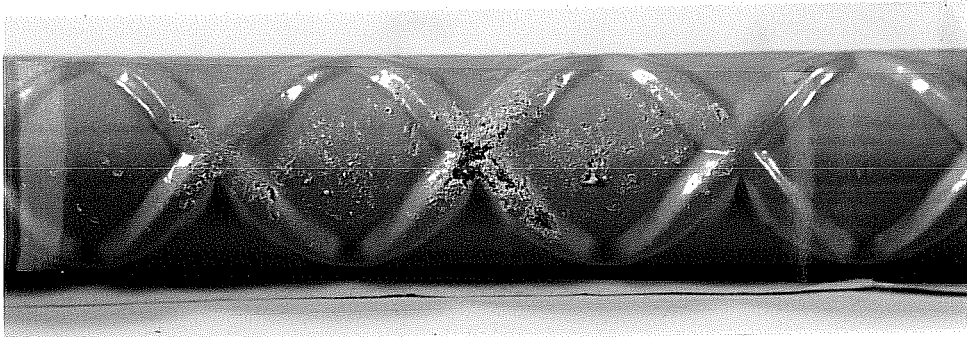
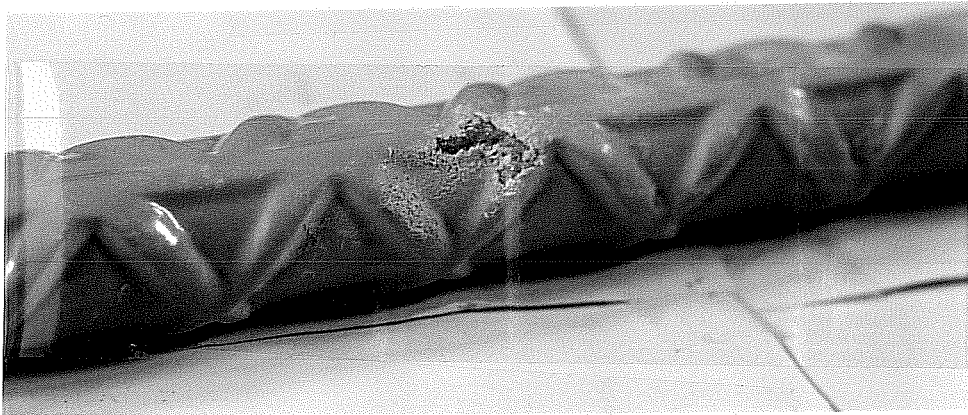
(a) Damage on the lugs

(b) Damage on the side rib

**Figure 4.11** Damage due to vibration on the top side bars in the column specimen.

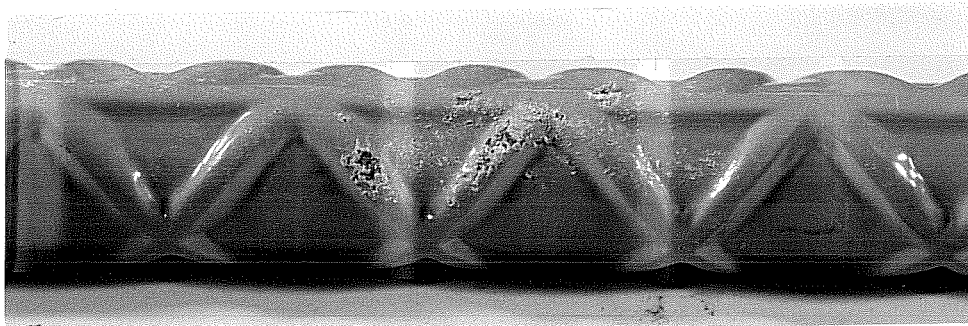
**Figure 4.12** Damage due to vibration on the bottom side bars in the column specimen.

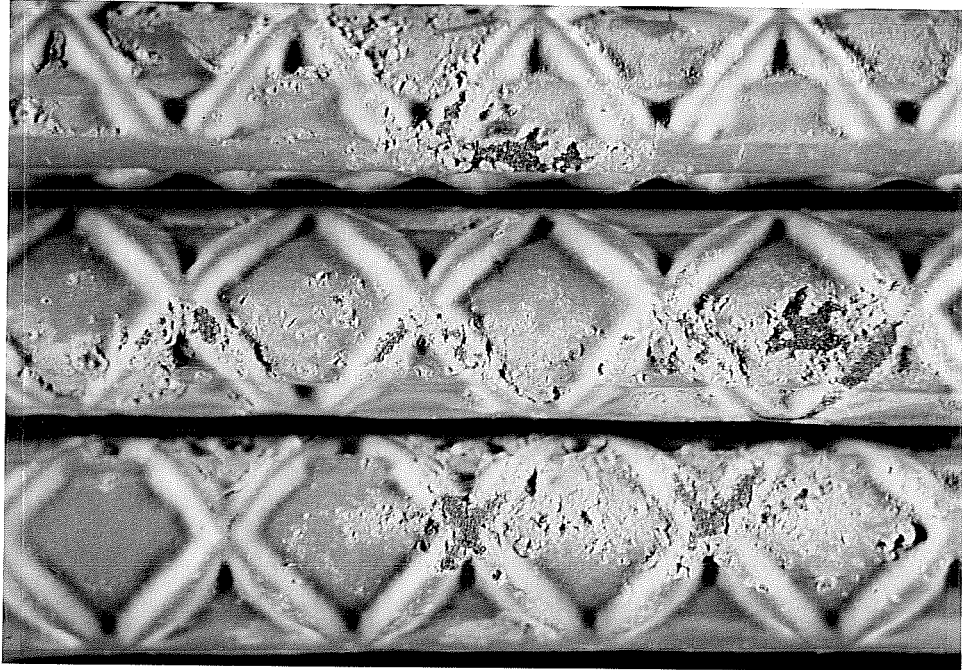
The upper bars in the mat were, generally, more damaged than the lower bars. Damage on the bars with either type of deformation (the parallel or cross deformations) was not significantly different. In any case, the pattern of damage or roughening of coating surface was typical of that observed in the other two specimens.

Figure 4.13 Damage due to vibration on #4 bars – slab specimen.

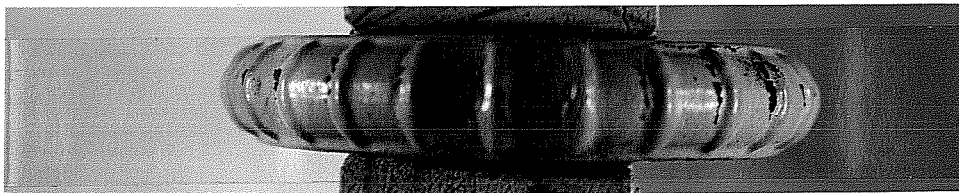
Figure 5.2 Deterioration of exposed areas on #4 bar with parallel deformations.

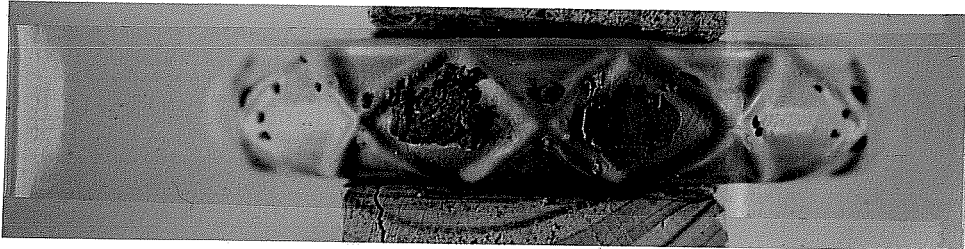
**Figure 5.3 Deterioration of exposed areas and holidays on #4 bar with cross deformations.**

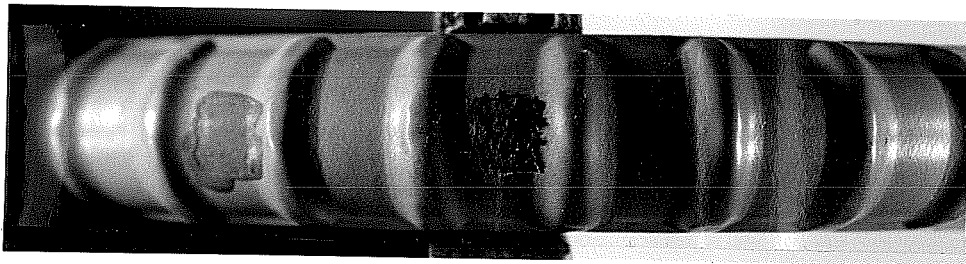
**Figure 5.4 Deterioration of exposed areas on #8 bar with parallel deformations.**

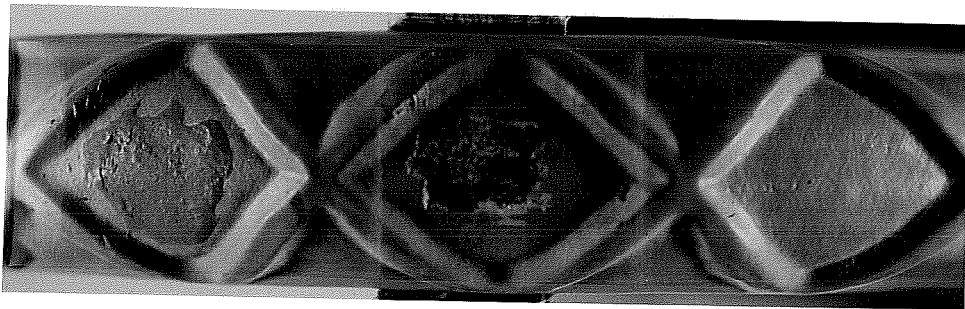
**5.3.2 #8 Bars.** No visible signs of deterioration were observed on any #8 bar where the damaged area was patched. However, damage on a few holidays was evident especially on bars with cross deformations. In addition, a considerable amount of rust was seen on the exposed steel areas (see Figures 5.4 and 5.5). Minor deterioration occurred on the damaged areas on the inside of bends.

**Figure 5.5 Deterioration of exposed areas on #8 bar with cross deformations.**
