**CORROSION PERFORMANCE OF EPOXY-COATED  
REINFORCEMENT–MACROCELL TESTS**

**Research Report No. 1265-3**

*STRUCTURAL INTEGRITY OF EPOXY-COATED BARS*

**Texas Department of Transportation**

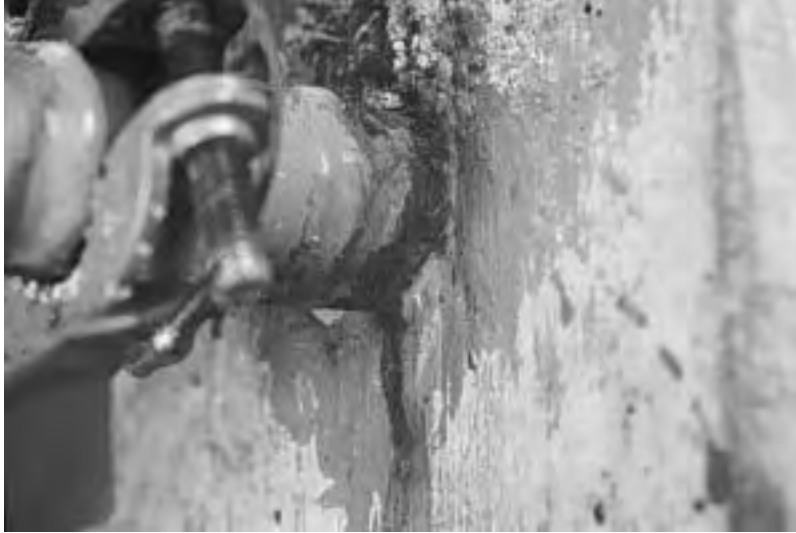
Overall, there was good correlation between crack width and concrete deterioration with measured corrosion currents. Most specimens with 13-mm (#4) coated bars did not develop cracks, maintained excellent surface condition, and exhibited very low corrosion currents. Most specimens with 25-mm coated bars developed fine cracks, experienced exudation of acidic solution with rust on the front face, underwent light to moderate concrete scaling, and had medium corrosion currents. Specimens with uncoated bars experienced extensive concrete scaling and cracking, developed extensive rust staining, and exhibited larger corrosion currents.

*Figure 2.10 Brown solution exuding from protruding bar at front face of specimen.*

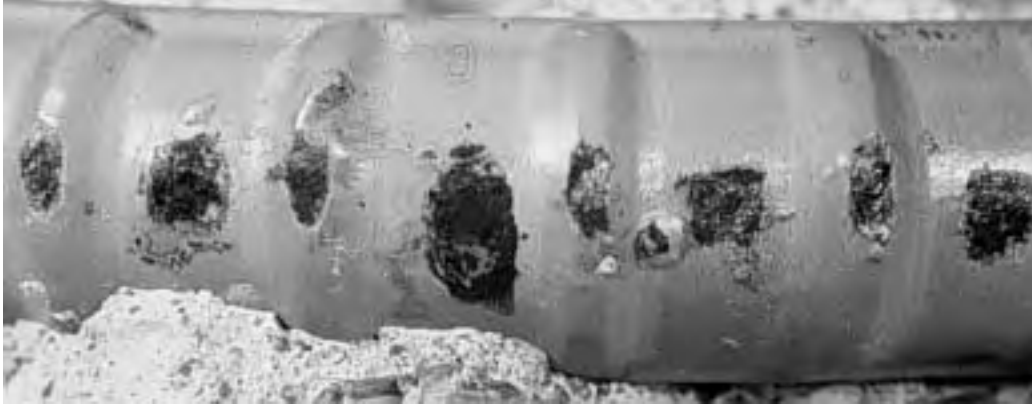
The large bars showed relatively more corrosion activity; however, metal loss was minor as shown in Figure 2.18. Rust spotting at some patched areas was visible. On the majority of the large bars, many variable size blisters distributed on the coated surface were noted. The blisters formed at spots facing air voids in concrete as shown in Figure 2.19. Based on appearance, the worst bars, from both series, were those with exposed damaged areas slightly exceeding 2% of the bar surface area.

*Figure 2.18 Example of 25-mm (#8) coated bar specimens after one year of exposure.*

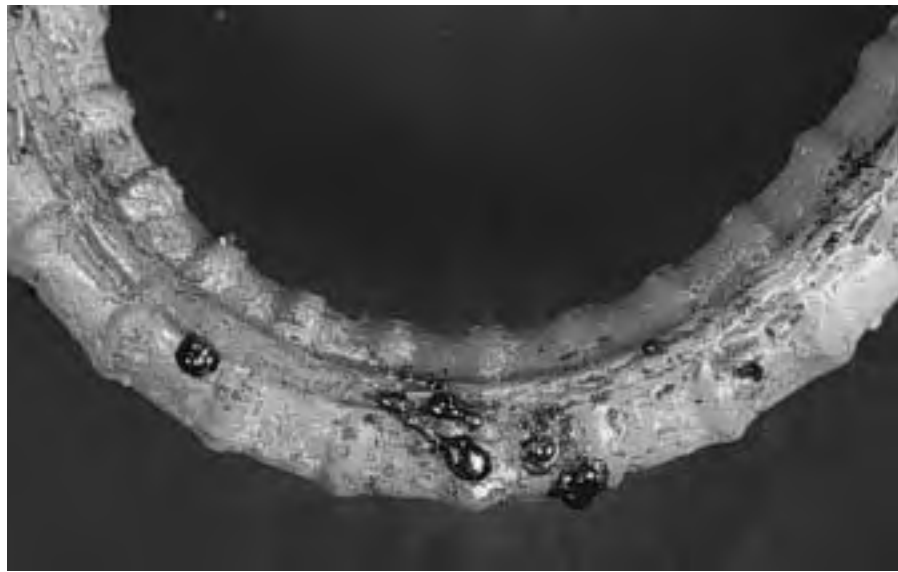
*Figure 2.30 Brownish, liquid solution exuded on surface of epoxy-coated bars.*

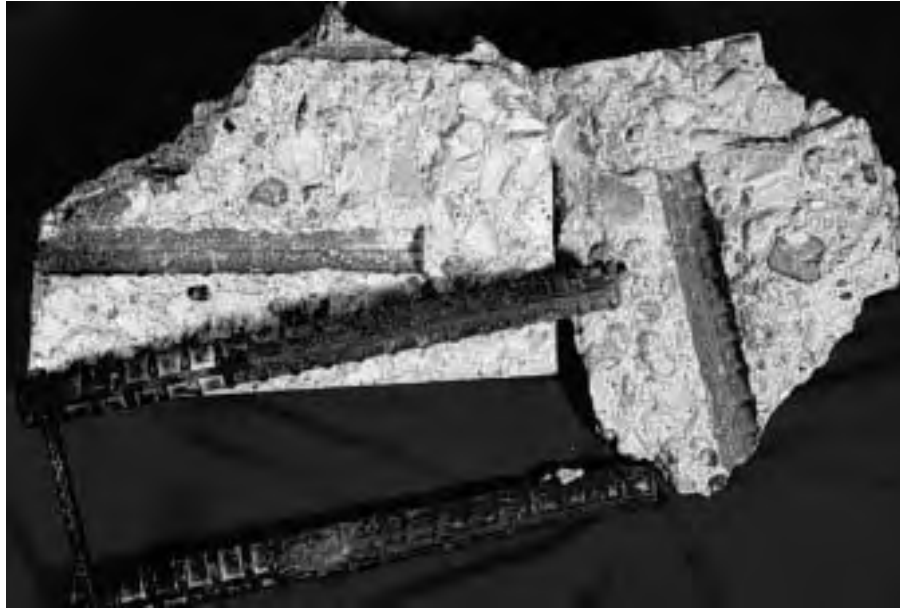
*Figure 2.31 Cathodic uncoated bars at bottom of macrocell specimens.*

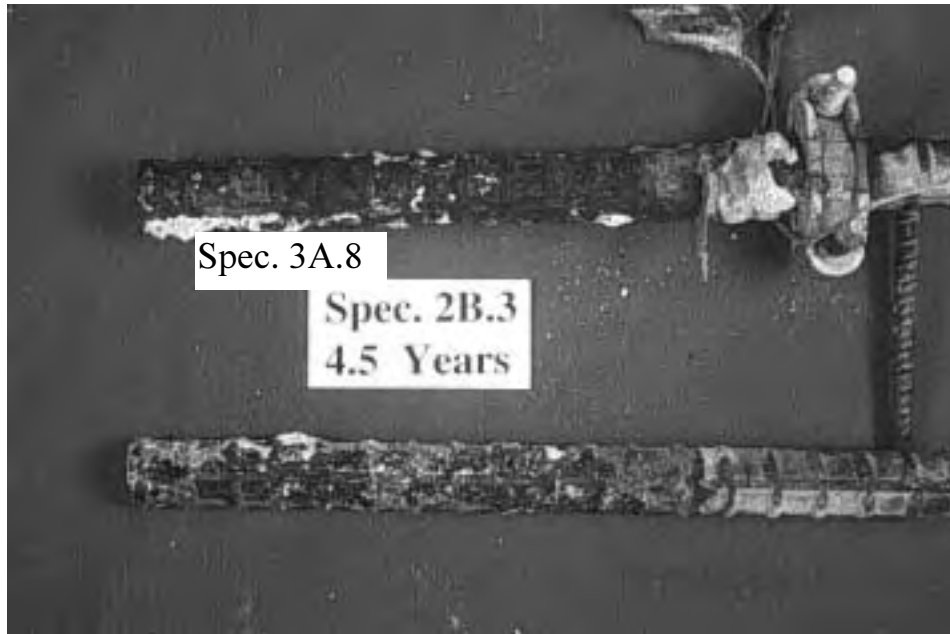
concrete showed extensive dark and reddish-brown rust staining, similar to the corrosion observed on the bars. Sites adjacent to pitted locations in the bars showed accumulation of solid rust products, usually inside concrete voids.

**Figure 2.32 Corrosion at bottom side of cathodic, bottom bars of specimen 3A.8.**

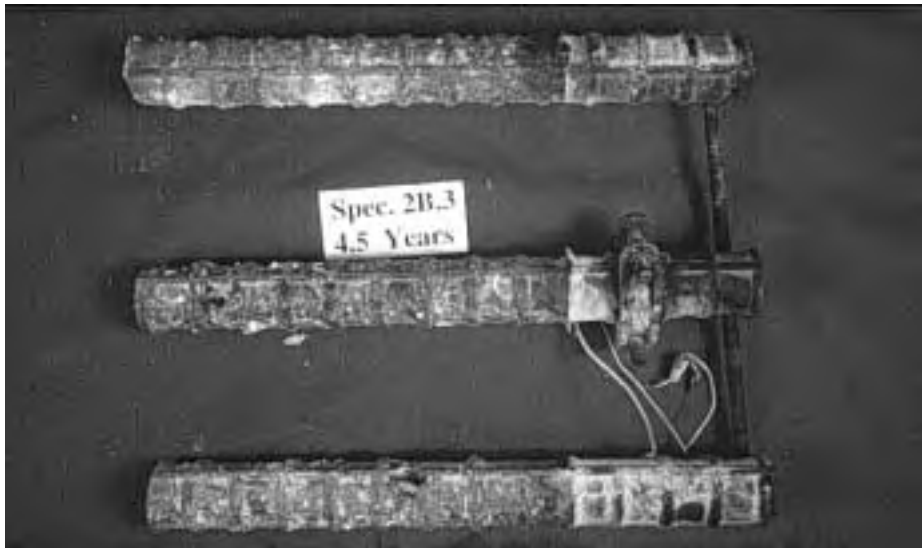
dark stains appeared at the uncorroded portion on the bottom side (a 11.5-cm long zone closer to the front face of the specimen). Laitance was present at the adjacent bar trace in concrete, suggesting that something occurred at the metallic surface (ions that were generated by the cathode may have reacted with concrete). Macrocell currents in specimen 3B.5 experienced incidental large drops between cyclic high and low peaks after 2 years. This suggests that corrosion of the cathodic bar started to affect the currents measured.

*Figure 2.33 Appearance of bottom side of cathodic, bottom bars of specimen 2B.3.*

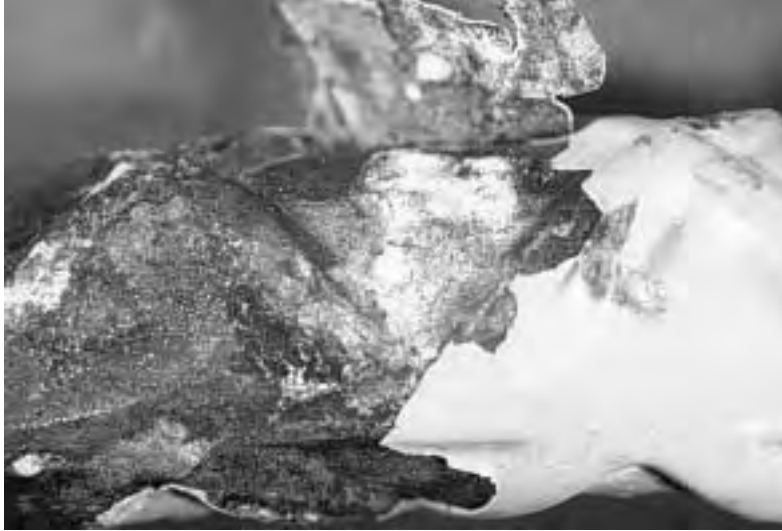
After two years, specimens showed moderate underfilm activity and pitting. There was a clear distinction between the appearance of the top and bottom sides of the bar. The top side was black, and sometimes moist, while the bottom side was dull with sporadic rust spotting as shown in Figure 2.38. Even the patched large bars showed surface darkening with minor metal loss or slight pitting as shown in Figure 2.39. Whitish and orange residue was occasionally observed in some pockets forming alongside the bottom continuous rib as shown in Figure 2.40. The blisters were often full of corrosion products and some had an acidic (pH 2 to 4) trapped solution. Figure 2.41 shows a close up of the solution detected underneath the coating.

*Figure 2.37 Underfilm corrosion (undercutting).*

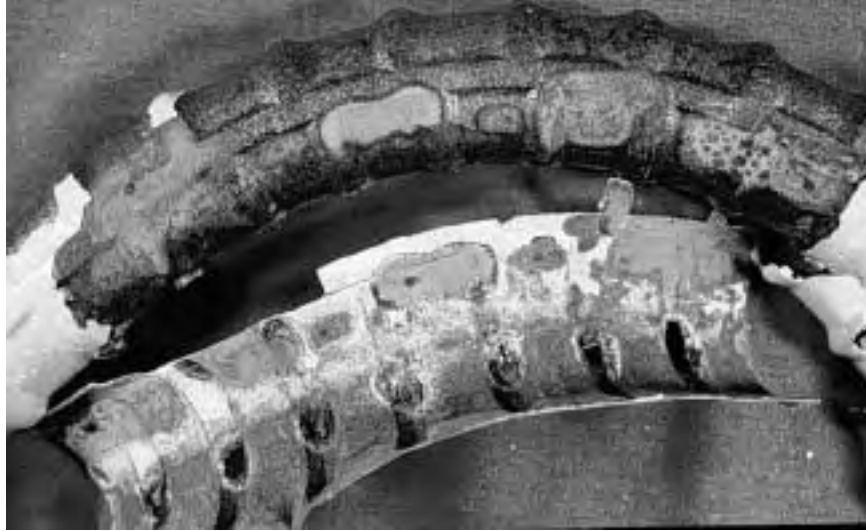
*Figure 2.40 Corrosion deposits on bottom side of steel surface.*

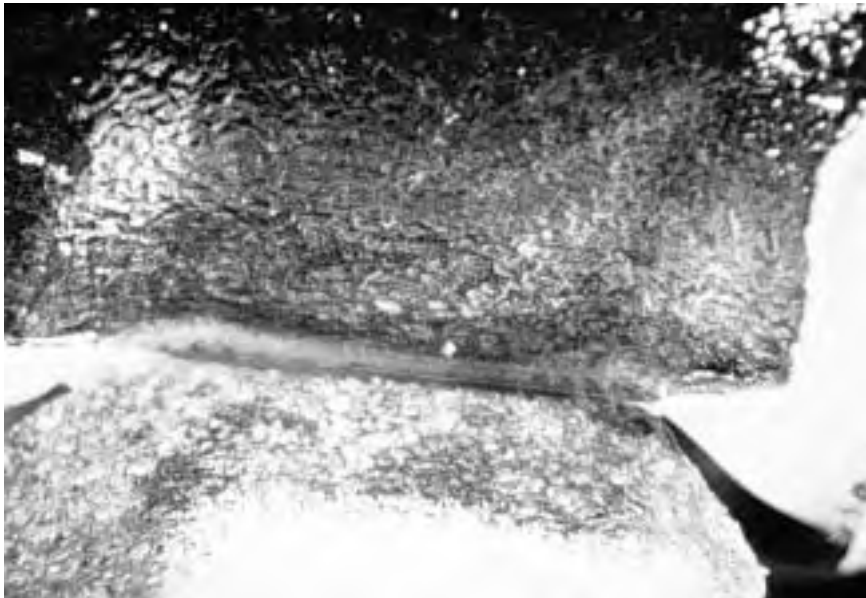
*Figure 2.41 Trapped solution beneath epoxy coating.*

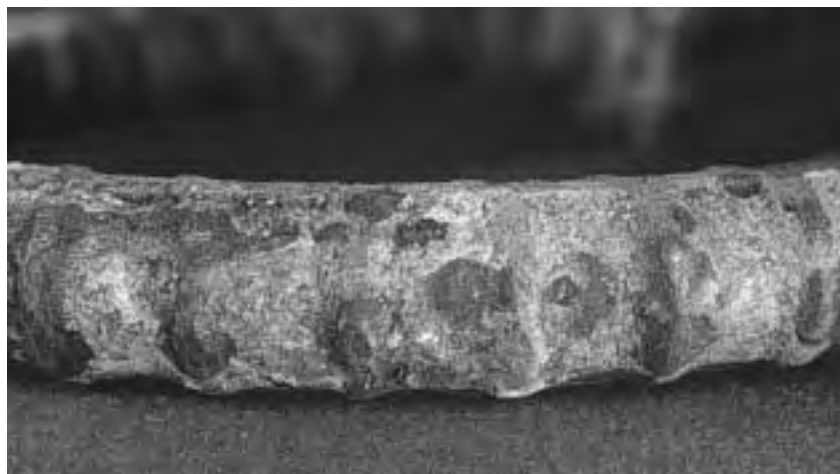
Areas with rust deposits or pockets of varying size, shape, appearance, color, and amount were usually present along the bar surface above the uniform black rusted surface (Figures 2.42 and 2.43). The size of such rust spots ranged from very large, occupying large areas of the bar surface, to small flecks. Appearance of rust spots was dependent on rust concentration, varying from a light film of rust, similar to a stain, to thicker layers of rust deposits. Rust layers at some spots were bulky enough to cause a bulge in the coating, but in most instances, rust amounts in such areas were light. At the time of autopsy, whitish products were the most prevalent. After a few days of being exposed to air, more commonly found colors were light-brown, reddish-brown, orange-brown, and yellowish-brown. Many of the larger and medium-sized rust stains often had shapes with clearly delineated boundaries, giving the appearance of traces or remains of a solution (Figure 2.43). Several rust spots or stains appeared to be wet. In one case (bar 3B.5), a silver-colored stain was detected (top side of bar between bent zone and right straight leg) immediately after removing the coating. One hour later its color changed to whitish, and 2 days later changed to dull-brown and orange-brown. At the bottom side of bar 1A.5, a whitish substance found alongside a longitudinal lug (bent zone and straight right leg) turned yellowish-brown a few hours after coating removal. Such matter was deposited along a strip, giving the appearance of a solution trace (Figure 2.44).

*Figure 2.42 Various rust products above uniformly black corroded surface under the coating.*

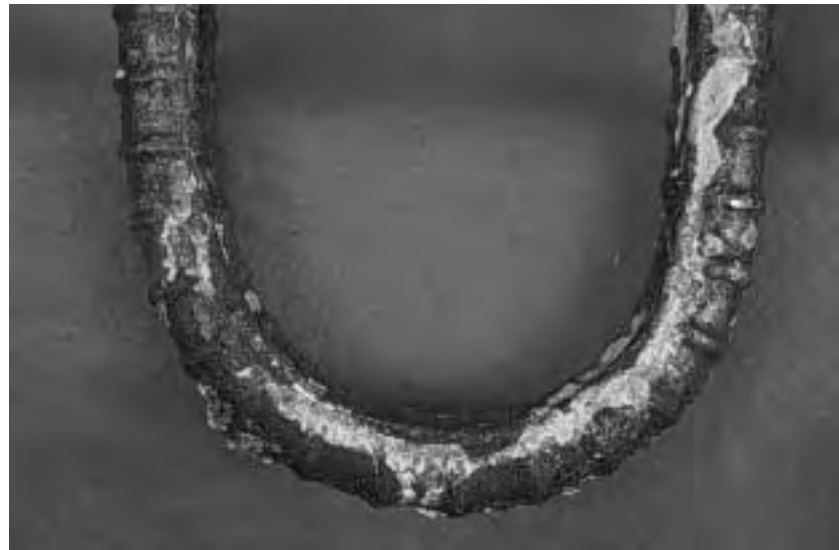
*Figure 2.44 Whitish products alongside longitudinal lug at bottom side of bar 1A.5.*

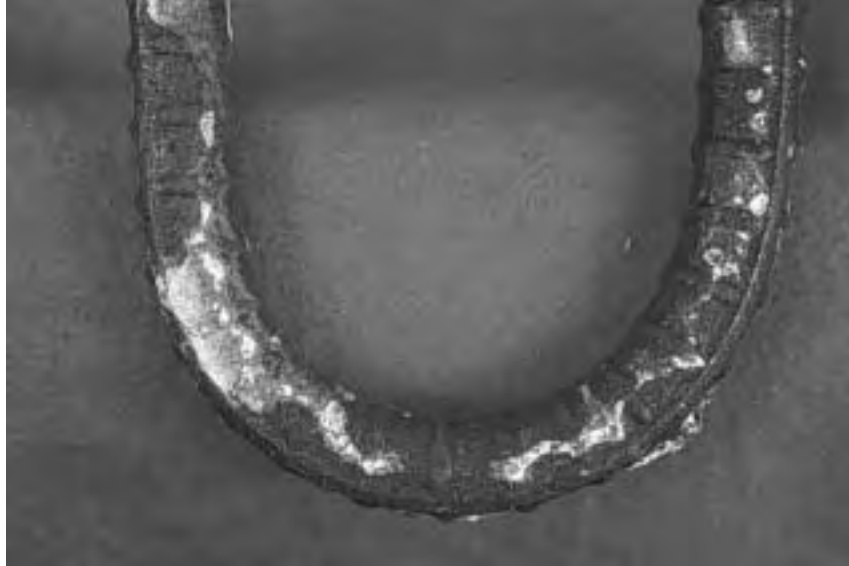
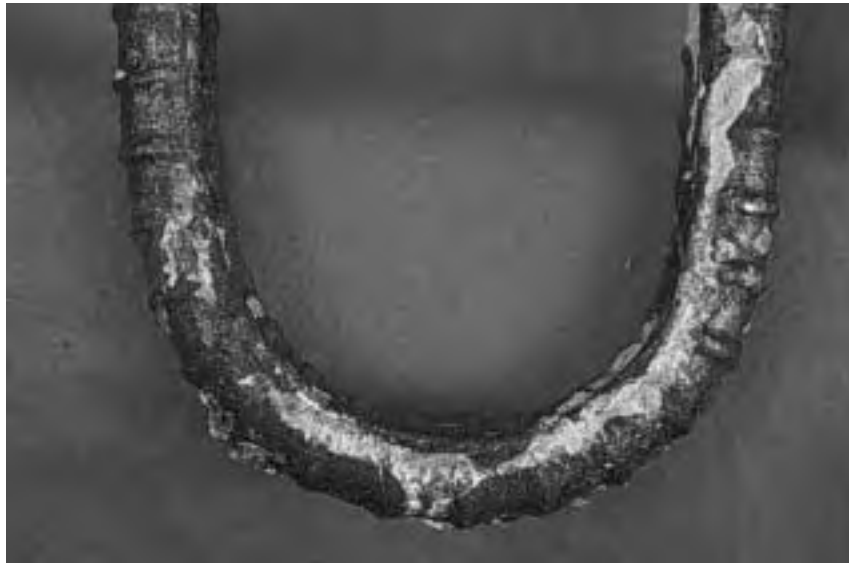
Among smaller bars, specimen 1A.5 (damage > 2%) suffered the worst corrosion (Figure 2.45), followed by bars 2A.6 (cracks with damage < 1%) and 1A.10 (damage > 6x6 mm). The bar with best condition was, amazingly, 3A.3 (damage > 6x6 mm) (Figure 2.46), followed by bar 3A.7 (damage < 2%). Among larger bars, specimen 3B.5 (damage > 2%) suffered the worst corrosion (Figure 2.47), followed closely by bar 3B.4 (damage > 2%, patched). The extent and severity of corrosion was similar for the remaining bars. Interestingly, in bars with damage greater than 6x6 mm, corrosion spread much more on the repaired bar (3B.2) than on the unrepaired bar (2B.3).

*Figure 2.45 Whitish and yellowish-brown corrosion products on bar 1A.5.*

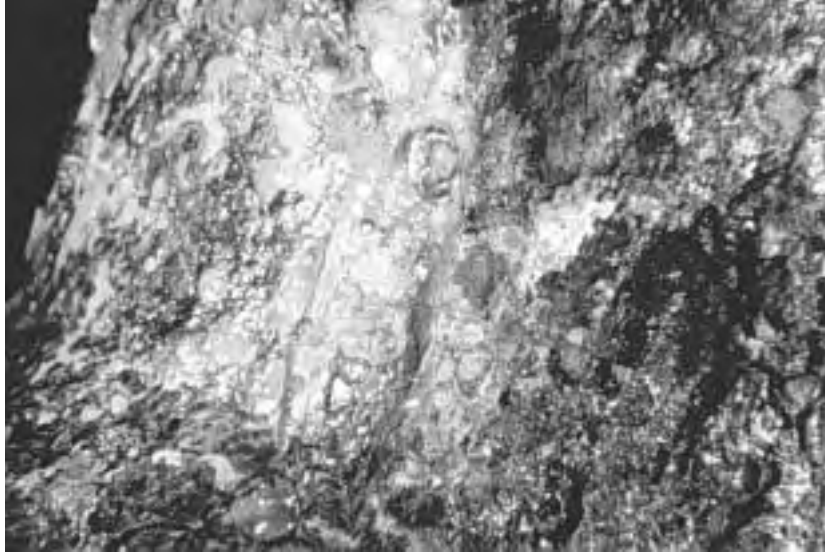
Forensic examination of bar specimens, in general, confirmed the findings of the rate of corrosion analysis. All epoxy-coated bar specimens experienced less steel corrosion than control specimens. Figures 3.16 and 3.17 show close ups of surface corrosion of an uncoated bar and a damaged coated bar specimens, respectively. The figures illustrate severe surface degradation of the uncoated bar relative to superficial corrosion on the exposed steel of the coated bar.

*Figure 3.16 Surface corrosion of uncoated bar after one year of exposure.*

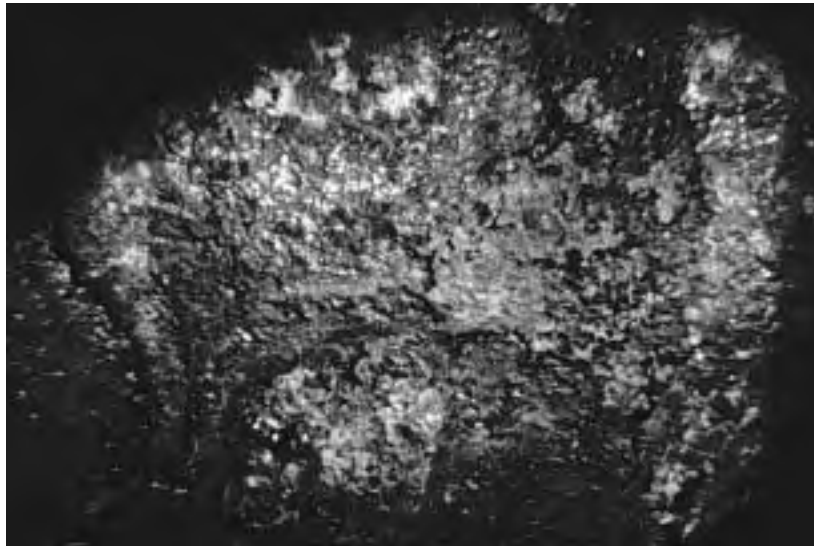
*Figure 3.17 Surface corrosion of coated bar after one year of exposure.*

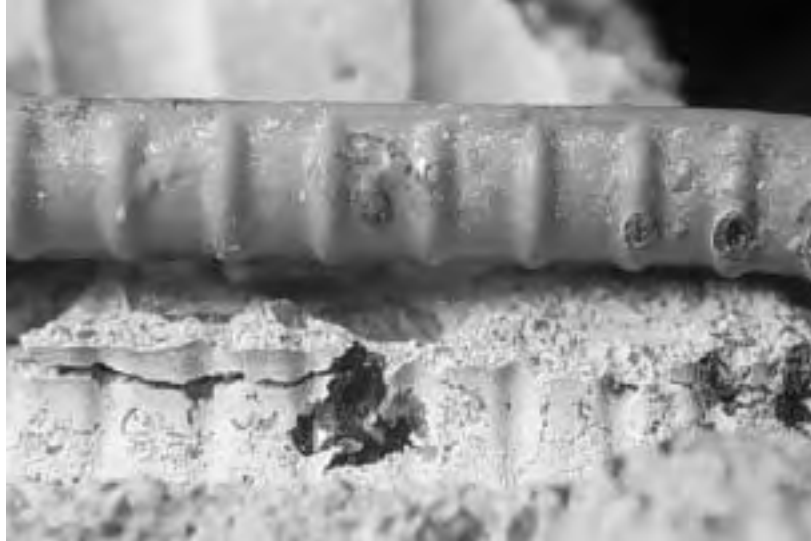
**Figure 3.24** *Blisters always formed adjacent to concrete voids.*

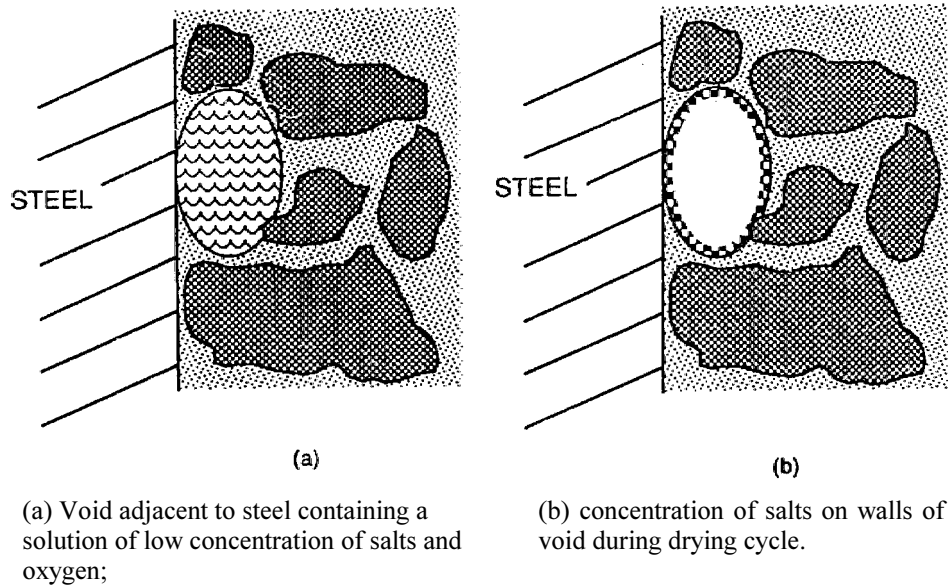
*Figure 3.28 Voids promoting steel corrosion in concrete.*

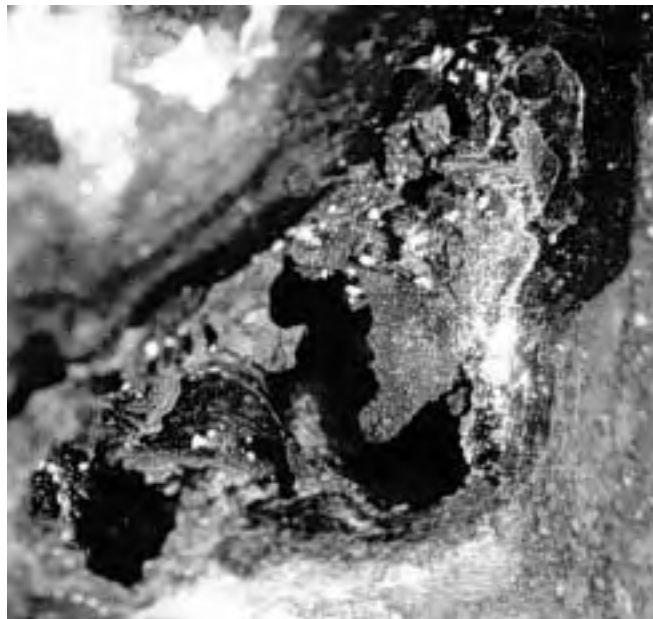
*Figure 3.29 Corrosion products found in voids at coated bar surface.*

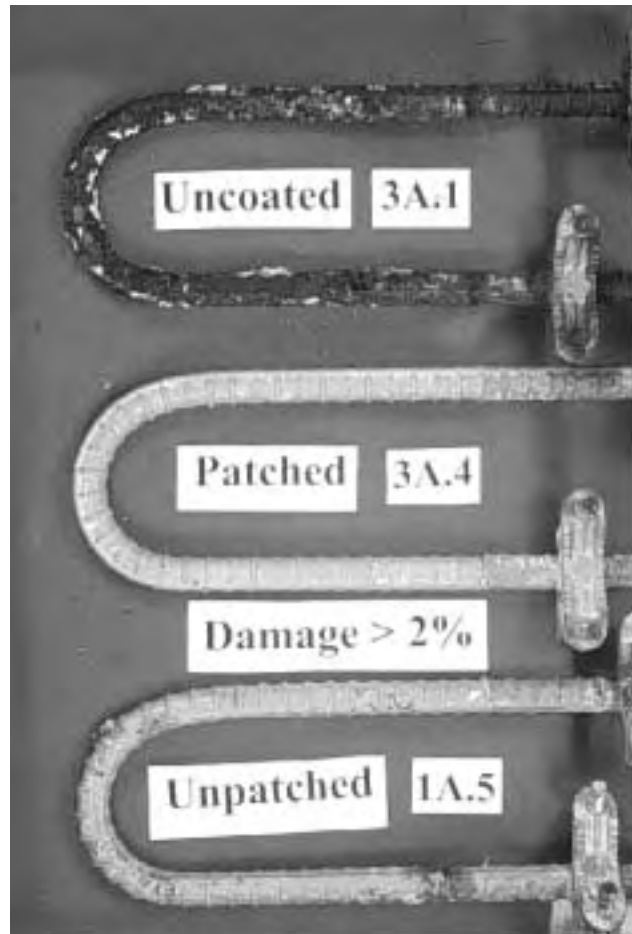
*Figure 3.35 Comparative performance of uncoated and coated bars after 4.5 years of exposure.*

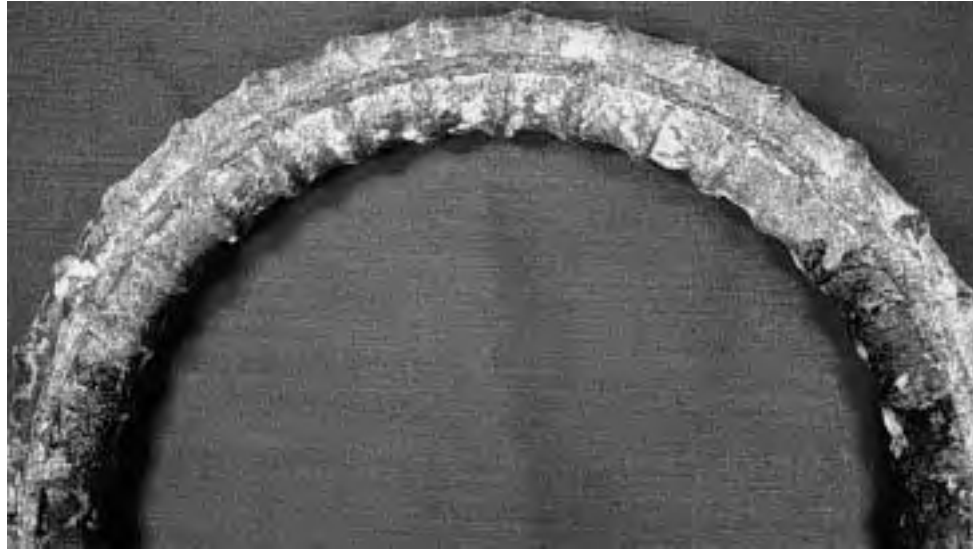
(a) Uncoated bar free of rust at bend

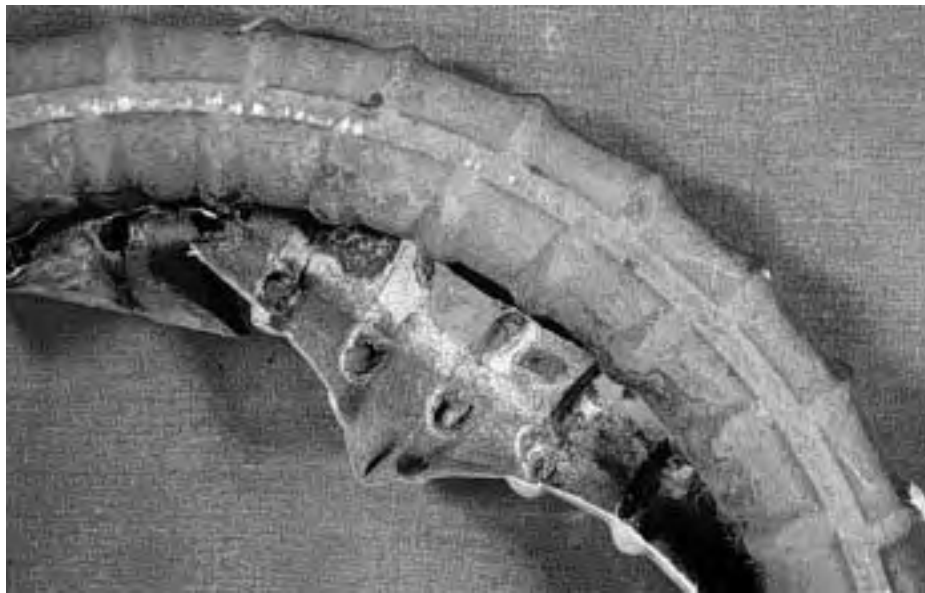
(b) Coated bar with corroded bend

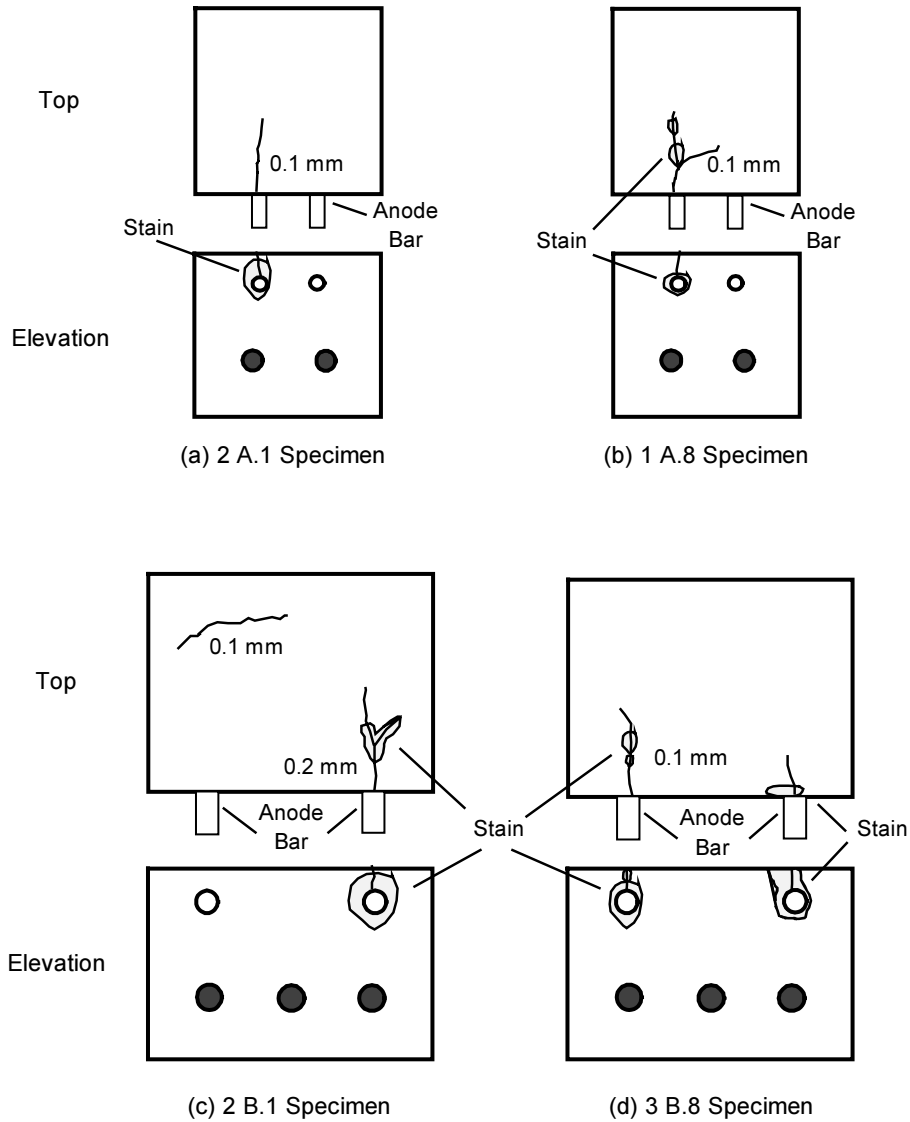
**Figure A.21** Cracks and stains on macrocell specimens autopsied after one year of exposure.

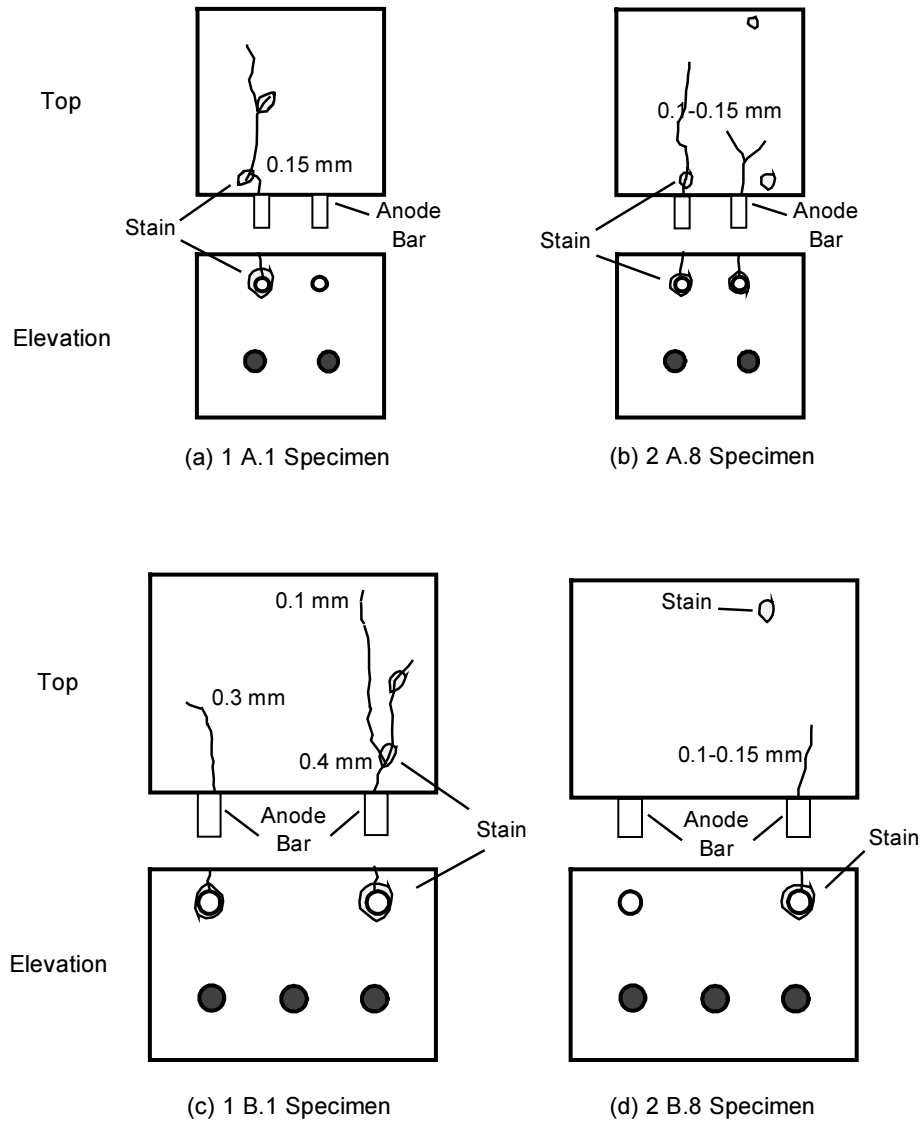
**Figure A.22** Cracks and stains on macrocell specimens autopsied after two years of exposure.

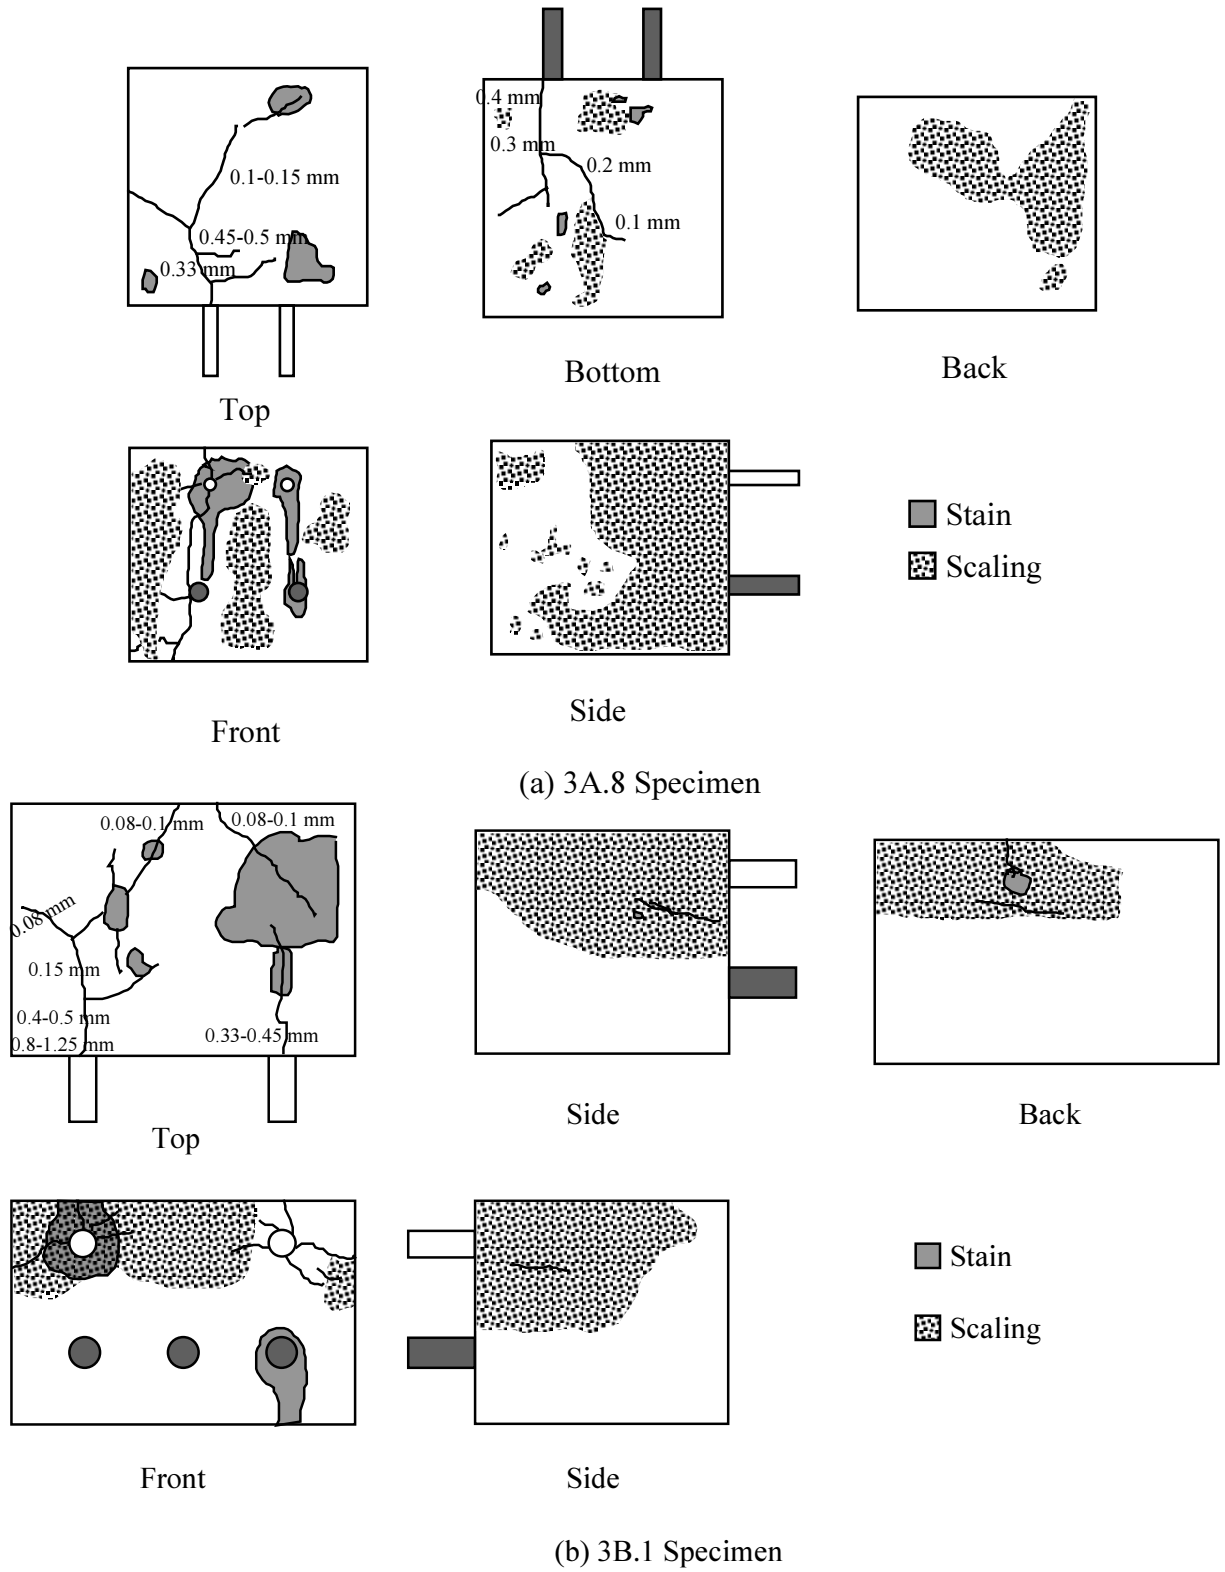
Figure A.24 Cracks and stains on macrocell specimens 3A.8 and 3B.1 inspected after 4.5 years of exposure.

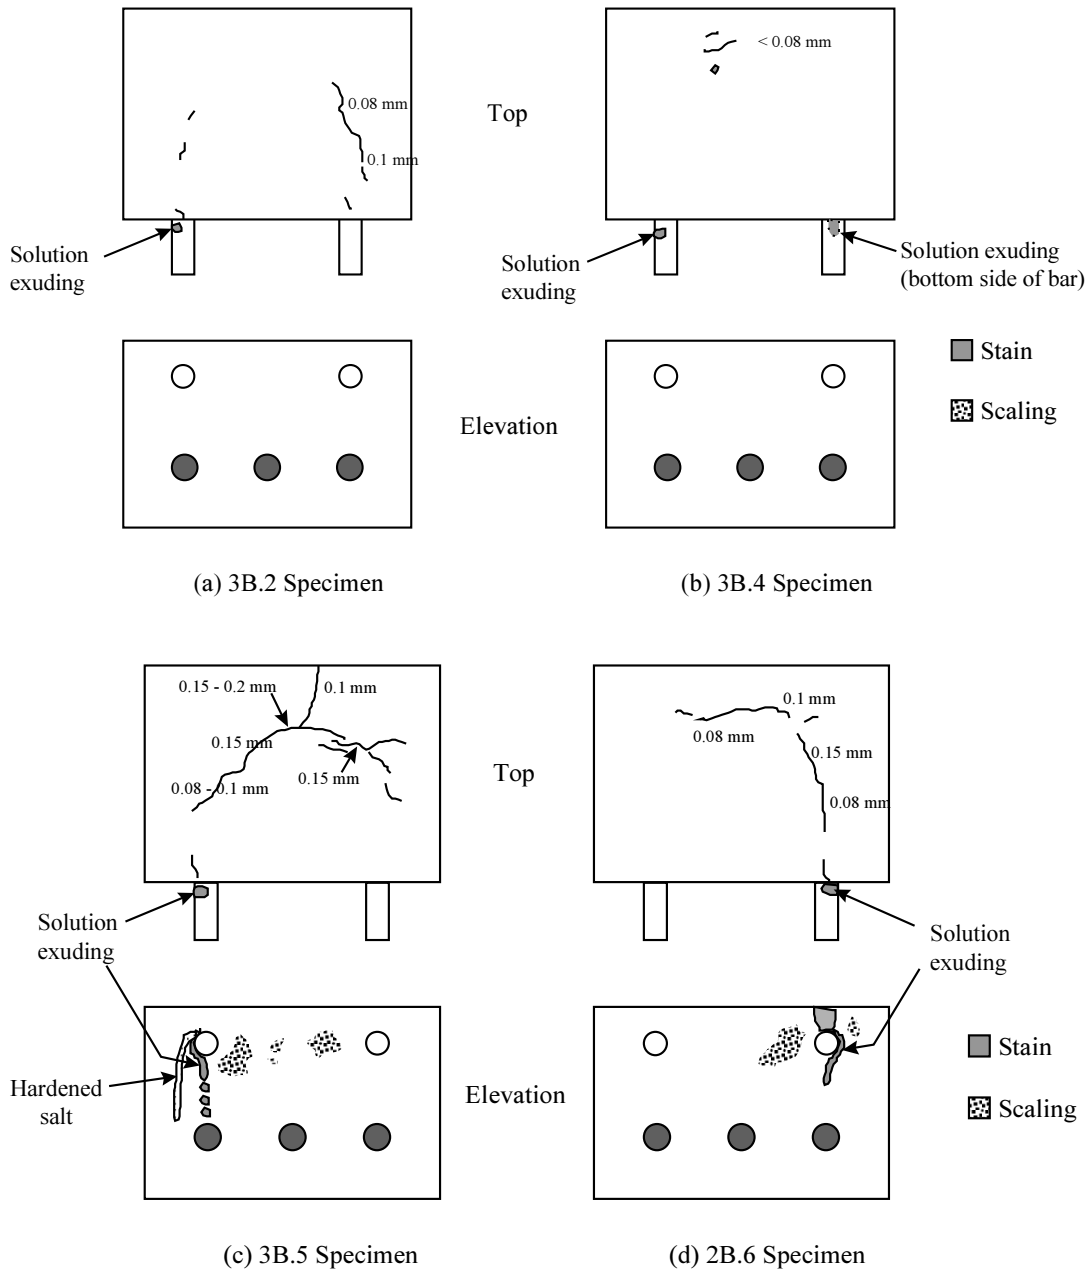
**Figure A.25** Cracks and stains on macrocell specimens 3B.2, 3B.4, 3B.5, and 2B.6 inspected after 4.5 years of exposure.
