# **Study of the I-345 Bridge in Dallas**

**Report**

**Master of Science in Engineering**

The bridge under study is an elevated section of I-345 near the interchange of I-45 and I-30 in downtown Dallas, Texas. The bridge is a twin steel plate girder bridge with transverse floor beams framing over the two main girders and supporting the concrete slab which is post-tensioned in both the longitudinal and transverse directions. Cracking has occurred in the connections of the floor beams to the girders in many places along the bridge. A retrofit was performed on the bridge in 2004 to try to mitigate this cracking, however new cracks later formed. The purpose of this study is to determine the reasons for continued cracking in this bridge. Field tests were performed on two sections of the bridge. The test consisted of running several controlled live load tests using trucks of known weights and monitoring the strain in the areas where cracking was most prevalent through the use of strain gages. These gages were then left on the bridge for one week after the live load tests to collect data which would be used to determine the fatigue performance of the bridge.

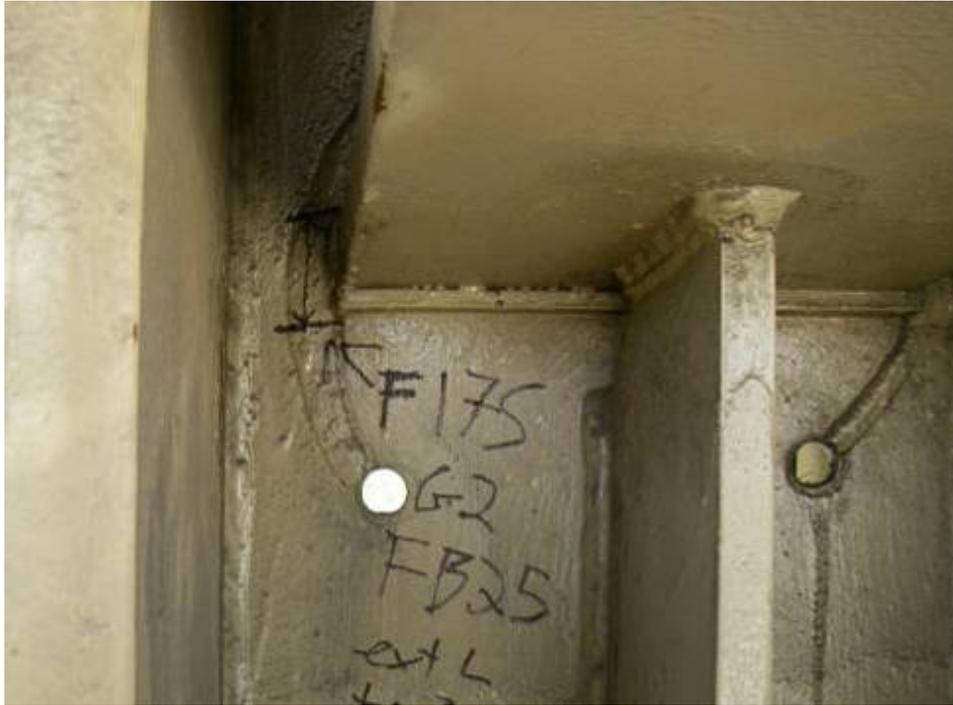
Cracking occurred in the girder web where the bottom floor beam flange is welded to the girder web. The floor beams at the pier locations had the flanges frame into the girder web between the bearing stiffeners (Figure 1.2). The resulting small gap between the stiffener and flange welds causes high stresses to occur at the weld toes from displacement of the floor beam flange. These cracks typically formed an arc shape in the girder web around the edges of the bottom floor beam flange. Figure 1.3 shows the cracking which occurred at these locations along with the attempted crack repair that is discussed later in this section. Cracking also occurred on the girder web in the gap between the top flange of the girder and the web of the connecting floor beam. The stiffener connecting the floor beam and girder webs is not attached to the top flange of the girder. This creates a small gap in the girder web where differential deflection between the two girders causes the floor beam to rotate creating very high stresses. Figure 1.4 shows an example of cracking at this location.

**Figure 1.3: Cracked Weld Repair in Gap between Bearing Stiffener and Bottom Flange of Floor Beam**

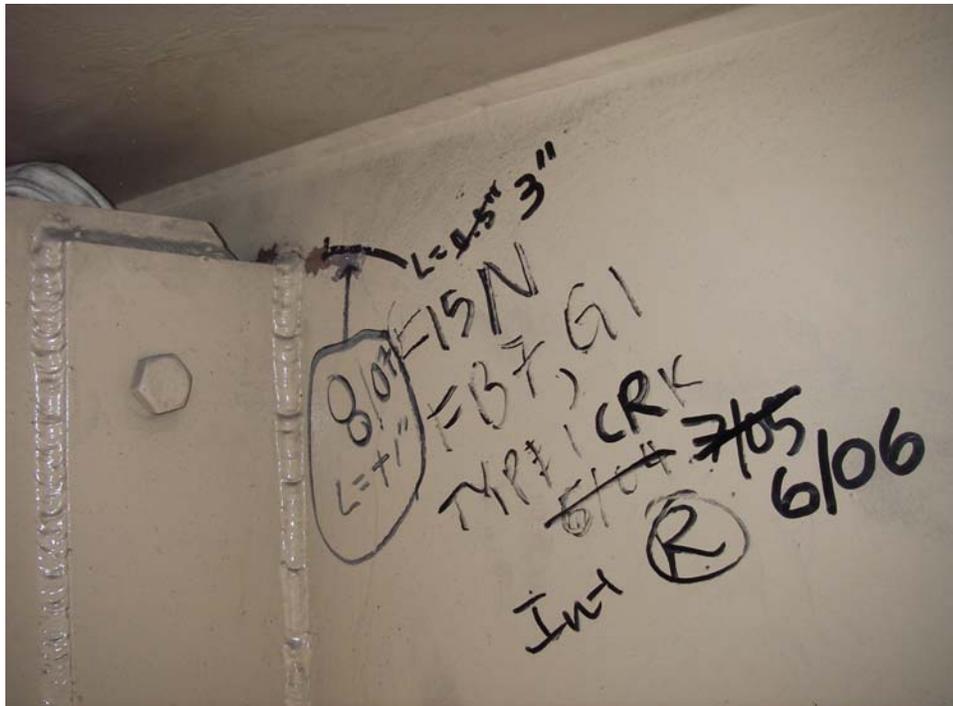
**Figure 1.4: Crack in Web Gap**

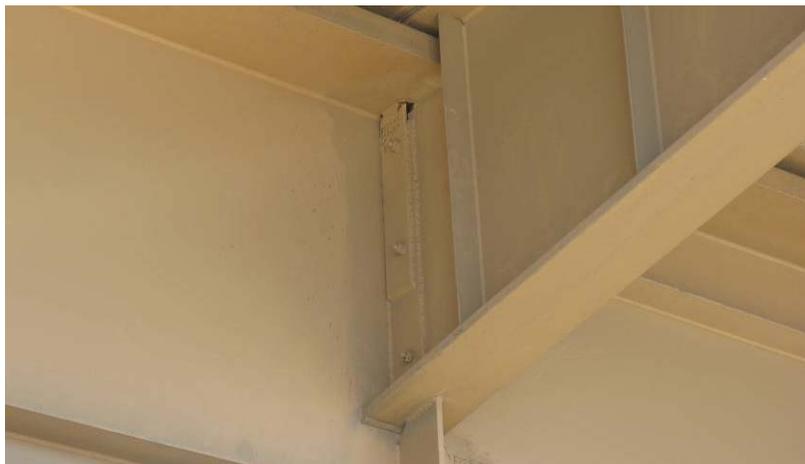
**Figure 1.6: Retrofitted Connection**

A retrofit was performed in 2004 in an attempt to mitigate the cracking. Many of the cracks were welded and arrestor holes were drilled at the crack tips to relieve the stress. This repair was shown in Figure 1.3. The retrofit also consisted of adding retrofit stiffeners on top of the stiffeners connecting the floor beams to the girders. These stiffeners were welded to the top flange of the girder in order to close the previously mentioned gap where cracking had occurred. Figures 1.5 and 1.6 show a detail and picture of a retrofitted connection. Some of the welds were also subjected to ultrasonic impact treatment to improve their fatigue performance.

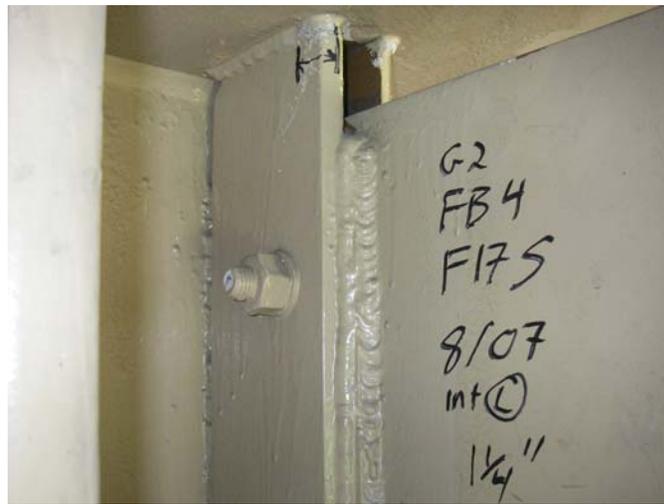
Since the completion of the retrofit, new cracks have developed at the connections. Figures 1.7 through 1.9 show three types of new cracks that formed where retrofit stiffeners were placed. New cracks also developed in the area between the bearing stiffeners and the bottom flange of the floor beams. Figure 1.10 shows an example of this type of crack which formed at the toe of the bearing stiffener weld. This type of crack formed due to the rotation of the floor beams which creates a region of high stress in this small area.

**Figure 1.7: Crack at Connection of Retrofit Stiffener to Top Girder Flange**

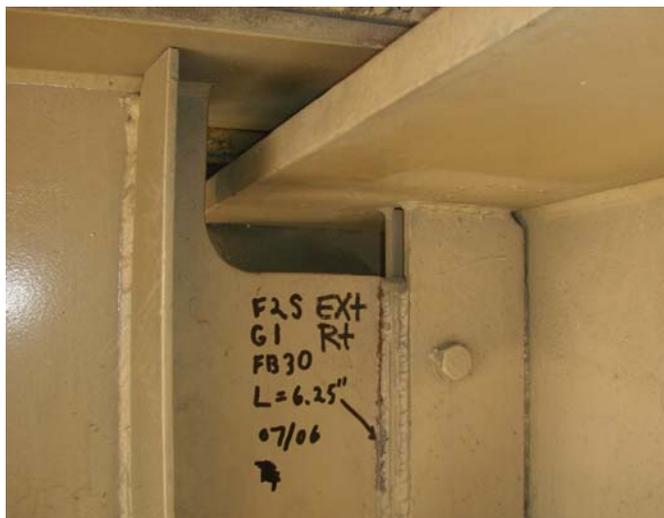
**Figure 1.8: Crack at Weld Connecting Existing Stiffener to Floor Beam Web**

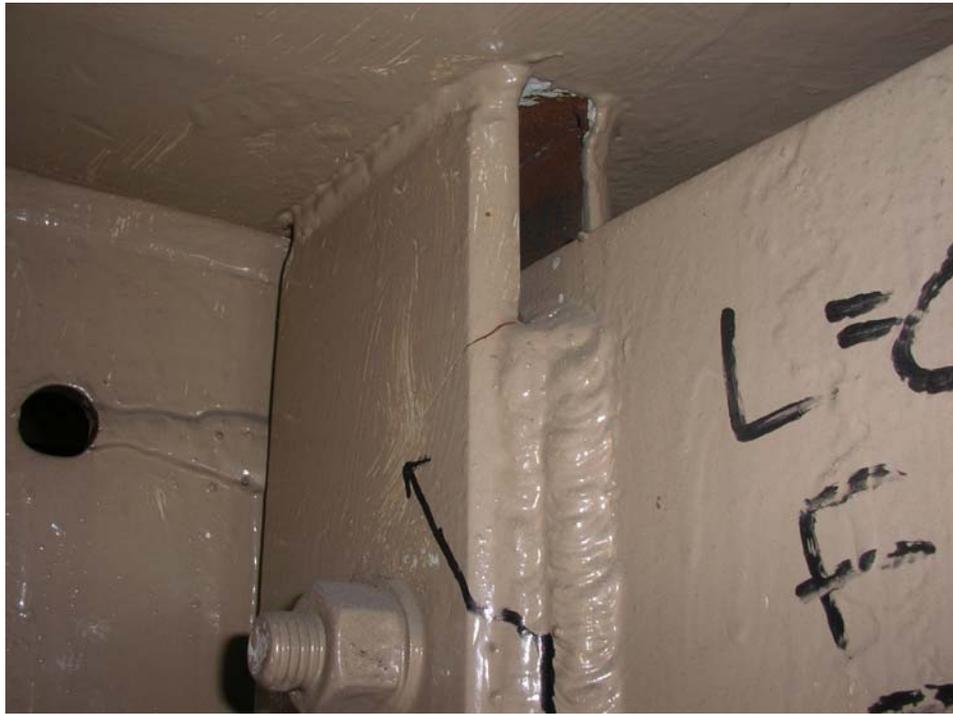
*Figure 1.9: Crack at Weld Connecting Retrofit Stiffener to Existing Stiffener*

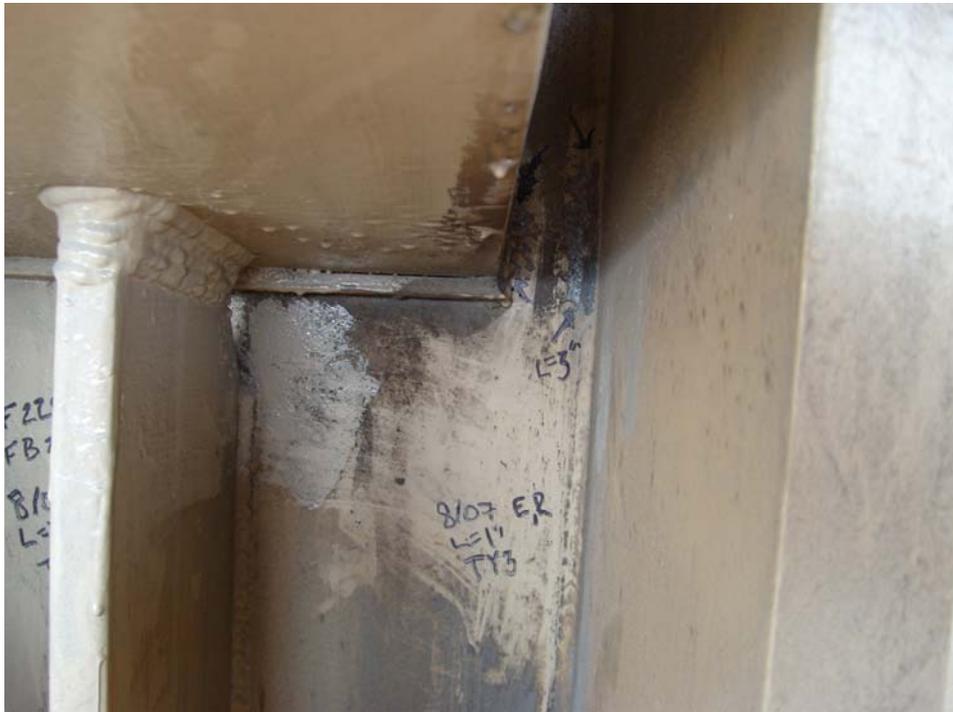
*Figure 1.10: Cracks between Bearing Stiffener and Bottom Flange of Floor Beam*

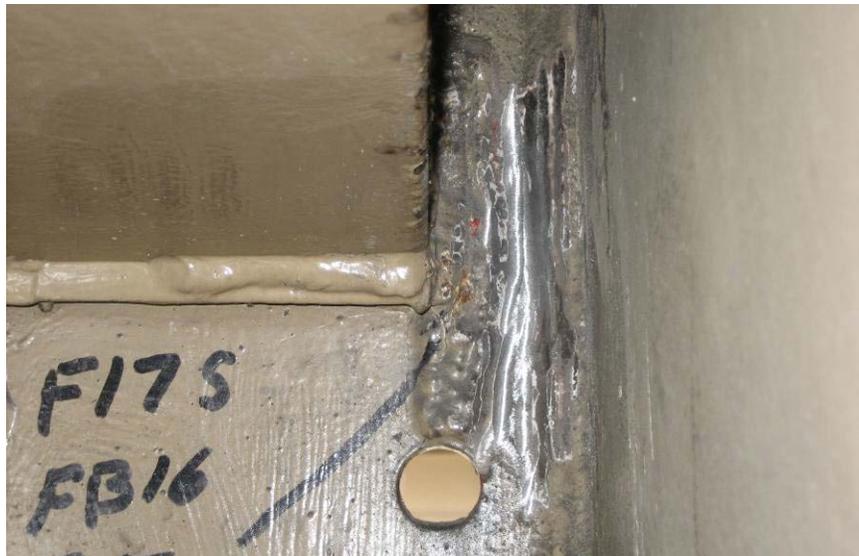
**Figure 2.8: Gap between Bottom Flange of Floor Beam 16 and Bearing Stiffener**
