Fatigue Performance of Stay Cables

Jennifer Elizabeth Ridd, B.S.C.E.

Thesis

The University of Texas at Austin

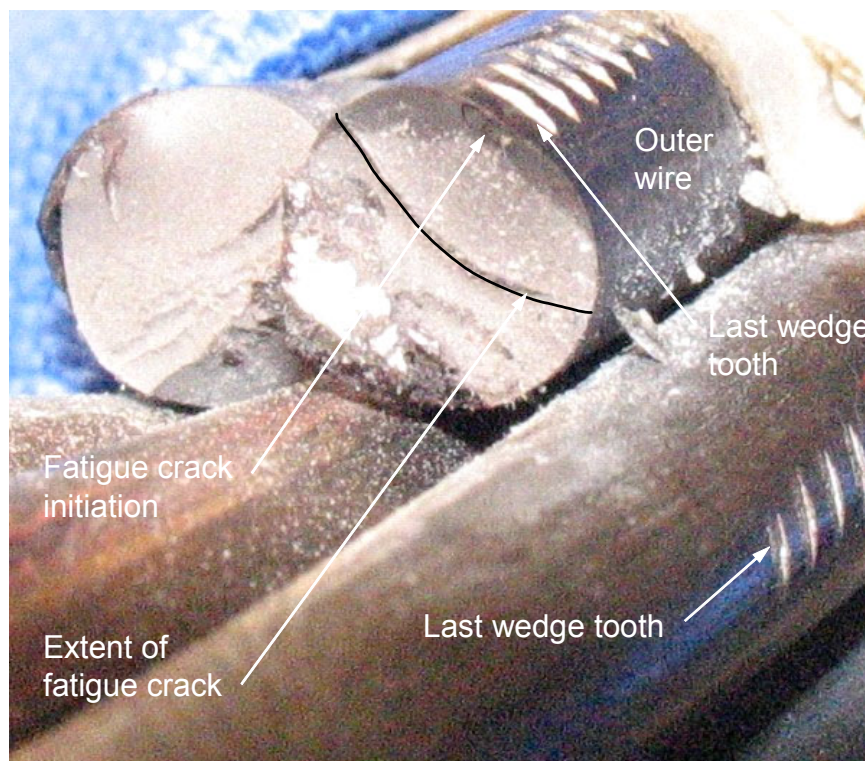
A third, less common type of fatigue failure was also observed where the fatigue crack was initiated at a point that was not in contact with other wires in the strand. This type of failure tended to occur near the wedges at the stressing end of the cable where fatigue cracks were initiated by a wedge. Figure 4-5 shows an external wire that failed near the wedge.

Figure 4-5: Isolated fatigue failure at wedge

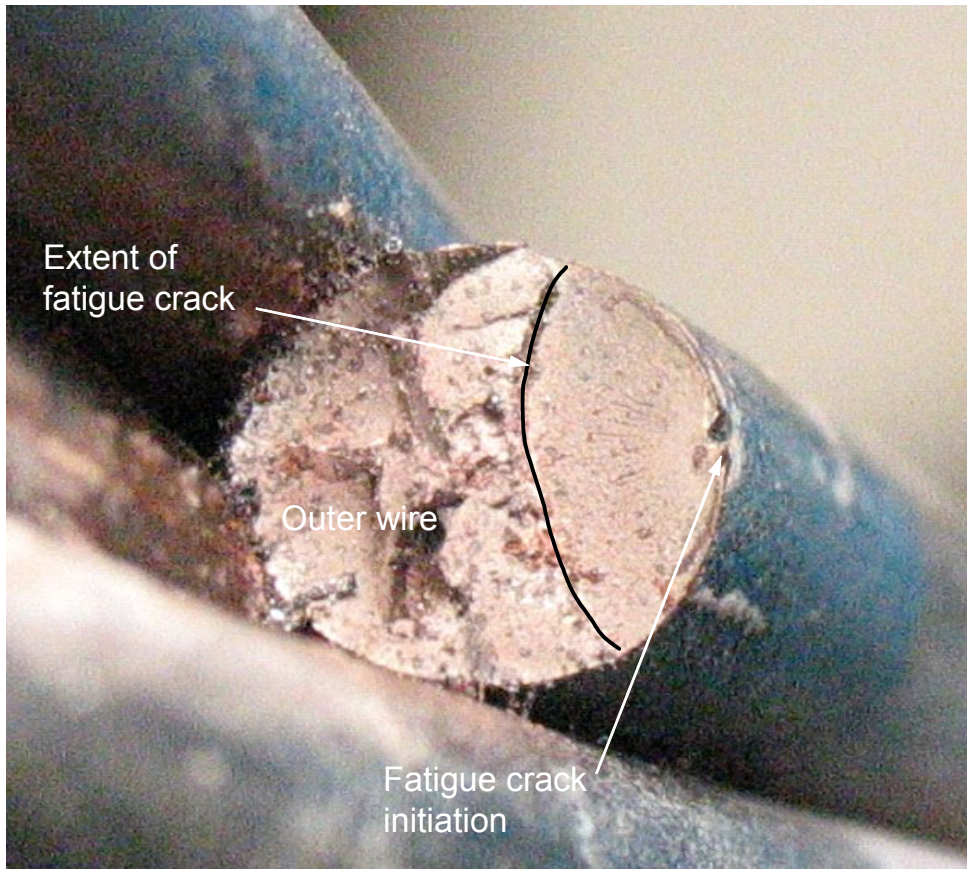
Occasionally fatigue failures were also observed to initiate at a point where an exterior wire was not in contact with the other wires in the strand. It is unknown what caused this type of failure, although possible sources are corrosion, defects on the wire, or fretting with the helical spacer wire (Figure 4-6).

Figure 4-6: Fatigue caused by external source

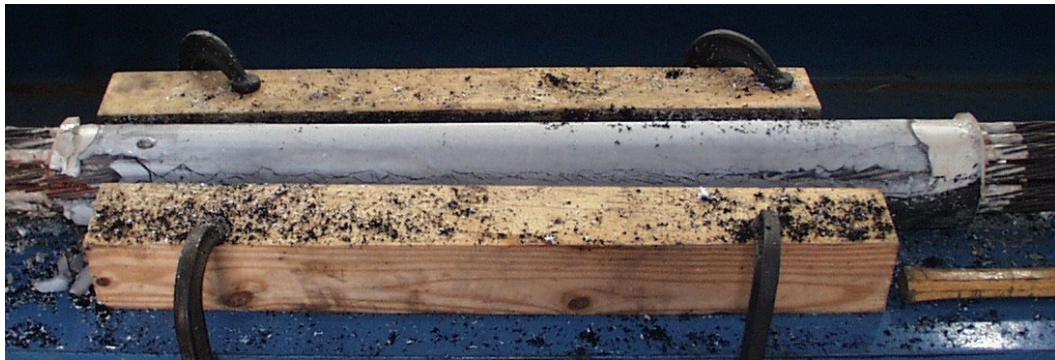
The only portion of Specimen 5 that was grouted was a 3-ft section at the center. Following completion of the fatigue test, the polyethylene pipe was opened using a router. The grout had no appreciable voids apart from a small defect at the location of the vent hole used for grouting and appeared to be homogeneous. The grout appeared to be essentially uncracked immediately upon opening the PE pipe, as shown in Figure 4-9. The only large crack was directly under the line cut by the router; no longitudinal cracks characteristic of regions where wire breaks are present were found. However, within minutes of opening the polyethylene pipe, circumferential shrinkage cracks began to appear and the grout began to fall away in pieces.

Figure 4-9: Grout condition - Specimen 5

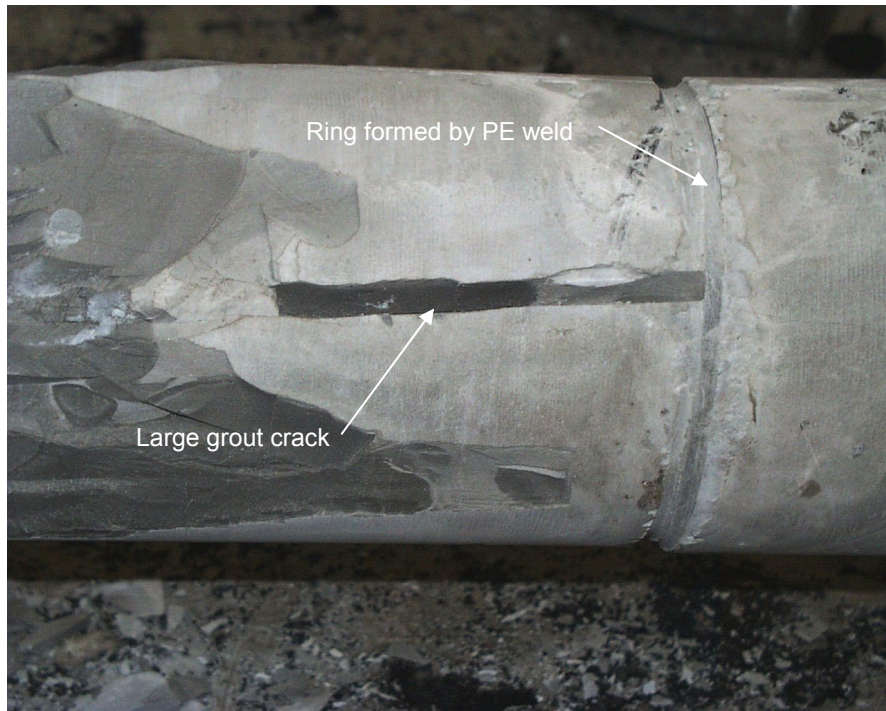
Figure 4-17 shows the grout condition upon opening the polyethylene pipe. At the deck anchorage, a large grout crack was observed on the bottom of the specimen near the ring formed in the grout due to the weld in the polyethylene transition pipe. Other than this large crack and several small (less than 0.25-in. diameter) air voids, no other visible grout damage was seen at the deck end.

Figure 4-17: Large grout crack at deck anchorage - Specimen 6

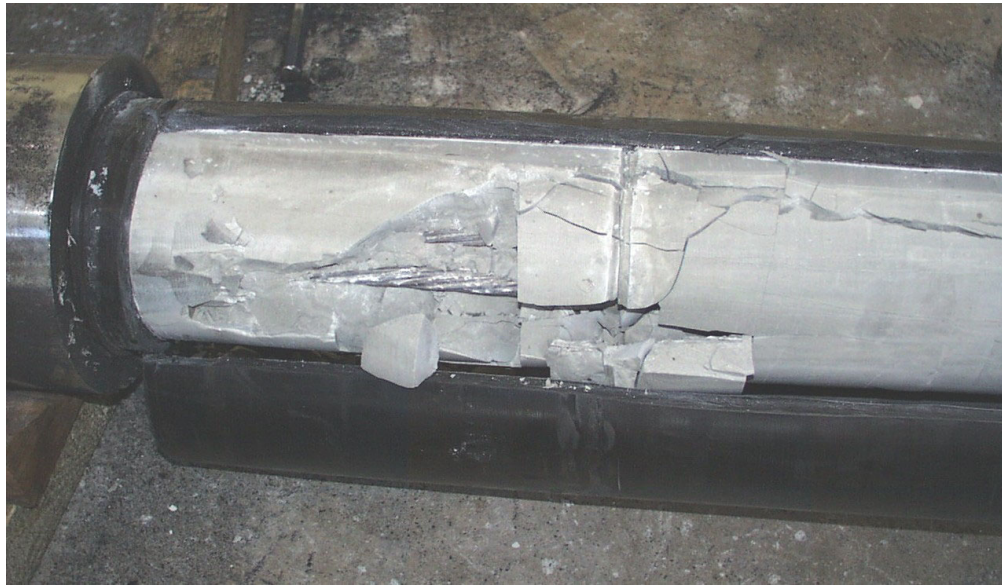
At the tower end, large longitudinal cracks characteristic of areas where wire breaks were present immediately upon opening the stay. As the grout was exposed to the open air, parallel circumferential cracks began to form and pieces of grout began to fall away, exposing two strands as seen in Figure 4-18. Apart from the cracking, the grout had no visible imperfections and appeared to be homogenous.

Figure 4-18: Grout cracking at tower end - Specimen 6

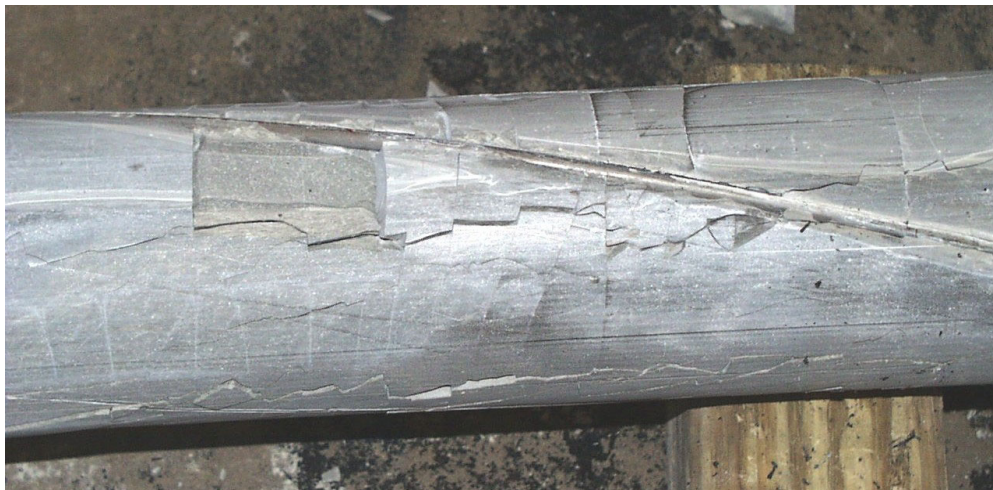
The grout in the portion of the cable under the ram during fatigue testing showed severe longitudinal cracks characteristic of regions near wire breaks as shown in Figure 4-19. Thin, parallel circumferential cracks can also be seen. As with the other portions of the stay, the cracking in the center portion of the specimen became more severe upon exposure to the air.

Figure 4-19: Grout cracking under the ram - Specimen 6

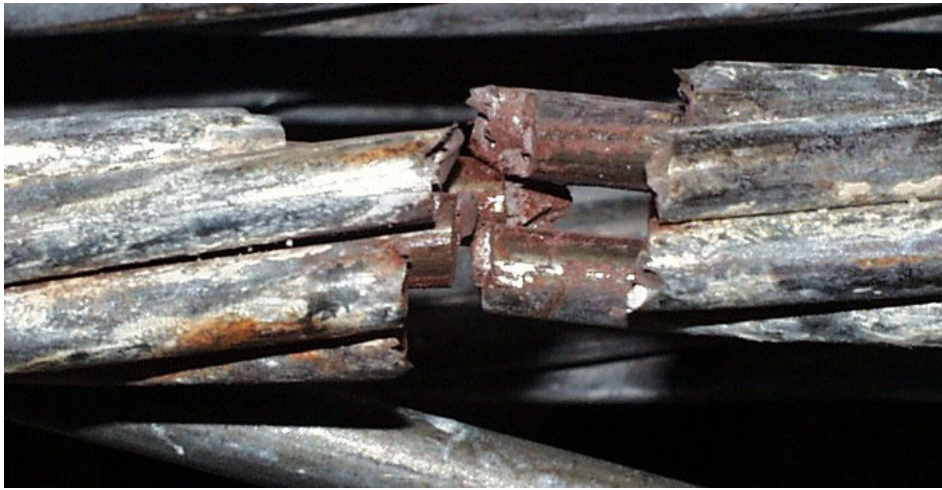
In the case of Specimen 6, the evidence of fretting near the wire breaks at the tower anchor head was more severe than the evidence of fretting found elsewhere. In some places, corrosion was evident on the exterior of the strand and was accompanied by a white substance that coated the strand, shown in Figure 4-21. In this region, corrosion was also seen on the grout surface at the interface between the grout and the strand (Figure 4-22).

Figure 4-20: Corroded fretting product on Strand 19 – Specimen 6

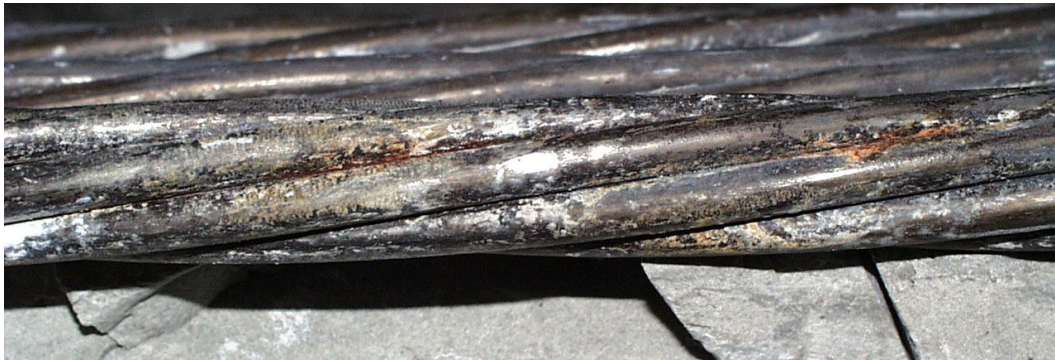
Figure 4-21: Corrosion on Strand 19 near tower anchor head - Specimen 6

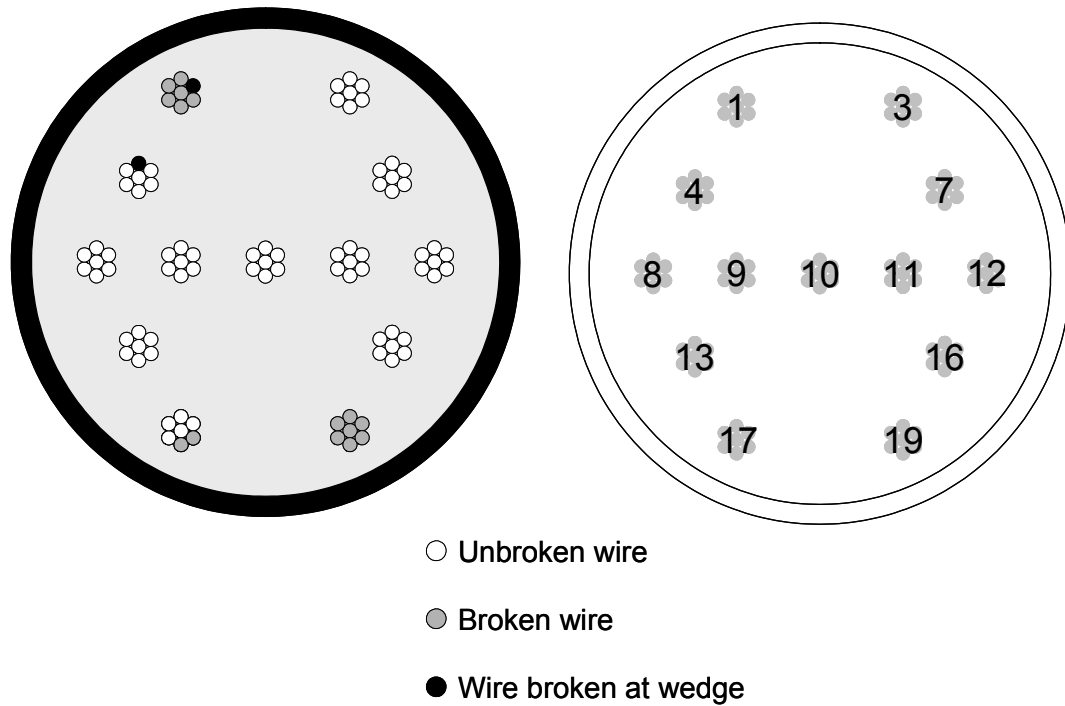
Two wires broke inside the anchor head at the contact point between the strand and the wedge. At the wedge, the fatigue of the strand due to bending stress is accelerated by the first tooth of the wedge which creates a localized stress concentration.

Figure 4-24: Wire breaks at the tower end - Specimen 6

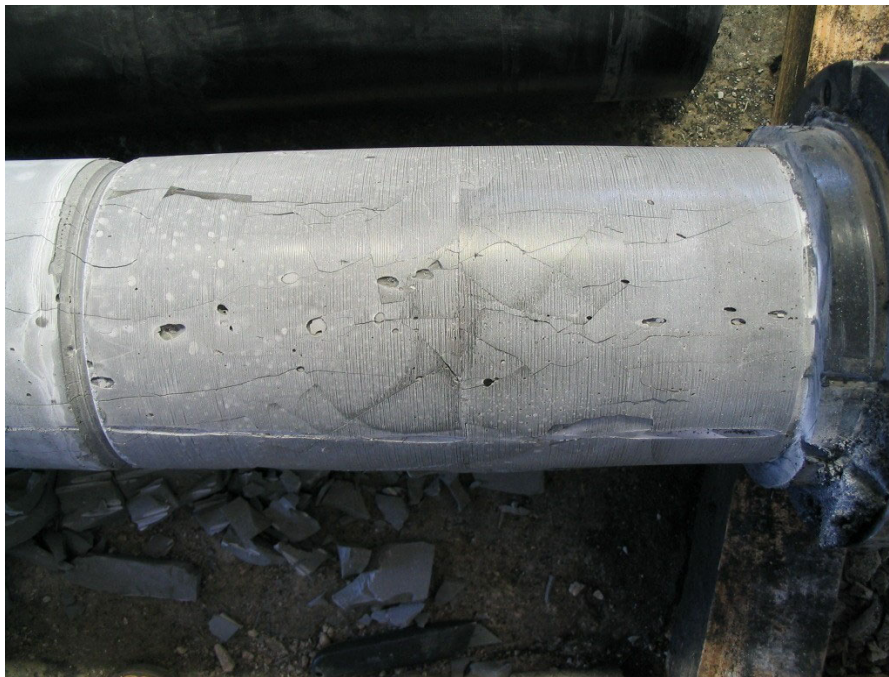
Several air voids, approximately $\frac{1}{2}$ in. in diameter, were found after exposing the grout at the tower end of the stay, as shown in Figure 4-34. Longitudinal cracks indicative of wire breaks were also observed. Figure 4-34 also shows the ring-shaped deformity in the grout caused by the weld in the polyethylene transition pipe.

Figure 4-34: Grout condition at tower end - Specimen 7

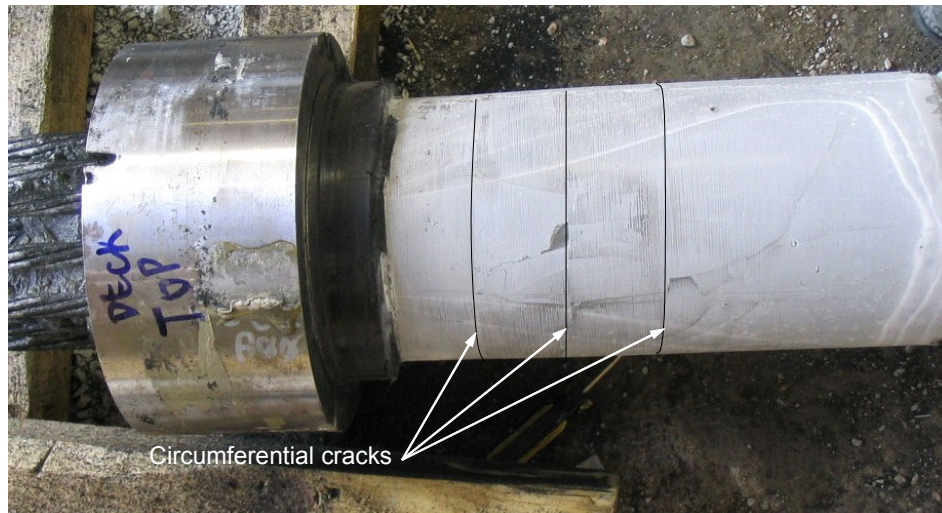
(Figure 4-35). However, after being exposed to the open air, the grout cracked violently as observed when opening Specimen 6. This cracking is due to a loss of confinement which occurs when the PE pipe is removed. The condition of the stay after this cracking is shown in Figure 4-36.

Figure 4-35: Grout condition at deck anchor head immediately after removing polyethylene pipe - Specimen 7

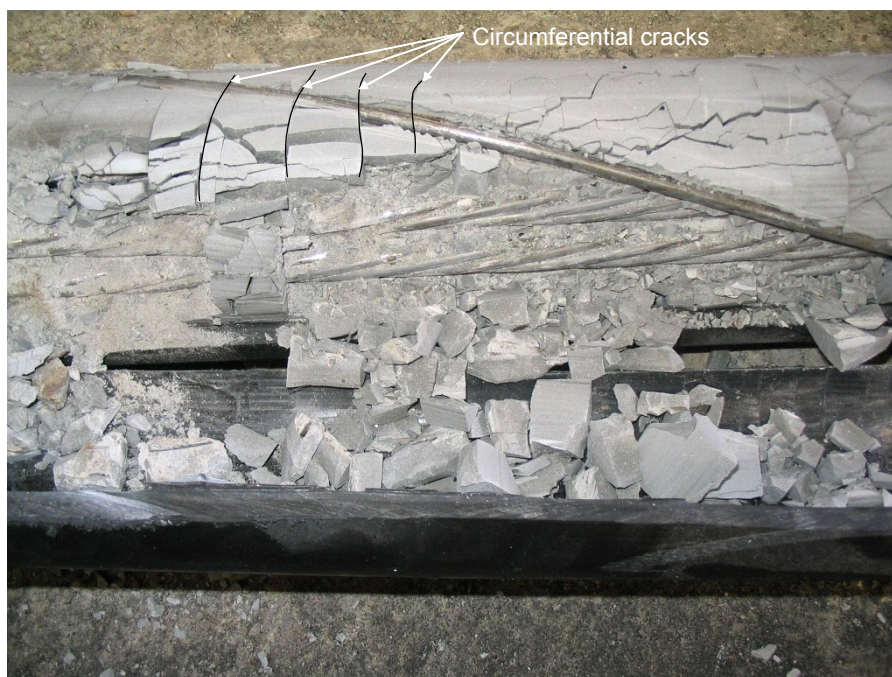
Grout in the section of the cable under the ram during the fatigue tests was severely damaged immediately upon opening the specimen, as shown in Figure 4-37. No further cracking was observed after removing the PE pipe, most likely due to the high level of damage already sustained by the grout. Some evidence could be seen of circumferential cracks.

Figure 4-37: Grout condition under load point - Specimen 7

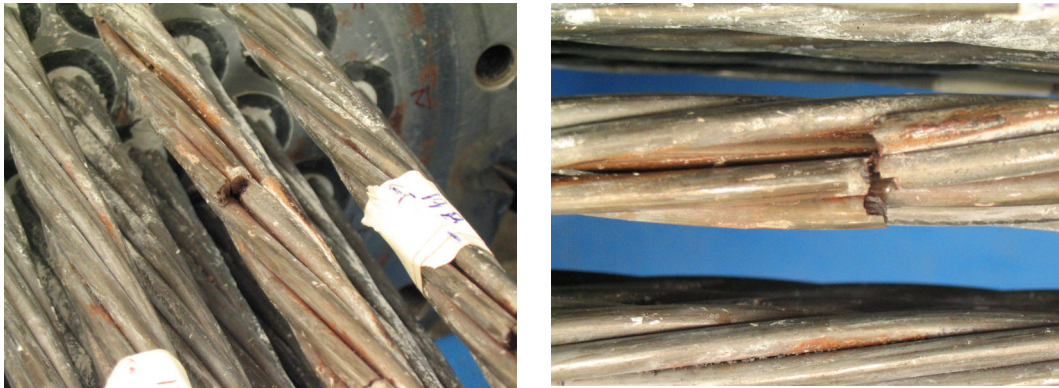
Most of the corrosion and corroded fretting product found upon opening the specimen was near wire breaks. Figure 4-38 shows a typical example of the corroded fretting product found in these areas.

Figure 4-38: Corrosion found near anchorage on strand 18 - Specimen 7

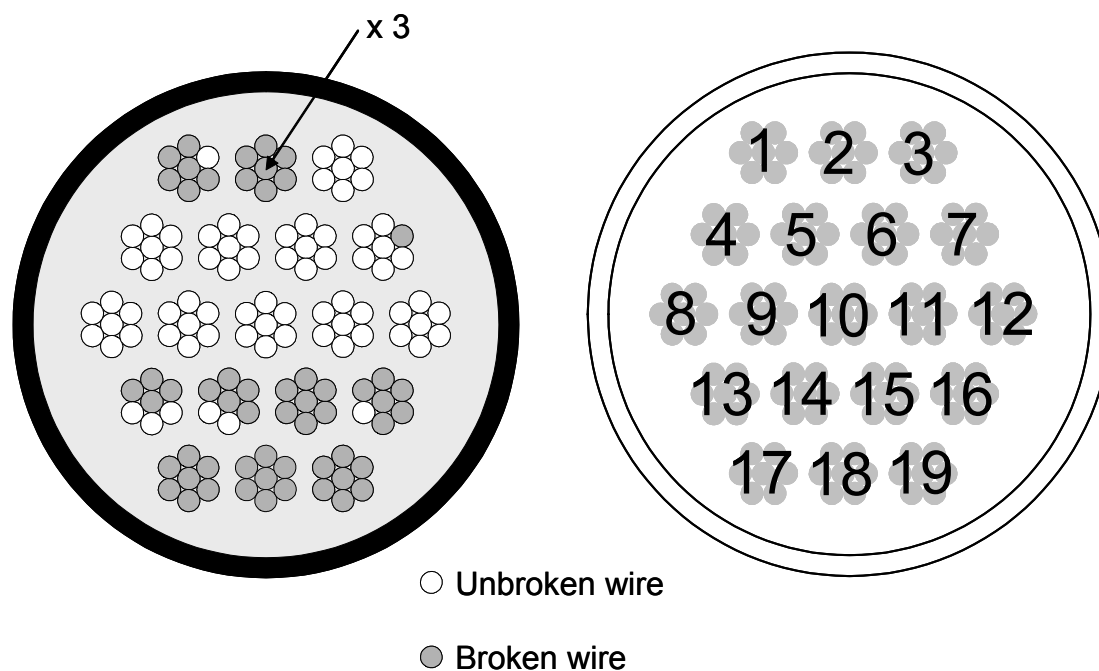
The center wire on strand 2 fractured in three places; two breaks were found near the edge of the load plate on the tower side, and one break was located at the edge of the steel clamp on the deck side of the load point.

Figure 4-46: Wire breaks under the load point - Specimen 7

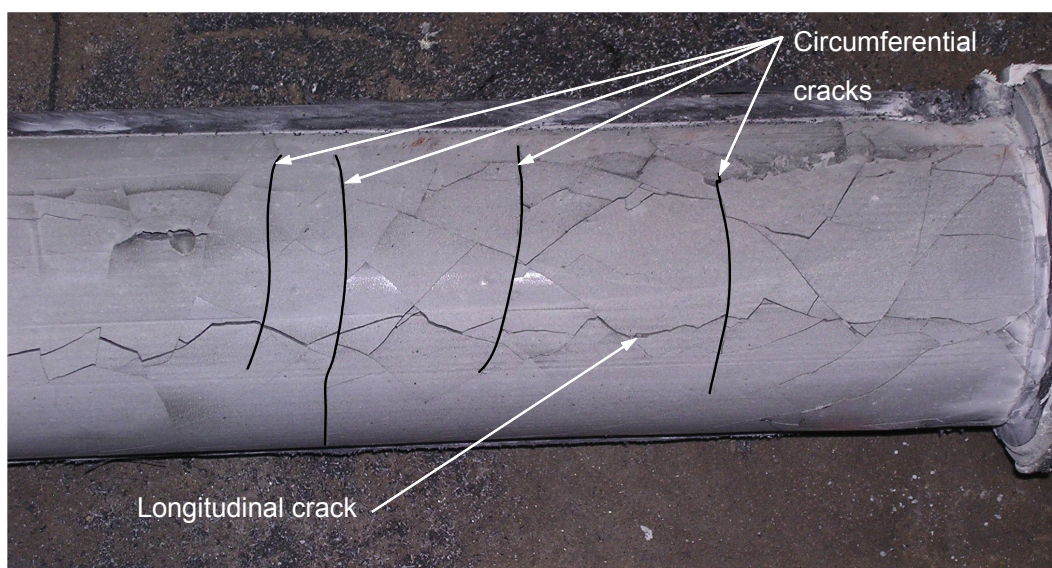
Figure 4-54: Grout condition at center of Specimen 8

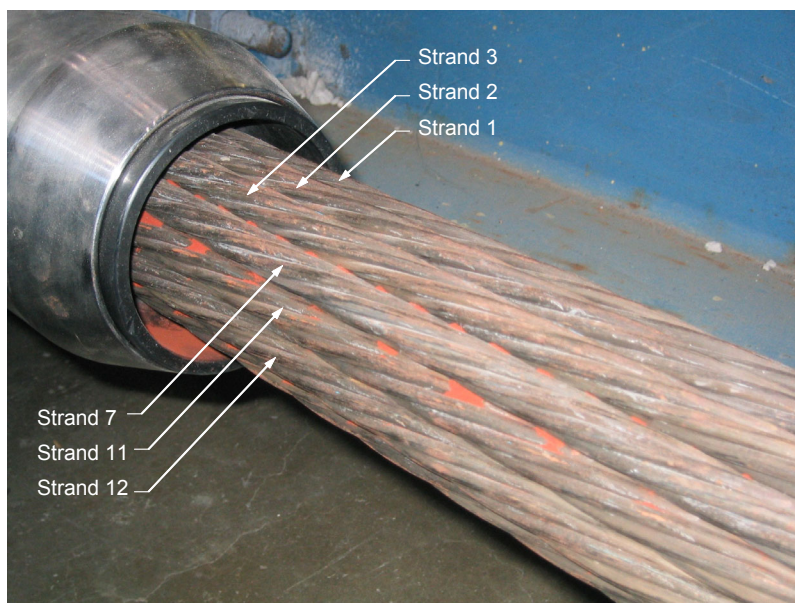
Figure 4-55: Evidence of fretting fatigue at deck tension ring – Specimen 8

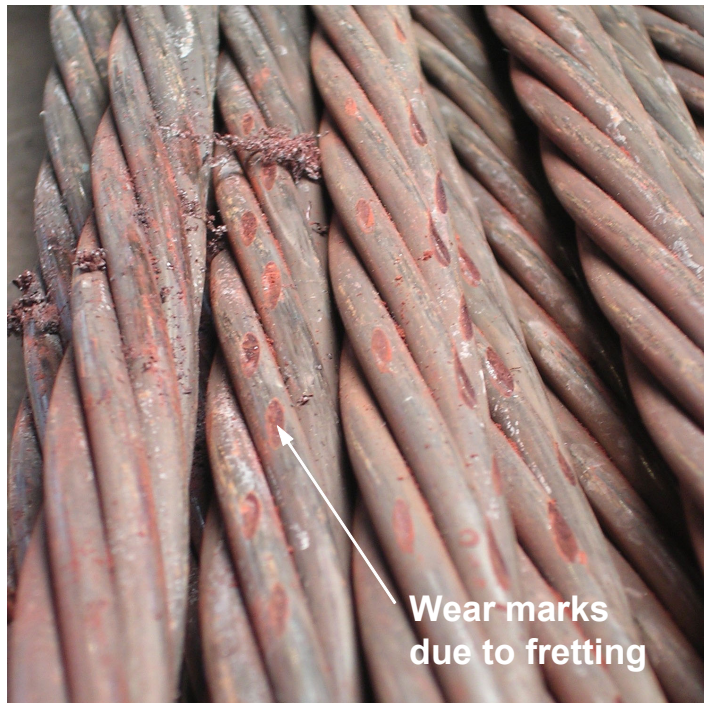
Figure 4-56: Wearing of the strands due to fretting - Specimen 8

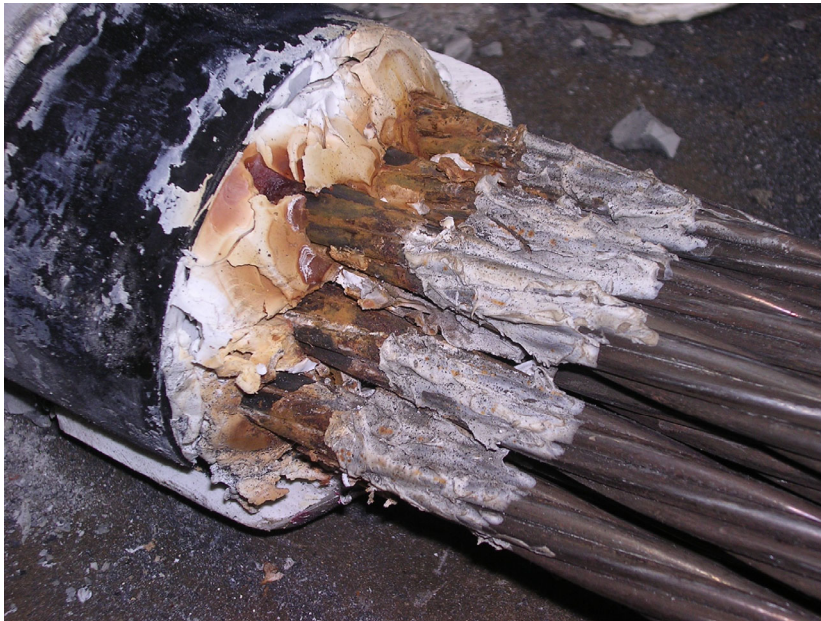
Figure 4-57: Corrosion at interface between strand and caulk - Specimen 8

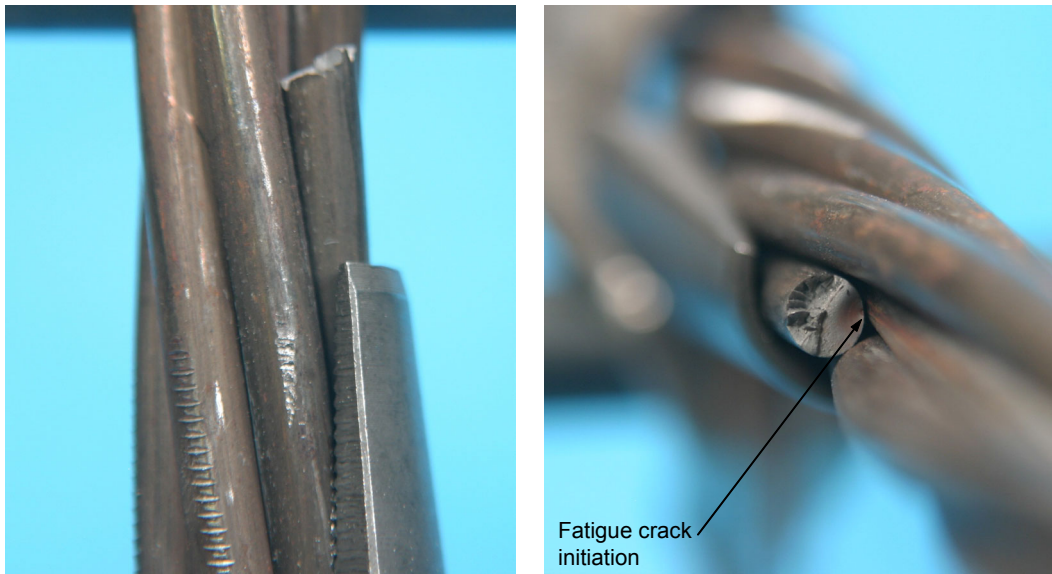
Figure 4-65: Wire break on strand 11 near wedge on the deck end - Specimen 8

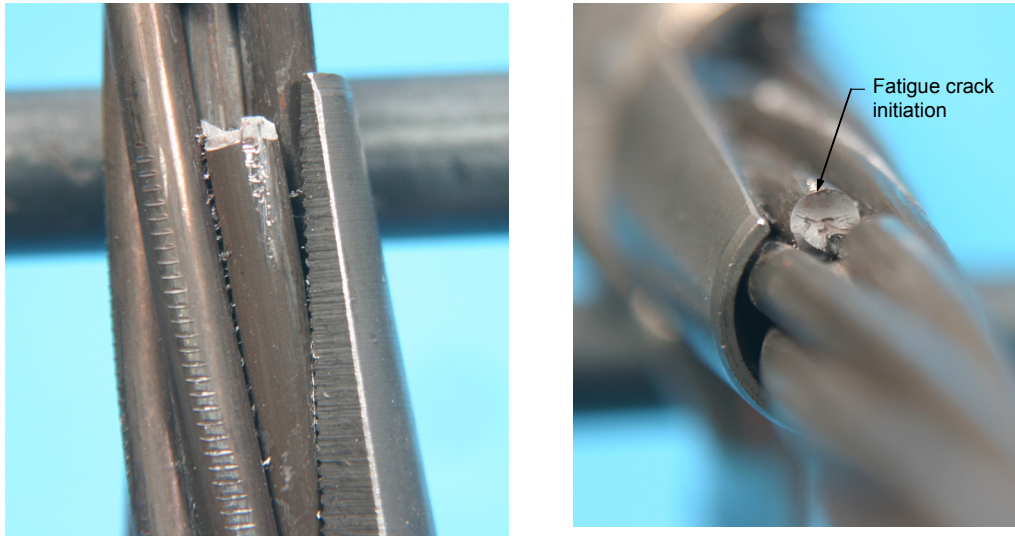
Figure 4-66: Wire breaks on strand 9 at wedge on tower end - Specimen 8

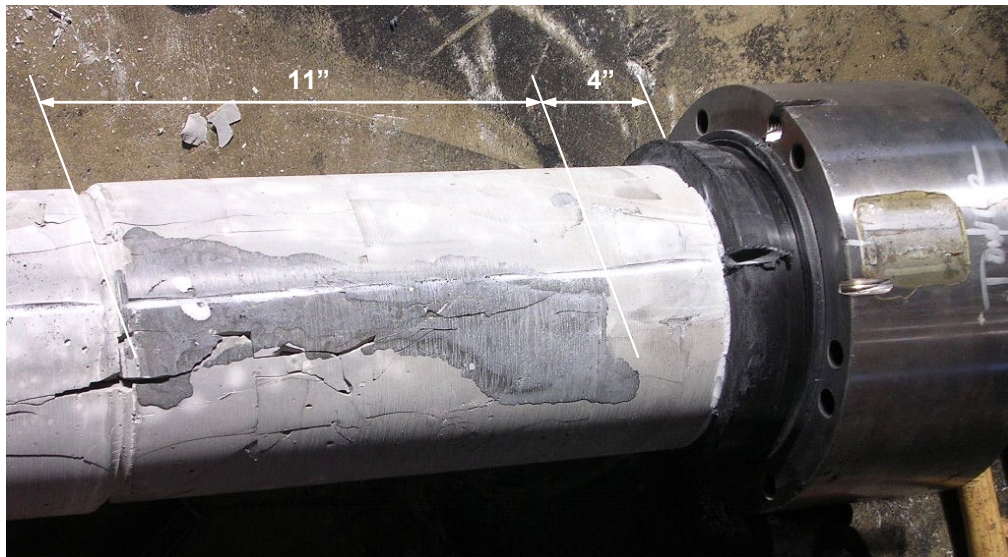
Figure 4-71: Grout lens at tower anchorage - Specimen 9

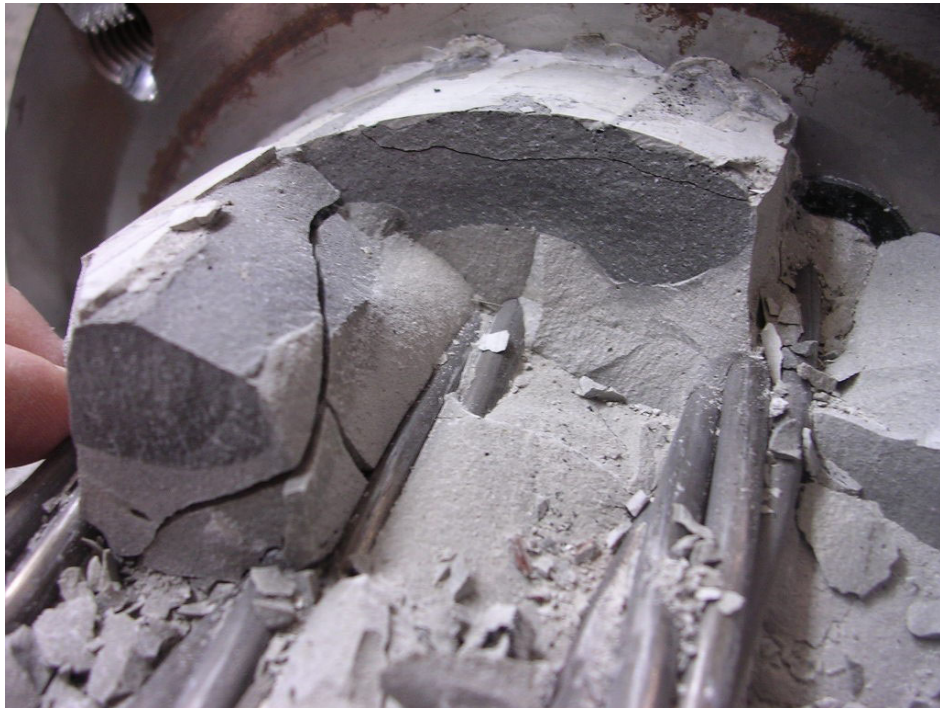
Figure 4-72: Grout void at tower anchorage - Specimen 9

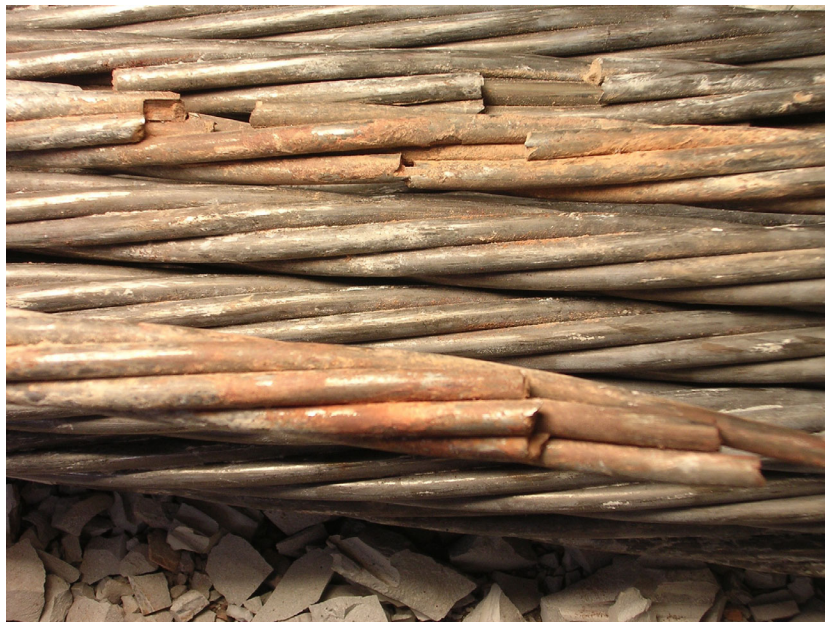
Figure 4-75: Corrosion under the load point - Specimen 9

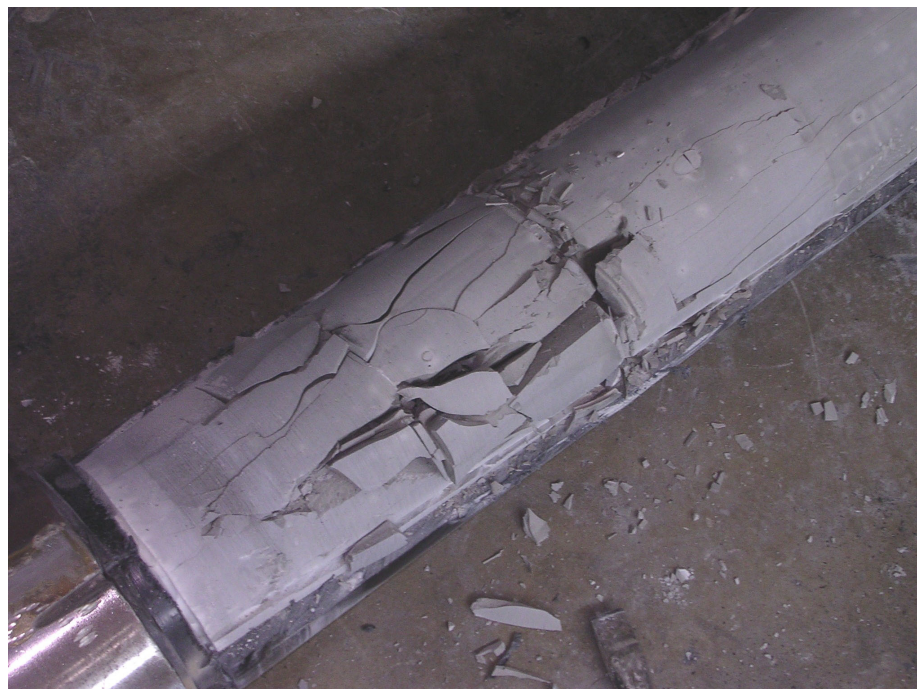
Figure 4-88: Grout at tower end immediately after opening - Specimen 10

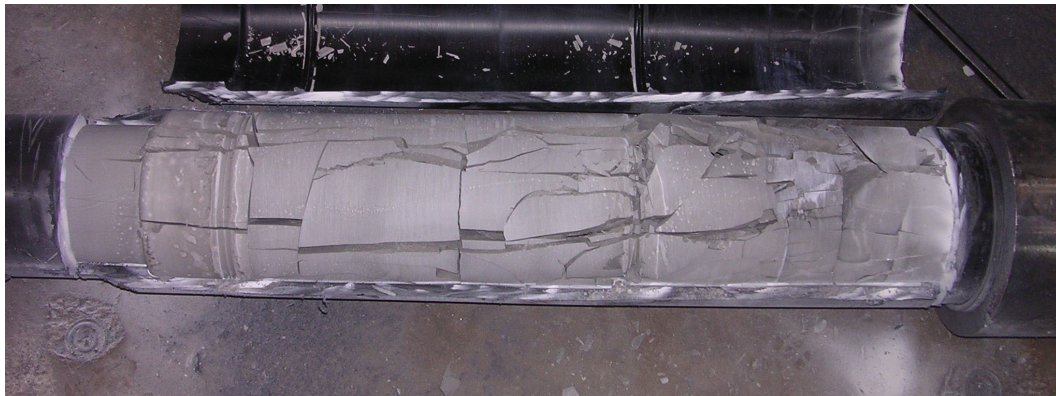
Figure 4-90: Grout at deck end immediately after opening - Specimen 10

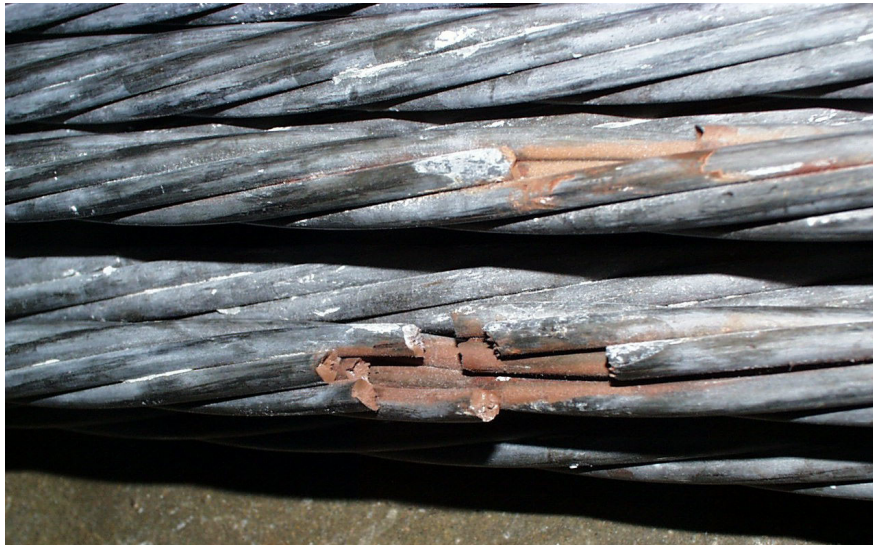
Figure 4-91: Corroded fretting product under the load point – Specimen 10

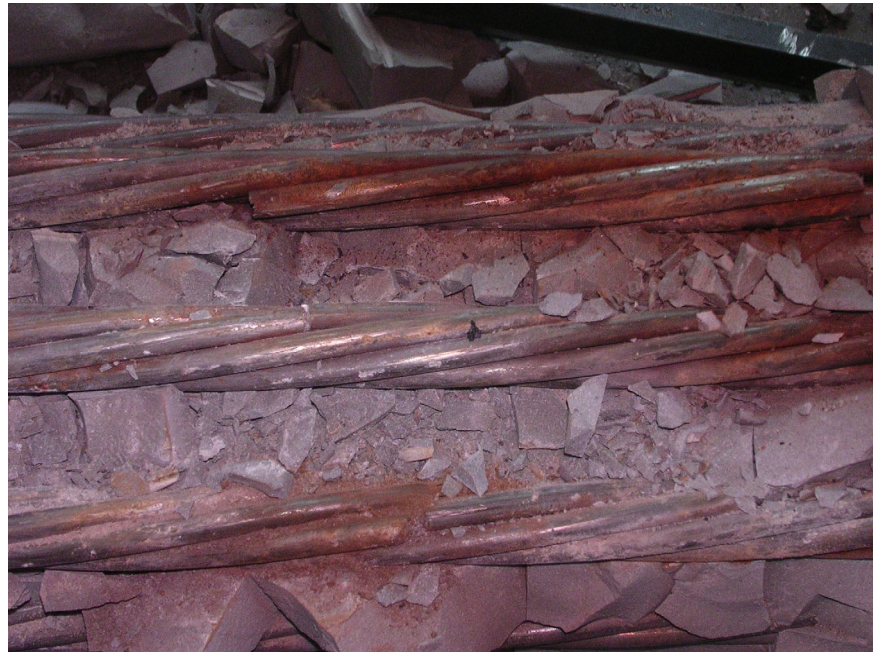
Figure 4-92: Corroded fretting product at the tower end - Specimen 10
