**Evaluation of Corrosion Resistance of New and Upcoming Post-Tensioning  
Materials After Long-Term Exposure Testing**

**Thesis**

The University of Texas at Austin

**December 2010**

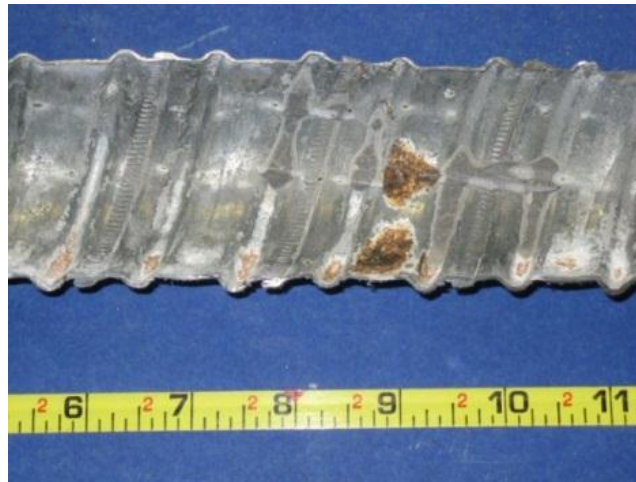
The north and south ducts both had localized severe corrosion damage. Most damage on the north duct occurred at midspan and at the live end quarter point. At these locations, the outside of the duct experienced severe pitting as well as some area loss on top of the duct only. This is shown in Figure 5.17. Pitting and corrosion were more extensive on the inside of the duct, extending nearly the full length of the duct on its top inside surface. The shape and extent of the damage indicate the presence of small grout voids along the top of the entire duct. Significant corrosion and pitting also extended along the bottom inside surface. Here, the location of damage suggests that voids may have formed under the strands during grouting (see Figure 5.16). The inner surface of the duct also showed discoloration along its entire length, especially where the strands had rubbed against it.

*Figure 5.16: Specimen T.1, Corrosion Along Gouges on Bottom Half of North Duct*

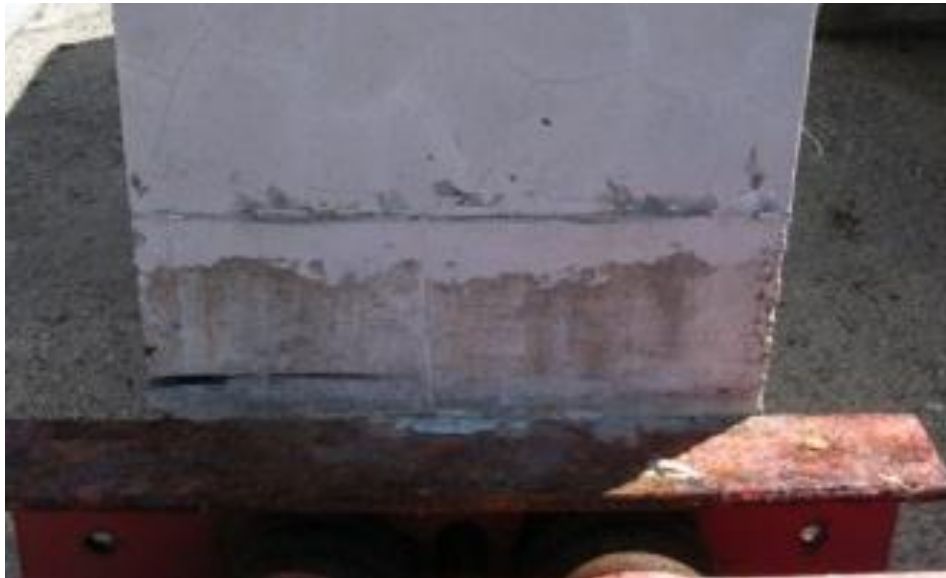
The specimen had two large transverse cracks running along its top face and down its north and south faces, each with an average width of 0.03 inches. The epoxy used to seal the vertical portions of these cracks to prevent leakage was intact. The transverse crack nearest to the dead end was not continuous across the specimen. One discontinuous longitudinal crack was present approximately 6 inches from the south face of the specimen. Its maximum width was 0.01 inches. This crack was not continuous. It was not visible within about six inches of the south grout vent. Similar to specimen T.1, a large crack had formed at the re-entrant corner of the dead end corbel during live load application<sup>7</sup>. This crack had been sealed with non-shrink mortar, which was still intact at the time of autopsy. The dead end anchorage pourback showed significant separation as well as some delamination near its interface with the rest of the specimen. This is shown in Figure 5.23. In addition, pattern cracking was found on the top and dead end surfaces of the pourback. This suggests the action of plastic shrinkage during the life of the specimen. Crack width data is shown in Figure 5.24, and the crack diagram is shown in Figure 5.28.

***Figure 5.23: Specimen T.2, Separation and Delamination Around Dead End Pourback***

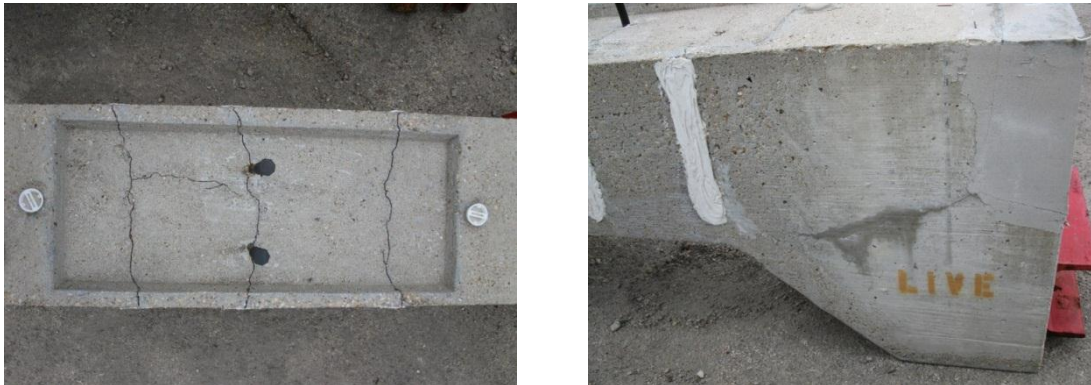
*Figure 5.33: Specimen 1.2 Top Surface (Left) and Leakage at Live End Corbel Crack (Right)*

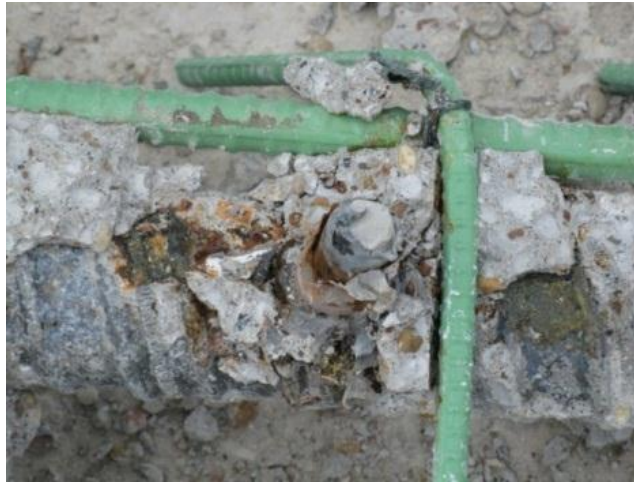
The specimen showed light scaling in and around the saltwater tray and near the bottom edges of both corbels. The saltwater tray had many small surface air voids and popouts. There were a few on the north and south faces of the specimen, as well. Some light spalling was visible around the specimen's transverse cracks. This was most noticeable in the center of the saltwater tray. Corrosion staining was found around the base of both grout vents, indicating the presence of corrosion inside the specimen. This staining is shown in Figure 5.43. In addition, extensive staining was discovered just beneath the surface of the saltwater pond in this vicinity during autopsy (see Figure 5.44).

*Figure 5.44: Specimen 2.2, Corrosion Staining Under North Grout Vent*

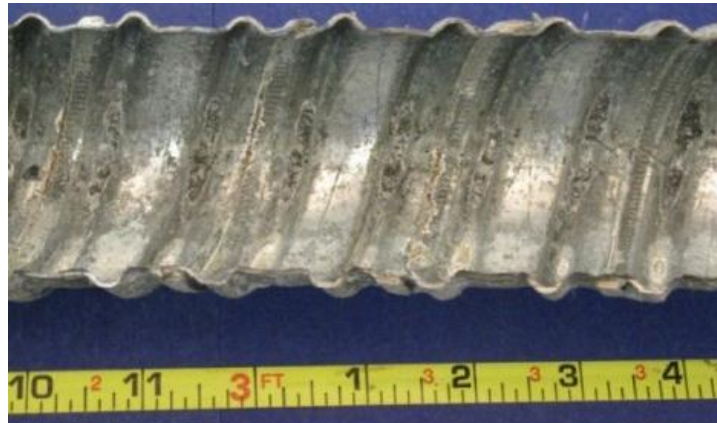
***Figure 5.46: Specimen 2.2, Discoloration Inside South Duct Showing Signs of Cracked Grout***

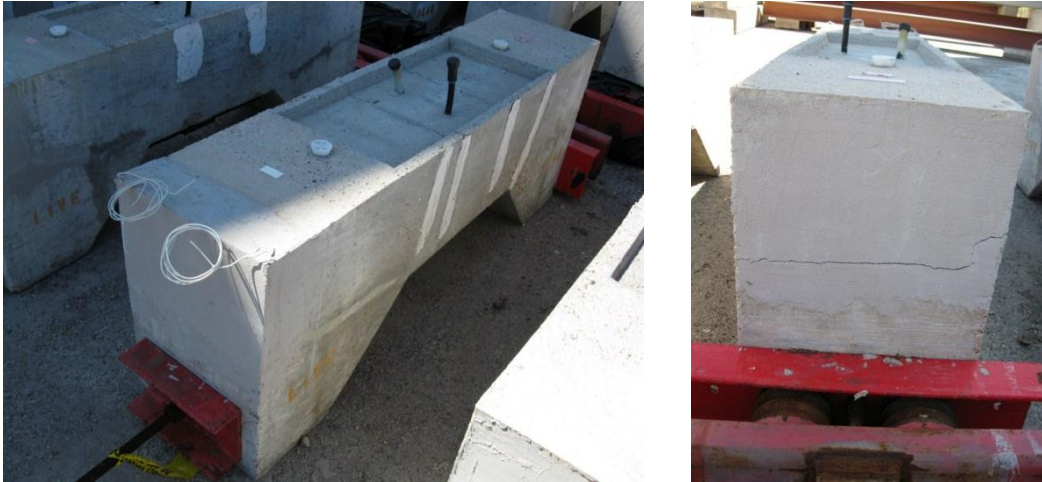
Figure 5.52: Specimen 2.4 Overall (Left) and Cracking at Dead End Pourback (Right)

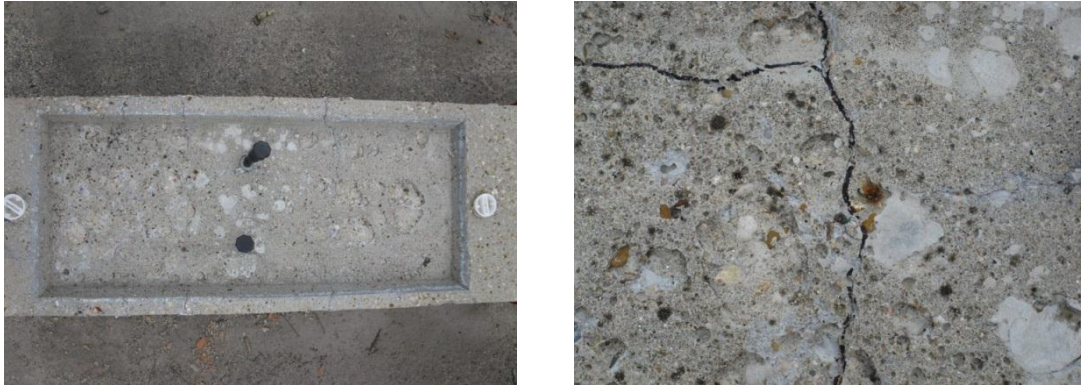
*Figure 5.62: Specimen 3.1 Top Surface (Left) and Corroded Wire Tie at Top Surface (Right)*

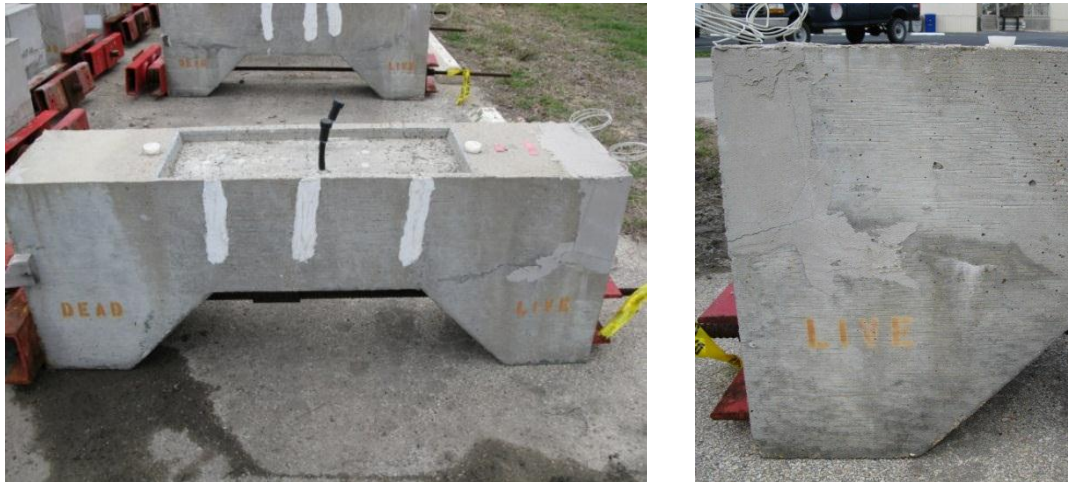
Figure 5.74: Specimen 3.2 Overall (Left) and Efflorescence at Live End Corbel Crack

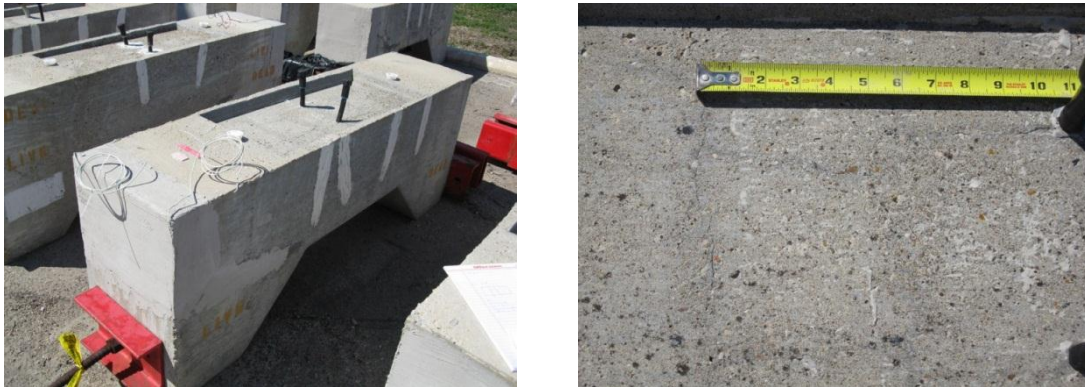
*Figure 5.86: Specimen 3.4 Overall (Left) and Discoloration Around Surface Cracks (Right)*

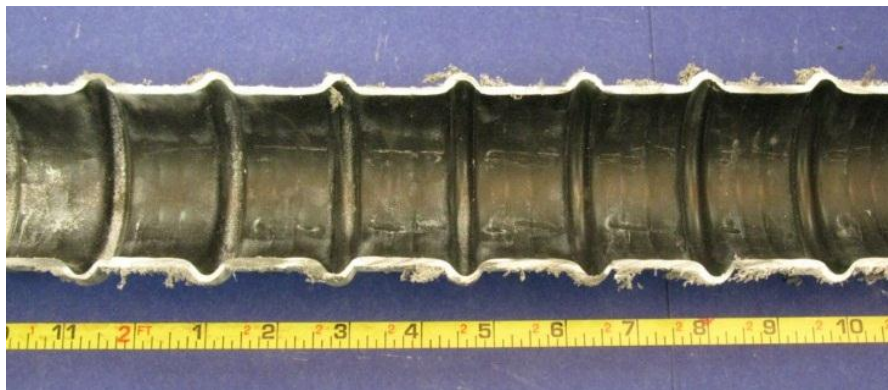
***Figure 5.89: Specimen 3.4, Strand Gouging on Bottom of North Duct***

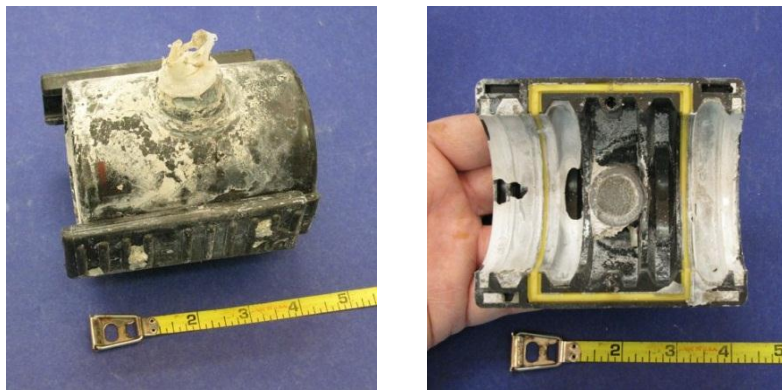
**Figure 5.90: Specimen 3.4 North Duct Coupler Outer Surface (Left) and Breach in Upper Gasket (Right)**

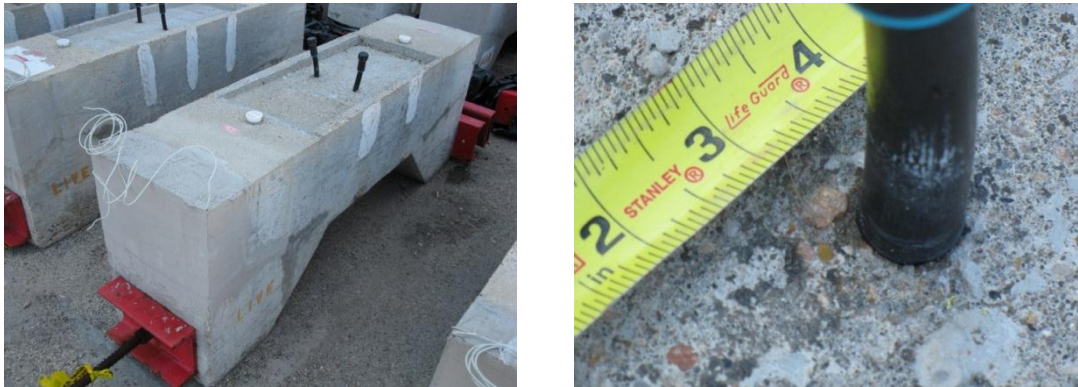
*Figure 5.96: Specimen 4.2 Overall (Left) and Discoloration Around North Grout Vent (Right)*

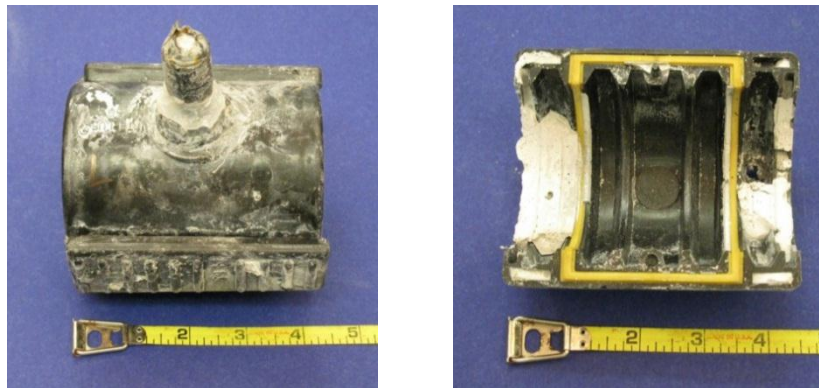
***Figure 5.99: Specimen 4.2 Coupler Outer Surface (Left) and Lower Gasket Breach (Right)***

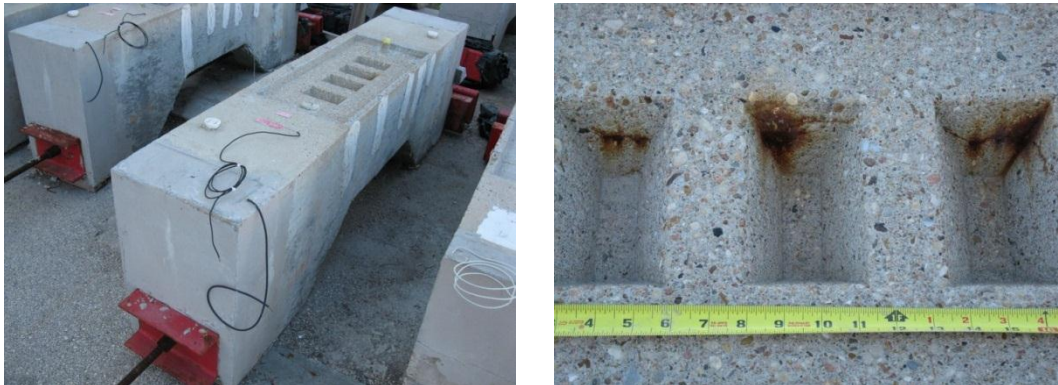
*Figure 5.106: Specimen 7.1 Overall (Left) and Corrosion Staining in Saltwater Tray Wells (Right)*

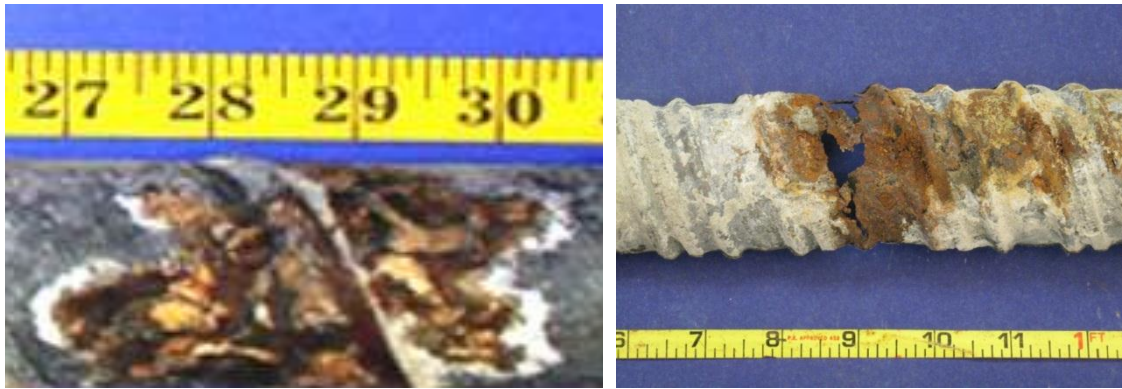
*Figure 6.20: Typical Galvanized Steel Duct from Project 0-1405<sup>8</sup> (Left) and Project 0-4562 (Right)*
