**Corrosion Performance of Epoxy-Coated Reinforcement in
Aggressive Environments**

Dissertation

The University of Texas at Austin

May, 1998

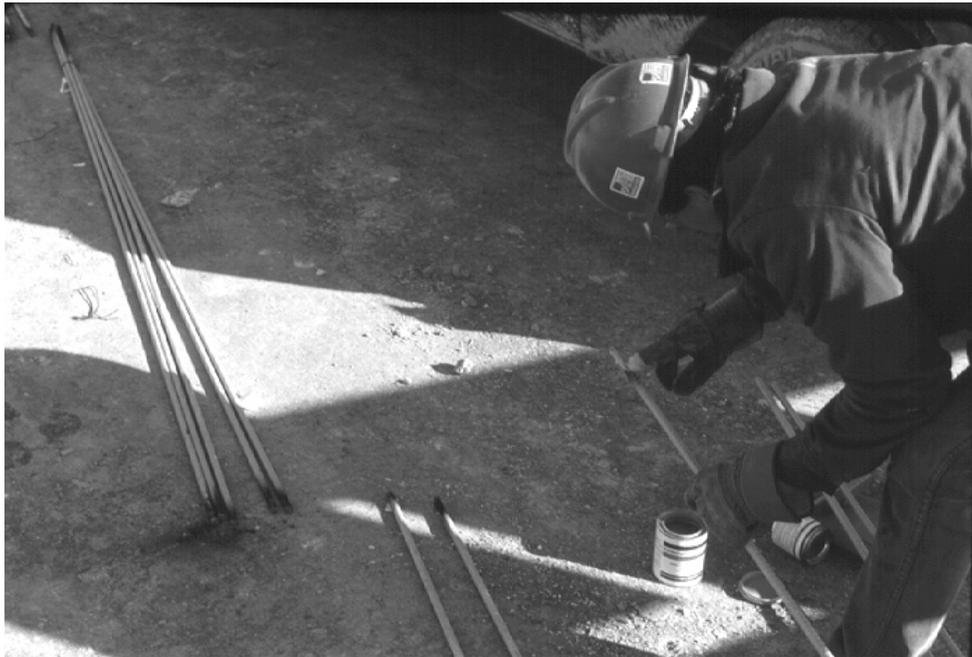
Figure 6.1: Improper field practice: Epoxy coated bars were flame cut and, immediately thereafter, bar ends are being touched up by hand.

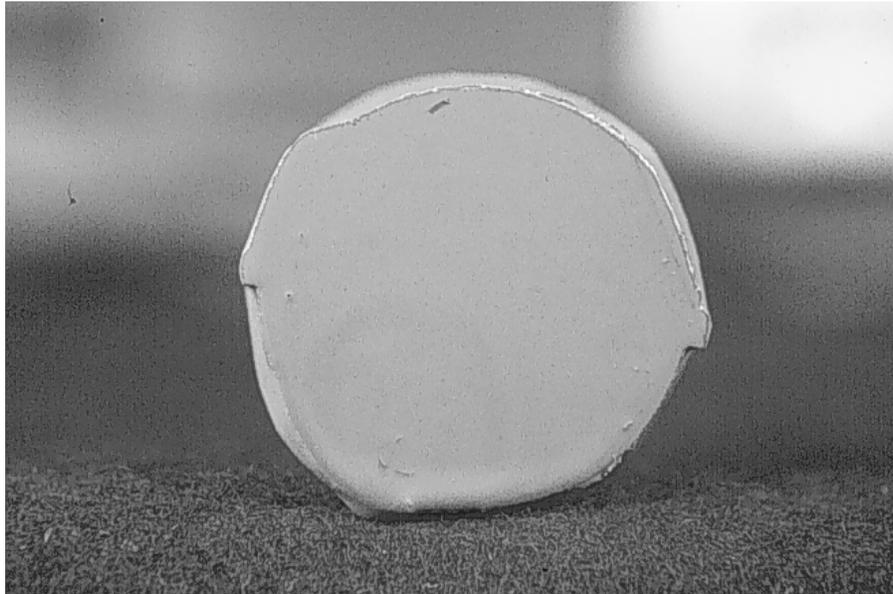
Figure 6.15: Visible steel due to very thin patch around perimeter edge on bar end.

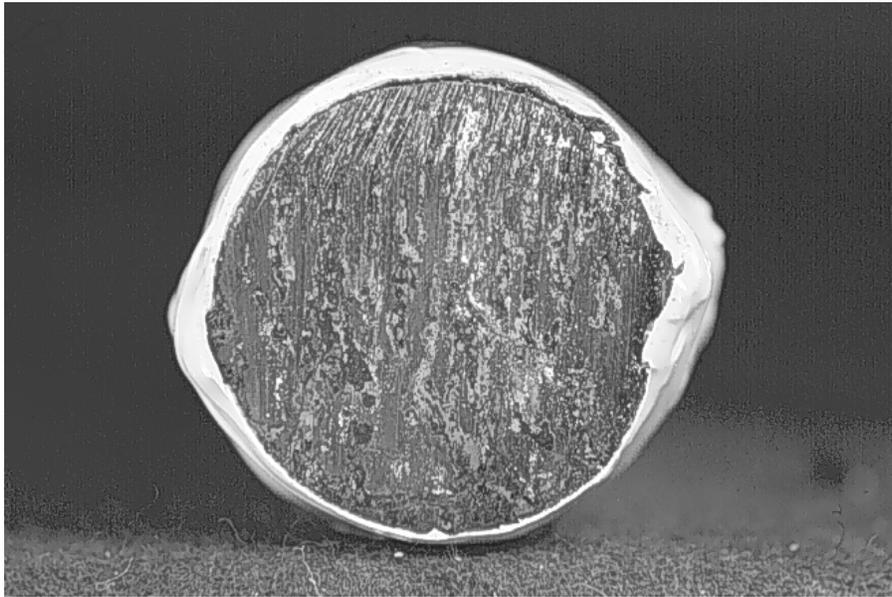
Figure 6.17: Appearance of bar end surface after 200 days of exposure to 3.5% NaCl solution. Surface was not cleaned before patching. This specimen exhibited good corrosion performance.

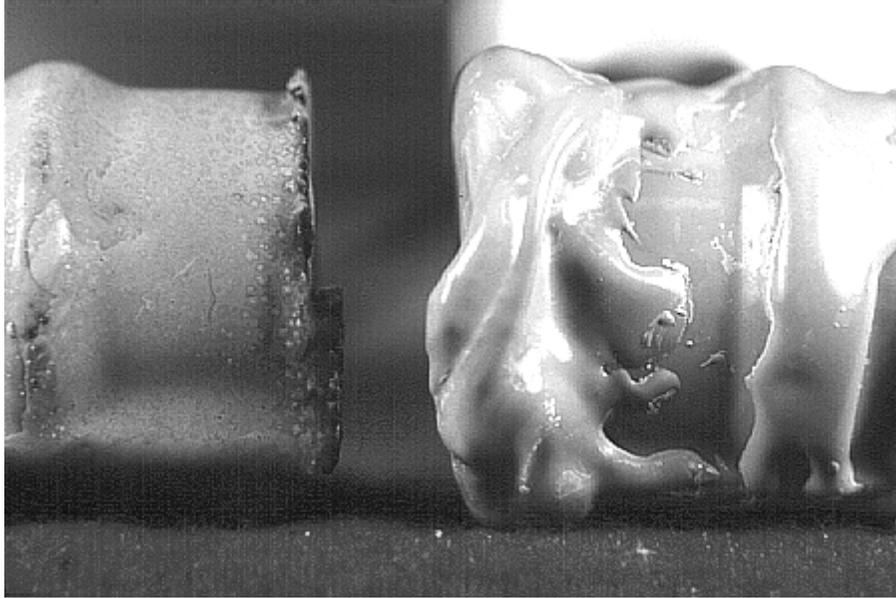
Figure 6.25: Patching material *A* (left side specimen) performed worse than material *C* (right side specimen).

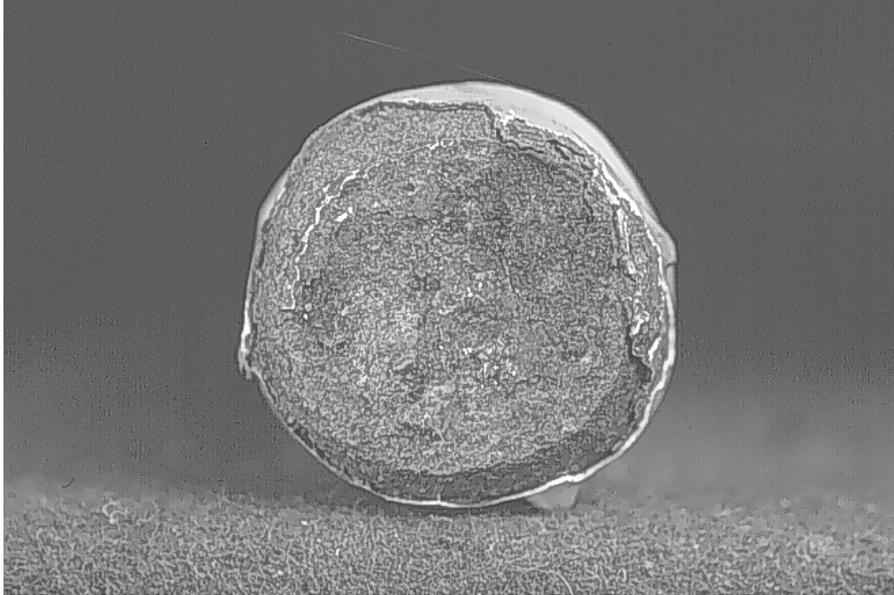
Figure 6.29: Corrosion of bar end surface that was specially cleaned before patch application.

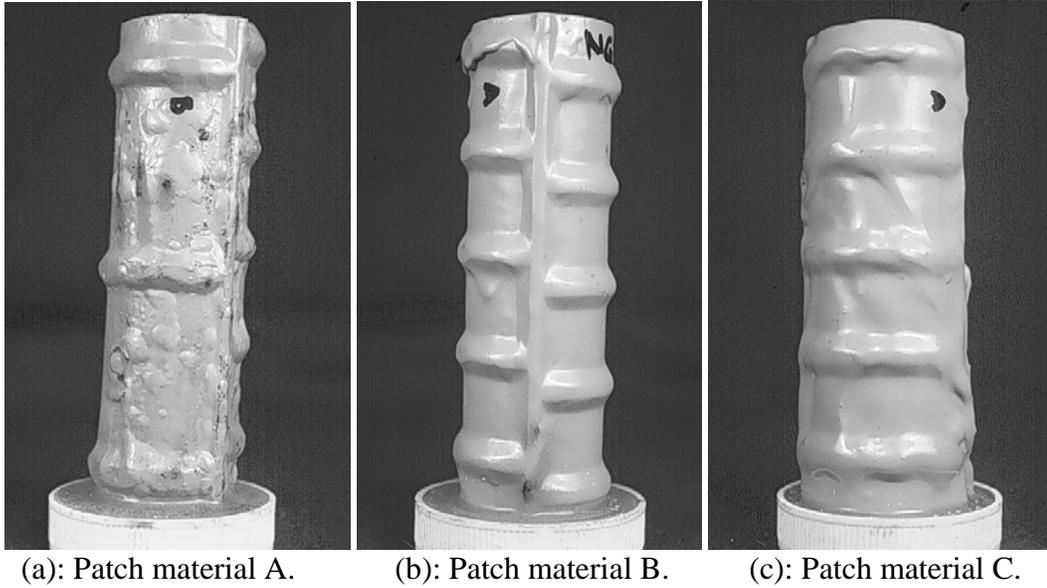
Figure 6.34: Surface condition of specimens coated with patching materials A, B, and C after 100 days in 3.5% NaCl solution.

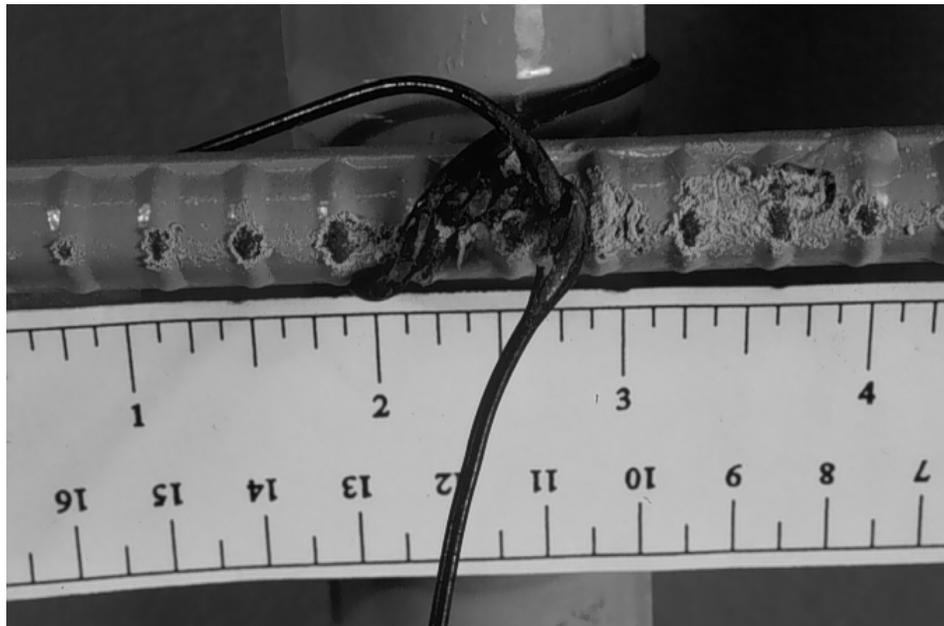
Fig. 7.5: Damage to stirrup coating and coated tie caused by metal head vibrator.

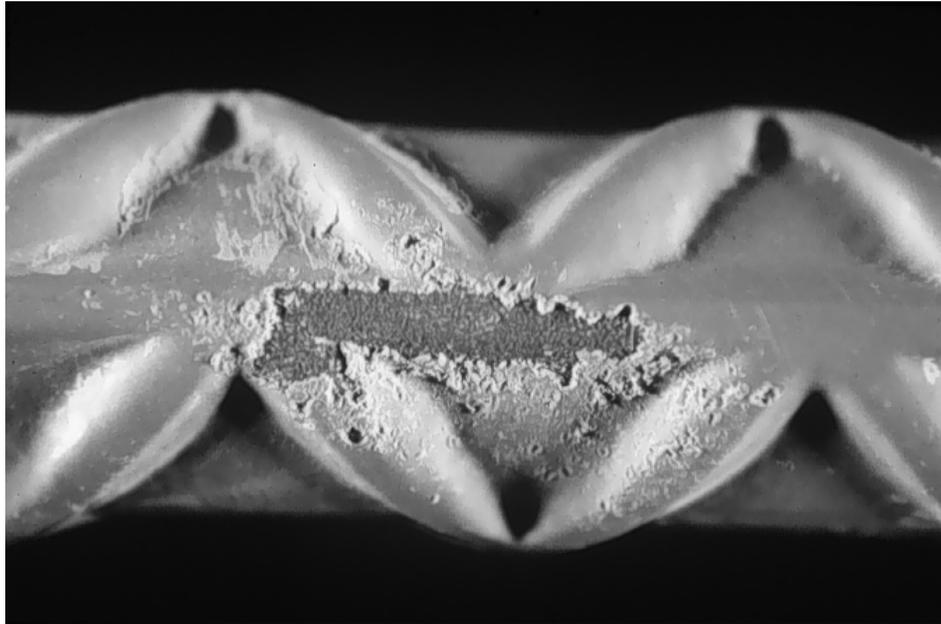
Fig. 7.6: Damage to coating caused by metal head vibrator on test bar from Phase 1 study.

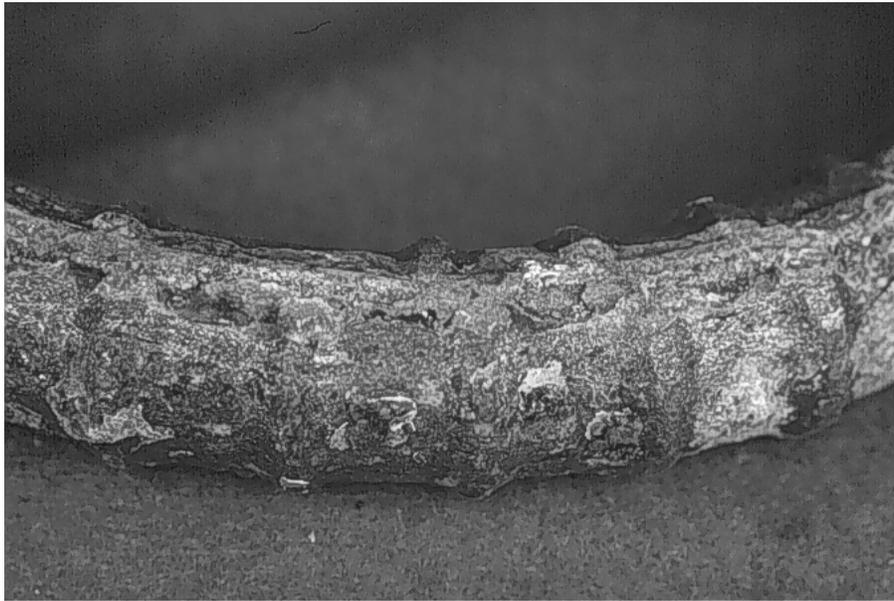
Fig. 8.34: Shallow pitting and accumulation of rust products on steel surface under the coating (outside bend).

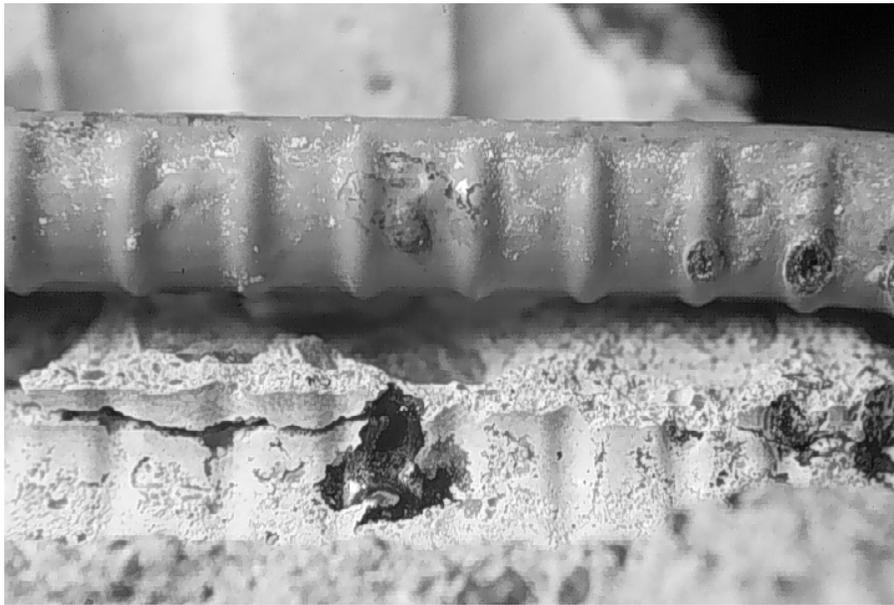
Fig. 8.61: Blisters always formed adjacent to concrete voids.

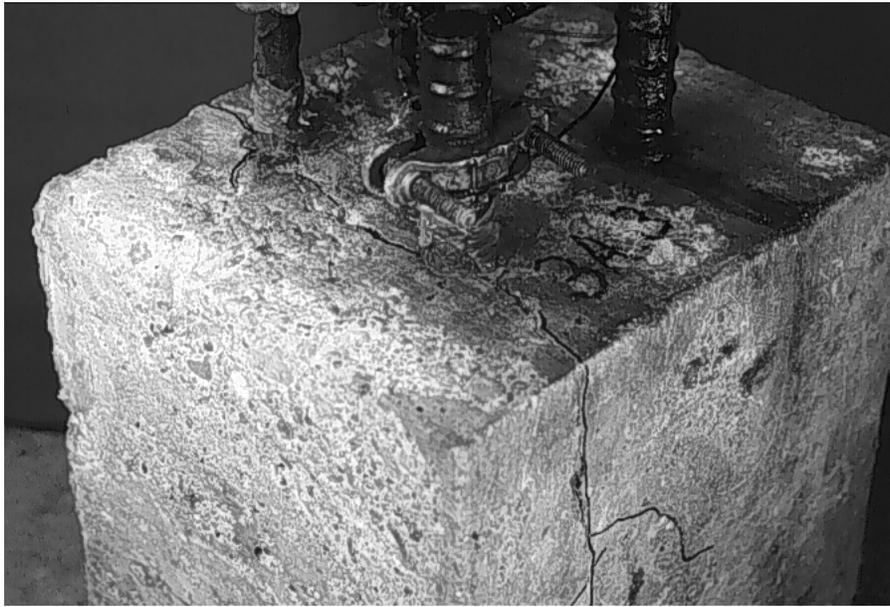
Fig. 8.64: Severe concrete scaling on specimen 3A.8 with uncoated bars.

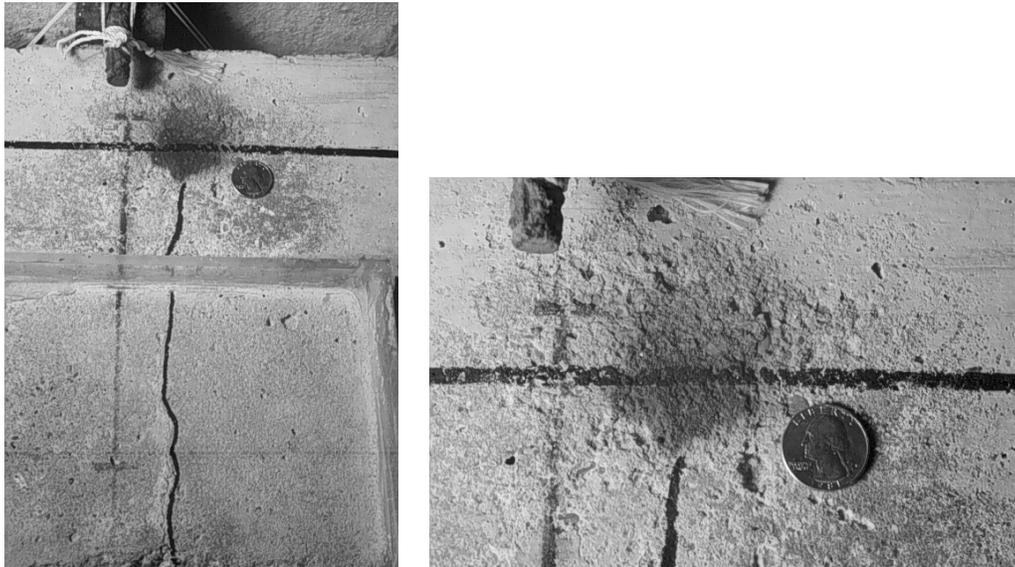
Figure 9.48: Rust spot on top surface of beam B17 at black bar location at midspan.

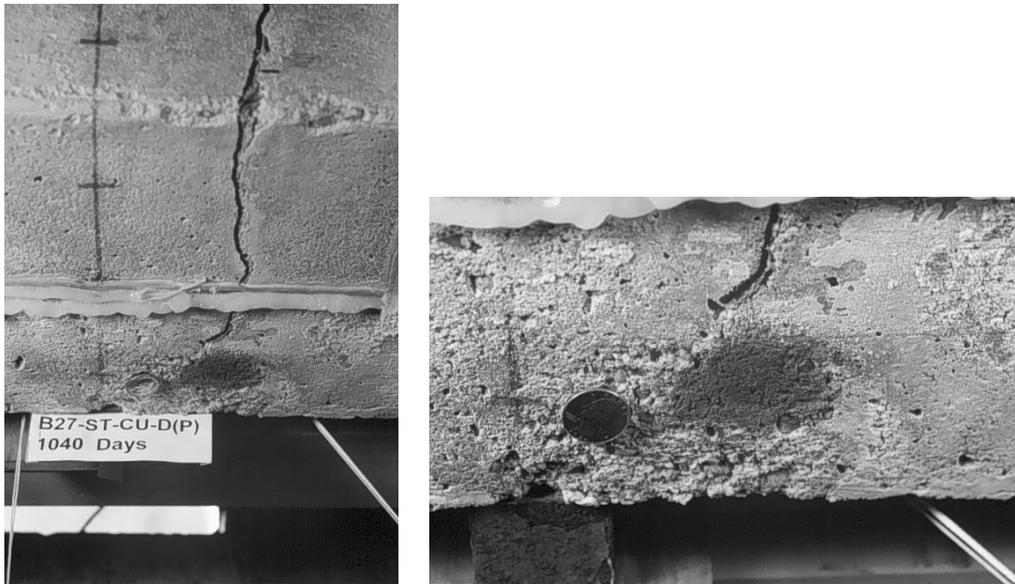
Figure 9.49: Large rust spot on bottom surface of beam B27 at black bar location at midspan.

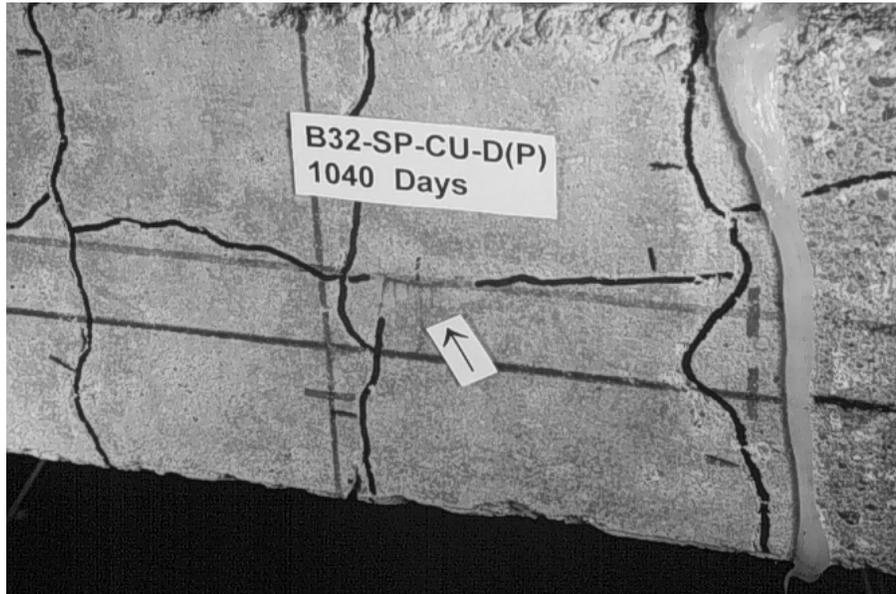
Figure 9.50: Horizontal cracking on front surface of beam B32.

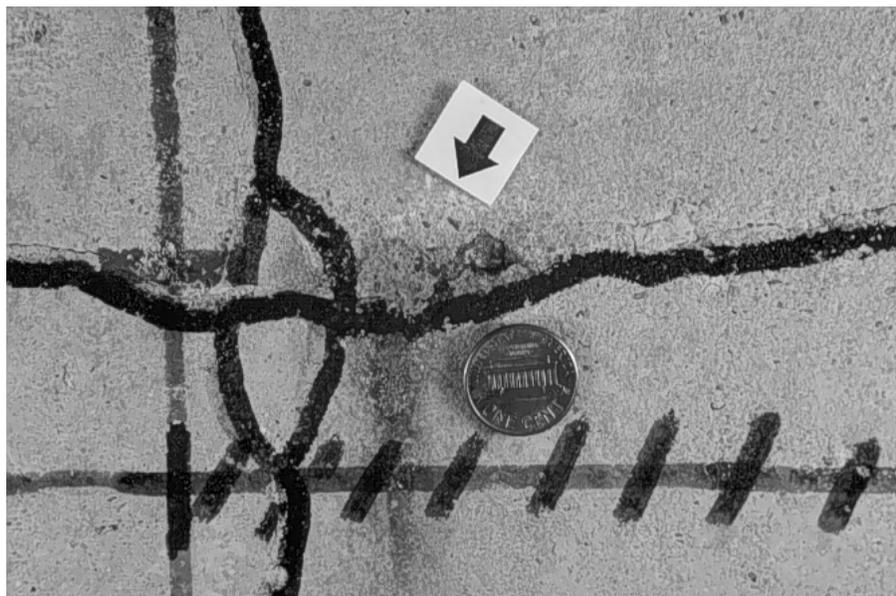
Figure 9.51: Rust exuding through cracks on front surface of beam B32

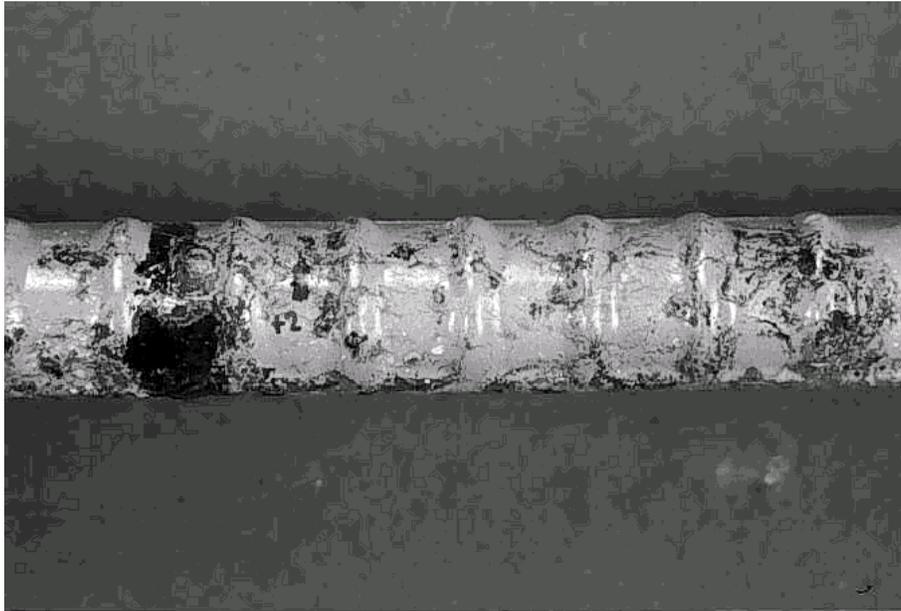
(a) Rust stains at lower bar of beam B10, portion within the wetted zone. Damaged spot at crack location.

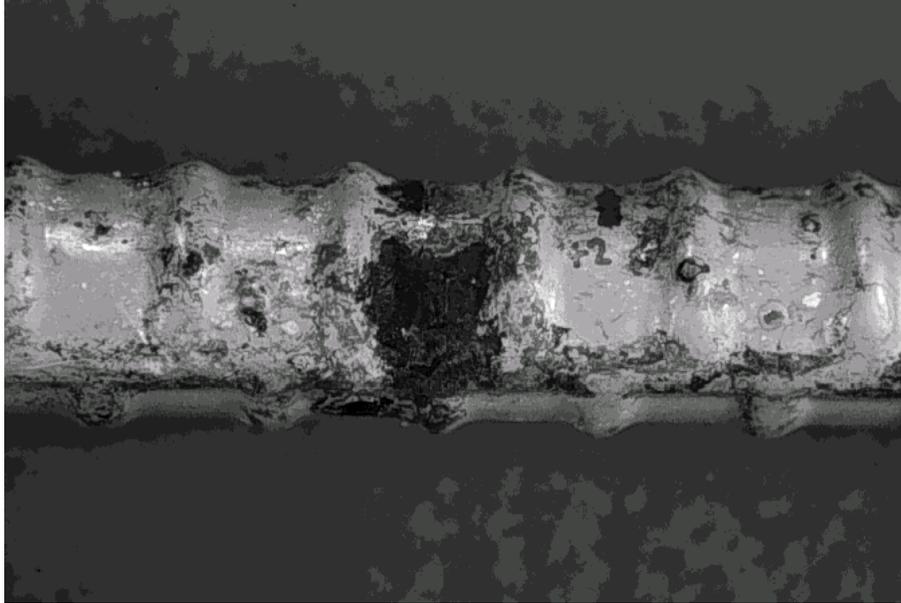
Figure 9.54: Build up of rust products at damaged spot on bar from beam B10.

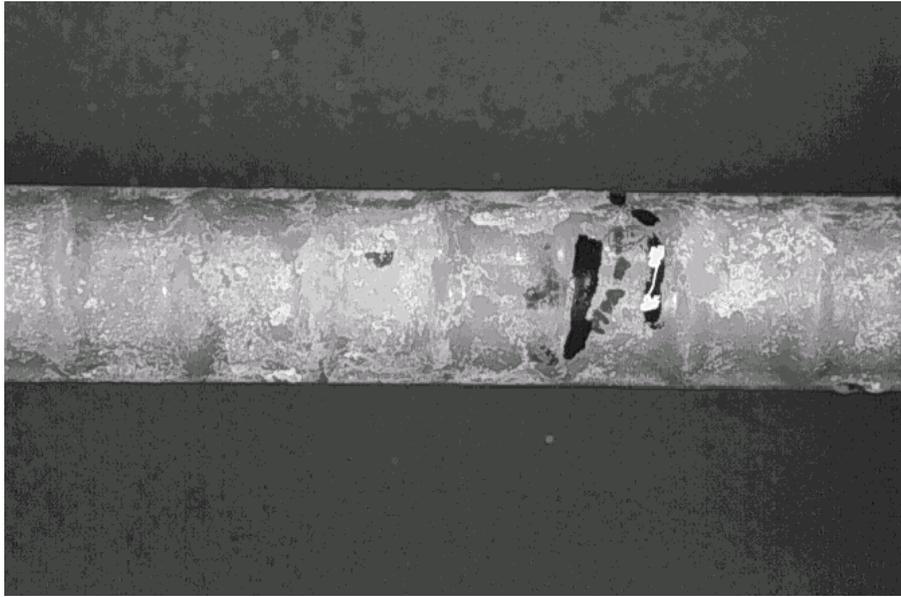
Figure 9.56: Aspect of uncorroded patched area on upper bar in beam B14, near crack location within the wetted zone.

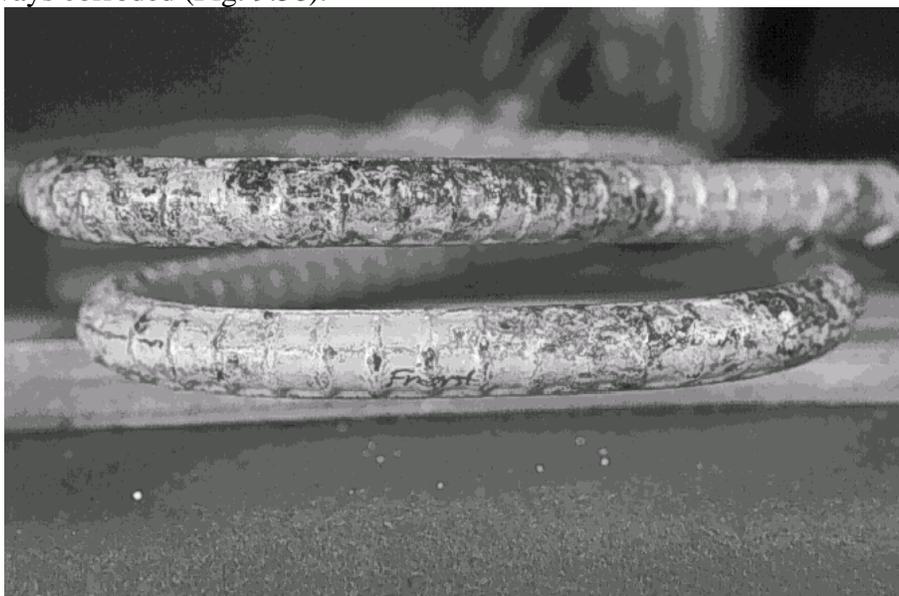
Figure 9.57: Rust staining of stirrup from beam B17 (portion within the wet zone).

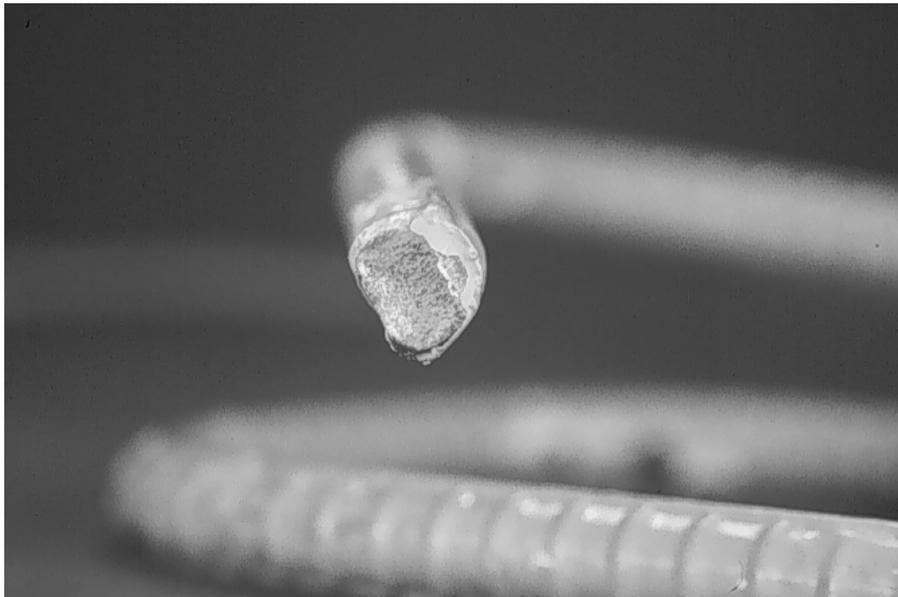
Fig. 9.58: Patch at bar end of a stirrup hook that broke during autopsy (beam B23). Metallic surface beneath the patch was uncorroded.

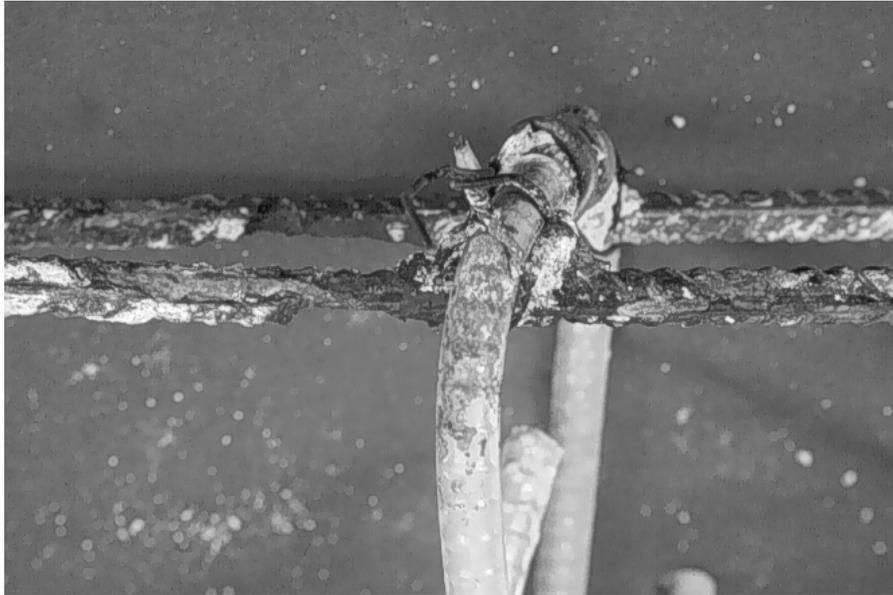
(a) Severe pitting on lower black bar near coated stirrup (beam B23).

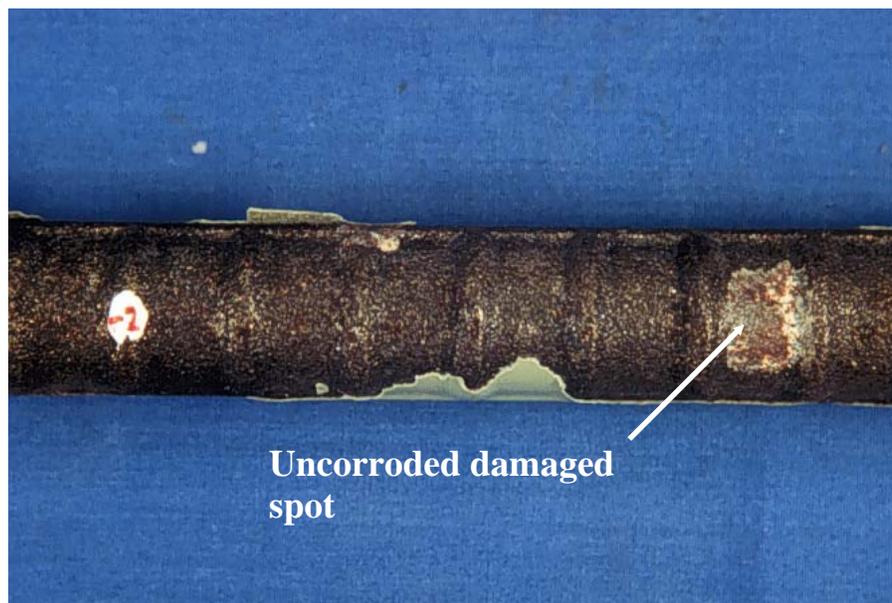
Fig. 9.70: Mottled surface at lower bar of beam B8 within the wetted region.

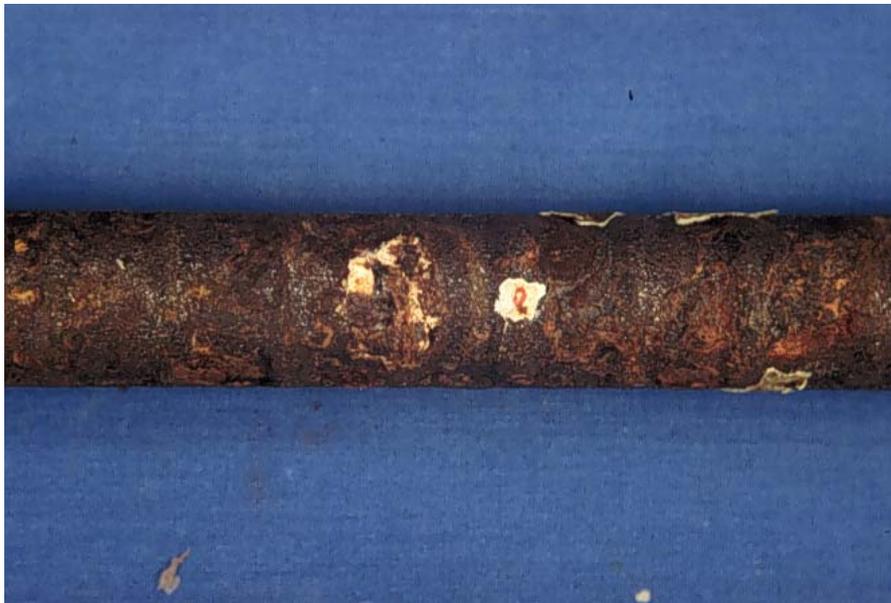
Fig. 9.71: Dark corroded surface on longitudinal upper bar of beam B8 within the wetted region (zone at midspan).

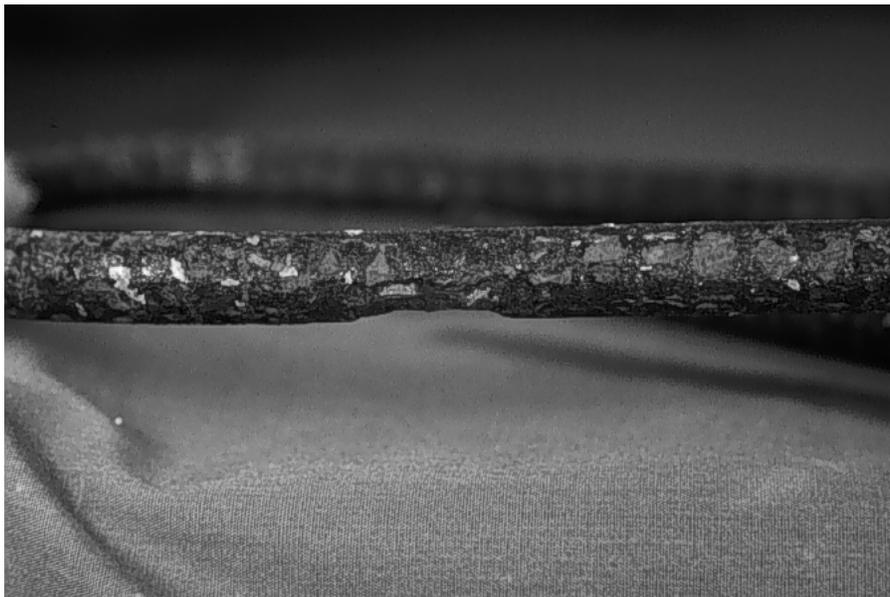
Fig. 9.72: Pitting on stirrup leg near the bottom beam surface (beam B17).

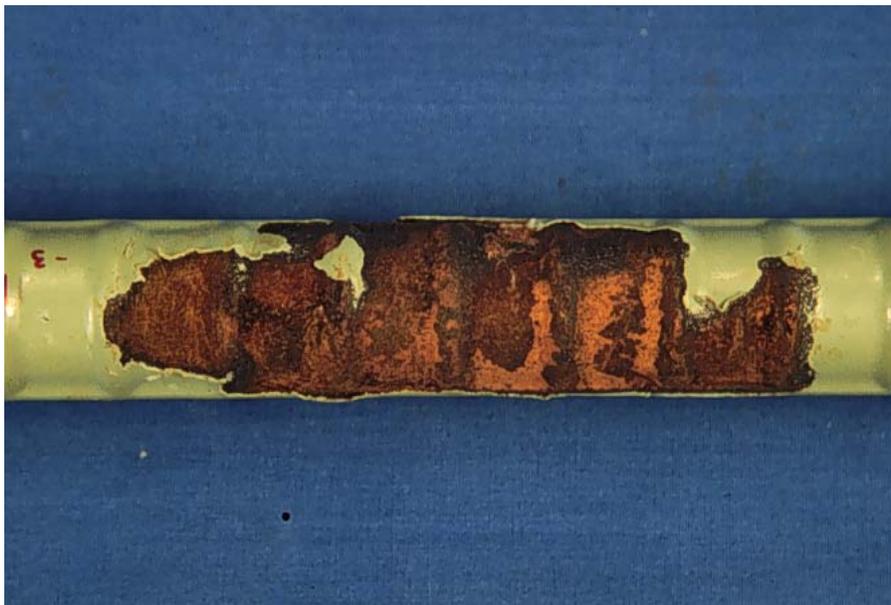
Fig. 9.73: Reddish-brown rust products on lower bar of beam B8 (Zone just outside of wetted region).

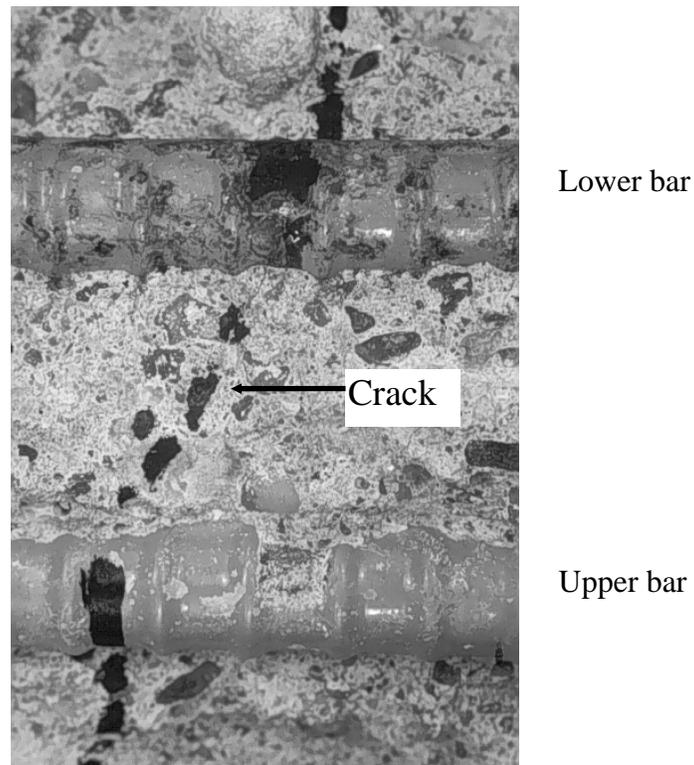
(b) Uncorroded damaged spot near a crack on upper bar. Damaged spot at crack location experienced extensive corrosion on lower bar.

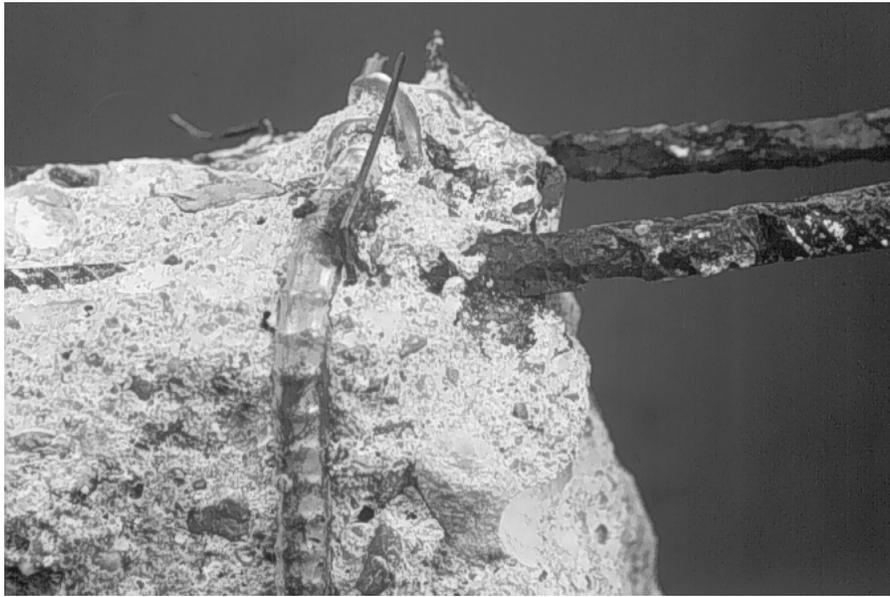
Fig. 9.87: Pitting corrosion of uncoated bars at crack location (beam B25).

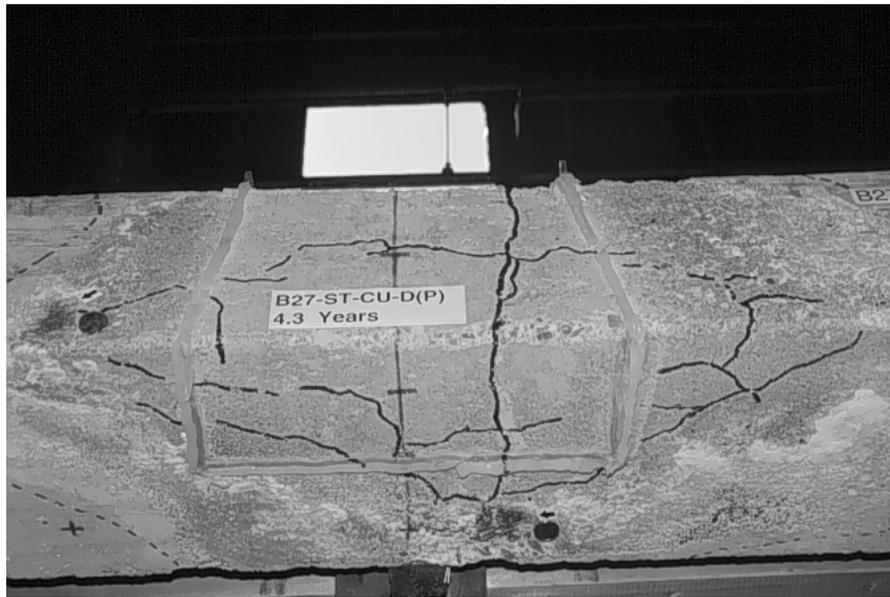
Fig. 9.94: Random cracking at and around wetted region of beam B27.
