PMFSEL REPORT NO. 06-01

**Investigation of the Vibrations on Overhead
Sign Bridges on US290/SH71**

FINAL REPORT

**Department of Civil Engineering
The University of Texas at Austin**

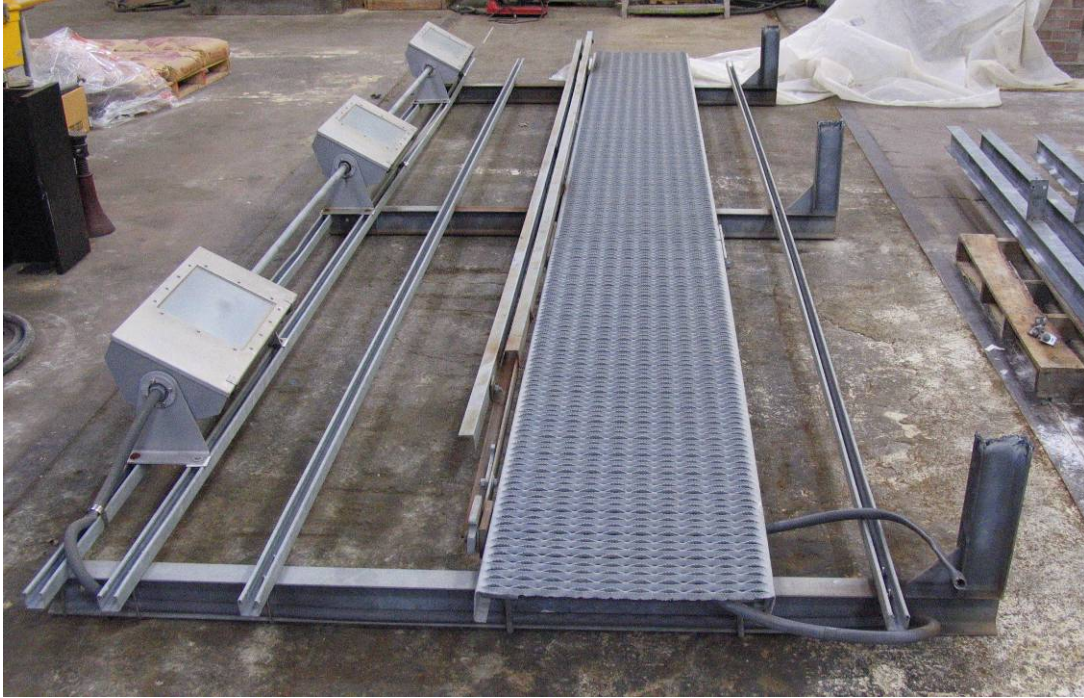
Figure 1.2 Horizontal Leg of L Frame

The critical location for fatigue cracking is the connection between the vertical and horizontal elements of the supporting L frame. Figure 1.2 shows the horizontal portion of the L frame with walkway and lights mounted. The vertical part of the L frame was cut off for shipping. A close-up of the welded connection is shown in Figure 1.3.

1. Remove the horizontal cantilever portion of the wide flange L brackets. This will reduce the vibrations in the OSB and eliminate the fatigue prone weld detail at the connection of the vertical and horizontal legs of the bracket.
2. Tighten all bolts on the sign bridge using the turn of the nut method. Loose bolts have been found in an inspection prior to this study. The movement of the sign bridge will loosen bolts unless they are properly tightened.
3. Mount the sign as close as possible the bridge pier to reduce the movement of the highway bridge at location of the OSB.

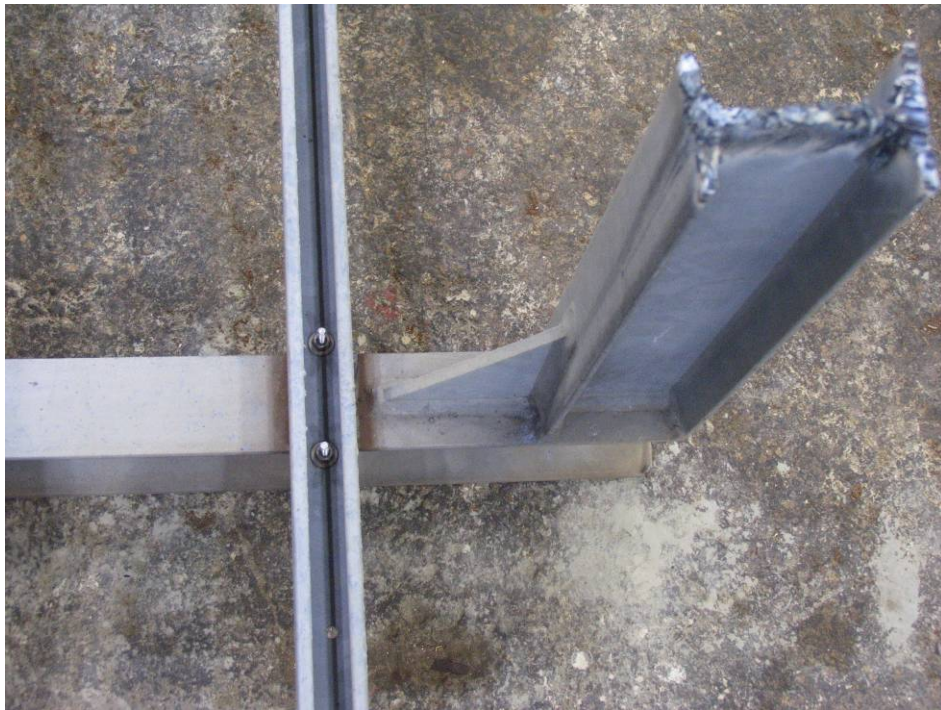
Figure 1.3 Critical Fatigue Detail

The ends of the stiffener fillet weld on both the vertical and horizontal leg are probable locations for fatigue cracking. These locations were visually examined. No fatigue cracks were found.

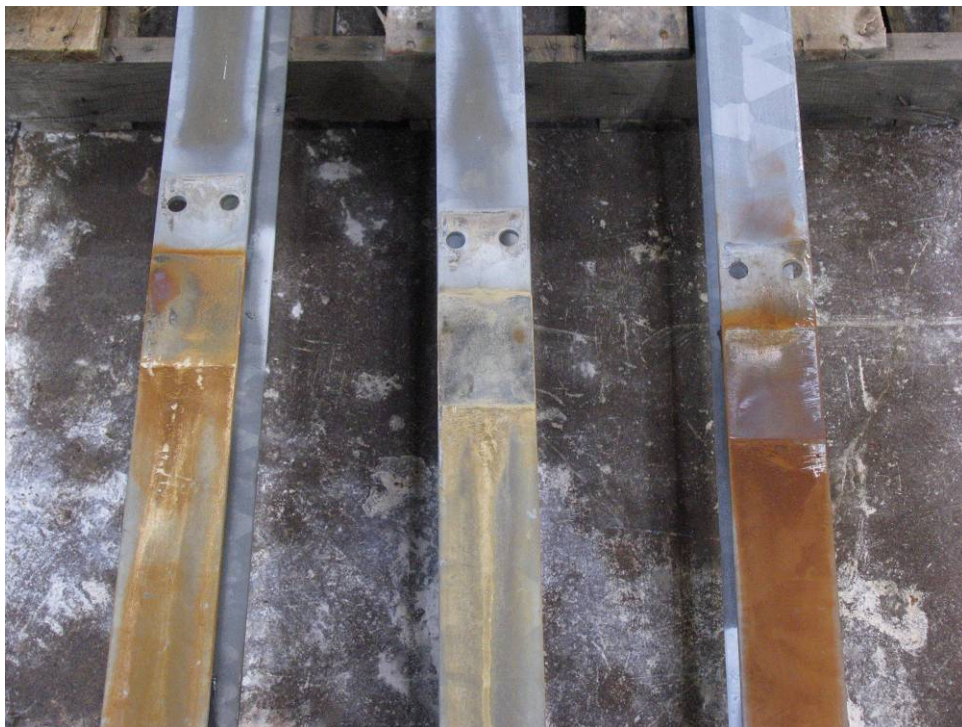
Figure 1.4 Fretting and Rust Staining on Vertical Supports

The mounting points between the L frame and the OSB showed signs of movement between the two structures. The galvanizing had worn away and corrosion staining was evident as shown in Figure 1.4. Considerable fretting has occurred at the connection point, which has removed the zinc coating from the support. The sign serves as a shear diaphragm between the L frames, causing them to resist the deformation of the OSB. Rust stains below the connection on other structures are as a visual indicator of OSB oscillations.

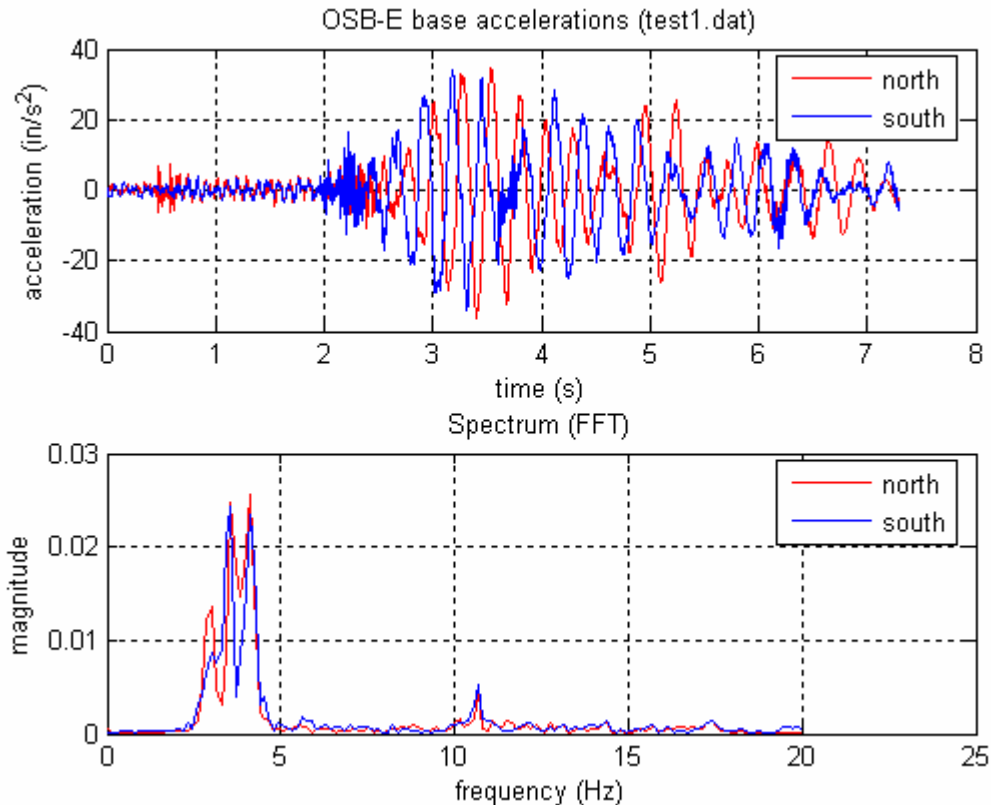
Figure 2.4 Horizontal Vibration of OSB-E

Time series acceleration data was recorded under normal weekday traffic conditions. Figure 2.4 illustrates a typical event in which the motion of the bridge deck at the OSB-E location, measured at the north and south sides of the bridge, increases rapidly from a very quiet, low-motion state to vibrations in excess of 0.1 g. The spectral analysis of the data indicates that the dominant responses of the highway bridge are at frequencies above and below the frequency of 4.2 Hz excited in the pluck test. The measured acceleration was caused by the passage of a truck on the bridge. The measured bridge deck acceleration was as high as 0.2 g. Although the peak displacements of bridge deck are calculated to be no more than 0.1 inch, human observers standing on the bridge deck

Large amplitude motion was observed visually on OSB-E. Movement is especially noticeable at the tips of the horizontal arms of the L-brackets supporting the lights and walkway. The acceleration measurements taken at the OSB horizontal truss had peaks as high as 360 in/sec^2 (0.94 g) at the top of the south column and 266 in/sec^2 (0.69 g) at the midspan of the OSB truss in the east-west motion of the OSB which is parallel to traffic direction.

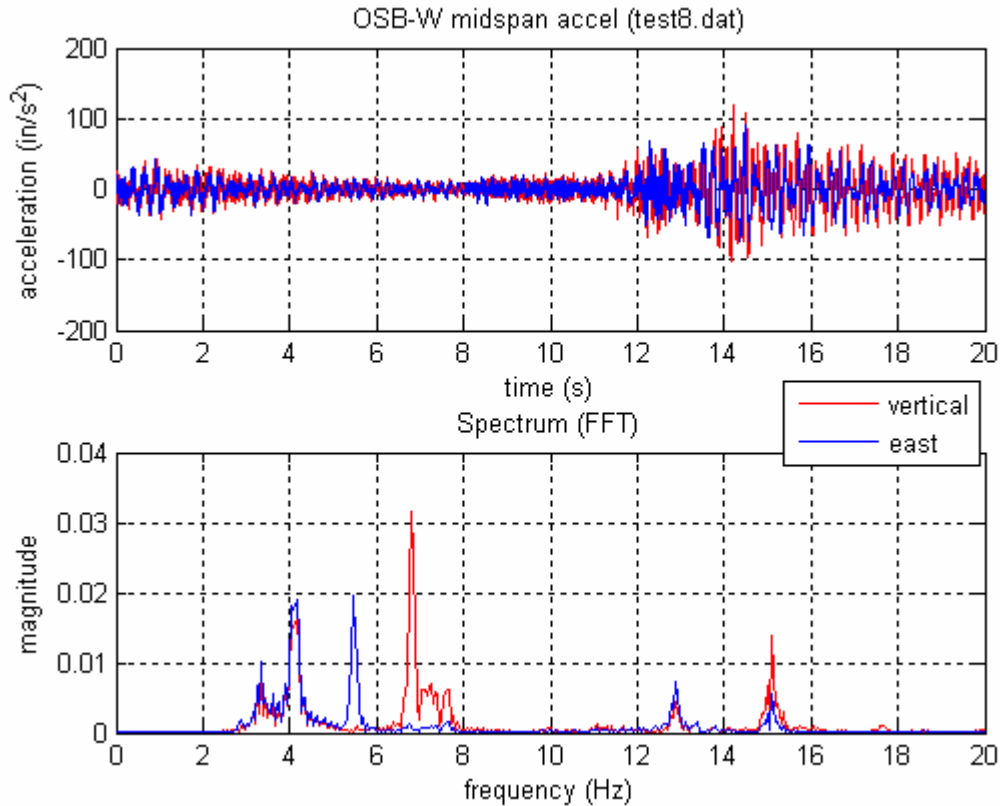
Figure 2.5 Oscillations of OSB-W

OSB-W exhibited little observable motion under traffic. This can be attributed to the lack of attachments (i.e. signs and cantilever supports with the walkway and lights in front of the signs). The measured accelerations were also considerably lower than those of OSB-E with vertical midspan peak amplitude of 119 in/sec^2 (0.31 g) in the event shown in Figure 2.5. The large spectral peak near 7 Hz appearing in the vertical midspan motion signal is similar to the pluck test. Also noteworthy is the typically rapid onset of the oscillation after a period of low motion.

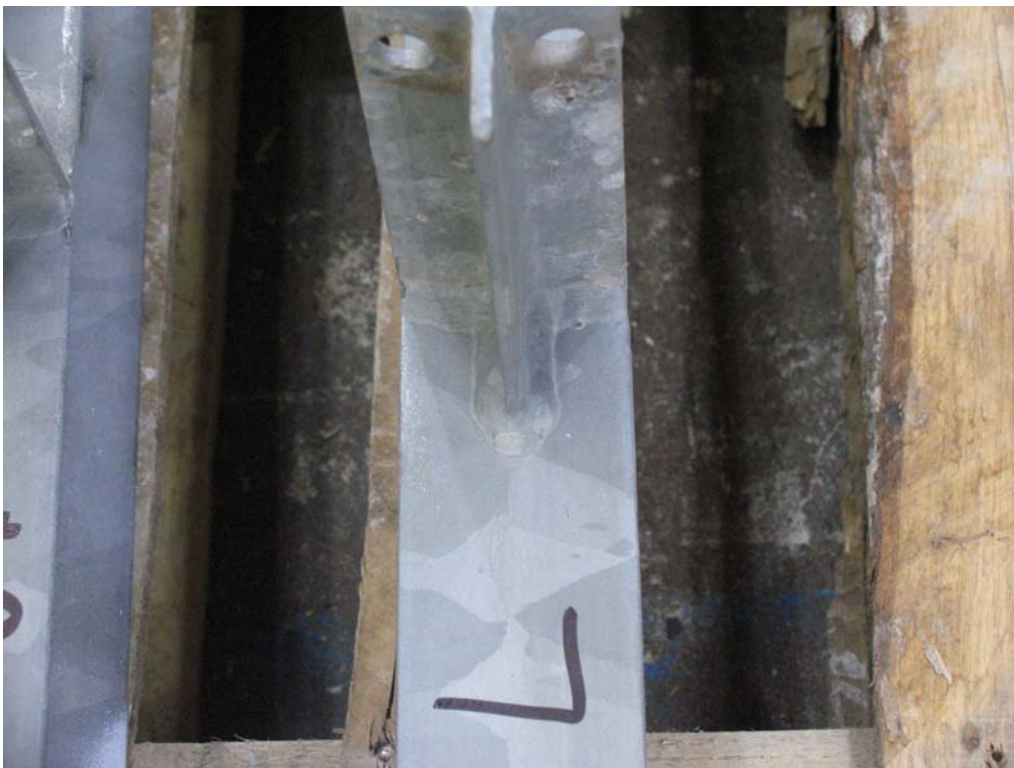
Figure 2.14 Support Bracket Weld Detail

Fatigue of the sign bridge structure was not found to be of concern. The calculated and measured stress ranges in the bolted truss members and the welds on the vertical supports were too small to cause fatigue problems. The welds connecting the two legs of the small W shape L brackets, which are used to mount the sign and support the walkway and lights in front of the sign, were found to be of concern. The maximum stress range measured was from 9.6 to 13.9 ksi with an effective stress range of 1.9 to 2.2 ksi. The expected minimum fatigue life would be less than 10 years. The analytical study indicated that removal of the cantilever portion of the L bracket along with the walkway and lights reduced the dynamic oscillations of the OSB for some modes of highway bridge vibration.
