# **Evaluating the Redundancy of Steel Bridges:**

# Full-Scale Destructive Testing of a Fracture Critical Twin Box-Girder Steel Bridge

# Thesis

The University of Texas at Austin May, 2009 **Evaluating the Redundancy of Steel Bridges:**

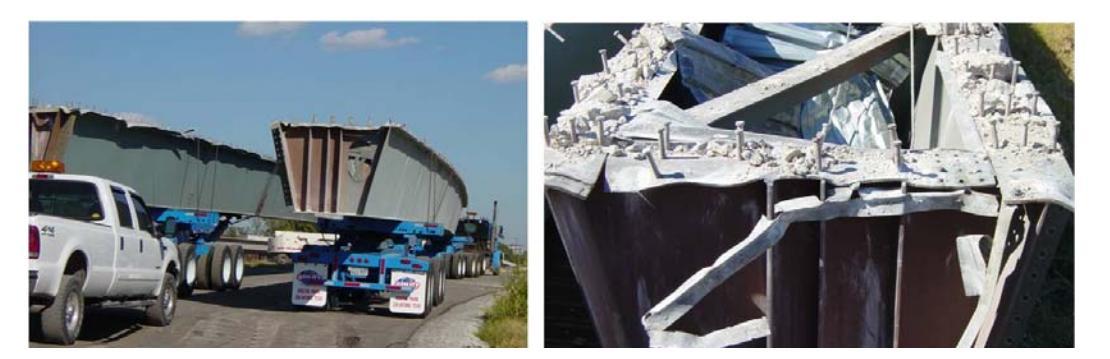
Figure 2-6 (left): Transportation of the girders Figure 2-7 (right): Girder damage resulting from deconstruction

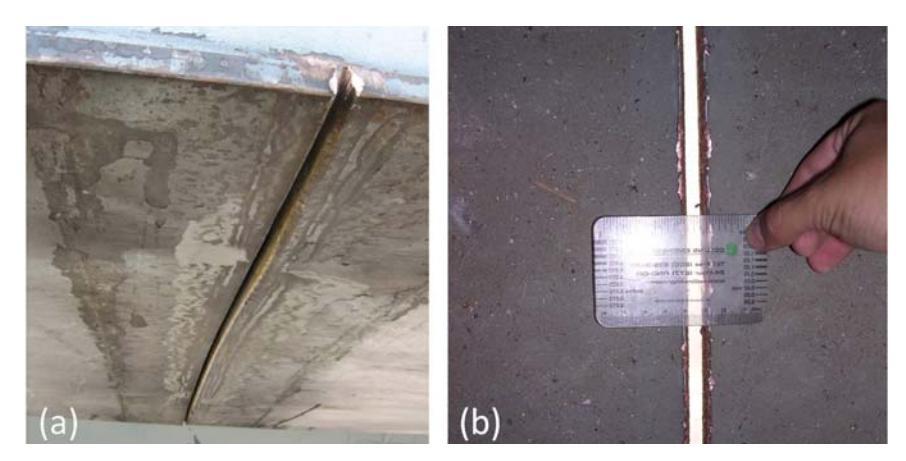
The explosion successfully induced a fracture in the bottom flange of the exterior girder. The fracture extended the complete width and depth of the bottom flange, and was a consistent 0.25-in. thick across its length (Figure 4-2). The fracture did not extend into the webs of the girder. Thus, despite losing one of its primary tension resisting elements (i.e., a fracture critical component), the fractured girder was able support the load without any further material failures. The tension forces previously carried by the flange were simply transferred to the intact components of the bridge system, including the webs in the area of the fracture, which showed minimal signs of distress (Figure 4-3).

Figure 4-2: (a) Underside view of the fracture showing its full depth and length, (b) Inside view of the fracture showing its width

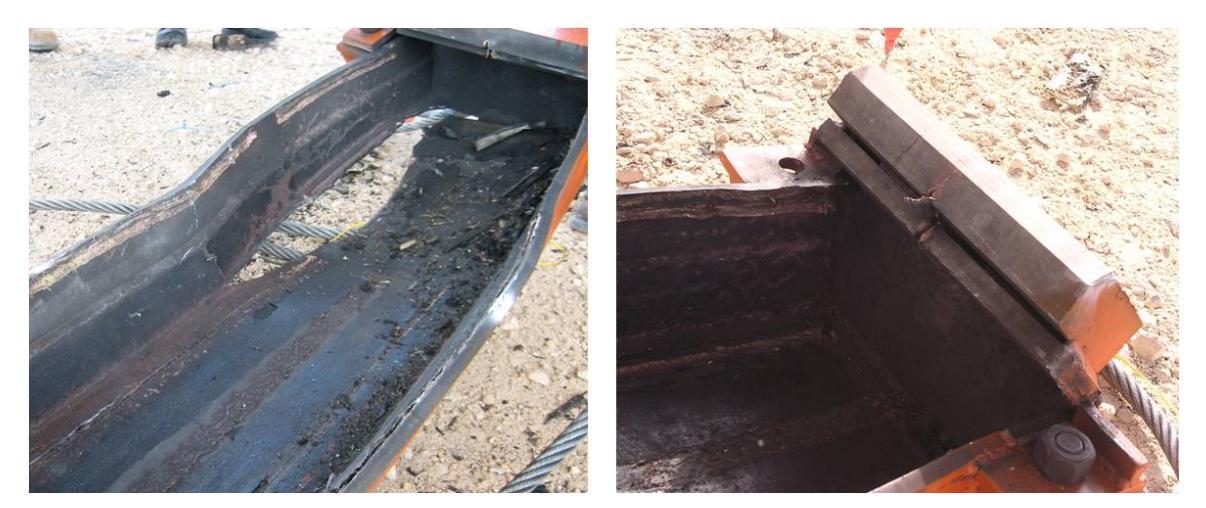
Figure 4-6 (left): Rupture of the web to flange connection of the channel section Figure 4-7 (right): Damage to the 2 in. capping sections, including partial fracture and weld rupture

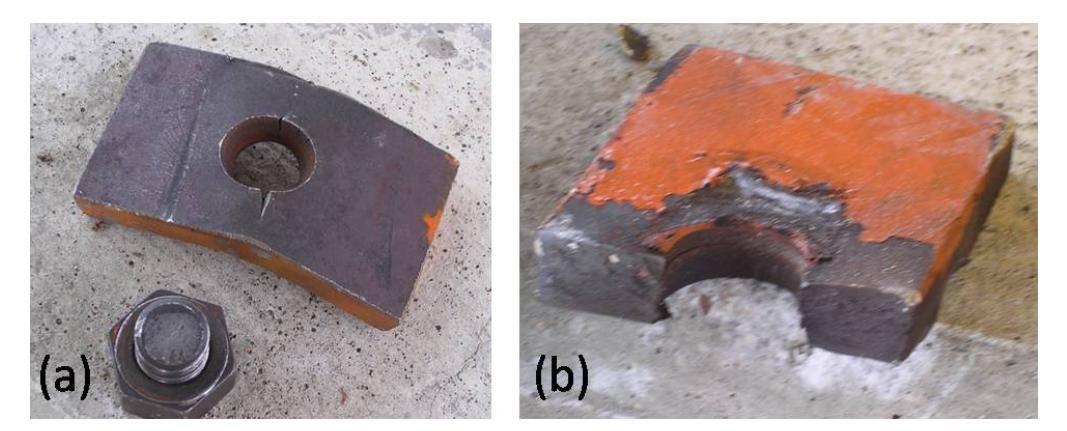
Figure 4-8: (a) Undesirable bolt rupture at tab of hanging angle connection, (b) Desirable tab rupture

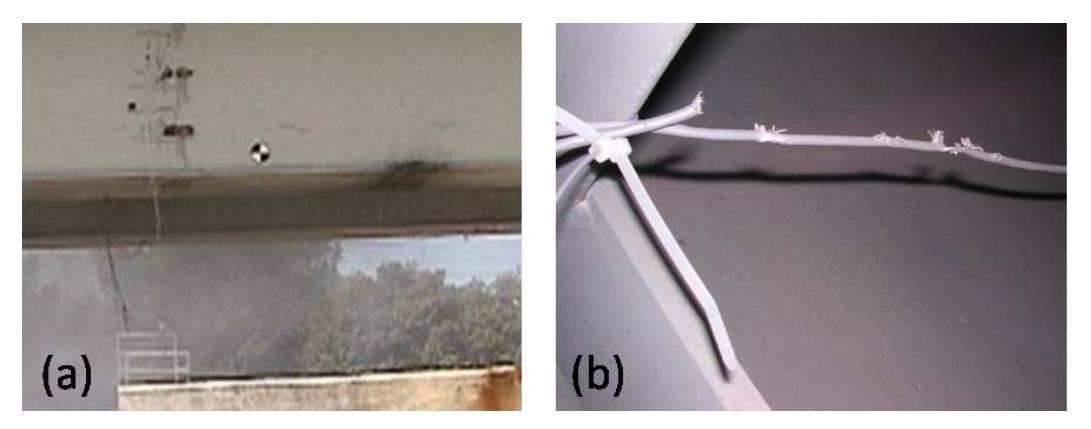
Figure 4-10: (a) Disconnected wires just south of the fracture location, (b) Shredded wires inside the fractured girder near the fracture location

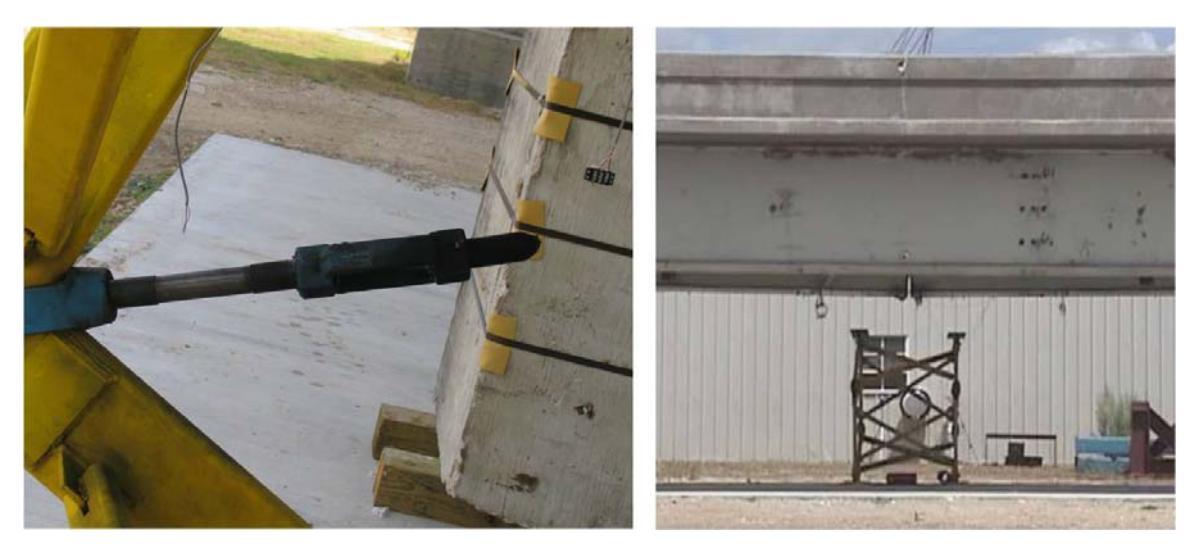
Figure 6-2 (left): Completely severed tension-tie Figure 6-3 (right): Rear view of the test-bridge showing differential deflection between the two girders

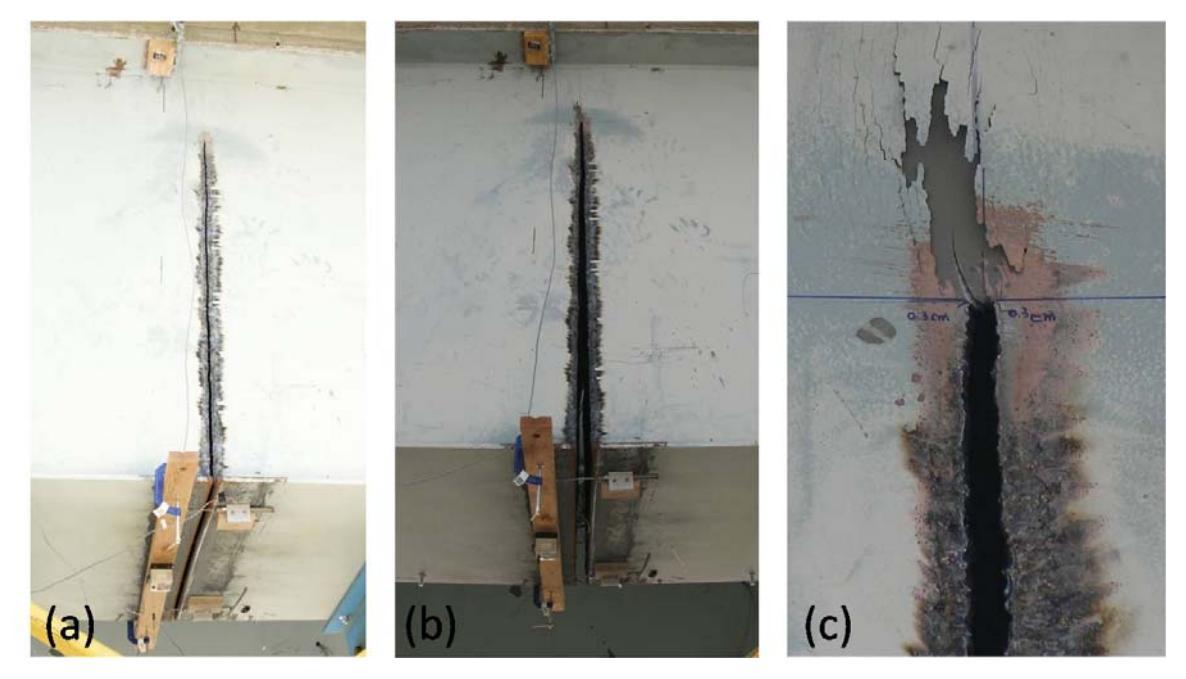
Figure 6-6: View of (a) the fracture before releasing the scissor-jacks, (b) the fracture after releasing the scissor-jacks, (c) the 1 in. propagation of the fracture on the exterior web of the fractured girder

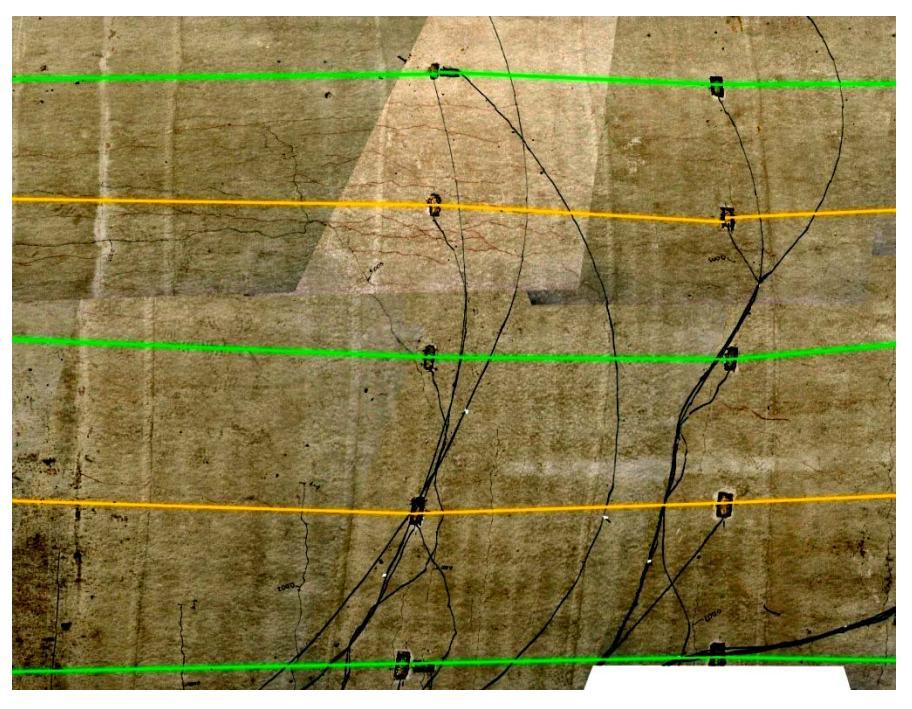
Figure 6-9: Crack map section, faintly showing cracks above the interior flange of the intact girder

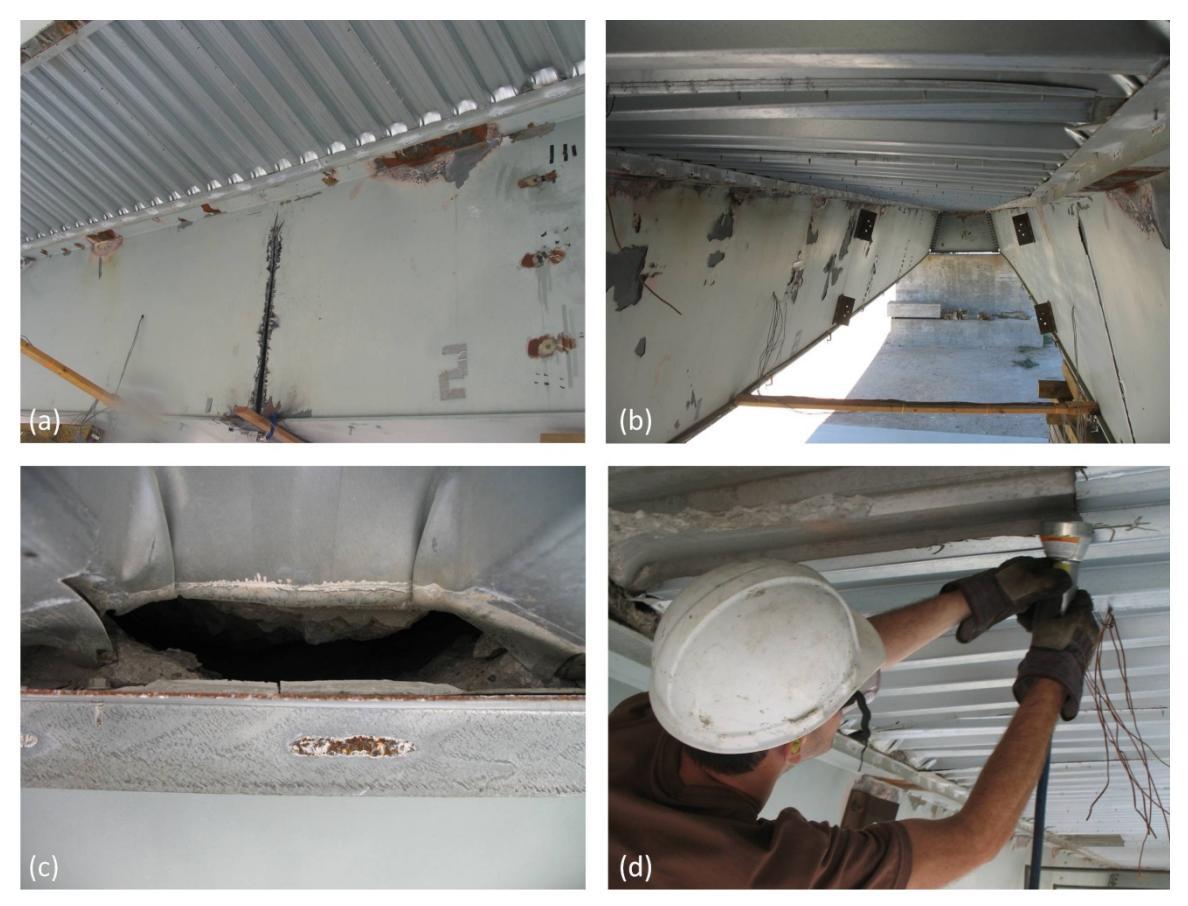
Figure 6-14: (a) Ground view showing no clear signs of damage, (b) Deck level view showing deflection, (c) View into metal formwork showing separation, (d) Cutting away the metal formwork

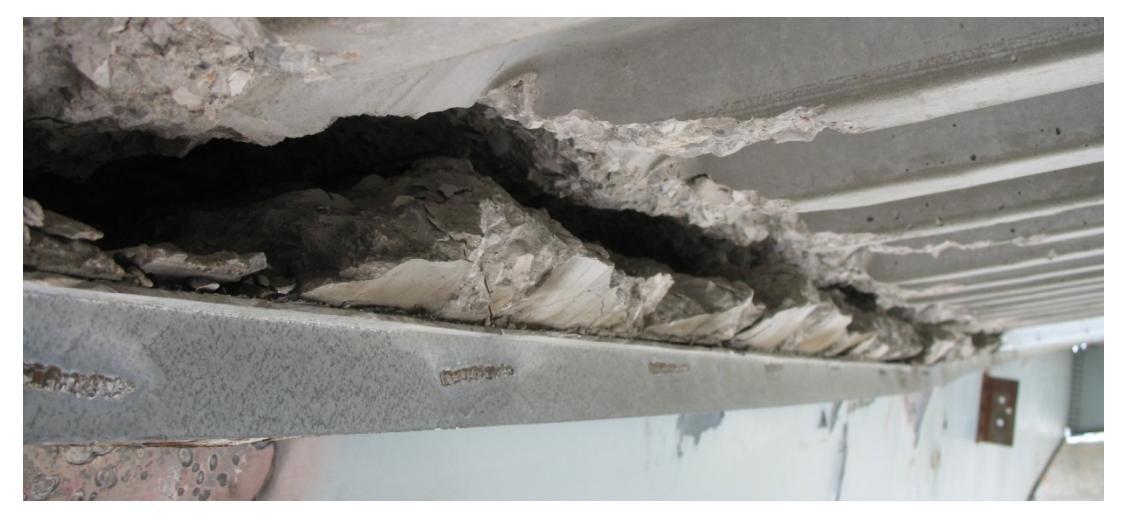
Figure 6-15: Extent of separation of fractured girder apparent after removal of metal formwork

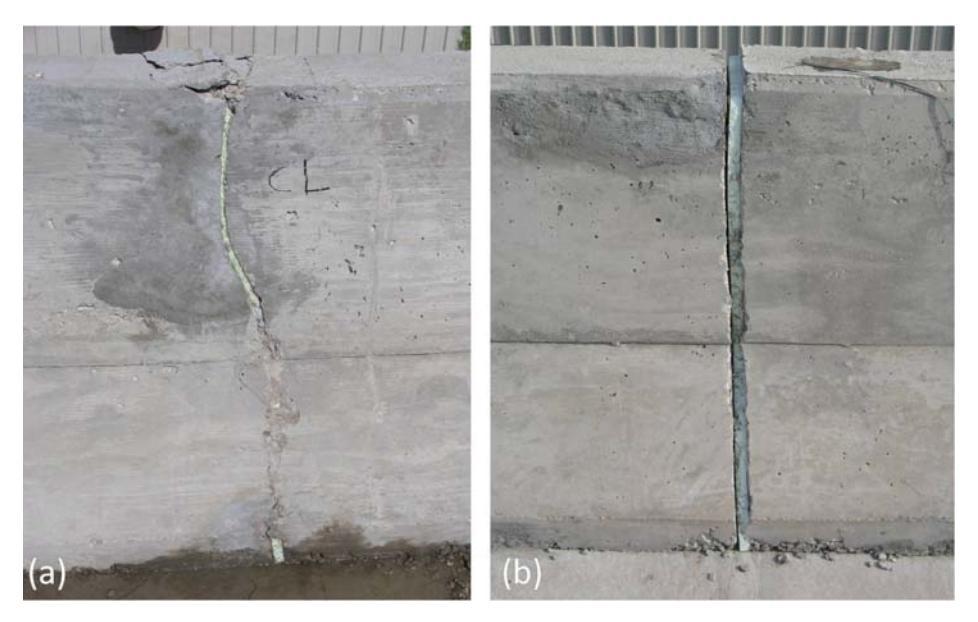
Figure 6-19: (a) Contact at the central expansion joint above the fractured girder, (b) Slight opening of the N3 expansion joint above the fractured girder

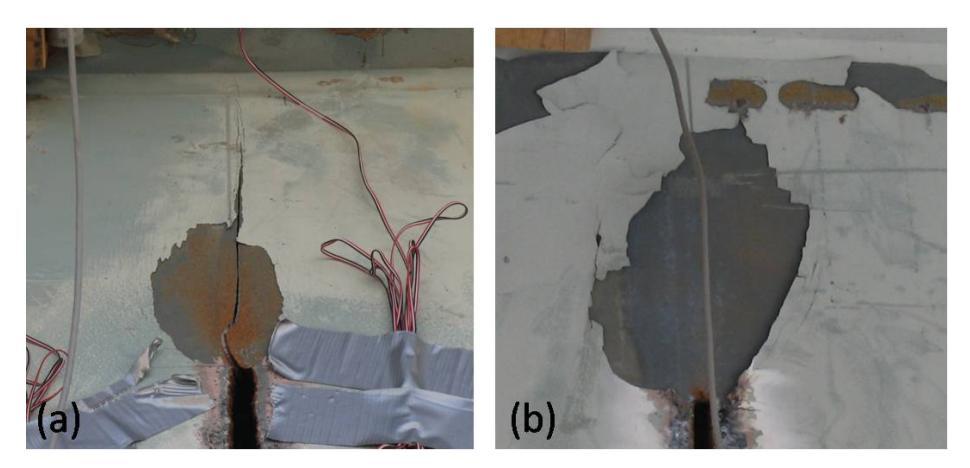
Figure 8-7: (a) Propagation of the fracture on the exterior web of the fractured girder,

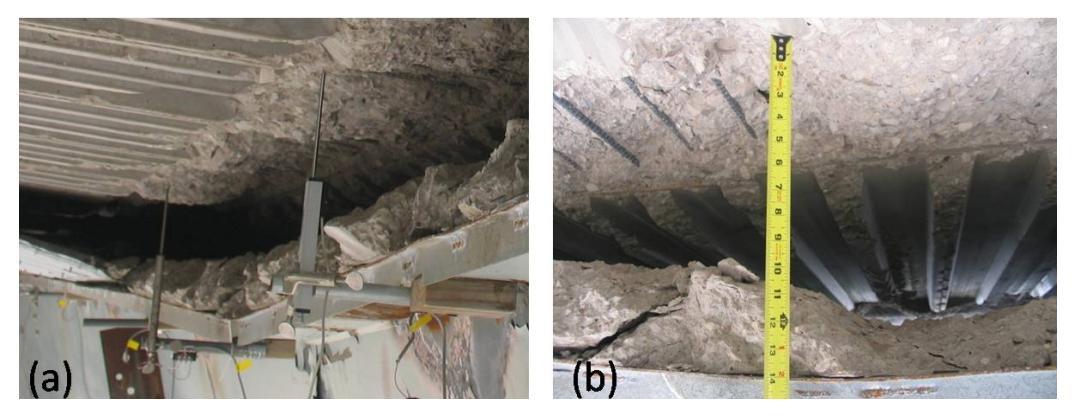
Figure 8-11: (a) Exhausted stroke of the linear potentiometers on the interior top flange of the fractured girder, (b) 11 in. separation at the interior top flange of the fractured girder

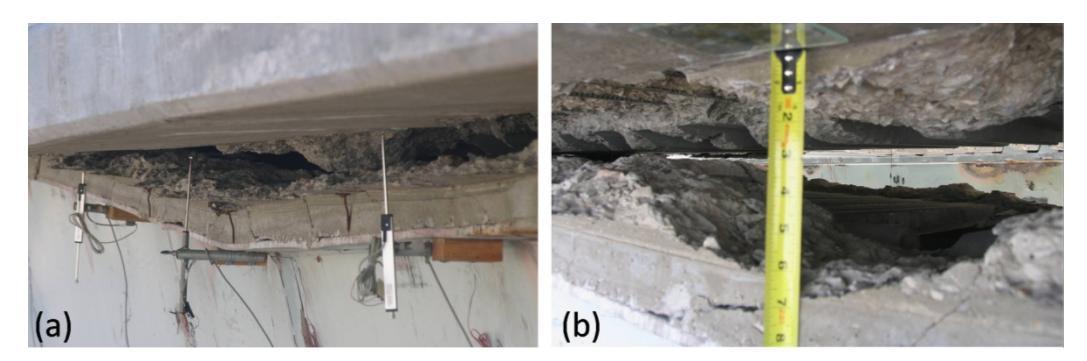
Figure 8-13: (a) Exhausted stroke of the linear potentiometers on the exterior top flange of the fractured girder, (b), 6.5 in. separation at the exterior top flange of the fractured girder

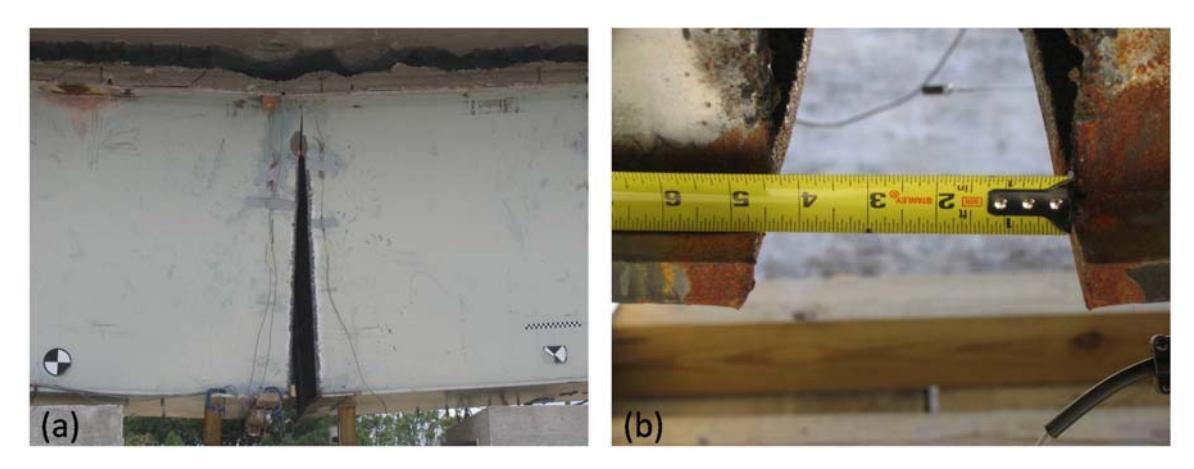
Figure 8-14: (a) Wide view of the opened fracture, (b) Close-up of the width of the fracture at its base

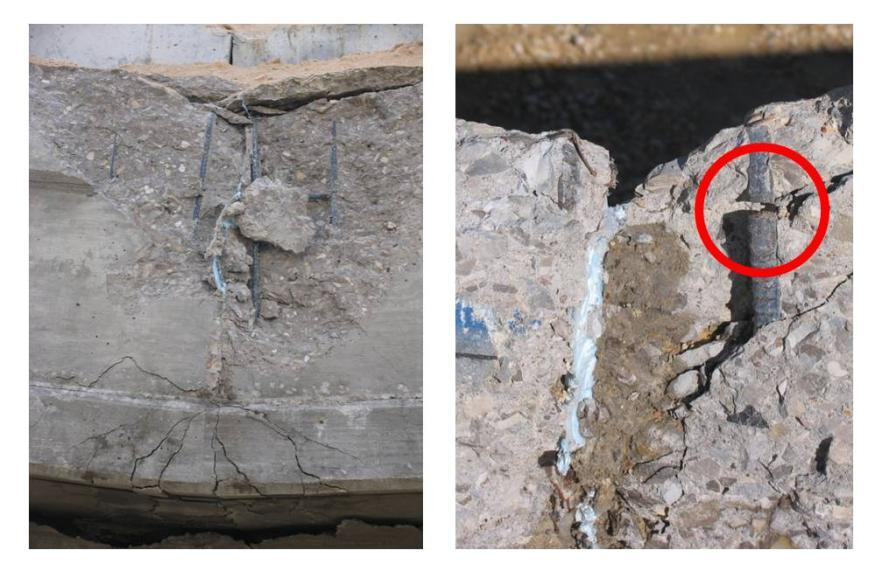
Figure 8-18 (left): Extensive crushing of the exterior railing at mid-span following bridge collapse Figure 8-19 (right): Close-up top view of the failed railing showing a fractured reinforcing bar

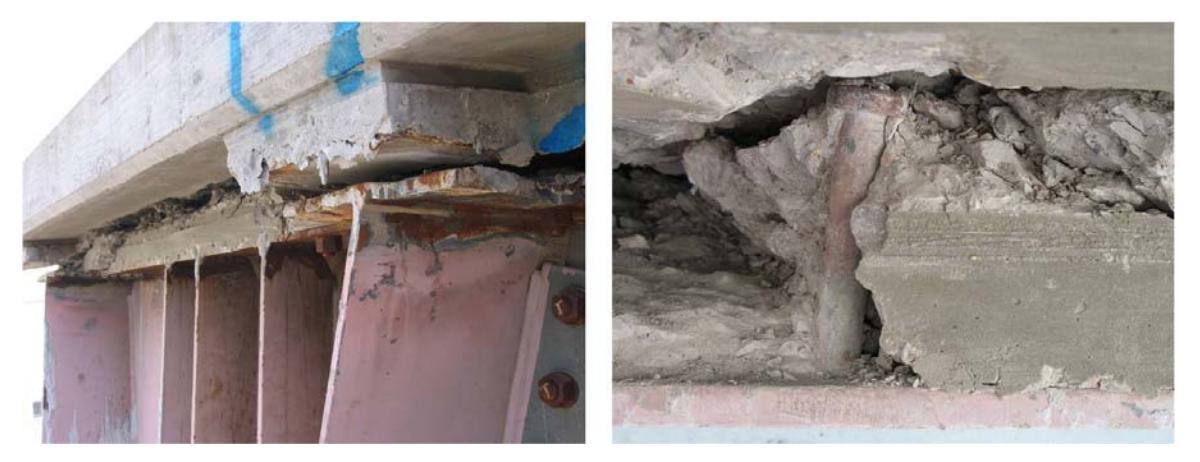
Figure 8-21 (left): Slip between the fractured girder and the concrete deck at the north support Figure 8-22 (right): Shear stud on the fractured girder bent due to slip between the girder and the deck

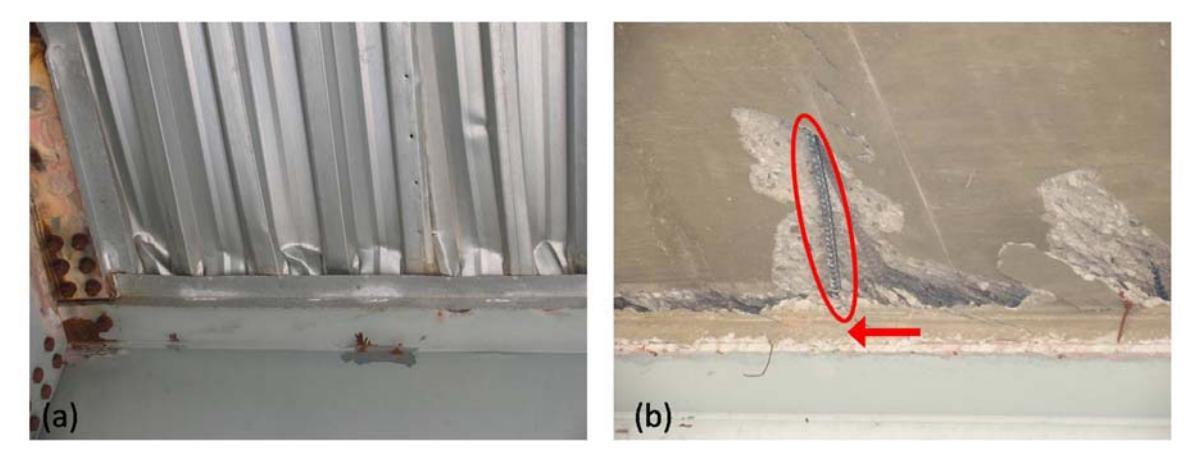
Figure 8-23: Evidence of slip from (a) crumpling of the metal formwork, and (b) rebar bending
#### 8.2.4.3 Flexural Hinging of the Deck above the Interior Flange of the Intact Girder

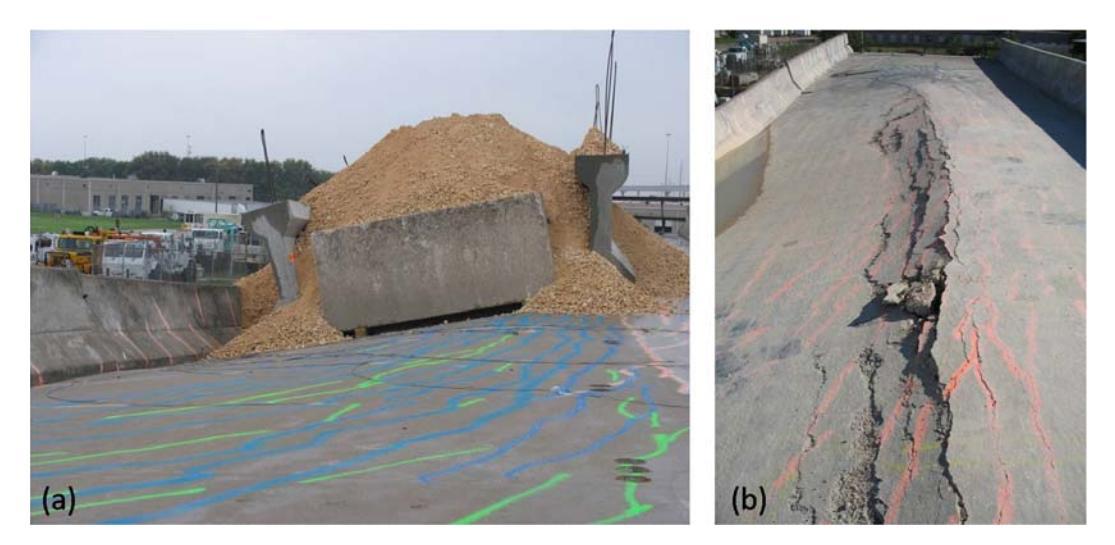
Figure 8-24: Effects of deck hinging shown (a) With load applied, (b) After load removed

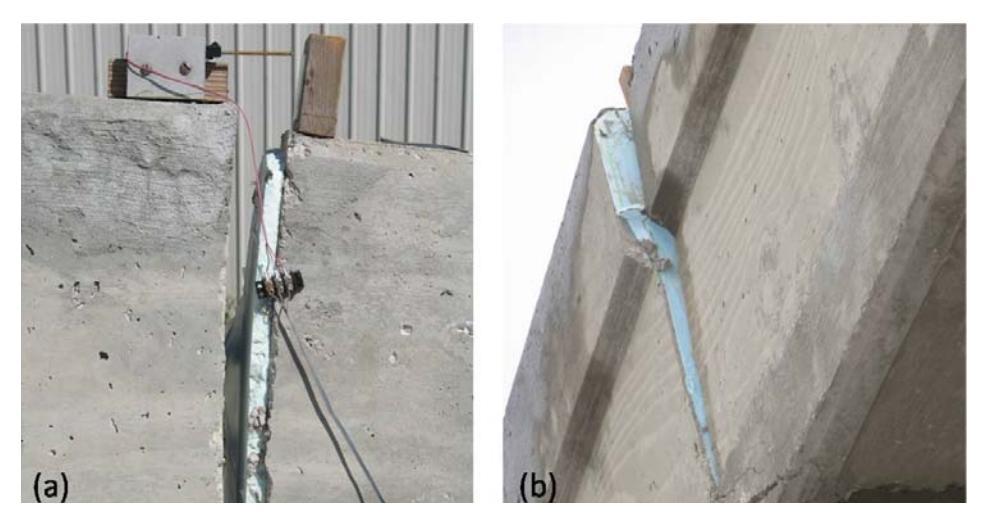
Figure 8-25: Deformation of the 1/4 expansion joint showing (a) opening shift, and (b) out of plane shift

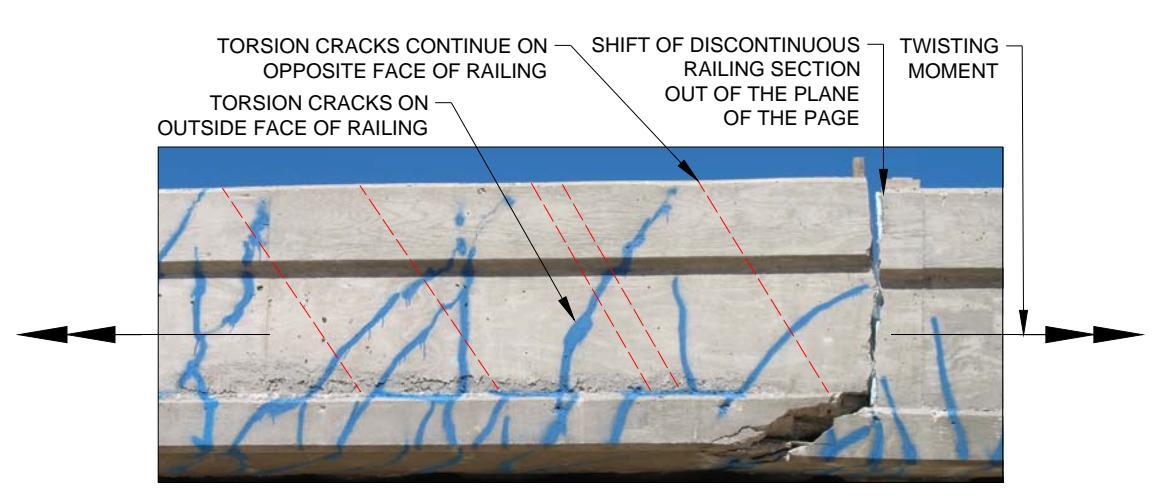
Figure 8-26: Torsional effects on exterior railing

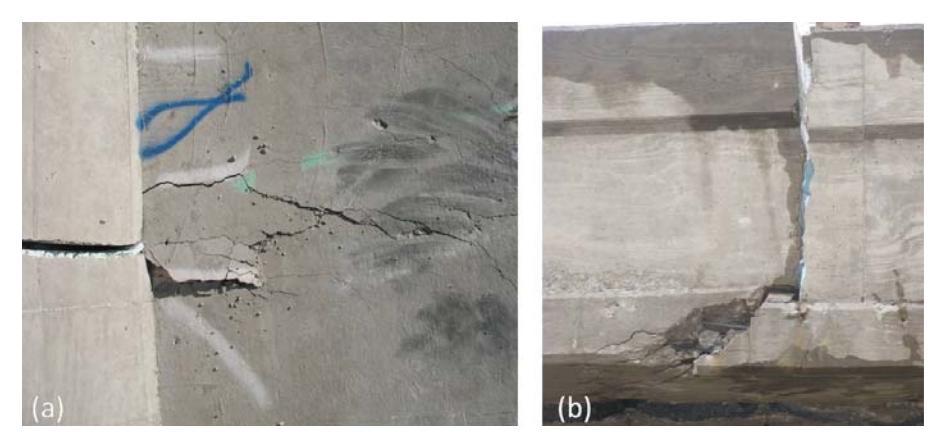
Figure 8-27: Deck shear failure at the expansion joint, shown (a) from above, and (b) from the side
