**CONCLUSIONS, RECOMMENDATIONS AND DESIGN
GUIDELINES FOR CORROSION PROTECTION OF POST-
TENSIONED BRIDGES**

Research Report 0-1405-9

*DURABILITY DESIGN OF POST-TENSIONED
BRIDGE SUBSTRUCTURE ELEMENTS*

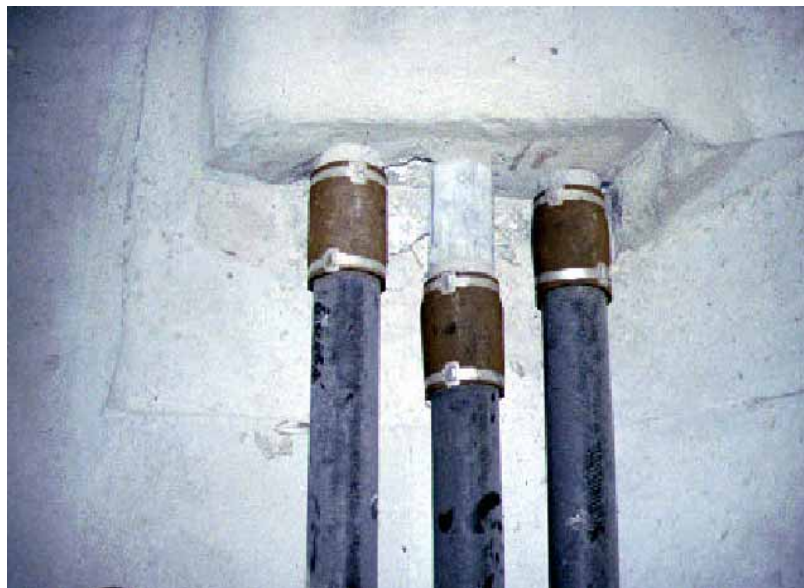
Figure 2.5 Plan View of Slipped Tendon at Deviation Saddle Niles Channel Bridge¹⁶

Recently, some tendon failures and corrosion related problems have come to light, especially in the state of Florida.^{6,16} In 1999, one of the external tendons in the Niles Channel Bridge built in 1983, failed due to corrosion at an expansion joint. A 9-inch movement of the tendon through one of the deviation saddles was noticed first. When the tendon was removed for replacement, a void in the grout and heavy pitting in the prestressing strands inside the anchor head were found. (See Figures 2.5 and 2.6). In 2000, eleven tendons out of a total of 846 were replaced in the Mid-Bay Bridge built in 1993. Ten of the eleven tendons that were replaced were located at expansion joints. (See Figures 2.7, 2.8 and 2.9) Also, in 2000, several corroded tendons were discovered in segmental piers of the Sunshine Skyway Bridge, built in 1986, where the corrosion resulted from seawater in ducts, permeable concrete anchorage protection at the top of piers and splitting of polyethylene ducts.⁶ (See Figures 2.10 and 2.11)

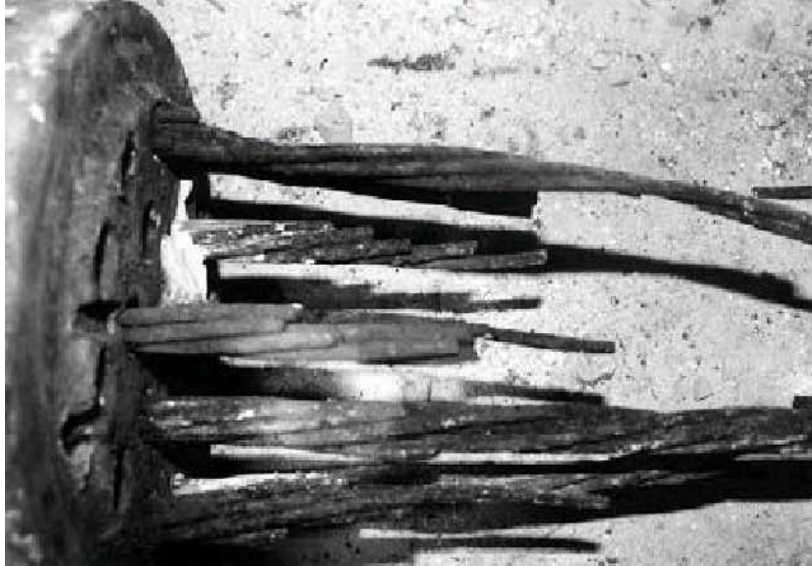
**Figure 2.6 Advanced Corrosion of Strands within Anchorage
Niles Channel Bridge¹⁶**

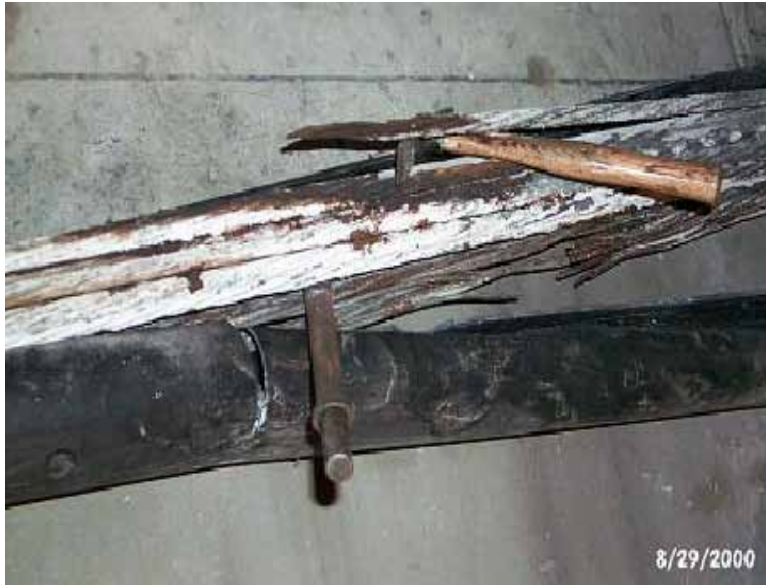
Figure 2.8 Failure of Tendon 28-6 on the Mid-Bay Bridge¹⁶

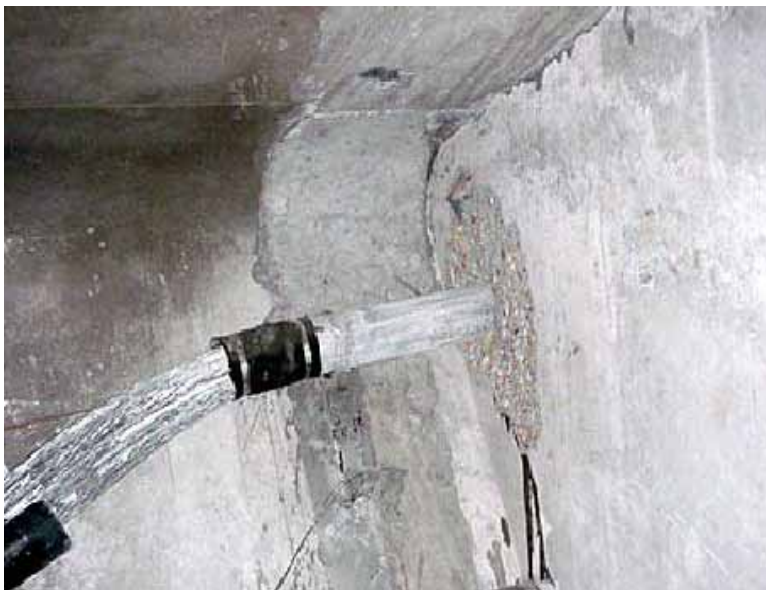
Figure 2.9 Failure of Tendon 57-1 on the Mid-Bay Bridge at Expansion Joint Diaphragm¹⁶

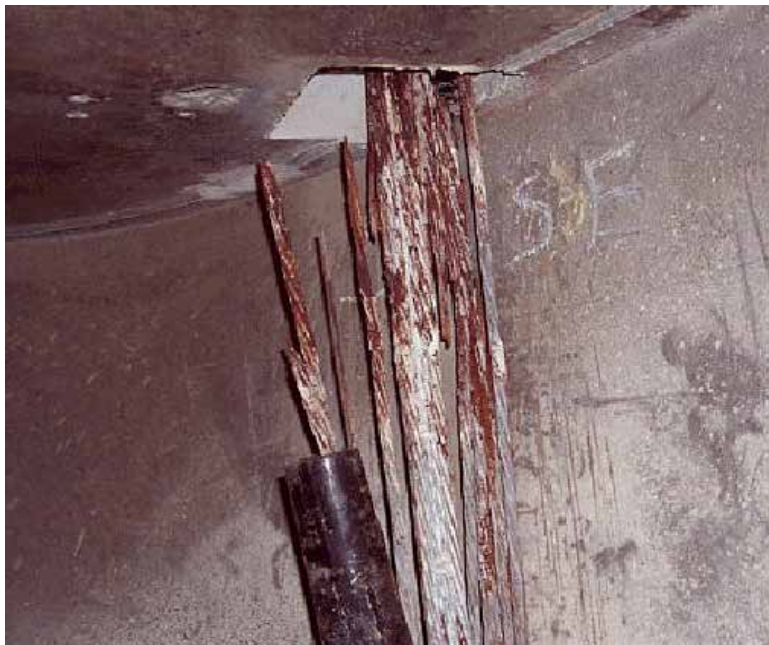
Figure 2.11 Tendon Corrosion inside the Sunshine Skyway Bridge Piers (Refer to Figure 2.3)¹⁶

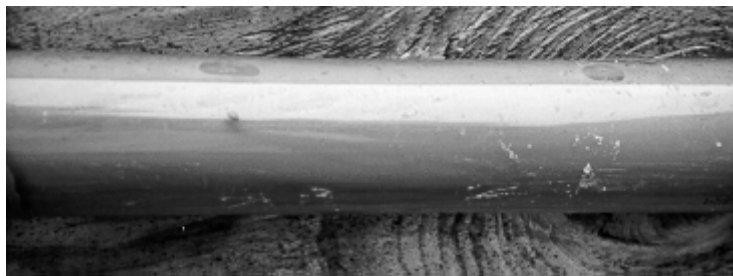
Figure 3.5 TxDOT Grout – Bubbles Traveling Toward Intermediate Crest³⁴

Observation of grouts during pumping and setting (See Figures 3.5 and 3.6) as well as examination of slices cut from the large scale grouted ducts (See Figure 3.7) indicated:

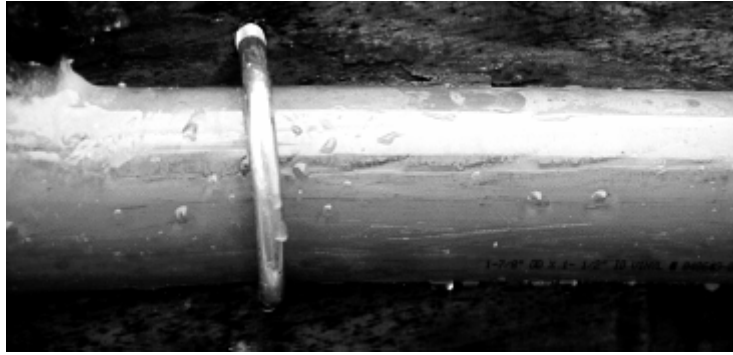
Figure 3.6 Beginning of Void Formation at Intermediate Crest³⁴

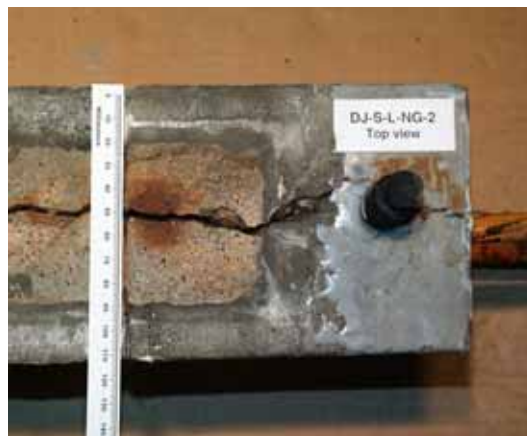
Figure 3.10 Example of Specimen Condition Prior to Autopsy Specimen DJ-S-L-NG-2⁸³

Thirty eight macrocell specimens were used to investigate the corrosion protection of internal tendons at segmental joints (See Figures 3.8 and 3.9). Half of the specimens were autopsied after approximately four and a half years of highly aggressive exposure and preliminary conclusions were reported.³⁰ The variables analyzed during the testing program included: joint type (dry or epoxy), duct type (galvanized steel or plastic), grout type (3 grouts with differing additives) and level of joint compression (3 different levels). The second half of the specimens were autopsied with over eight years of very aggressive exposure. Example of macrocell condition prior to autopsy is shown in Figure 3.10. Numerous conclusions can be drawn.

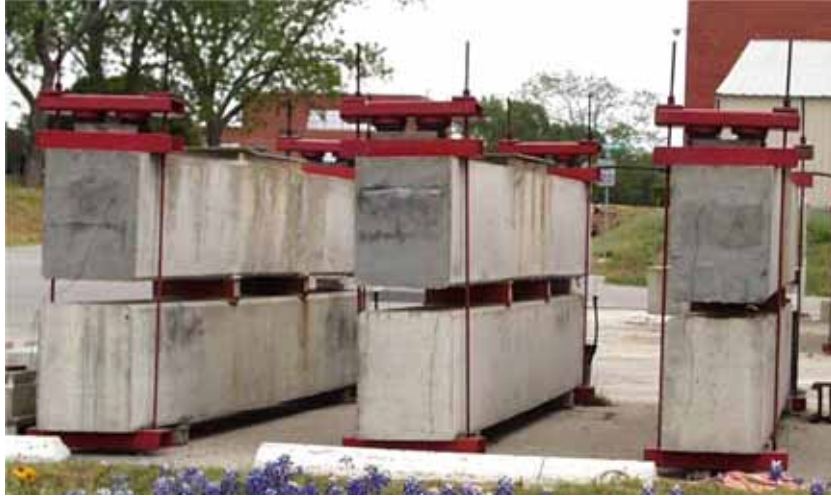
Figure 3.11 Beam Test Setup at North End of Ferguson Laboratory³⁷

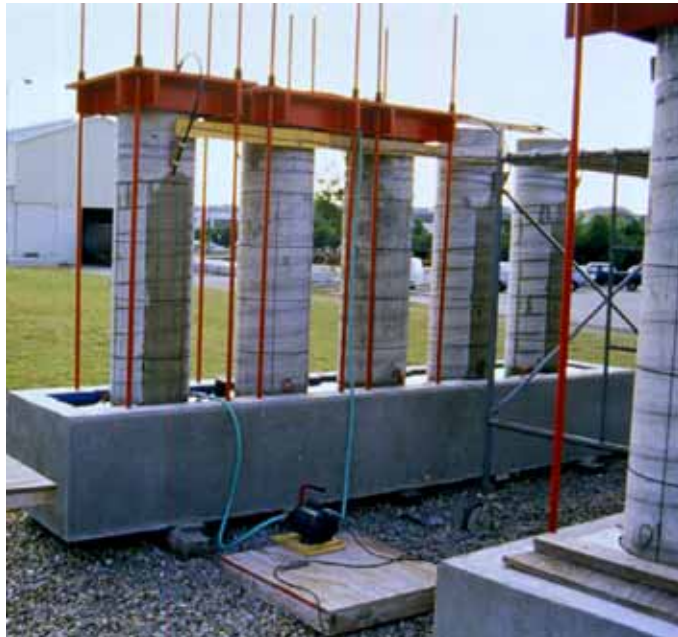
Figure 3.14 Column Test Setup³⁷

Five non-prestressed and five post-tensioned columns specimens were used to investigate corrosion mechanisms and chloride ion transport (“wicking effect”) in various column connection configurations and to evaluate column corrosion protection measures (See Figures 3.14 and 3.15). Variables included column to foundation connection (no dowel joint, doweled joint and post-tensioned joint), loading (no loading and service load – with combined moment and axial load), concrete type (TxDOT Class C concrete, and Class C Fly Ash concrete – 35% replacement by volume), prestressing bar coatings (uncoated, galvanized PT-bars, and epoxy coated PT-bars), and post-tensioning ducts (plastic and galvanized steel). Trickle water was used on one face of each column to determine the effect of salt water spray or dripping. Test specimen exposure started in July of 1996 and ended in January of 2003, after six and a half years. Full autopsies were performed at the end of testing (See Figure 3.16), and conclusions are as follows.

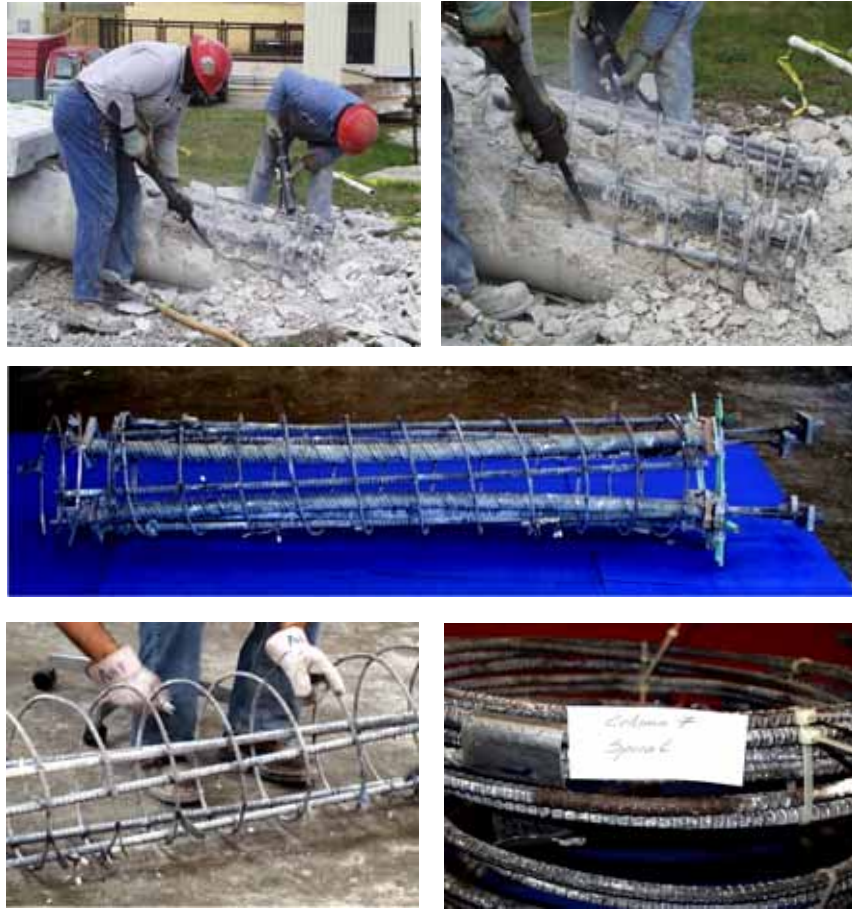
Figure 3.16 Column concrete Removal and Reinforcement Dismantling³⁷

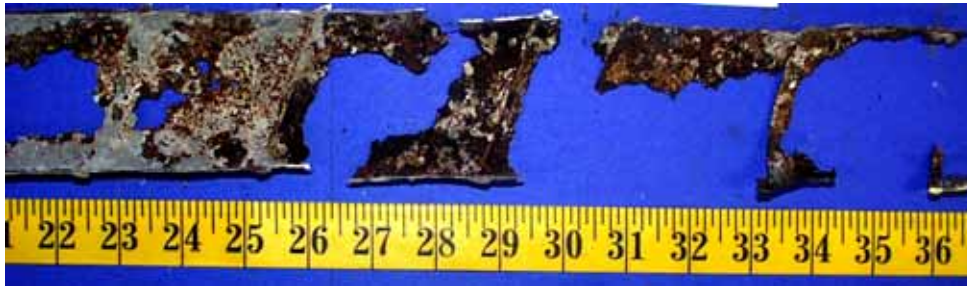
- The use of galvanized steel ducts appears unwise. Severe duct destruction and pitting was found in most specimens with this type of duct, as seen in Figure 3.17. From macrocell and column corrosion test results the superiority of plastic ducts was evident. The use of encapsulated anchorage protection systems appear very promising but cannot be conclusively evaluated until after final autopsies of the remaining beam specimens. However, in view of the substantial corrosion found with galvanized ducts, it seems like a prudent step to use plastic duct in any application that has even a moderate risk of exposure to chlorides.

Figure 3.17 Large Galvanized Steel Duct Destruction Due to Corrosion^{37,38}

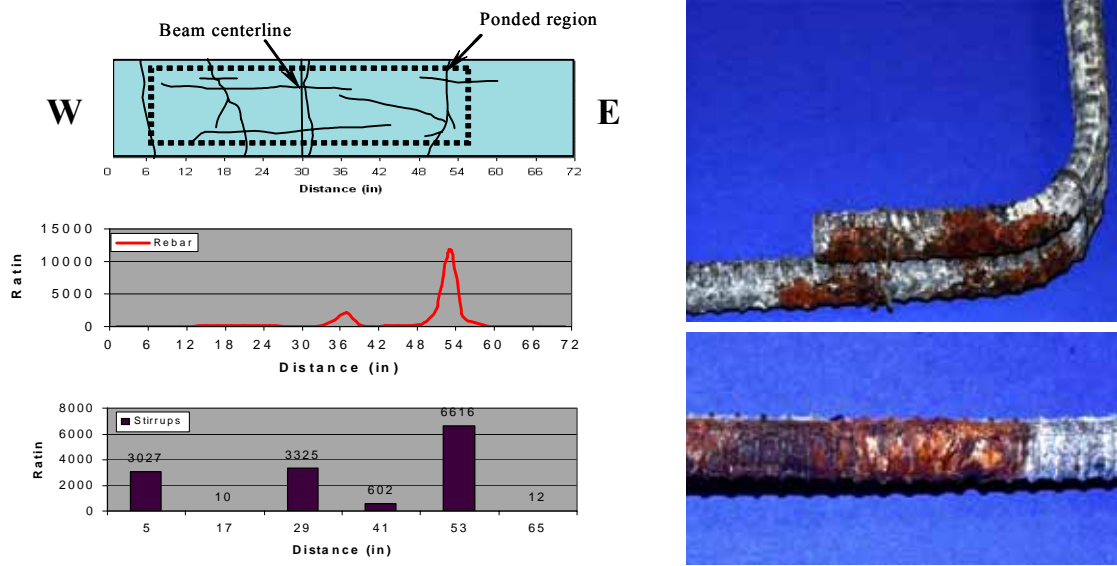
- Transverse cracking due to loading had a definite effect on corrosion damage. As cracking increased, reinforcement corrosion increased. Larger crack widths and crack density were found to be the cause of very severe localized and uniform reinforcement corrosion activity. (See Figure 3.18)
- Longitudinal or splitting cracks always indicated very severe corrosion within the member, as shown in Figure 3.19.
- Sound epoxy joint filling is mandatory to prevent moisture and chloride ingress. Dry joints and incompletely filled epoxy joints in the macrocell specimens showed very poor performance. (See Figure 3.20) Similar results were observed in the column tests at the column bases for the non-doweled specimens. Dry joints performed as preset cracks.

Figure 3.18 Effect of Transverse Concrete Cracking Due to Service Loading on Reinforcement Corrosion^{37,38}

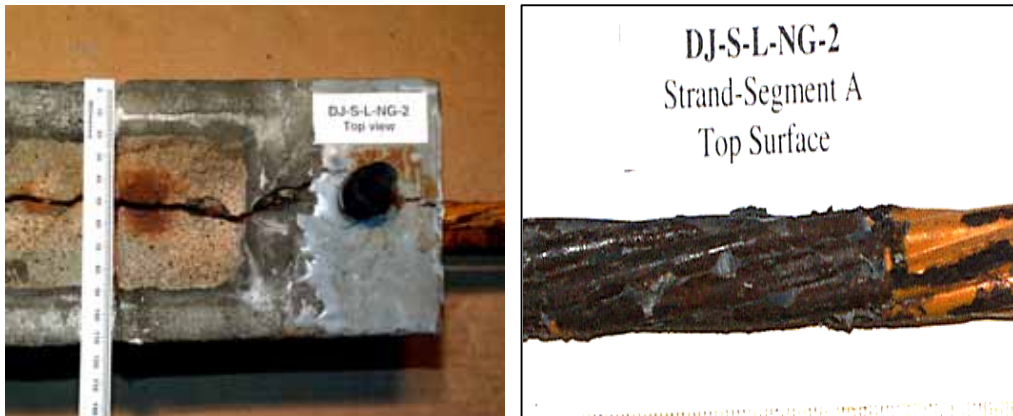
Figure 3.19 Example of Longitudinal (Splitting) Crack in Macrocell Specimen⁸³

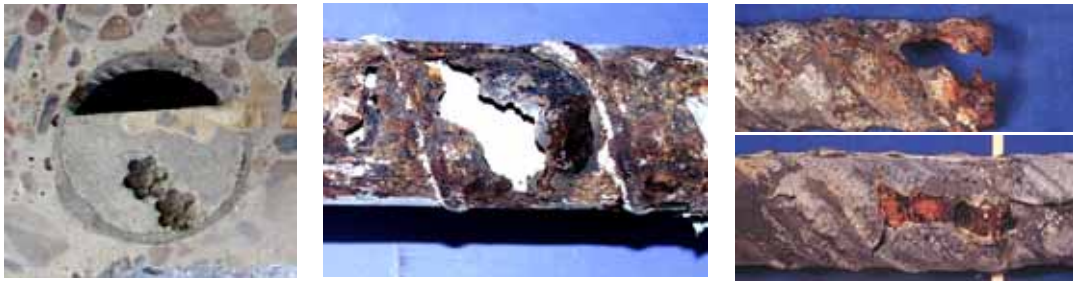
Figure 3.24 Bleed Water Voids and Duct Corrosion³⁷

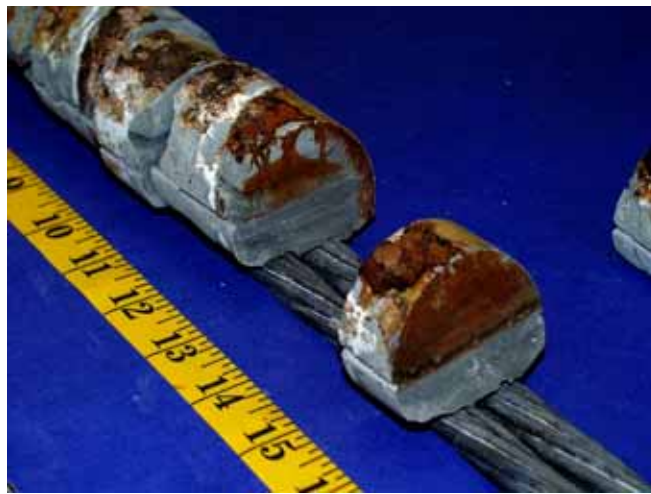
- Stringent grouting procedures must be enforced.
- Grout is not prestressed and often cracks where found under service loading. Figure 3.25 shows the effect of grout cracking.

Figure 3.25 Effect of Grout Cracking³⁷

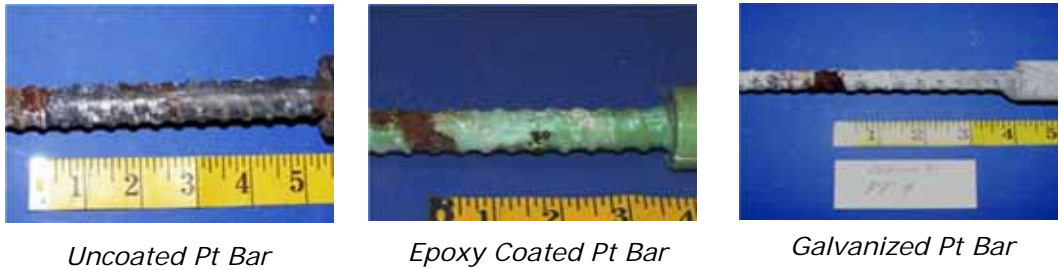
Figure 3.26 Bar Coating Performance when Subjected to Localized Attack³⁷
