| 4. Title and Subtitle EFFECT OF EPOXY COATING ON BOND AND ANCHORAGE OF REINFORCEMENT IN CONCRETE STRUCTURES | | | | 5. Report Date December 1990 | |
| 7. Author(s) Bilal S. Hamad, James O. Jirsa, and Natalie I. d'Abreu d Paolo | | | | 8. Performing Organization Report No. Research Report 1181-1F | |

Research Report 1181-1F

Research Project 3-5-88/90-1181
"Bond and Anchorage of Epoxy-Coated Reinforcement"

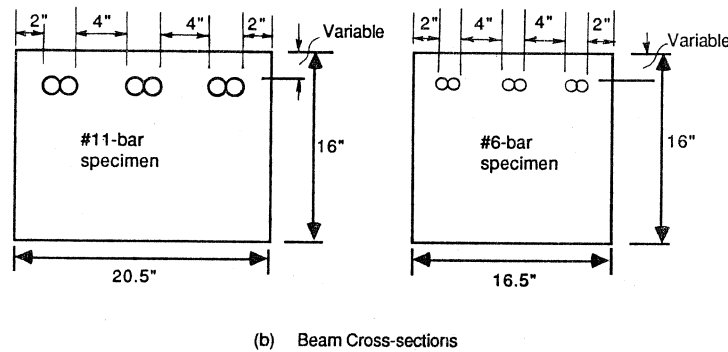
Figure 3.11 Beam reinforcement details, Treece^[25].

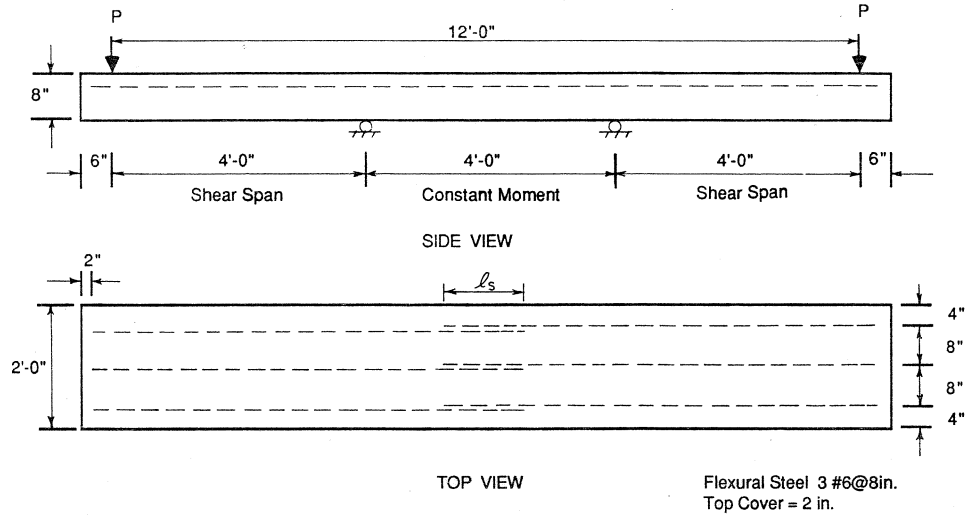
Figure 3.12 Slab specimen details and load setup, Cleary and Ramirez [26].

middle of the specimen. The arrangement also provided for convenient observation and measurements of cracks. Slab specimens and load setup are shown in Figure 3.12. The load was gradually applied in 500 pound increments. At each increment the load was held while the dial gages, measuring deflections, were read and cracks marked and measured.

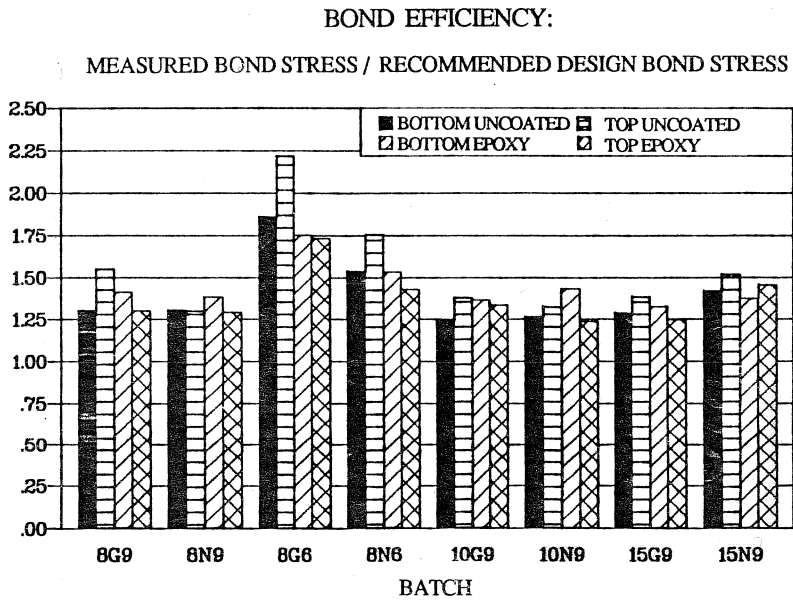
Figure 3.15 Bond efficiencies relative to the recommended design bond stress, DeVries and Moehle^[27].

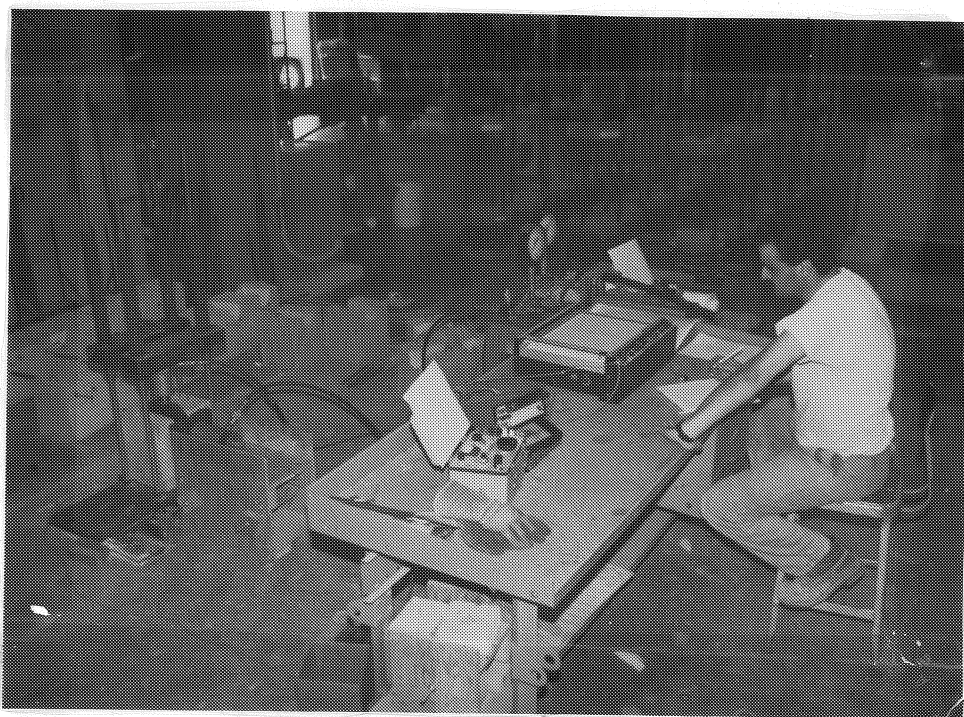
Figure 4.21 Overall view of the test setup of the pullout specimens.

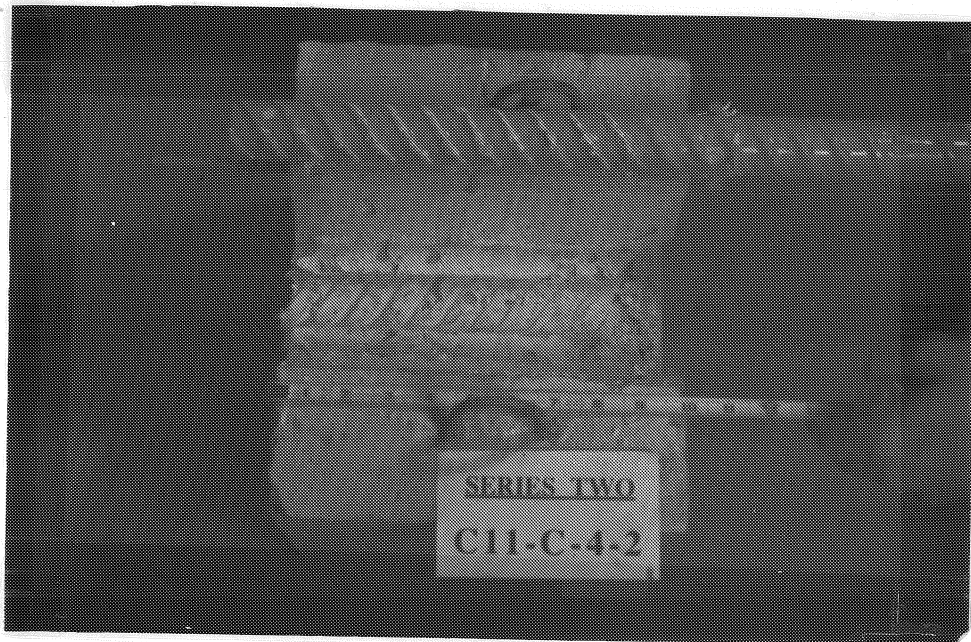
Figure 5.9 Epoxy-coated crescent deformation pattern #11 bar Type A pullout specimen after failure, top load = 10 kips, normal strength concrete.

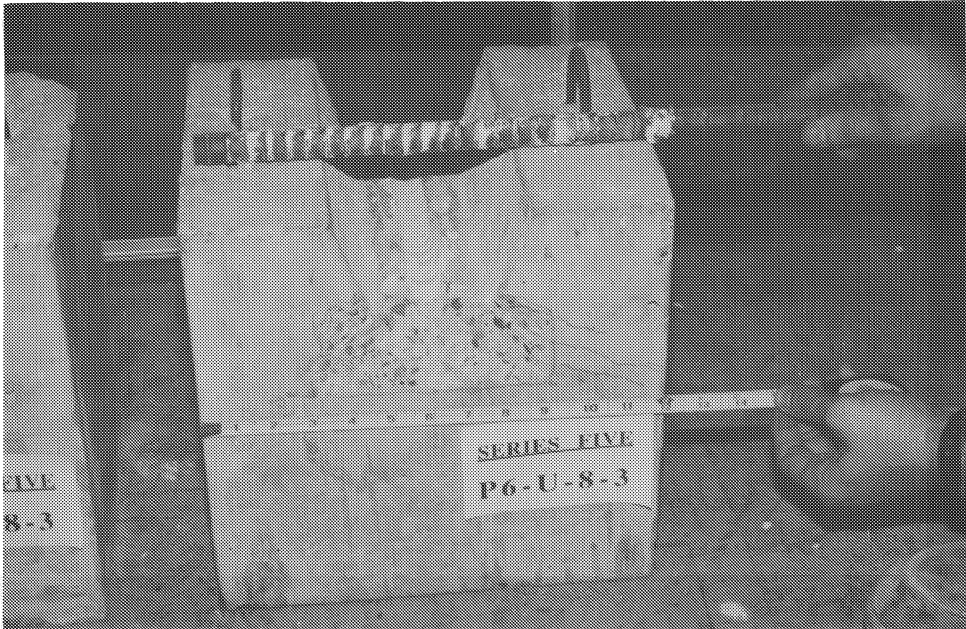
Figure 5.10 Parallel deformation pattern #6 bar Type A pullout specimens after failure, top load = 15 kips, high strength concrete.

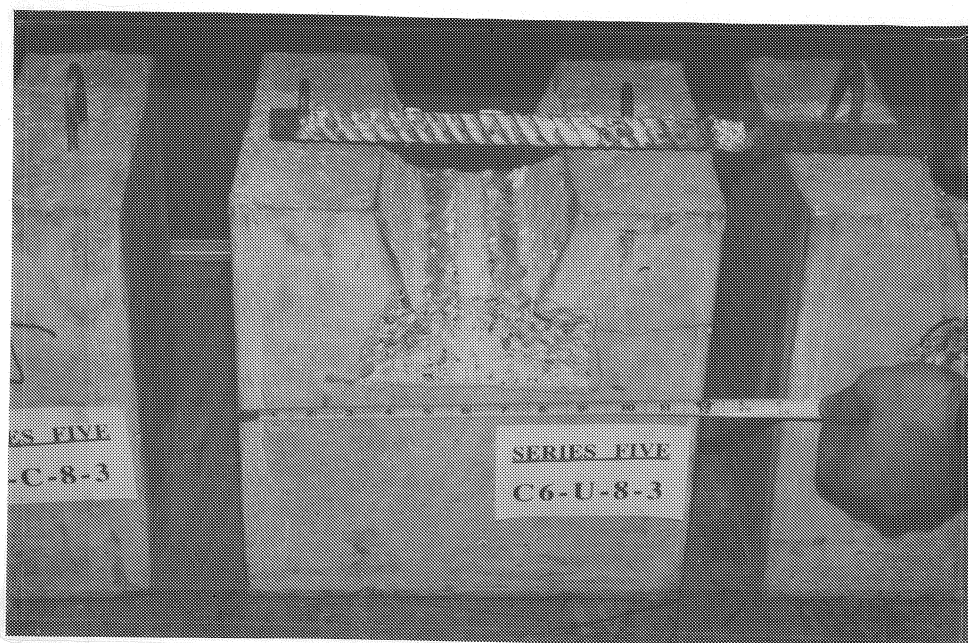
Figure 5.11 Crescent deformation pattern #6 bar Type A pullout specimens after failure, top load = 15 kips, high strength concrete.

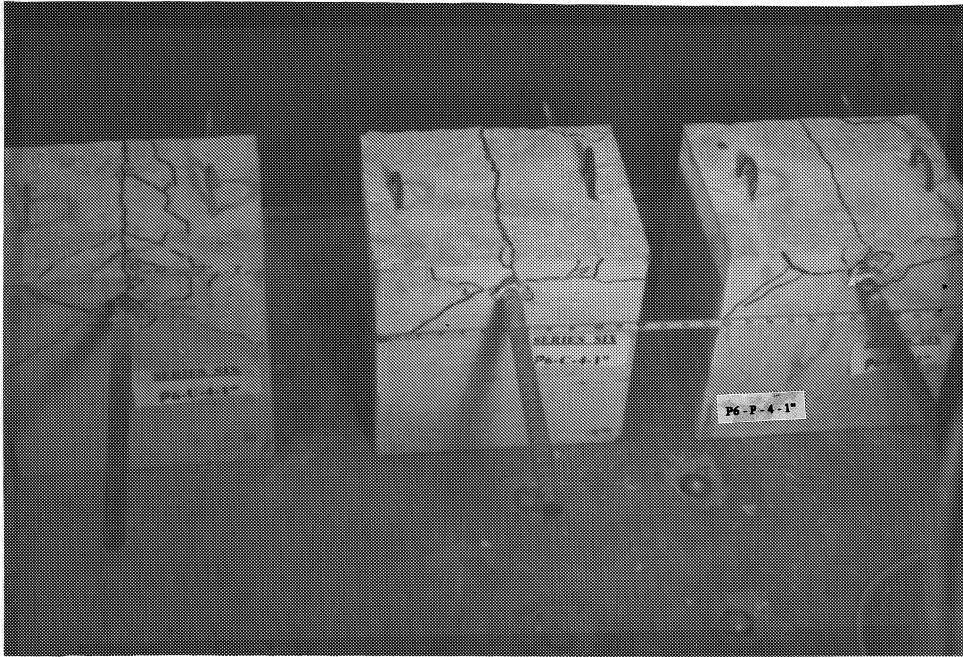
Figure 5.16 V-notch failure of #6 bar type B pullout specimens with 1-in. clear cover, series SIX, $f'_c = 4500$ psi.

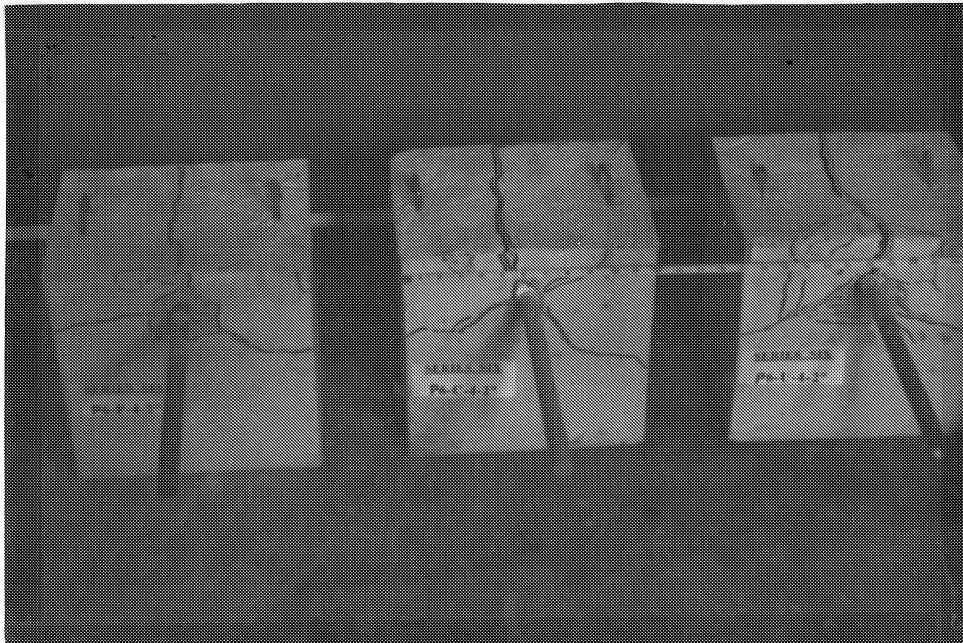
Figure 5.17 Face-and-side splitting of #6 bar Type B pullout specimens with 2-in. clear cover, series SIX, $f'_c = 4500$ psi.

Uncoated, epoxy-coated, and painted bar specimens with 2-in. cover to the reinforcing bar, exhibited more of a face-and-side splitting pattern (see Figures 5.17 and 5.18). Along with the longitudinal crack in the cover along the reinforcing bar, other cracks radiated from the bar to the sides of the concrete specimen. For the uncoated bar specimens, splitting broke the block into three pieces separated by the crack lines as shown in Figure 5.18(a). The presence of a #3 bar hooked over the bar at the middle of the anchorage length, was intended to confine the anchored bar but did not change the load-slip behavior nor the mode of failure.

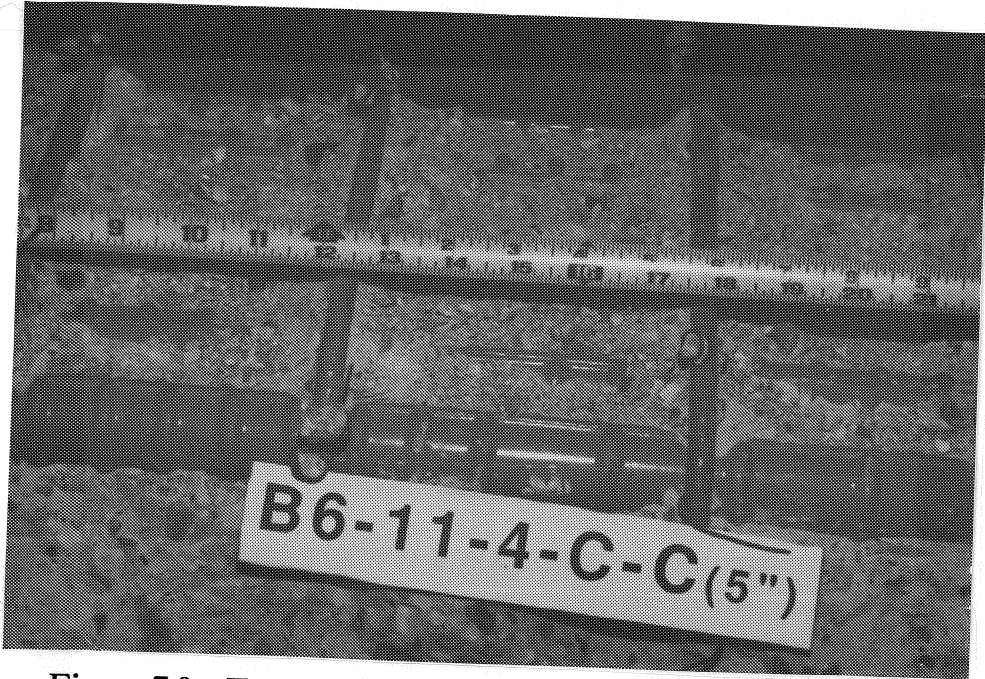
Figure 7.9 Epoxy-coated reinforcing bars after splice failure.

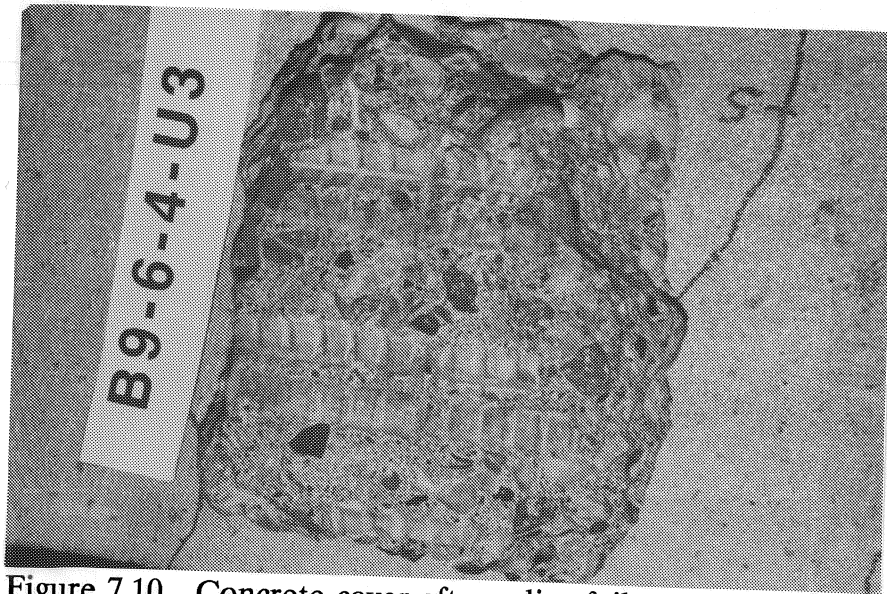
Figure 7.10 Concrete cover after splice failure, uncoated bars.

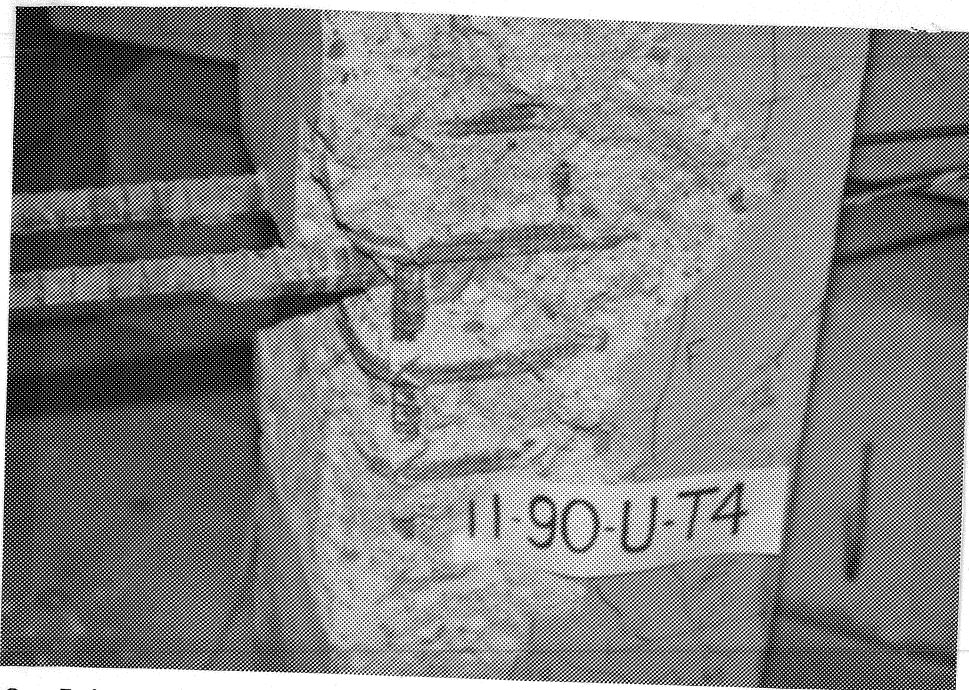
Figure 8.18 Joint region of the #11 uncoated hooked bar specimen of the fifth series, #3 at 4 in., $f'_c = 4225$ psi.
