**BONDING OF EXTERNAL TENDONS
AT DEVIATORS**

**Research Report No. 1209-1
Research Project 3-5-89-1209**

**"Effect of Improved Bonding of External Tendons and the Use of
Supplemental Continuous Bonded Tendons in External Post-
Tensioned Bridge"**

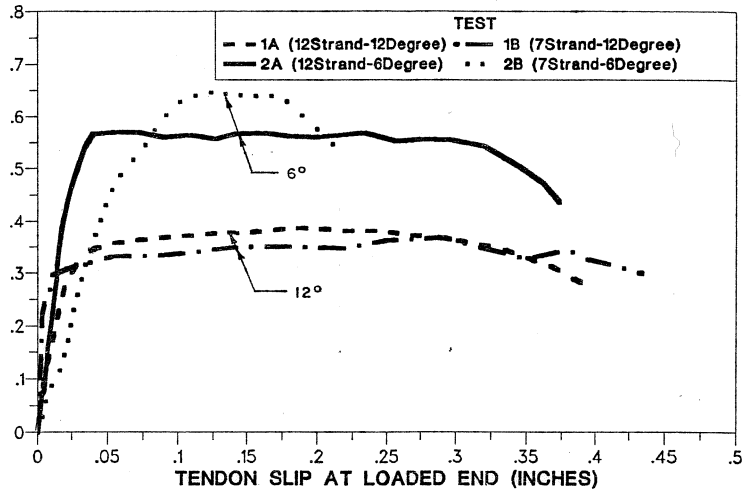
Figure 4.3 Bond Stress-Slip Performance of Specimens with Deviated Tendons.
