| 4. Title and Subtitle FRETTING FATIGUE IN EXTERNAL POST-TENSIONED TENDONS | | | | 5. Report Date December 1992 | |
| 7. Author(s) K. K. Ryals, J. E. Breen, and M. E. Kreger | | | | 6. Performing Organization Code | |

Research Report No. 1211-1F

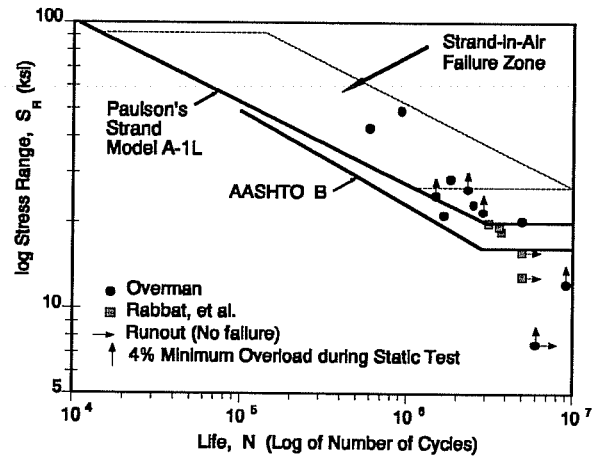
Figure 2.4 Fatigue life of pretensioned girders, compared to Paulson's model (after Overman²⁵ and Paulson²⁶).

Tests have shown that the fatigue characteristics of strand are not altered substantially when the strands are integrated into a pretensioned concrete member.⁴⁰ Figure 2.4 shows the results of pretensioned girder tests conducted by Overman²⁵ along with those he collected from Rabbat, et al.,³⁰ plotted to compare with the strand-in-air failure region. The pretensioned girder data is in fairly close agreement with the model that Paulson recommended, except that Paulson's suggested endurance limit of 20 ksi does not agree with Overman's data; Overman recommends using Paulson's model with the 1977 AASHTO endurance limit for redundant load path steel structures (Category B) of 16 ksi.^{1,25} In the 1989 edition of AASHTO, the recommended endurance limit for Category B has remained 16 ksi, but the values for the allowable range of stress at 100,000 and 500,000 cycles have been increased. The current 1989 AASHTO design curve for Allowable Fatigue Stress Range (Category B for Redundant Load Path Structures), shown in the figure, fits Overman's data a bit more conservatively than Paulson's model and would be a desirable design recommendation for pretensioned girders. This is especially true because, just as used with the Post-Tensioning Institute²⁸ cable stay fatigue design recommendations, use of the AASHTO Category B curve also would allow the designer to use an overall design philosophy relating desired life to class of highway and daily truck traffic. These provisions are summarized in the 1989 AASHTO design tables reproduced in Figure 2.5.

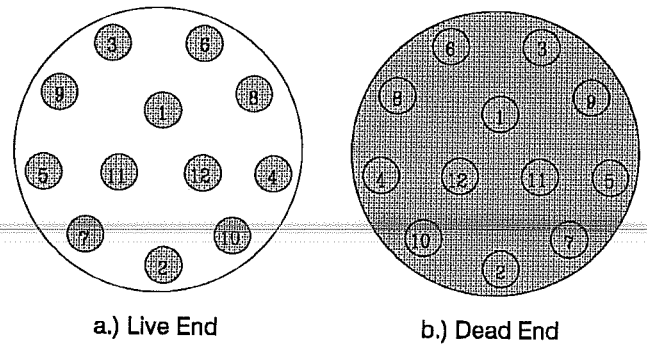
After testing, each concrete segment was jack-hammered open and the deviator duct was removed. The duct was cut open and the grouted tendon was removed. The duct and each strand were examined for evidence of fretting and these observations were catalogued. The strands are identified by a number that refers to the order in which they were stressed. A key to the numbering system is shown in Figure 4.1.

Figure 4.1 Strand arrangement in anchor heads.

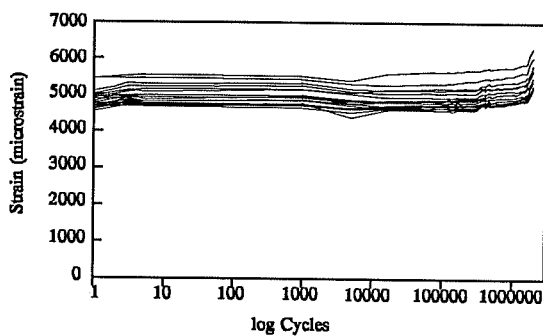
4.2.1.1 Variation of Strain. Figures 4.2 and 4.3 show the strain gage readings taken throughout the life of test specimen #1 excluding those gages that appeared to malfunction.

Figure 4.2 Strain gage readings for Test #1 @ 80 kips applied load.

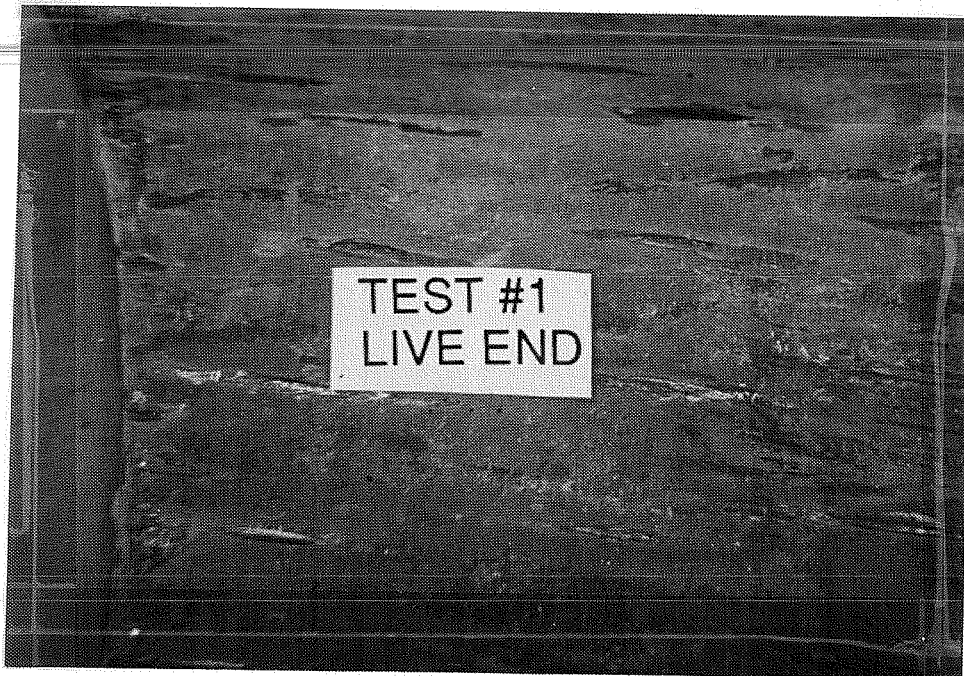
Figure 4.9 Evidence of fretting damage to inner section of the deviator duct in Test #1.

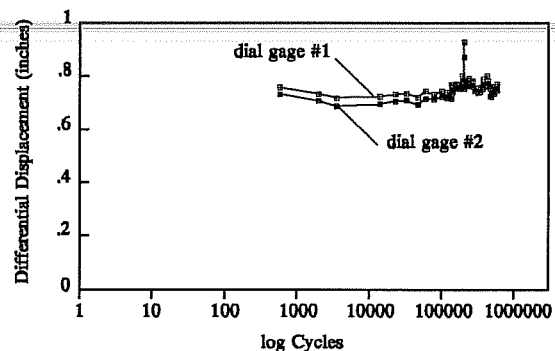
Figure 4.16 Differential displacement of the segment during Test #2.

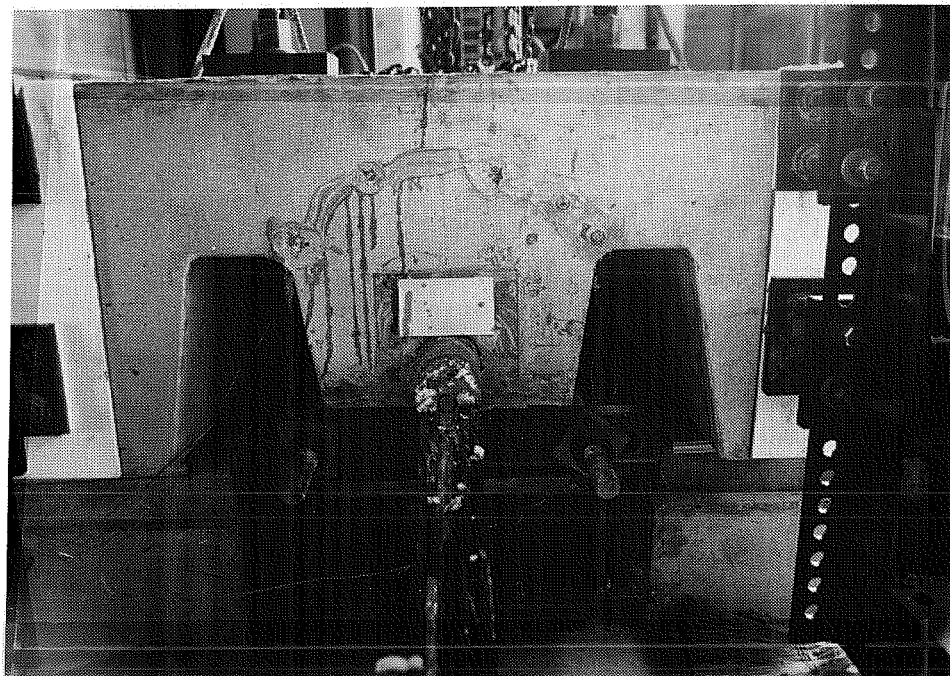
Figure 4.23 Rehabilitated live end deviator of the Test #2 segment.

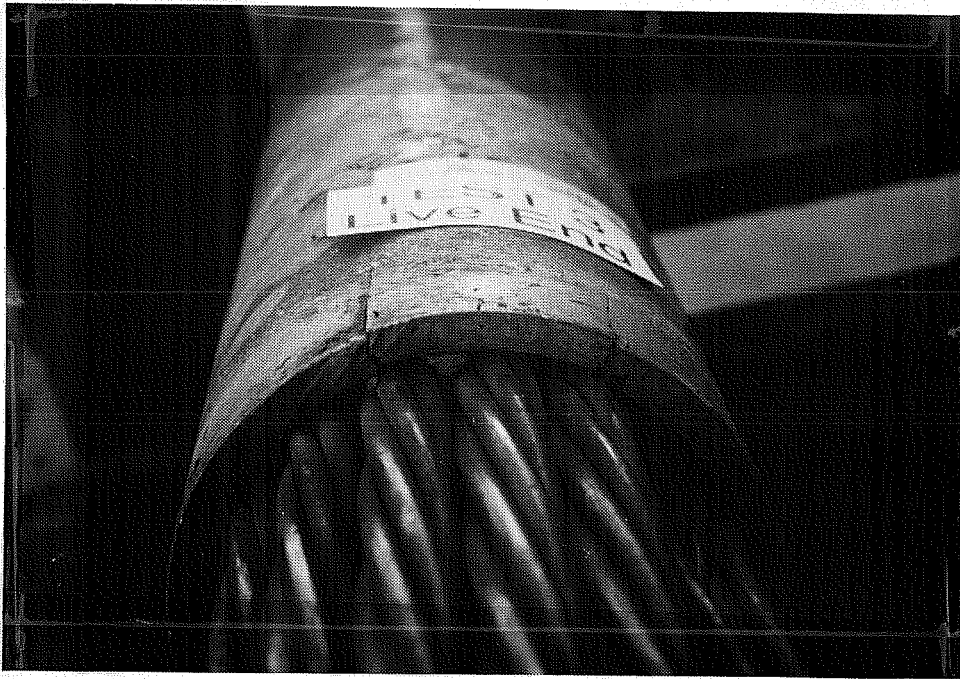
Figure 4.34 End view of the cracking of the outside end of a Test #3 deviator duct.

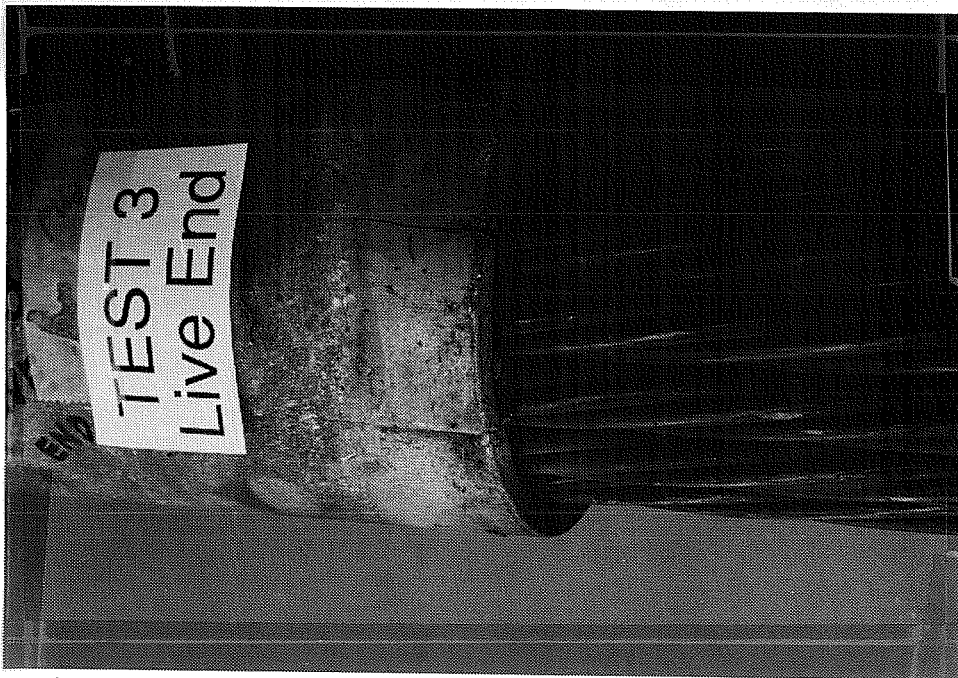
Figure 4.35 View of the underside of the cracked Test #3 deviator duct.

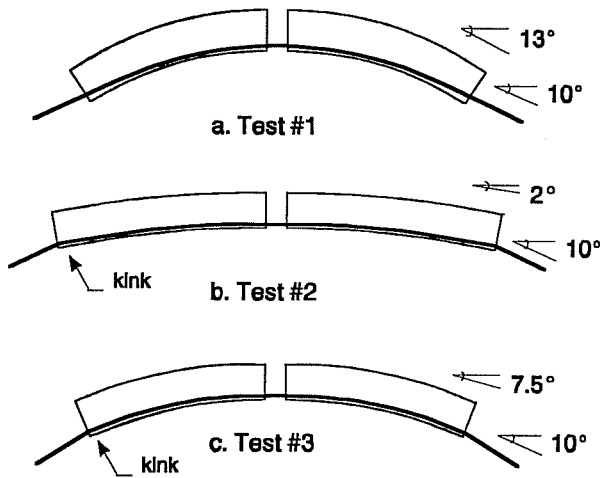
Figure 5.10 Shape of the tendon in the duct.
