**COMPOSITE STRUCTURAL MEMBERS FOR
SHORT SPAN HIGHWAY BRIDGES**

Research Report 1773-1

Research Project 0-1773

APPLICATIONS FOR COMPOSITE MATERIALS IN TXDOT

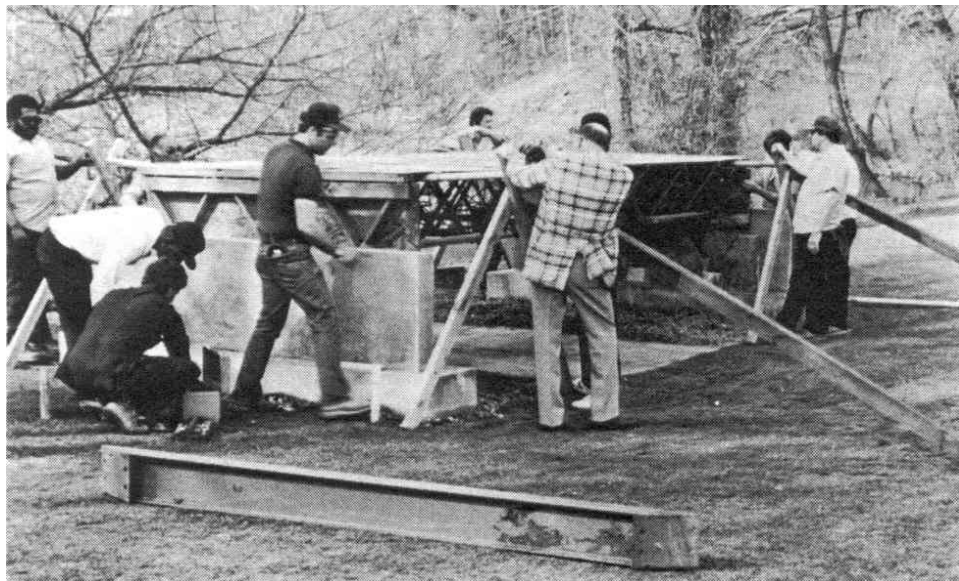
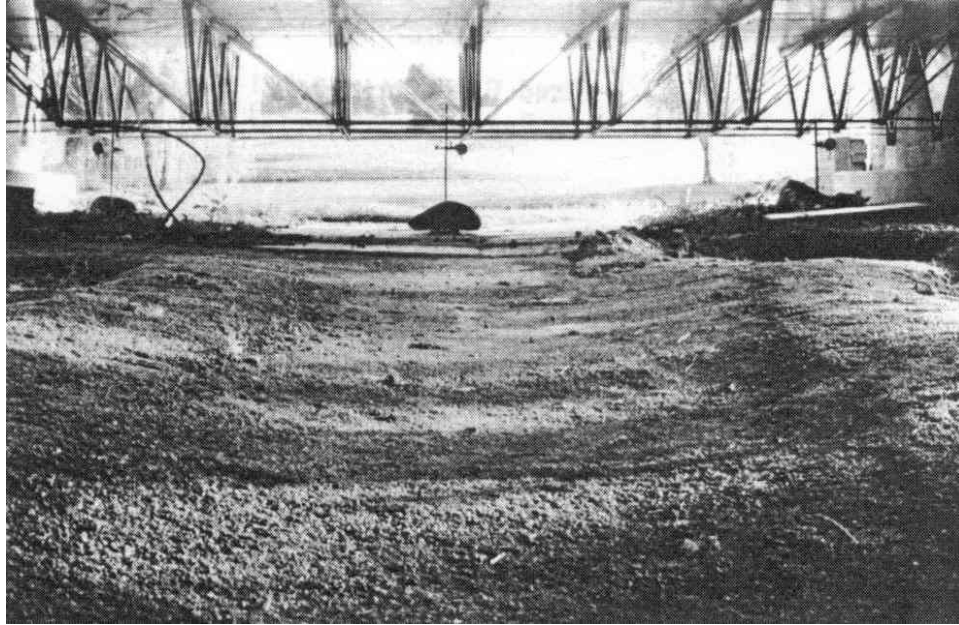
Figure 2.3. Virginia Footbridge. Set in Place ^(McCormick, 1986).

Figure 2.4. Virginia Footbridge. Finished (McCormick, 1986)

However, the use of FRP materials for civil engineering applications has been limited due to the lack of comprehensive design guidelines (ASCE, 1984). In order to be accepted in the civil engineering profession, composites must be competitive in cost with conventional materials. The improved corrosion resistance and other advantageous properties of composites add value to the product. However, this additional value may be relatively small. This contrasts with the aerospace industry, which places emphasis on weight reductions. The need to reduce costs in civil structures has a major influence in design and fabrication methods. One of the early civil engineering structures using FRP was a footbridge designed and built in 1977 at the University of Virginia (McCormick, 1986). This bridge used a low cost winding process to fabricate the triangular truss structure. Figures 2.3 and 2.4 show the Virginia footbridge.

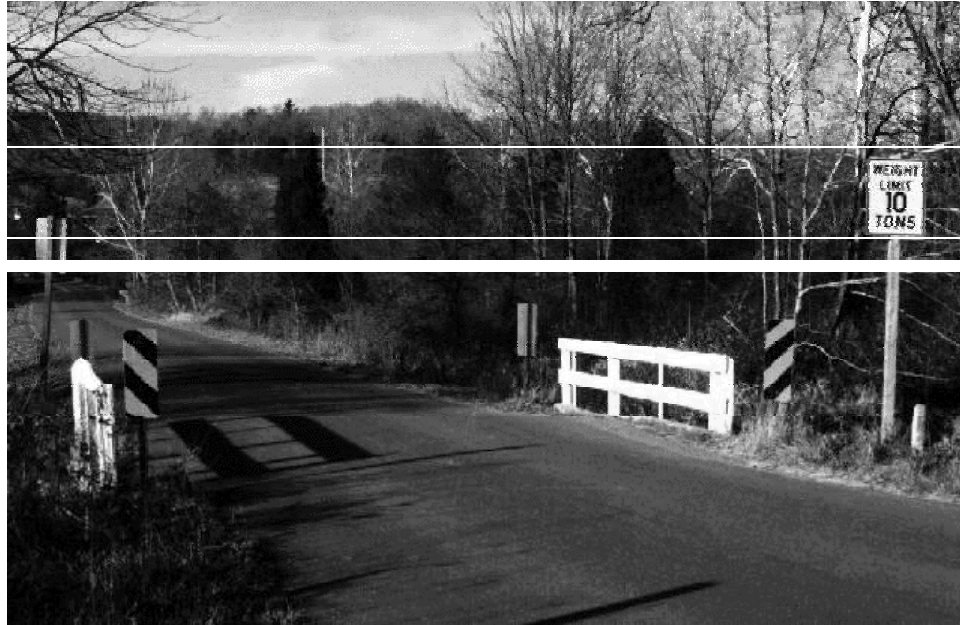
Figure 2.15. Tom's Creek Bridge (Before Repair) (Lesko, Hayes, 1998)

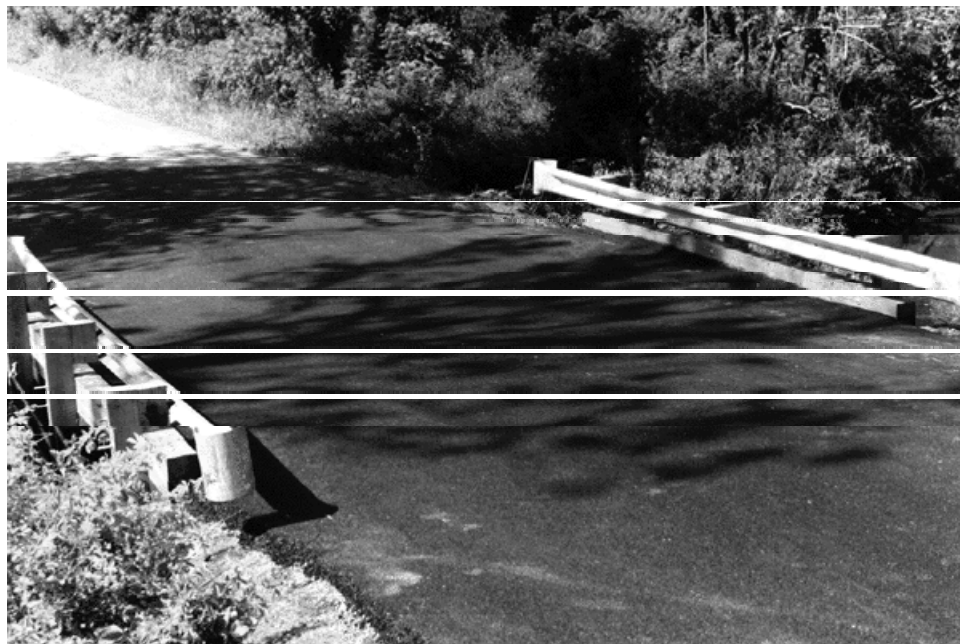
Figure 2.16. Tom's Creek Bridge (After Repair) (Lesko, Hayes, 1998)

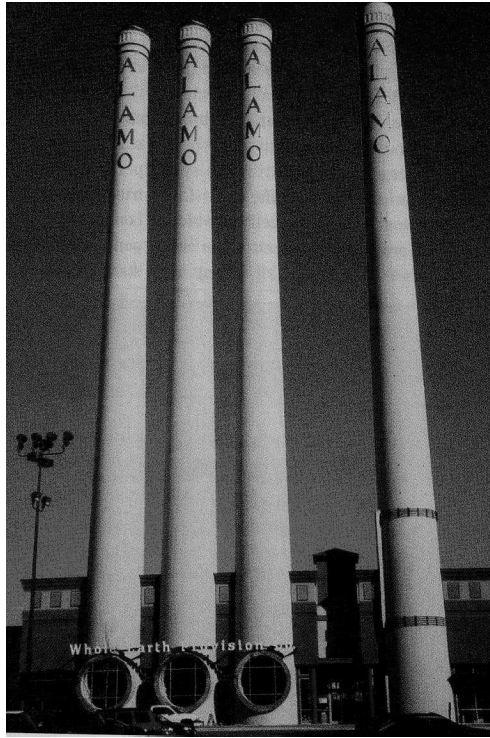
Figure 2.20. Alamo Cement Co. Stacks ^(Hull, 1996).
 Repaired Stacks (Left), Top of Stack before Repair (Right).

1. Foulk Road Bridge, 1995 ^(Hull, 1996).
Materials: CFRP sheets.
Description: Rehabilitation of severely damaged bridge.
2. Alamo Cement Co., 1997 ^(Hull, 1996). Figure 2.20.
Materials: Epoxy wrap
Description: Rehabilitation of aging smokestacks.

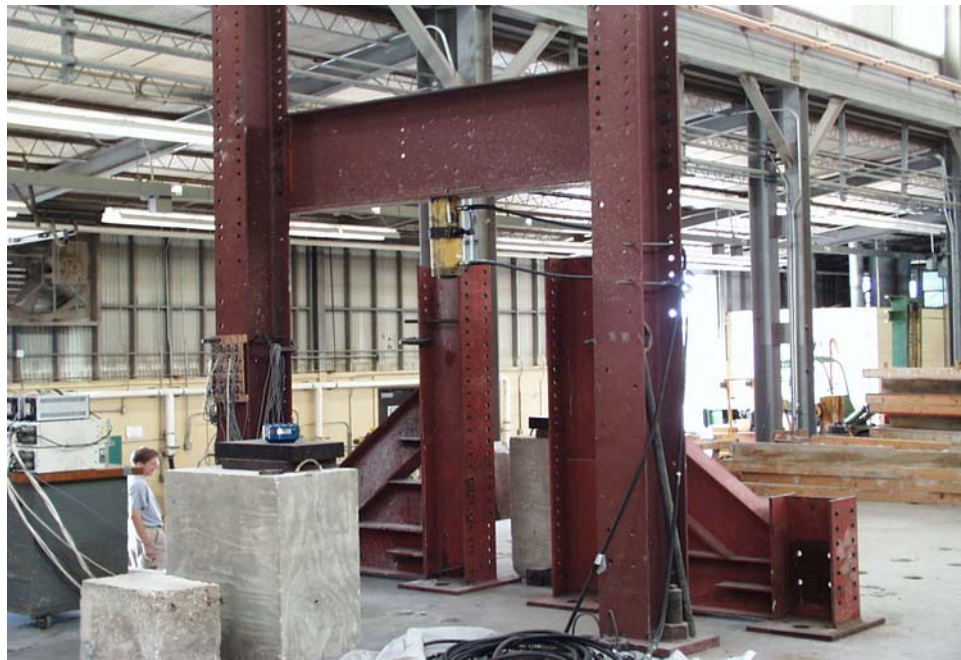
Figure 3.8. Loading Frame.

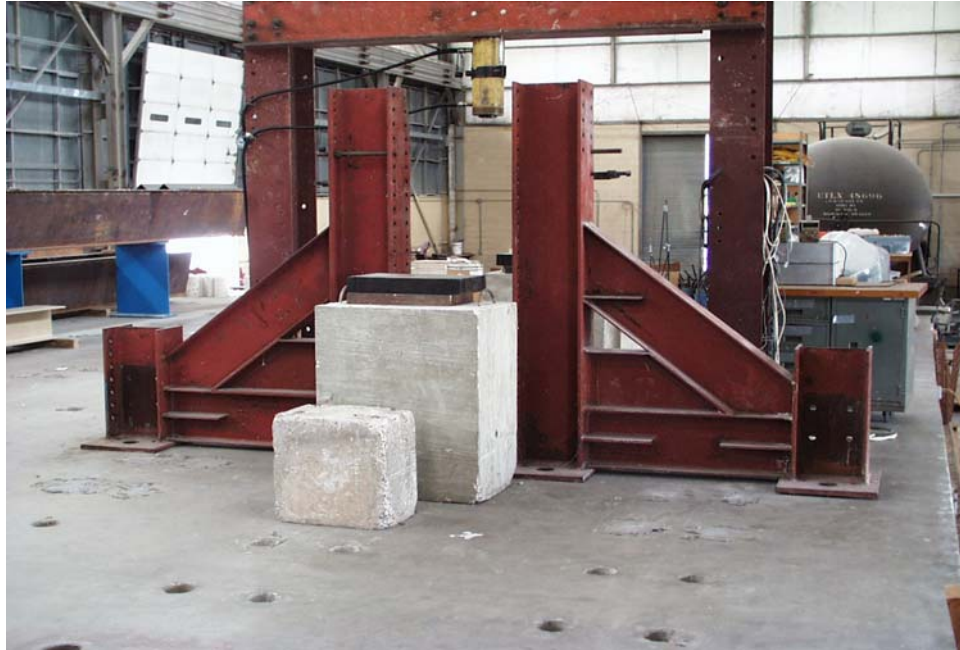
Figure 3.9. Lateral Support Frames.

All the specimens in this experimental program were full-scale. Each specimen had a length of 30 ft. and a width of 4 ft. Handling and testing a specimen of these dimensions involves some sort of hazard. Of special concern was the possibility of the specimens accidentally overturning under load. To prevent this from happening lateral support by means of triangular steel frames was provided. These frames were placed at the specimen midspan and at each end, on both sides of the specimen. It should be noted that these frames were never in contact with the specimen; they were just placed close enough in case the specimen moved and needed to be held in place to prevent accidental overturning. Figure 3.9 shows a pair of such frames.

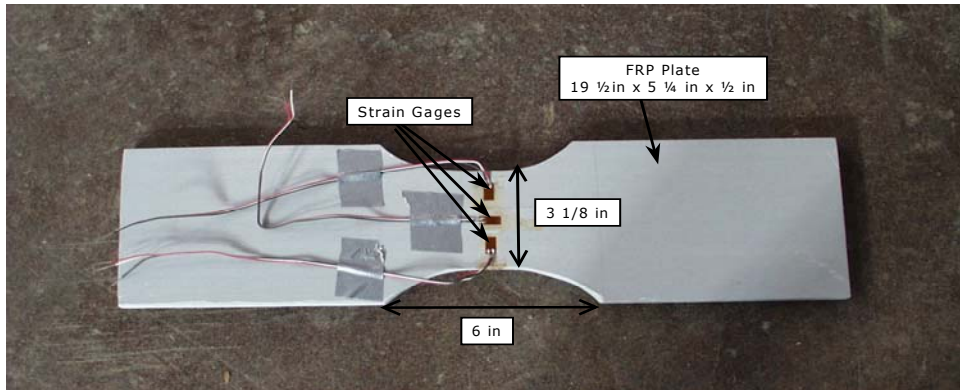
Figure 4.12. FRP Girder Coupon Before Test.

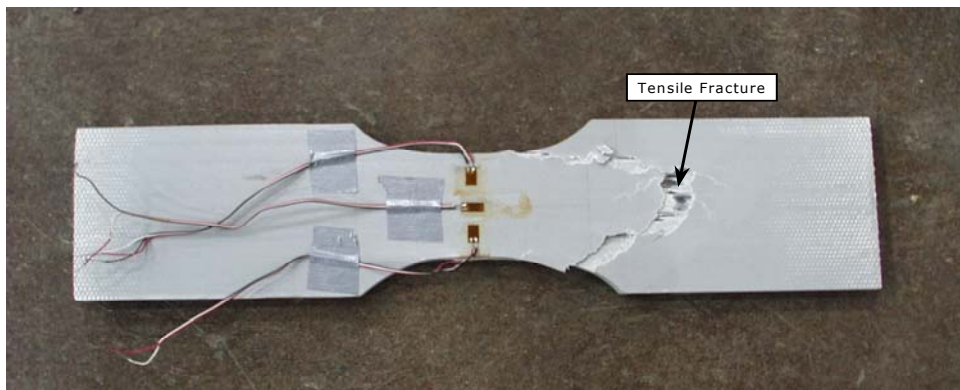
Figure 4.13. FRP Girder Coupon at Failure.

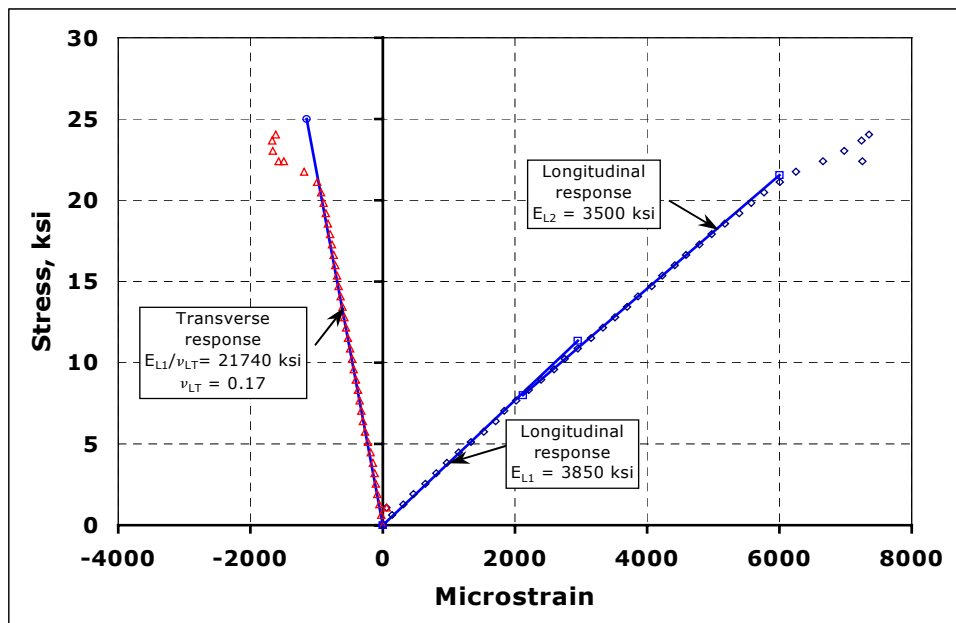
Figure 4.14. Tensile Test Stress-Strain Curves.

A plot of the applied stress vs. measured strain is shown in Figure 4.14. The maximum applied stress was 24 ksi. The behavior exhibited was essentially linear for both axial and transverse directions until close to failure. Based on this response a longitudinal elastic modulus of $E_{L1} = 3850$ ksi, for stresses less than 8 ksi; and $E_{L1} = 3500$ ksi, for stresses over 8 ksi. A Poisson ratio of $\nu_{LT} = 0.17$ was determined. The fabricator listed a value for the elastic modulus of $E_L = 2800$ ksi.

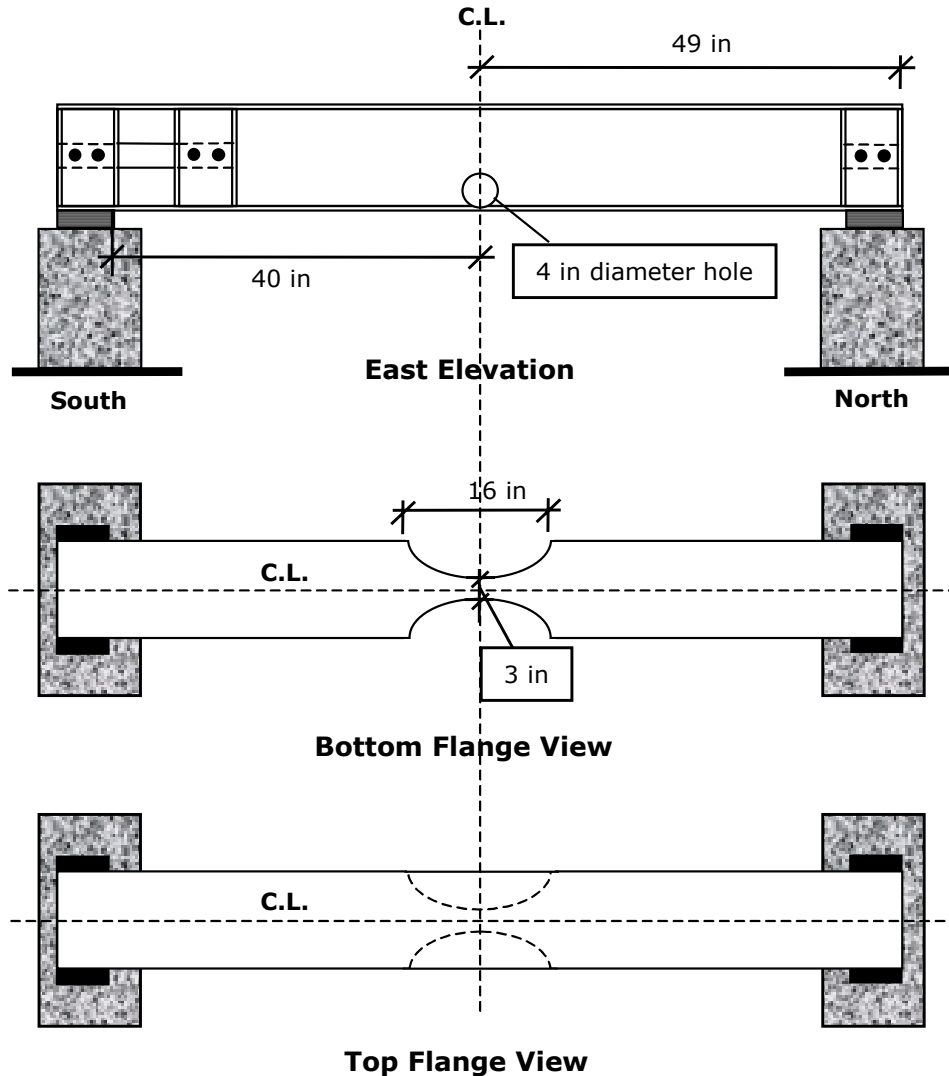
Figure 4.15. Four-Point Bending Test Specimen.

The specimen had a 98 in. length, and a cross section corresponding to the FRP girder WF 12 in. x 12 in. x 1/2 in. Part of the bottom flange was removed symmetrically at midspan. Also, a 4 in. diameter hole was cut out from the web as shown in Figure 4.15. These alterations to the cross section were intended to reduce the strength of the flange so that it reached its tensile capacity at a load similar to the load that caused the top flange to buckle.

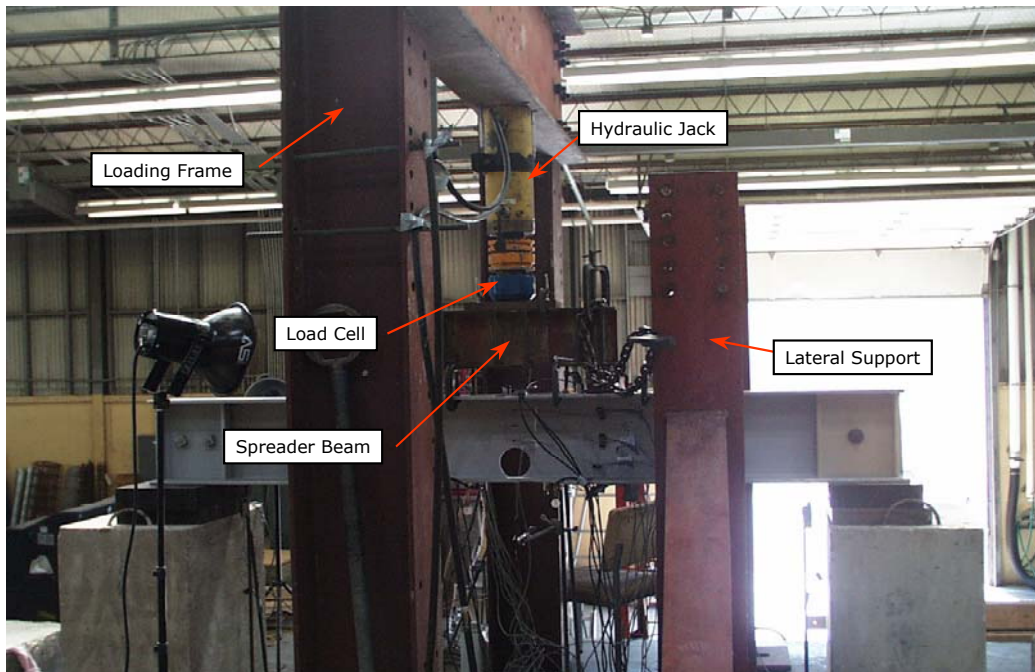
Figure 4.19. Test Setup.

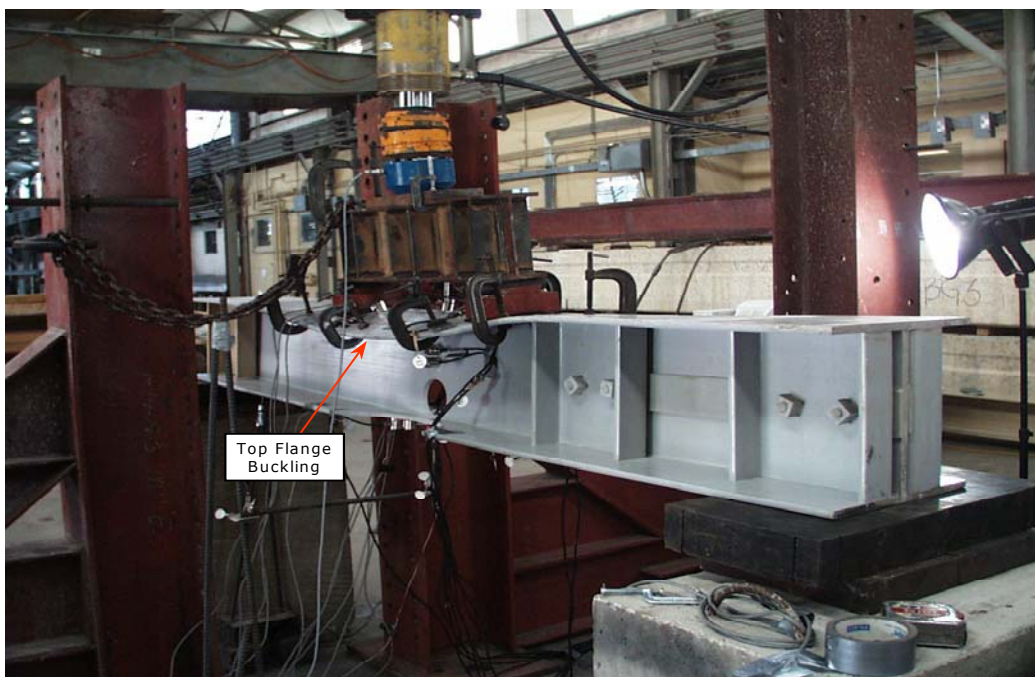
Figure 4.20. Buckling of Top Flange.

In the first test the top flange buckled. Figure 4.20 shows the buckling of the top flange. The response was essentially linear until buckling of the top flange. Figure 4.21 shows the load deflection curve at midspan for this test. The straight line on this figure is used to define a stiffness, hence the elastic moduli of the FRP. Based on this curve a value for the effective elastic modulus was found as $E_{FRPgirder} = 3425$ ksi.

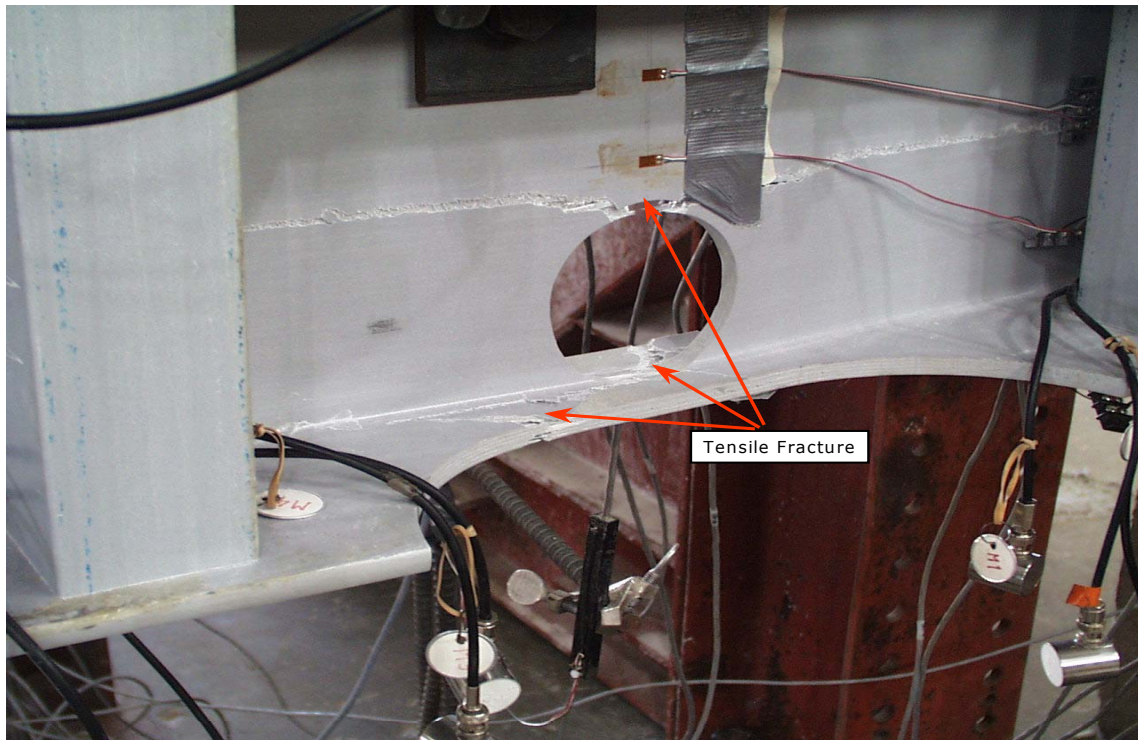
Figure 4.23. Tensile Fracture.

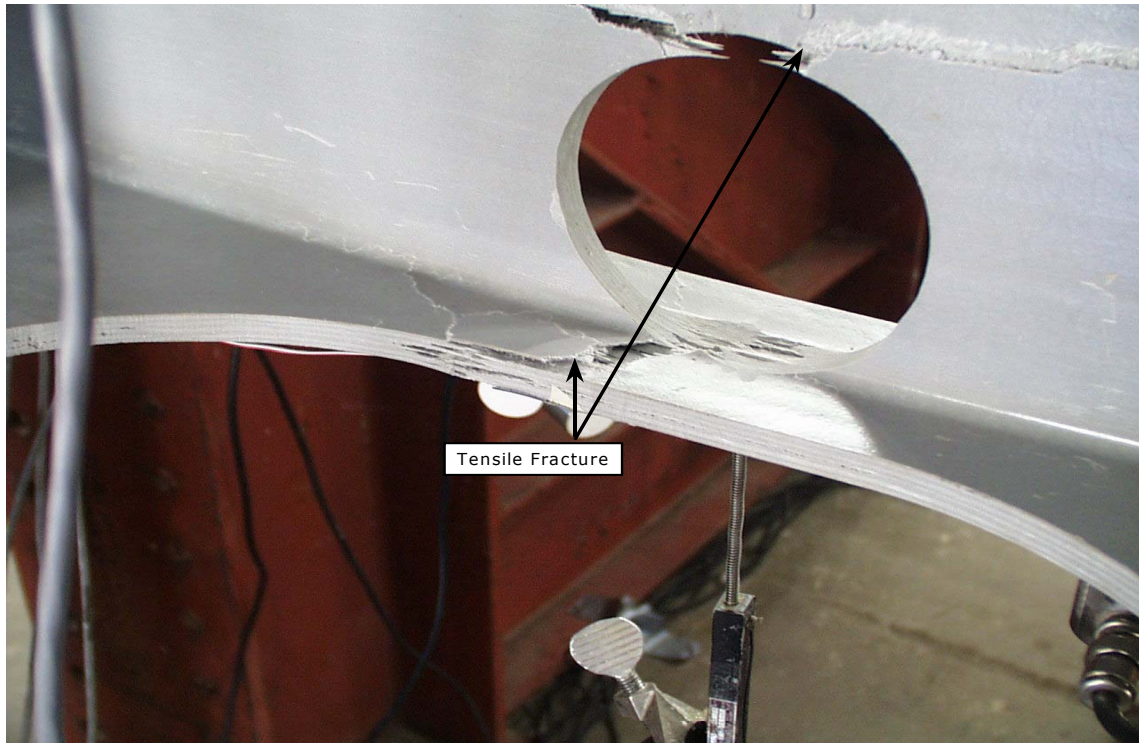
Figure 4.24. Tensile Fracture.

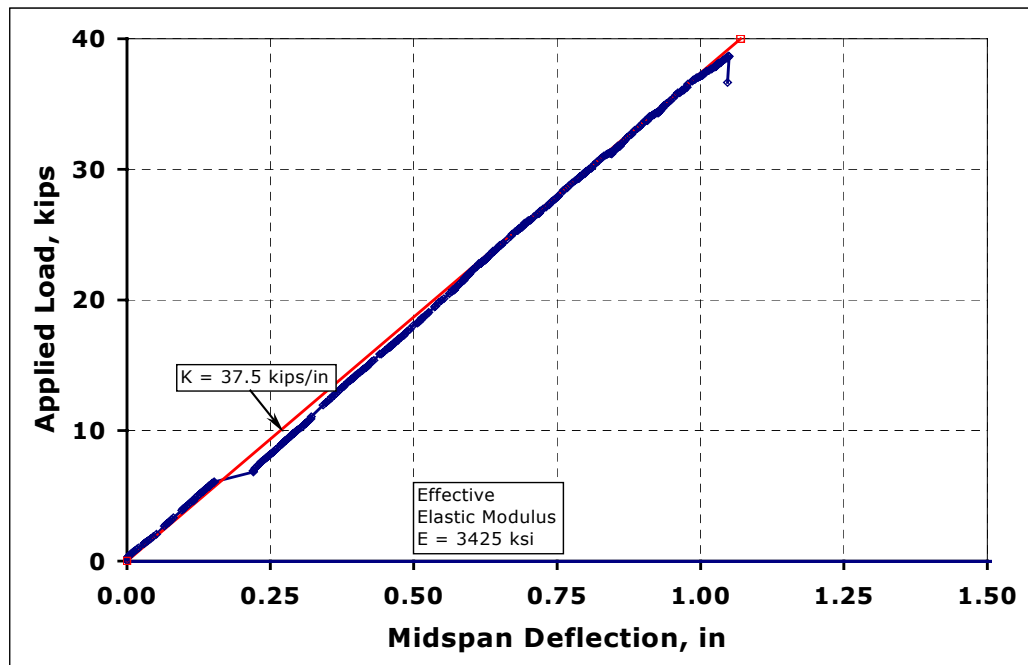
Figure 4.25. Load Deflection Response at Midspan.

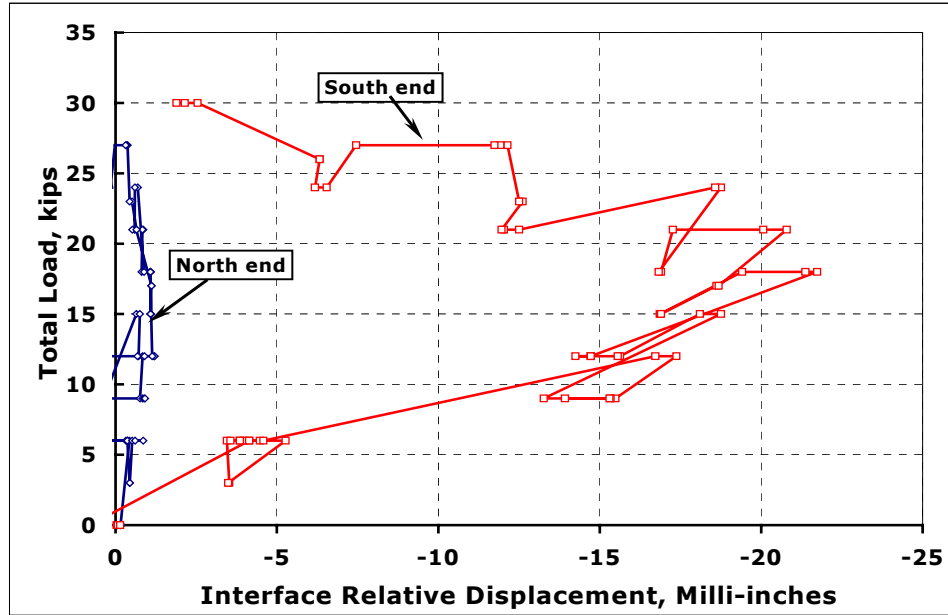
Figure 4.33. Deck-Girder Relative Horizontal Displacement at each End.

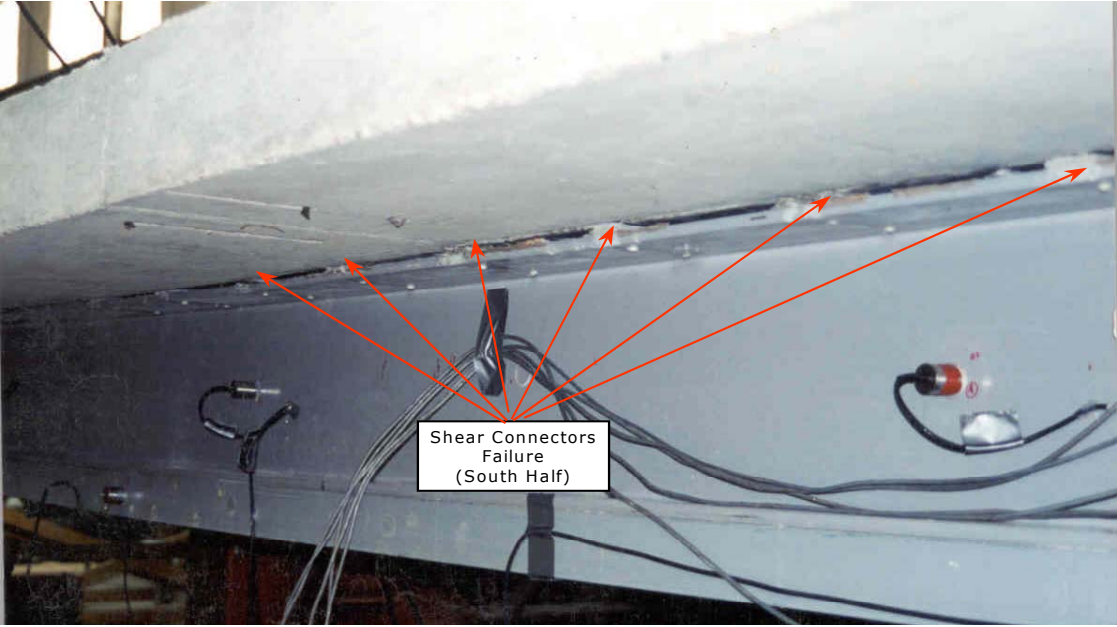
Figure 4.34. Failure of Shear Connectors (South Half).

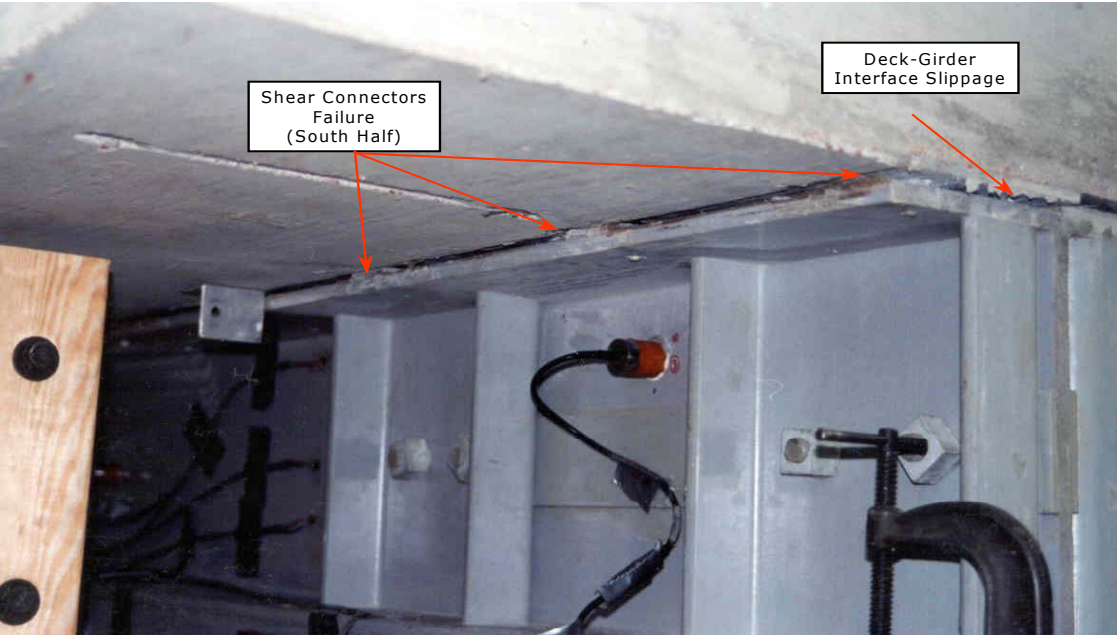
Figure 4.35. Failure of Shear Connectors (South End).

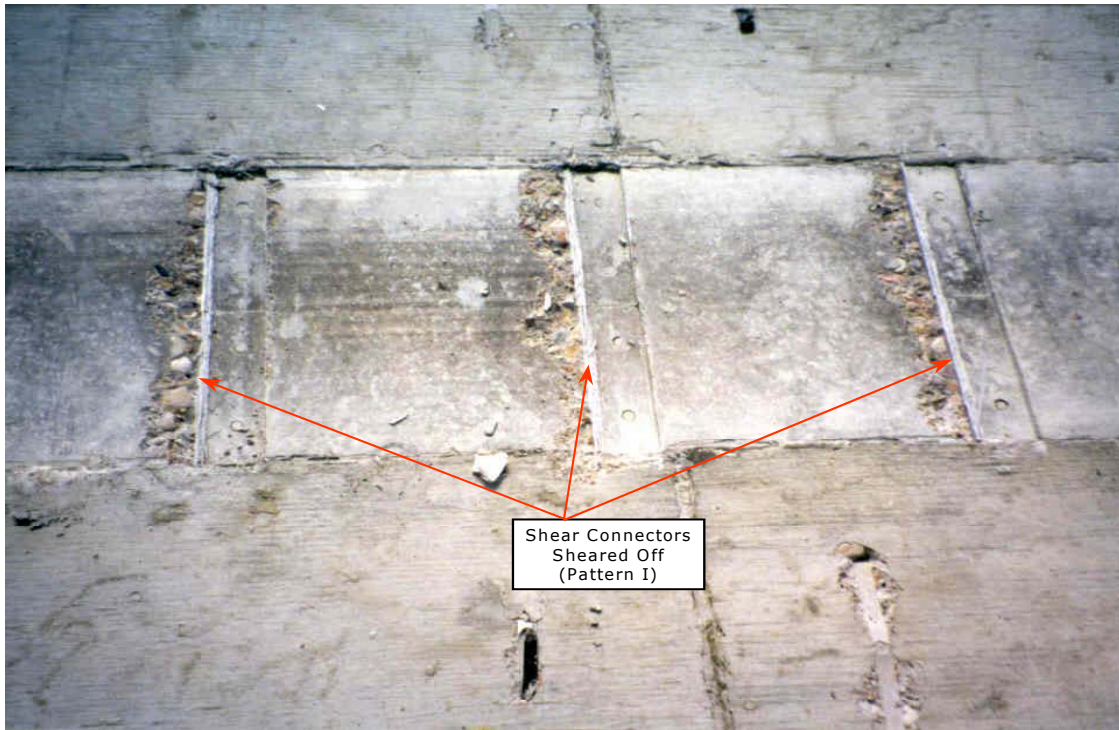
Figure 4.36. Shear Connectors Failure: Pattern one.

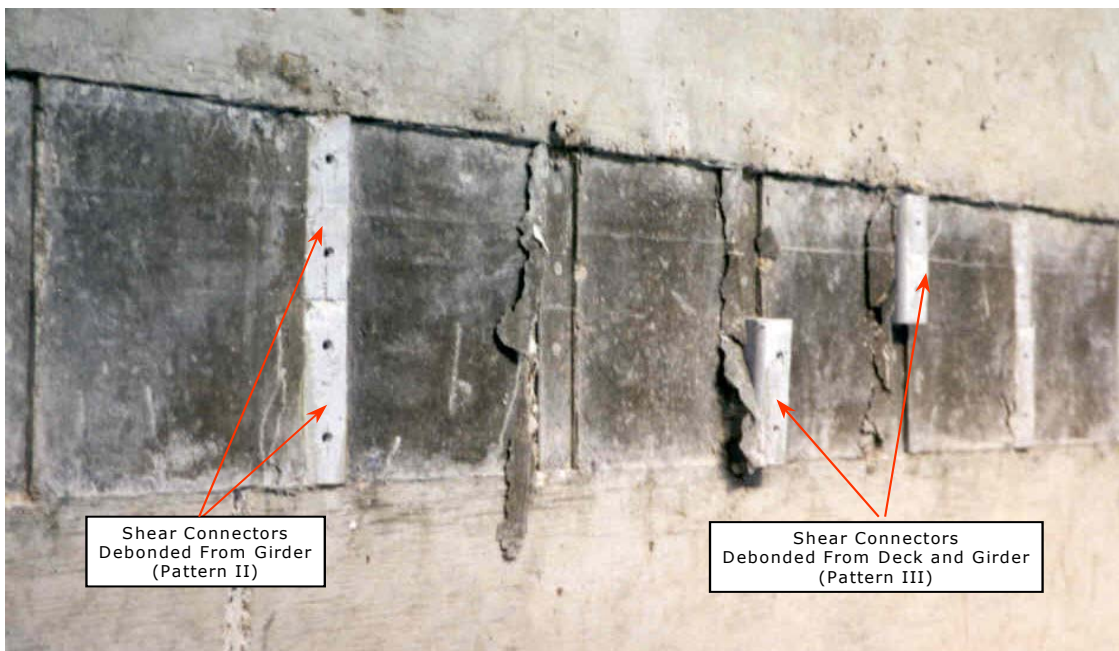
Figure 4.37. Shear Connectors Failure: Patterns two and three.

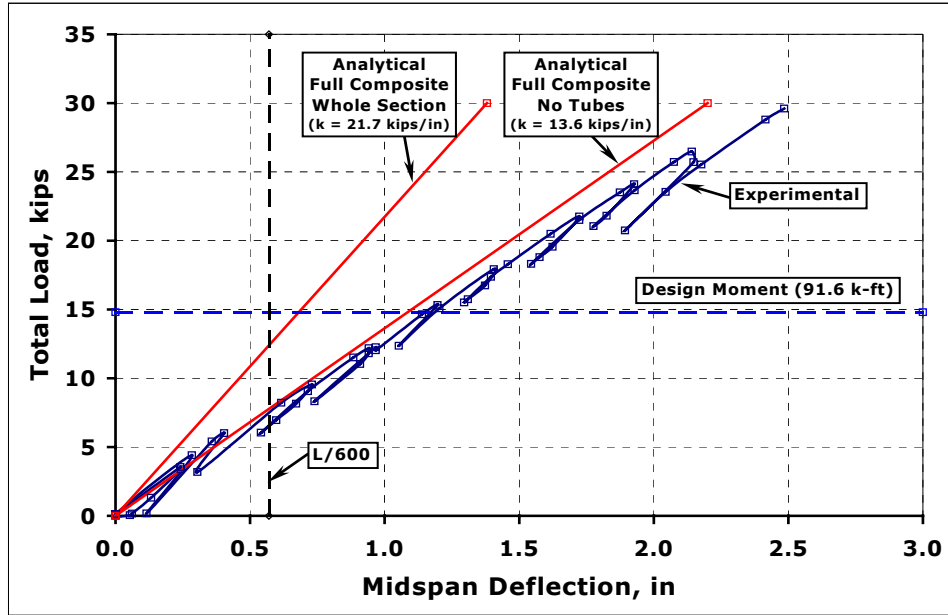
Figure 5.11 shows the specimen had an initial stiffness of about 15 kip/in, which began to deteriorate very early as the load was applied. By the time the applied load exceeded 6 kips, the system lost almost 20 % of its initial stiffness, down from 15 kips/in to 12 kips/in. The stiffness of 12 kips/in remains almost constant up to failure. The main reason for this unexpected behavior was the early debonding of the tubes on the bottom flange. AE data from the specimen showed that debonding of the tubes began early during the test. Visually it was not possible to see this taking place.

Figure 5.11. Specimen FG2, Load-Deflection Curve.

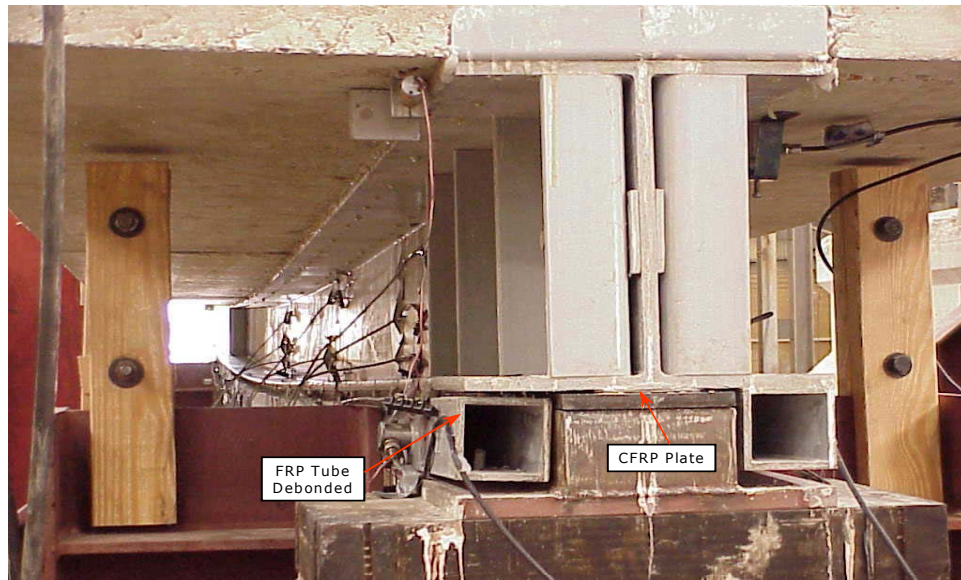
Figure 5.13. West Side Tube Debonded, View From South End.

towards the south end. See Figures 5.13 and 5.14. This was the most significant damage. A visual inspection, showed the shear connectors had suffered some damage, similar to that with specimen FG1. Specimen FG1 sustained 2.0 times the design load before failure.

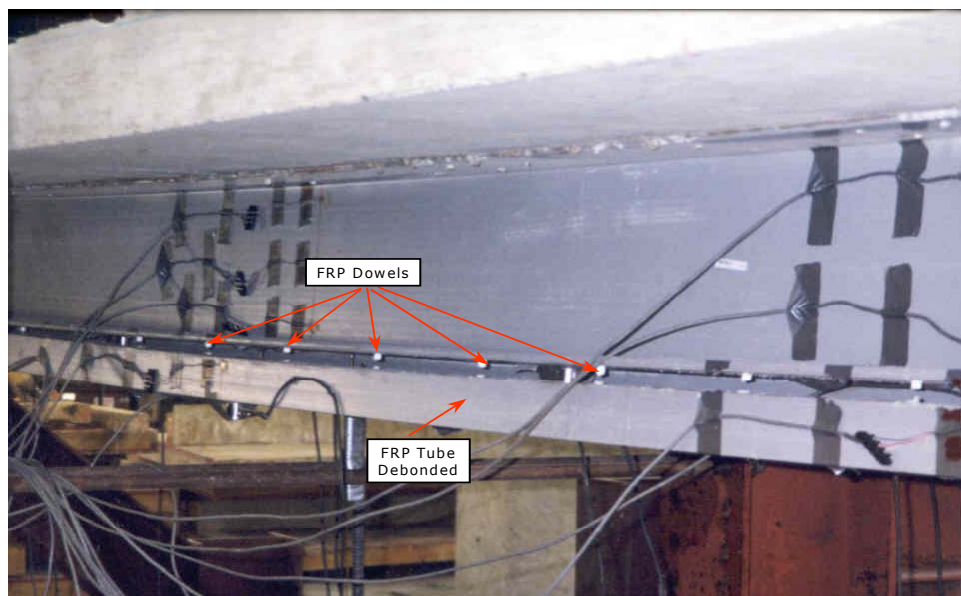
Figure 5.14. West Side Tube Debonded, View From West Side.

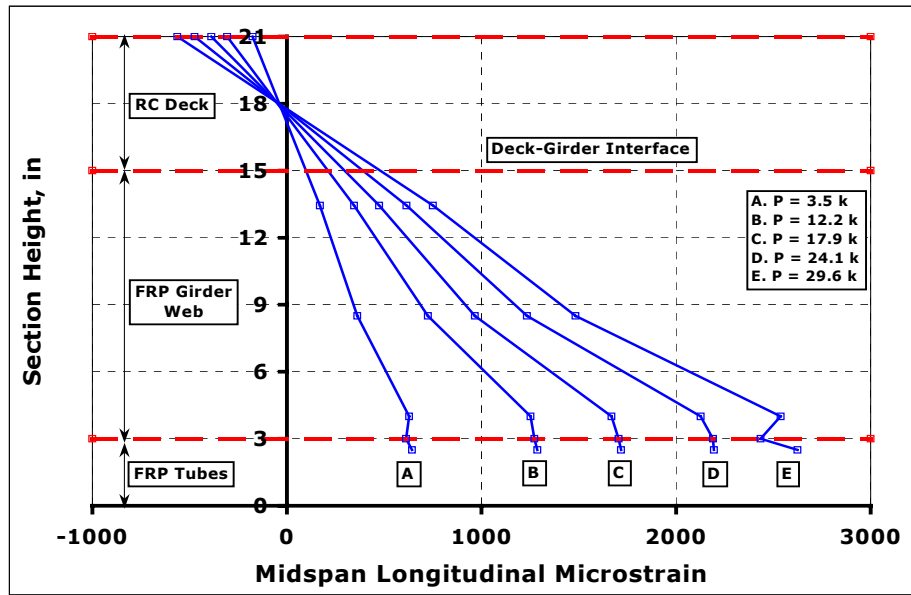
Figure 5.15. Longitudinal Strain at Midspan.

Specimen FG2 featured an increased number of shear connectors. The strain profiles for sections at similar locations as specimen FG1 are shown in Figures 5.15 and 5.16. These figures show the longitudinal strain distribution along the depth at midspan and at a section 3.5 ft. from the south end.

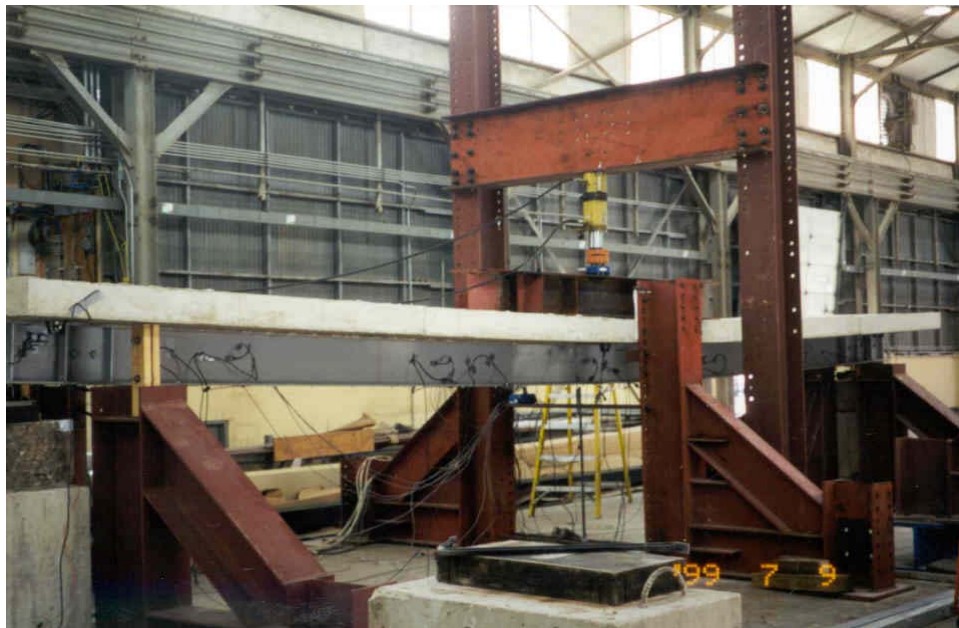
Figure 5.17. Specimen Without Tubes, Excessive Deflections.

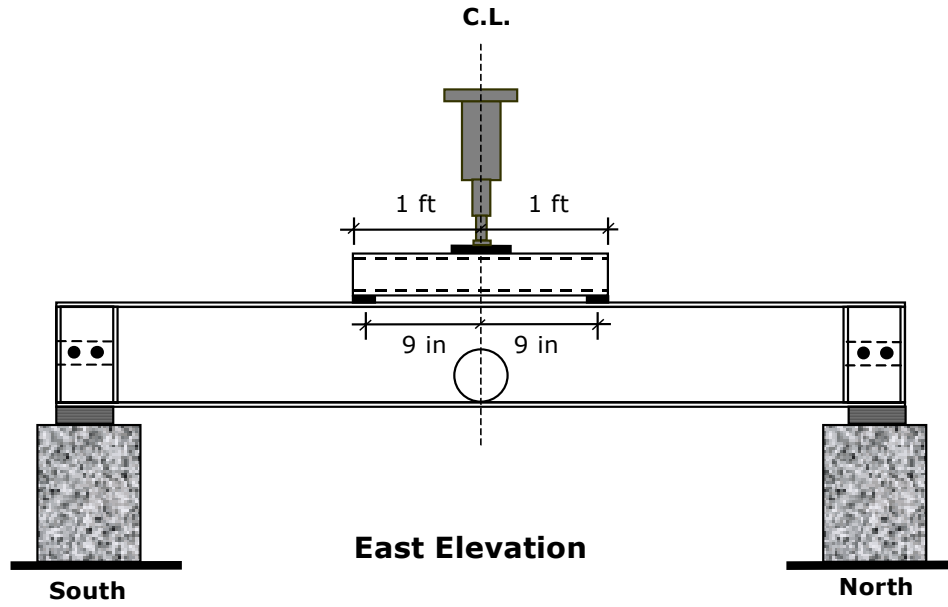
Figure 6.10. Specimen IKG2 - Loading.

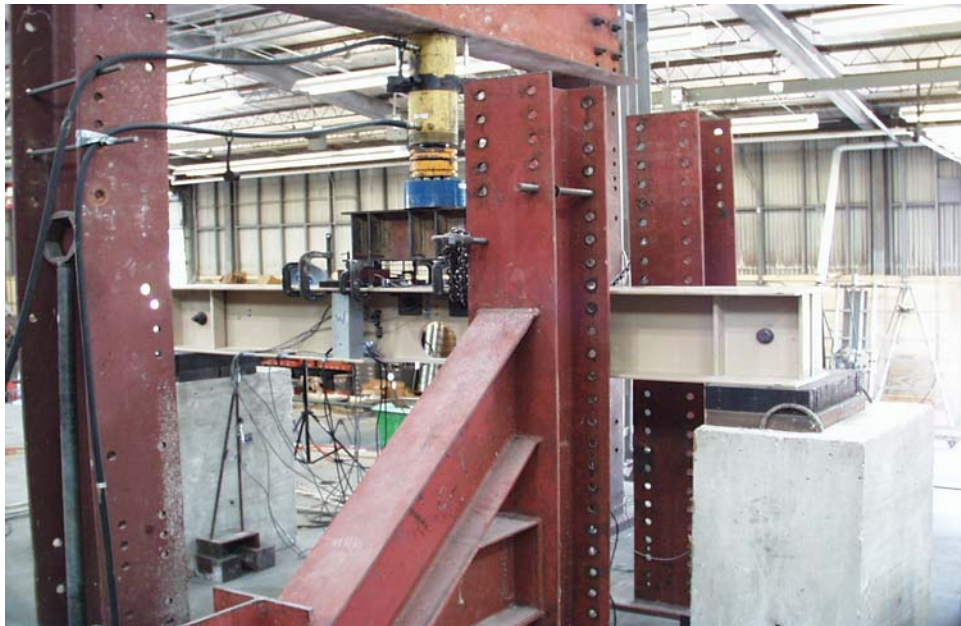
Figure 6.13. Specimen IKG2 During Testing.

The applied loading and the symmetry of the specimen cross section away from the web hole and flange cut out allowed for both flanges to fail at essentially the same load, with the top and bottom flanges being subject to compressive and tensile stresses respectively. Figures 6.12 and 6.13 show the specimen before and during testing respectively.

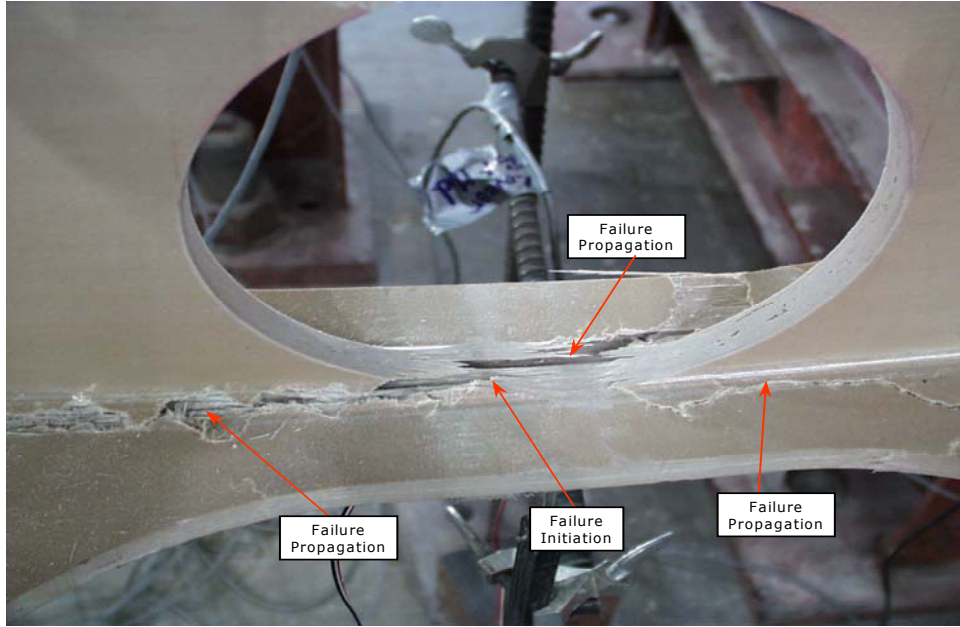
Figure 6.14. Specimen IKG2 Failure of Bottom Flange.

The specimen failed at a maximum total load of 51 kips, corresponding to a midspan deflection of 1.4 in. The specimen failed when the bottom flange of the section at midspan experienced a longitudinal shear failure. The failure appeared to be caused by shear transfer due to the reduced cross section, this failure is shown in Figures 6.14 and 6.15. It developed at the section with the smallest width at the junction of the web and flange, and propagated longitudinally towards the North end.

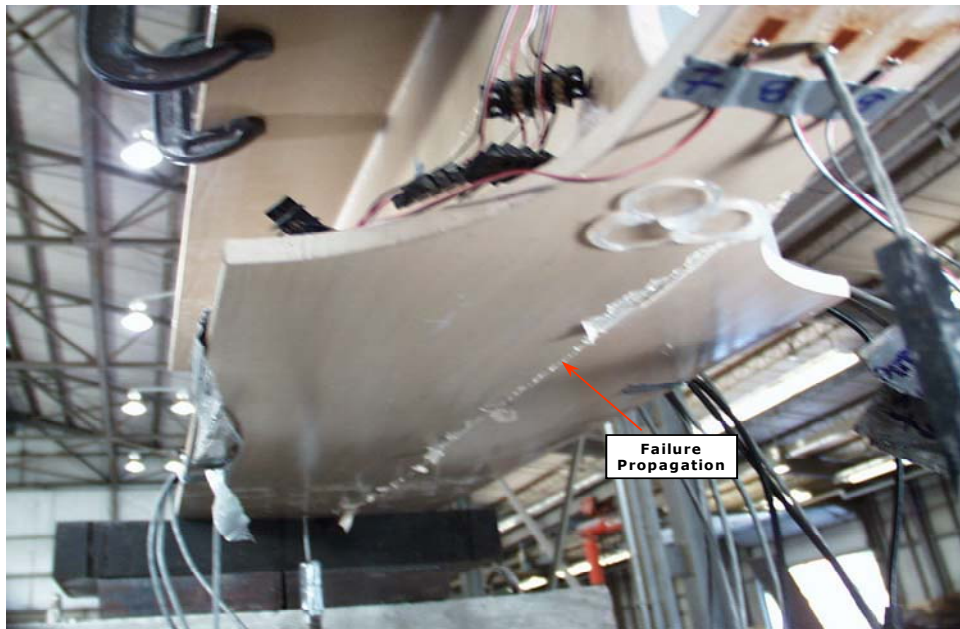
Figure 6.15. Specimen IKG2 Bottom View of Failure.

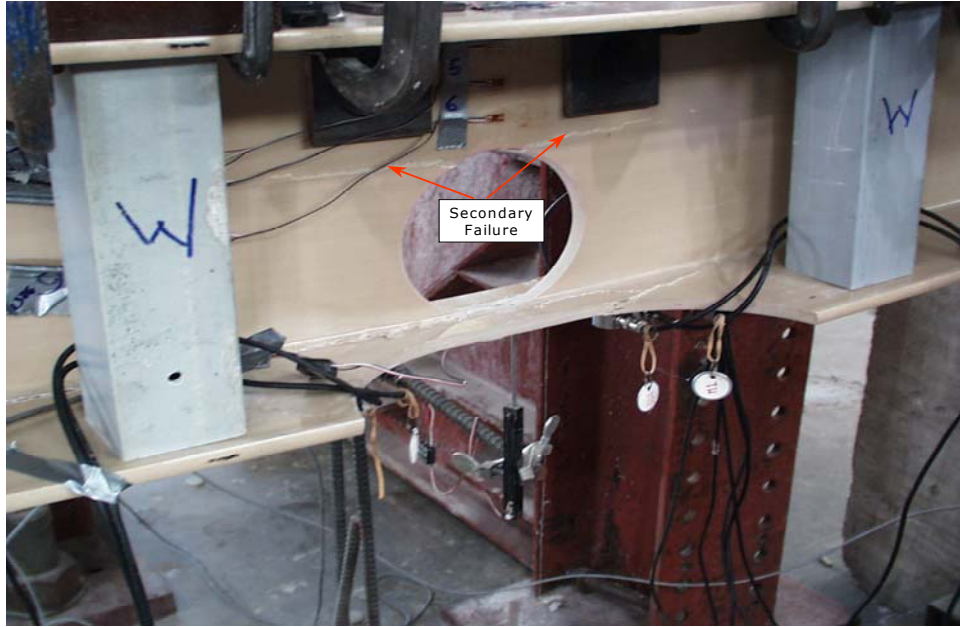
Figure 6.16. Specimen IKG2 Failure of Web.

As the load was increased the next failure developed at the top of the circular hole on the web. This failure is shown in Figures 6.16 and 6.17. Figure 6.18 is an overall view of the specimen after testing. It is observed from Figures 6.14 through 6.18 that the failure propagated a significant distance.

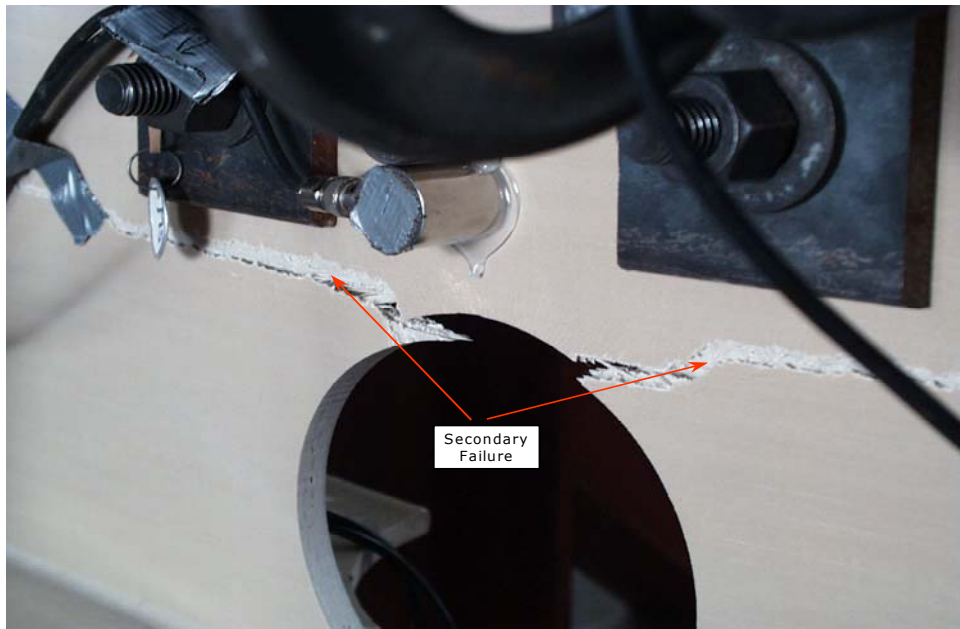
Figure 6.17. Specimen IKG2 Details of Failure of Web.

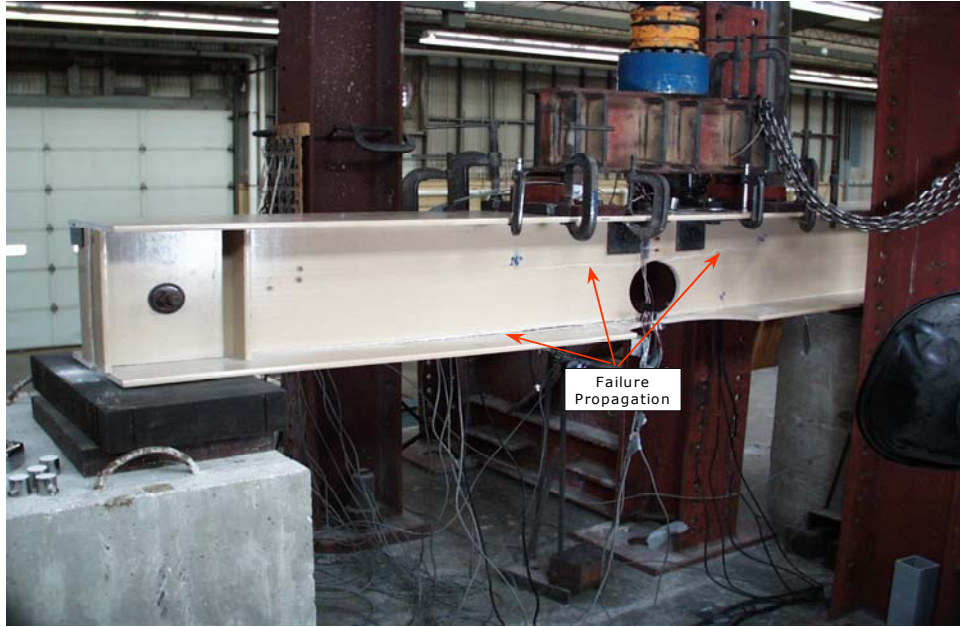
Figure 6.18. Specimen IKG2 after Testing.
