**COMPOSITE STRUCTURAL MEMBERS FOR
SHORT SPAN HIGHWAY BRIDGES**

Research Report 1773-1

Research Project 0-1773

APPLICATIONS FOR COMPOSITE MATERIALS IN TXDOT

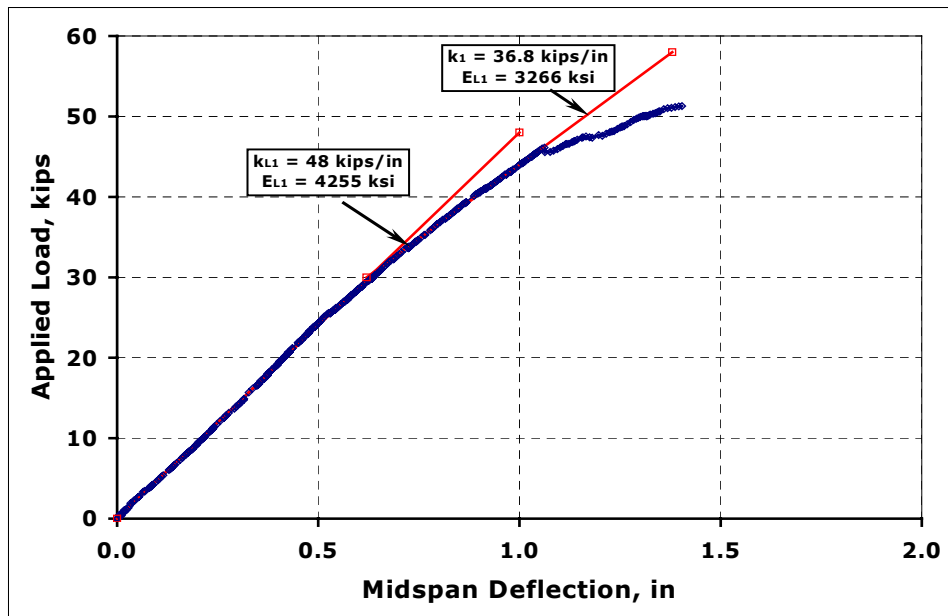
Figure 6.19. Specimen IKG2 Midspan Load-Deflection Curve.

Figure 6.19 shows the load-deflection curve corresponding to the midspan of the specimen. It is seen in this figure that the behavior of the specimen is linear up to an applied load of 30 kips. A gradual loss of stiffness is observed beyond this point. At a load of 46 kips, failure at the bottom flange takes place, and as the applied load is increased, failure on the web begins to develop. It is the failure in the web that finally causes the system's failure when the applied load reaches a value of 52 kips. The straight lines on this figure are used to define the stiffness of the system as the test progressed. These values of stiffness are used to calculate a value for the longitudinal elastic modulus of the FRP girder.

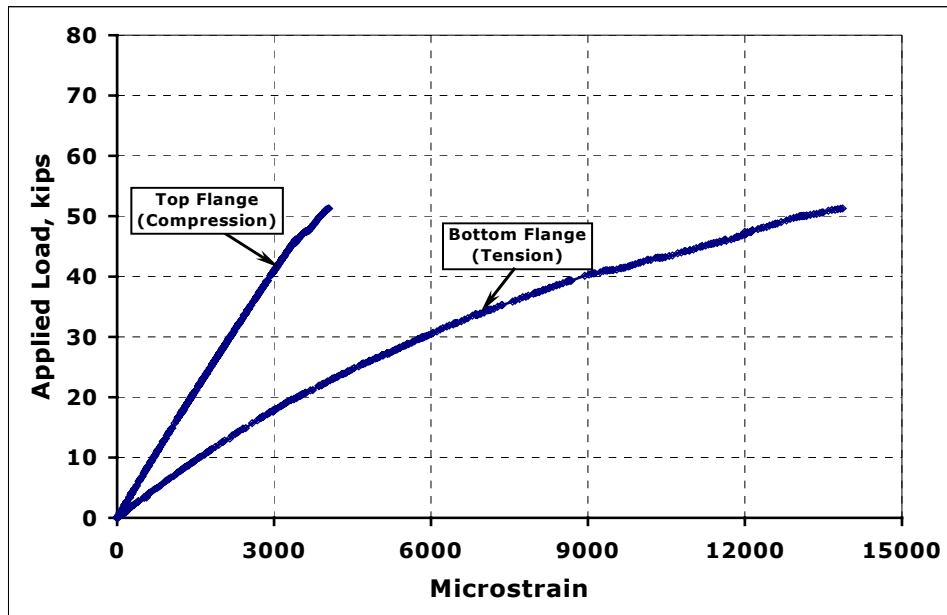
Figure 6.20. Specimen IKG2 Bottom Flange Average Strain.

Figure 6.20 shows the average of the strain measurements at midspan on the bottom and top flanges respectively. It is seen that the magnitude of the strains acting on the bottom flange are 3.5 times greater than the magnitude of the strains taking place on the top flange. Also it is seen that the strains on the bottom flange (under tensile stress) is highly nonlinear. This can be explained by the very abrupt change in geometry on the bottom flange at midspan, this idea is supported by the strain distribution on the top flange where it is seen that the behavior is fairly linear.

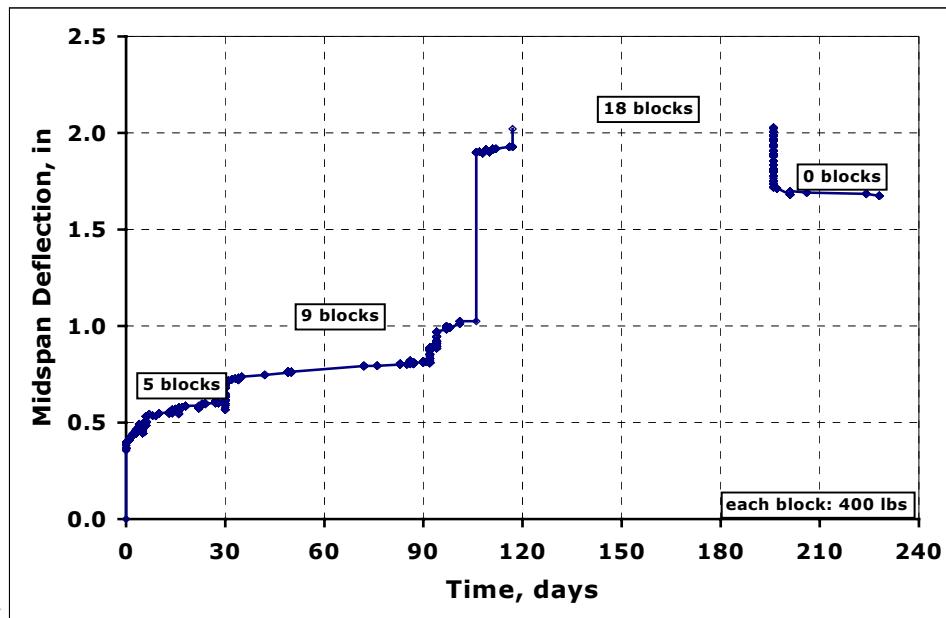
Figure 6.31. Midspan Deflection vs. Time.

The specimen midspan deflection as a function of time is shown in Figure 6.31. It can be observed on this figure the development of creep with time and level of loading. Initially only five blocks were loaded on the specimen; after a month four additional blocks were put on; finally, after three months this number was doubled up to a maximum of eighteen blocks. The specimen was then subjected to this level of loading for an additional three and a half months. At the end of this period, the loading was removed. As it is shown in Figure 6.31, only a small amount of recovery was observed. This behavior can be explained if we consider that the deck-girder interface experienced slippage during the test, the recovery then was prevented by friction at this interface. Non-recoverable permanent deformations on the RC deck were observed at its midspan; the FRP girder on the other hand did recover back to its initial configuration after a few hours.

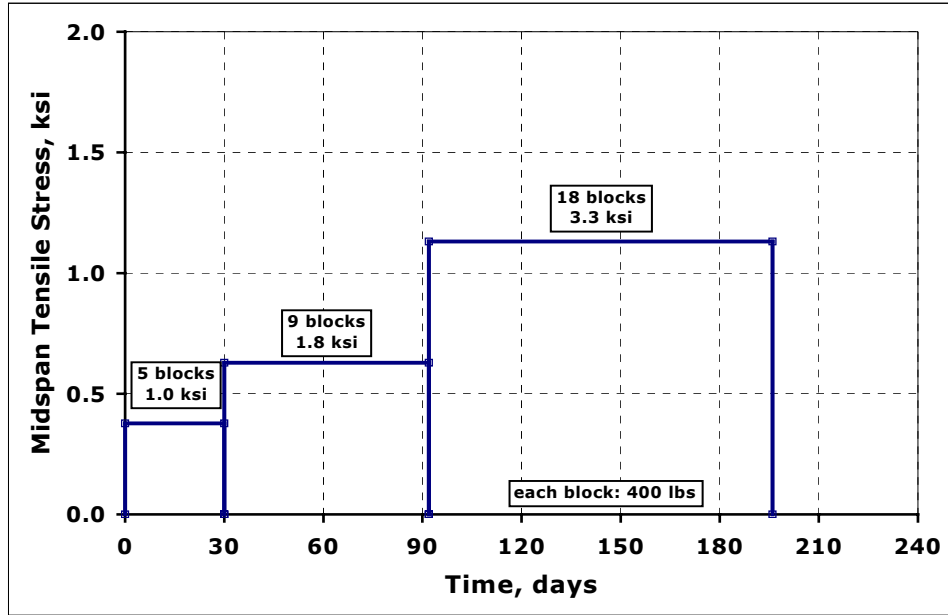
Figure 6.32. Midspan Stresses vs. Time.

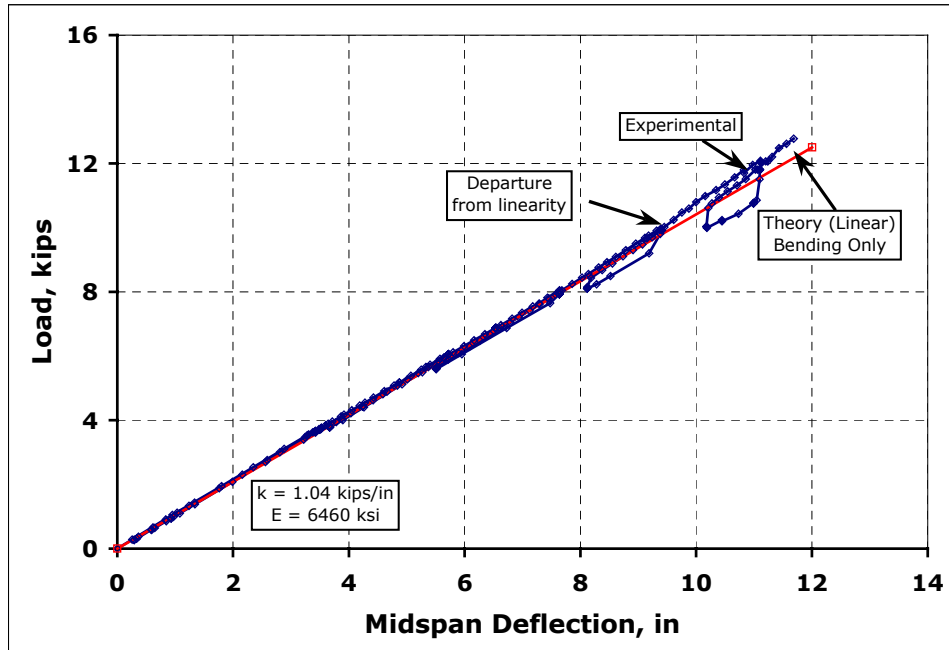
Figure 7.12. Specimen SW2 Load-Deflection Response.

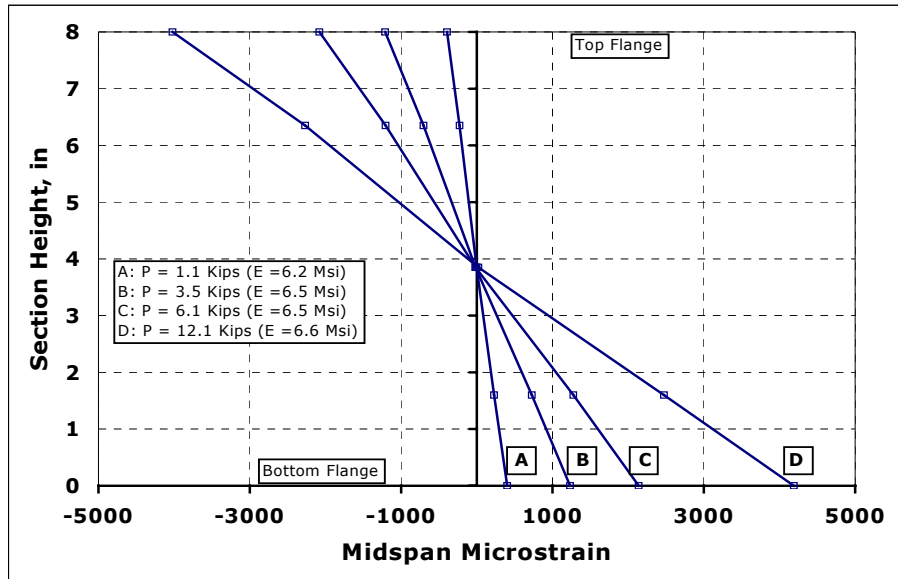
Figure 7.13. Specimen SW2 Linear Strain Distribution at Midspan.

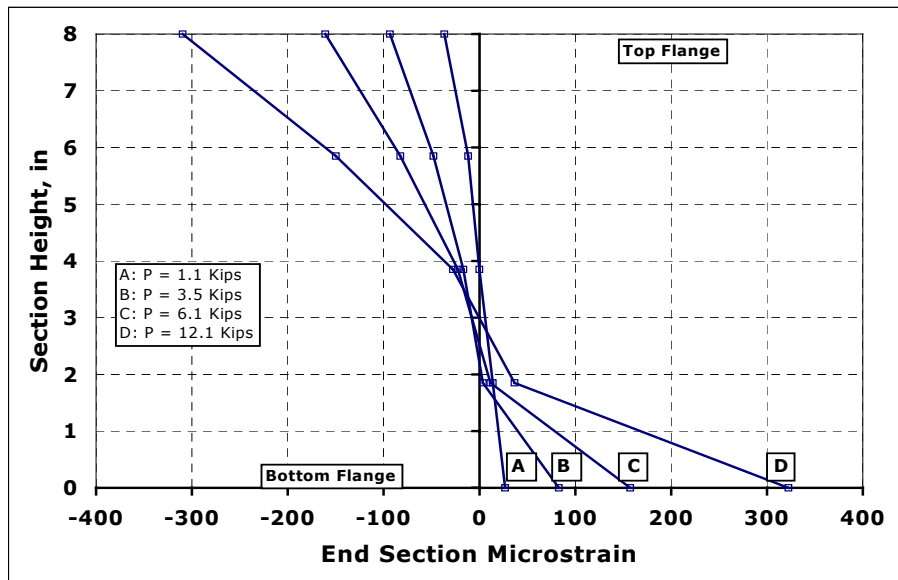
Figure 7.14. Specimen SW2 Nonlinear Strain Distribution at South End.

This behavior is similar to the behavior observed in Specimen FG1 (See Section 4.38 and Figure 4.39). Since the reinforcement in the FRP is provided only in the longitudinal direction, the shear stresses in the cross section are carried primarily by the resin. This results in the behavior shown in Figure 7.14.

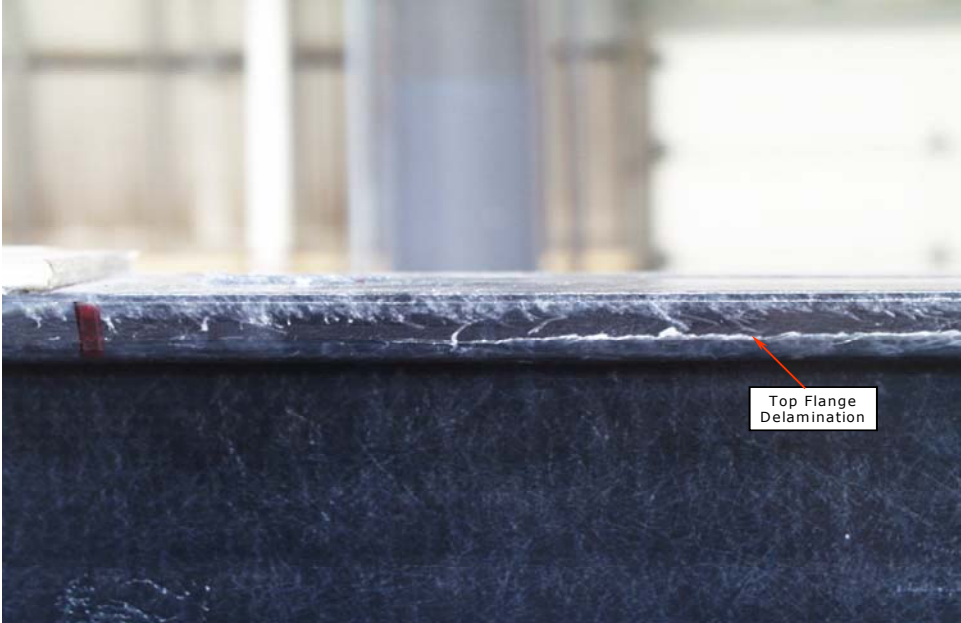
Figure 7.15. Specimen SW2 Top Flange Early Delamination.

Specimen SW2 failed by delamination of the top flange at a load of 12.8 kips. The corresponding compressive strain was 4260 microstrain. Delamination of FRP materials is caused by interlaminar shear stresses, which tend to slide one lamina over adjacent laminae. Figure 7.15 shows early delamination taking place on the top flange of the girder close to its midspan. Figures 7.16, and 7.17 show the top flange of the girder at midspan at failure, delamination had caused buckling of the fibers and as a result the flange at this area has been completely delaminated.

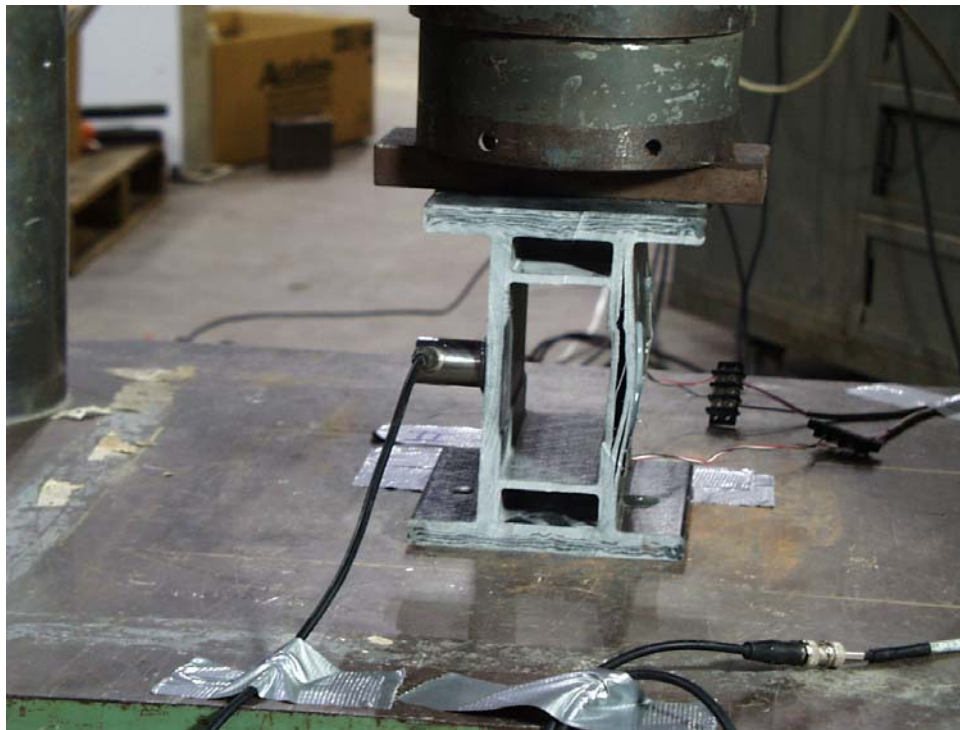
Figure 7.20. Specimen SW2 Web Buckling Test Failure.

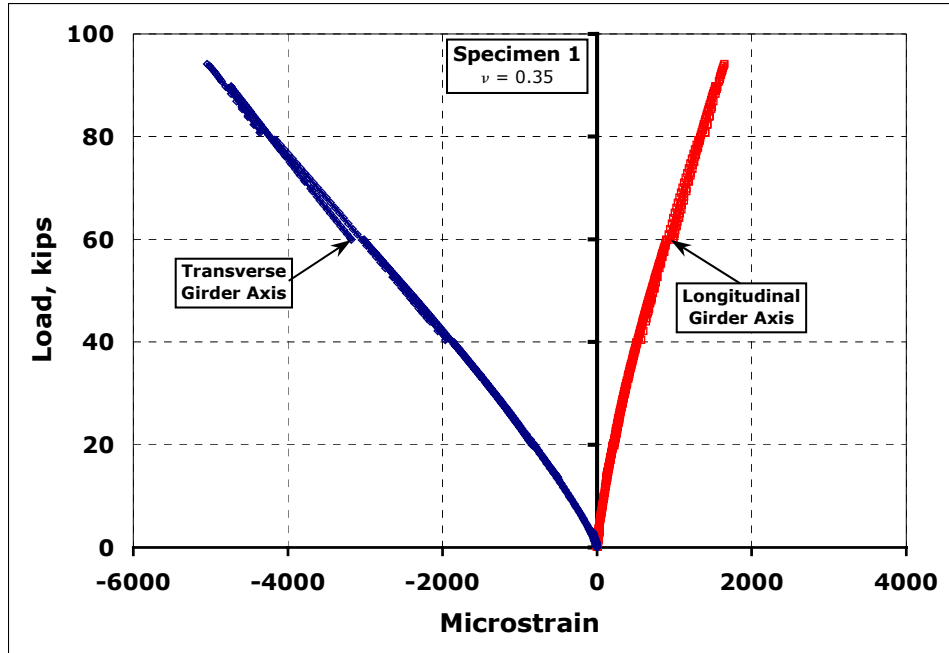
Figure 7.21. Web Buckling Test Specimen 1 Load-Strain Curve.

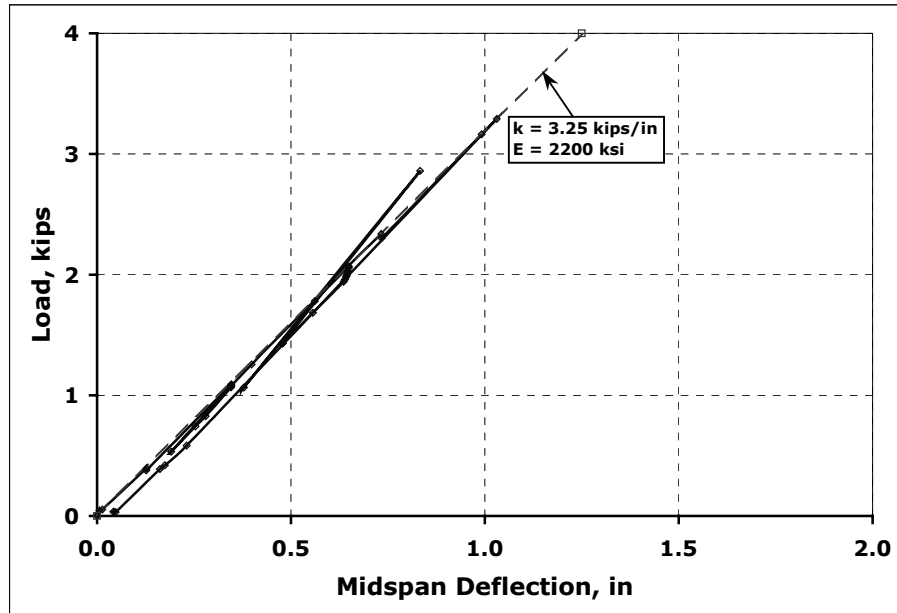
Figure 8.7. FRP Girder Load Deflection Curve.

The FRP girder was tested alone under a load applied at midspan, the clear span between supports was 28.5 ft. The girder was loaded up to 3 kips, unloaded and reloaded up to 3.5 kips. The load deflection curve is shown in Figure 8.7. Based on this test a value for the elastic modulus of the FRP was found to be $E_{FRPgirder} = 2200$ ksi. The fabricator reported an ultimate tensile strength of 25 ksi.

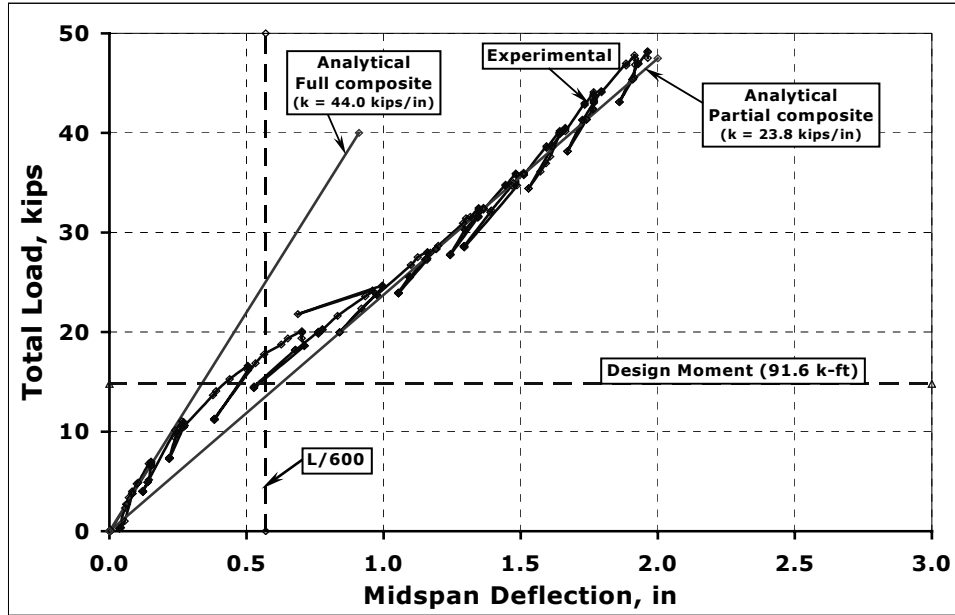
Figure 8.14. Load Deflection Curve at Midspan.

The predicted response matched the experimental data at levels of load under 10 kips, with a stiffness of about 44 kip/in. As the applied load increased over 10 kips the system stiffness began to degrade. For levels of load between 10 and 30 kips a nonlinear response is observed. The average stiffness of the system is now about half of the initial stiffness 24 kips/in. Figure 8.15 shows the deck-girder relative displacement developing almost at a constant rate although of very small magnitude. Figure 8.15 also shows that most of the relative displacement took place at the south end of the specimen. No measurable relative displacement was recorded at the north end indicating full composite action.

As the loading increased, composite action at the south end continue to deteriorate and the deck and girder were kept together only by the action of the web connectors. So the structural system switched from a fully composite system, into a partially composite system with only the north half working under composite action; in the south half the RC deck and the FRP girder sustained the load independently. This hypothesis seems to agree with the experimental data as shown in Figure 8.14.

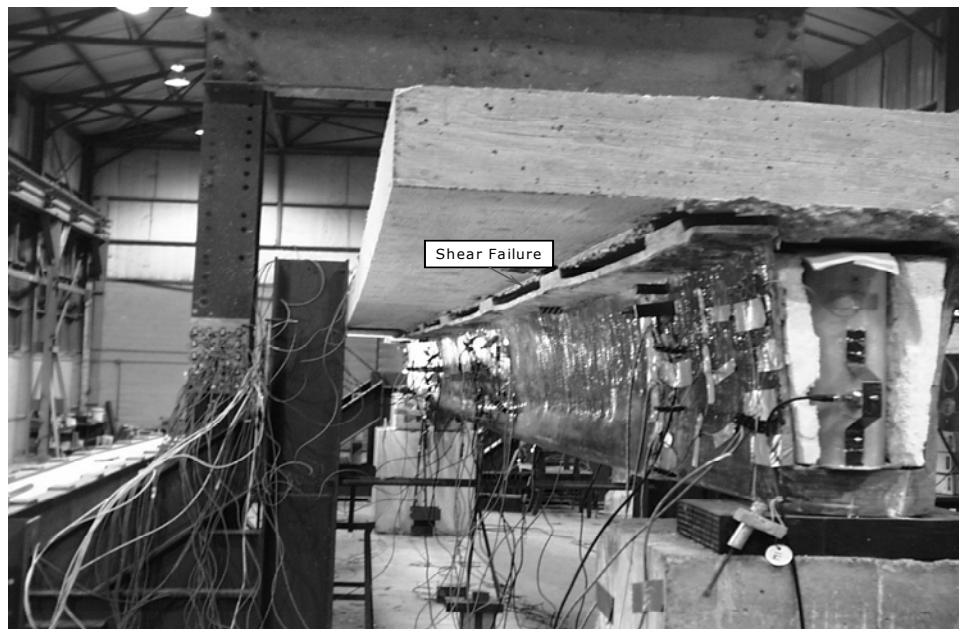
Figure 8.16. Shear Failure at Deck-Girder Interface at South End.

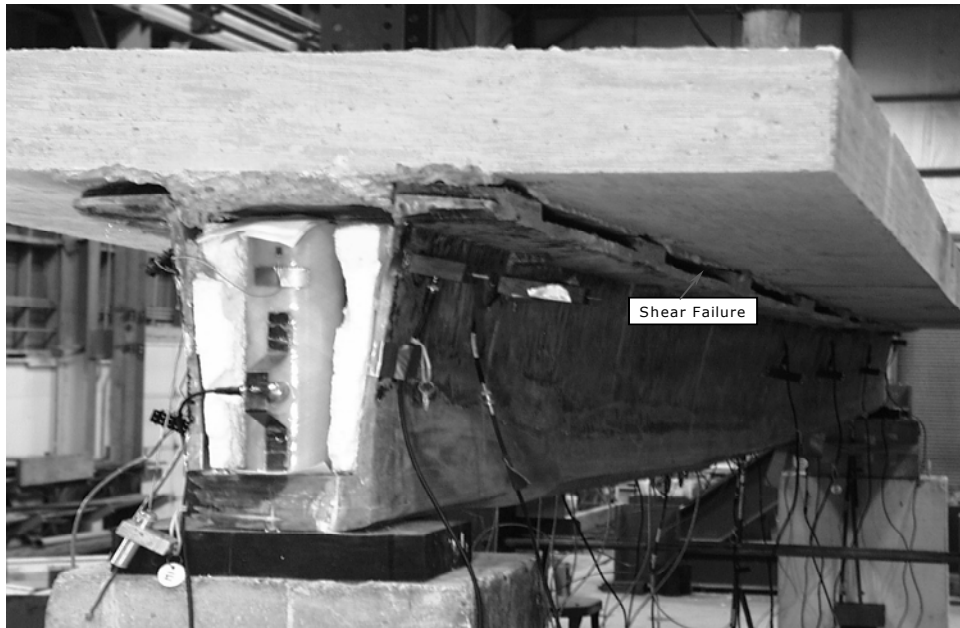
Figure 8.17. Shear Failure at Deck-Girder Interface at South End.

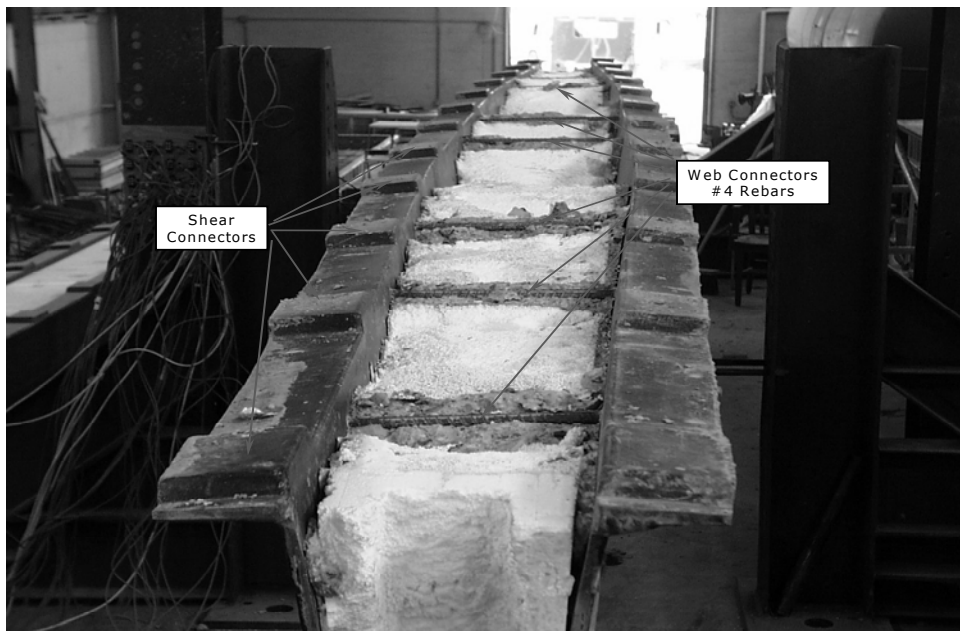
Figure 8.18. Girder with RC Deck Removed.

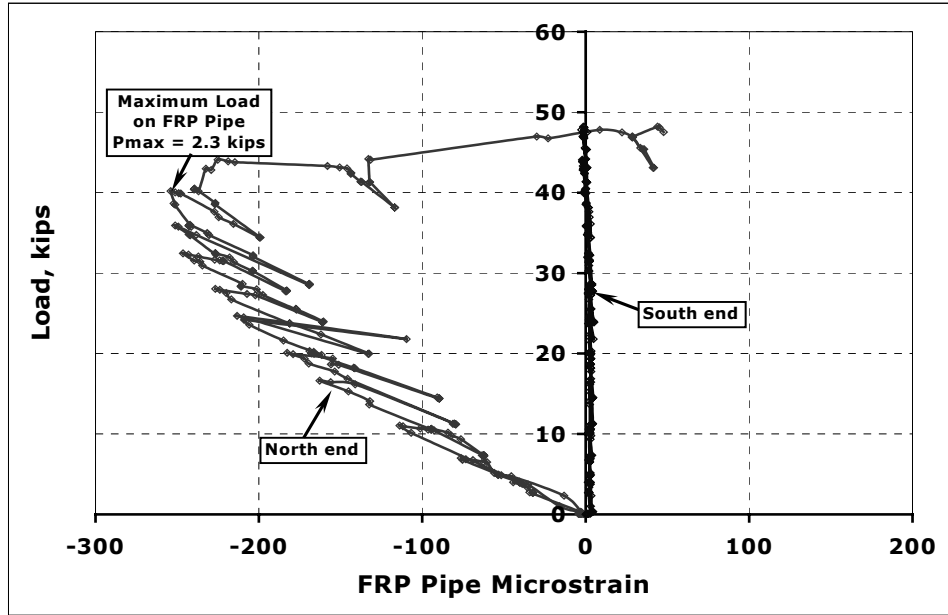
Figure 8.22. Load on Web Stiffeners (FRP Pipes).

The lack of axial load transferred to the FRP pipe stiffener at the south end, which is the half that split from the FRP girder, suggests that the RC deck is lifting off the girder at this end at very low loads. As the RC deck lifted from the FRP girder the FRP girder flanges showed some local buckling as shown in Figures 8.23 and 8.24 under a load of 40 kips. This buckling was probably triggered by the early deterioration of the shear connectors, which caused the flanges to switch from being subjected under tensile stresses to being subject to compression stresses.

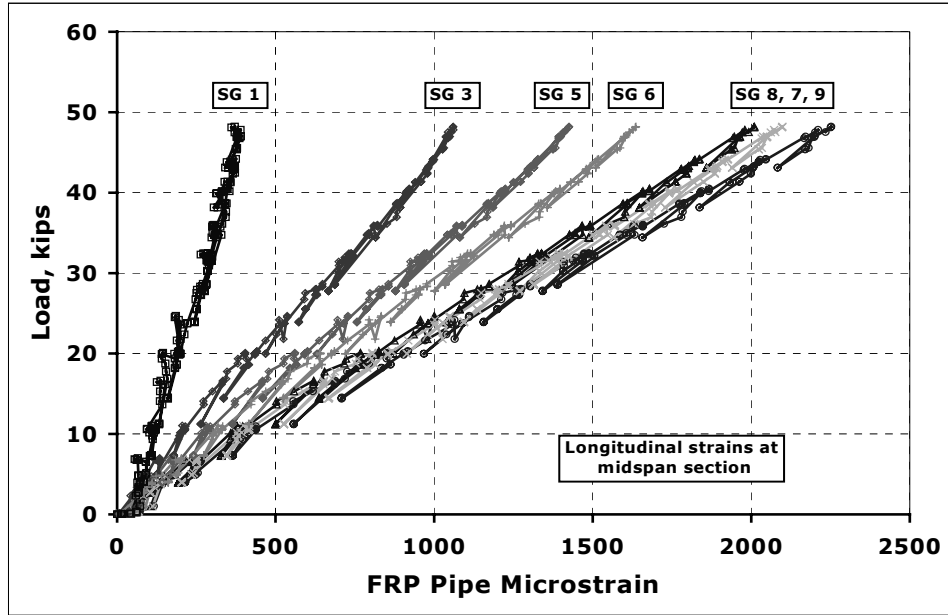
Figure 8.25. Longitudinal Strain Distribution at Midspan Section.

Overall, the specimen was subjected to a maximum longitudinal tensile strain of $\epsilon_{T_{max}} = 0.0025$, which took place on the FRP girder's bottom flange, and which corresponds to a maximum tensile stress of $\sigma_{T_{max}} = 5$ ksi, again 20% of the $\sigma_{Tu} = 25$ ksi. The maximum compressive stress took place on the RC deck and had a value of $\sigma_{C_{max}} = 1$ ksi, 20 % of the $\sigma_{Cu} = 5$ ksi. That is, the specimen experienced stresses well below the strength capacity of both components: RC deck and FRP girder, by a factor of 5. This means that with a more adequate shear connectors, and proper reinforcing of the web connectors in the transverse direction the specimen will be able to sustain much higher values of load.

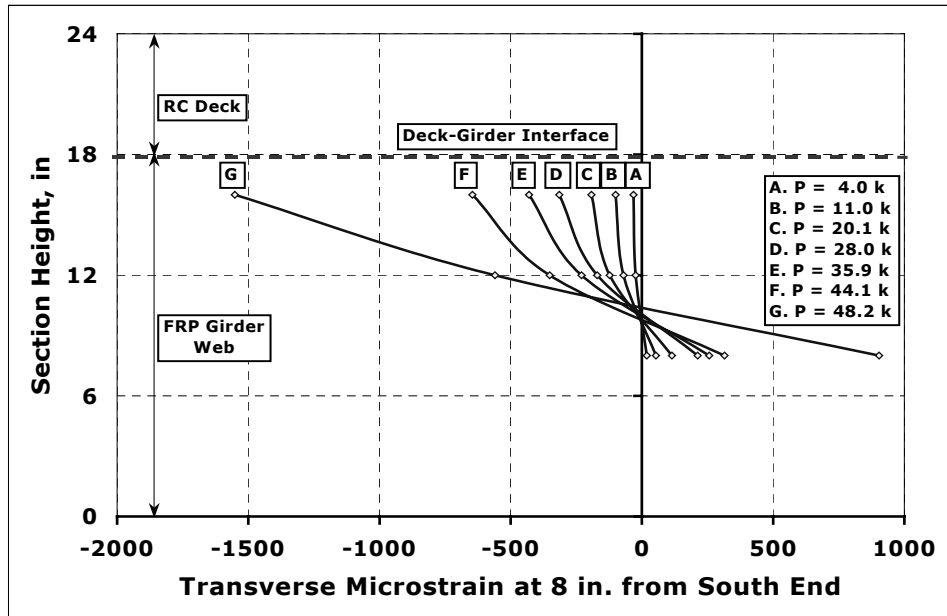
Figure 8.32. Transverse Strain vs. Section Height at 8 in. from South End.

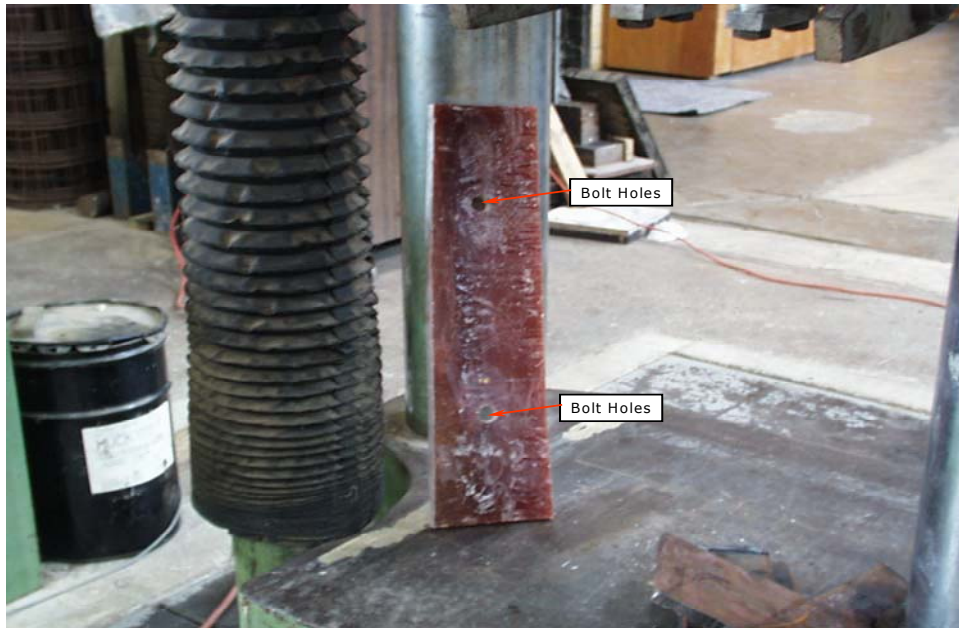
Figure 8.33. Coupon 1.

An additional test was performed on two coupons taken from the web of the FRP girder. The purpose of this test was to investigate the behavior of the girder web under the bearing stress caused by the web connectors. The coupons were 2 ft. long and 6 in. wide. Coupon 1 had a linearly varying thickness with an average of $\frac{3}{4}$ in. This variation in thickness was observed along the web wall of the element. Coupon 2 had a more uniform thickness of $\frac{1}{2}$ in. Two $\frac{7}{8}$ in. diameter holes, 1 ft. apart were symmetrically located about both the length and width as shown in Figure 8.33.

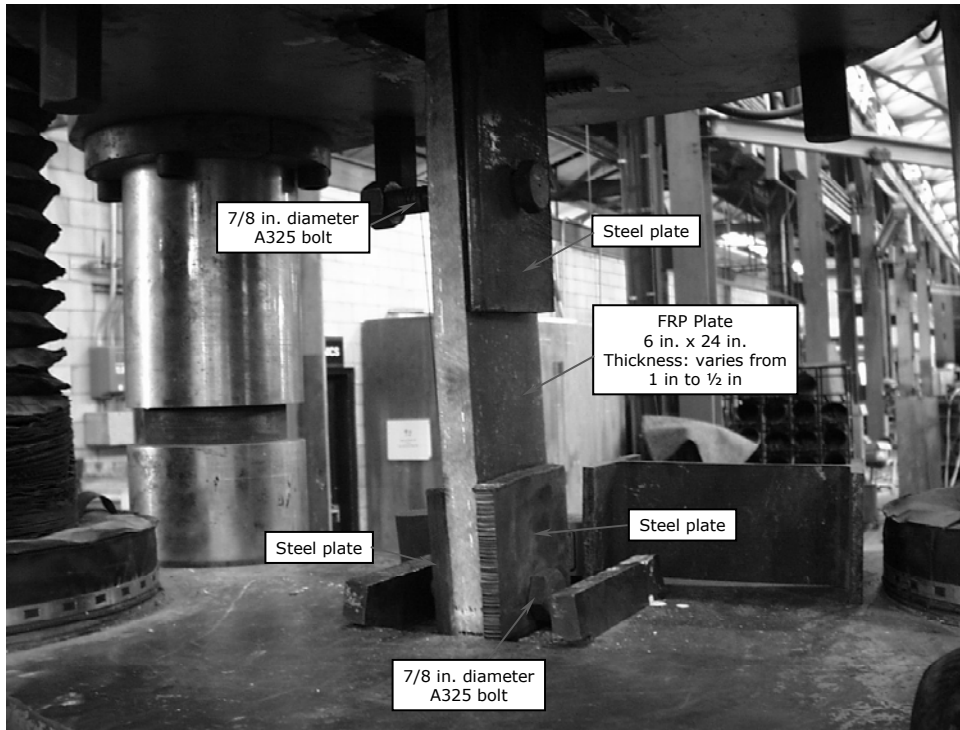
Figure 8.34. Coupon 1 during testing.

Bolt hole elongation was measured by subtracting the elongation of the plate from the relative displacement of both bolts. Tensile stress vs. longitudinal bolt hole elongation (sum of both holes) curves for both coupons are shown in Figure 8.37, the response was linear as it is seen. Coupon 1 sustained a maximum tensile stress of 6.2 ksi, and a bearing stress around the holes of 36.3 ksi; similarly, Coupon 2 sustained a maximum tensile stress of 7.1 ksi, and a bearing stress around the holes of 41.7 ksi.

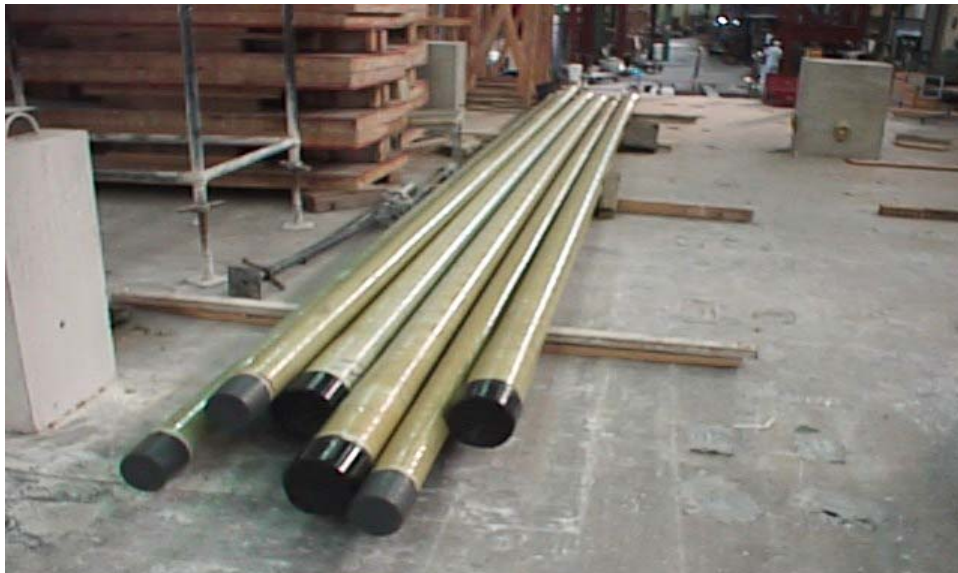
Figure 9.1. FRP Pipes (Downhole and Line types).

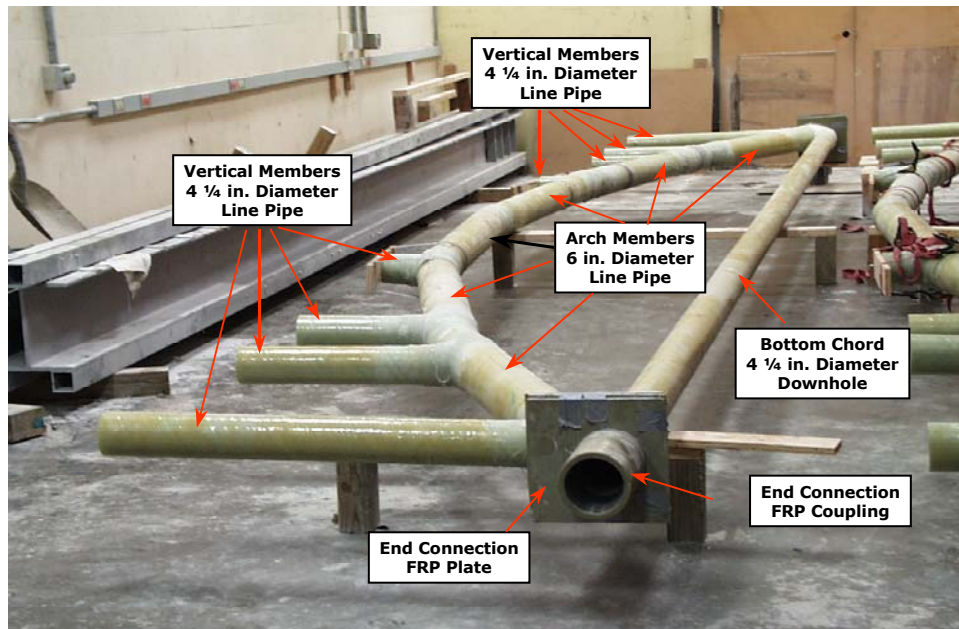
Figure 9.2. Finished Assembled Arch.

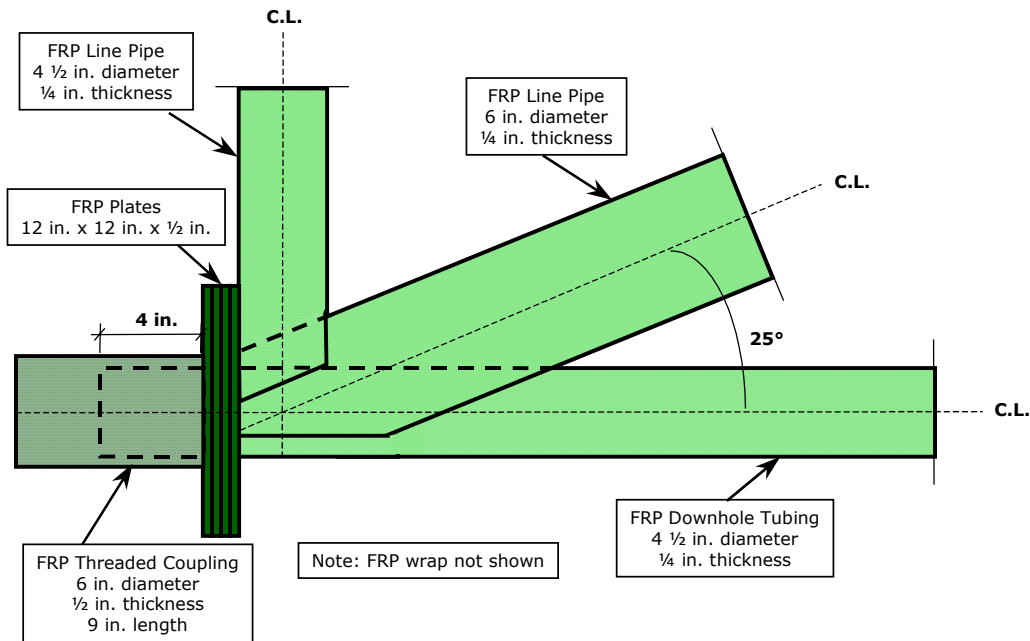
Figure 9.11. Schematic of Connection Type 3.

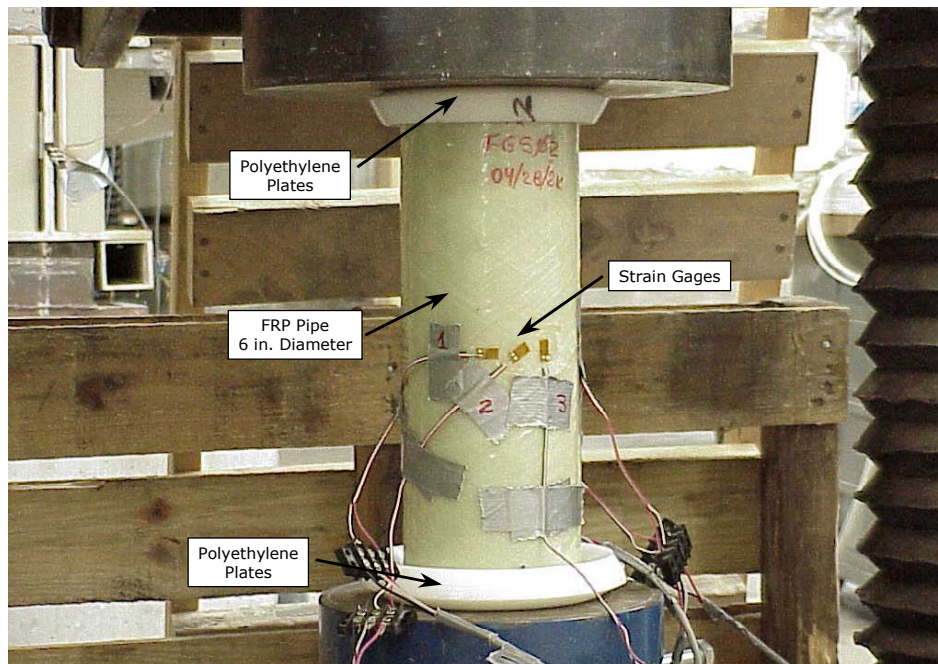
Figure 9.21. 6 in. Diameter Sample under Compressive Load.

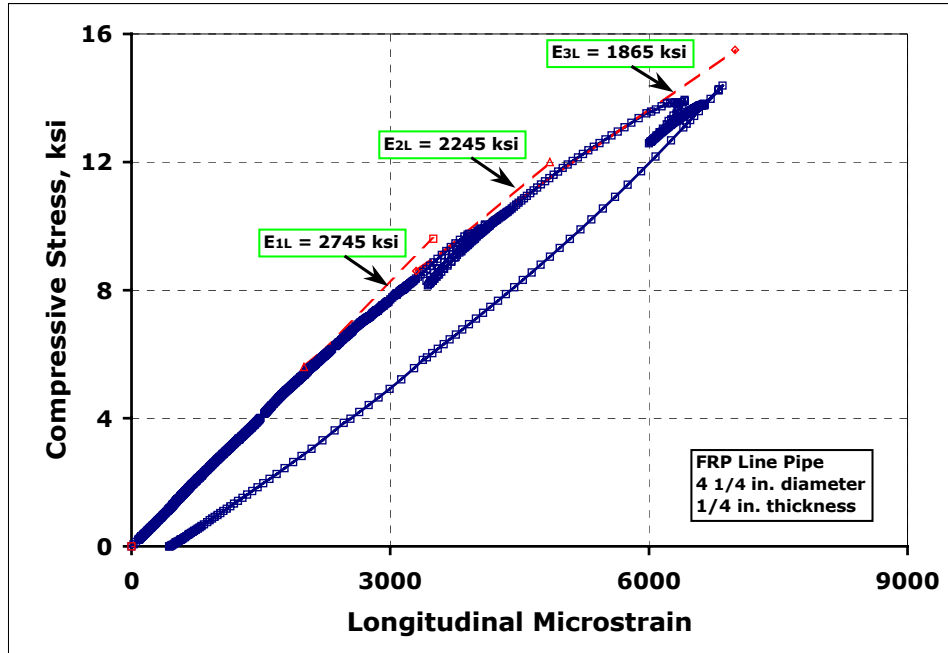
Figure 9.22. 4 ¼ in. Diameter Pipe (Vertical Members) Stress-Strain Curve.

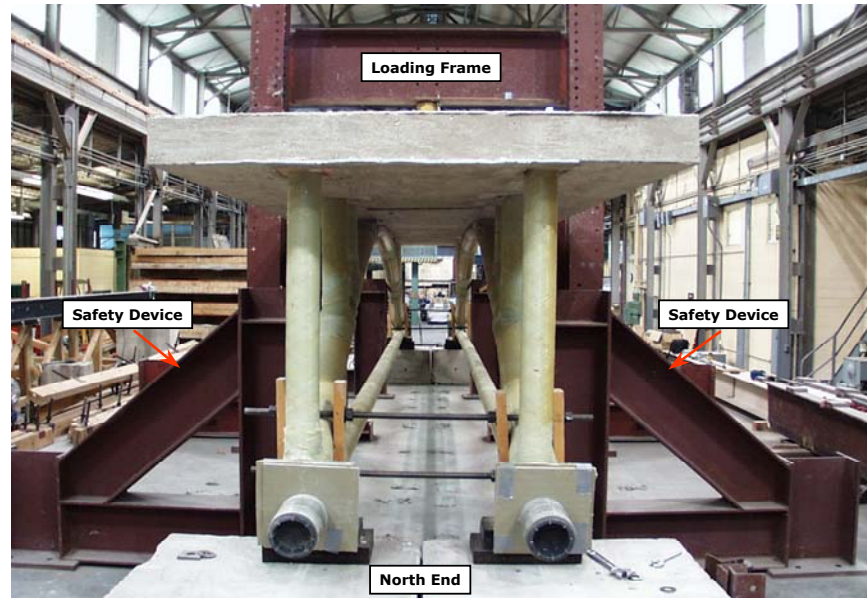
Figure 9.26. Safety Devices Against Lateral Collapse.

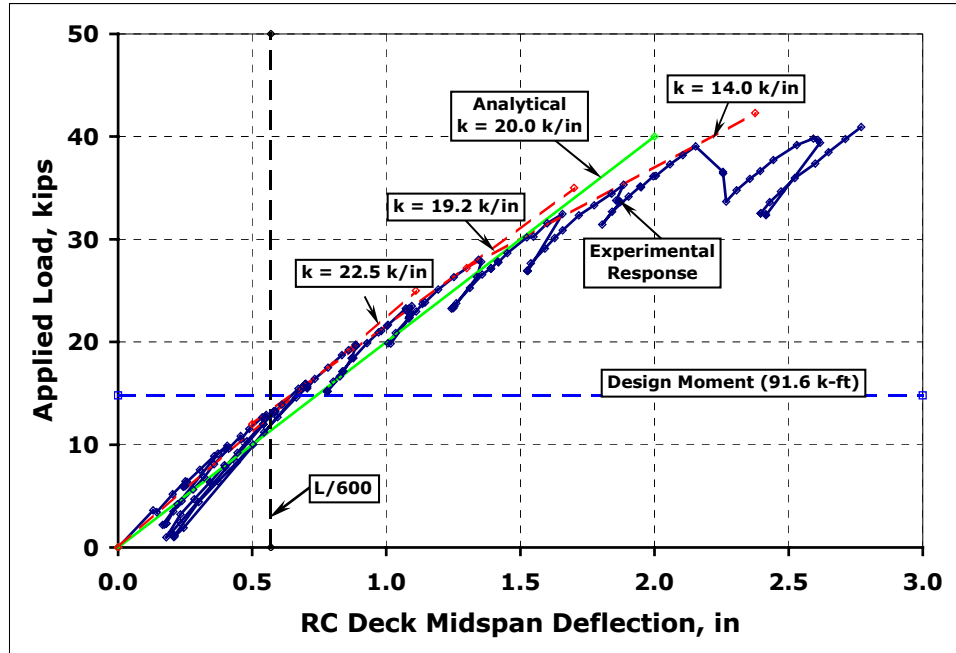
Figure 9.30. Load-Deflection Curve at Midspan.

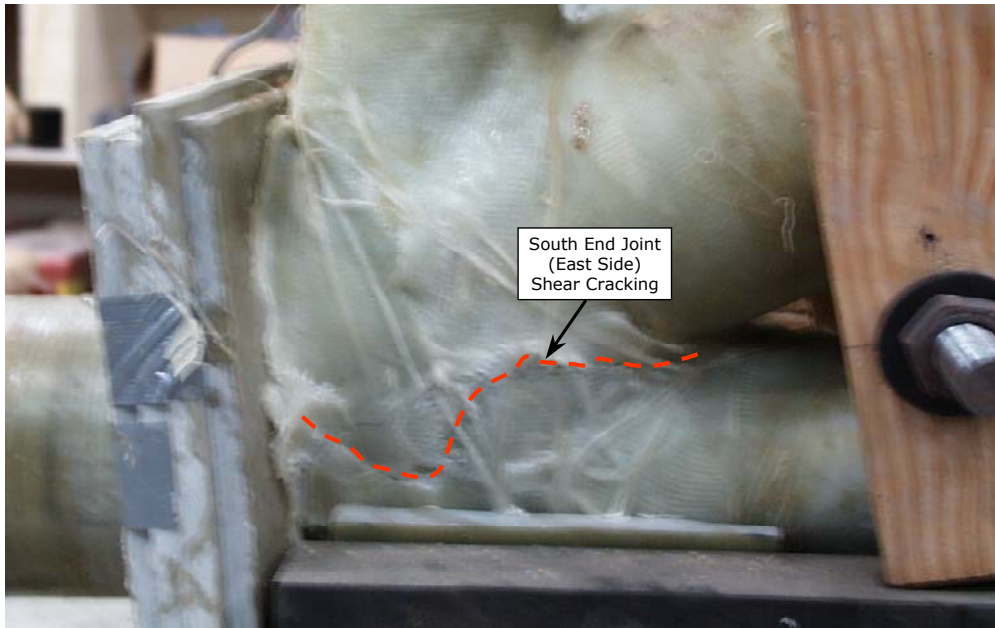
Figure 9.31. Wrap Shear Cracking at the South End Joint, East Arch.

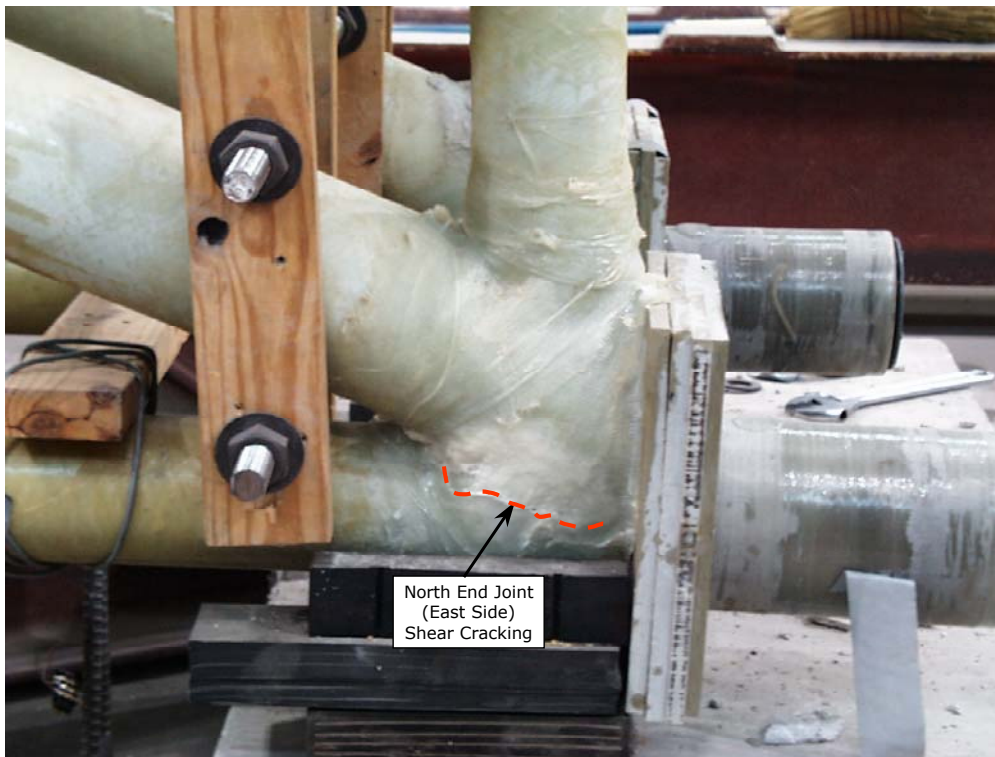
Figure 9.32. Wrap Shear Cracking at the North End Joint, East Arch.

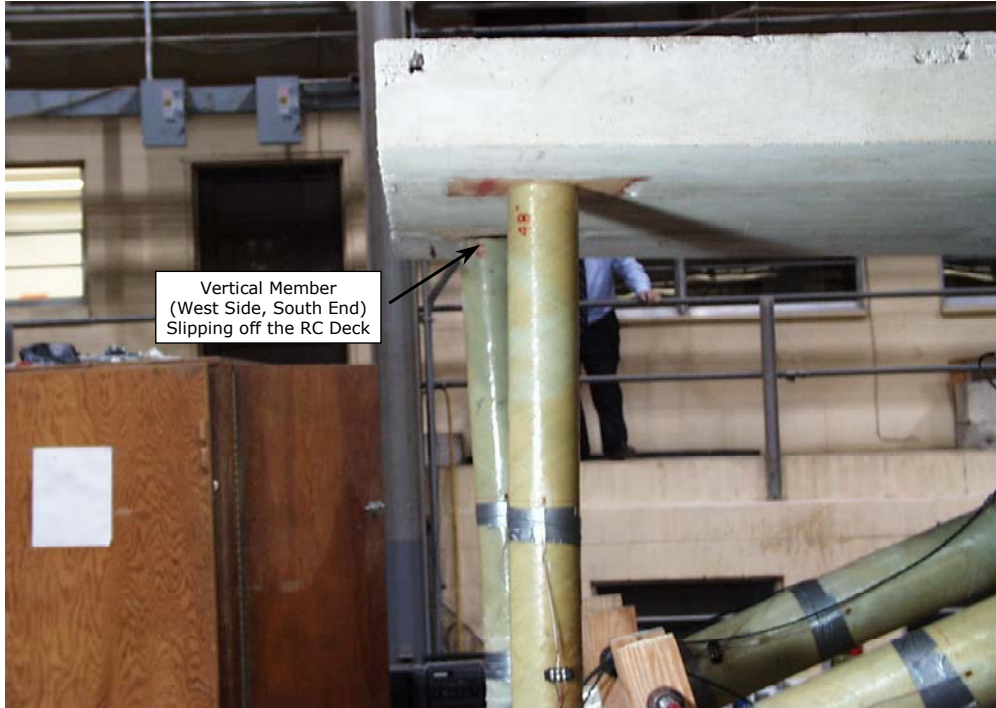
Figure 9.33. Slippage of Vertical Member at South End of East Arch.

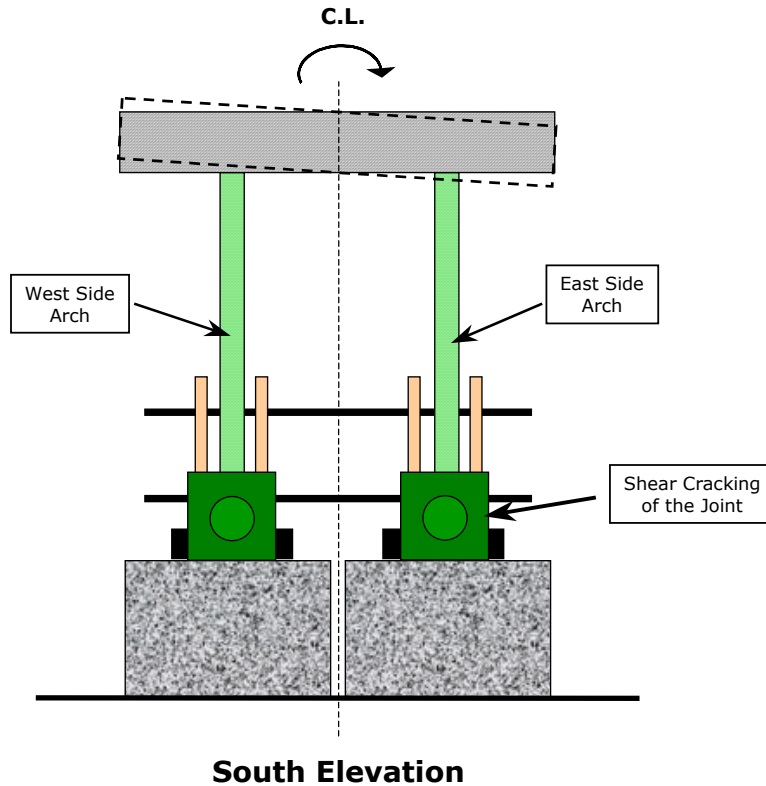
Figure 9.35. Rotation of RC Deck Caused by Shear Cracking.

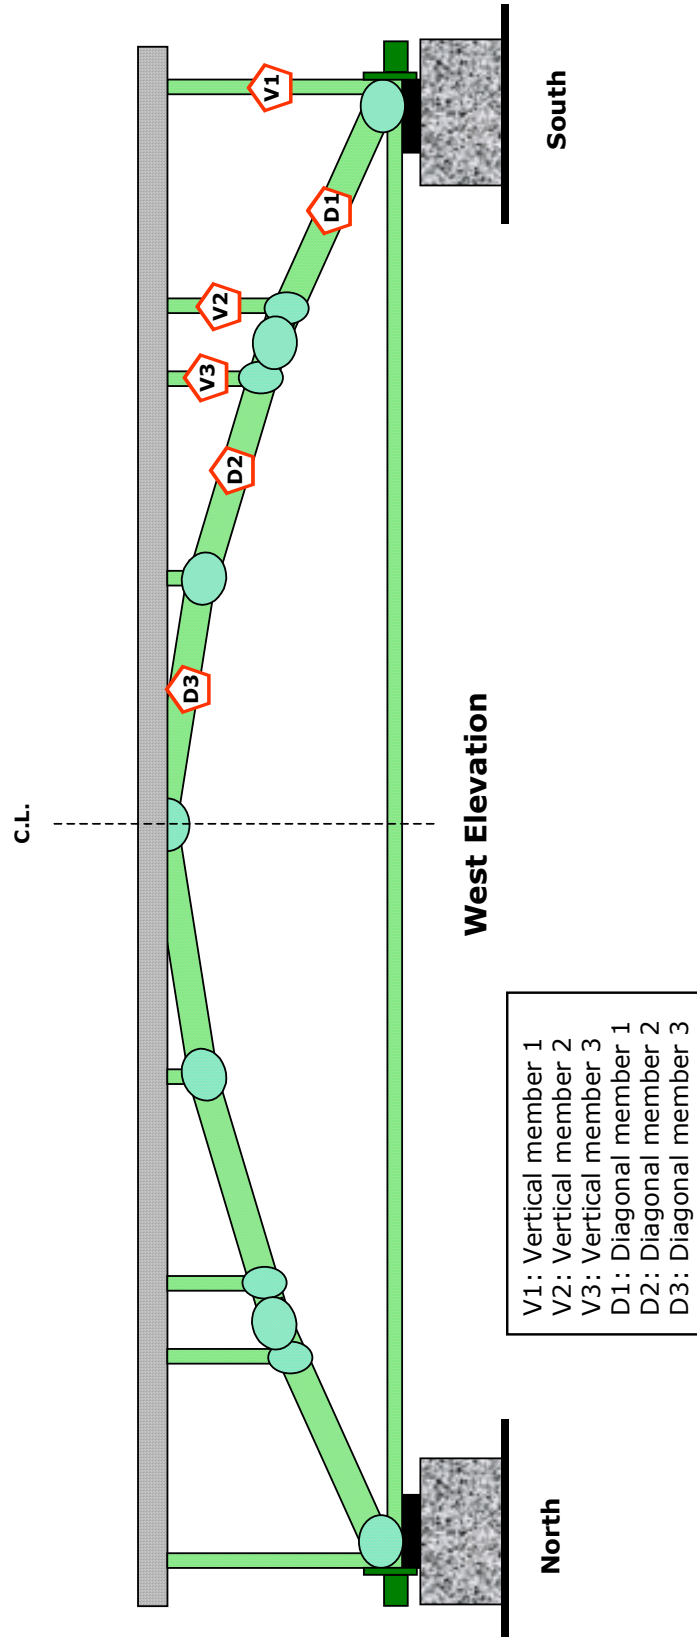
Figure 9.36. Specimen FGS12 Member Notation.

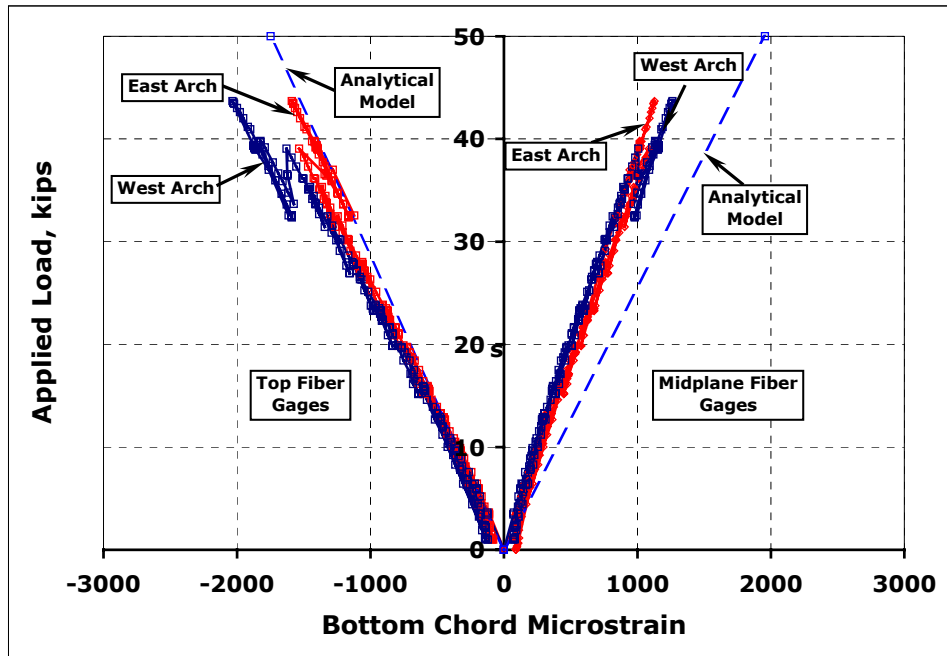
Figure 9.43. Bottom Tying Chords, Strain Distribution.
