# EVALUATION AND PERFORMANCE MONITORING OF CORROSION PROTECTION BY FIBER-REINFORCED COMPOSITE WRAPPING

Research Report No. 1774-1

“Effect of Wrapping Chloride Contaminated Structural Concrete with Multiple  
Layers of Glass Fiber/Composites and Resin”

**Texas Department of Transportation**

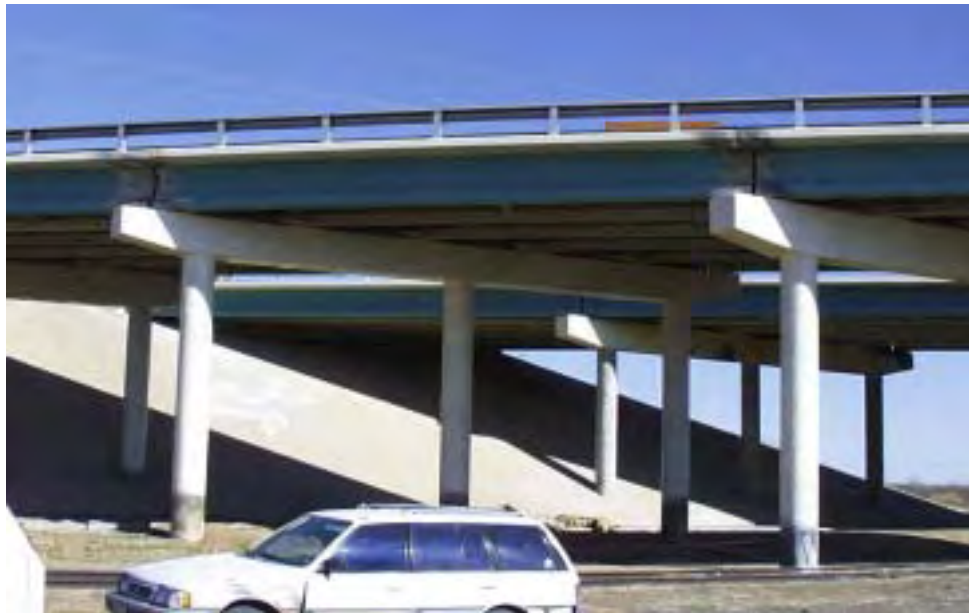
*Figure 1.1 Structure wrapped with FRP*

In recent years, FRP composite wrapping has been considered and implemented (on a few projects) for corrosion protection. Corrosion due to chloride ingress is purportedly arrested by the prevention of further chloride contamination and penetration by the oxygen and water needed to continue a corrosion process that has begun or has caused damage. Figure 1.1 shows a structure that has been repaired with a composite wrapping system.

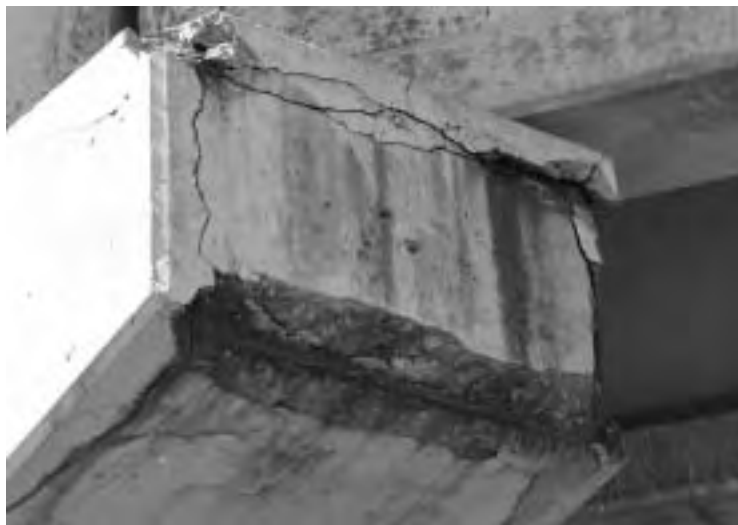
*Figure 1.2 Damage at downstream endcap*

The structures being studied in the field research program are bridge overpass substructures located in and around Lubbock, TX and Slaton, TX. These structures have been in a corrosive environment containing chlorides. Corrosion of the reinforcing steel and spalling and delamination of the concrete cover in areas where the chlorides were allowed to concentrate is evident, as shown in Figure 1.2. Due to the extent of the damage, a project involving repair and FRP wrapping to shield the elements from further chloride penetration was begun. In conjunction with this project, some data collection before and after repair was necessary to evaluate the effectiveness of this repair method.

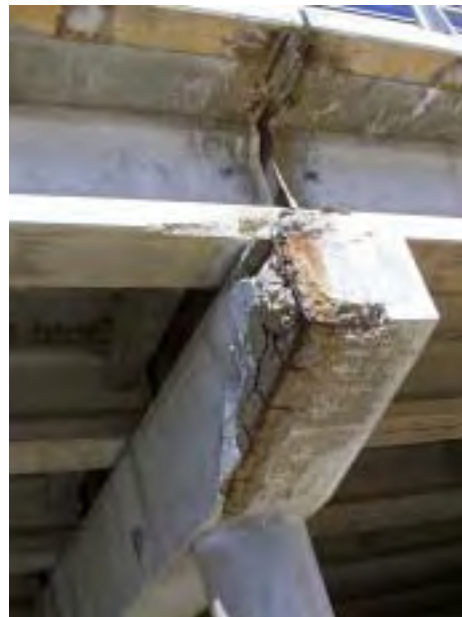
**Figure 3.1 Endcap delamination**

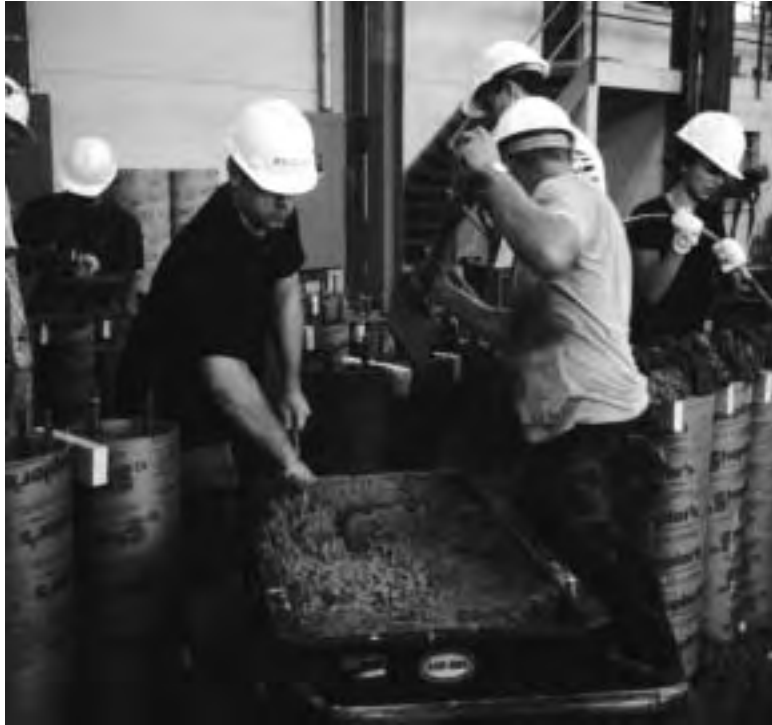
*Figure 4.3 Placing concrete in cylindrical forms*

Concrete was placed into the forms in successive layers to minimize segregation. Each layer was consolidated with immersion-type vibrators immediately after deposit as shown in Figures 4.3 and 4.4. Points of vibration were established to ensure complete consolidation and placement of the concrete around the steel cages and into all corners of the forms. For the rectangular specimens, the vibrator was inserted at sloping angles and allowed to penetrate a few inches into each preceding layer. Vibration was more complicated for the columns due to their smaller opening, increased height, and bulky reinforcement. These factors made it difficult to consolidate the lower layers of concrete.

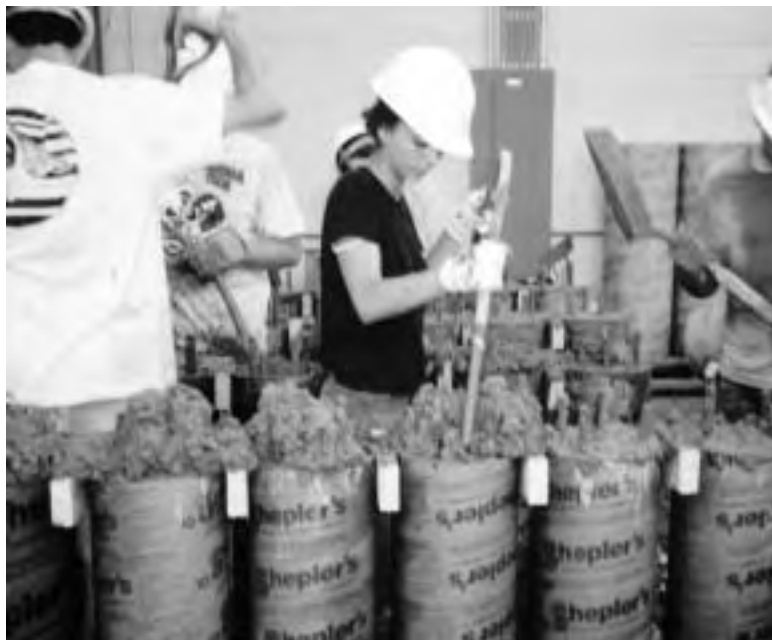
*Figure 4.4 Vibrating concrete in columns*

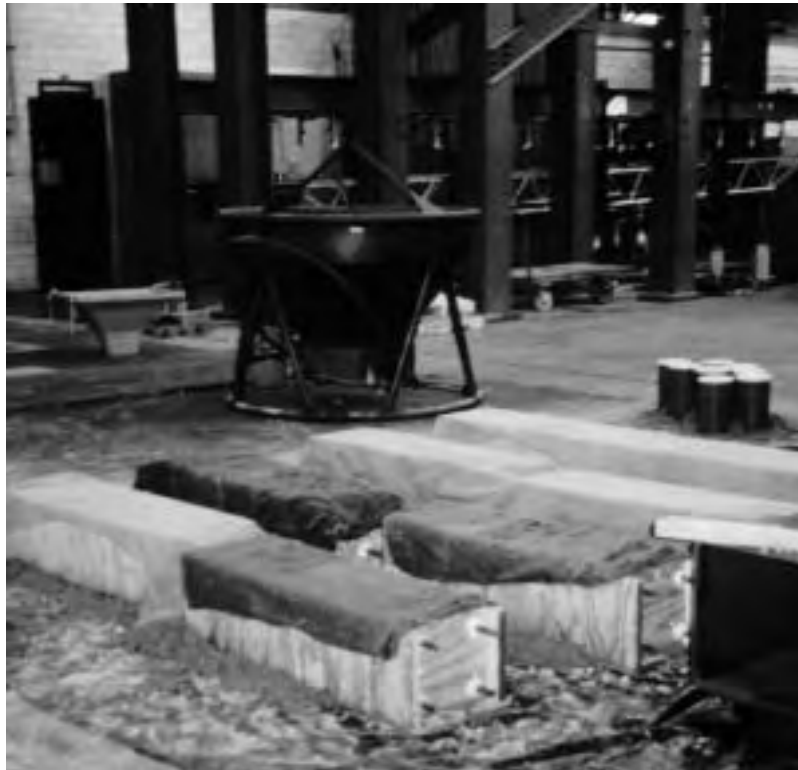
*Figure 4.5 Wet-mat curing of beams*

The specimens were covered with plastic sheets and damp burlap mats for wet mat curing (Figure 4.5). This method kept the concrete continuously wet throughout the curing period. The specimens were cured for 28 days.

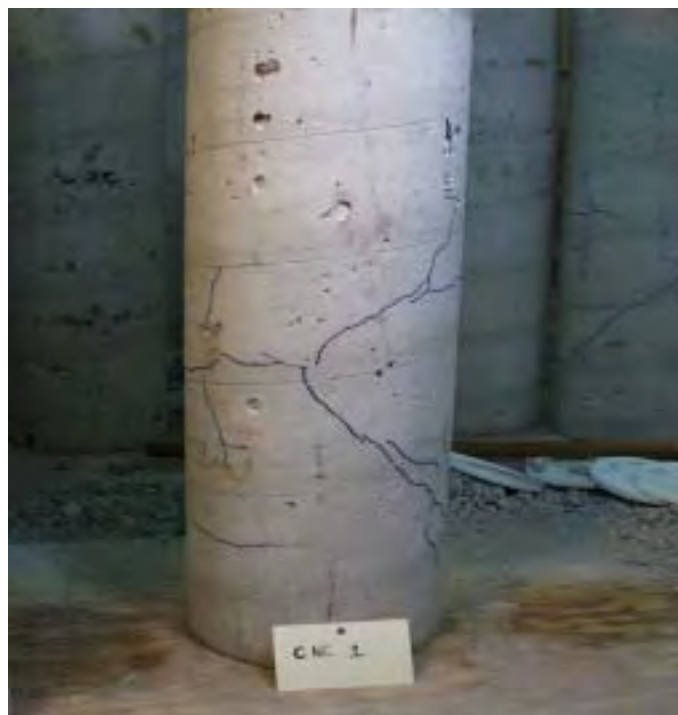
*Figure 4.7 Cracked specimen*

The specimens selected for flexural cracking were loaded until cracks of sufficient width appeared on their surface. The maximum crack width allowable in service is 0.33 to 0.51 mm (13 to 20 mils). Similar crack widths were developed during loading. Figure 4.6 presents the loading configuration and Figure 4.7 shows typical cracks.

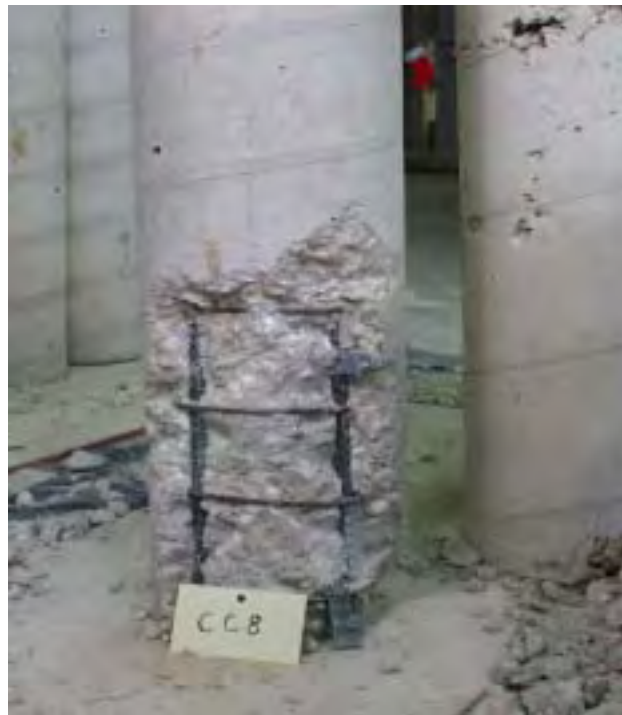
**Figure 4.8** *Concrete removed prior to repair*

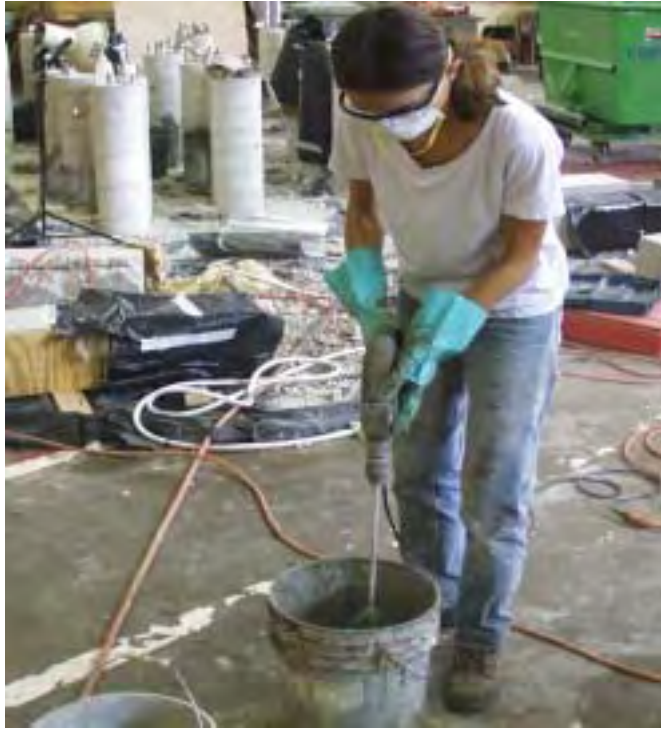
*Figure 4.9 Mixing repair materials*

The separate components for both materials were mixed mechanically with a low speed drill according to Sika specifications (Figure 4.9). Small fractions of the components were held back or added to the mix as appropriate and necessary to achieve a good flow. Materials were poured into the forms (with cups and scoops), consolidated and leveled. The latex-modified concrete had to be scrubbed into the repair zone of the beams, while the epoxy grout poured freely, filling all voids and edges. Both products were made to fill the cylindrical forms. Vibrators were tapped along the side of the metal flashing for the columns (Figure 4.10), and carefully inserted into the repair at an inclined angle for the beams. Small repair areas were patched by drypacking (Figure 4.11). Repairs were covered with plastic and wet burlap, and left to cure for 4 days.

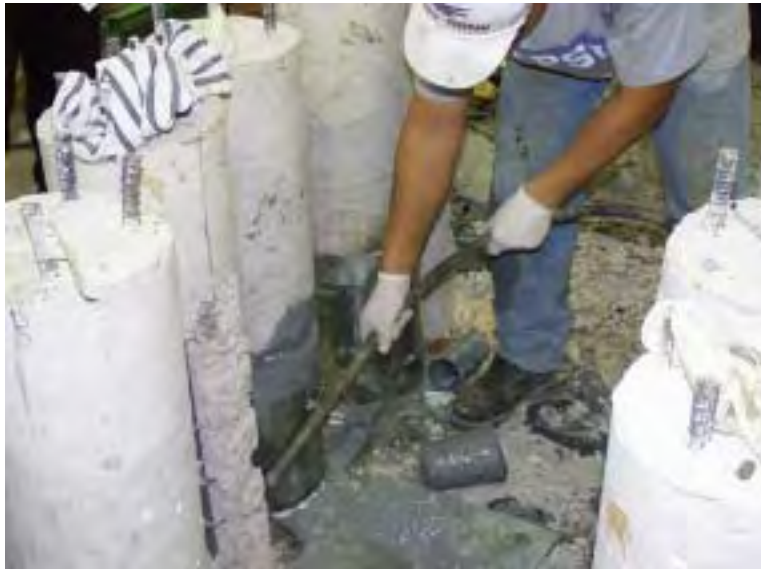
*Figure 4.10 Vibrating columns*

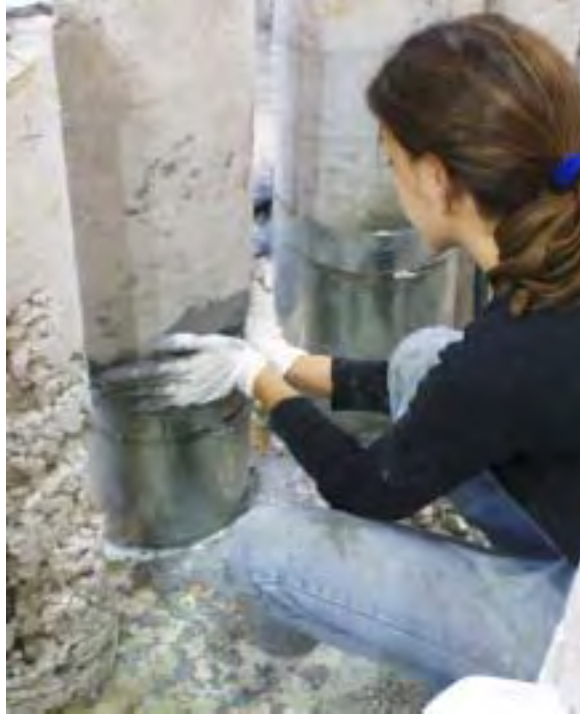
*Figure 4.11 Drypacking procedure*

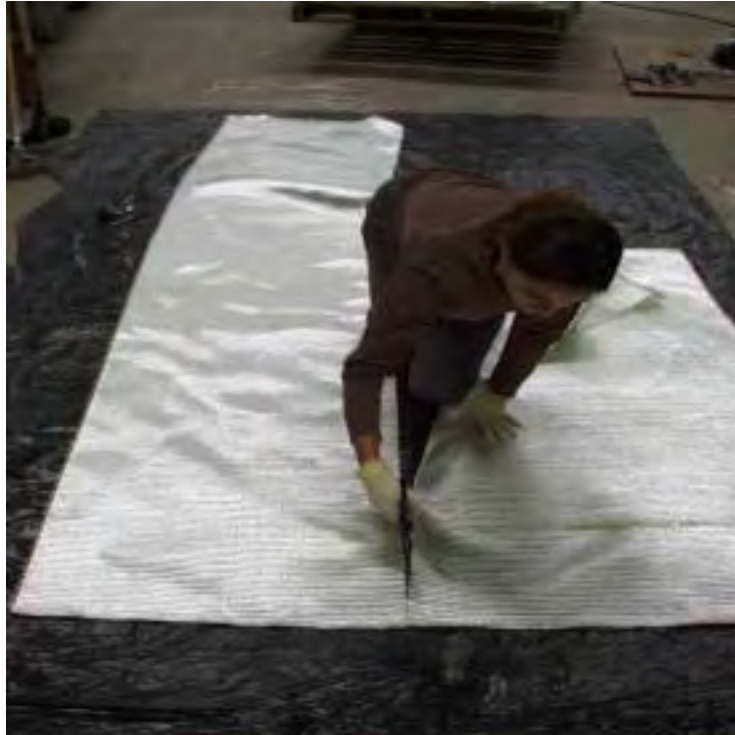
*Figure 4.12 Cutting the fabric*

The specimens designated for wrapping were divided into two main categories according to the composite used for wrapping. The composition, material properties, and application methods for both systems are described in this chapter. A photographic record at the end of this section illustrates all steps of the encapsulation procedure (Figures 4.12-4.18).

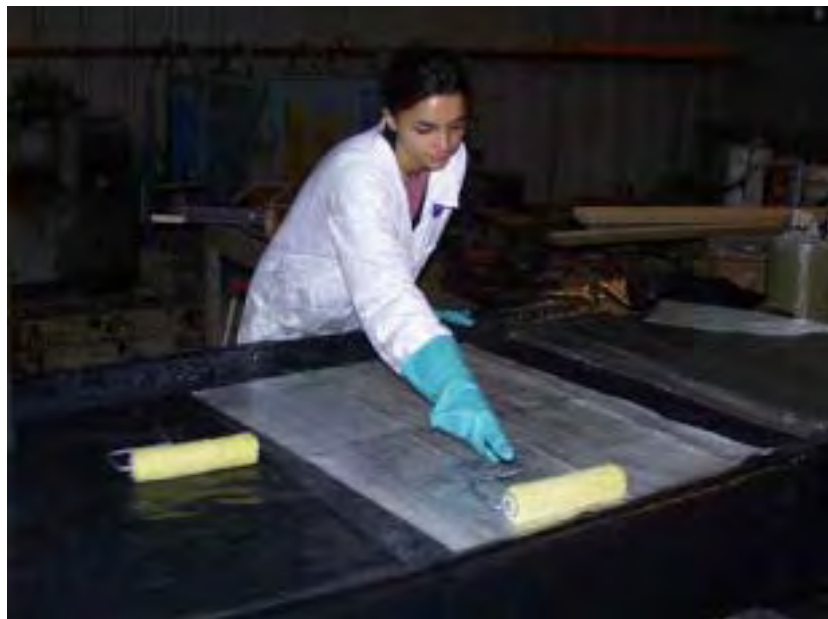
*Figure 4.13 Saturating fabric with resin*

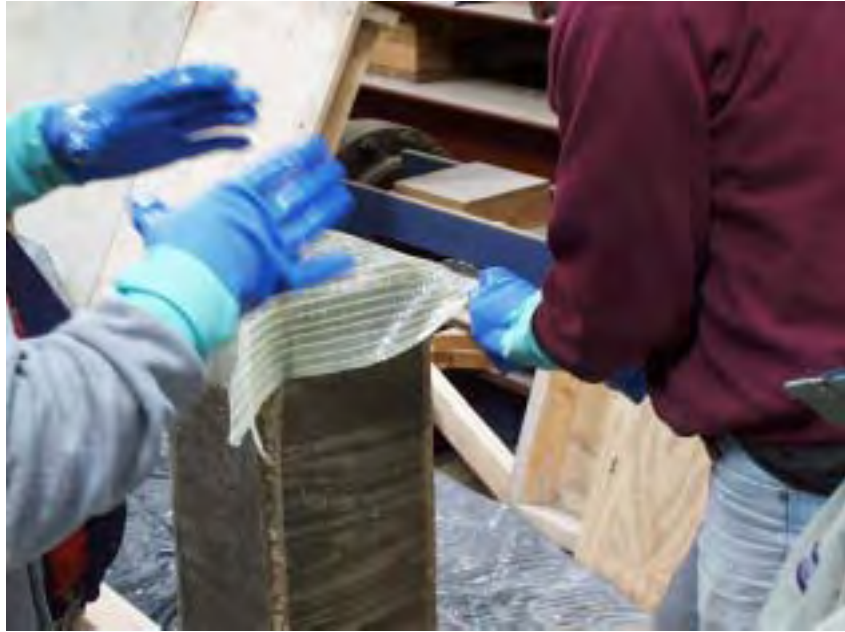
*Figure 4.14 Wrapping beam end*

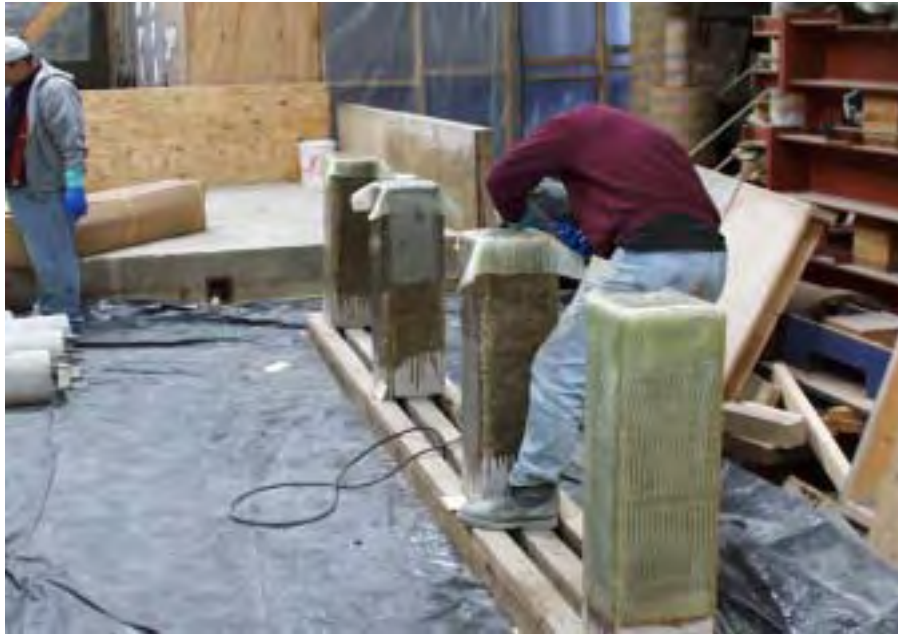
*Figure 4.15 Wrapping beams*

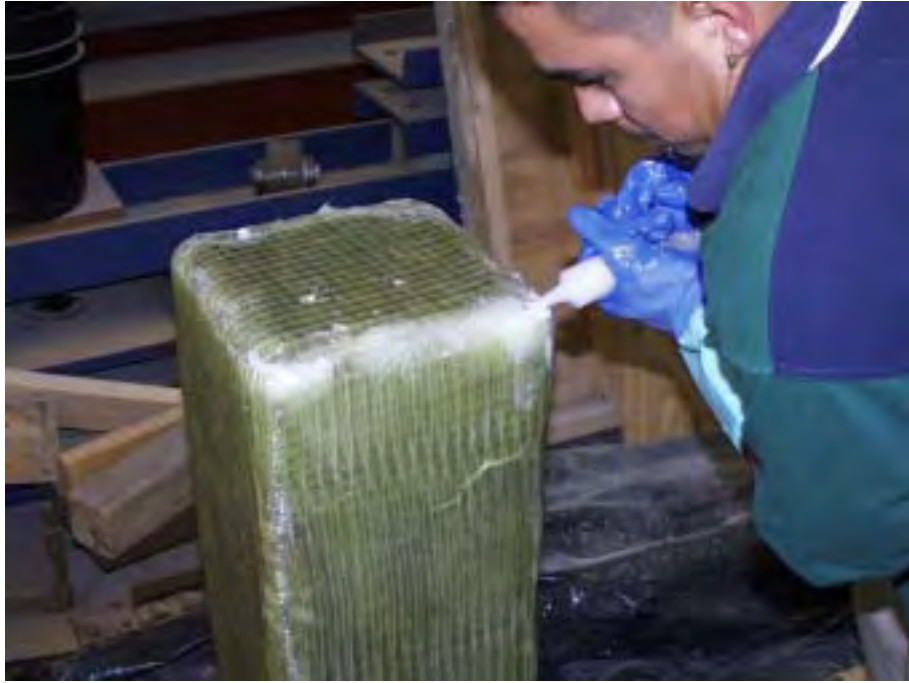
*Figure 4.16 Injecting voids*

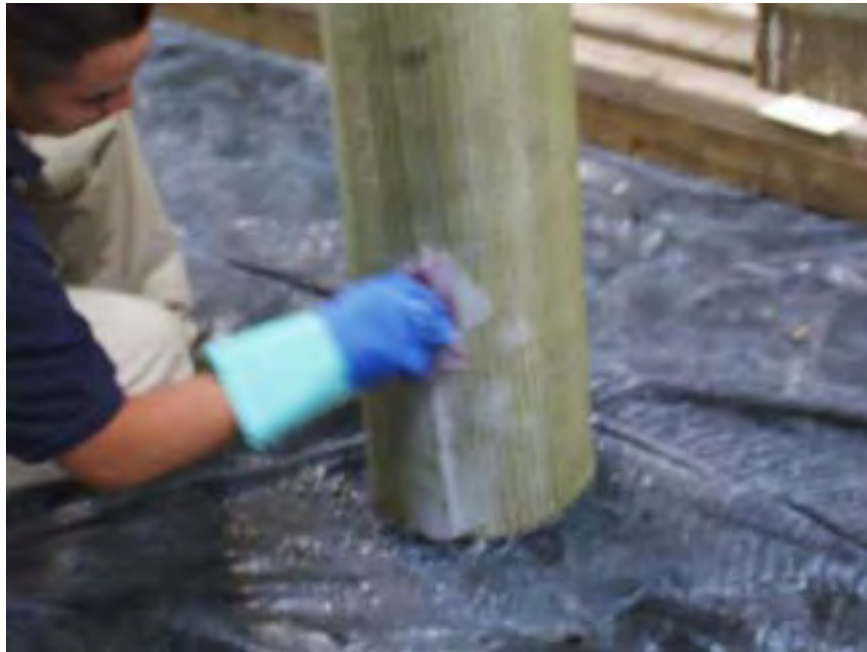
*Figure 4.17 Sealing joints of column wrap*

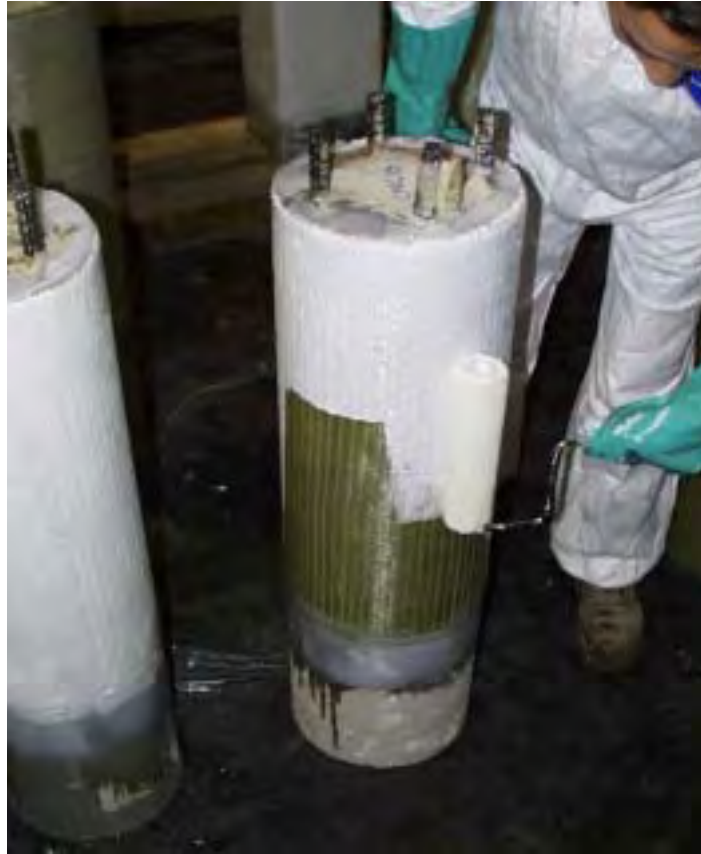
*Figure 4.18 Painting wrapped column*

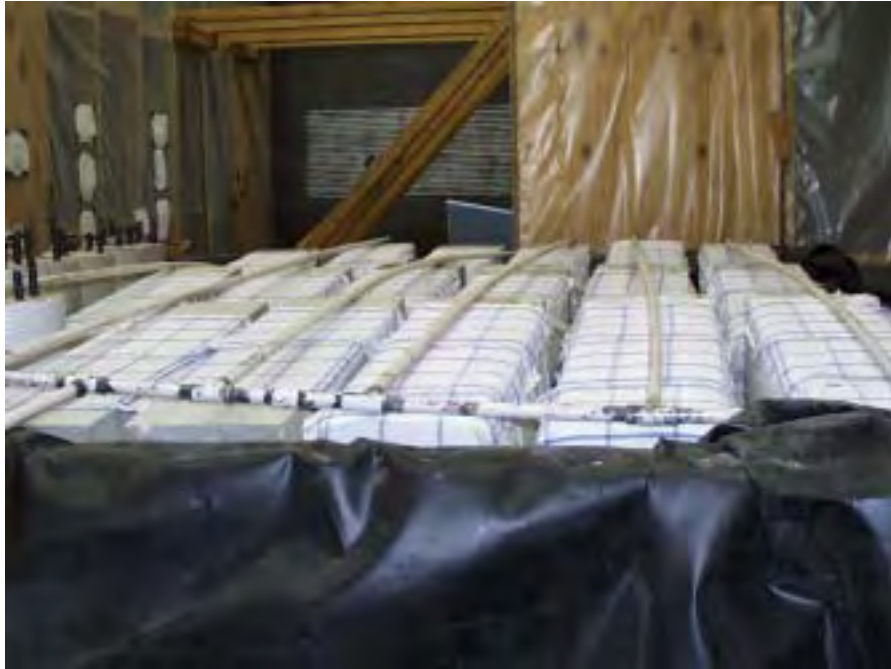
*Figure 4.19 Irrigation pipes over beams*

The columns were placed vertically in the pool on small pieces of wood to prevent them from standing in puddles of excess water during the dry cycles. The beams were laid on their side on blocks covered with plastic. The beams were placed at a shallow angle to allow the water to flow across the top surface (Figure 4.19). Laminated identification tags (Figure 4.20) were attached to the exposed steel on all specimens to facilitate data recording and cataloging. A drainage hole in the base of the pool allowed for a connection between the pool and a pump. A 10-ft. diameter galvanized steel storage tank (Figure 4.21) was placed next to the pool, and filled with a saline solution. A 3.5 percent saline solution was created by mixing 136.1 kg (300 lbs.) of salt into the water. The solution is stirred before each cycle to achieve a homogeneous mix. On the first day of each wet cycle, the pump draws water from the storage tank into the pool, to a 300 mm (1-ft.). The pump then circulates the water within the retaining pool through a system of PVC pipes placed over the beams. Holes were drilled into the pipes for water distribution. The beams were covered with cloth to ensure a wet condition throughout the cycle. Upon completion of the wet cycle, the pump is disconnected from the PVC irrigation system and begins to draw water out of the pool and back into the storage tank. A filter attached to the drainage hole prevents dirt and other loose particles from entering the pump and damaging it.

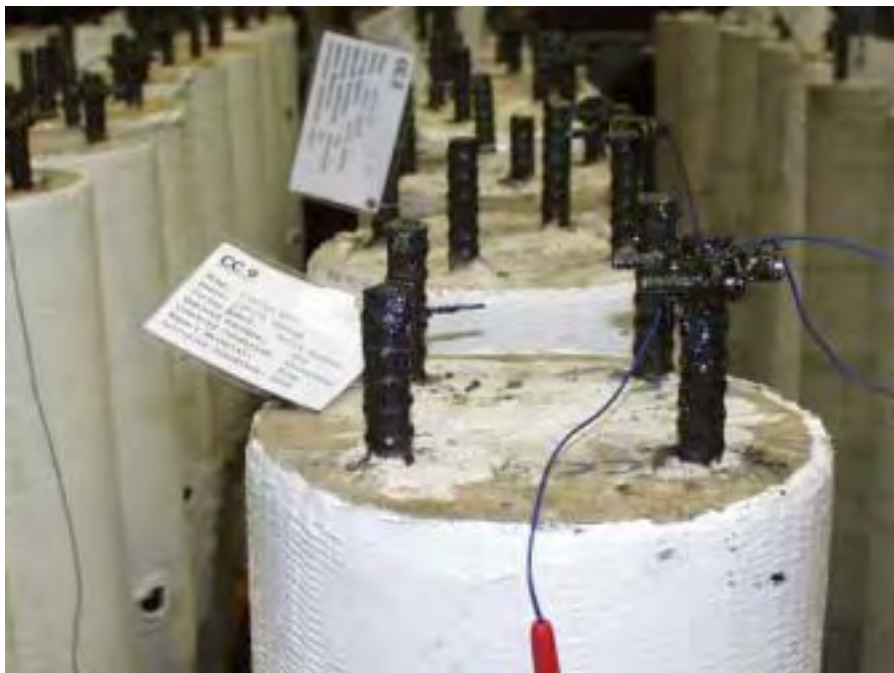
*Figure 4.20 Row of columns*

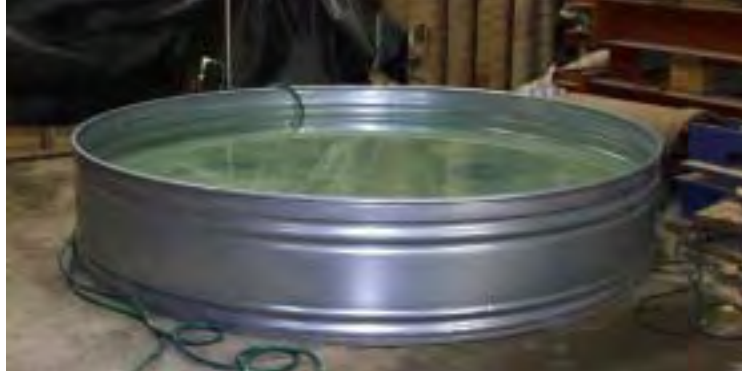
*Figure 4.21 Storage tank filled with salt water*

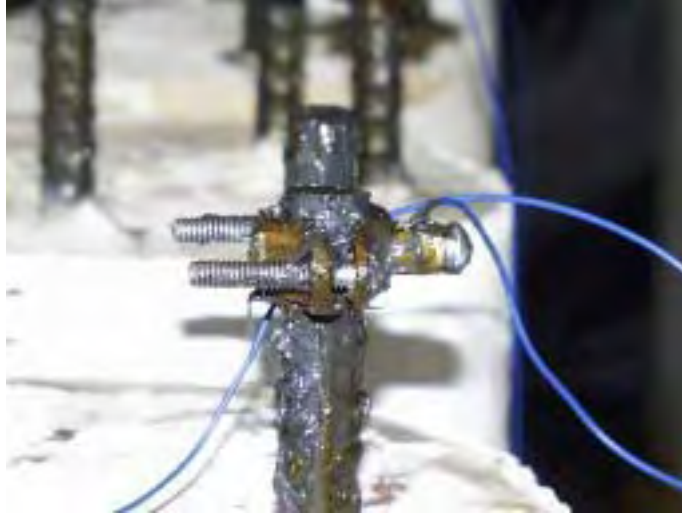
*Figure 4.23 Detail of greased ground clamp*

The connection to the steel was made with lead wire attached to ground clamps. The clamps were then attached to the exposed end of the bar over which the opening in the composite wrap was made. The exposed ends of the bars had all been previously ground to remove any rust that could interfere with the readings. All exposed steel and metal clamps were covered with grease to prevent corrosion (Figure 4.23).

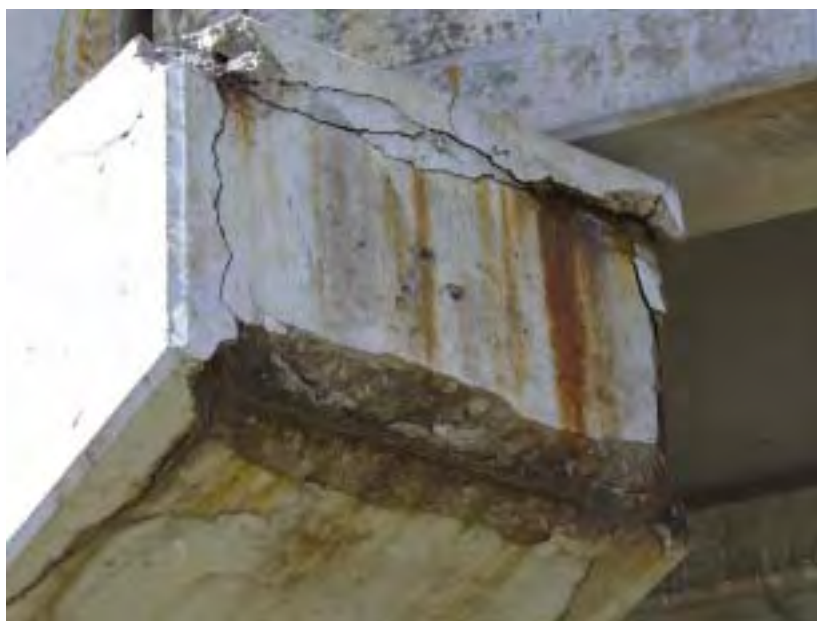
*Figure 5.1 Endcap damage to Structure #5*

Figures 5.1 and 5.2 show typical corrosion damage to bent endcaps. The project specifications call for cover removal back to sound concrete for the damaged portions of the downstream endcaps. The reinforcement is to be cleaned and/or replaced as necessary to remove all previous corrosion products. Welding of the reinforcing steel is not permitted on this project. Figure 5.3 shows an endcap with the steel exposed and the preparations made for repair. During the period of structural repair, the structures are supported and bridges are not open to traffic.

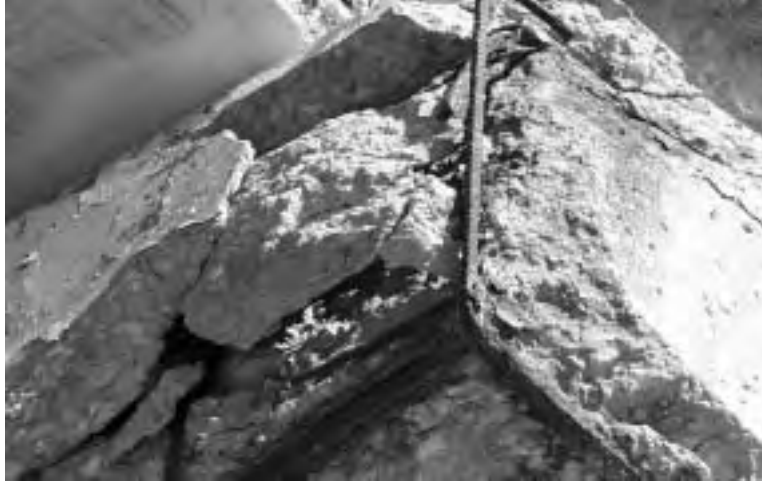
*Figure 5.2 Closeup of corrosion damage on Structure #8*

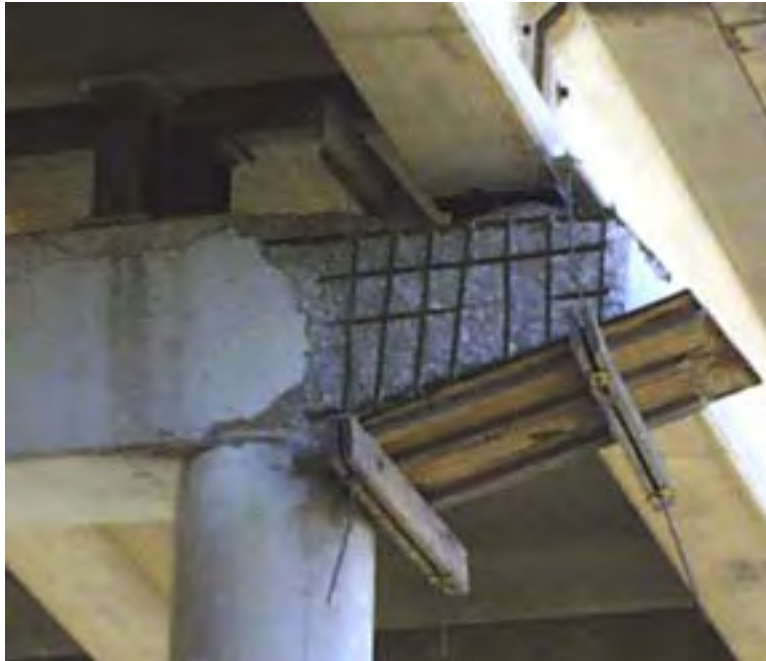
*Figure 5.3 Endcap prepared for application of repair material on Structure #3*

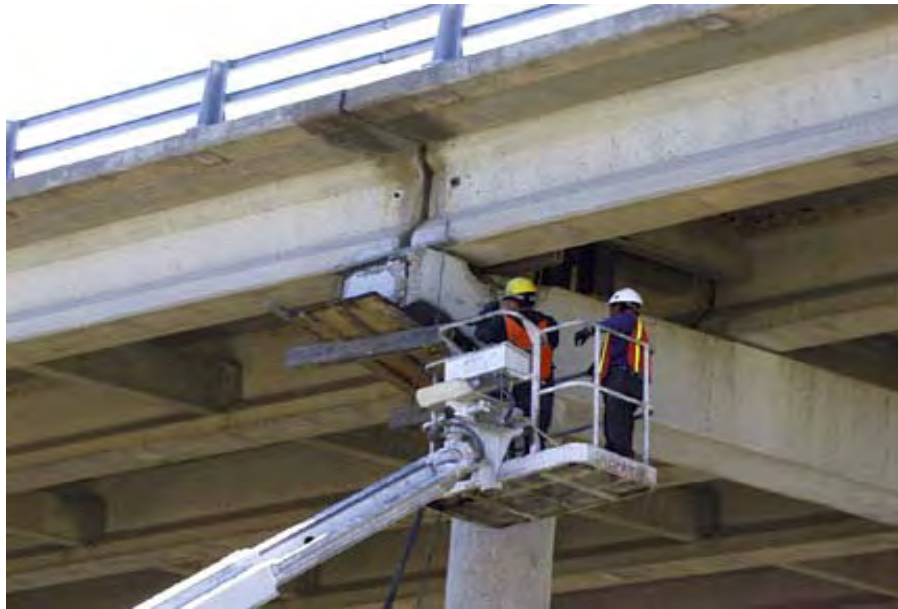
*Figure 5.4 Application of Shotpatch® 21F to Structure #3*

Shotpatch<sup>®</sup> 21F is applied by a shotcrete process. This application and the temporary formwork are shown in Figure 5.4. Figure 5.5 illustrates a typical endcap after the formwork has been removed. It is evident that the concrete cover was removed to just inside the outer column face at this particular location (Structure #3).

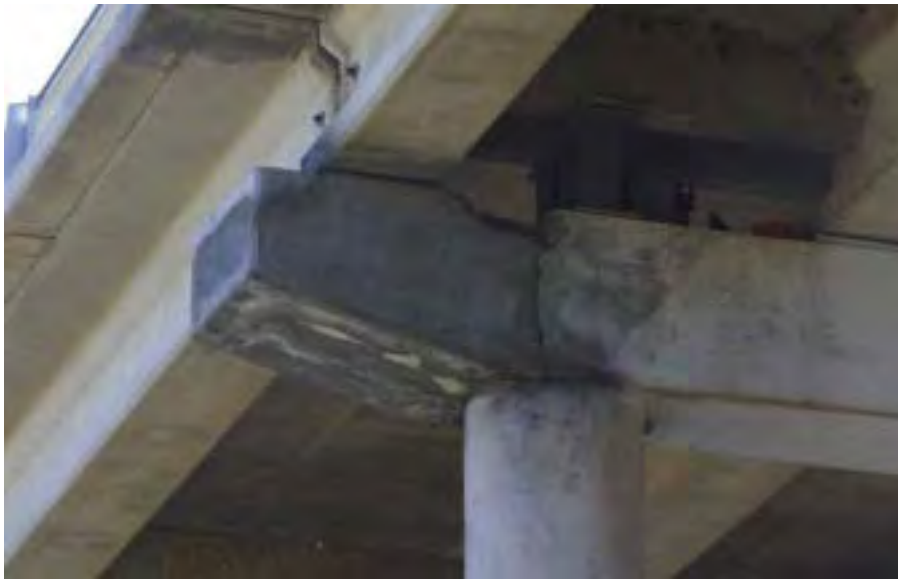
*Figure 5.5 Endcap repair material on Structure #3*

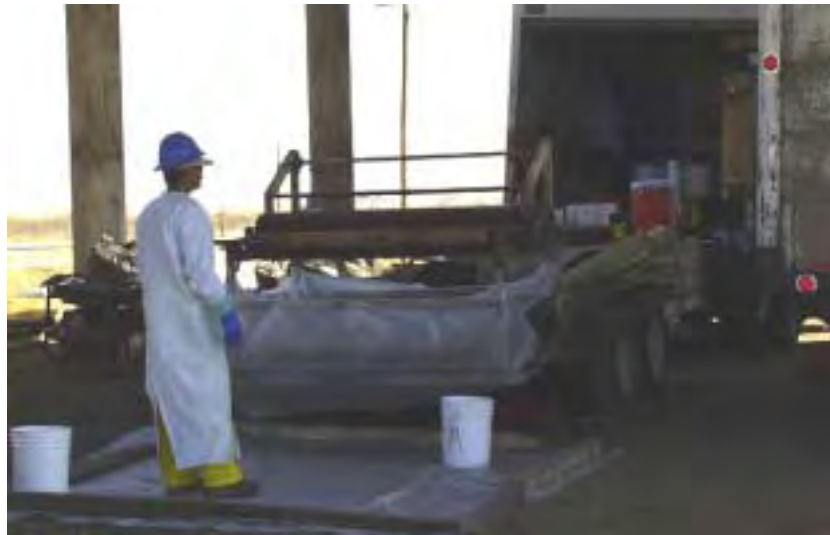
*Figure 5.6 Saturation machine used by Delta Structural Technology, Inc.*

The mechanism used to provide saturated fabric is displayed in Figure 5.6. The epoxy is in effect rolled into the fabric. Once the fabric is saturated, it is applied to the substructure. Figure 5.7 shows the wrap being placed on an endcap of Structure #2. Three layers of wrap are applied in succession, to prevent polymerization of the previous layer. This ensures complete bonding between layers.

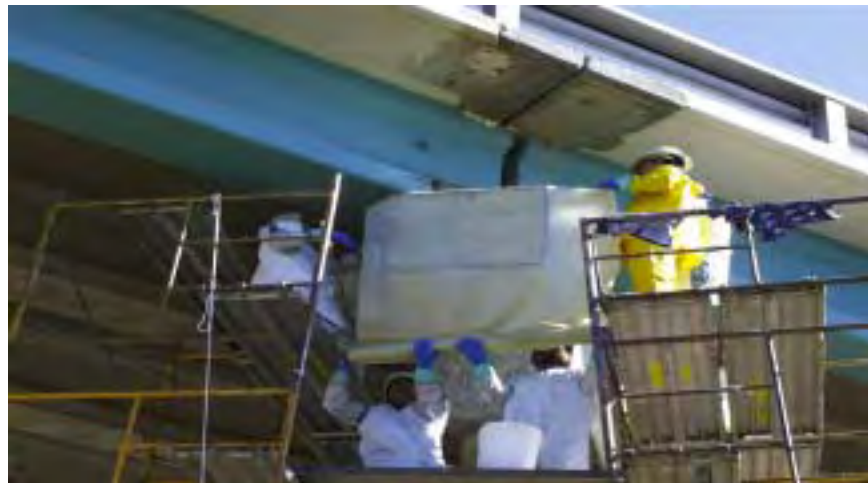
*Figure 5.7 Application of Fibrwrap® to endcap on Structure #2*

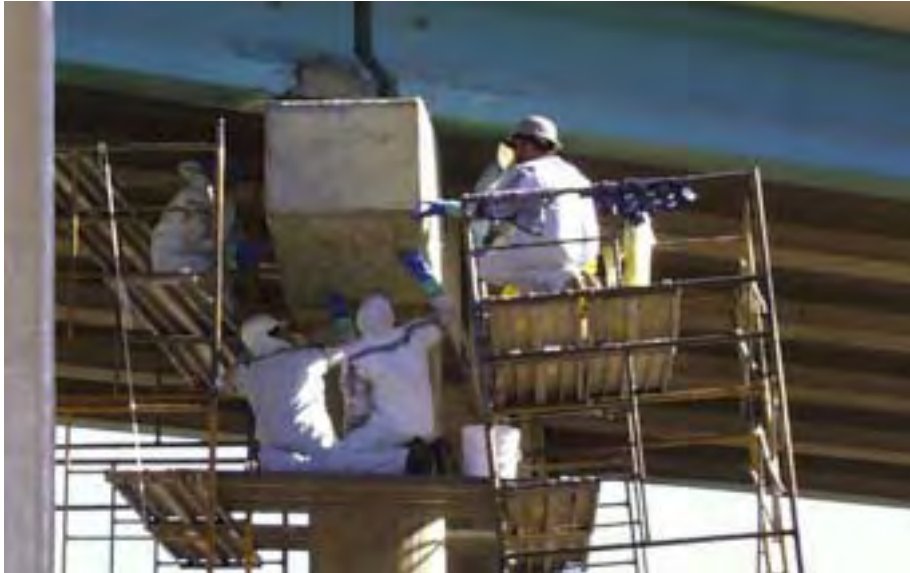
*Figure 5.8 Removal of air pockets beneath a layer of Fibrwrap®*

After each layer is placed, any air pockets (or “bubbles”) must be removed by rubbing or rolling. This is a major construction concern and the process is demonstrated in Figure 5.8. About 24 hours after the final layer is applied, the entire surface is painted with a high-solids paint to provide UV protection for the wrapping system and to match the color to that of the existing structure. An example of a finished and painted endcap is shown in Figure 5.9. The Fibrwrap® system can be applied at a rate of about 2 bents in 2 days on skewed bridges, and a little faster on structures with more orthogonal geometry.

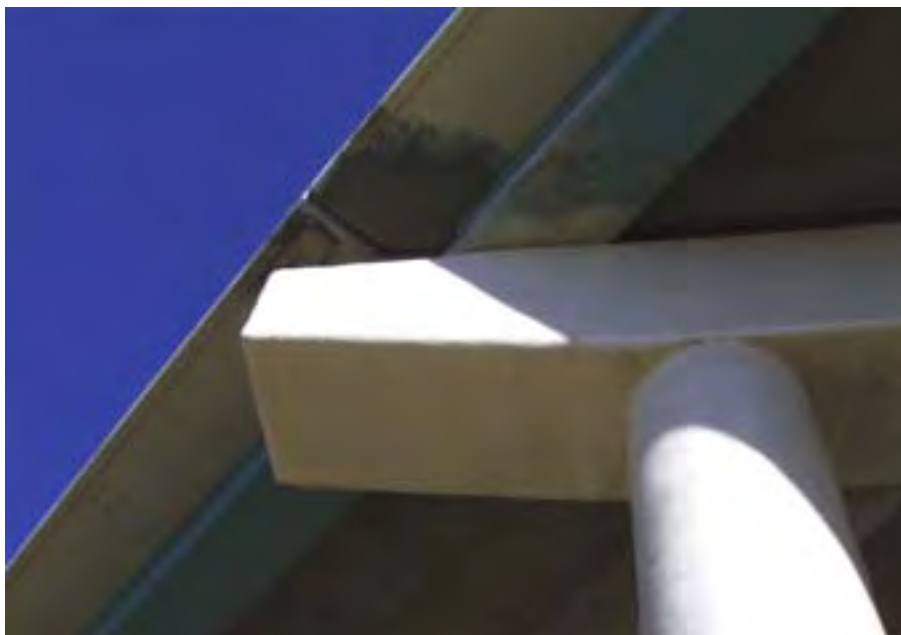
*Figure 5.9 Wrapped and painted endcap on Structure #2*

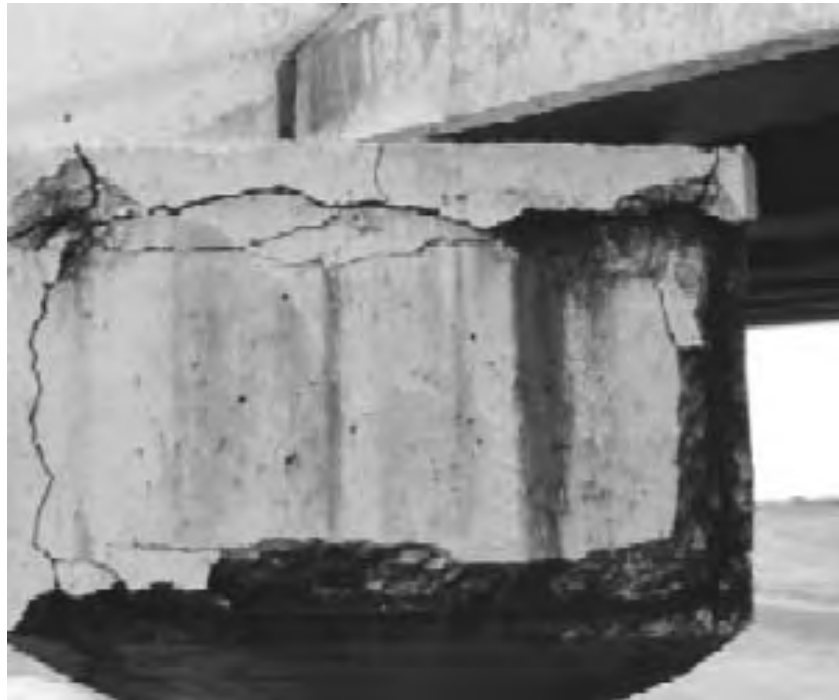
*Figure 5.10 Corrosion damage on downstream endcap*

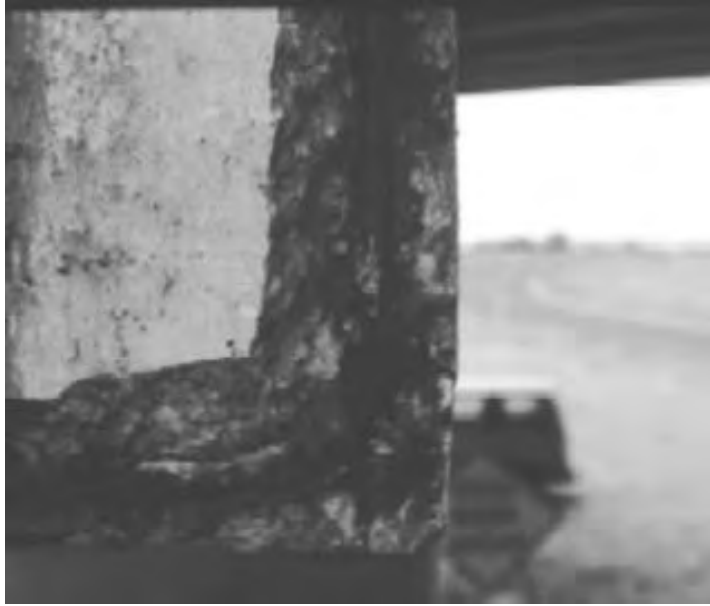
*Figure 5.11 Closeup of area with severe concrete spalling*

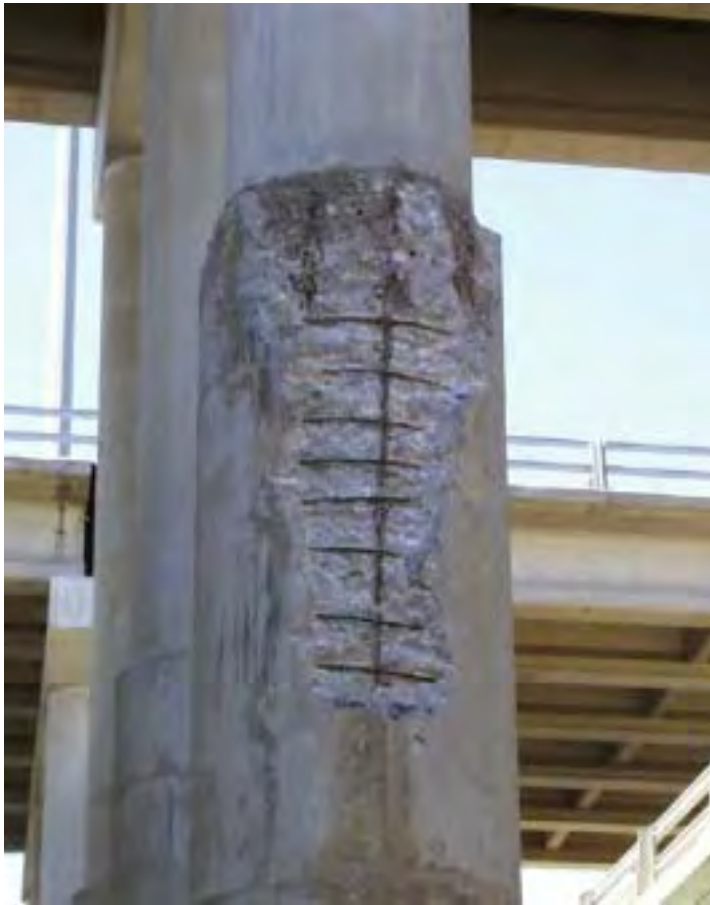
*Figure 5.12 Concrete spalling on a bridge support column*

Just as the substructure beams show distress in the areas subjected to drain water, the columns in the drainage path exhibited cracking and delamination. Figure 5.12 shows the damage on one such column located on Structure #3, at the interchange of US Highways 62 and 82 and Loop 289. There is also some delamination evident on the top portion of the substructure bents near the center and downstream supports, where water drains along the deck beams.

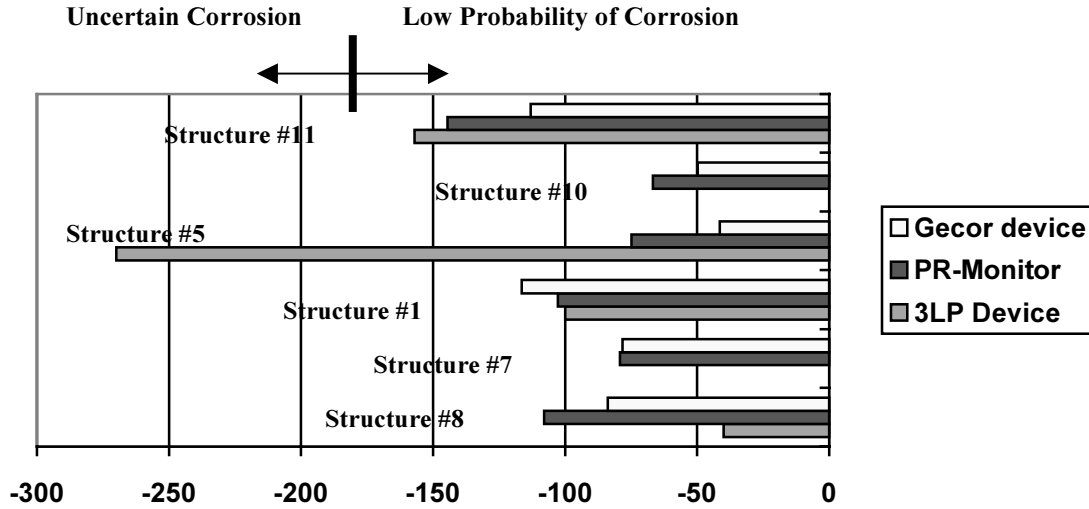
Figure 5.13 Corrosion potential (mV vs. CSE) values from different equipment

The PR-Monitor and Gecor device provided similar corrosion potential measurements as shown in Figure 5.13. The higher the corrosion potential, the more negative are the values. There may be error in some readings from each device due to the difficulty of applying the electrode sponges to vertical surfaces with limited overhead clearance. However, all of the readings were greater than -200 mv vs. CSE, which indicates a low probability of corrosion according to ASTM C 876 (ASTM).

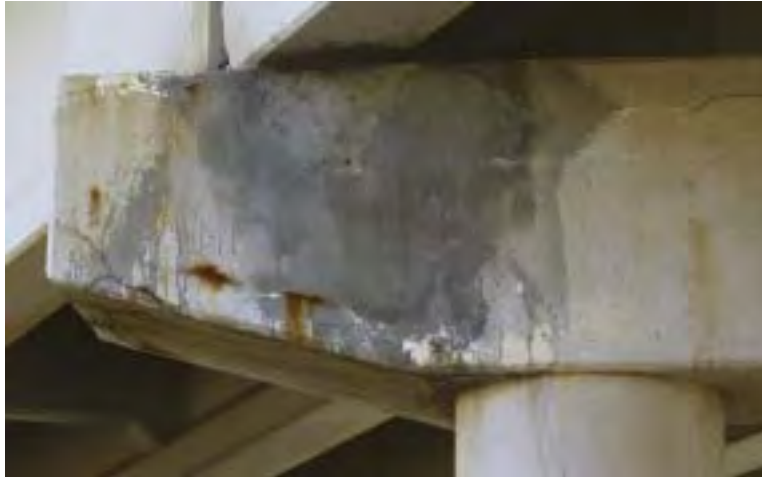
**Figure 5.15 Delaminations and corrosion stains on a downstream endcap**

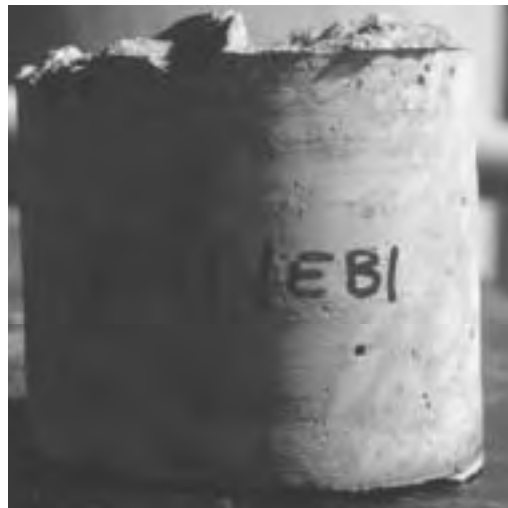
**Figure 5.16 Permeability core taken from Structure #10**

The cores were drilled with a 10.2-cm (4-in.) nominal diameter and then cut to thicknesses of 5.1 cm (2 in.) before being subjected to electrical current according to ASTM C 1202-94. They were then evaluated for chloride ion penetrability based on the amount of charge passed through the sections (ASTM 1994). An example of a core sample (prior to cutting) taken from Structure #10 is shown in Figure 5.16.

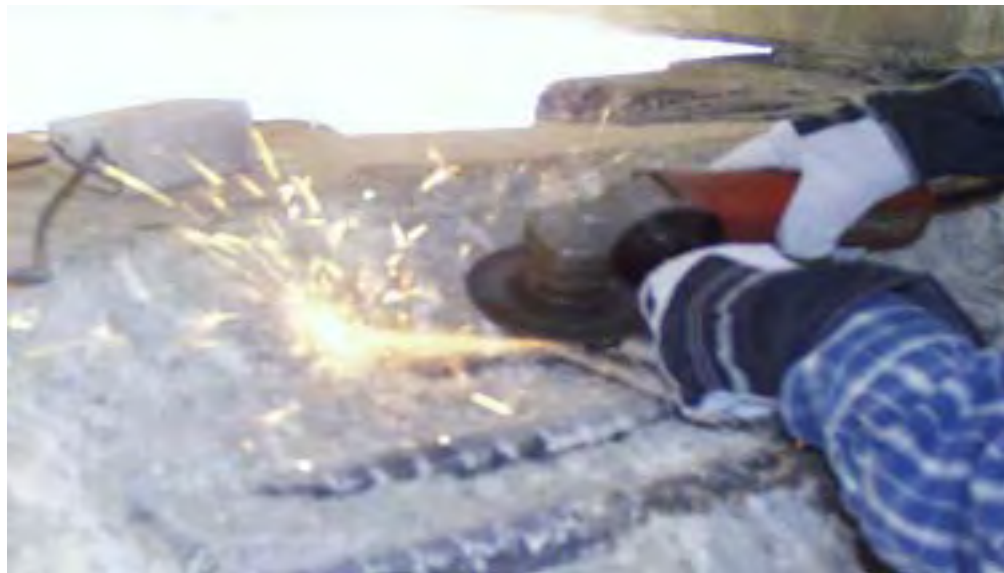
*Figure 5.17 Grinding of the reinforcement to prepare for soldering*

An electrical connection was established by means of silver soldering the copper ground wire from the probe to the reinforcement. To prepare the steel surface for the soldering procedure, the surface was ground as shown in Figure 5.17. Once a length of about 2.5 to 5 cm (1 to 2 in.) of bright steel was produced, a cleaning agent (flux) was applied to all surfaces and the copper ground wire was placed in contact with the steel reinforcement.

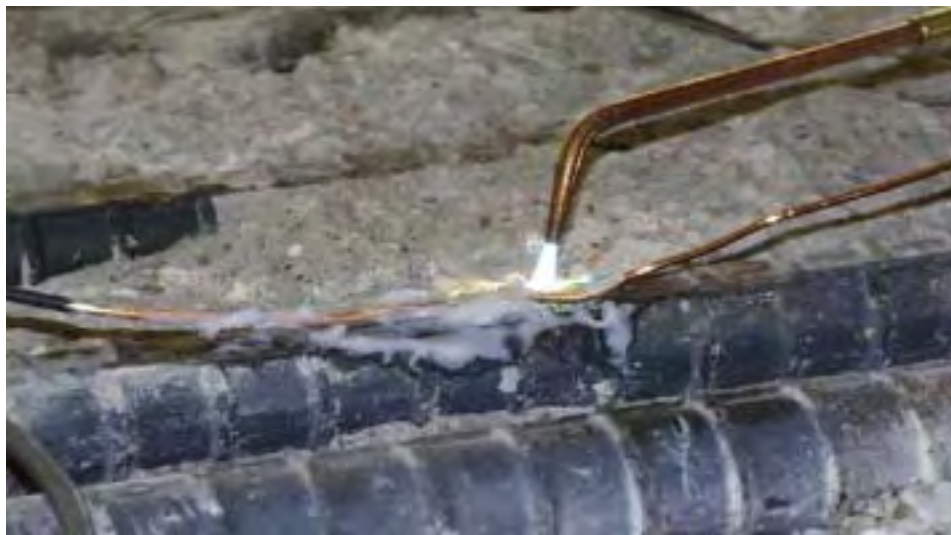
*Figure 5.19 Application of flame to the copper-steel interface*
