# EVALUATION AND PERFORMANCE MONITORING OF CORROSION PROTECTION BY FIBER-REINFORCED COMPOSITE WRAPPING

Research Report No. 1774-1

“Effect of Wrapping Chloride Contaminated Structural Concrete with Multiple  
Layers of Glass Fiber/Composites and Resin”

**Texas Department of Transportation**

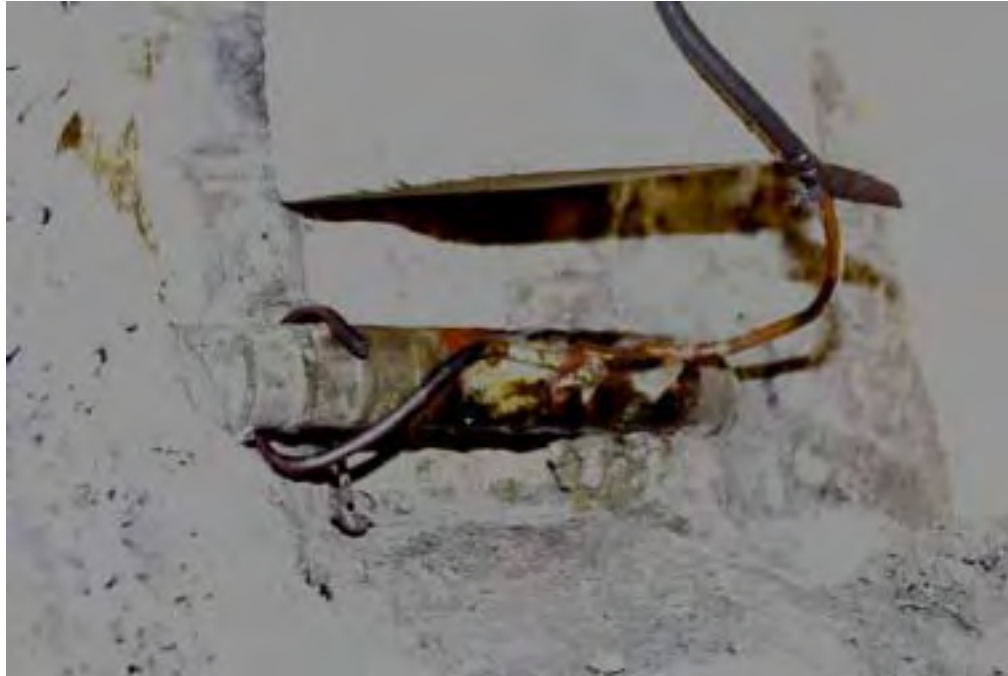
*Figure 5.20 Typical silver soldered electrical connection*

Figure 5.20 shows a typical finished soldered connection. The probe is installed some distance away from the solder point to prevent the erroneous measurement of corrosion due to the other metals and the heat-treated steel. Figure 5.21 displays a fully installed embedded corrosion rate probe.

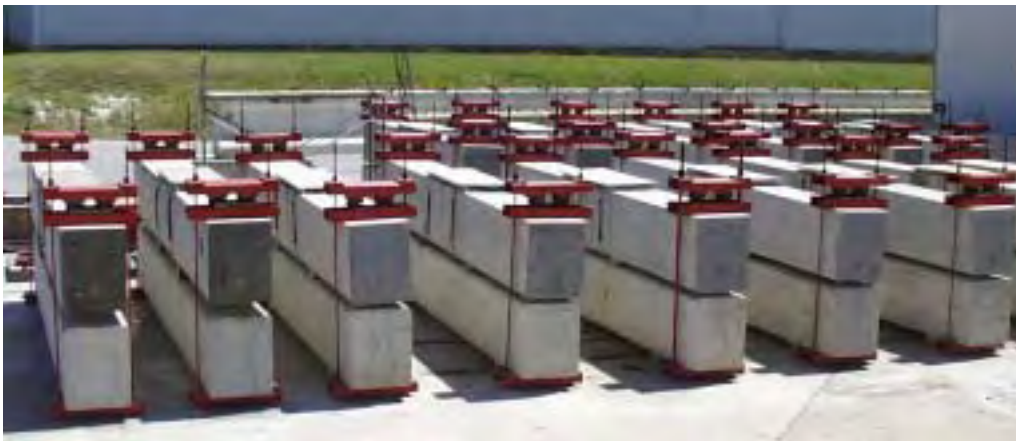
*Figure 5.23 The saltwater ponding beams (from an ongoing project at Ferguson Structural Engineering Laboratory) used for corrosion rate testing*

After the field testing was completed, further tests were conducted with the 3LP device and with the PR-Monitor. These tests were carried out on several beams, shown in Figure 5.23, which underwent continuous wet/dry (two weeks wet and two weeks dry) cycling in a saltwater ponding condition and had previously been examined only with half-cell potential measurements. The Gecor device was not available for this evaluation.

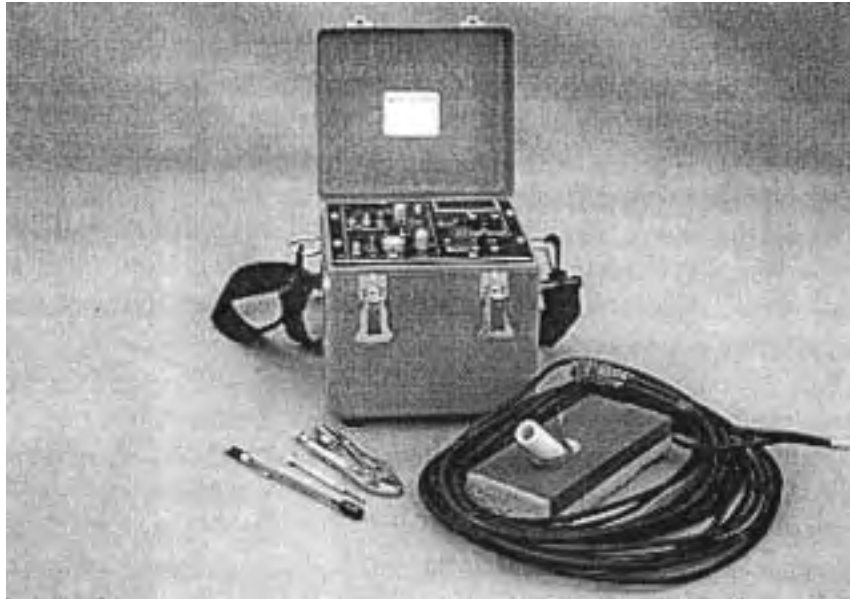
*Figure 5.24 The 3LP device*

3LP device, which consists of a self-contained power source and polarization console connected by wire to the electrodes. A sponge serves as the medium for electrode contact.

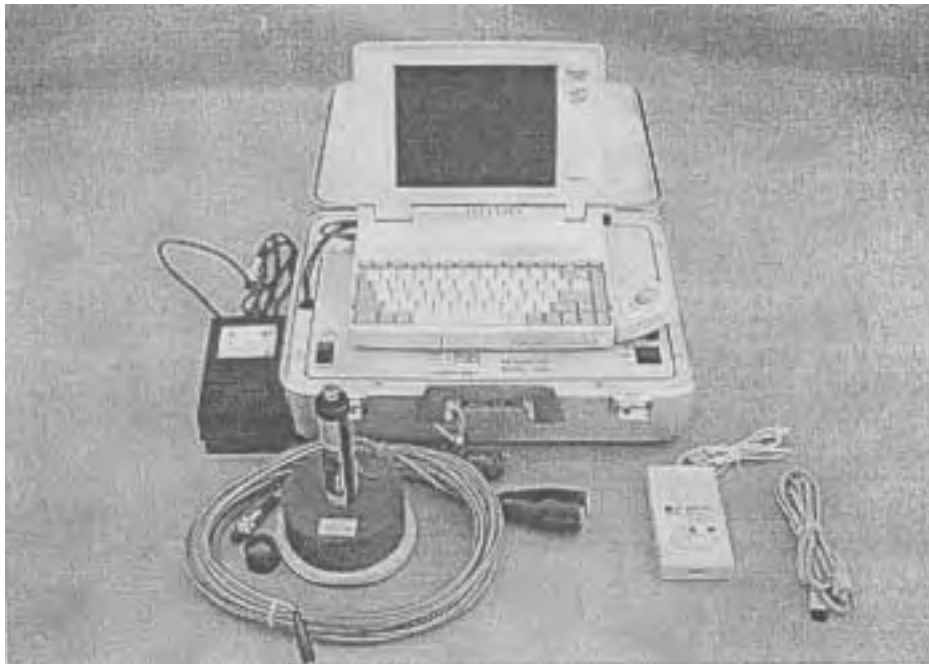
*Figure 5.25 The PR-Monitor device (Scannell, Sohangpurwala, and Islam 1996)*

In addition to the computer console, the PR-Monitor system includes a 120 volt AC power supply and the reference and counter electrodes with the necessary wiring. The PR-Monitor is displayed in Figure 5.25.

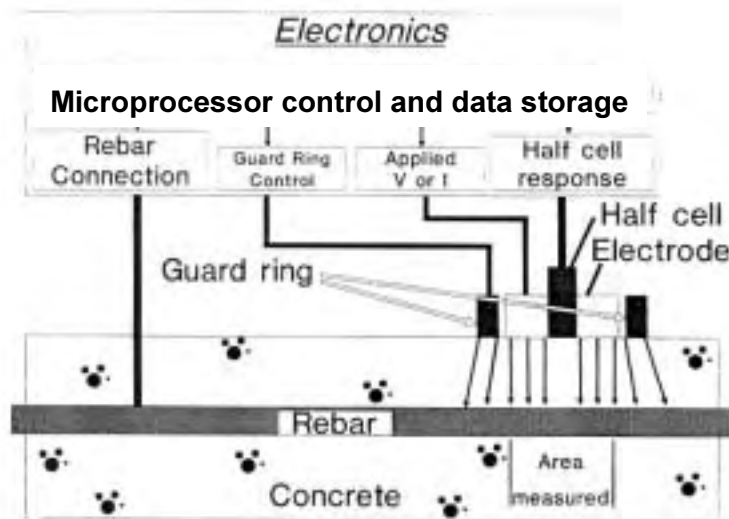
Figure 5.27 Schematic of equipment with a CE guard ring (Broomfield 1997)

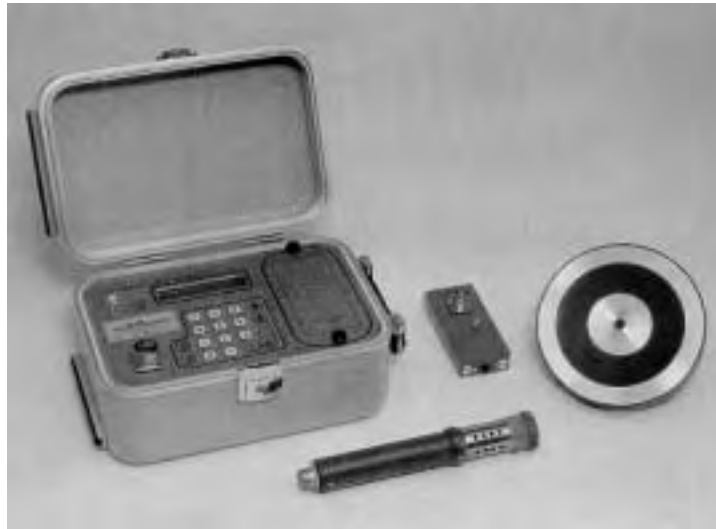
*Figure 5.28 Gecor 6 device – sensors and rate meter (James Instruments)*
