**Indications about Thermal Gradient Magnitudes from
Field Studies of Concrete Box Girder Bridges**

Research Report Number 1820-S

Research Project 0-1820

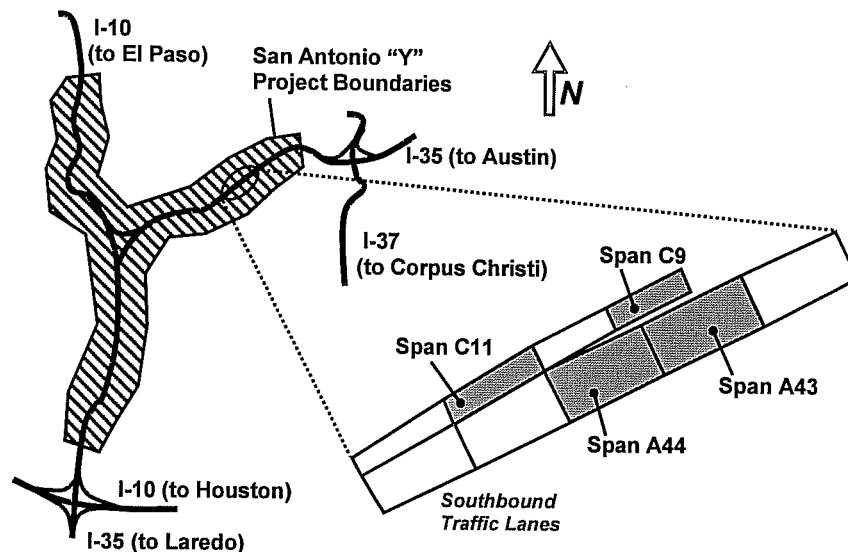
Figure 1.1: Project 0-1234 field instrumentation locations (San Antonio, TX).

Data collected from this study led to design recommendations concerning such topics as losses in external post-tensioning tendons, stress distributions in box girders, thermal gradients in box girders, segmental joints, discontinuity zone behavior, behavior under construction and live loads of segmental box girder bridges, and temperature induced deformations in match cast segments. Roberts presented the results of the study in CTR 0-1234-3F [4]. Figure 1.1 shows the location of the 0-1234 field studies (instrumented spans are shaded gray).

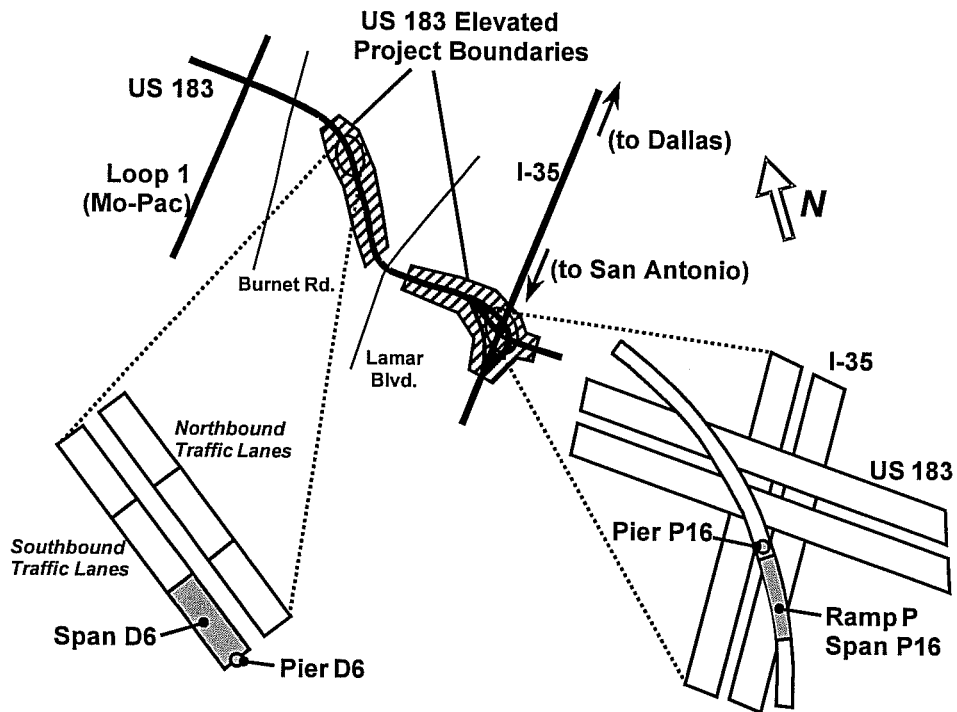
Figure 1.2: Project 0-1404 field instrumentation locations (Austin, TX).

Antonio “Y” were also studied in US 183. The project contained many of the same goals as project 0-1234. Data collected from US 183 included losses in external post-tensioning tendons, stress distributions in box girders, thermal gradients in box girders, discontinuity zone behavior, behavior under construction and live loads of segmental box girder bridges, behavior of segmental piers, and behavior of an innovative “Y”-shaped pier. This data has lead to many design recommendations on these topics. CTR reports 0-1404-1 through 0-1404-3F discuss the project in much greater detail [1, 2, 3]. Figure 1.2 shows the location of the 0-1404 field studies (instrumented regions are shaded in gray). Project 0-1820 continued the study of Ramp P shown in the lower right in Figure 1.2.

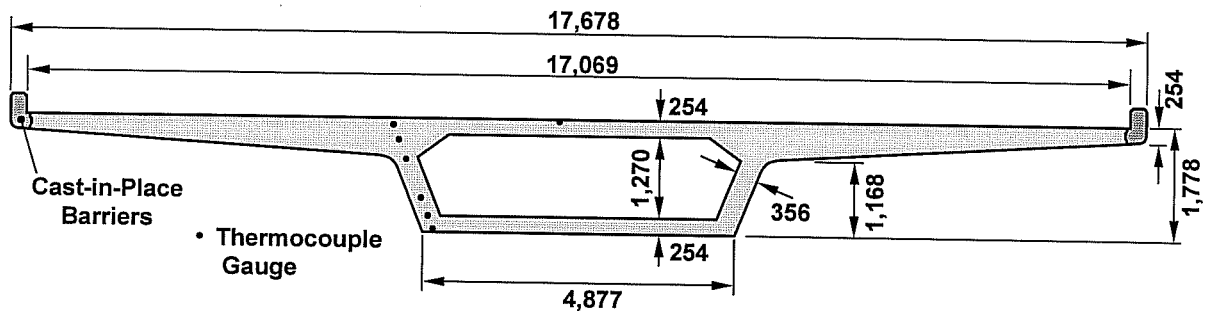
Figure 2.1: Cross-section and instrumentation for Span A44 of the San Antonio "Y."

Seven thermocouples were monitored in Span A44 of the San Antonio "Y" from August 8, 1992, through November 15, 1995. Figure 2.1 shows the thermocouple arrangement and the cross-sectional dimensions of the span. The top and bottom thermocouples were located 25mm (1") from the surface of the concrete. All dimensions are in millimeters.

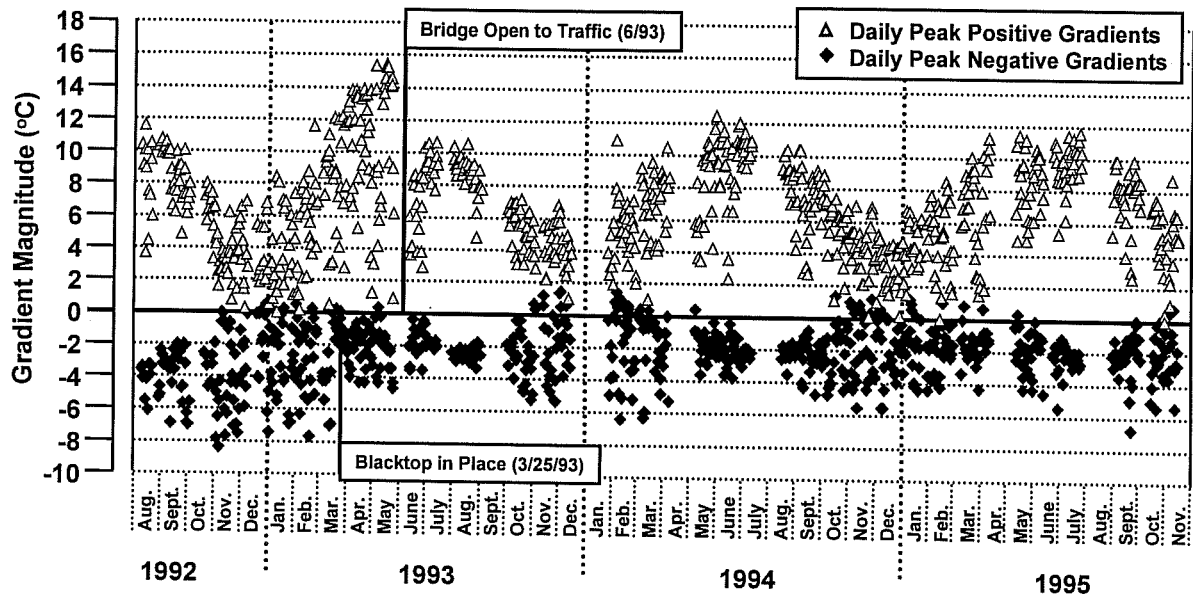
Figure 2.2: San Antonio "Y" daily maximum gradient data.

Figure 2.2 shows the maximum positive and negative gradient magnitudes from each day that data was available. Roberts reported that a 50mm (2") asphalt topping was placed on the deck of the bridge by March 25, 1993 [4]. An exact date was not available, but it is believed that the bridge was opened to traffic in early June of 1993. There are 863 days of complete data for positive and negative gradients.

Two trends are noticed in the data. First, peak negative gradients after application of the asphalt topping were only about 75% of the magnitude of peak negative gradients before application of the asphalt topping. Second, peak positive gradients after the opening of the bridge to traffic are only about 80% of the magnitude of peak positive gradients before the bridge was opened to traffic. The design gradient specifications provided in the *AASHTO LRFD Bridge Design Specifications (1994 Edition)* [6] indicate a reduction in gradient magnitude after asphalt is placed on the bridge. However, the data from San Antonio indicates that the highest positive gradients occurred after the asphalt was placed, but before the bridge had opened to traffic. Succeeding summers with the asphalt in place had lower positive gradients (Summer is the season that generally produces the highest positive gradients). This trend suggests that reduction in positive gradient magnitudes is better attributed to the opening of the bridge to traffic rather than the application of an asphalt topping. Maximum negative gradients are caused by sudden cooling of the deck of the bridge from cold fronts or precipitation. Asphalt insulates the concrete against sudden temperature changes and causes a reduction in the magnitudes of negative gradients. In contrast, maximum positive gradients are caused by steady heating of the bridge deck and are not dependent on sudden temperature changes. Thus, the insulating nature of the asphalt topping has less effect. It has previously been suggested that traffic causes a reduction in peak gradient magnitudes. Hawkins and Clark concluded from the data in their 1982 study of the Denny Creek Bridge in Washington State that traffic reduced thermal gradients by stirring surface air on the deck of the bridge [7]. This certainly appears true from the measurements in Figure 2.2.

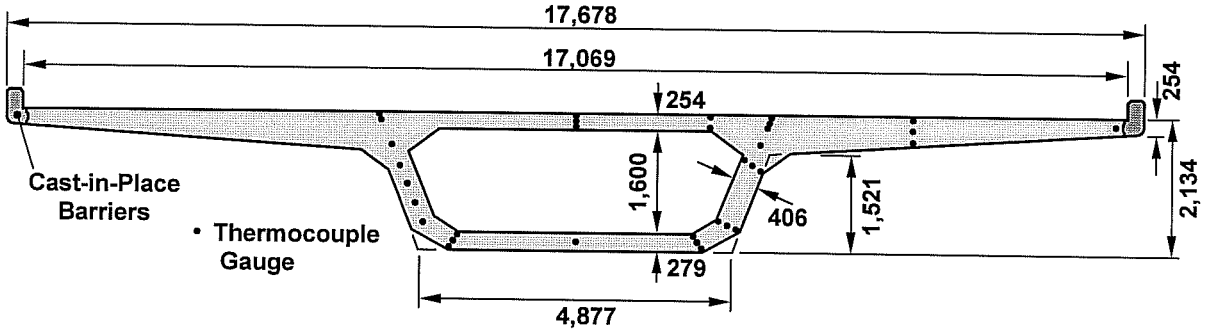
Figure 2.3: Cross-section and instrumentation for Span D6 of the US 183 Mainlane.

Thirty-three thermocouples were monitored in mainlane Span D6 of US 183 in Austin, Texas from March 23, 1995, through August 30, 1998. Figure 2.3 shows the thermocouple arrangement and the cross-sectional dimensions of the span. The top and bottom thermocouples were located 25mm (1") from the surface of the concrete. All dimensions are

in millimeters. Note that the US 183 mainlane has very similar dimensions to the San Antonio “Y” except for the depth of the box and the thickness of the webs. This difference is because US 183 had longer span lengths than the San Antonio “Y” and needed greater shear and moment capacity in the bridge cross-section.

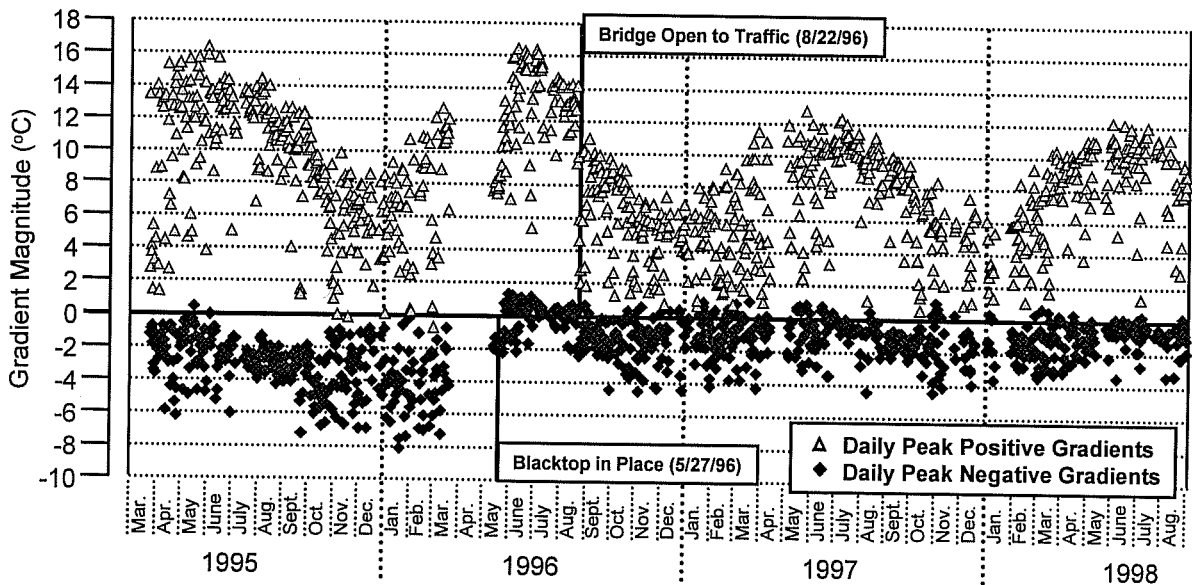
Figure 2.4: US 183 Mainlane daily maximum gradient data.

The US 183 mainlane data was examined in the same manner as the San Antonio “Y” data. Figure 2.4 shows the maximum positive and negative gradients from each day that data was available. There are 1,009 days of complete data for positive and negative gradients. Additionally, the same trends that were noted in the San Antonio “Y” data were also noted here. Further evidence that the asphalt topping did not affect the magnitude of the positive gradients is provided by comparing the summer before the asphalt was applied to the summer just after the asphalt was applied. Both time periods have roughly the same magnitudes of maximum positive gradients though during the latter summer the bridge deck had a 50mm (2") asphalt covering. Again, the opening of the bridge to traffic with consequent stirring of the air on the deck results in substantially reduced gradients (20% to 25% smaller).

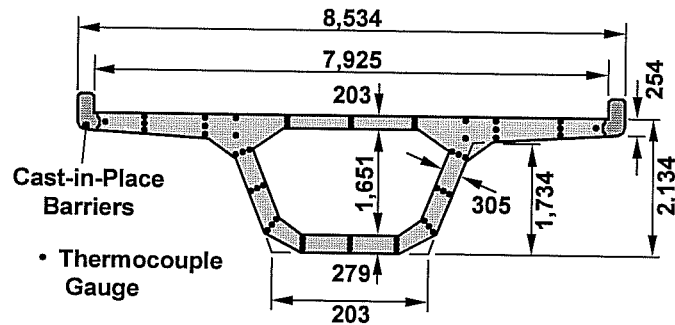
Figure 2.5: Cross-section and instrumentation for US 183 Ramp P.

Fifty-four thermocouples were monitored in US 183 Ramp P from November 1, 1996, through August 30, 1998. Figure 2.5 shows the arrangement of the thermocouples and the cross-section dimensions of the bridge. Note that Ramp P has much smaller proportions than either of the two previously instrumented bridge sections. The top and bottom thermocouples were placed 25mm (1") beneath the surface of the concrete. All dimensions are in millimeters.

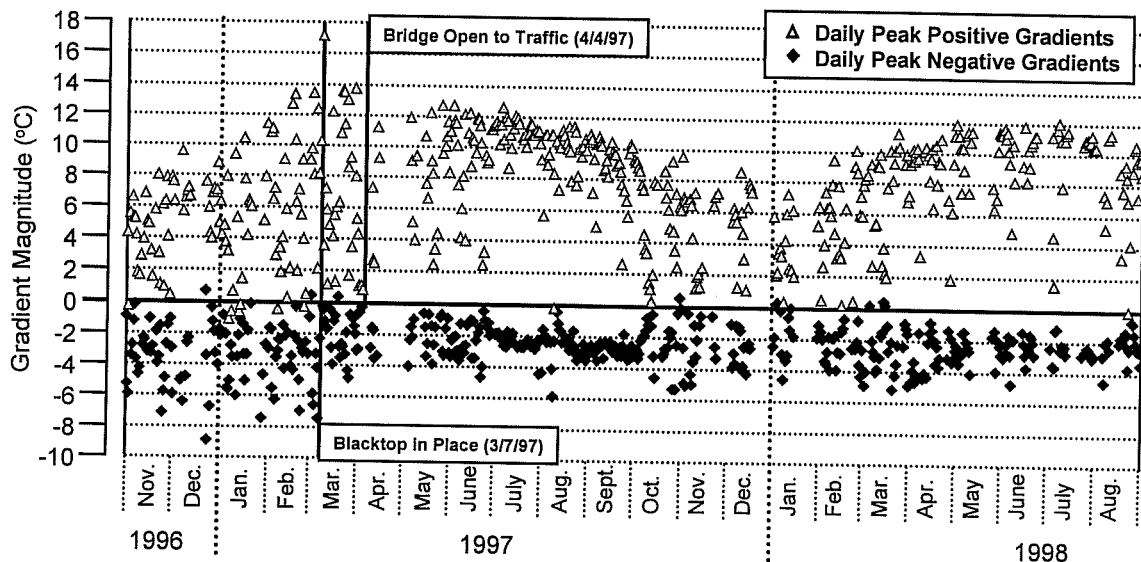
Figure 2.6: US 183 Ramp P daily maximum gradient data.

Figure 2.6 shows the maximum positive and negative gradients from each day that data was available. There are 492 days of complete data. Because there is less data for Ramp P, trends are not as evident in this plot as for the previous two bridges. However, one can see that there is a noticeable reduction in negative gradient magnitude after the asphalt is placed on the bridge deck. Except for a single "outlier" point, which has been associated with the spraying of hot asphalt on the bridge deck, the most severe positive gradients in this bridge were much less than the 16°C magnitude generally seen in the two previous bridges. This fact is probably due to differences in the proportions of the bridge cross-sections (The effect of cross-section proportioning on gradient shape will be discussed in sections 2.2.1 and 2.2.2). Again, positive gradient magnitudes were reduced somewhat (between 10% to 15%) after the bridge was opened to traffic.

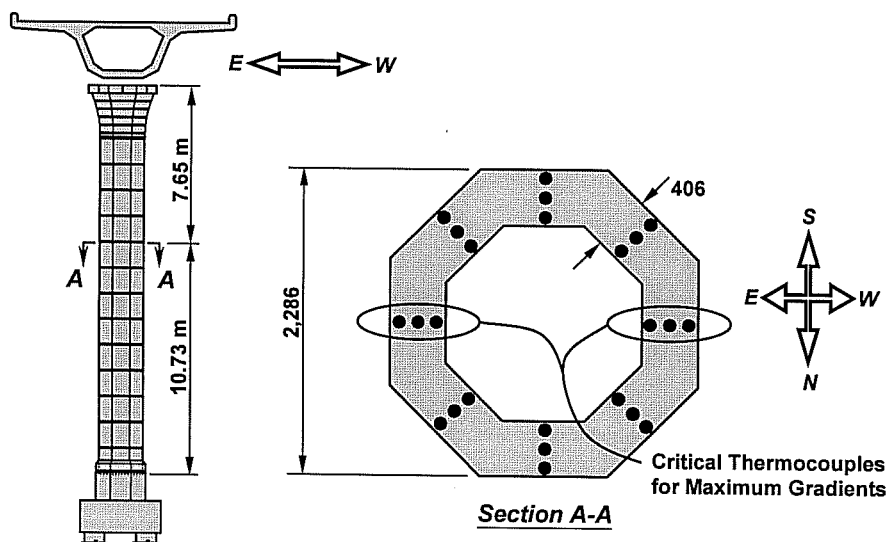
Figure 2.7: Cross-section and instrumentation for US 183 Pier P16.

Twenty-four thermocouples were monitored in one of the tallest piers, Pier P16, in the US 183 project. Figure 2.7 show the location of the instrumentation and the pier cross-section. The instrumentation was located at a height along the pier that was generally unshaded by the superstructure or any other surrounding structures. Principal sunlight exposure was on the east and west faces of the pier and the thermocouples along that axis were used to measure the thermal gradients in the pier. Outer and inner thermocouples were located 25mm (1") beneath the concrete surface. Dimensions are in millimeters except where noted. Positive and negative thermal gradients were measured as the temperature difference between the outermost thermocouples and the innermost ones.

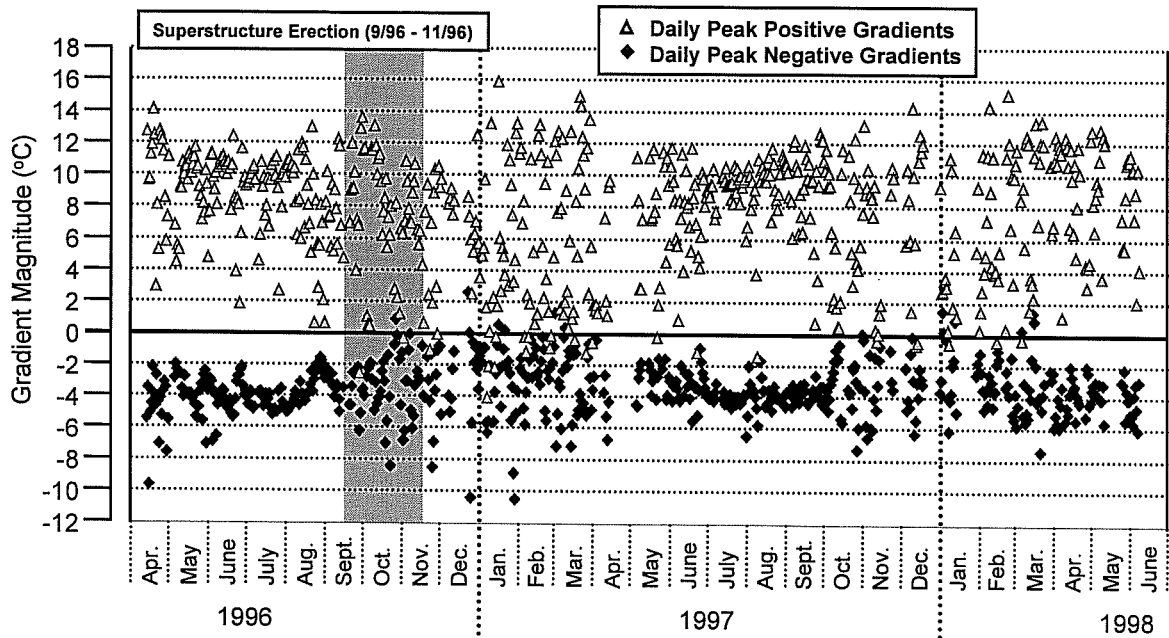
Figure 2.8: US 183 Pier P16 daily peak gradient data.

Figure 2.8 shows the maximum positive and negative thermal gradients from each day of available data. The dates when the superstructure was being erected in balanced cantilever are indicated in the figure. There was no major effect on thermal gradient magnitudes from placement of the superstructure, which provided little shade at the instrumented location. Unlike the superstructure, the most severe positive gradients occurred in the winter months. The maximum positive gradients were about the same magnitude as those seen in the superstructures of the San Antonio "Y" and the US 183 Mainlane, but the maximum negative gradients were more severe than had been seen in any of the superstructures.

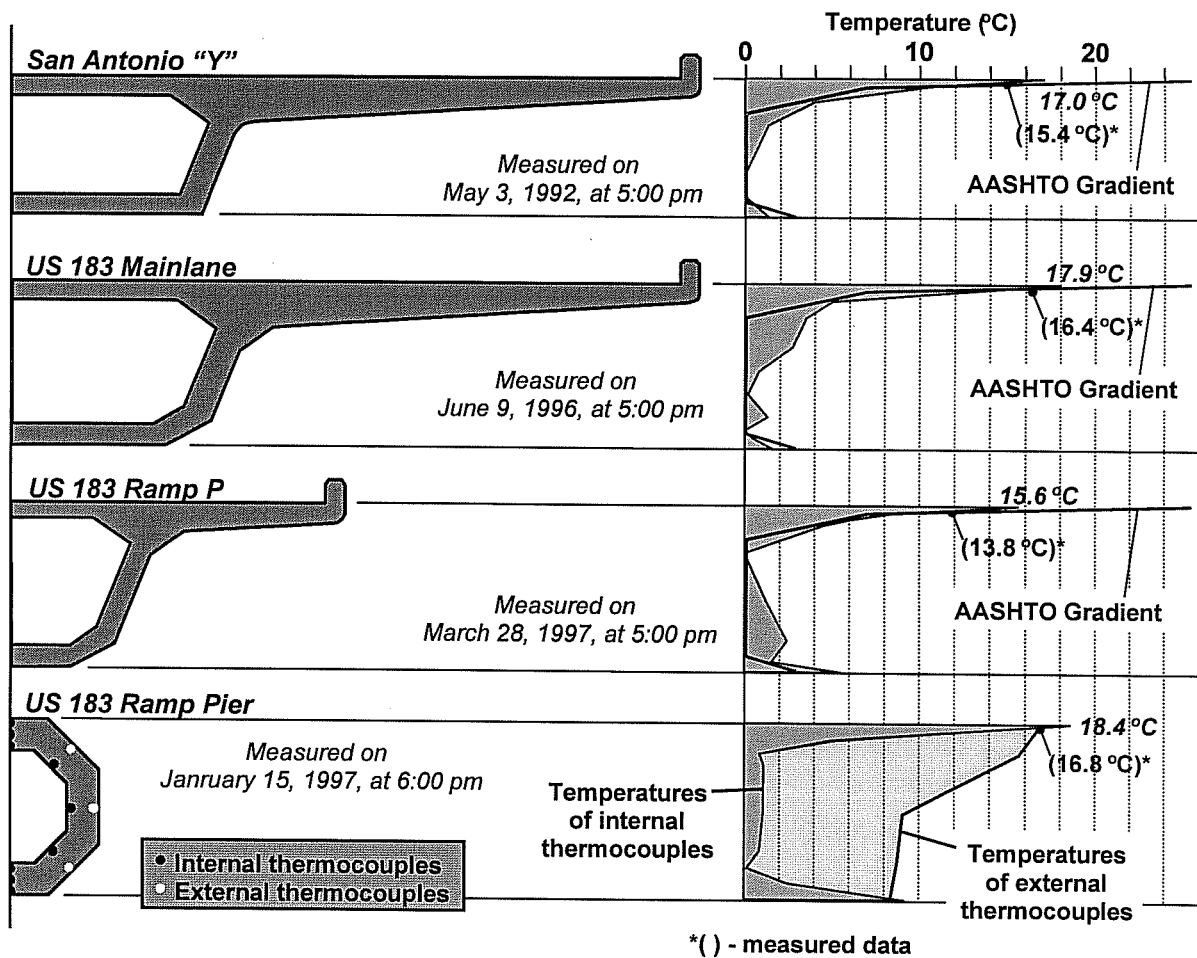
Figure 2.9: Maximum positive gradient shapes.

Figure 2.9 shows the relative proportions of the different cross-sections and the maximum measured positive gradients that occurred in each structure. The gradient shape presented for each superstructure cross-section is averaged across the width of the section. The peak gradients in each superstructure all occurred at 5:00 pm in the late afternoon. The temperature value at the surface of the concrete was linearly extrapolated from the data. The extrapolated magnitude is presented in italics next to each gradient. Typically, the extrapolated surface temperature was 10% to 13% higher than the measured temperature 1" beneath the surface. Thus, the actual magnitude of the gradients are estimated to be 10% to 13% higher than the values derived from direct measurements by the thermocouples.

The San Antonio "Y" and US 183 Mainlane had very similar gradient shapes and magnitudes. This is not surprising since the proportions of the two box girders are similar. The elevated temperatures of each of those gradients extends deep into the web of the cross-section. However, US 183 Ramp P had a maximum positive gradient with a 10% smaller magnitude that extended far less into the web. The difference between the shapes of these gradients may be due to the difference in the widths of the deck compared to the width of the webs. The deck is the primary surface through which the cross-section absorbs heat. That heat is transmitted into the rest of the cross-section through the webs. The relative proportioning of the webs to the deck would be an important influence in the development of the temperature distribution in the cross-section.

The AASHTO design gradient for Zone 2 with a plain concrete surface is presented next to the superstructure gradients (*AASHTO LRFD Specifications, 1994 ed.* [6]). None of the superstructure gradients reach more than about 75% of the magnitude (60% for Ramp P) of the design gradient (25.6°C). Furthermore, the temperature of the webs is not zero as is indicated by the AASHTO gradient shape.

The gradient shape for the US 183 Ramp Pier contains two lines of data. The gradient temperatures along the interior of the box pier wall and along the exterior of the box pier wall

are both presented. The difference between these two lines of data shows that a large gradient is present from the inside to the outside of the pier wall. A thermal gradient does exist from one side of the pier to the other. After averaging across the width of the pier, this gradient would be less in magnitude than the gradients that were seen in the superstructures.

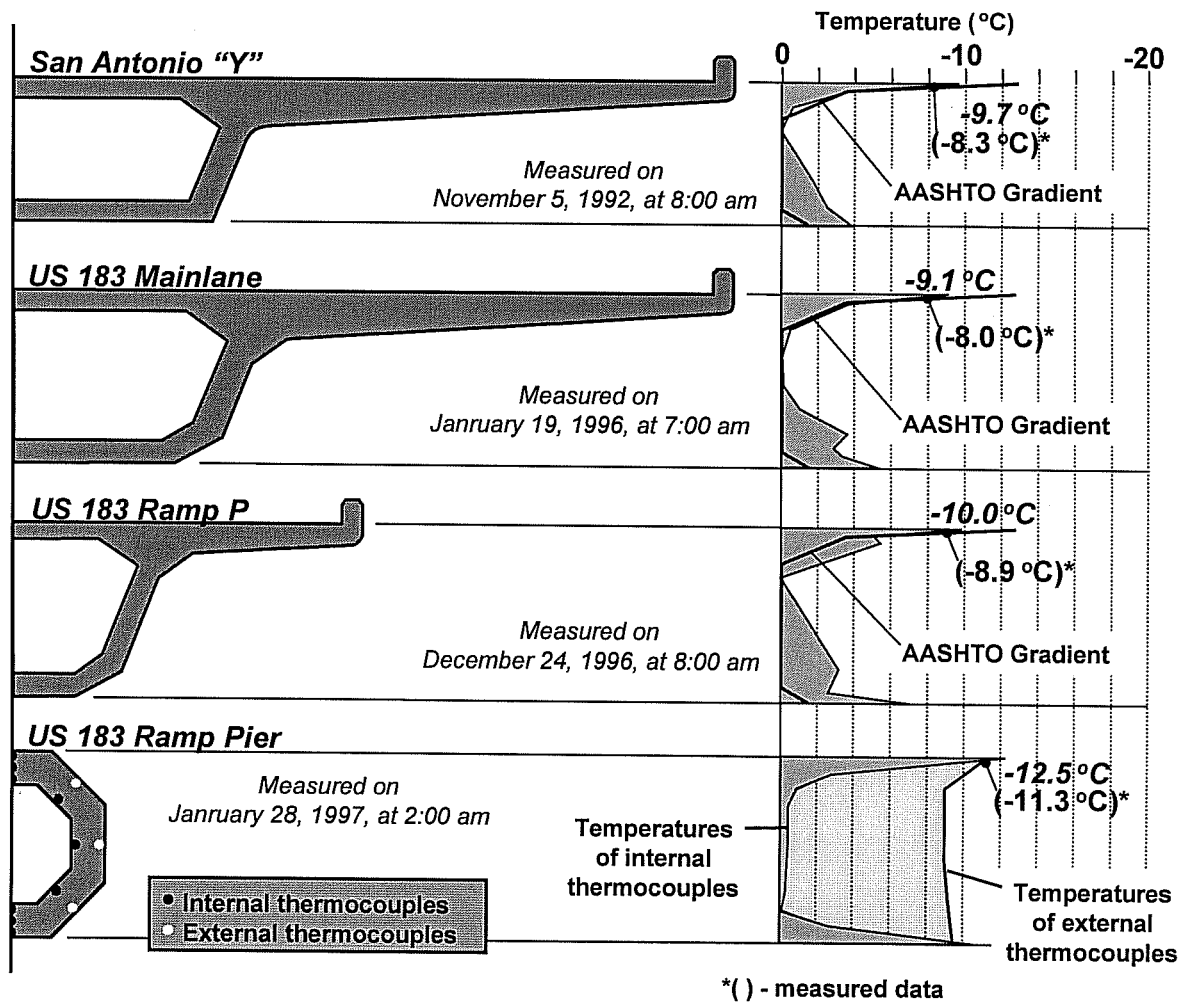
Figure 2.10: Maximum negative gradient shapes.

Figure 2.10 shows relative proportions of the different cross-sections and the maximum negative gradients that occurred in each structure. The peak negative gradients for the superstructures all occurred in the morning at 7:00 or 8:00 am. The temperature value at the surface of the concrete was linearly extrapolated from the data. The extrapolated magnitude is presented in italics next to each gradient. Typically, the extrapolated surface temperature was 10% to 17% lower than the measured temperature 1" beneath the surface. Thus, the actual magnitude of the gradients are estimated to be 10% to 17% higher than the values derived from direct measures of the thermocouples.

All three superstructures had similar negative gradient shapes and magnitudes. The magnitudes of these gradients on the average were 25% less than the magnitude of the

AASHTO LRFD design gradient (The Zone 2 plain concrete surface negative design gradient has a magnitude of -12.8°C) [6]. The top portion of each superstructure gradient was generally matched by the design gradient. However, the portion of the gradients through the webs and bottom flange was not well matched by the design gradient.

Once again, temperature values along the inside and outside of the pier wall are presented. The shapes indicate that there was no resultant negative gradient of significance across the width of the pier. However, there is a large gradient from the inside to the outside of the pier wall.

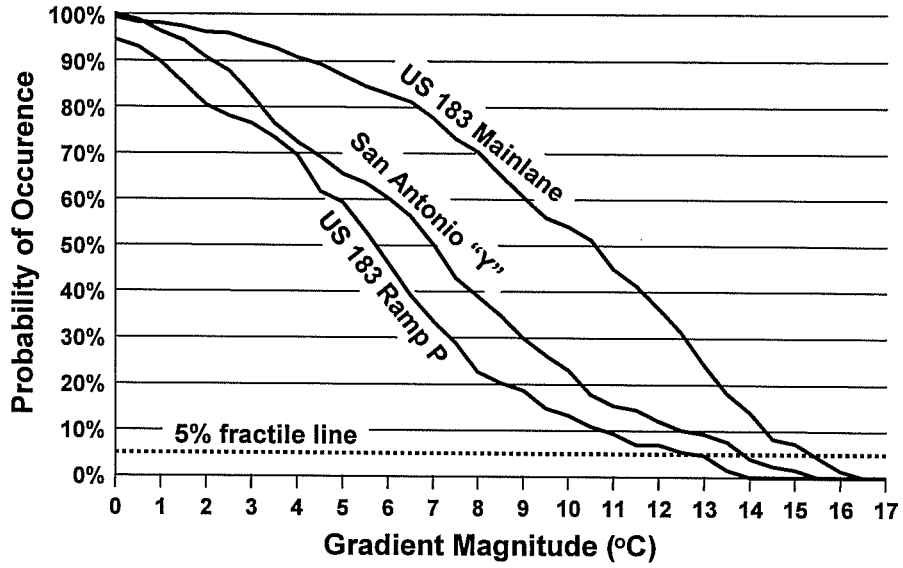
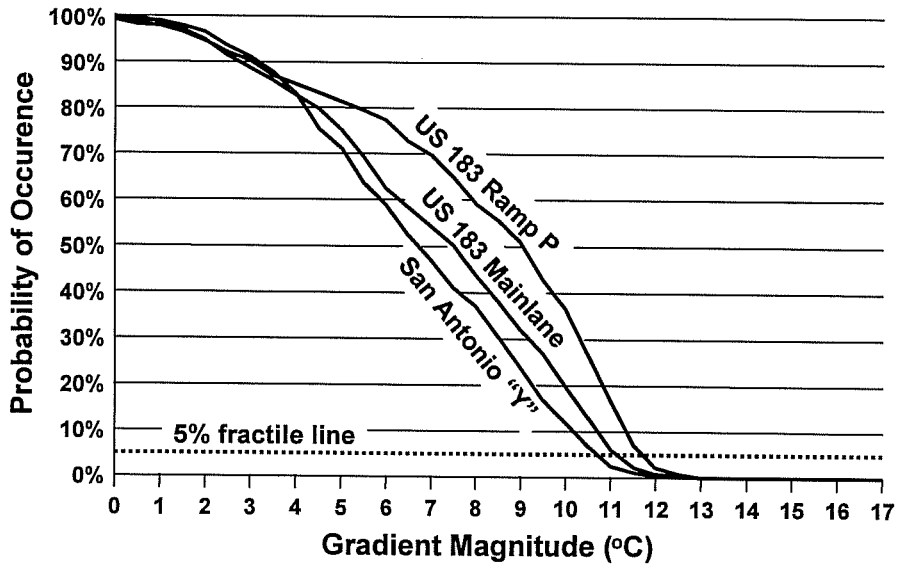
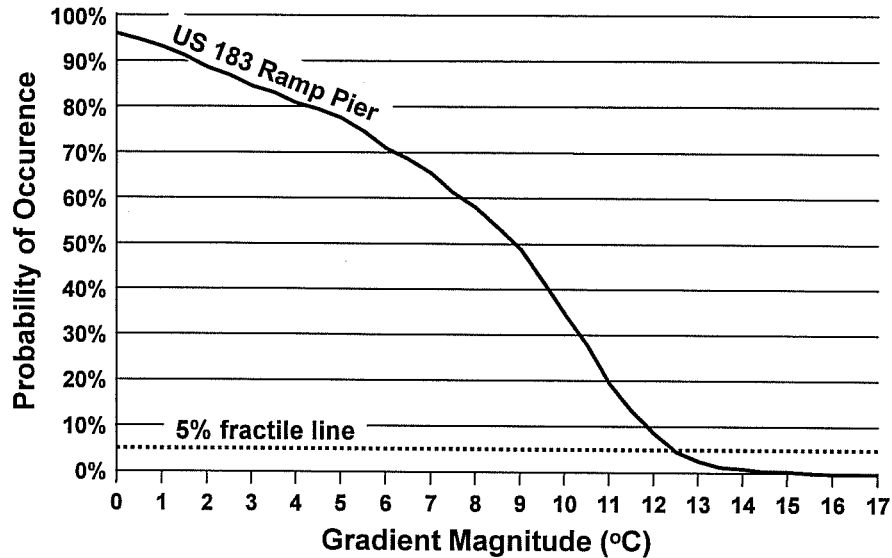
Figures 2.11, 2.12, and 2.13 present plots that show the probability that a positive gradient of a given magnitude or greater occurred on a given day in each of the different instrumented structures. For some of the structures, on particularly cold days, positive gradients did not occur during the course of the day. Thus, some of the plots do not show 100% probability that a positive gradient with a magnitude greater than 0°C will occur on a given day (i.e., They do not intersect the vertical axis at 100%).

The gradients that coincide with a 5% probability of occurrence are the values that are of interest in the plots. Selection of these gradients as design gradients will provide a 95% confidence that an appropriate gradient is used. The highest recorded gradient is not an appropriate design gradient because it occurs too infrequently. Rather, a lower magnitude gradient with a more frequent rate of occurrence should be chosen for practicality. A 95% confidence level is consistent with other statistically determined design loads (i.e., wind gusts, water loads, etc.). Thus, the gradients that coincide with a 5% probability of occurrence (the 5% fractile) are recommended for design purposes. The probability plots presented in this section are intended for the selection of appropriate design gradient magnitudes. The temperature values for the plots are based upon the measured data (the thermocouple temperature values measured 1" into the surface of the concrete), not the extrapolated temperatures at the surface of the concrete. In accordance with the observations presented in the previous two sections dealing with gradient shapes, the estimated magnitudes of the actual gradients (measured to the surface of the concrete) are between 10% to 17% higher than the measured magnitudes.

From Figures 2.11 through 2.13, the 5% fractile gradients are 15.5°C for positive gradients without traffic, 12.0°C for positive gradients after traffic, and 12.5°C for positive gradients in hollow box pier substructures. These values should be increased by 15% to account for the difference between measured and actual gradients (giving magnitudes of 17.8°C, 13.8°C, and 14.4°C respectively).

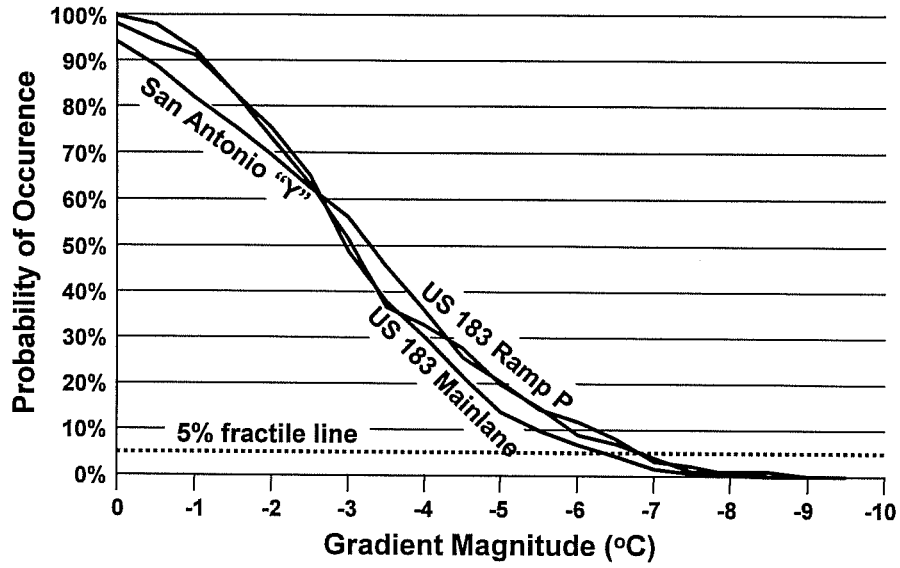
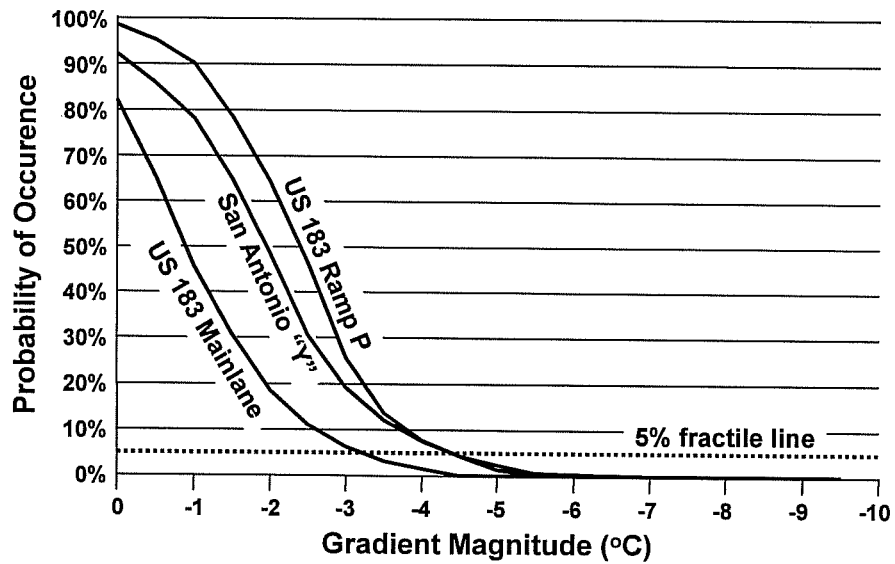
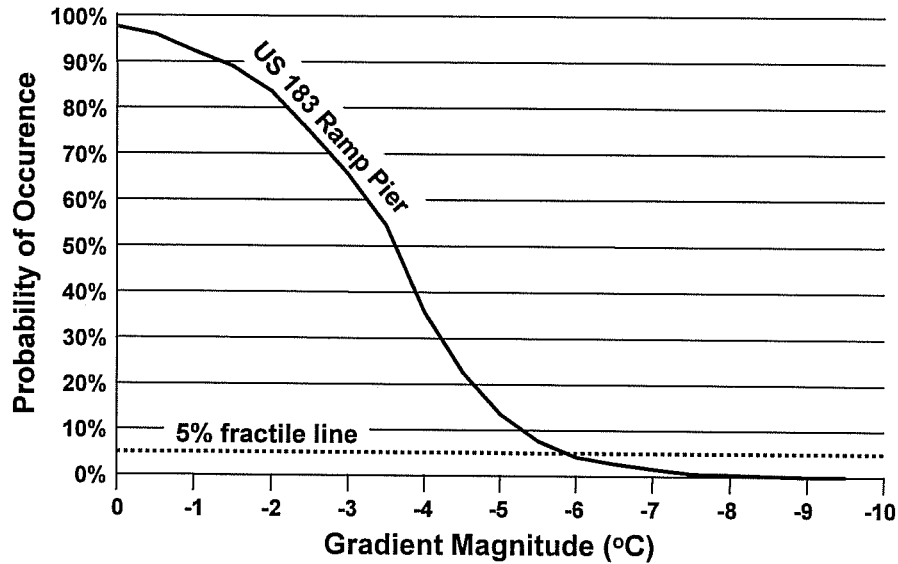
Figures 2.14 through 2.16 present plots that show the probability that a negative gradient of a given magnitude or greater occurred on a given day in each of the different instrumented structures. From these figures, the 5% fractile gradients are -6.7°C for negative gradients without asphalt, -4.5°C for positive gradients with 50mm (2") asphalt topping, and -6.0°C for positive gradients in hollow box pier substructures. These values should be increased by 15% to account for the difference between measured and actual gradients (giving 7.7°C, 5.2°C, and 6.9°C respectively).

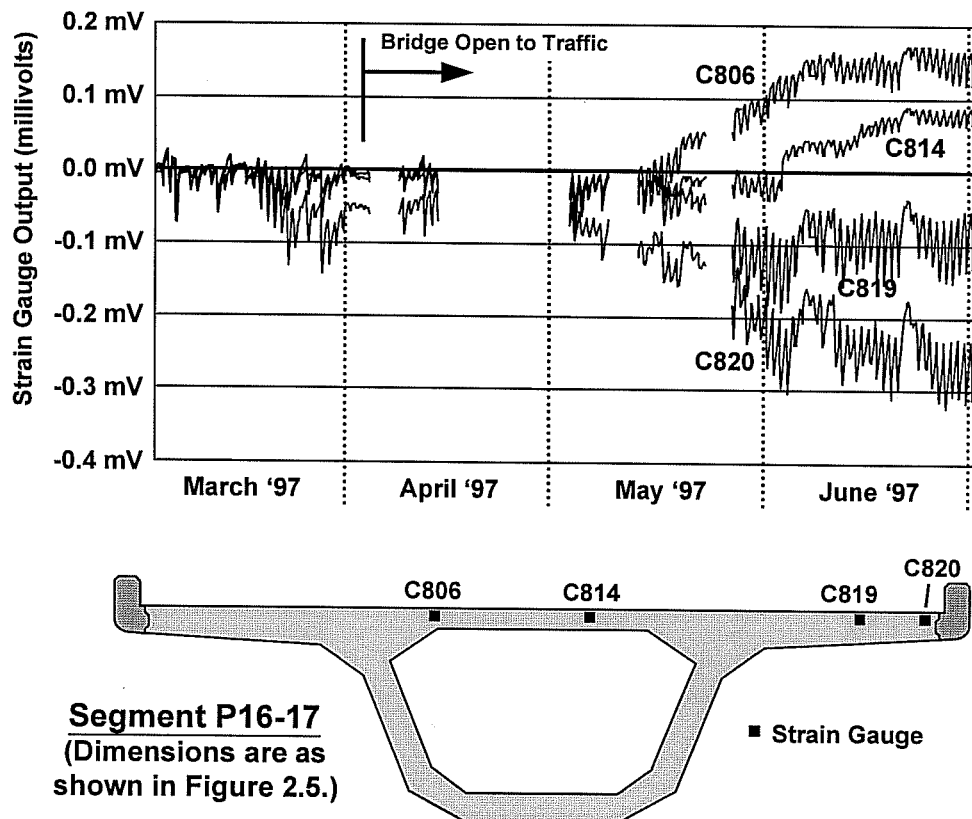
Figure 3.1: Concrete strain gauge performance in US 183 Ramp P.

Originally it was hoped that the concrete strain gauges placed in the US 183 structures could be used to provide information on long-term creep and shrinkage effects in the bridges. However, analysis of the data over the past year has shown that the significant degeneration of these gauges after the bridges opened to traffic has rendered them useless for long-term and even short-term strain change readings. Figure 3.1 shows the output of four top flange concrete gauges in segment P16-17 of US 183 Ramp P. This segment is near the mid-span of a 54.8m (180') span (see Thompson [2] for more information on the location of instrumentation in US 183 Ramp P).

There are gaps in the data from this time period due to data retrieval problems that are unrelated to the strain gauge output. The figure shows that in mid-May, the gauge output began to drift into unreliable output levels. Furthermore, the behavior of each of these four gauges was inconsistent. Some of the gauges tended towards increasing negative output and some towards increasing positive output. The behavior of the gauges cannot be interpreted to be a consistent trend in the top flange strain. This behavior was typical of all the strain gauges in Ramp P, even for the gauges on the external tendons. Figure 3.2 shows the behavior of four external tendon strain gauges in the same span.
