STRENGTH AND BEHAVIOR OF BOLT
INSTALLATIONS ANCHORED IN
CONCRETE PIERS

J. O. Jirsa, N. T. Cichy, M. R. Calzadilla,
W. H. Smart, M. P. Pavlucik,
and J. E. Breen

RESEARCH REPORT 305-1F

BUREAU OF ENGINEERING RESEARCH
THE UNIVERSITY OF TEXAS AT AUSTIN
NOVEMBER 1984

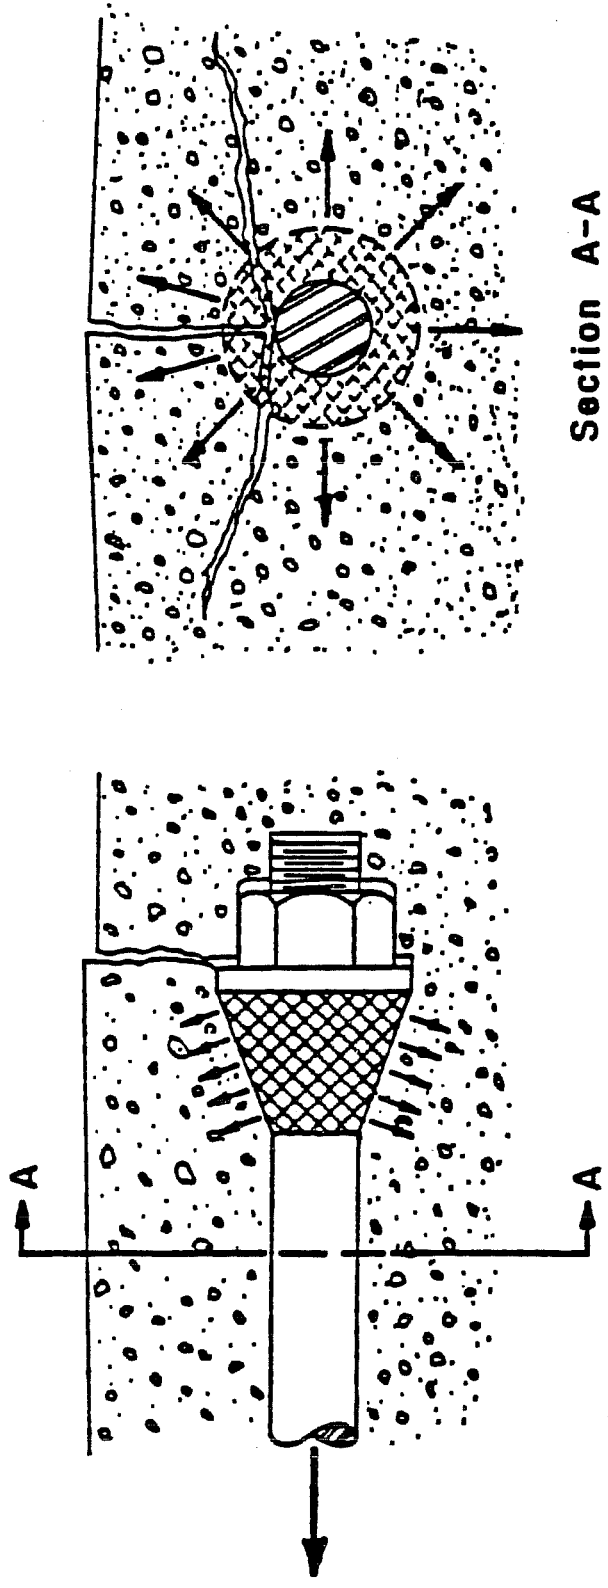
Fig. 1.1 Conditions around the anchorage after formation of the cone of crushed concrete

Section A-A

The design equation was developed from a regression analysis on test results of bolts failing in the wedge-splitting mode only. A minimum embedment length of $12(D_w - D)$ was suggested to allow the wedge-splitting mechanism to form (Fig. 1.1). A restriction which accounted for a reduced bearing efficiency observed for large washers, limited the bearing area to $4D^2$. Furthermore, a minimum washer thickness, $D_w/8$, was suggested to prevent excessive flexibility of the washer.

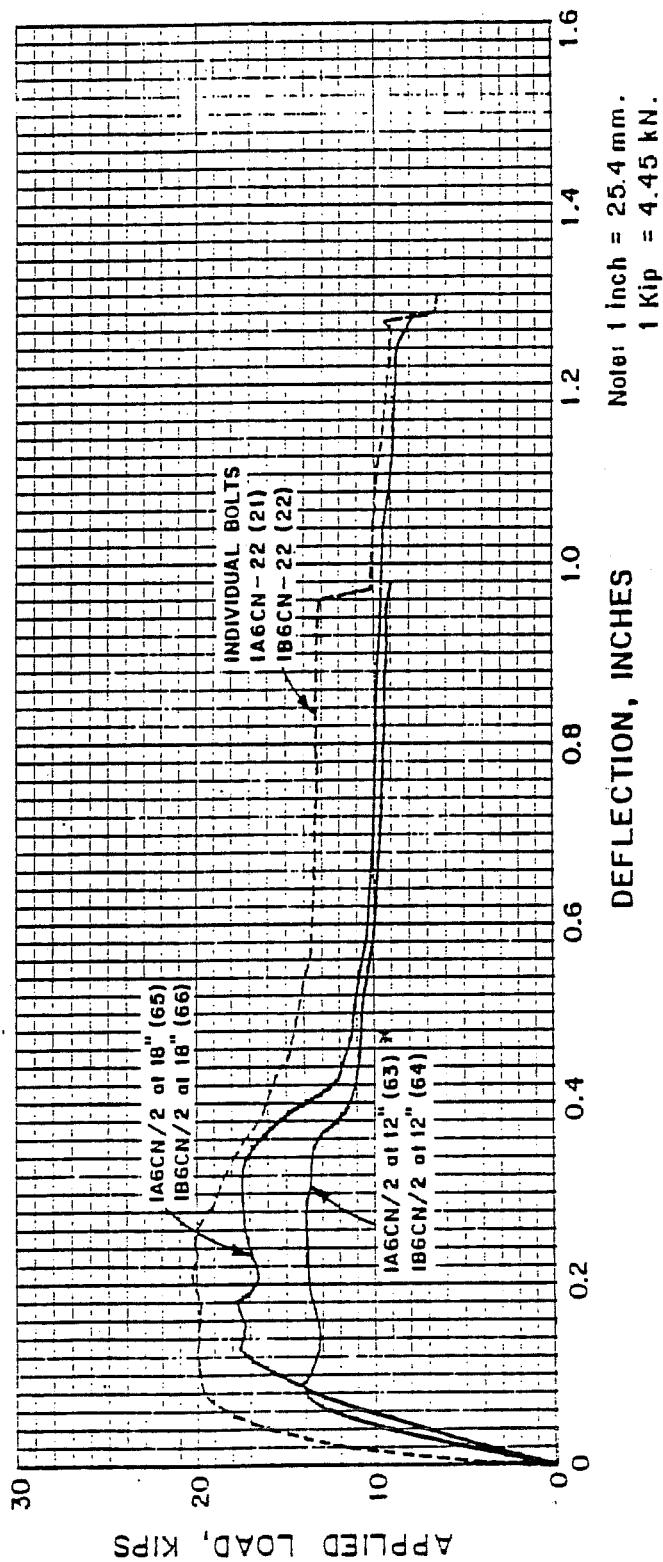
Fig. 2.9 Effect of bolt spacing on the lateral resistance of anchor bolt pairs (Ref. 6)

Diameter. : 1"
 Type of steel. : Mild
 Edge distance. : 6"
 Method of installation. : Cast-in-place
 CONCRETE REINFORCING. : Nominal
 TYPE OF LOADING. : Shear
 SPACING BETWEEN BOLTS : Varies

Results from the tests on bolt pairs are shown in Fig. 2.9. The curves for the bolt pair tests are drawn to one-half vertical scale so that the ordinate represents the applied load per bolt. As can be seen from this figure, there are significant reductions (approximately 15 to 30%) in per-bolt load-carrying capacity with reduction in spacing between bolts. Although the group action test data were limited, the report noted that the combined load resistance of an anchor bolt pair is less than the sum of the individual bolt capacities if the spacing perpendicular to the loading direction is less than approximately four times the minimum edge distance.

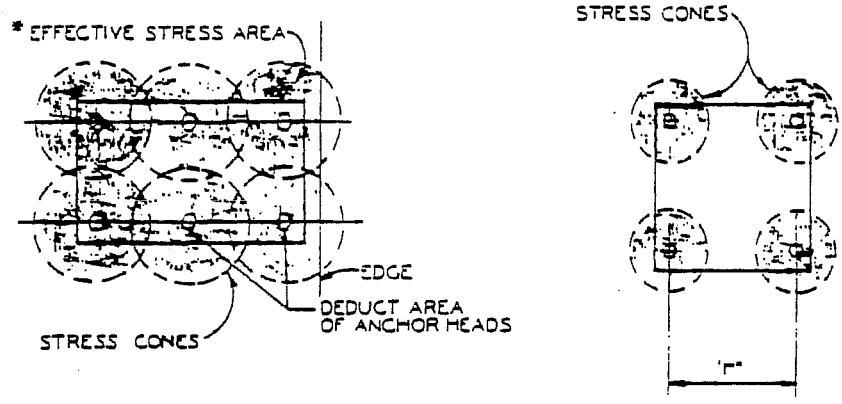
Fig. 2.10 Effective stress area for anchorage pullout (Ref. 3)

*REDUCE BY THE TOTAL BEARING AREA OF THE ANCHOR STEEL.

This design concept is illustrated in Fig. 2.10. Note the concrete cone pullout failure, characteristic of this type of installation.

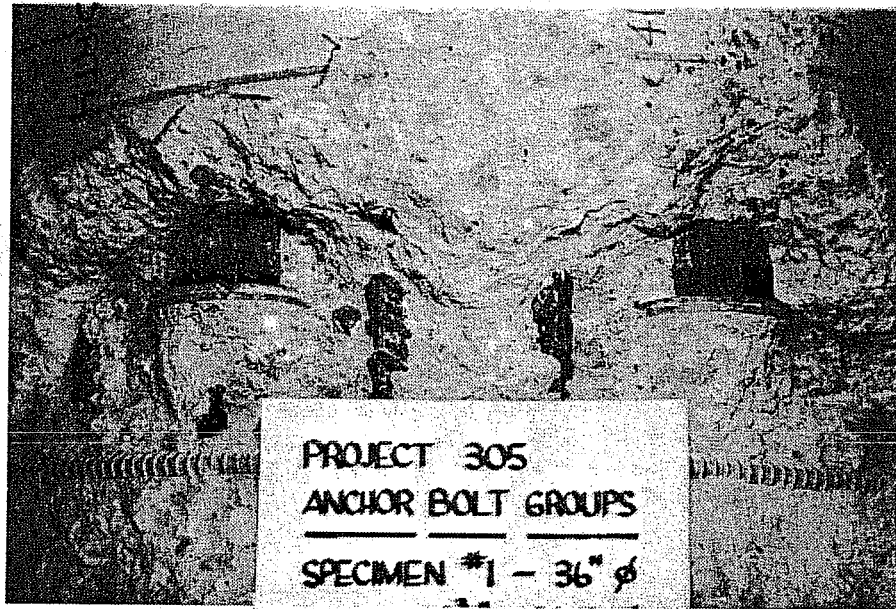
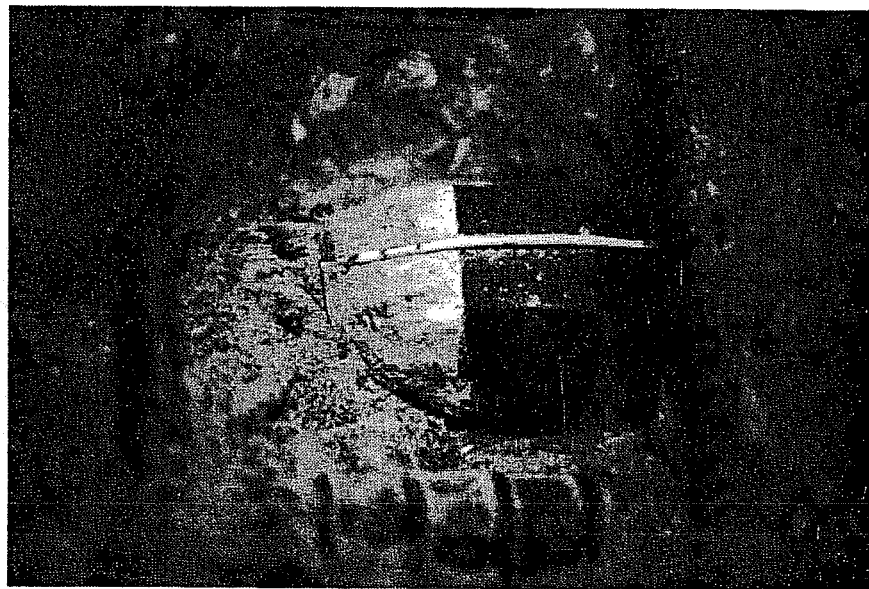
Fig. 4.16 Cone of crushed and compacted concrete
in front of anchorage device

Fig. 4.17 Anchor bolts after removal from test specimen showing cone of compacted concrete

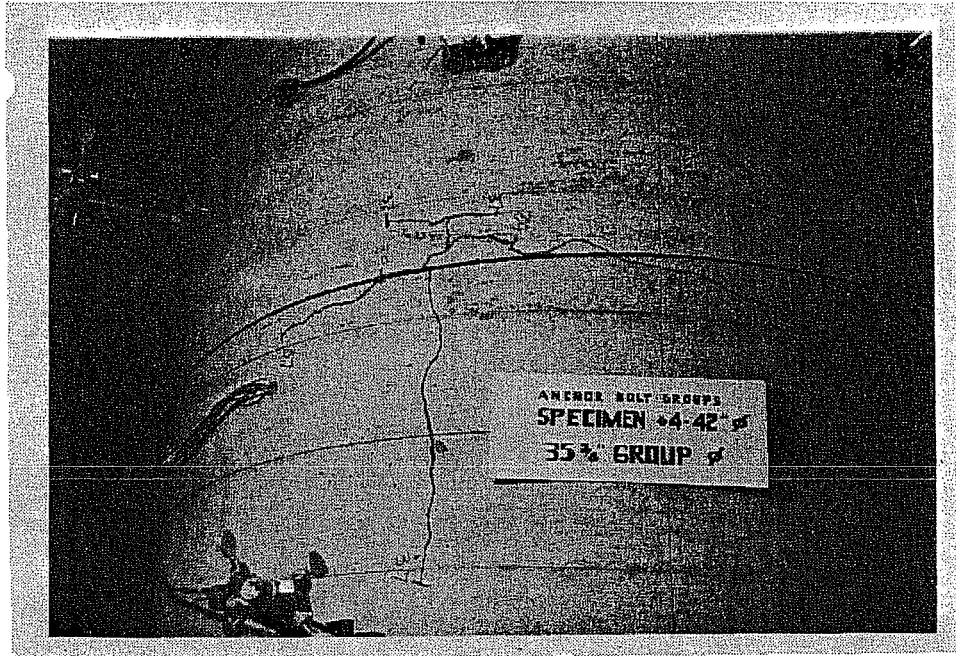
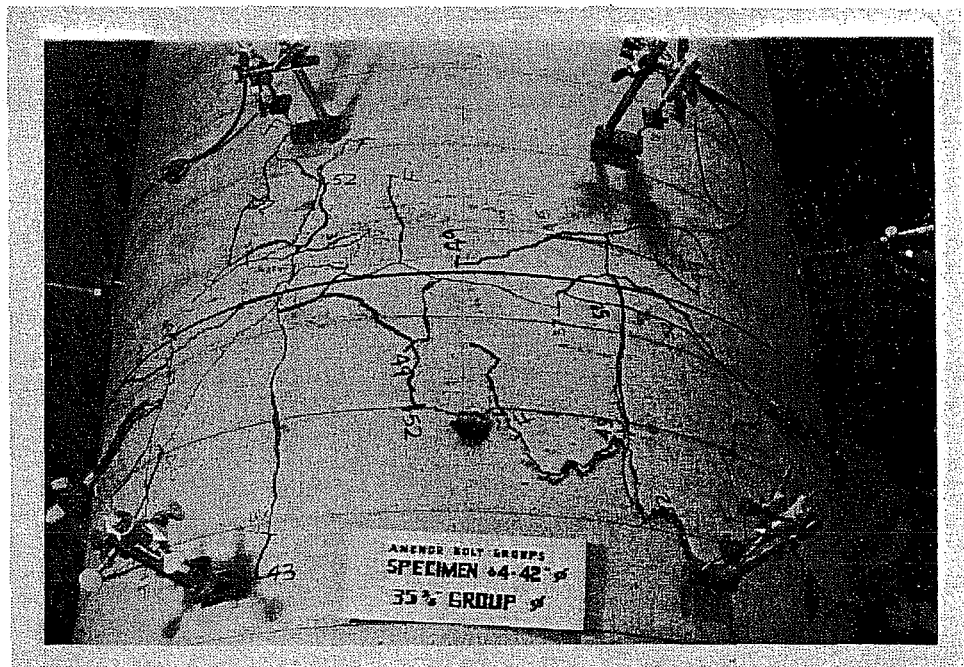
Fig. 4.18 Crack pattern, SC7

Initial cracking

At failure

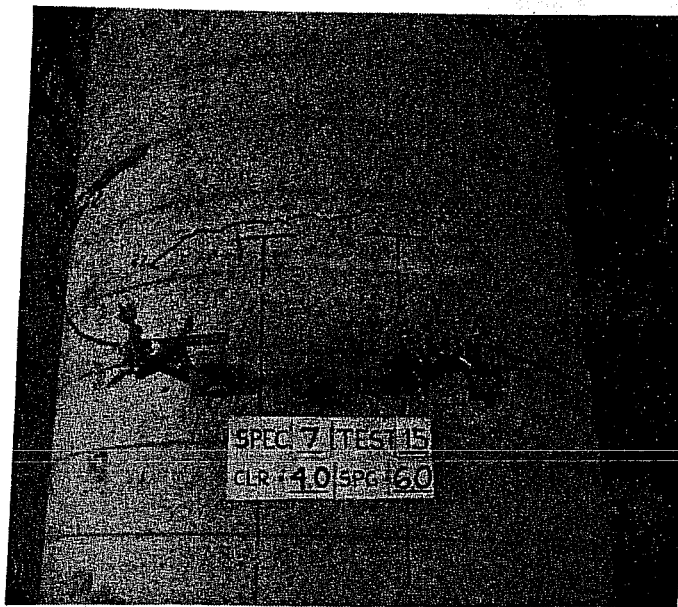
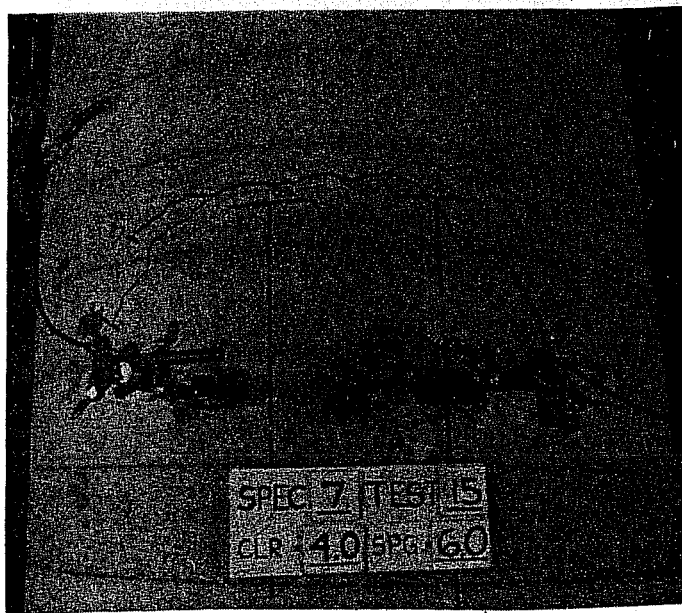
Fig. 4.21 Crack development: test TB5

(a) Initial cracking

(c) Ultimate

(b) Crack propagation

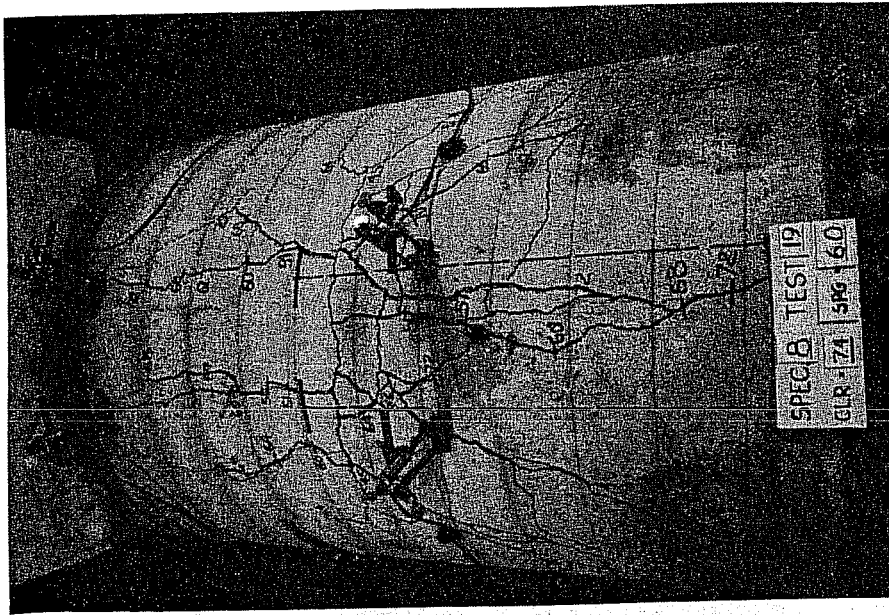
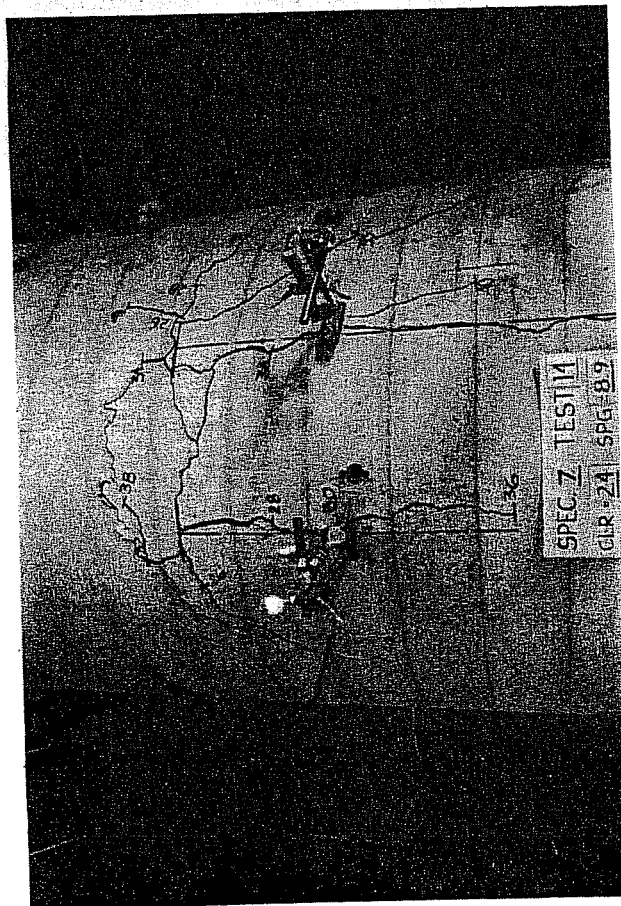
Fig. 4.22 Effect of cover on cracking at ultimate

(a) Small cover, TB4

(b) Large cover, TB9

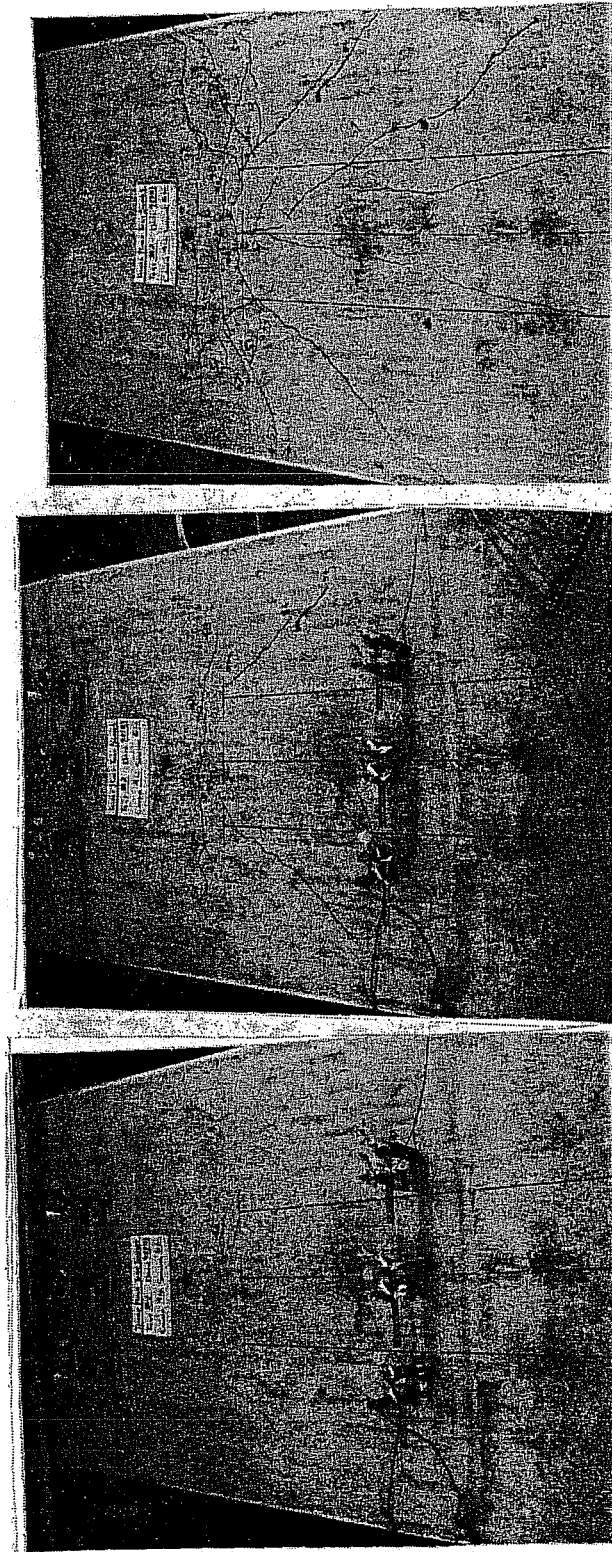
Fig. 4.23 Cracking, 3-bolt group, 3B-2

(a) Initial cracking

(b) Crack development

(c) Cracking at ultimate

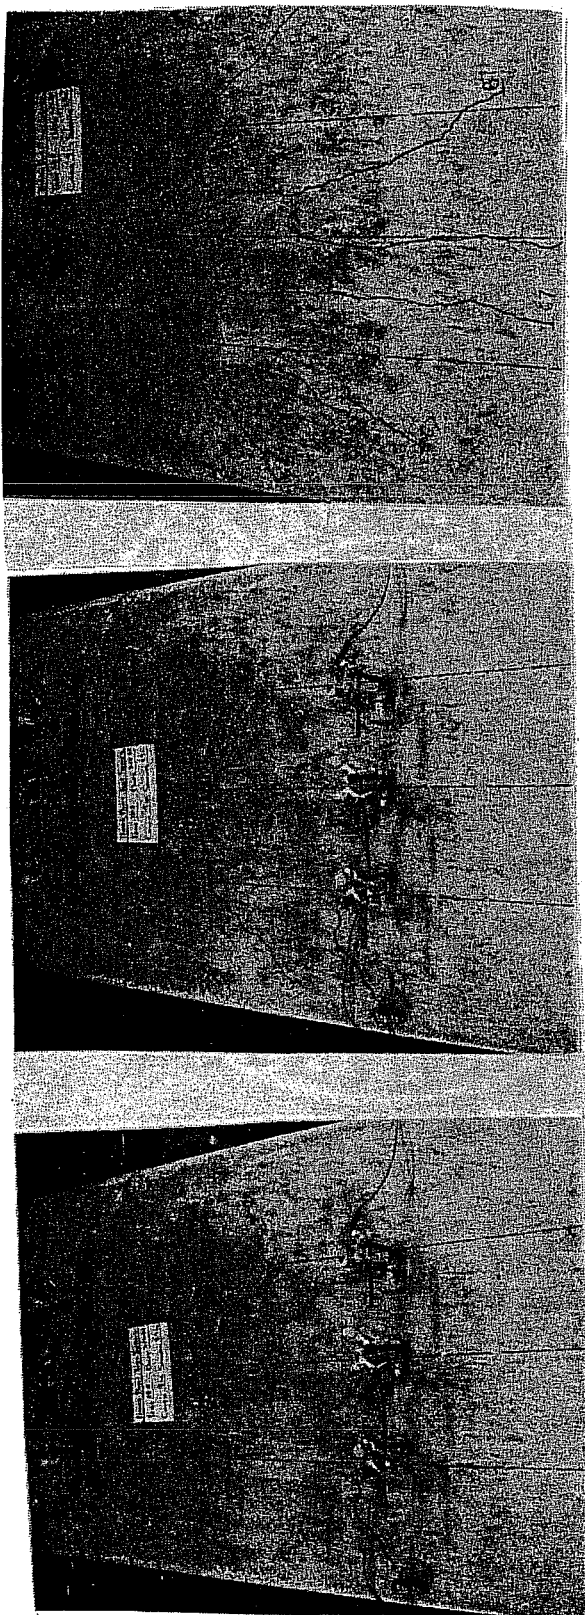
Fig. 4.24 Cracking, 3-bolt group, 3B-3

(a) Initial cracking

(b) Crack development

(c) Cracking at ultimate

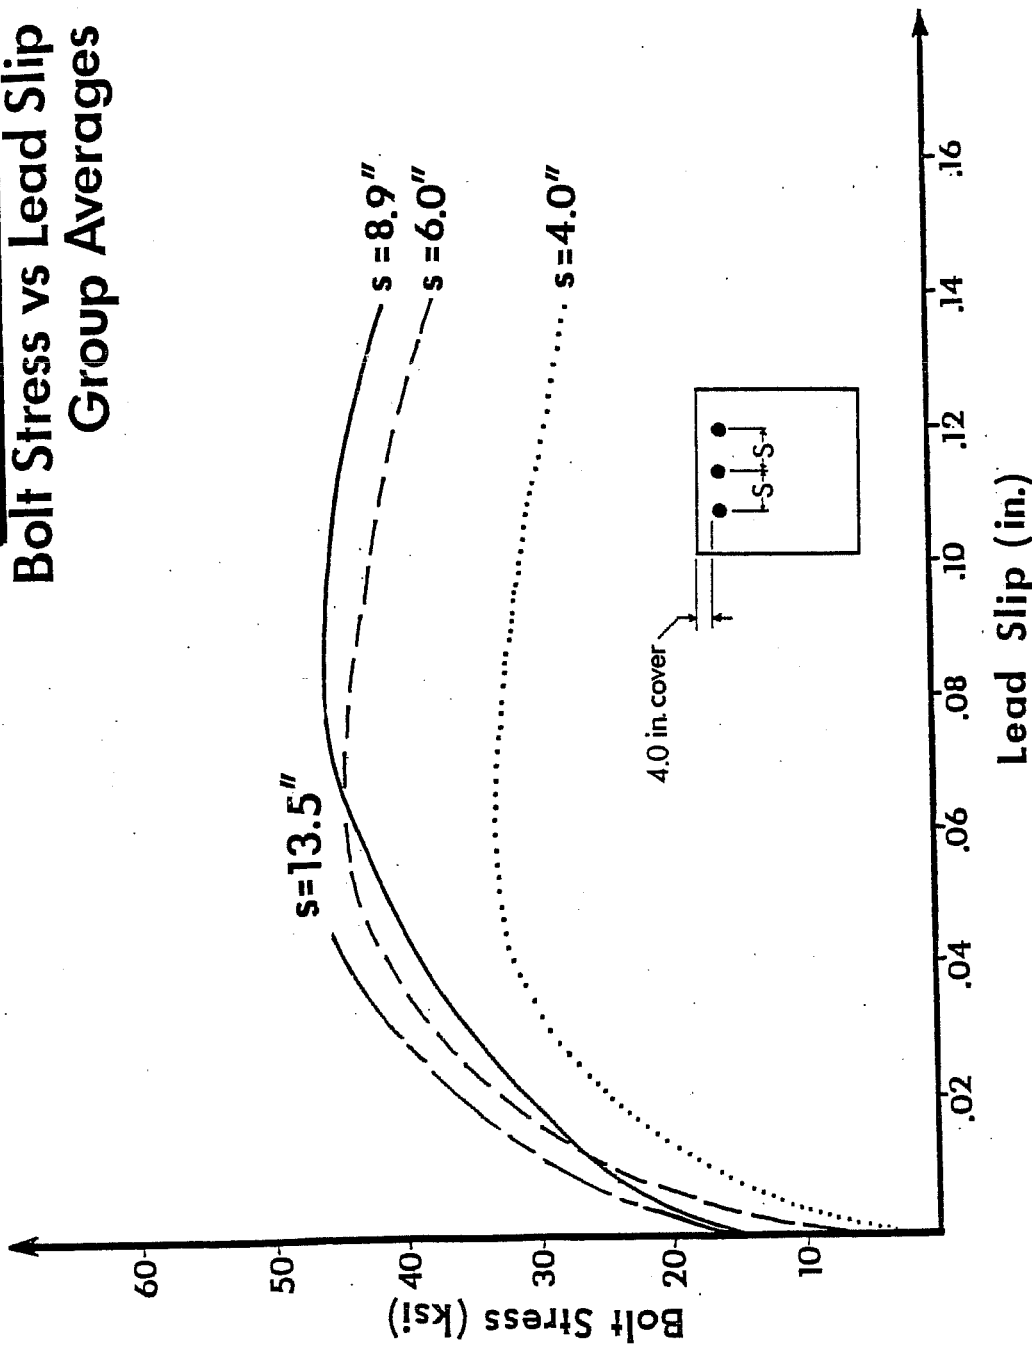
Fig. 5.9 Average stress-slip curves for 3-bolt groups

Three-Bolt Test Series Bolt Stress vs Lead Slip Group Averages

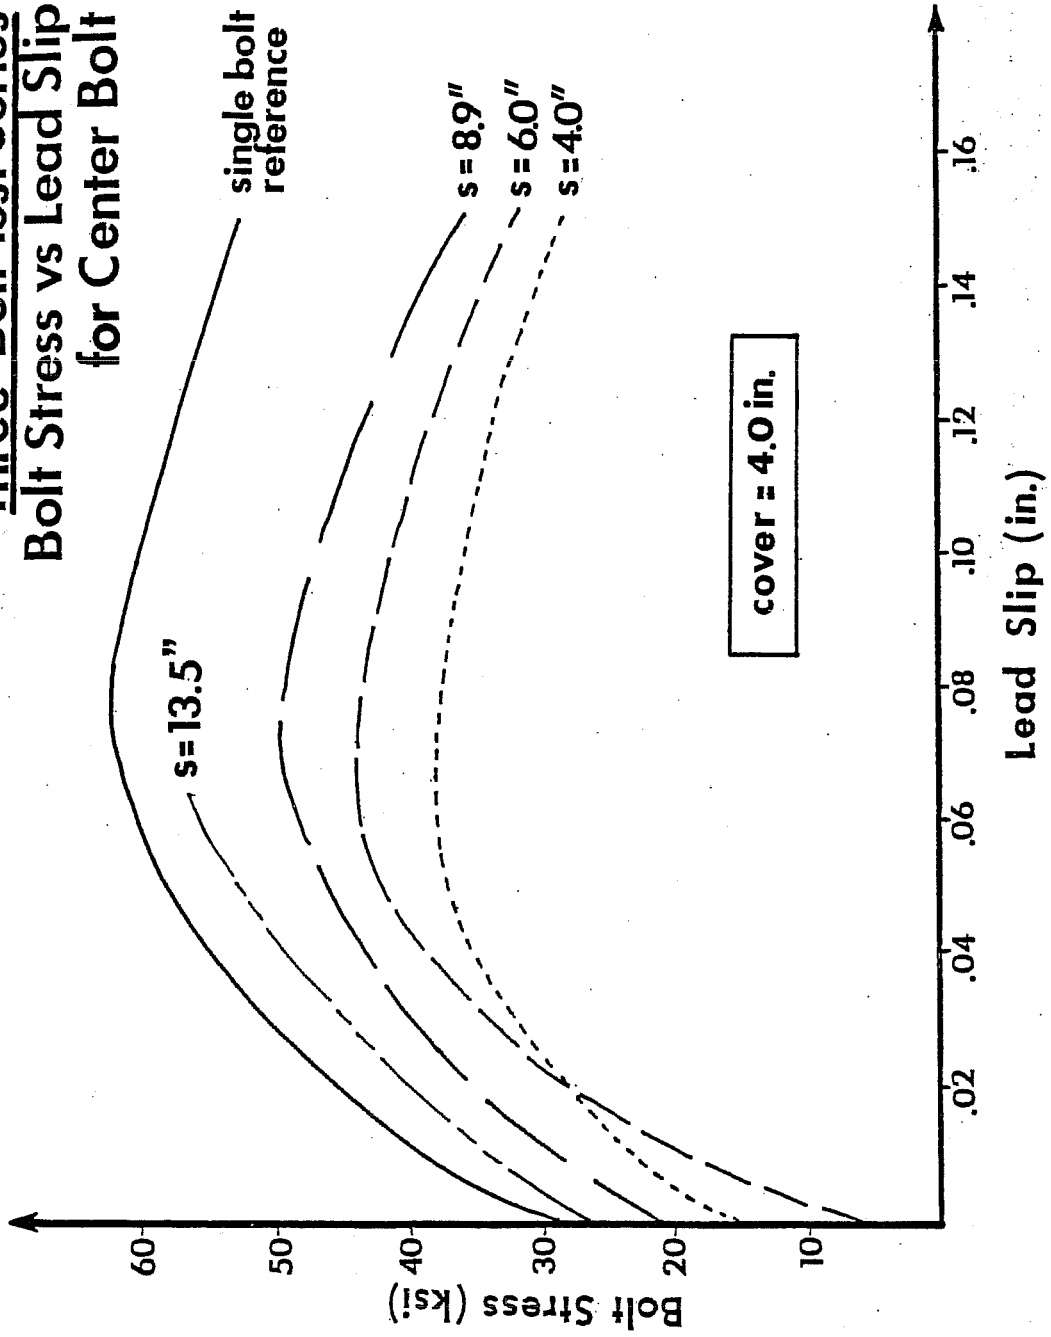
Fig. 5.10 Stress-slip curve for center bolts of 3-bolt groups

Three-Bolt Test Series Bolt Stress vs Lead Slip for Center Bolt

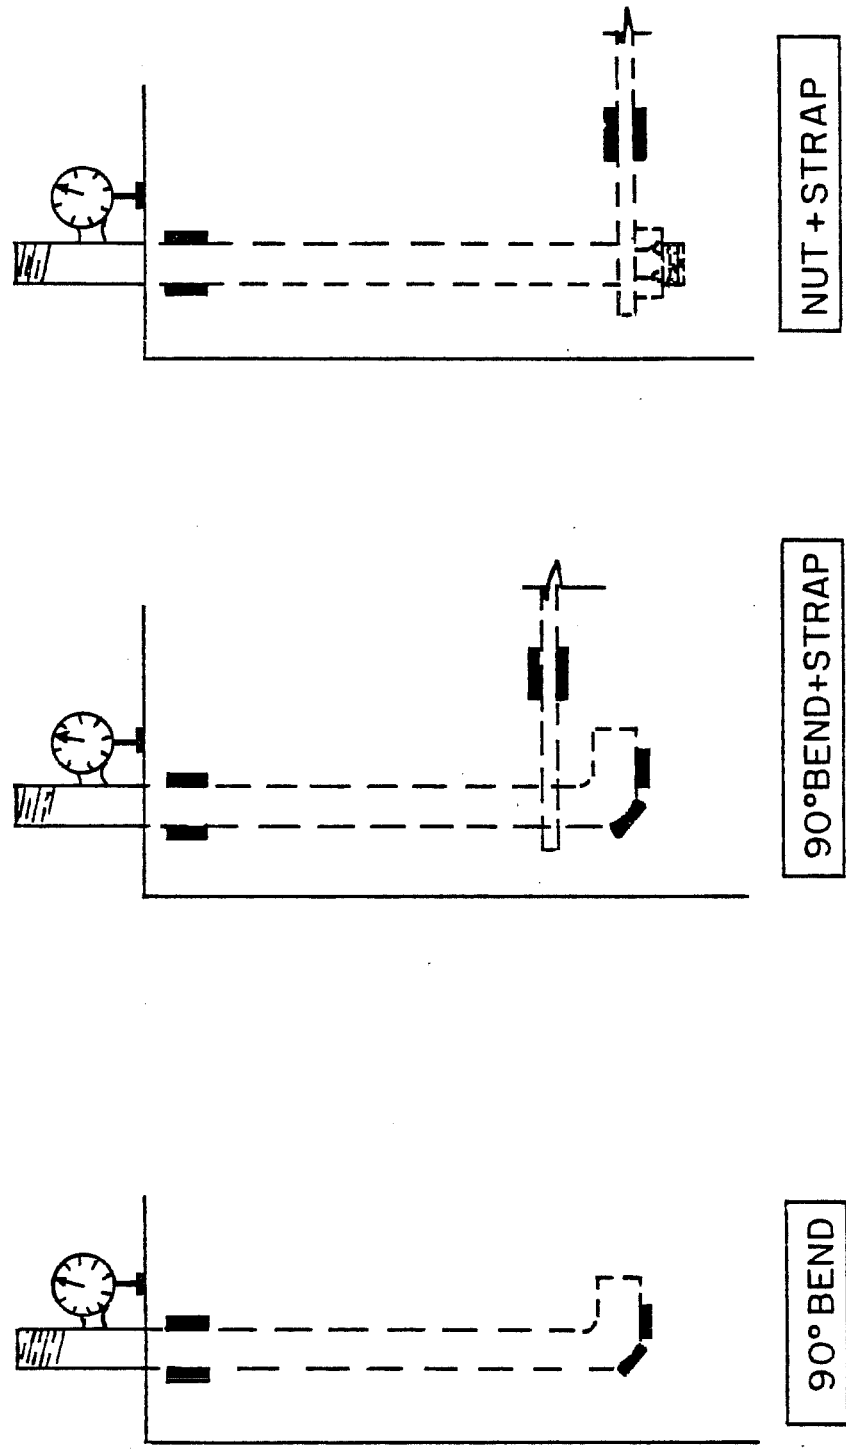
Fig. 7.6 Bolt instrumentation

■ STRAIN GAGE ⊙ DIAL SLIP MEASUREMENT

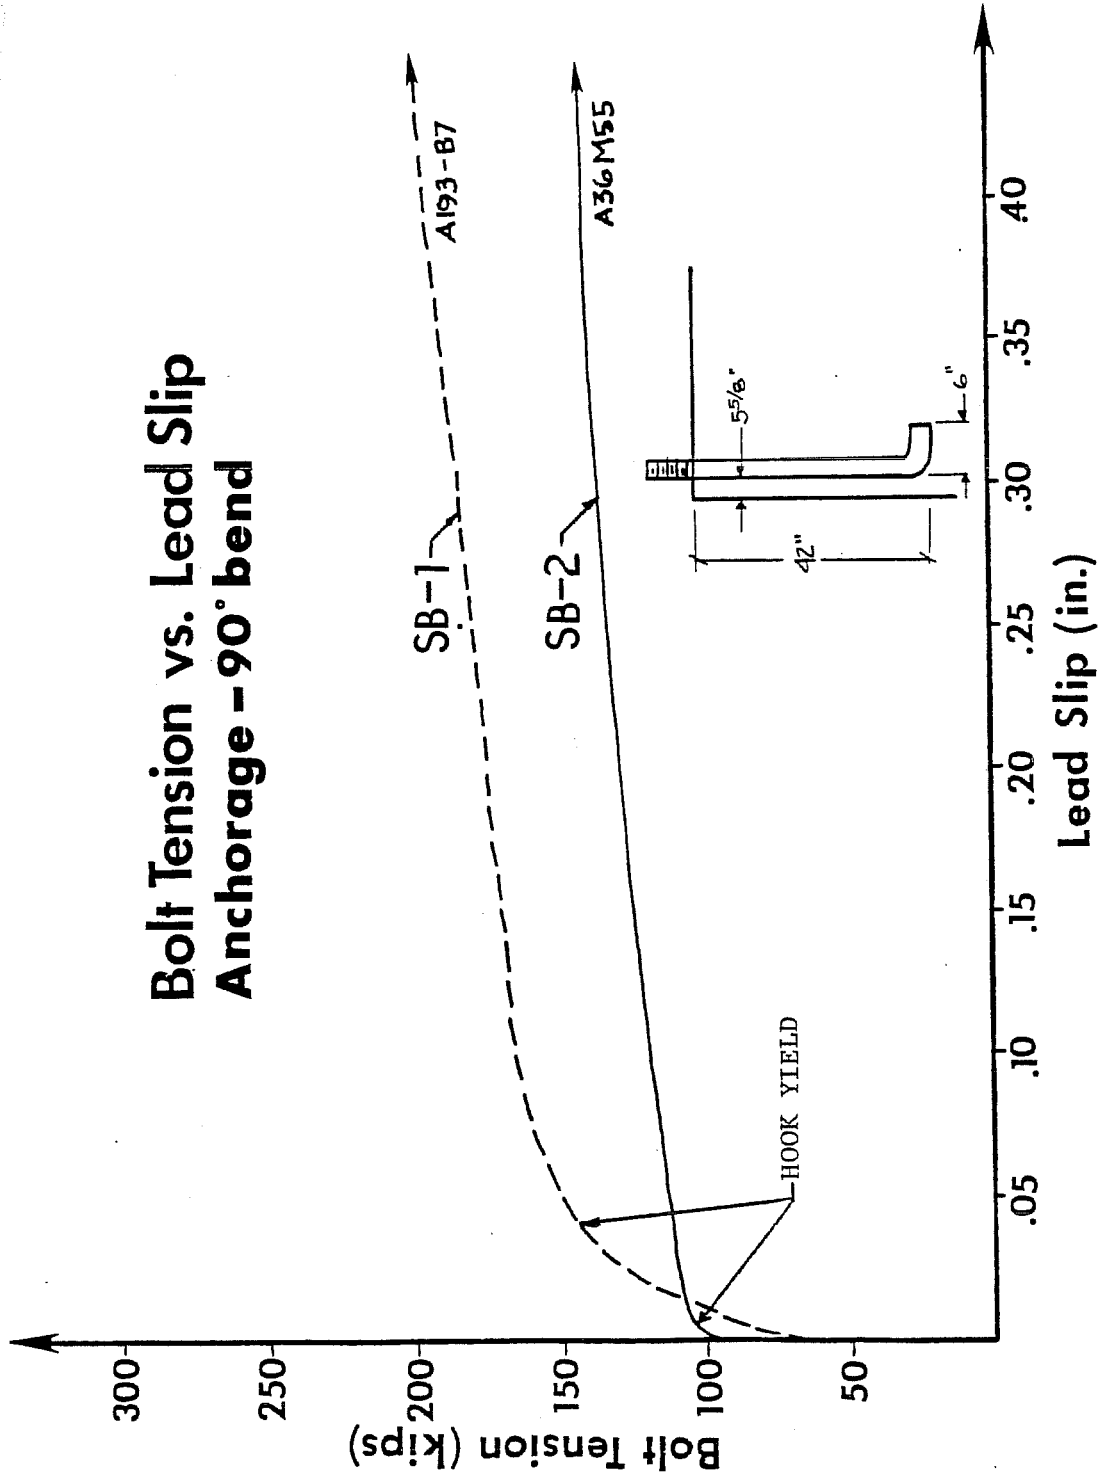
Fig. 7.7 Load-slip curves for tests SB1 and SB2

Bolt Tension vs. Lead Slip Anchorage - 90° bend

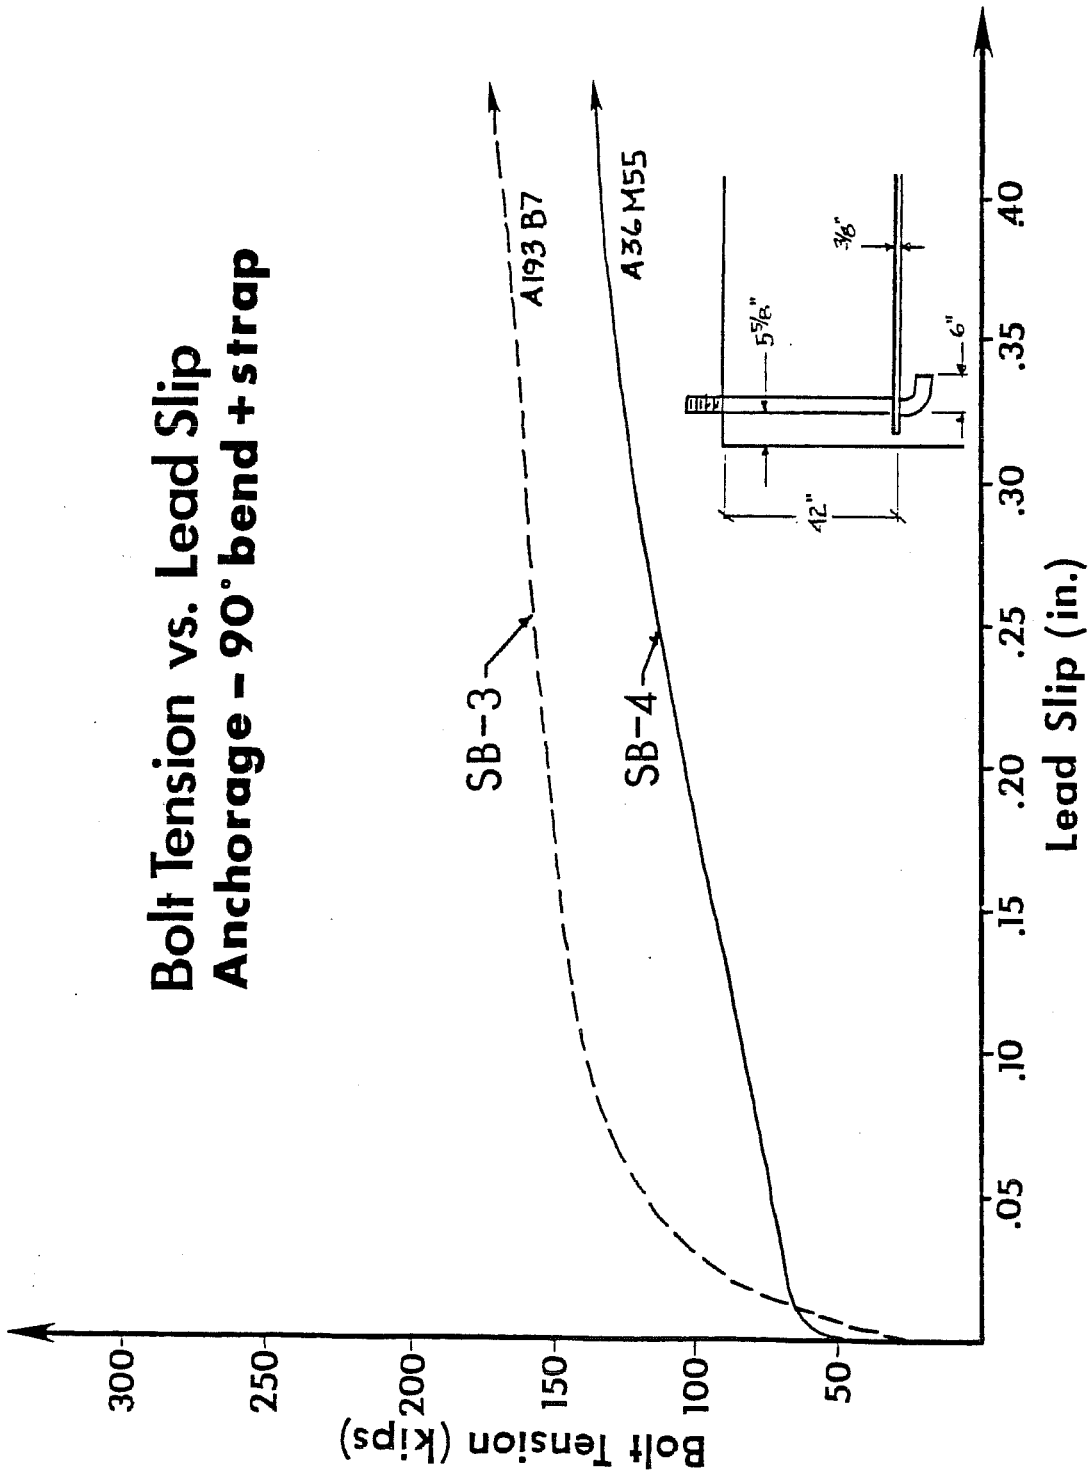
Fig. 7.8 Load-slip curves for tests SB3 and SB4

Bolt Tension vs. Lead Slip Anchorage - 90° bend + strap

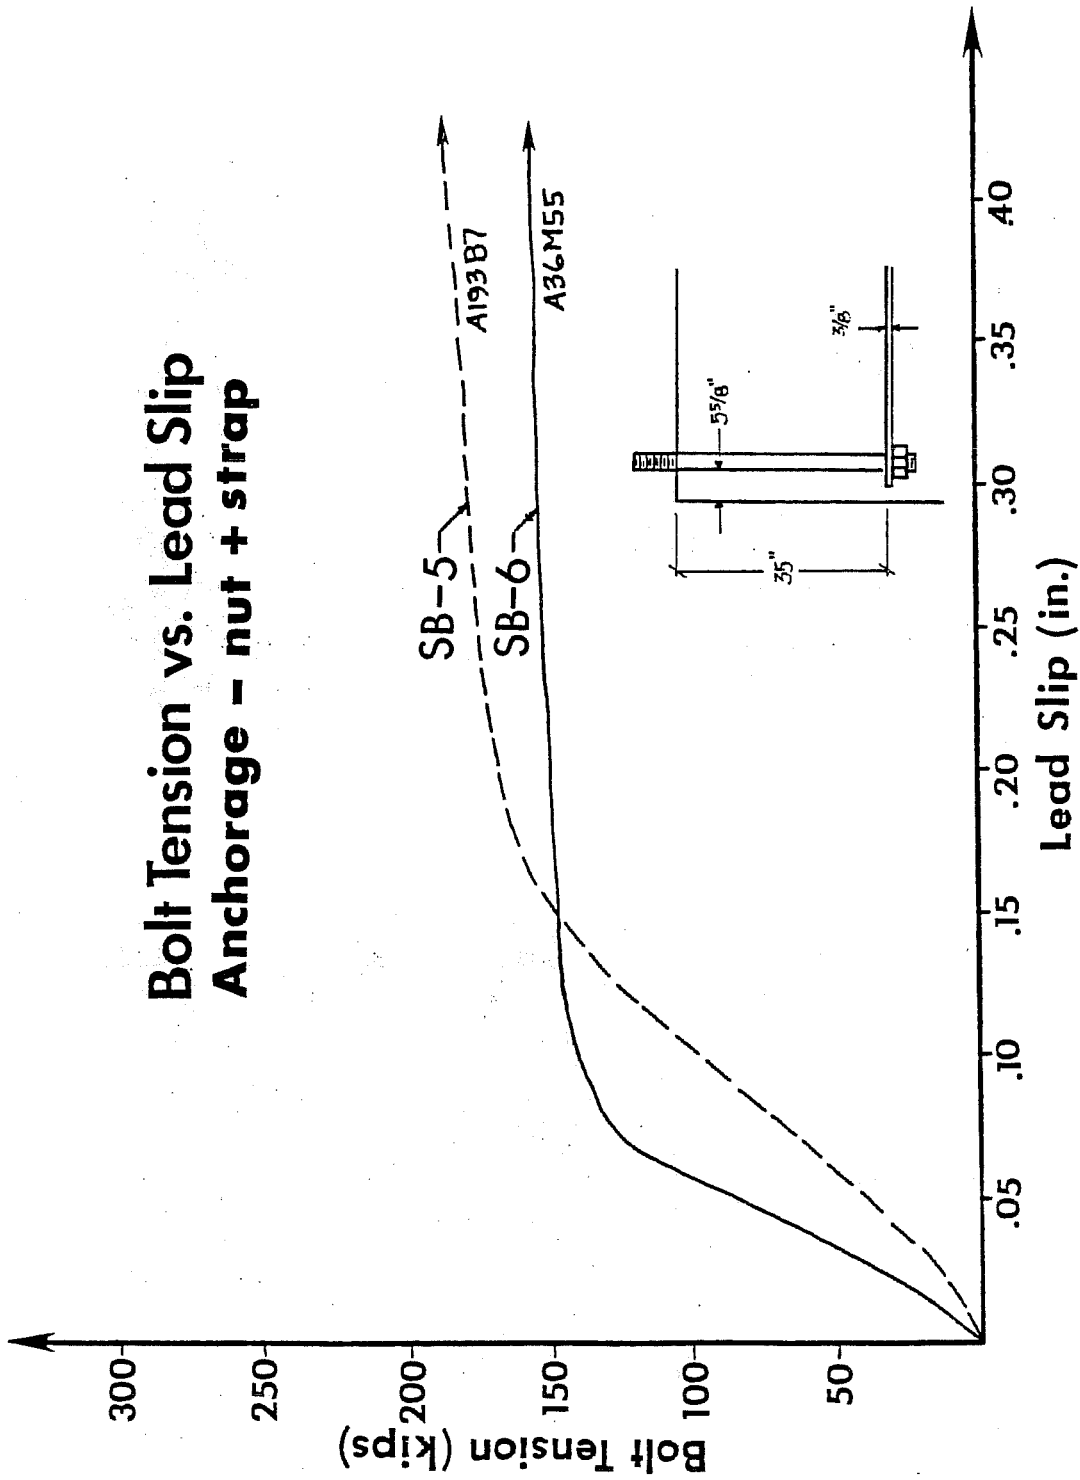
Fig. 7.9 Load-slip curves for tests SB5 and SB6

Bolt Tension vs. Lead Slip Anchorage - nut + strap

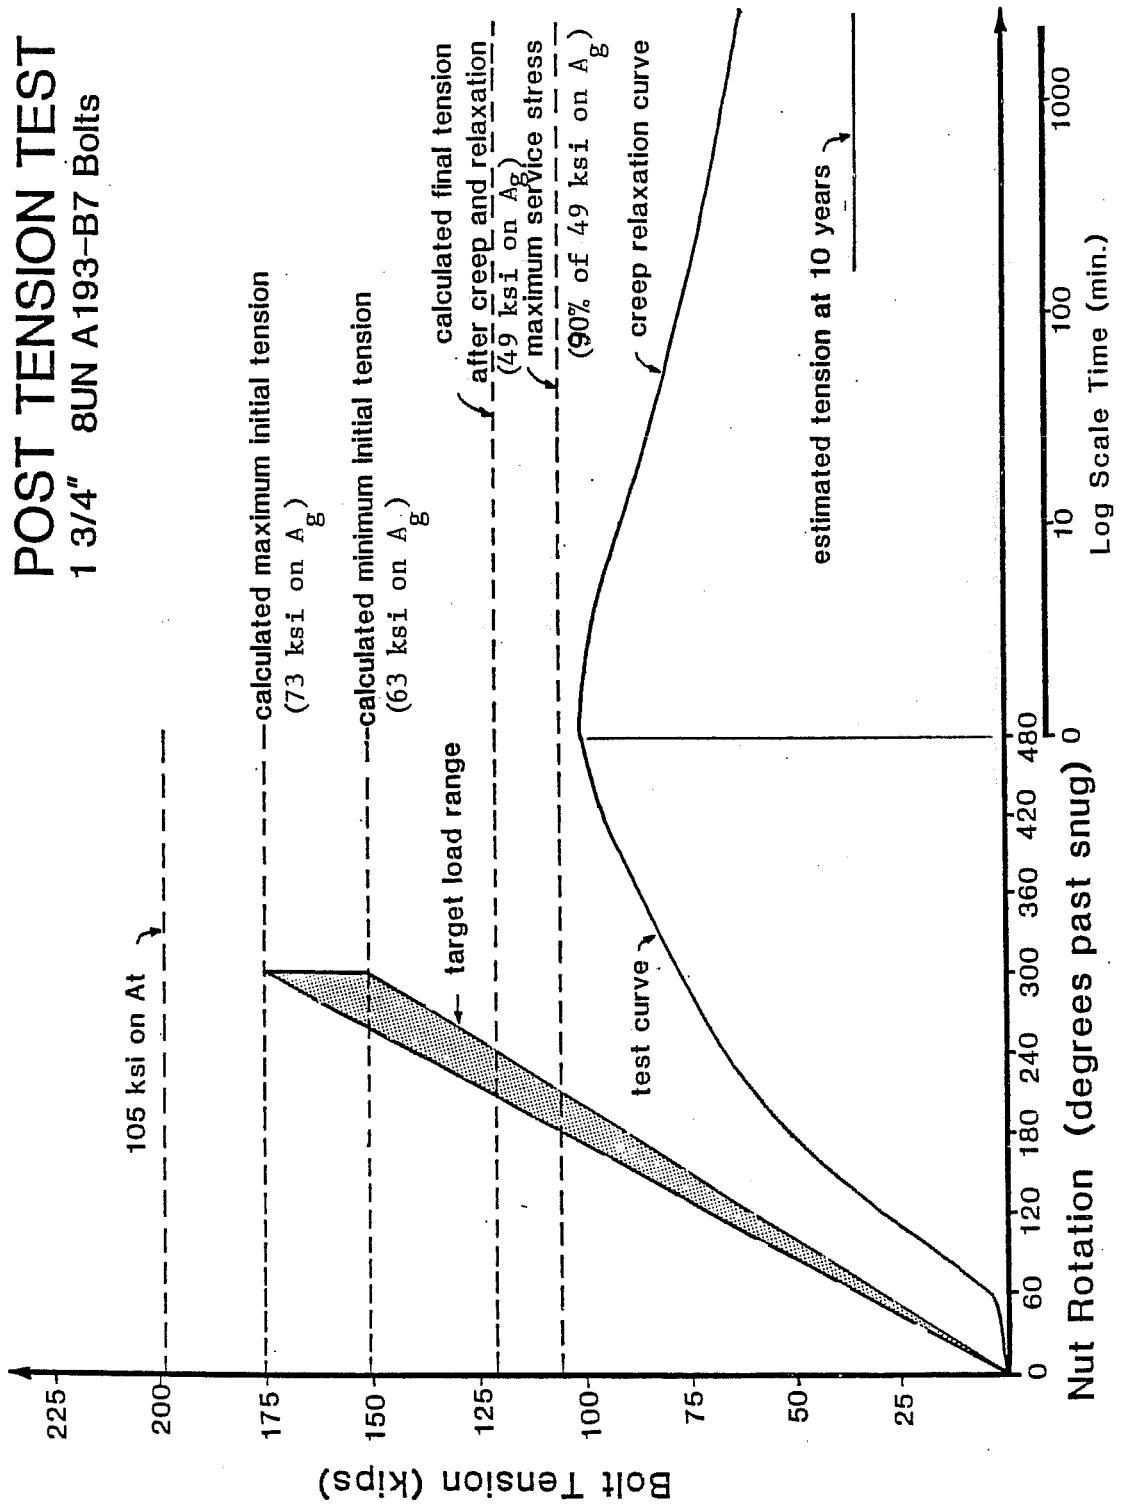
Fig. 7.18 Results of post-tension test

1 3/4" 8UN A193-B7 Bolts

The results of this test are presented in Fig. 7.18. A target load range based on 17.2 sq. in. bearing area and 300 degrees of rotation is shown as 68 ± 5 ksi on the gross area of the bolts. The calculated values in this figure are values currently used in the SDHPT Specification. The test curve represents the tension induced in the bolt as a function of nut rotation. Tension in the bolt group was maintained for 23 hours during which time the strain gages were read at 1-, 7-, 10-, and 1380-minute stages. The resulting bolt tension versus time relationship is shown as an extension of the test curve.

It is evident that the induced bolt stress did not reach the target load range. This has been attributed to possible compression of the washer, initial tightening of the nut, slip of the anchorage device, or a combination of the above.
