POST-TENSIONED BRIDGES DESIGN FOR

**LOADING SADDLE BEHAVIOR AND DESIGN FOR EXTERNALLY  
POST-TENSIONED BRIDGES**

**R.J. Beaupre, L.C. Powell, J.E. Breen and M.E. Kreger**

**Research Report No. 365-2**

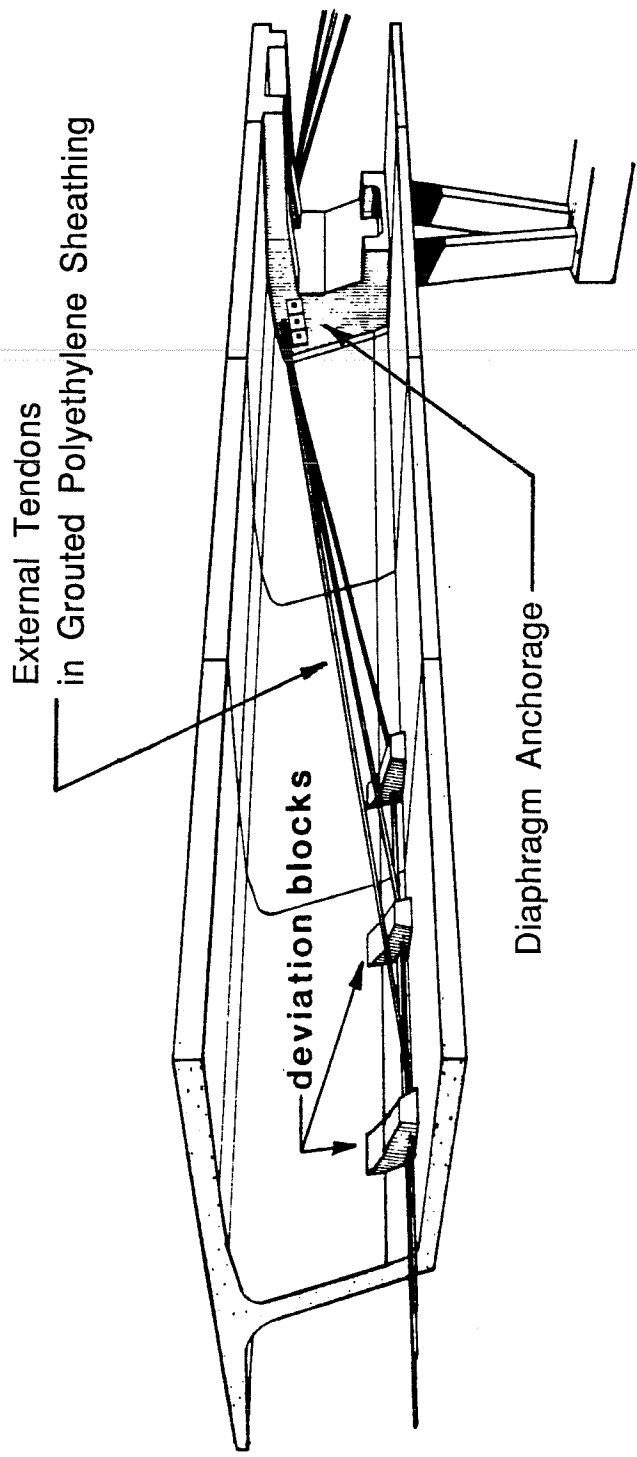
Figure 1.1 External Post-Tensioning in Long Key Bridge (From Ref. 1)

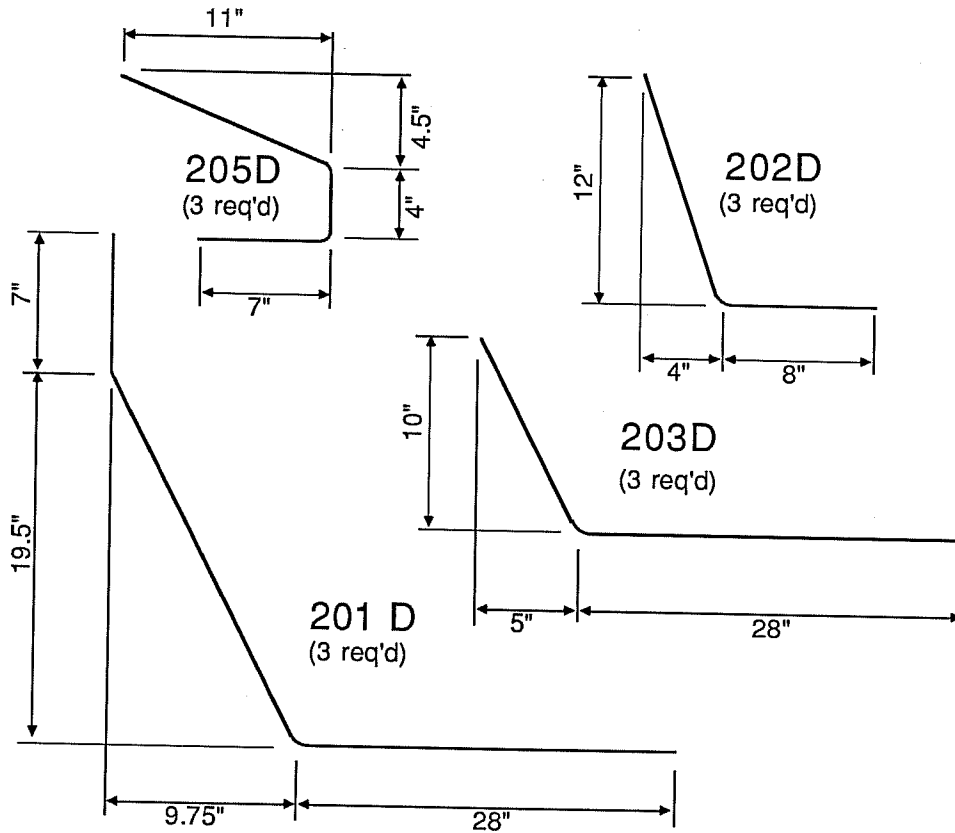
NOTE: Diameter of bends = 1" unless otherwise noted.

Figure 2.4c Deviator Reinforcement Bending Diagram  
Specimens 1A, 1B, 2A, 2B, 3A, 3B (From Ref. 1)

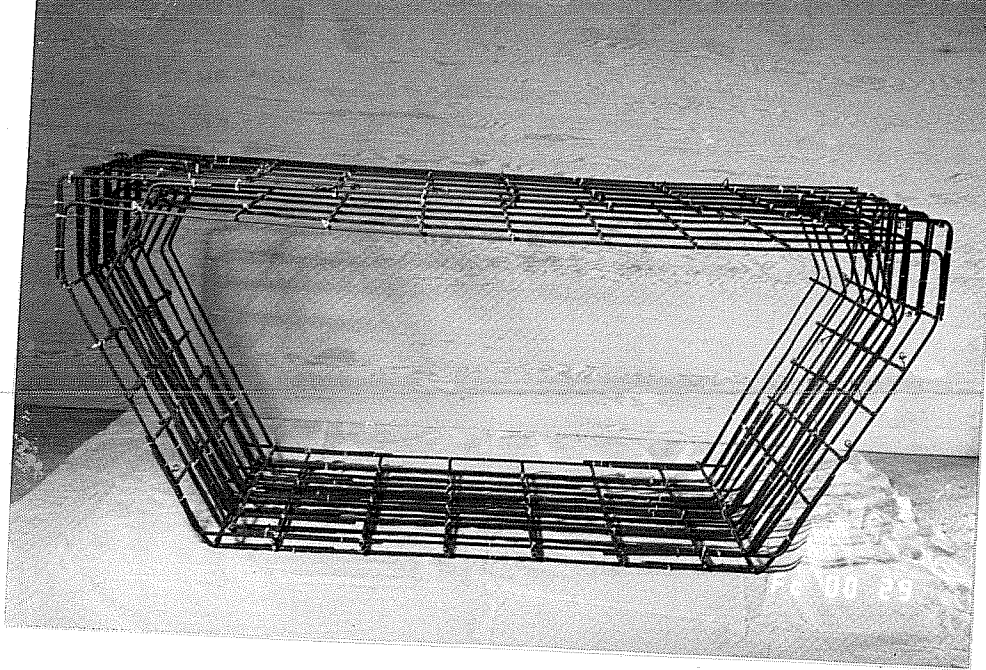
**Figure 2.11** Box Reinforcement Cage

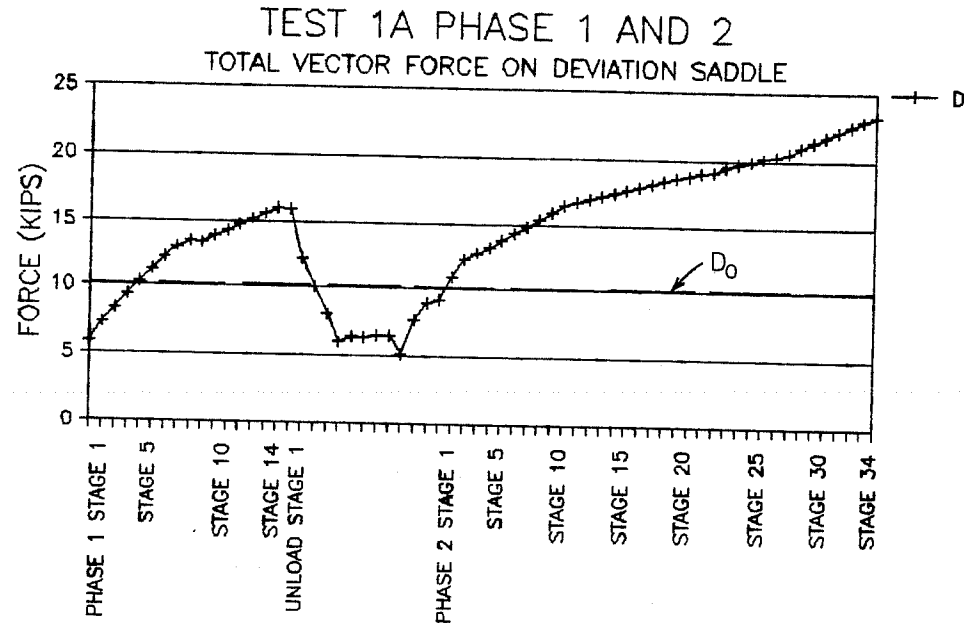
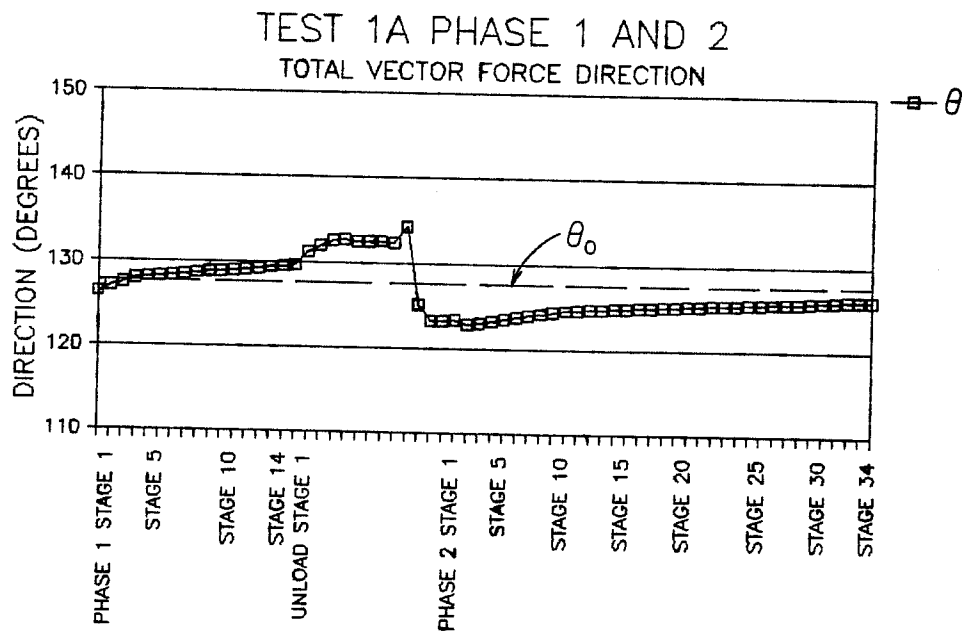
Figure 3.2 Test 1A Loading History

The total vector force and direction are shown in Fig 3.2. The crack patterns are shown in Fig. 3.3. The first crack was on the saddle north face probably a splitting crack influenced by the large horizontal compression forces from tendons 1 and 2. A failure mechanism formed whereby the top of the deviation saddle (from the tendon ducts up) moved towards the web. Estimated maximum crack width before failure was 1/8 in. at the intersection of the web wall and the top surface of the deviation saddle.

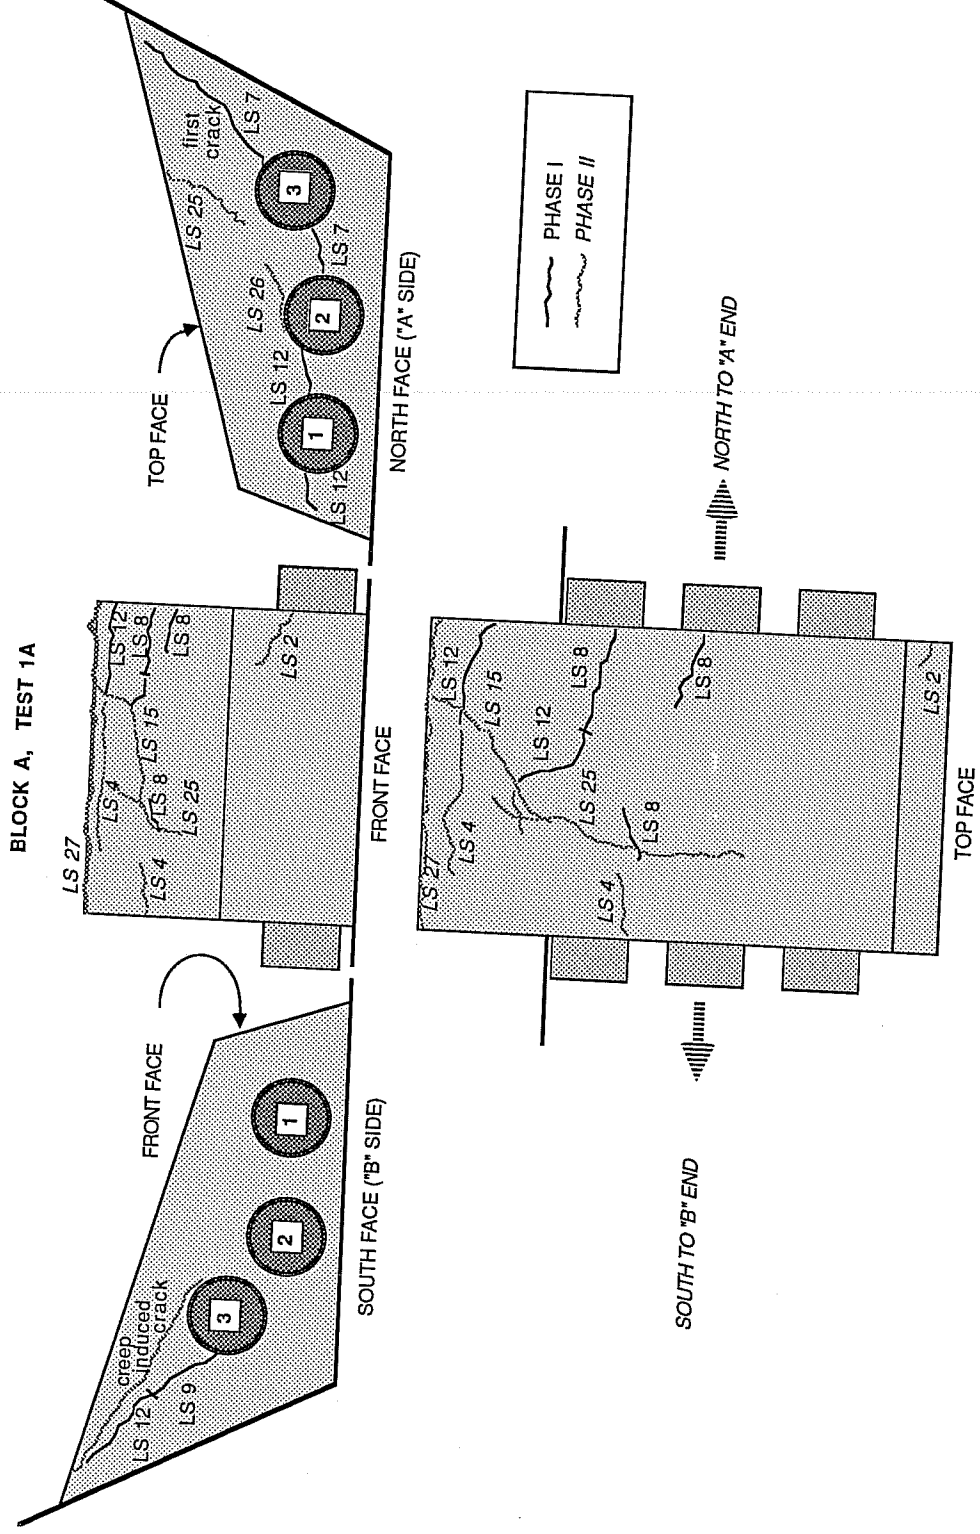
Figure 3.3 Test 1A Crack Patterns

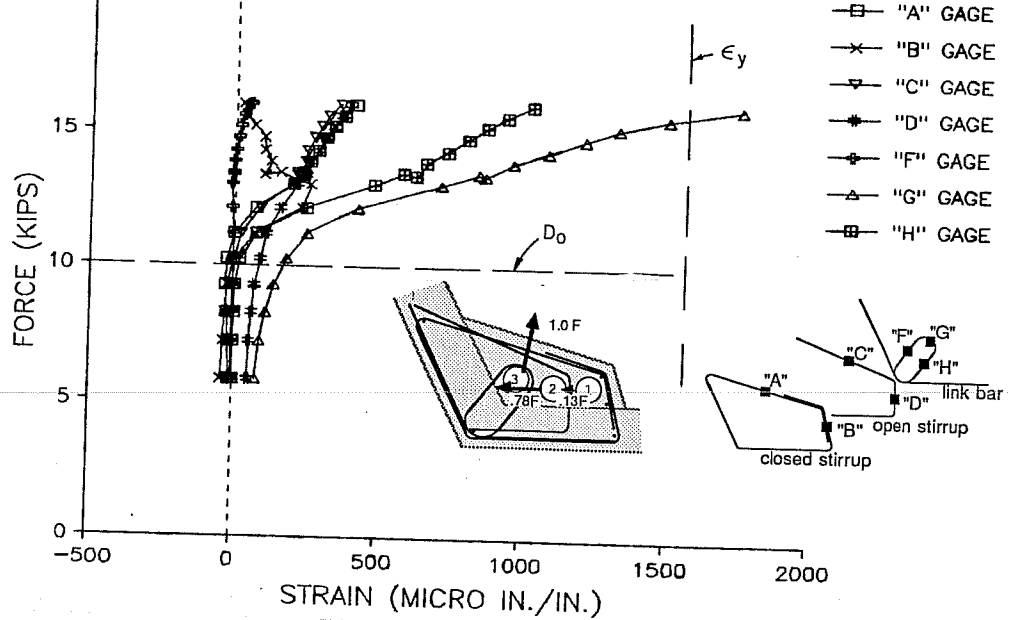
Figure 3.4 Test 1A Reinforcement Strain Data - Phase 1

The observations from the strain data shown in Fig. 3.4 for phase 1 in which loading was discontinued before final failure are as follows:

- 1) The link bars had the highest strain at the "G" and "H" gage, while, the "F" gage had almost zero strain in comparison. The "G" gage location yielded after the last load stage.
- 2) The strain increased until the end of phase 1 in the "A" and "C" gages which were located on the top surface reinforcement. The strain in the "A" gage was slightly greater than that in the "C" gage.

- then it started to decrease. Load stage 7 corresponded to the first visible crack.
- 4) The strain in the vertical leg of the open stirrup ("D" gage) was increasing to the end of phase 1.

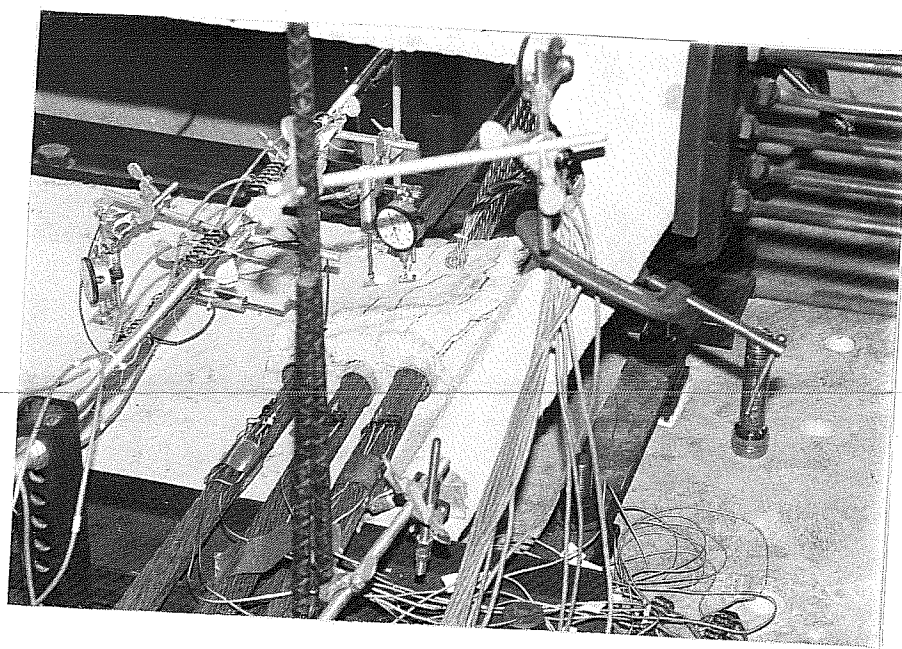
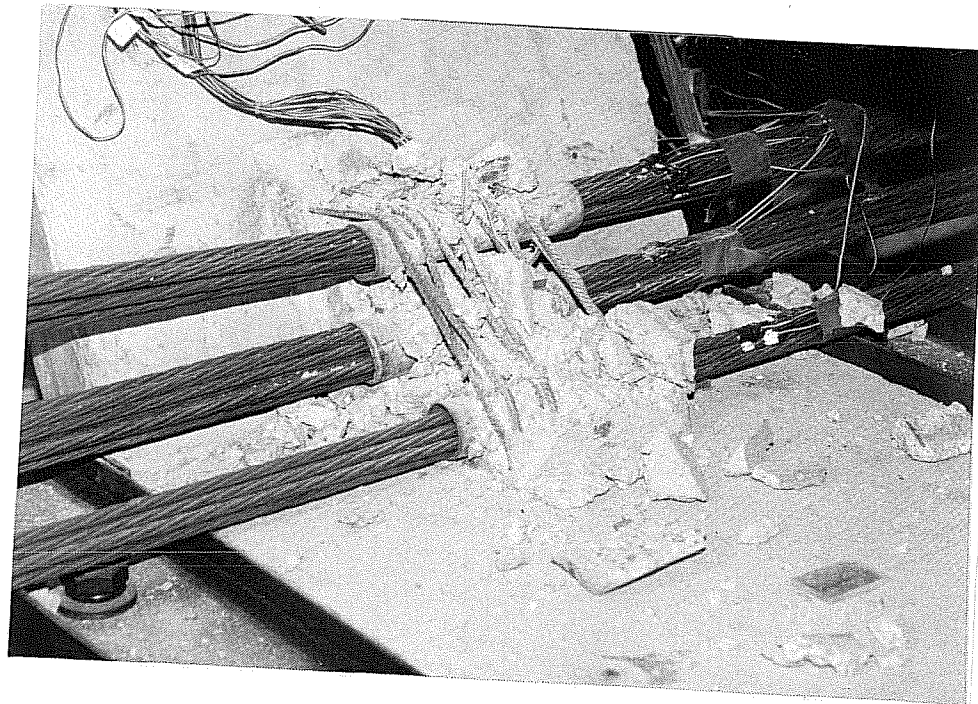
Figure 3.8 Test 1A - Before and After Failure

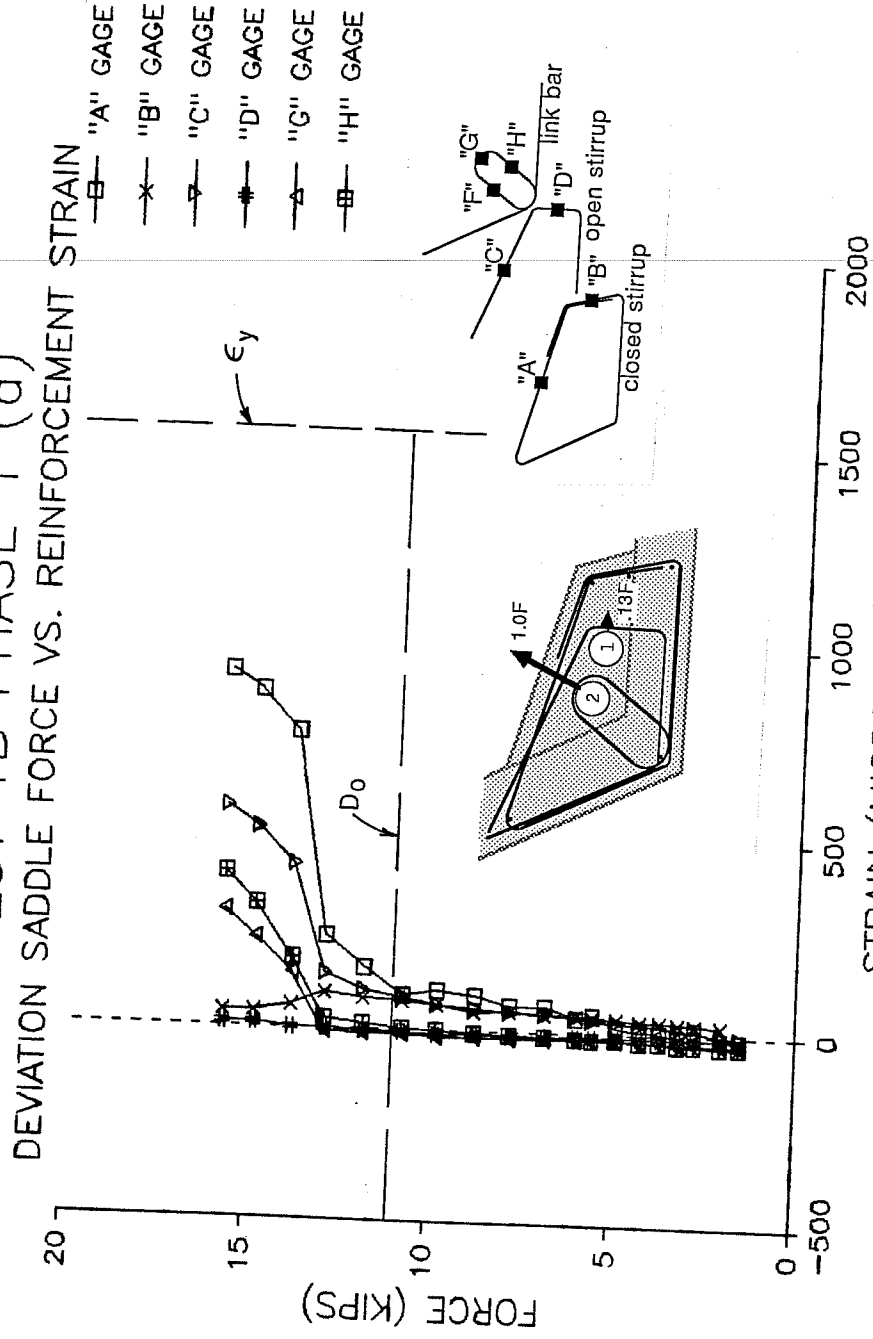
Figure 3.12 Test 1B Reinforcement Strain Data - Phase 1 (a)

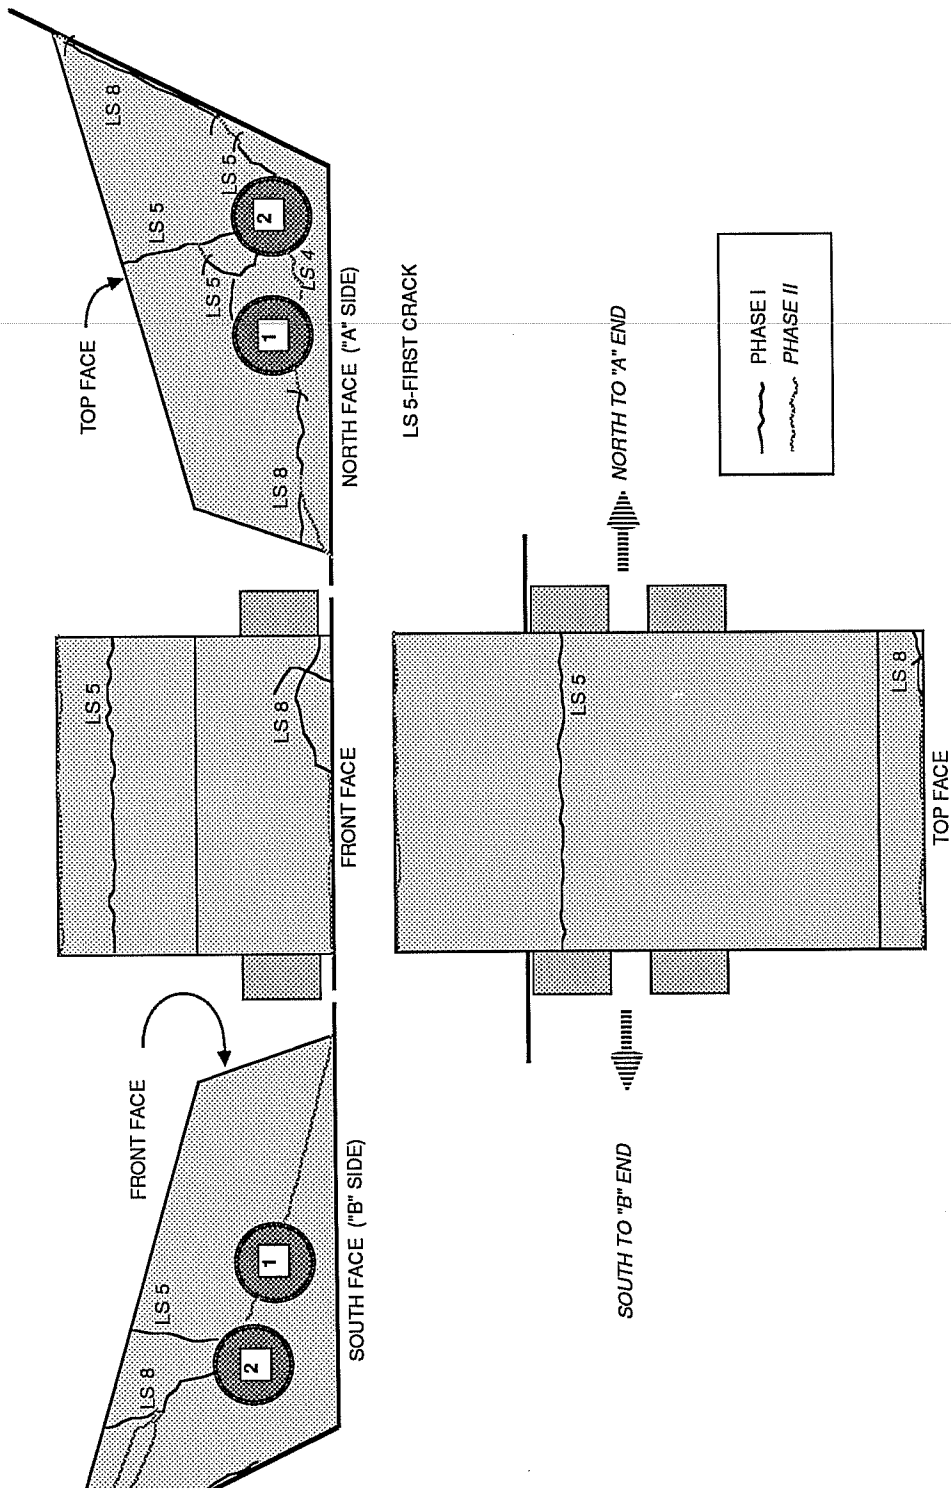
Figure 3.19 Test 2A Crack Patterns

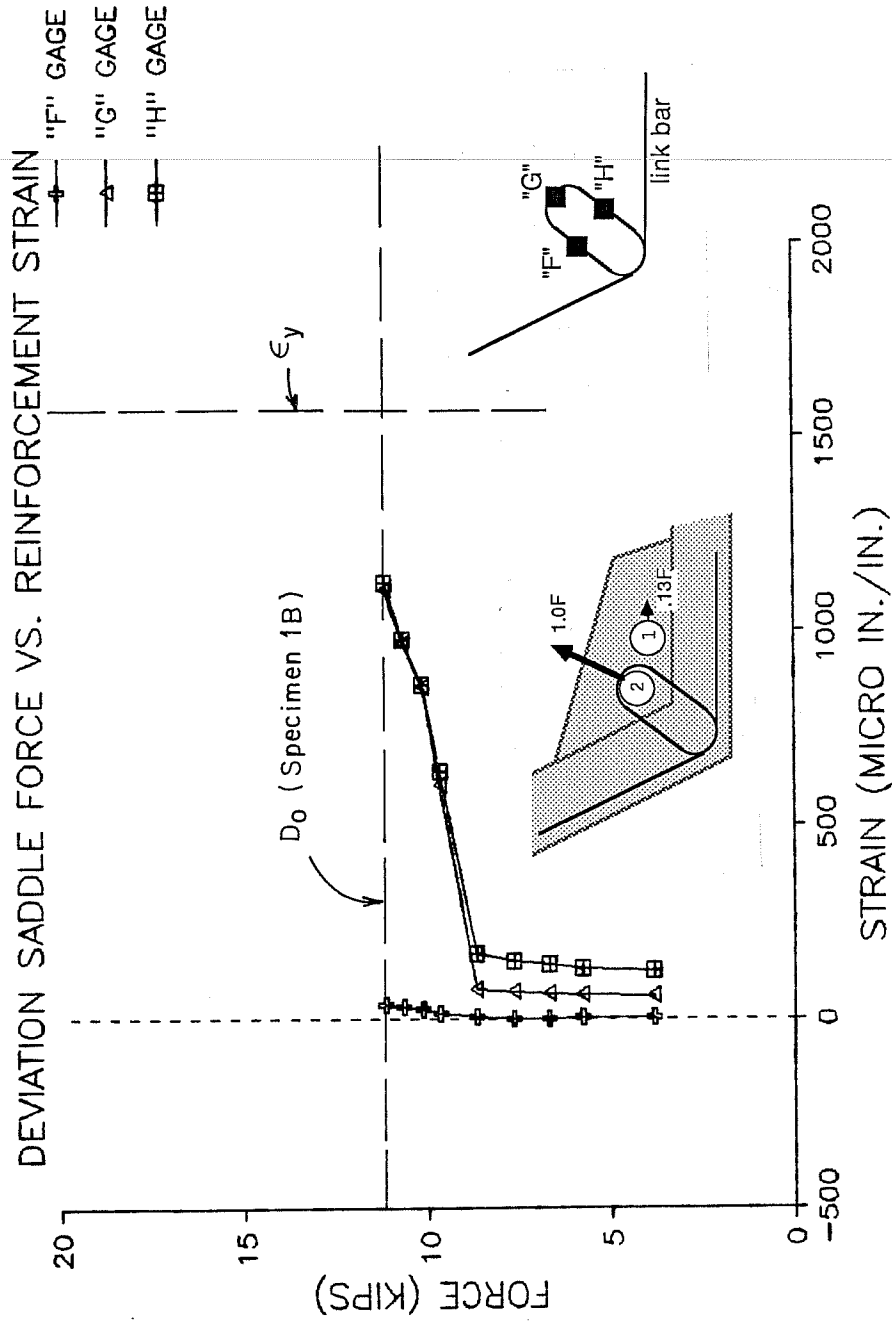
Figure 3.20 Test 2A Reinforcement Strain Data - Phase 1

- 1) The strain jumped dramatically at load stage 5 in the bottom leg (“H” gage) and the top (“G” gage) of the link bar. The first crack appeared at load stage 5.
- 2) The top leg (“F”) of the link bar had almost zero strain.

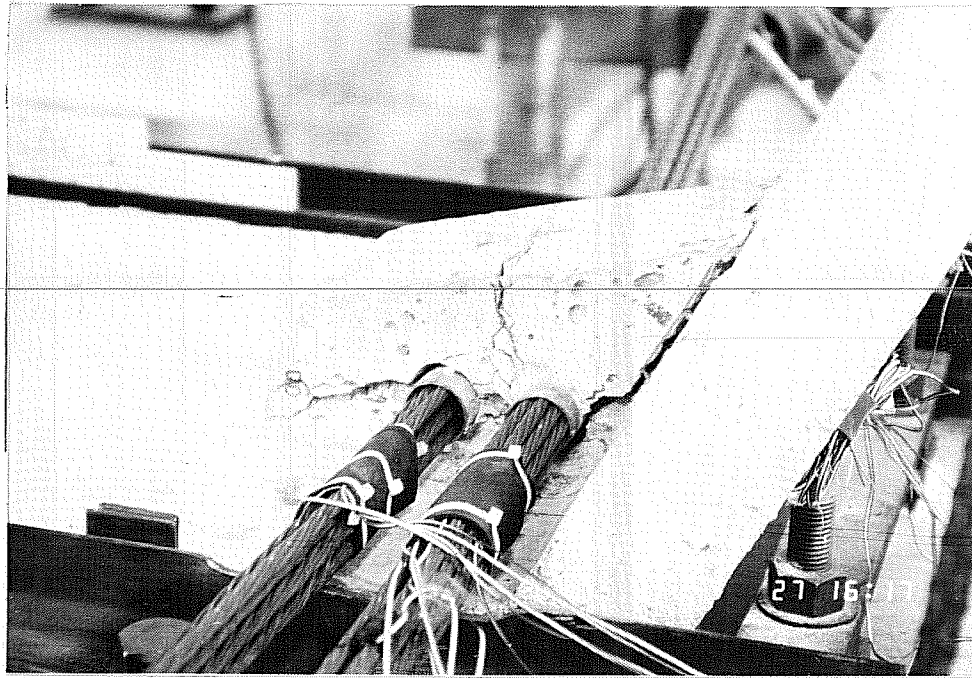
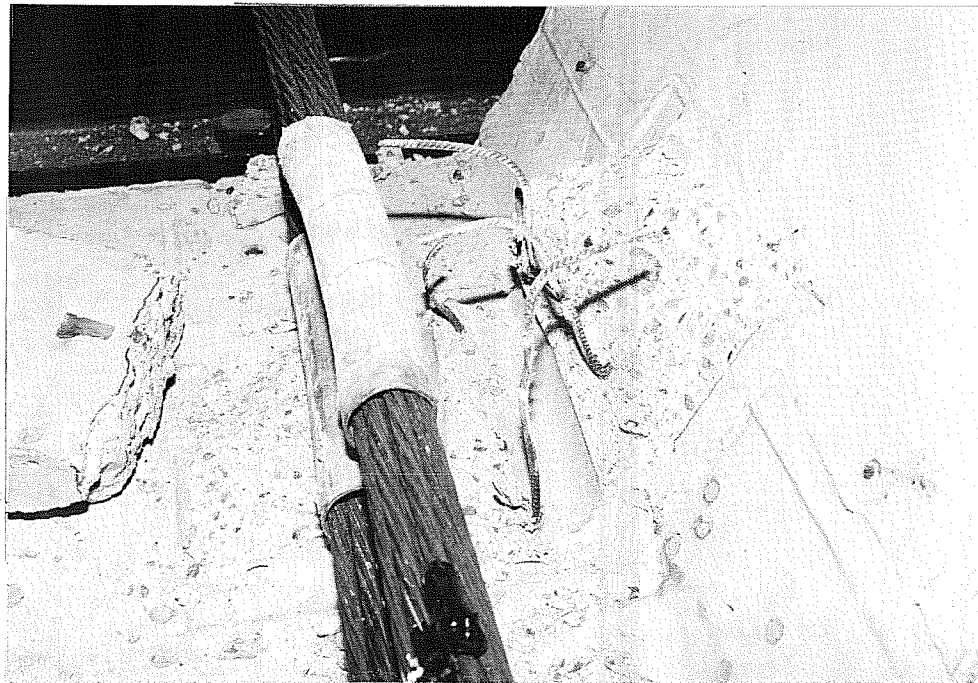
Figure 3.24 Test 2A - Before and After Failure

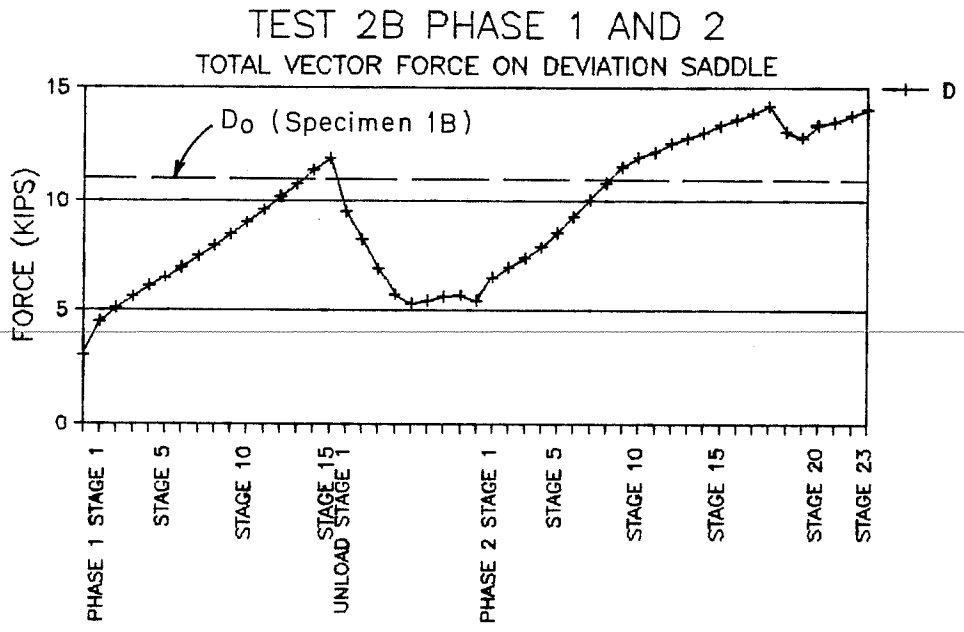
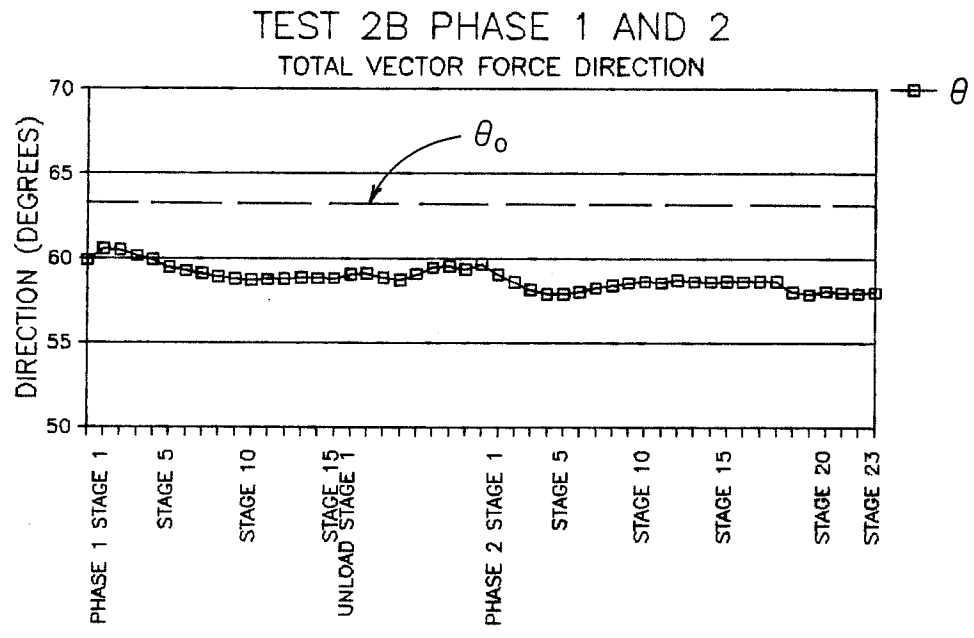
Figure 3.25 Test 2B Loading History

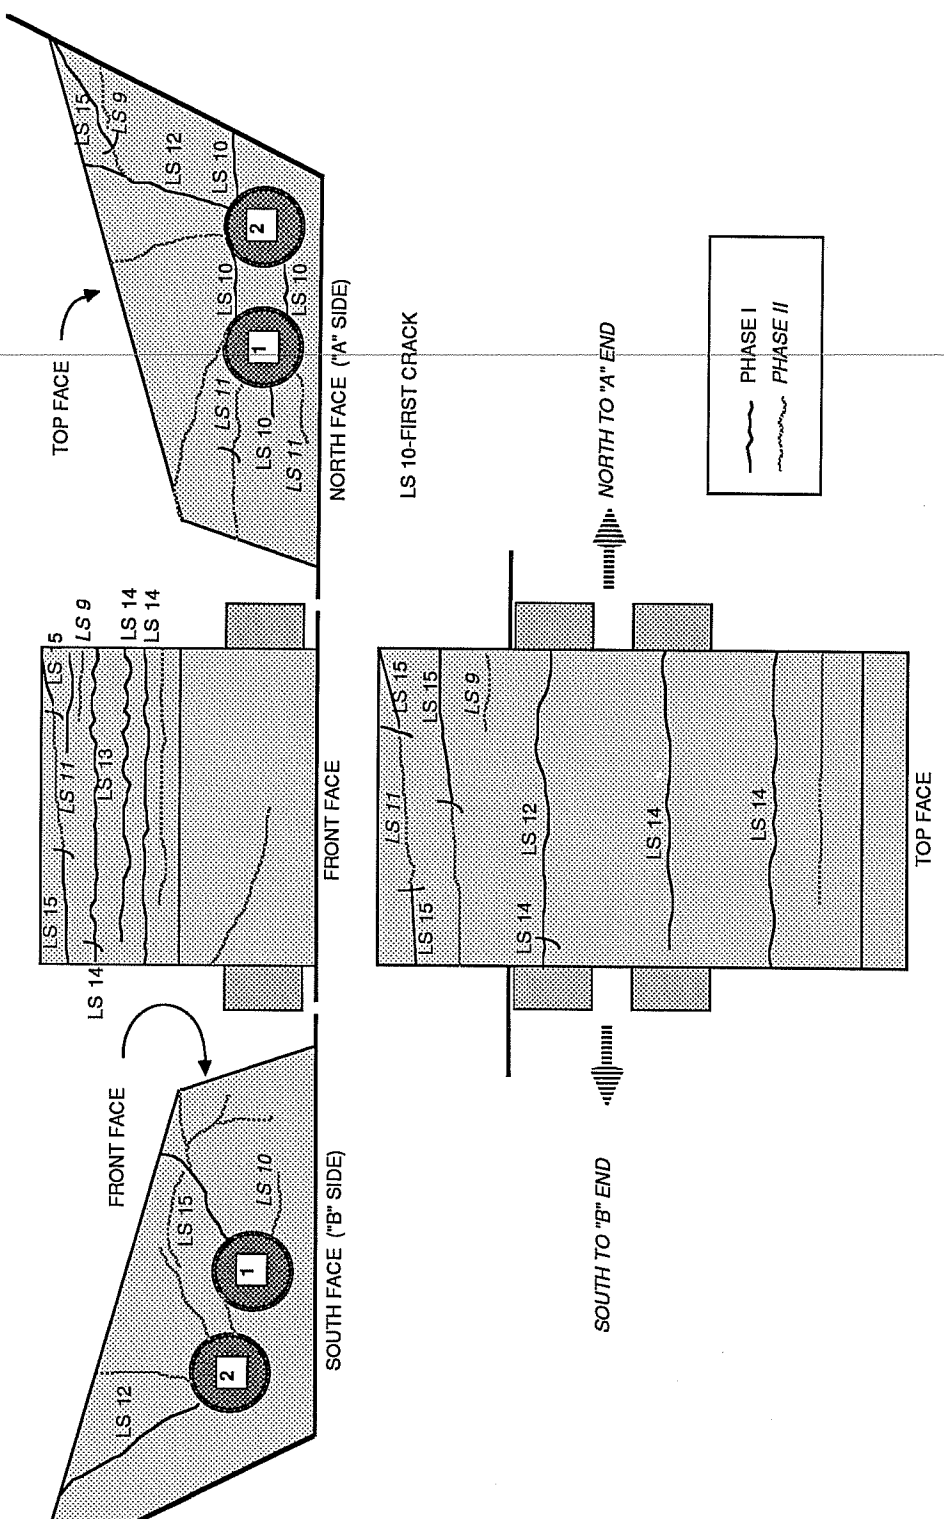
Figure 3.26 Test 2B Crack Patterns

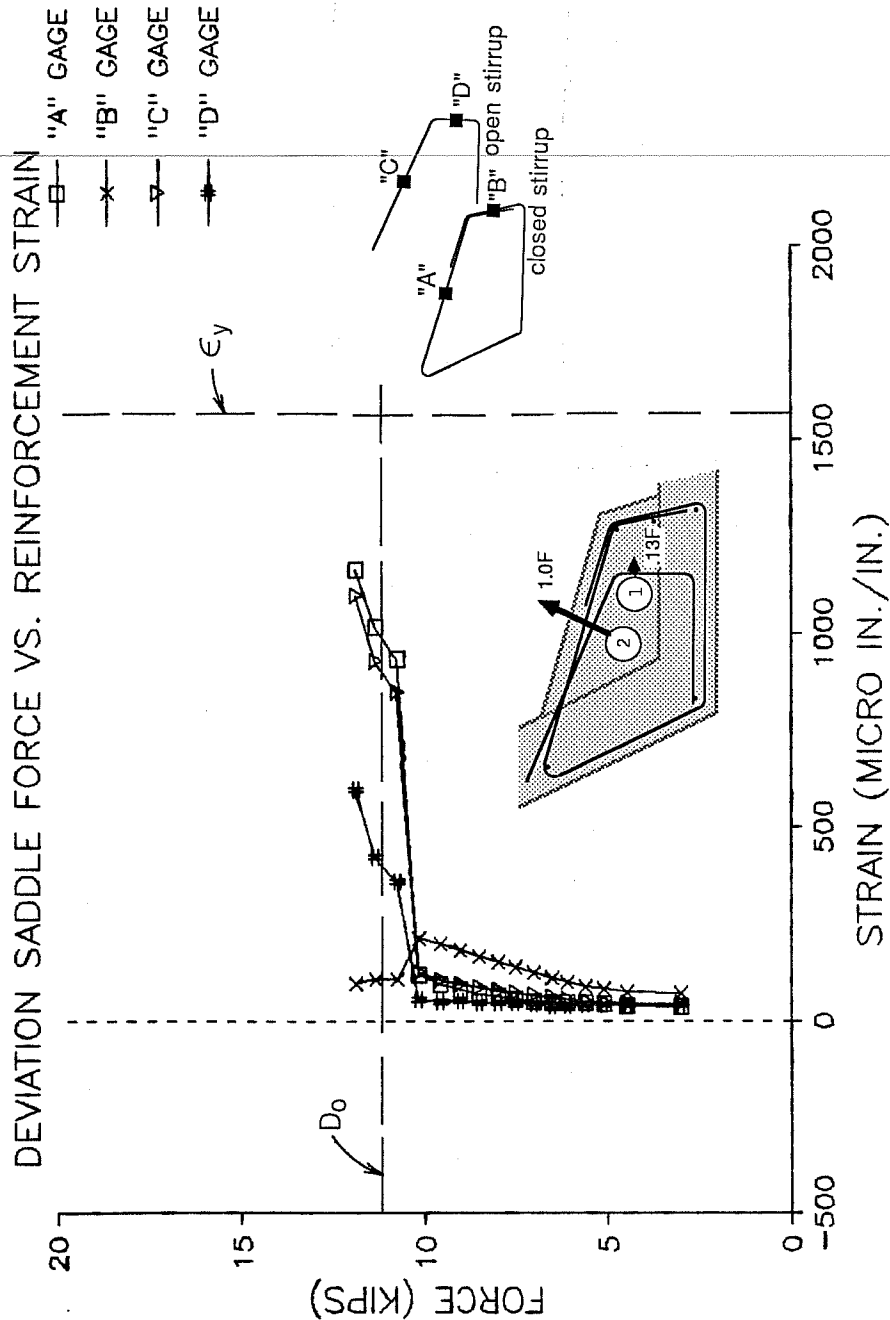
Figure 3.27 Test 2B Reinforcement Strain Data - Phase 1

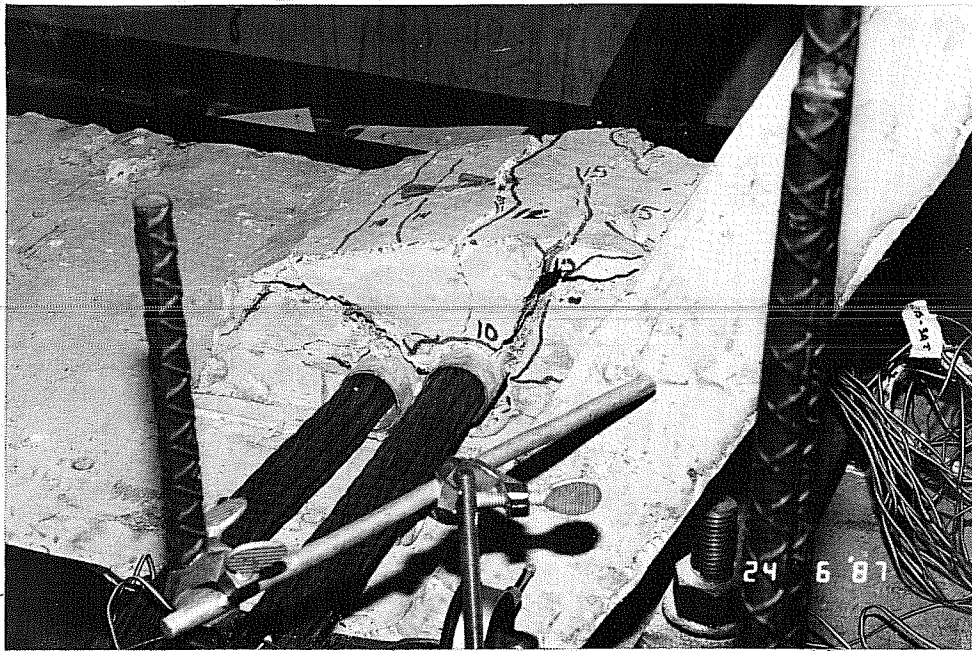
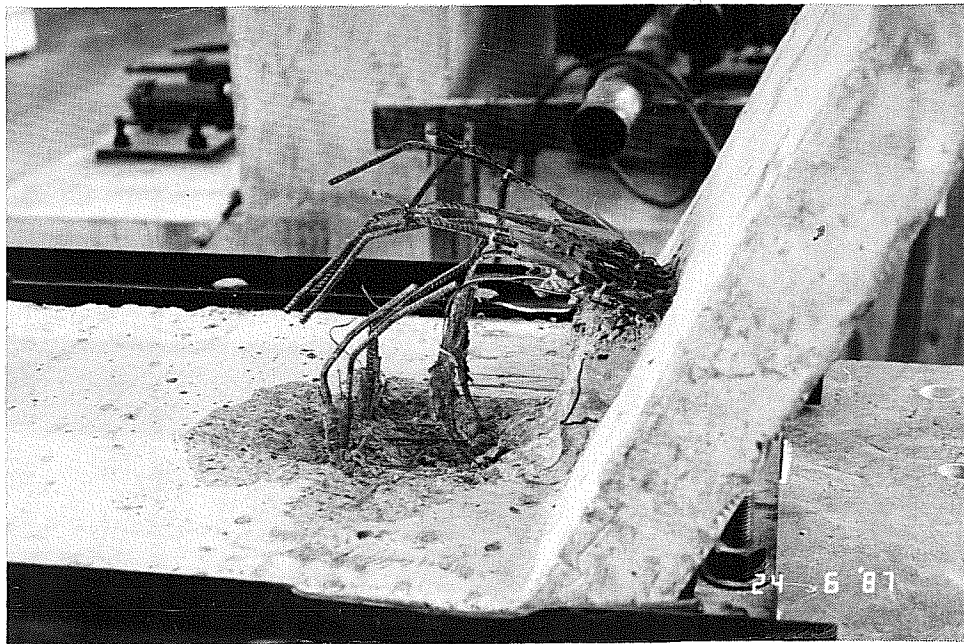
Figure 3 31 Test 2B Before and After Failure

The reinforcement failure locations are shown in Fig. 3.29. The lap splice on the outer stirrup was the weakest junction in this specimen. The before and after photographs show the tension net that formed after the top surface collapse (Fig. 3.31). Again as in test 2A, the strength is compared to  $D_o$  for the complete prototype detail (Fig. 3.30) even

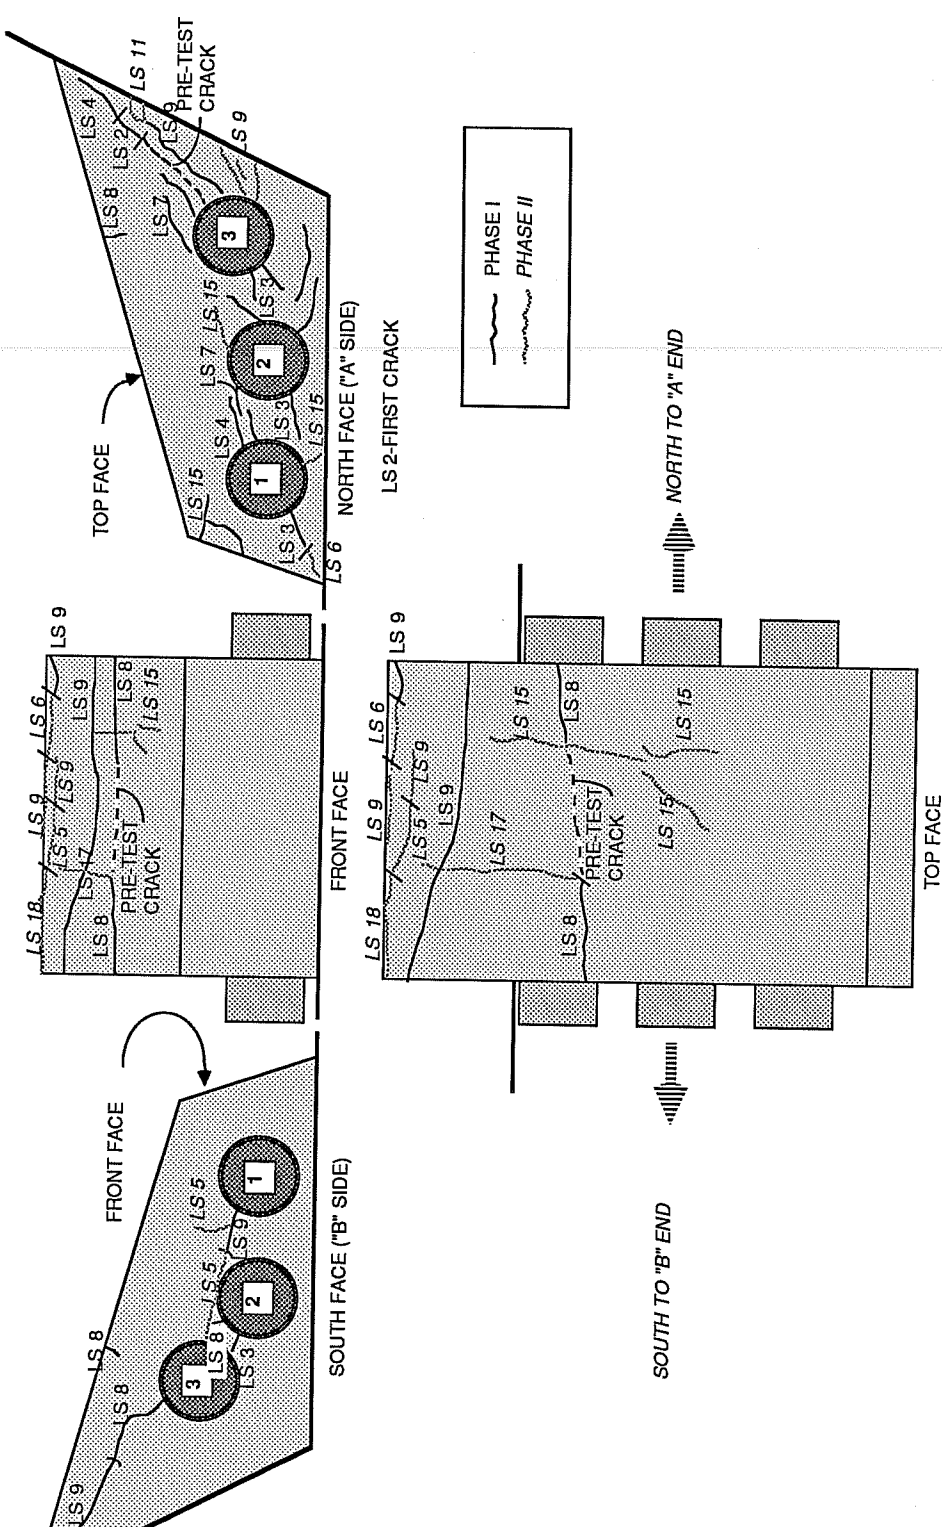
Figure 3.33 Test 3A Crack Patterns

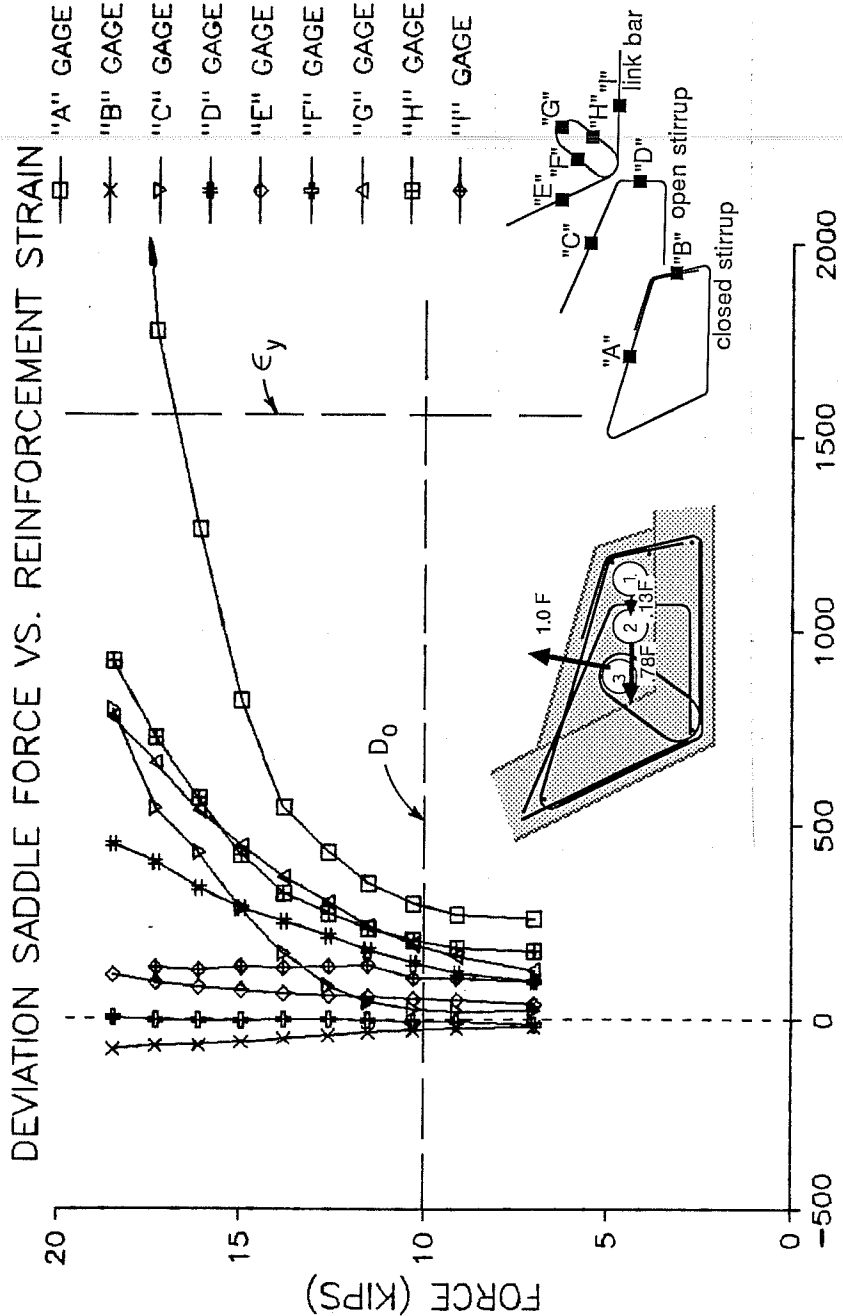
Figure 3.34 Test 3A Reinforcement Strain Data - Phase 1

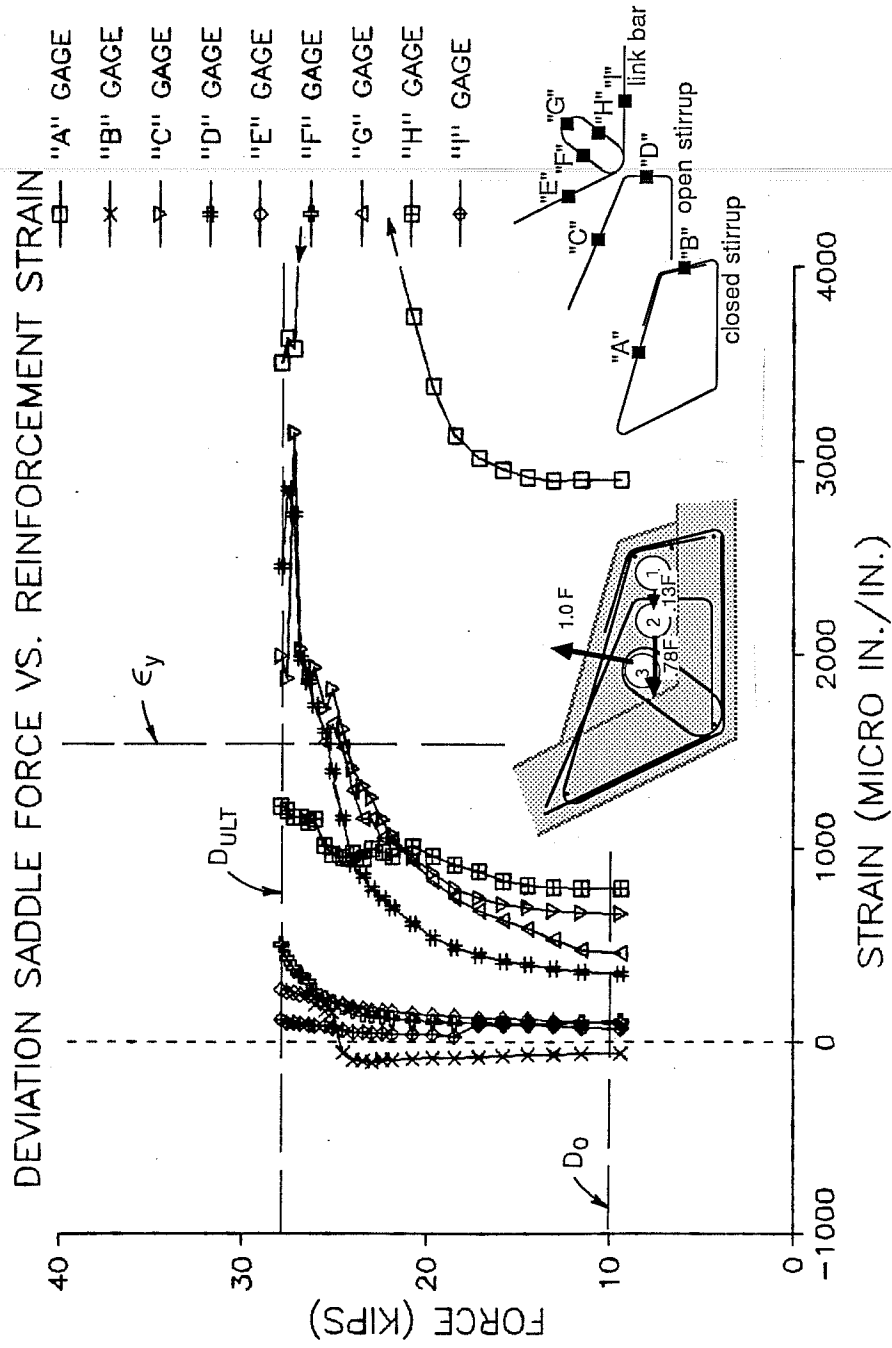
Figure 3.35 Test 3A Reinforcement Strain Data - Phase 2

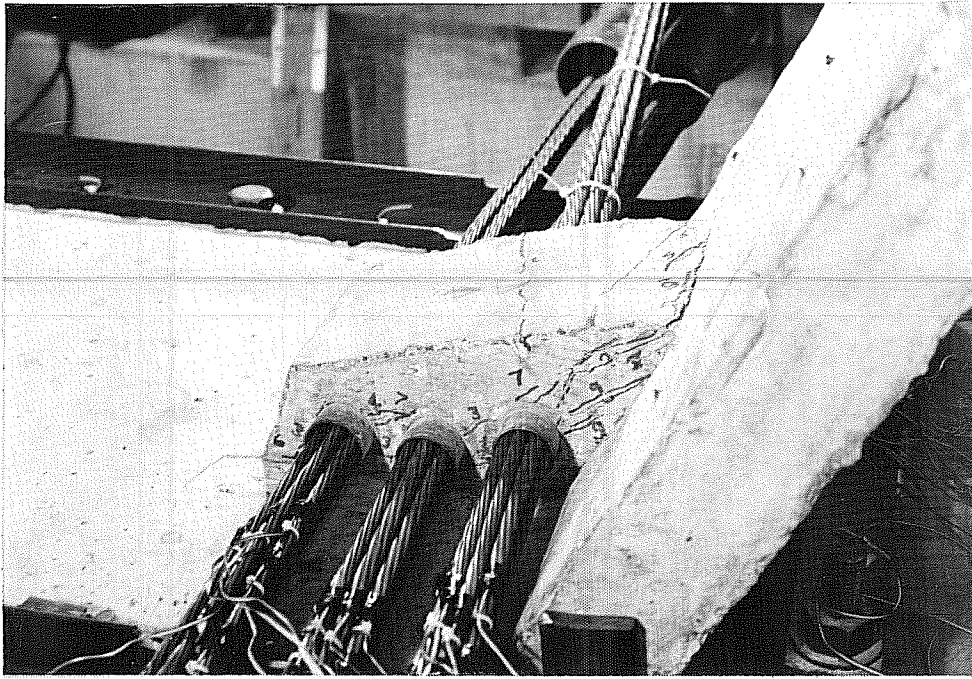
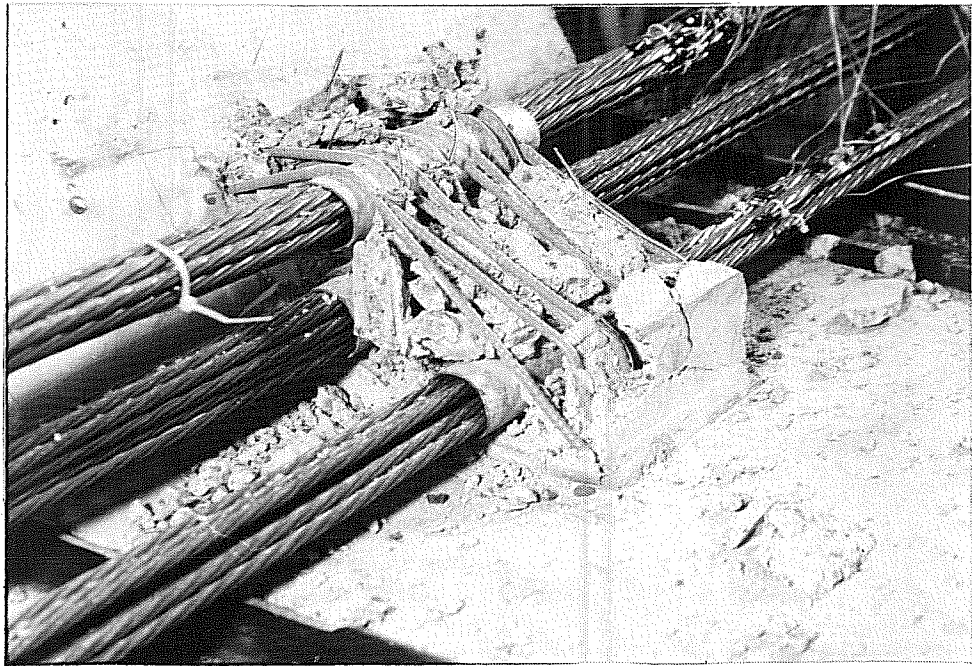
Figure 3-38 Test 3A - Before and After Failure
