POST-TENSIONED BRIDGES DESIGN FOR

**LOADING SADDLE BEHAVIOR AND DESIGN FOR EXTERNALLY  
POST-TENSIONED BRIDGES**

**R.J. Beaupre, L.C. Powell, J.E. Breen and M.E. Kreger**

**Research Report No. 365-2**

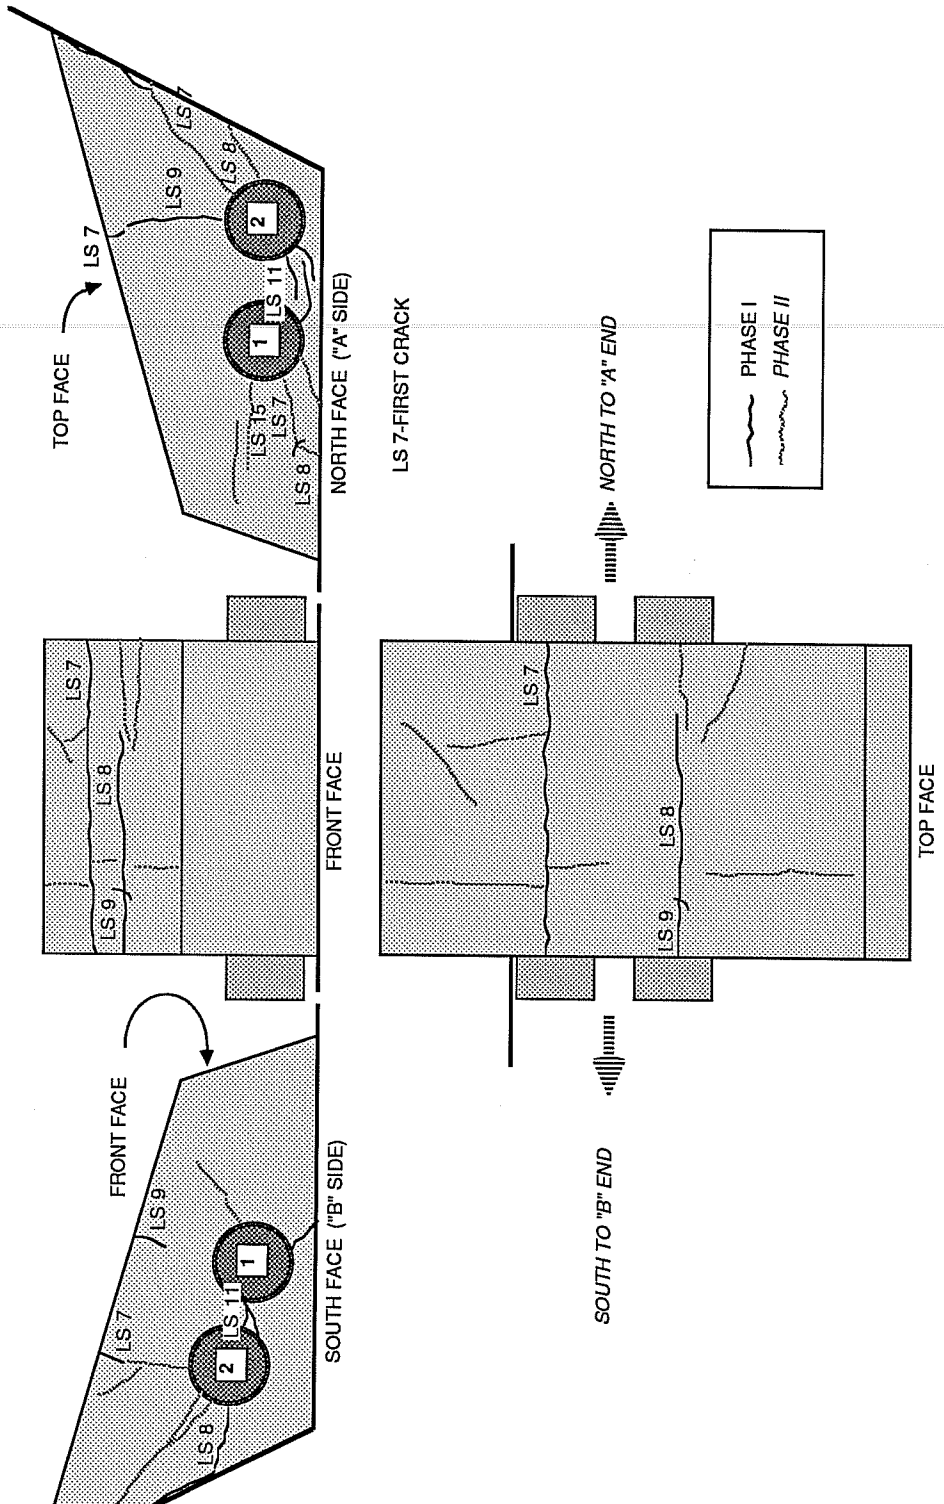
Figure 3.41 Test 3B Crack Patterns

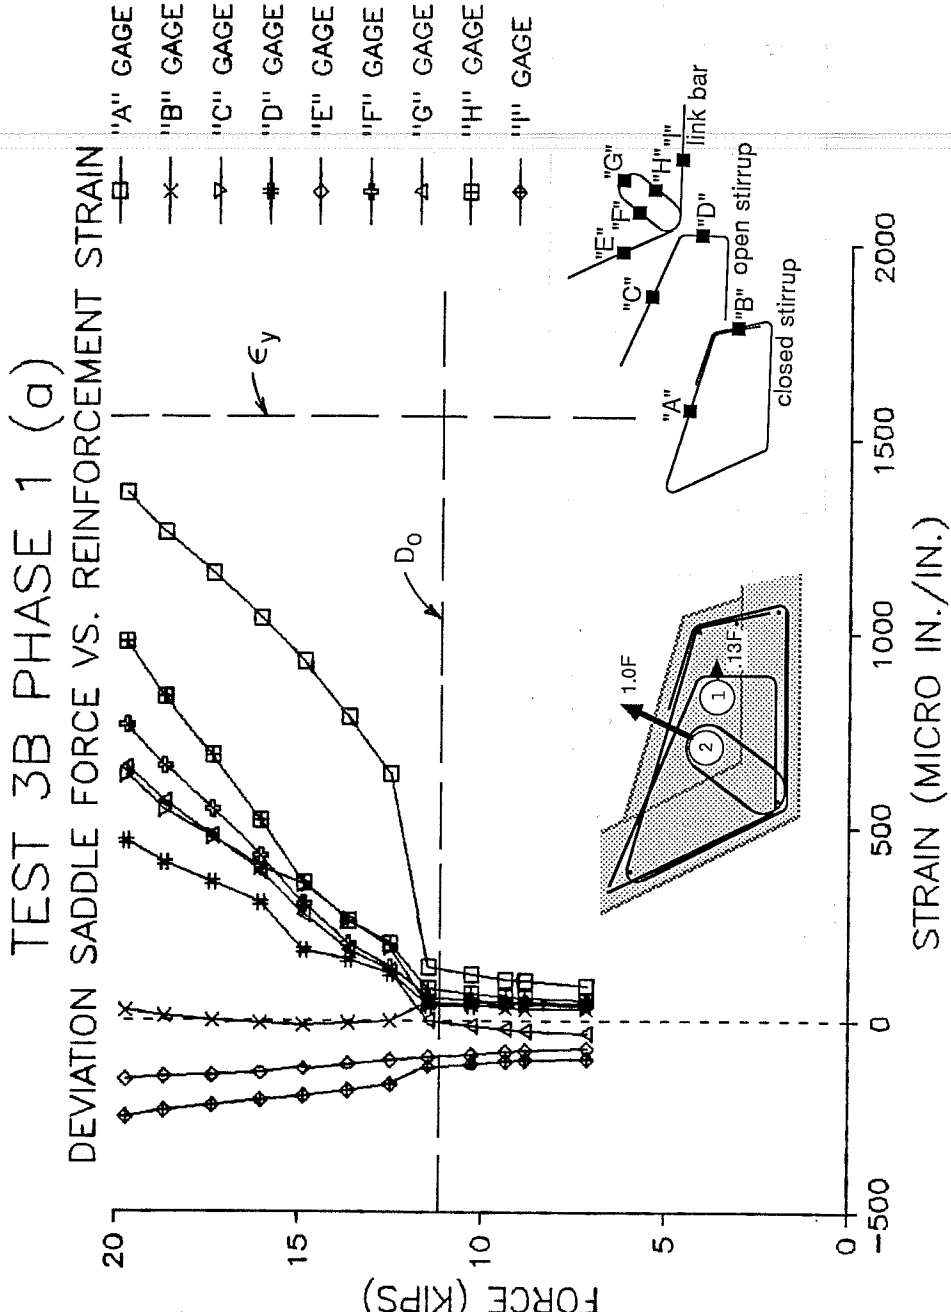
Figure 3.42 Test 3B Reinforcement Strain Data - Phase 1 (a)

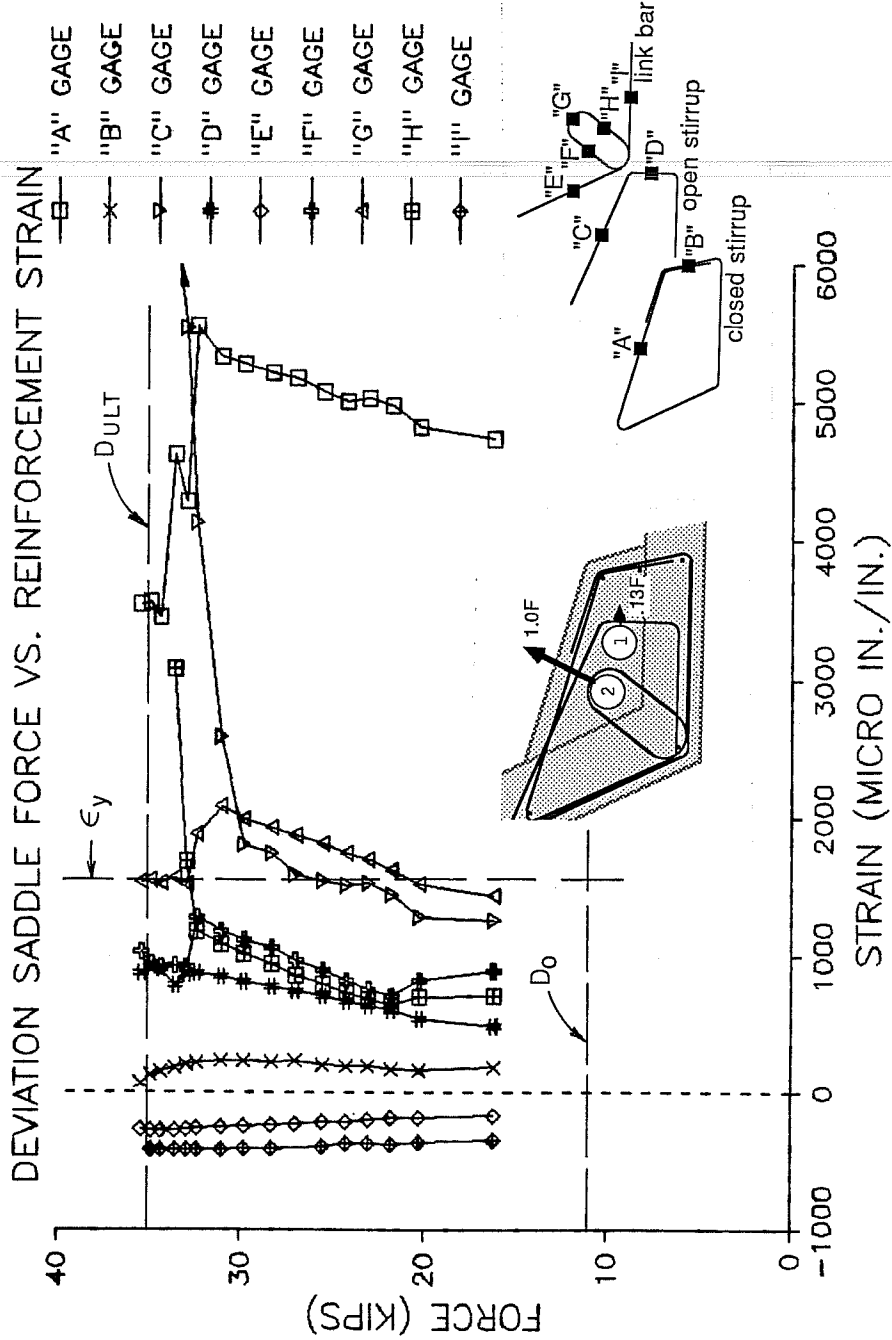
Figure 3.45 Test 3B Reinforcement Strain Data - Phase 2

- 1) As in phase 1, the strain was greatest in the "A" gage of the top surface reinforcement. This strain was three times greater than that of test 1B. The "C" gage which was on the other top surface reinforcement increased greatly several load stages before failure. The "A" gage appeared to have failed several load stages before failure.
- 2) All locations on the link bar ("F", "G", "H" gages) yielded as was the case in phase 1.
- 3) The "D" gage of the vertical leg of the open stirrup strained steadily until failure of the specimen, as it did in test 1B, but it did not yield.
- 4) The strain in the "B" gage on the reinforcement in the front face remained at a low strain and was almost at zero strain at failure. This was not the case in test 1B where the strain was somewhat higher.
- 5) The "E" and "I" gages of the link bar remained in compression.

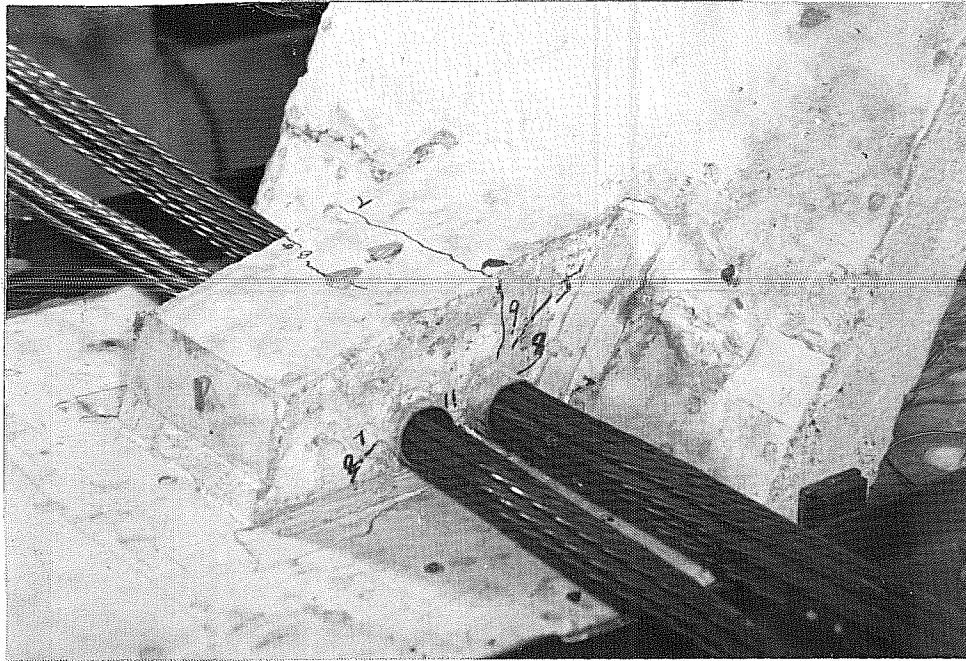
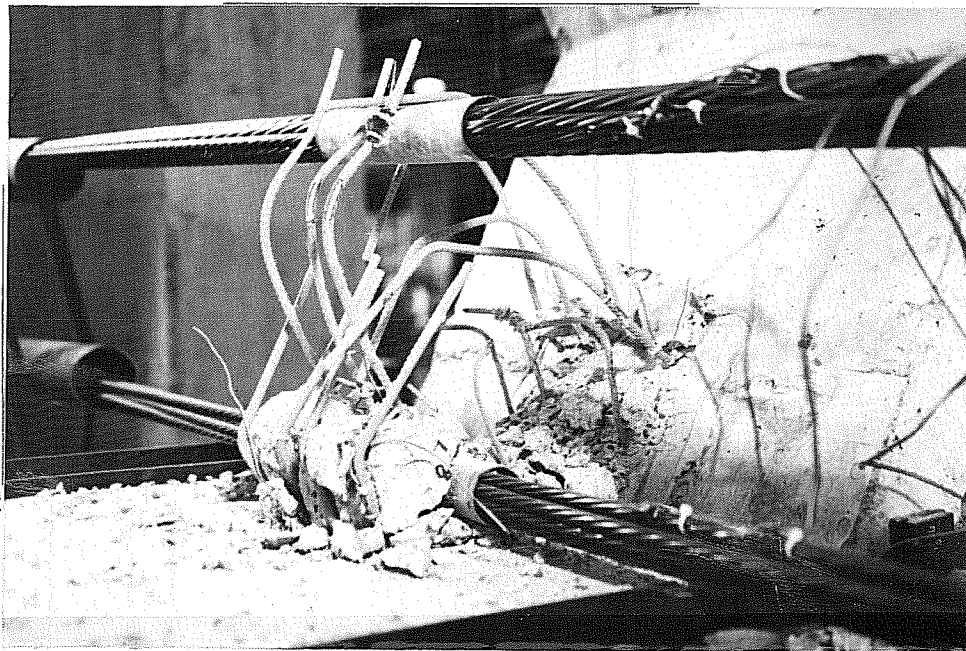
Figure 3.48 Test 3B - Before and After Failure

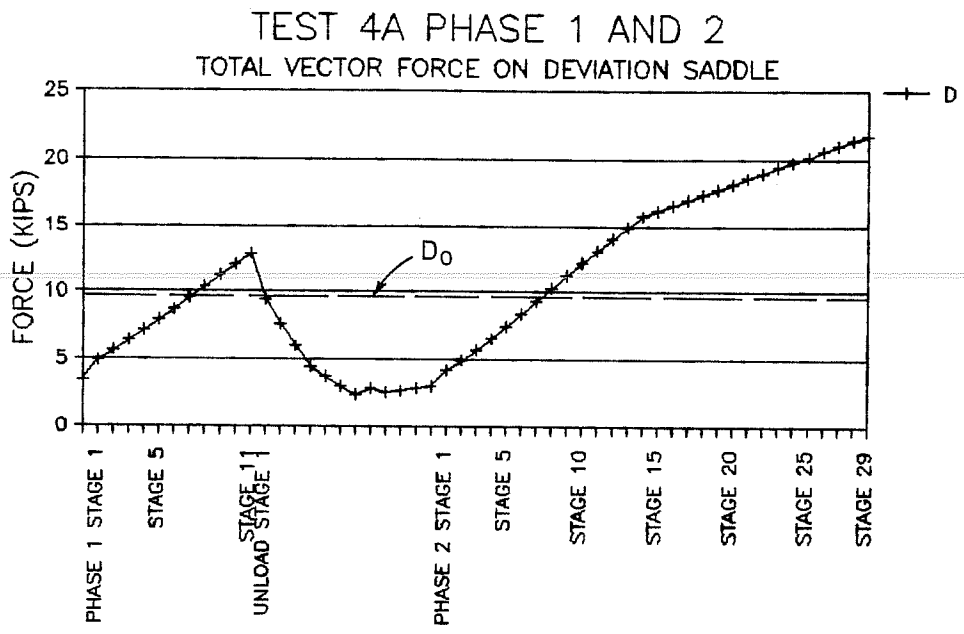
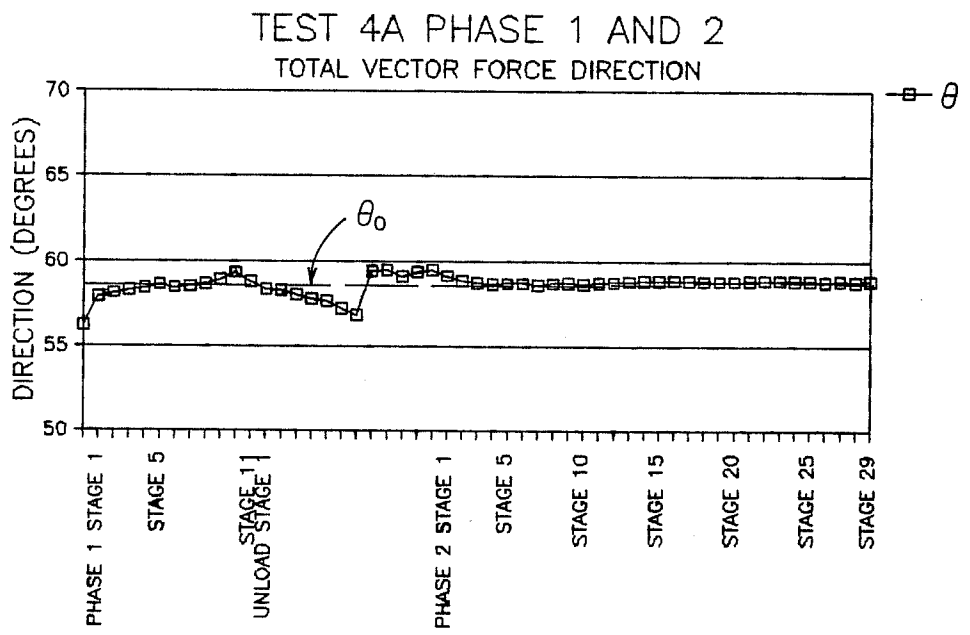
Figure 3.49 Test 4A Loading History

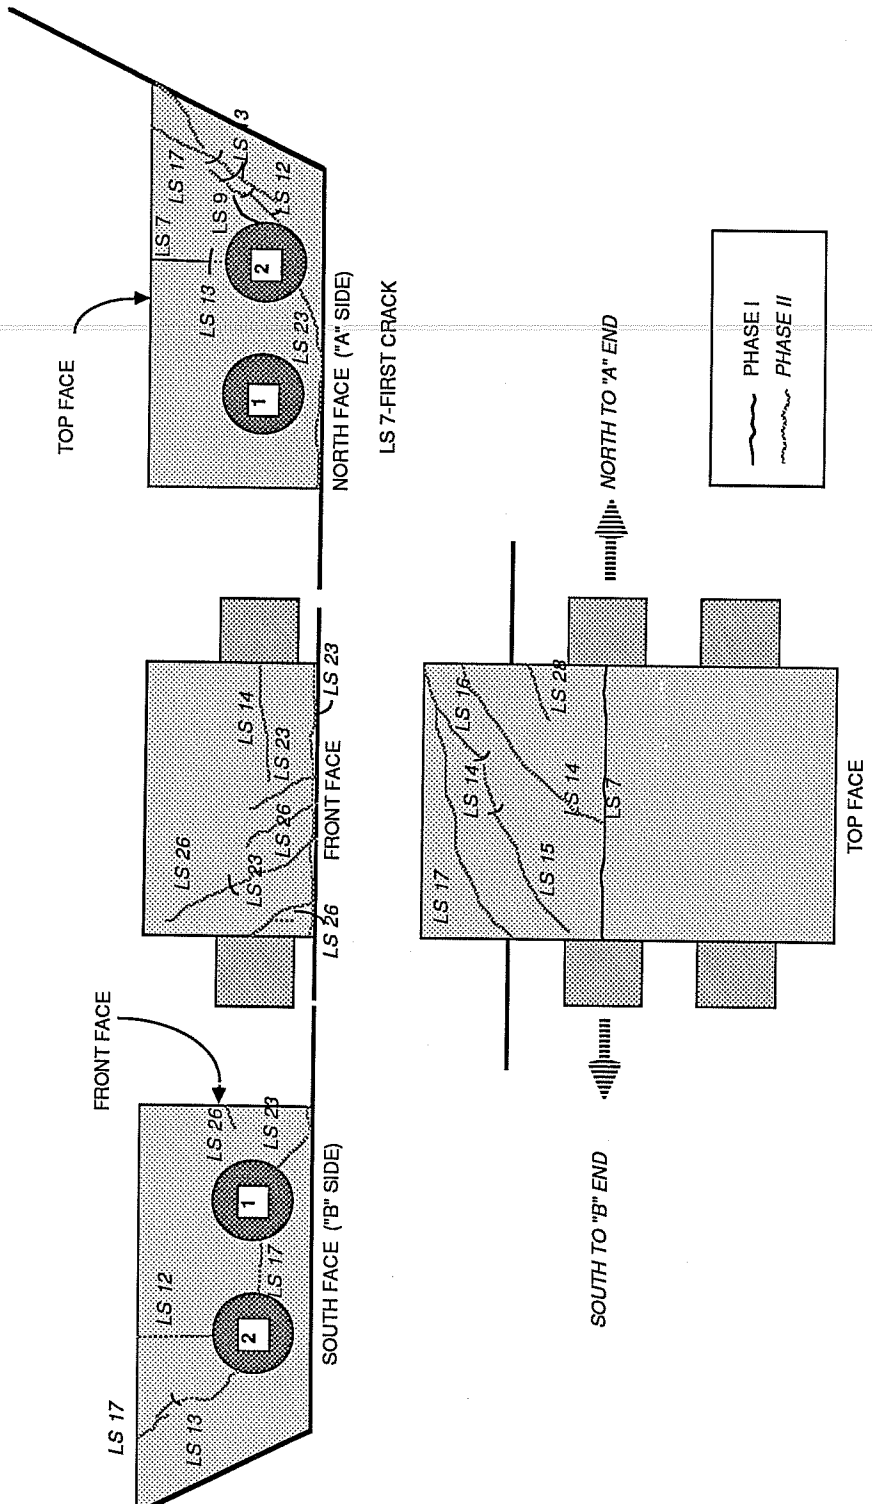
Figure 3.50 Test 4A Crack Patterns

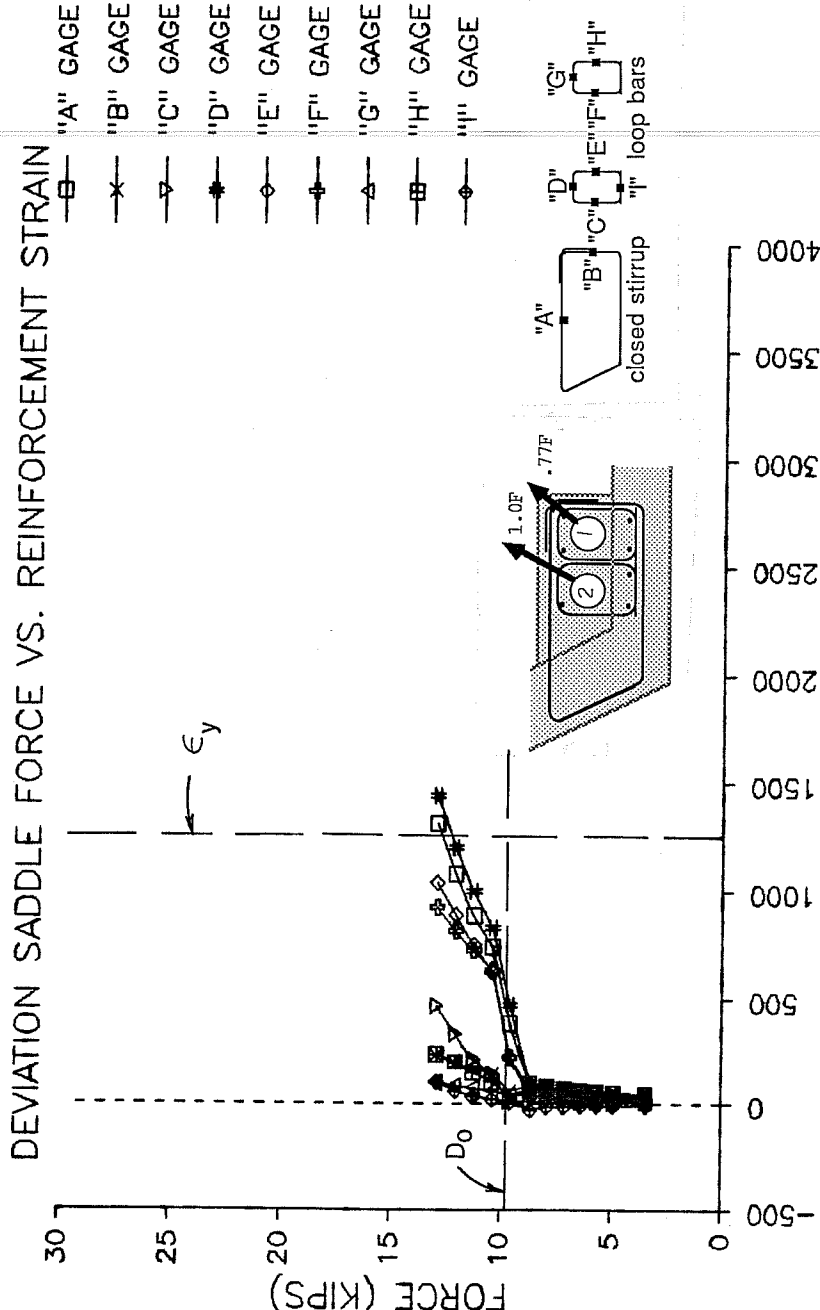
Figure 3.51 Test 4A Reinforcement Strain Data - Phase 1

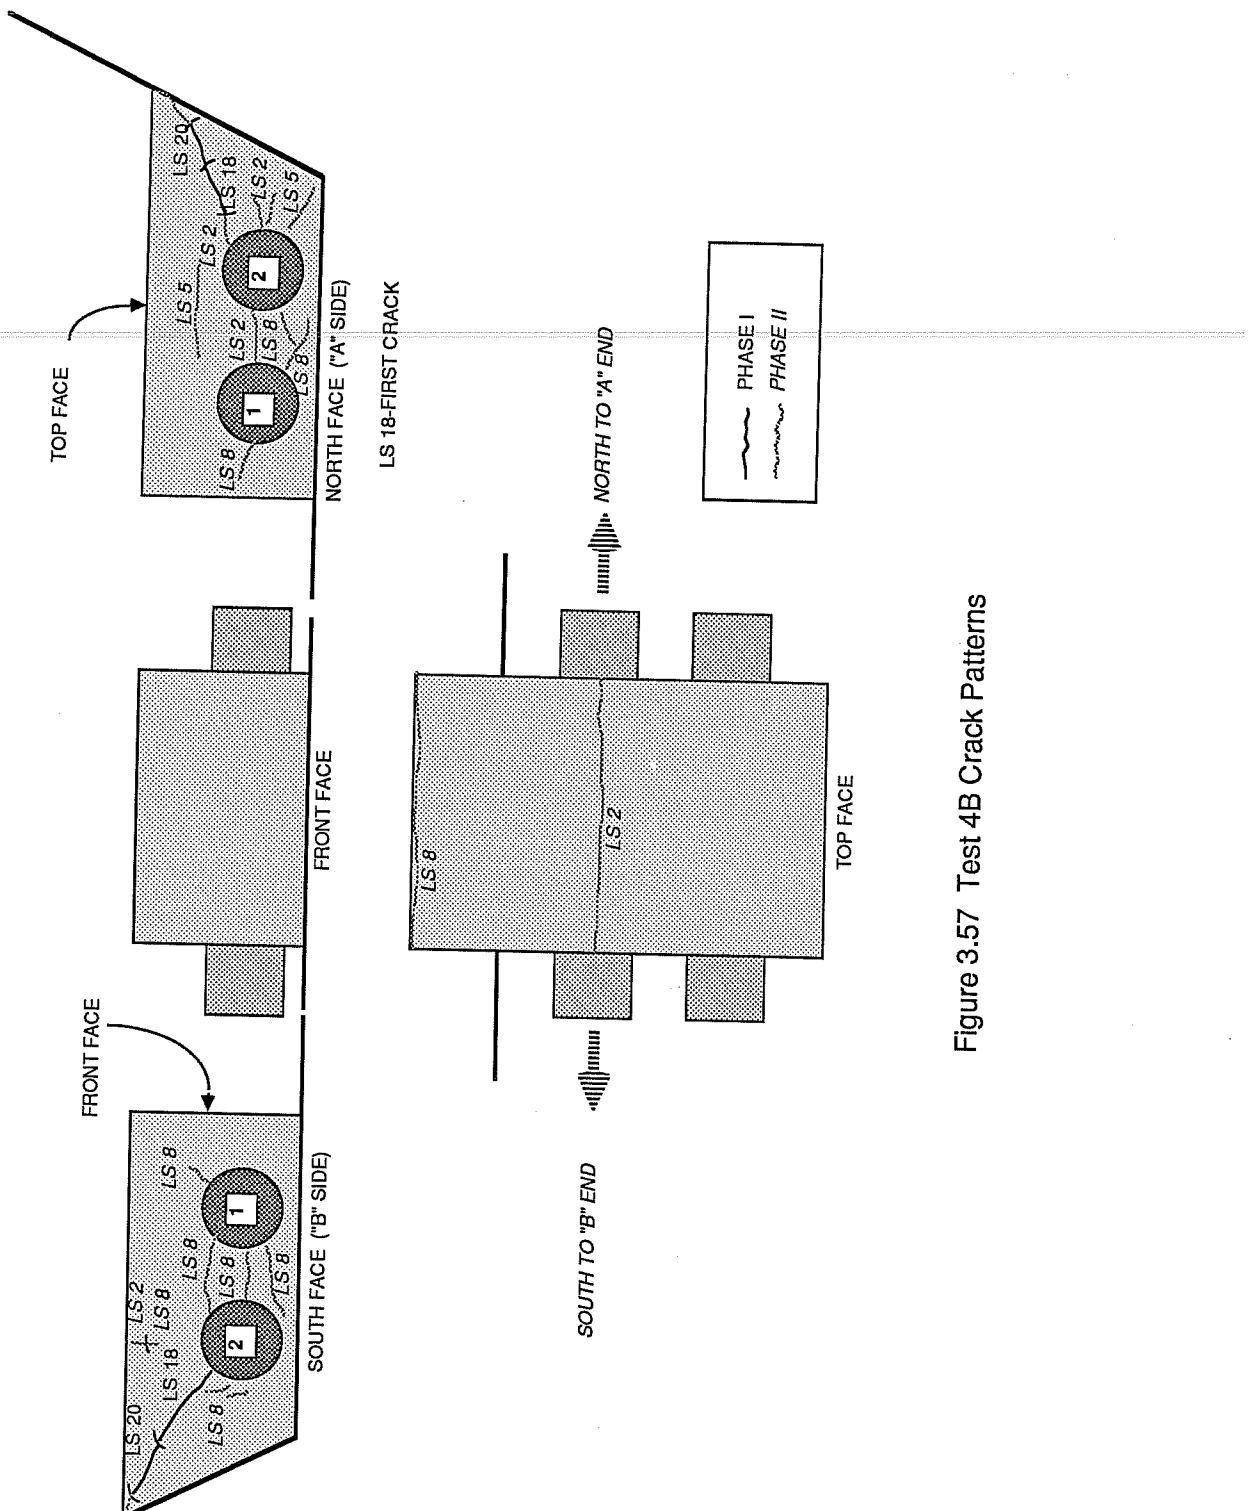
Figure 3.57 Test 4B Crack Patterns

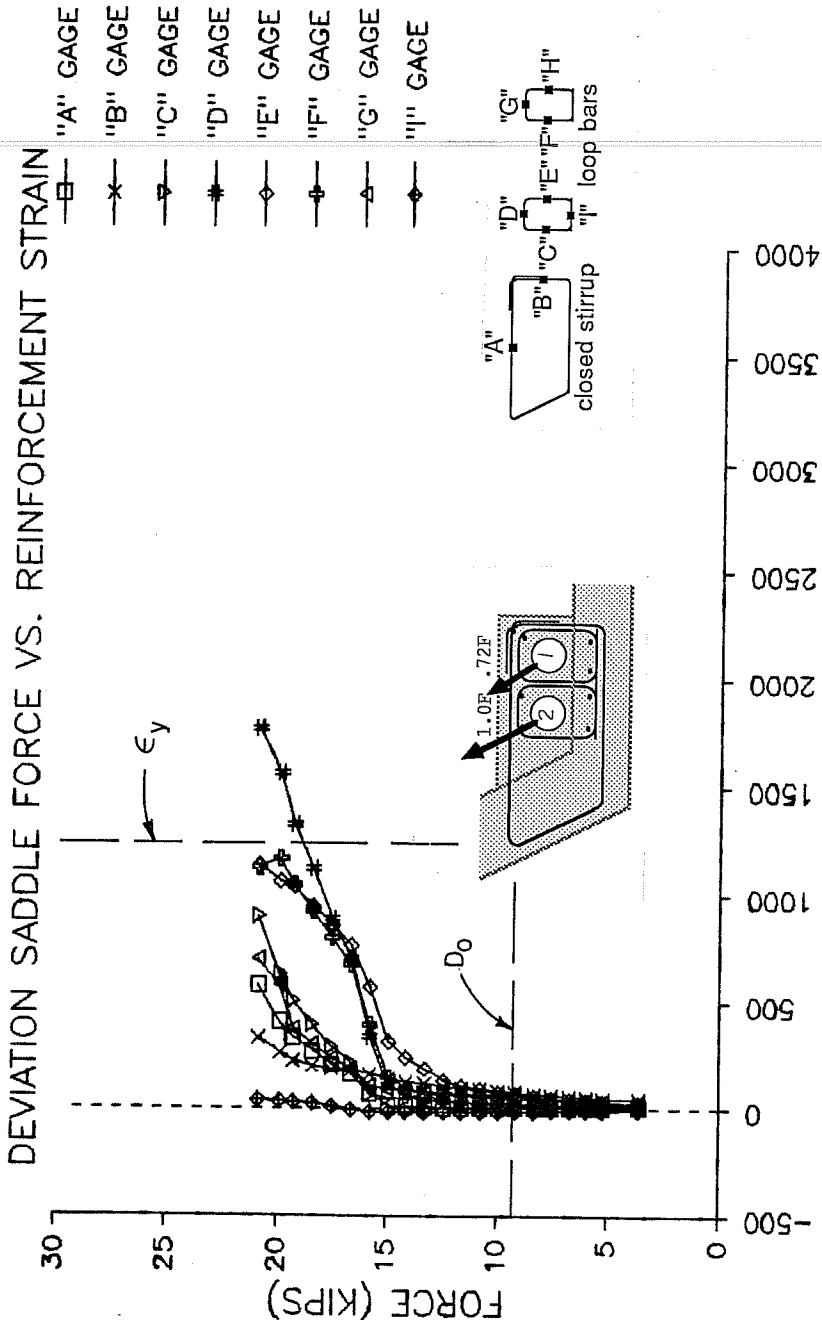
Figure 3.58 Test 4B Reinforcement Strain Data - Phase 1

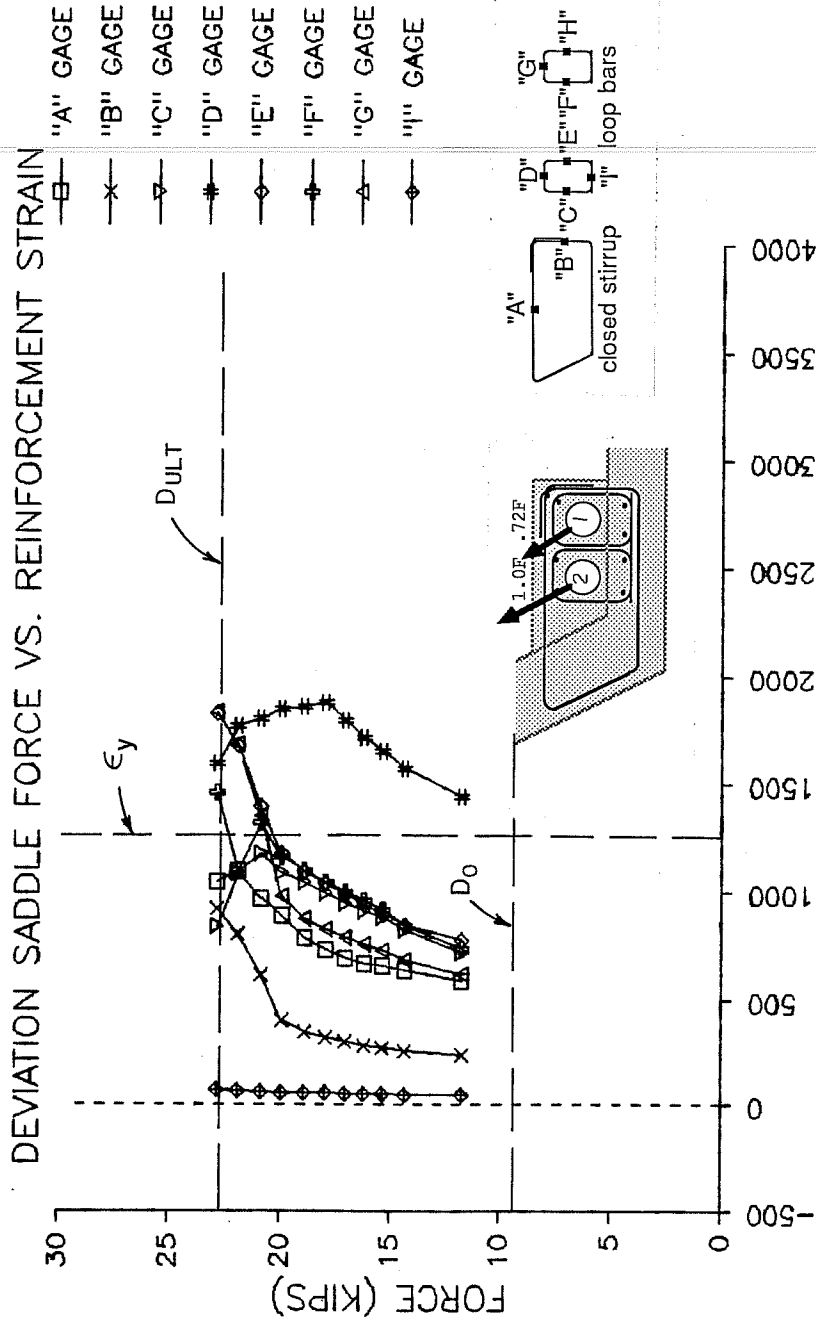
Figure 3.59 Test 4B Reinforcement Strain Data - Phase 2

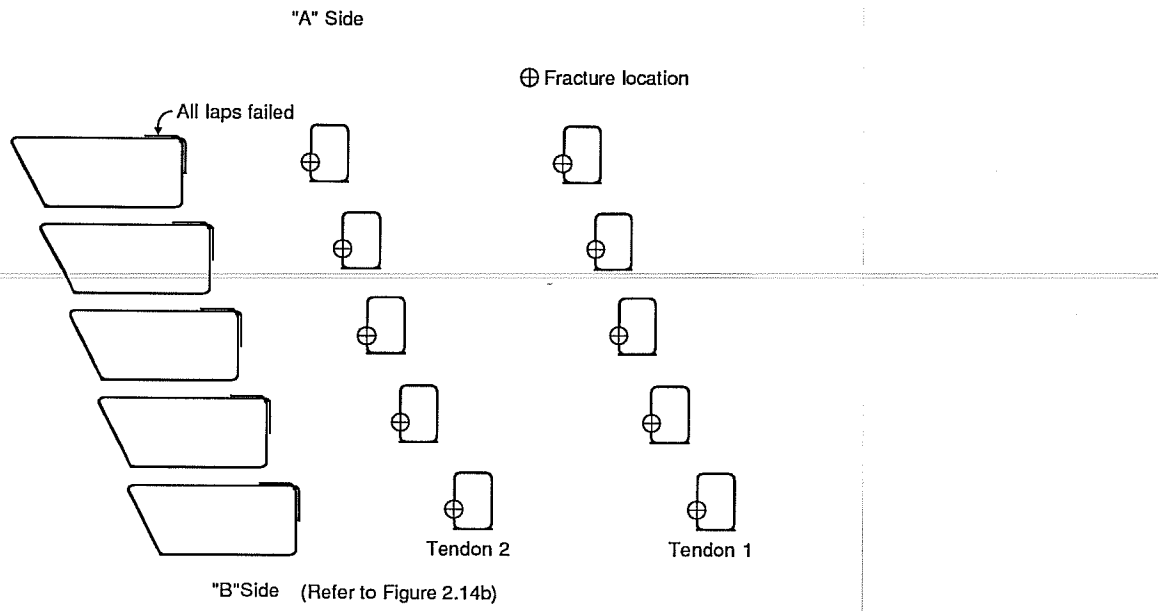
**Figure 3.60 Test 4B Reinforcement Failure Locations**

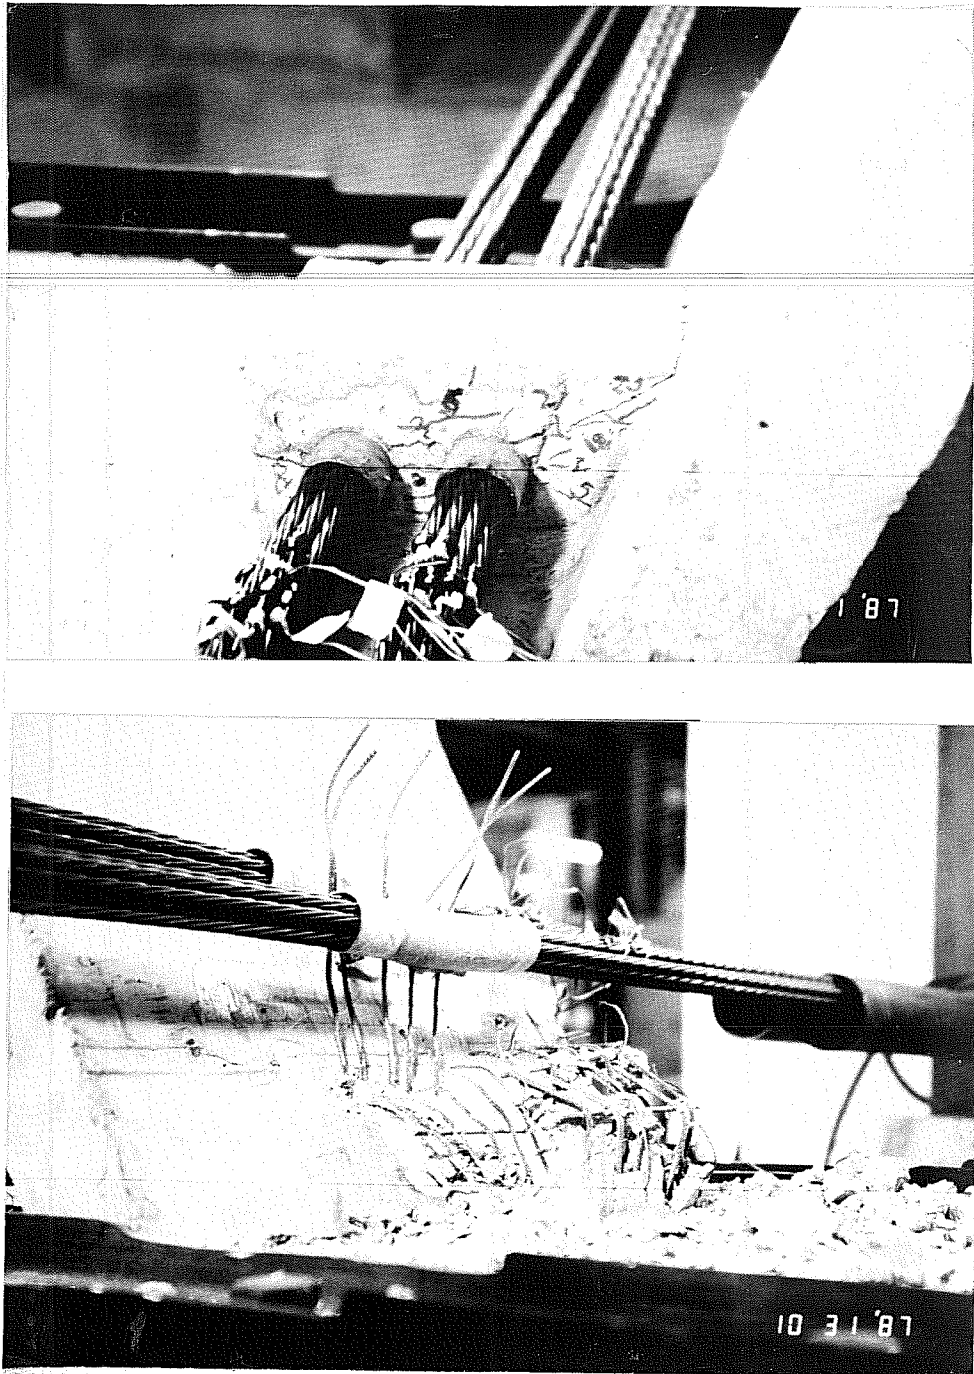
Figure 3.62 Test 4B - Before and After Failure

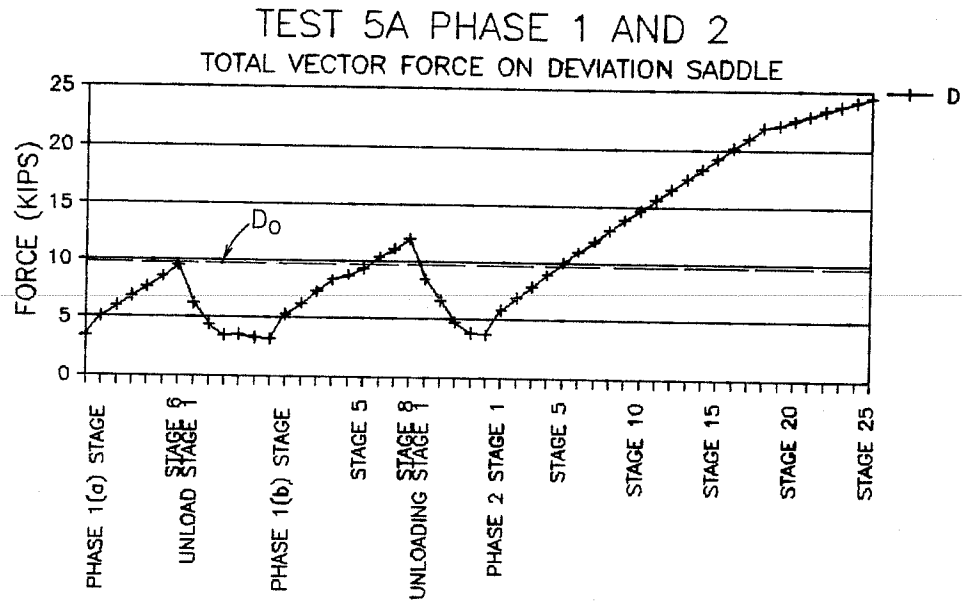
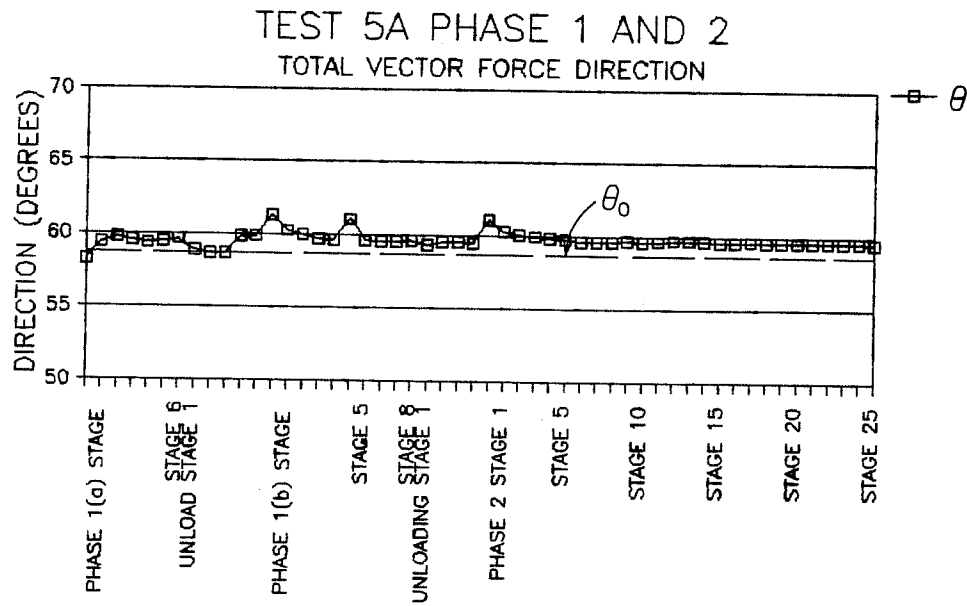
Figure 3.63 Test 5A Loading History

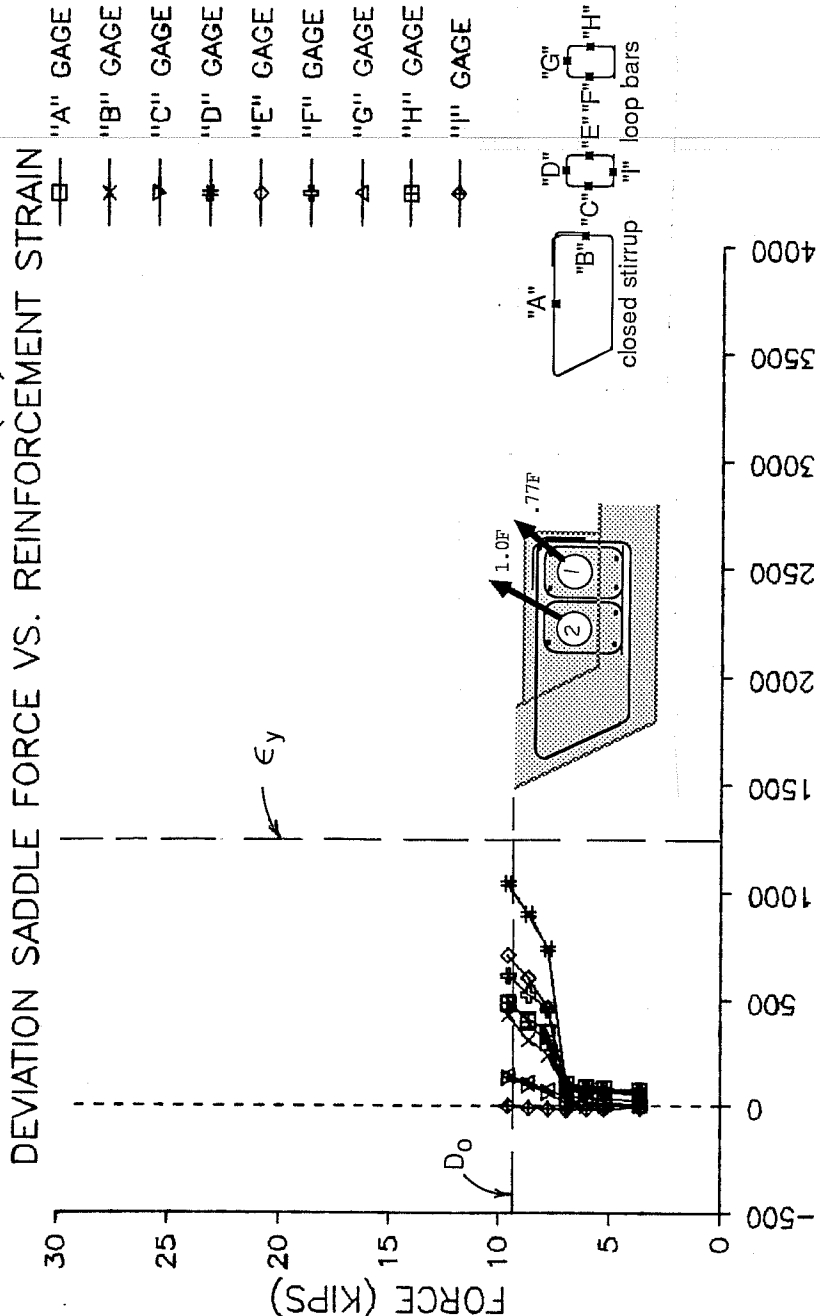
Figure 3.65 Test 5A Reinforcement Strain Data - Phase 1 (a)

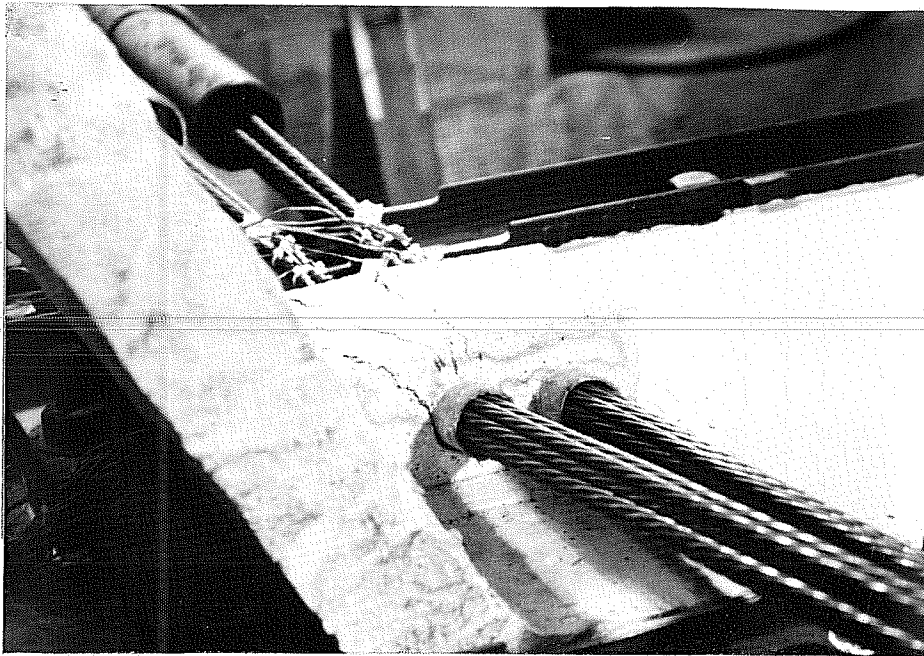
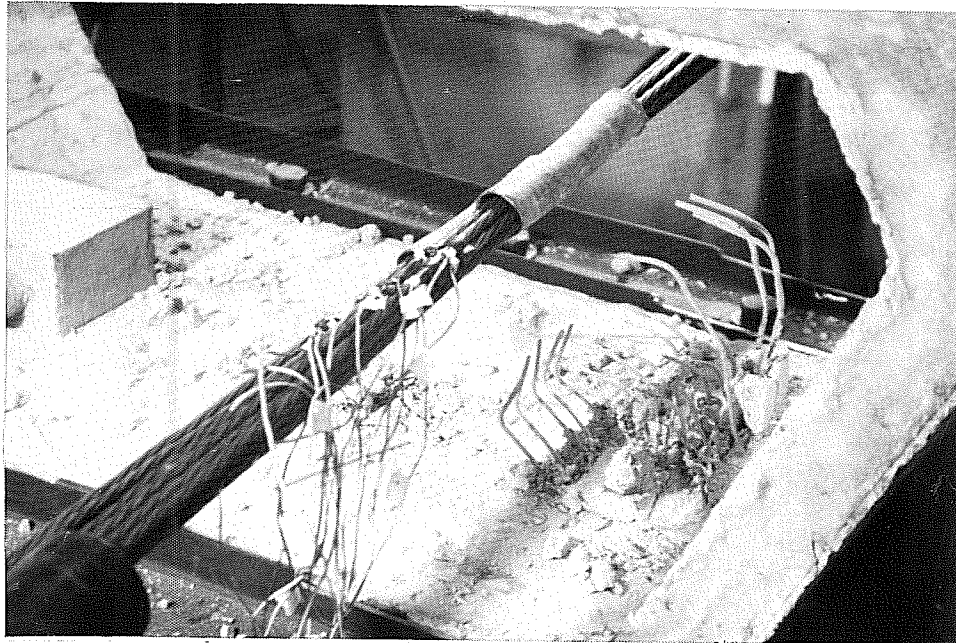
Figure 3.70 Test 5A - Before and After Failure

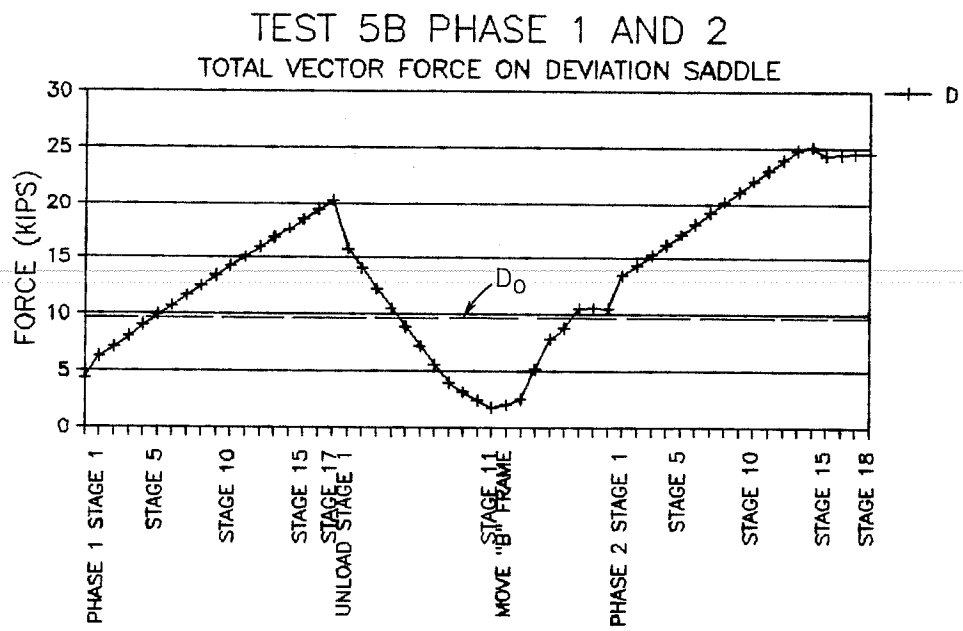
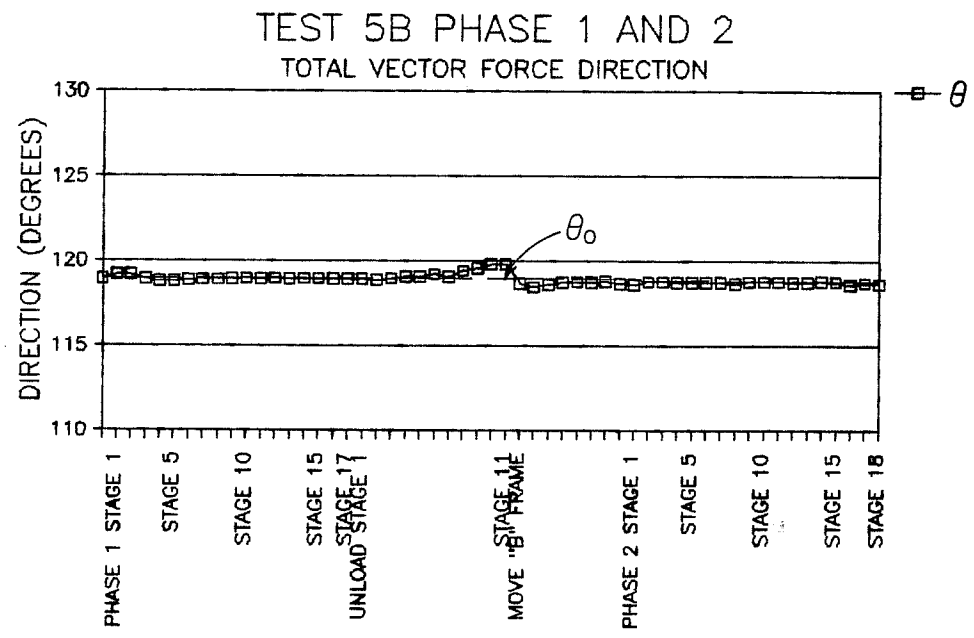
Figure 3.71 Test 5B Loading History

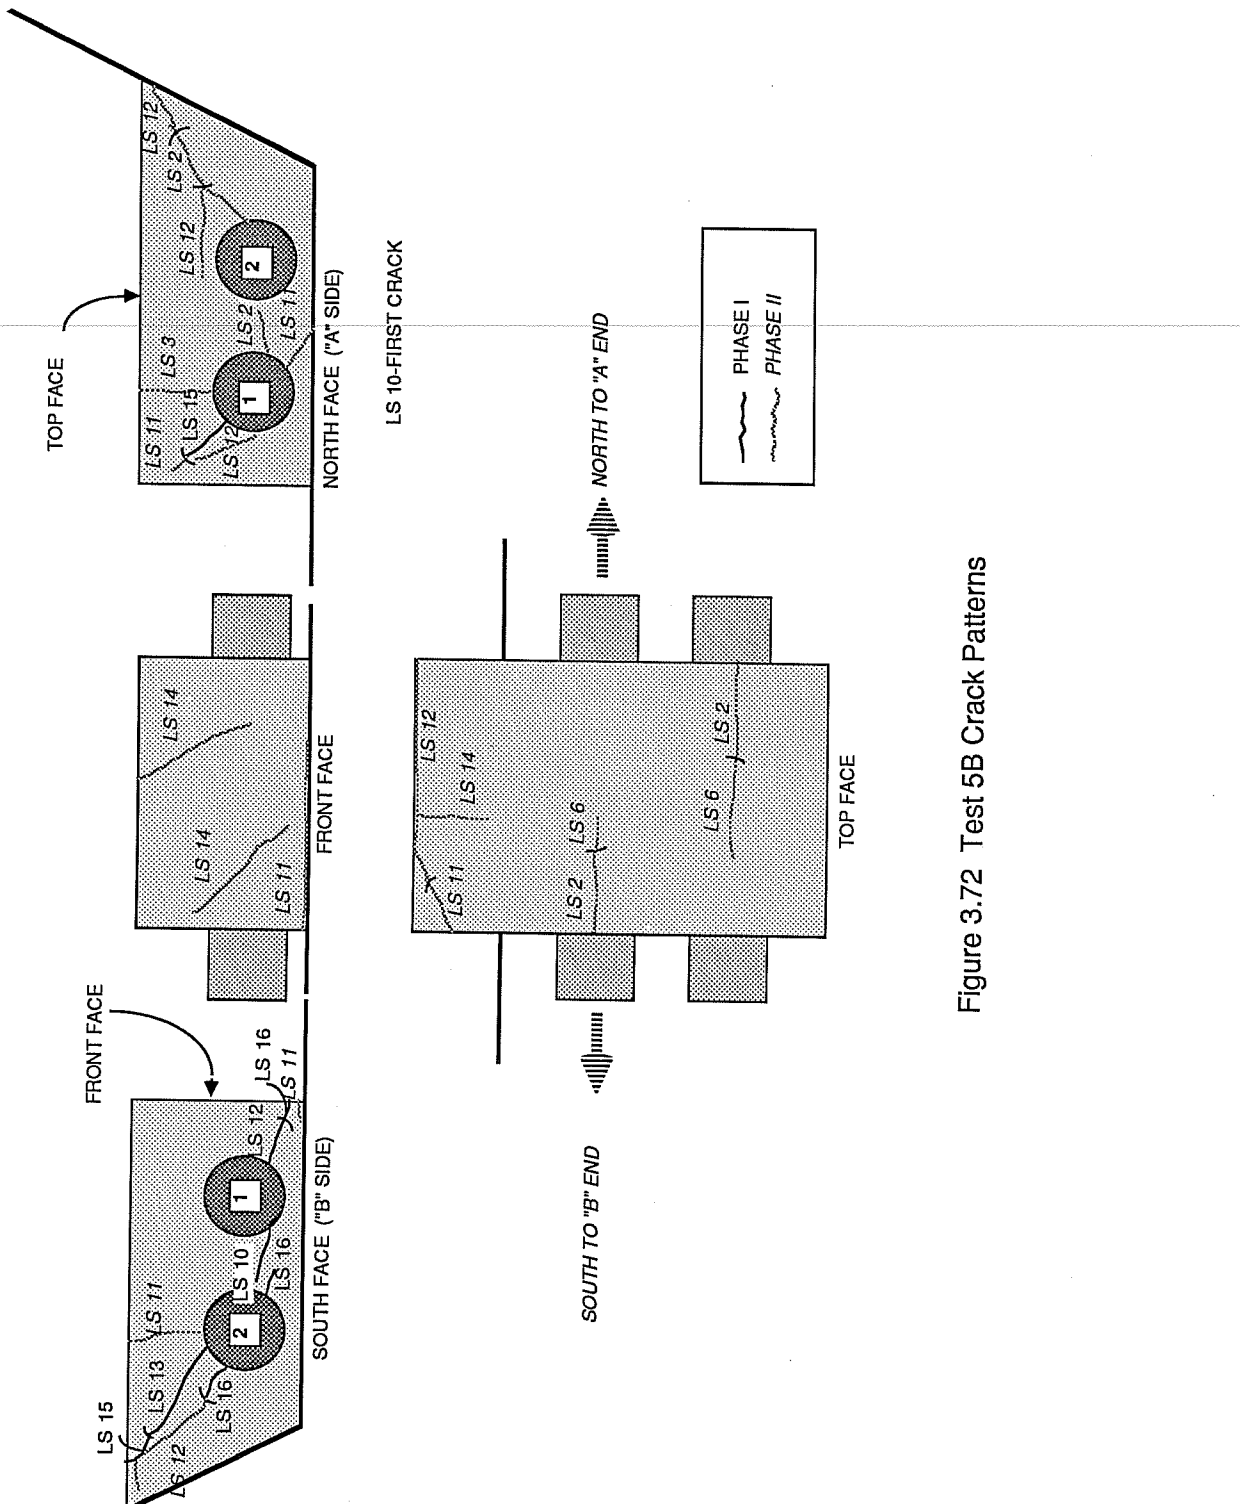
Figure 3.72 Test 5B Crack Patterns

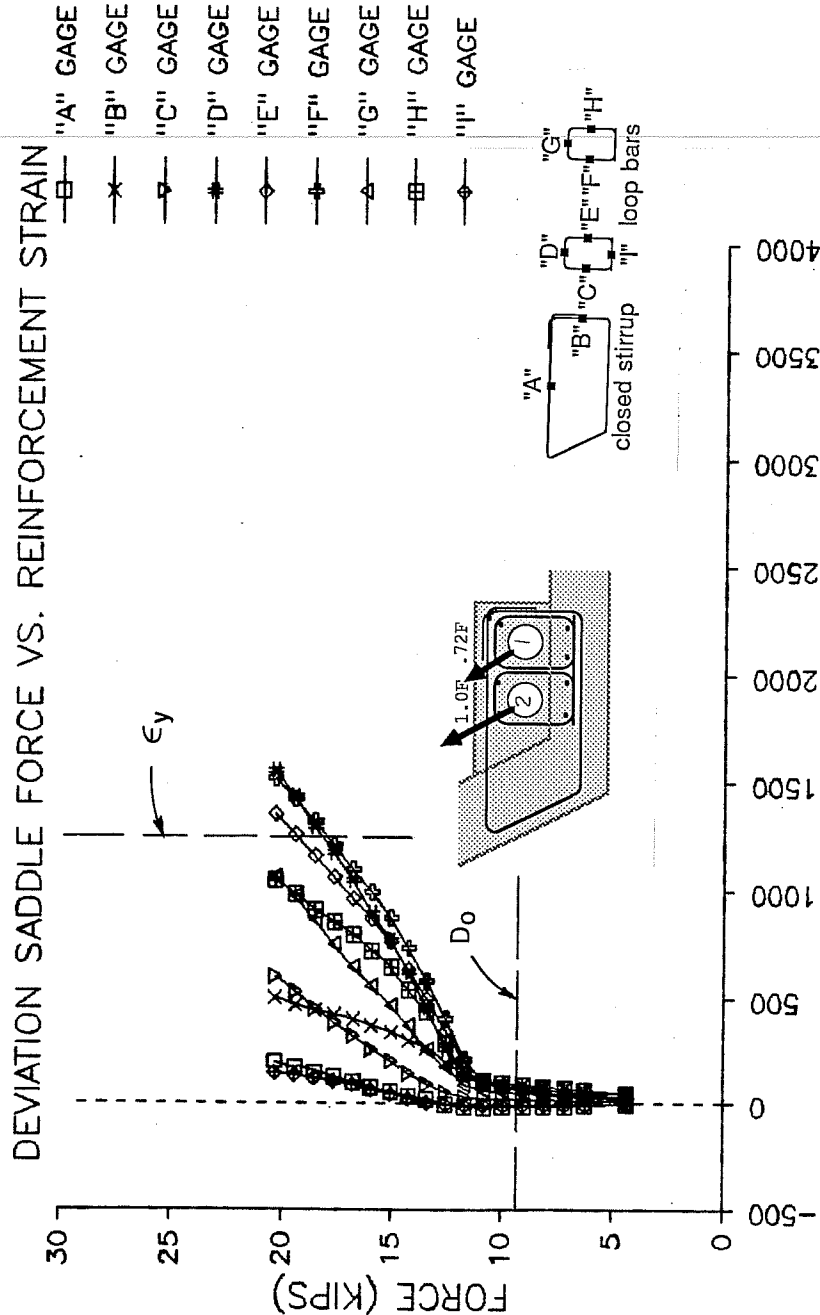
Figure 3.73 Test 5B Reinforcement Strain Data - Phase 1

- 3) The "B" and the "H" gage which were located on the reinforcement in the front face did not have the same strain as they did in the previous tests. A comparison cannot be made with test 4B because the "H" gage failed before testing.
- 4) The strain in the "A" gage was lower than it was in test 4B.
- 5) The other gages were at a lower strain with the strain being the lowest in the "I" gage which was located at the bottom of the tendon 2 inner loop.
