POST-TENSIONED BRIDGES DESIGN FOR

**LOADING SADDLE BEHAVIOR AND DESIGN FOR EXTERNALLY  
POST-TENSIONED BRIDGES**

**R.J. Beaupre, L.C. Powell, J.E. Breen and M.E. Kreger**

**Research Report No. 365-2**

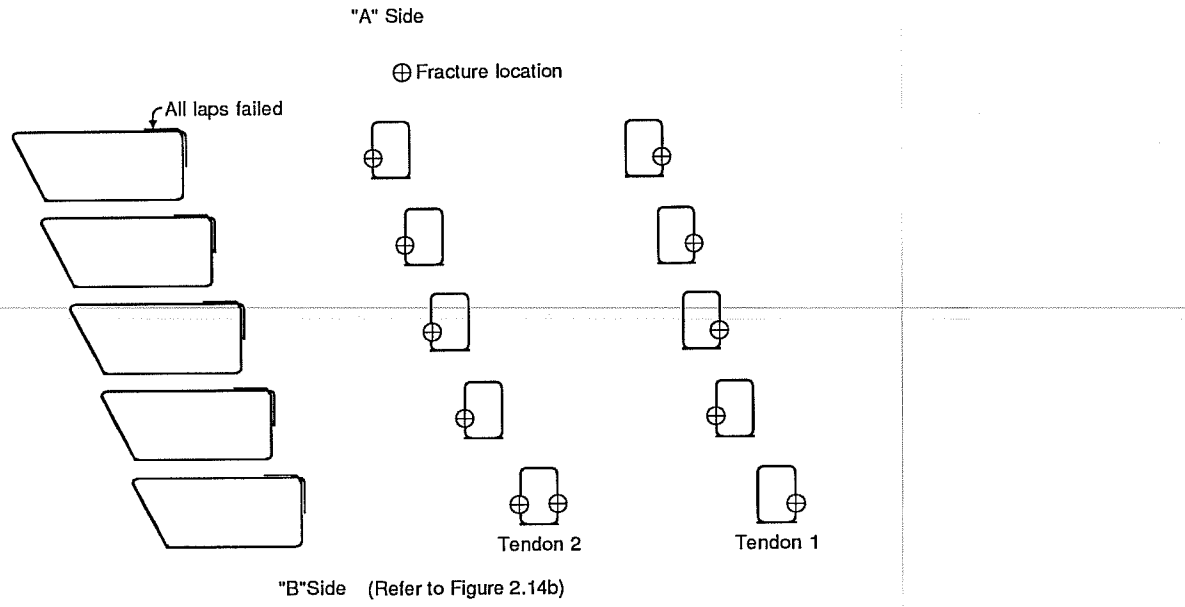
**Figure 3.75 Test 5B Reinforcement Failure Locations**

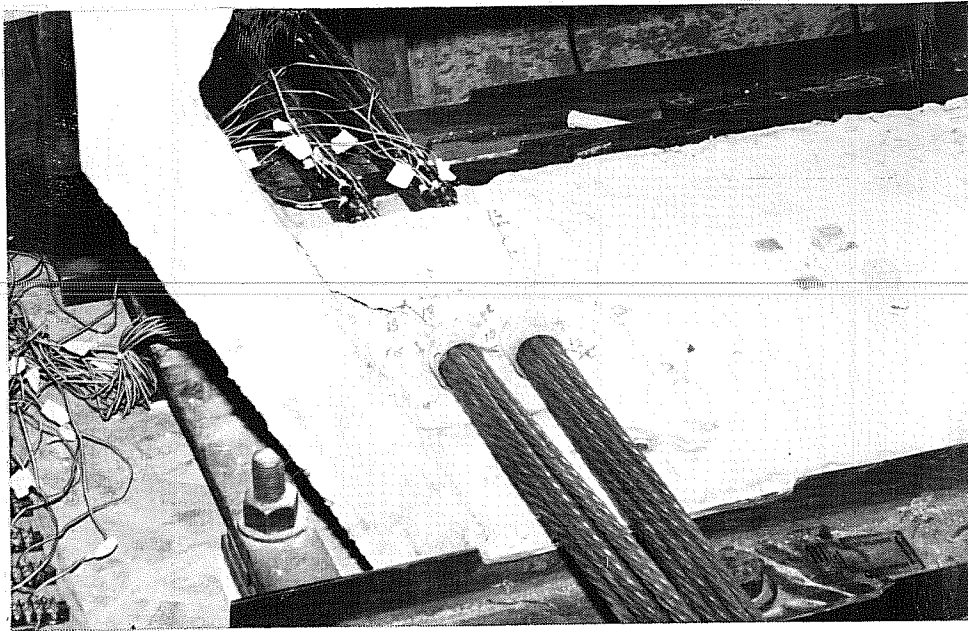
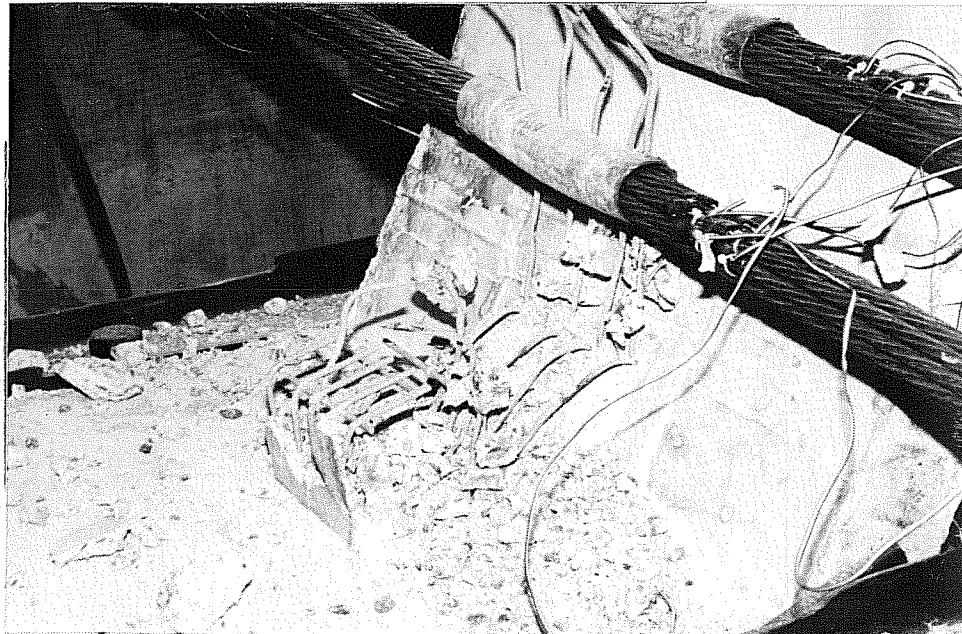
Figure 3.77 Test 5R - Before and After Failure

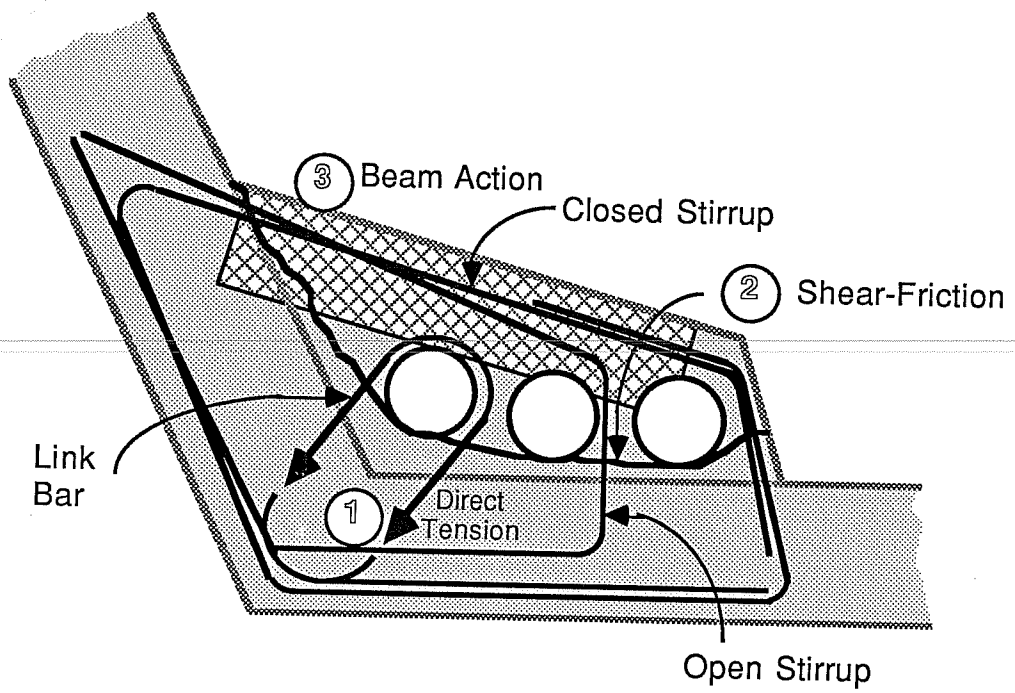
a) Early configuration

*4.2.1 Direct Tension Model.* The behavior of the direct tension reinforcement in the deviation saddle is straightforward in that the reinforcement is stressed

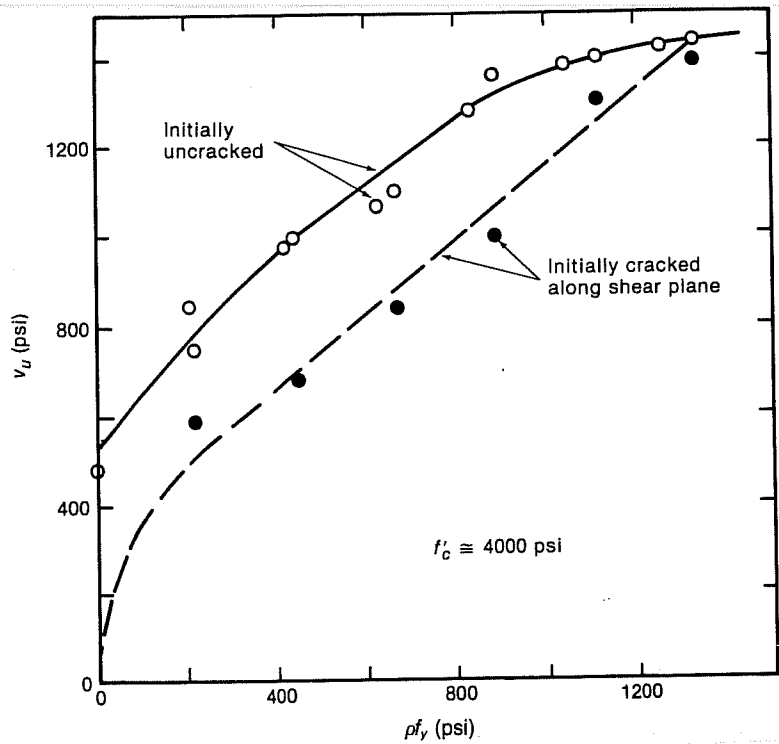
Figure 4.4 Typical Test Results for Shear Friction Study (From Ref. 9)

- 5) The shear transfer strength of initially uncracked concrete is developed by a truss action after diagonal tension cracking across the shear plane occurs. Failure occurs when the inclined concrete struts fail under a combination of shear and axial force. This is shown in Fig. 4.5. Similar diagonal cracking below the ducts

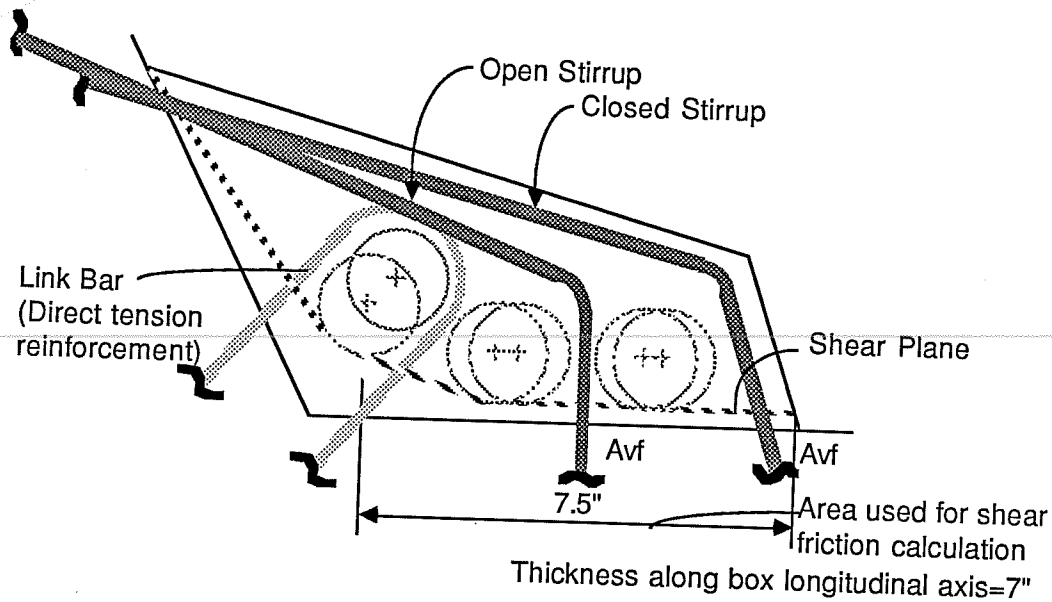
Critical shear plane located below the ducts.

(Horizontal shear friction strength compared against total deviated tendon force horizontal component.)

The shear friction calculation for tests 1A, 1B, 2B, 3A, and 3B, is shown in Fig. 4.7. This is the ultimate shear friction capacity but is based on yielding of the reinforcement. Shear friction transfer is questionable at larger strains approaching reinforcement ultimate. Deviator loads at first reinforcement yielding are compared to this ultimate shear friction capacity in Sec. 4.2.4 to provide further comparisons between test results and calculations. The specimen 2A detail did not include the open and closed stirrup. Most of its horizontal force component was resisted by the link bar. In addition, the unreinforced concrete in front of the tendon resisted the small horizontal force of tendon 1. The shear friction calculation for tests 1A, 1B, 2B, 3A, and 3B is somewhat simplified since the rein-

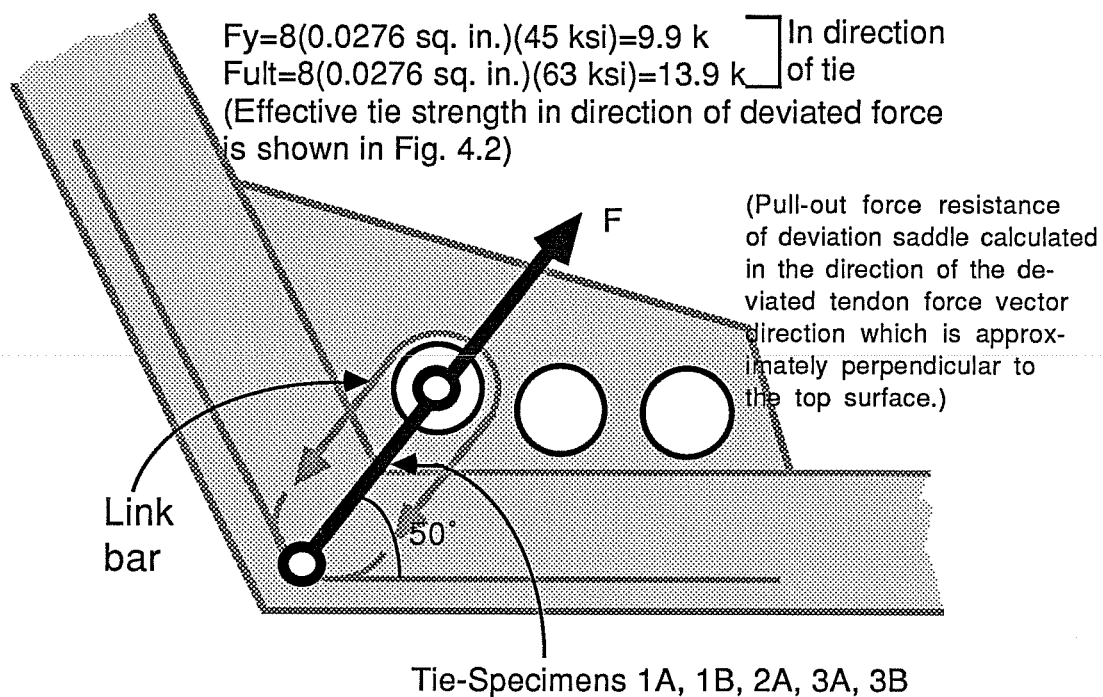
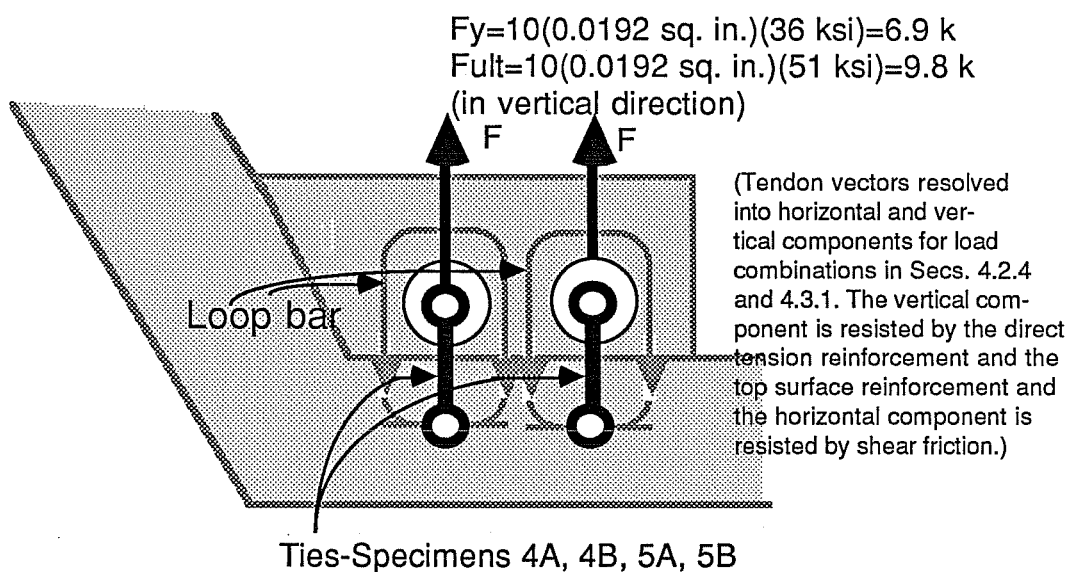
**Figure 4.14 Strut-and-Tie Models – Primary Reinforcement**

The reinforcement utilized in direct tension in the deviation saddles (link bars for specimens 1A, 1B, 2A, 3A, 3B and loop bars for specimens 4A, 4B, 5A, 5B) are simply tension ties linking the deviation force to the box reinforcement. This is shown in Fig. 4.14. In both cases, the direct tension reinforcement closely confined the tendon duct. For this reason, only a small volume of concrete was located between the reinforcement and the tendon duct. This facilitates an efficient transfer of force from the tendon ducts to the

reinforcement. This is much like the transfer of force in a properly detailed corbel where the bearing plate is directly attached to the primary tension reinforcement. The tension tie capacity is determined for yield and ultimate and is the same as that presented in the direct tension model of Sec. 4.2.1.

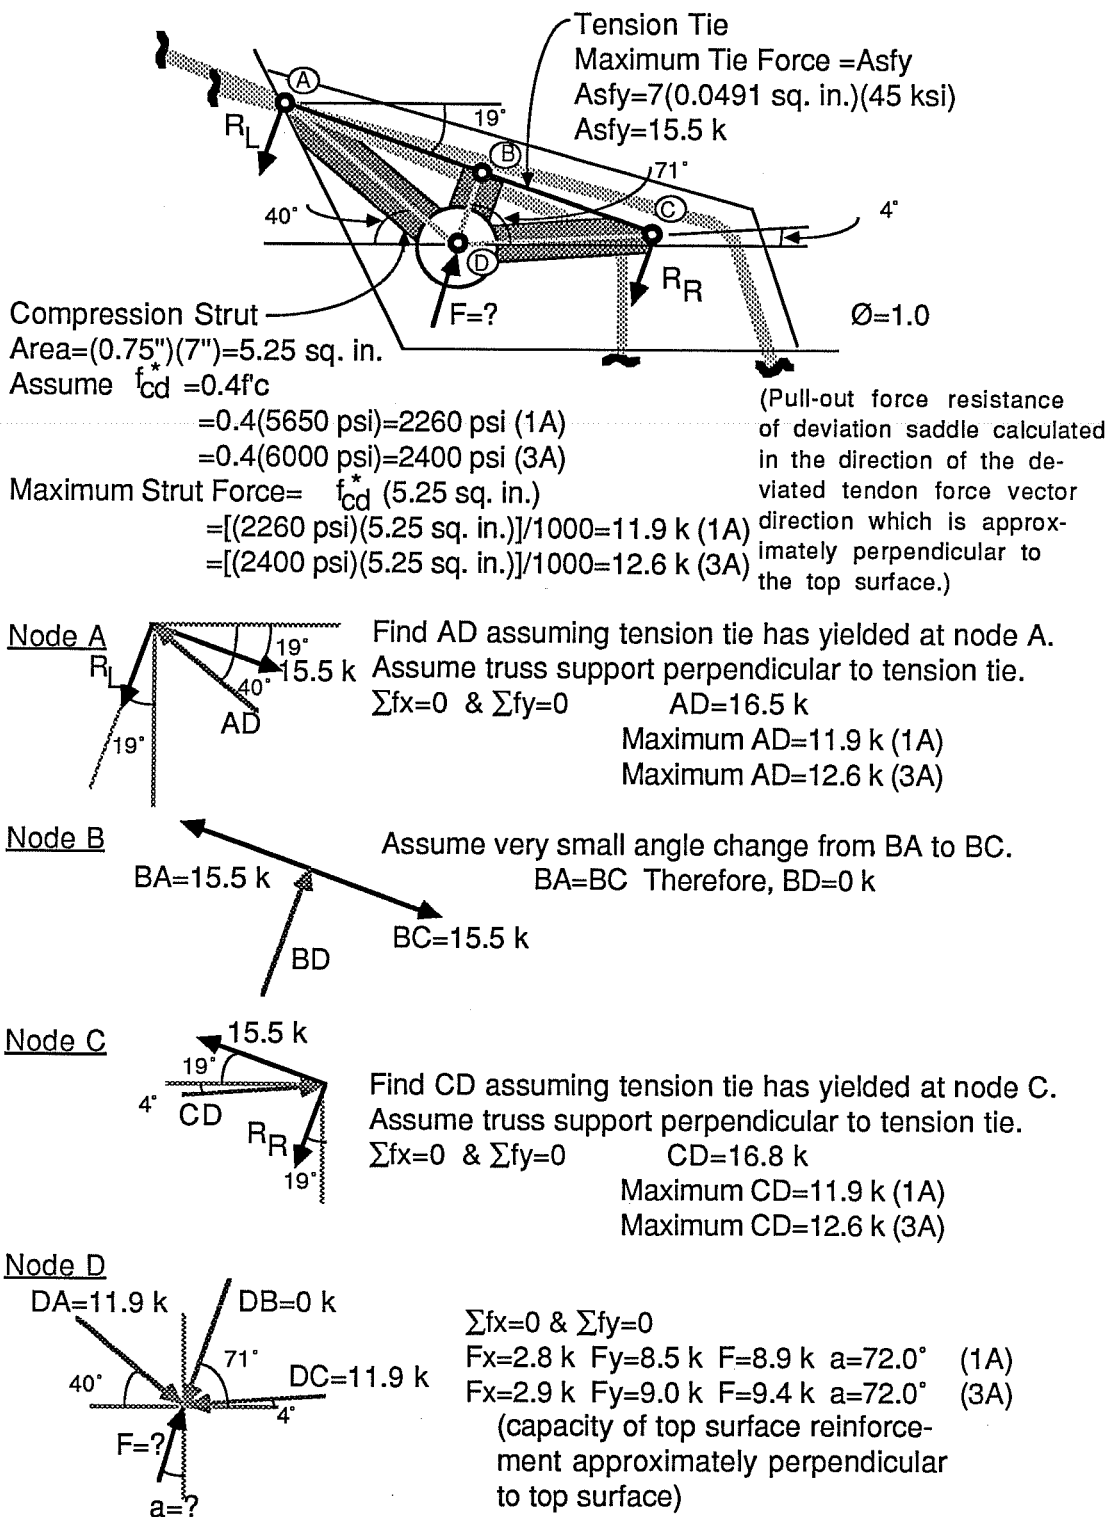
Figure 4.15 Strut-and-Tie Model – Top Surface Reinforcement – Tests 1A, 3A

The strut-and-tie models for the top surface reinforcement for specimens 1A, 1B, 2B, 3A, 3B are shown in Figs. 4.15-4.17. The tie was assumed to be at the centroid of the top surface reinforcement with one reaction located halfway between the vertical legs of the stirrups and the other at the web wall. An assumption of the maximum tie force based on yield of the reinforcement is made since it is unlikely the top surface reinforcement reached strain hardening because deformations were limited by the restraint of the direct tension reinforcement (all tests except 2B). Therefore, this strut-and-tie model for the top surface reinforcement will be used in the load combinations of Sec. 4.3.1 for yield and ultimate load stages. The size of the concrete compression struts was determined by drawing the truss to scale. The thickness of the struts in the deviation saddle was controlled by the size of the tendon duct. A maximum thickness taken so that the struts did not overlap at the tendon duct was determined from the scaled truss drawing to be 0.75". The angle of the struts (which was controlled by the tendon duct and tension tie location) was measured from the scaled drawings. The concrete strut widths were 7" which was the longitudinal length of the deviation saddle. The concrete struts on the outside (AD and CD) carry the force to the assumed reactions. The middle strut (BD) was provided because this is a location where a hinge forms. The force in the concrete struts was determined by initially assuming that the maximum tie force would be based on yield of the reinforcement. The corresponding compressive strut forces were then calculated as shown. In tests 1A, 3A, and 2B the calculated force for the compression struts (AD and CD) was greater than the maximum compressive strut force allowed for the maximum simplified concrete strength  $f_{cd}^*$  discussed above. Therefore, for the calculation of the force resistance in these specimens, the

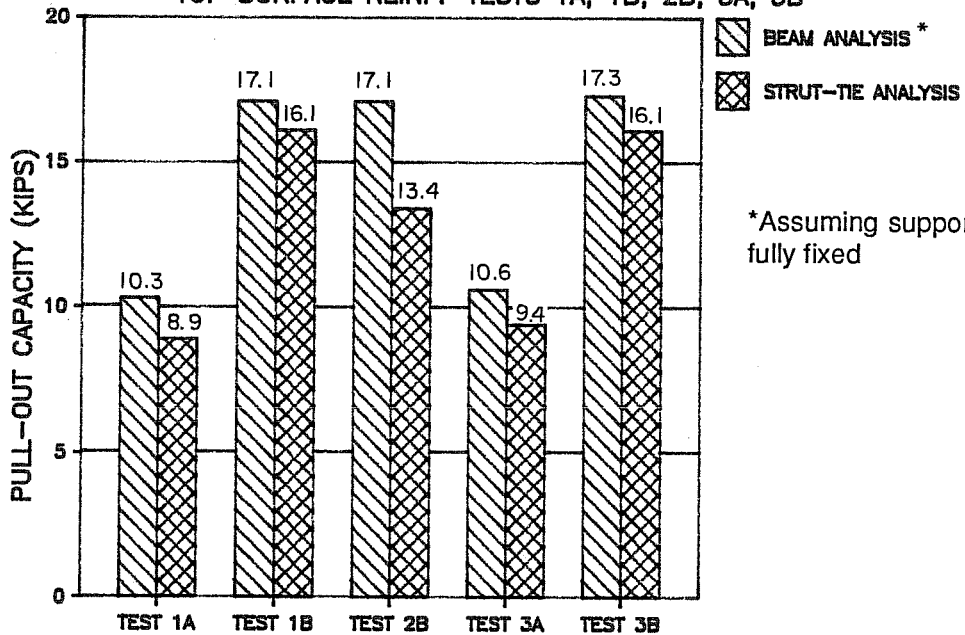
Figure 4.20 Comparison of Analysis Methods for Supplementary Top Surface Reinforcement Only

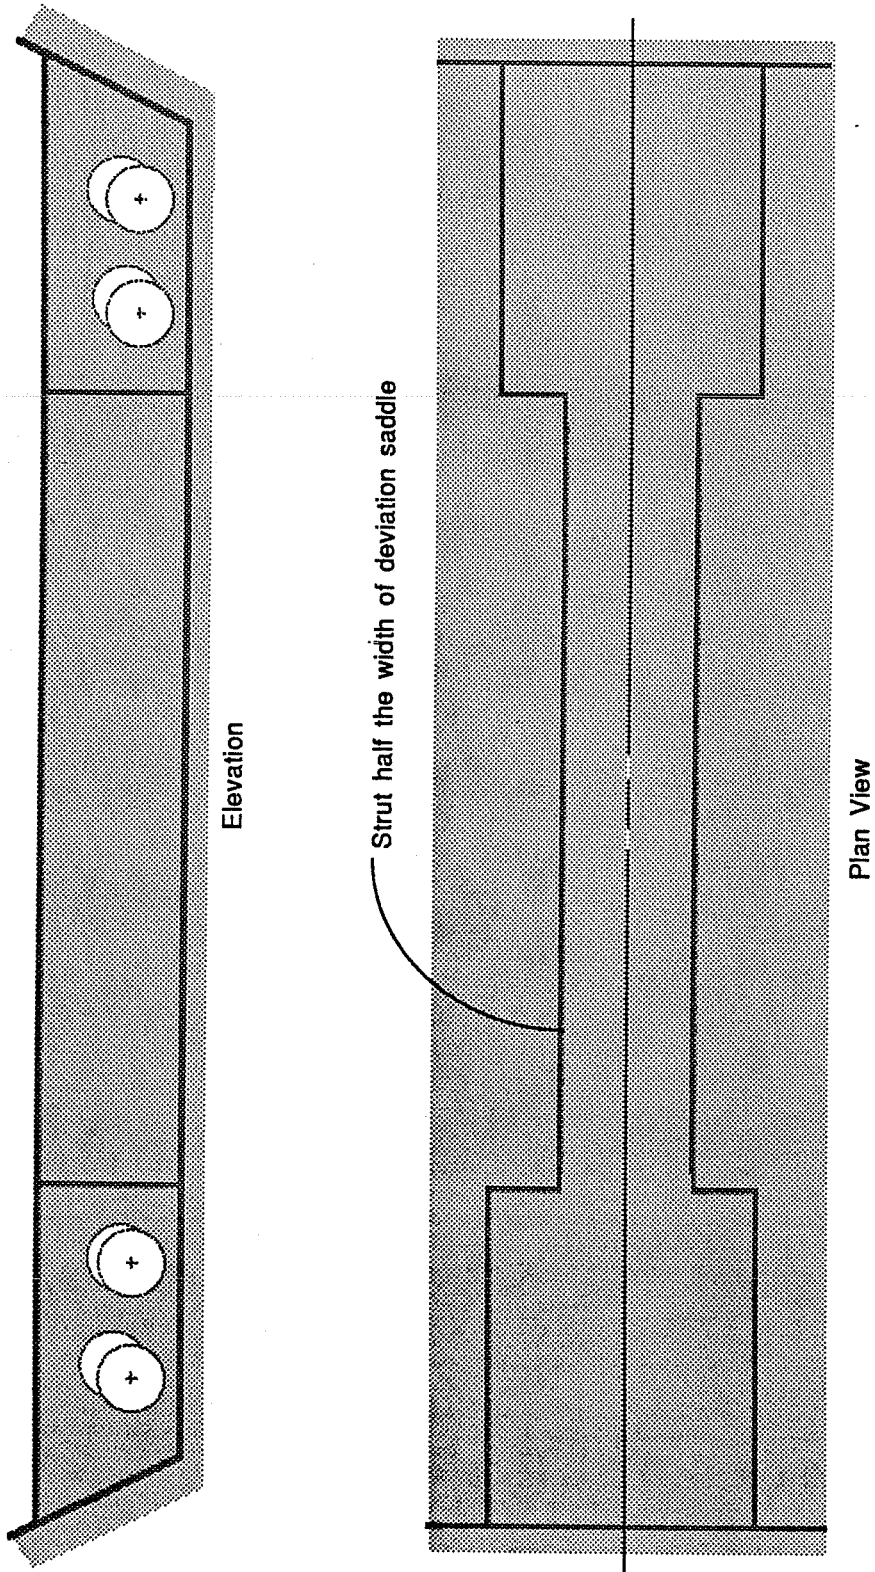
Figure 5.5 Plan And Elevation of Full Bottom Flange Deviation Saddle

The concrete dimensions of the deviation saddle are controlled by the requirements of the tendon duct curvatures and outer diameter, reinforcement clearances, and cover requirements. The lowest point of the tendon duct above the top of the bottom flange should be based on required clearance (1" to 2") for constructability (protective sheathing placed on extension of tendon duct is generally used for external post-tensioning). The location of the ducts transversely should be as close as possible to the web wall since it is desirable to have as small an eccentricity to the web as possible to minimize bending
