**PMFSEL REPORT NO. 96-2**  
**February, 1996**

**CORROSION PERFORMANCE OF A  
SECOND-GENERATION HIGH RATIO  
ZINC SILICATE COATING IN A  
REINFORCED CONCRETE  
ENVIRONMENT**

**INORGANIC COATINGS, INC.**

**PHIL M. FERGUSON STRUCTURAL ENGINEERING LABORATORY**  
**Department of Civil Engineering / Bureau of Engineering Research**  
**The University of Texas at Austin**

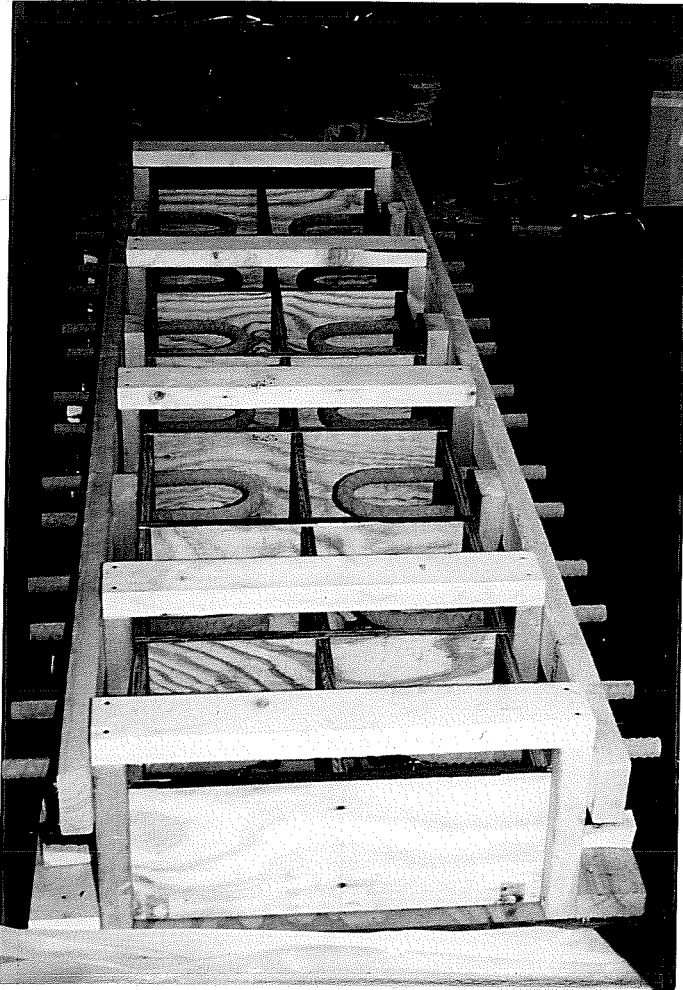
Figure 4-13 Completed macrocell formwork

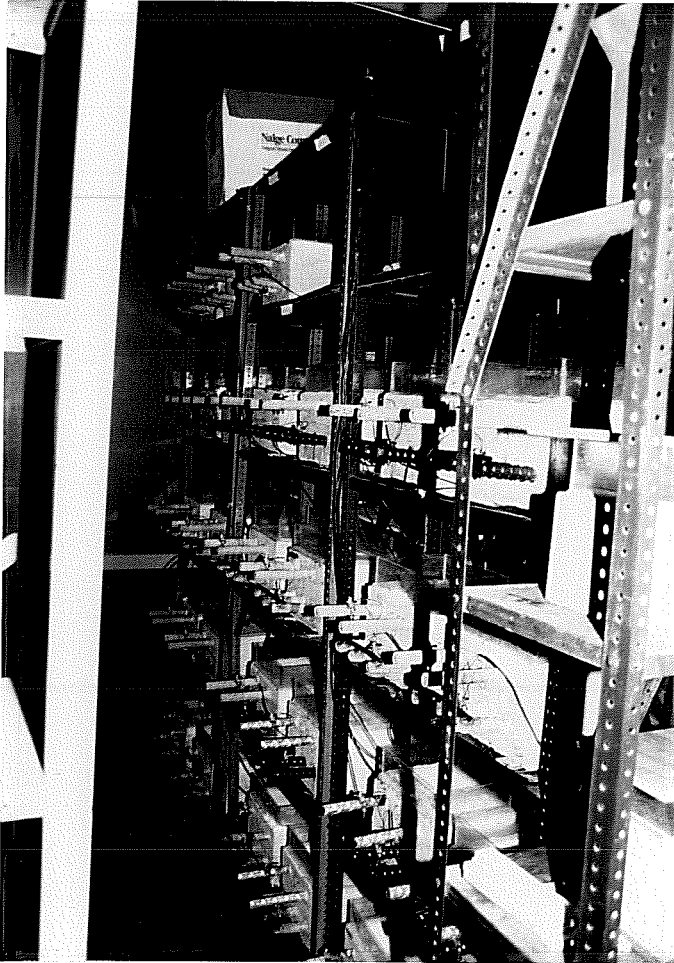
Figure 4- 16 Macrocells prior to first exposure

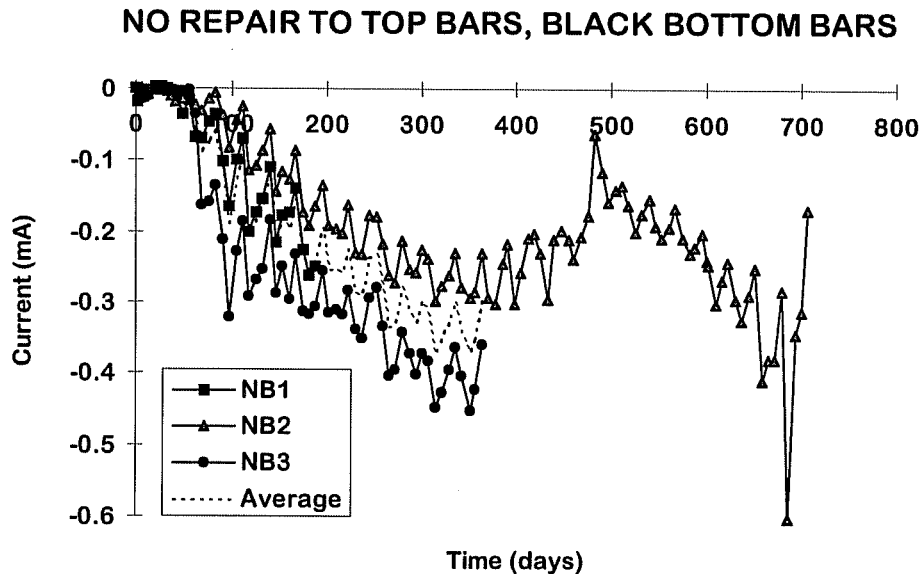
Figure 5- 1 Corrosion currents: Group 1

Figures 5.1-5.9 are presented below, and give the corrosion currents as a function of time for all the macrocell groups. The currents represent the flow of electrons from the top steel to the bottom steel. A high negative current is indicative of significant corrosion.

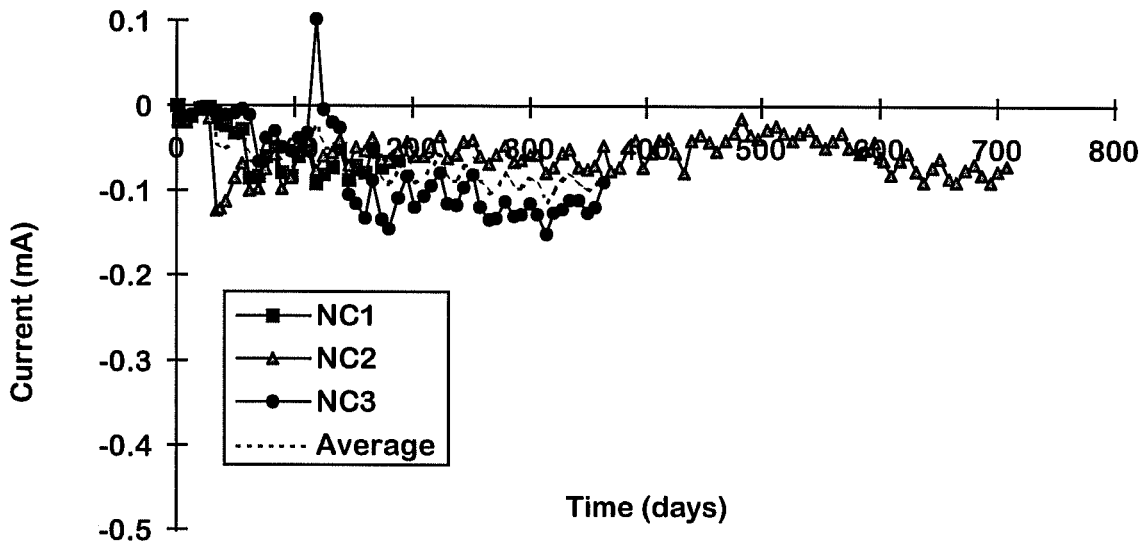
### NO REPAIR TO TOP BARS, COATED BOTTOM BARS

Figure 5-2 Corrosion currents: Group 2

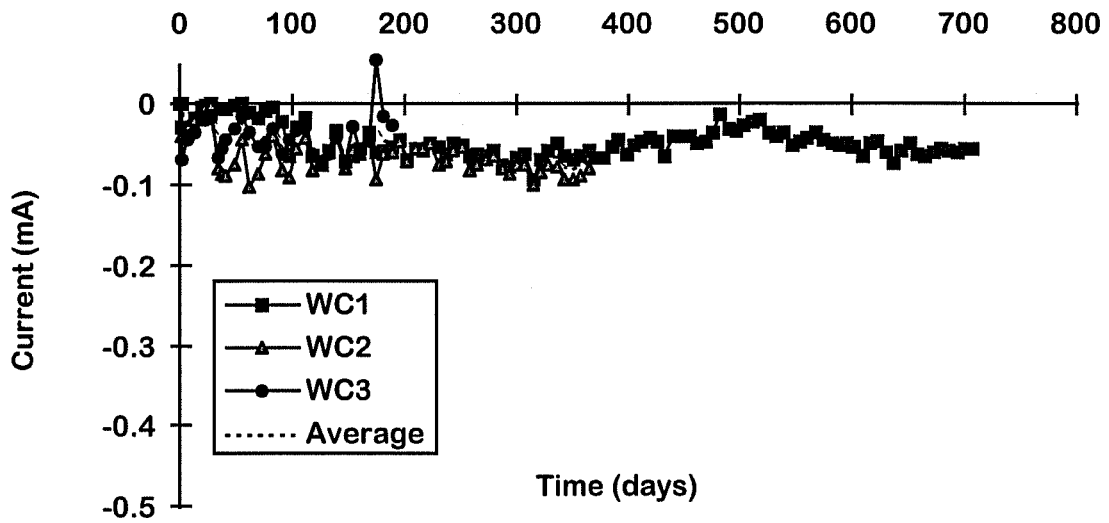
### WIRE BRUSHED AND RECOATED TOP BARS, COATED BOTTOM BARS

Figure 5-4 Corrosion currents: Group 4

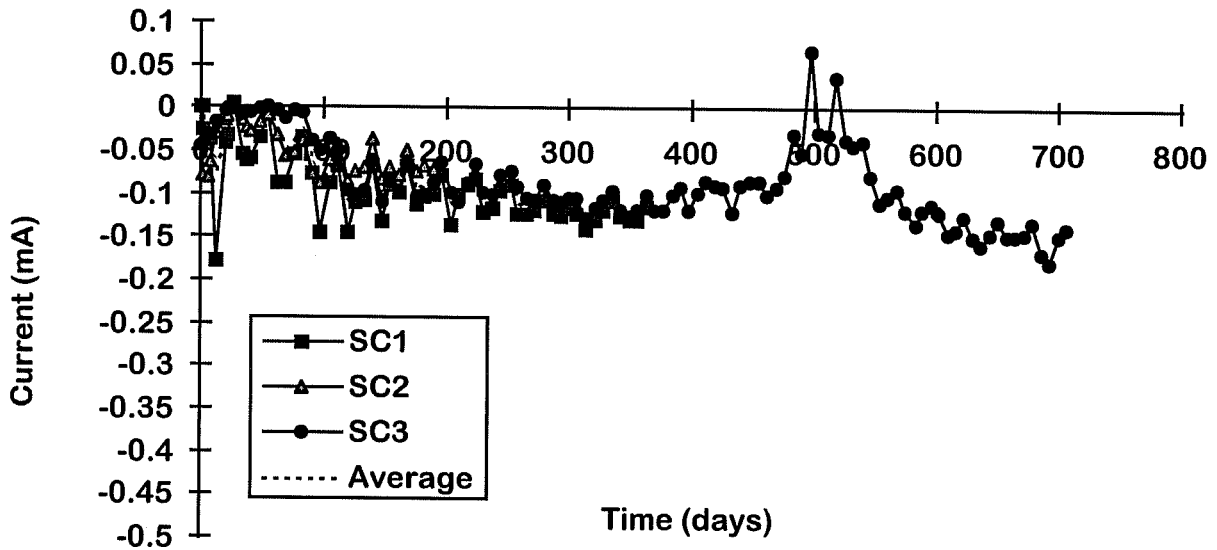
### GRIT-BLASTED AND RECOATED TOP BARS, COATED BOTTOM BARS

Figure 5-6 Corrosion currents: Group 6

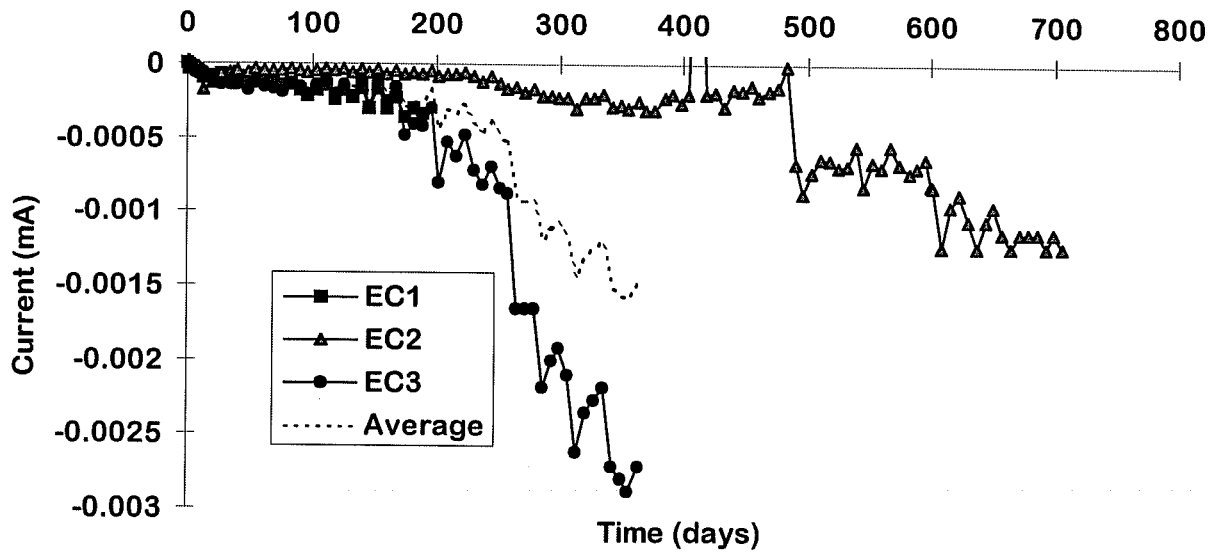
### EPOXY COATED TOP BARS, ZINC SILICATE COATED BOTTOM BARS

Figure 5-7 Corrosion currents: Group 7

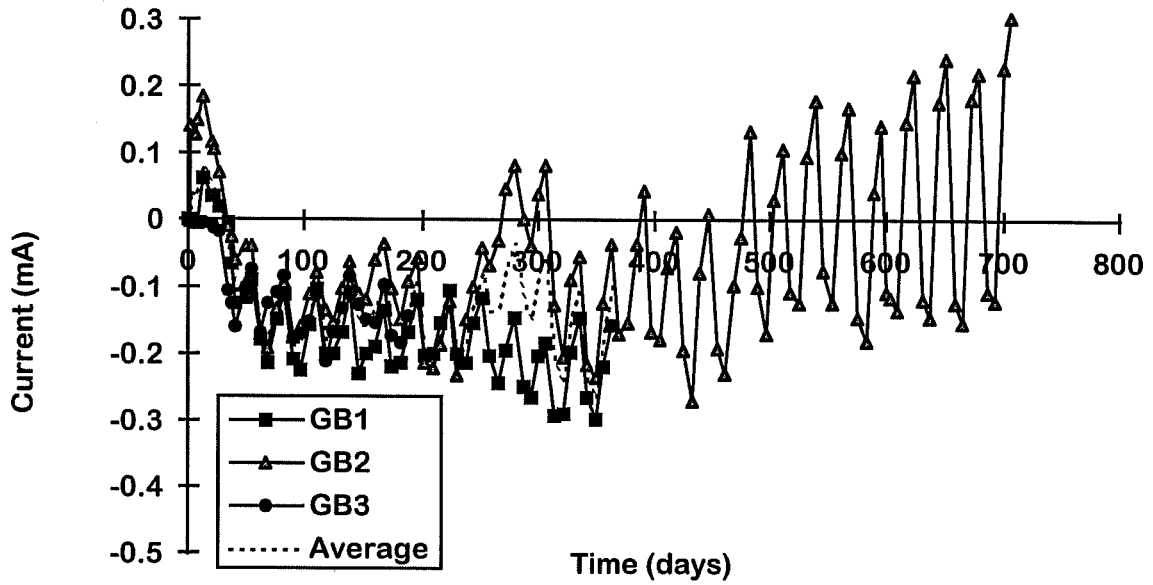
### GALVANIZED TOP BARS, BLACK BOTTOM BARS

Figure 5-8 Corrosion currents: Group 8

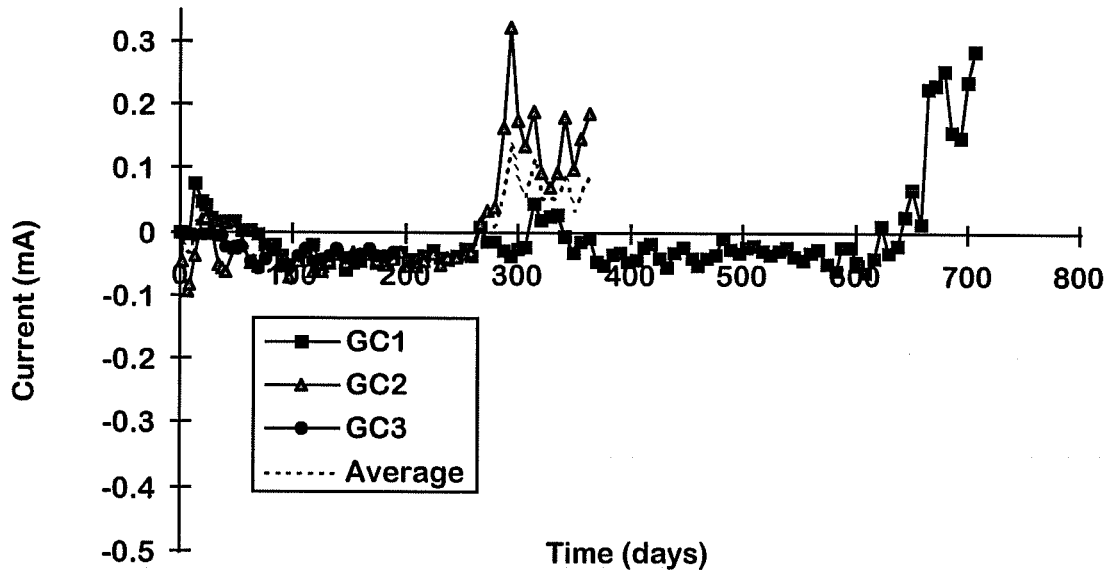
### GALVANIZED TOP BARS, COATED BOTTOM BARS

Figure 5-9 Corrosion currents: Group 9

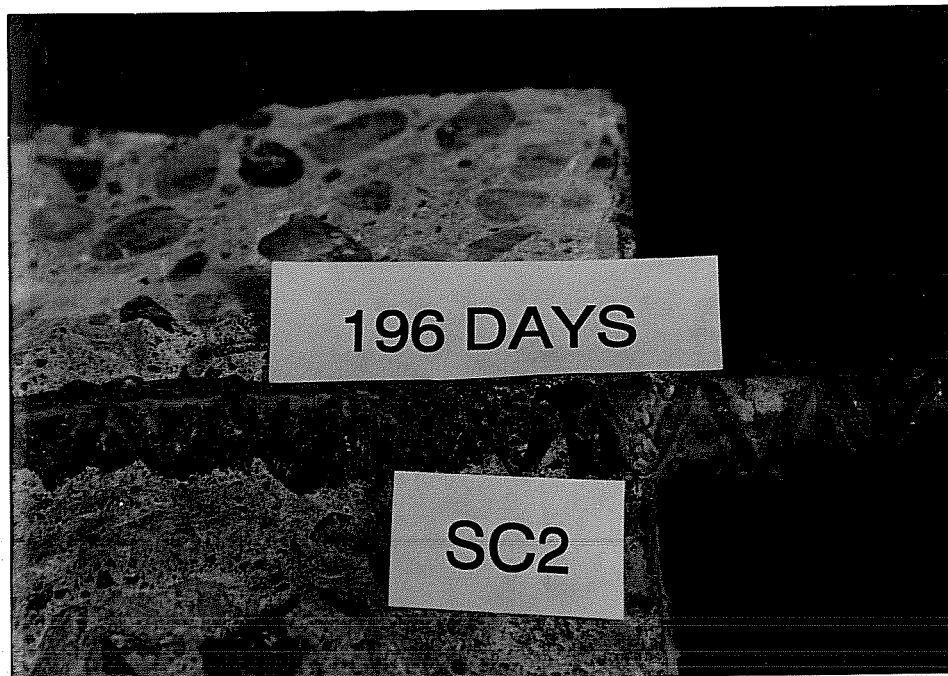
Figure 5- 19 Corrosion locations typical of high ratio zinc silicate specimens

The prominence of corrosion at the front-face locations indicates that the corrosion mechanism in the specimens during the first six months of exposure was likely the result of the test specimen geometry and was the result of microcell, rather than macrocell, action. Corrosion was concentrated in the areas highest in oxygen content, both in the specimens with uncoated cathodes and in the specimens with zinc silicate-coated cathodes. Oxygen affects corrosion primarily through the cathodic reaction, suggesting that both anodic and cathodic reactions were taking place on the top steel coated with the high ratio zinc silicate. Microcell corrosion near the front face was the initial governing mechanism with the new zinc silicate specimens.

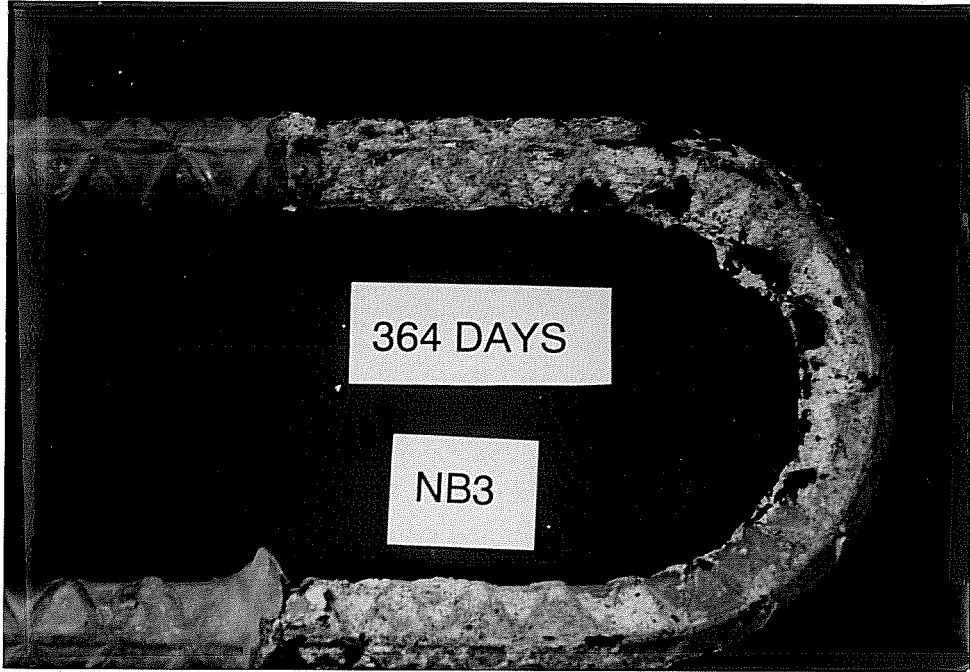
*Figure 5- 20 Corrosion: Top surface of NB3*

Specimens examined after 24 months of exposure exhibited many of the corrosion patterns previously observed after 7 and 13 months of exposure. Rust appeared in the first 1-3 inches from the front face of the macrocells. No corrosion preferential was observed for the resistor or the non-resistor ends of the

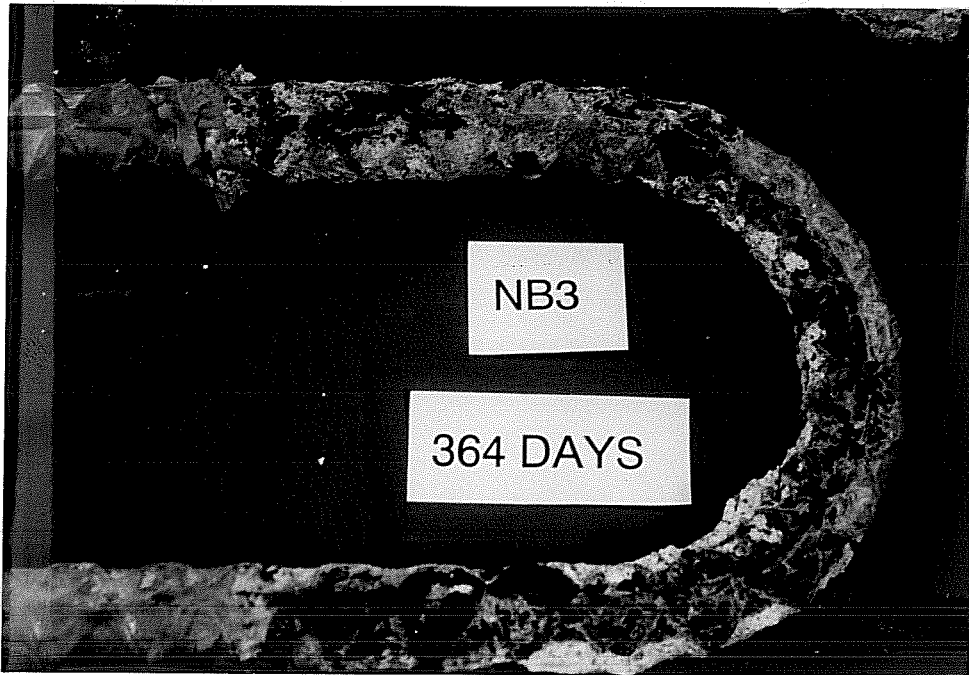
*Figure 5- 21 Corrosion: Bottom surface of NB3*

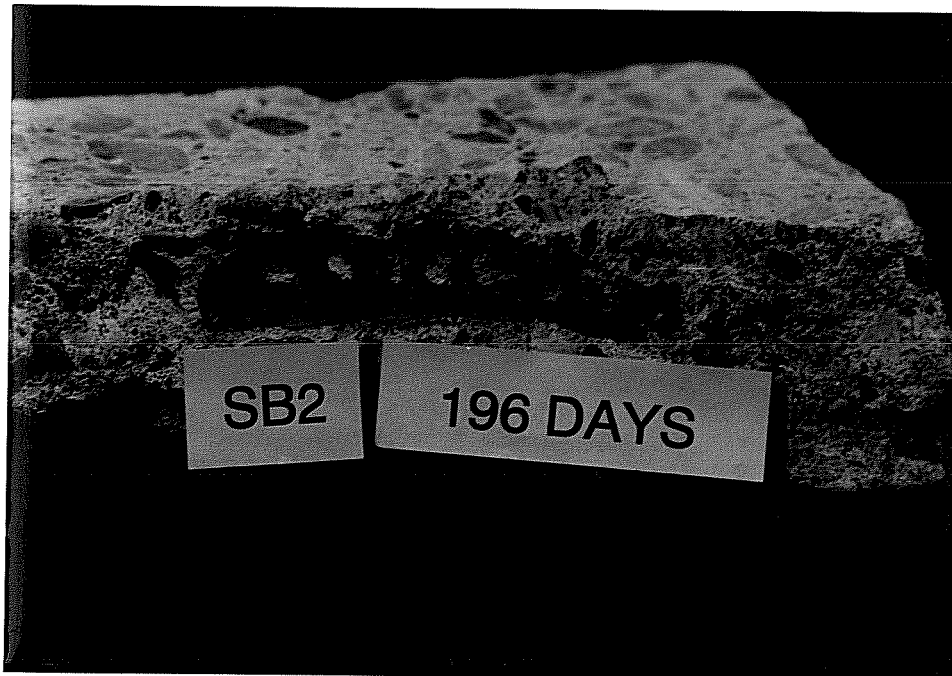
*Figure 5-25 Adhesion of high ratio zinc silicate coating to surrounding concrete*

The concrete-to-coating adhesion did not seem to be as strong as in the first generation of high ratio zinc silicate tested. Concrete adhesion seemed to be a critical factor in the failure of the earlier coating, and it was therefore a goal in the development of the second-generation zinc silicate to obtain a coating that

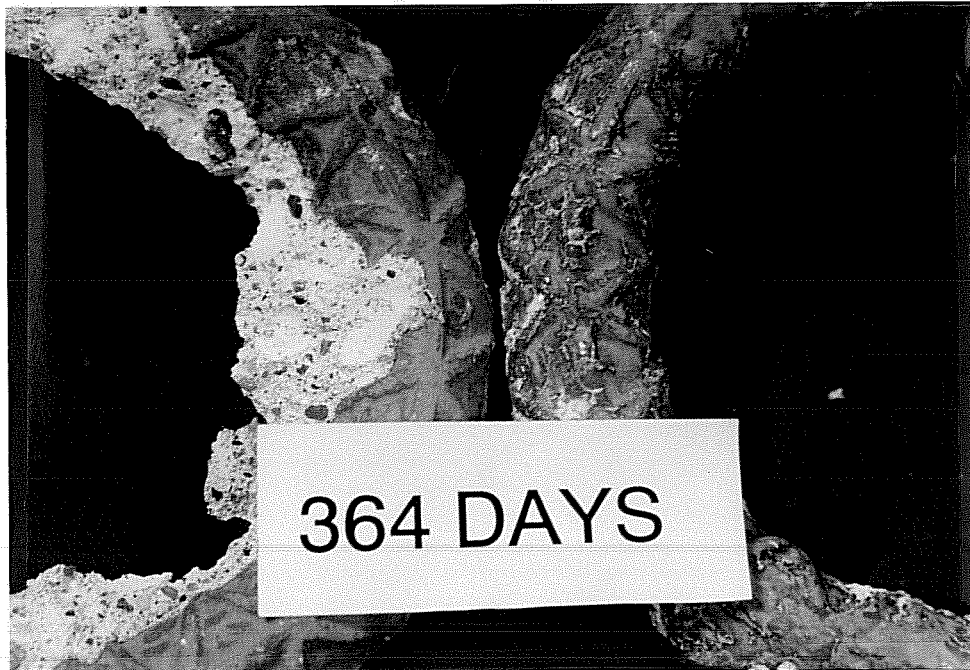
Figure 5- 27 Difference in texture — top and bottom surfaces
