**Evaluation of an Encapsulation and Epoxy
Resin
Injection Procedure for Rehabilitating
Corroding
Reinforced Concrete Structures**

Muhammed Alp Ünal and James O. Jirsa

PMFSEL Report 98-3

Ferguson Structural Engineering Laboratory

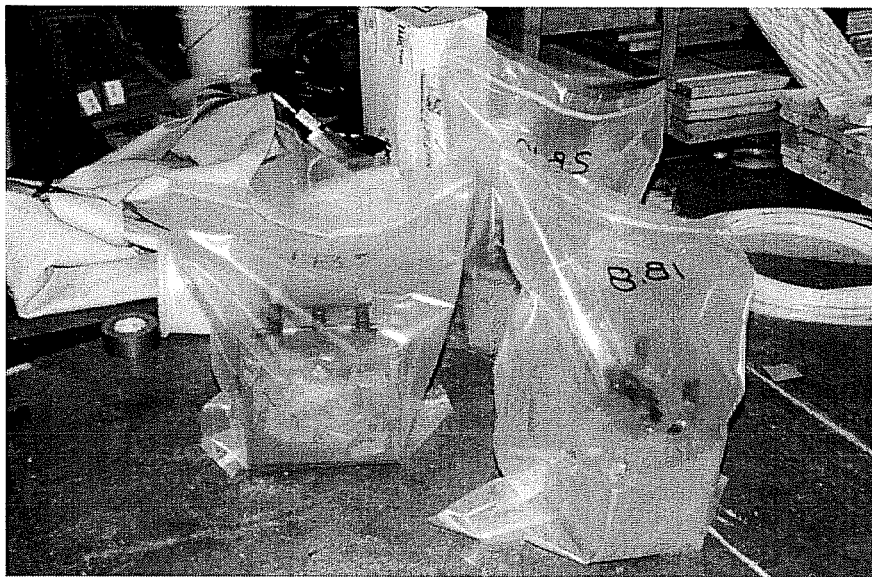
After the placement of the distribution media, injection ports were installed on the top and bottom faces of the macro-cells. Omega-shaped channels were used as injection ports (Figure 3.17). The macro-cells were placed in plastic bags and the ends of the bags were sealed (Figure 3.18).

Figure 3.18 Application of Plastic Bags.

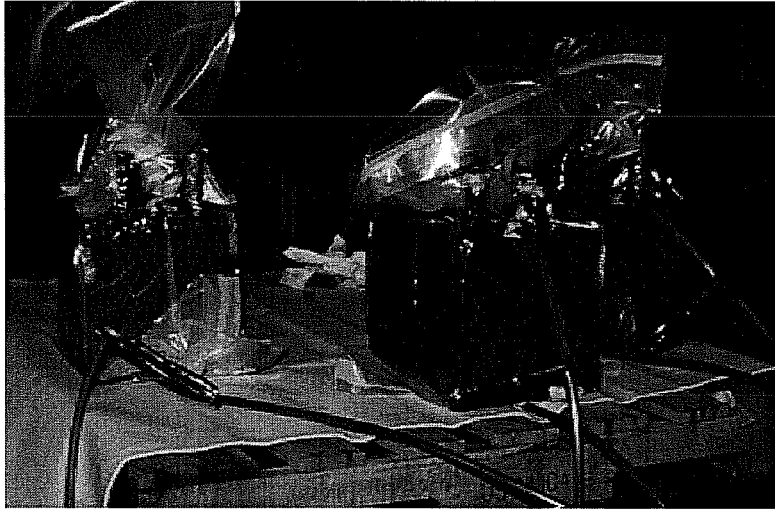
The feeder inlets were then installed (Figure 3.19). Leak checks were performed and all leaks were sealed with tackey tape. After 24 hours of evacuation at 27 inches of mercury, the resin was injected (Figures 3.20, 3.21 and 3.22). After a 24-hour curing period, all hoses were removed and the macro-cells were removed from the plastic bags (Figure 3.23).

Figure 3.22 End of Process.

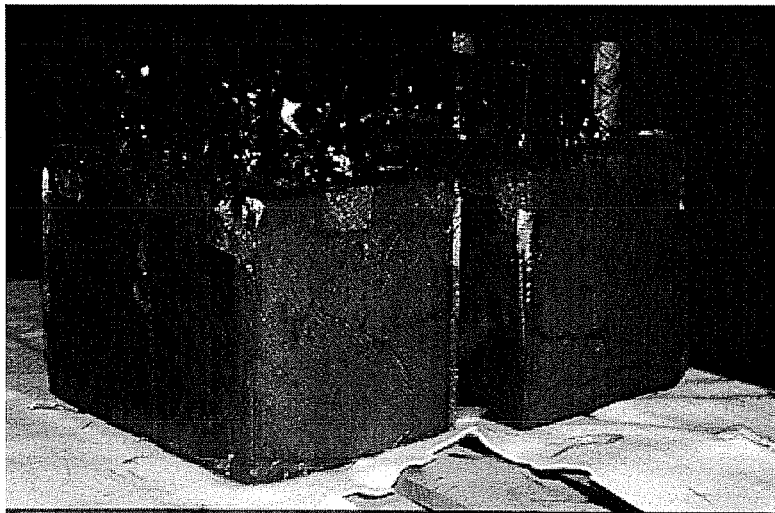
Figure 3.23 Post Infusion Clean-up.

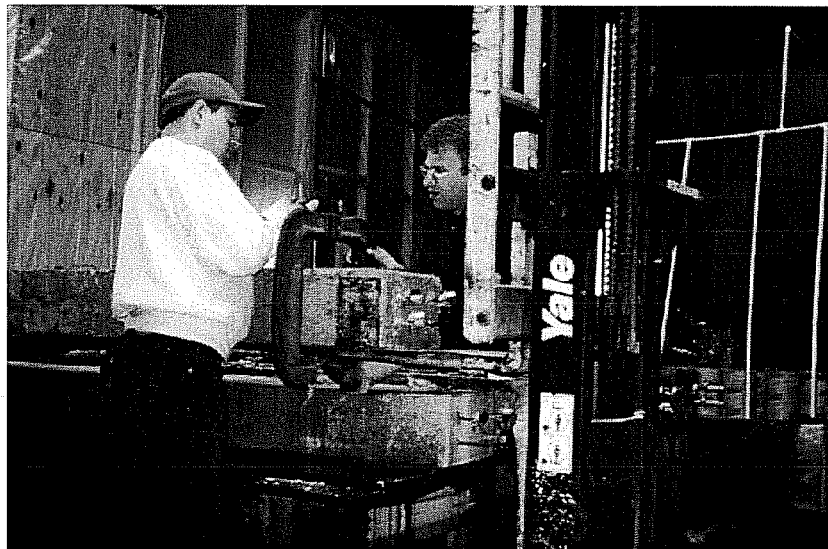
The beams were placed on wood stands inside the pool to support them above the collected water. Figure 4.3 shows the placement of the beams on the stands. Figure 4.4 shows the retaining pool, the recirculation pump, and the PVC distribution pipes.

Figure 4.3 Placing the Beams on Wood Stands in the Retaining Pool.

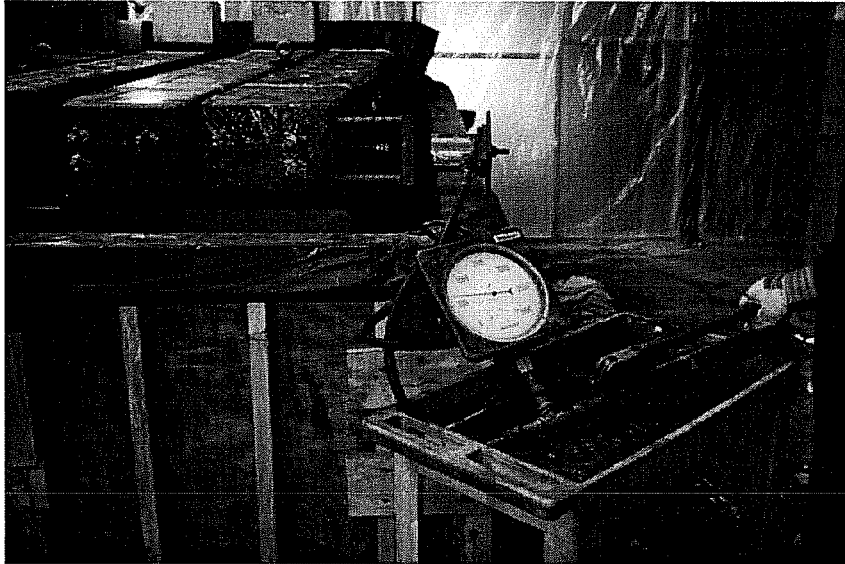
Once the exposure study started, four of the six beams (two encapsulated, two control beams) were loaded back to back, while two were not loaded. The loading setup can be seen in Figure 4.6. Once each week the four loaded beams were unloaded and reloaded 5 times. The last load was maintained to keep the cracks open (this was done in the previous study). Load levels were the same as in the previous study.

Figure 4.6 The Loading Process.

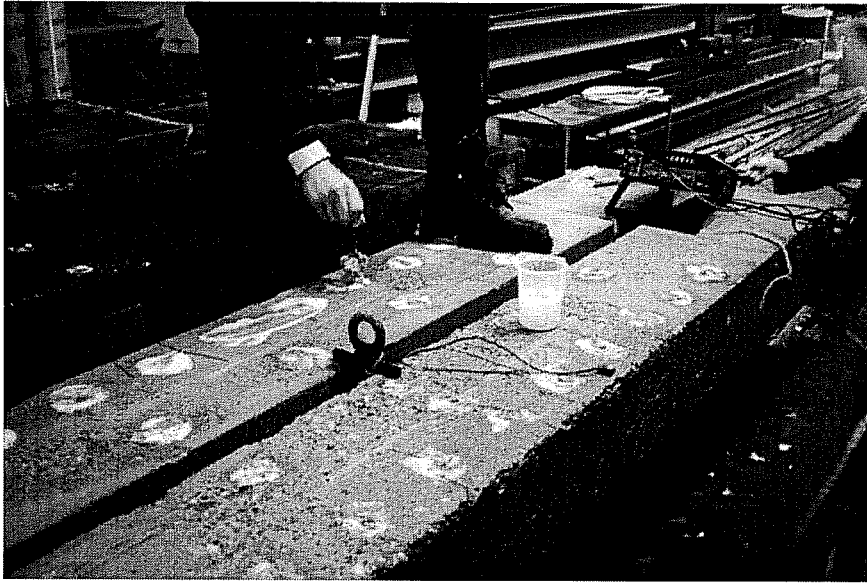
For one year, half-cell potential readings against a saturated calomel reference electrode (SCE) were taken. The readings were taken weekly for the control specimens and every 3 months for the encapsulated ones. The 3-month intervals were selected so that the composite shell on the encapsulated beams would not be disturbed. Figures 4.7 and 4.8 show the procedure for taking half-cell potential readings for unencapsulated and encapsulated beams respectively. For the encapsulated beams, a number of access holes through the fiber composite were provided along the beams at the level of the bars in order to access the concrete surface for half-cell potential measurements. The holes were limited in number in order to avoid disturbing the continuity of the encapsulated beams. Figure 4.9 shows the access holes on encapsulated beams. After taking the readings, the access holes were sealed using silicon. When the access holes were opened in order to take the readings a clear fluid was found inside the holes. The fluid was collected and analyzed; the results are discussed in Chapter 5. For the control specimens, readings were continued on a weekly basis since the surface could be accessed at the same locations as in the previous study.

Figure 4.7 Macro-Cell Readings-Unencapsulated Beams.

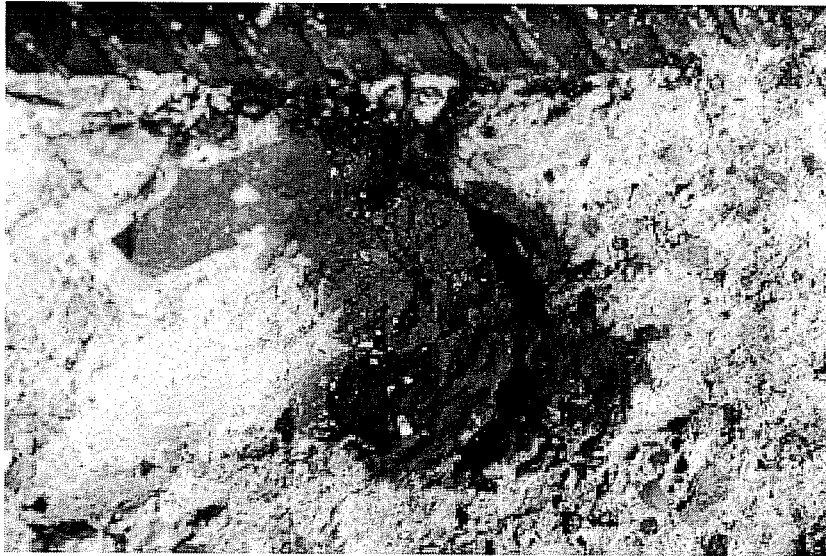
When the beams were opened, a dark green fluid, generally indicative of active corrosion was found along the black (uncoated) bars in all beams. The amount and viscosity of this fluid changed from beam to beam. Figures 5.7 and 5.8 show this corrosion fluid in beams 30 and 34.

Figure 5.7 Green Corrosion Fluid on Beam 30.

Figure 5.8 Green Corrosion Fluid on Beam 34.

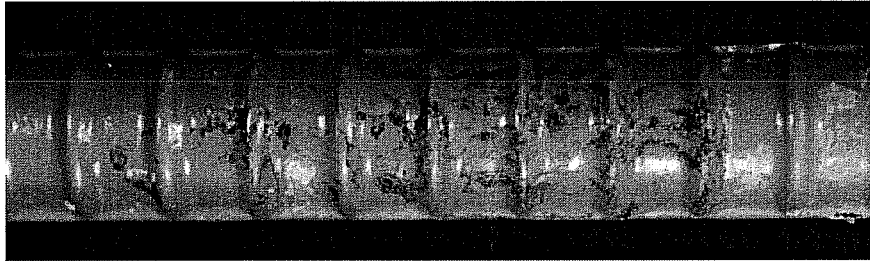
coating generally corresponded with the locations of splices, intentionally damaged areas on epoxy coating, intentionally damaged and patched areas on epoxy coating, and crack locations. Figure 5.10 shows how well the epoxy-coated bars performed. Figures 5.11 and 5.12 show the rust stains on and underneath the epoxy coating. Figure 5.13 shows the damage underneath the epoxy coating for Beam 12, while the same bar is seen without any damage in spite of the intentional damage shown in Figure 5.14. These differences were primarily related to crack locations.

Figure 5.11 Rust Stains on Epoxy-coated Bar (Beam 6).

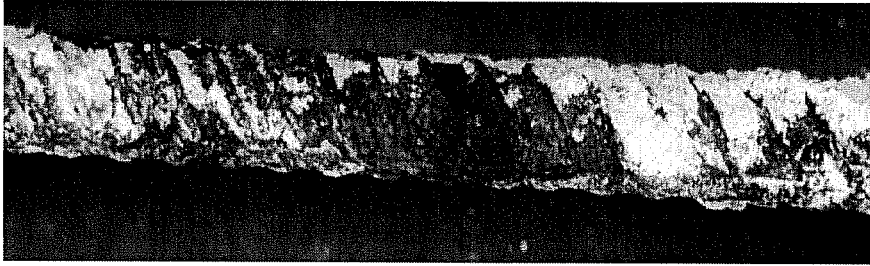
In the uncoated bars of all beams, significant loss of steel areas as well as pitting in several locations was observed. Significant loss of steel area is shown in Figure 5.15 for the Beam 19 bottom black bar near the stirrup, in Figure 5.16 for Beam 6 bottom black bar in the previously exposed region, and in Figure 5.17 for Beam 12 top black bar in the previously exposed area. The loss of bar area shown was typical of the black bars of all the beams. Significant loss of bar area is defined as loss of more than 15-20 percent of the bar area. For the control specimens, corrosion damage extended outside the previously exposed region in the form of pitting (Figures 5.18, 5.19). In pitting corrosion, the profile of the bar remains the same. There are pits that do not significantly (less than 10 percent) change the bar area. For the encapsulated specimens the damage was usually within the previously exposed region. All of the encapsulated specimens, however, showed pitting corrosion at the end of the beams (Figures 5.20, 5.21). It is likely that the ends of the encapsulated beams were not sealed properly around the protruding bars, and corrosion was initiated in regions where no corrosion had occurred earlier. Corrosion activity on the black bars in the encapsulated specimens appeared to be greater than the damage in the control (unencapsulated) specimens.

Figure 5.18 Corrosion Outside the Previous Exposed Region (Beam 12).

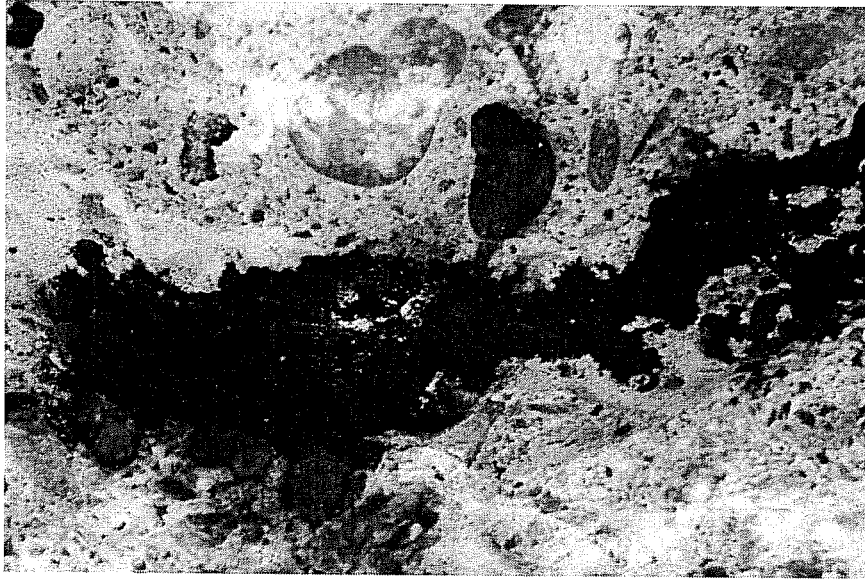
When the macro-cells were opened, a green fluid was found in all the macro-cells on and near the straight black bars and on the bent black bar. 5.30, 5.31, and 5.32 show the fluid and stains on specimens 2B11, 3B9, and 2B10. Figure 5.33 shows the fluid staining the concrete after removing the bent black bar from specimen 1B8.

Figure 5.33 Active Corrosion on Concrete Bent Black Bar Side (1B8).
