**STRENGTHENING OF INFILLED NON-DUCTILE CONCRETE FRAME
COLUMN REINFORCEMENT SPLICES**

THESIS

The University of Texas at Austin

December 1990

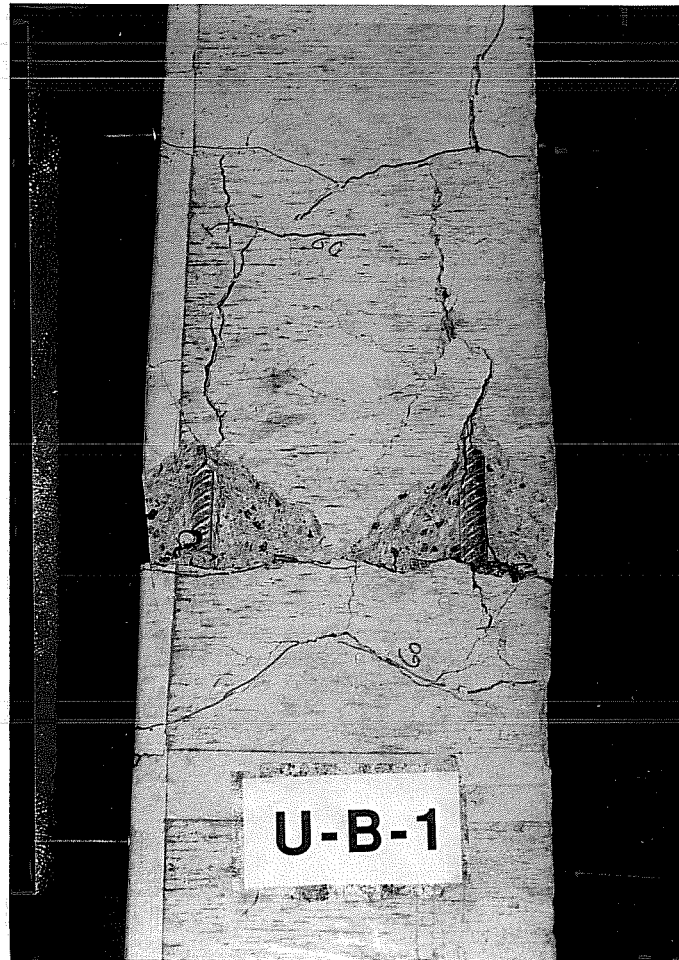
Figure 35. Failure mode of U-B-1.

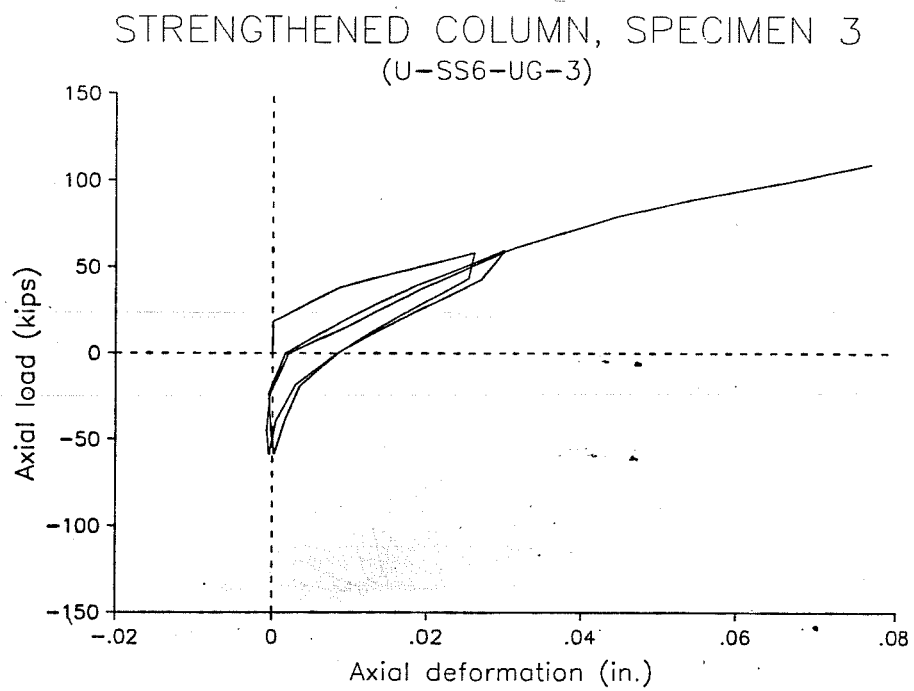
90 kips (see Figure 37) while U-SS6-UG-2 and U-SS6-UG-3 reached 120 kips (see Figures 38 and 39). The end connection hooks failed at 120 kips (the yield load). Specimen U-SS6-UG-1 failed in tensile splitting while the confining steel in Specimens U-SS6-UG-2 and U-SS6-UG-3 was tight enough on the column to hold the splitting cracks closed. Though U-SS6-UG-1 failed in a different mode, the strengthening technique still improved the splice performance by preventing

Figure 38. Response of steel straps, ungrouted specimen 2 (U-SS6-UG-2).

Figure 39. Response of steel straps, ungrouted specimen 3 (U-SS6-UG-3).

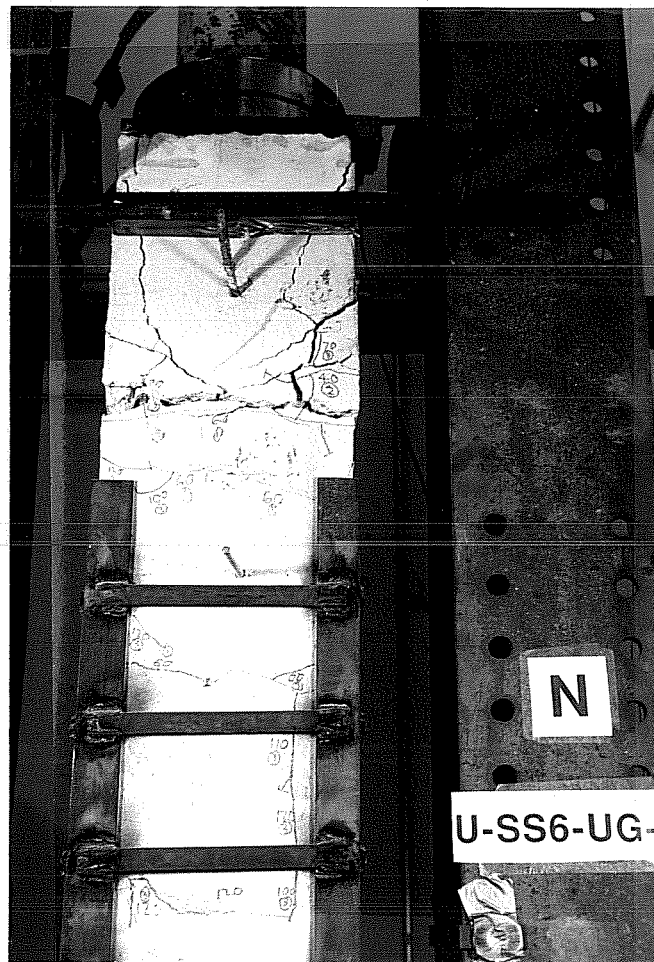
Figure 41. Failure mode of specimen U-SS6-UG-2 and U-SS6-UG-3.

Also, failure in each specimen occurred on the same face of the column. The specimens were cast horizontally. No top bar effect had been anticipated since there was less than 12" of concrete below the bars (see ACI 318-83), but each specimen failed at the top face.
