TENSILE CAPACITY OF HIGH-STRENGTH  
ANCHOR BOLT GROUPS EMBEDDED IN  
CIRCULAR CONCRETE PIERS

T H E S I S

Presented to the Faculty of the Graduate School of  
The University of Texas at Austin  
in Partial Fulfillment  
of the Requirements  
for the Degree of  
MASTER OF SCIENCE IN ENGINEERING

December 1982

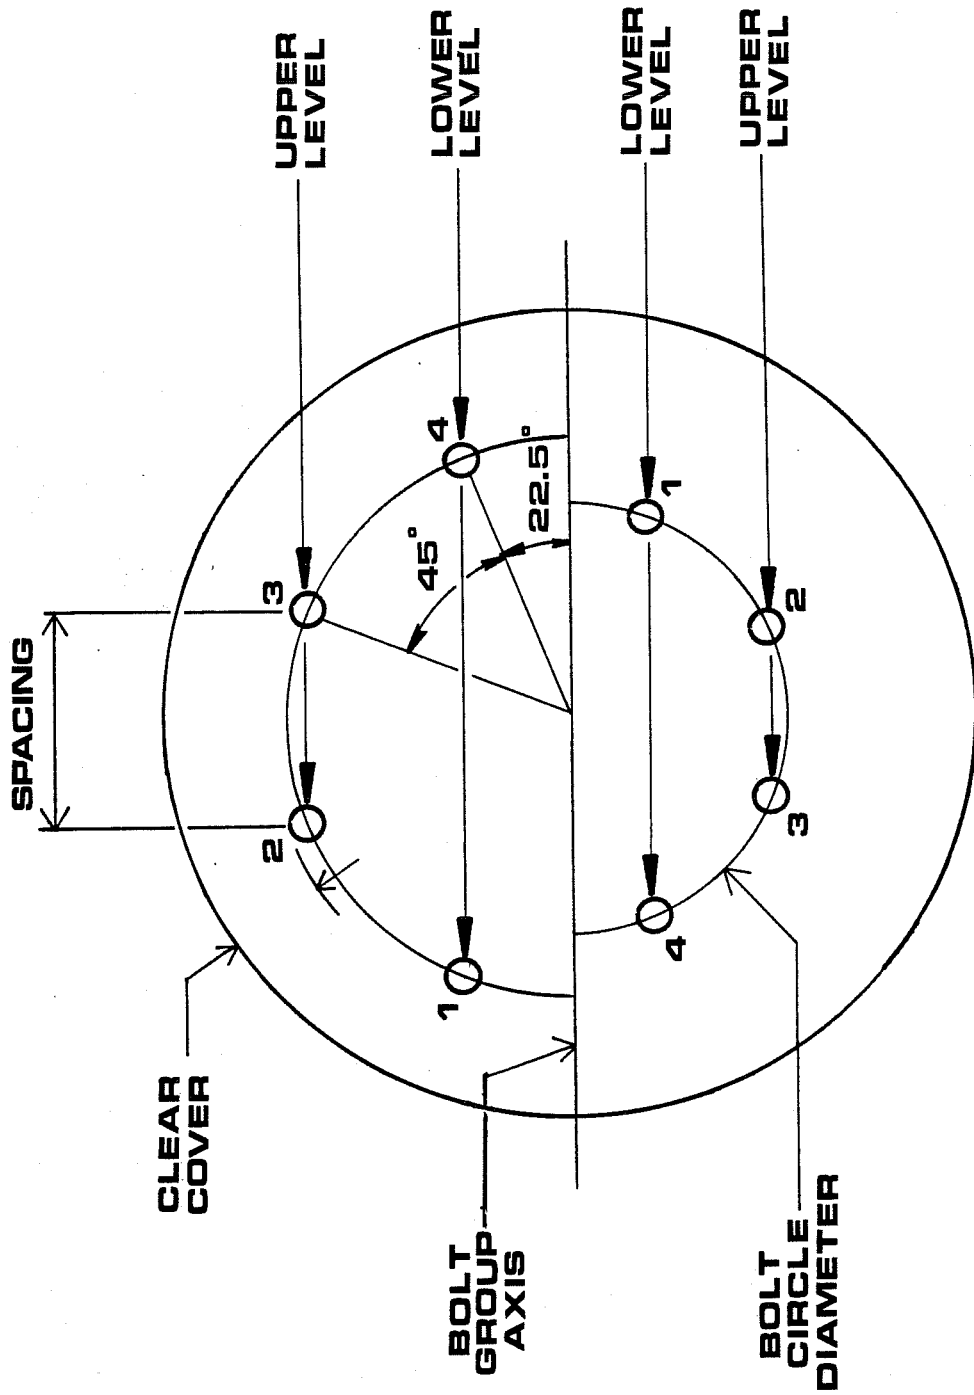
Fig. 2.5 Bolt group nomenclature

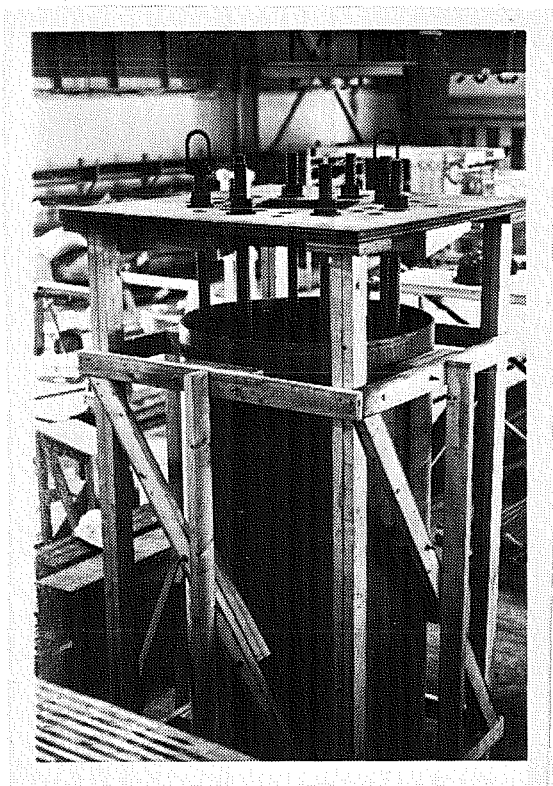
Fig. 2.6 Bolt template mounted on wood frame

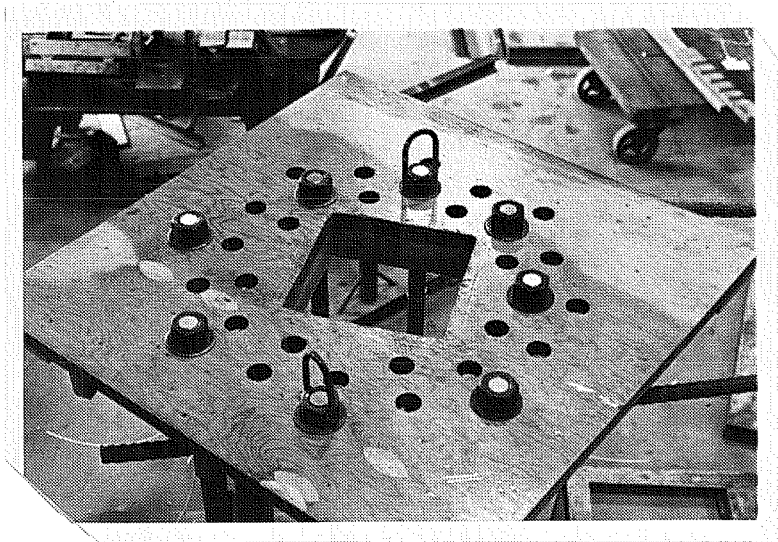
Fig. 2.8 Anchor bolt template

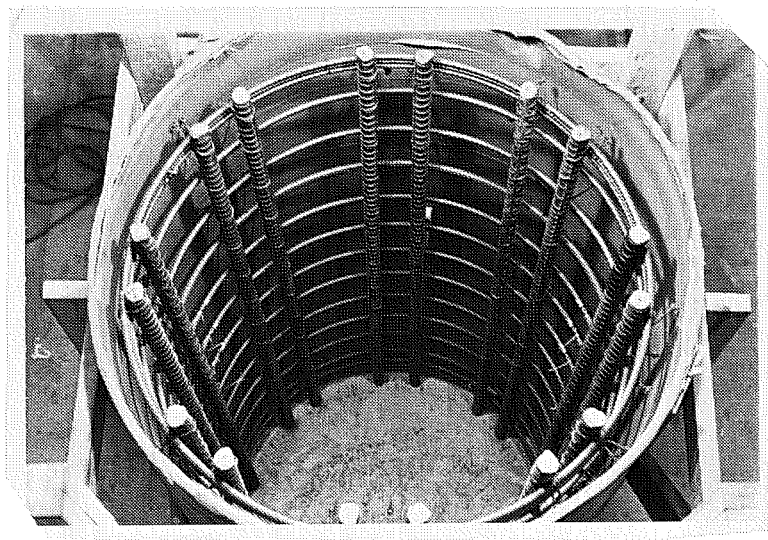
Fig. 2.9 Spiral cage in place

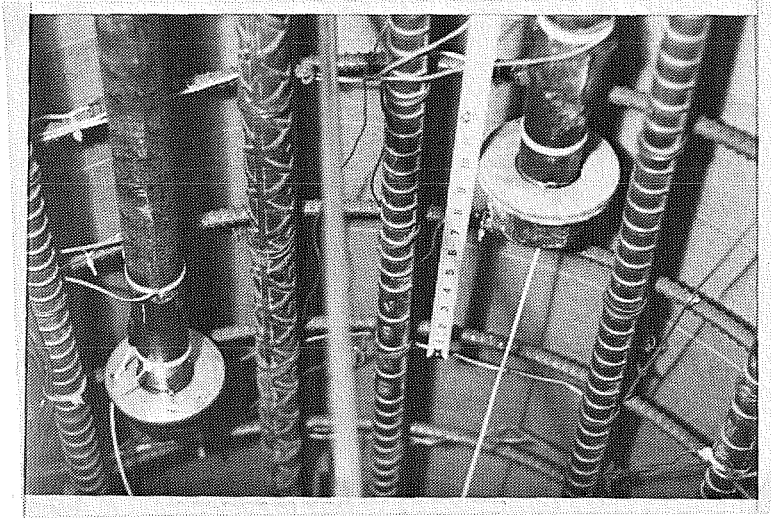
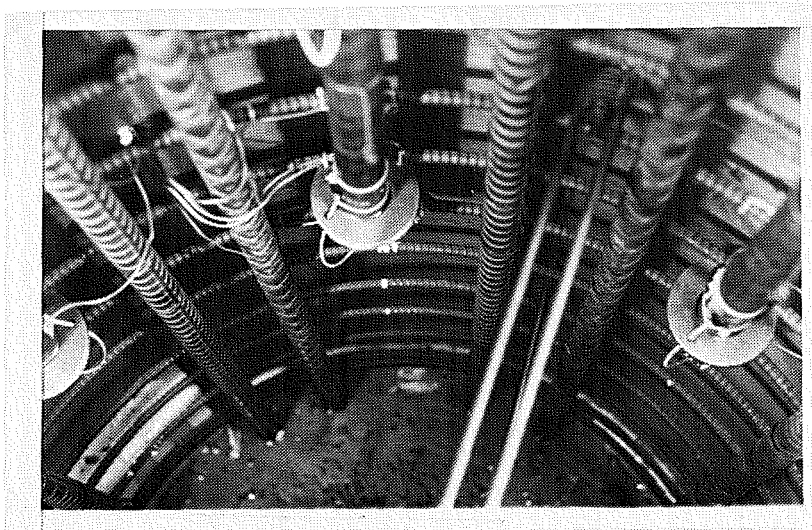
Fig. 2.10 Bolts inside formwork – tests STG1 and SC7

As suggested in Fig 3.21c (front view), the splitting in plane 2BB'2 and 3DD'3 is most likely restrained by the spiral bars placed in the test specimens (Fig. 2.10). A large cover also diminishes the likelihood of these planes extending completely to the exterior of the specimen.

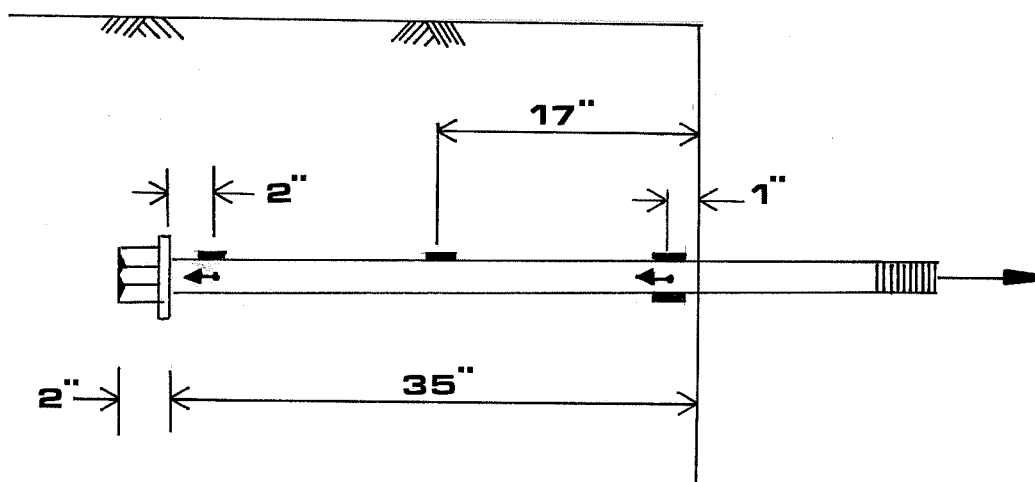
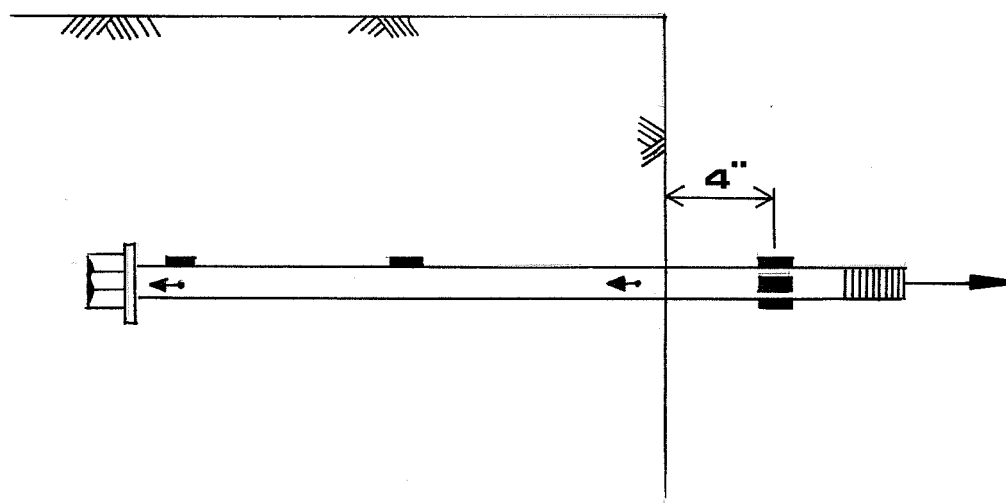
The location of strain gages along the bolt is illustrated in Fig. 2.13. For the first four tests, two gages were placed just below the face of the concrete; one at mid length, and one at the anchorage

(a) Tests SC1 through SC4

(b) Tests NOW through STG2

Fig. 2.13 Location of bolt instrumentation

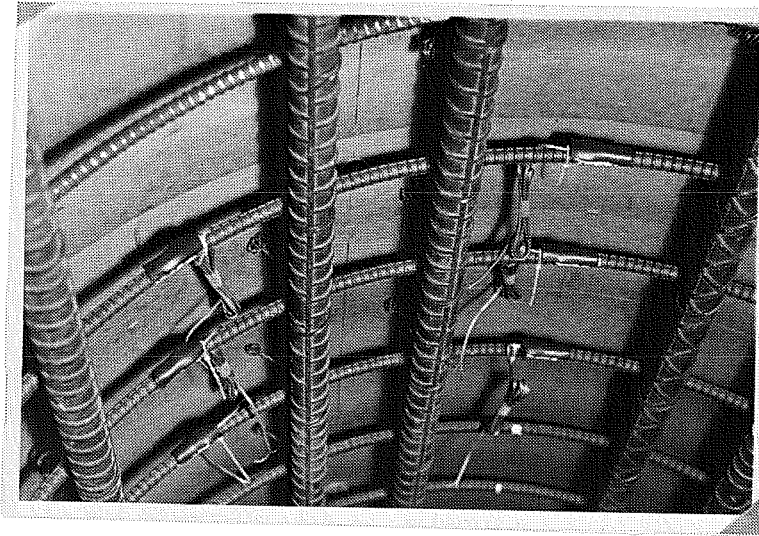
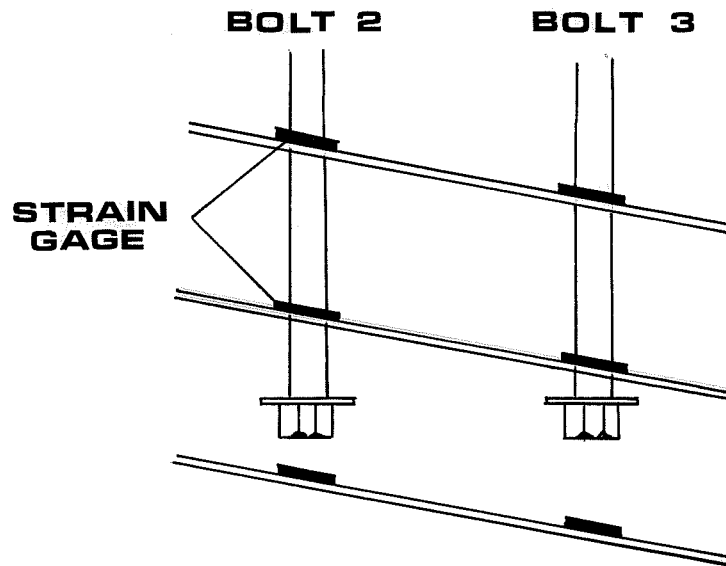
Fig. 2.14 Strain gages mounted on spiral bars at the anchorage end of the top bolts

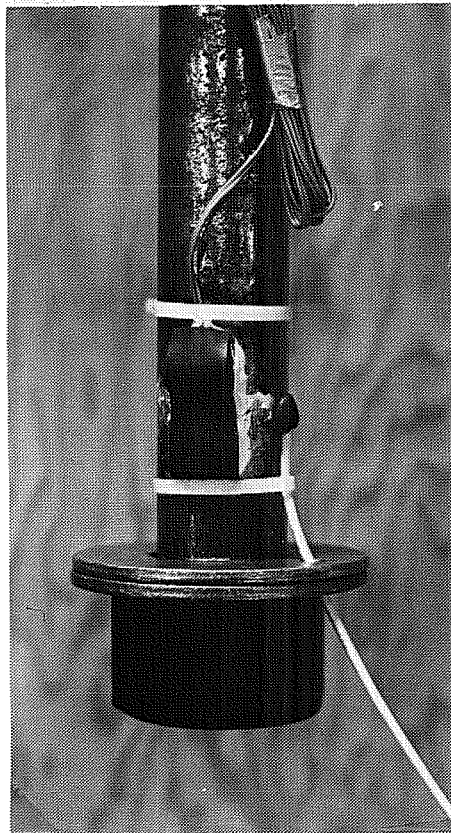
Fig. 2.15 (a) Lead slip wire; (b) tail slip wire and strain gage at the anchorage end.

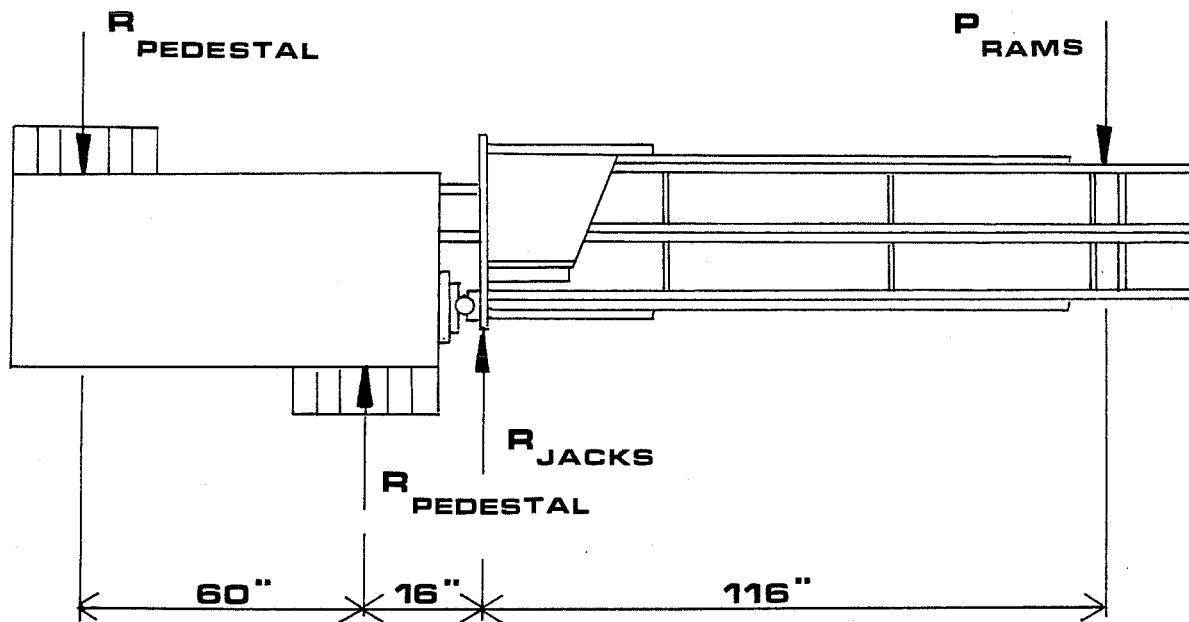
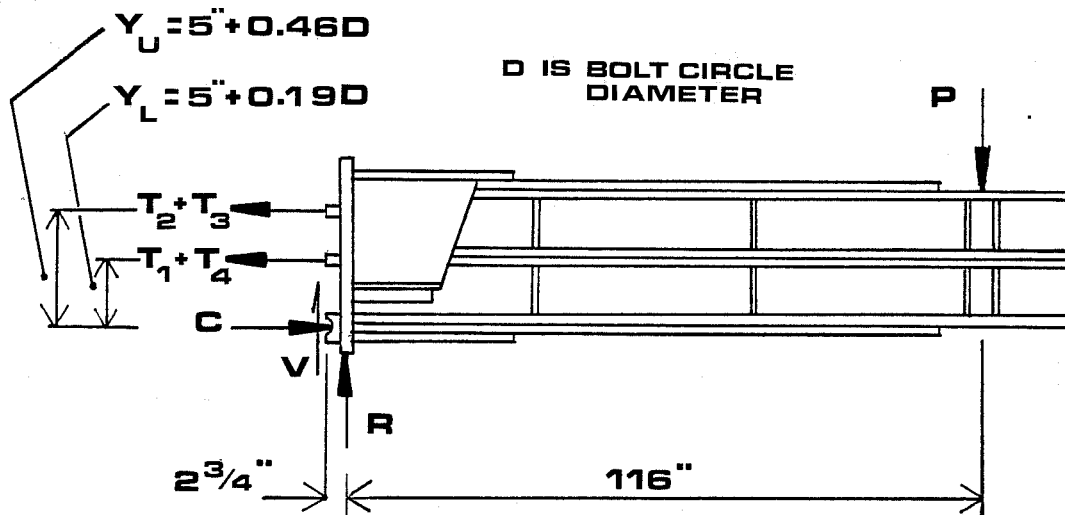
(b) Loading beam

(a) Specimen and loading beam

Fig. 2.17 Free body diagrams of test set-up

The equilibrium check, as expressed in Fig. 2.17b and Eq. A.1, was derived with several simplifications, which introduced inaccuracies

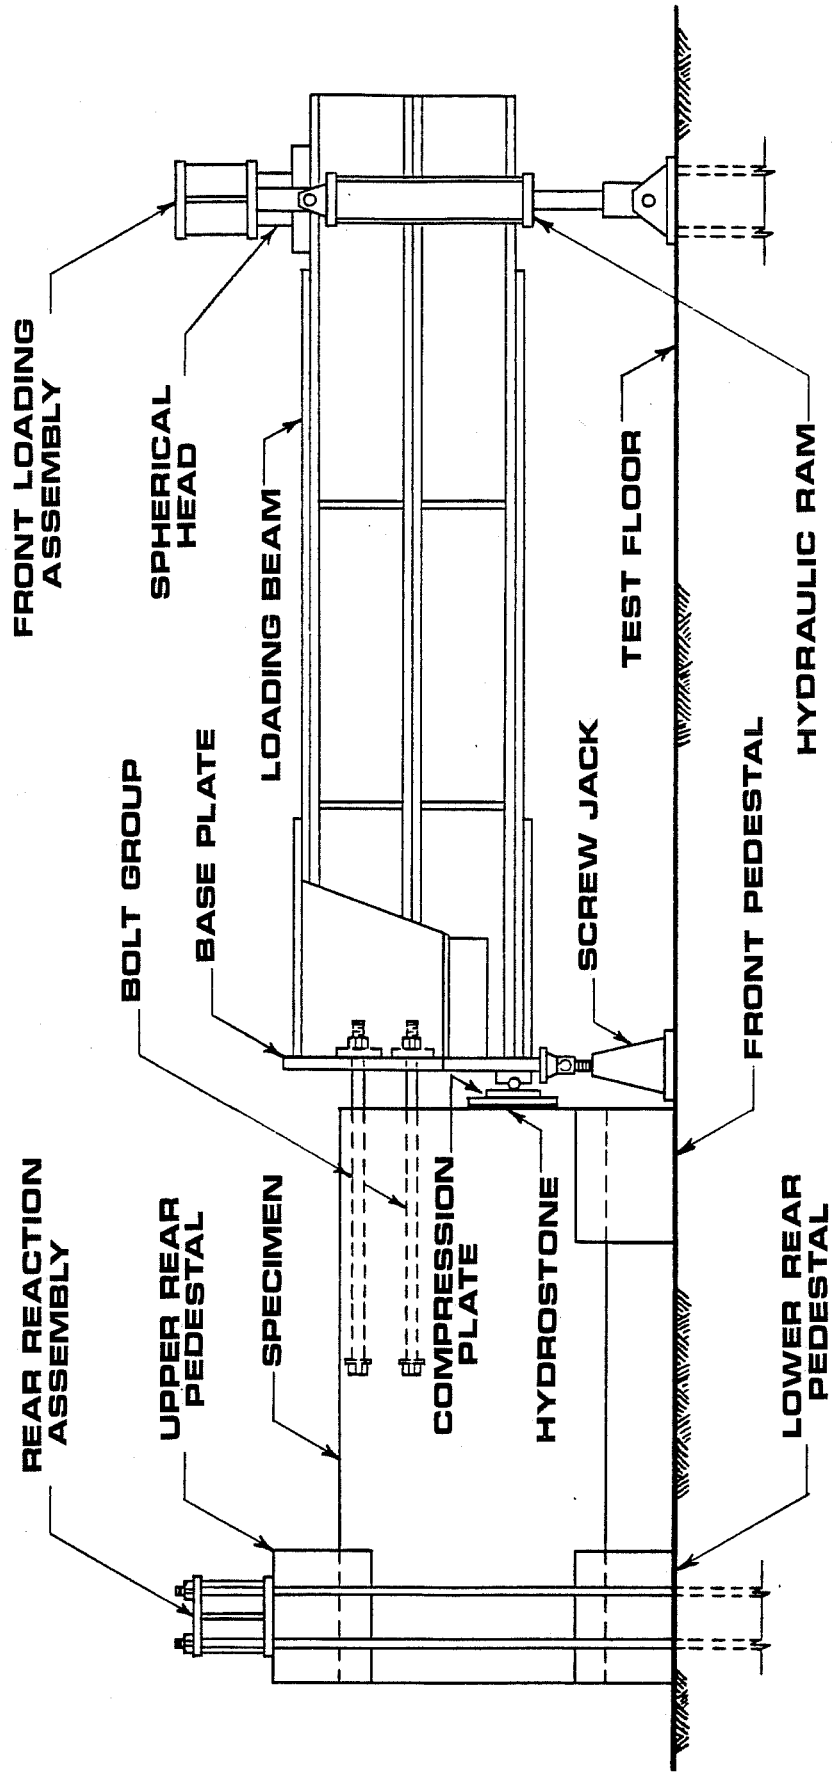
Figures 2.18 to 2.20 are schematic drawings and views of the test frame. Three reinforced concrete collars were set on a thin layer of grout to hold the specimen in place. The rear of the specimen was

Fig. 2.18 Test frame - elevation

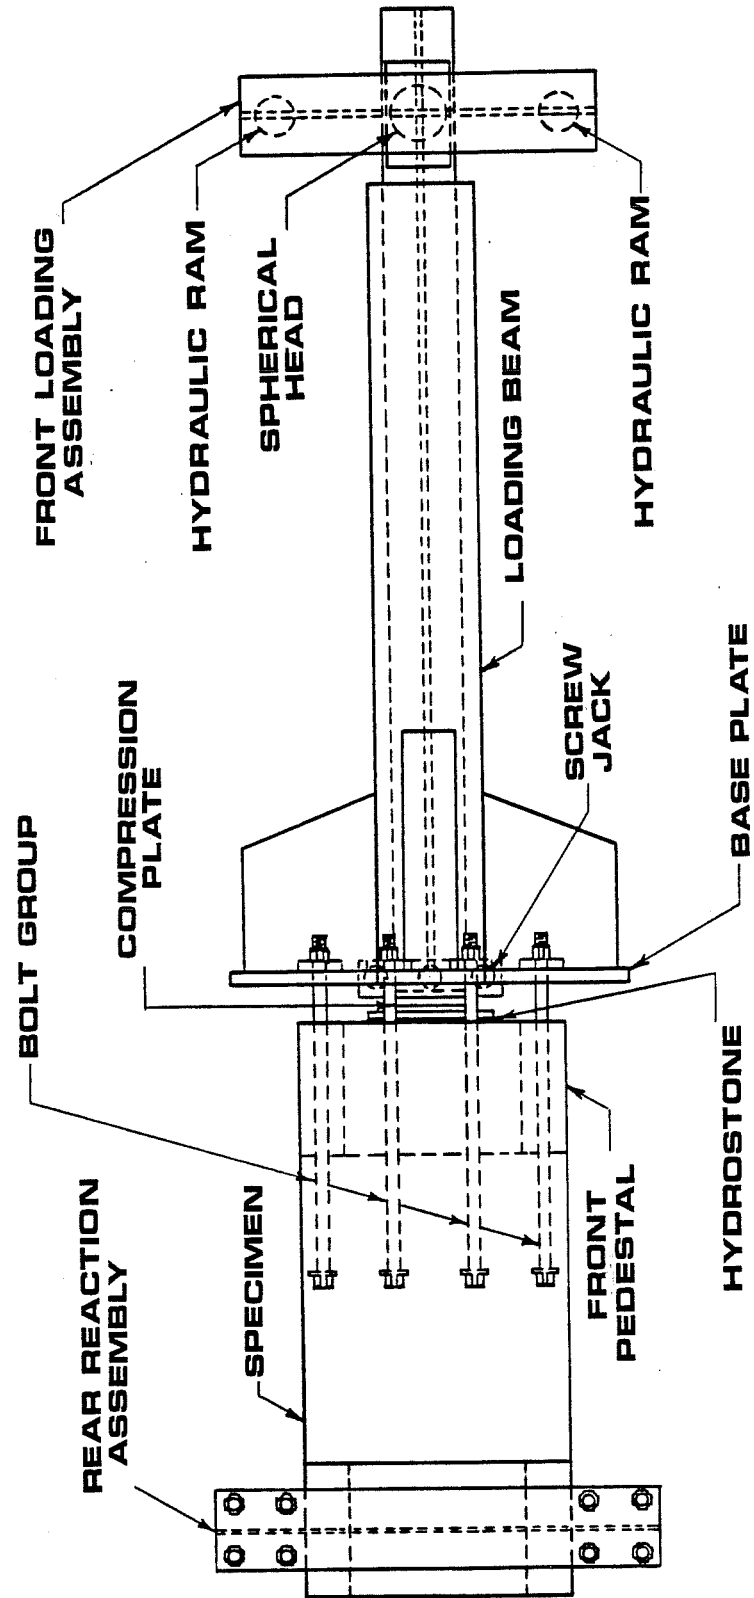
Fig. 2.19 Test frame - plan view

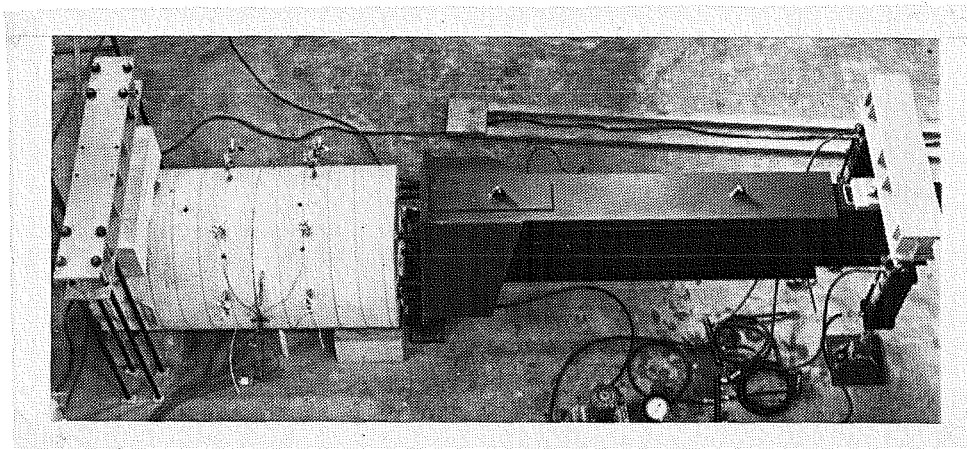
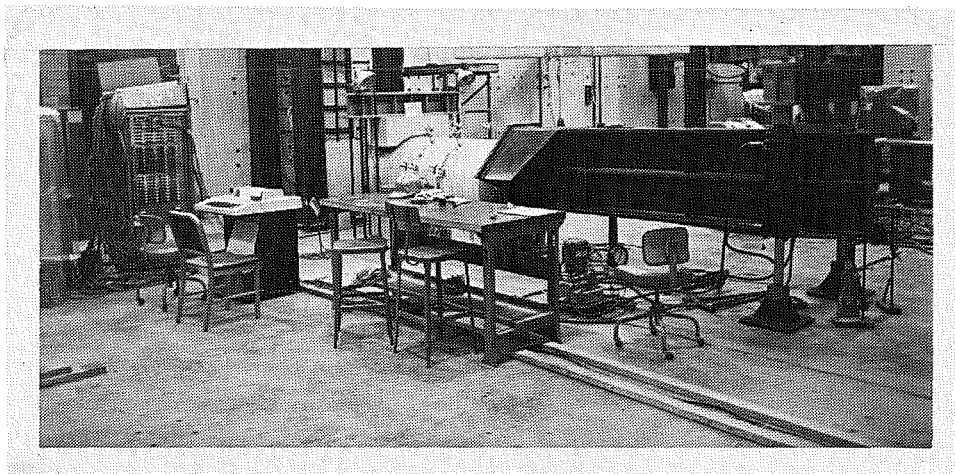
Fig. 2.20 Test set-up prior to testing

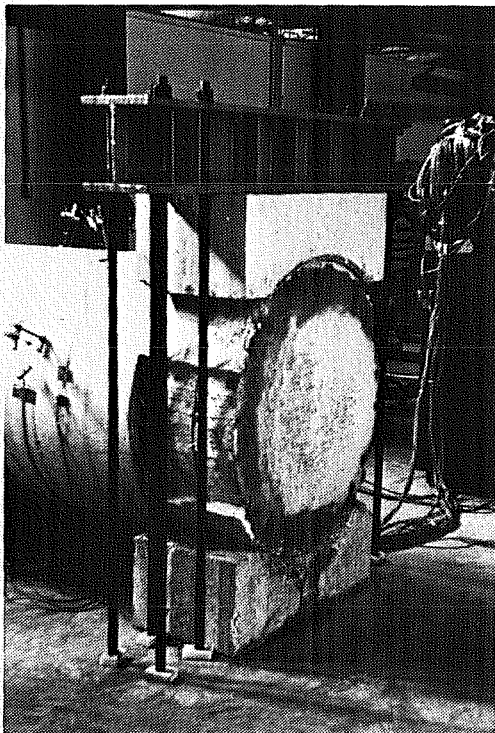
tied down to the test floor with eight high-strength rods and collars, as shown in Fig. 2.21. The lower pedestals aligned and supported the specimen before the test.

Fig. 2.21 Rear reaction assembly of test frame

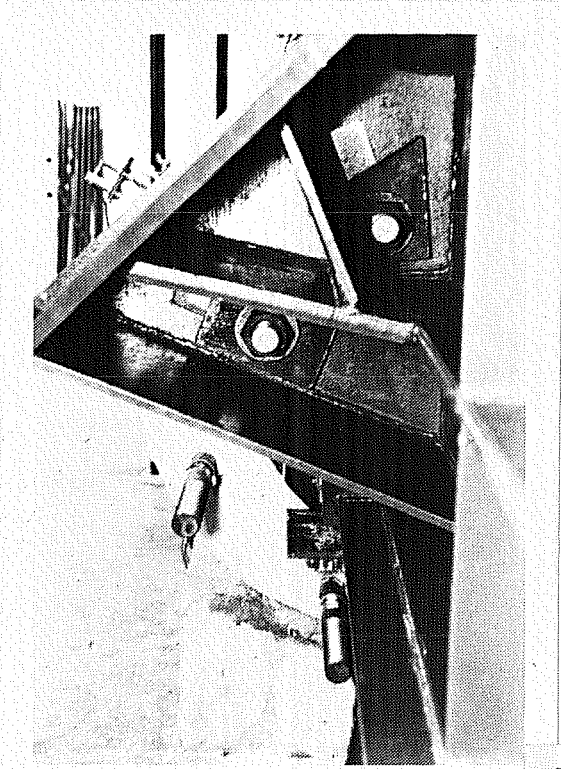
Fig. 2.23 Anchor bolts fixed to loading beam

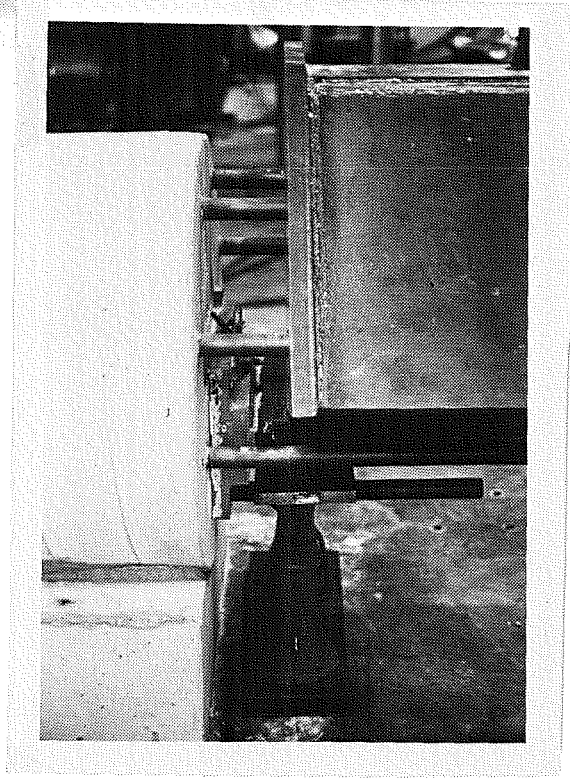
At the interface (Fig. 2.24), a bearing plate on a 1/2 in. thick hydrostone layer transferred the compression force to the specimen. Swiveling jacks were placed under the beam to channel the applied (shear) force directly to the test floor.

Fig. 2.24 Specimen — loading beam interface

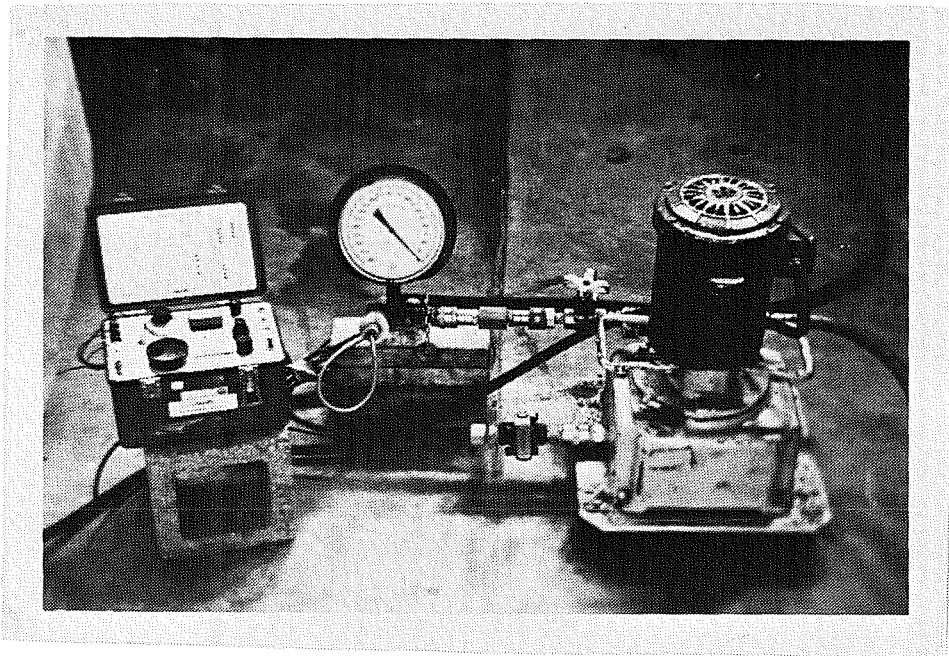
Fig. 2.25 Electric pump, pressure gage, and strain box used to control the load applied on the beam

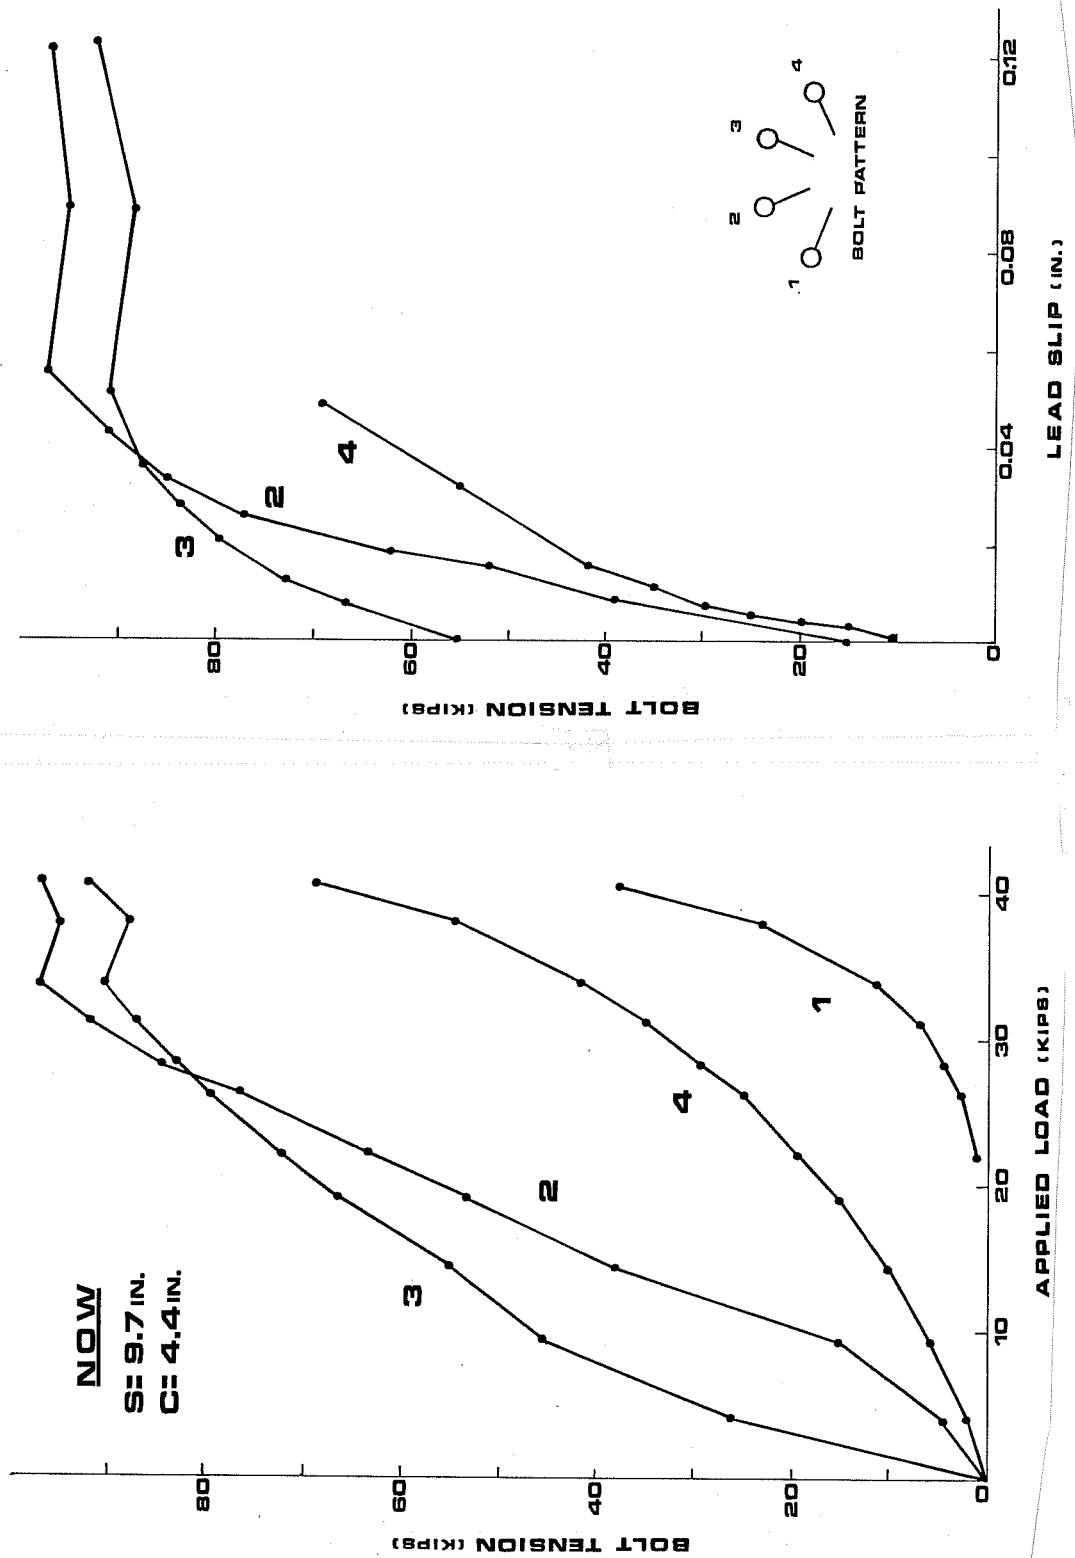
Fig. 3.2 Loading and load-slip curves of anchor bolts in test NOW

NOW. Spiral bars, very far from the bearing face ( $h_s = 5.0$  in. and 5.5 in.), did not record any significant stress before the bolts reached their capacity (see Fig. 3.23). At 100 percent  $T_{\max}$ , few cracks were visible on the surface, and a small tail slip was measured for the top bolts ( $P_n = 35$  k in Fig. 3.8). Two stages later ( $P_n = 41$  k), tail slip quadrupled to an average 0.086 in. and extensive cracking was observed. The spirals yielded rapidly during these load stages, and the load on neither bolt dropped to less than 97 percent of their peak value.

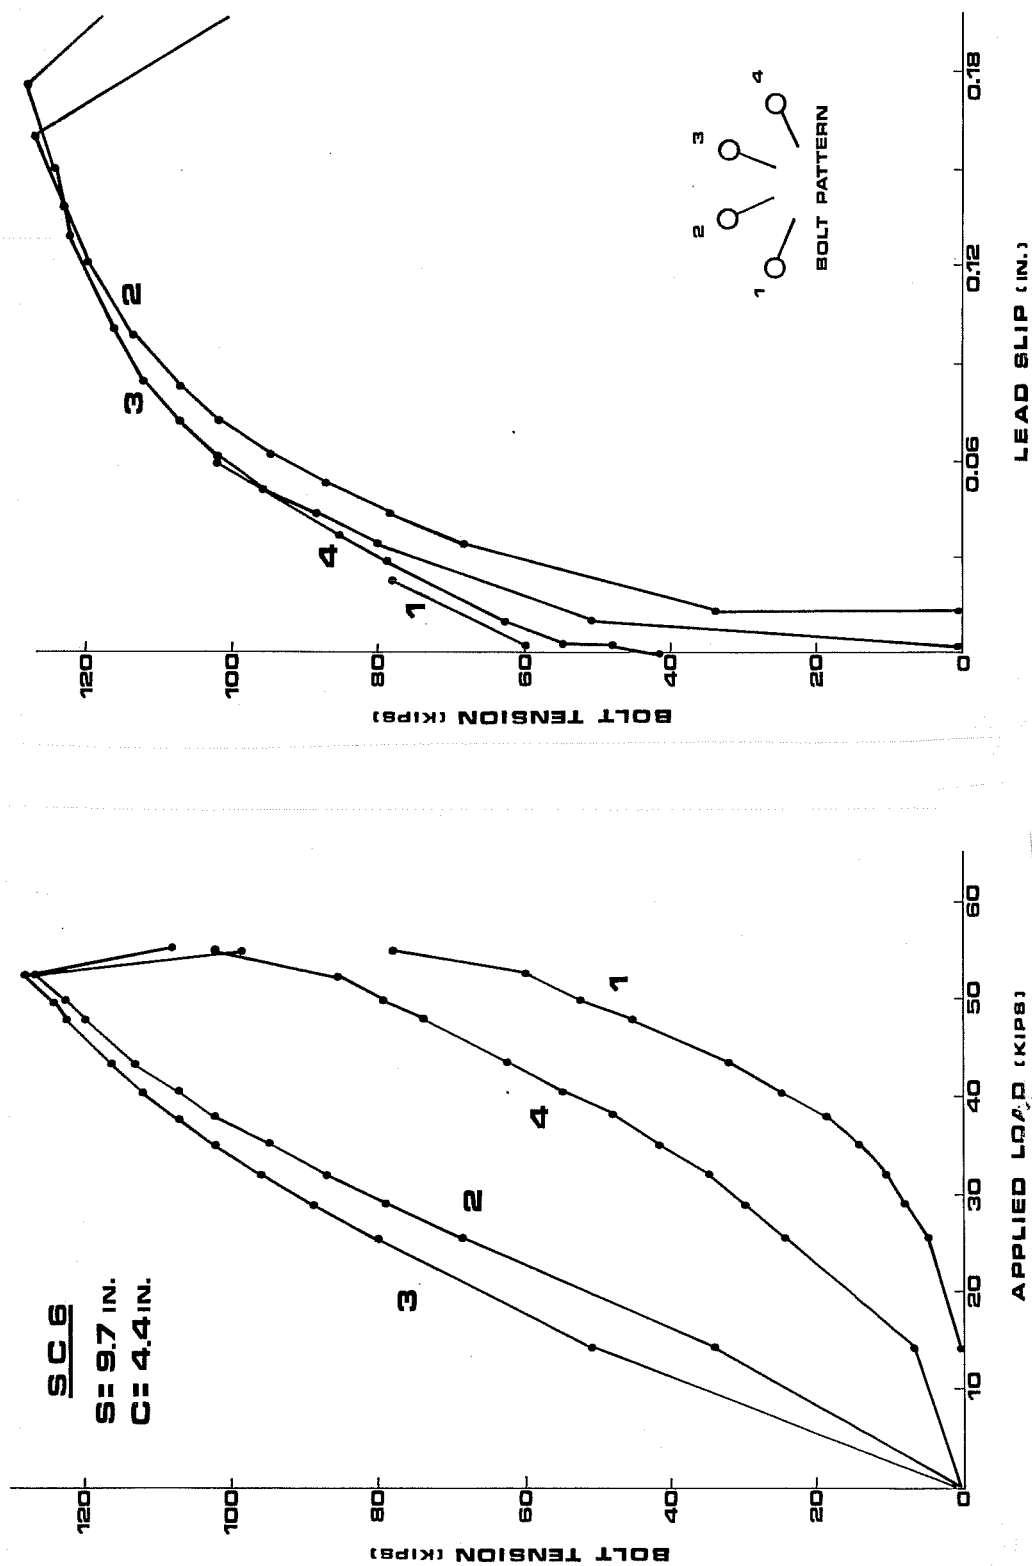
Fig. 3.3 Loading and load-slip curves of anchor bolts in test SC6

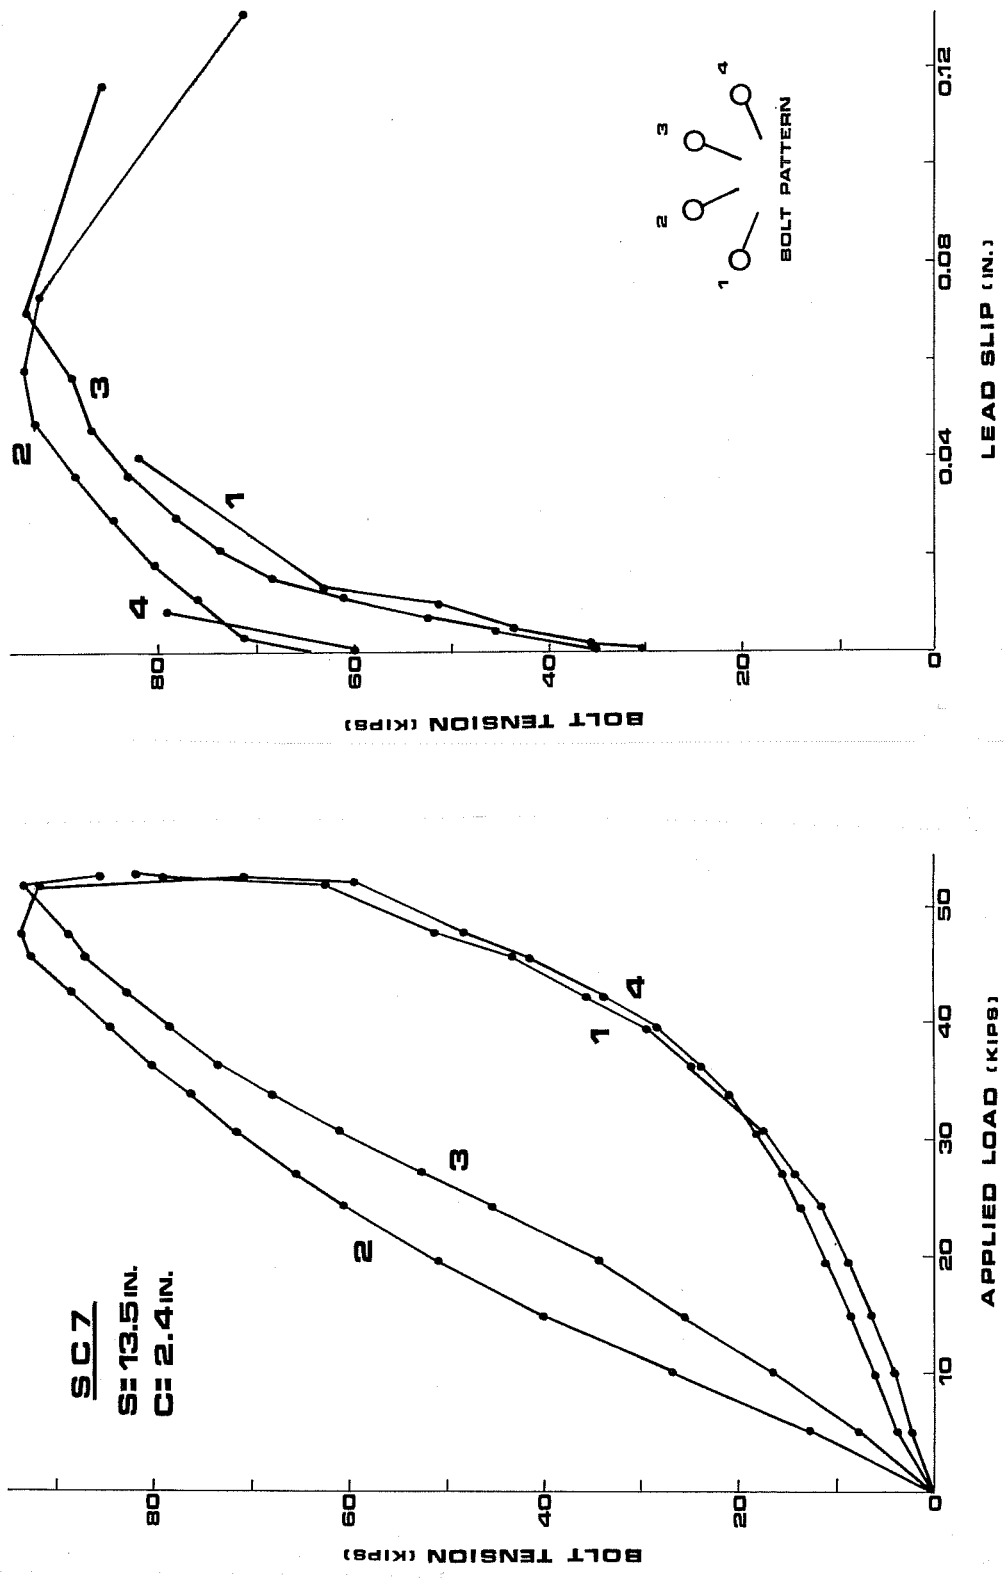
Fig. 3.4 Loading and load-slip curves of anchor bolts in test SC7

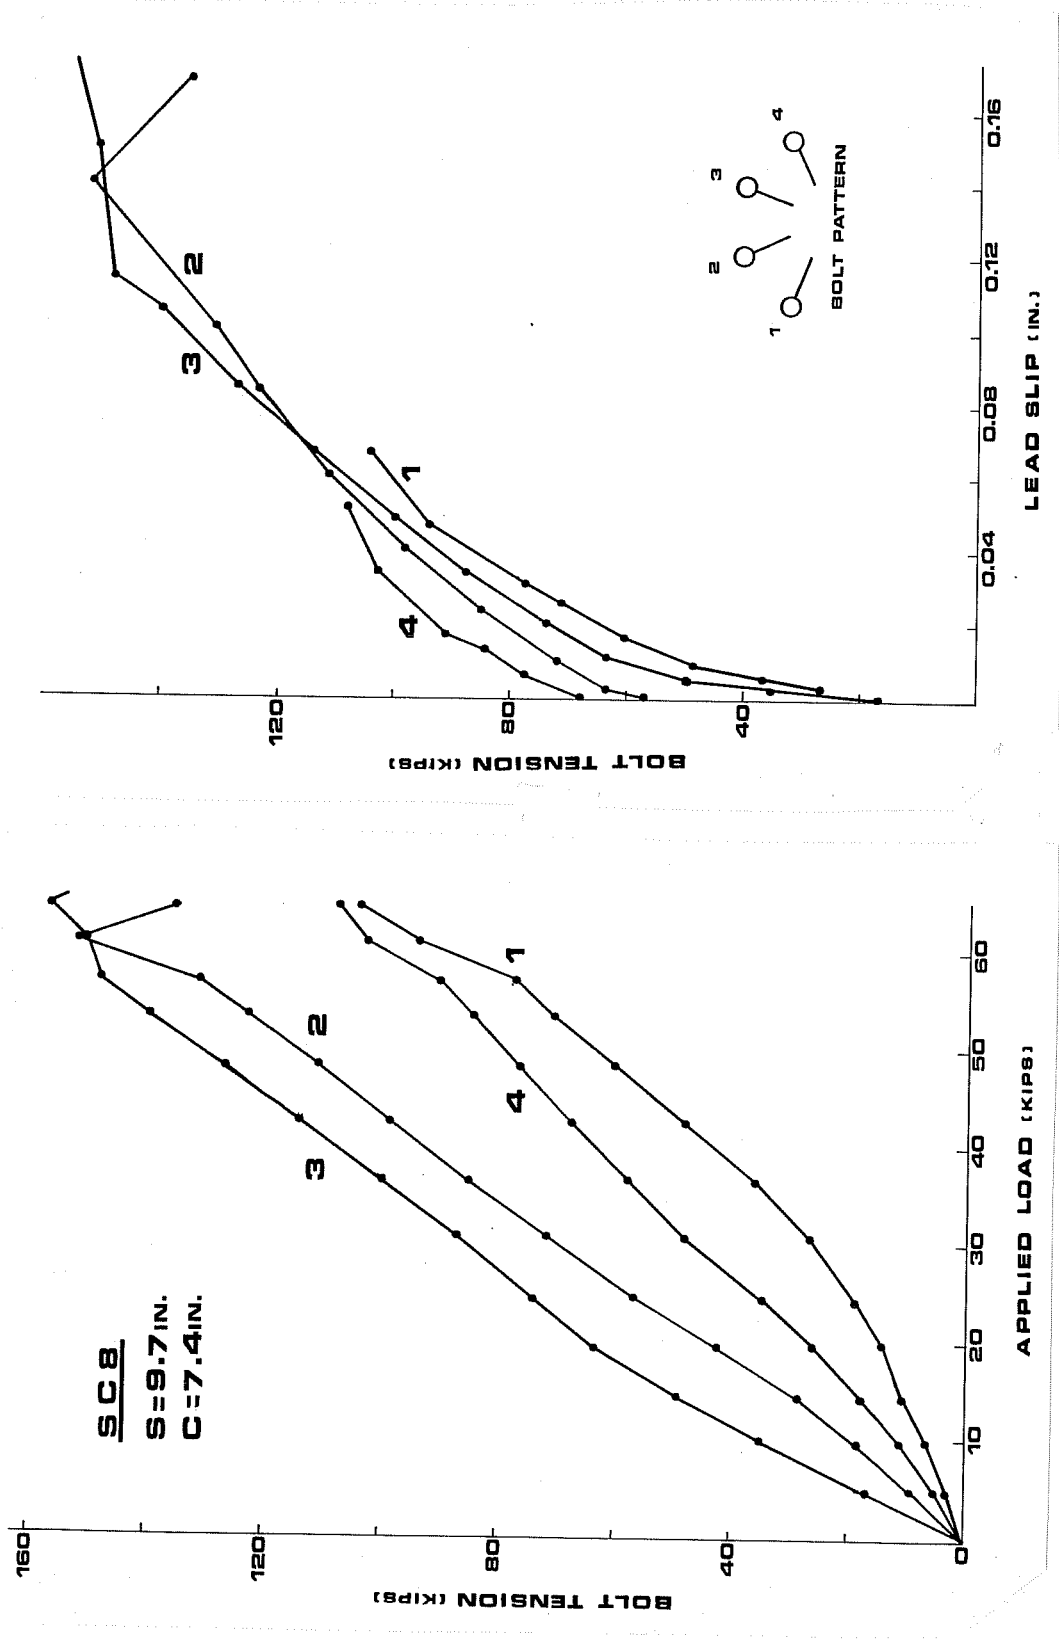
Fig. 3.5 Loading and load-slip curves of anchor bolts in test SC8

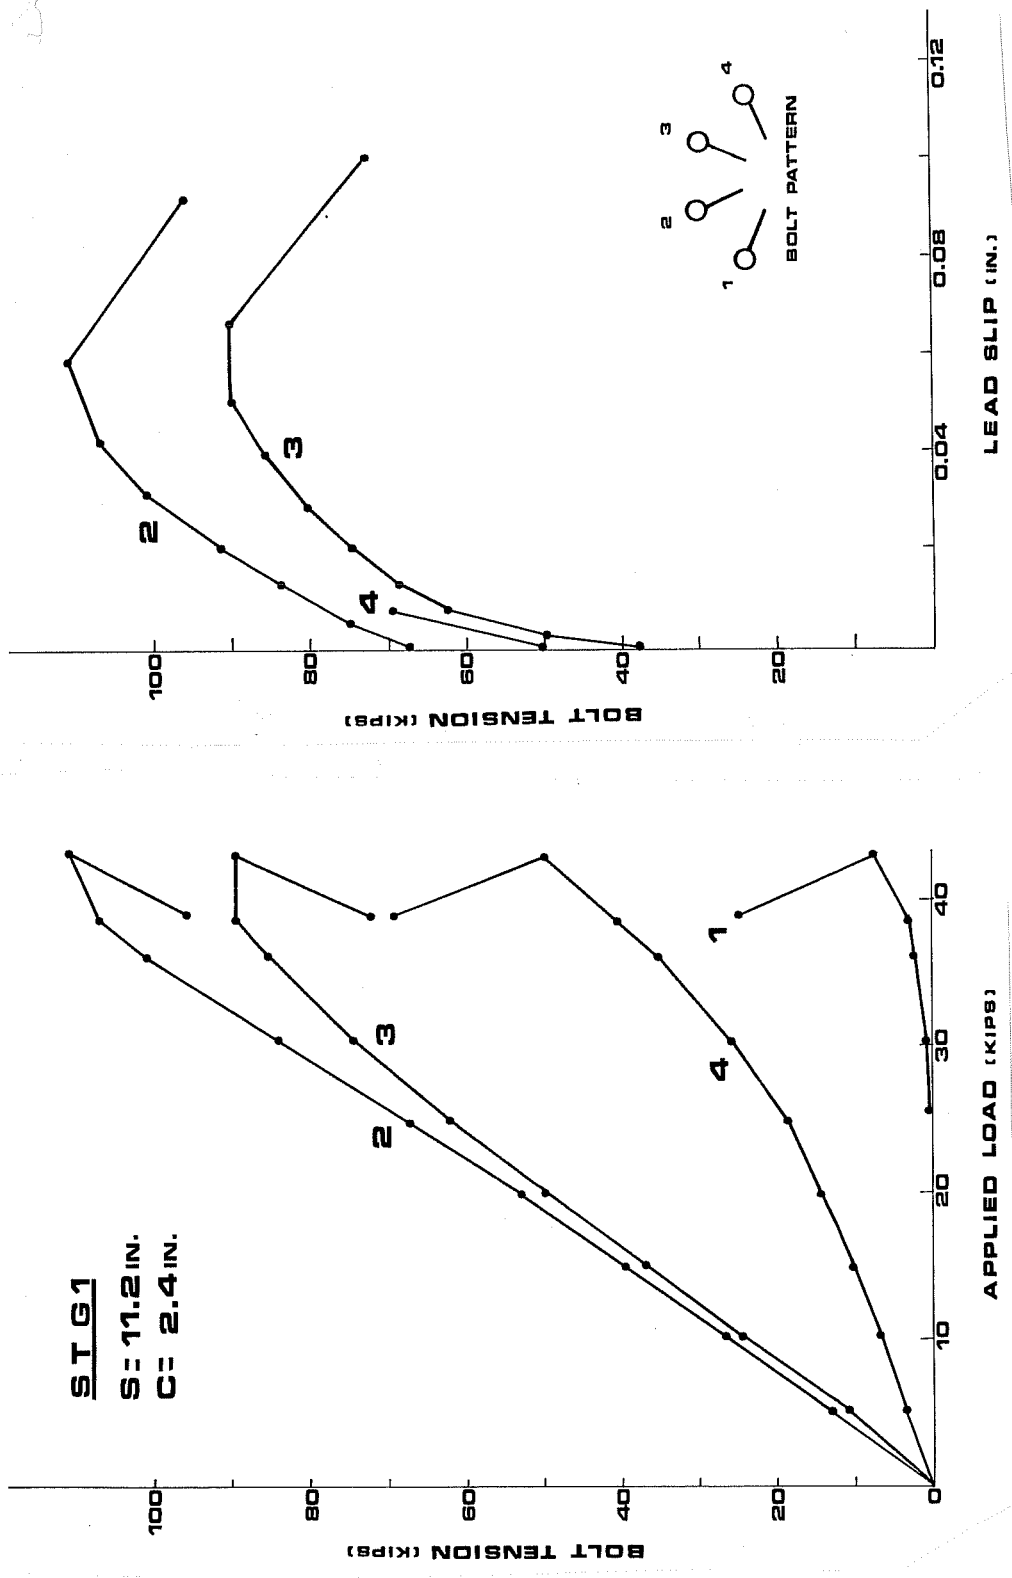
Fig. 3.6 Loading and load-slip curves of anchor bolts in test STG1

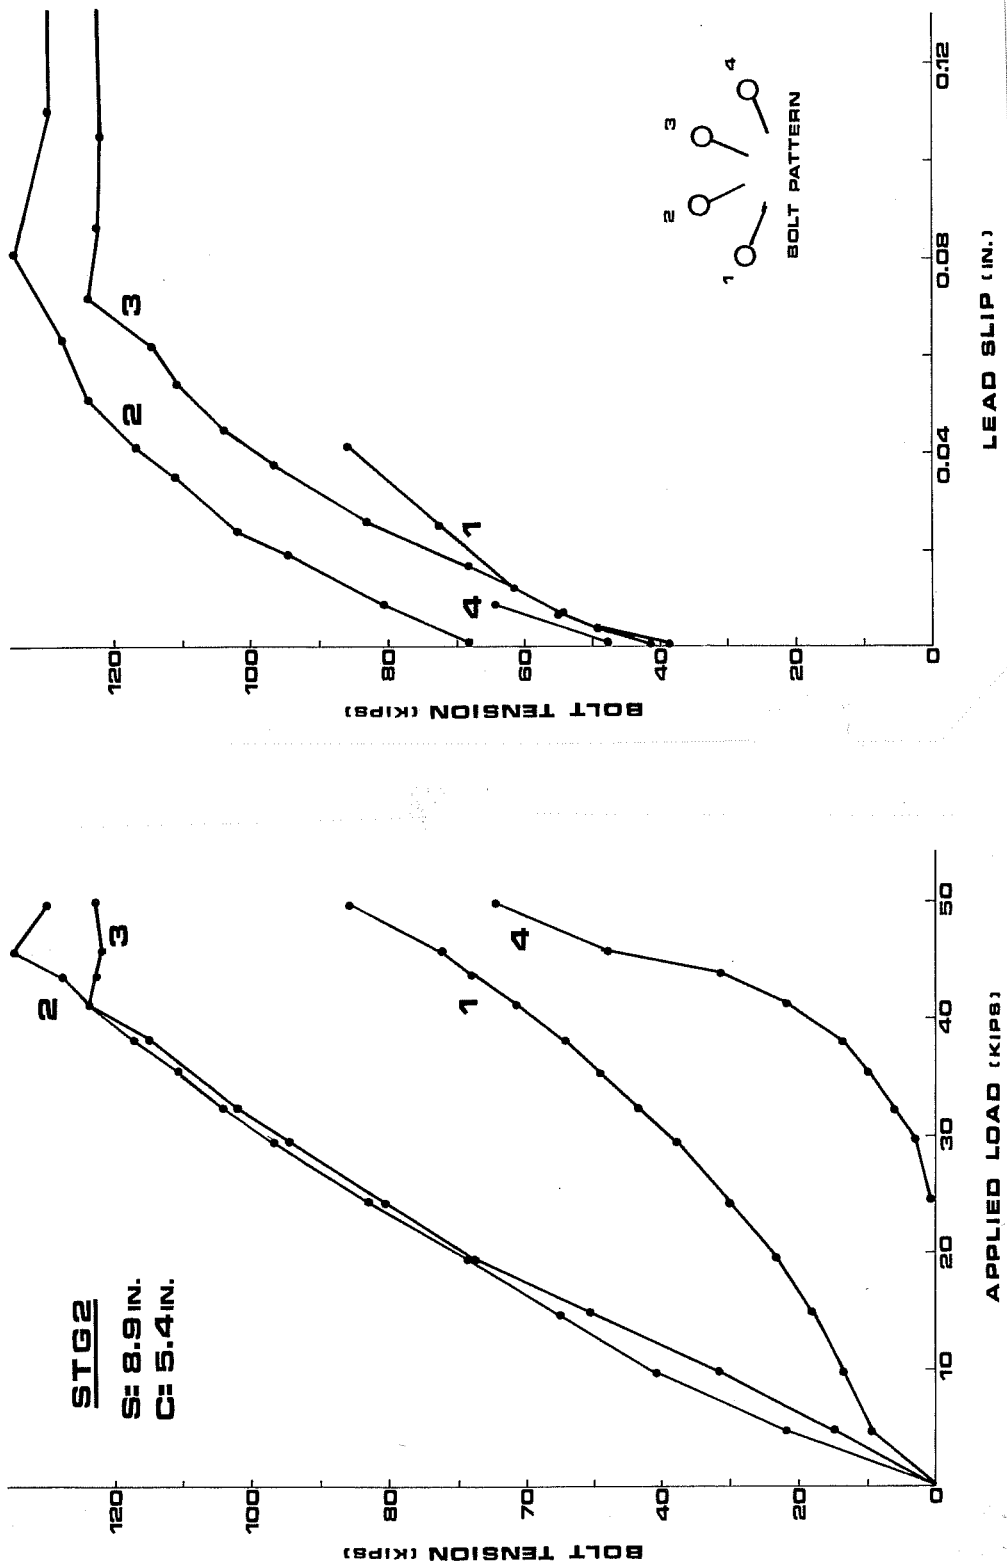
Fig. 3.7 Loading and load-slip curves of anchor bolts in test STG2
