TENSILE CAPACITY OF HIGH-STRENGTH  
ANCHOR BOLT GROUPS EMBEDDED IN  
CIRCULAR CONCRETE PIERS

T H E S I S

Presented to the Faculty of the Graduate School of  
The University of Texas at Austin  
in Partial Fulfillment  
of the Requirements  
for the Degree of  
MASTER OF SCIENCE IN ENGINEERING

December 1982

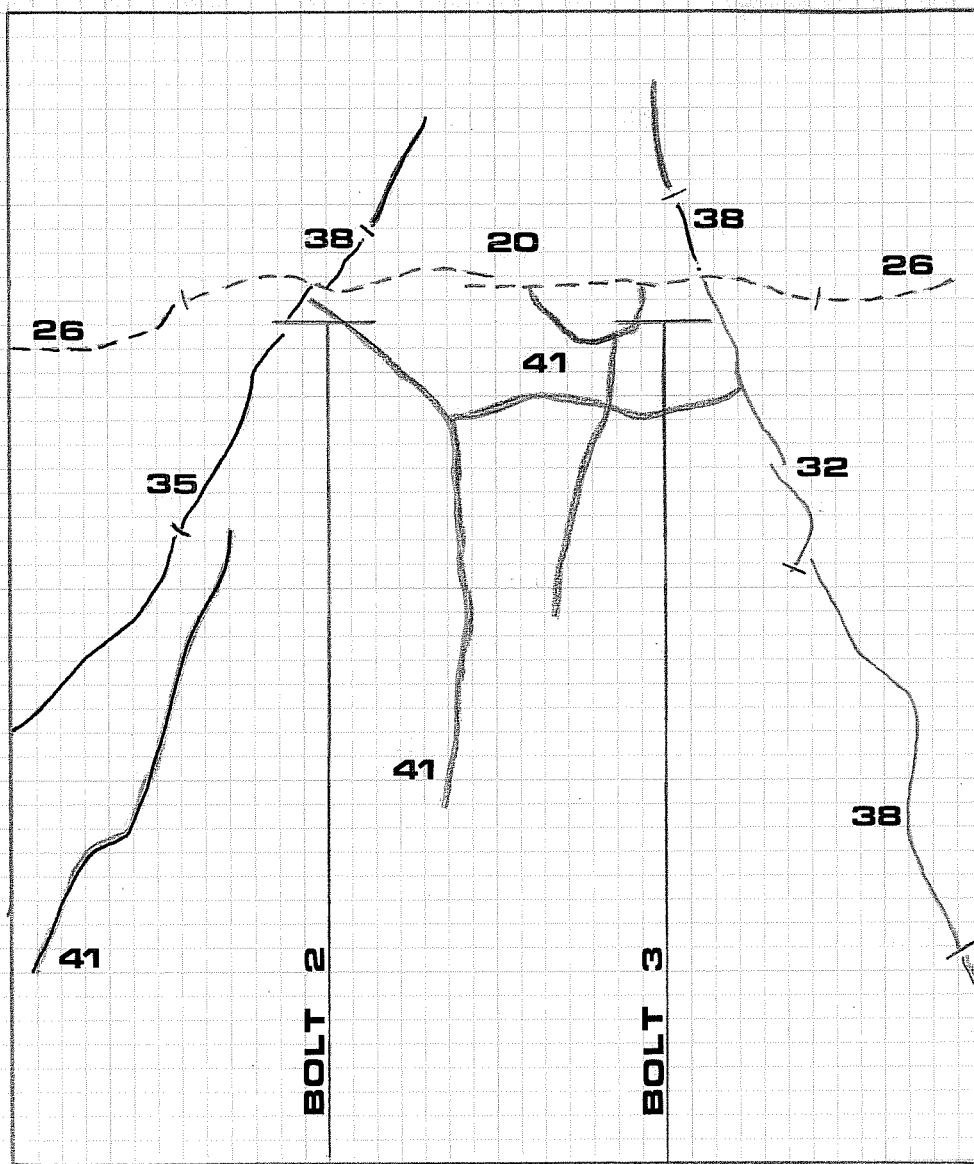
Nominal load $P_n$ (k)	Bolt tension (k)	Tail slip (in.)	Lead slip (in.)	Bolt tension (k)	Tail Slip (in.)	Lead Slip (in.)
20	53.5	.000	.015	66.6	.000	.007
32	92.1	.009	.042	87.2	.017	.035
35	97.5	.016	.054	90.7	.027	.050
38	95.2	.050	.091	88.3	.070	.088
41	96.9	.079	.121	92.5	.093	.123

Fig. 3.8 Development of crack patterns of top bolts in test NOW

The average bolt capacity was reduced by 26 percent when washers were not used at the anchorage end. However, a much greater decrease, 44 percent (102/183 in Table 4.1), equivalent to the reduction in the bearing area ( $A_b$ ) was predicted by the expression for the nominal bolt capacity (Eq. 4.1). The discrepancy above is clearly explained by noticing (Table 4.5) that the anchor bolts in test NOW failed with very little, if any, bolt interaction (average  $T_{max}/T_n = 0.92$ ), while for test SC6 the interaction was considerably greater ( $T_{max}/T_n = 0.69$ ). As illustrated in Fig. 3.8 for test NOW, the surfacing of two longitudinal

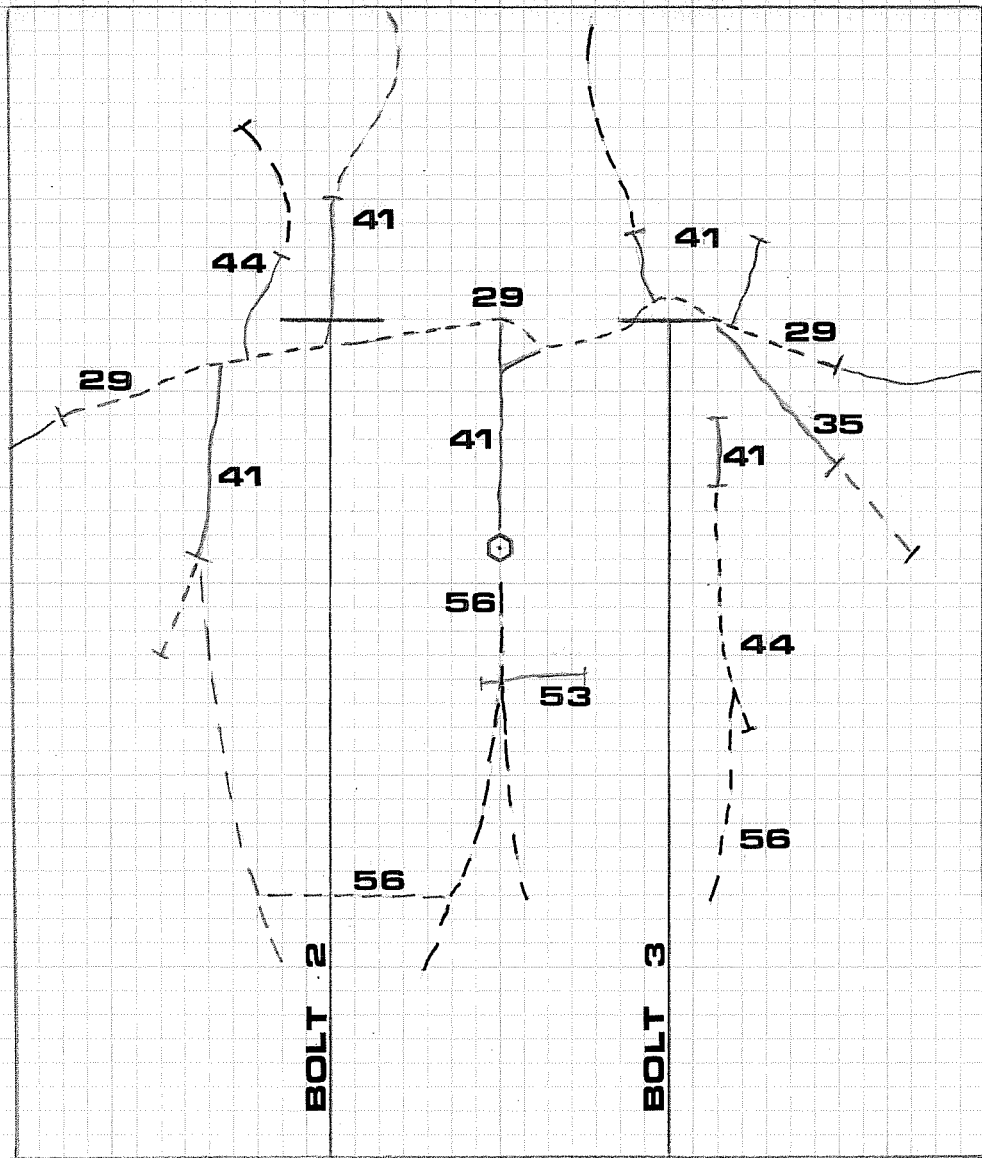
Nominal load $P_n$ (k)	Bolt tension (k)	Tail slip (in.)	Lead slip (in.)	Bolt tension (k)	Tail slip (in.)	Lead slip (in.)
29	78.8	.011	.044	88.8	.011	.043
41	107	.041	.083	112	.040	.084
44	113	.054	.098	116	.052	.100
53	127	.121	.159	128	.111	.176
56	102	.160	.198	98.6	.150	.215

Fig. 3.9 Development of crack patterns of top bolts in test SC6

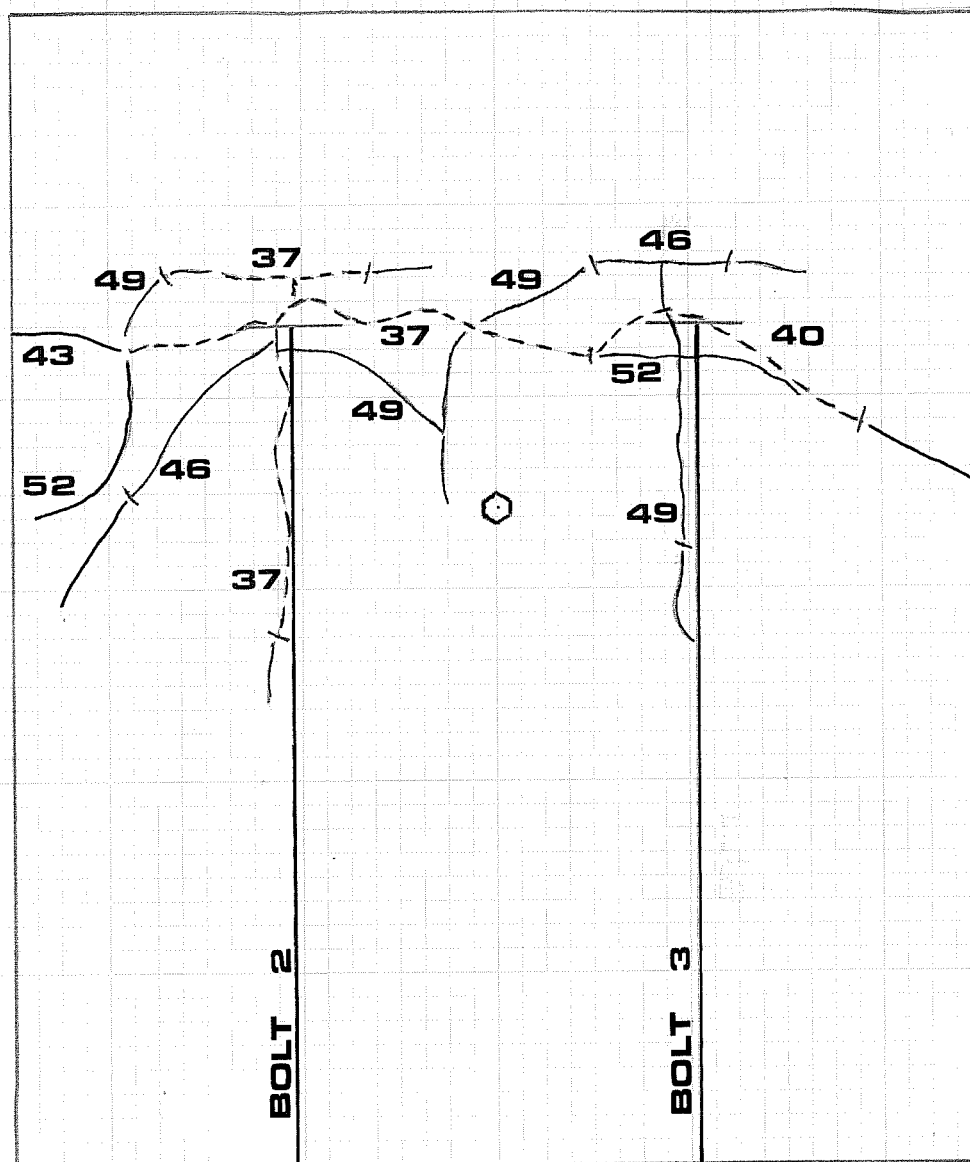
Nominal load $P_n$ (k)	Bolt tension (k)	Tail slip (in.)	Lead slip (in.)	Bolt tension (k)	Tail slip (in.)	Lead slip (in.)
37	80.1	.015	.018	73.4	.000	.021
40	84.3	.020	.027	77.9	.000	.028
46	92.6	.035	.047	86.7	.005	.046
49	93.6	.048	.058	88.4	.014	.057
52	92.1	.067	.073	93.4	.023	.070

Fig. 3.11 Development of crack patterns of top bolts in test SC7

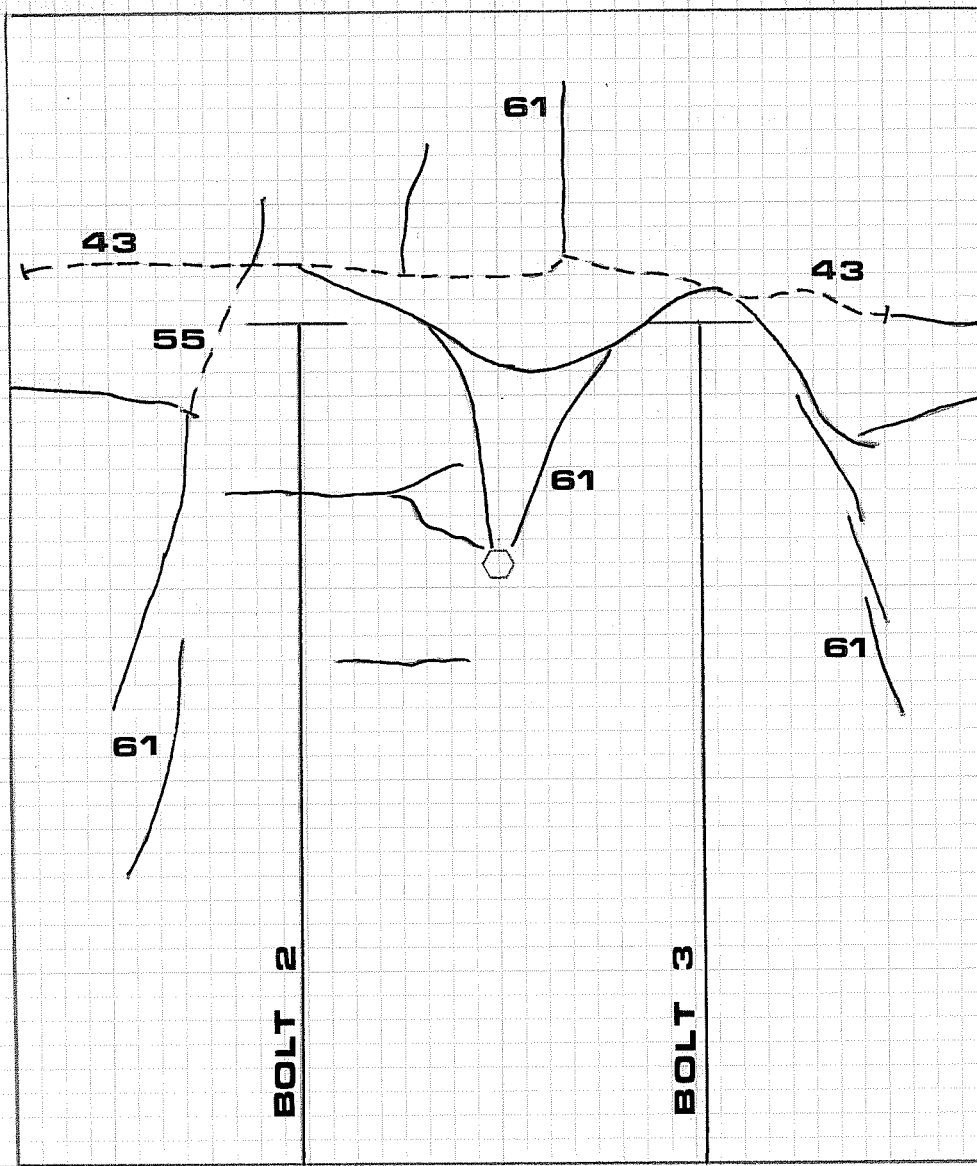
Nominal load $P_n$ (k)	Bolt tension (k)	Tail slip (in.)	Lead slip (in.)	Bolt tension (k)	Tail slip (in.)	Lead slip (in.)
43	99	.013	.041	114	.010	.067
55	123	.039	.084	140	.037	.106
61	152	.082	.142	151	.082	.151

Fig. 3.13 Development of crack patterns of top bolts in test SC8

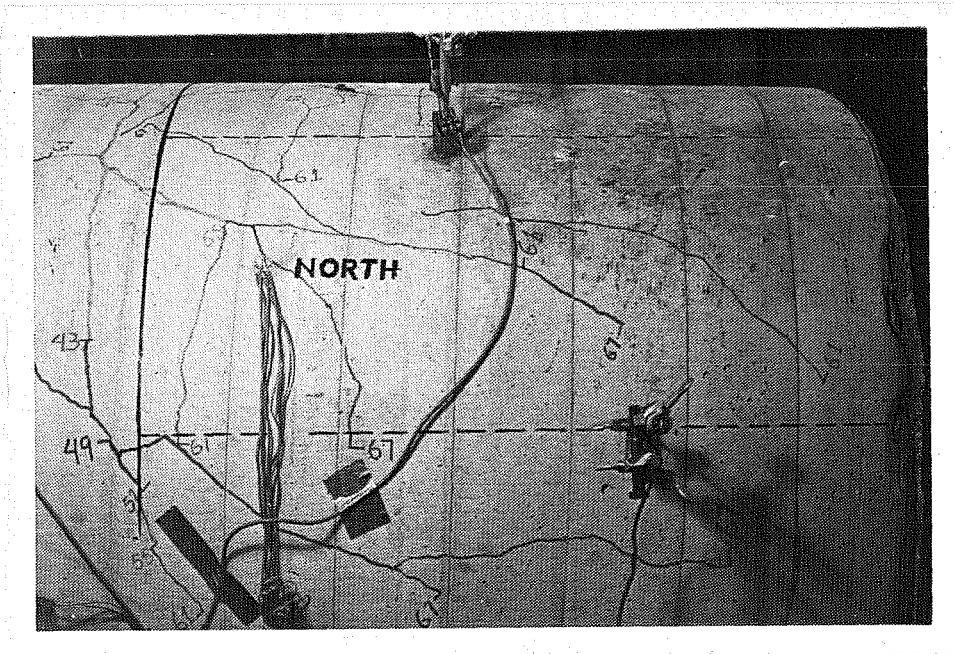
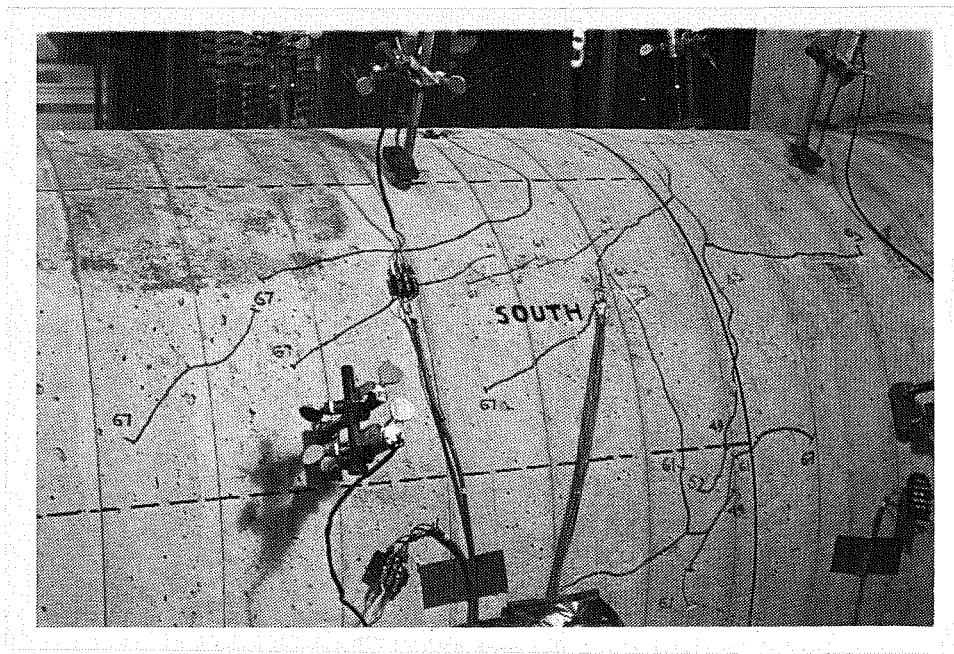
Fig. 3.14 Specimen surface at failure: test SC8

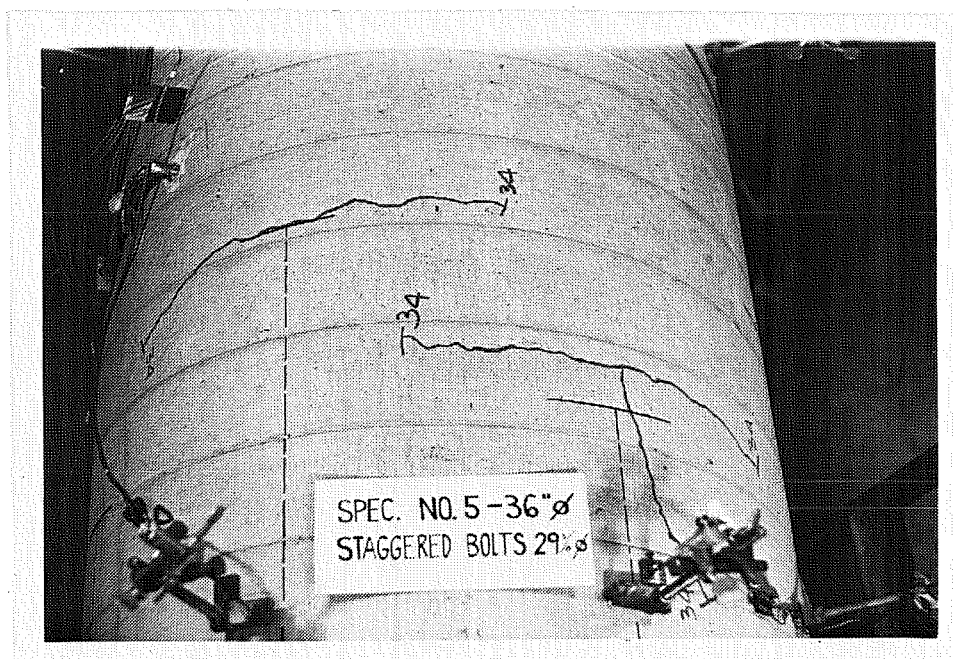
Nominal load $P_n$ (k)	Bolt tension (k)	Tail slip (in.)	Lead slip (in.)	Bolt tension (k)	Tail slip (in.)	Lead slip (in.)
34	92	.000	.021	80	.000	.029
37	101	.003	.032	86	.001	.040
43	111	.028	.059	90	.031	.067
46F	96	.071	.093	72	.088	.101

Fig. 3.15 Initial cracks and bolt data near failure in test STG1

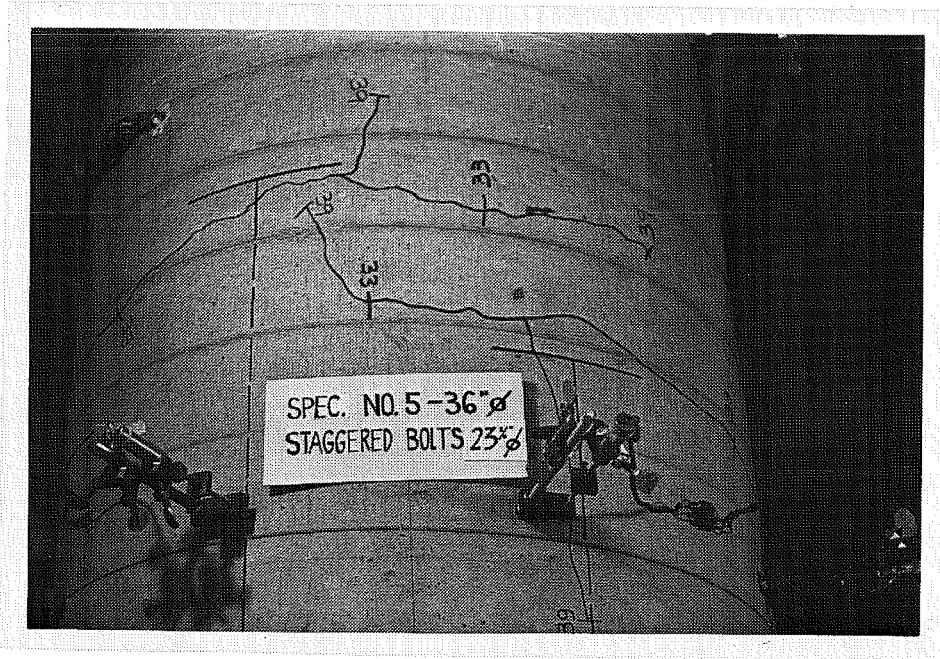
Nominal load $P_n$ (k)	Bolt tension (k)	Tail slip (in.)	Lead slip (in.)	Bolt tension (k)	Tail slip (in.)	Lead slip (in.)
33	102	.003	.025	104	.014	.045
39	117	.013	.041	115	.023	.062
42	124	.021	.051	124	.034	.072
45	128	.031	.063	123	.046	.086
48	135	.046	.081	122	.062	.105
51	130	.073	.110	123	.086	.131

Fig. 3.17 Initial cracks and bolt data near failure in test STG2

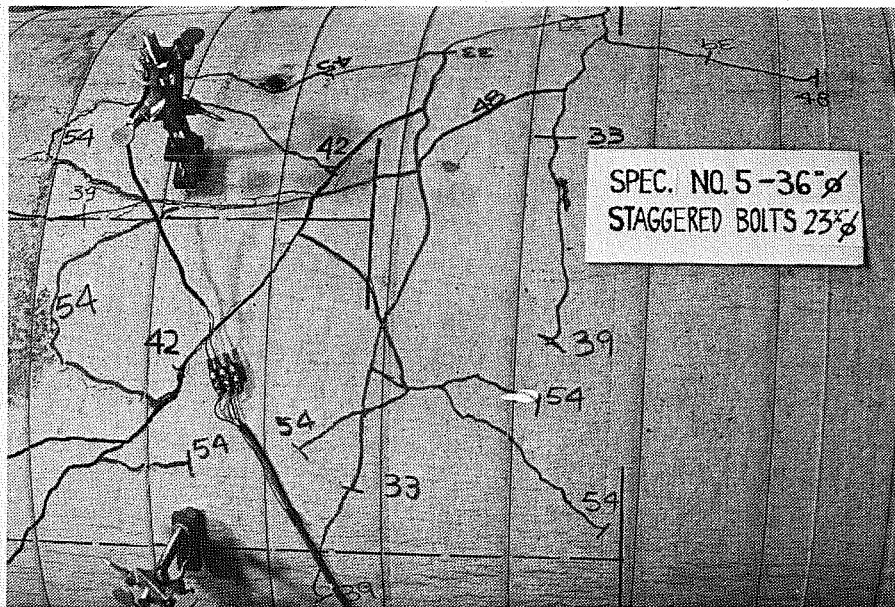
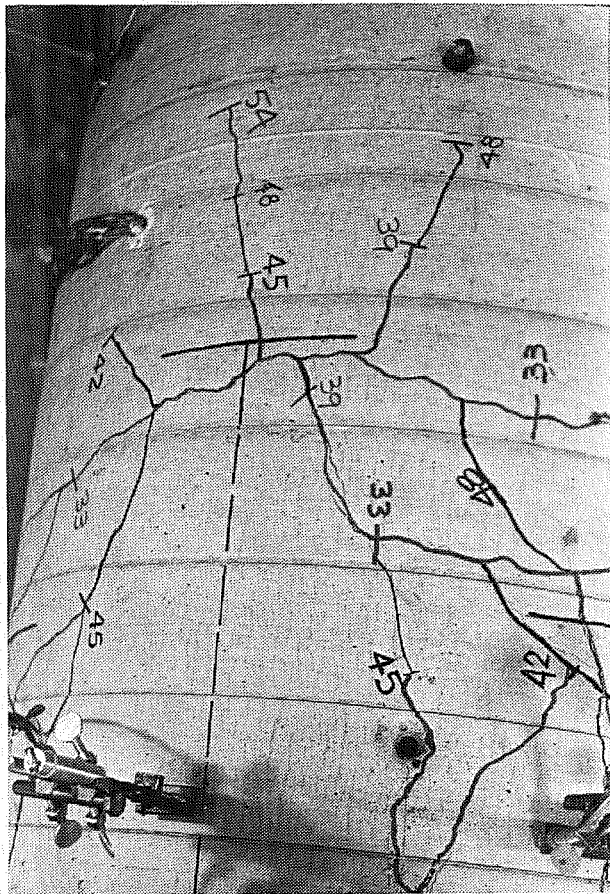
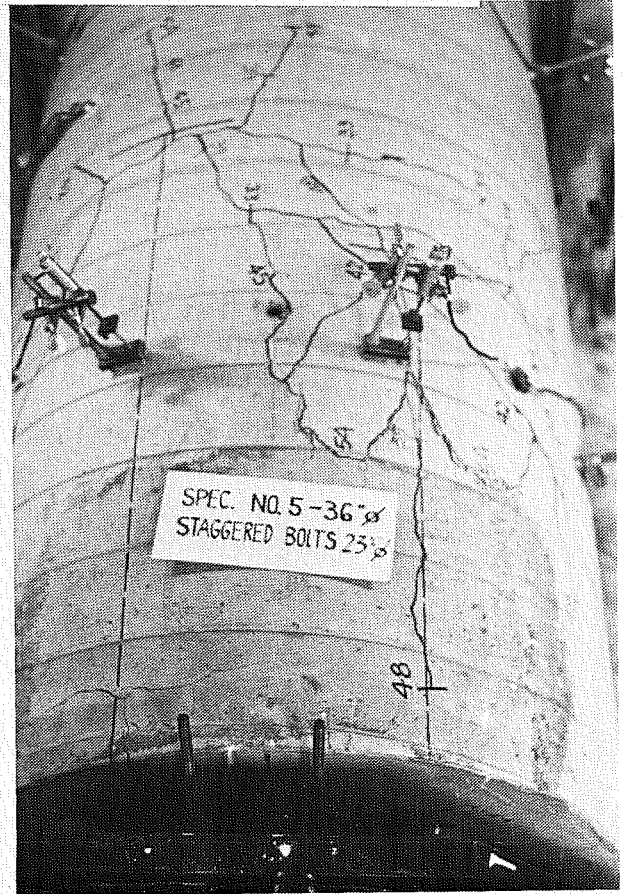
Fig. 3.18 Crack patterns of top bolts: test STG2

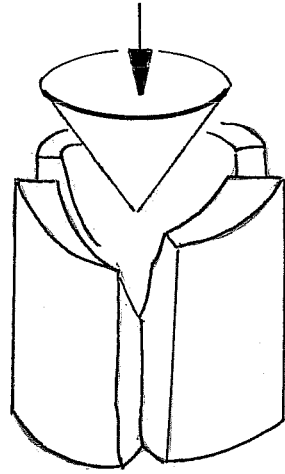
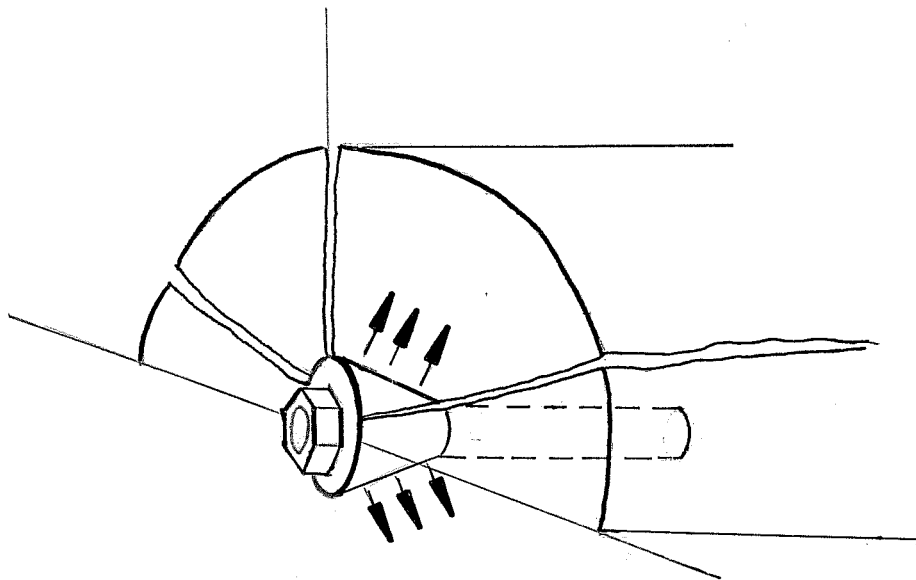
(a) Shear cone splitting concrete cylinder

(b) Compressive stresses splitting concrete at the anchorage end of anchor bolt

Fig. 3.20 Splitting force radiated out of concrete cone

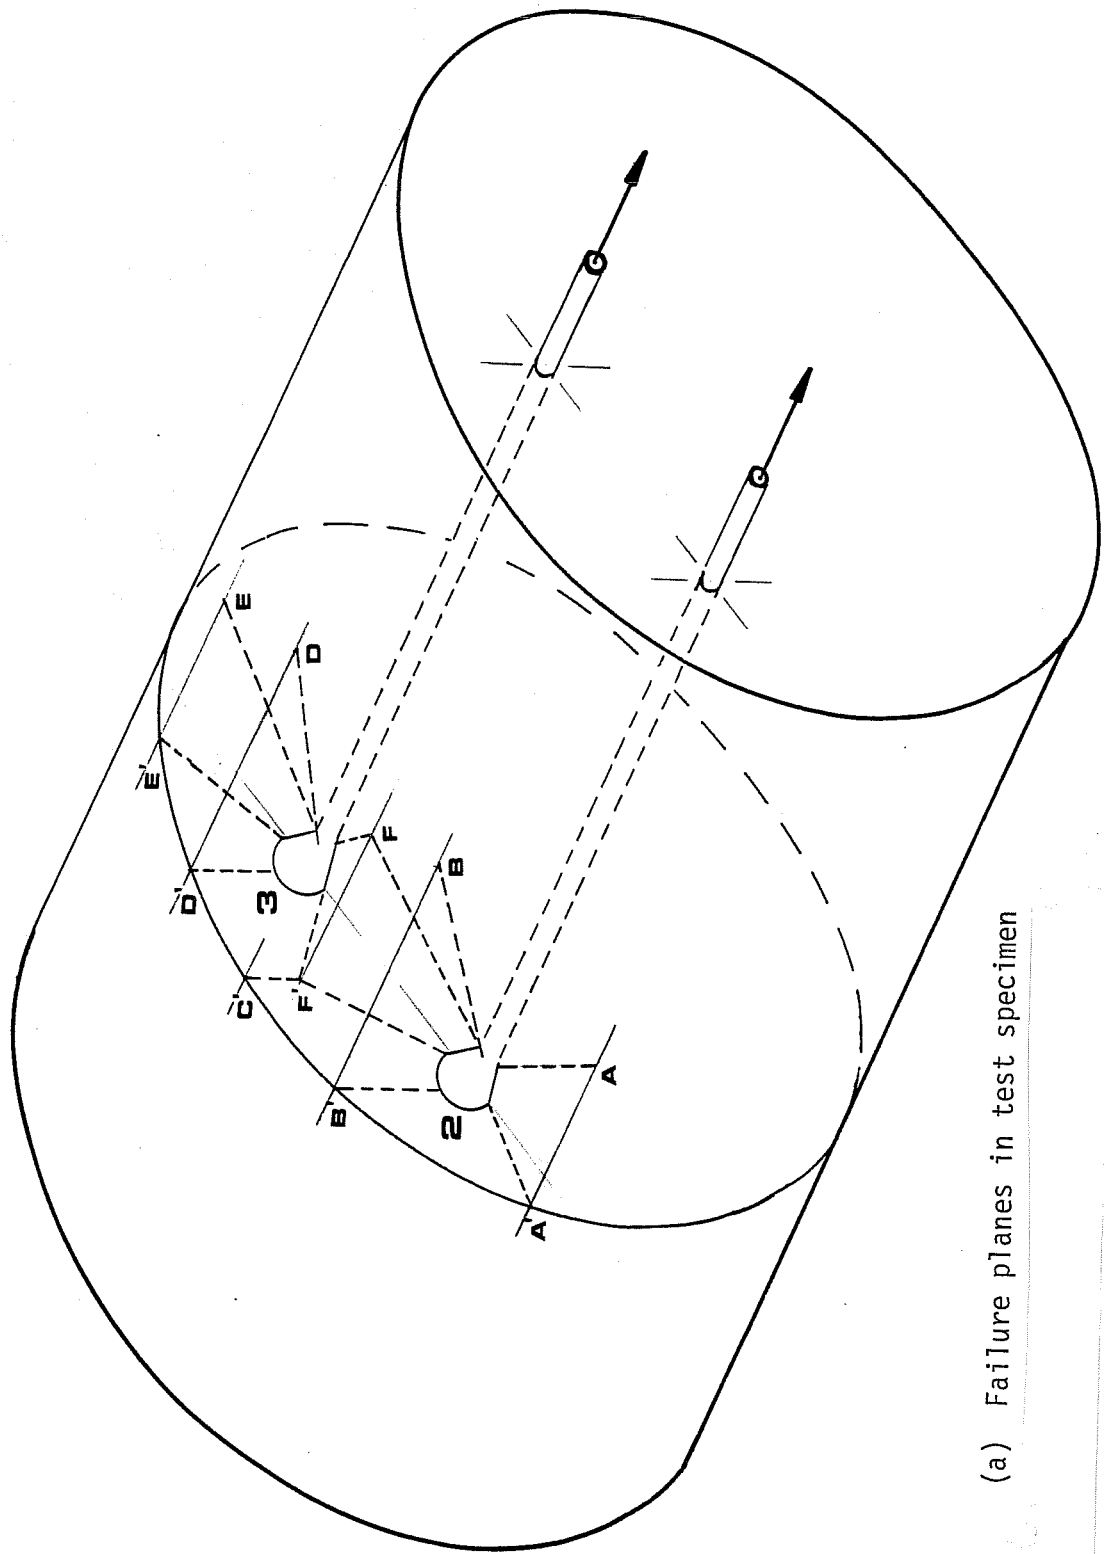
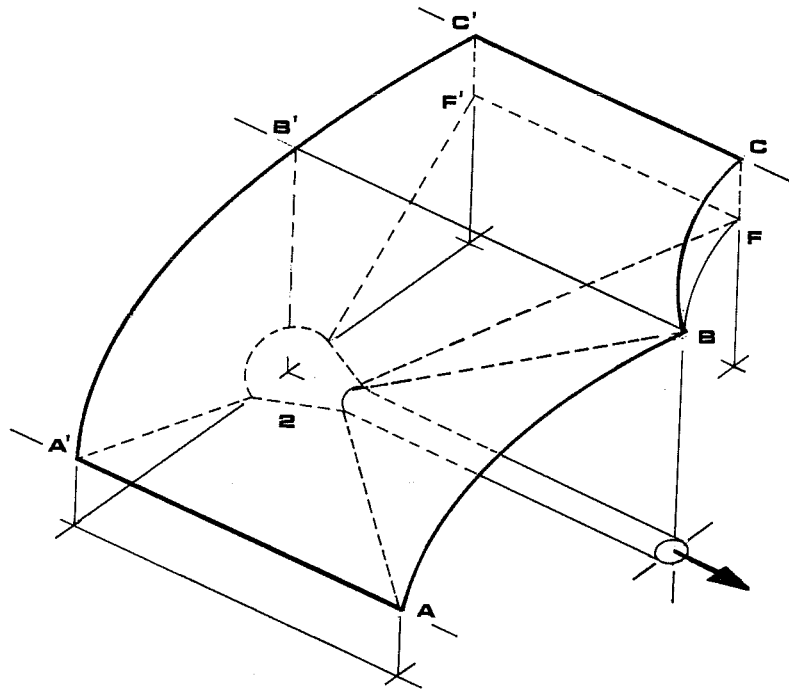
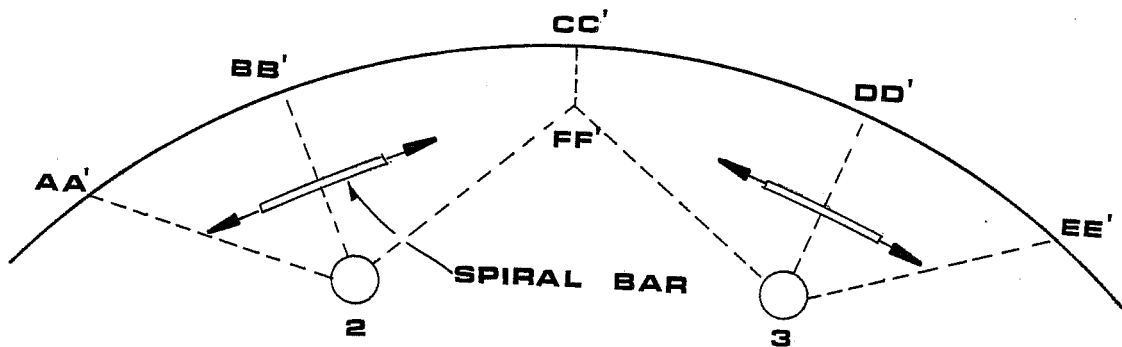
(a) Failure planes in test specimen

Fig. 3.21 Model of wedge-splitting failure of top bolts

(b) Concrete uplift - bolt 2

(c) Front view at the anchorage end

As suggested in Fig 3.21c (front view), the splitting in plane 2BB'2 and 3DD'3 is most likely restrained by the spiral bars placed in the test specimens (Fig. 2.10). A large cover also diminishes the likelihood of these planes extending completely to the exterior of the specimen.

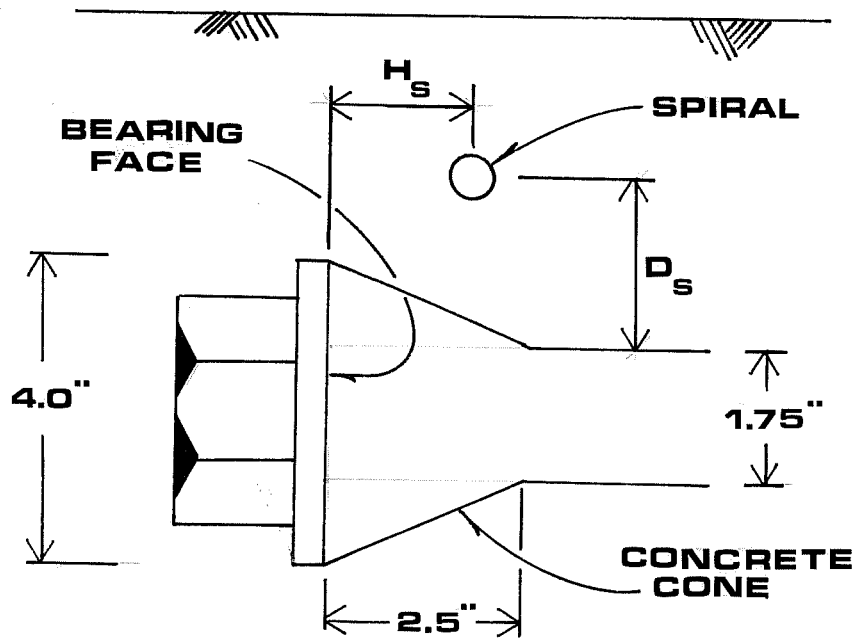
Test	Bolt	$h_s$ (in.)	$d_s$ (in.)
NOW	2	5.0	2.0
	3	5.5	2.0
SC6	2	0.5	2.0
	3	1.0	2.0
SC7	2	1.0	0.0
	3	1.5	0.0
SC8	2	3.5	5.0
	3	4.0	5.0
STG1	2	5.0	0.0
	3	3.0	0.0
STG2	2	2.0	3.0
	3	0.0	3.0

Fig. 3.22 Position of spiral bars ahead of bearing face

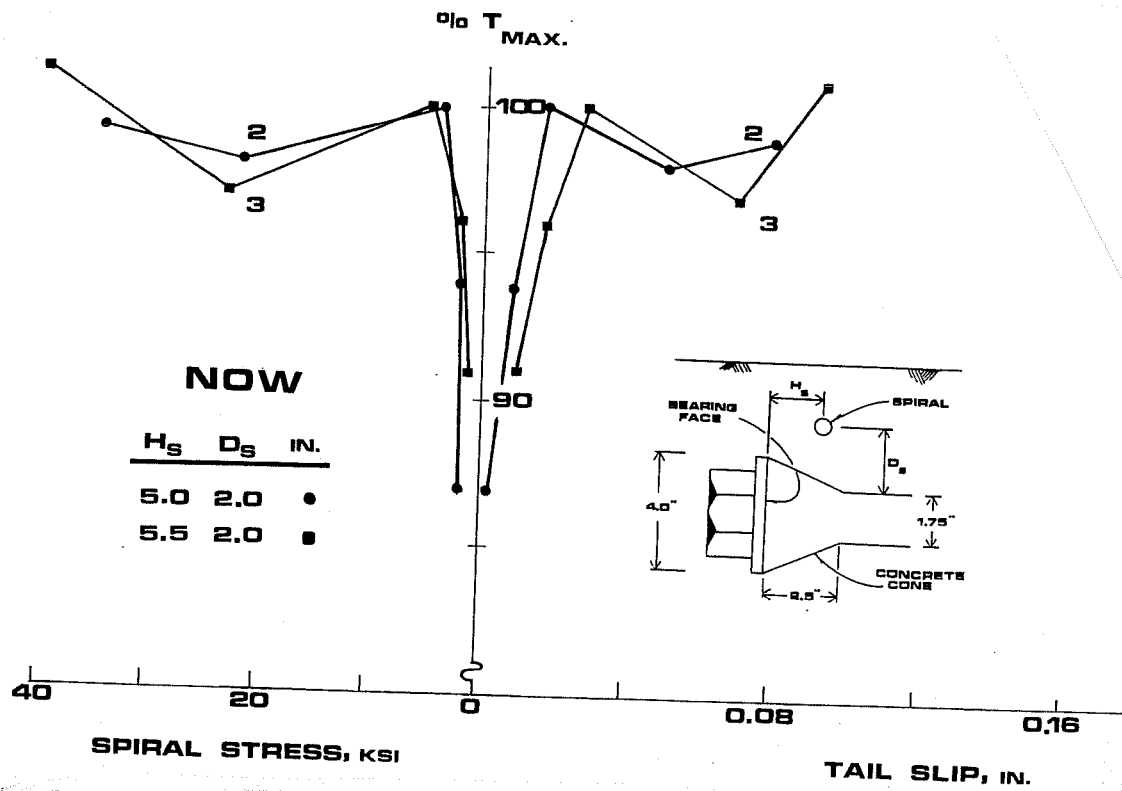
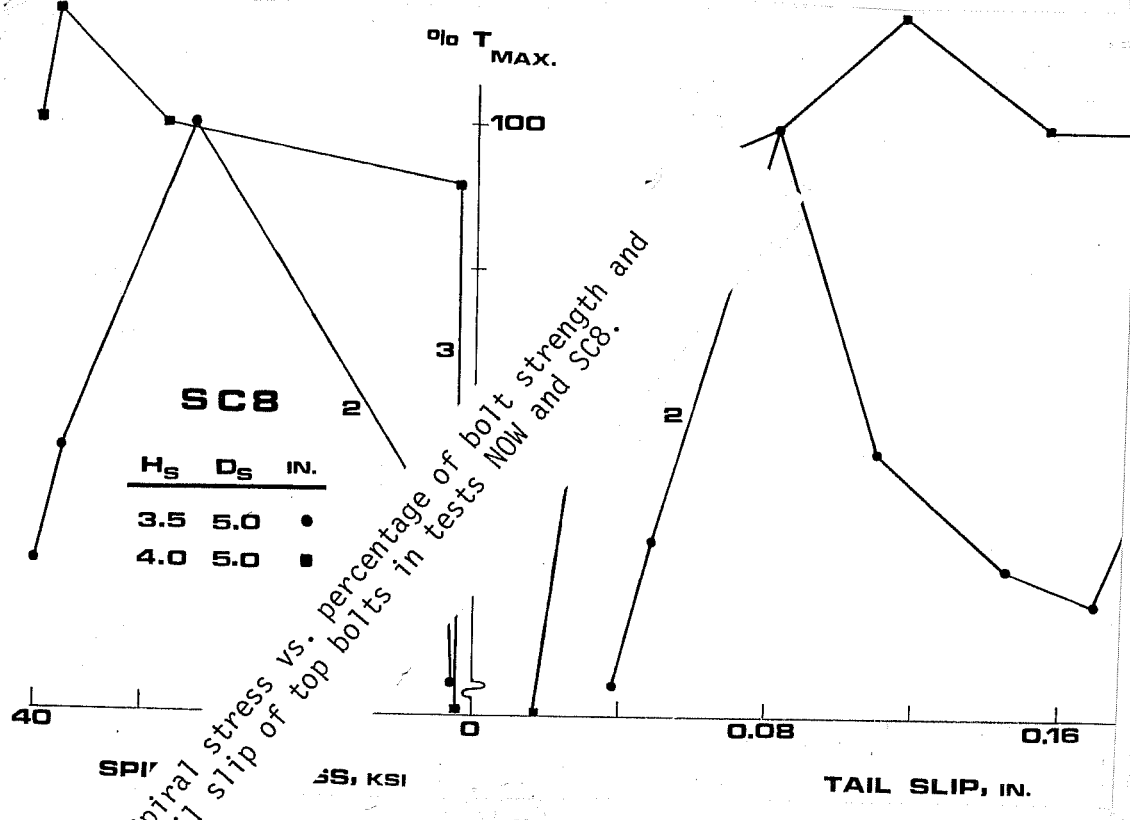
Fig. 3.23 Spiral stress vs. percentage of bolt strength and tail slip of top bolts in tests NOW and SC8.

NOW. Spiral bars, very far from the bearing face ( $h_s = 5.0$  in. and 5.5 in.), did not record any significant stress before the bolts reached their capacity (see Fig. 3.23). At 100 percent  $T_{\max}$ , few cracks were visible on the surface, and a small tail slip was measured for the top bolts ( $P_n = 35$  k in Fig. 3.8). Two stages later ( $P_n = 41$  k), tail slip quadrupled to an average 0.086 in. and extensive cracking was observed. The spirals yielded rapidly during these load stages, and the load on neither bolt dropped to less than 97 percent of their peak value.

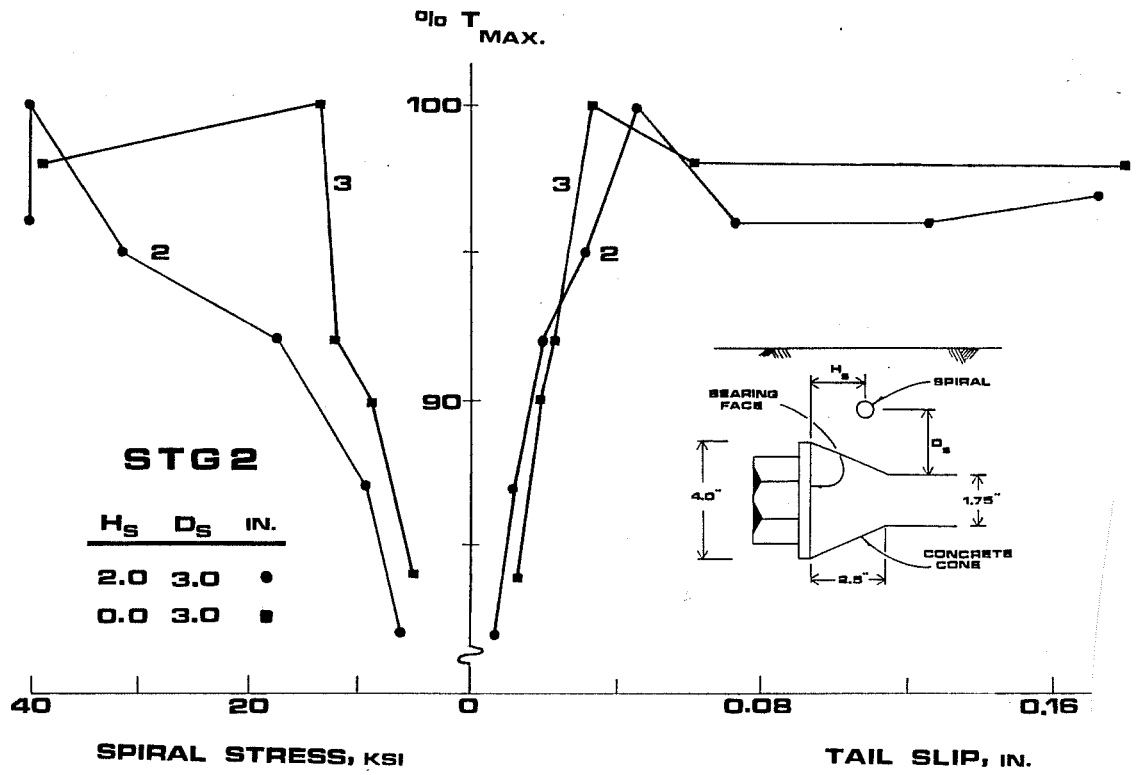
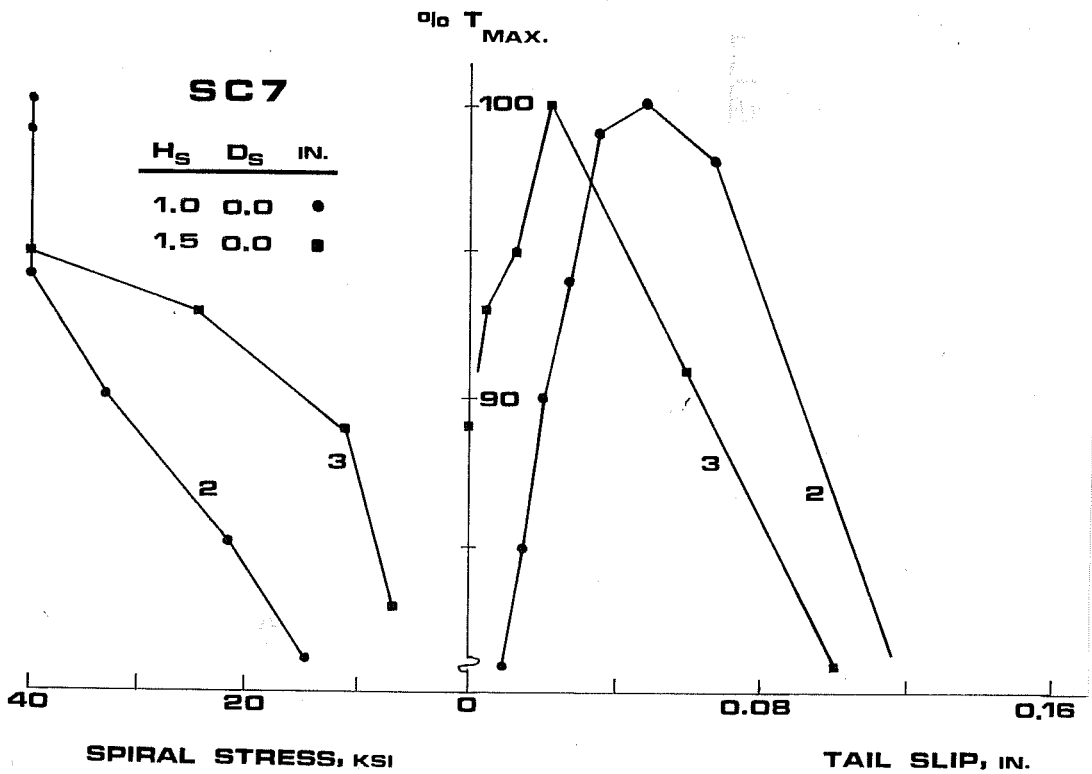
Fig. 3.24 Spiral stress vs. percentage of bolt strength and tail slip of top bolts in tests STG2 and SC7.

SC7. Top bolts resting against the spiral bars in shallow cover ( $C = 2.4$  in.), exhibited an abrupt failure as shown in Fig. 3.24. The spiral hoops, at 1.0 in. and 1.5 in. ahead of the washers, were posi-

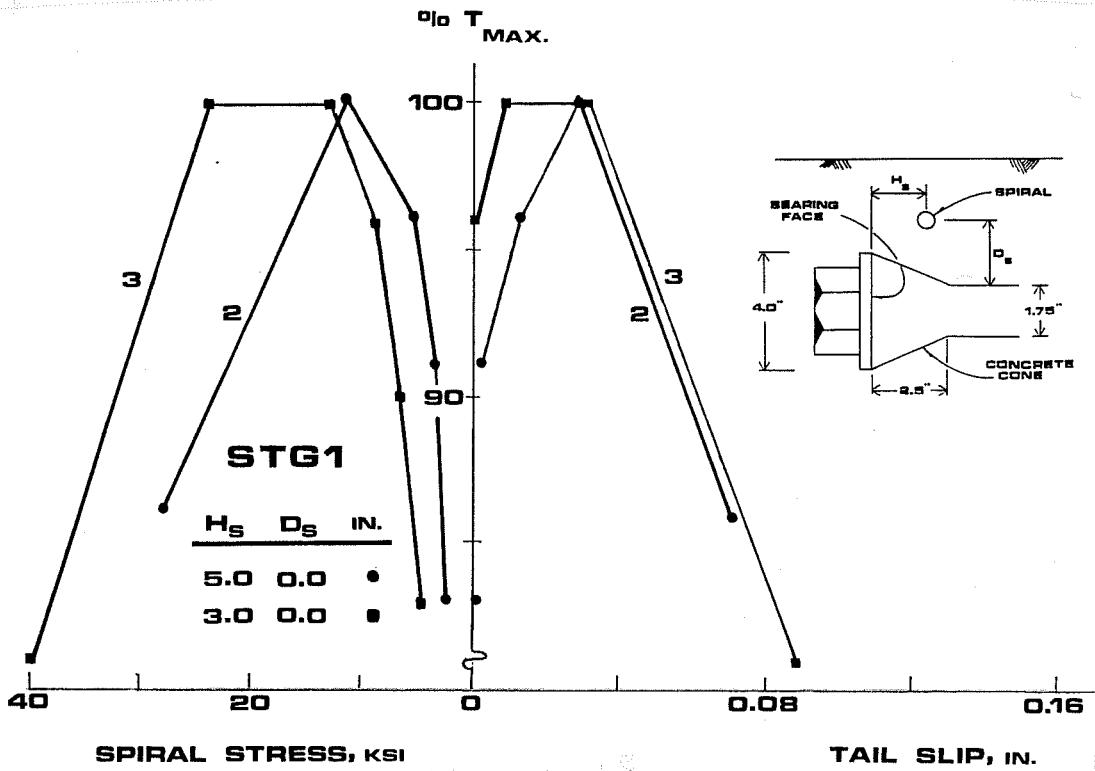
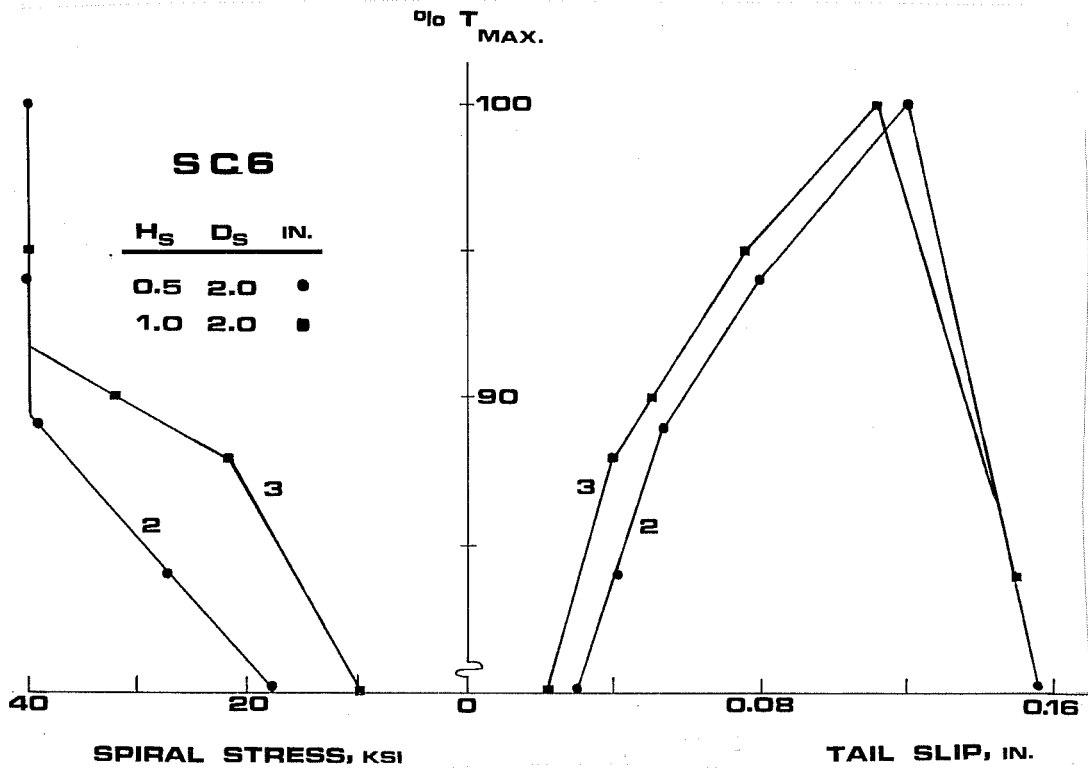
Fig. 3.25 Spiral stress vs. percentage of bolt strength and tail slip of top bolts in tests STG1 and SC6.

SC6. Adequate placement of the transverse reinforcement in test SC6 was observed to increase the strength of the anchor bolt installation. The spiral hoops were positioned very close to the washer, on top of the expected concrete cone, as illustrated in Fig. 3.22. The first hoop in front of the bearing face yielded near 90 percent  $T_{max}$  for bolts

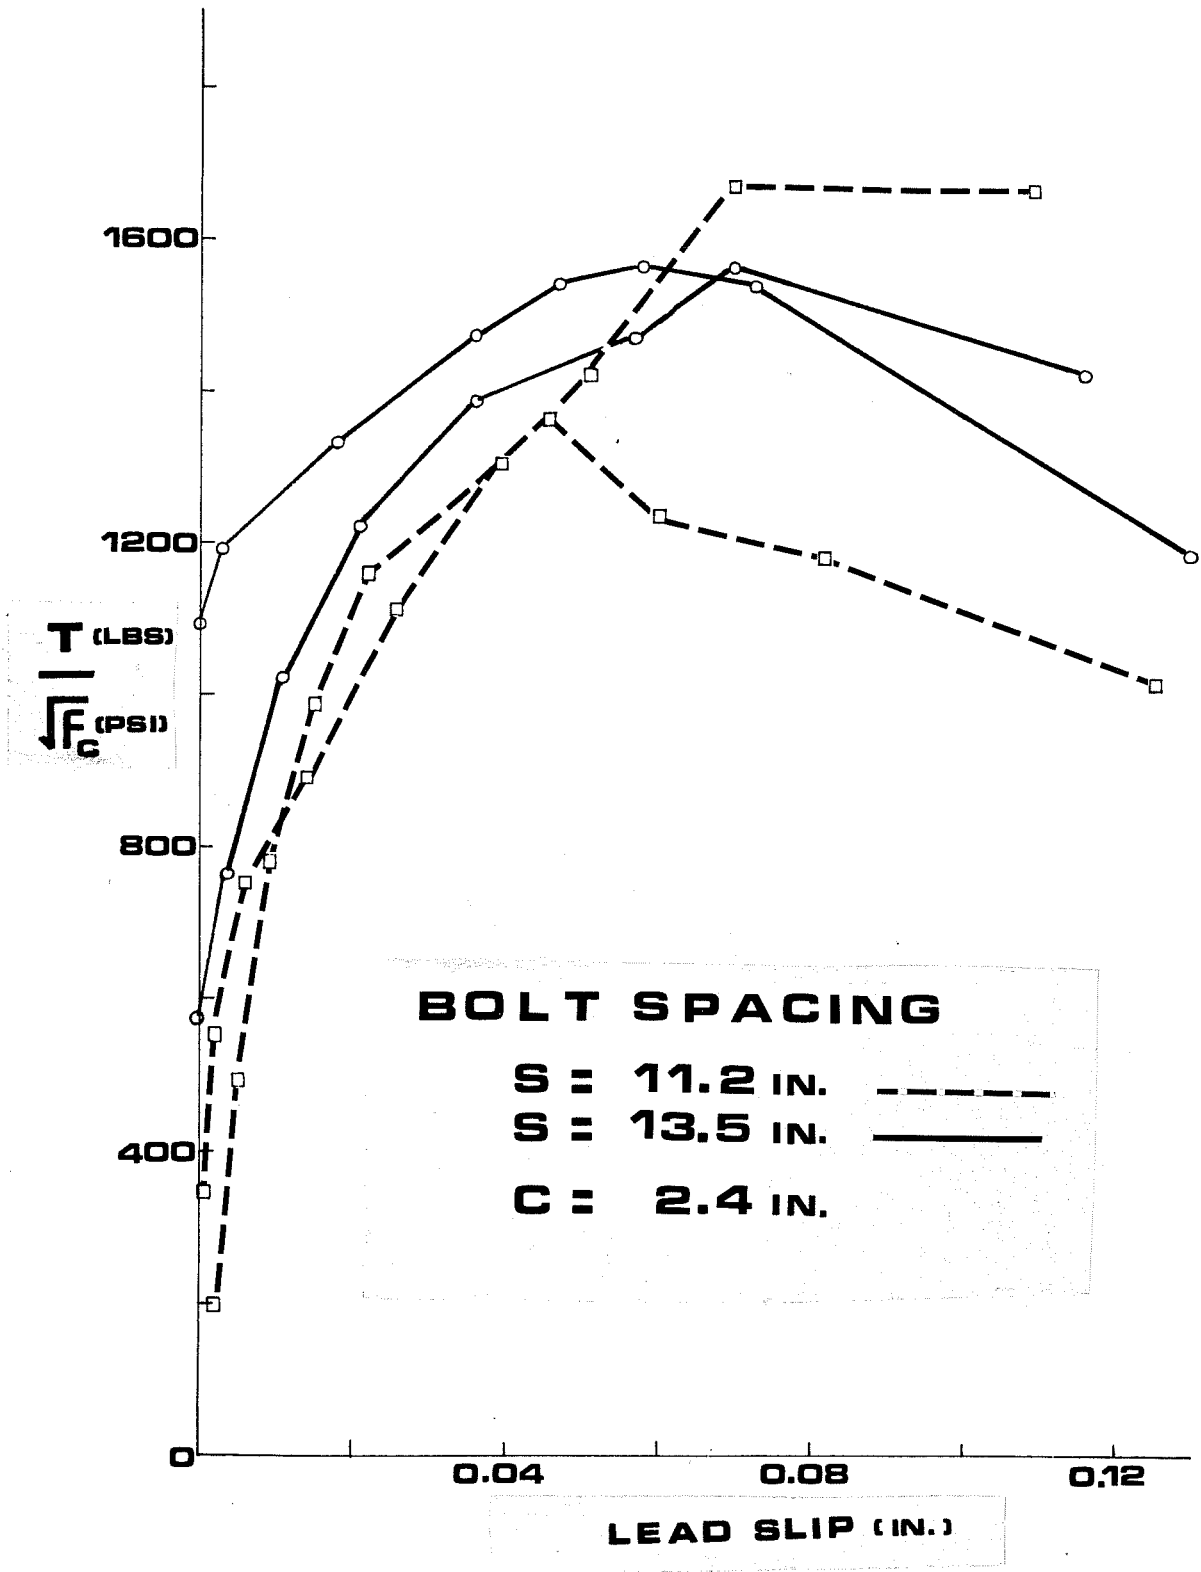
Fig. 4.1 Effect of bolt spacing: tests SC1 and SC7

As shown in Fig. 4.1, an increase in bolt spacing from 11.2 in. to 13.5 in., with a 2.4 in. clear cover, did not effect significantly the average bolt capacity. The average of the bolts' loads in each group is about the same. On the other hand, the same 2.3 in. increase

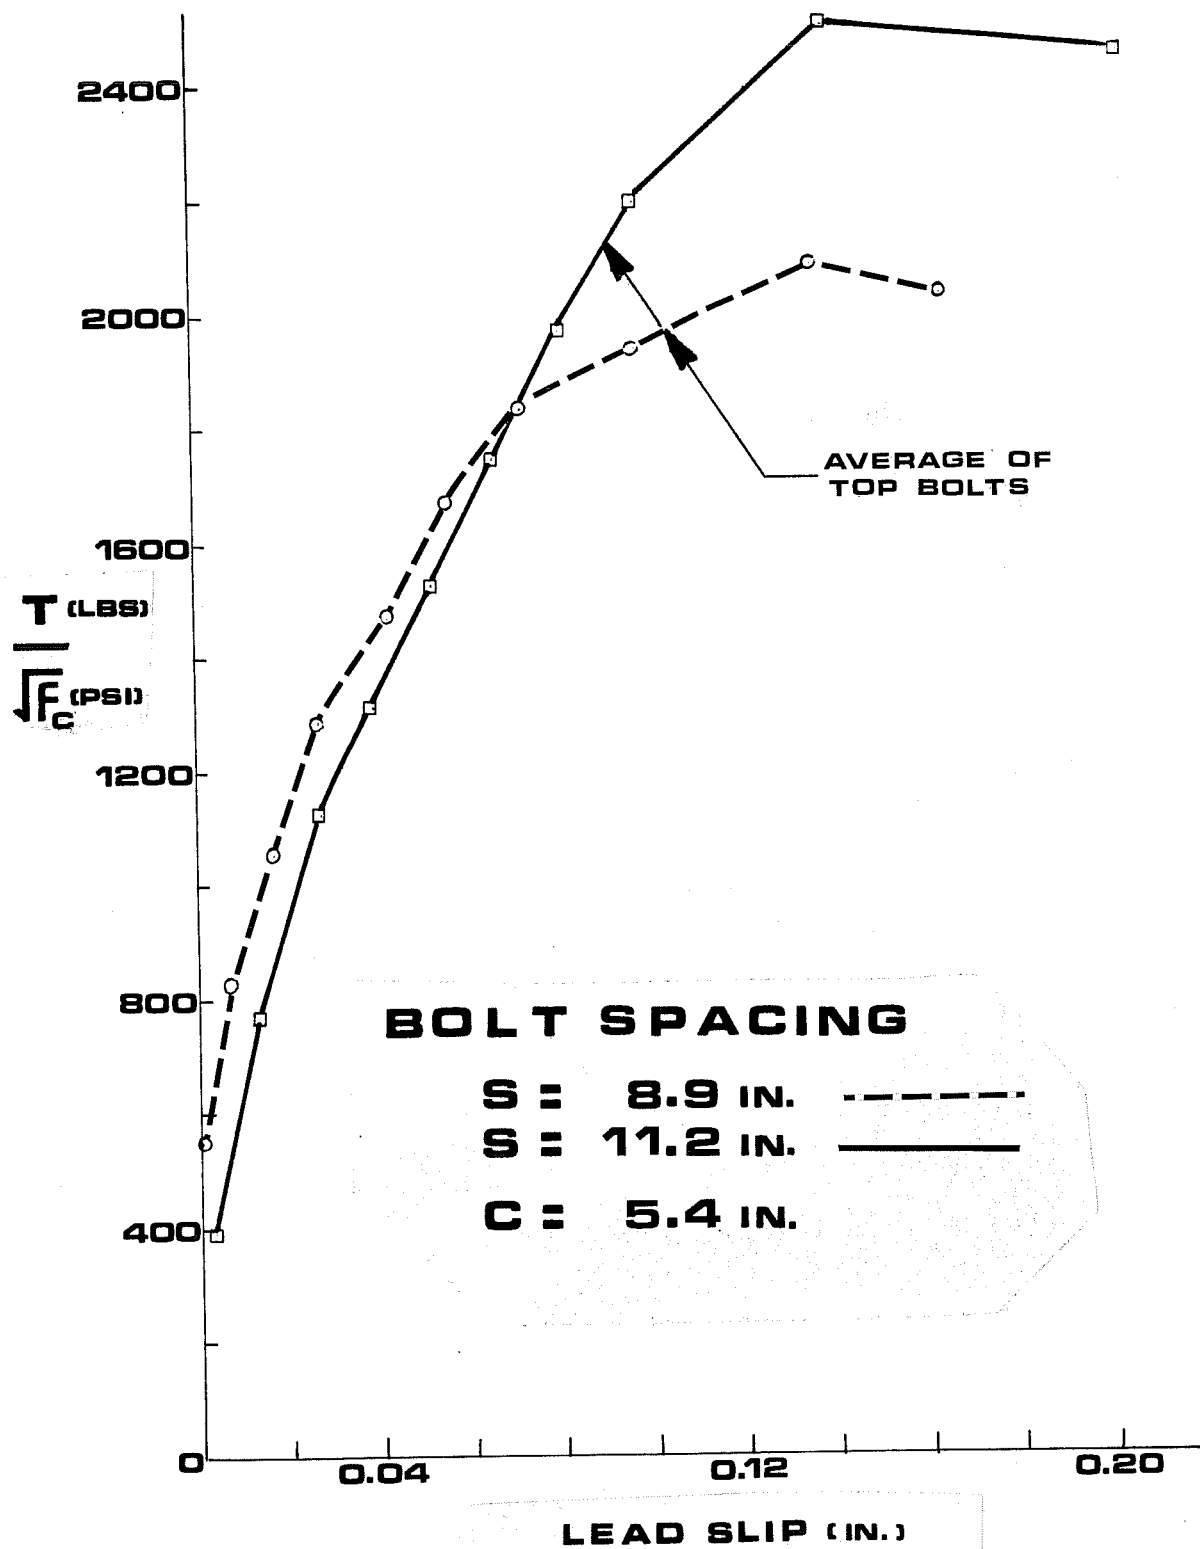
Fig. 4.2 Effect of bolt spacing: tests SC2 and SC4
