TENSILE CAPACITY OF HIGH-STRENGTH  
ANCHOR BOLT GROUPS EMBEDDED IN  
CIRCULAR CONCRETE PIERS

T H E S I S

Presented to the Faculty of the Graduate School of  
The University of Texas at Austin  
in Partial Fulfillment  
of the Requirements  
for the Degree of  
MASTER OF SCIENCE IN ENGINEERING

December 1982

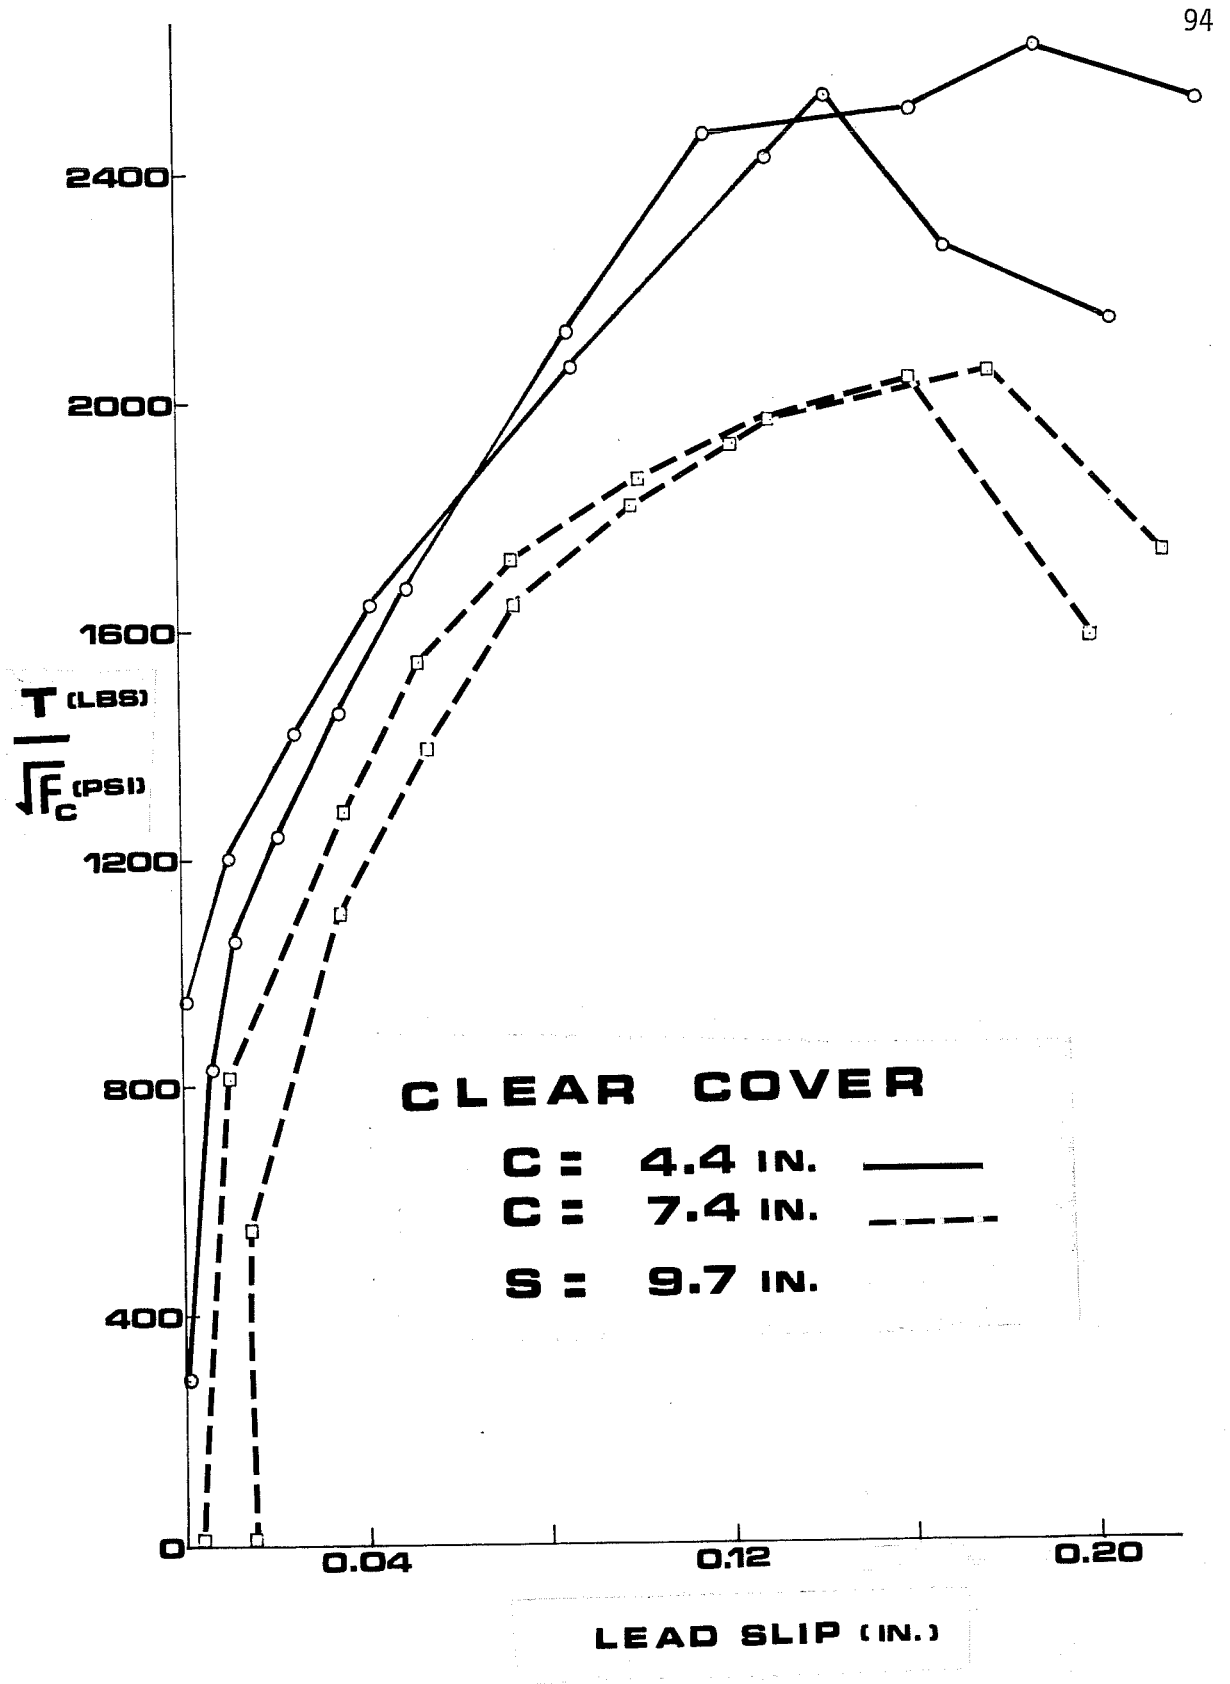
Fig. 4.3 Effect of clear cover: tests SC6 and SC8

In Figs. 4.3 and 4.4, bolt groups with different clear covers and constant spacing are compared. In Table 4.3, normalized bolt strength and relative capacity for the top bolts in the groups are listed. Increasing clear cover from 4.4 in. to 7.4 in., with a 9.7 in. spacing, resulted in a 24 percent increment in the average bolt capacity, as shown in Table 4.3 for tests SC6 and SC8. The increment in capacity predicted for an isolated bolt under similar clear cover conditions was 20 percent (220/183 from Table 4.1).

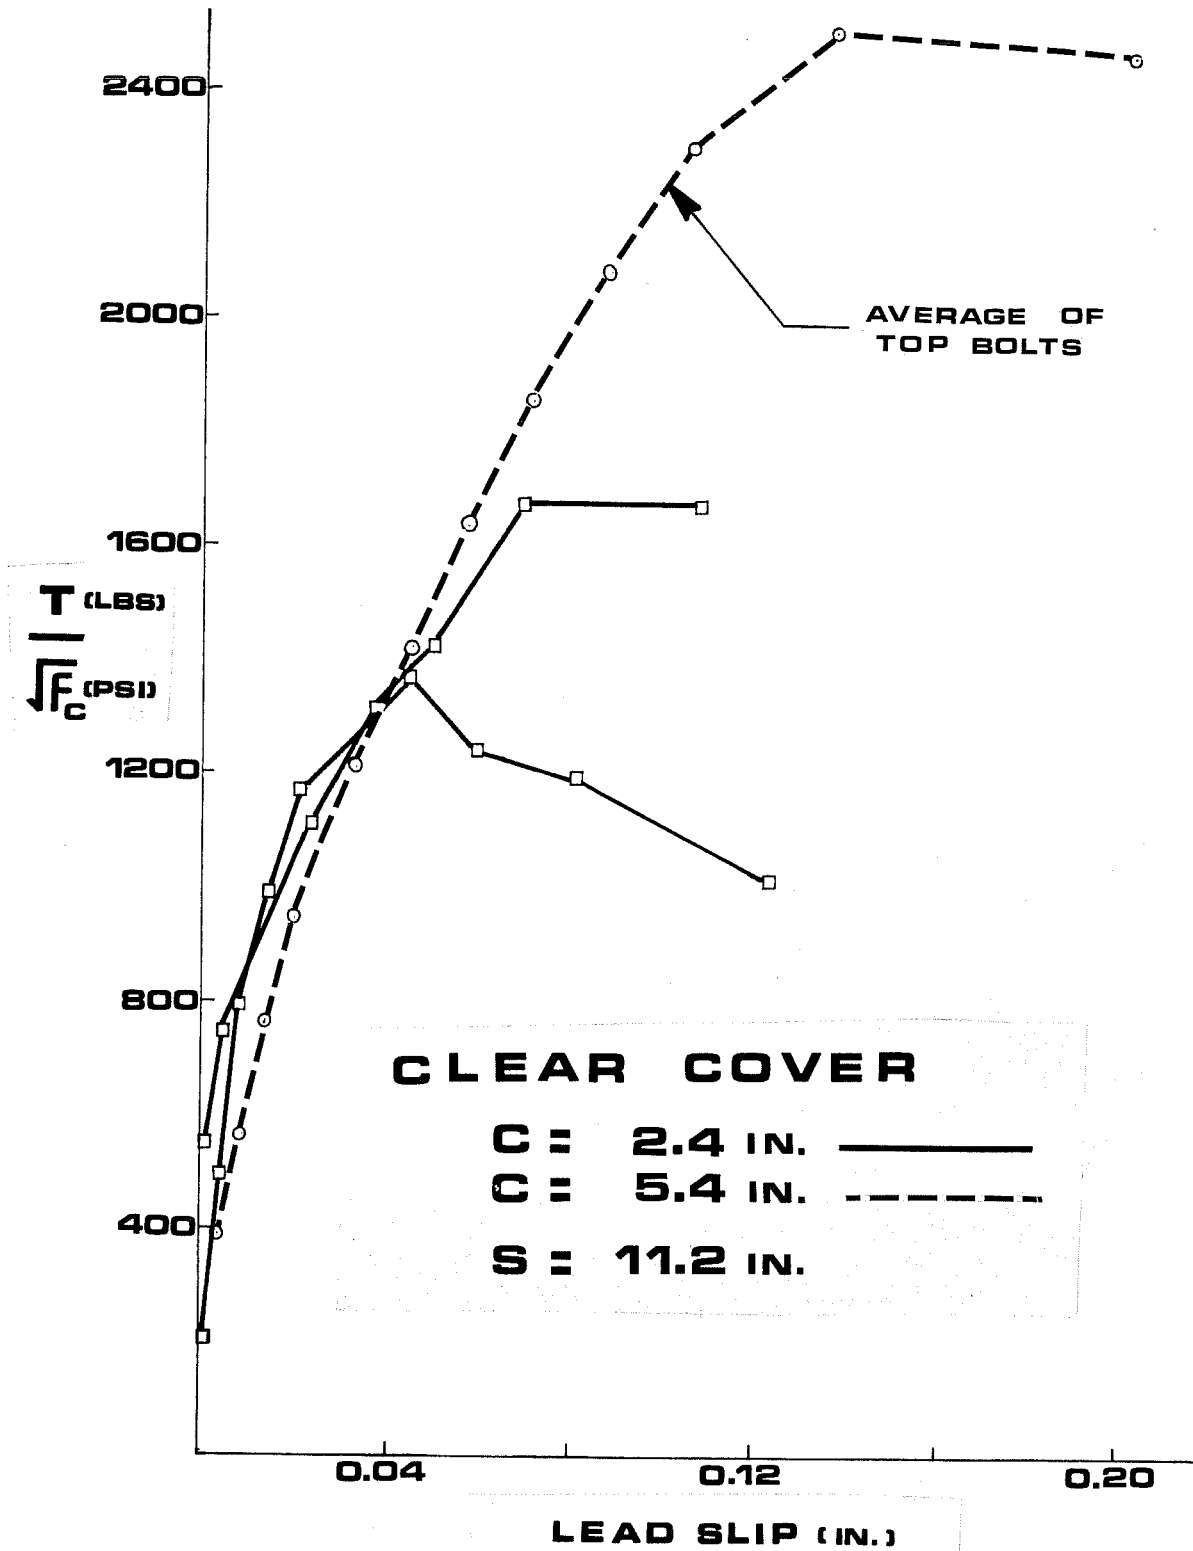
Fig. 4.4 Effect of clear cover: tests SC1 and SC4

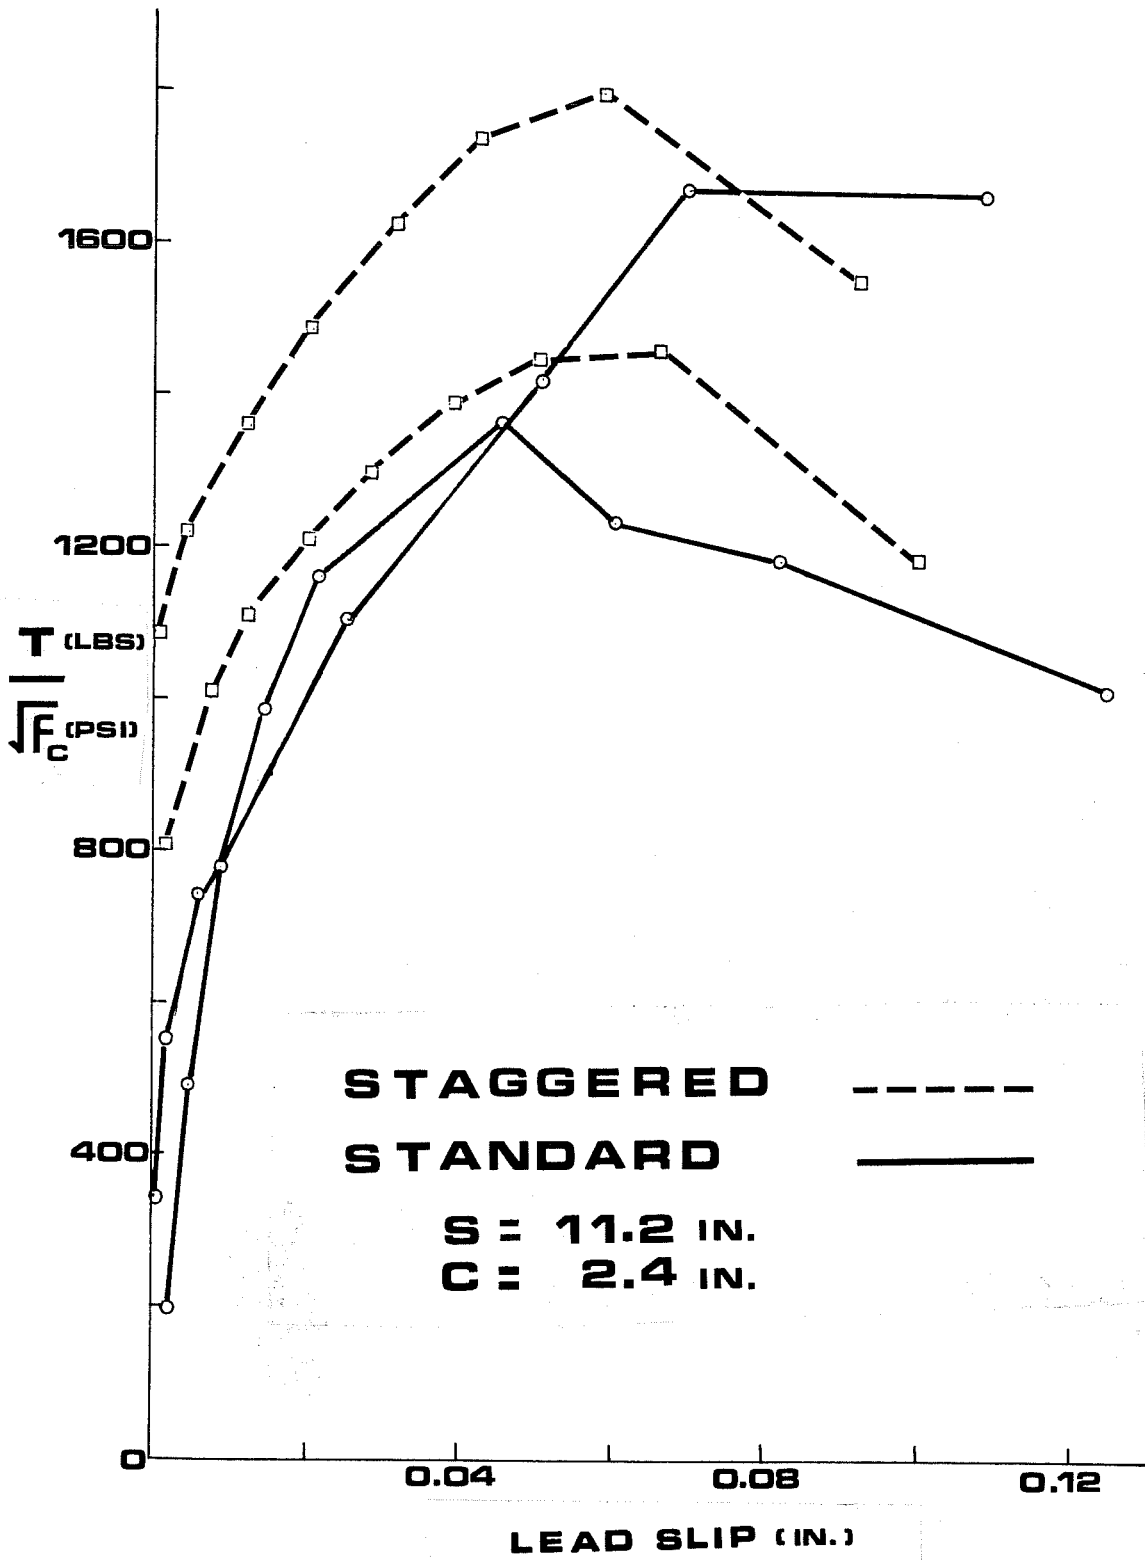
Fig. 4.5 Effect of bolt staggering: tests SC1 and STG1

Staggered bolts in test STG1 with a 2.4 in. clear cover and 11.2 in. spacing showed a slight increase (8 percent) in the average bolt capacity over a bolt group (SC1) with similar geometry and uniform embedded

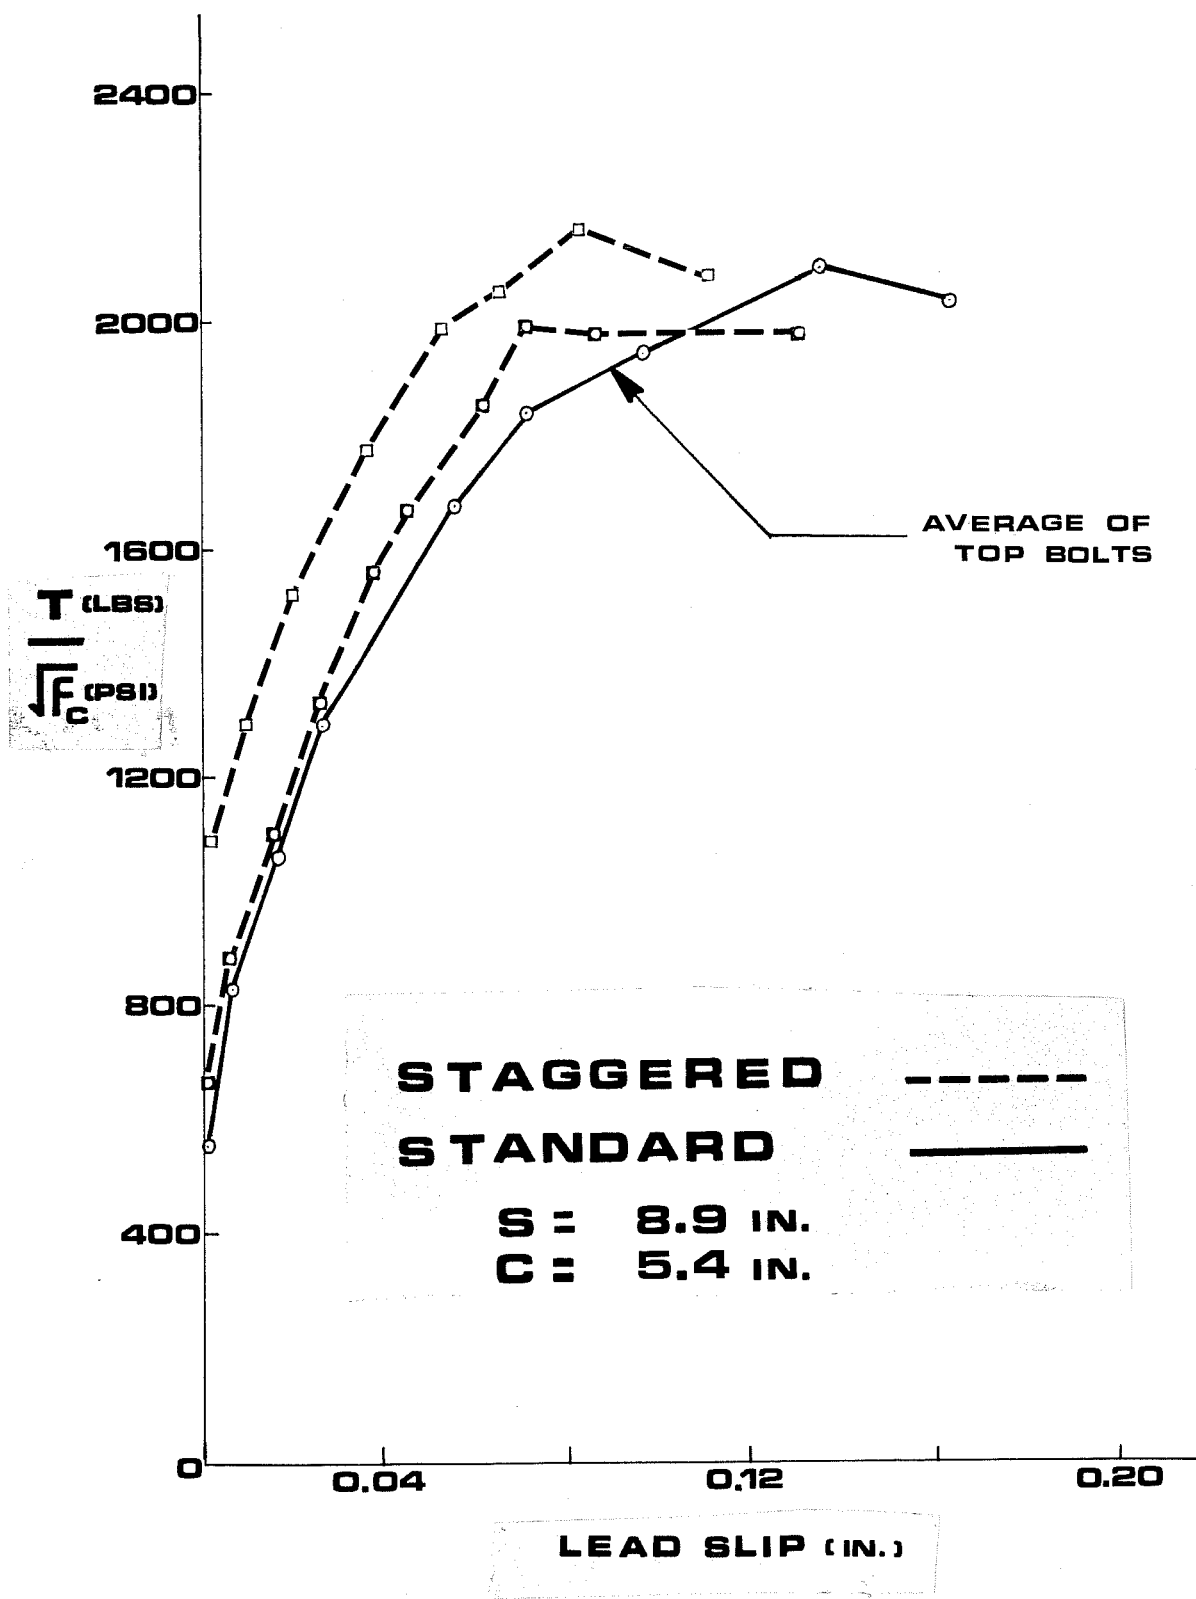
Fig. 4.6 Effect of bolt staggering: tests SC2 and STG2

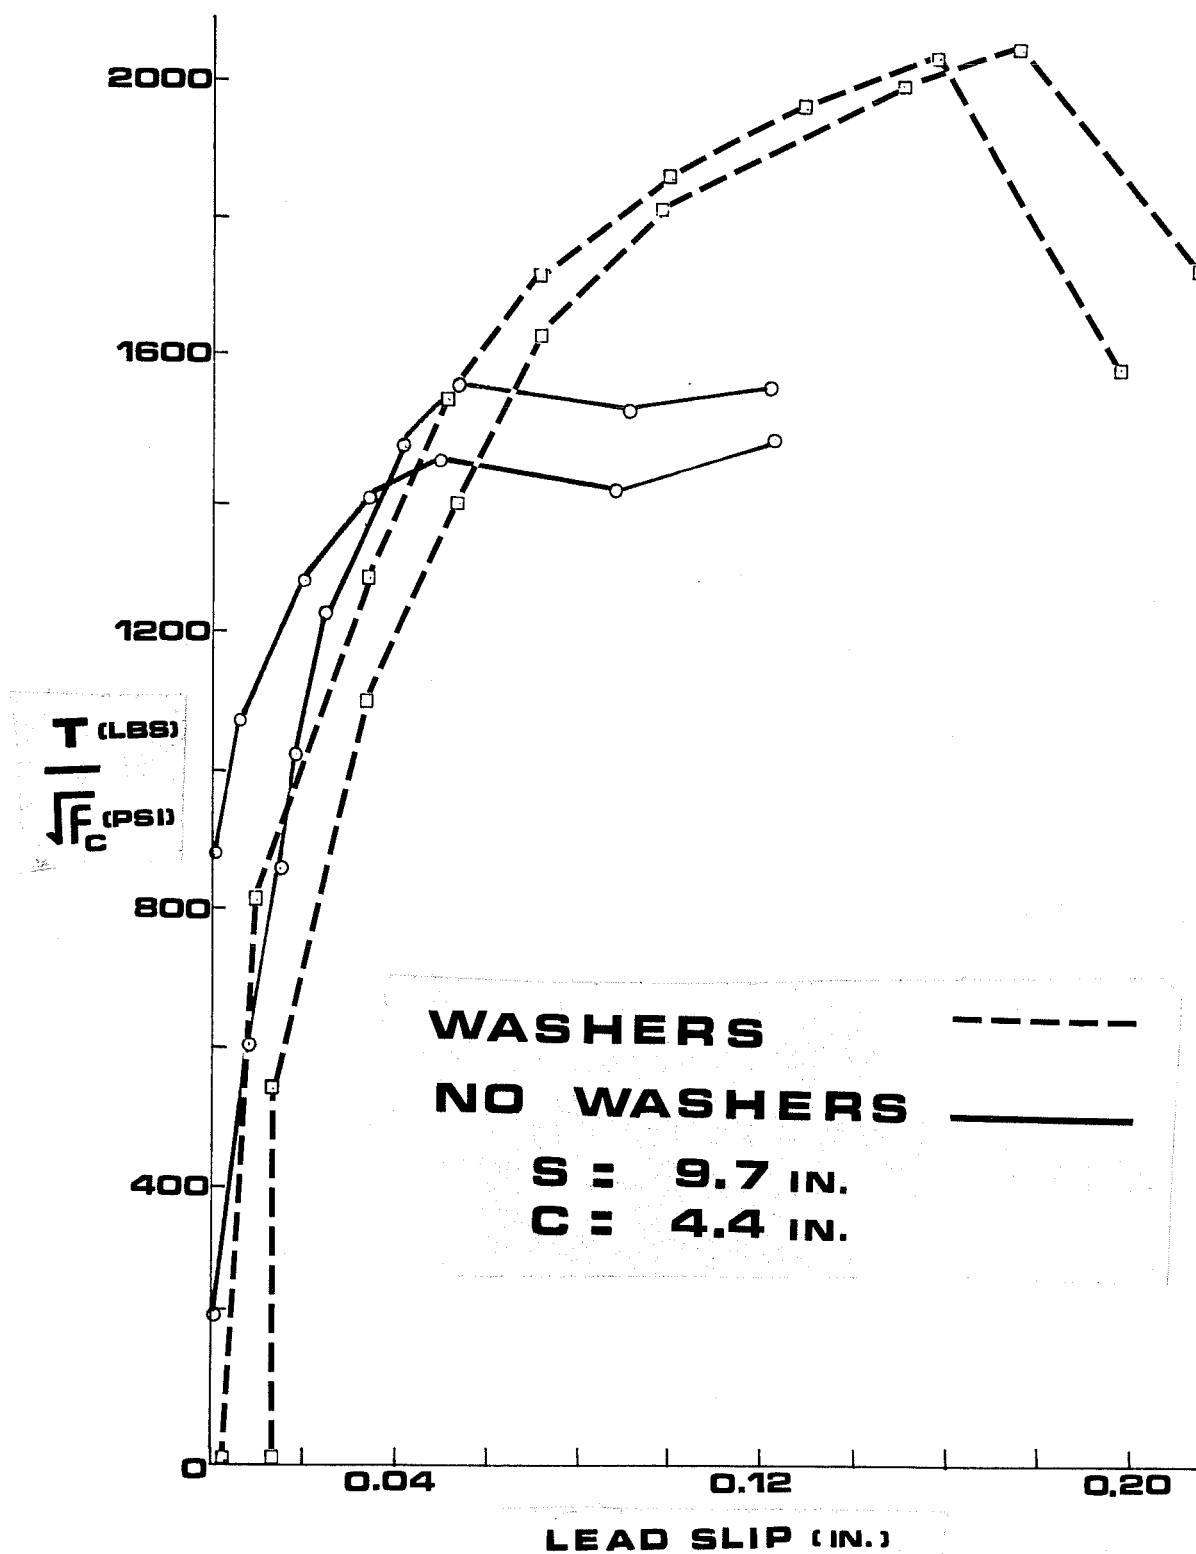
Fig. 4.7 Effect of reduced bearing area: tests SC6 and NOW

The average bolt capacity was reduced by 26 percent when washers were not used at the anchorage end. However, a much greater decrease, 44 percent (102/183 in Table 4.1), equivalent to the reduction in the bearing area ( $A_b$ ) was predicted by the expression for the nominal bolt capacity (Eq. 4.1). The discrepancy above is clearly explained by noticing (Table 4.5) that the anchor bolts in test NOW failed with very little, if any, bolt interaction (average  $T_{max}/T_n = 0.92$ ), while for test SC6 the interaction was considerably greater ( $T_{max}/T_n = 0.69$ ). As illustrated in Fig. 3.8 for test NOW, the surfacing of two longitudinal

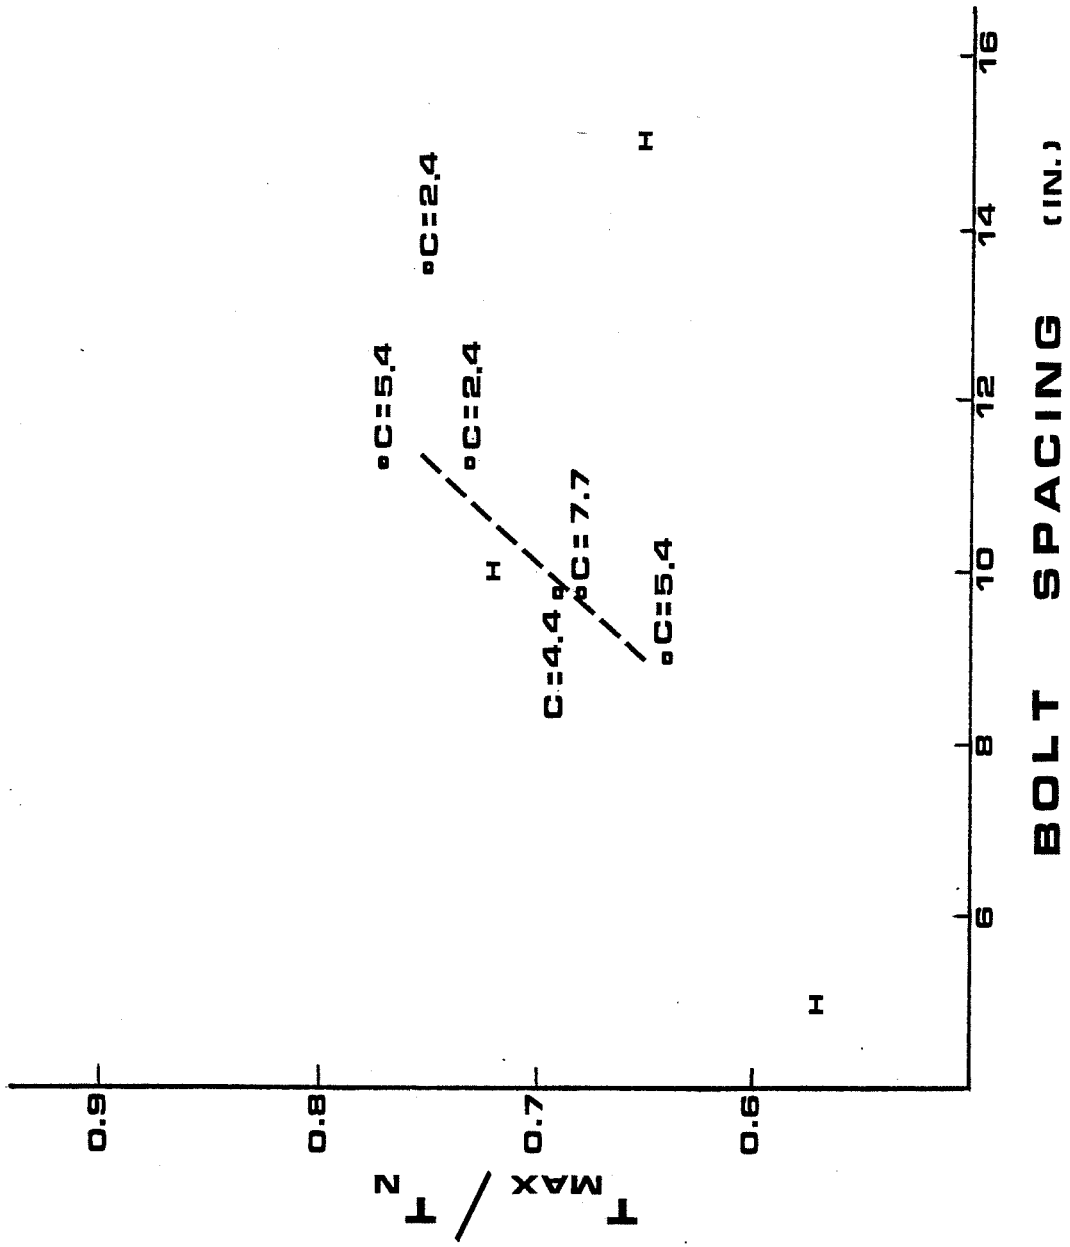
Fig. 4.8 Reduction in average capacity for bolts in a group with spacing

The strength of a two-bolt group should exhibit a theoretical variation with spacing between 50 and 100 percent of the nominal capaci-

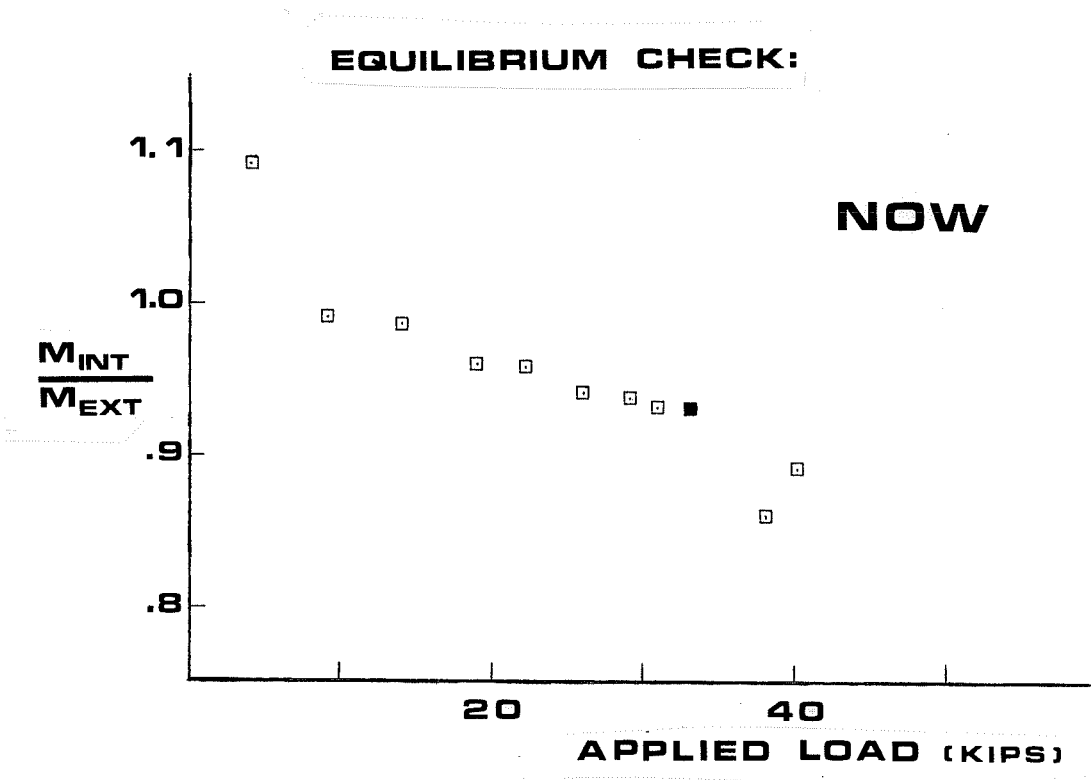
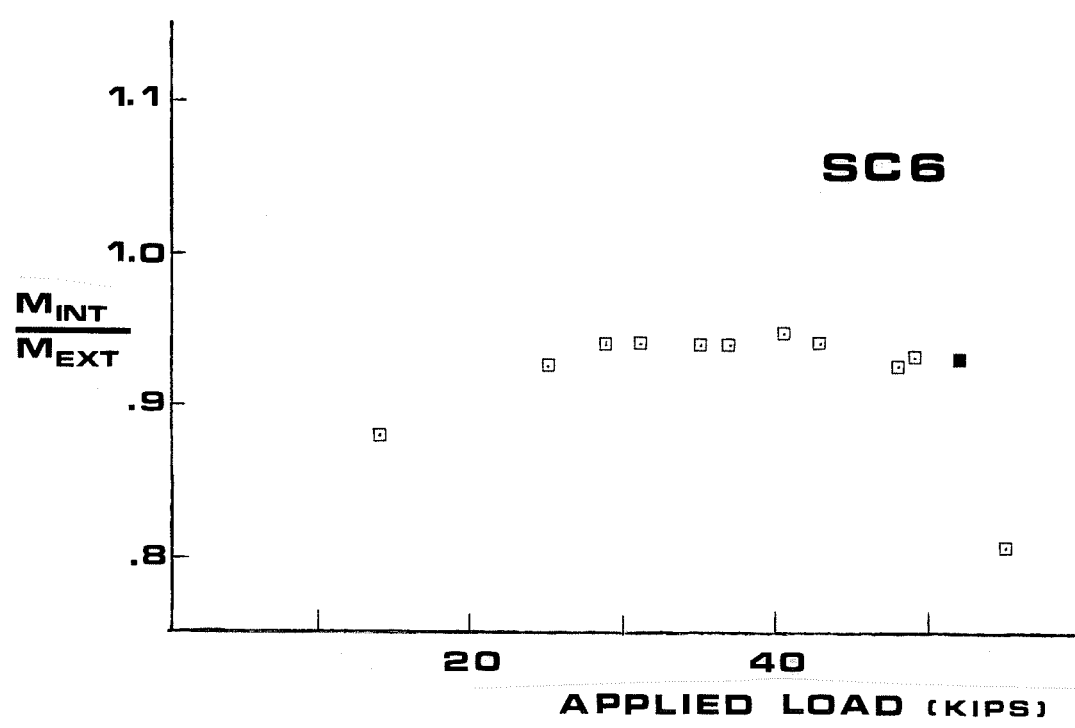
Fig. A.1 Equilibrium check in tests NOW and SC6

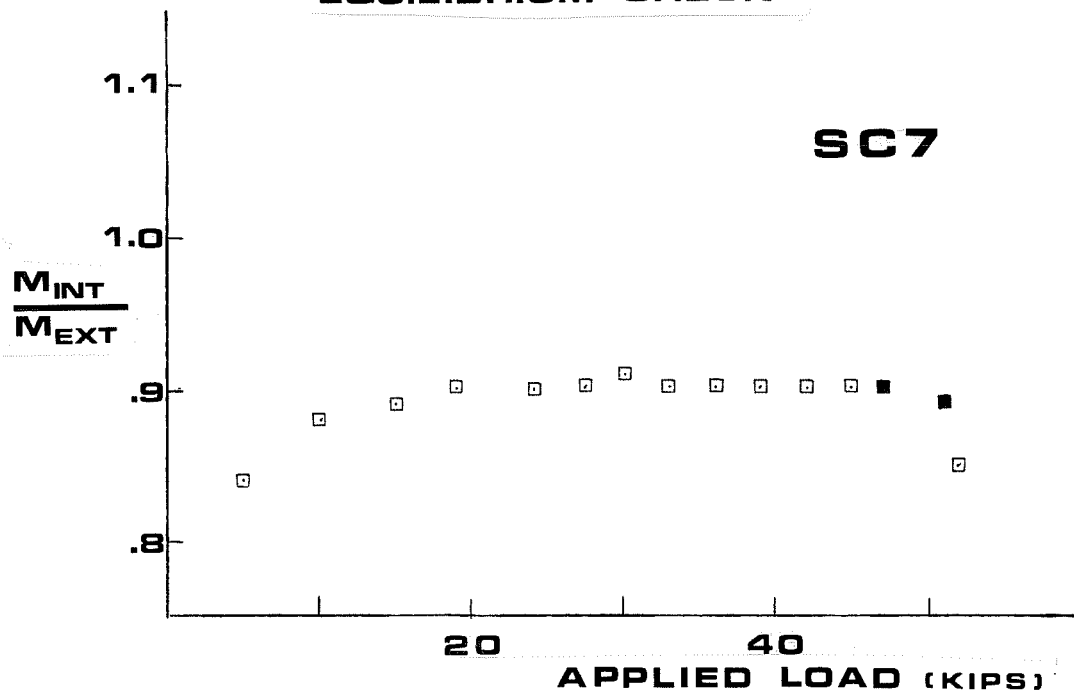
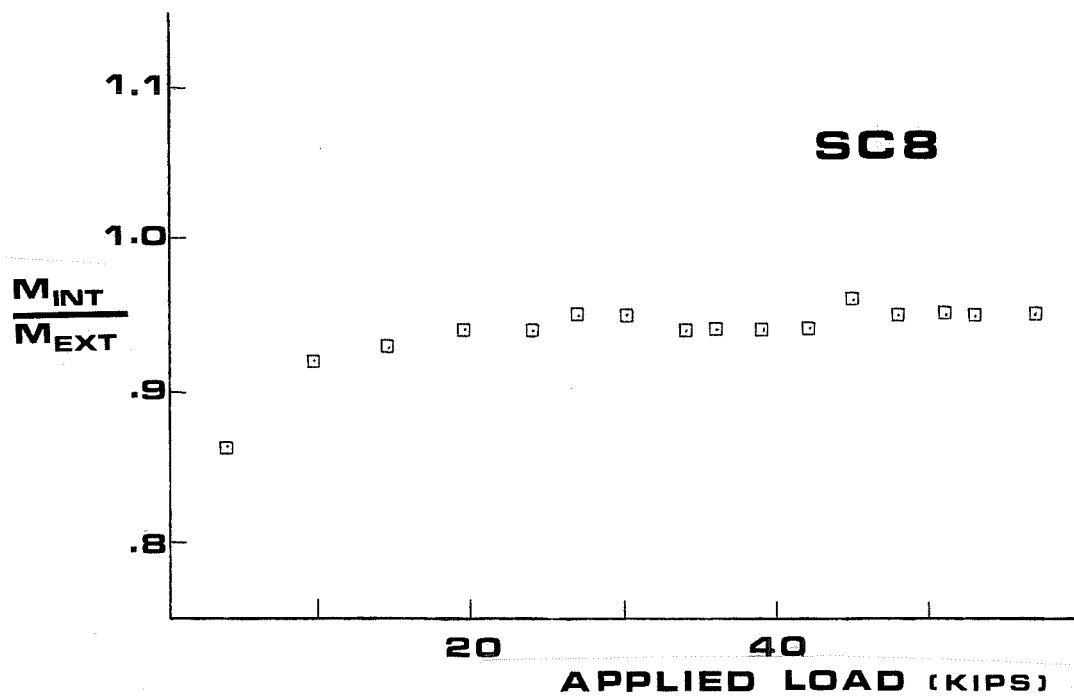
Fig. A.2 Equilibrium check in tests SC7 and SC8

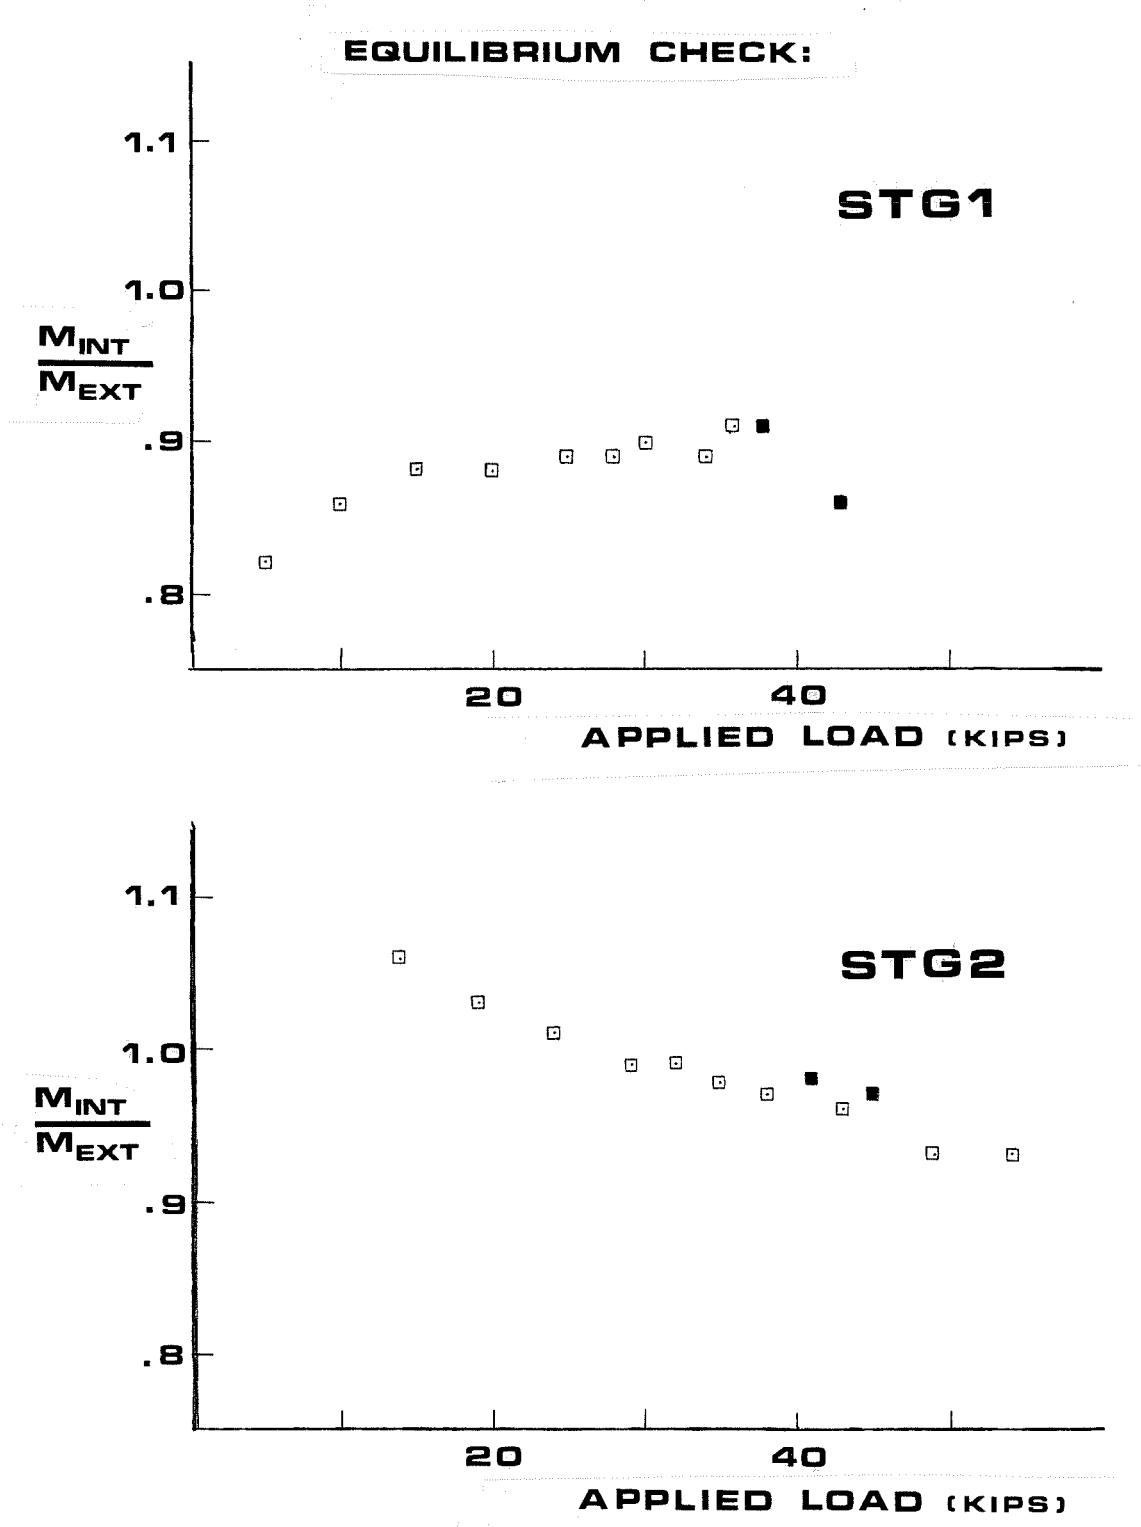
Fig. A.3 Equilibrium check in tests STG1 and STG2

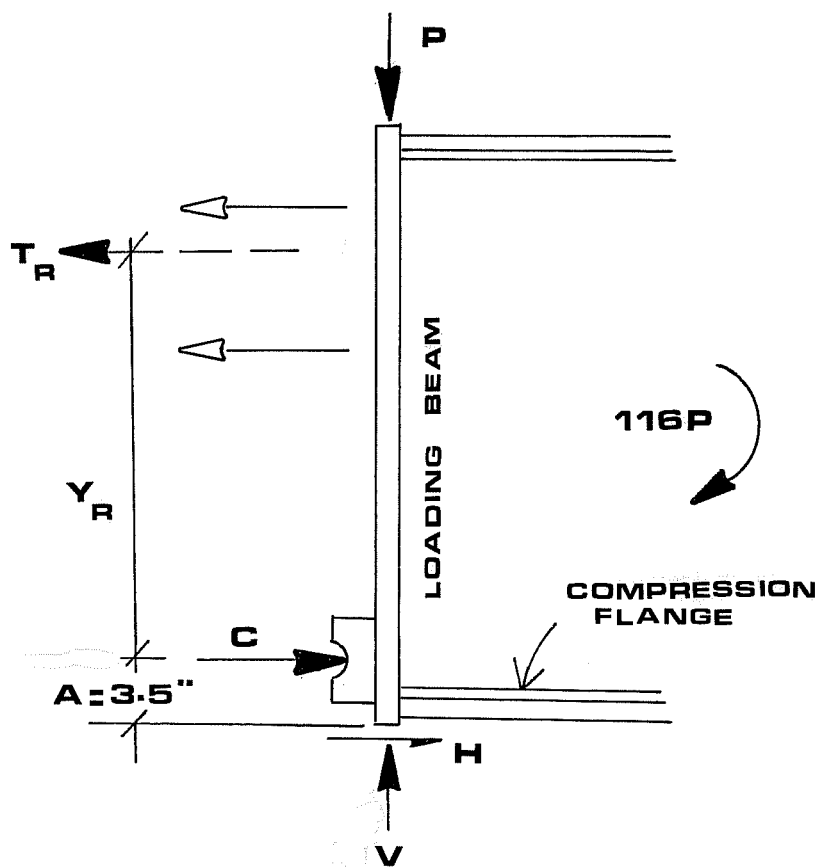
Fig. A.4 Reactions at the specimen - loading beam interface

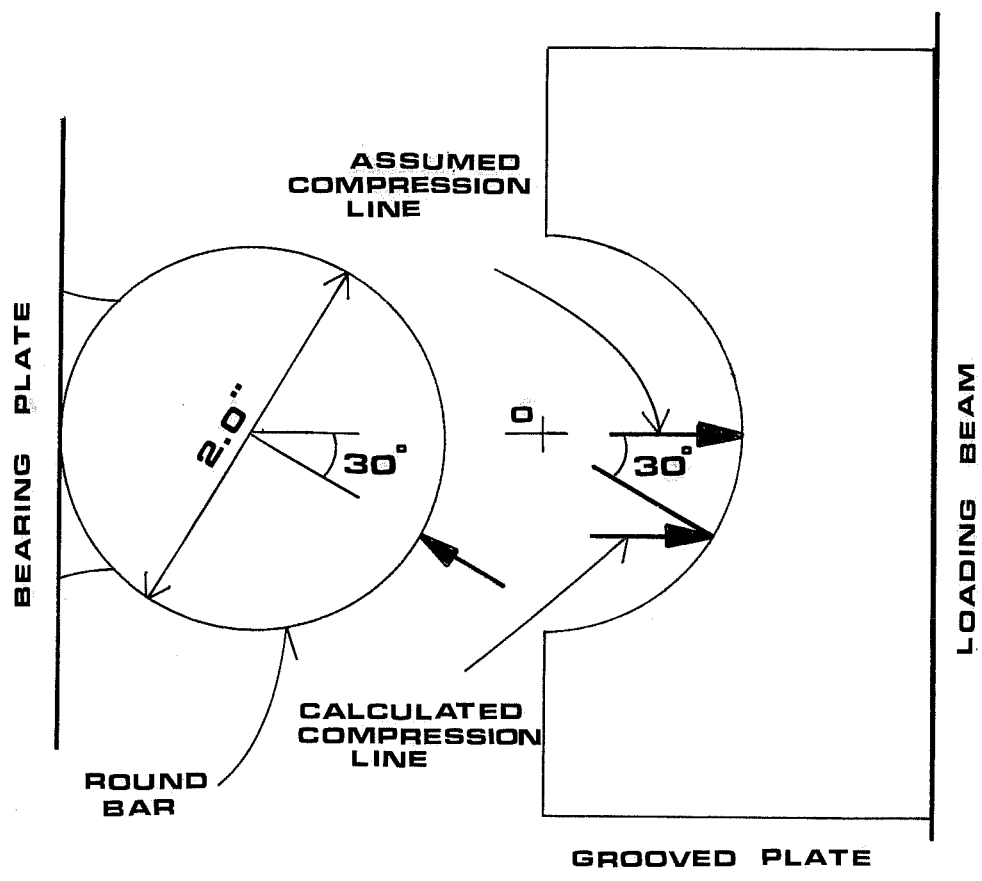
Fig. A.5 Grooved plate detail

A most significant approximation in deriving Eq. A.1 was to assume the compressive force  $C$  acting horizontally through point  $0$  on the beam, as shown in Fig. A.5. Actually, the compression in the bottom
