DEVIATOR BEHAVIOR IN EXTERNALLY POST-TENSIONED BRIDGES

THESIS

The University of Texas at Austin

August 1987

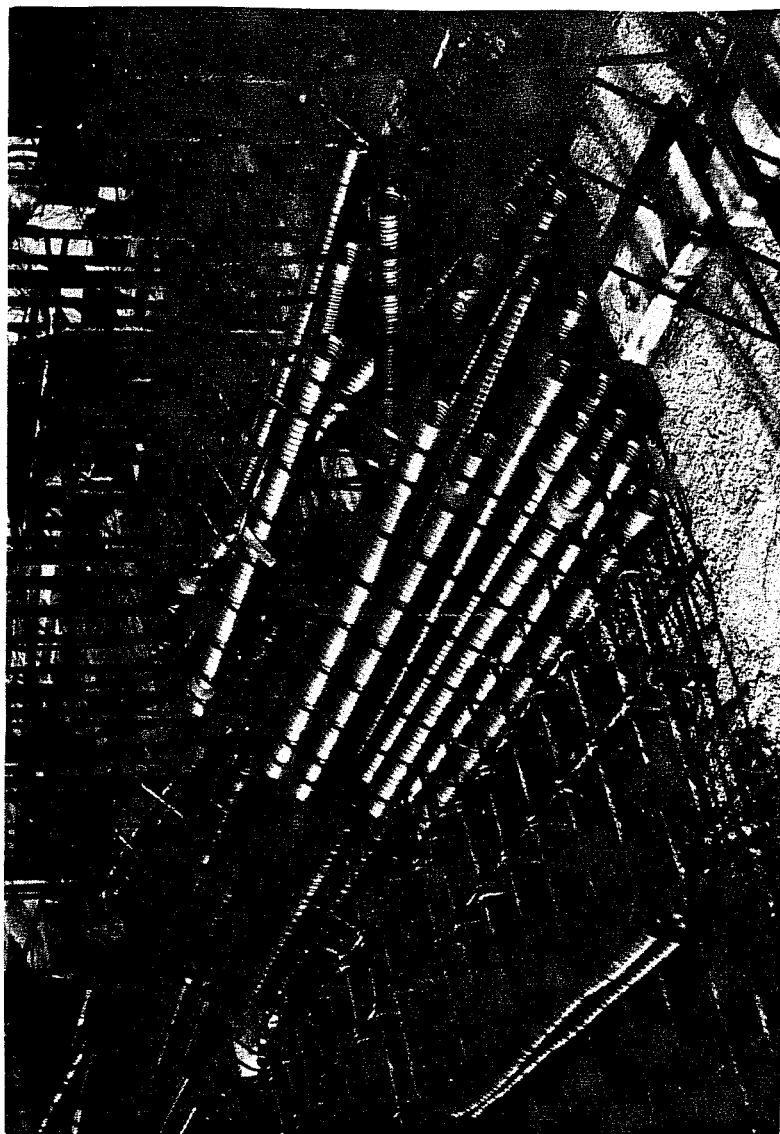
Figure 1.1 Congestion of Ducts for Internal Tendons

"External post-tensioning" implies that the tendons are removed from the webs and flanges of the concrete section, and are relocated inside the void of the box girder, or between the webs of non-box girders. The draped profile is maintained by passing the tendons through deviation devices cast monolithically with the webs and/or flanges at discrete points along the span. These "deviators" vary in shape and size, though the most common form is a small block or saddle located at the junction of the web and flange of the box girder section. Anchorages for the external tendons are usually placed in thick diaphragms situated over the piers, although blister anchorages are sometimes used at intermediate points within a span. Tendons typically overlap at

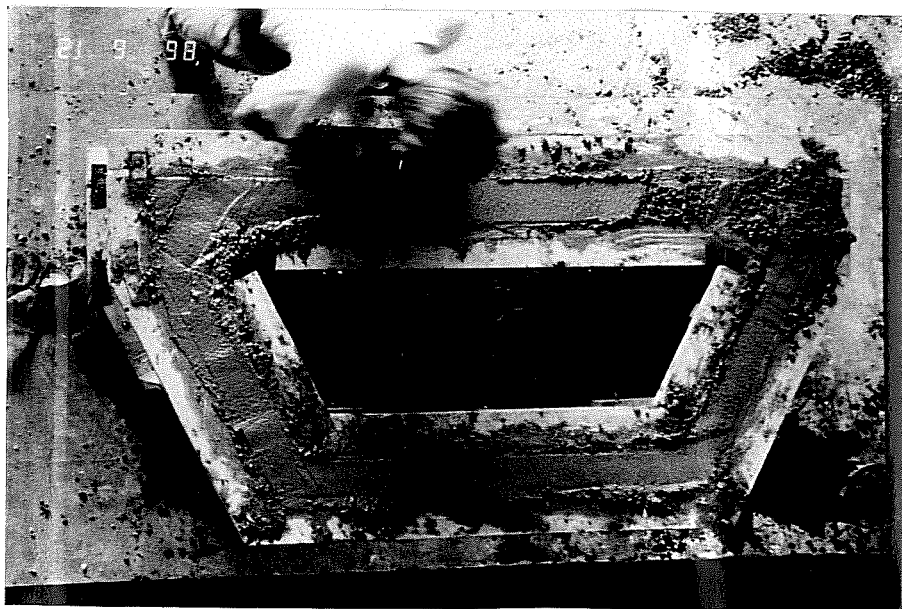
Figure 4.11 Placing Specimen Concrete

4.2.4 Concreting. A local ready-mix supplier delivered two yards of concrete to the laboratory with a slump of 2-1/4 inches. One gallon of water was added on site to bring the slump up to 3-1/4 inches. The fresh concrete was hand shoveled into the forms in several lifts (Fig. 4.11). One inch diameter stick vibrators were used to consolidate the concrete. After concrete was placed up to the level of the deviator ports, and the

deviator blocks had been well vibrated, the ports were sealed and the remaining concrete was placed. The exposed concrete at the top of the forms was trowel-finished. Several test cylinders were also prepared.

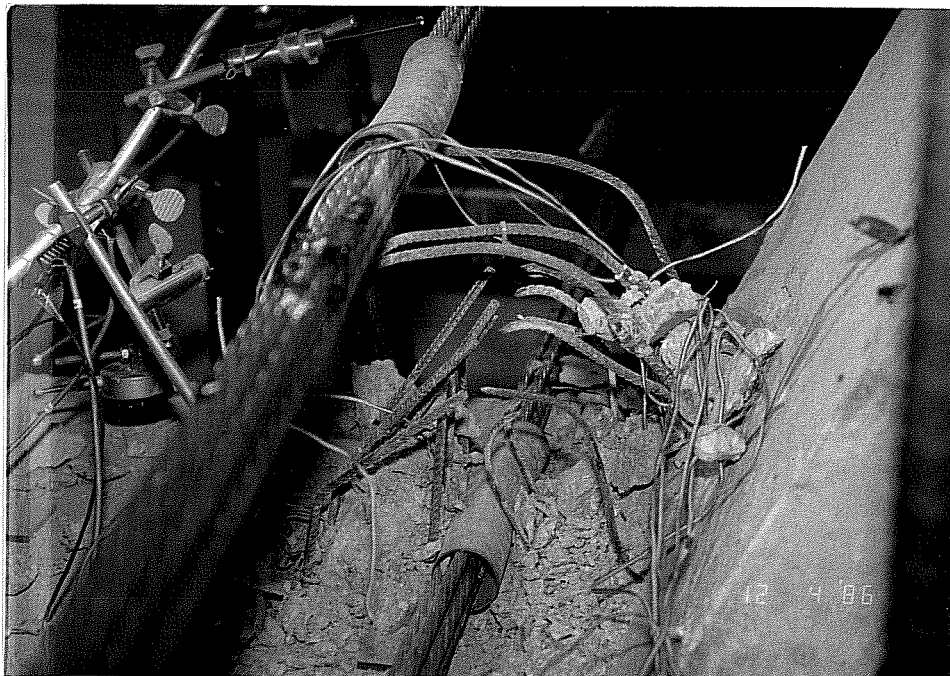
Figure 6.11 Block B: Immediately After Failure

The series of photographs in Figures 6.11 and 6.12 attest to the catastrophic nature of the failure. In Fig. 6.11, Tendon 2 is seen to have ripped free entirely from the block. Tendon 1 remained wedged against the unbroken concrete in the bottom of the block. Figure 6.12 shows the ends of the failed lap splices in the outer loops and the necked down break points

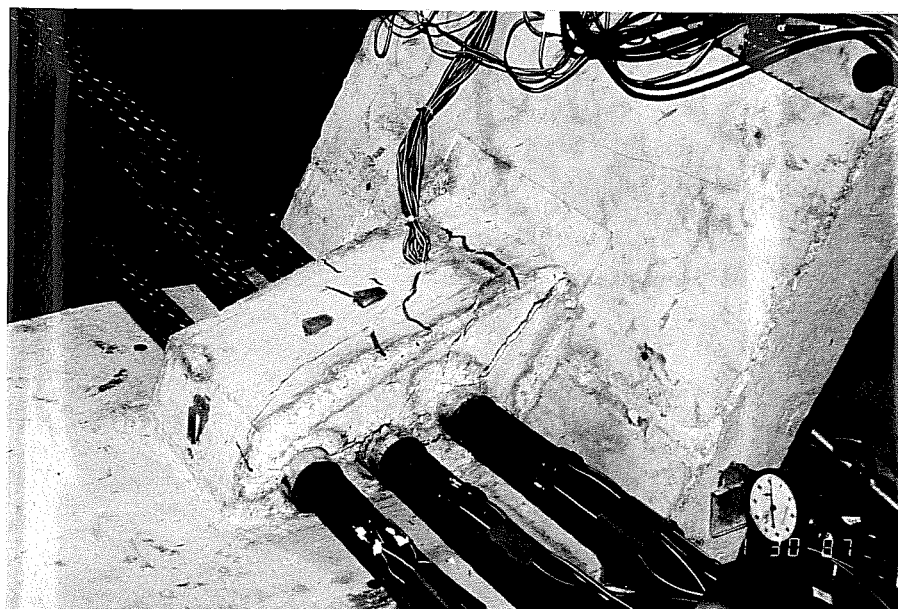
Figure 6.15 Block A: Advanced Cracking

The deviator failed after completing Load Stage 34, at which point the total force, D , was 24 kips ($D/D_0=2.40$). The deviator held this load for several minutes, while dial gage readings and photographs were being taken. The bottom photo in Fig. 6.15 shows the deviator just after completing Load Stage 34. During loading to Stage 34, the only new sign of damage was a slight widening of existing cracks. Two minutes after reaching this load, however, the concrete at the interface of the large crack on the south face began to spall. At the same time, the top face of the block began to bulge and new cracks formed in several locations. Sixty seconds after this spalling and cracking, the deviator block failed. The failure was explosive, but less so than in Test 1B. Again the force of the deviated tendons tearing out destroyed the concrete of the deviation block, but only the link reinforcement broke. Breaks in three of the link bars occurred at the junction of the deviation block and the bottom flange of the box. The remaining link, which was located close to the "B" face of the deviator, broke near the web of the box. The laps in the outer loops remained bonded and both the outer loops and the inner loop bars stayed anchored in the remaining concrete. The box section was unharmed. Figure 6.16 shows photographs of the deviator immediately after failure.

web (Fig. 6.15). This very ductile behavior contrasted markedly with the brittle failure seen in the previous test.

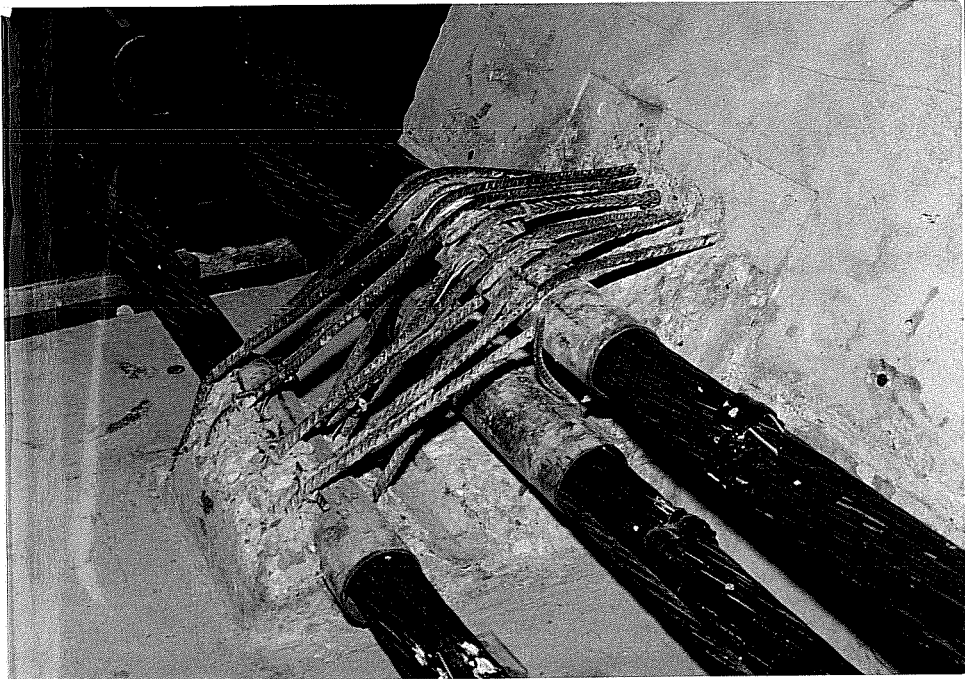
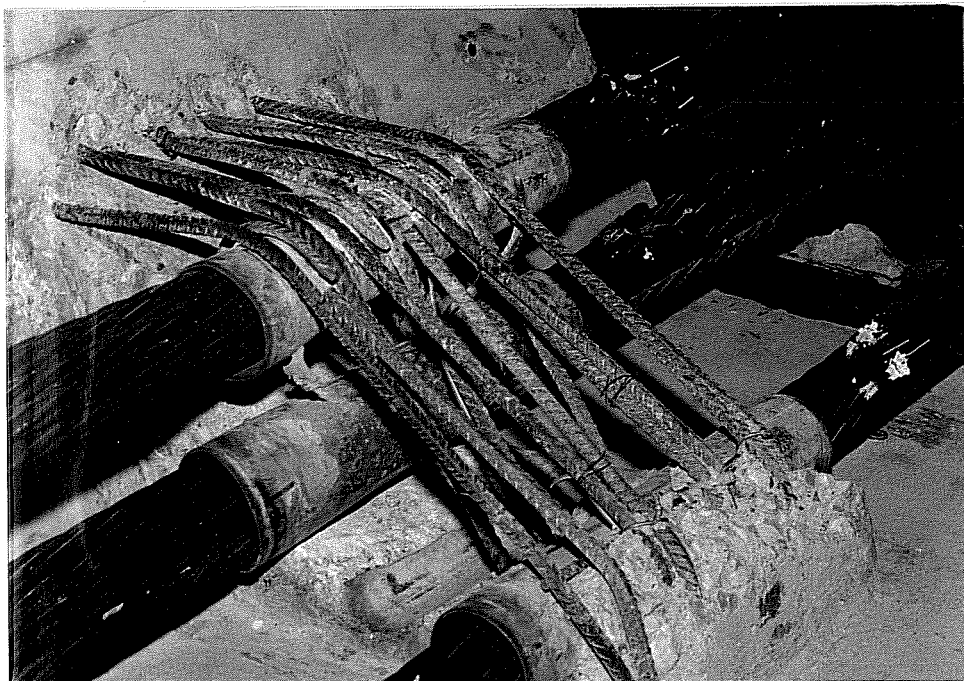
Figure 6.17 Block A Failure: Details

The differences in tendon geometry between blocks A and B may account for the dramatic difference in ultimate behavior between the two deviators. While Block B exhibited only minimal damage before failing catastrophically, Block A developed very large cracks and noticeable displacements relative to the specimen box before breaking. Figure 6.18 shows both deviators as they appeared after failure with concrete rubble cleared away and tendons removed.
