Performance of Epoxy-Coated Reinforcing Steel in Saline Media

Dissertation

The University of Texas at Austin

May 1996

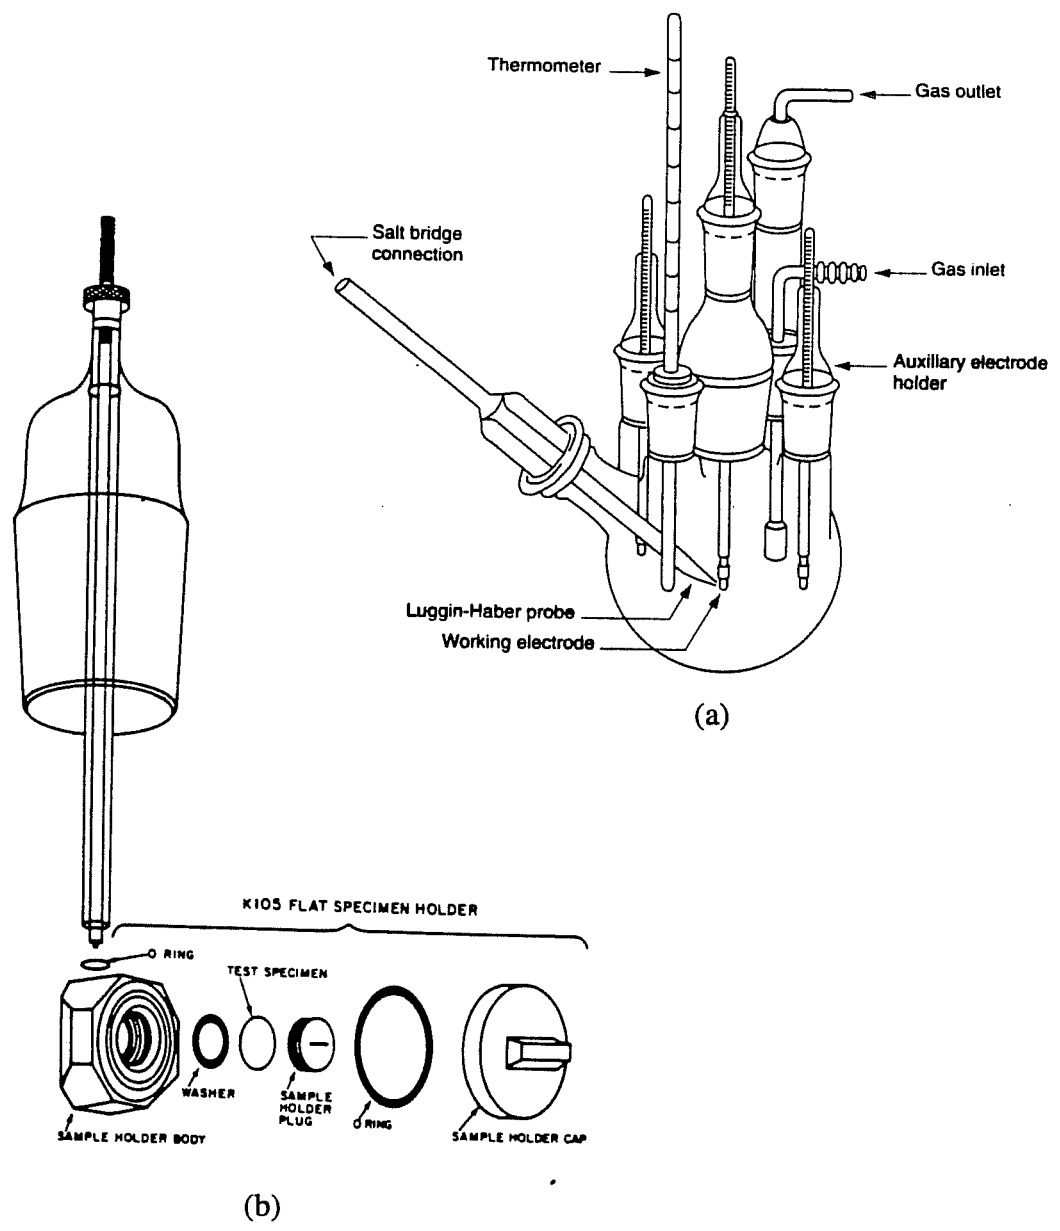
Fig. 3.1. (a) Standard corrosion flask used in testing polished rebar disks, and (b) the exploded view of the specimen holder.

The polished reinforcement disks were mounted in an EG&G sample holder, which exposed an area of 1 cm², and immersed in a standard five-mouthed corrosion flask of 1000 ml capacity. A saturated calomel reference electrode and two graphite-rod counter electrodes were employed. The electrolyte used was 3.5% NaCl solution made of reagent grade sodium chloride crystals and distilled water. The flask and the sample holder accessories are shown in Fig. 3.1.

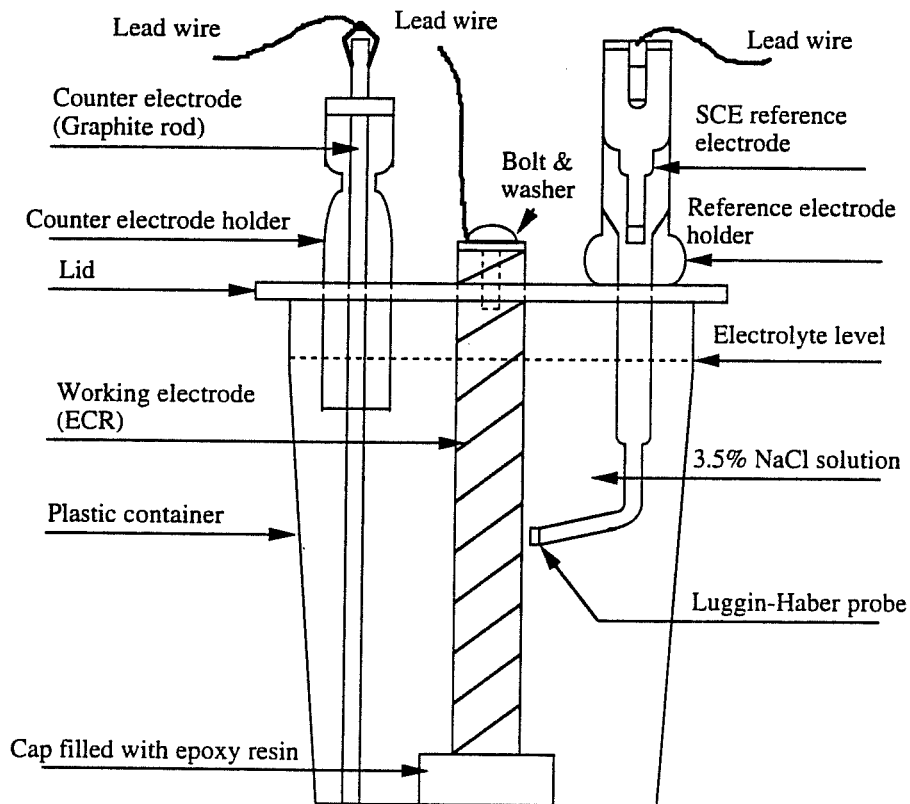
Fig. 3.2. Configuration of corrosion cell used in testing bar specimens.

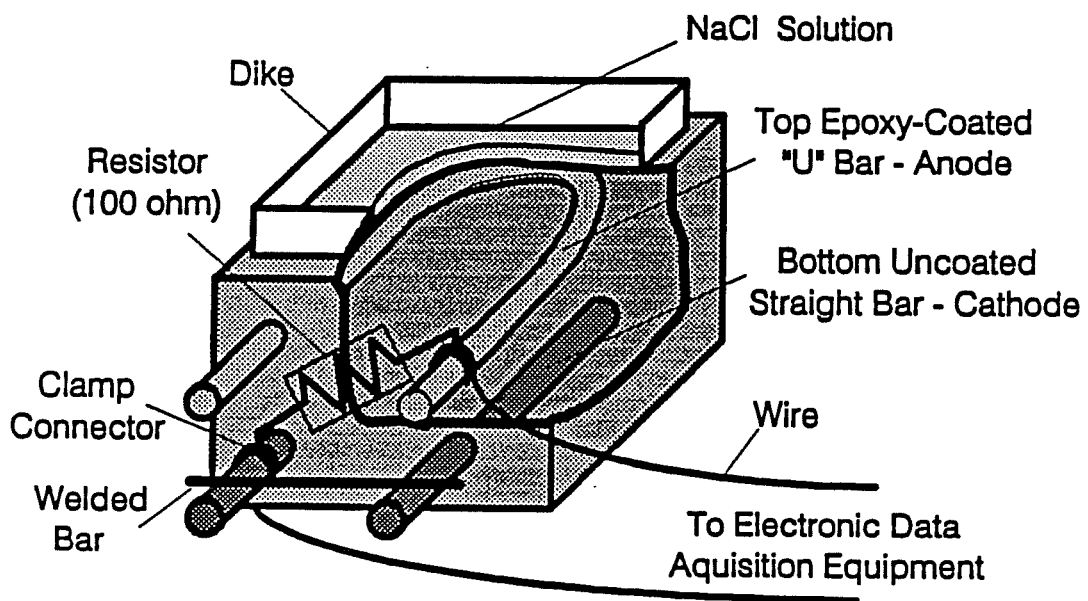
Fig. 3.3. Configuration of concrete block macrocell specimen [10].

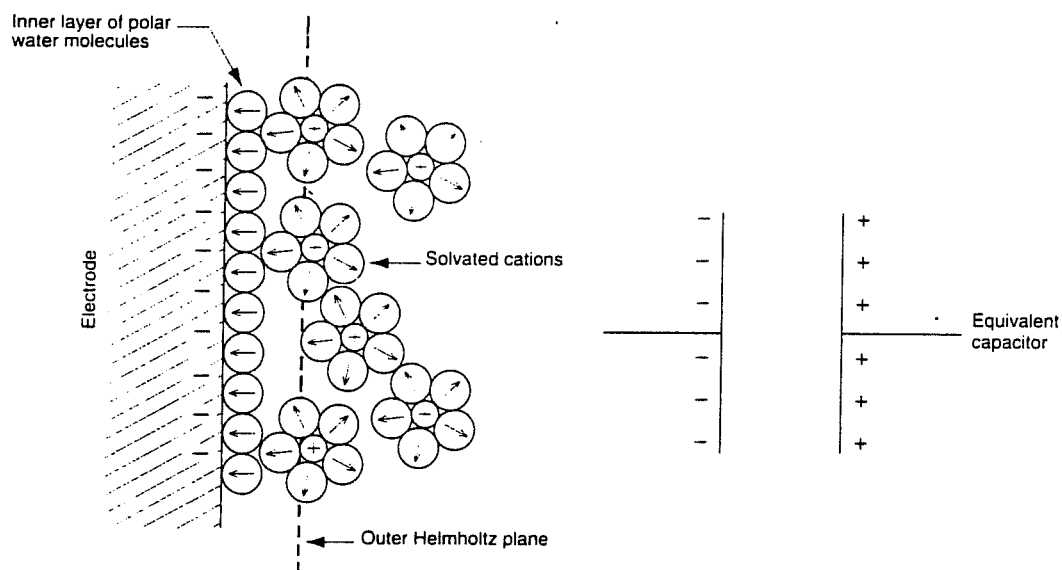
Fig. 4.5. Schematic electrode surface structure and its equivalent electric capacitor (i.e. electrical double layer) [62].

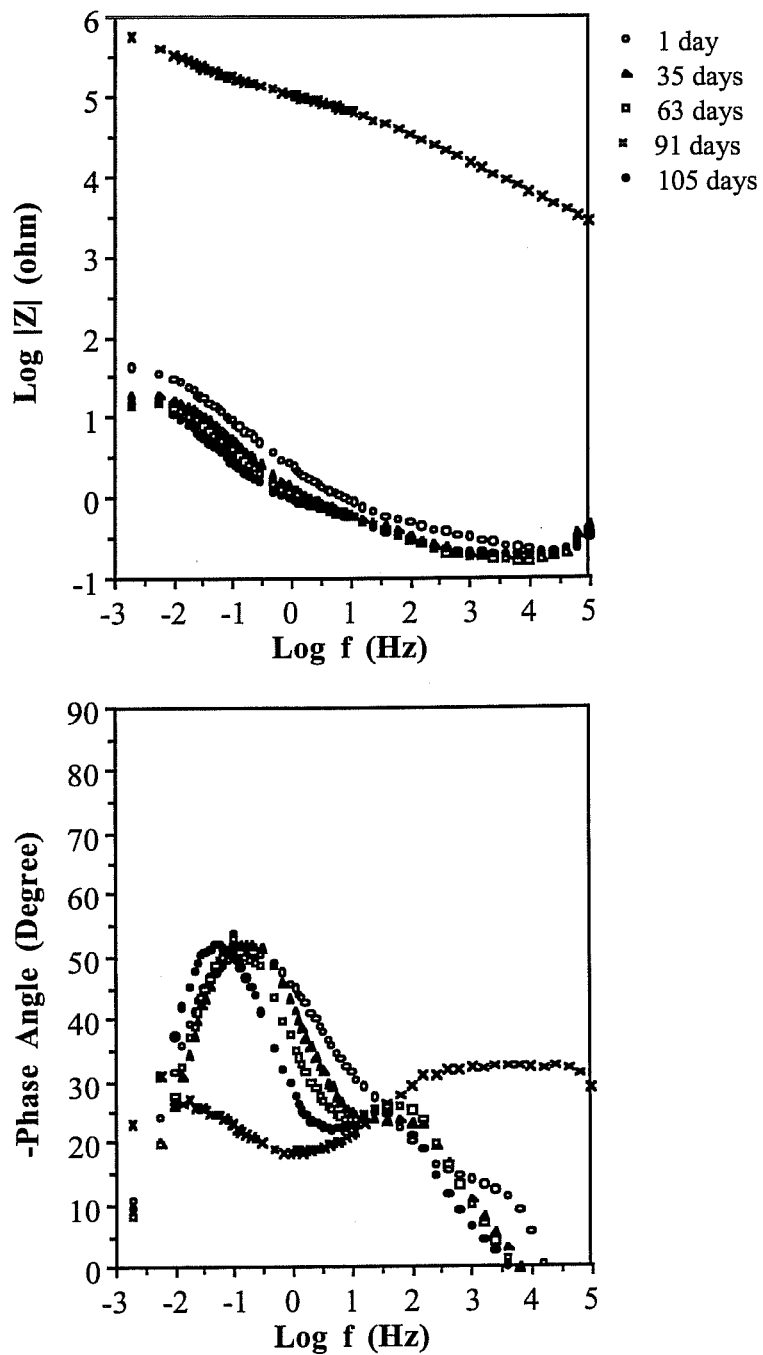
Fig. 5.4. The corresponding Bode plots of Fig. 5.3.

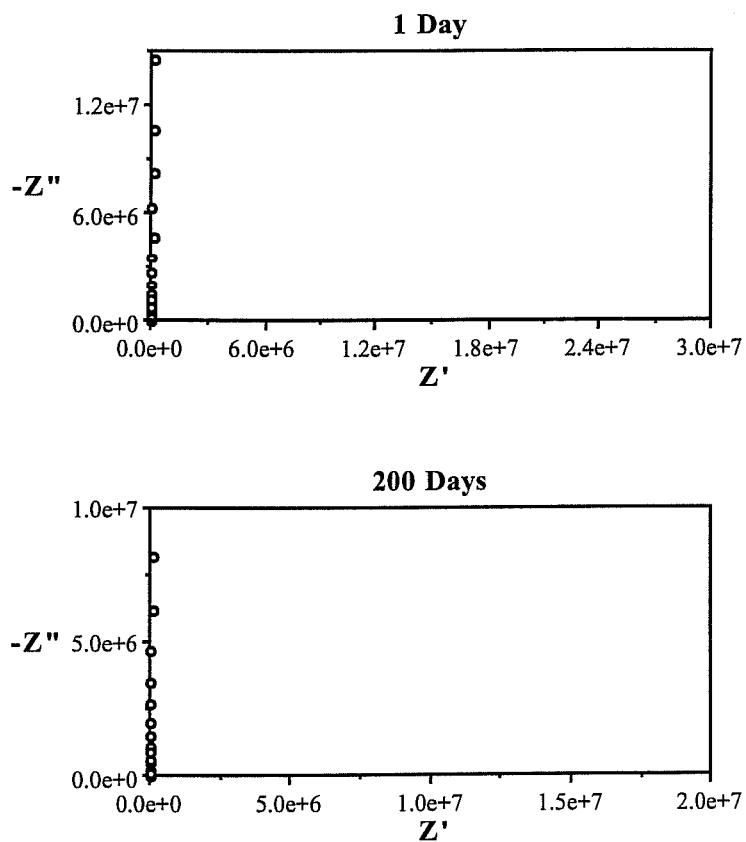
Fig. 5.5. Nyquist plots for the representative ECR bar specimen exhibiting good coating performance during 200-day immersion in 3.5% NaCl solution.

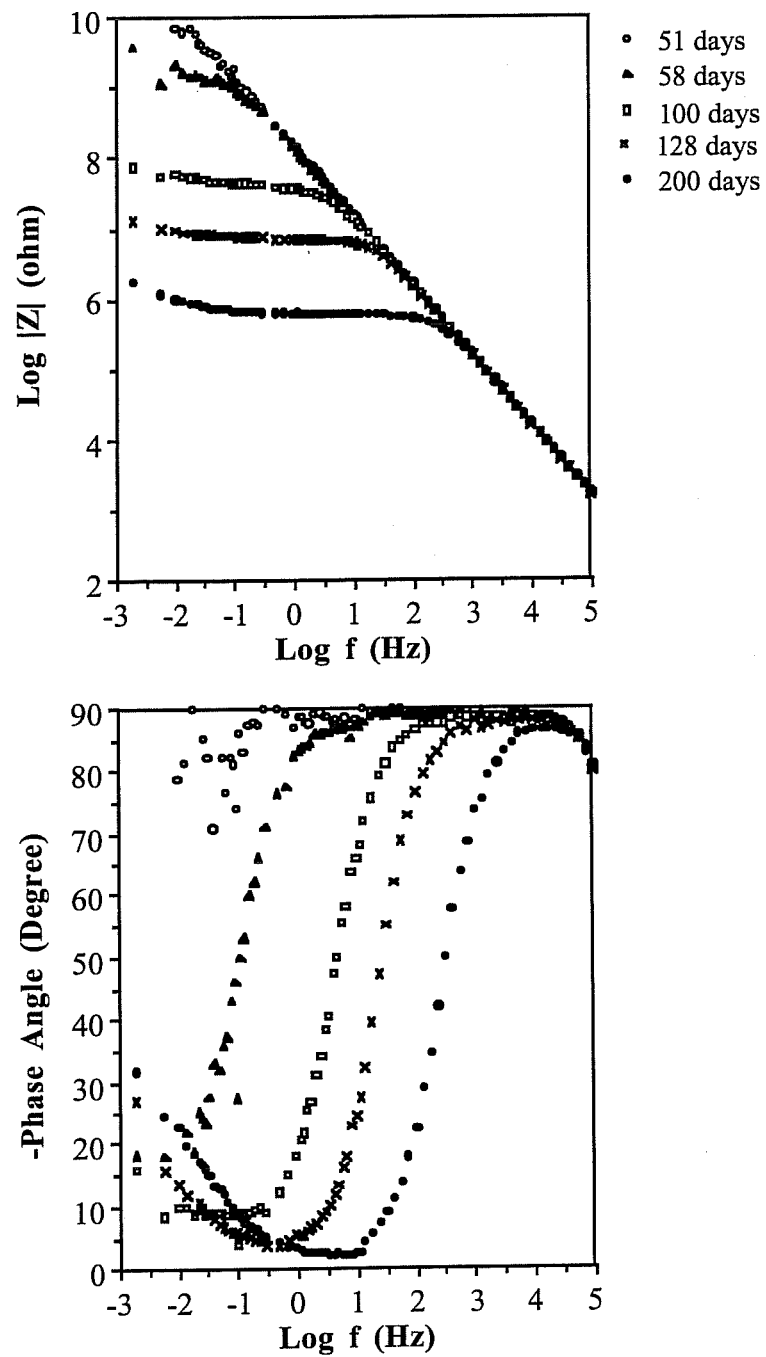
Fig. 5.8. The corresponding Bode plots of Fig. 5.7.

The Nyquist and Bode plots of the first specimen are shown in Fig. 5.7 and Fig. 5.8. It was found that this specimen remained intact and with capacitive behavior up to the 51st day of immersion. On the 58th day, an incomplete semi-

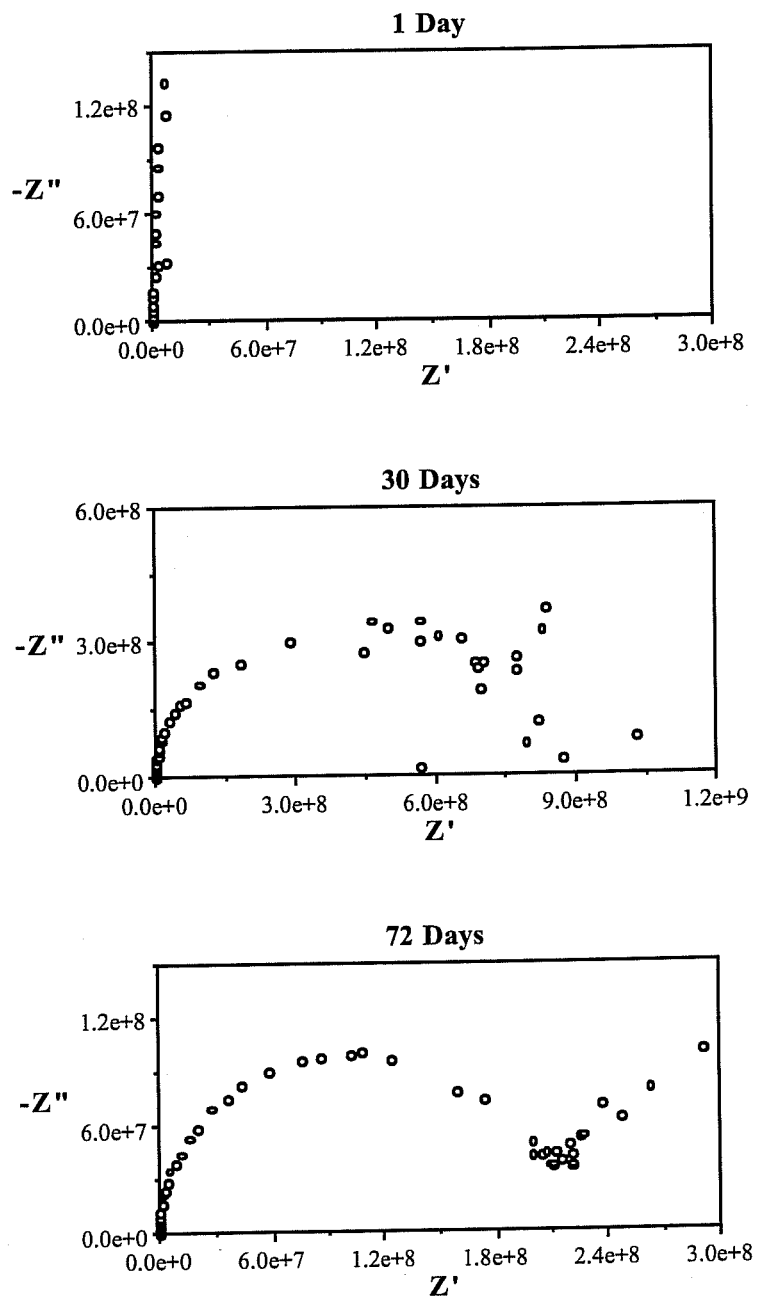
Fig. 5.9. Nyquist plots for the second representative ECR bar specimen exhibiting intermediate coating performance during 200-day immersion in 3.5% NaCl solution.

For the second specimen, its Nyquist and Bode plots have similar curve shapes to those of the first specimen. They are shown in Fig. 5.9 and Fig. 5.10.

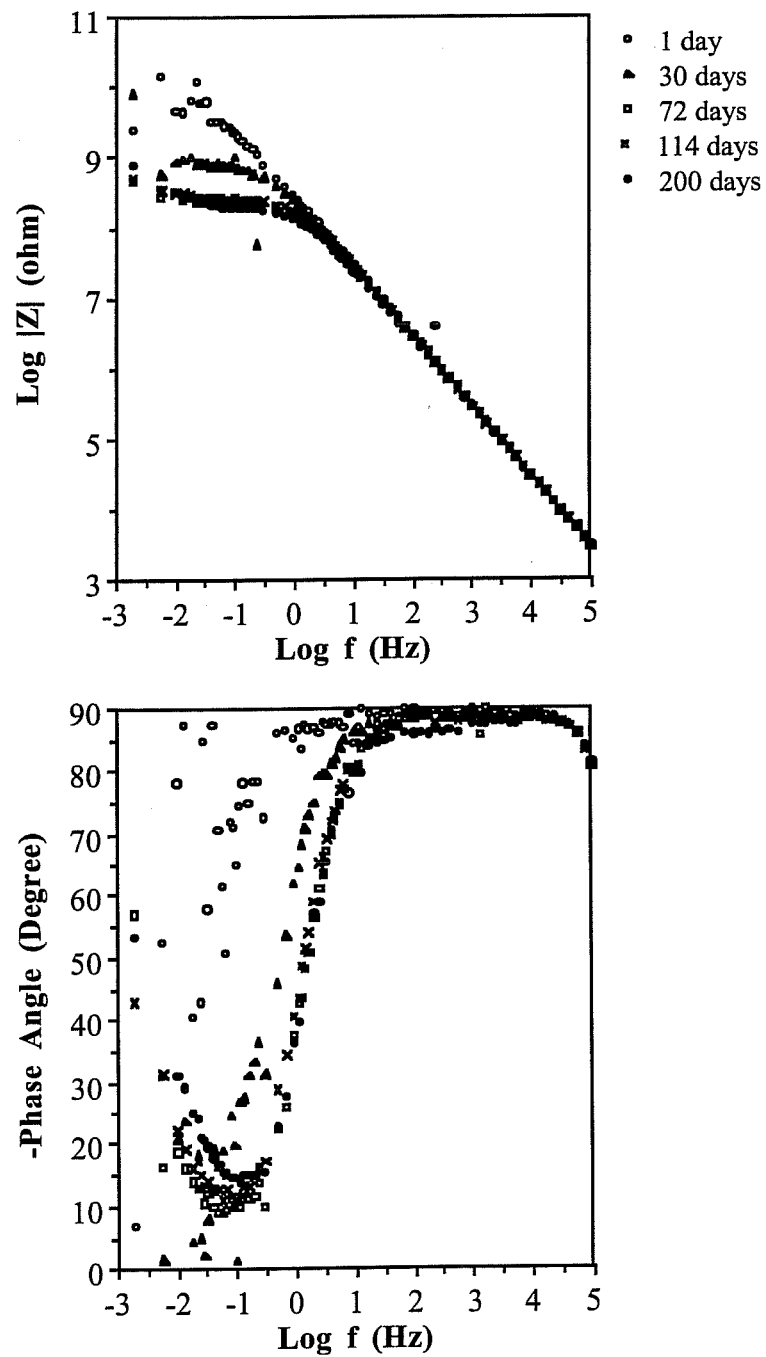
Fig. 5.10. The corresponding Bode plots of Fig. 5.9.

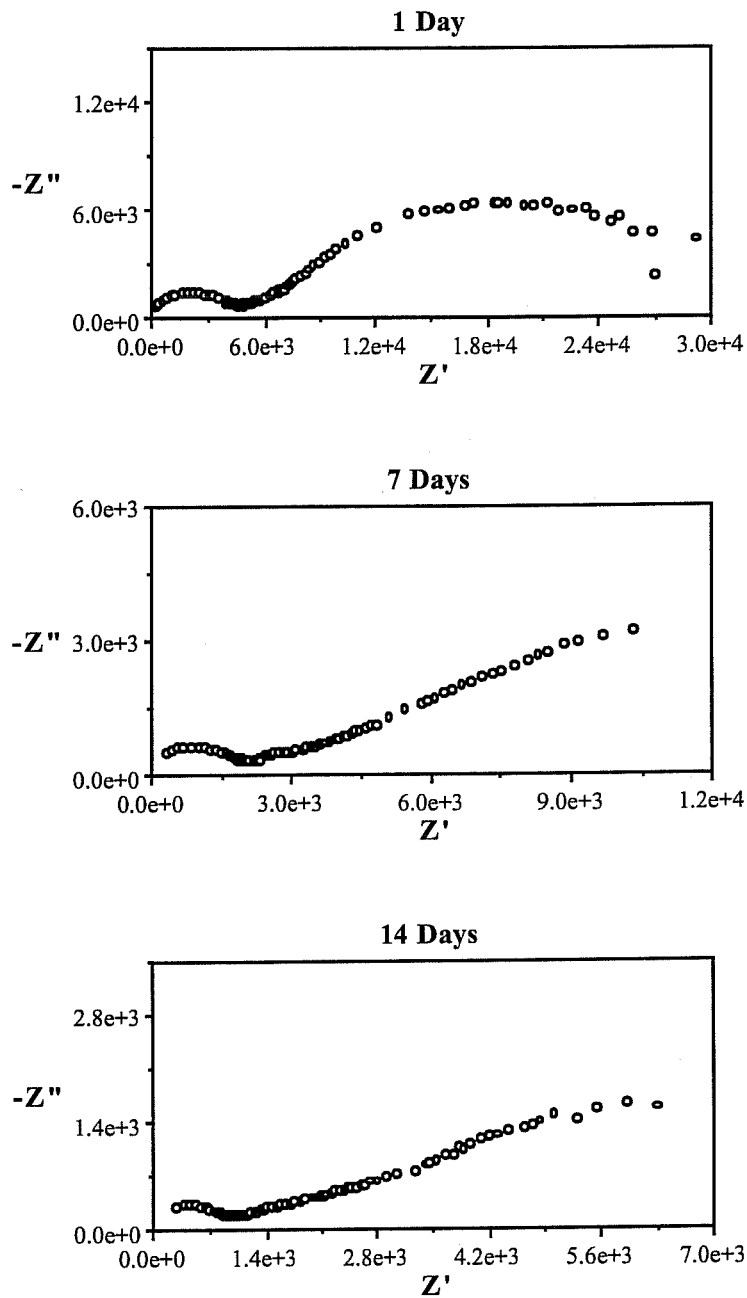
Fig. 5.11. Nyquist plots for the first representative ECR bar specimen exhibiting poor coating performance during 200-day immersion in 3.5% NaCl solution.

The Nyquist and Bode plots of the first specimen are shown in Fig. 5.11 and Fig. 5.12. Two semi-circles are observed in the Nyquist plot on the first day. The high frequency semi-circle in the Nyquist plot is attributed to the coating pore resistance; while the skewed one at the low frequencies is believed to be due to the combined effects of charge transfer reaction and diffusion processes. The actual charge transfer reaction semi-circle in this case is smaller than the skewed one observed in the plot, and may still be masked when interacting with the impedance tail. The fact that the charge transfer reaction also plays a role in controlling the corrosion rate is actually an indication that this coating does not retard the ingress of corrosive elements as effectively as those coatings with good and intermediate qualities do. By the 7th and 14th day, the low frequency curve is gradually changing from the skewed semi-circle shape to a depressed tail. This depressed tail is also believed to be due to the combined effects of charge transfer reaction and diffusion processes. On the 51st day and later on, it is observed that an intermediate frequency semi-circle and a low frequency tail gradually become more and more distinguishable (even though they still interact with each other).

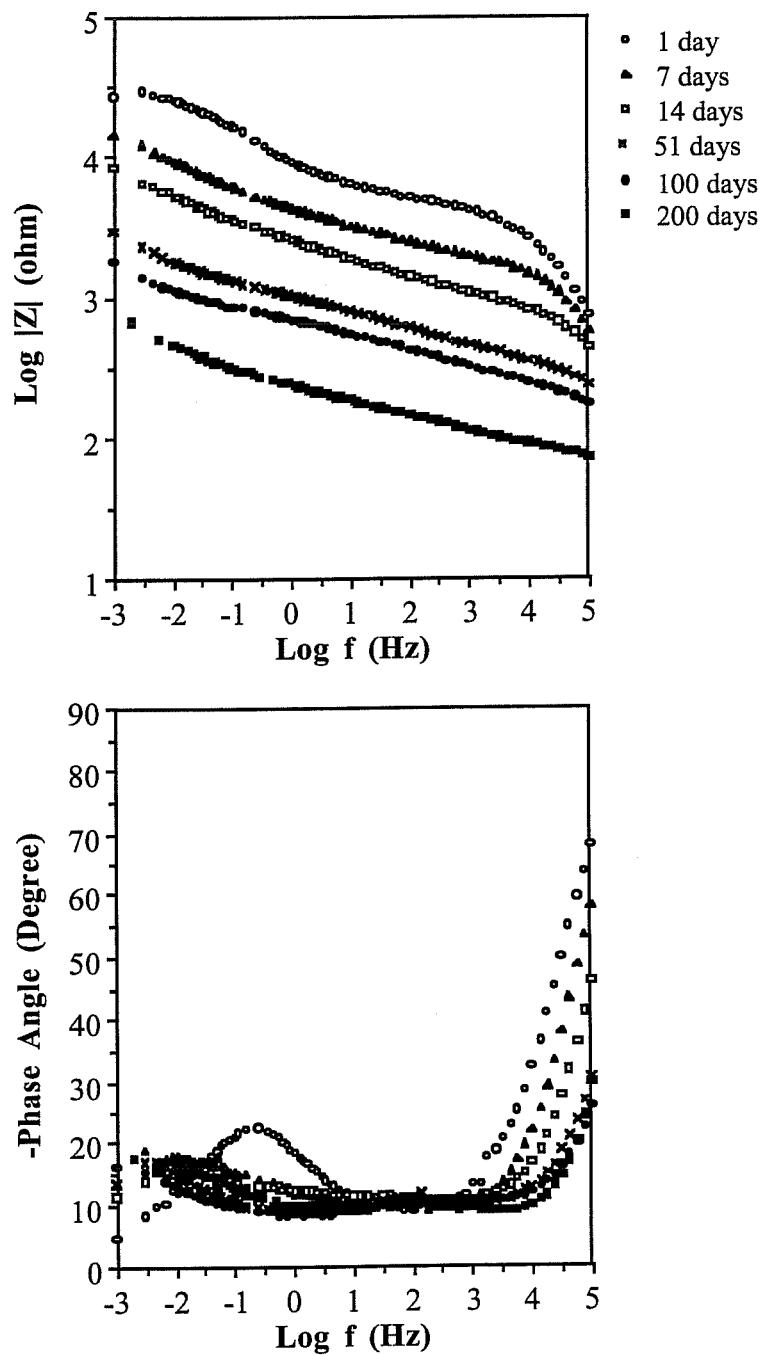
Fig. 5.12. The corresponding Bode plots of Fig. 5.11.

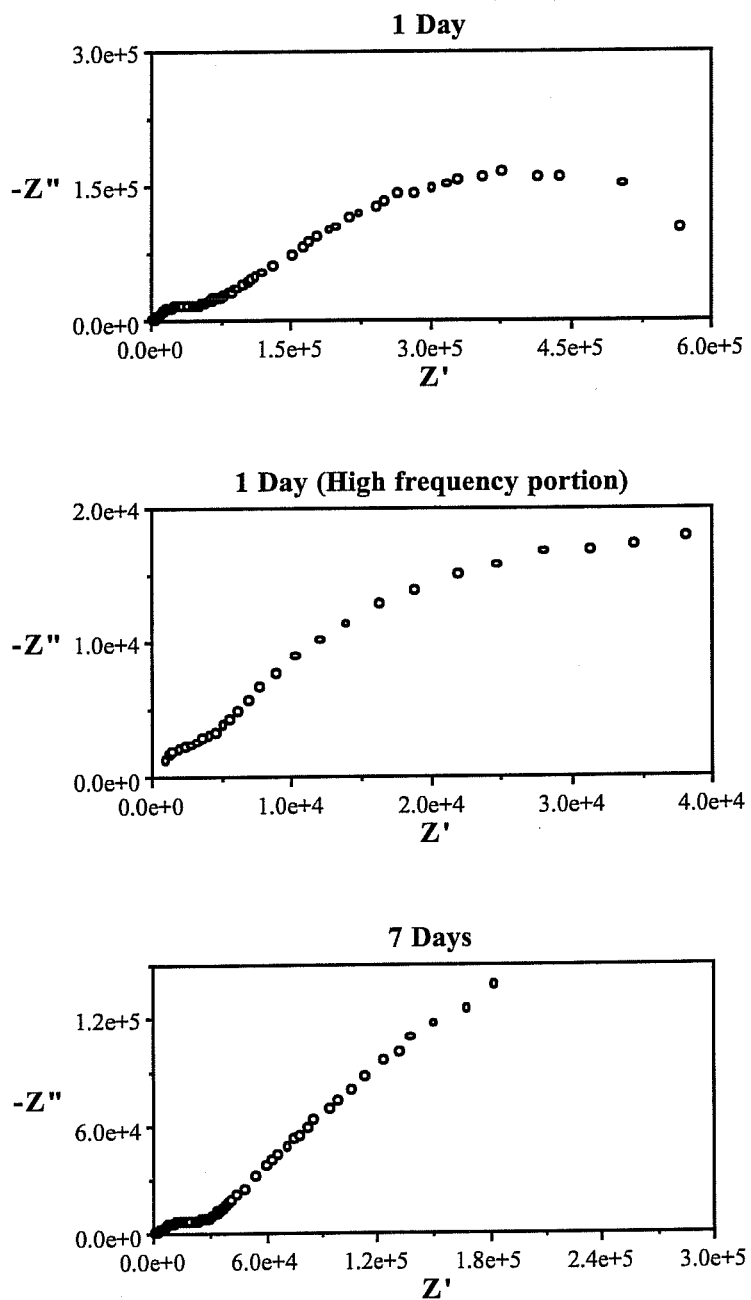
Fig. 5.13. Nyquist plots for the second representative ECR bar specimen exhibiting poor coating performance during 200-day immersion in 3.5% NaCl solution.

The Nyquist and Bode plots of the second specimen are shown in Fig. 5.13 and Fig. 5.14. For this case, at first glance, it seems that there are two semi-circles in the Nyquist plot on the first day, with the high frequency one presumably related to the coating quality as discussed in the case of the first specimen. However, another semi-circle which actually represents the coating quality is observed on an extended plot of the highest frequency portion. Therefore, the intermediate and low frequency semi-circles are actually attributed to the combined effects of charge transfer reaction and diffusion processes. The very important point is that for the Nyquist plots during the early immersion period, the high frequency semi-circle which is related to the coating quality may be masked due to its relatively small scale; and this may lead to misinterpretation of the results if one does not look into the extended highest frequency portion or refer to the Bode plots. On the 14th day and later on, two semi-circles and a diffusion tail become distinguishable on a single plot (even though they are always incomplete and skewed). Thus, the corrosion process is known to be under

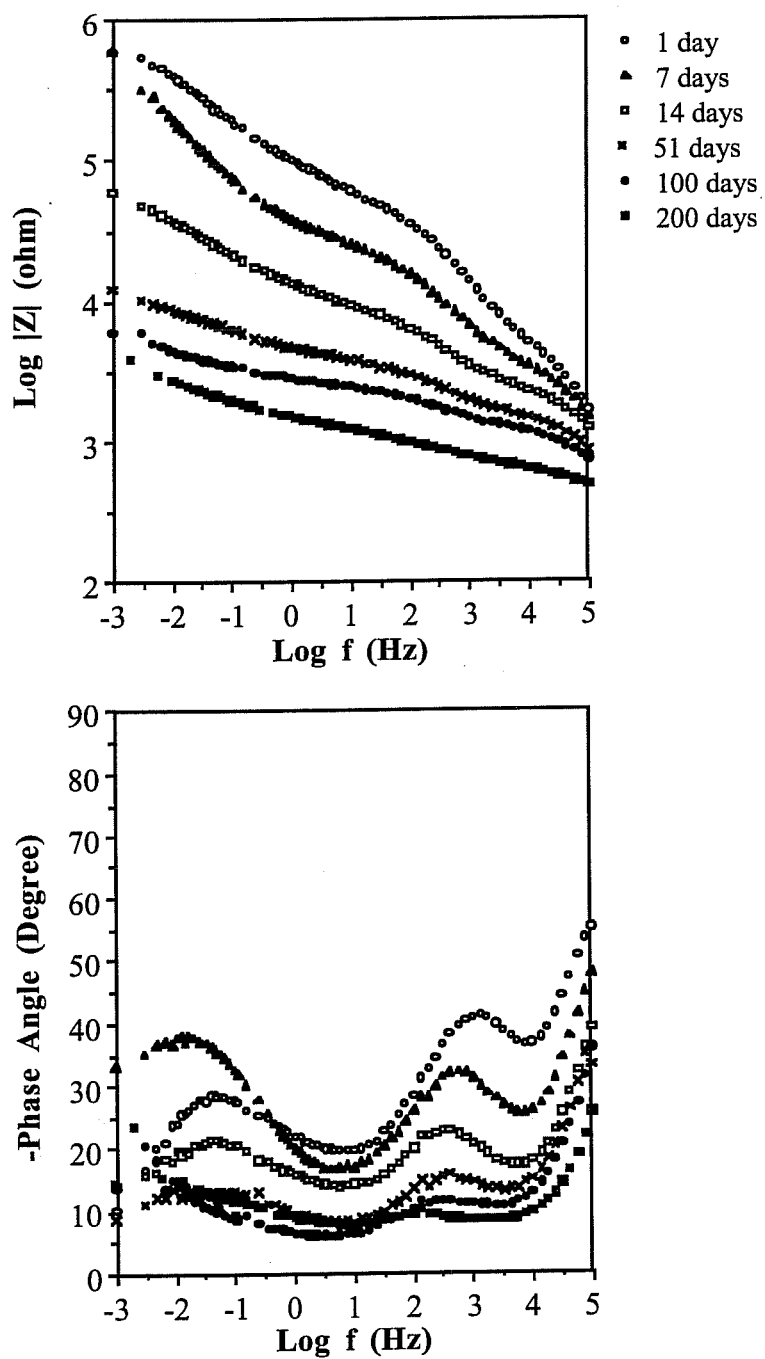
Fig. 5.14. The corresponding Bode plots of Fig. 5.13.

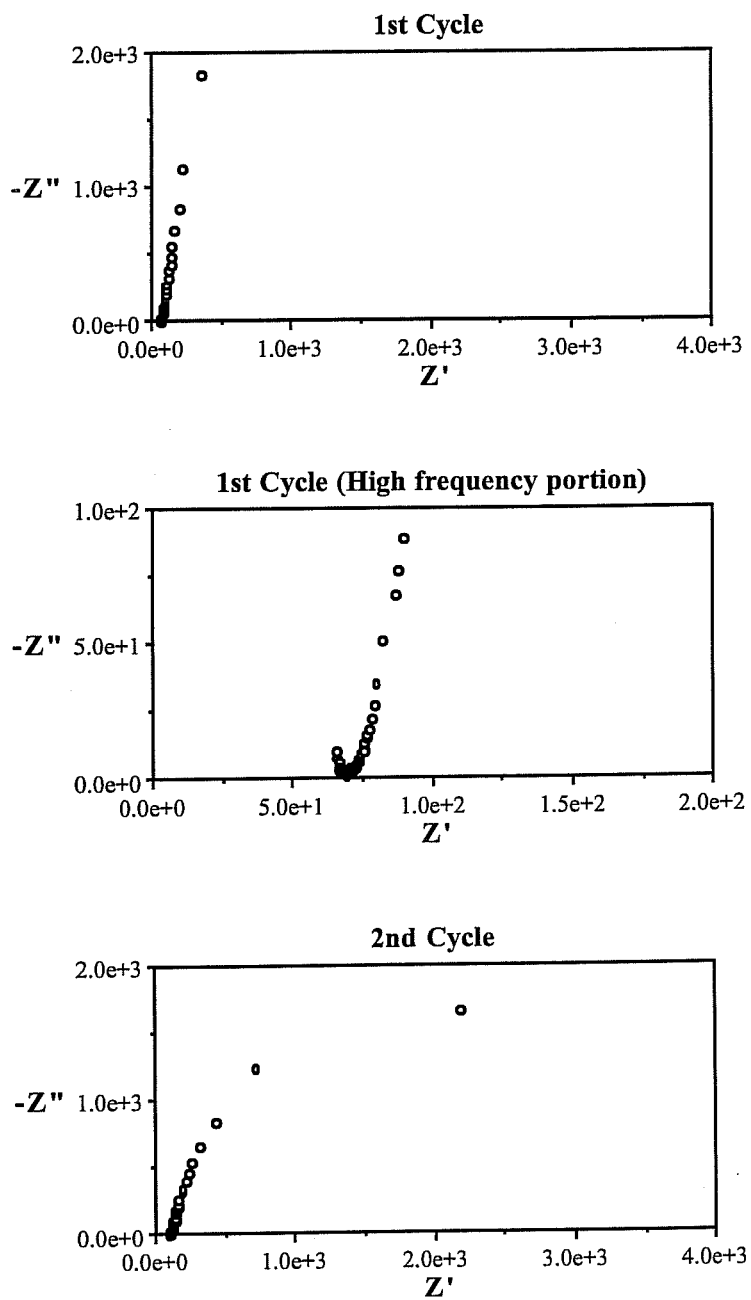
Fig. 5.15. Nyquist plots for the representative uncoated reinforcing steel bar embedded in a concrete block and subjected to periodic wet-dry ponding with 3.5% NaCl solution.

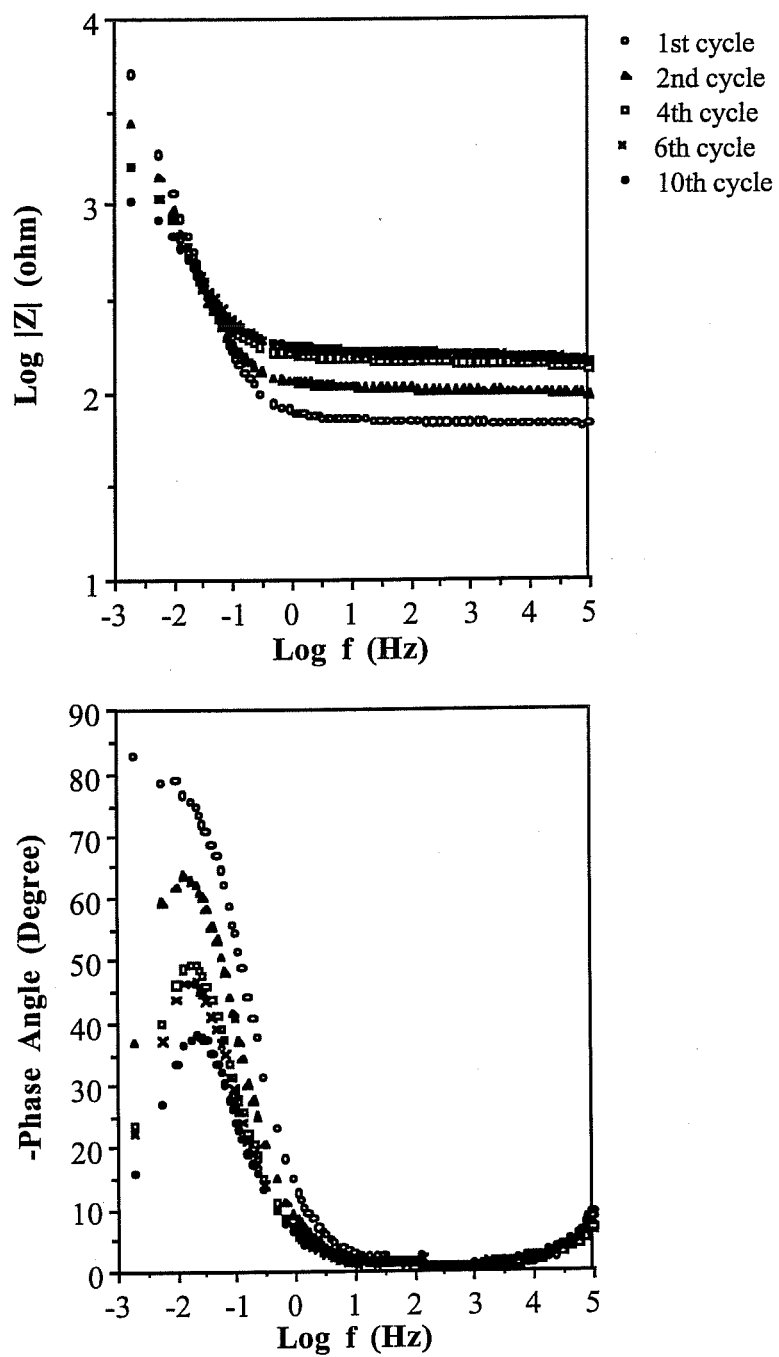
Fig. 5.16. The corresponding Bode plots of Fig. 5.15.

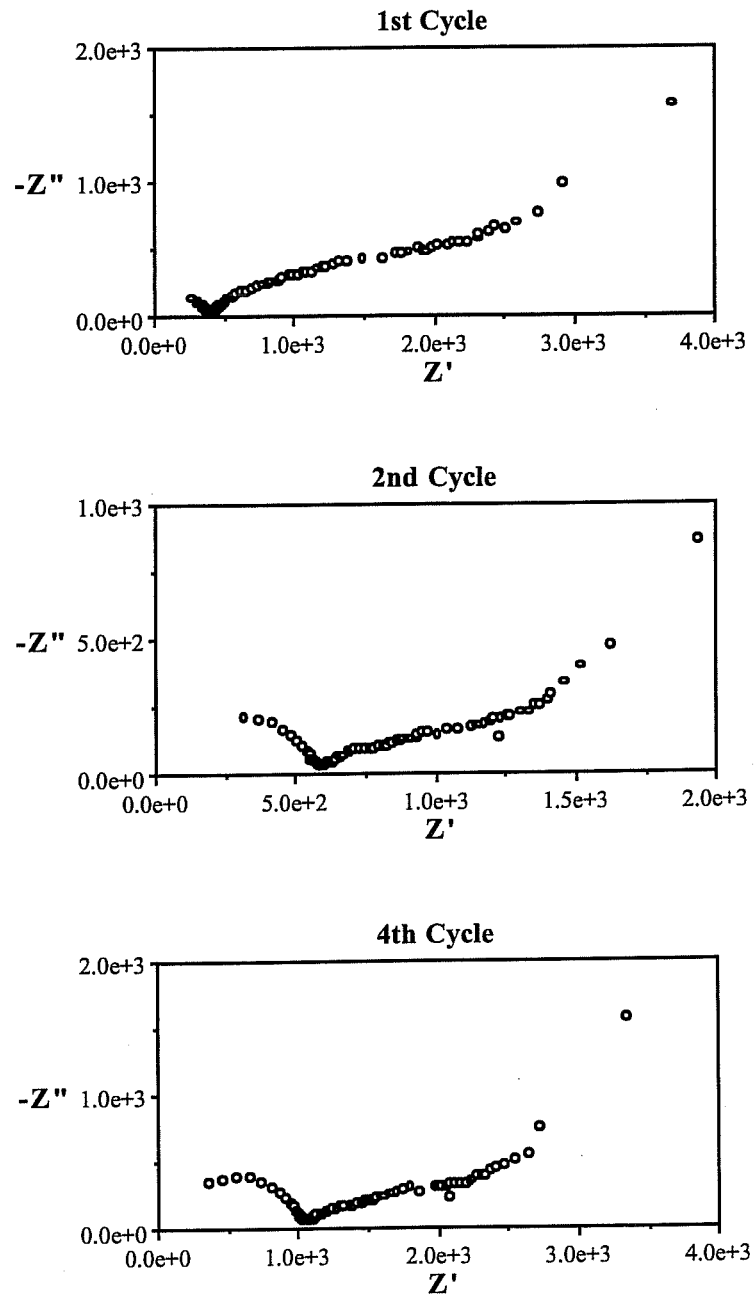
Fig. 5.17. Nyquist plots for the first representative ECR bar embedded in a concrete block and subjected to periodic wet-dry ponding with 3.5% NaCl solution.

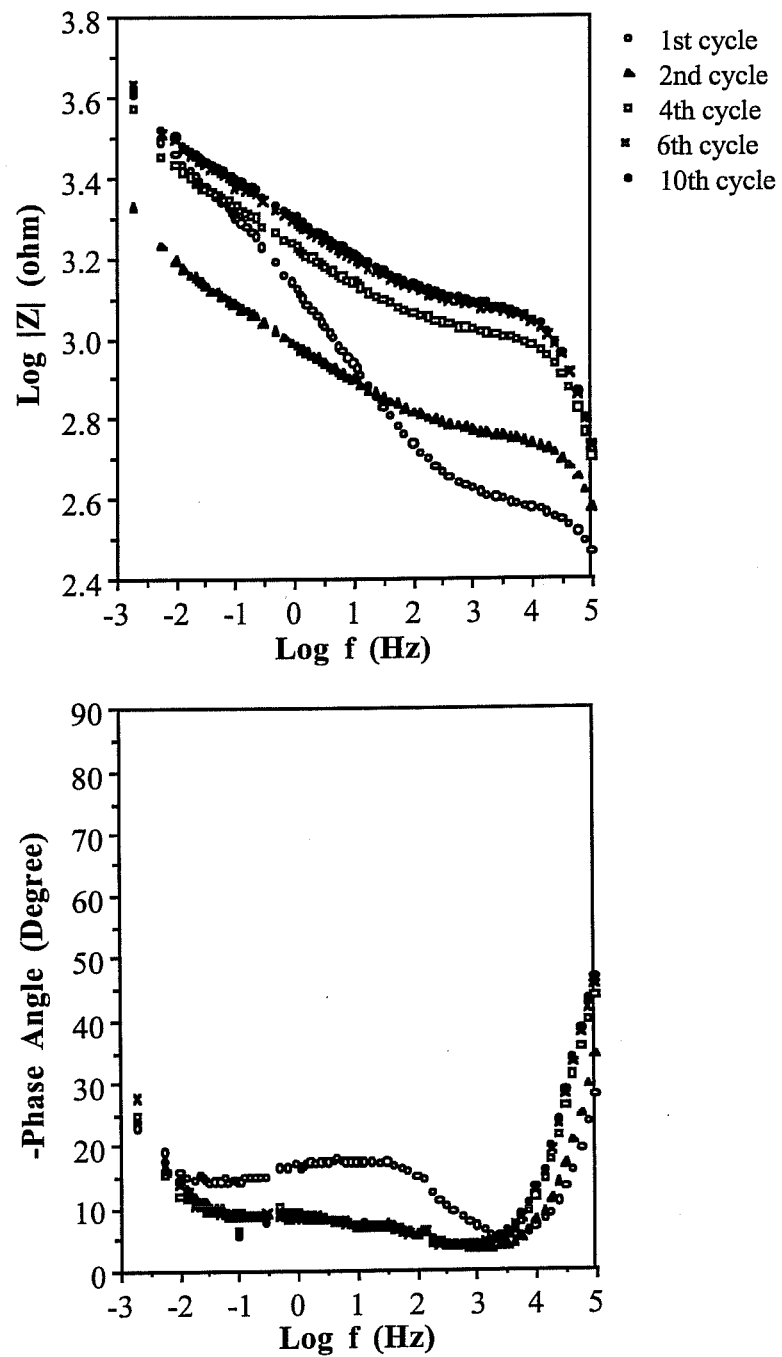
Fig. 5.18. The corresponding Bode plots of Fig. 5.17.

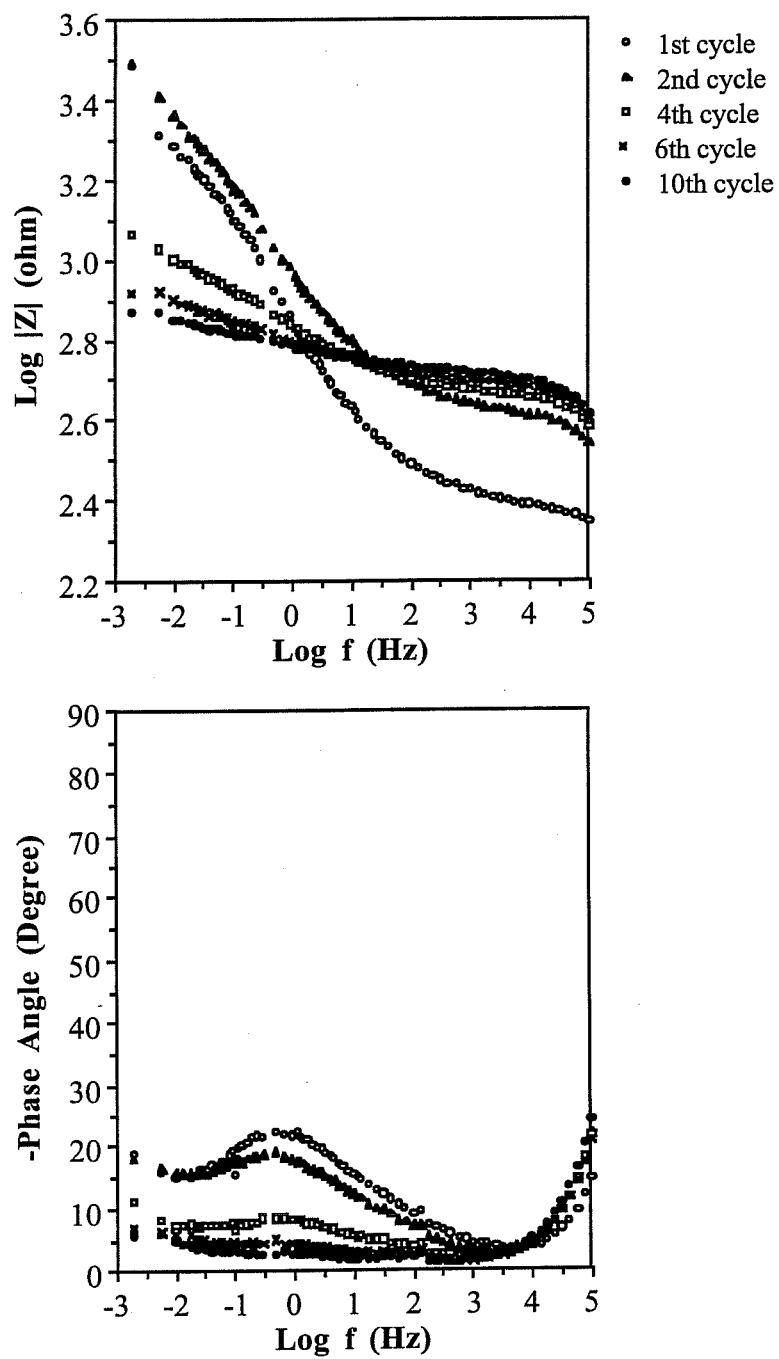
Fig. 5.19. Bode plots for the second representative ECR bar embedded in a concrete block and subjected to periodic wet-dry ponding with 3.5% NaCl solution.

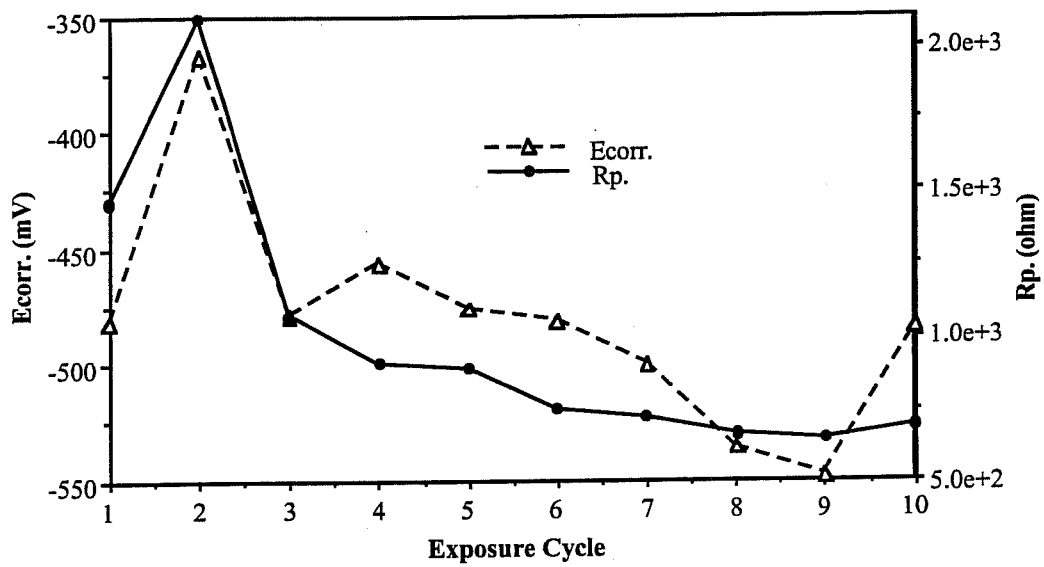
Fig. 5.26. Variation of E_{corr} and R_p with time for the second representative ECR bar embedded in a concrete block.

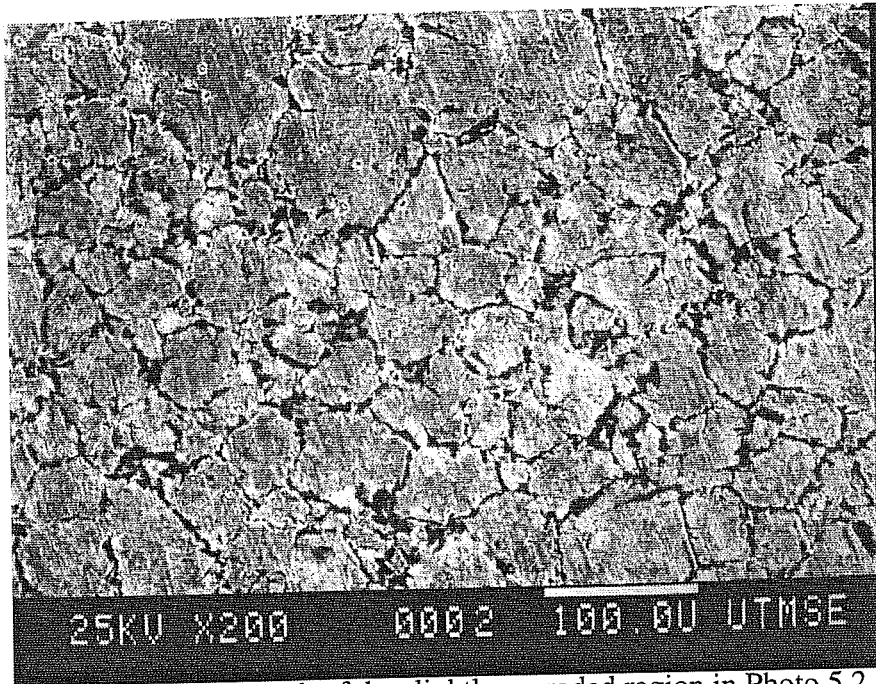
Photo 5.3. SEM micrograph of the slightly corroded region in Photo 5.2 showing intergranular-like corrosion.

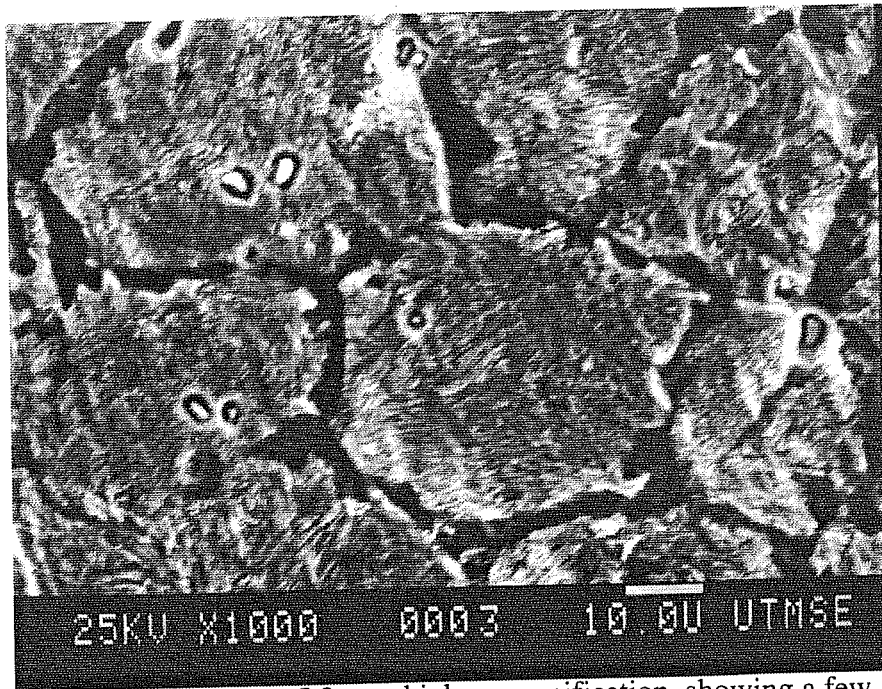
Photo 5.4. Same as Photo 5.3, at a higher magnification, showing a few scattered signs of pitting corrosion.

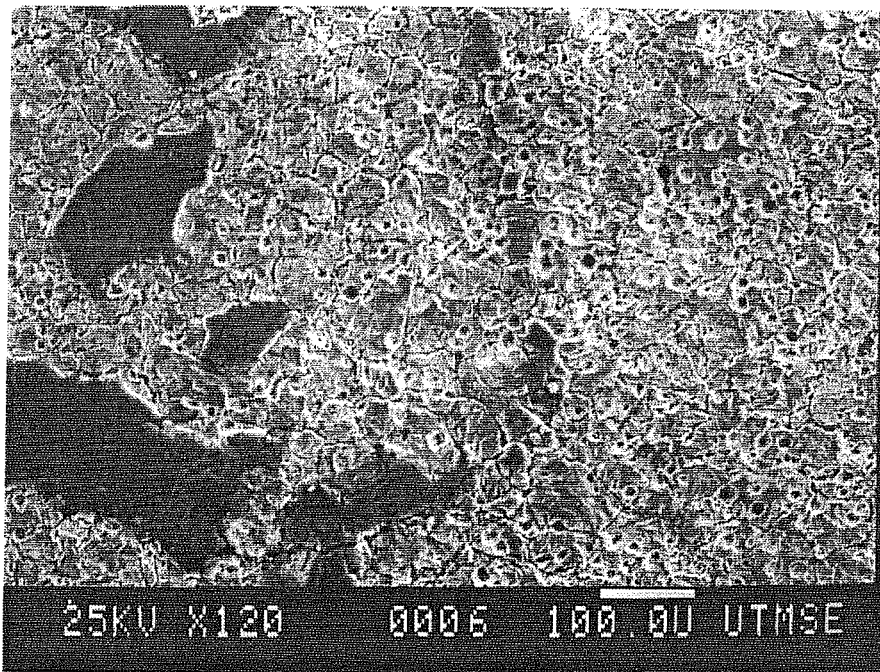
Photo 5.6. SEM micrograph of the severely corroded region on the same disk in Photo 5.2 through Photo 5.5 showing extensive surface pitting in addition to the intergranular-like corrosion.

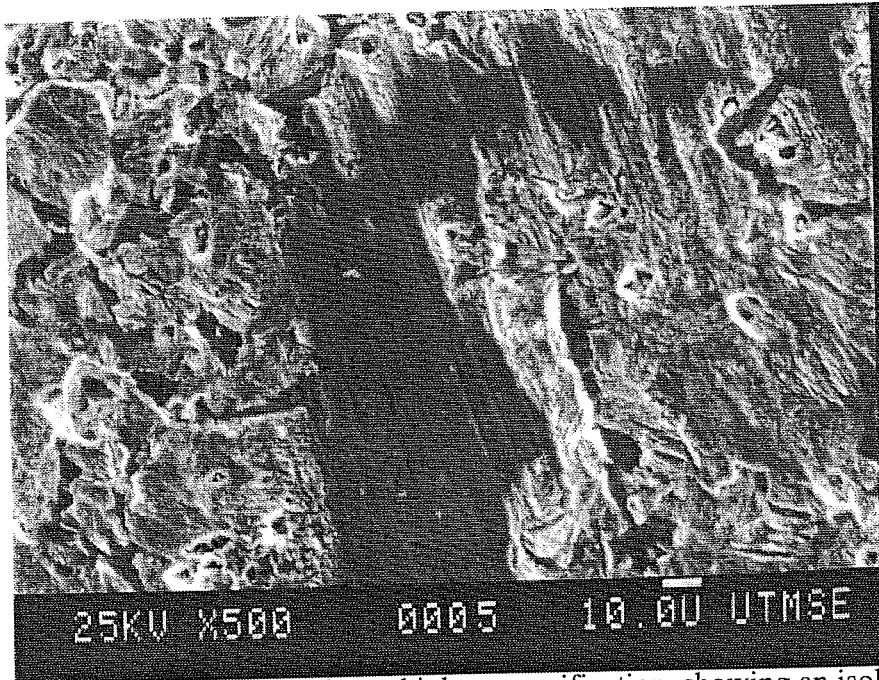
Photo 5.7. Same as Photo 5.6, at a higher magnification, showing an isolated, uncorroded area among the severely corroded region.

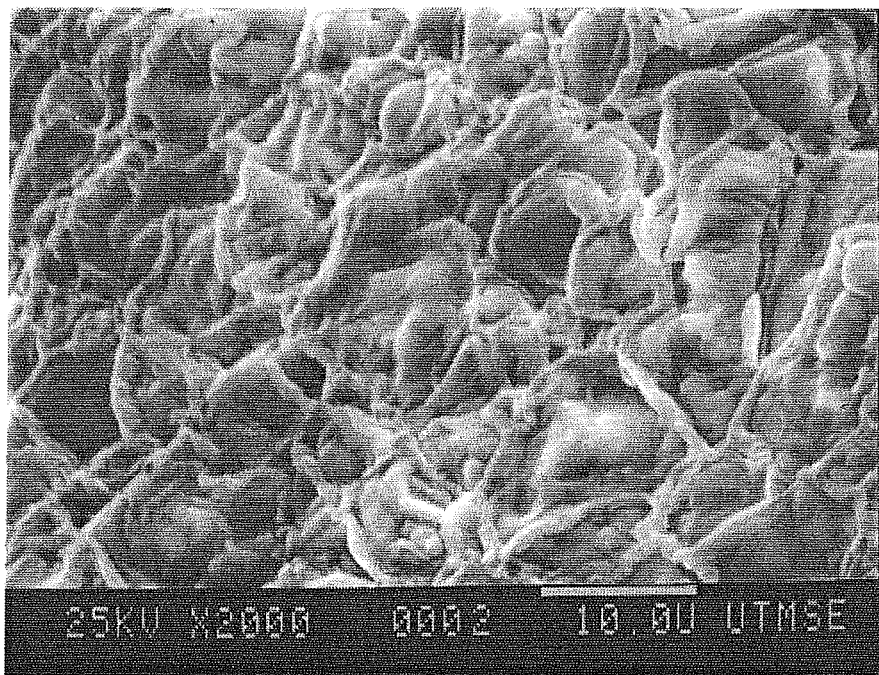
Photo 5.10. High magnification picture of the shell-like outer layer in Photo 5.9 showing continuous and uniform film.

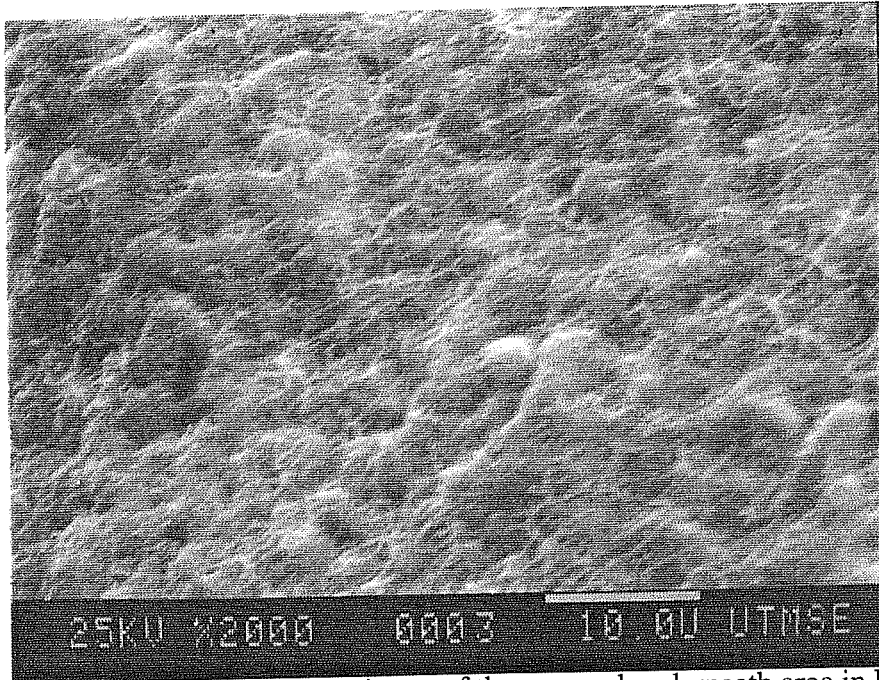
Photo 5.11. High magnification picture of the exposed underneath area in Photo 5.9, also showing continuous and uniform film but with different coarseness compared to that in Photo 5.10.
