Performance of Epoxy-Coated Reinforcing Steel in Saline Media

Dissertation

The University of Texas at Austin

May 1996

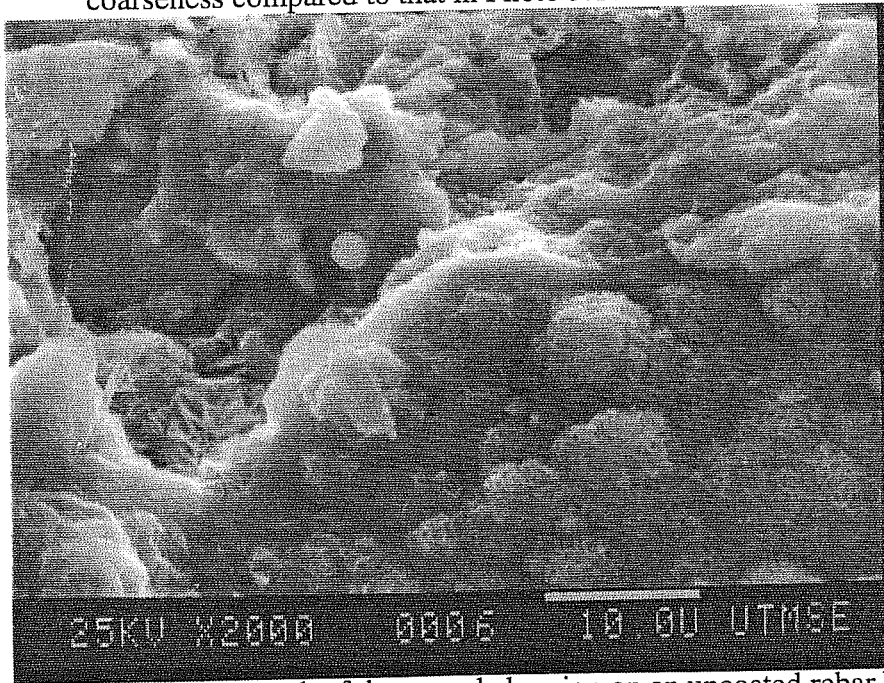
Photo 5.12. SEM micrograph of the corroded region on an uncoated rebar before exposure to solution showing irregularly sized and shaped corrosion products.

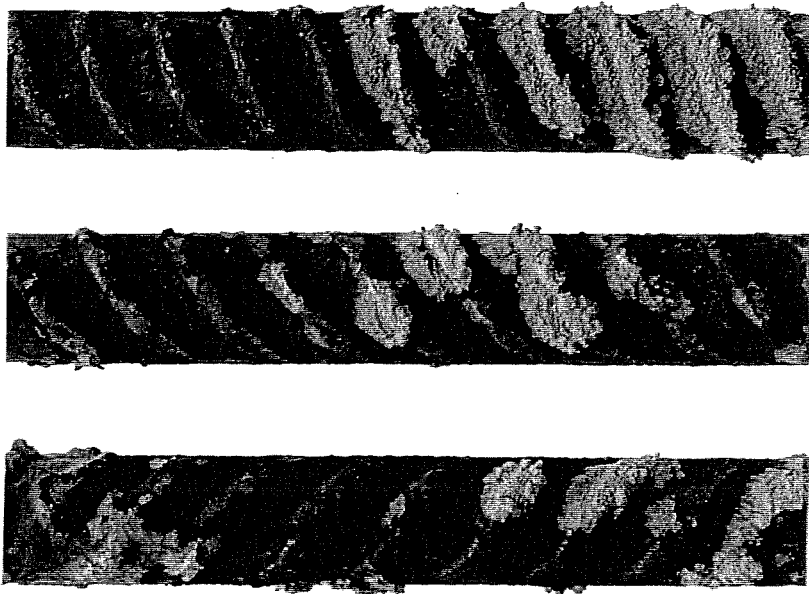
Photo 5.13. Photograph showing typical appearance of uncoated reinforcing steel bars after 105 days of immersion in 3.5% NaCl solution.

During the immersion period, flocculent oxide corrosion products are observed to form on the surface of the reinforcing steel. They are very loose and may fall off from the surface sometimes. However, corrosion products that are orange to red brown in color always continue to form at the outermost rim, while the layer right beneath it is black in color. After removal from the solution, the orange-colored corrosion product becomes more compact and turns dull as it dries up. Typical appearance of the specimens after 105 days of immersion is shown in Photo 5.13. A close-up picture of the corroded surface is shown in Photo 5.14, in which various types of corrosion products are observed. The corrosion products are generally characterized by their colors as below:

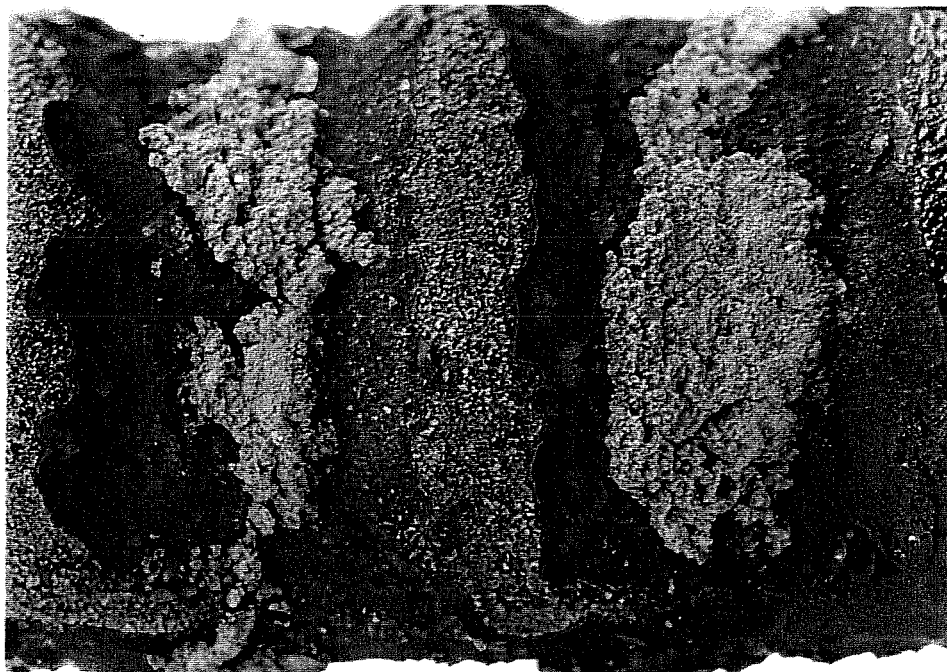
Photo 5.14. Close-up picture of a corroded surface showing various types of corrosion products.

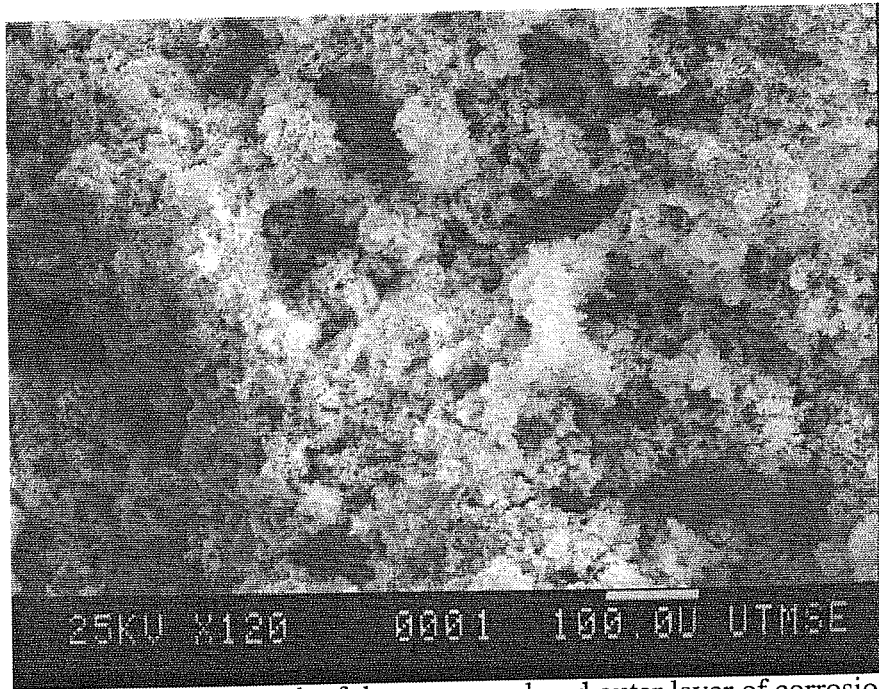
Photo 5.15. SEM micrograph of the orange-colored outer layer of corrosion product showing a coralloid, jagged and porous, network.

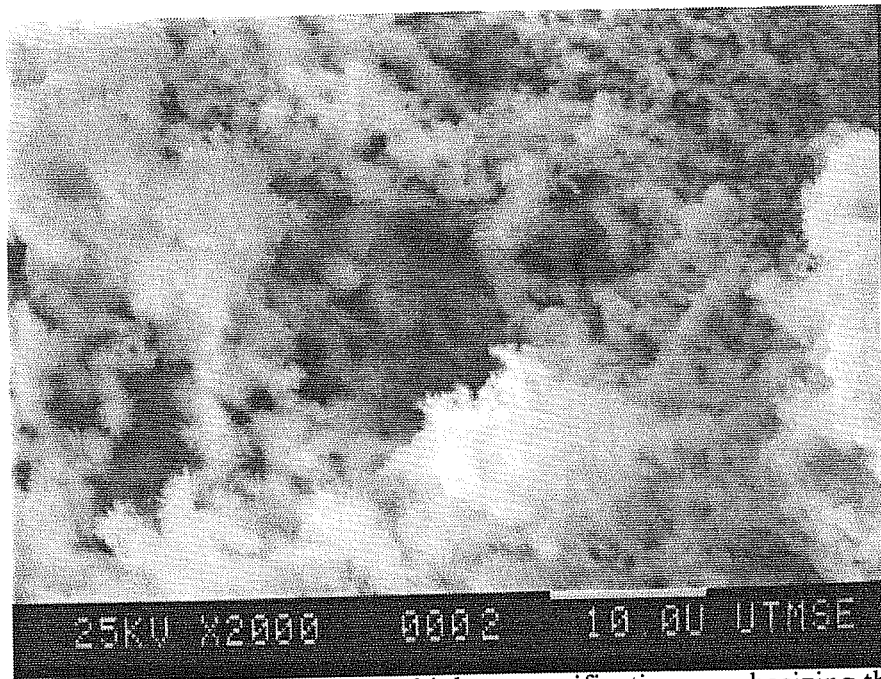
Photo 5.16. Same as Photo 5.15, at a higher magnification, emphasizing the porous structure.

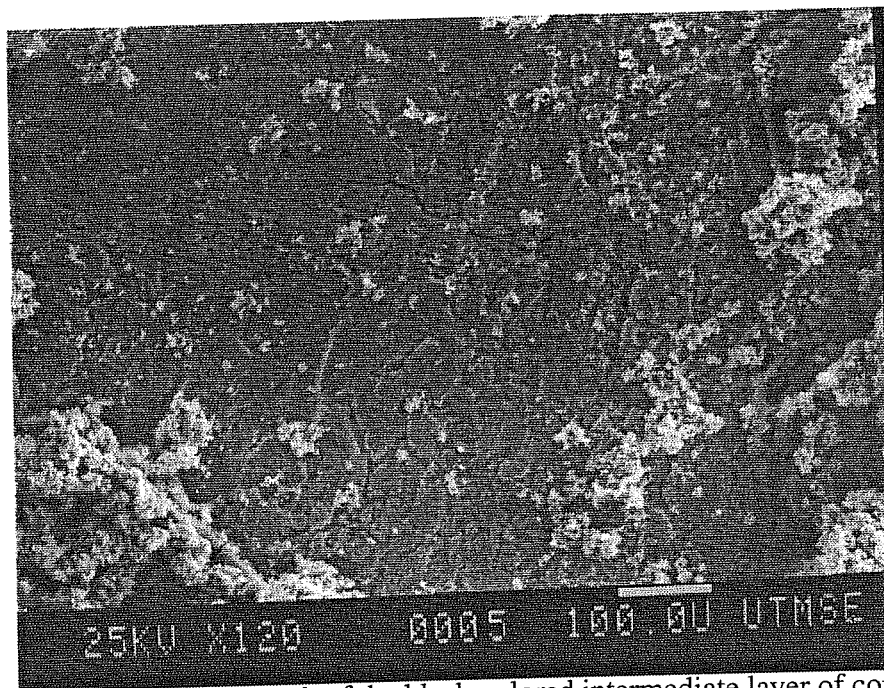
Photo 5.17. SEM micrograph of the black-colored intermediate layer of corrosion product showing a solid and uniform film.

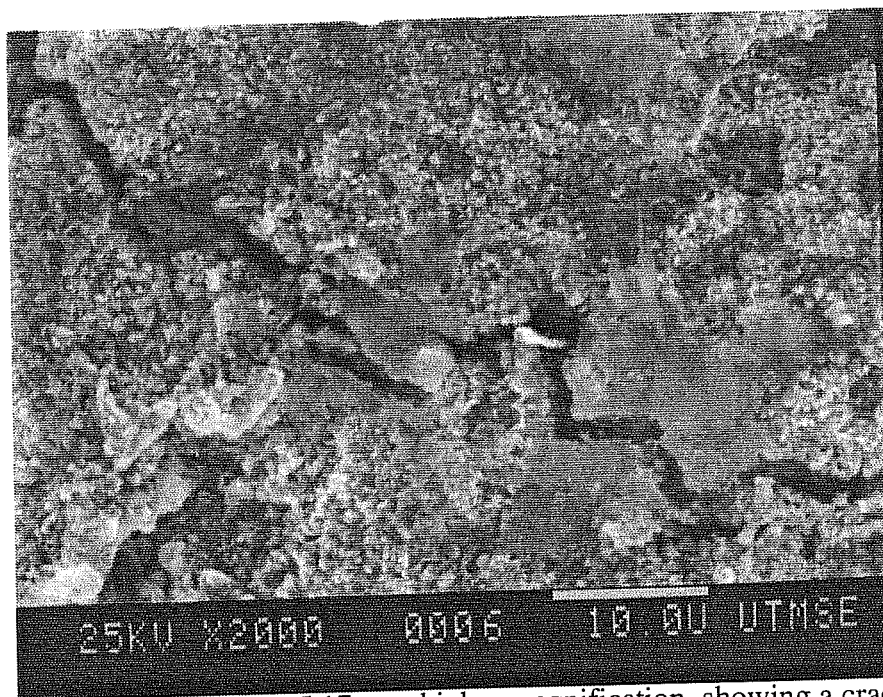
Photo 5.18. Same as Photo 5.17, at a higher magnification, showing a crack on the generally solid and uniform film.

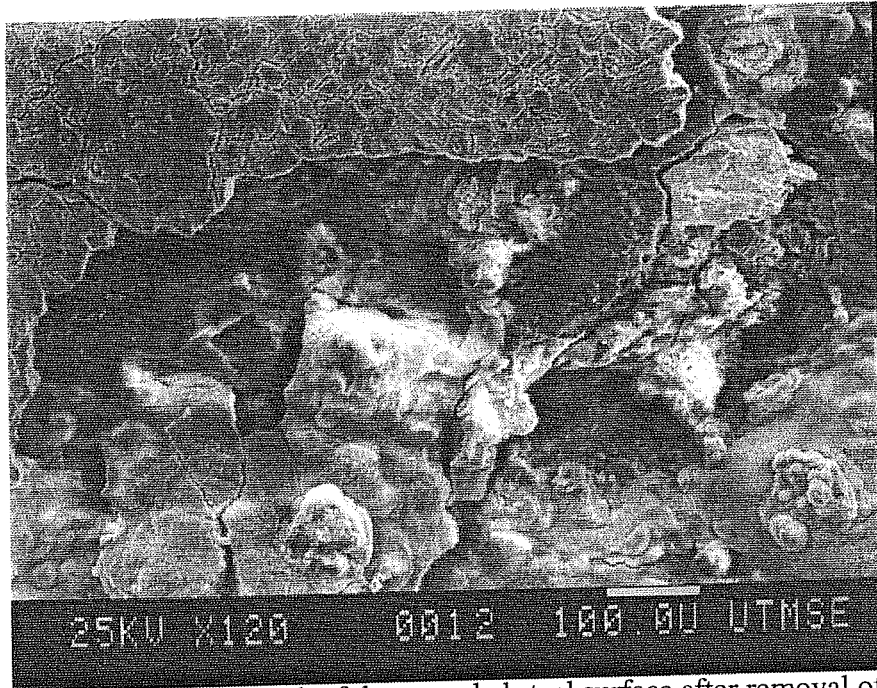
Photo 5.21. SEM micrograph of the corroded steel surface after removal of the corrosion products showing a shell-like outer layer and a portion of exposed area underneath, as in Photo 5.9.

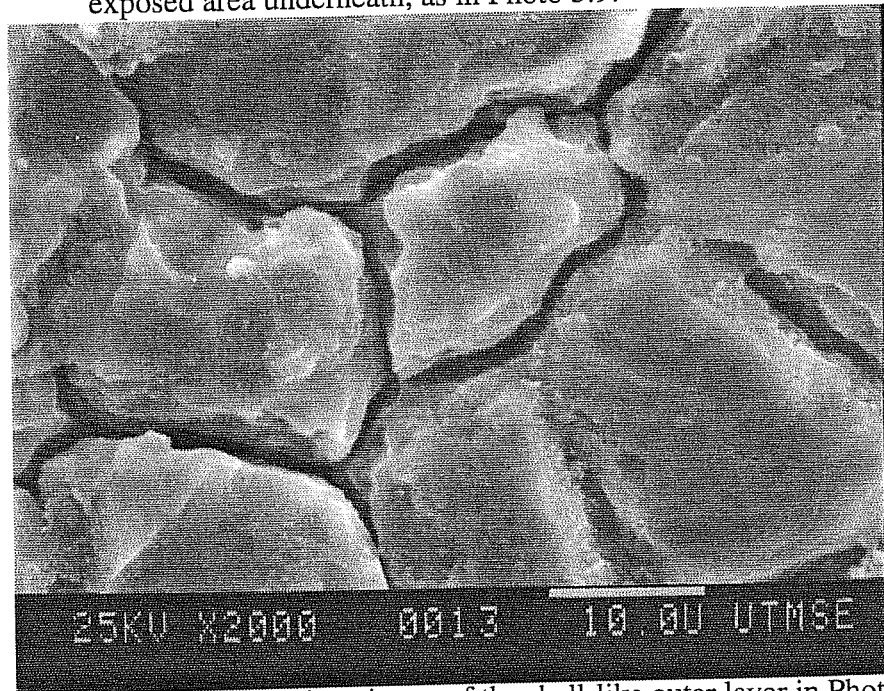
Photo 5.22. High magnification picture of the shell-like outer layer in Photo 5.21 showing intergranular-like corrosion.

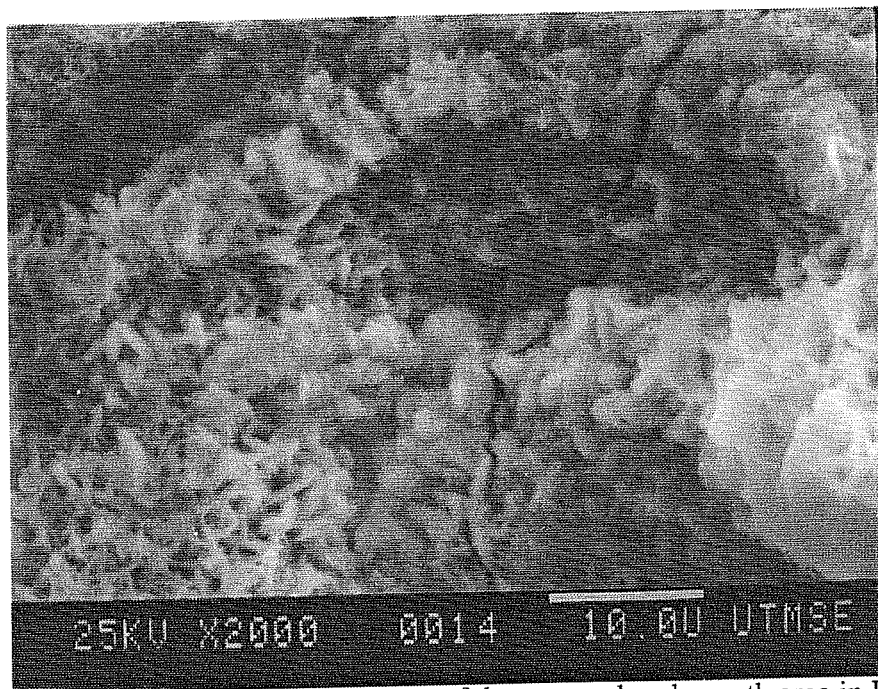
Photo 5.23. High magnification picture of the exposed underneath area in Photo 5.21 showing a gathering of irregularly sized and shaped particles that are believed to be some residual corrosion products.

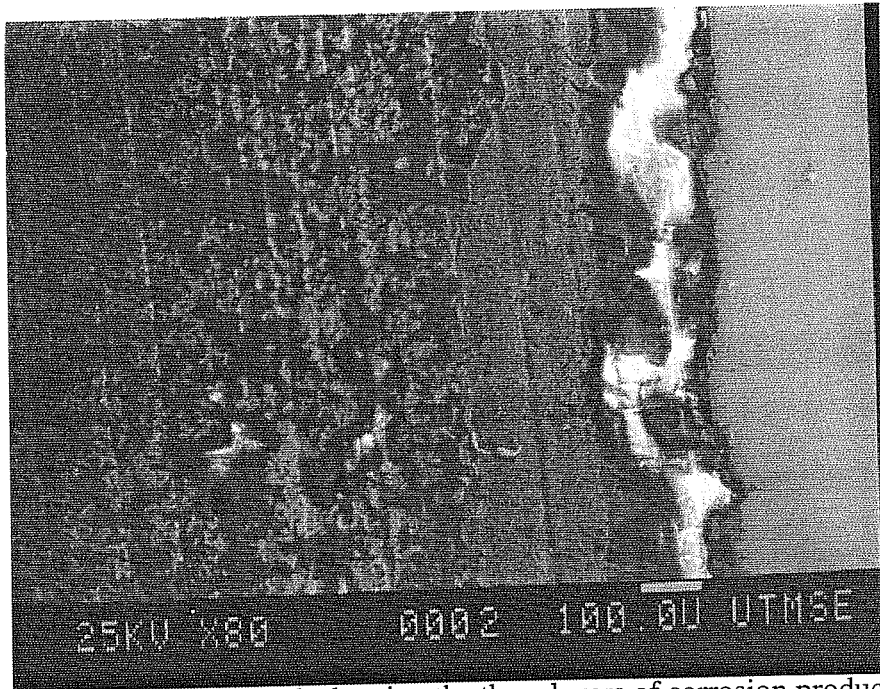
Photo 5.25. SEM micrograph showing the three layers of corrosion products formed on the steel surface. (The bright areas are caused by the charging effect on nonconducting epoxy cold mount.)

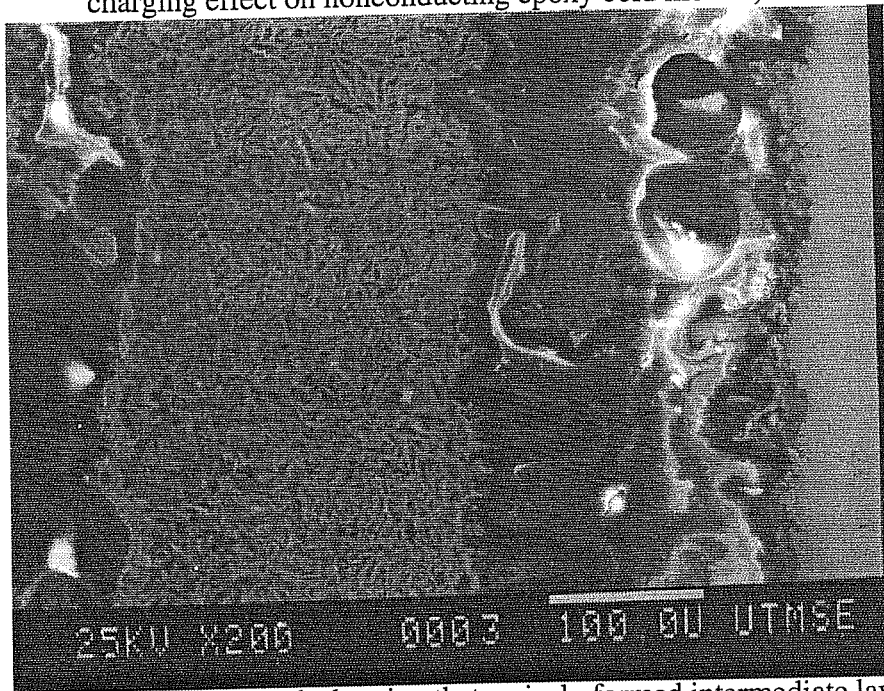
Photo 5.26. SEM micrograph showing that a nicely formed intermediate layer can effectively block the flow of epoxy cold mount.

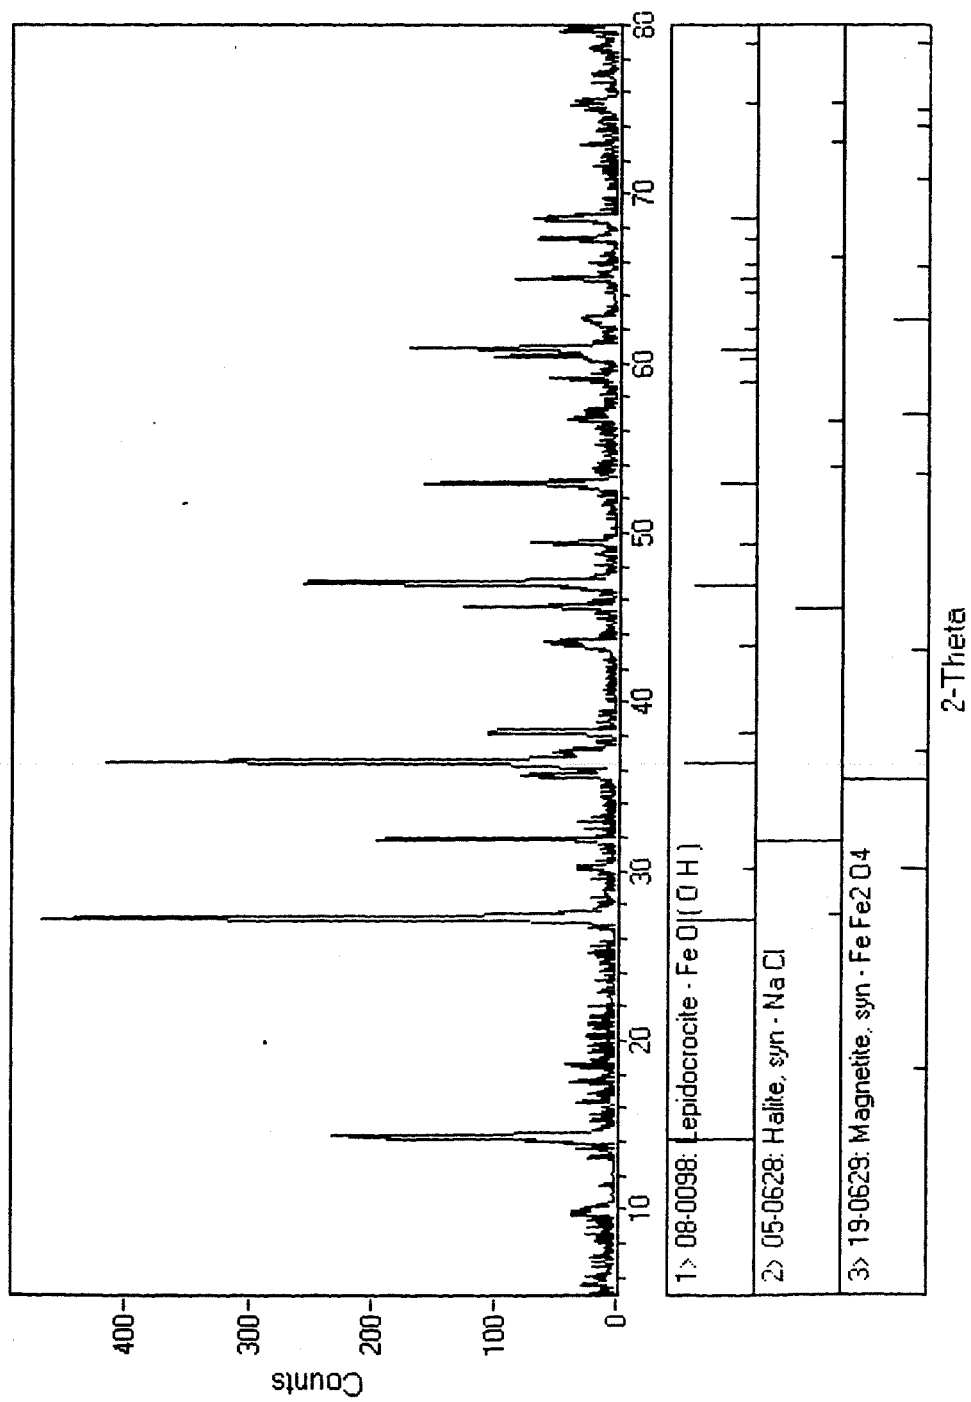
Fig. 5.38. X-ray diffraction spectrum of the corrosion products which comprise mostly the outer layer of orange-colored rust.

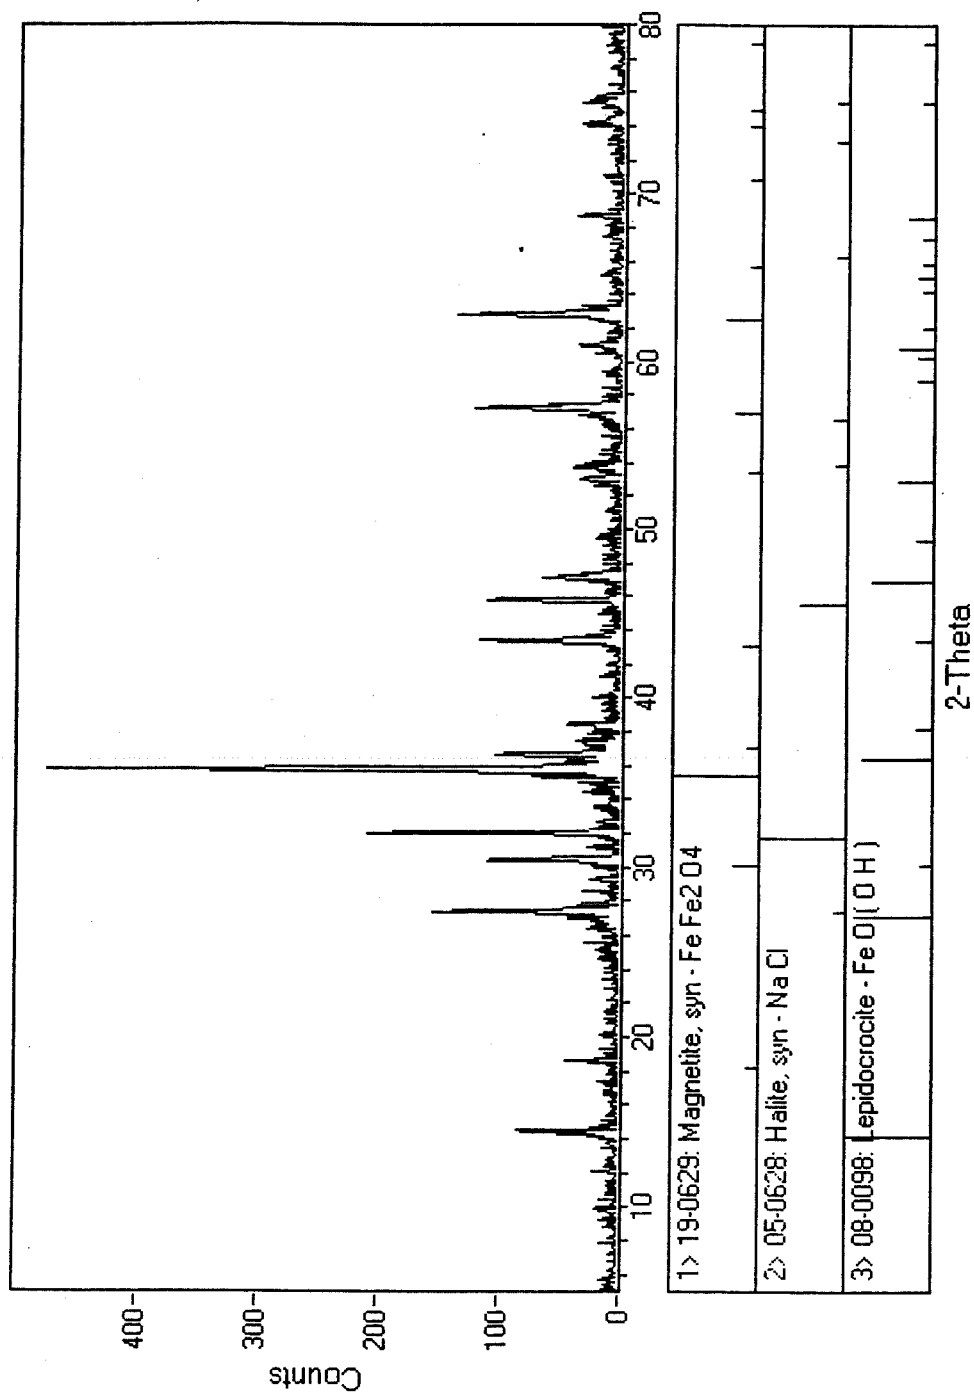
Fig. 5.39. X-ray diffraction spectrum of the corrosion products which comprise mostly the inner layers of dark-colored rust.

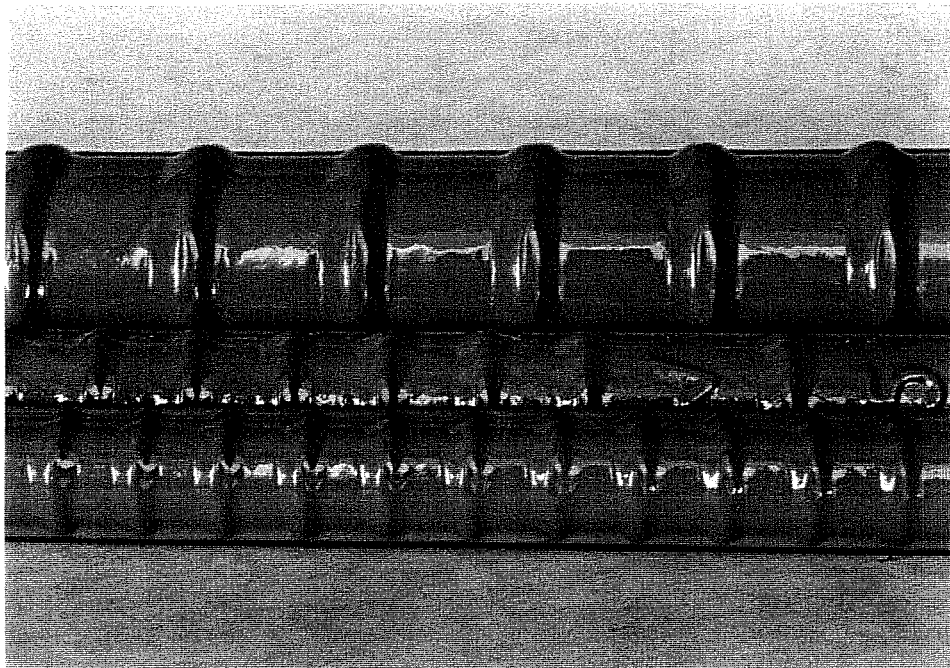
Photo 5.29. Photograph showing typical appearance of as-received ECRs with good coating integrity.

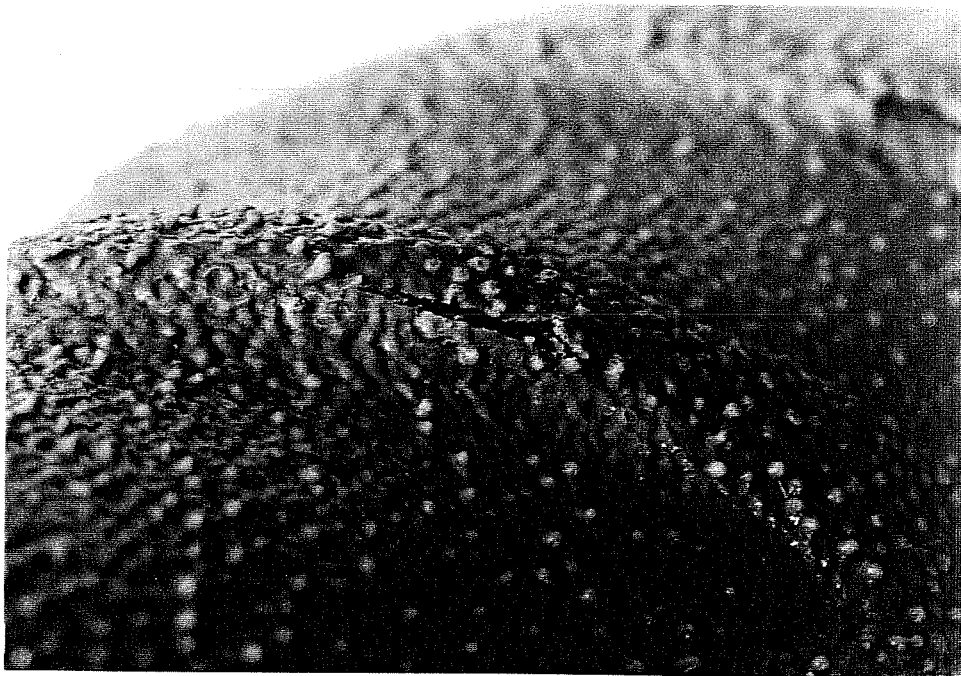
Photo 5.32. Close-up picture showing another coating crack on an as-received ECR and the abnormally rough surface.

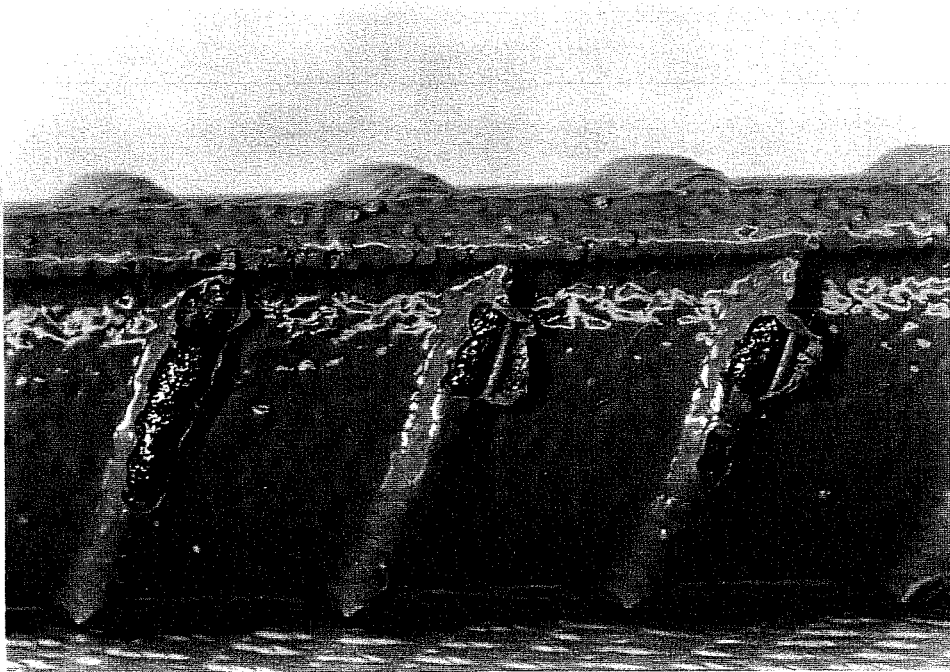
Photo 5.34. Photograph of bare areas on an as-received ECR showing premature corrosion.

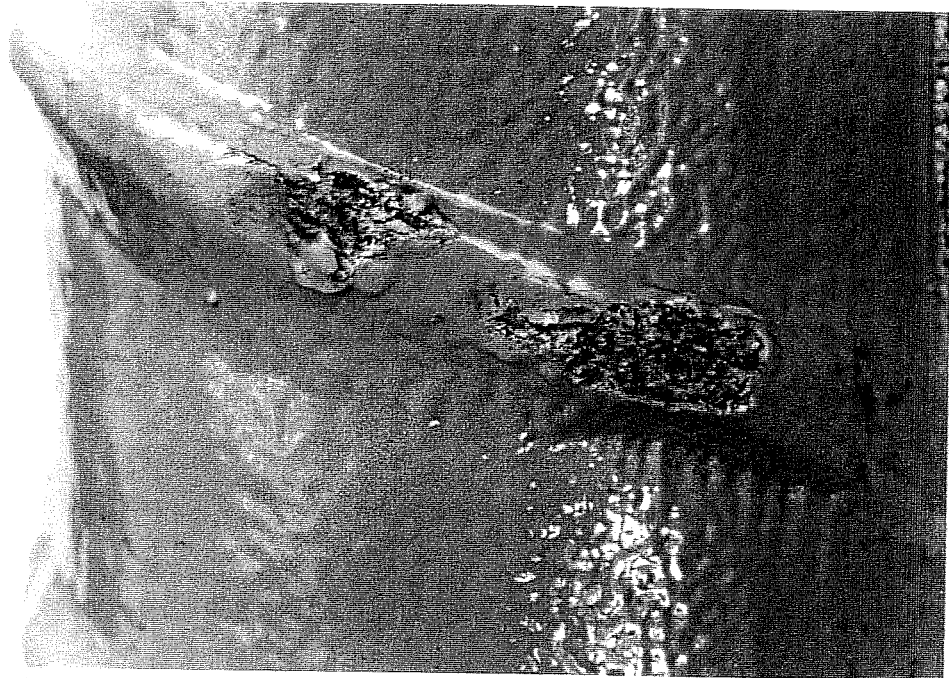
Photo 5.35. Close-up picture of two severe scratches on the rib of an as-received ECR.

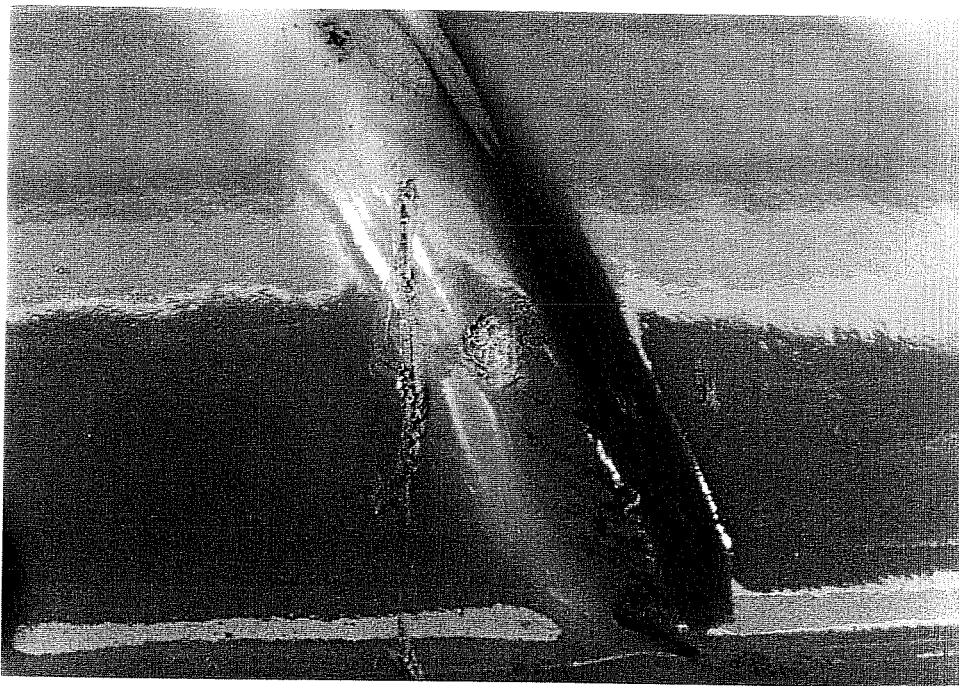
Photo 5.36. Close-up picture of some minor scratches on an as-received ECR.

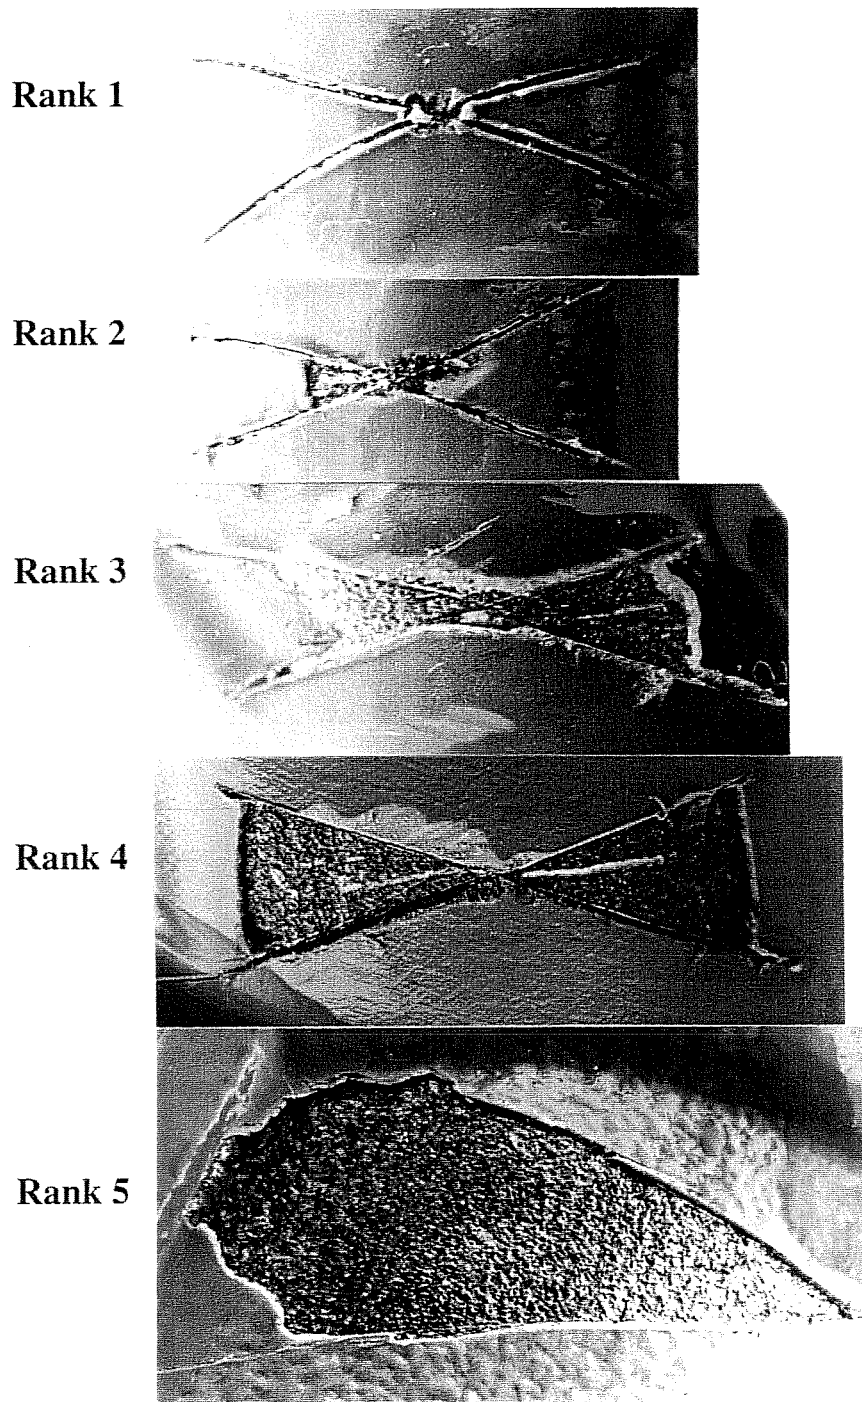
Photo 5.37. Photograph showing the real view of the five-rank adhesion rating system.

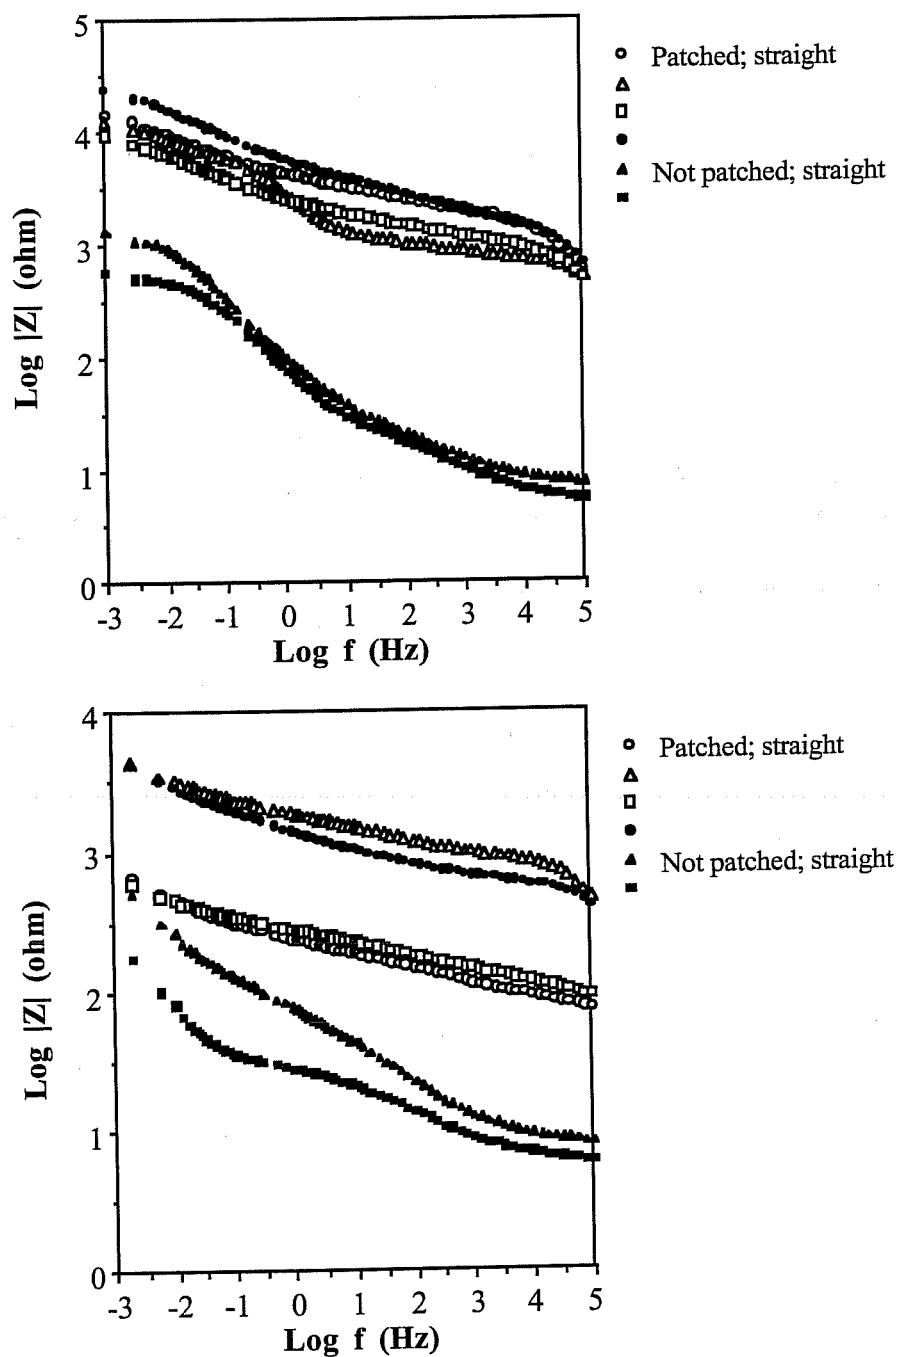
Fig. 5.40. Bode magnitude plots for A#a10 specimens on the 7th day (top) and the 200th day (bottom) after being immersed in 3.5% NaCl solution.

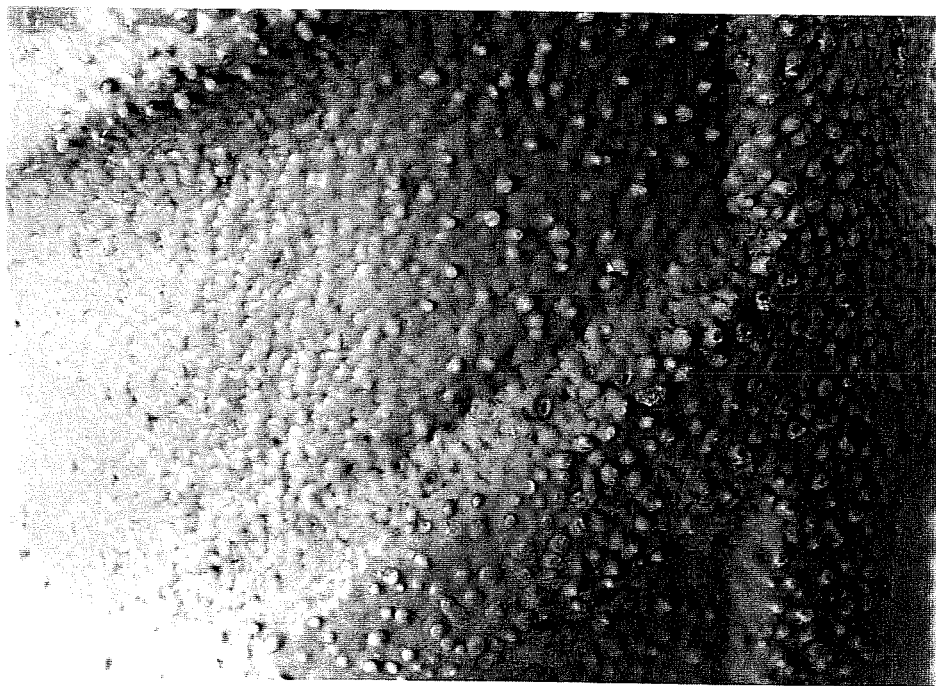
Photo 5.39. Close-up picture showing pin-hole corrosion on the ECR with abnormally rough surface after immersion in 3.5% NaCl solution for 200 days.

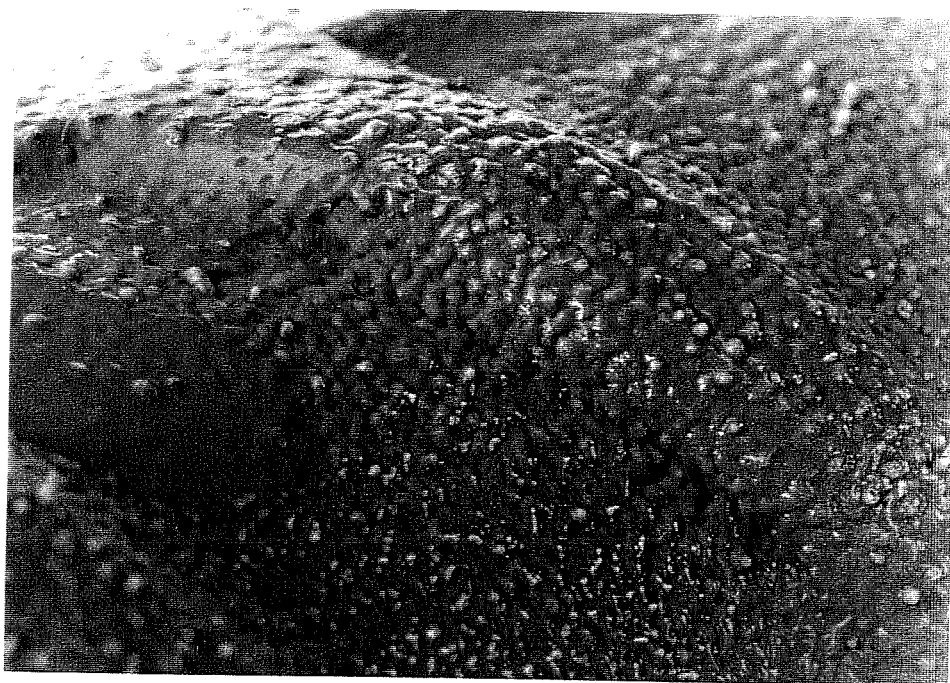
Photo 5.40. Close-up picture of pin-hole corrosion on a patched ECR indicating these tiny pin-holes might easily be neglected during patching practice.

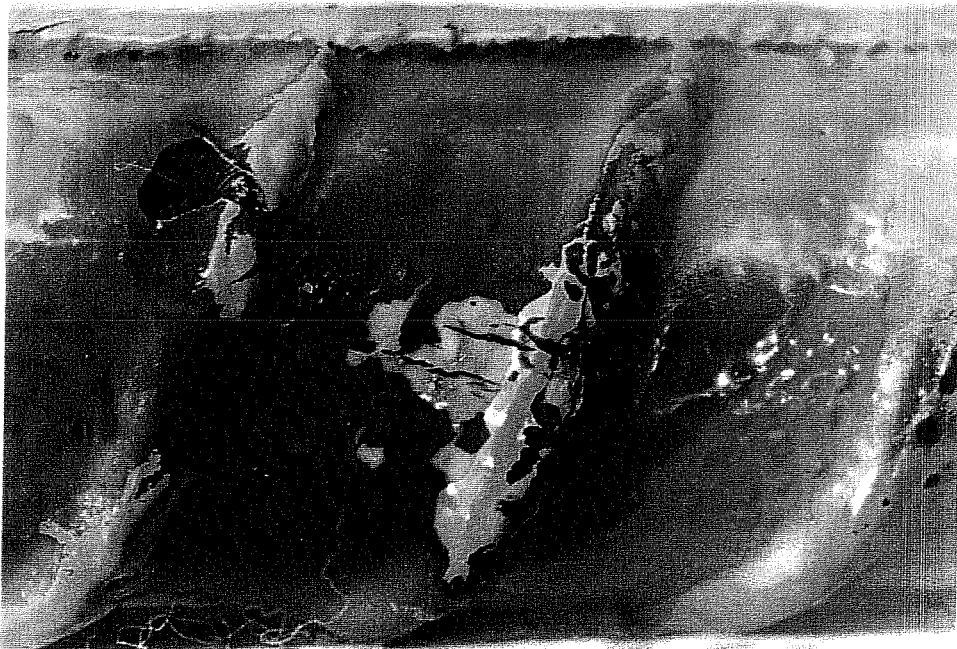
Photo 5.43. Close-up picture showing cracks formed on a patched ECR specimen after immersion in 3.5% NaCl solution for 200 days.

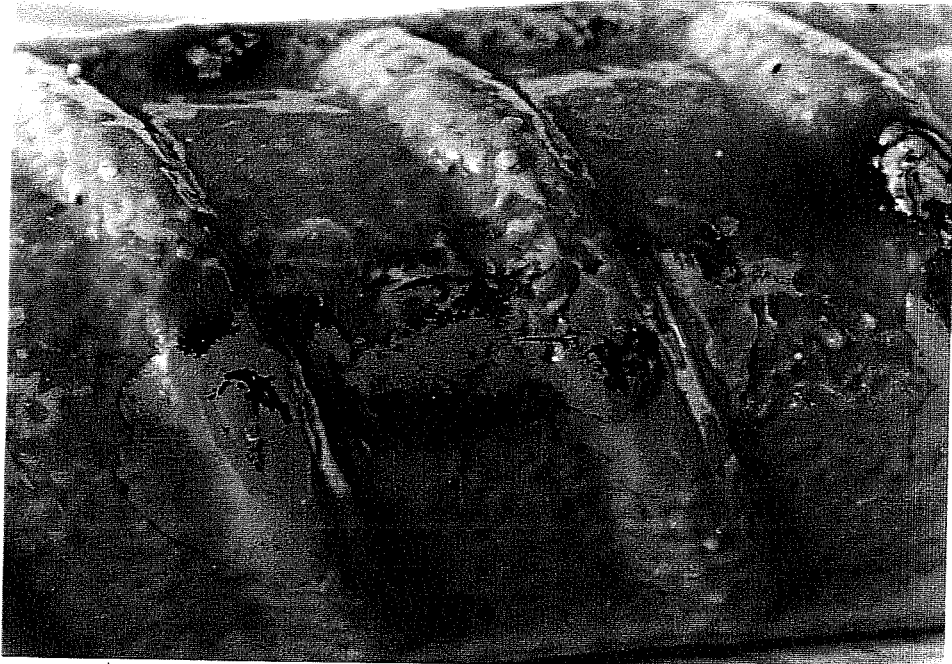
Photo 5.44. Another close-up picture also showing cracks formed on ECR after immersion in NaCl solution.

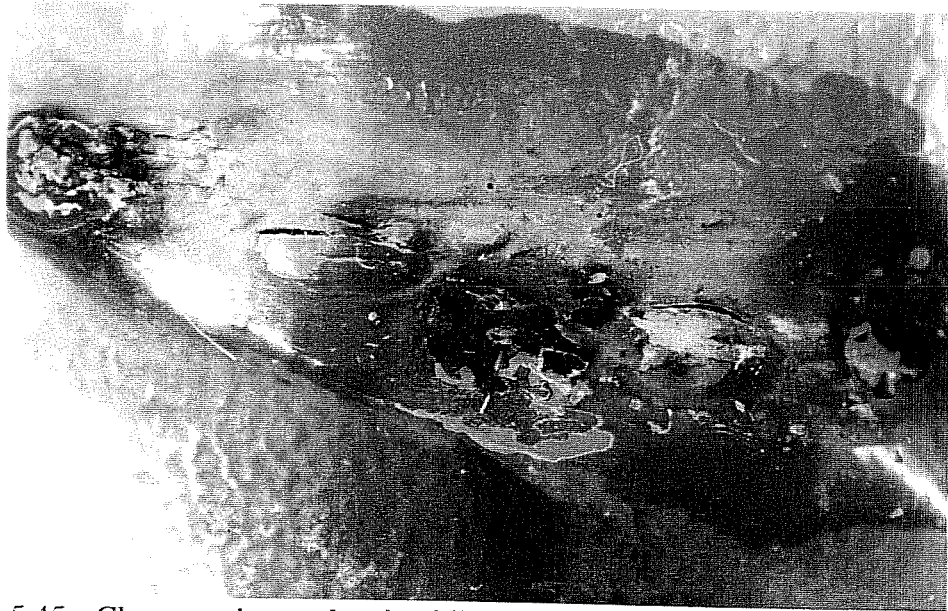
Photo 5.45. Close-up picture showing blisters formed on the patched ribbed area of an ECR specimen after immersion in 3.5% NaCl solution for 200 days.

Those signs of deterioration observable by the naked eye are further examined and classified into several major types. Pictures of the representative types are shown in Photo 5.39 through Photo 5.50, and are described as follows. Photo 5.39 and Photo 5.40 show us the pin-hole corrosion on the surface of A#b10 specimens. As mentioned earlier in this section, patching does not seem to provide improvement on performance for this type of ECR. It becomes apparent here that the extremely rough surface and those masked tiny pin-holes will be the causes for that phenomenon. The pin-holes become apparent after immersion due to the color of rust. Photo 5.41 and Photo 5.42, again, show the pin-hole corrosion. Those pin-holes on the base of ribs of A#a10 specimens were observed but not patched before immersion. After immersion, very different extents of corrosion were observed. In Photo 5.41, the corrosion is seen to be mild; while in Photo 5.42, evidence of severe corrosion is still apparent even though the corrosion products were removed. Photo 5.43 and Photo 5.44 show the coating cracks on A#a4 specimens. The formation of these cracks is the consequence of corrosion activity, since both the specimens shown were thoroughly patched on every possible defect before immersion. It is believed that the corrosion reaction is caused by the diffusion of corrosive ions and water into the iron substrate. As the corrosion activity proceeds, the accumulation of corrosion products begin to lift the coating, and finally breaks it. In the upper left portion of Photo 5.43, a small piece of coating is even observed to fall off due to the oxide lifting. One hypothesis to make here is that the degradation of the epoxy may also facilitate this deterioration process, since the coating seems to become fragile after immersion. Photo 5.45 and Photo 5.46 show the blisters formed on A#a10

specimens. It is observed that all the blisters develop on the patched areas. The deterioration mechanism for blistering is similar to that in the case of cracking, while the formation of blisters may be because the patching material has better ductility than the original coating does. However, the blister is actually also very fragile. Photo 5.47 shows a broken blister and the corrosion products within it. Photo 5.48 shows the unpatched bare areas on an A#a4 specimen after immersion. It is apparent that severe corrosion has taken place here; while the red brown and the black colors are the evidence of $\text{Fe}_2\text{O}_3 \cdot \text{H}_2\text{O}$ and Fe_3O_4 , respectively, as discussed previously. Finally, Photo 5.49 and Photo 5.50 show signs of slight corrosion around the unpatched scratches on A#b10 and C#d10 specimens. Actually, many other scratched areas do not show signs of corrosion because the coating is thick enough to withstand this minor damage. The specimen shown in Photo 5.50 is one of the two exceptional cases among those ECR combinations which are generally observed to be good, as mentioned earlier in this section.

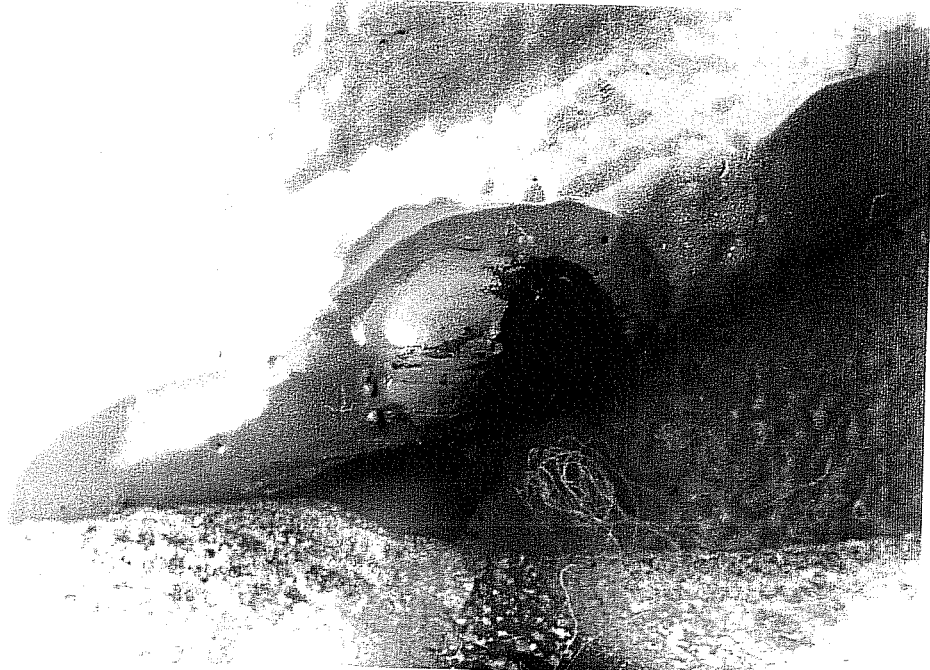
Photo 5.46. Close-up picture showing another blister formed on the patched ribbed area of ECR after immersion in NaCl solution.

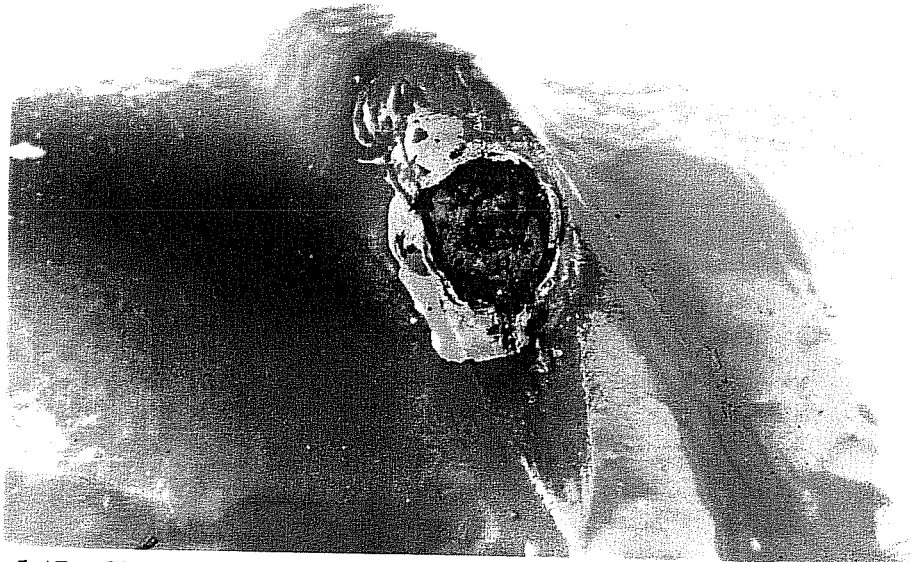
Photo 5.47. Close-up picture of a broken blister showing the corrosion products accumulated within it.

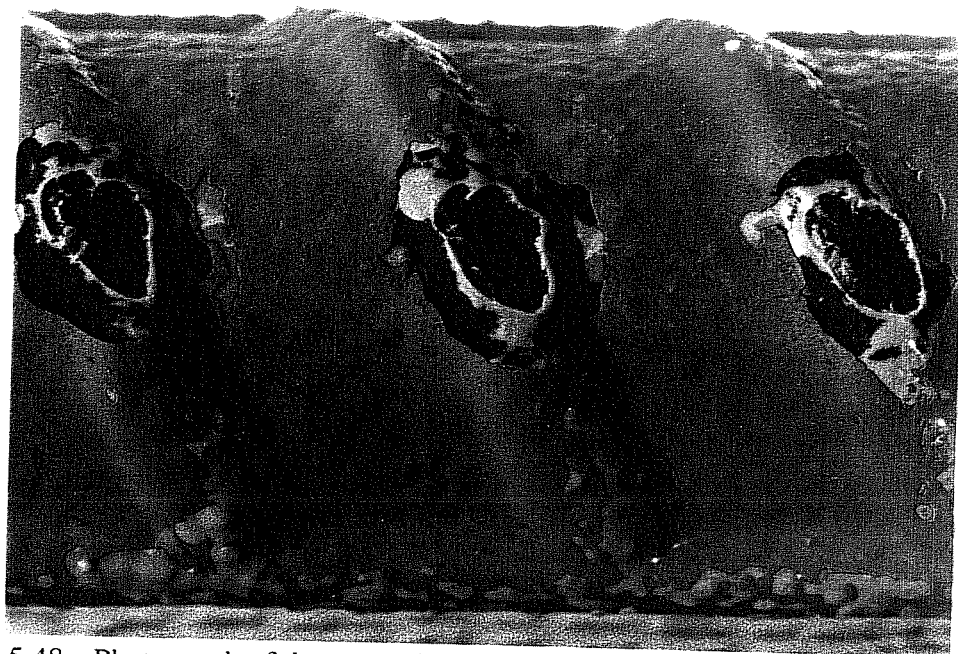
Photo 5.48. Photograph of the unpatched bare areas on an ECR specimen after immersion in 3.5% NaCl solution for 200 days showing evidence of severe corrosion.

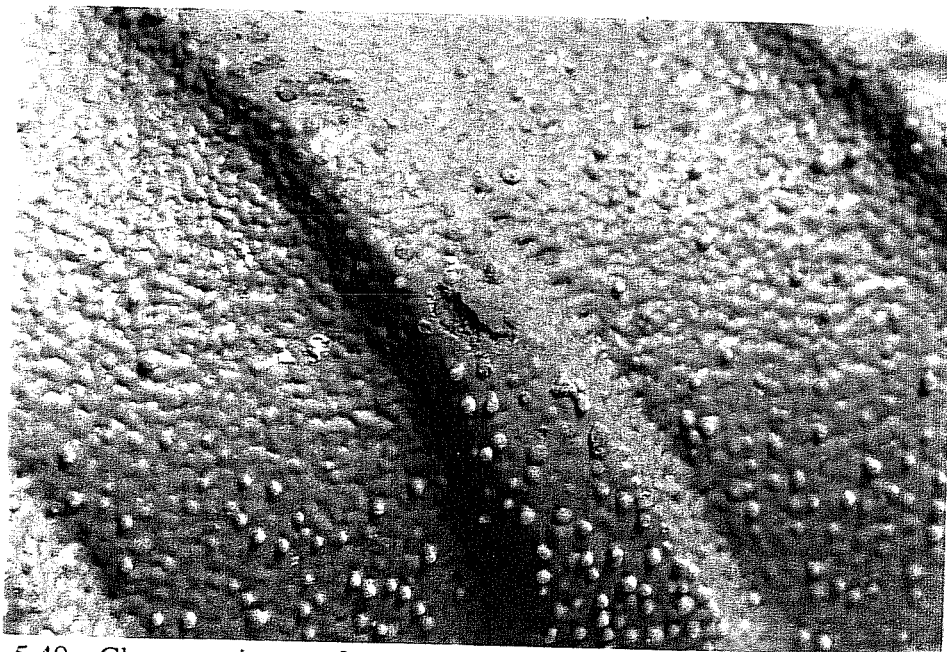
Photo 5.49. Close-up picture of an unpatched scratch showing evidence of slight corrosion after immersion in 3.5% NaCl solution for 200 days.
