Performance of Epoxy-Coated Reinforcing Steel in Saline Media

Dissertation

The University of Texas at Austin

May 1996

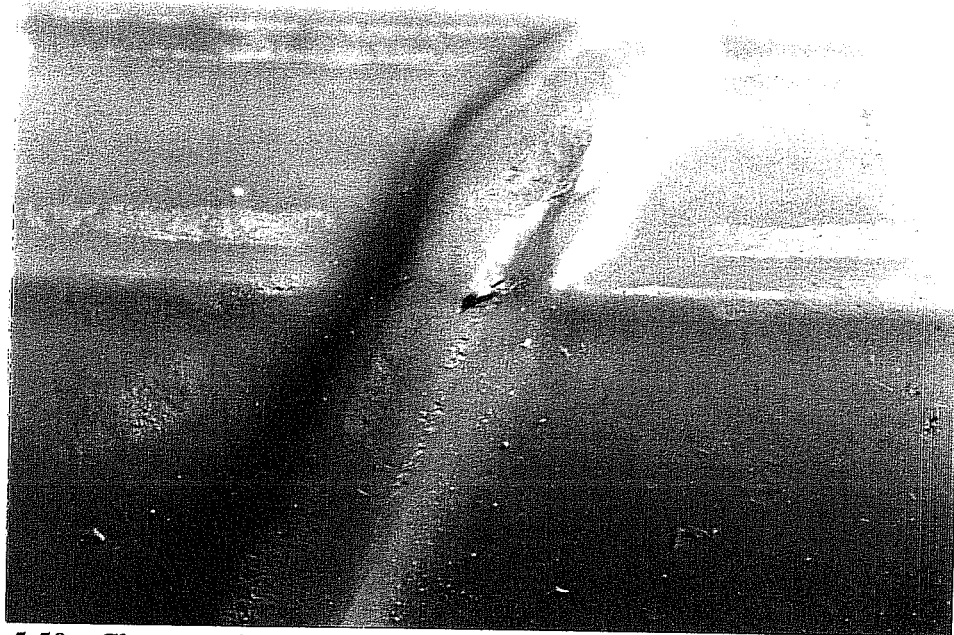
Photo 5.50. Close-up picture of another unpatched scratch also showing evidence of slight corrosion after immersion in NaCl solution.

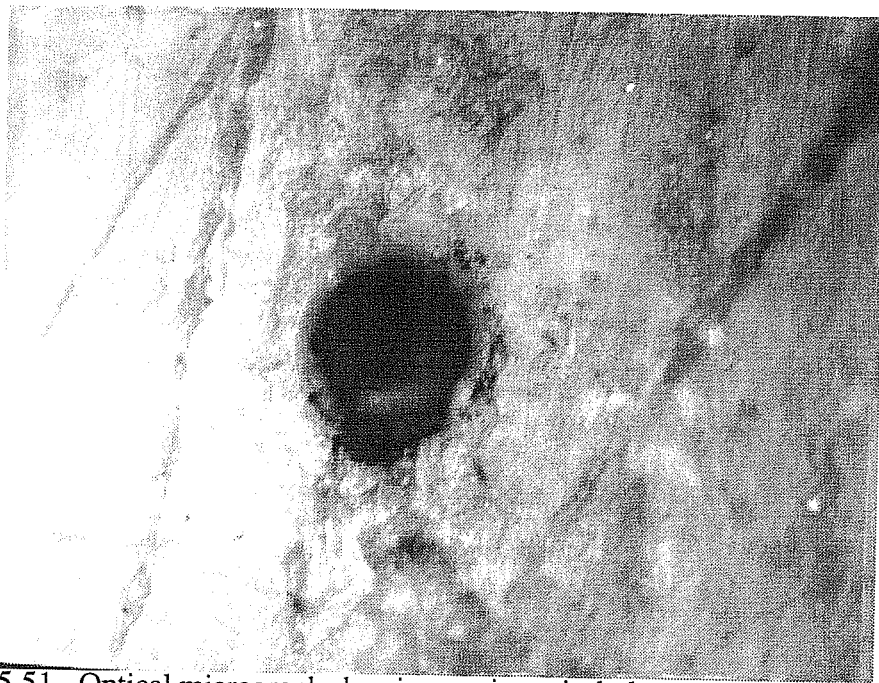
Photo 5.51. Optical micrograph showing a micro pin-hole on epoxy coating with the exposed iron substrate corroded. (x200)

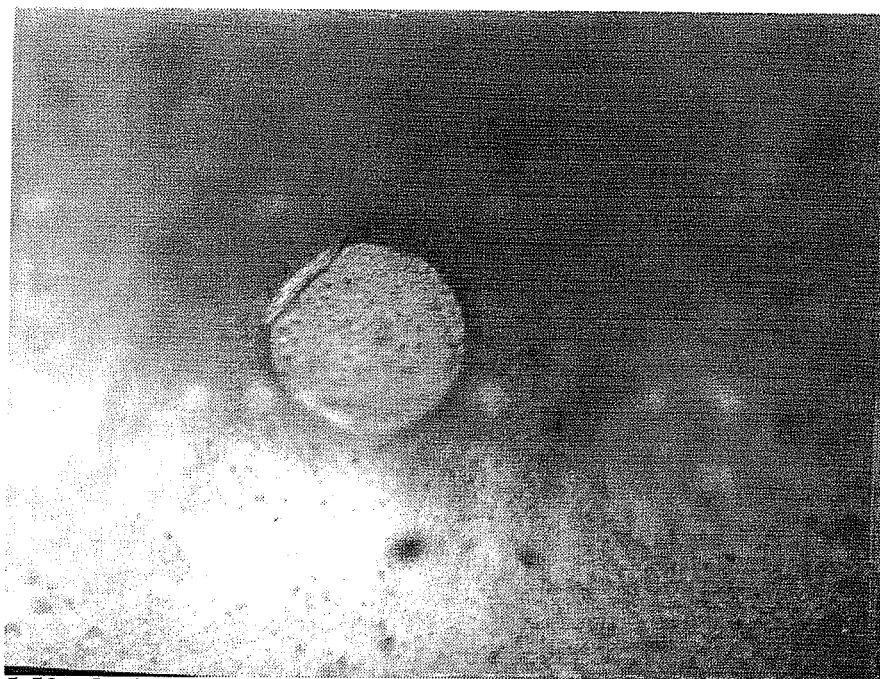
Photo 5.52. Optical micrograph showing another micro pin-hole on epoxy coating with the exposed iron substrate uncorroded. (x200)

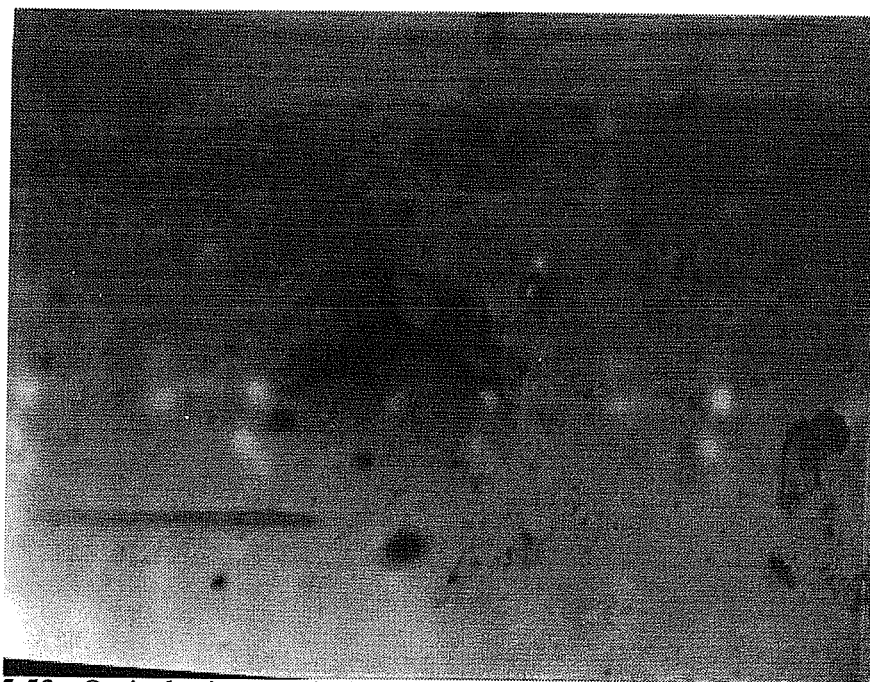
Photo 5.53. Optical micrograph showing a micro crack on epoxy coating. (x200)

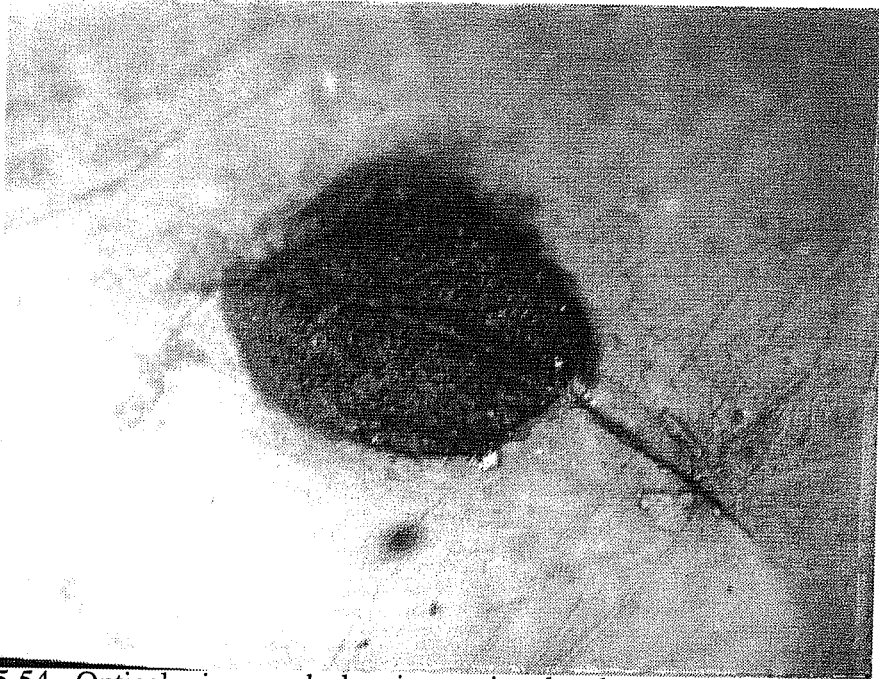
Photo 5.54. Optical micrograph showing a micro break on epoxy coating. (x200)
The circle shown is actually an orange-colored stain around the break,
which is evidence of corrosion.

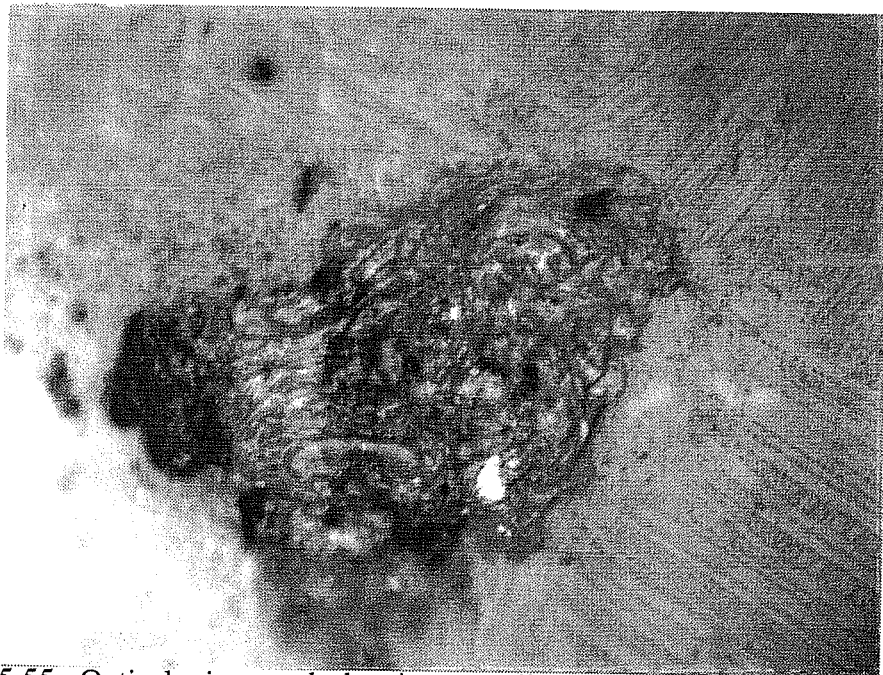
Photo 5.55. Optical micrograph showing a small region on coating where the
epoxy was apparently not well cured. (x200)

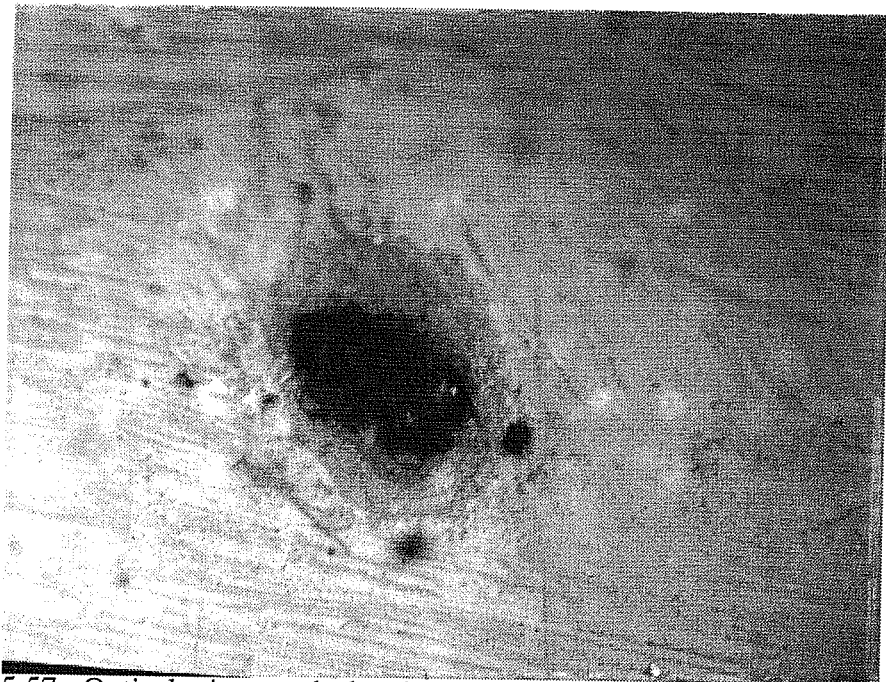
Photo 5.57. Optical micrograph showing a region of corroded exposed iron substrate. (x200)

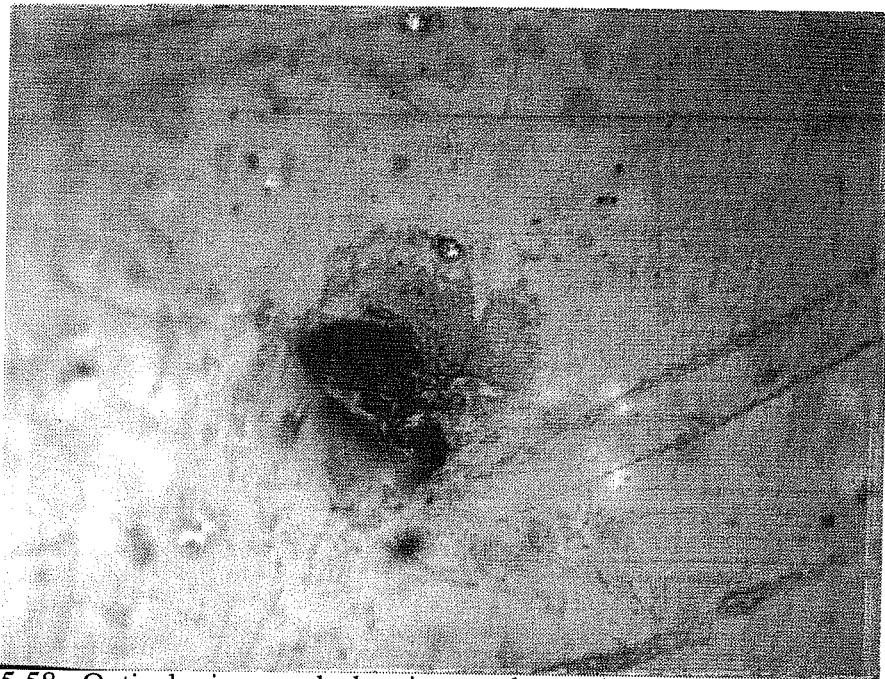
Photo 5.58. Optical micrograph showing another region of corroded exposed iron substrate. (x200)

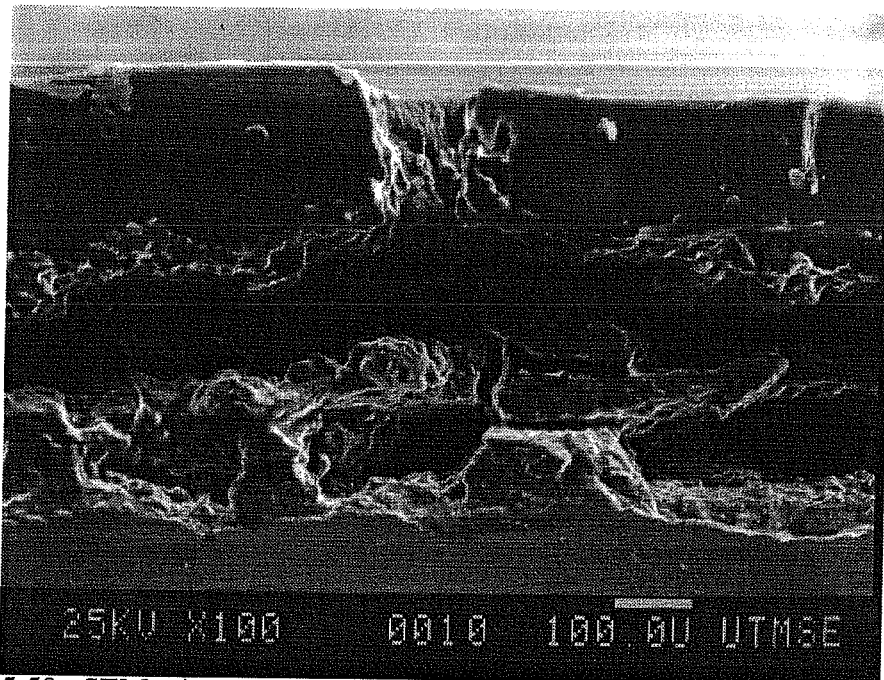
Photo 5.59. SEM micrograph showing a coating break on an unpatched ECR specimen and the severe corroded region beneath it.

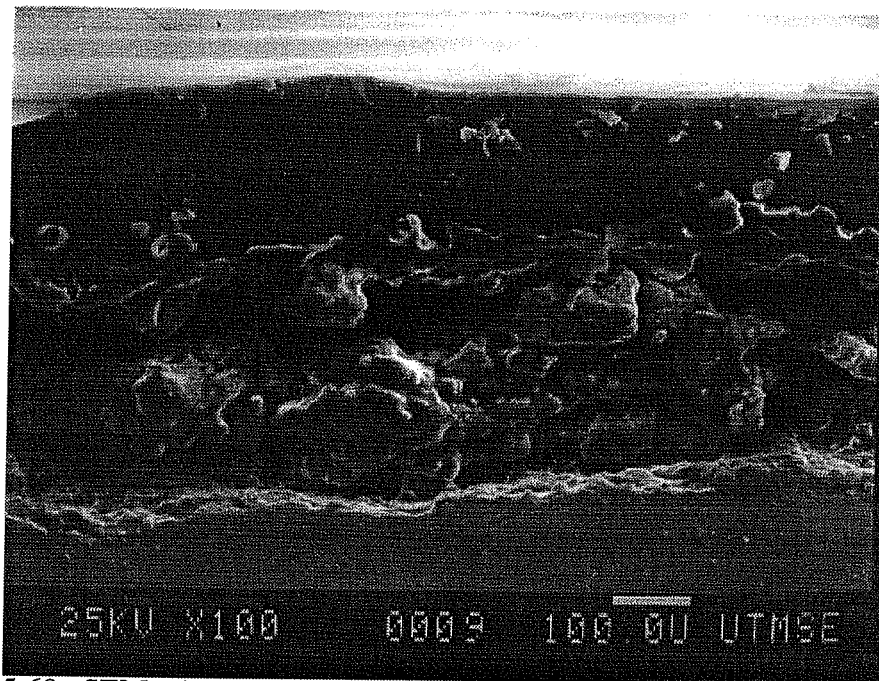
Photo 5.60. SEM micrograph which was taken at a distance from the break in Photo 5.59 showing corrosion developed underneath and along the coating.

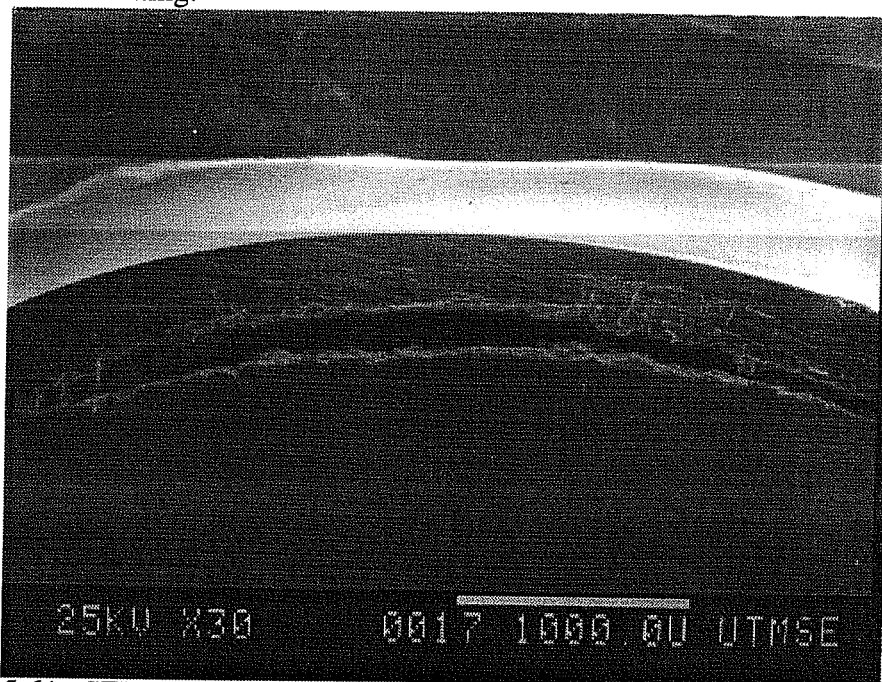
Photo 5.61. SEM micrograph showing a complete disbondment between the coating and the iron substrate due to corrosion.

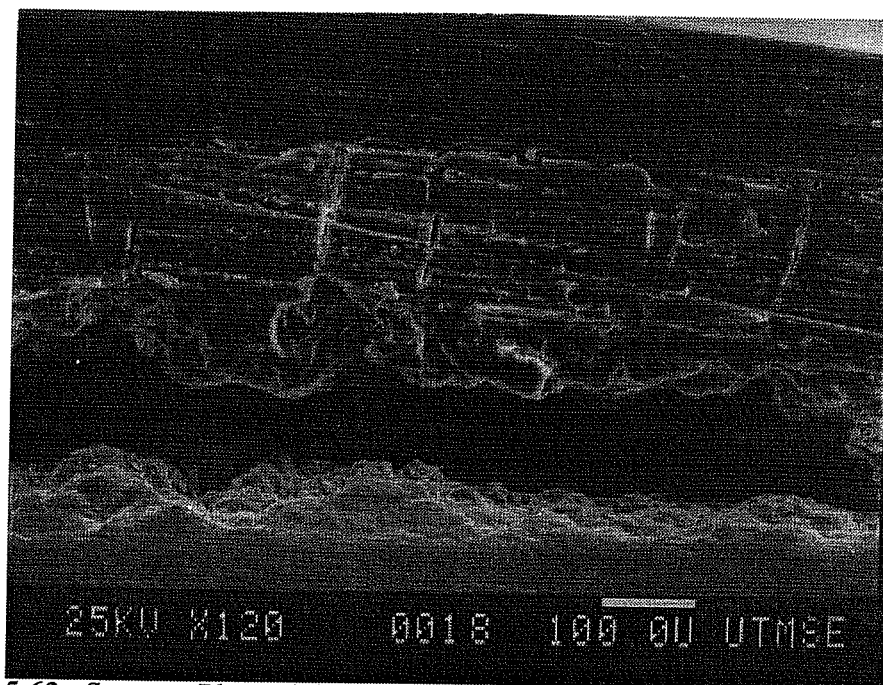
Photo 5.62. Same as Photo 5.61, at a higher magnification, showing coating cracks (observed as vertical lines) right above the corroded region.

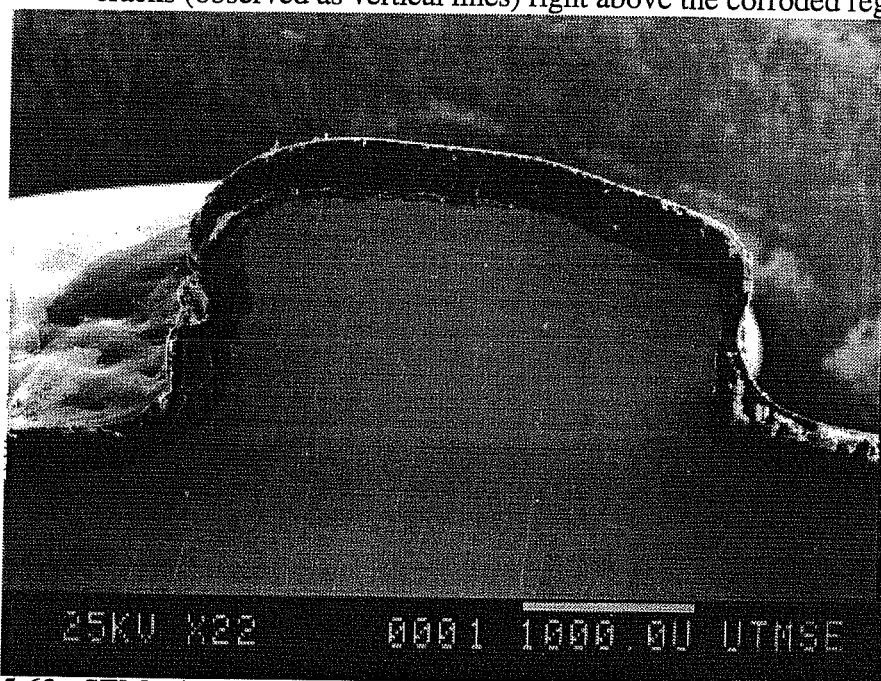
Photo 5.63. SEM micrograph of the ribbed area of a unpatched ECR specimen showing abnormally thin coating on the right hand side of the rib, and corrosion along with coating break due to pin-holes on the left hand side of the rib.

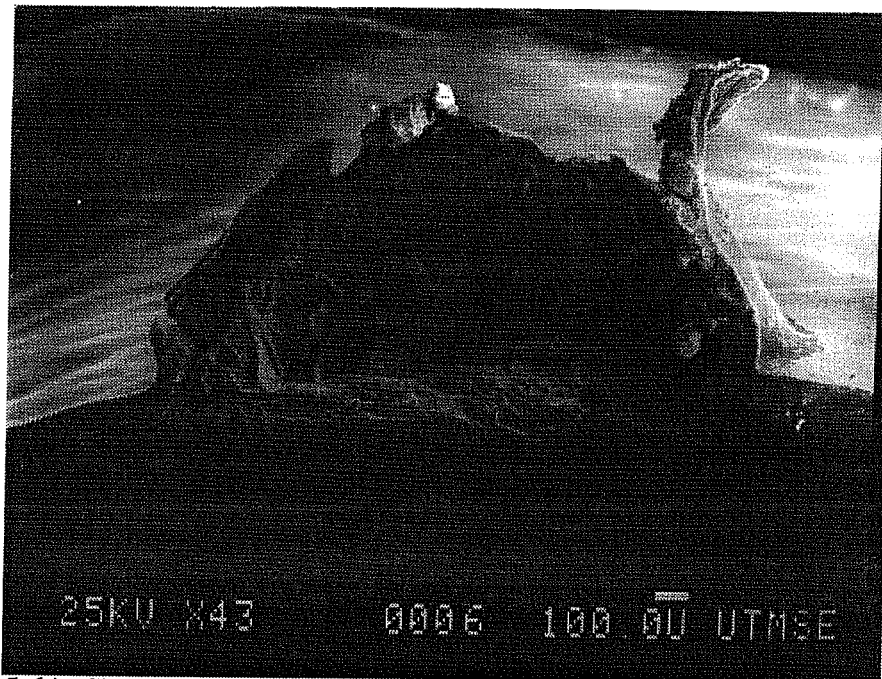
Photo 5.64. SEM micrograph of a blister formed on a patched area. The corrosion products within the blister were washed away during cutting.

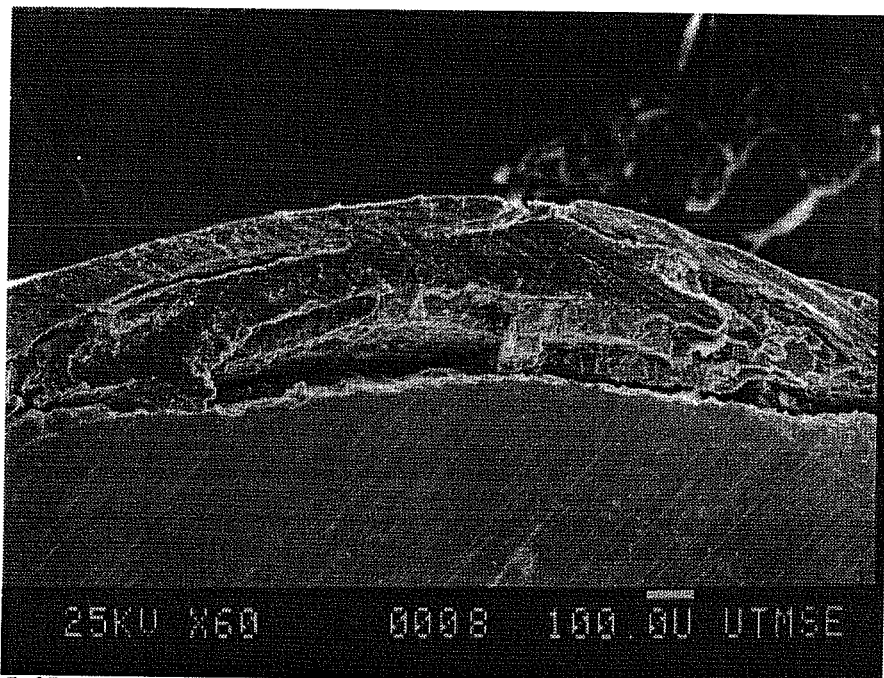
Photo 5.65. SEM micrograph of another blister with some epoxy cold mount cured within it. (Epoxy cold mount was applied to fix the corrosion products.)

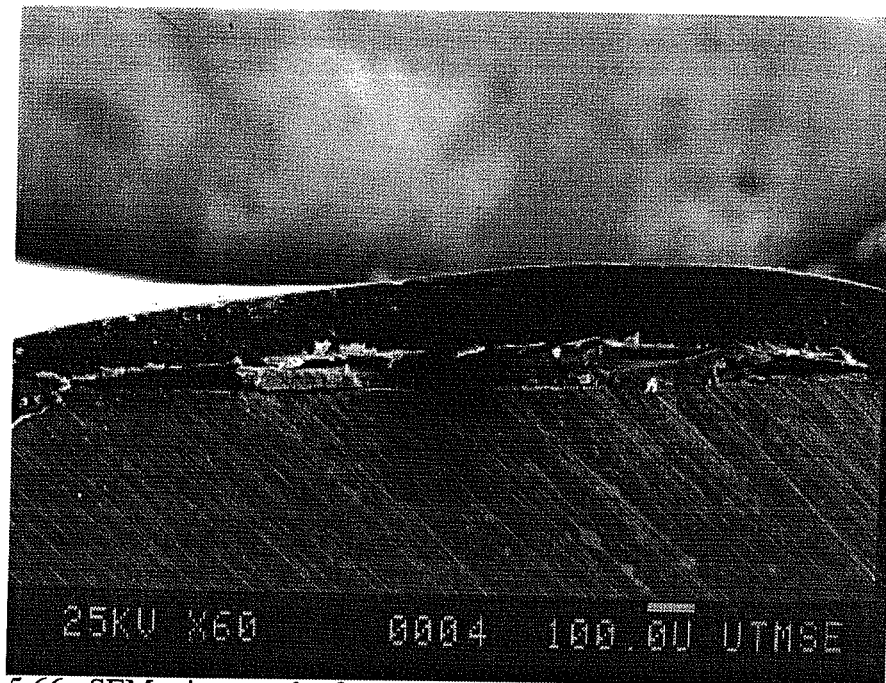
Photo 5.66. SEM micrograph of a newly formed, small blister with no sign of corrosion within it, indicating the possibility of cathodic disbondment at the early stages of blister formation.

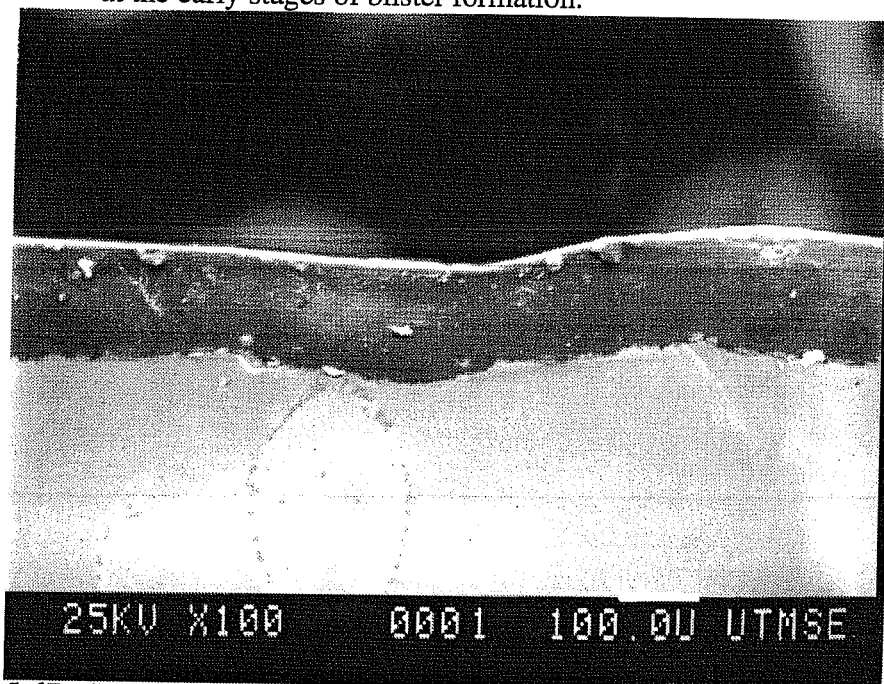
Photo 5.67. SEM micrograph of the iron/coating interface for an ECR with thin coating before exposure to solution. (Adhesion was of rank 2.)

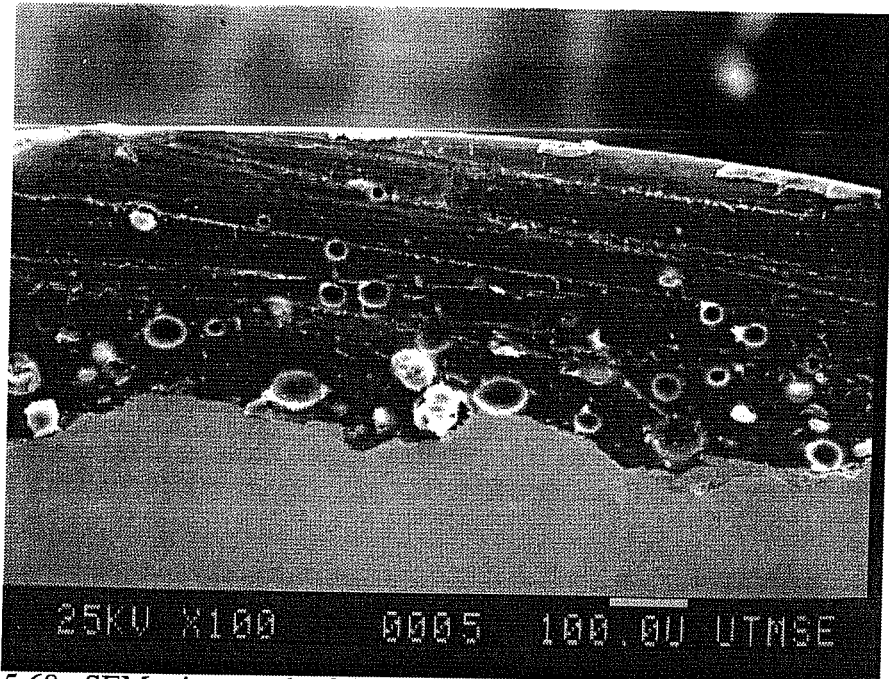
Photo 5.68. SEM micrograph of the iron/coating interface for a straight ECR specimen exhibiting good performance. (Adhesion was of rank 1.)
