DYNAMIC RESPONSE OF CANTILEVER HIGHWAY SIGN STRUCTURES

SUBJECTED TO GUST LOADINGS

THESIS

The University of Texas at Austin

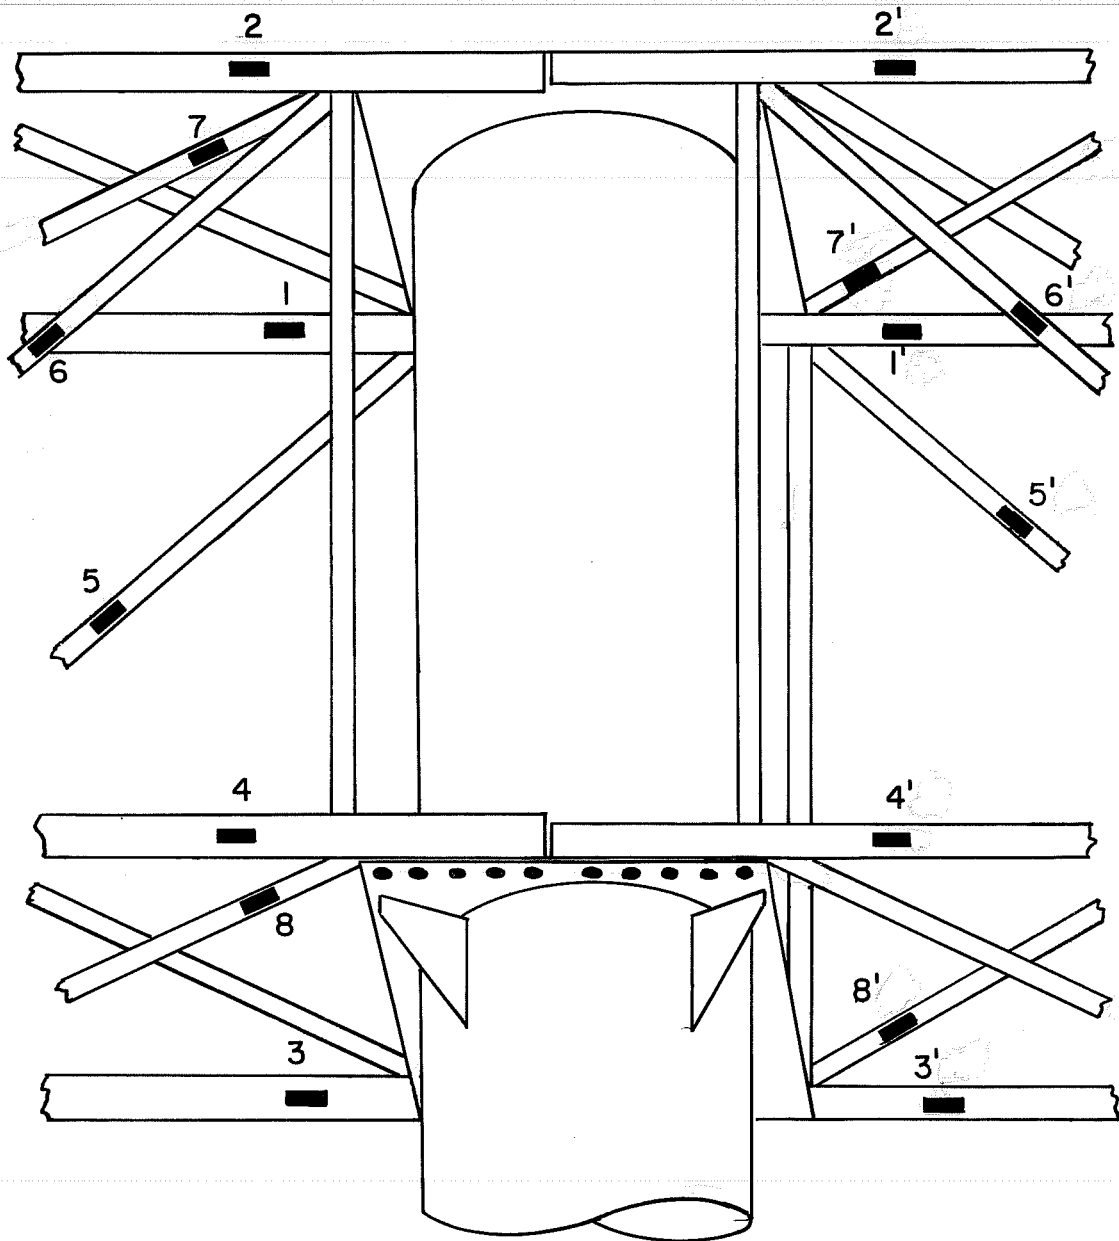
The lack of accessibility to signs on Interstate Highway 35 did not allow instrumentation of any signs there. The first sign chosen was the double cantilever (Fig. 1.2a), located at the intersection of Highways 183 and 290 in northeast Austin. The majority of traffic flow at this location is on Highway 183. The centerline of the sign face is 2 ft. from the centerline of the curb lane in Highway 183, as shown in Fig. 2.1.

In addition to the determination of the stresses and the corresponding magnitudes of the loadings in selected truss members on the Highway 183 side of the sign, stresses were also obtained for members on the other side of the support. It was then possible to examine the effect of the second arm (over the exit ramp) and sign face on the dynamic response of the structure and the possible reduction in the resultant base torque due to the aerodynamic resistance of the sign not subjected to truck-induced gusts. The dimensions of this sign are shown in Fig. 2.1 and the location of strain gages is shown in Fig. 2.2.

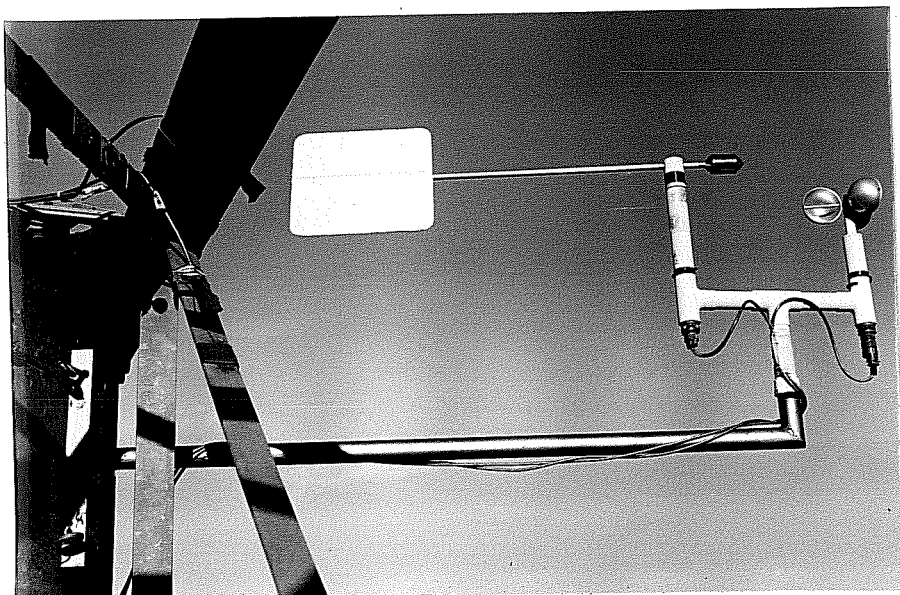
Fig. 2.6 Anemometer and wind vane mount

2.2.2 Wind-sensing Equipment. For each sign a mount was constructed to attach both a wind vane and an anemometer to the support at the height of the center of the sign face, as shown in Fig. 2.6. It was thus possible to determine the velocity and direction of the ambient wind at the sign face. An attempt at determining the magnitude of the gust by placing an anemometer in front of the sign face was not successful.

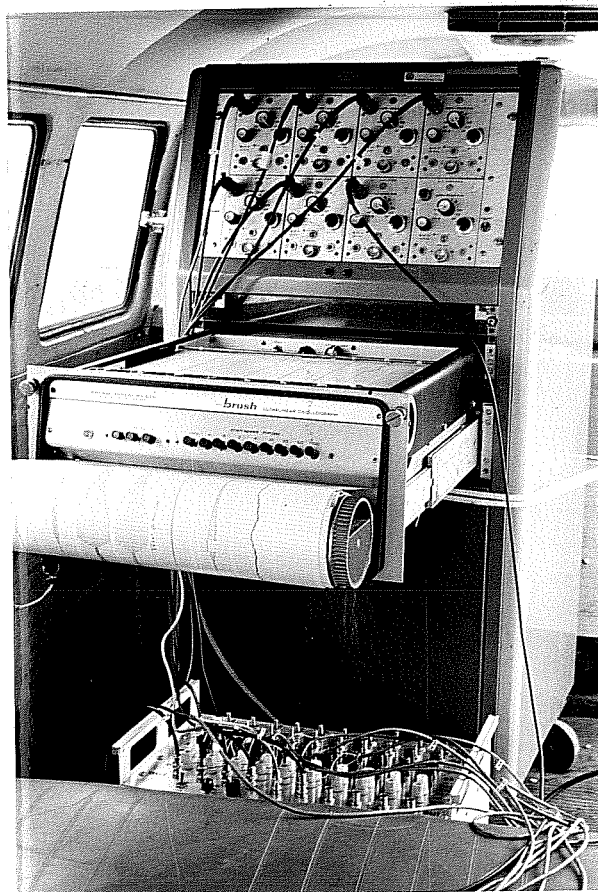
Fig. 2.7 Recording equipment

2.2.3 Recording Equipment. A Hewlett-Packard model 7100 B, two-channel, strip chart recorder was initially used for recording wind velocity. Wind direction was monitored visually and noted on the recording chart paper.

A ten-channel, variable gain (1x, 1000x), low-noise amplifier was developed at the Civil Engineering Structures Research Laboratory of The University of Texas Balcones Research Center for this

project. The high gain of the amplifier was required to allow measurement of very small strains. The signals from the strain gages constituted the input to the amplifier. The amplifier output was connected to a Brush eight-channel, strip chart recorder, model RD1 684-00. The recorder produced a trace of dynamic strains with respect to time.

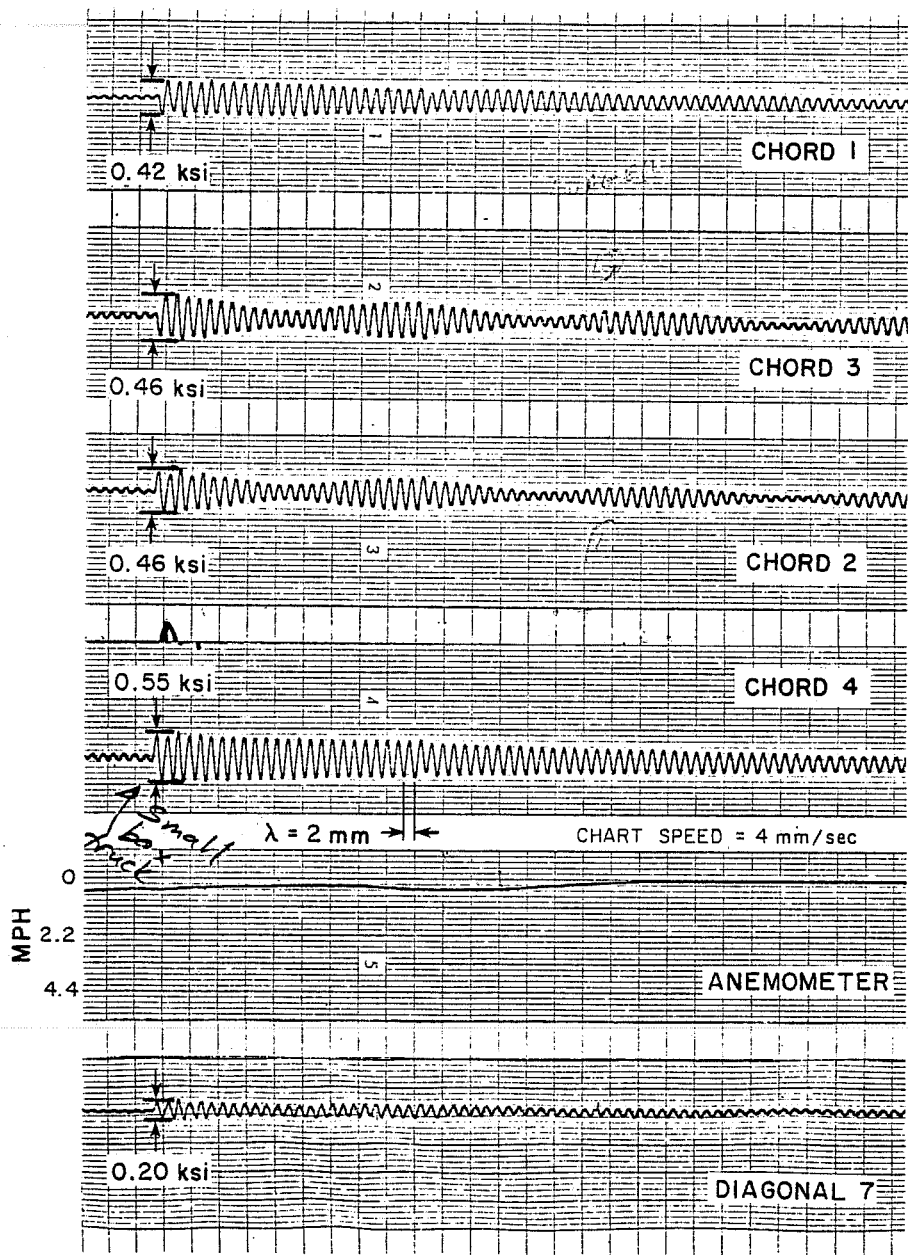
Fig. 3.1 Truck-induced strains in double cantilever truss members

calculated. The maximum stress range for each trace shown in Fig. 3.1 is included in the figure. The 0.55 ksi stress range of chord member 4 is the largest truck-induced stress range recorded in this study. This indicated that the superstructure stresses were low and presented no fatigue problem.

The effects of damping on the structure are seen in the progressive decay of the strain amplitudes of the traces shown in Fig. 3.1. This decay can be characterized by the damping ratio ξ . The large number of cycles in the trace indicate that the value of ξ must be small. The procedure for calculating ξ is given in Sec. 3.1.1.

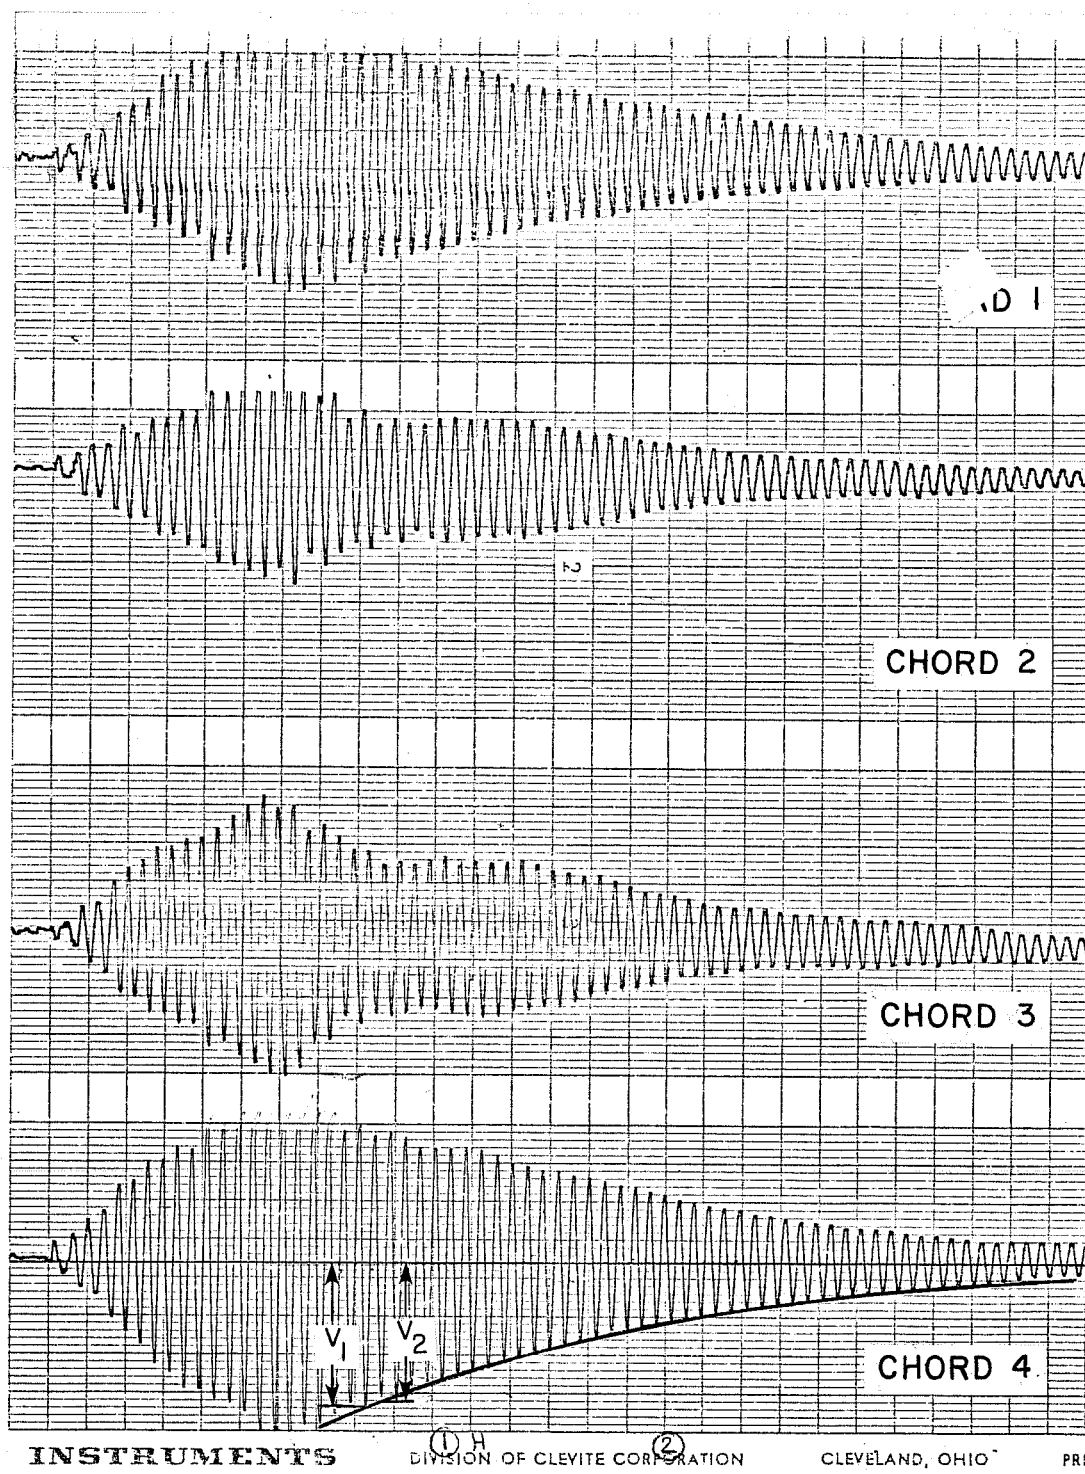
Fig. 3.3 Strain traces from a horizontal forced vibration test of double cantilever signs

To accurately determine the value of the natural frequencies and the damping ratio, the behavior of the structure was examined when subjected to a forced vibration. This was accomplished by standing on the truss as close to the support as possible so as to decrease the effects of the added mass, and rocking the truss either vertically or horizontally. This procedure was repeated several times and produced outputs as shown in Figs. 3.2 and 3.3. It was thus possible to calculate the natural frequencies and damping ratio for the horizontal and vertical deflection modes. The natural frequencies were calculated for four traces of each mode and yielded values ranging from 1.89 to 1.90 cycles per second

for the vertical mode, and 2.0 to 2.04 cycles per second for the horizontal. The average values for the first mode natural frequency and period are 1.90 cycles per second and 0.53 seconds, respectively. For the second mode these values are 2.01 cycles per second and 0.50 seconds, respectively.

The closeness of these values strengthened the belief that the beating noted in the outputs was caused by a mixing of the first and second modes.

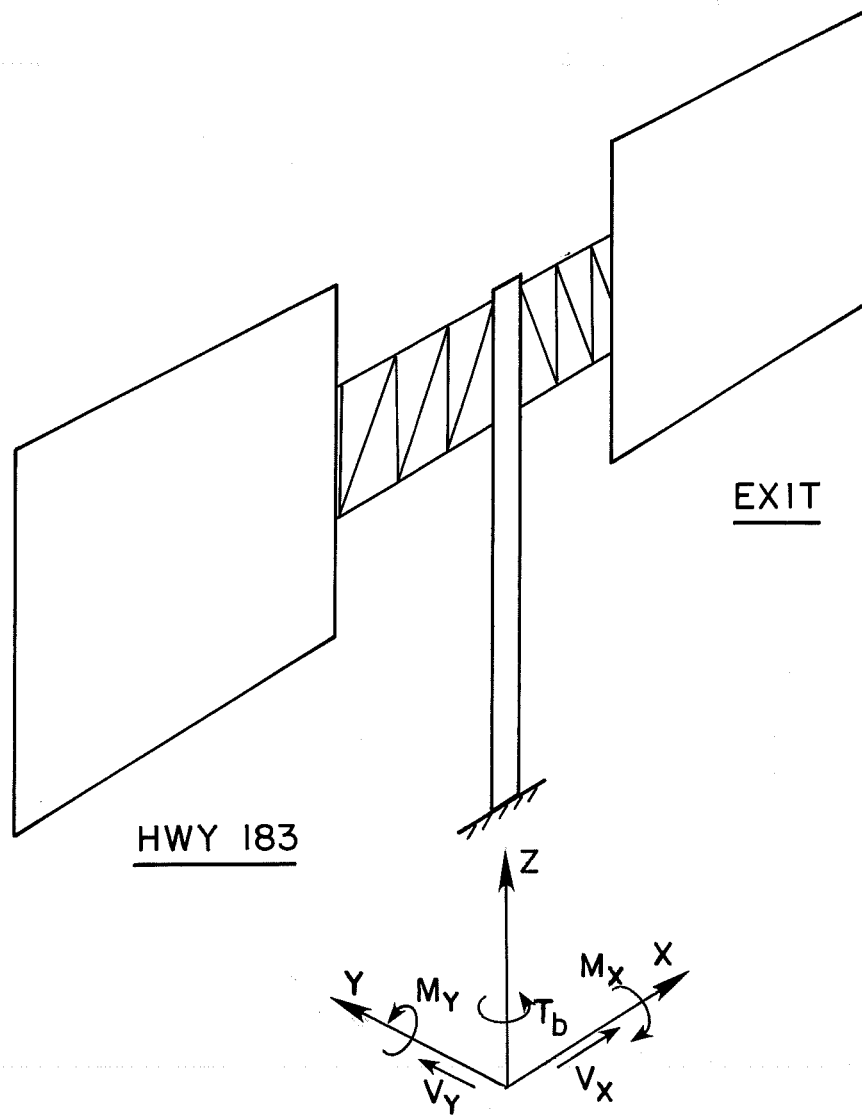
Fig. 3.4 Forces acting on base of structure

The torque, biaxial shears and moments at the base of the sign, shown schematically in Fig. 3.4, were calculated from the member forces in the sign truss. In the equations given below, summation of forces in members refers to members on both sides of the support unless otherwise stated.

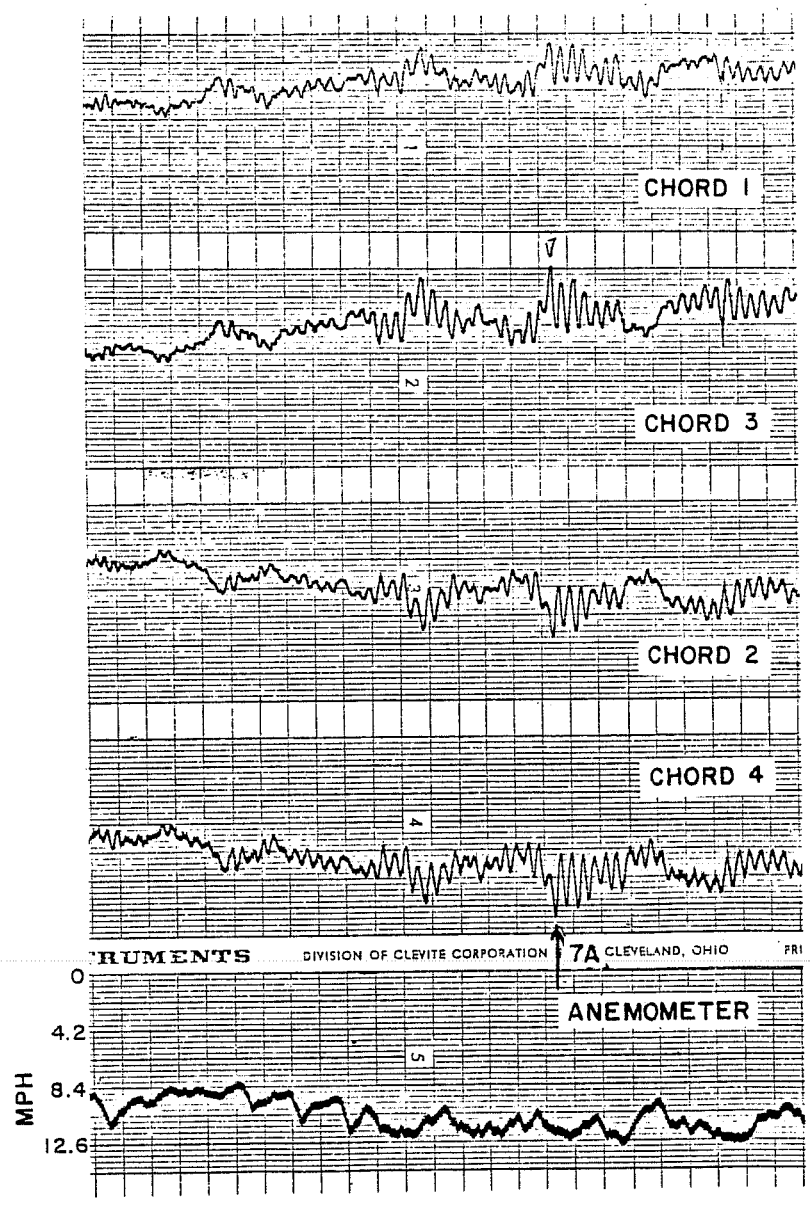
Fig. 3.5 Wind-induced strains in double cantilever truss members

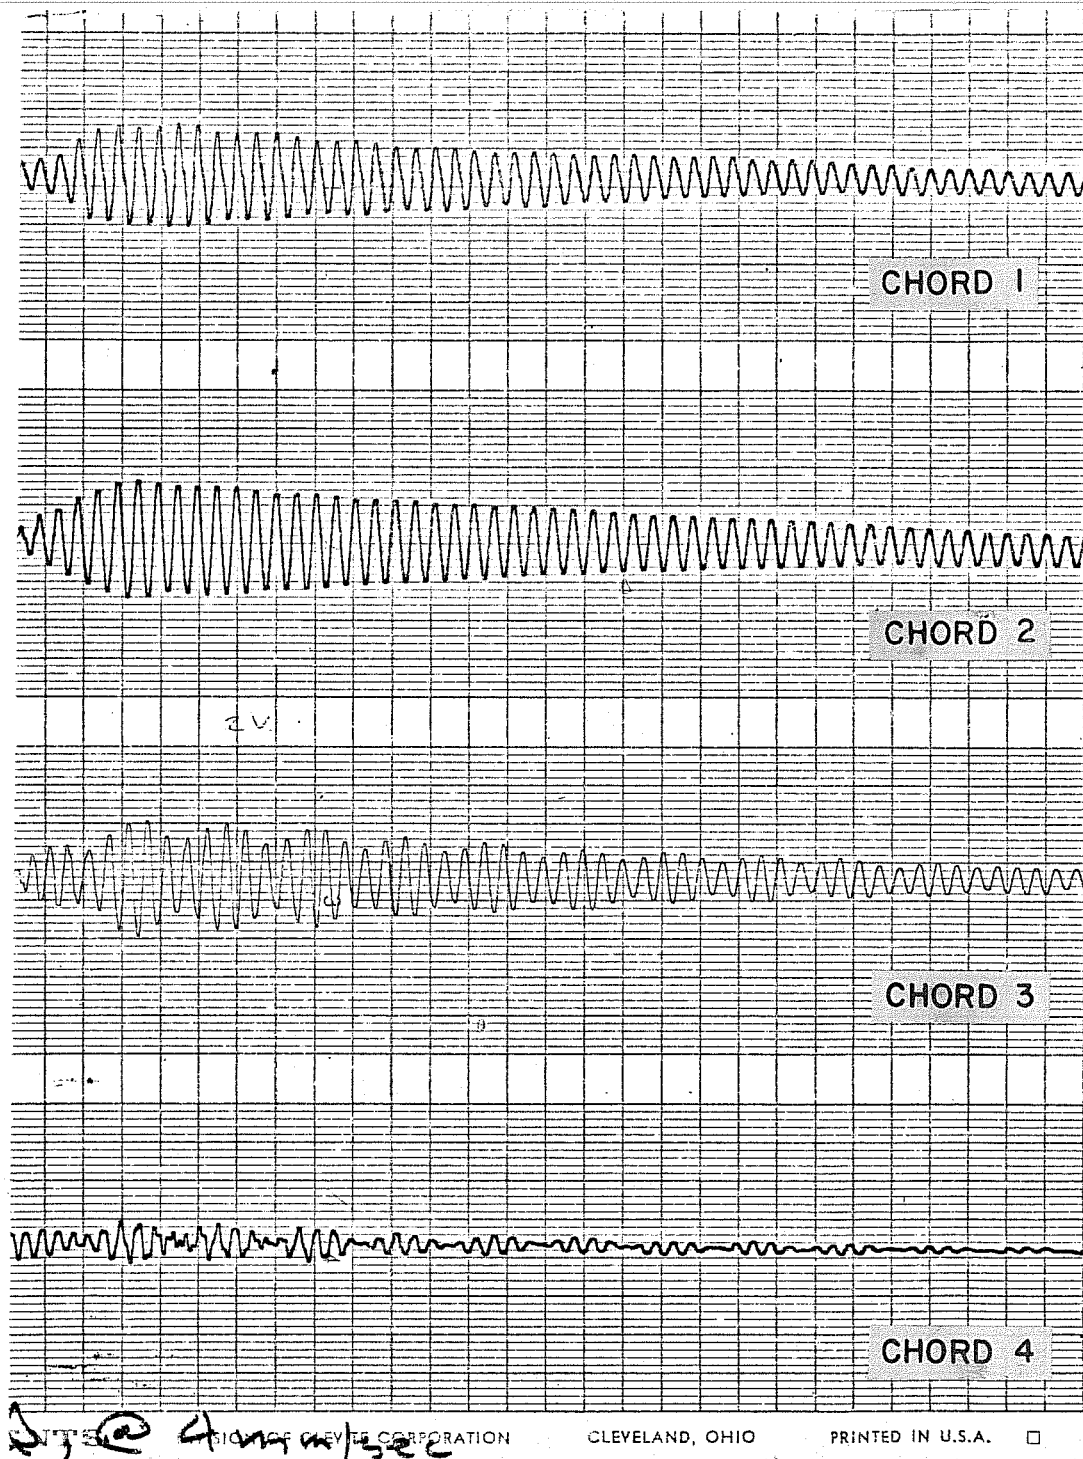
Fig. 3.6 Strain traces from a vertical forced vibration test of single cantilever sign

The damping ratio was calculated for four sets of points in two traces of the first mode and yielded values ranging from 0.62 to 0.82 percent of critical, with a mean of 0.73 percent of critical and a standard deviation of 0.08 percent. For the second mode, eight pairs of points in five traces were used to calculate ξ and yielded values ranging from 0.64 to 1.11 percent of critical, with a mean value of 0.77 percent of critical and a standard deviation of 0.19 percent. The mean values of ξ are, as was for the double cantilever, much less than the 3 percent generally taken for steel structures. Thus, large numbers of load cycles occur in the structure after application of a load.

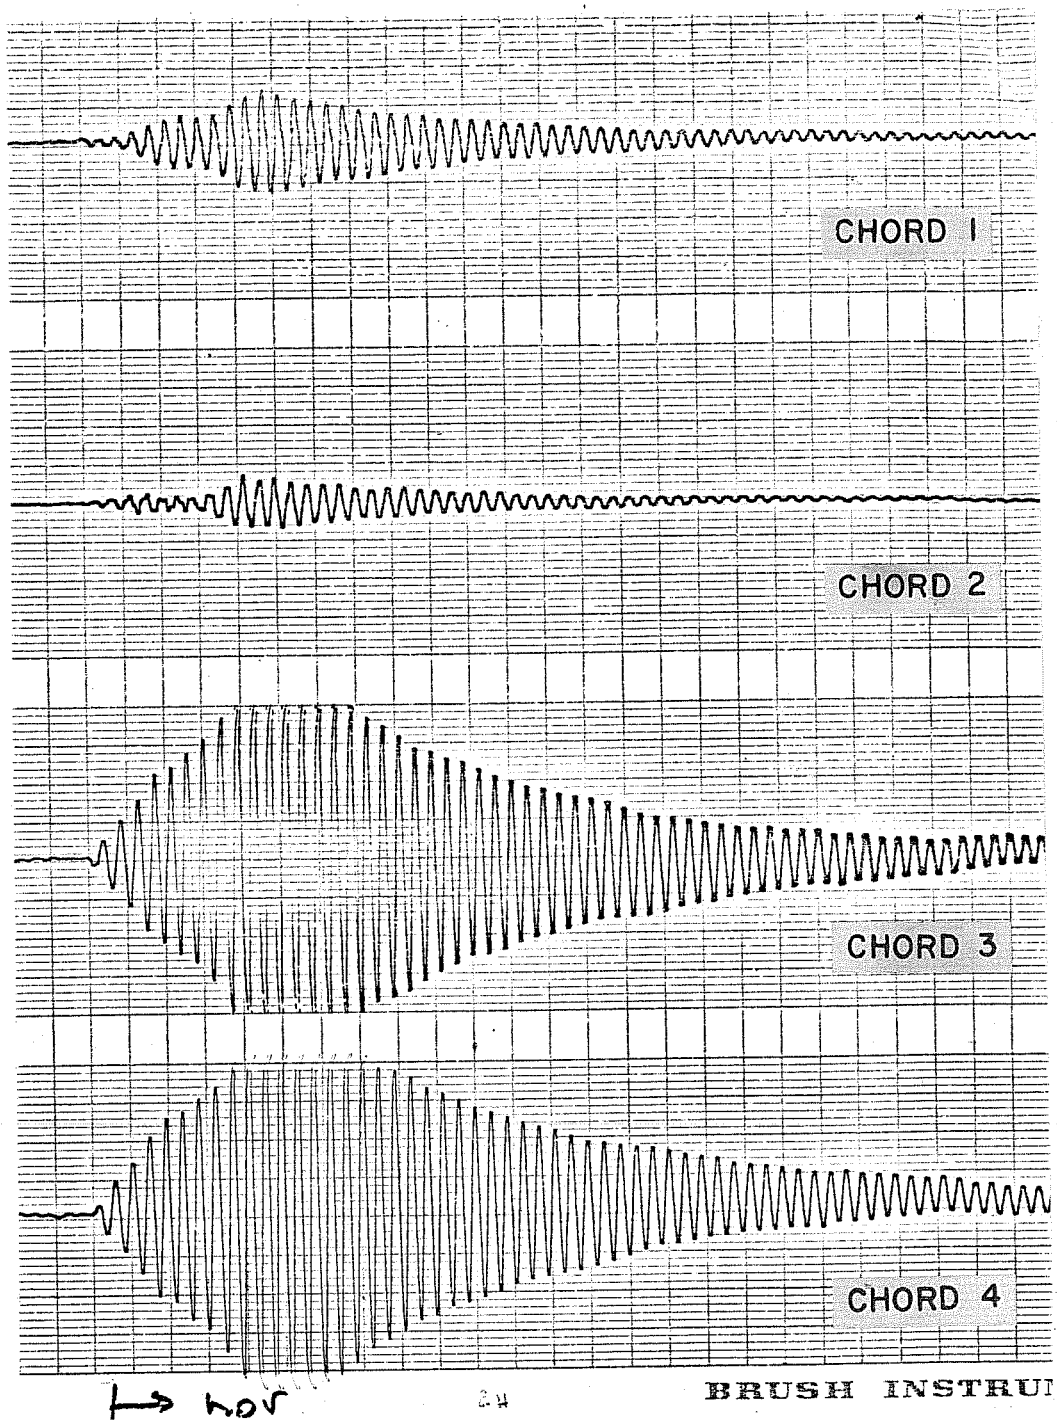
Fig. 3.7 Strain traces from a horizontal forced vibration test of single cantilever sign

It should be noted that in the horizontal mode outputs, the stress ranges in the lower chord members 3 and 4, refer to Fig. 2.4, were approximately four times the magnitude of the stress ranges in the upper chord members 1 and 2. Two possible explanations of this behavior were considered. The first possible explanation was that slip was occurring at the connection of the top chord and the

support. This connection involves the bolting of the top chord members into a gusset plate which is welded to a sleeve fitting around the vertical pipe support. Two through bolts are used to connect the sleeve and the support. Slip can occur in this two bolt joint due to the oversize holes, as the truss deflects horizontally. This slip would continue until the bolts are in bearing. The lower panel, on the other hand, is bolted to a gusset plate welded to the support. Consequently, no slip occurs between the gusset plate and the support.

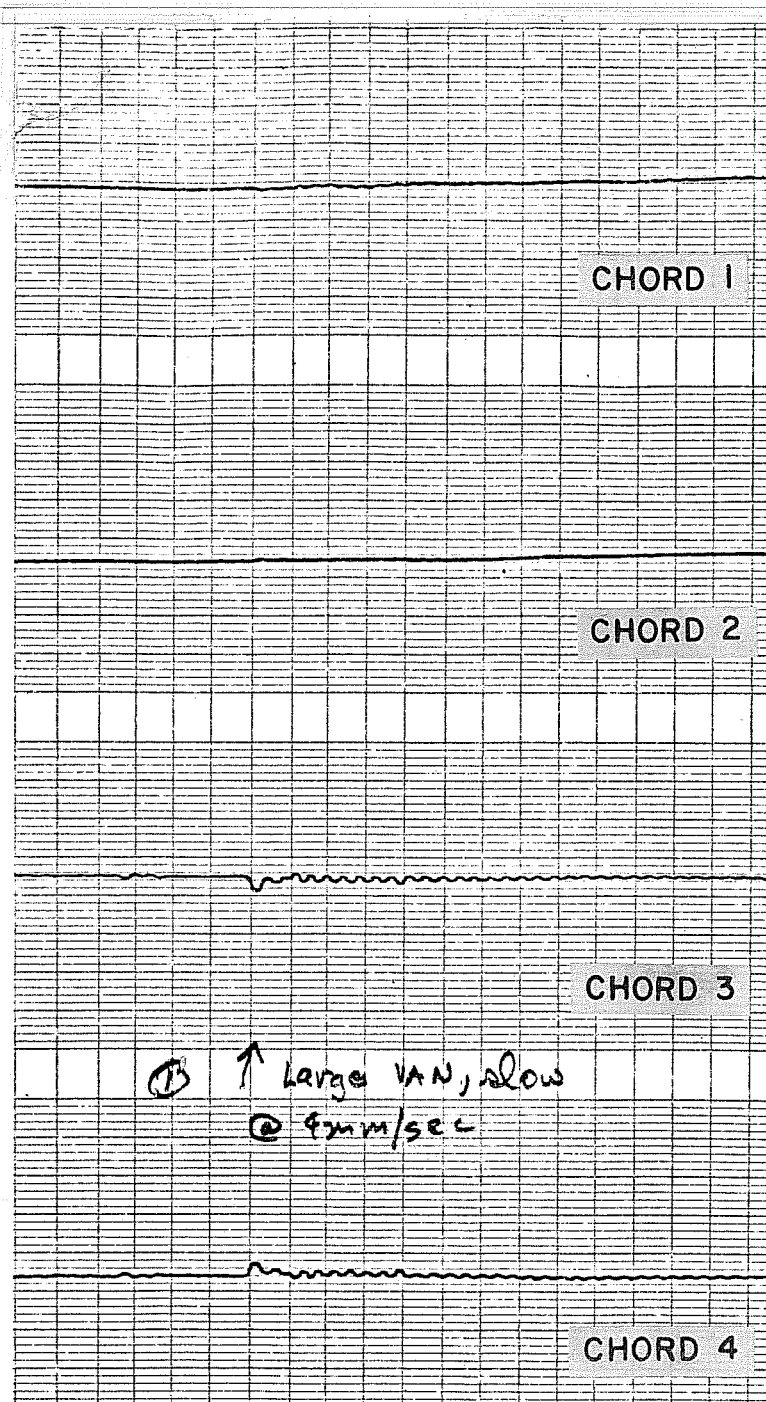
Fig. 3.8 Truck-induced strains in single cantilever

3.2.2 Truck-induced Data. Most of the truck-induced response was insignificant, as shown in Fig. 3.8, due to the stop-light ahead of the sign which reduced the speed of the trucks. However, it can be seen that the lower chord members are stressed, whereas the top chord members are not. This result is similar to that of the horizontal forced vibration tests.

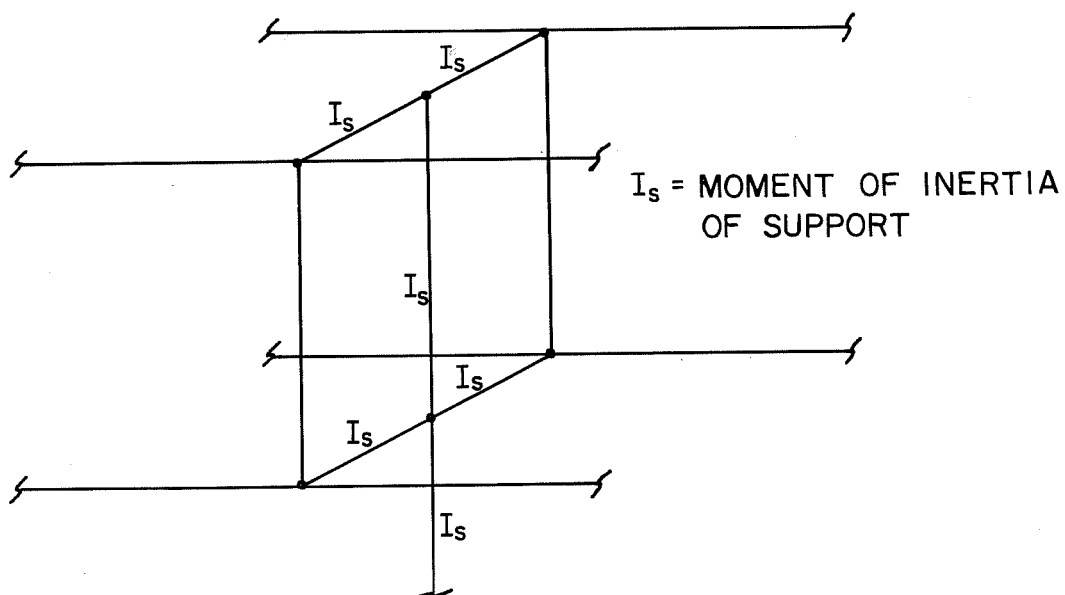
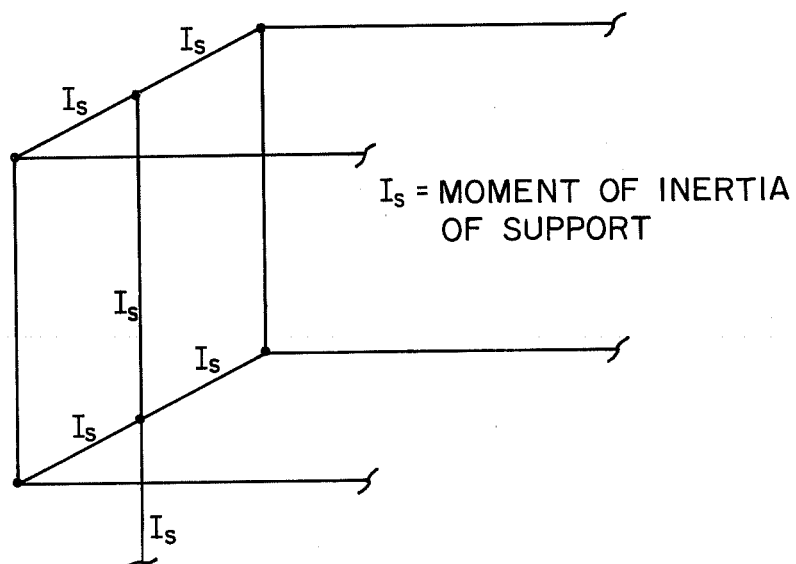
Fig. 4.1 Modeling of truss-to-support connections

(a) DOUBLE CANTILEVER

(b) SINGLE CANTILEVER

- (a) The sign face, walkway, and lights were input as lumped masses at the models' nodal points on the side facing the direction of traffic.
- (b) The truss to support connections were modeled as shown in Fig. 4.1, with the members connecting the chords to the support having a stiffness equal to that of the pipe support of the sign under investigation to provide the rigidity achieved by the actual connections.
- (c) The support and chord members, since the latter were continuous, were input as beam elements; the remaining members were treated as simply supported truss elements.
- (d) Full base fixity was assumed.

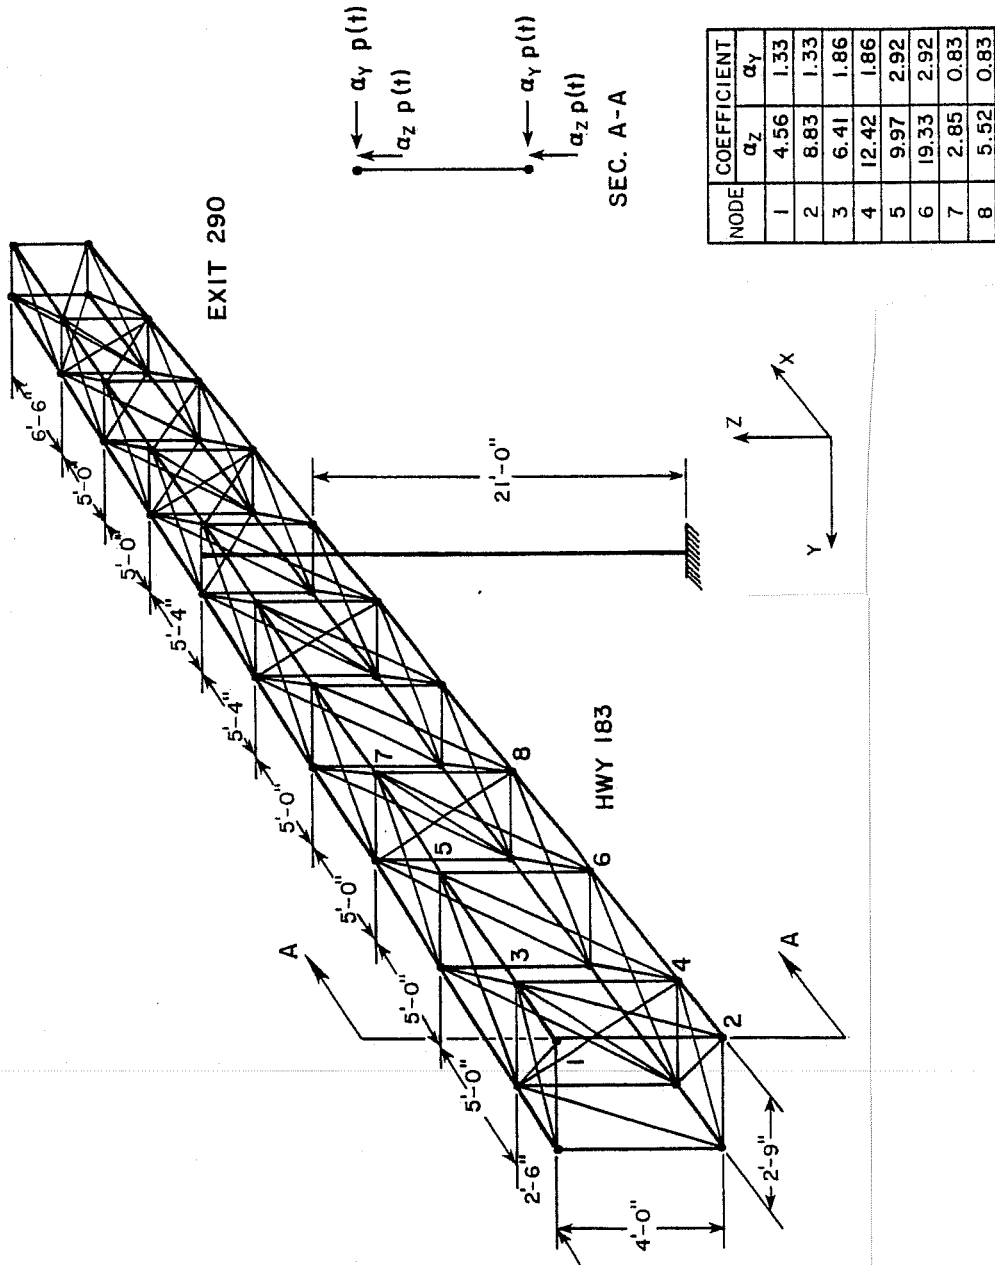
Fig. 4.3 Analytical model of double cantilever sign

4.1.2 Double Cantilever. The analytical model of this sign is shown in Fig. 4.3. Good agreement between the experimental and analytical natural frequencies was found, as shown in Table 4.1.

The corresponding eigenvectors indicated that the first mode was primarily a vertical rocking of the sign about the vertical pipe support, while the second mode was a horizontal twisting about this support.

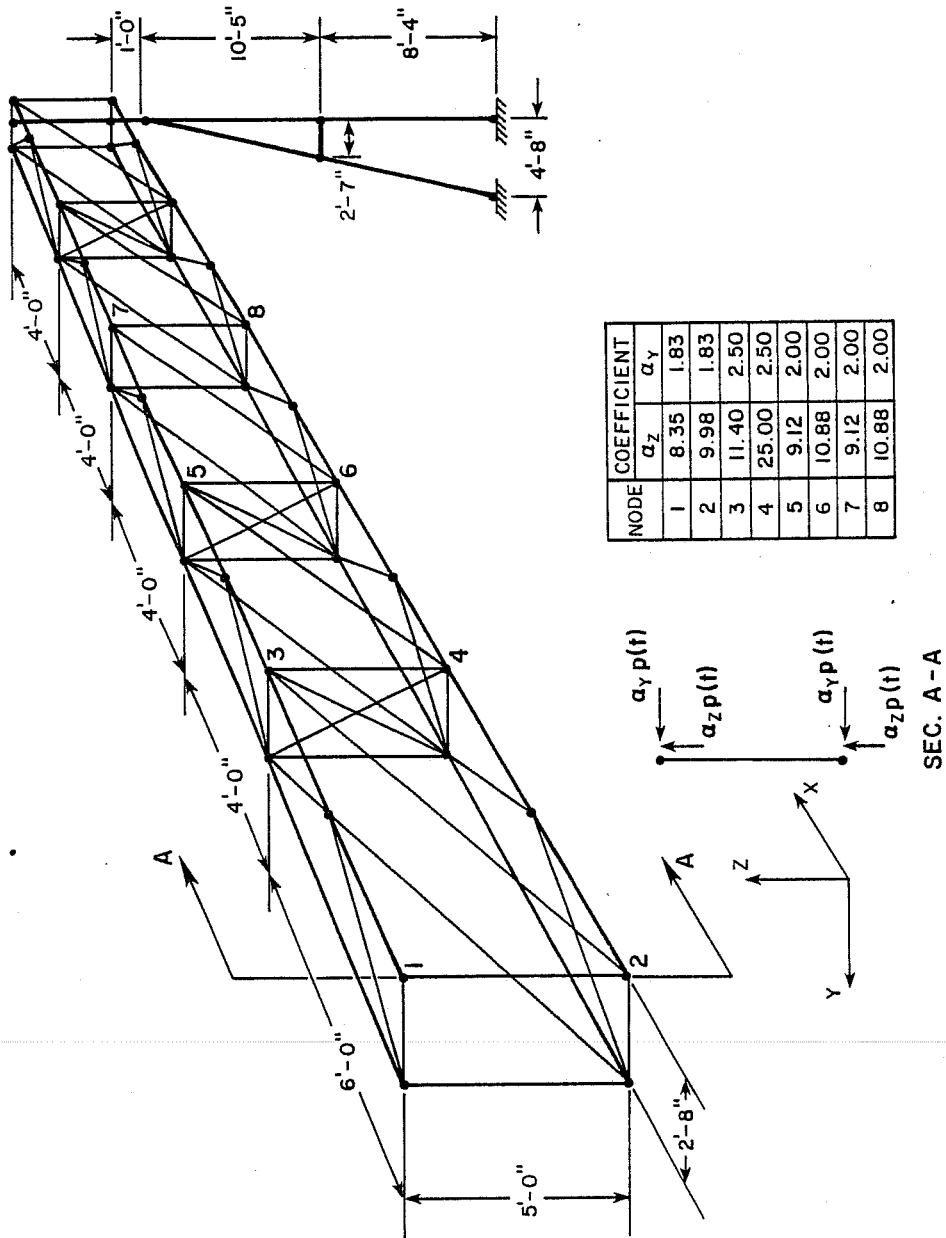
Fig. 4.4 Analytical model of single cantilever sign

4.1.3 Single Cantilever. The analytical model for this sign is shown in Fig. 4.4. The program computed eigenvalues and eigenvectors for this system, and close agreement was found between the experimental and analytical frequencies, as given in Table 4.3.

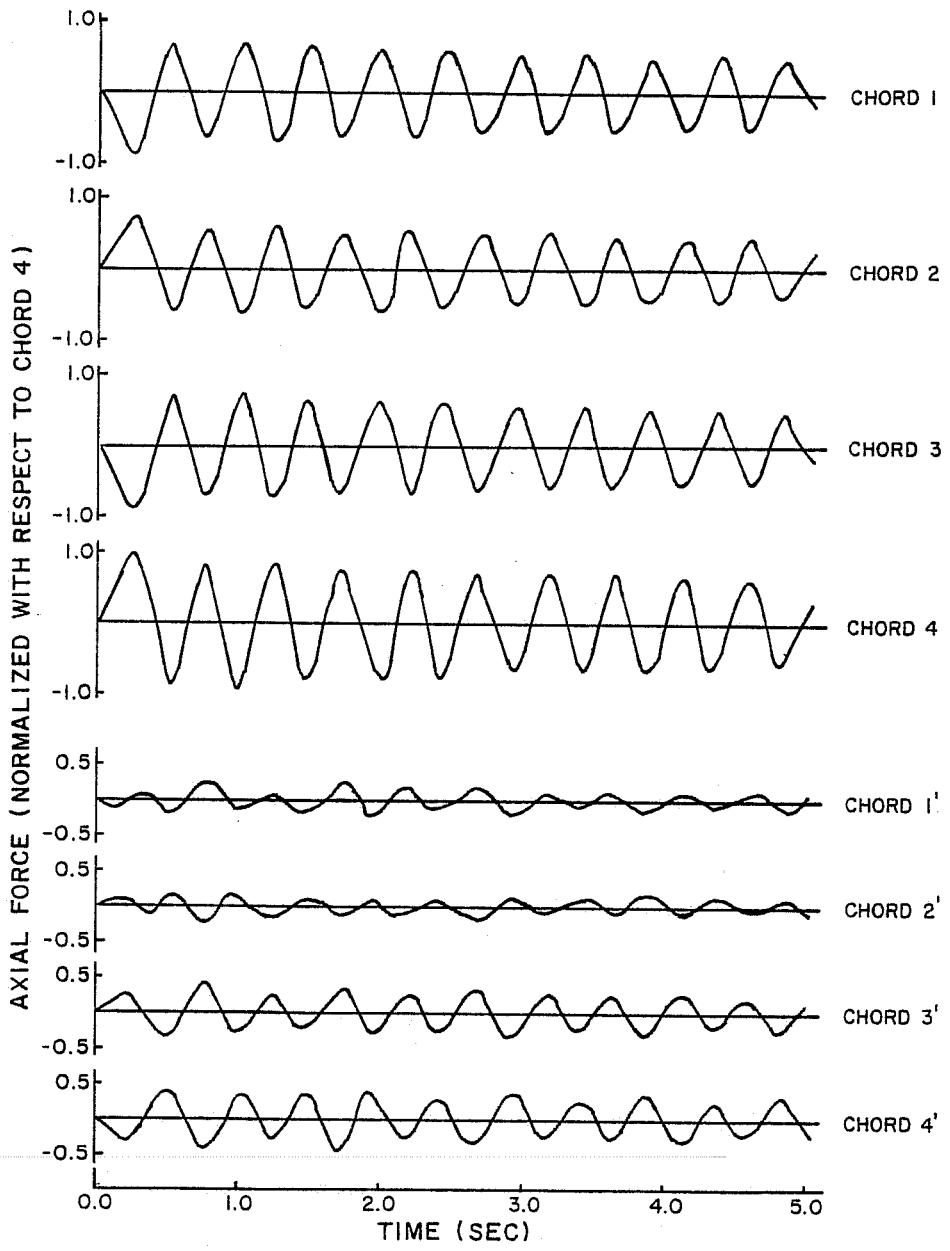
NOTE: POSITIVE VALUES FOR
AXIAL FORCE DENOTE
TENSION

Fig. 4.5 Analytically derived and normalized chord member forces for double cantilever sign

The analytically derived axial chord and diagonal member forces, normalized with respect to the maximum force in chord 4, versus time are shown in Figs. 4.5 and 4.6. The ratios of maximum axial force to that of chord 4 for the chord members on the loaded arm of the truss and for diagonal member 7 are very close to the values obtained from the traces shown in Fig. 3.1. For chords 1, 2, 3, and diagonal member 7, the analytically derived ratios are 0.83, 0.80, 0.87, and 0.13, respectively, as compared to values of 0.78, 0.83, 0.84, and 0.15 found experimentally. It can be seen in Fig. 4.5 that the maximum forces in the chord members of the unloaded arm of the truss did not occur simultaneously with those of the loaded arm. The maxima of normalized force for these four members vary from approximately 0.21 to 0.48, as compared with 0.21 to 0.33 found experimentally and given in Table 3.1. The analytical solution underestimated the values of normalized force for diagonal members 5, 6, 5', and 6', whereas gave better agreement for diagonal members 7', 8, and 8'.

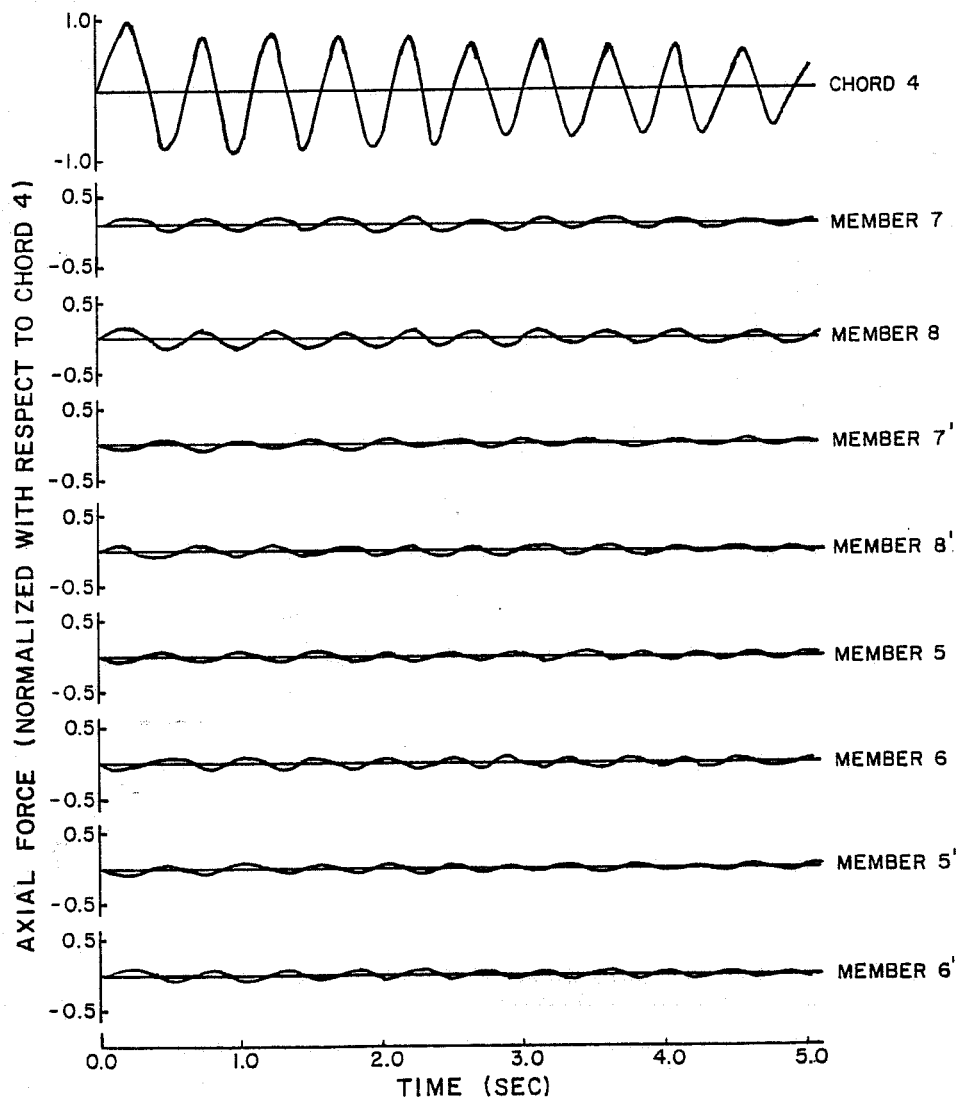
NOTE: POSITIVE VALUES FOR
AXIAL FORCE DENOTE
TENSION

Fig. 4.6 Analytically derived and normalized diagonal member forces for double cantilever sign

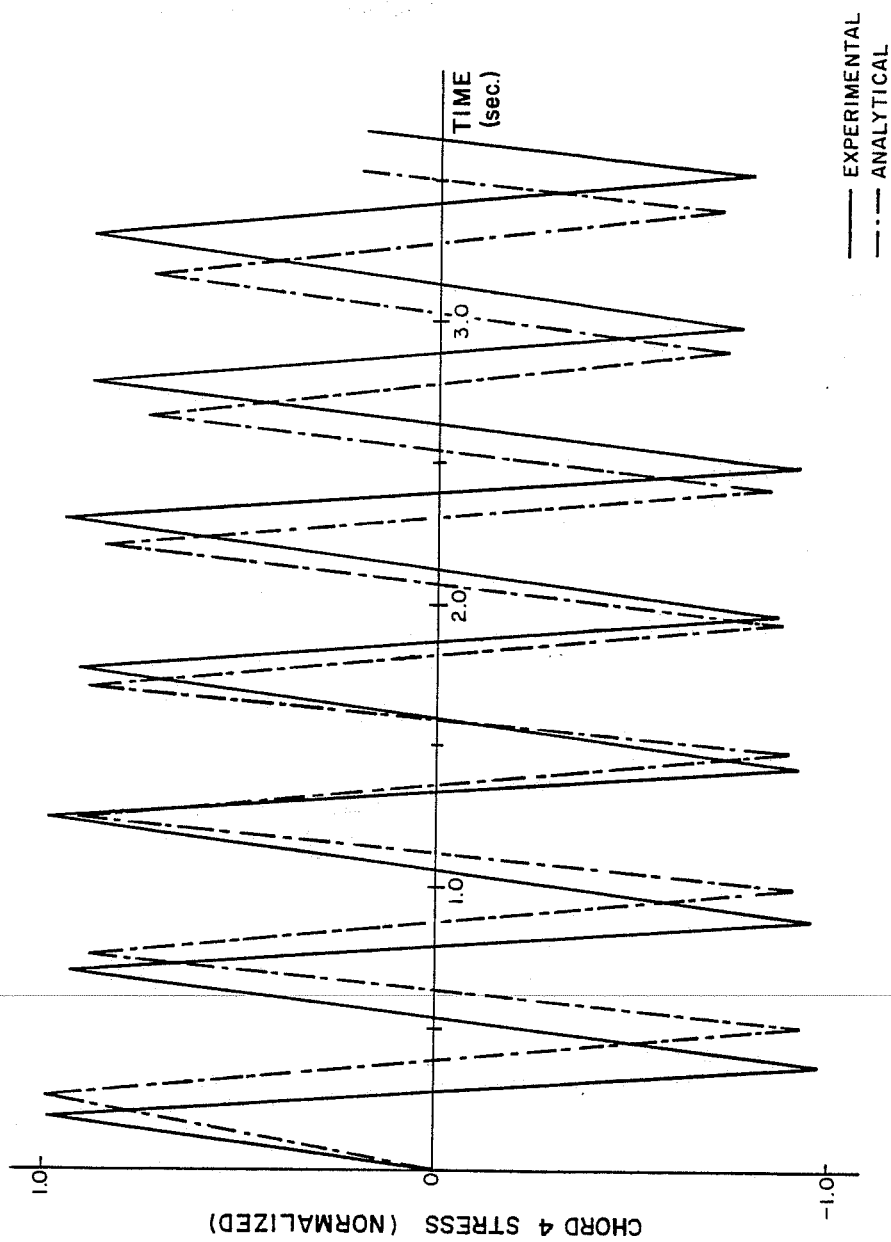
Fig. 4.7 Normalized force outputs for chord member 4 of double cantilever

The predicted behavior of chord member 4 and that obtained from the experimental trace shown in Fig. 3.1 are compared in

Fig. 4.7. This figure shows the analytical solution slightly underestimates the force in the chord after the first peak, when the maxima occur for both plots. The phase difference in the traces is caused by the difference in natural frequency values between the experimental and analytical solutions, as shown in Table 4.1.

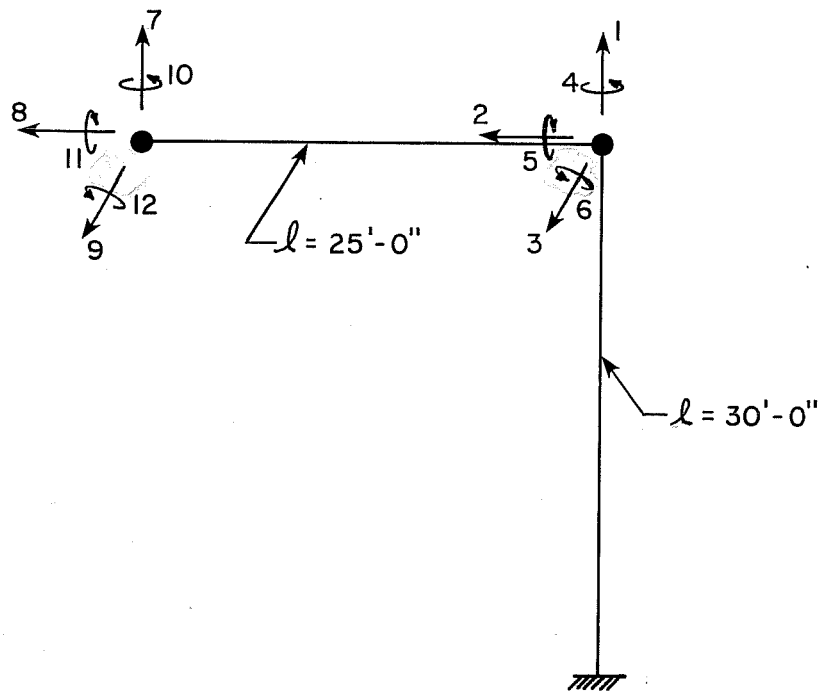
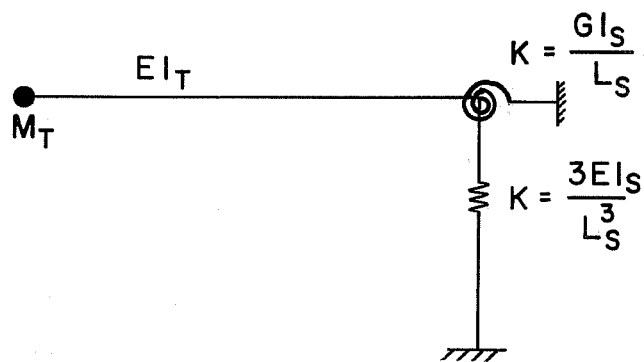
Fig. 4.8 Simplified single cantilever analytical models

(a) 12 DOF MODEL

(b) MODIFIED 3 DOF MODEL

The dynamic response of a single cantilever sign, with dimensions approximately equal to those of the sign instrumented, was investigated using a computer program written by Bohl and the author [4]. The analytical model had 12 DOF, used consistent mass, and is shown in Fig. 4.8(a). Various horizontal impulses were applied to the system and the results indicated that the effects of higher modes on the response of the structure were negligible. Since the model used did not include the individual members found in the actual structure, stress analysis was not possible. However, it was concluded that a simple 3 DOF analysis can adequately predict the response. This is preferred, since it reduces the computations down to hand calculations. This could enable the designer to obtain a preliminary estimate of the importance of dynamic effects on the
