DYNAMIC RESPONSE OF CANTILEVER HIGHWAY SIGN STRUCTURES

SUBJECTED TO GUST LOADINGS

THESIS

The University of Texas at Austin

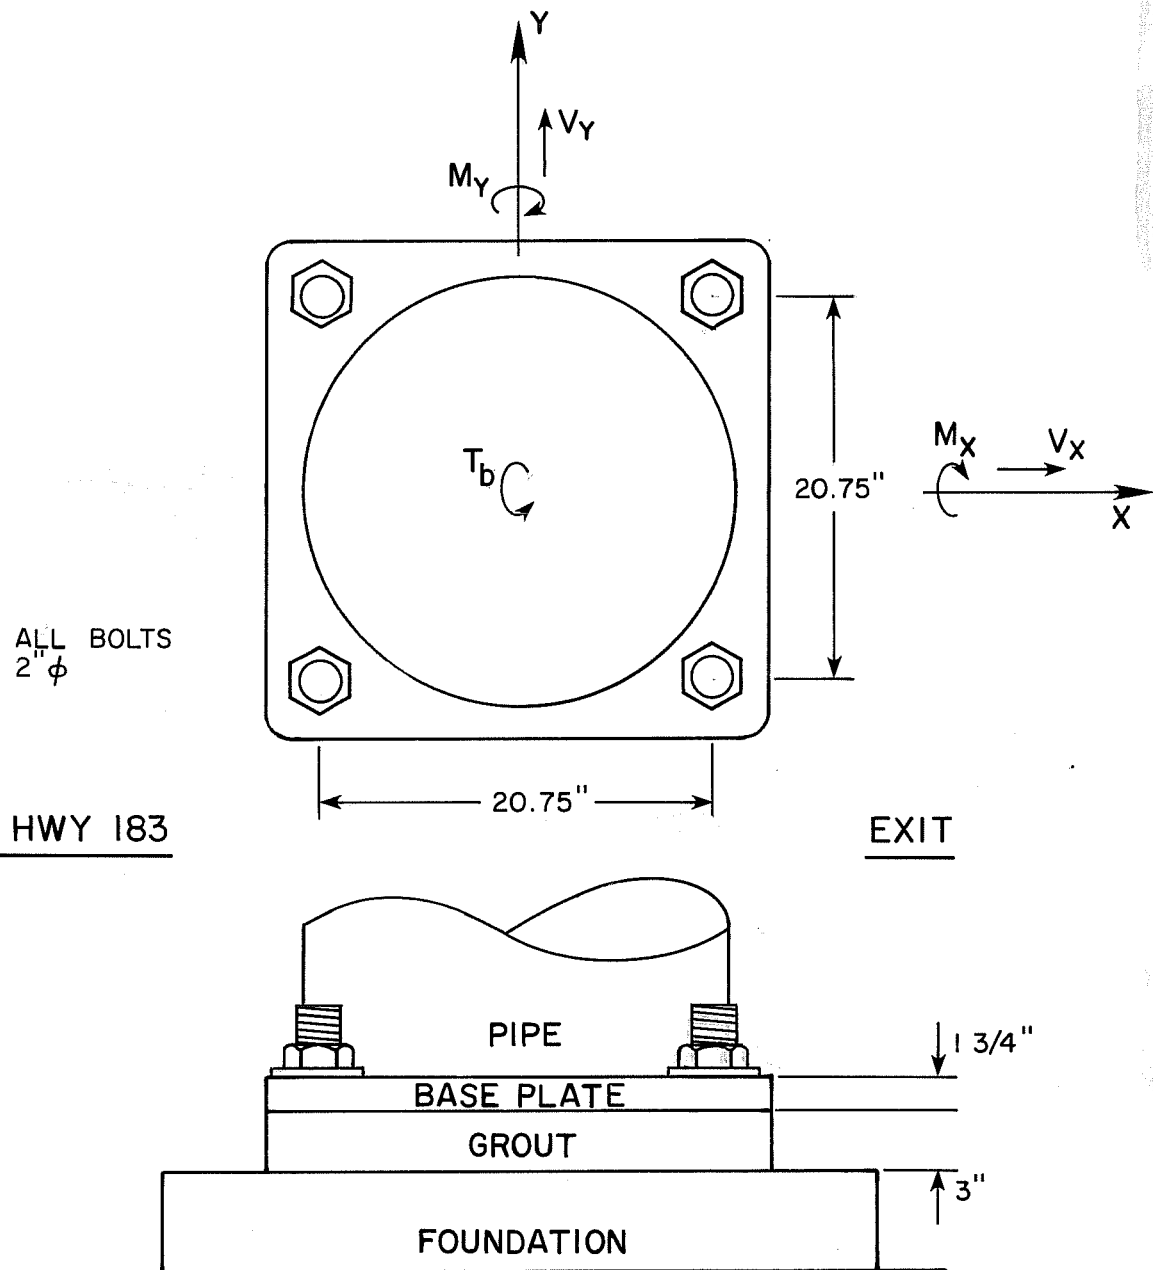
Fig. 5.1 Double cantilever support-to-foundation connection

A sketch of the connection at the base of the vertical support of the double cantilever sign and the forces that act on this connection are shown in Fig. 5.1. These forces are transmitted to the foundation by the anchor bolts. The base forces for the nine events shown in Table 3.2 were used to calculate the anchor bolt stress ranges.

The four 2 in. nominal diameter anchor bolts shown in Fig. 5.1 are subjected to fluctuating direct tension or compression stresses resulting from the biaxial overturning moments M_x and M_y , and a fluctuating bending and shear stress resulting from the resultant shear, V_r . The resultant shear is equal to the vector sum of the portion of the biaxial shears V_x and V_y acting on each

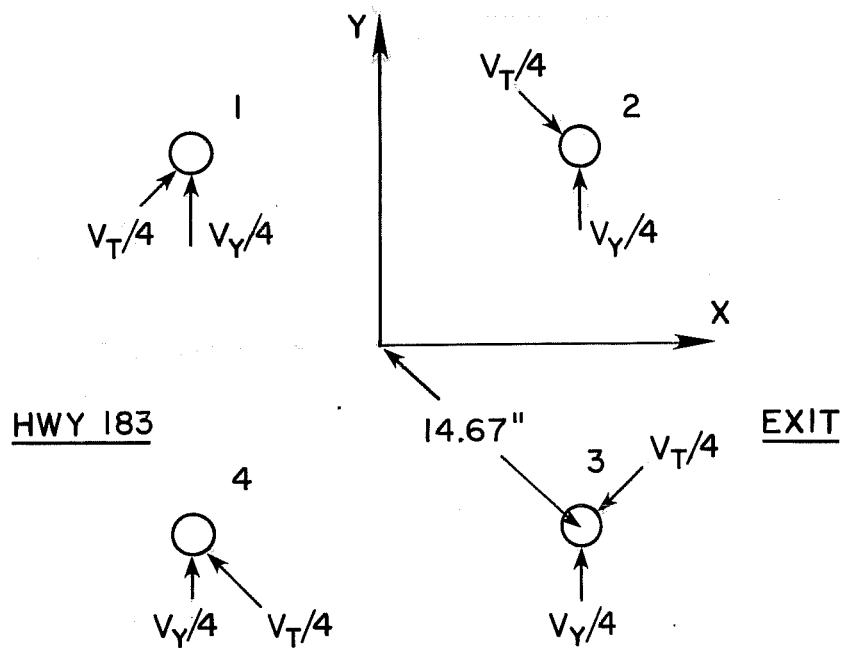
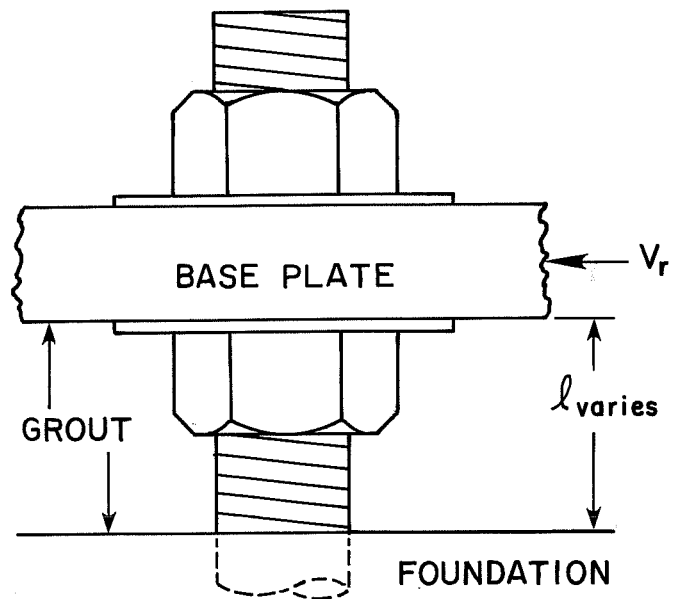
Fig. 5.2 Forces acting on anchor bolts

(a) SHEARS ON BOLT GROUP

(b) RESULTANT SHEAR ON BOLT

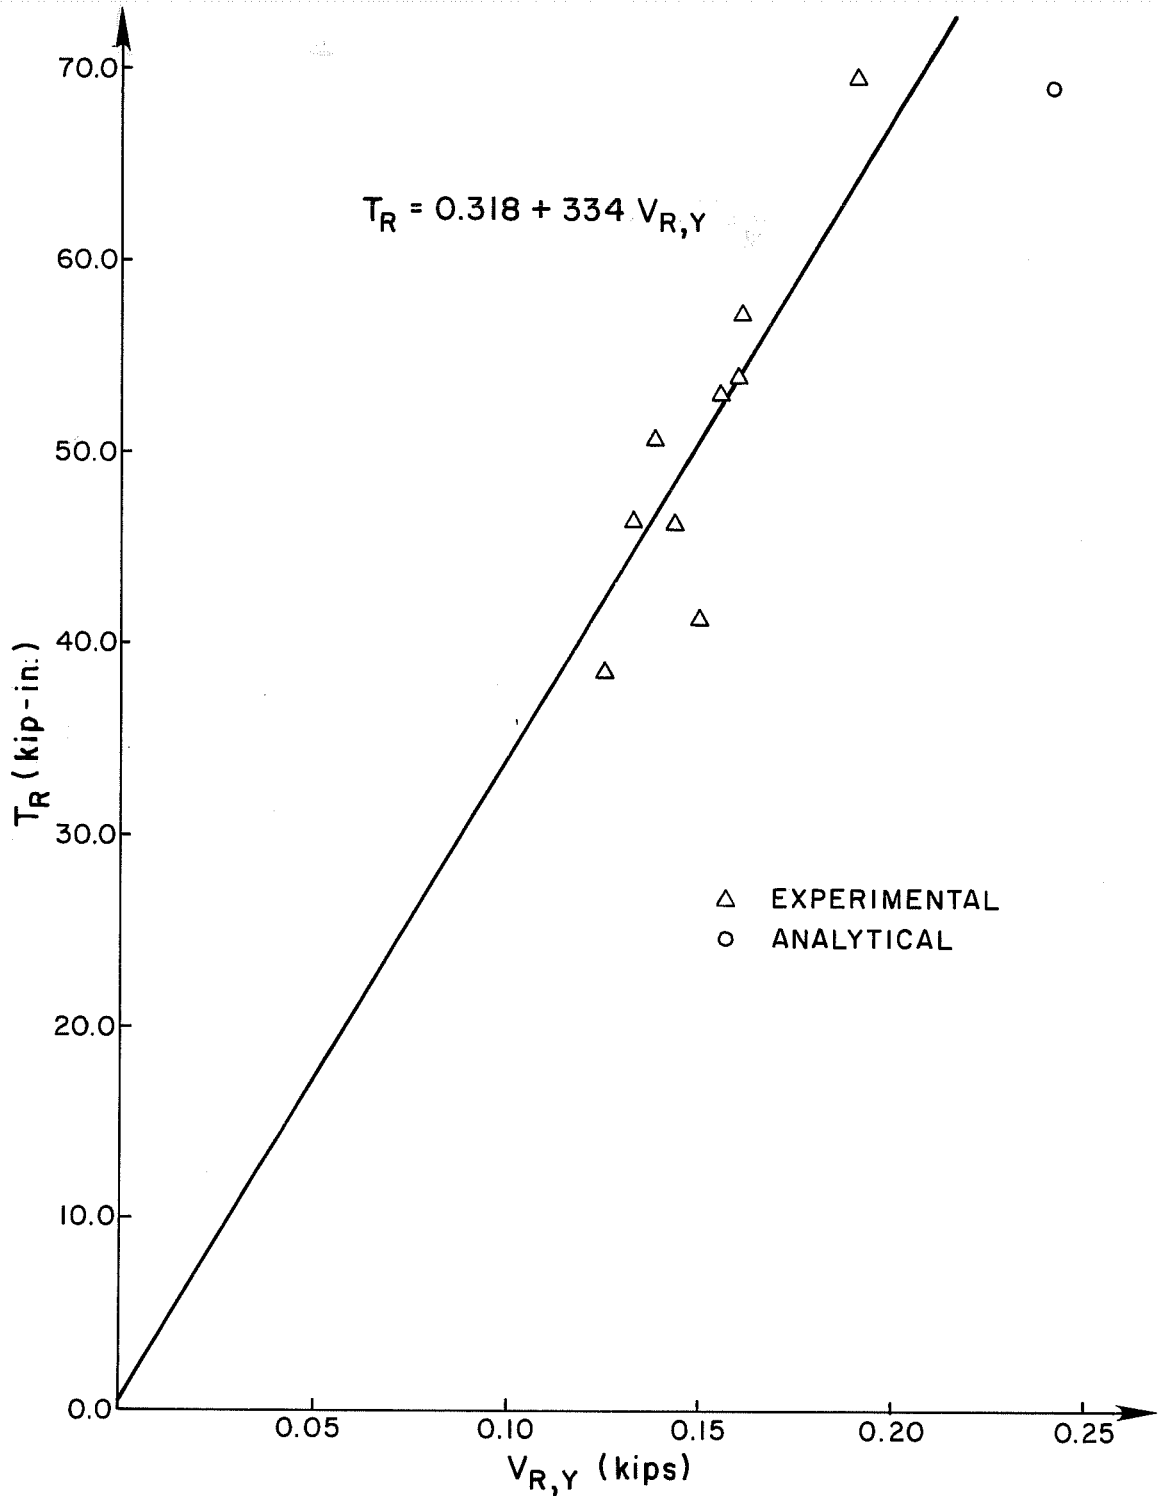
Fig. 5.3 Base torque range, T_R , as a function of base shear range, $V_{R,y}$

The values of stress shown in Table 5.1 indicated that the bending moment caused by the base shear resultant, V_r , on the anchor bolt produced the highest anchor bolt stresses. The major components of this shear resultant are the shear due to the base torque and the shear, V_y . Consequently, the stress range, S_r , in the anchor bolt is proportional to the base torque range, T_R , and to the shear range, $V_{R,y}$. A linear relationship between T_R and $V_{R,y}$ would be expected for a simple static loading with $T_R = LV_R$, where L is a length corresponding to the point of application of a statically equivalent horizontal load on the sign. A plot of T_R versus $V_{R,y}$ based on the results shown in Tables 3.2 and 4.2 was constructed and is shown in

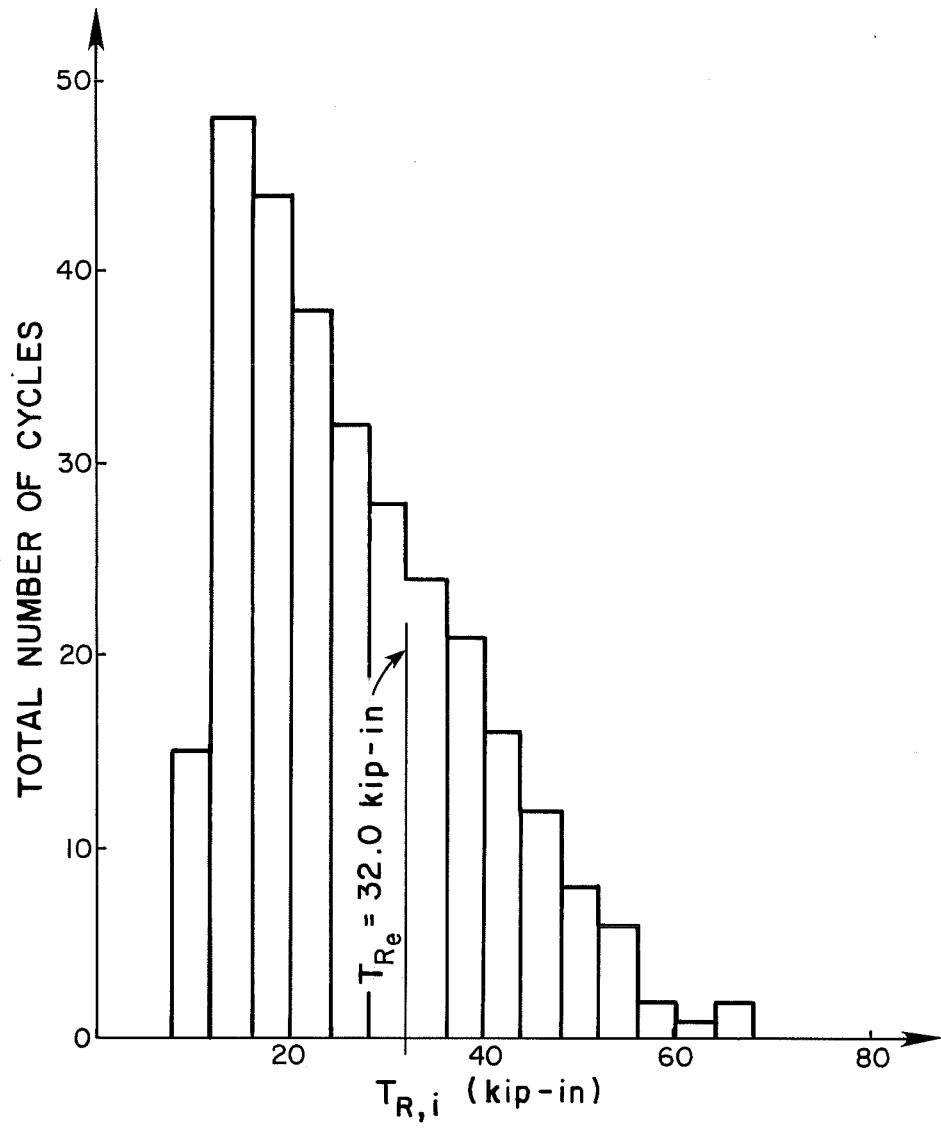
Fig. 5.4 Histogram of torque range, T_R
