**PROCEDURES TO REHABILITATE EXTREMELY DAMAGED
CONCRETE MEMBERS USING INNOVATIVE MATERIALS AND
DEVICES**

Guillermo David Huaco Cardenas, B.S., M.S.E.

Dissertation

The University of Texas at Austin

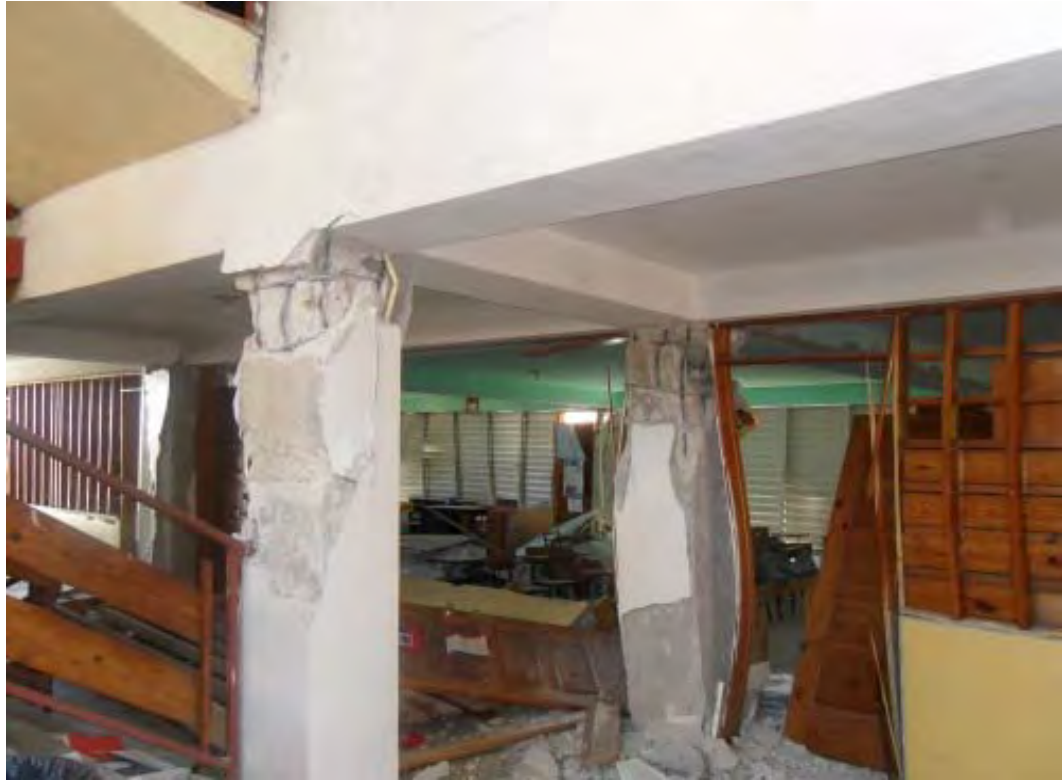
Older structures and poorly constructed or badly designed structures are likely to be damaged in an earthquake. Figure 1.1 shows a building located at Port of Prince, Haiti having two columns severely damaged at the top joint of each one after the mag. 7 Earthquake in 2010. This building has a moment resisting frame system to carry lateral load induced from earthquake events. It can be observed that the reinforced concrete columns had insufficient stirrups where the shear hinge formed. It is also noticed in Figure 1.1 that the column has a small cross-sectional area compared with the beams connected at the top of those columns. The members form a weak column-strong beam system. The longitudinal bars buckled the stirrup spacing was too great to confine the longitudinal bars under the compression load from the floor above.

Figure 1.1 Weak Column Strong Beam Join. Haiti Earthquake – 2010 Mag. 7.0

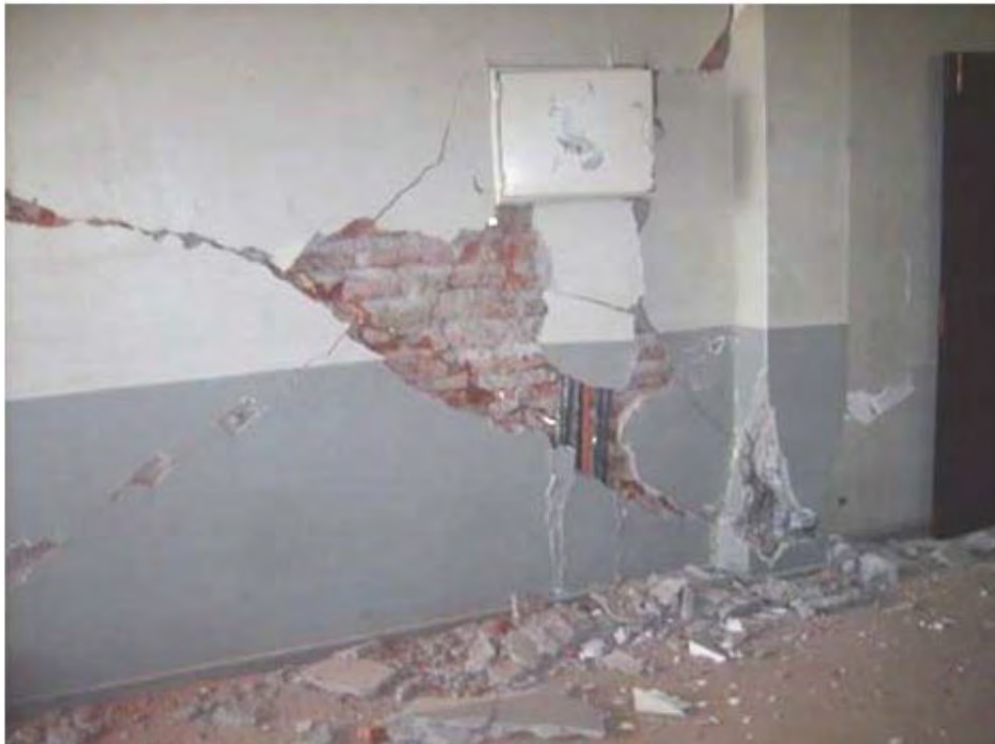
Masonry walls are commonly used as infills in frame structures. Figure 1.4 shows a wall damaged in the 2010 earthquake in Chile. Generally for pattern of damage consists of diagonal cracks crossing the entire section of the wall starting from a top corner extending diagonally to the opposite bottom corner.

Figure 1.4 Masonry wall with shear cracks. Chile Earthquake – 2010 Mag. 8.8

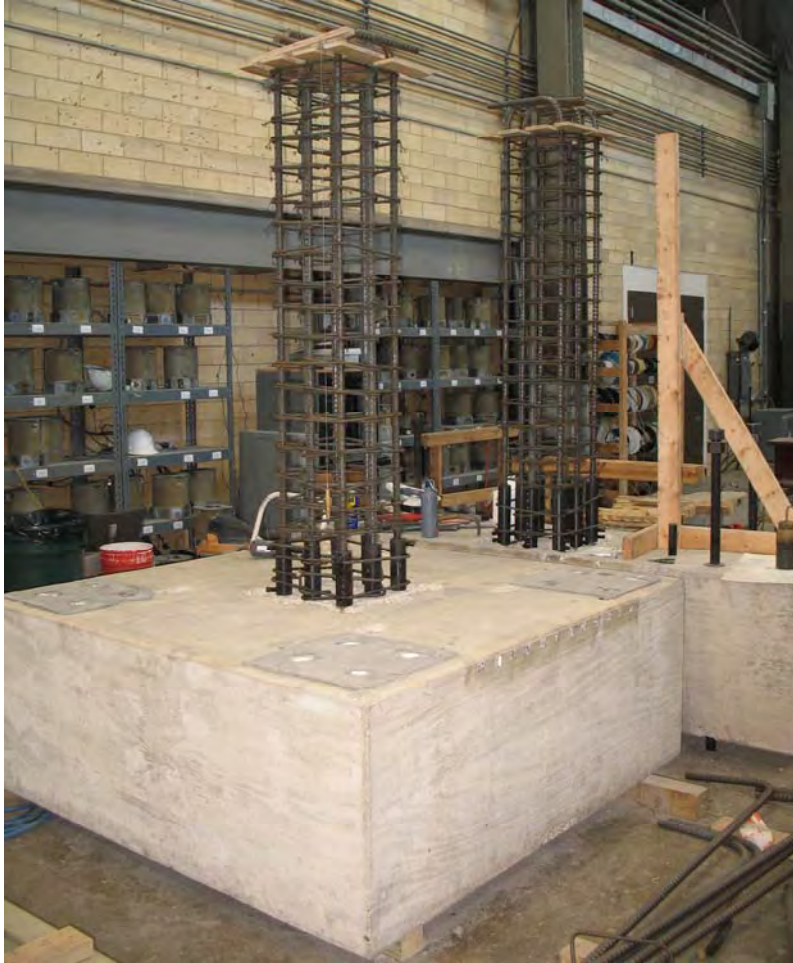
Figure 1.8 New columns connected to existing support with mechanical splices after buckled longitudinal bar removed.

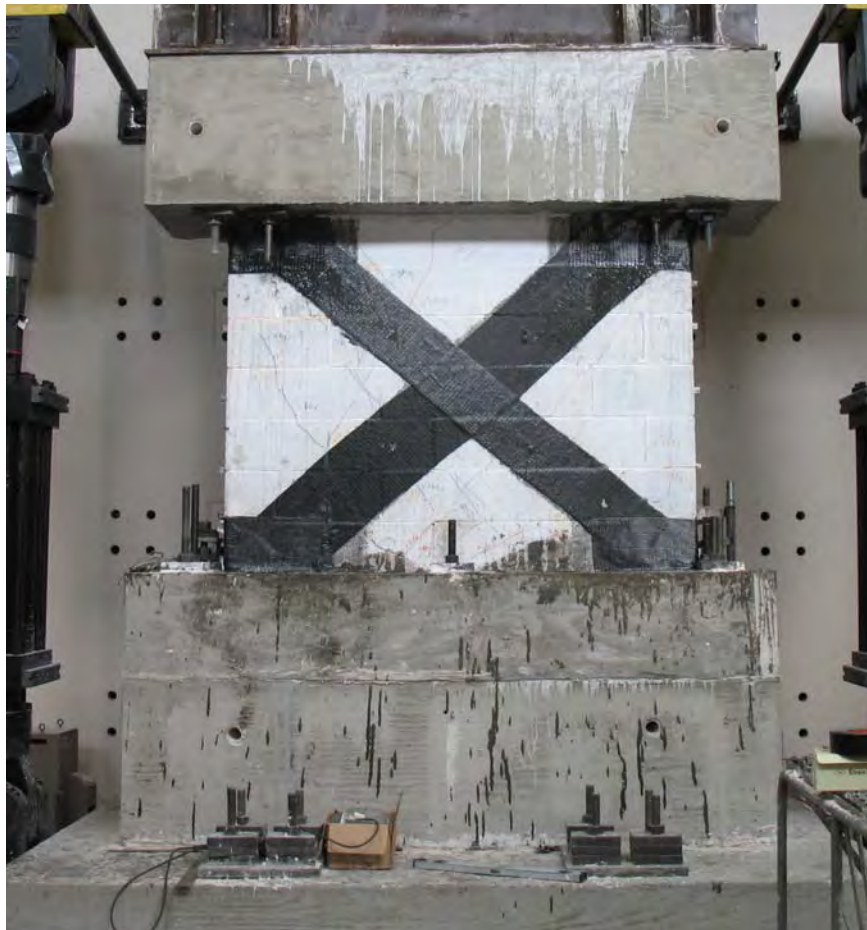
There was sliding of the wall at the base, resulting in the first two courses of concrete blocks crushing and the internal longitudinal bars buckling. To repair the wall, a reinforced concrete ring encased the base of the wall and CFRP diagonal ties with CFRP anchors were attached to both sides of the wall. The masonry was tested after the concrete ring was added in order to measure the initial stiffness of the masonry wall with a reduced aspect ratio. The second test was performed after the application of the diagonal CFRP sheets. The retrofitted wall is shown in Figure 1.9.

Figure 1.9 Masonry wall repaired by the concrete ring and diagonal ties of CFRP

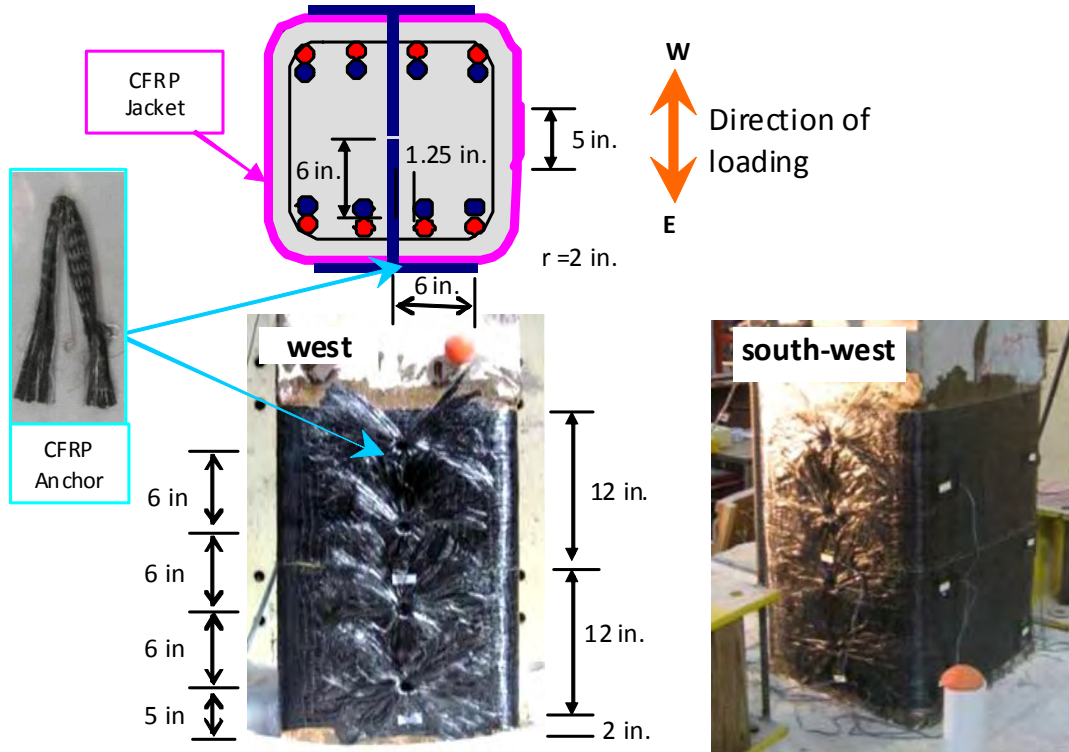
To retrofit the column cracks were injected with epoxy, the corners of the column were rounded (0.5in radius), and the CFRP jacket was installed to improve the confinement, CFRP anchors were on the faces of the column where the splices were located. The final size of the column was not increased at comparison than the steel jacking retrofit case.

Figure 2.8 Cross Section of the 2-A-S8-M with details of the CFRP material applied (Kim, 2008)

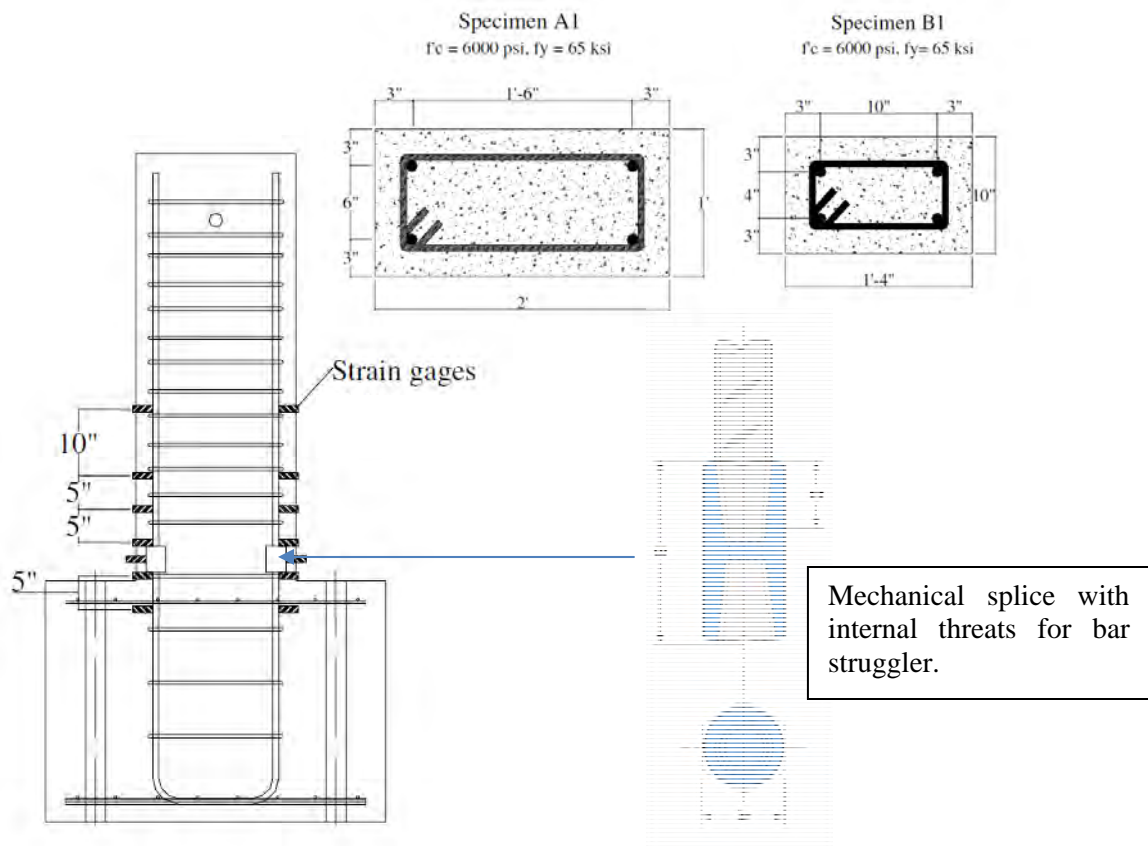
A set of two reinforced concrete cantilever beams built using mechanical splices at the joint were tested to control the behavior of the plastic hinge section of the beams. Those mechanical splices were threaded at both ends to connect bars that were also threaded. The beams had 12in x 24in or 10in x 16in. Cross-section reinforcement of each beam was 4 bars #7 longitudinal bars and the same shear reinforcement. The mechanical splices were located 3in below the base of the cantilever beams and no stirrups were placed around the splices.

Figure 2.20 Elevation view of the Beam with the location of the mechanical splice and the two different cross section for each beam (Pampanin & Akguzel 2011)

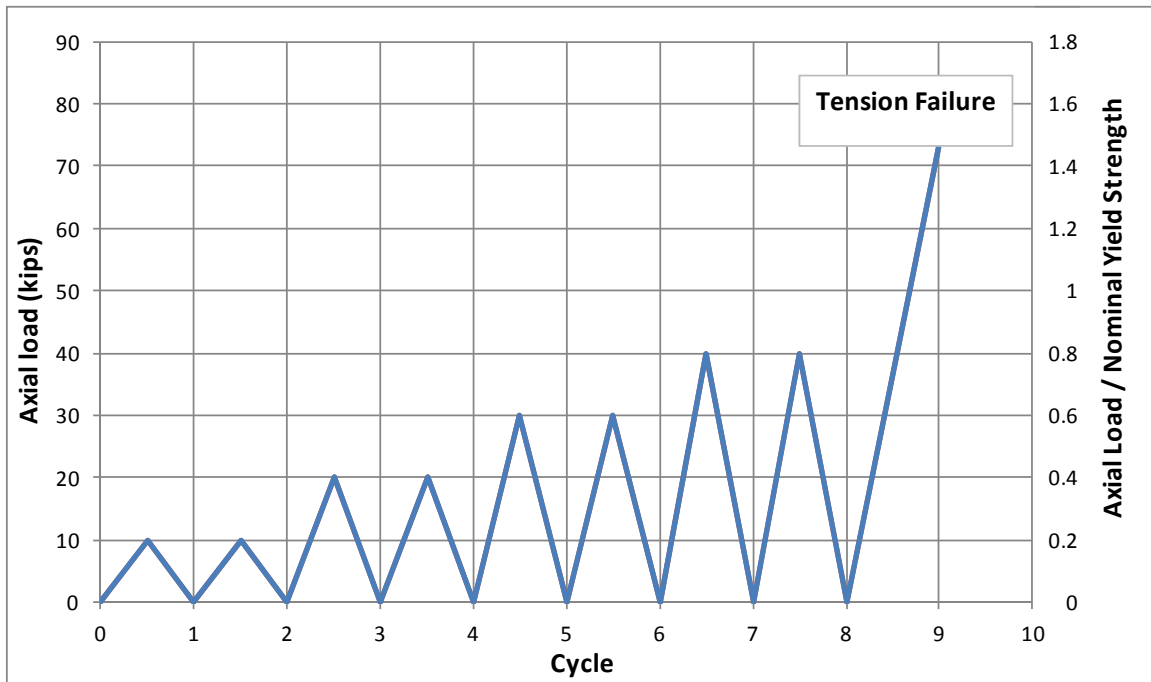
The specimen was subjected to two cycles of tension load to 10, 20, 30, 40 kips and a final load to failure. The loading protocol was established to capture the deformation in the linear range of the mechanical splice and bars. (Figure 3.20)

Figure 3.20 Protocol of load to the cycle tension axial load test.

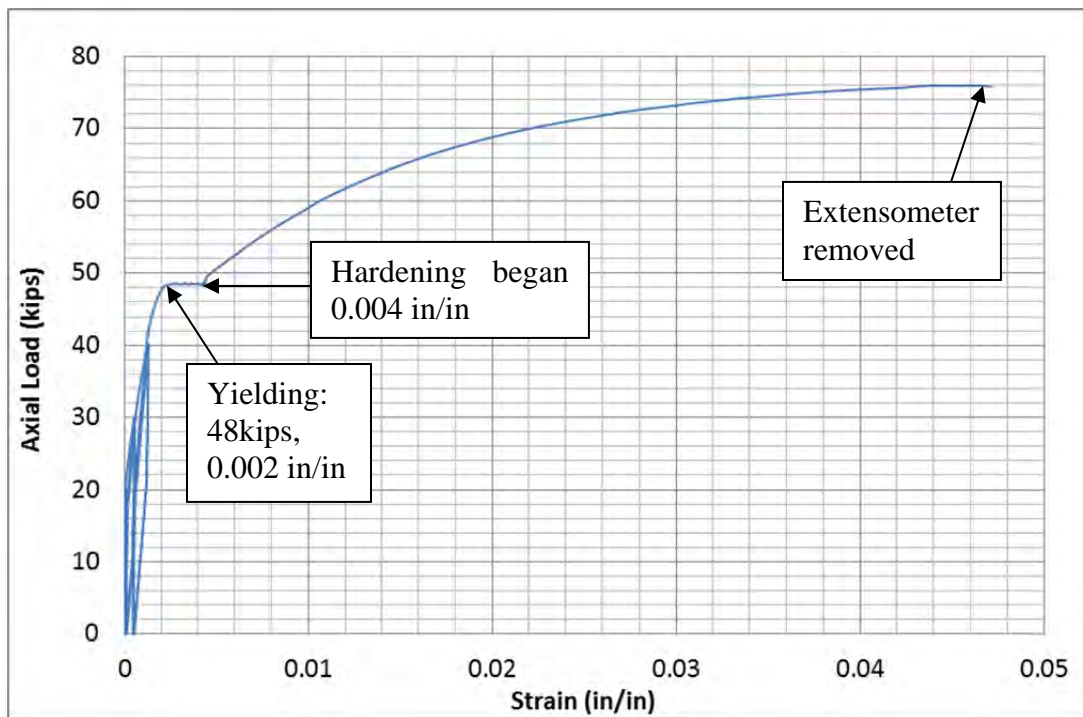
Figure 3.22 Deformation pattern measured by extensometer for MS-L1

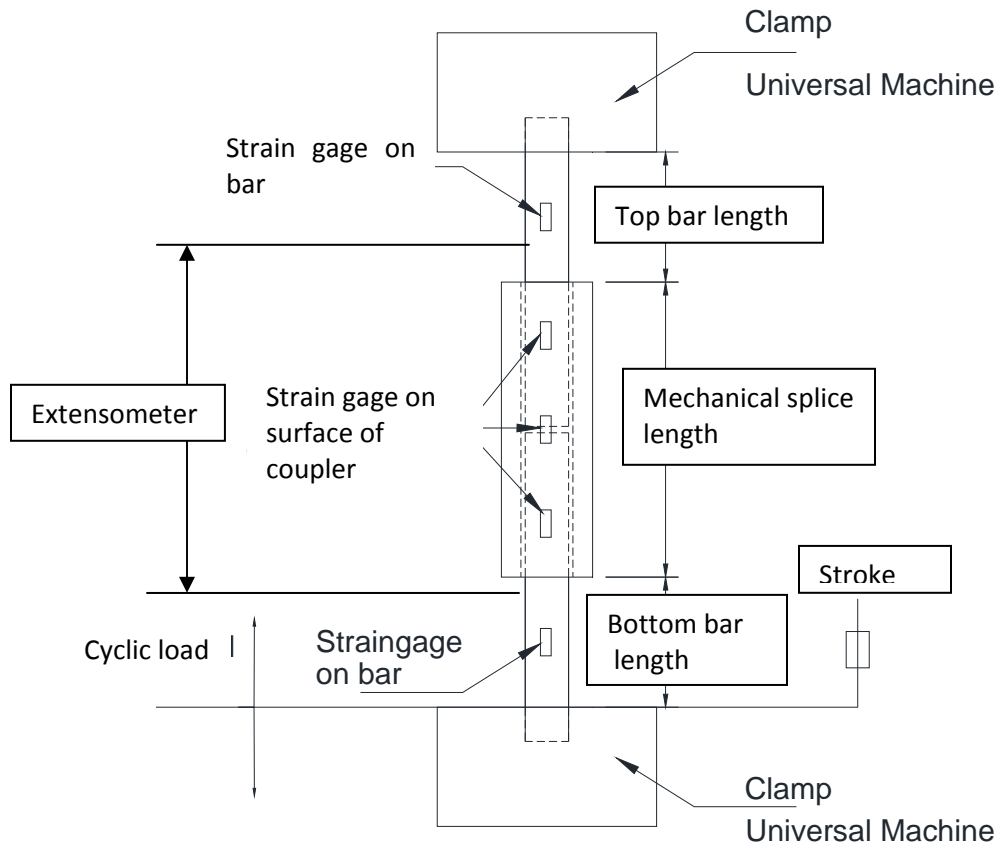
A-615 Grade 60 bars were used. The test specimen is shown in Figure 3.26.

Figure 3.26 General scheme of specimen for the compression-tension test

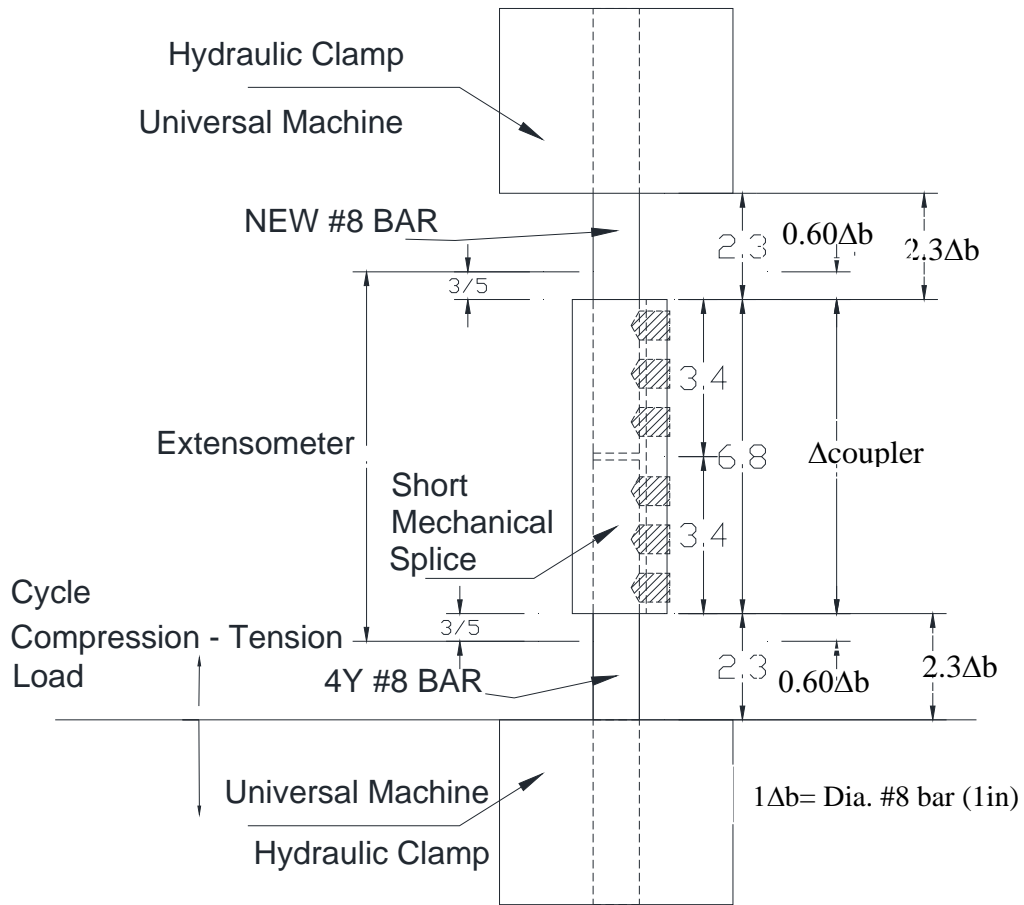
Figure 3.30 shows the scheme for specimen MS-S3. Each bar connected with mechanical splice has a length of 3.4 in into the splice. The total length of the specimen between clamps or the clear space of the universal machine was 11.4in.

Figure 3.30 Dimensions for MS-S3 specimen

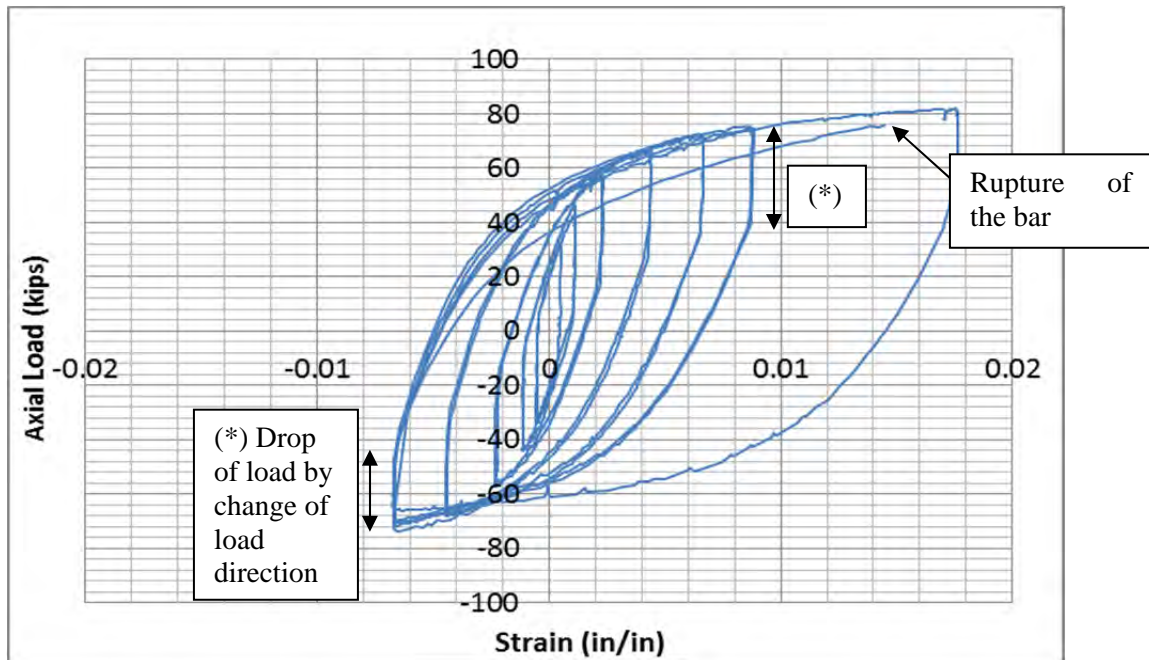
Figure 3.35 *Strain Deformation of the system measured by the Extensometer*

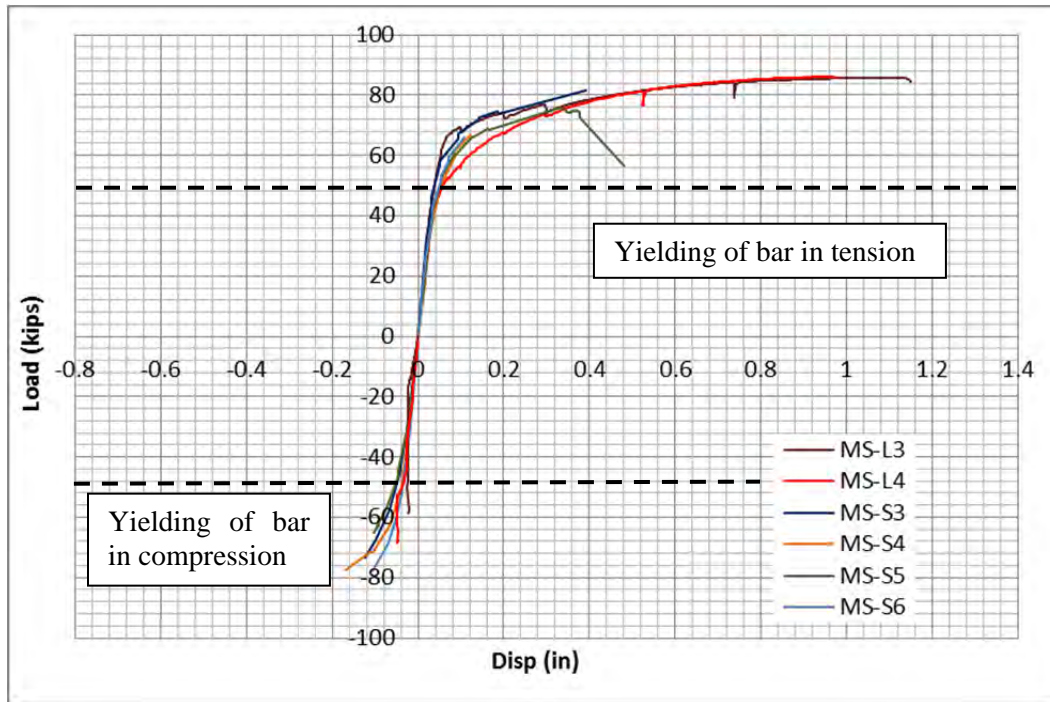
Figure 3.37 shows the measurements of the top platform of the universal machine, considering the deformation of the total length of each mechanical splice up to the failure. It can be seen that the elongation of the long mechanical splices is greater than the short mechanical splices.

Figure 3.37 Peak cycles displacement of the universal machine

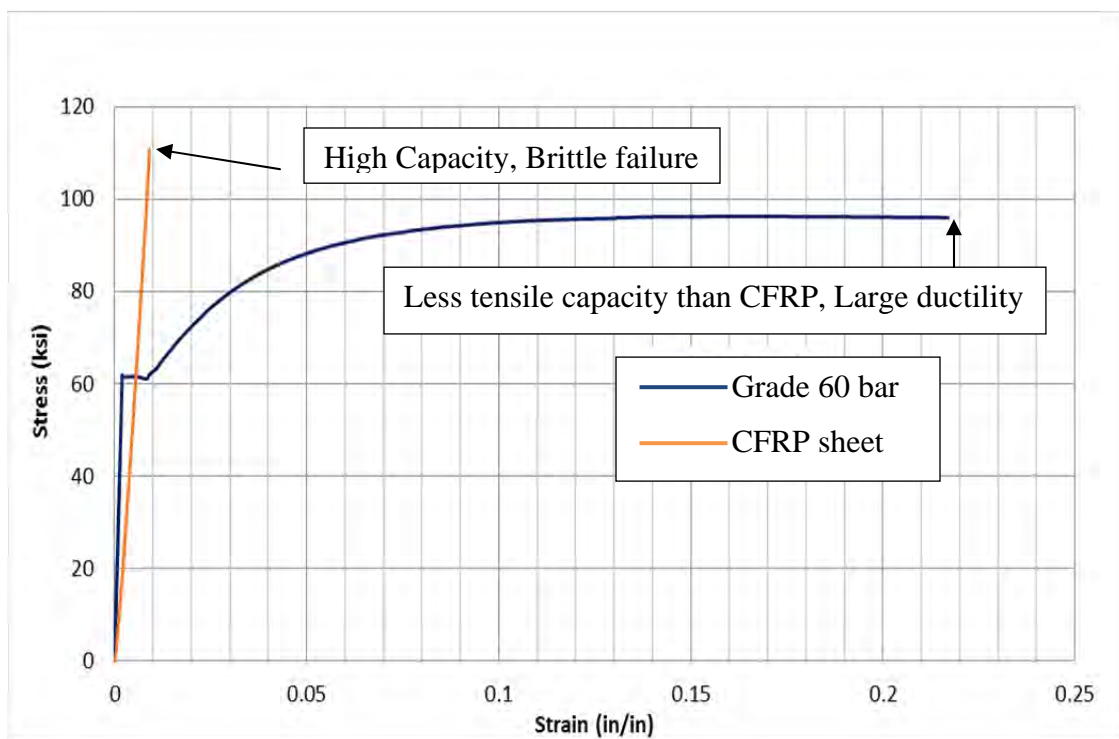
The resulting installation is anisotropic. CFRP is an elastic material up to failure having an ultimate tensile strain of 0.01 or higher. Figure 4.5 shows the stress-strain curves for CFRP and Grade A60 reinforcement. Details of the tests of coupons are shown in Appendix E. It can be seen that the tensile capacity of the CFRP is 50% greater than the steel bar; however the CFRP sheet is a brittle material having no ductility and a brittle failure. Those curves were obtained by axial monotonic test of CFRP sheet coupons and a Grade 60 reinforcing bar (Appendix D) that were conducted in the current research.

Figure 4.5 Differences in material tensile properties of Grade 60 reinforcing bar and CFRP sheet coupons

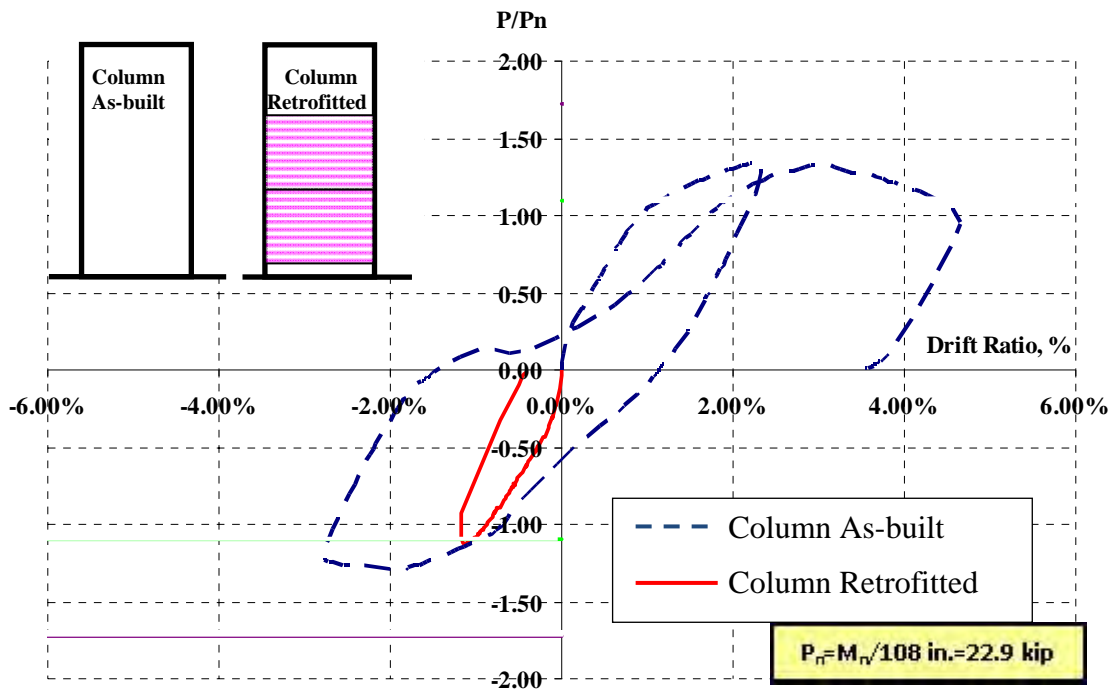
After determining the needed value of V_j , the area of the CFRP sheet needed to jacket the concrete member can be determined. For retrofitting purposes is difficult to define the value of V_c because internal cracks, may cross the core of the transversal section. The CFRP jacket provides extra shear capacity making the column stronger in shear than the original column. Figure 4.8 shows the shear force vs. lateral displacement (normalized by nominal shear force and height respectively) behavior. It can be seen that the retrofitted column had higher shear capacity than the column without the jacketing.

Figure 4.8 Comparison between one column with and without CFRP jacketing (Kim, 2008)

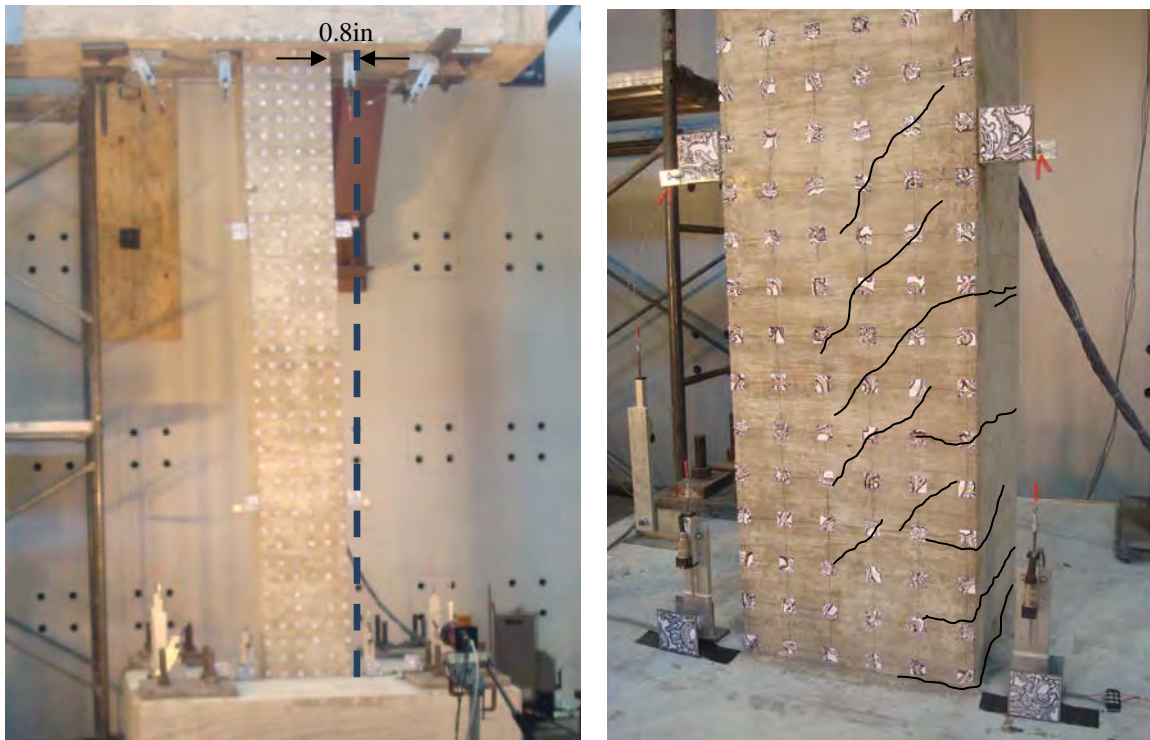
Yielding in tension of the longitudinal bar was noted at a lateral deformation of 0.8 in. (0.77% drift ratio) at both ends of the column. The lateral load measured was 44.6 kips. The yielding in compression of the bars was reached in the 13th cycle at 59 kips lateral load. Figure 5.16 (left) shows the deflection shape of the column at the 10th cycle loading to north when the yielding occurred. The double curvature shape of the column can be seen. Shear and flexural cracks developed, especially at bottom right side of the column (tension side). Shear cracks developed 15 in. above the column base, with the largest crack at the bottom of the column (Figure 5.16-right). Flexural cracks appeared on the top of the column as well.

Figure 5.16 Shape of the column at 0.8 in. lateral deformation to north direction (left).
Shear and flexural cracks appeared (right)

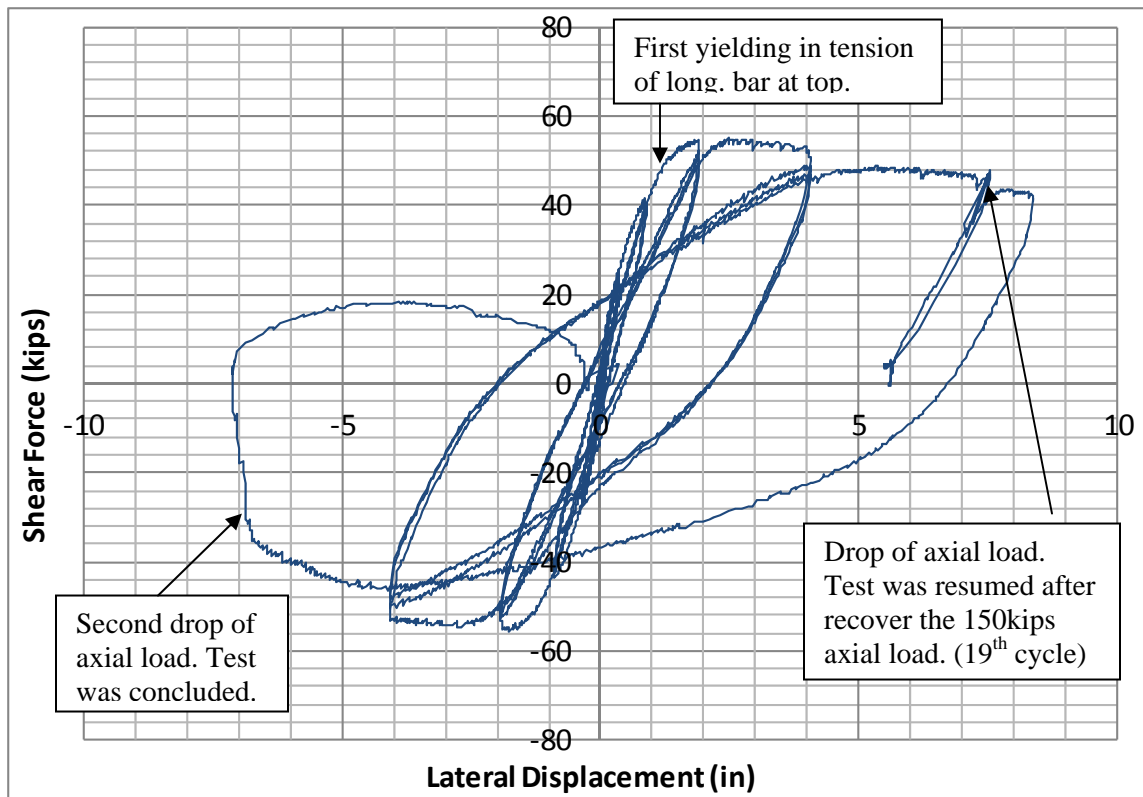
Severe damage occurred at both ends (Figure 5.18). The cover at the top of the column (Figure 5.19) spalled over a 12 in. height of the column. No buckling bar was presented. Crushing of the concrete and buckling of every longitudinal bar was observed at the bottom of the column (Figure 5.20), the horizontal ties also were opened in that zone of buckling. Several diagonal and horizontal cracks were through the bottom and top of the column. The maximum shear capacity of the column was 61.8kips in both direction of loading (north and south).

Figure 5.17 Shear Force vs. Lateral Displacement of RC-1. Axial Load 150kips

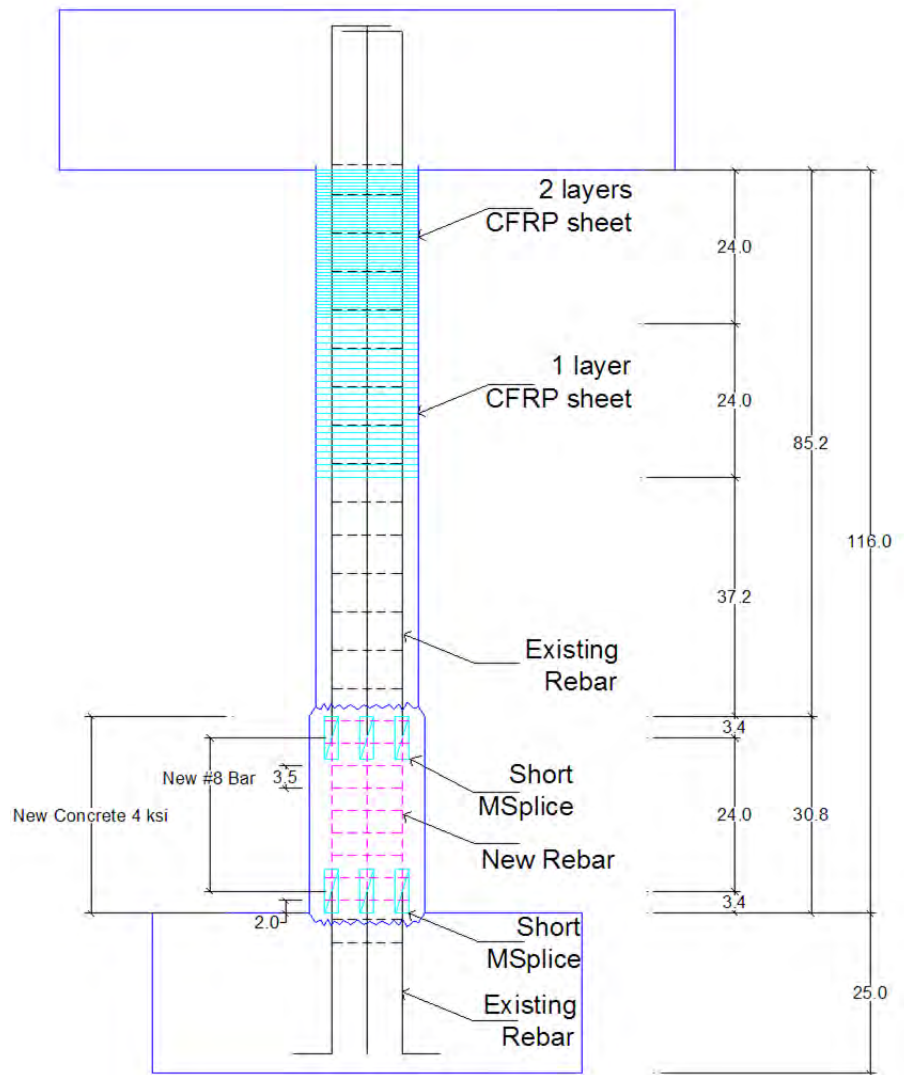
The two hinging zones of the column had different patterns of damage, therefore two retrofit procedures were used. Figure 5.37 shows the two different types of repair used for RC-1. A CFRP jacket was installed in the top hinge zone of the column and concrete and reinforcement were replaced in the heavily damaged bottom hinging region. Mechanical splices were used to replace the buckled bars.

Figure 5.37 Retrofitting using short mechanical splices and CFRP materials

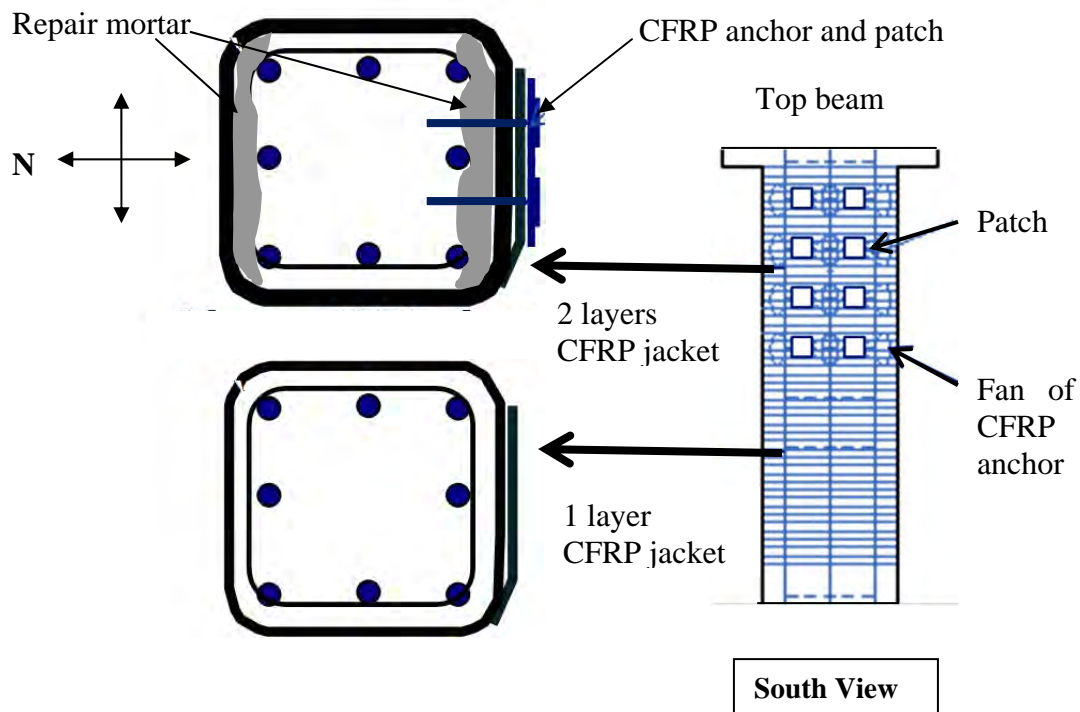
For RC-1 the top end of the column where the cover spalled but no buckling occurred, loose concrete was removed and repair mortar (properties in Appendix E) was used to replace the concrete removed. There was no attempt to inject epoxy into the cracks at the top of the column. The damaged region was wrapped with two layers of CFRP sheets that extended 24in from the top of the column and one layer on the 24in below. Intermediate CFRP anchors were installed midway between the corners. Figure 5.39 shows details of the jacketing procedure.

Figure 5.38 Details for the retrofit of top of column

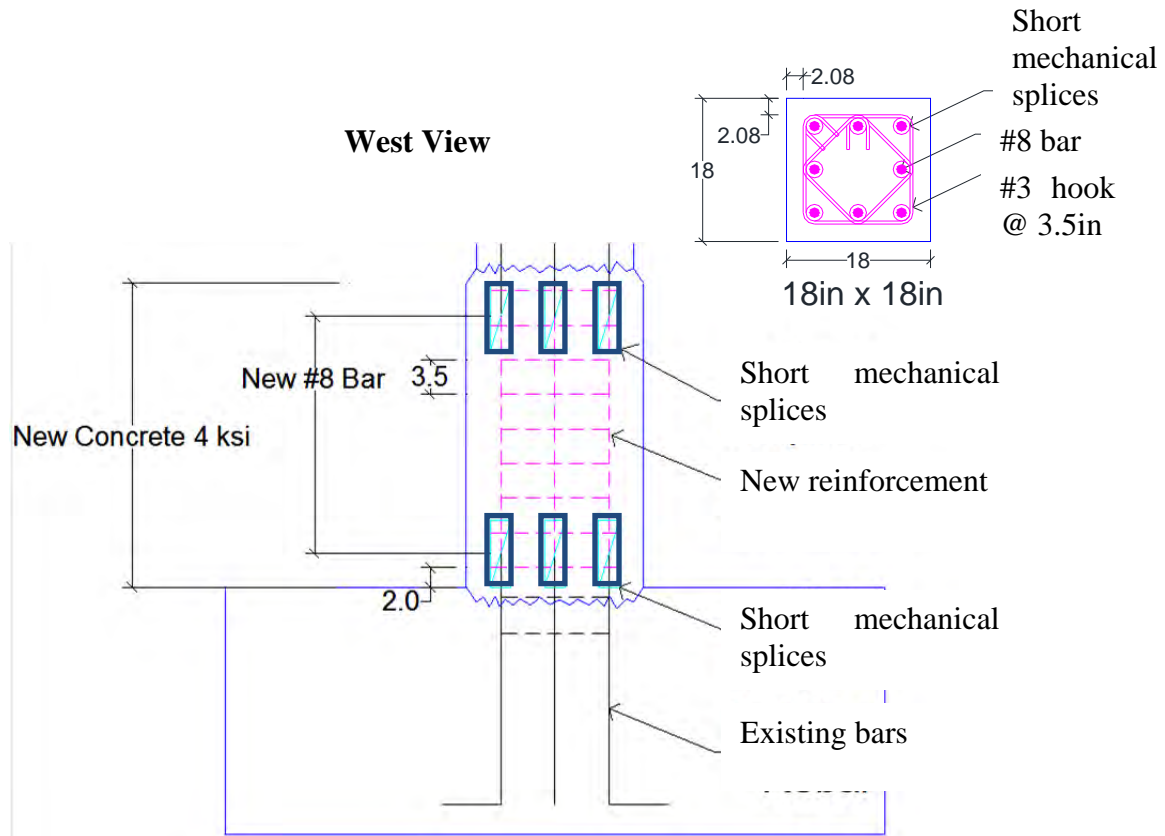
At the bottom of the column, short mechanical splices were used to replace the buckled bars and to provide continuity to the longitudinal bars. The strength of the new concrete was higher than the original column concrete. The cross section was increased 1 in per side to provide sufficient cover over the mechanical splices. The new reinforced was the same type of the existing bar: A-615 Grade 60 steel. Figure 5.40 shows details of the jacketing procedure used. The process is explained in Appendix B.

Figure 5.40 Details for the retrofit at bottom of column

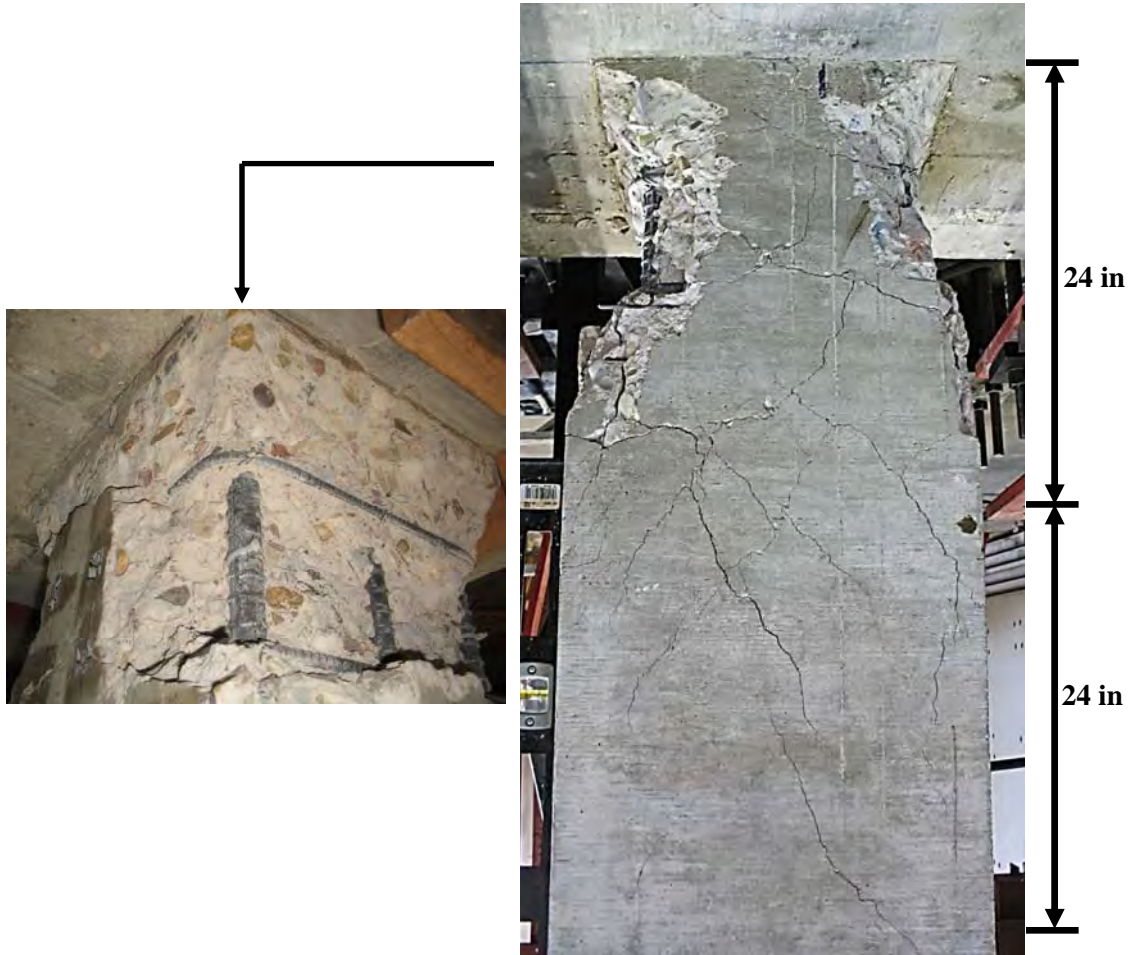
The top and bottom of the column exhibited of concrete crushing. And bar buckling. All damaged concrete was removed. Figure 5.41 and Figure 5.42 show details of the damage to the top and bottom of column.

Figure 5.41 Condition of column top hinge

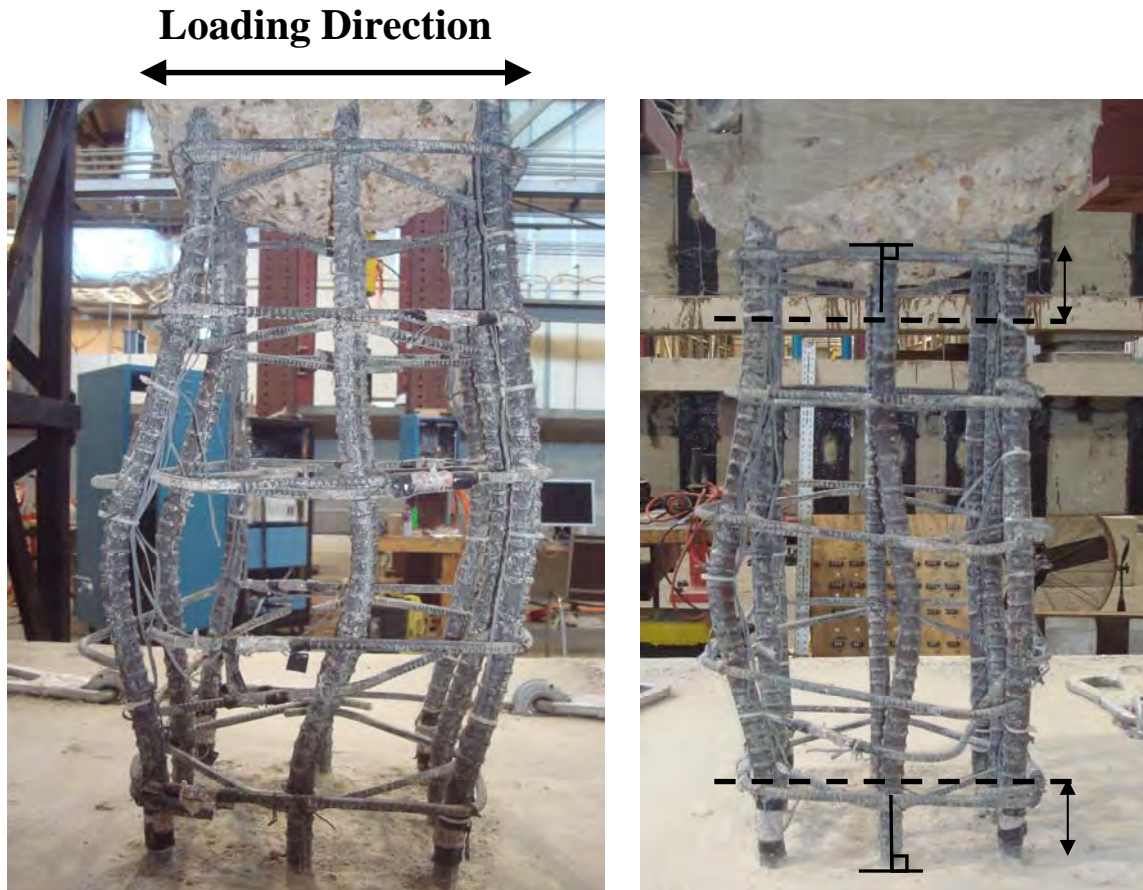
The crushed concrete was removed from the bottom zone of the column, however it was necessary to remove more concrete in order to have enough clear space for installation of the short mechanical splices. The removal was done carefully to avoid further damage to the column. Figure 5.42 shows that lateral buckling was more dramatic in the direction of lateral loading.

Figure 5.42 Buckled bar at bottom of column

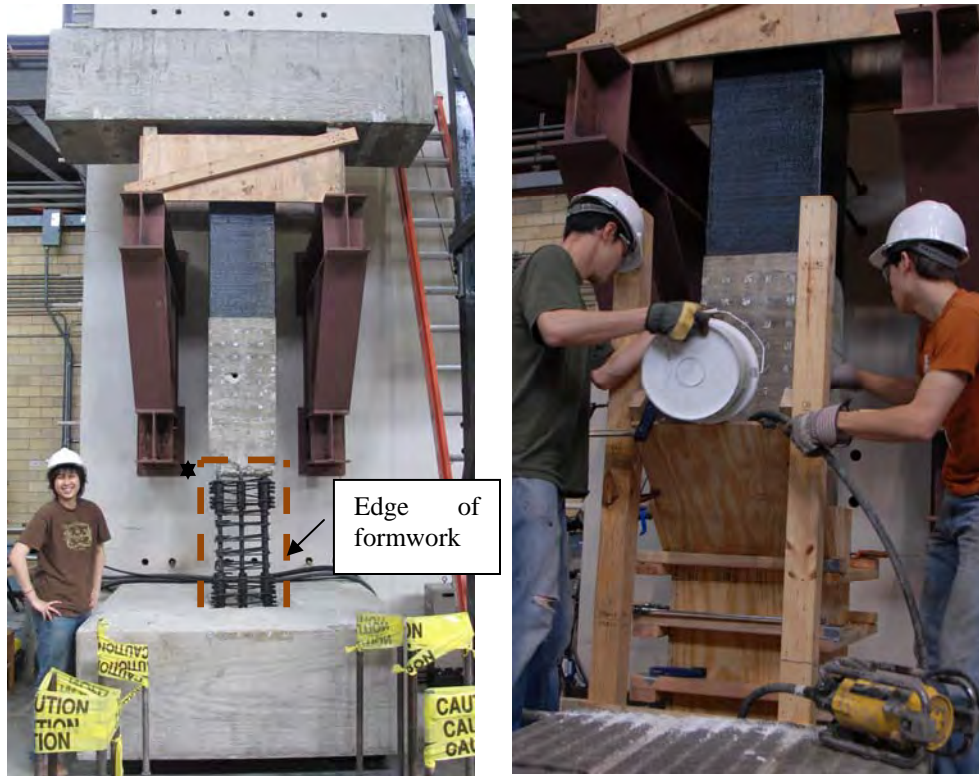
A special form was constructed with a chute for casting the concrete (Figure 5.49). No special additive was used, however, the maximum size of aggregate was 1/2in diameter and a high slump was specified (6 ½ in.) in order to place the concrete and consolidate it around the reinforcement and splices. Figure 5.49-left shows the columns prior to the formwork application and the right image shows the concrete placement. The top of the form was 1in above than the bottom of the existing concrete. In this way, the new concrete could be placed without leaving a gap. The strength of concrete was 4ksi. Details are in Appendix C.

Figure 5.49 Column with the Mechanical Splices Applied (left) and placement of concrete (right)

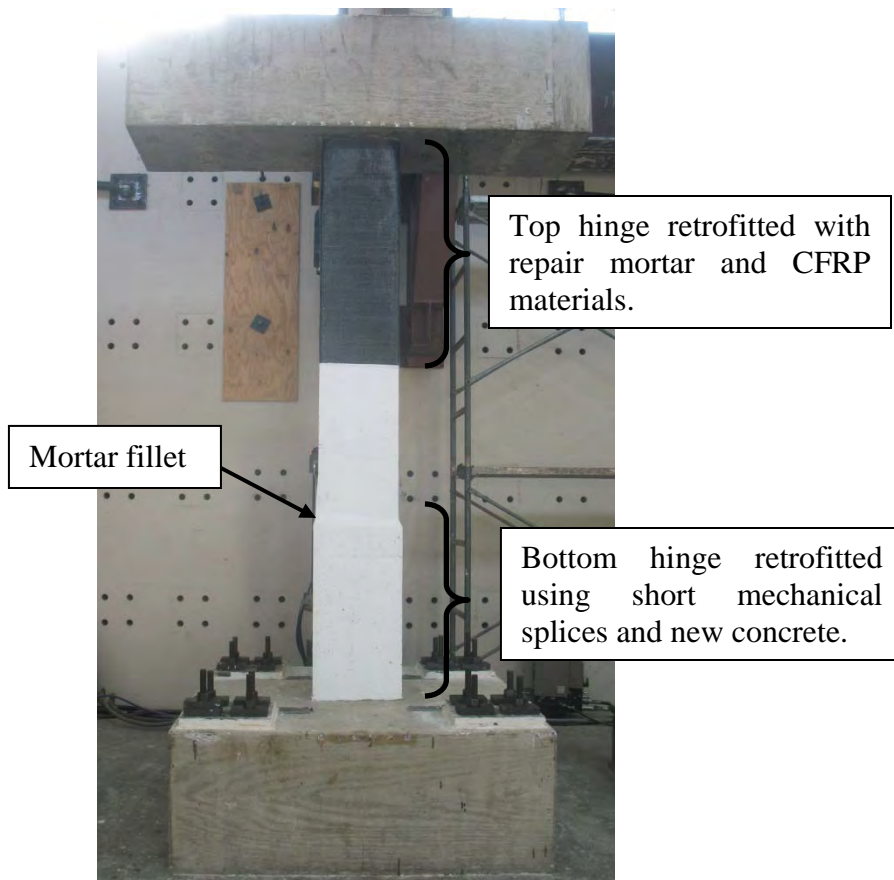
Figure 5.51 Column retrofitted
