**PROCEDURES TO REHABILITATE EXTREMELY DAMAGED
CONCRETE MEMBERS USING INNOVATIVE MATERIALS AND
DEVICES**

Guillermo David Huaco Cardenas, B.S., M.S.E.

Dissertation

The University of Texas at Austin

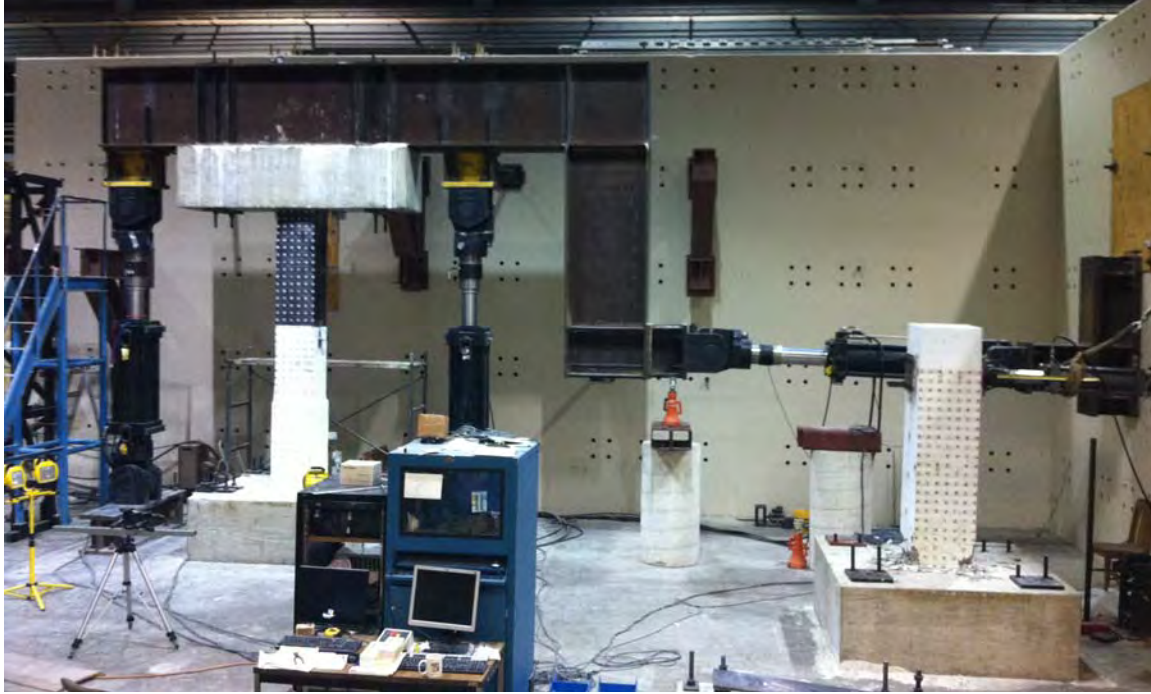
Figure 5.52 shows the repaired specimen after installation into the L-frame.

Figure 5.52 Test Setup for RC-1R

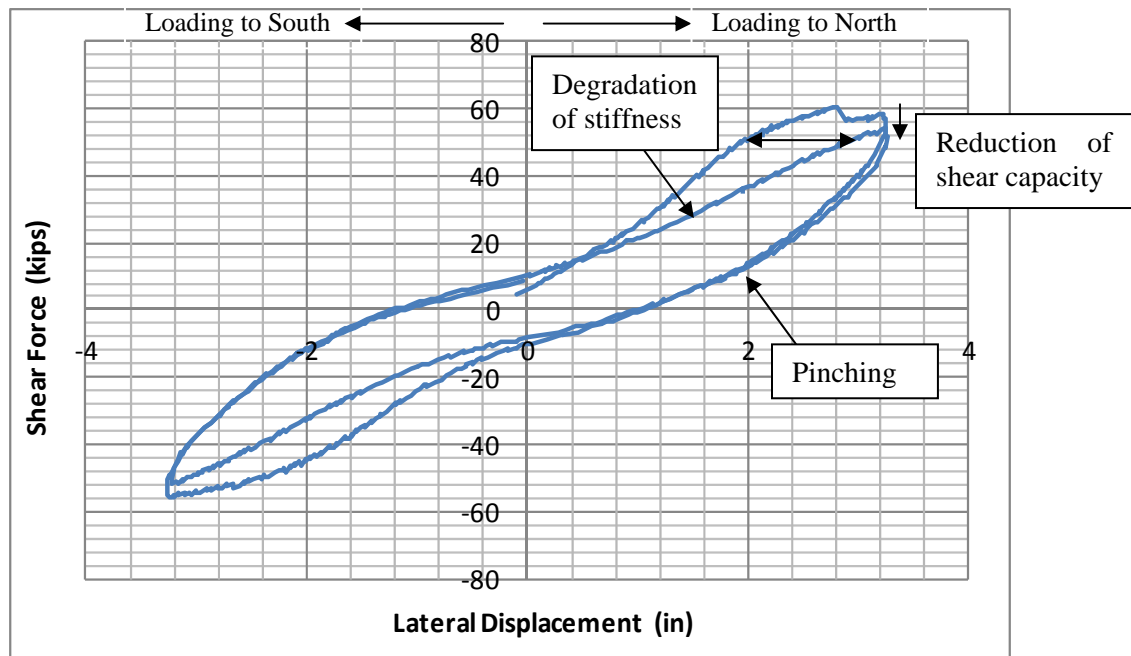
The maximum shear capacity was reached in the 6th and 7th cycles of the column: 60.9kips North and 56kips South. The lateral deformation was 2.80% drift ratio in both directions. The column dissipated more energy in 6th hysteretic cycle than the 7th cycle. There was some degradation of shear capacity in the 7th cycle. (Figure 5.61)

Figure 5.61 Shear force vs. Lateral displacement on the 6th and 7th hysteretic cycle

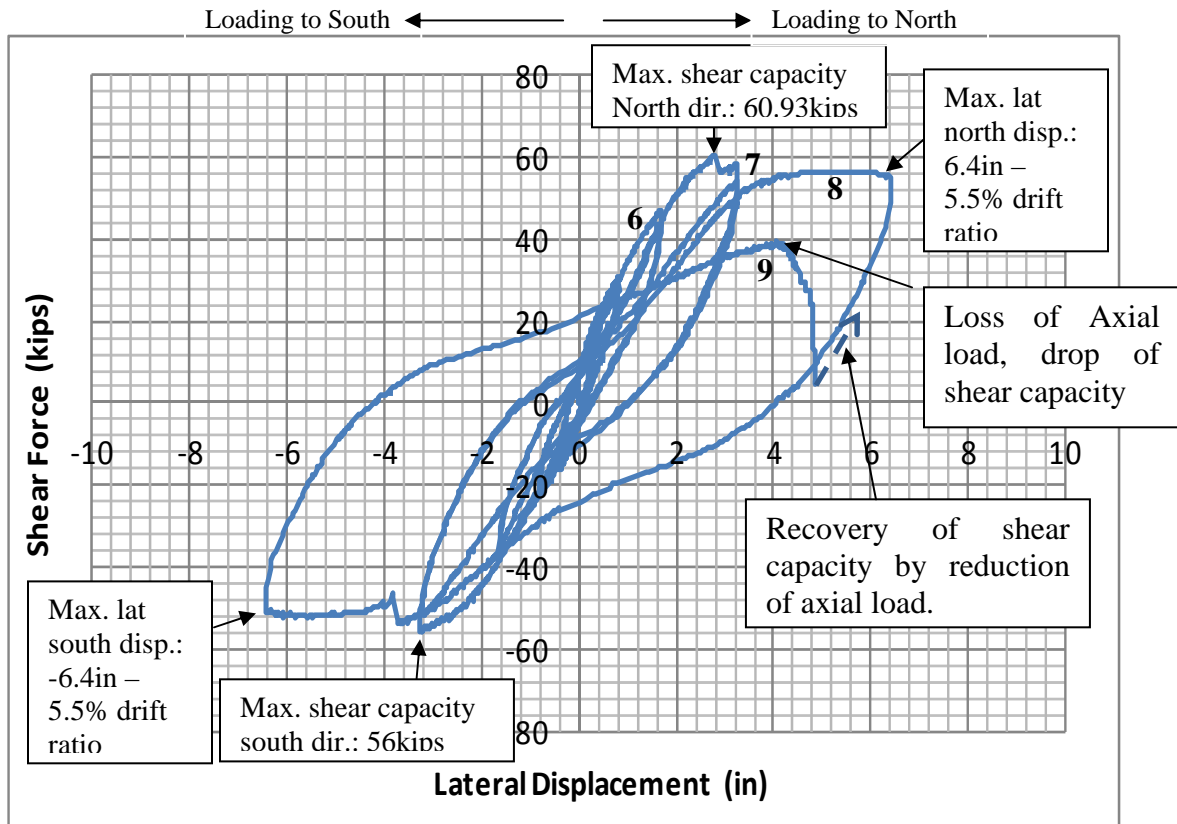
Degradation of stiffness and strength was seen in the 8th cycle (Figure 5.62) deformation (5.5% drift ratio) both directions. Pinching effect seemed to be appeared for pushing loading when the lateral load was dropped as can be seen in Figure 5.62. Figure 5.63 shows the column deformed under loading to north (left) and south (right) directions. The cracks appeared near the bottom became wider, while on top the CFRP started to debond.

Figure 5.62 Load cycling for specimen RC-1R

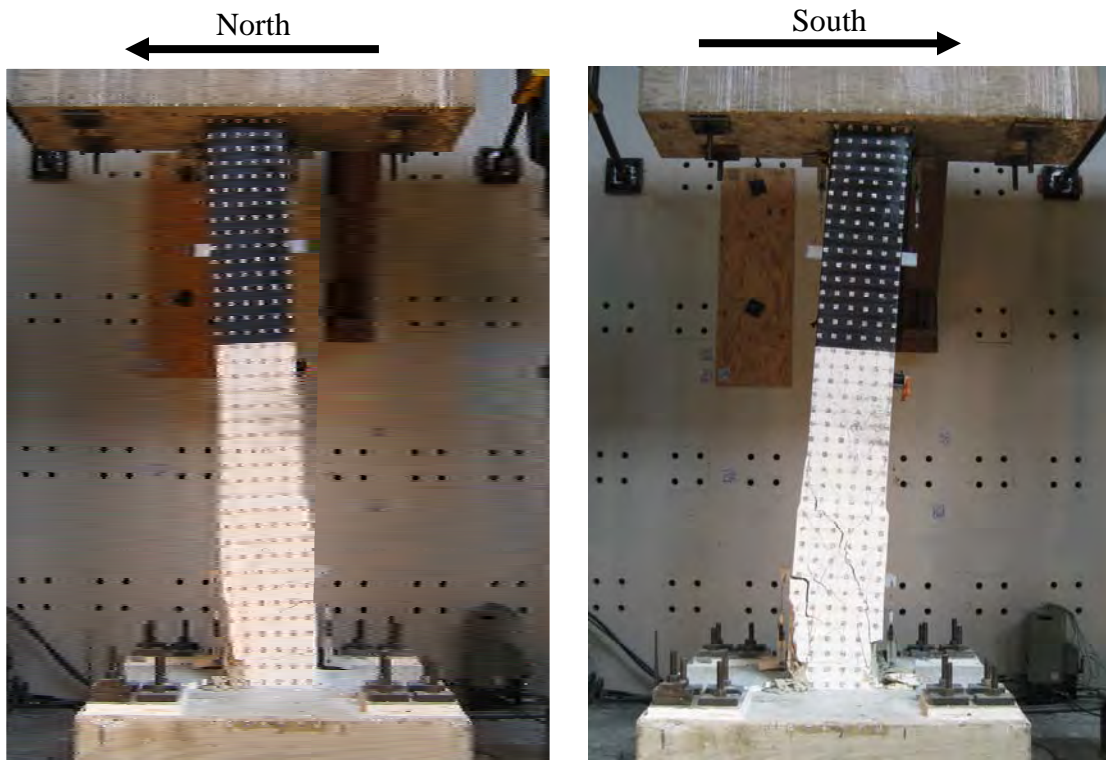
Figure 5.63 Condition of specimen RC-1R after pushing (left) and pulling (right) displacement applied for 1/17 drift ratio

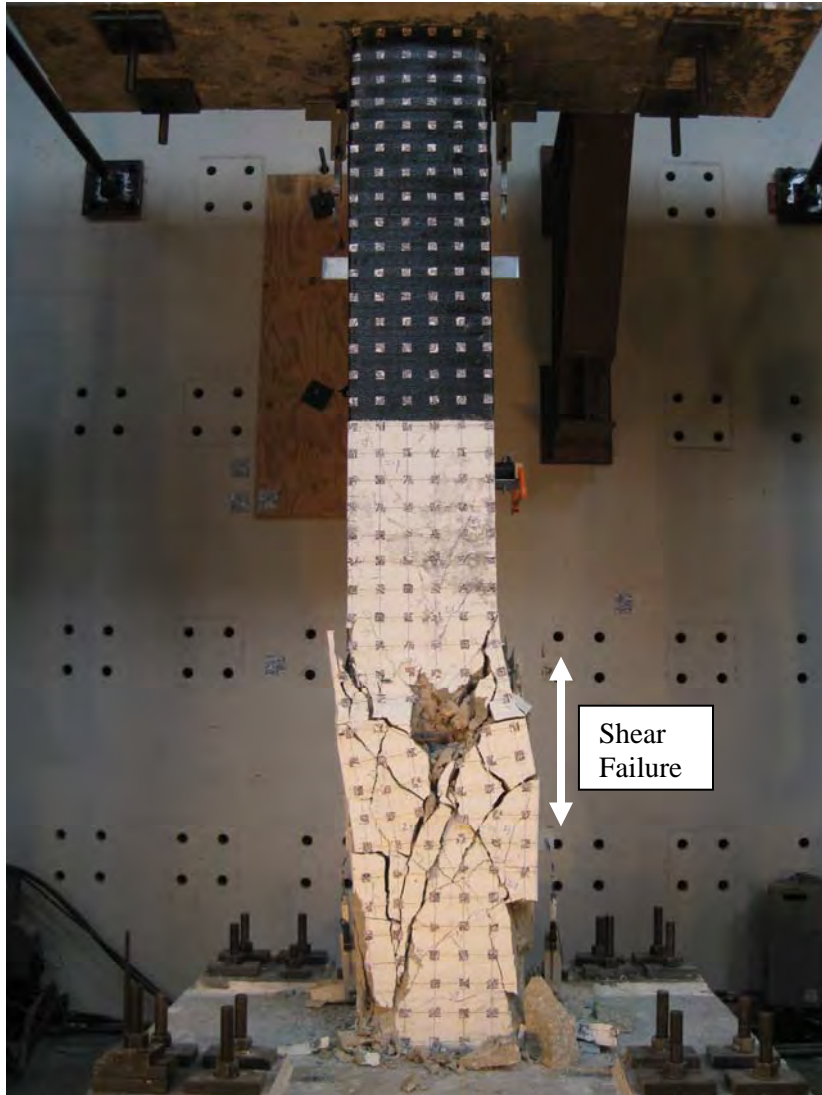
The specimen was not able to sustain the 150kips axial load in the 9th cycle and the test was stopped when the lateral load dropped by 30kips. Shear failure developed in the existing concrete above the mechanical splices zone as can be seen in Figure 5.64.

Figure 5.64 Condition of RC-1R at the drop of the axial load.

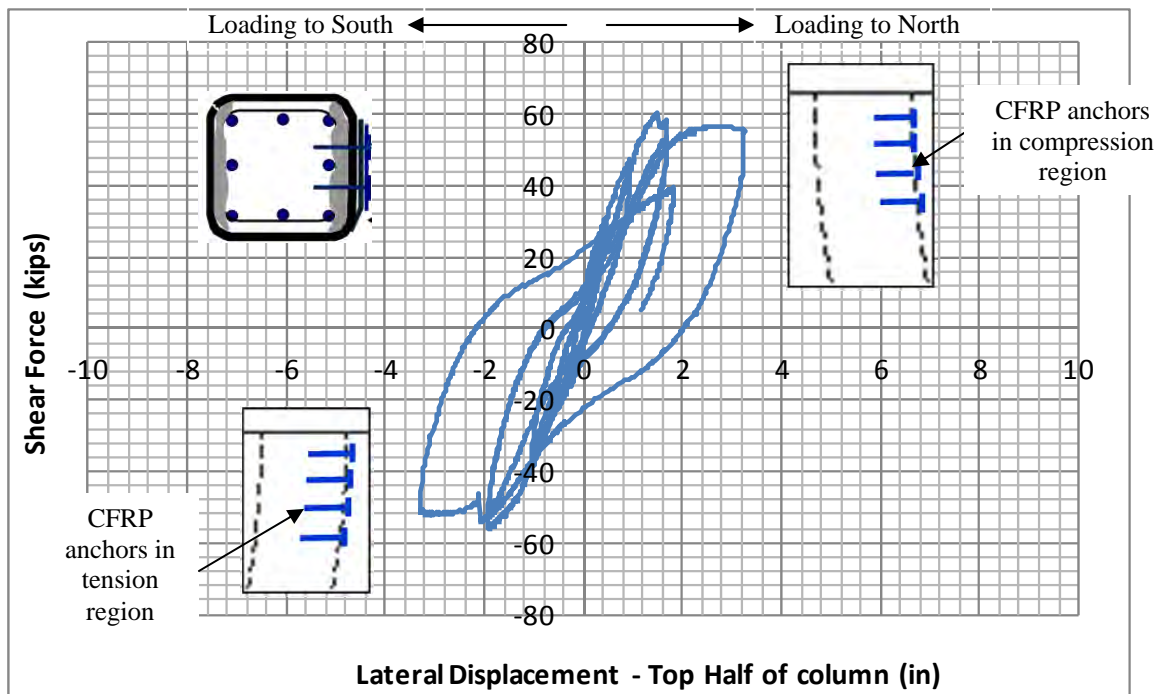
Figure 5.75 Shear force vs. Lateral Deformation of top half of specimen

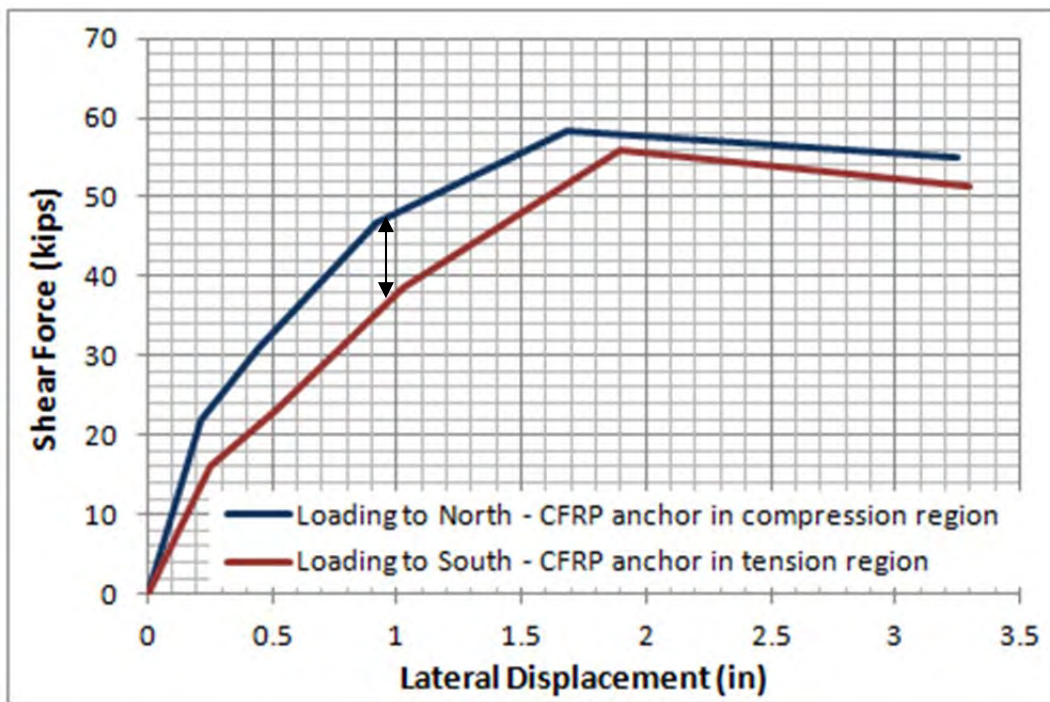
Figure 5.76 shows the envelopes of the behavioral response for top of column when it was loaded to north and south directions. It can be noticed that the Loading-to-North curve is stiffer than Loading-to-South. The reason is the presence of the CFRP anchors in the south face of the specimen. When the specimen is loaded to north, the CFRP anchors is in the compression region of stress, the anchors provided compression strength capacity. However, the specimen is loaded to the opposite side, the CFRP anchor is in the tension stress region. The anchors do not provide important tension capacity to the section.

Figure 5.76 Envelopes curves of RC-1R Top Half for loading to North and South

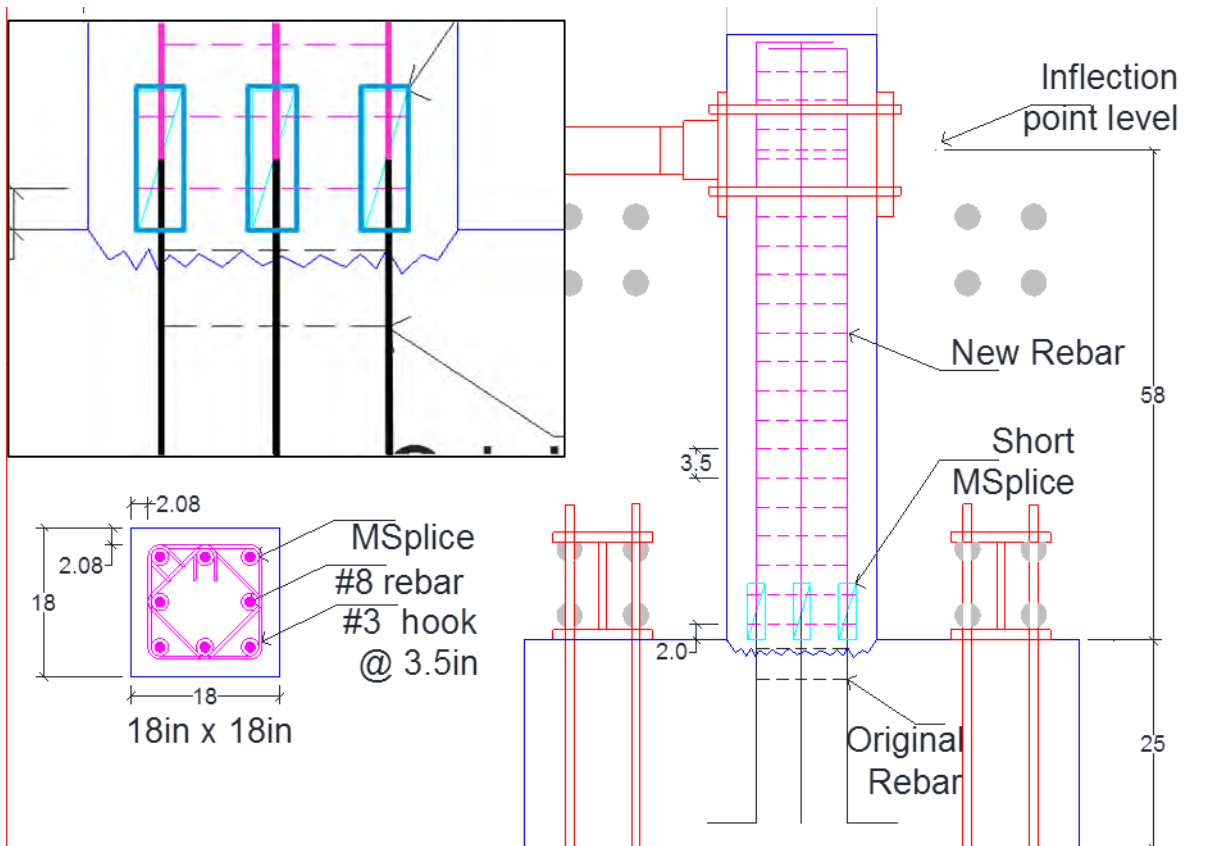
The yielded bars, which buckled and bent during the test RC-2, were removed and replaced with new longitudinal bars connected by the mechanical splices as shown in Figure 5.84. The new tie configuration in the region where the bars are coupled will have 135° hooks as recommended for constructions in high seismic zones. The space between the ties was decreased from 6in to 3.5in following the provisions in Chapter 21 of ACI 318.

Figure 5.84 Retrofitting using mechanical splices

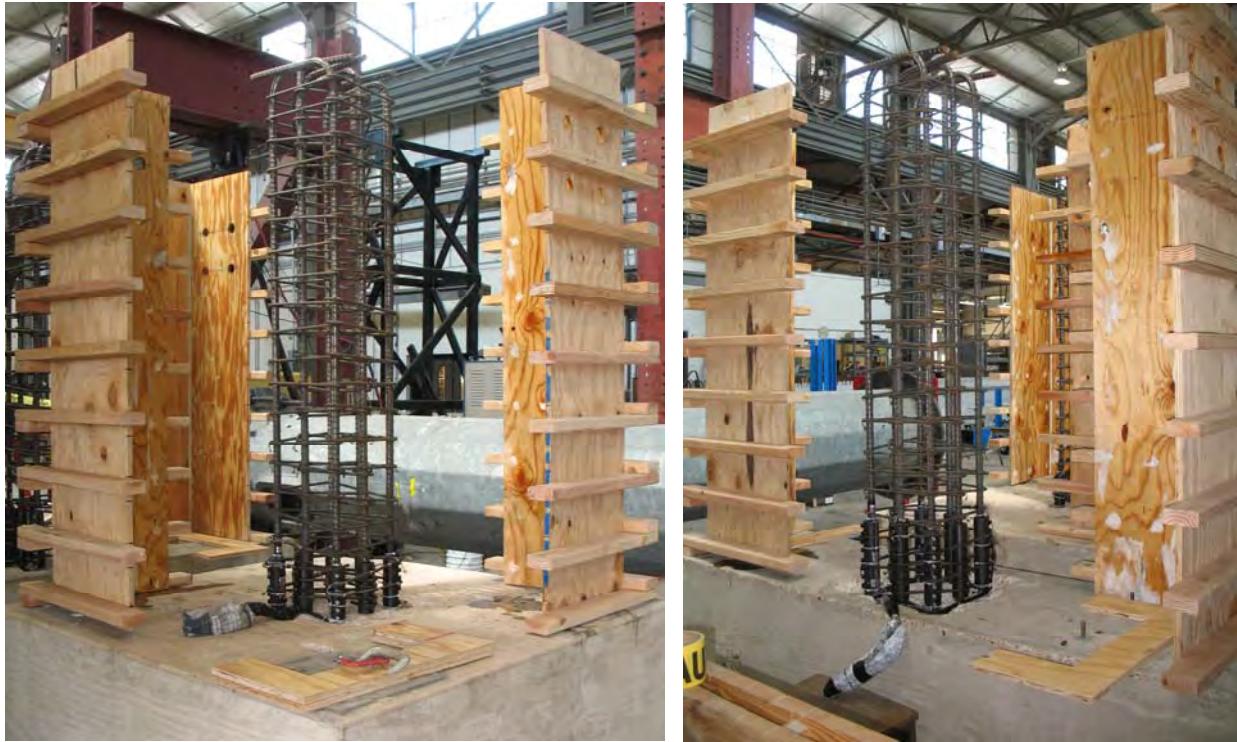
Figure 5.92 to Figure 5.94 show the formwork, concrete placement and finished replacement columns.

Figure 5.92 Internal reinforcement and formwork for each specimen

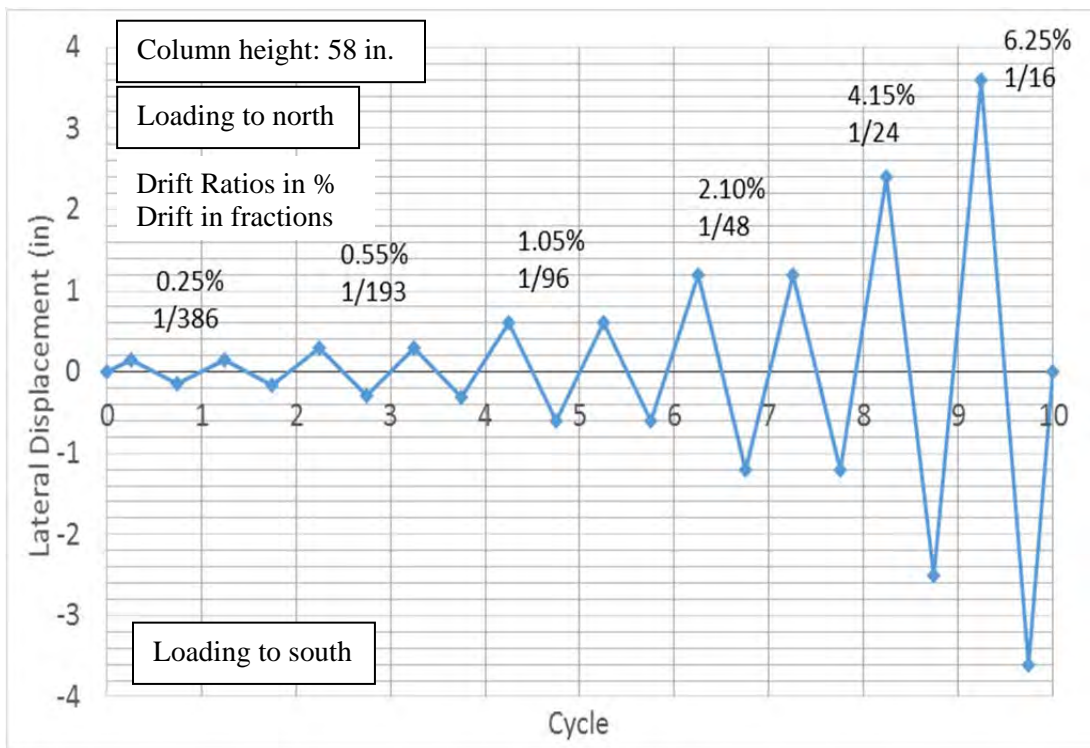
In the cyclic loading test, the specimen RC-2R-SMS was subjected to two cycles of tension compression increasing lateral displacements as shown in Figure 5.101. Protocol of load was following the procedures of FEMA 461 until 2.10% drift ratio which is above the maximum allowed drift recommended in the ASCE-07-05 seismic design provisions.

Figure 5.101 Cycle history for specimen RC-2R-SMS

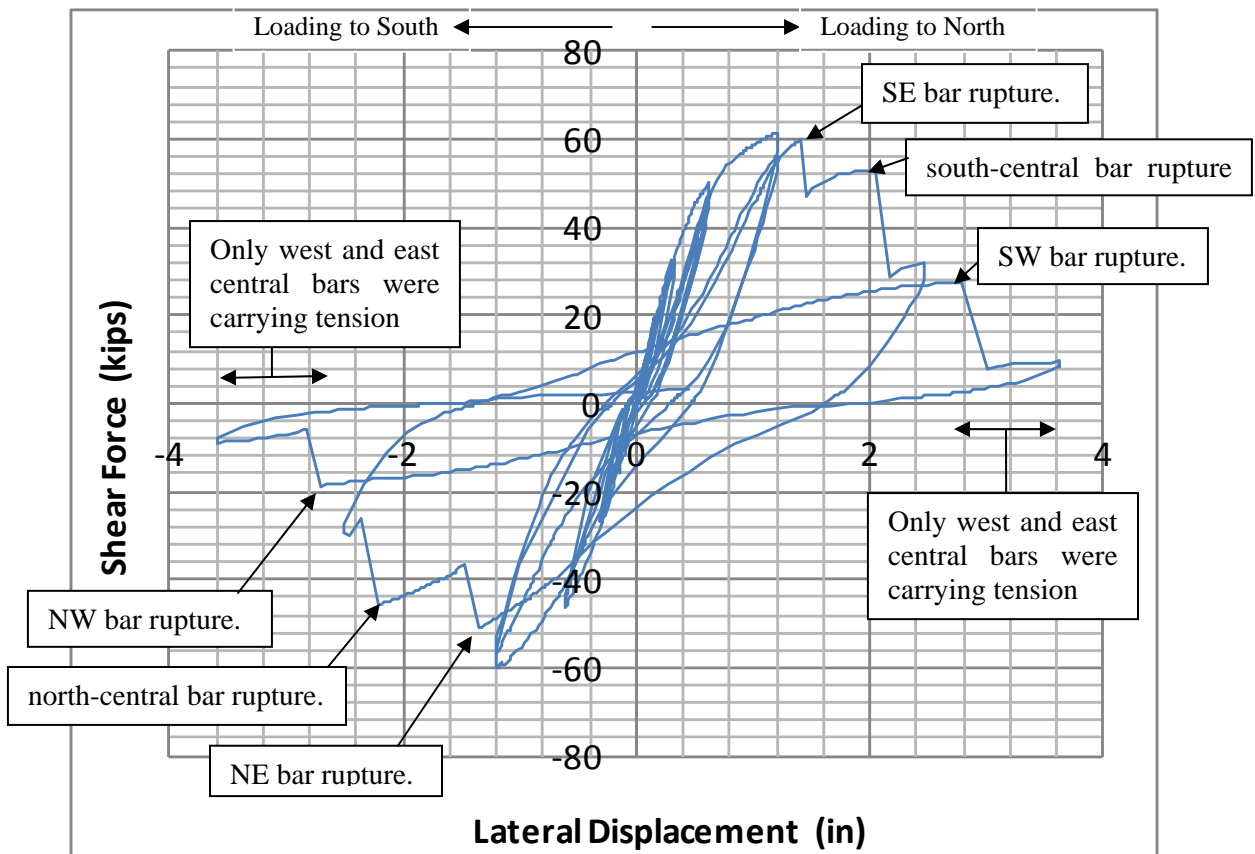
Finally, the shear force vs. lateral deformation of the specimen is shown in Figure 5.112, indicating the moment when the existing longitudinal bars ruptured. The behavior of the specimen was symmetric on both direction of loading, having similar initial stiffness, maximum load capacity and ductility.

Figure 5.112 Shear force response for specimen RC-2R-SMS.

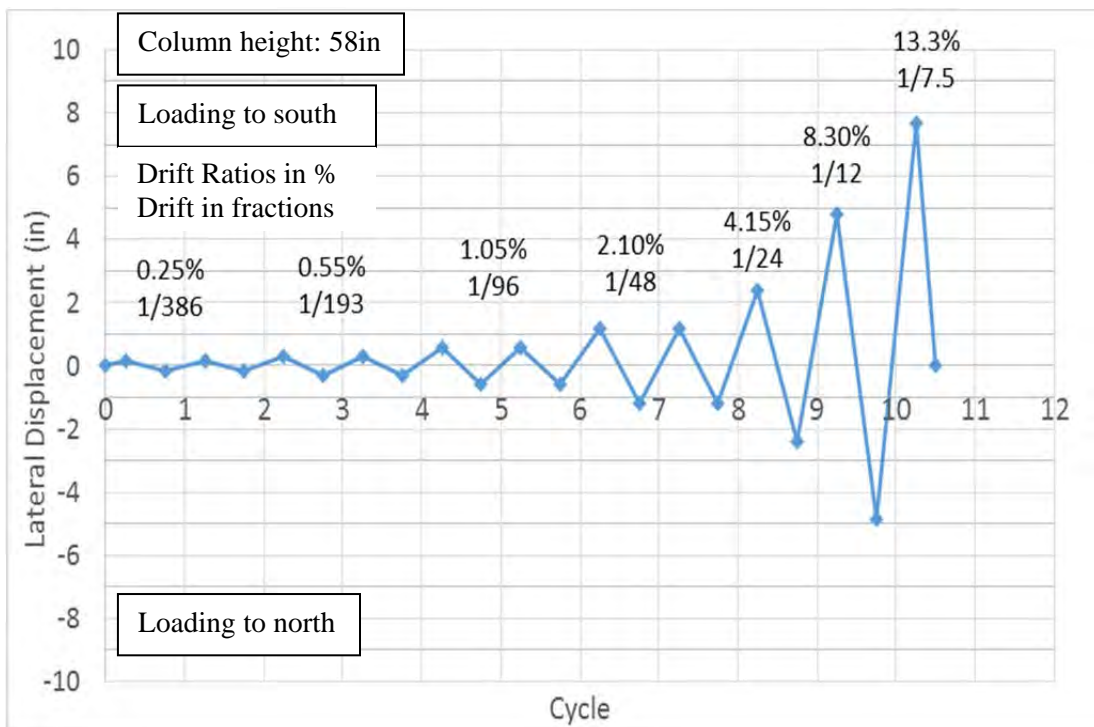
Figure 5.125 Cycle load history for specimen RC-2R-LMS

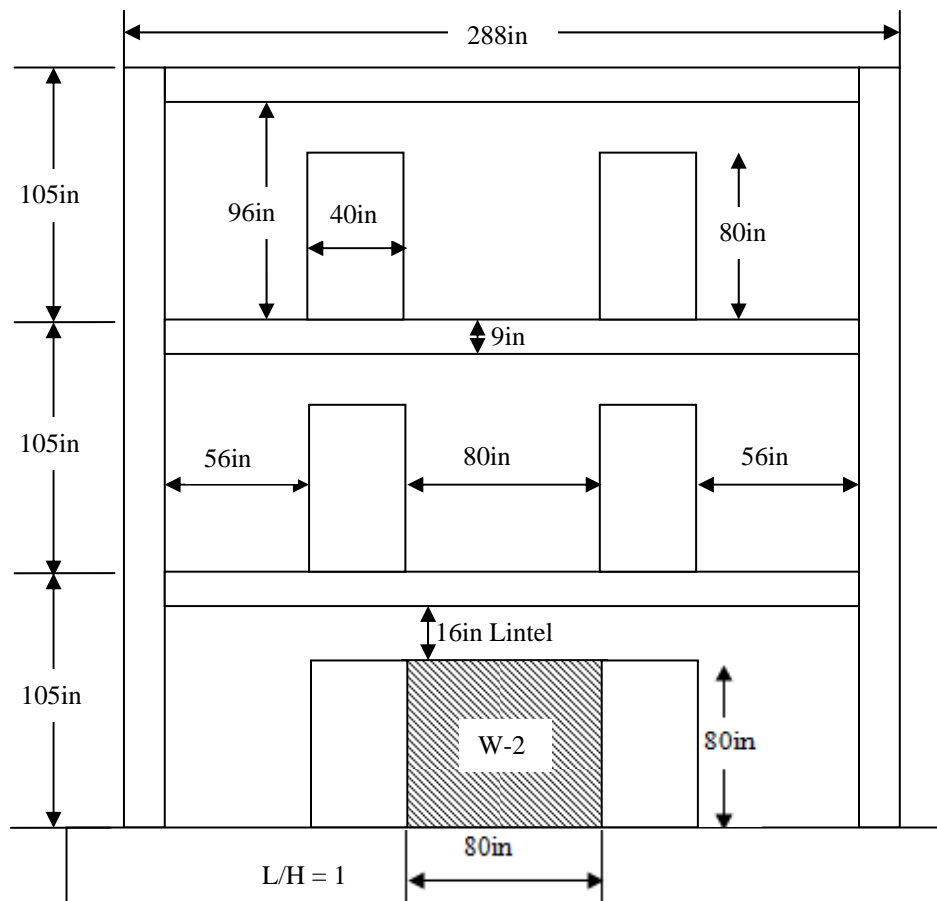
Figure 6.3 Elevation view of the three-story specimen. Masonry wall W-2 is shown.

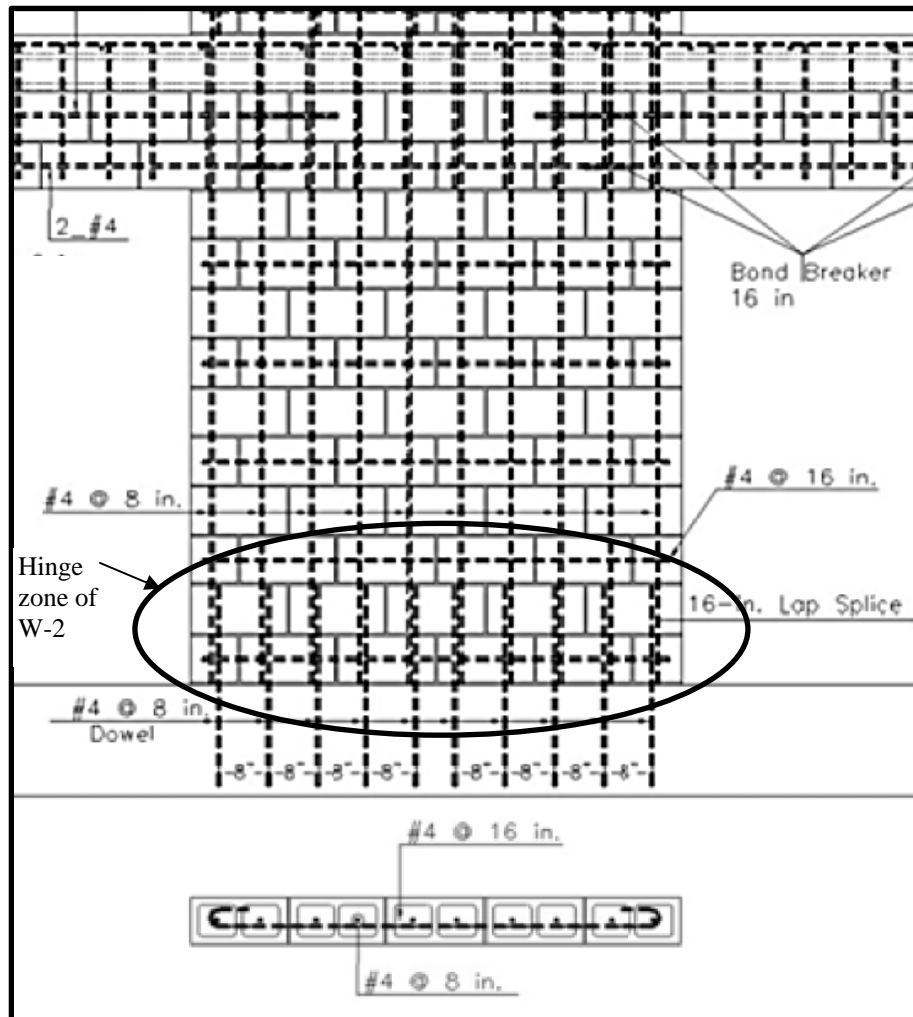
Figure 6.4 Internal reinforcement of W-2 and location of hinge zone (Stavridis, 2011)

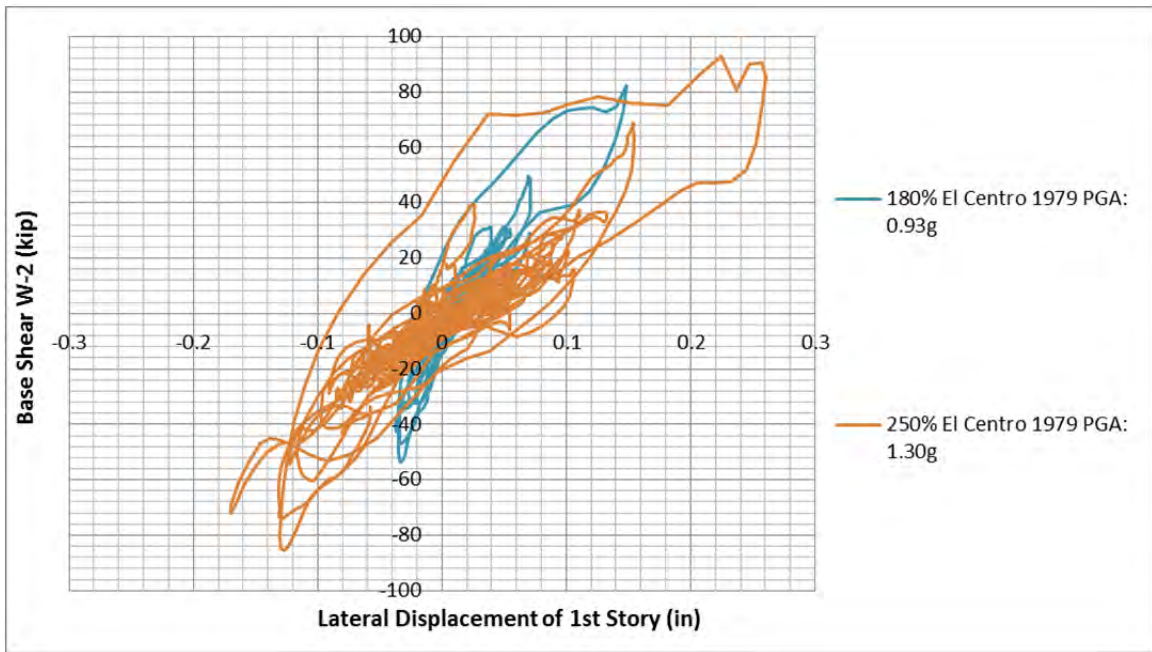
Figure 6.11 Base shear vs. lateral displacement hysteretic loops of W-2 for Test 6 to 7

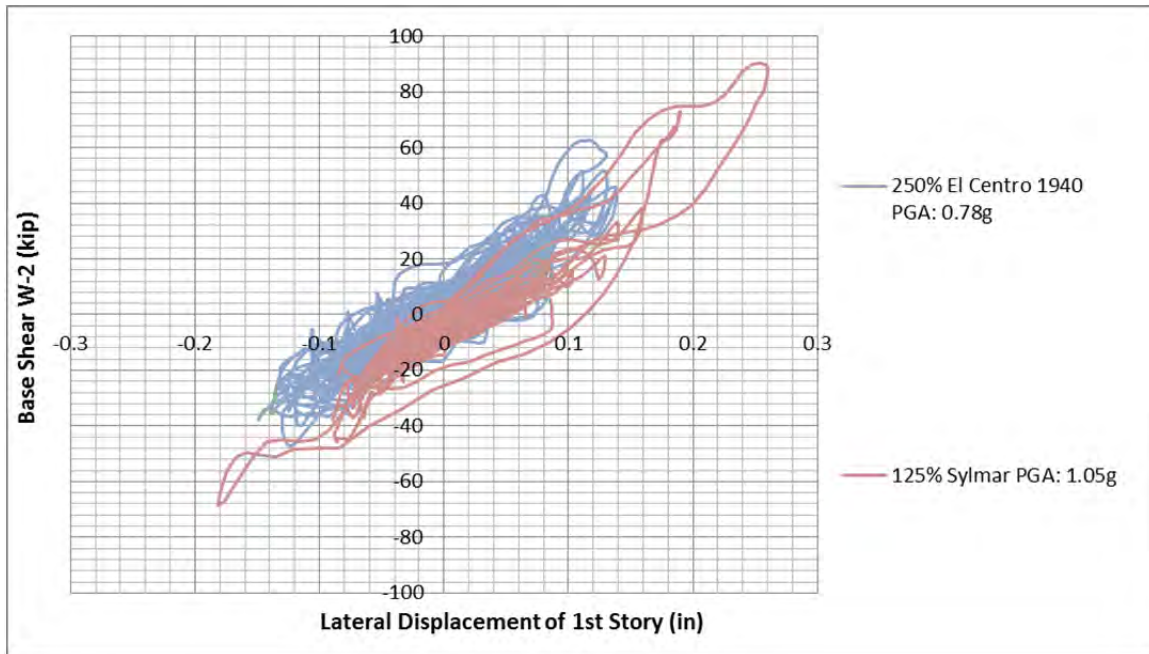
Figure 6.13 Base shear vs. lateral displacement hysteretic loops of W-2 for Test 8 to 9

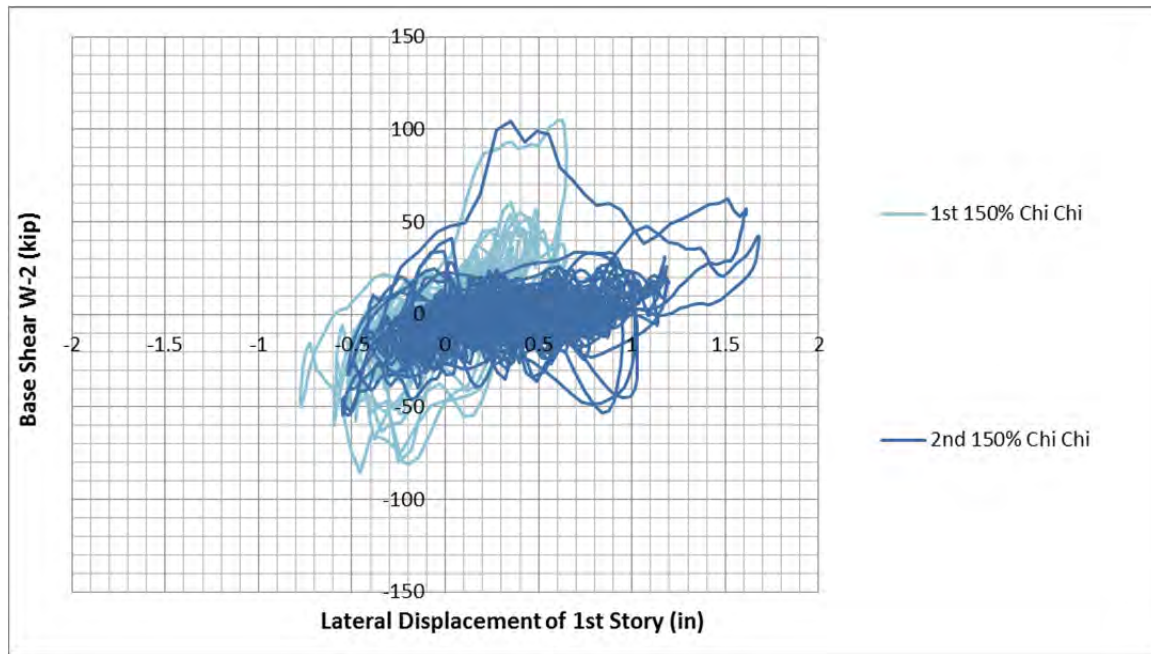
Figure 6.17 Base Shear vs. Lateral Displacement Hysteretic Loops of W-2 for Test 13 and Test 14

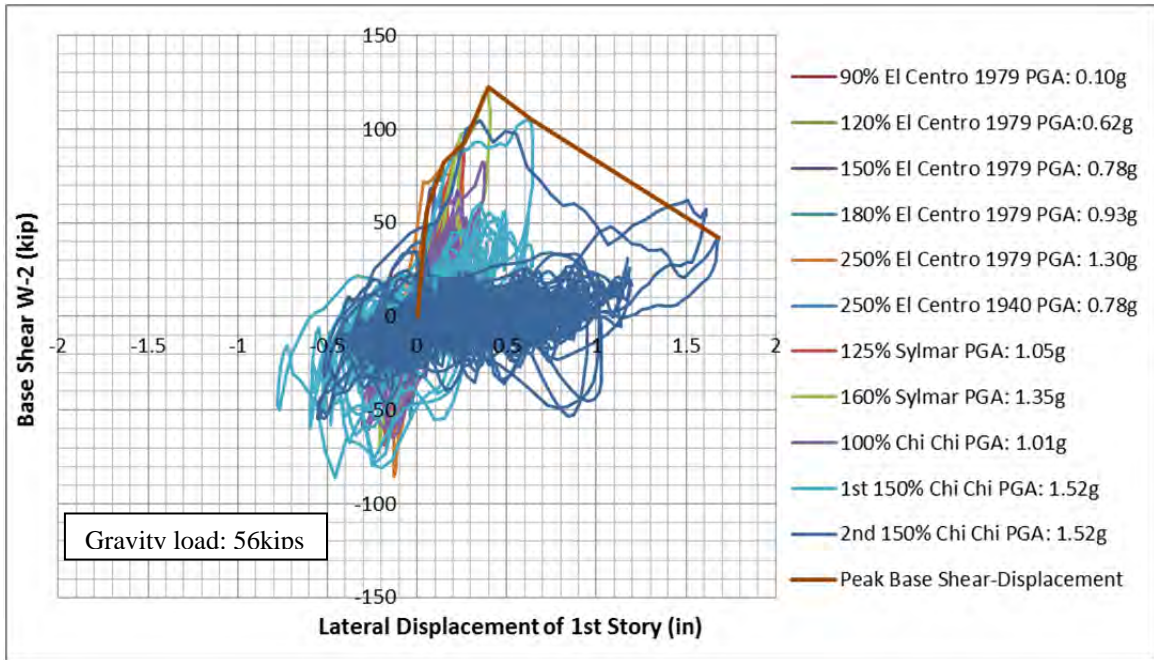
Figure 6.18 *Base Shear vs. Lateral Displacement Hysteretic Loops of W-2 for the 14 different ground motions imposed to the specimen.*

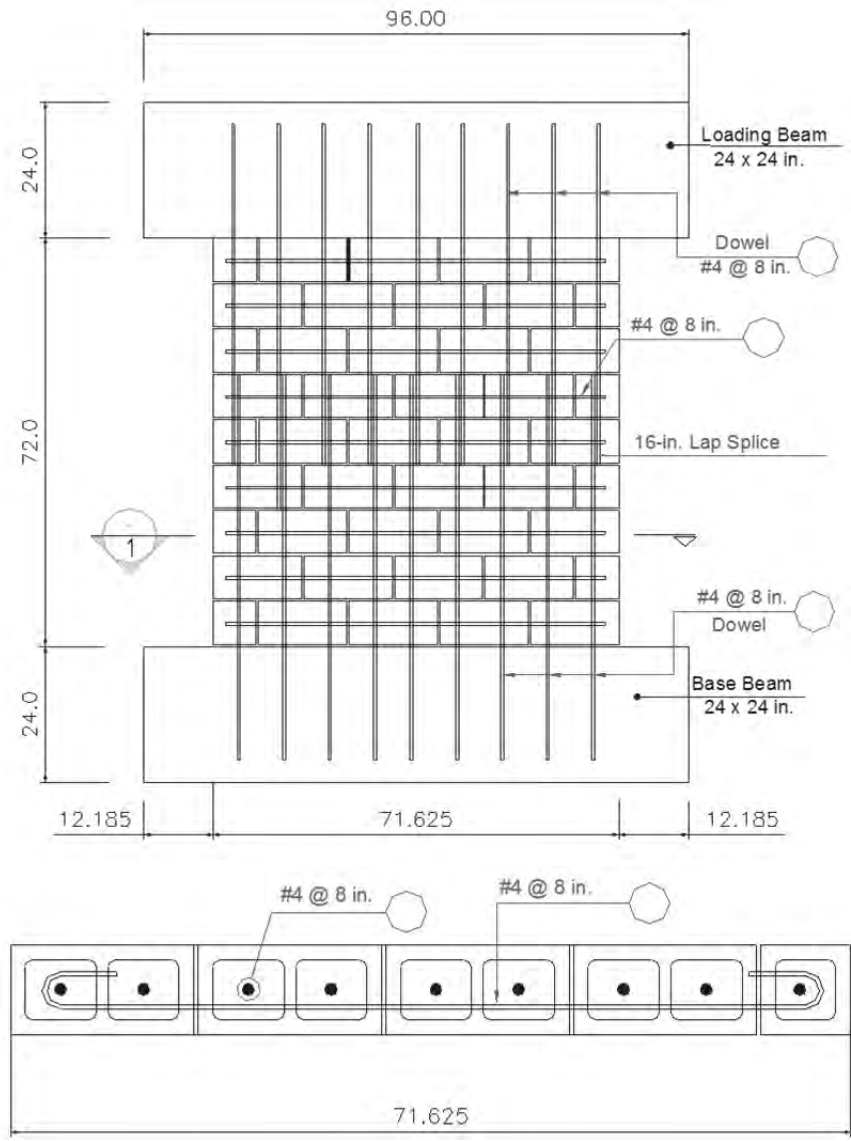
Figure 6.21 Dimensions of the original masonry wall and its internal reinforcement (Ahmadi 2012)

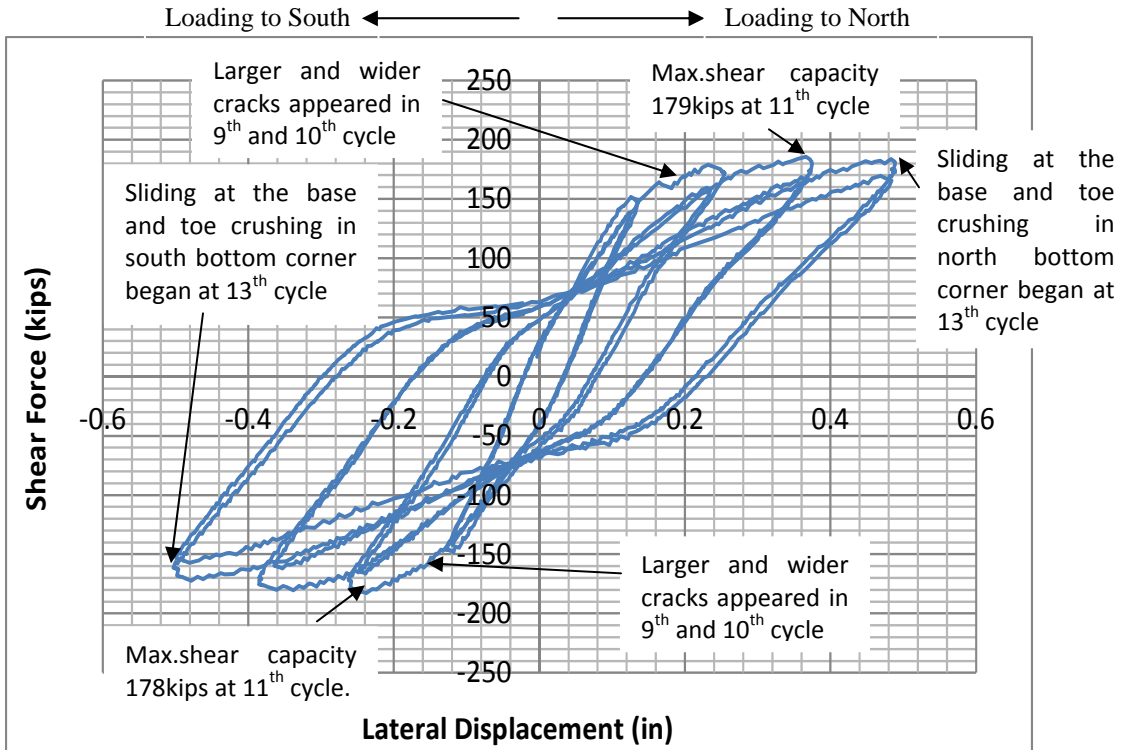
Figure 6.27 Shear response of the specimen for the 7th to 14th hysteretic cycle

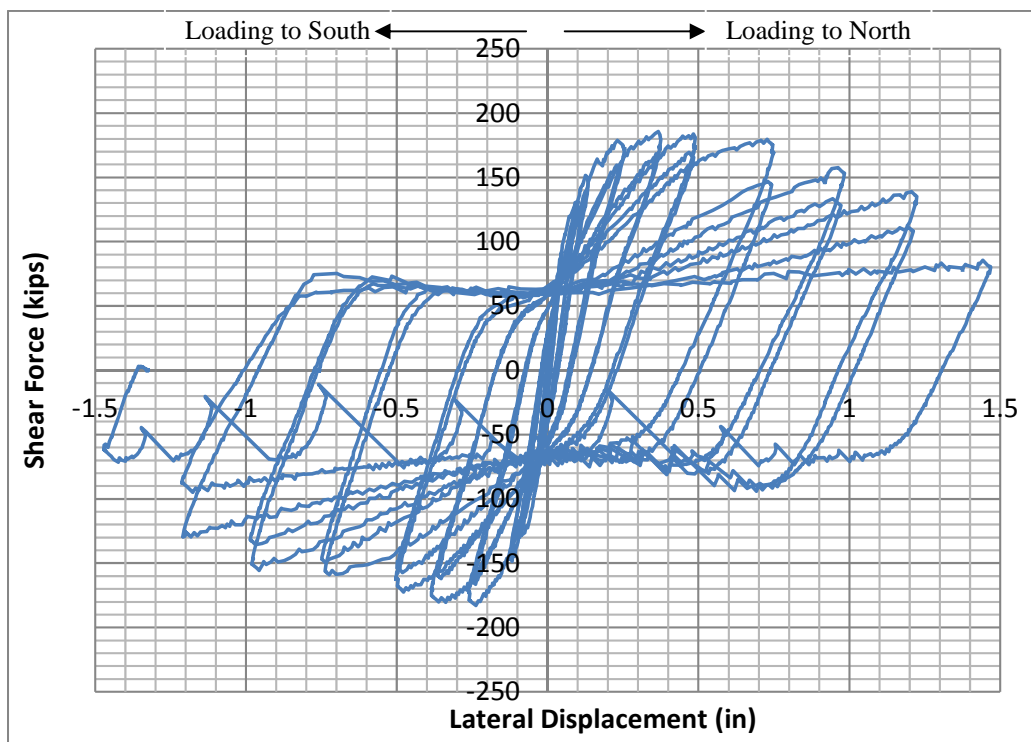
Figure 6.29 Shear Force Response of the masonry wall

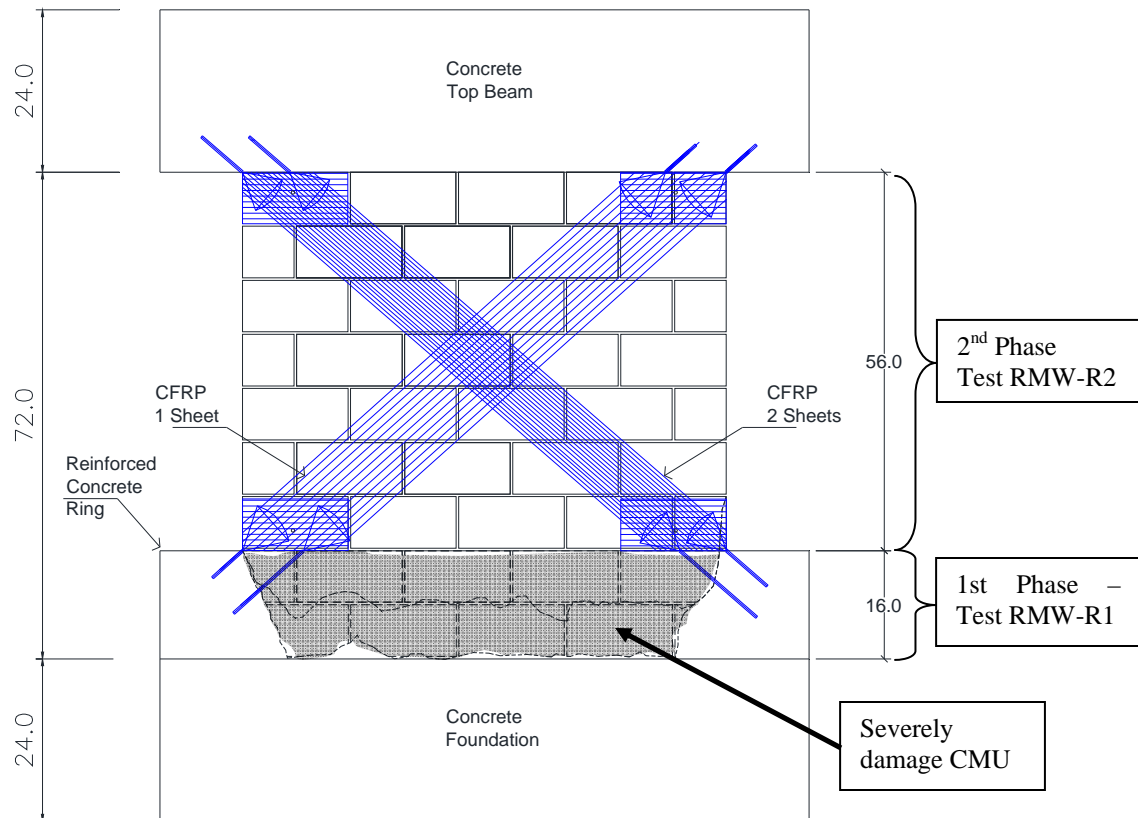
Figure 6.34 Details for the retrofit of the masonry wall

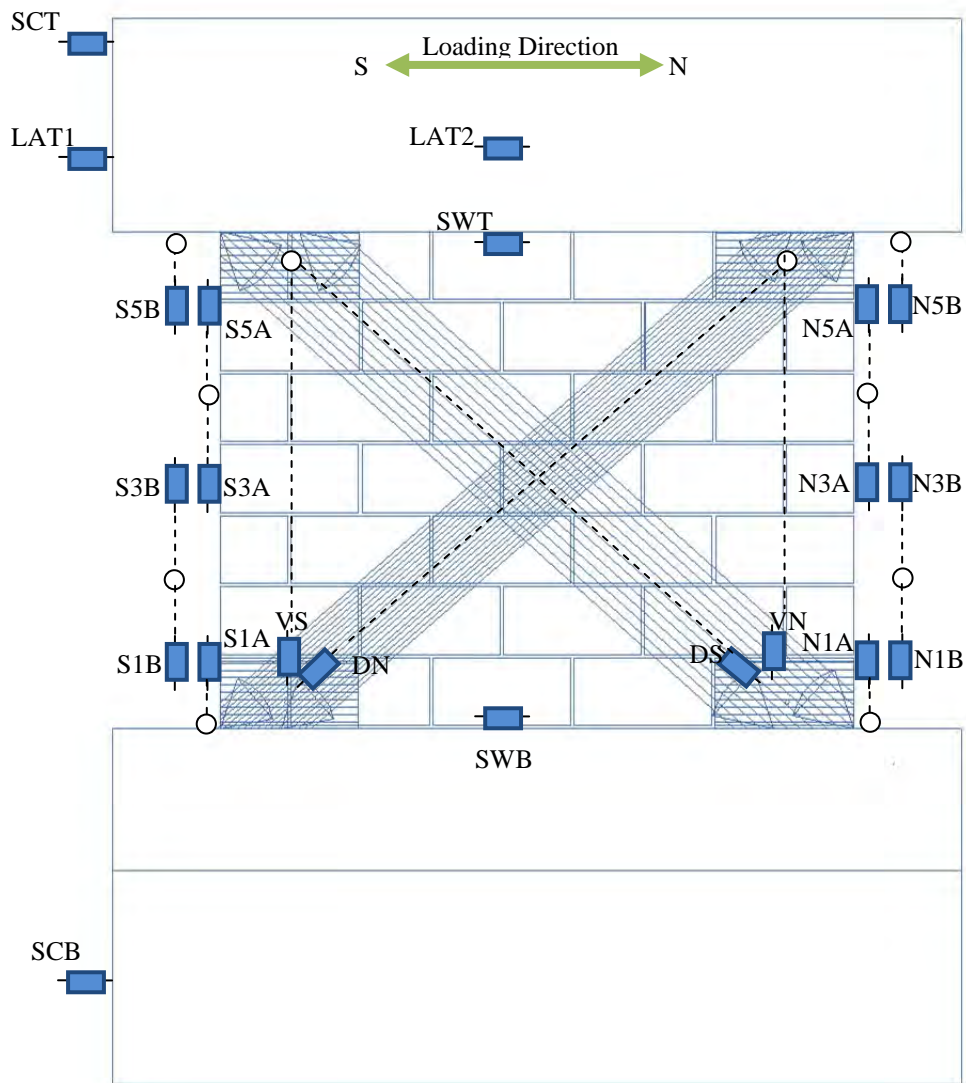
Figure 6.59 Linear potentiometer for local and global deformation measurement

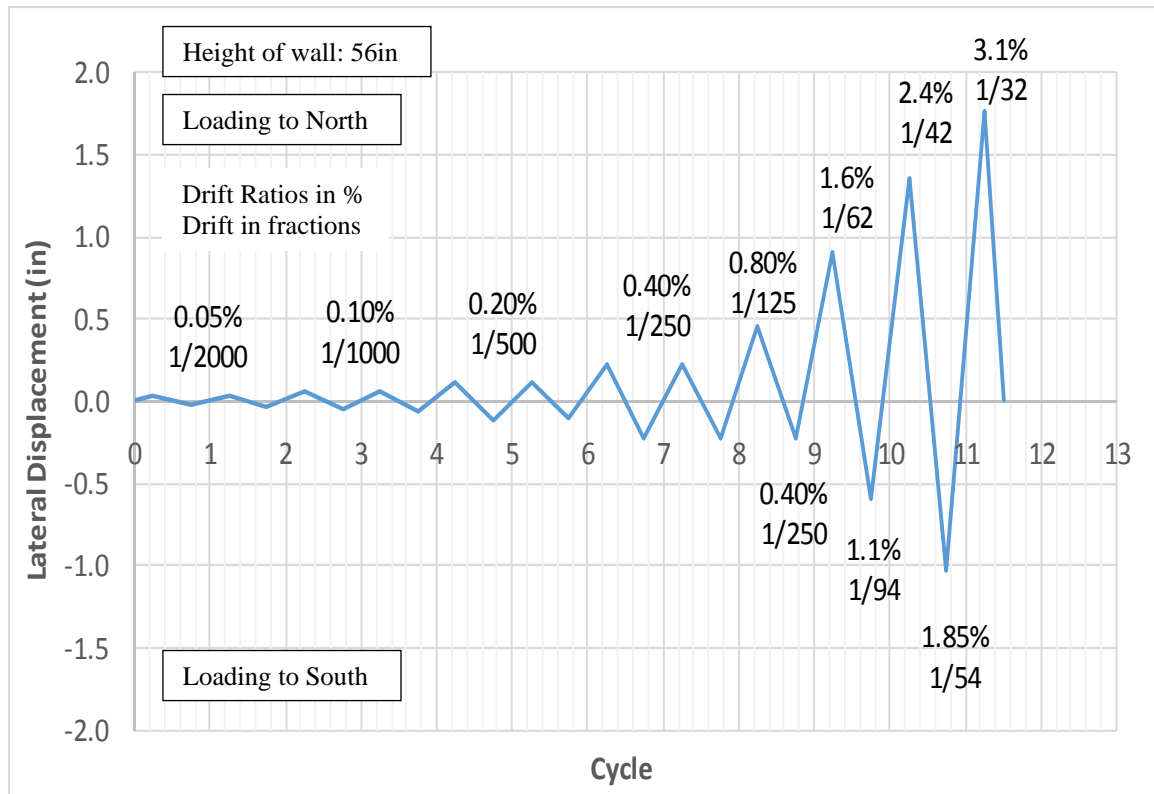
Figure 6.64 History of hysteretic cycle displacement applied to the specimen.

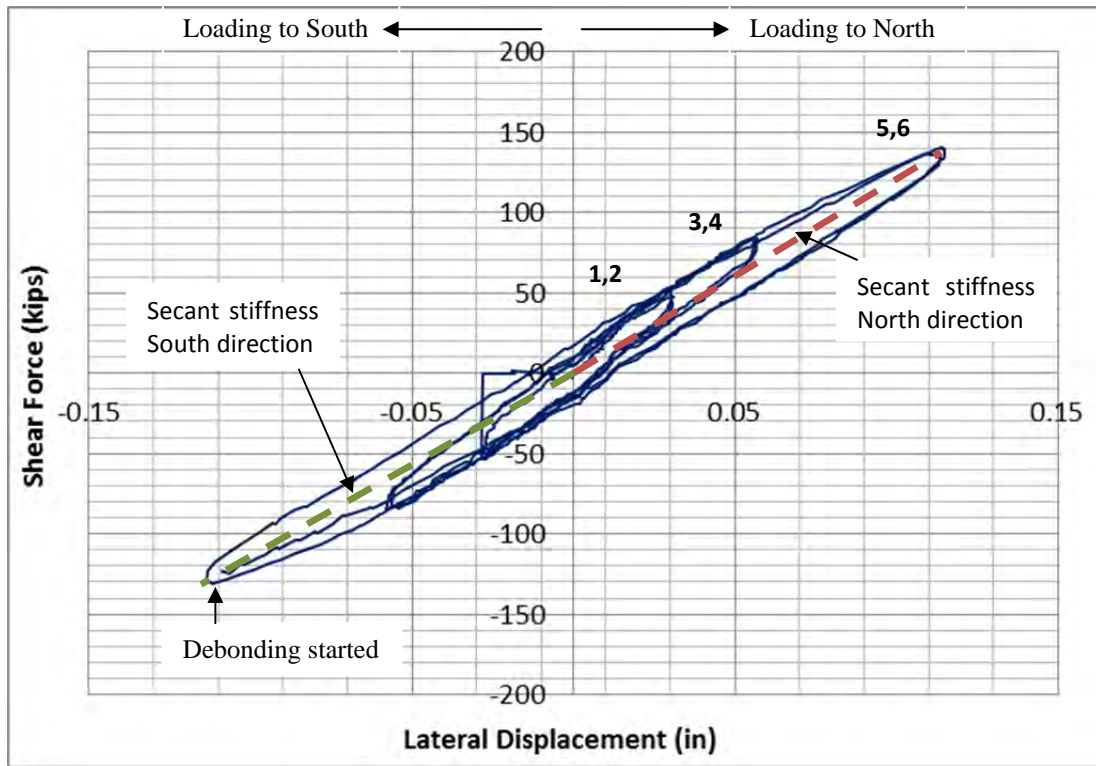
Figure 6.65 Shear force vs. Lateral displacement of the first 6 cycles – Linear range.
