**PROCEDURES TO REHABILITATE EXTREMELY DAMAGED
CONCRETE MEMBERS USING INNOVATIVE MATERIALS AND
DEVICES**

Guillermo David Huaco Cardenas, B.S., M.S.E.

Dissertation

The University of Texas at Austin

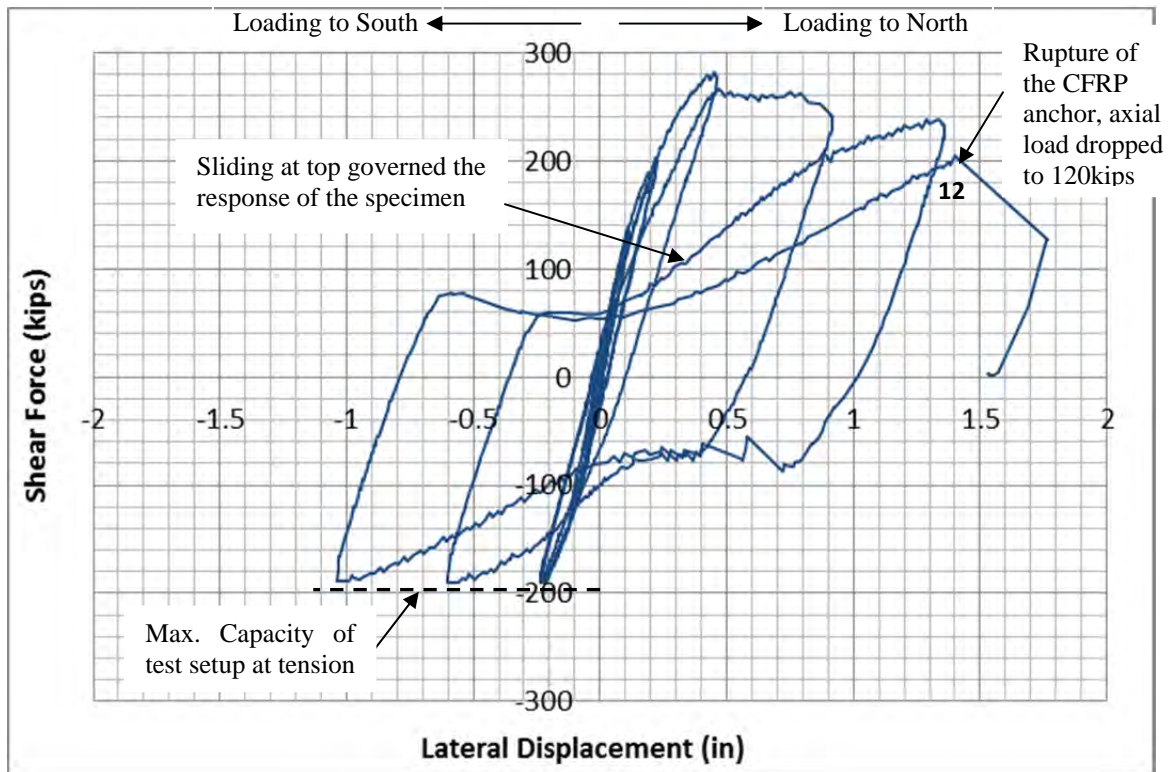
Figure 6.68 Shear force vs. Lateral displacement of RMW-R2.

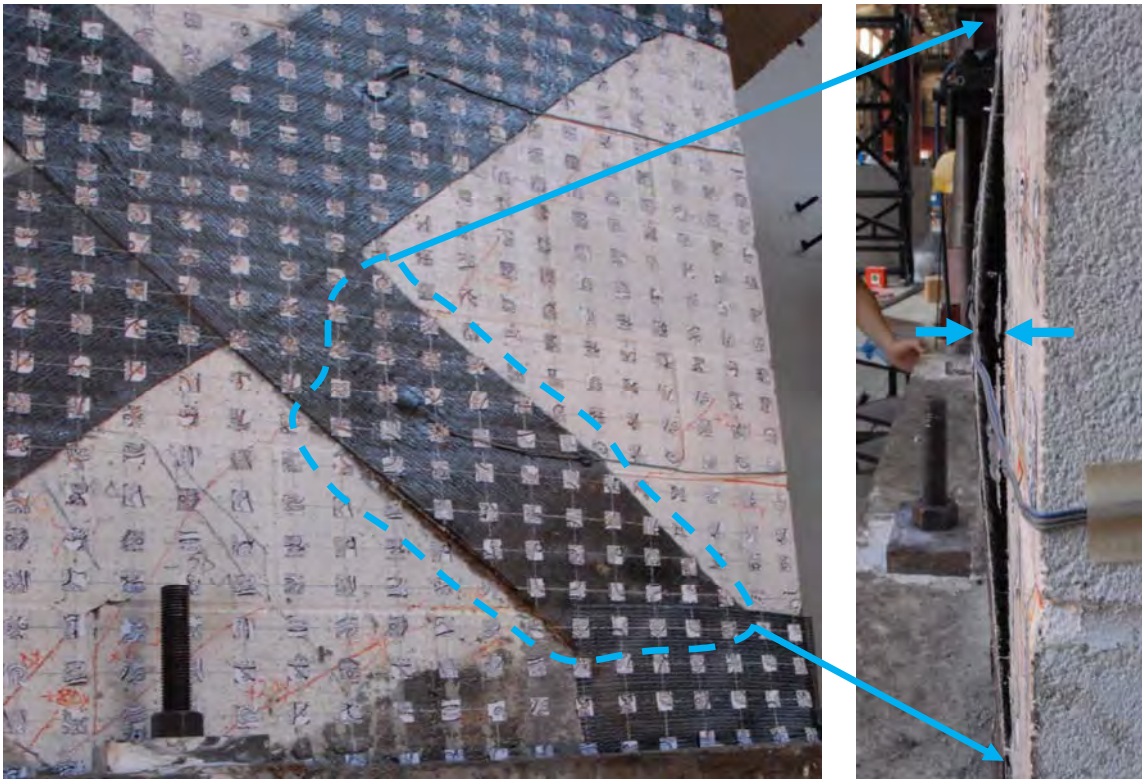
Figure 6.75 Buckling presented on 9in.wide CFRP sheet at 11th cycle.

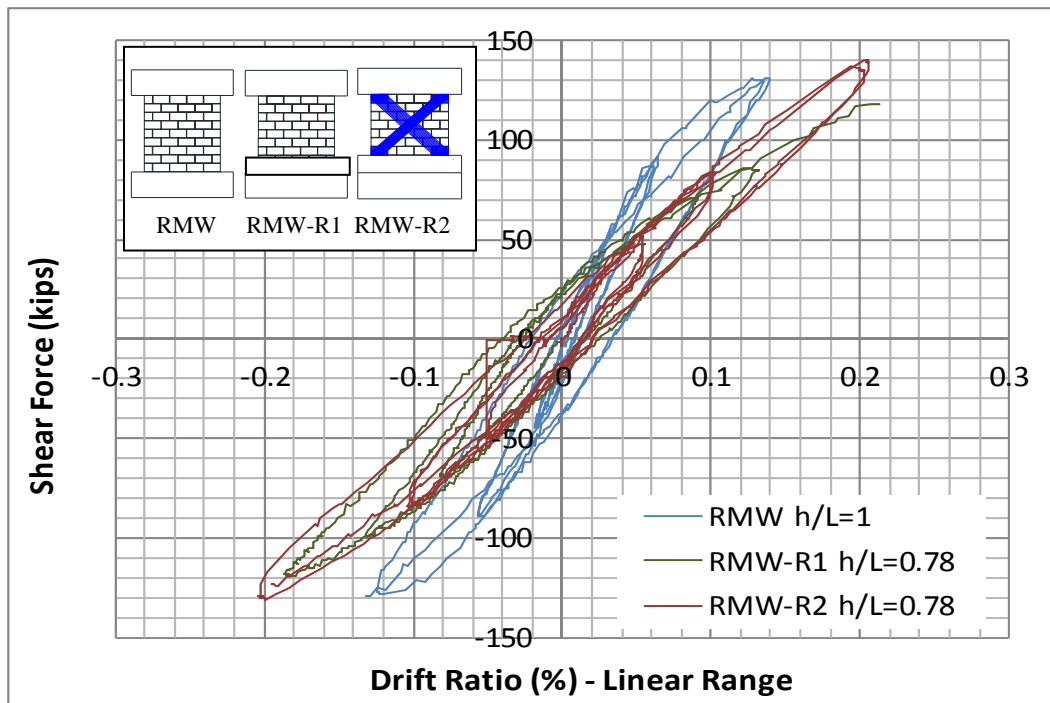
Figure 6.82 Shear force vs. drift ratio on linear range of RMW, RMW-R1 and RMW-R2

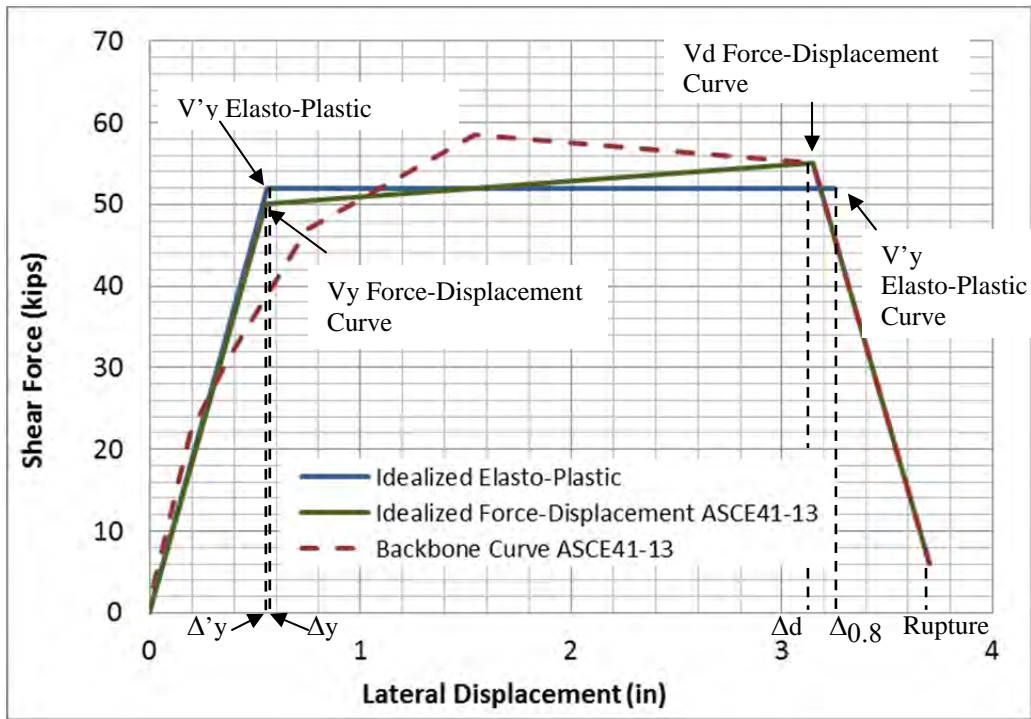
Figure 7.31 Idealized Curves for RC-1R Bottom Half

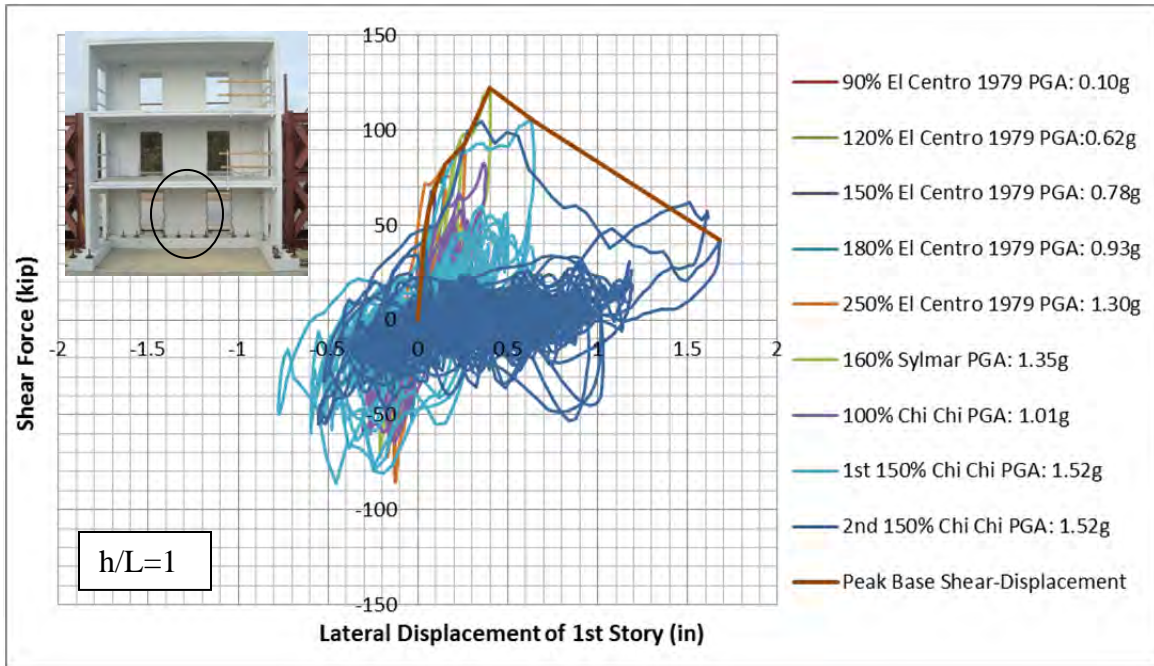
Figure 7.42 Backbone curve for UCSD W-2

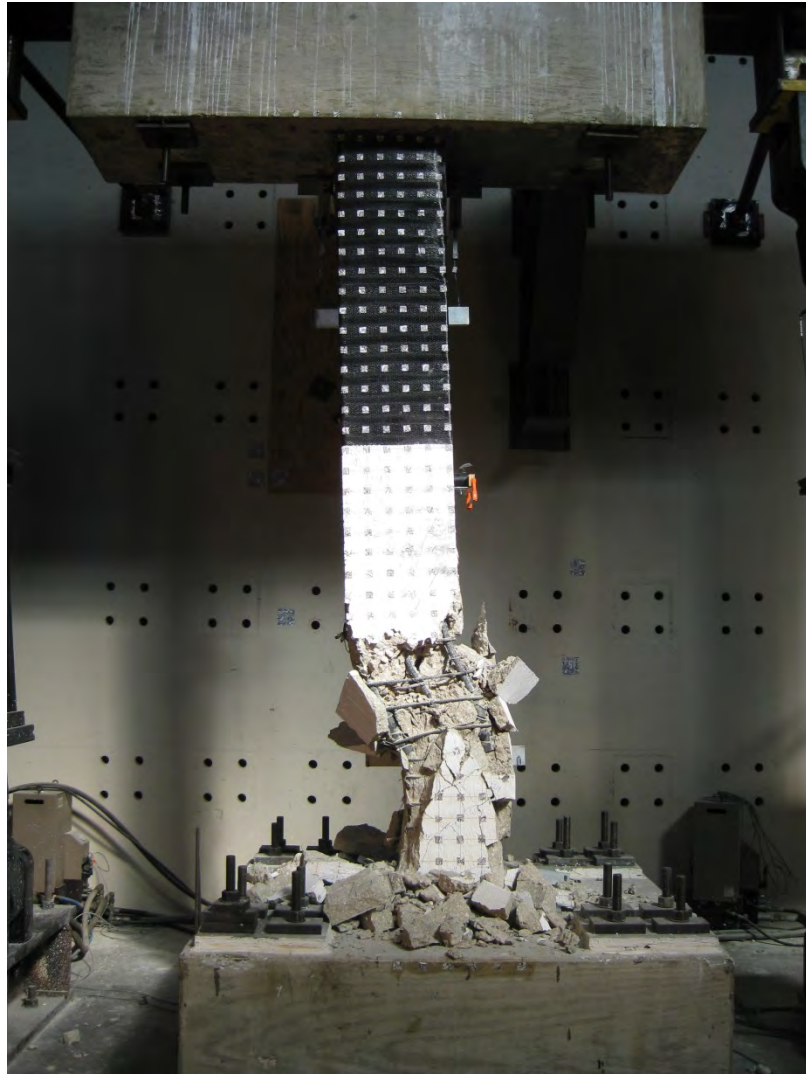
Figure G.2 Condition of the specimen at maximum lateral displacement.

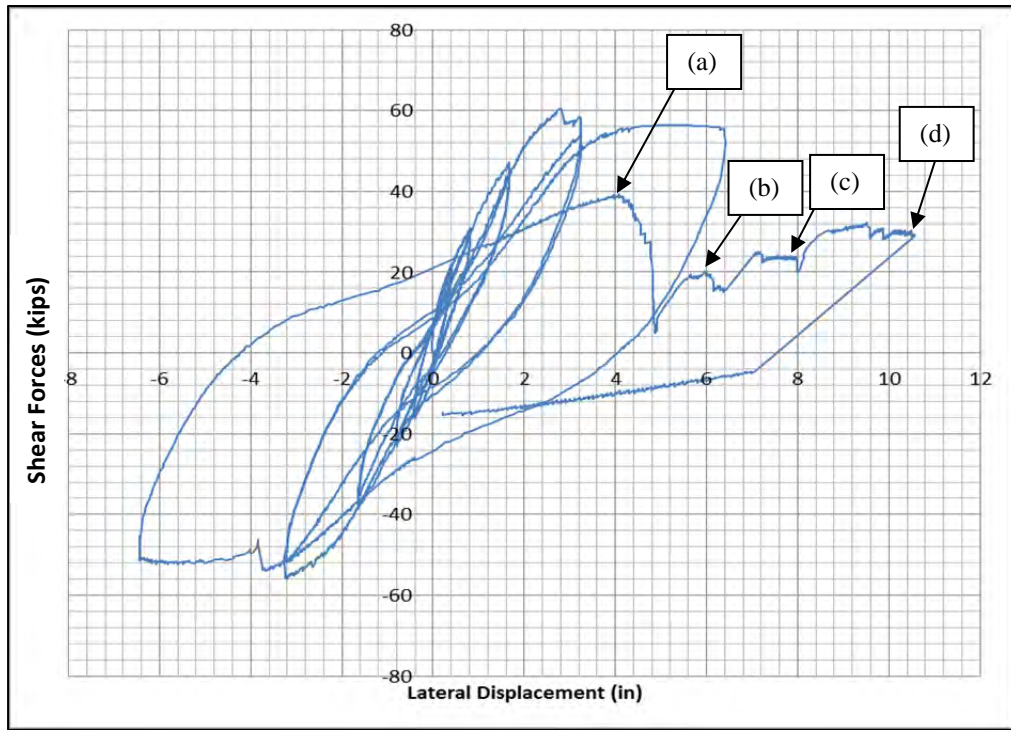
Figure G.3 Shear-displacement response of column RC-1R

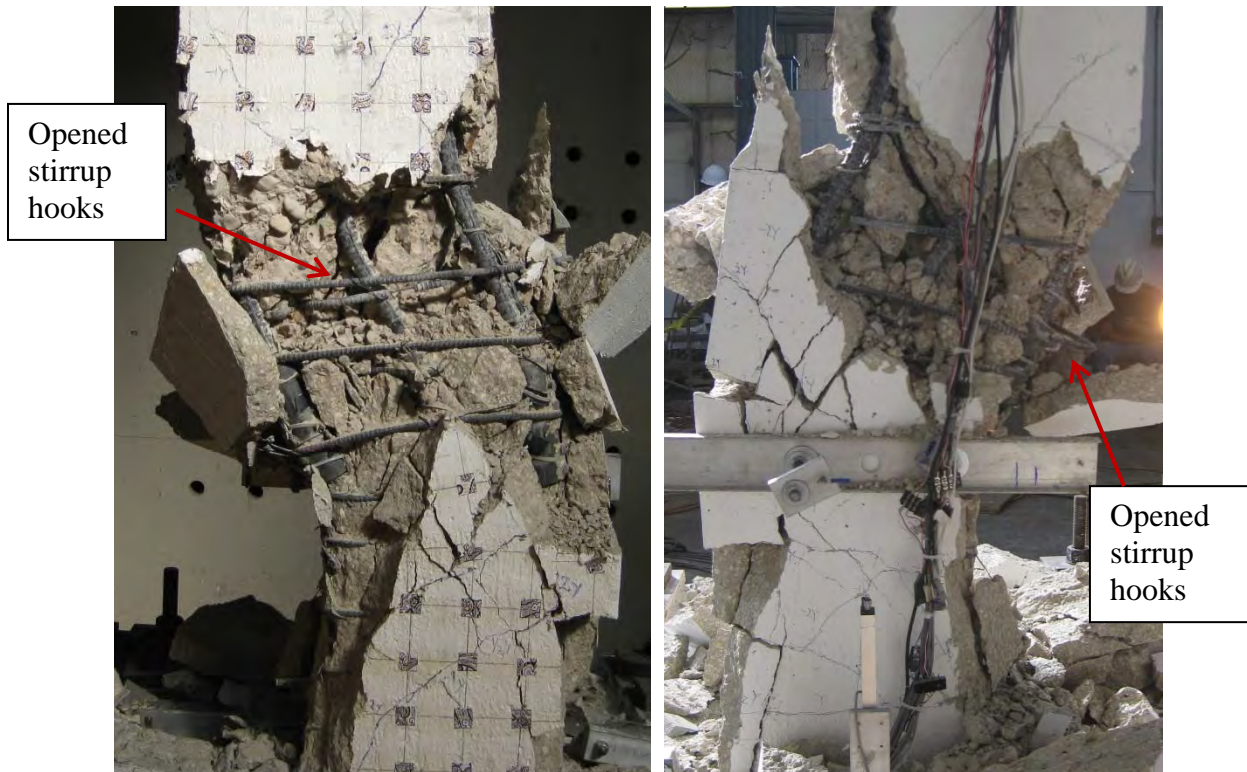
Figure G.5 West (left) and East (right) faces of the specimen at hinge region.

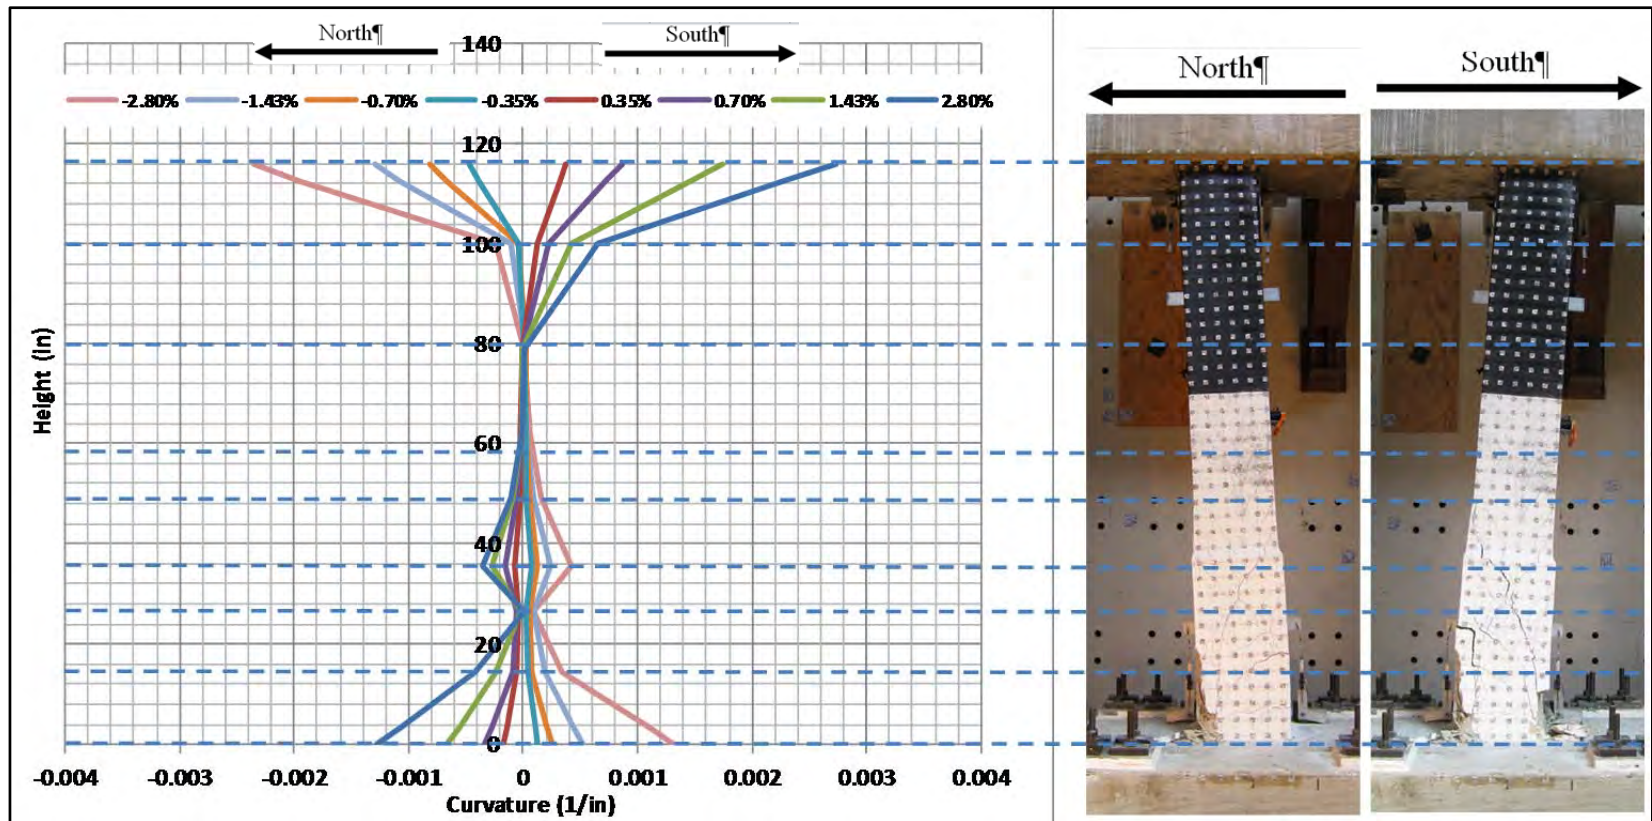
Figure H.6 Measured curvature for RC-1R

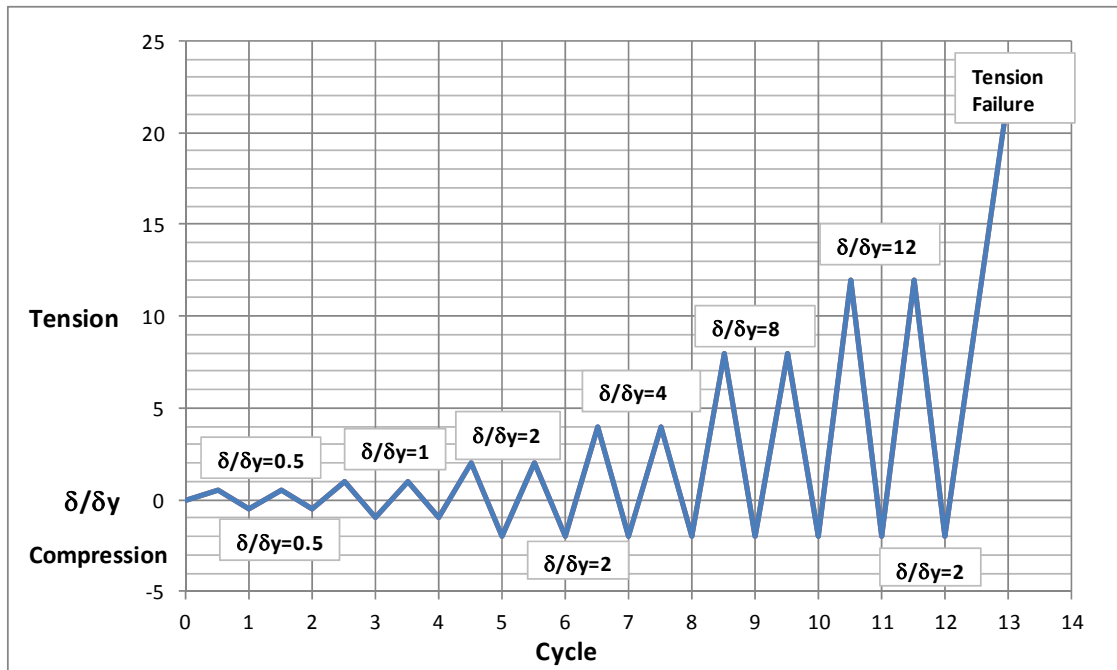
Figure I.45 Protocol of load for test of specimen MS-L4

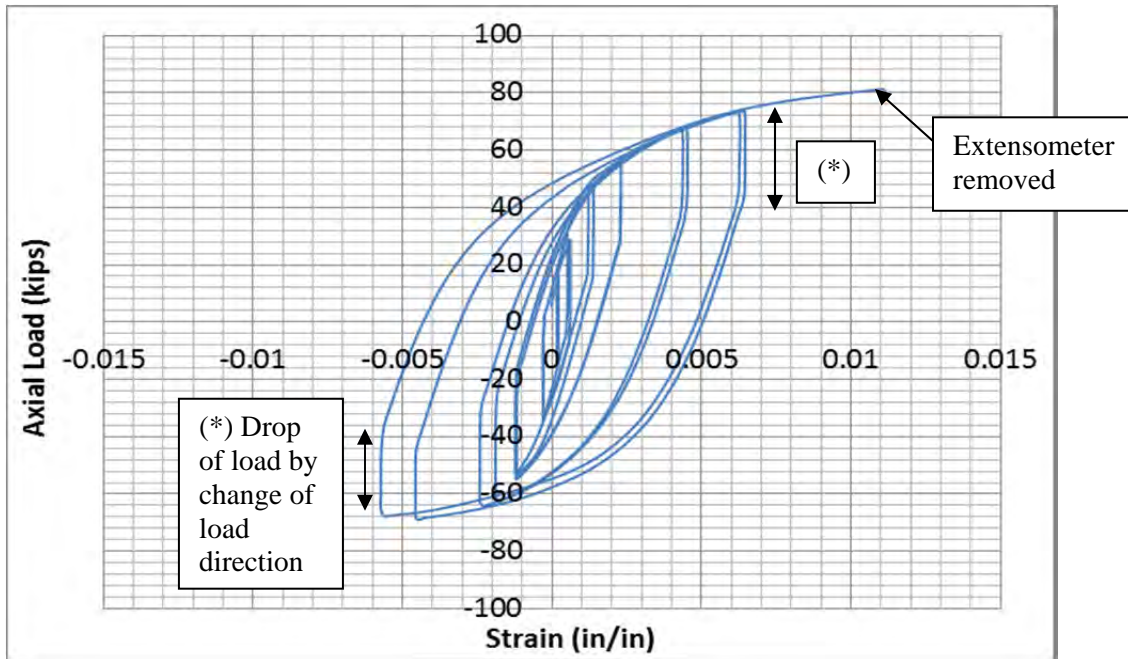
Figure I.47 Deformation measured by the extensometer for specimen MS-L4

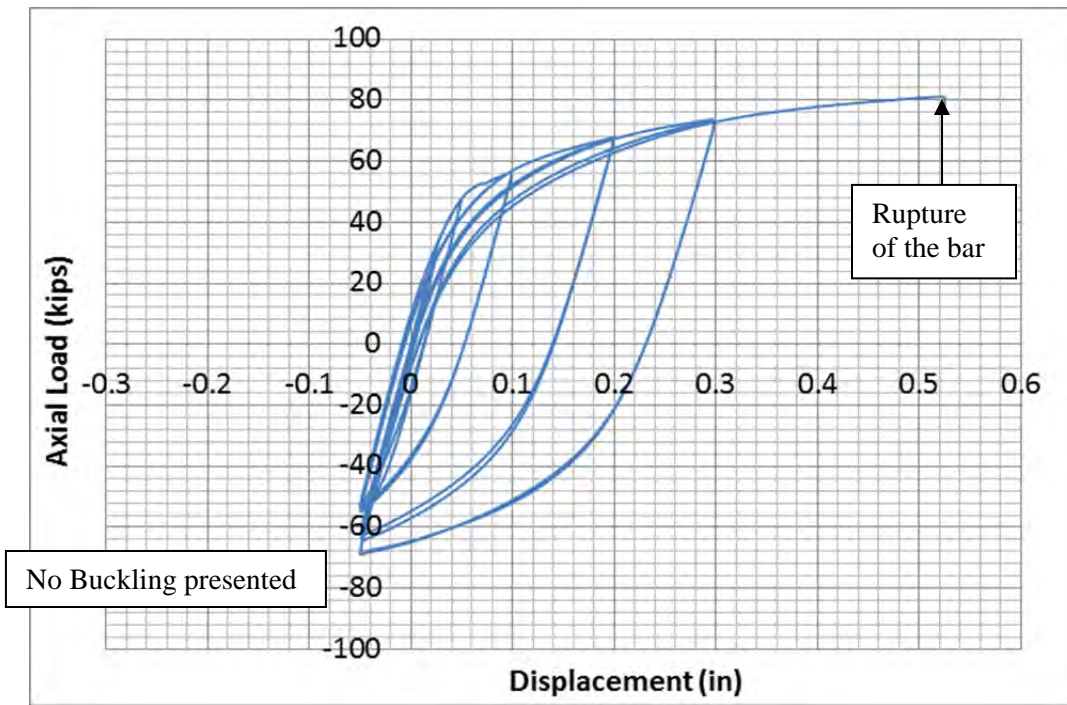
Figure I.48 Displacement measured by the stroke of the universal machine for MS-L4

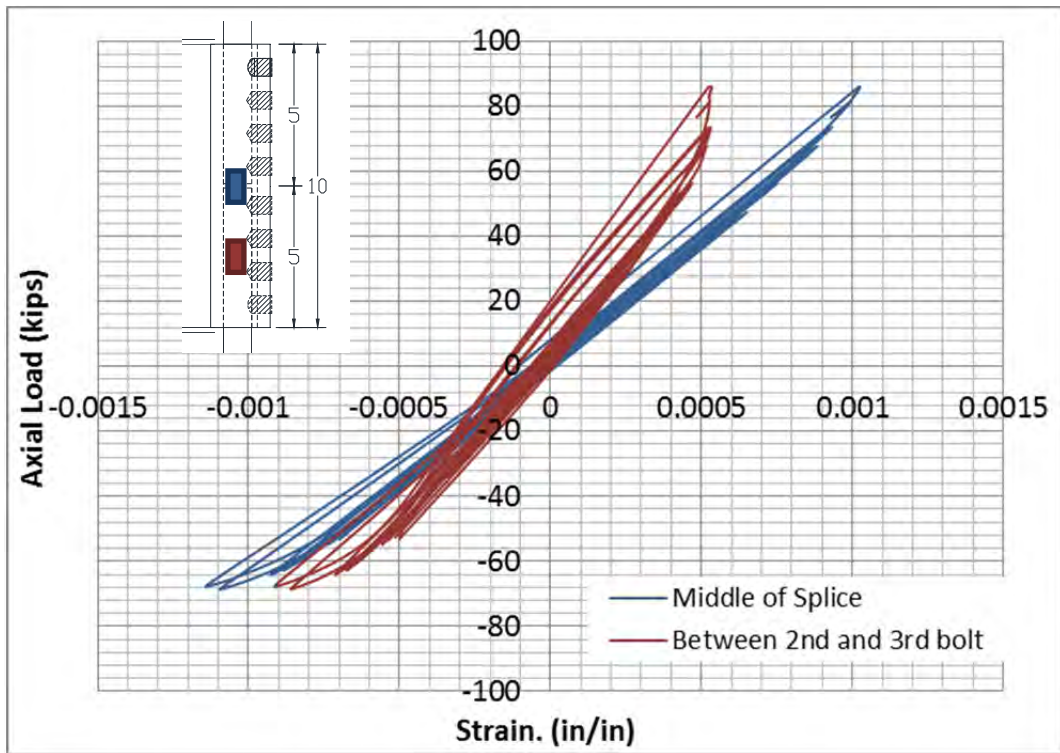
Figure I.49 Strain deformation on the short mechanical splice of MS-L4

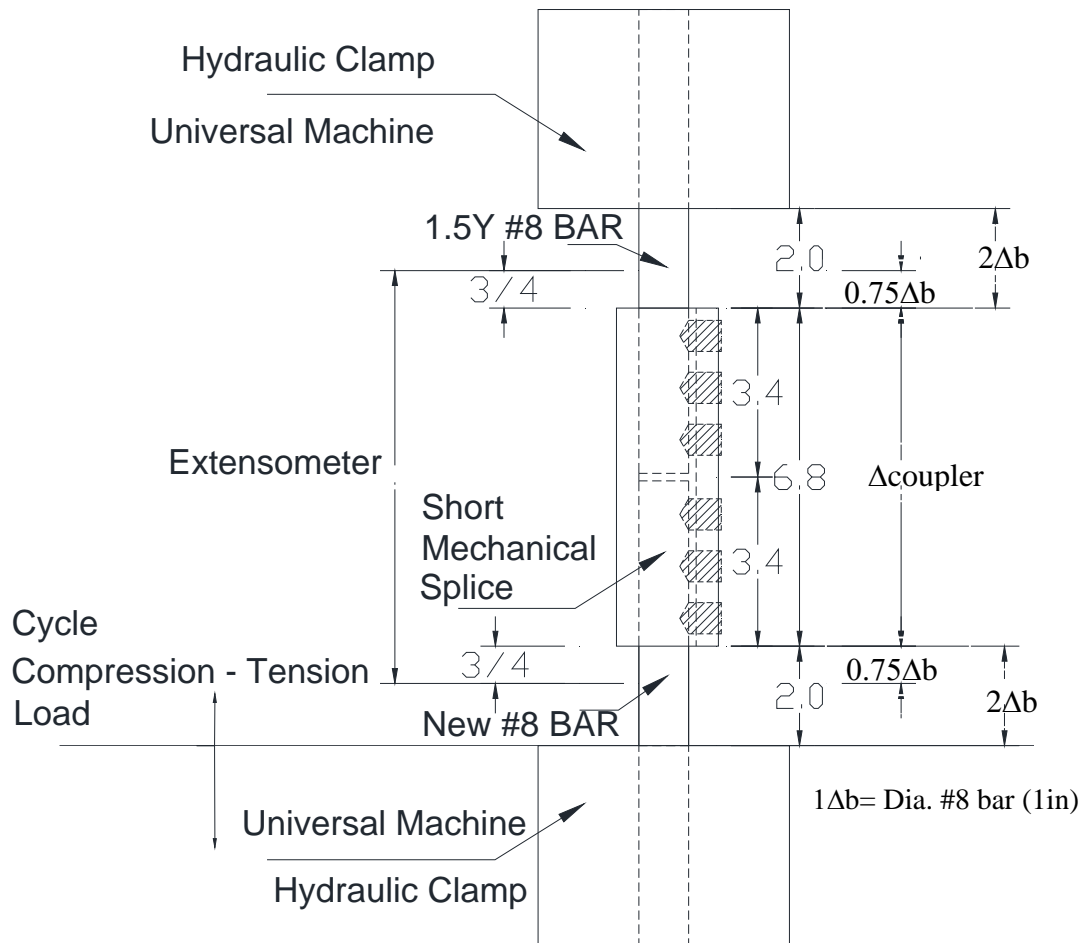
Figure I.53 Dimensions for Specimen MS-S4

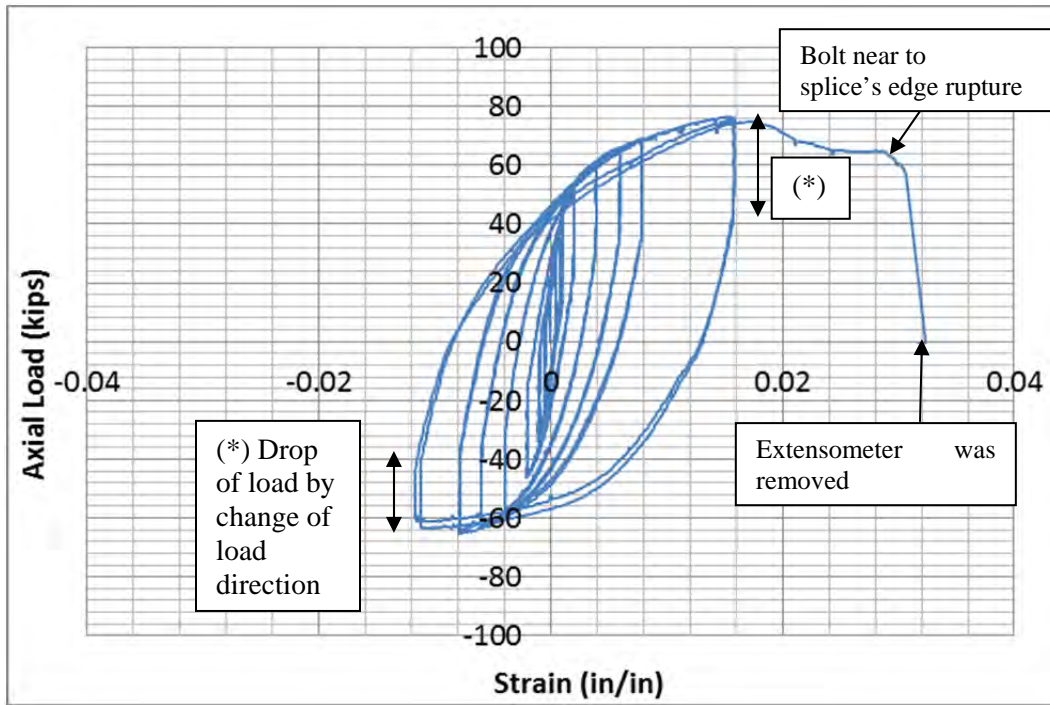
Figure I.68 Deformation measured by the extensometer on specimen MS-S5

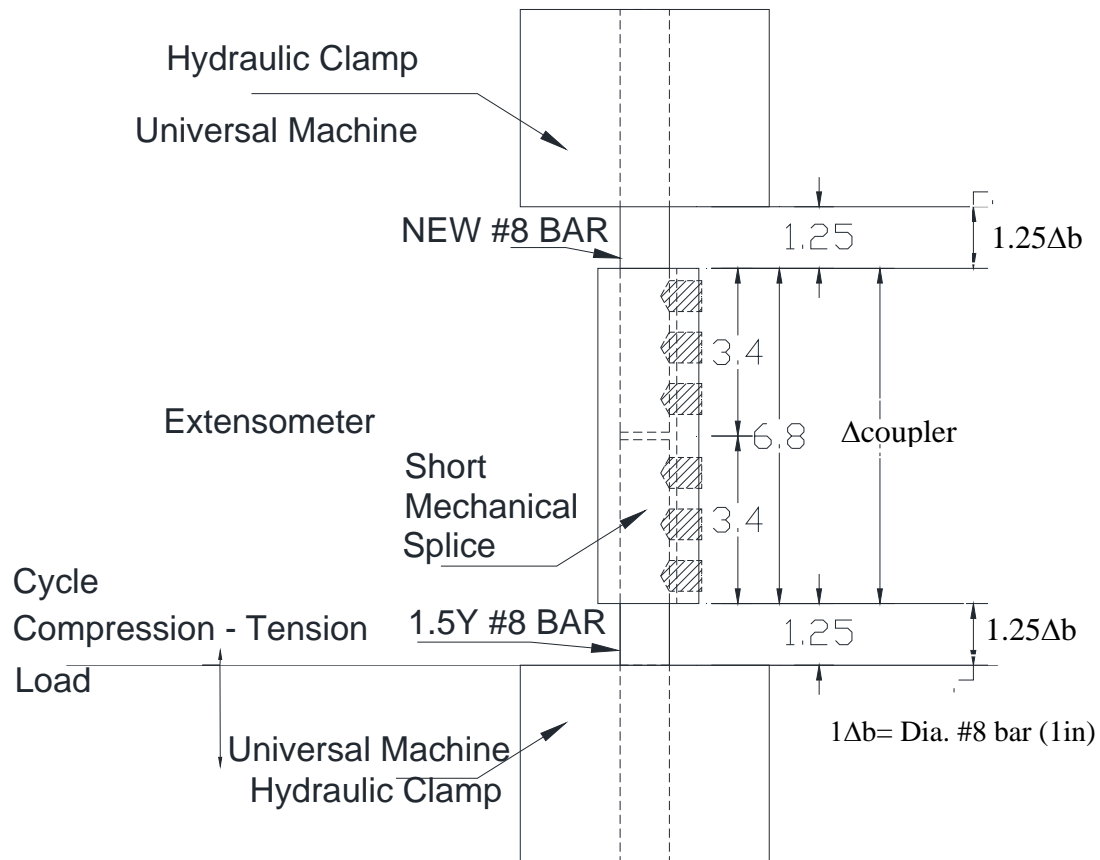
Figure I.75 Dimensions of specimen MS-S6

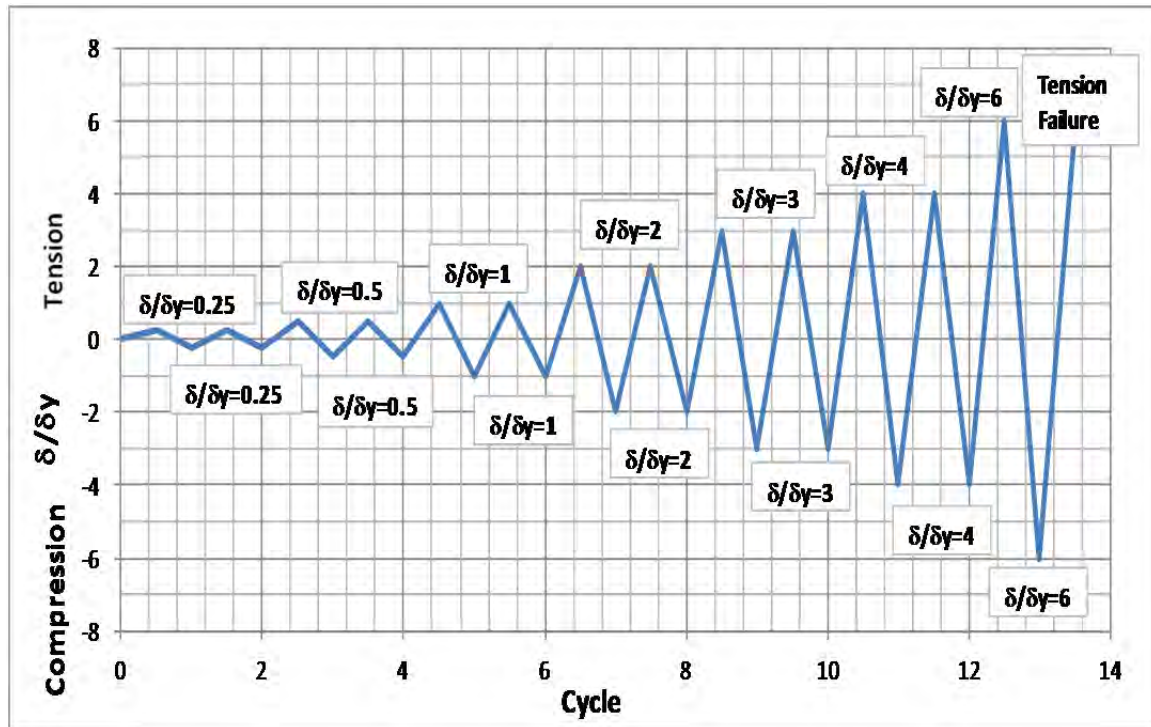
Figure I.77 Protocol of load for test of specimen MS-S5

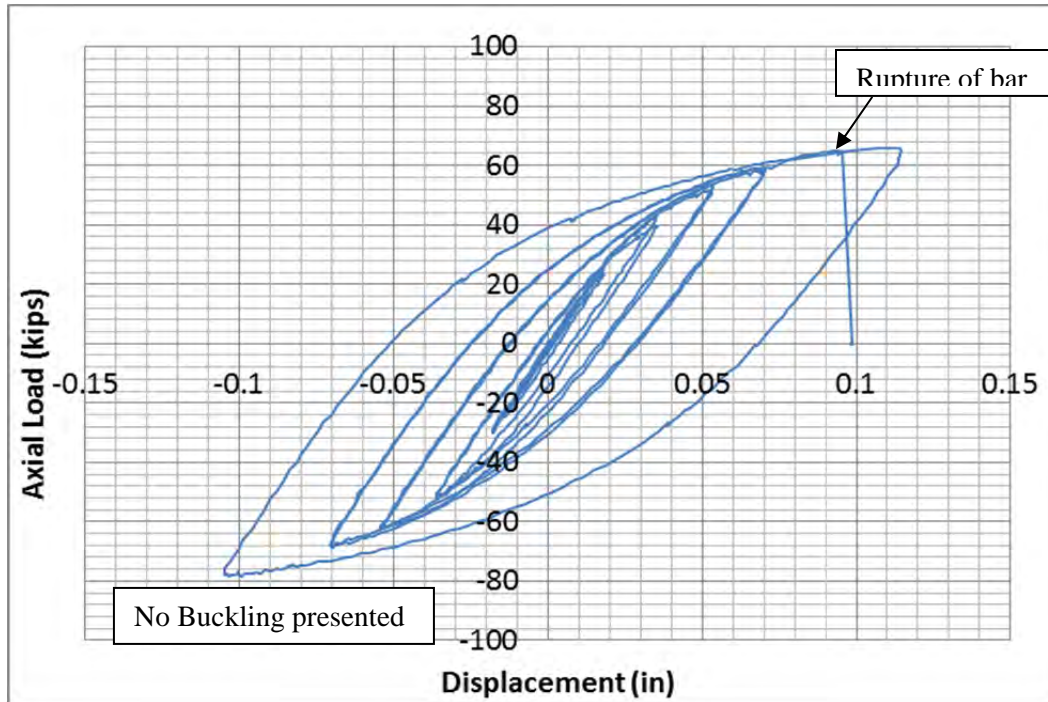
Figure I.80 Deformation measured for the system and the mechanical splice MS-S1

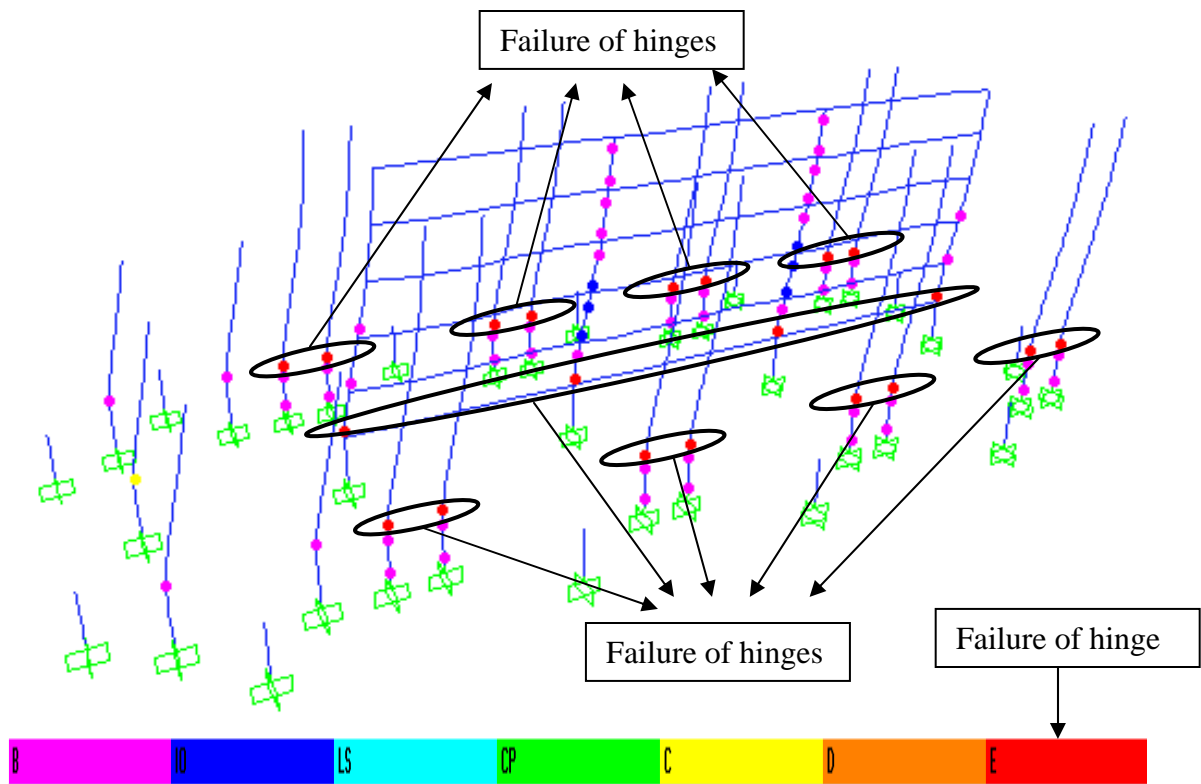
Figure J.9 Level of damaged hinges at 3.6in lateral displacement, maximum lateral capacity

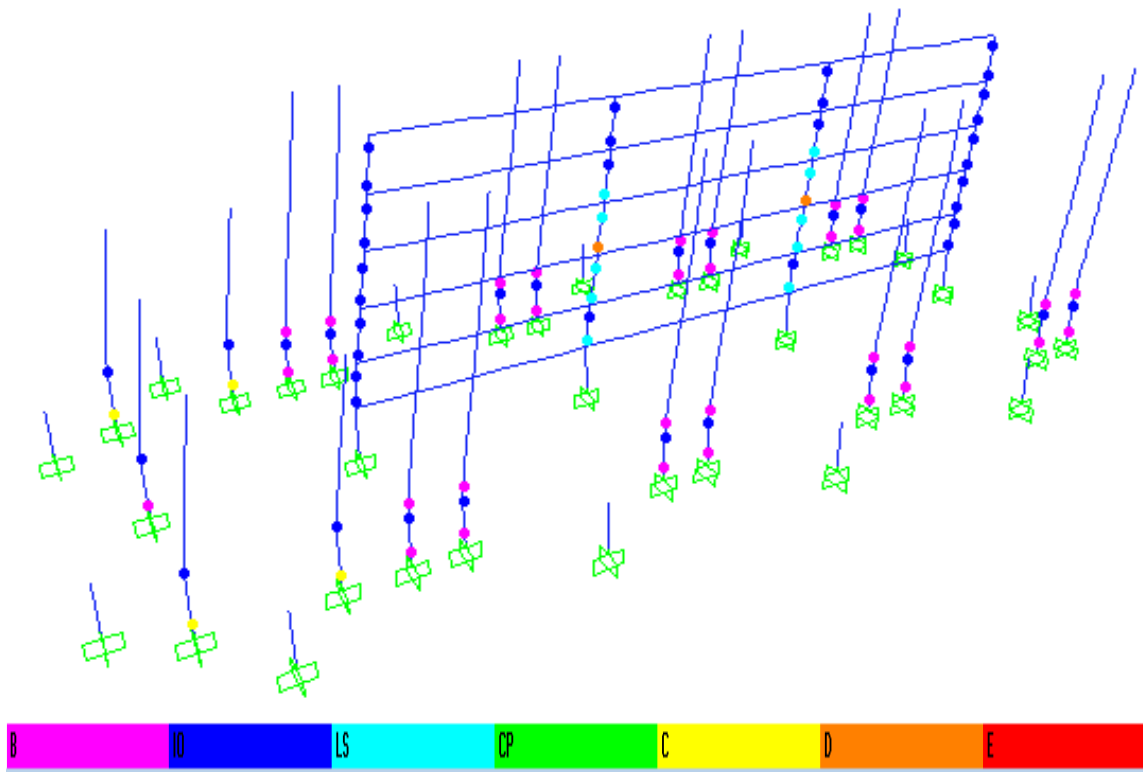
Figure J.13 Level of damaged hinges at 10.6in lateral displacement, maximum lateral capacity
