**ASR/DEF-DAMAGED BENT CAPS:
SHEAR TESTS AND FIELD IMPLICATIONS**

Thesis

The University of Texas at Austin

December 2009

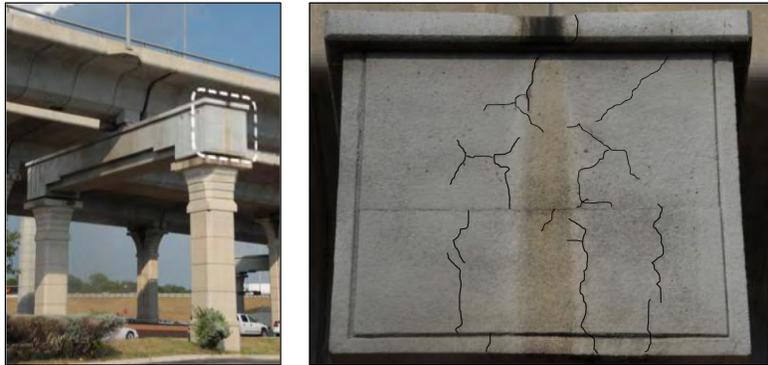
Figure 2-17: Condition of Straddle Caps within Three Years of Repair

Although the repair was recently completed in 2006, signs of persistent deterioration have already emerged. A brief visual survey of the structures in the summer of 2008 identified new damage in all but two of the repaired straddle bents. Map cracking patterns (visible to a passing motorist, Figure 2-17) were commonly found in the new cast-in-place end caps, suggesting that the waterproofing treatment has failed to arrest the internal expansion due to ASR and/or DEF. As previously suggested, field implementation of such techniques (in Texas and elsewhere, refer to Sections 2.4.1 and 2.4.2) successfully slows the progress of the mechanisms, but ultimately fails to arrest future crack development; thereby allowing further moisture ingress and the acceleration of deterioration. It should be noted that no definitive assessment of the repair technique can be made without a comprehensive study of the time-dependent deterioration.

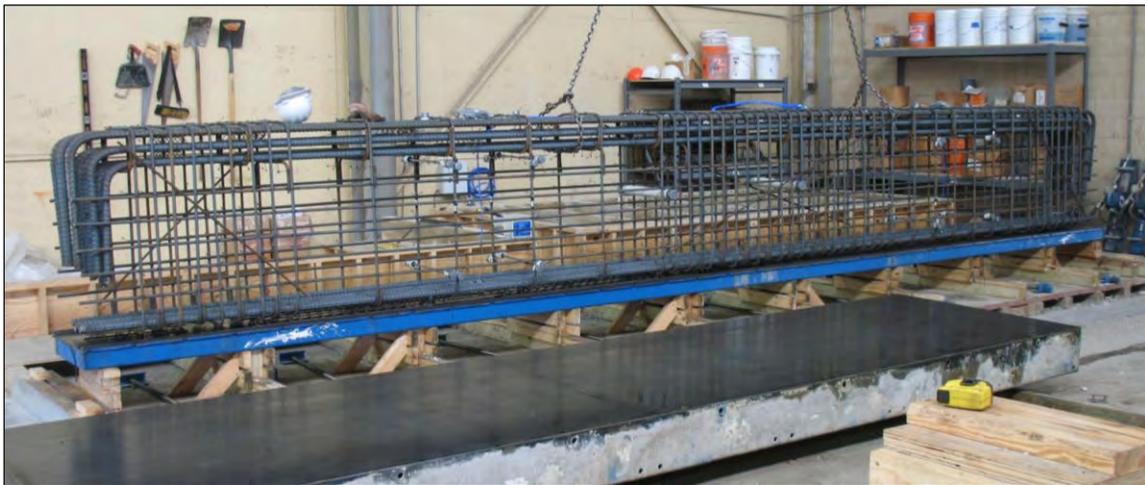
Figure 3-13: Instrumented Reinforcement Cage on Form Soffit

Each of the six identical reinforcement cages was fabricated in an inverted orientation within the laboratory. Careful placement of the reinforcement ensured uniformity across the series of bent cap specimens and facilitated the placement of instrumentation. The development and installation of the unique hardware for long-term expansion monitoring is described at length in Chapter 4. When completed, the reinforcement cage was enclosed within steel formwork, as shown in Figure 3-13. Please refer to Figure 3-4 and Figure 3-7 for fully dimensioned reinforcement layouts.

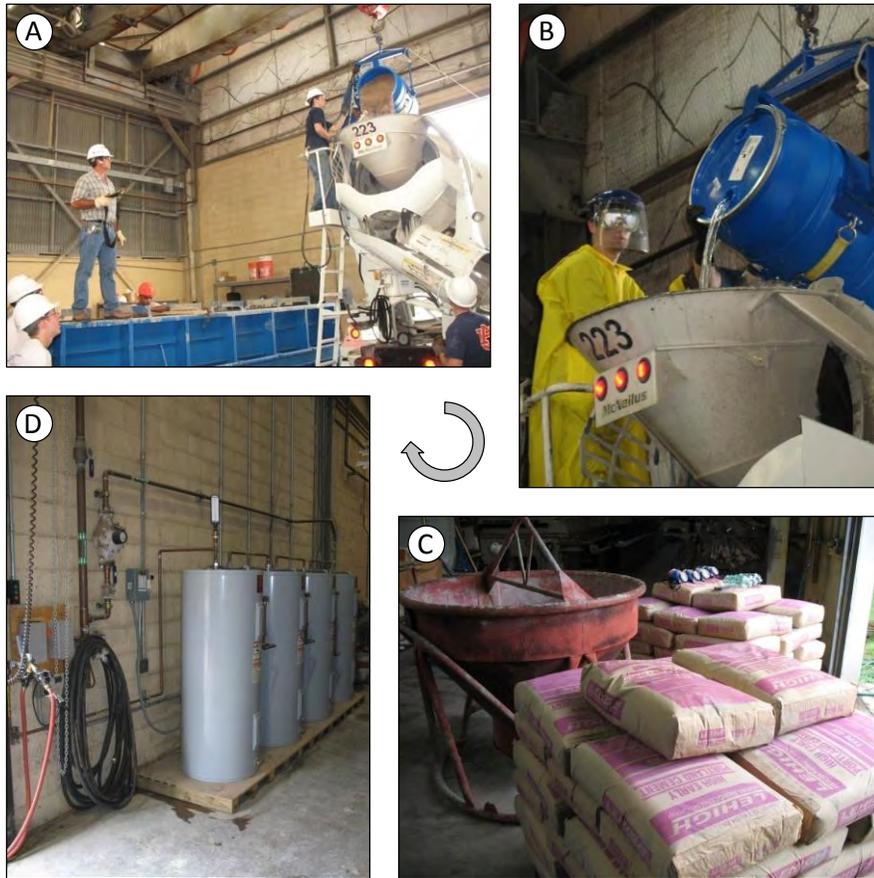
Figure 3-15: Concrete Materials Batching

An eleven cubic yard concrete mixer truck (supplied by a local ready-mix company) was used to produce the reactive concrete for the bent cap specimens. On the morning of each concrete placement, the truck was charged with the coarse aggregate at the ready-mix facility. The truck was then driven into the laboratory and an overhead crane allowed the remainder of the materials to be loaded into the concrete mixer. A geared drum turner attached to the crane was used to place the pre-weighed barrels of Jobe-Newman sand in a controlled manner (Figure 3-15A). Samples were taken from several barrels of sand to estimate of the moisture content and allow adjustment of the mixing water. The ready mix supplier did not track the moisture content of the coarse aggregate, so a similar adjustment could not be made for that material. Twelve to fourteen barrels of Jobe-Newman sand were placed into the mixer for each batch of reactive concrete.

(A) Reactive Sand (B) Sodium Hydroxide (C) High-Alkali Type III Cement (D) Hot Water

Based on the results of cement alkalinity tests conducted at a commercial laboratory (please see Table 3-5 for the results), up to seventeen pounds of sodium hydroxide was diluted in two fifty-five gallon drums of water. The solution was then poured into the concrete mixer; operator safety was addressed through the use of eye protection and a splash jacket (Figure 3-15B). As hot water was added to the mixture, the high-alkali cement was quickly batched into the ready-mix truck via a one cubic yard concrete bucket (Figure 3-15C). The total water addition was controlled through the use of a volumetric flow-meter plumbed into the hot water outlet. Four eighty-gallon water heaters (specifically installed for the study discussed here) supplied the mixing water at temperature in excess of 120°F (Figure 3-15D).

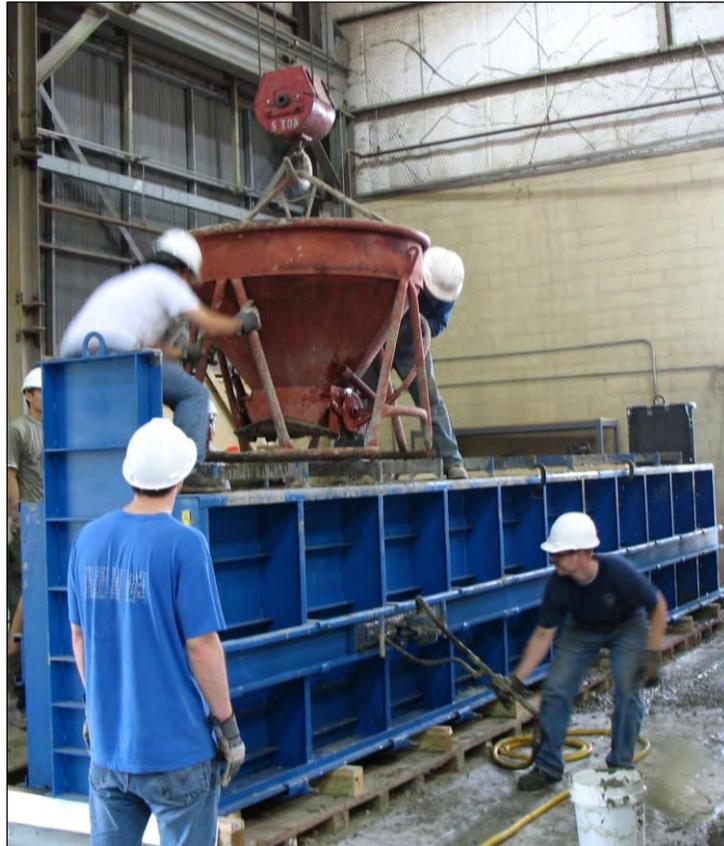
Figure 3-16: Concrete Placement and Form Vibration

Following the addition of all the concrete materials, the mixer was turned a minimum of two hundred revolutions to ensure uniformity. The mixture was then checked for consistency and additional revolutions and/or mixing water were added as necessary. Slump of the mixture ranged from eight to eleven inches and was easily placed using conventional and side form vibration as shown in Figure 3-16.

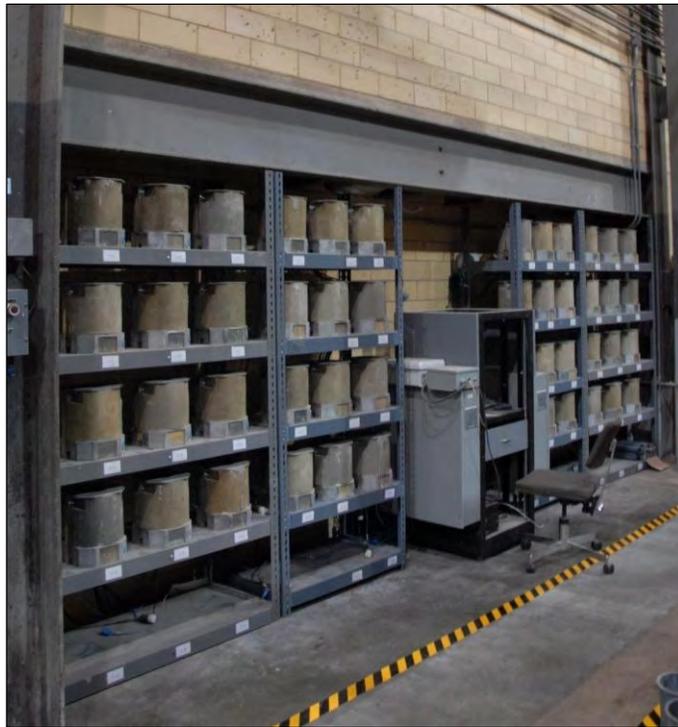
Figure 3-22: FSEL Sure Cure System – Controller and Molds

Temperature match curing was originally developed for the precast concrete industry. It is based upon the simple observation that the maturity (and strength) of a concrete element is controlled by the temperature history. The mass of an individual cylinder is incomparable to that of a precast concrete member and will therefore fail to generate the heat and temperatures necessary to mature at the same rate. The resulting cylinder strength will be unrepresentative of the precast concrete member. To obtain consistent maturity and strength, temperature match curing techniques use external sources of heat (i.e. generated by the mass concrete placement or an electrical source) to match the cylinder temperature to that of the precast member. When implemented during the current study, temperature match curing provided an additional benefit: cylinders simultaneously cast with each specimen possessed nearly identical expansion characteristics.

An in-house temperature match curing system (*Sure Cure*) was used to fabricate all of the cylinders in this study (Figure 3-22). The six thermocouples identified in the

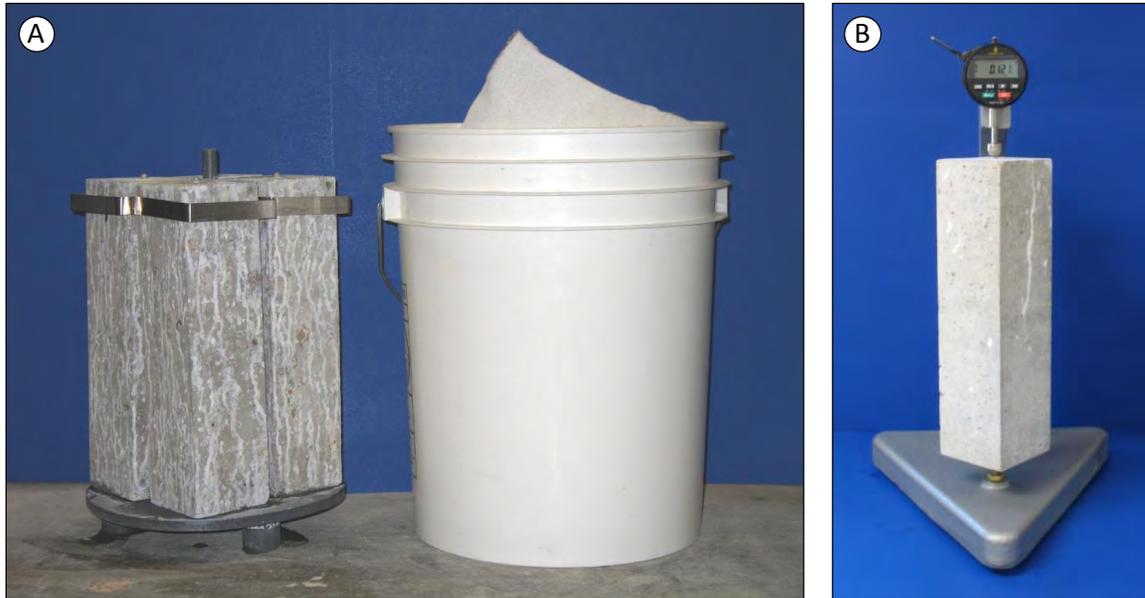
(38°C). Subsequent length change of each prism is periodically measured with a comparator (Figure 3-25B) over a period of one to two years. Pre-established criteria are then used to determine the severity of the resulting expansions. If the average expansion of the prisms exceeds 0.04 percent in one year, the concrete mixture (and constituent aggregate) will be classified as deleteriously reactive.

**Figure 3-25: Free Expansion Potential (A) Elevated Prisms Set in Felt-Lined Bucket
(B) Periodic Measurement of Length Change with Digital Comparator**

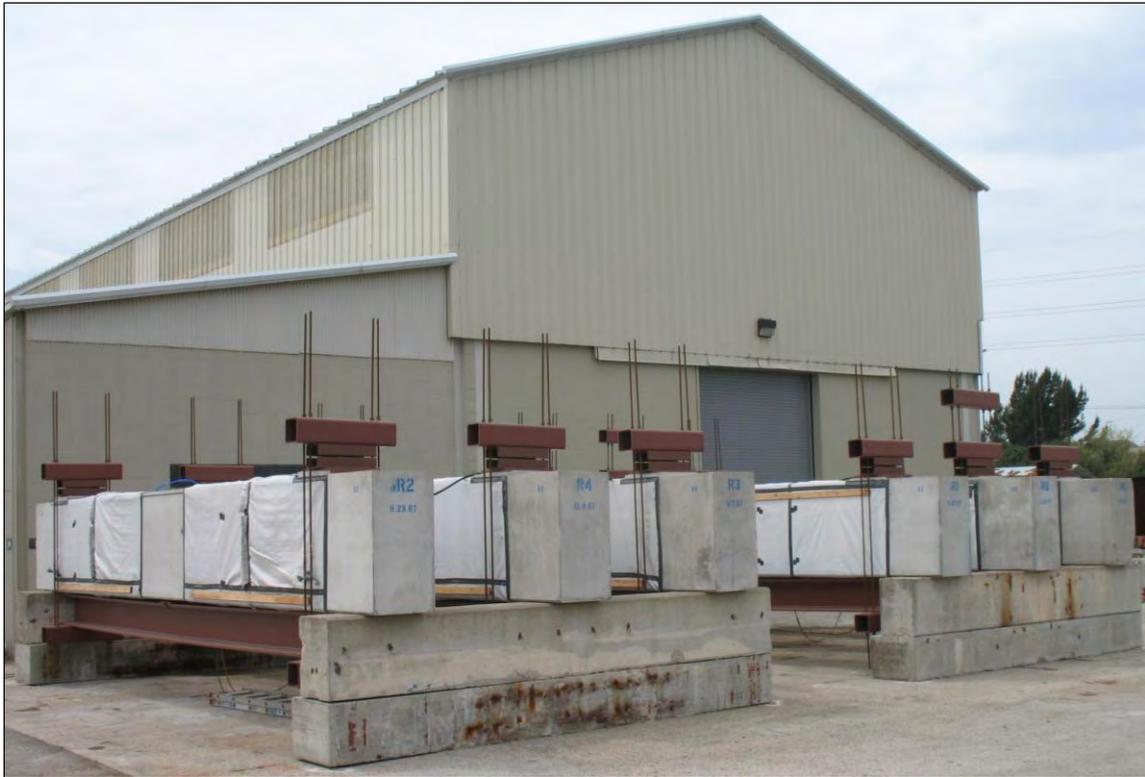
Figure 4-2: Exposure Site at Ferguson Structural Engineering Laboratory

Shortly after removal of the formwork, each beam was moved outside. A fifteen-ton forklift and set of rollers were used to maneuver the near full-scale specimens out of the laboratory doors. Careful planning and extreme care minimized spalling and cracks due to transport. The test regions did not incur any damage. Concrete dunnage placed at the north end of the laboratory supported the beams and all future conditioning operations (see Figure 4-2). It is worth noting that the Concrete Durability Center (UT Austin) has conducted a large number of long-term ASR/DEF studies at their own outdoor exposure site, located less than two hundred feet from Ferguson Structural Engineering Laboratory.

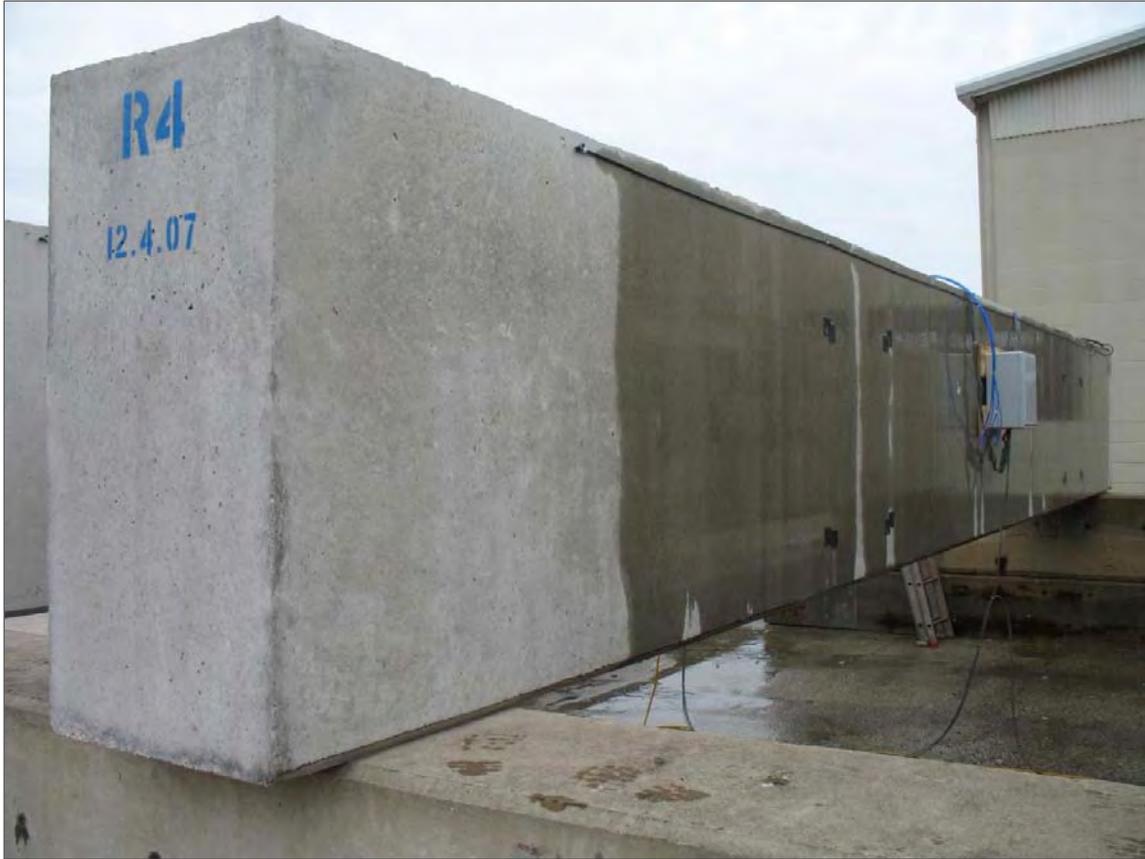
Figure 4-5: Demonstration of Watering System

To replicate the severe conditions described above, a watering system was installed at the exposure site. Three irrigation lines ran the length of each beam. Regularly spaced emitters ensured even water coverage over the top and sides of each shear span (see Figure 4-5). Moisture conditioning of the end regions was not necessary and the irrigation lines were therefore terminated to maximize efficiency. Poly-coated burlap was eventually applied to trap water at the end of each cycle; rapid drying of the specimen was thereby limited.

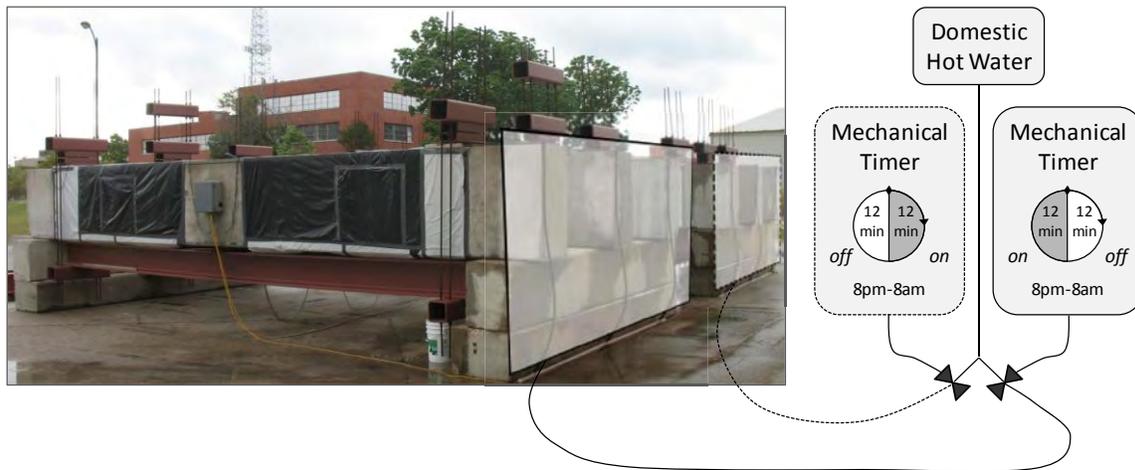
Figure 4-6: Alternating Two-Zone Watering System

Each specimen was plumbed in a parallel system with two companions. As a result, two individual watering zones were formed. The first zone contained specimens selected for short-term conditioning (R1, R2 and nR1), while the second zone contained those intended for further long-term study (R3, R4 and nR2); please see Section 4.3 for further explanation. Each zone was controlled by a commercial timer and sprinkler valve. Watering cycles were programmed to occur after dusk at an interval of twelve minutes. To maintain adequate pressure, the supply of water was diverted to one individual zone at any given time. A schematic of the completed watering system is shown in Figure 4-6. All of the plumbing fixtures used within the system were obtained from a local supplier of landscape irrigation products.

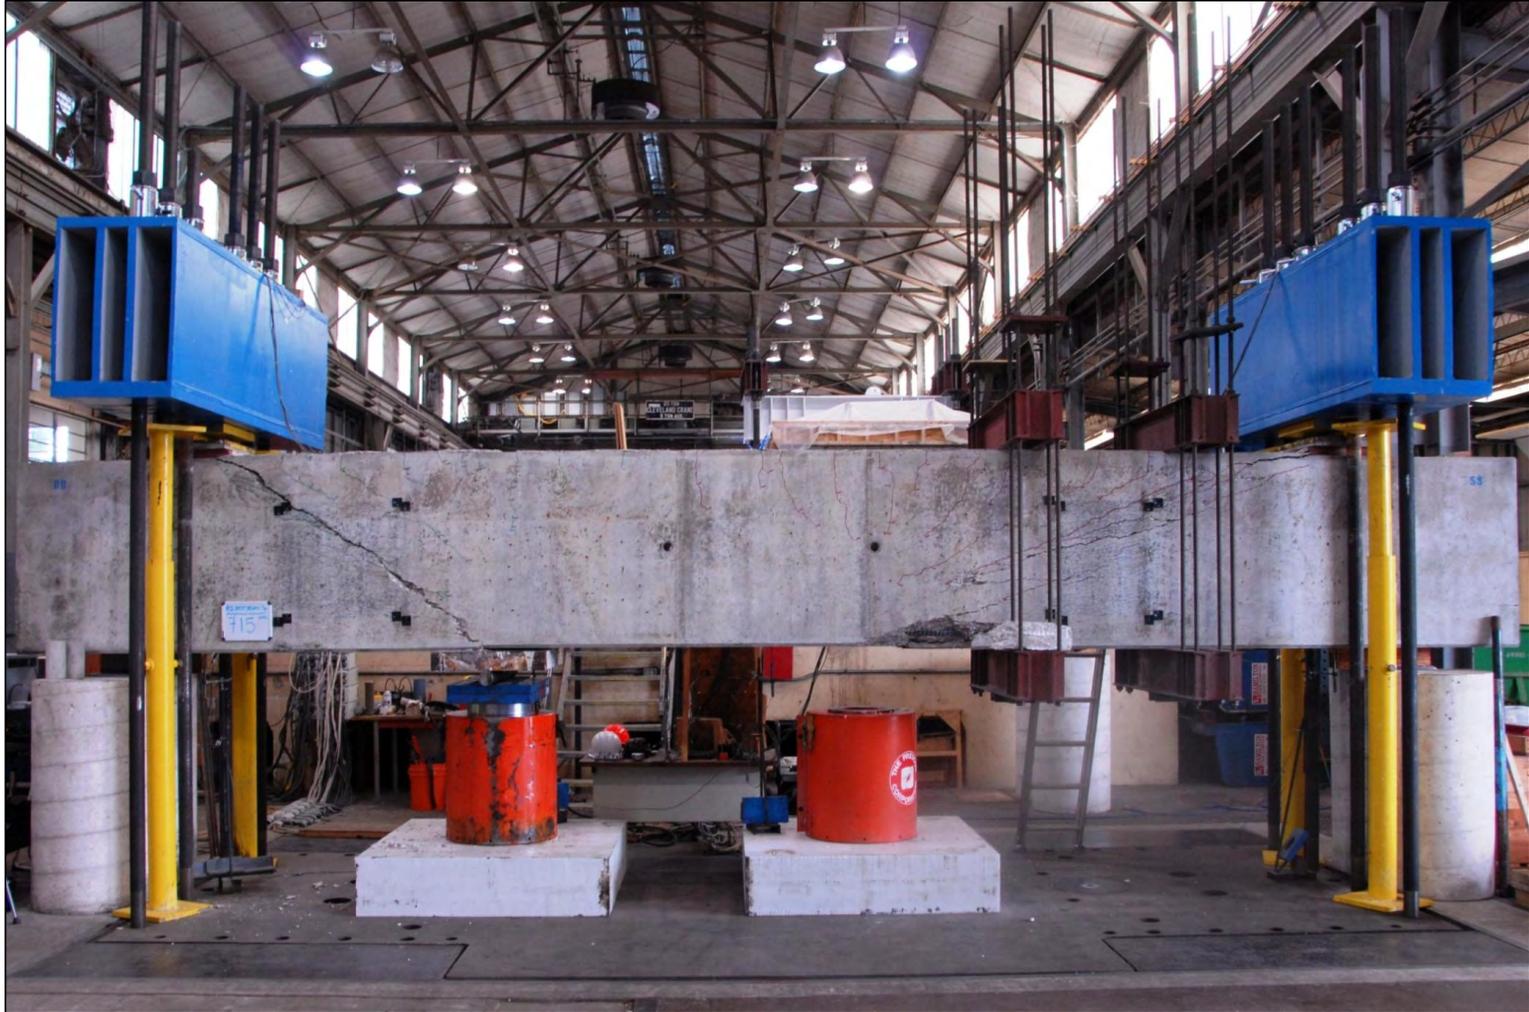
Figure 4-18: Large-Scale Beam Test Facility

The centerpiece of the new facility was a 96,000 pound cast-steel platen; donated to FSEL after a six million pound universal test machine was decommissioned by the U.S. Navy. The steel platen or *strong floor* provided the test frame with the *backbone* resistance necessary to test the bent cap specimens in shear. A two million pound capacity, double-acting hydraulic ram was supported by the strong floor and exerted an upward force at the desired shear span location. Simple supports were provided at the two large steel plate girders (i.e. transfer beams) and high strength threaded rods transferred the load back to the floor. Configuration of the test frame for the current study is illustrated in Figure 4-15, Figure 4-16, and Figure 4-17. The extraordinary scale of the facility is demonstrated in a photograph (Figure 4-18) taken at the conclusion of deep beam shear testing.

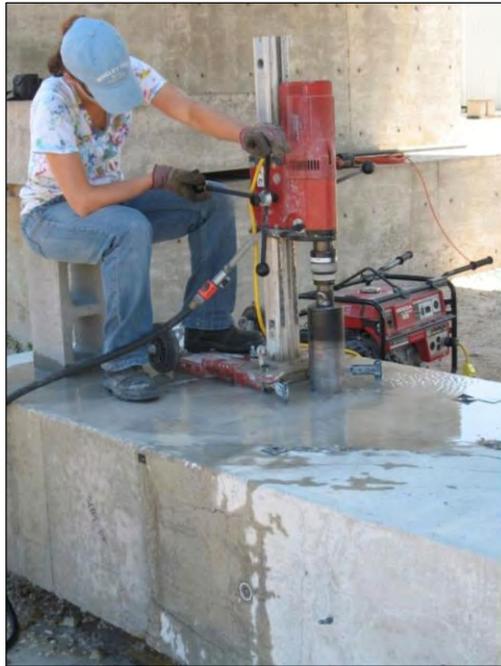
Figure 4-30: First Series Specimens - Extraction of Cores

All of the samples were extracted using a coring system outfitted with a four-inch diameter diamond core bit and powered by a 5000 watt generator (shown in Figure 4-30). Prior to installation of the coring system, the location of the reinforcement was marked on the concrete surface. The bit was then aligned and advanced halfway through the section. Following the removal of the first segment, an extension was placed on the core bit to allow removal of the remaining cross-section width. Each sample was towel dried immediately after extraction and then allowed to air dry for a maximum of one hour. Plastic wrap and a plastic bag were used to seal each core against further moisture loss during the interim period between extraction and testing. All relevant procedures found within ASTM C42 were implemented during the sampling process.

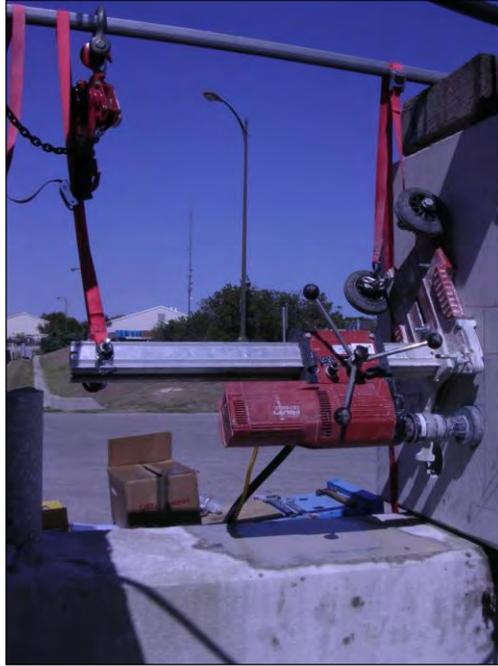
Figure 4-33: Second Series Specimens - Extraction of Cores

setup the coring system for the horizontal extraction of cores (shown in Figure 4-33). Aside from difficulties related to the upright orientation of the specimens, the sampling process was straightforward. Coring procedures detailed with Section 4.4.3 were implemented in the same manner as before.

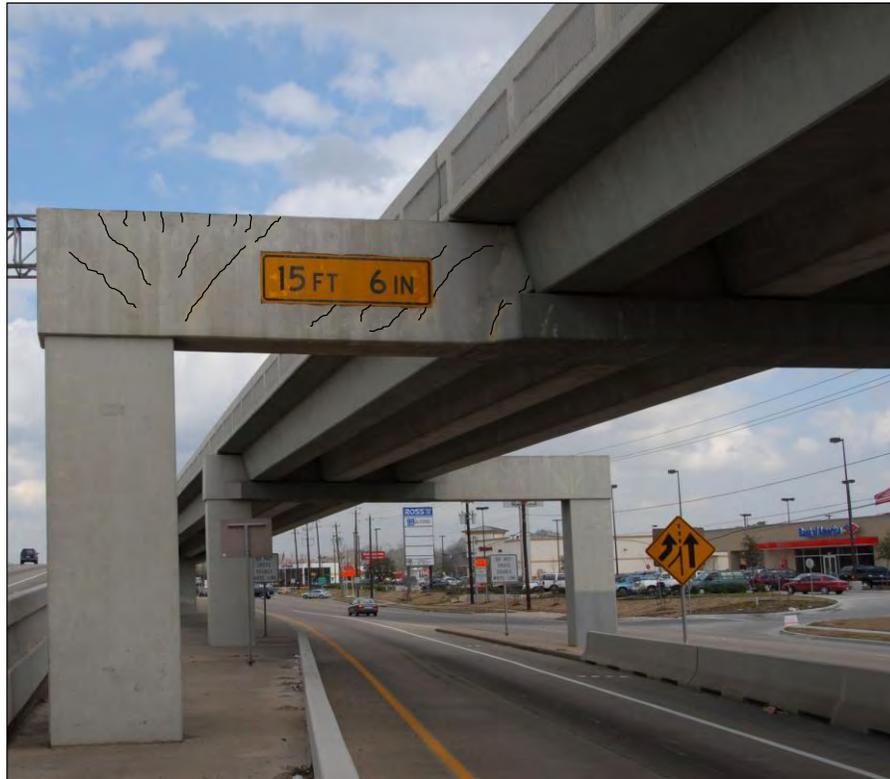
Figure 5-14: Diagonal Cracking within an Inverted Tee Bent Cap

Before reviewing the surface cracking patterns, the practicality of the current exercise will be considered. Under select circumstances, ASR/DEF-related surface cracking has formed a striking (occasionally deceiving) resemblance to commonly-recognized structural cracking. The researchers of TxDOT Project 0-1857 (Bridges with Premature Concrete Deterioration) discovered numerous longitudinal cracks within the bottom flanges of precast, pretensioned highway girders. While the cracks were initially characterized as splitting damage, material testing was ultimately necessary to expose the contributing role of ASR. High longitudinal compressive stresses had suppressed the development of tell-tale map cracking and forced a tight directionality of the damage. Shortly before the current study began, TxDOT engineers within the Houston District discovered a number of straddle bent caps with diagonal cracking (an example of the damage is shown in Figure 5-14). The discovery was made as engineers within the district were also trying to assess the severity of the ongoing ASR/DEF outbreak. As a result, Houston District engineers began to question the role of PCD: Could dead load stresses have forced the development of the ASR/DEF-related diagonal cracks within these bent caps? It is hoped that the following discussion will answer the former question and allow appropriate repairs to be made.

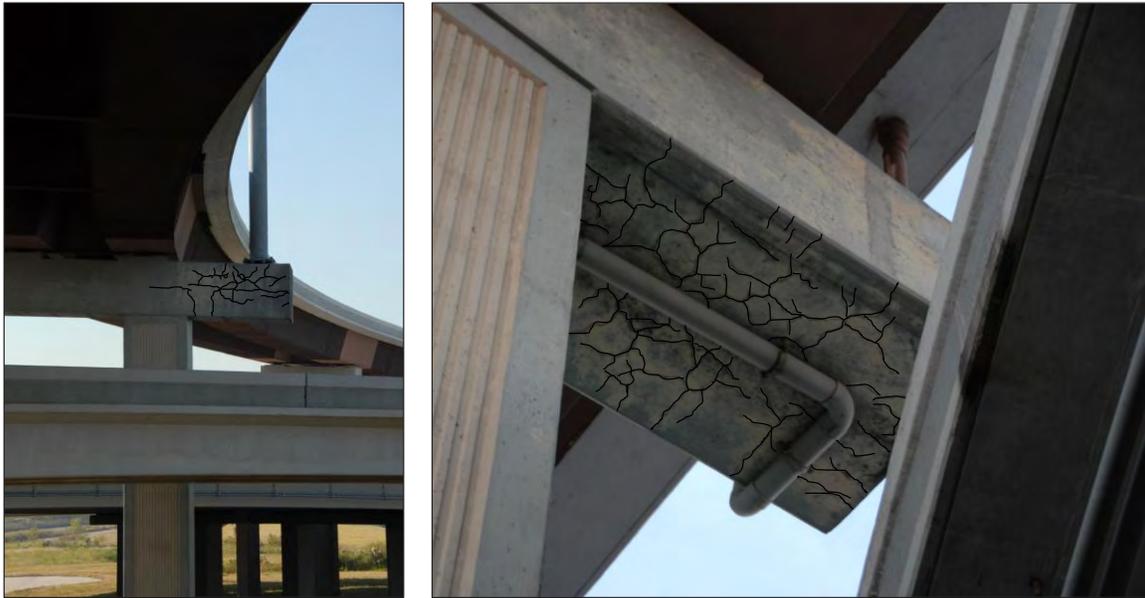
Figure 6-2: Signs of Deterioration within Connection Ramp Structures

Within seven years of the interchange opening, substructures of the US 59 North connection ramp to I-10 West displayed visual indications of ASR-related deterioration. During a preliminary visit to the structure in 2008, map cracking and a mottled buff color were clearly noticeable on the exposed sections of the hammerhead piers and straddle bent caps. It is important to note that these observations were made from the ground; affected elements were commonly forty to sixty feet above grade. Examples of the deterioration which appeared on a number of the substructure elements are provided within Figure 6-2.

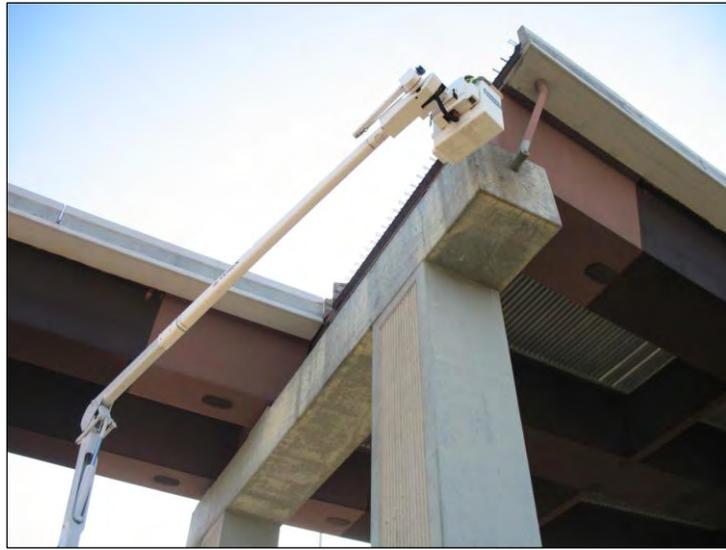
Figure 6-5: Bent 15 Inspection with Aerial Lift

The accommodation made for the future connection meant that a relatively long segment of the bent would remain unsheltered until the superstructure was put into place. In light of the aggregate reactivity, the resulting exposure conditions were severe. Run-off from the *stub-out* fell directly onto the top of the bent structure. Furthermore, a drain line from the superstructure was directed through the western end of the bent cap. From the moment the ramp opened, a high-volume, renewable source of moisture was present to fuel any deterioration mechanisms which may have been present. The condition clearly exacerbated the development of expansion within the first few years of construction. To more accurately characterize the deterioration which was present less than twelve years after the start of construction, an aerial lift (i.e. *bucket truck*) was used to conduct a close-up inspection of the Bent 15, as shown in Figure 6-5.

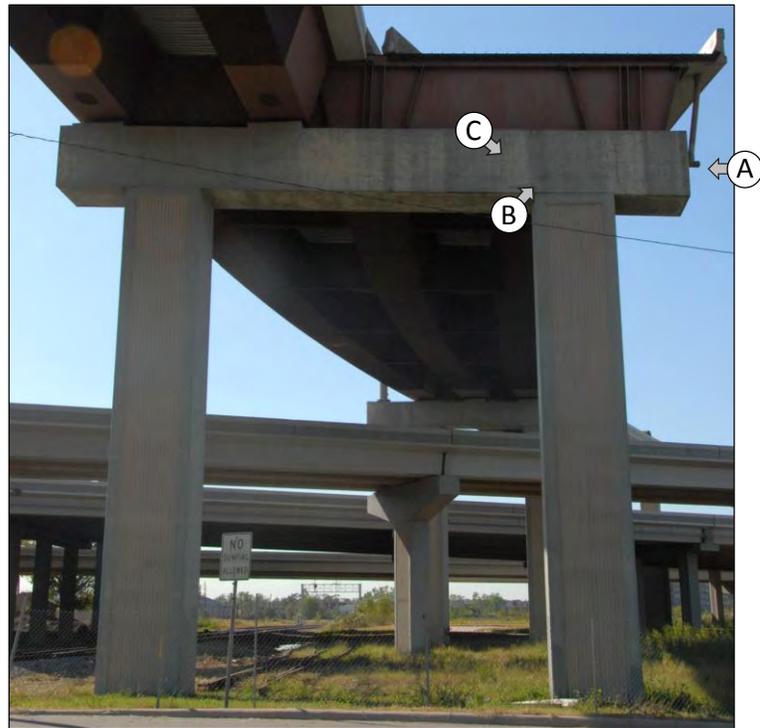
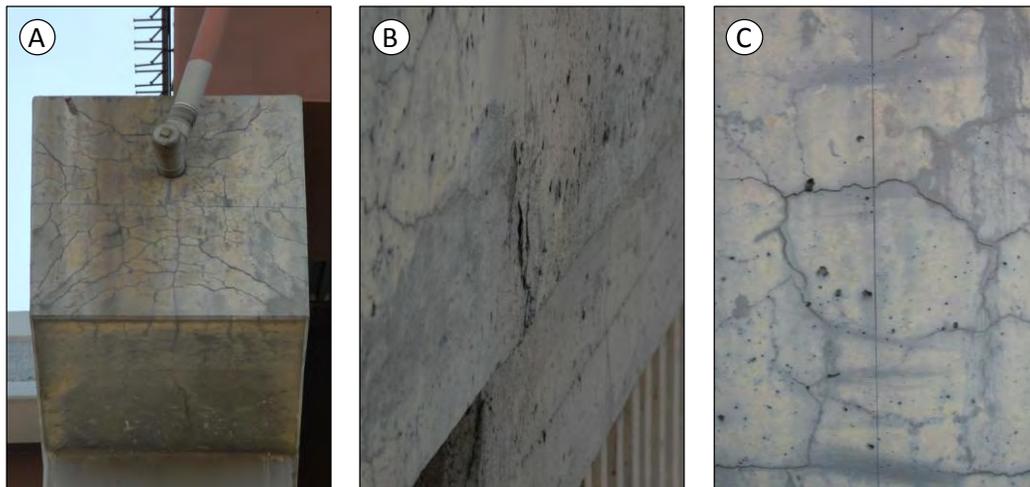
Figure 6-6: Visual Signs of Bent 15 Deterioration

Signs of deterioration noted within the exposed span of the bent cap are shown in Figure 6-6. The western end of the bent cap was subject to particularly heavy cracking which appeared to emanate from the point at which the drain line entered the structure. Cracking at the ends and throughout the bent cap was generally random in nature. Cracks were widely spaced (a general spacing of about four inches was noted) and unaccompanied by the fine cracks noted within the laboratory study. The overall pattern was best classified as map cracking. Alternate signs of deterioration included small areas of concrete subject to spalling and an atypical buff coloring of the concrete which was only found within the exposed sections of the structure.
