**Use of CFRP to Provide Continuity in Existing Reinforced Concrete
Members Subjected to Extreme Loads**

Dissertation

The University of Texas at Austin

August 2008

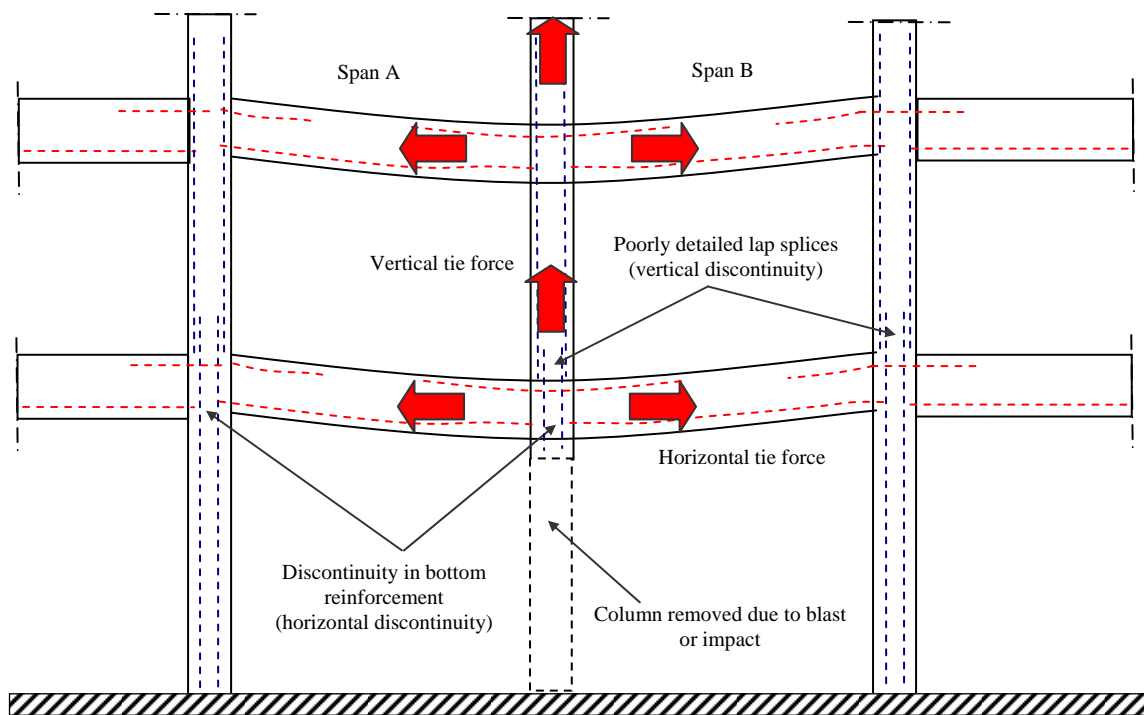
Figure 1.1 *Discontinuities in existing reinforced concrete structures*

Typical column details in ACI 315-74 are shown in Figure 1.3. The lap splices in longitudinal reinforcement were based on compression loads only and the length of those splices and the amount of transverse reinforcement are inadequate if the column is subjected to tension. Although ACI 315-74 recommends 30 times the bar diameter of longitudinal reinforcement for length of lap splices, ACI 318-63 allows using 24 times the bar diameter for length of lap splices in compression (GR 60 reinforcement). In addition, only two transverse ties are provided in the lap splice region in Figure 1.3. Therefore, the longitudinal reinforcement can not develop tension when a column is removed because of the short lap splice length and insufficient transverse reinforcement, and a vertical discontinuity may exist in the columns above the removed column.

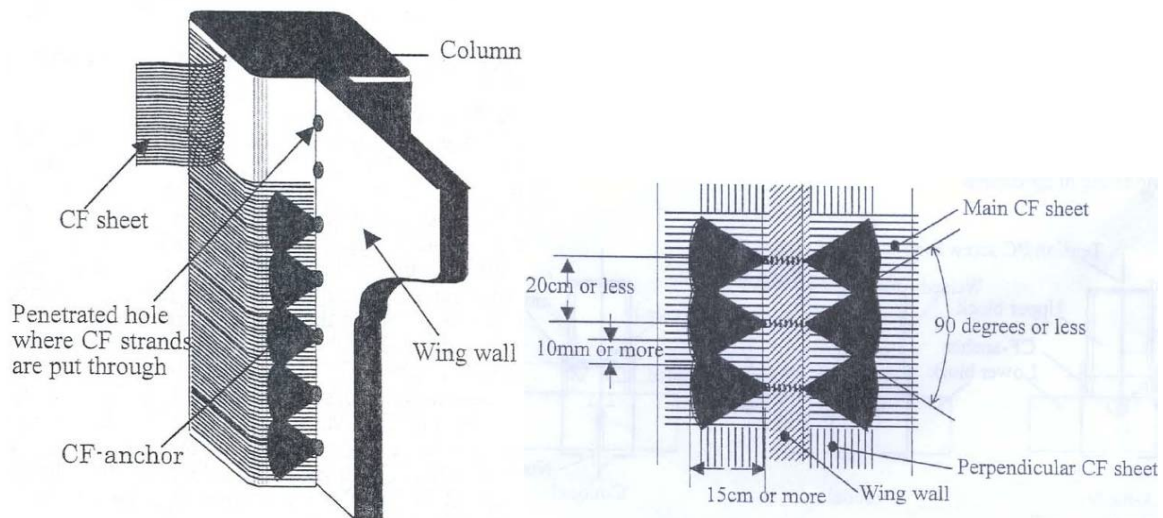
Figure 2.6 *CFRP anchors for CFRP wrapping the column with wing wall,*
(Kobayashi et. al., 2001)

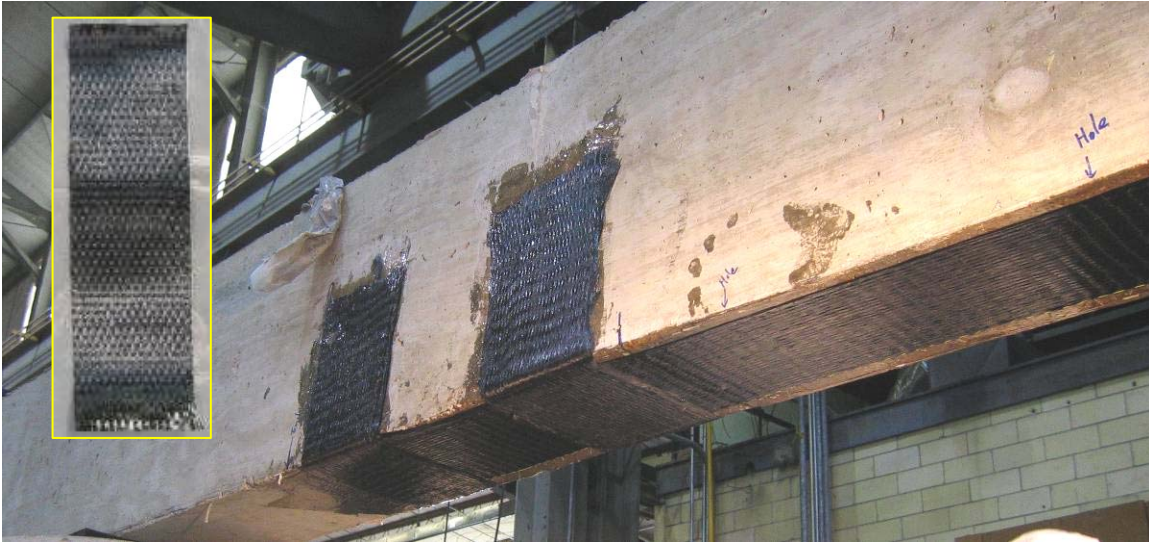
Figure 2.8 CFRP U-wrap

sheet for continuity (Figure 2.8). The CFRP sheets also developed the full tensile strength through the use of CFRP U-wraps or a combination of CFRP anchors and U-wraps. These anchorage methods are discussed in Chapter 3 and were also evaluated under a dynamic loading condition.

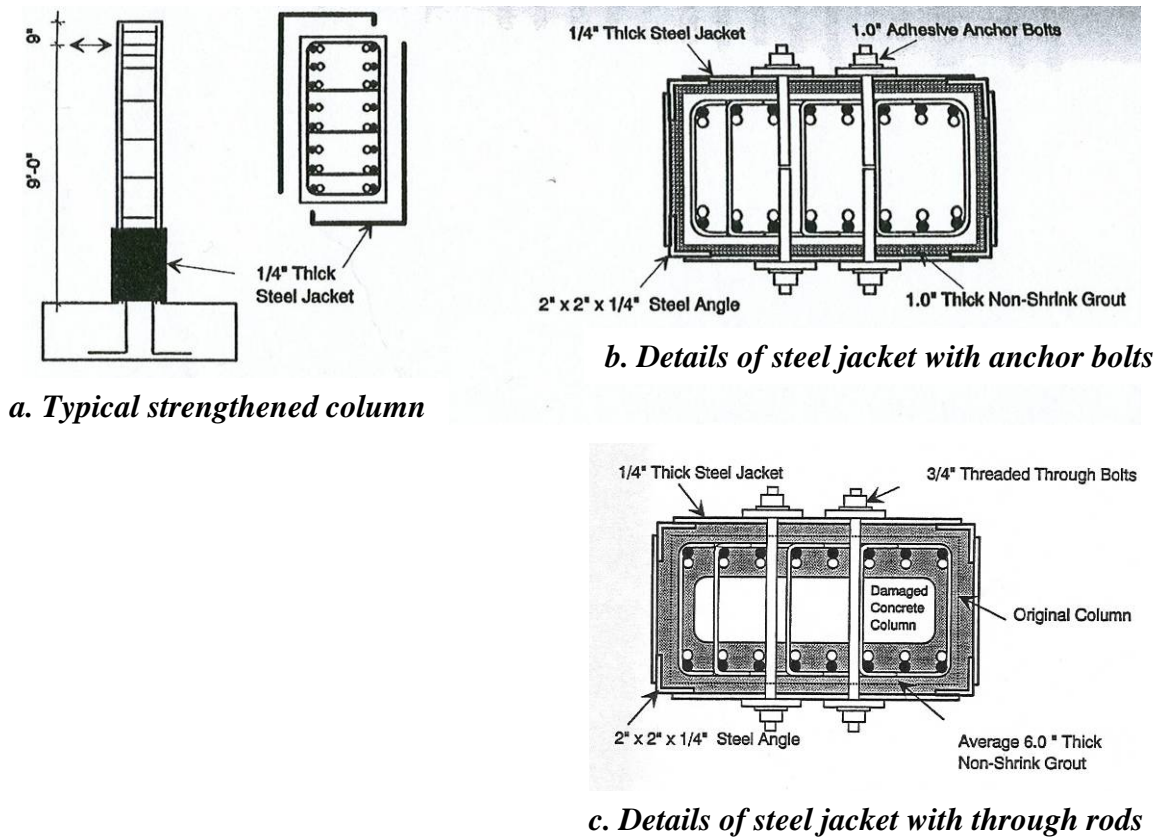
Figure 2.9 Repair of rectangular RC columns (Aboutaha et al., 1999)

Aboutaha et al. (1999) studied the effectiveness of rehabilitation methods using steel jackets with adhesive anchor bolts (Figure 2.9-b) and steel jackets with through rods (Figure 2.9-c) to repair damaged rectangular concrete columns. The columns were designed based on ACI 318 - 56 or 63 and had poorly detailed lap splices of longitudinal reinforcement. Lap splice failure occurred in the as-built columns and they showed poor strength and ductility. These columns were repaired using steel jacketing with adhesive anchor bolts or through rods. The test results indicated that the repair techniques improved strength and ductility. Although the columns repaired with steel jackets with through rods showed better performance than the columns repaired with adhesive anchor bolts, steel jackets with adhesive anchor bolts were effective in improving performance of the rectangular reinforced concrete columns. The adhesive anchor bolts restrained opening of splitting cracks in the splice region by improving the confining effects of steel jackets on splices not located near a corner of the jacket. CFRP anchors were intended to function in a similar manner in the rehabilitation using CFRP. In the study reported in this dissertation, CFRP jackets and CFRP anchors were used to repair and strengthen rectangular reinforced concrete columns with inadequate lap splices of longitudinal reinforcement. The design of the test columns and the test setup were based on the study of Aboutaha et al. Therefore, effectiveness of the rehabilitation methods using CFRP jackets and anchors could be compared with rehabilitation using steel jackets and adhesive anchor bolts.

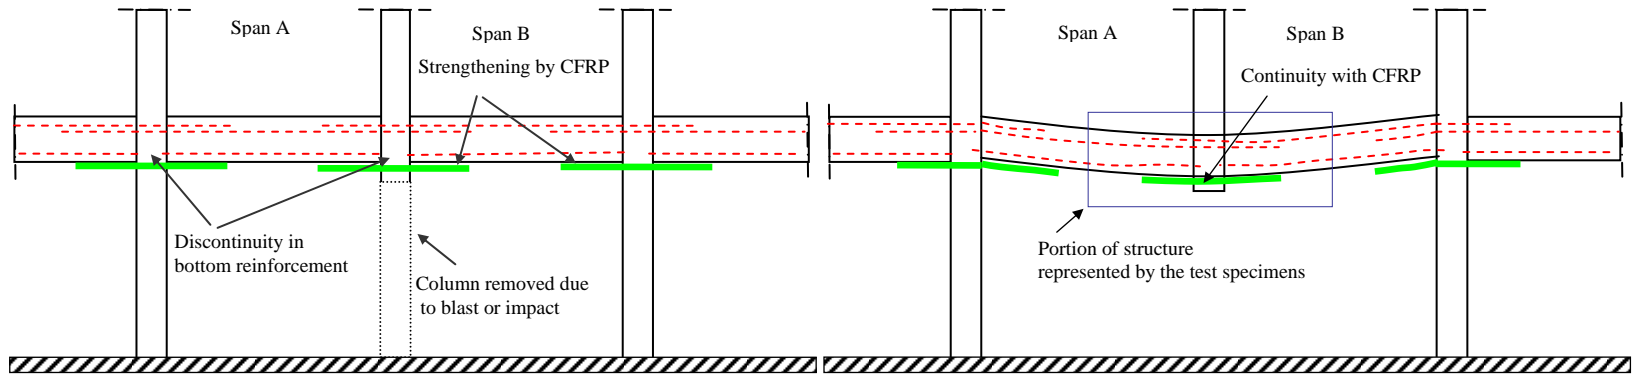
Figure 3.1 Rehabilitation technique, CFRP on the bottom face of beam

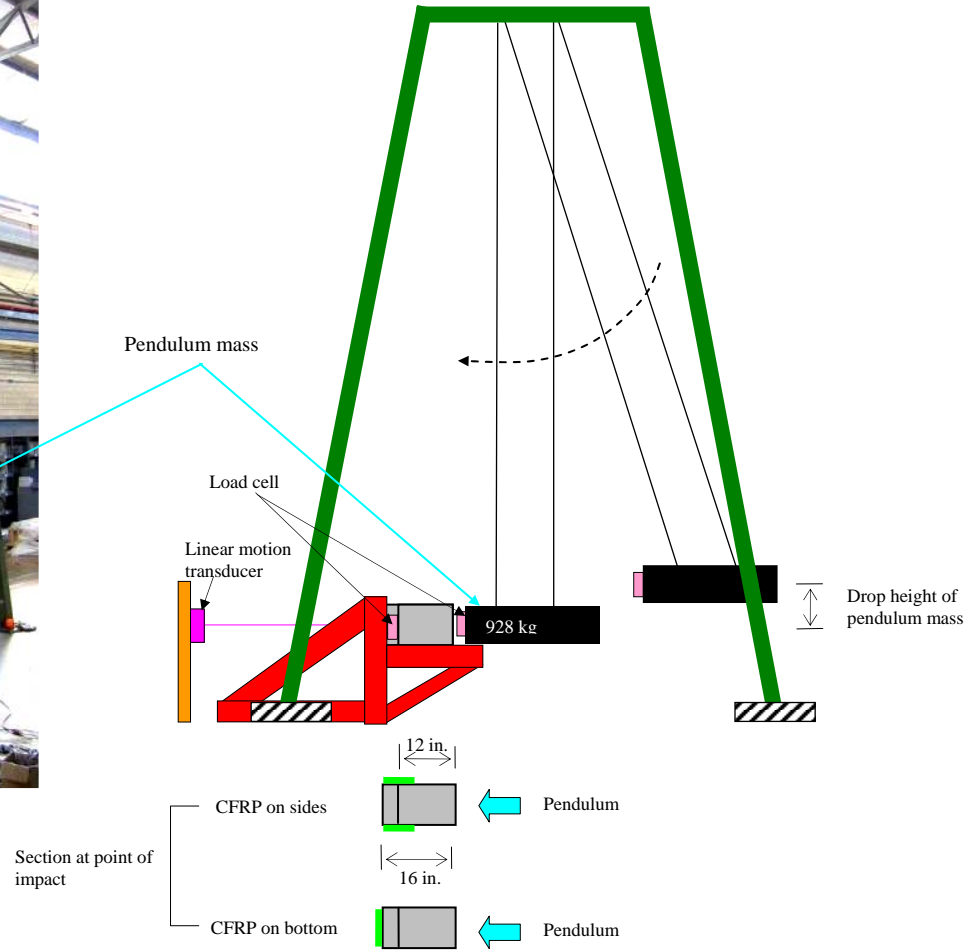
Figure 3.44 Test setup 1

The response duration of the test specimens to the pendulum mass impact was between 0.02 sec and 0.2 sec. It was about 0.1 sec if the specimens did not fail. Sasani (2007) reported that the response duration of structural members in an actual reinforced concrete building was about 0.1 sec when a column was removed due to explosion. Therefore, the test setup created similar loading rate which an actual structural member may experience in a case of a column removal.

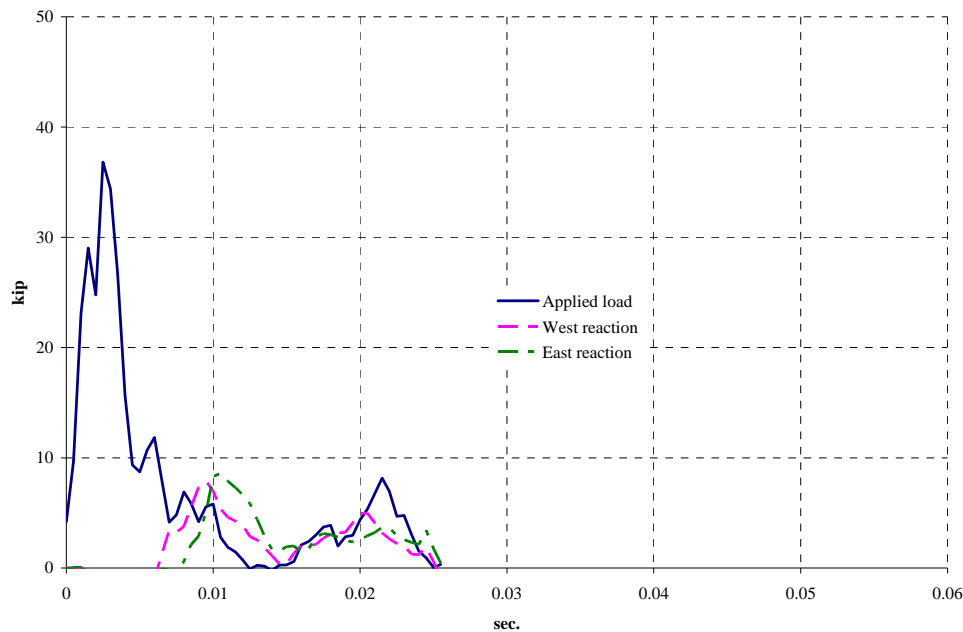
Figure 3.49 Measured applied load and reactions, A-BF-N-5S

load cells after the time of the contact of the pendulum mass because the bearing locations of the beam did not contact perfectly with the support load cells. The delay was about 0.01 sec in the tests but the theoretical duration for the wave due to the impact reaching the supports, was about 0.0005 sec. Therefore, the delay was mainly due to the imperfect contact between the specimen and the supports. This delay was observed in all the other tests. The peak applied load was 36.8 kip and the peak reaction was 8.6 kip at the east support. Impulse of the applied load was 0.18 kip-sec while that of sum of the reactions was 0.11 kip-sec.

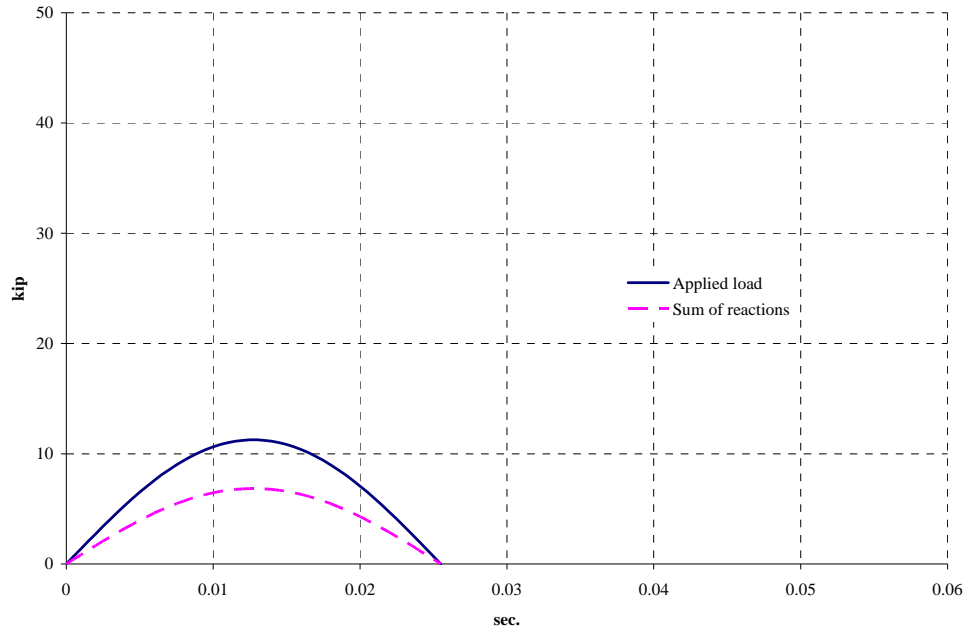
Figure 3.52 Normalized applied load and sum of reactions, A-BF-N-5S

was used. The calculated strength of A-BF-N-5S corresponding to the delamination of the CFRP was 4.4 kip.

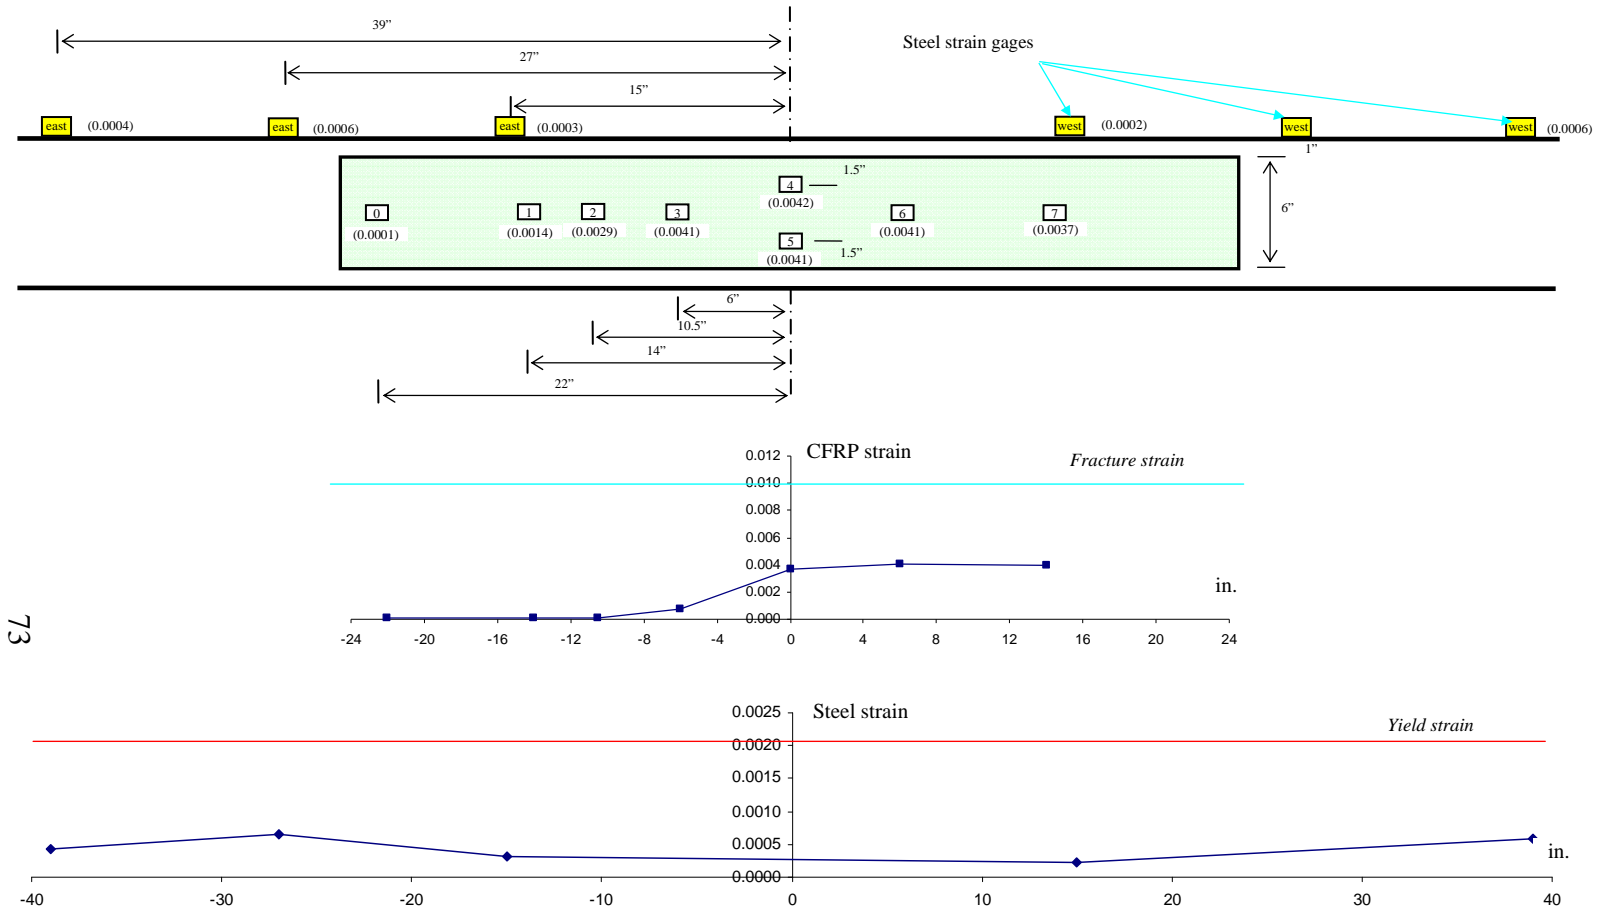
The location of steel strain gages from the center of the beam and maximum measured strain are also shown in Figure 3.53. The maximum strain measured in the #6 bars in A-BF-N-5S was 0.0006 which was about 1/3 of yield of the steel reinforcement.

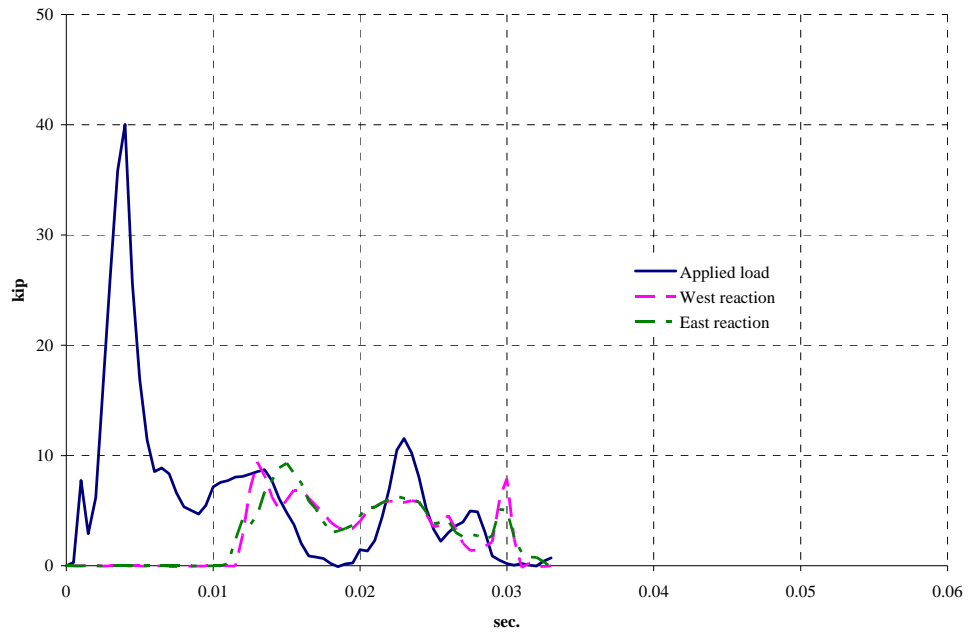
Figure 3.57 Measured applied load and reactions, A-BF-A-2S

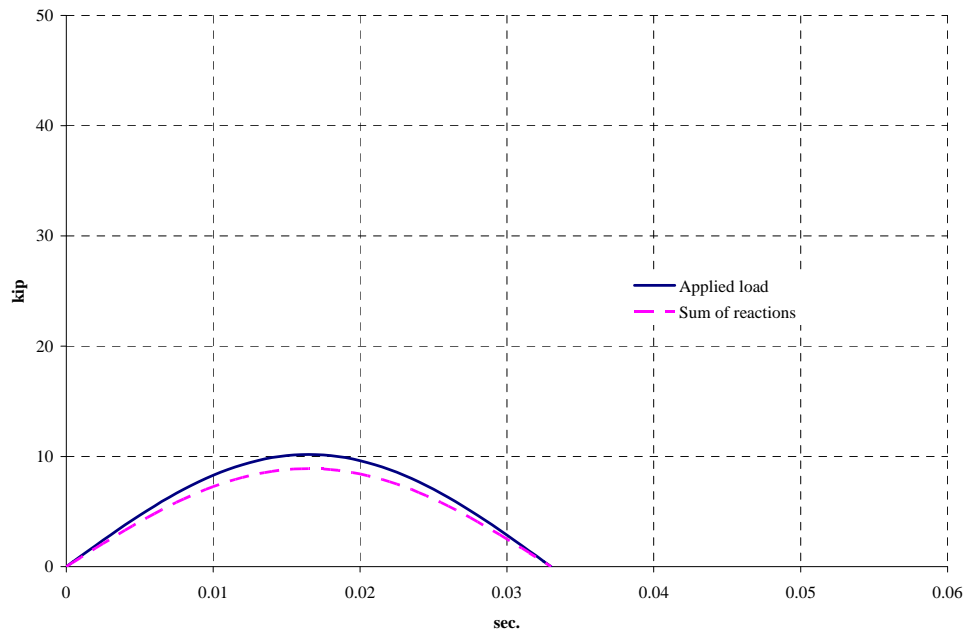
Figure 3.58 Normalized applied load and sum of reactions, A-BF-A-2S

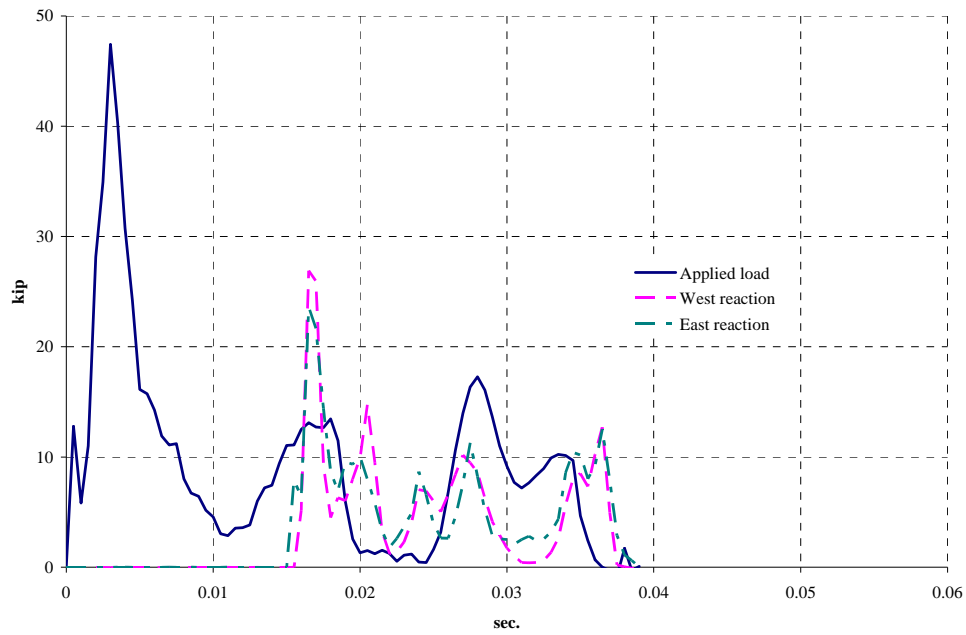
Figure 3.63 Measured applied load and reactions, A-BF-A-5S

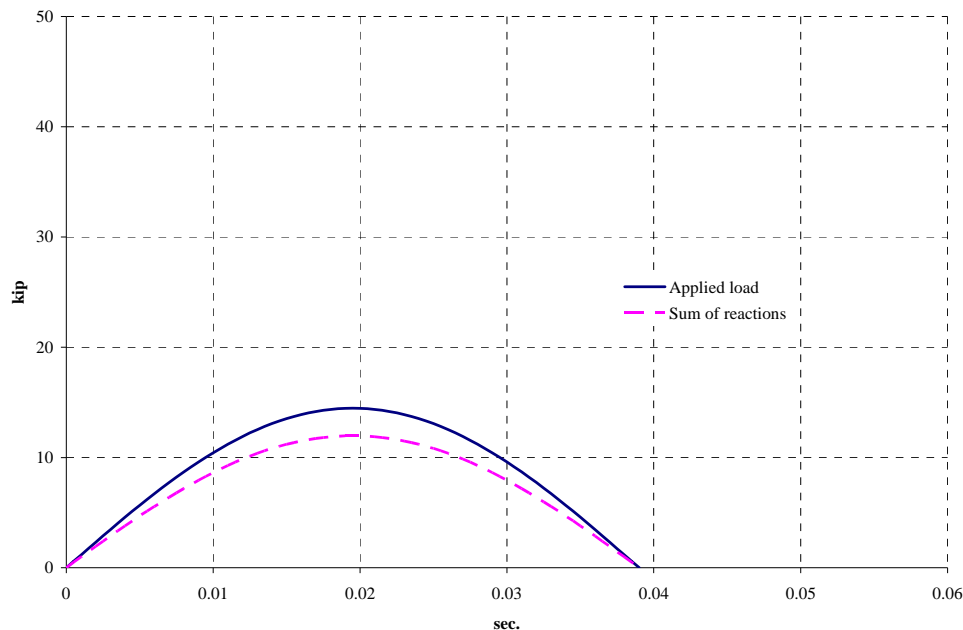
Figure 3.64 Normalized applied load and sum of reactions, A-BF-A-5S

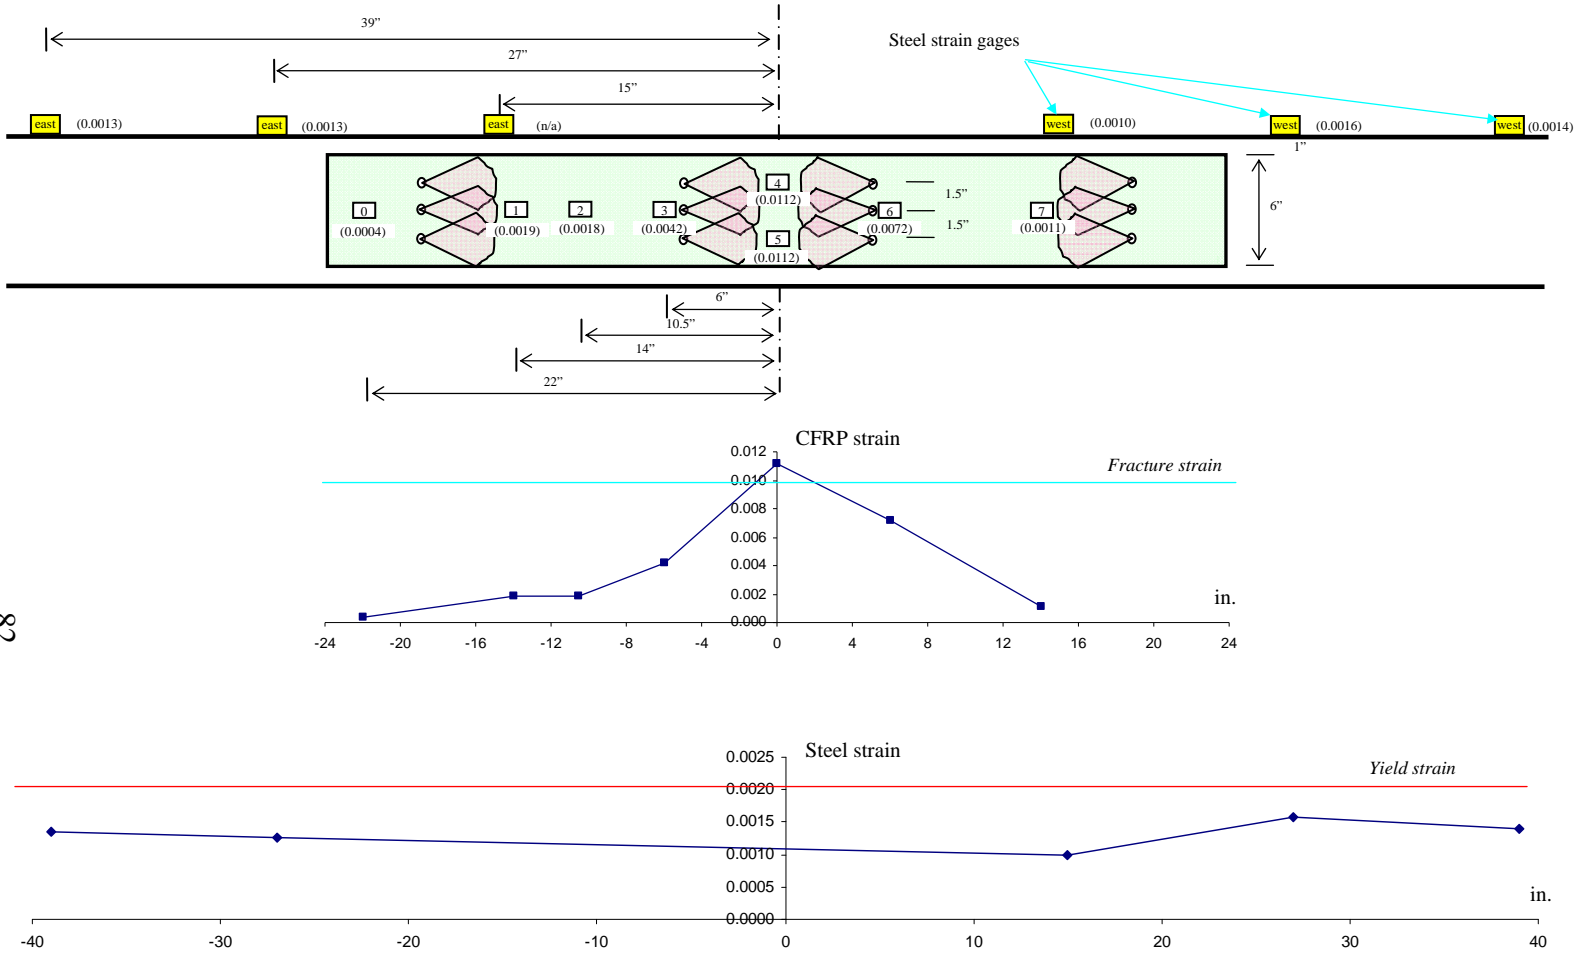
The location of steel strain gages from the center of the beam and maximum measured strain are also shown in Figure 3.65. The maximum strain measured in the #6 bars in A-BF-A-5S was 0.0016 which was about 80 % of yield in of the steel reinforcement.

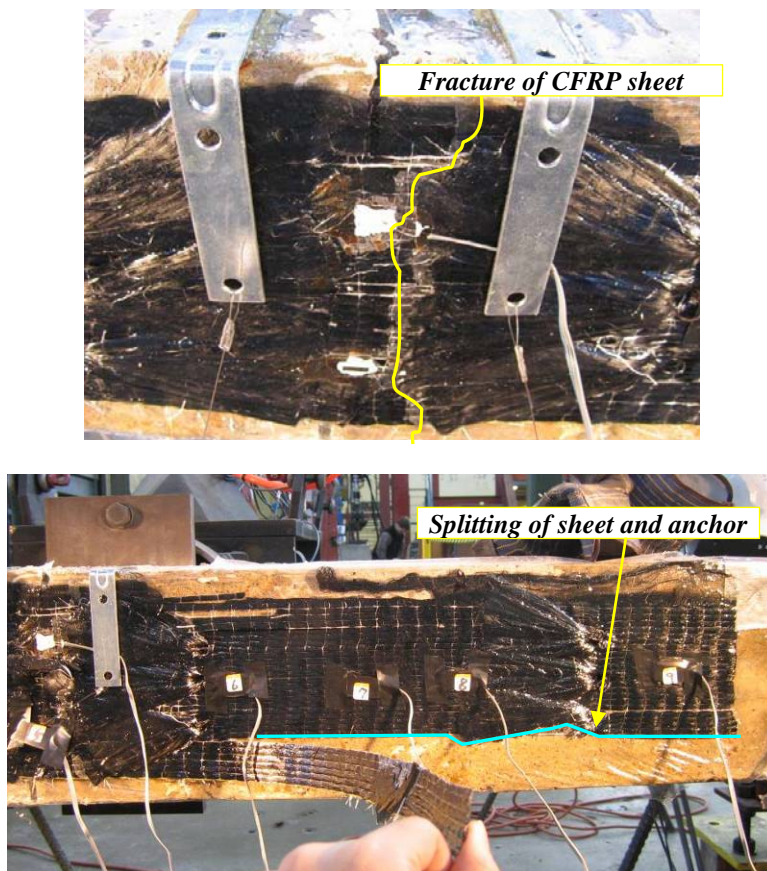
Figure 3.74 Failure of A-BF-1.3A-5N, fracture of CFRP sheet

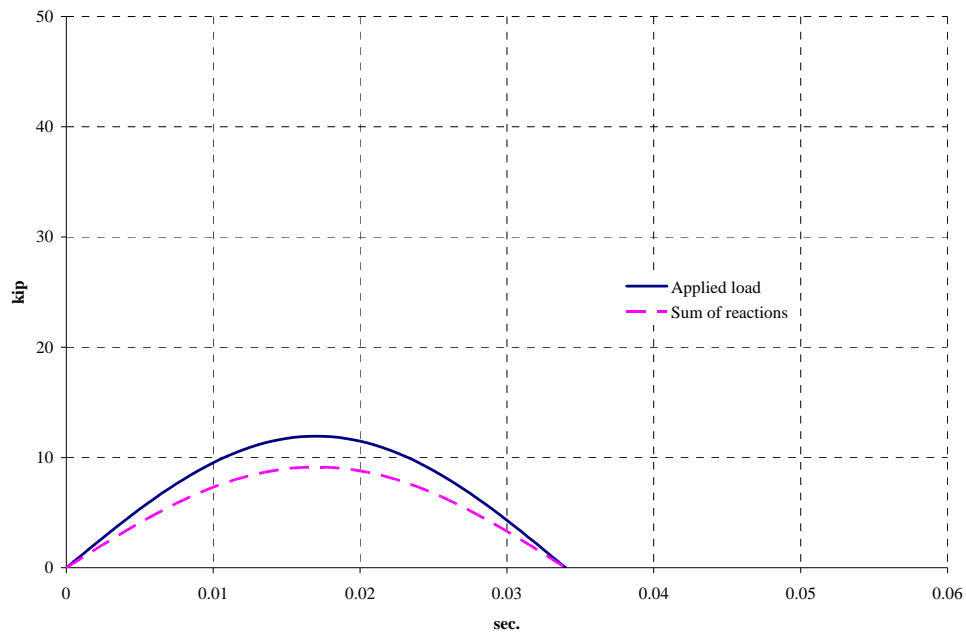
Figure 3.76 Normalized applied load and sum of reactions, A-BF-1.3A-5N

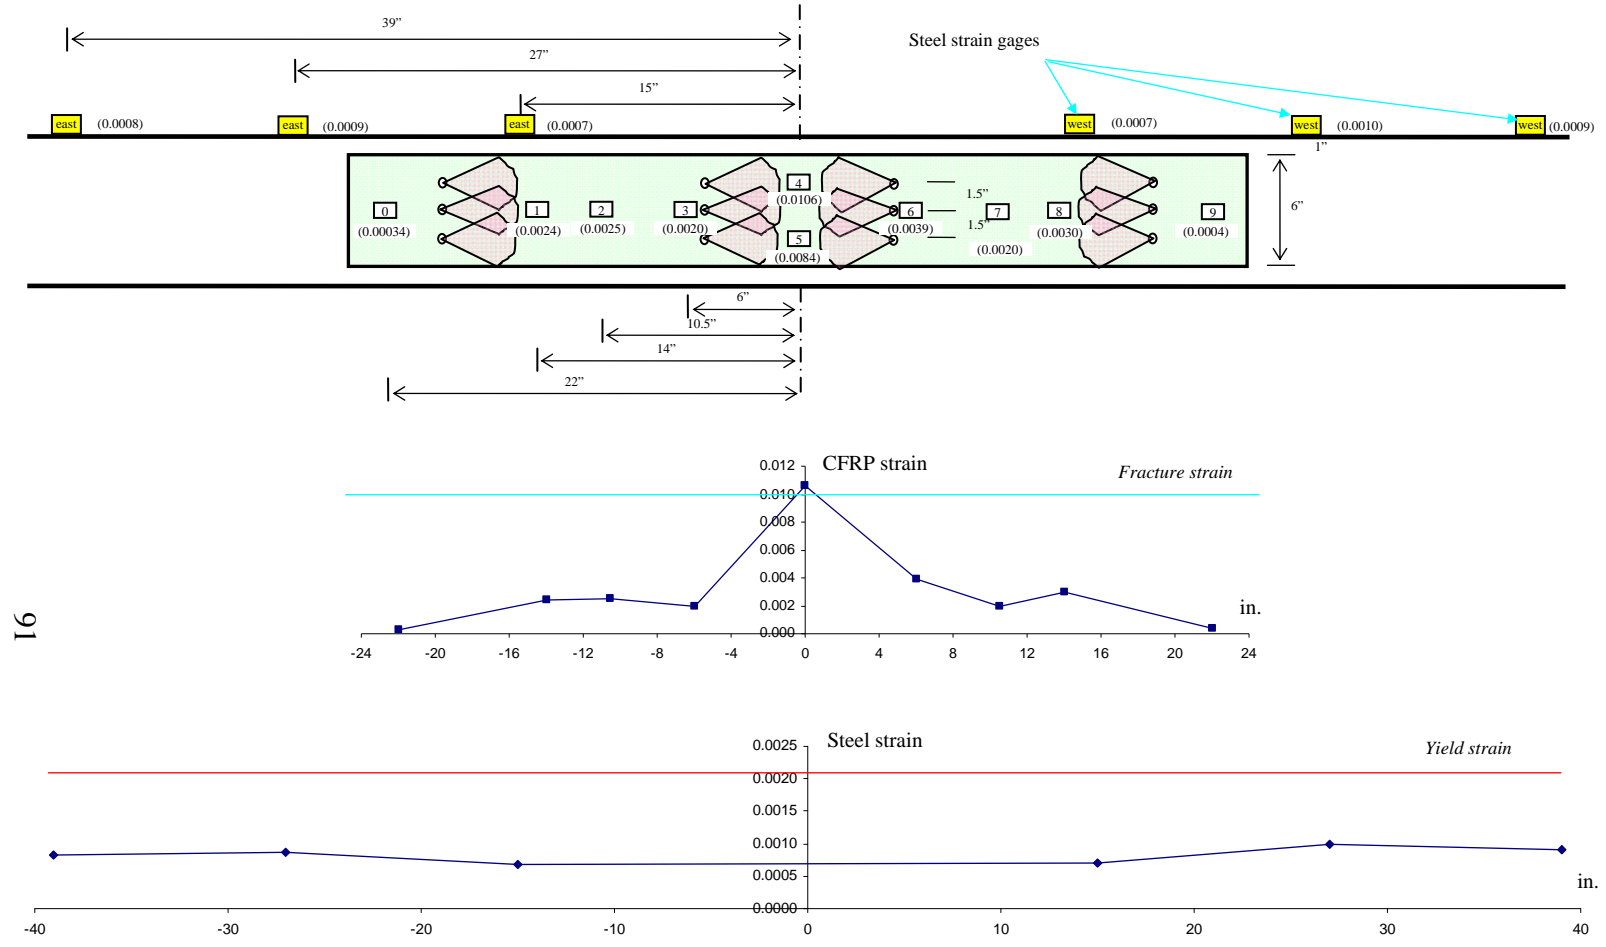
The maximum strain measured in the #6 bars in A-BF-N-5S was 0.0010 which was about 50 % of yield of the steel reinforcement.

Figure 3.77 Location of strain gages and distribution of strain in CFRP and bars, A-BF-1.3A-5N

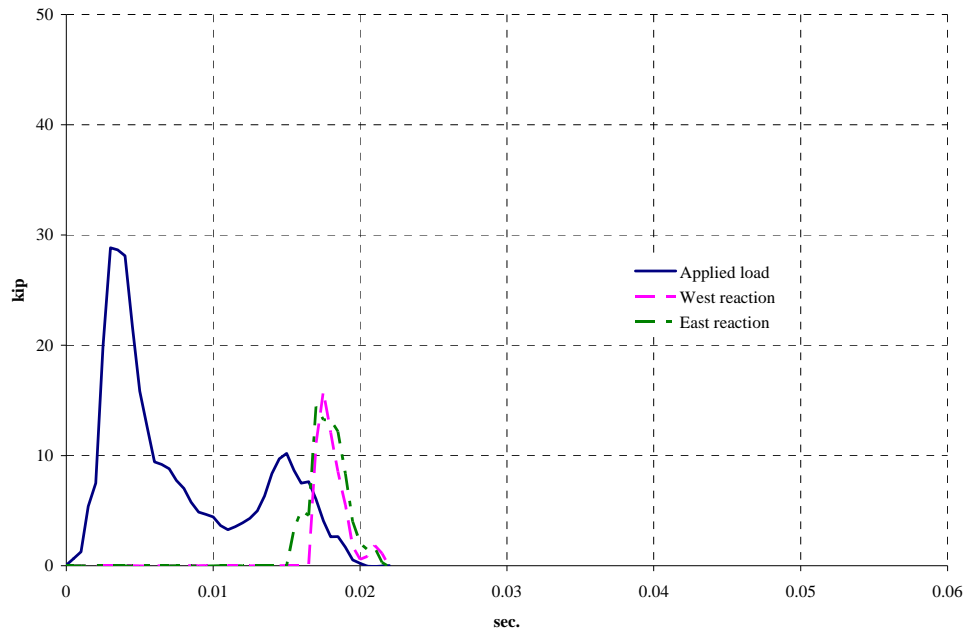
Figure 3.81 Measured applied load and reactions, A-BF-U-5S

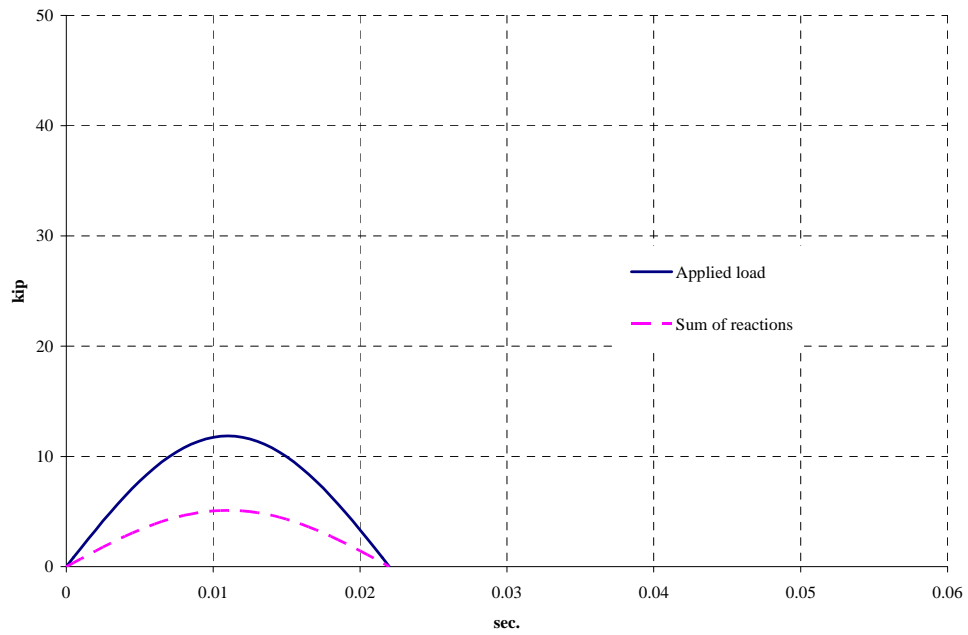
Figure 3.82 Normalized applied load and sum of reactions, A-BF-U-5S

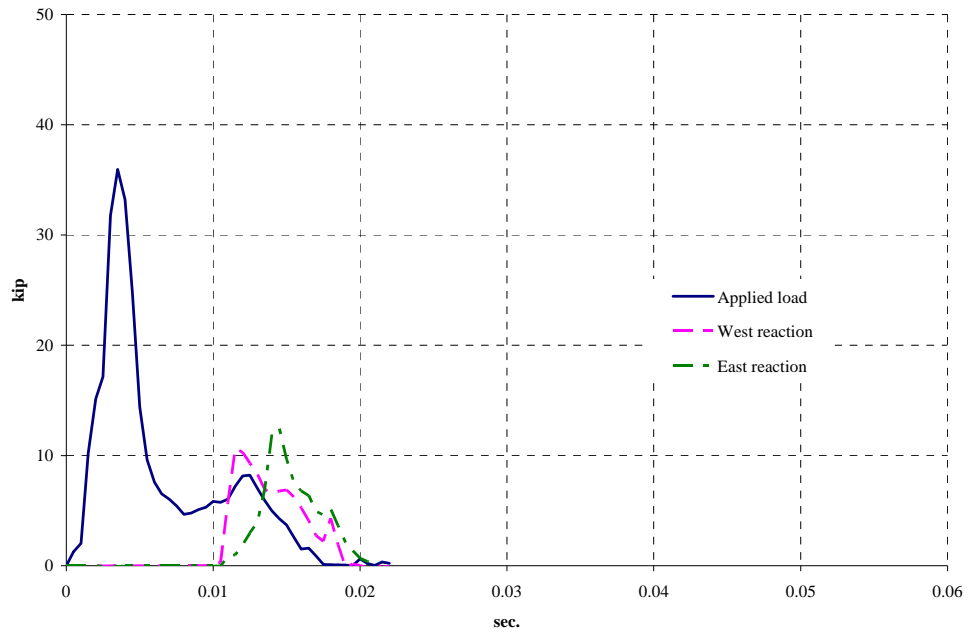
Figure 3.87 Measured applied load and reactions, A-BF-A/U-6G

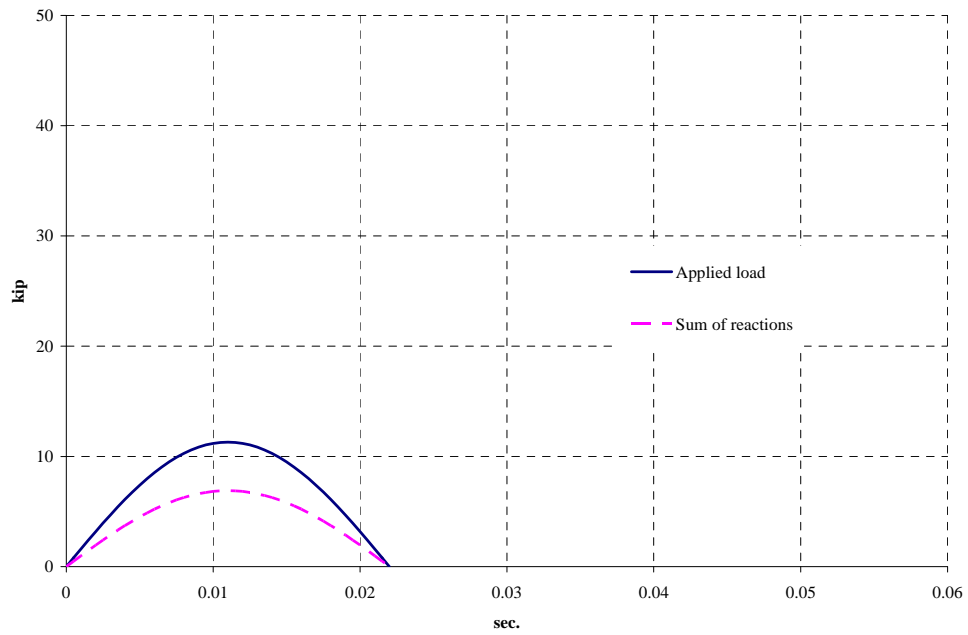
Figure 3.88 Normalized applied load and sum of reactions, A-BF-A/U-6G

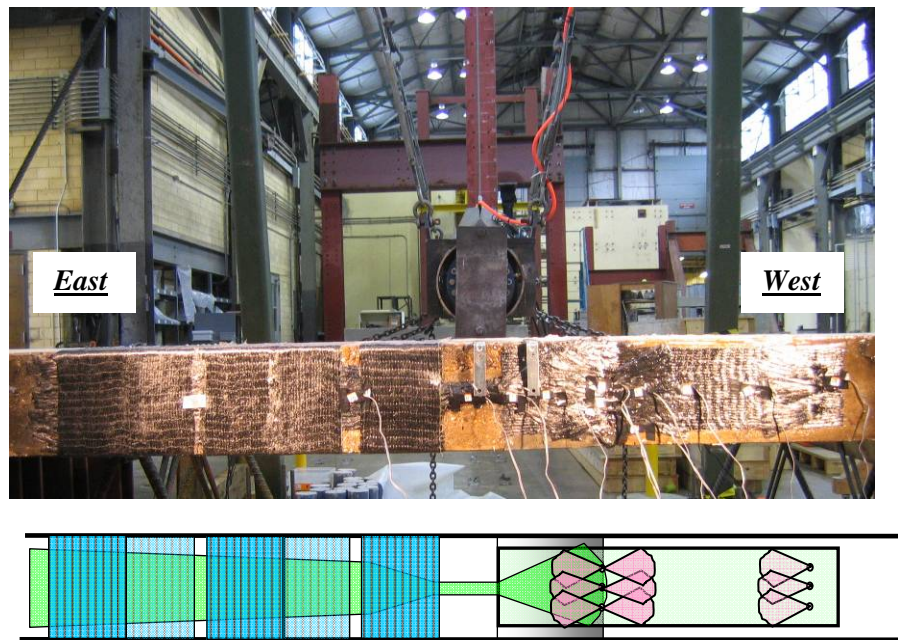
B-BH-A-6S was a Type B beam with one layer of beam sheet and CFRP anchors on the west side. The connection sheet was anchored with excess CFRP U-wraps on the east side to provide stronger anchorage than that on the west side. The test of this specimen focused on the lap spliced region of the beam and connection sheet. It also focused on behavior of the beam sheet and anchors on the west side. The surface of the bottom face was sand-blasted. The measured compressive strength of the concrete was 6,000 psi. Configuration of the beam is shown in Figure 3.93. The failure mode of B-BH-A-6S was fracture of the connection sheet in the center of the beam (Figure 3.94). The fracture occurred where fan shape spliced portion of the connection sheet merged into a strap.

Figure 3.93 Configuration of B-BH-A-6S

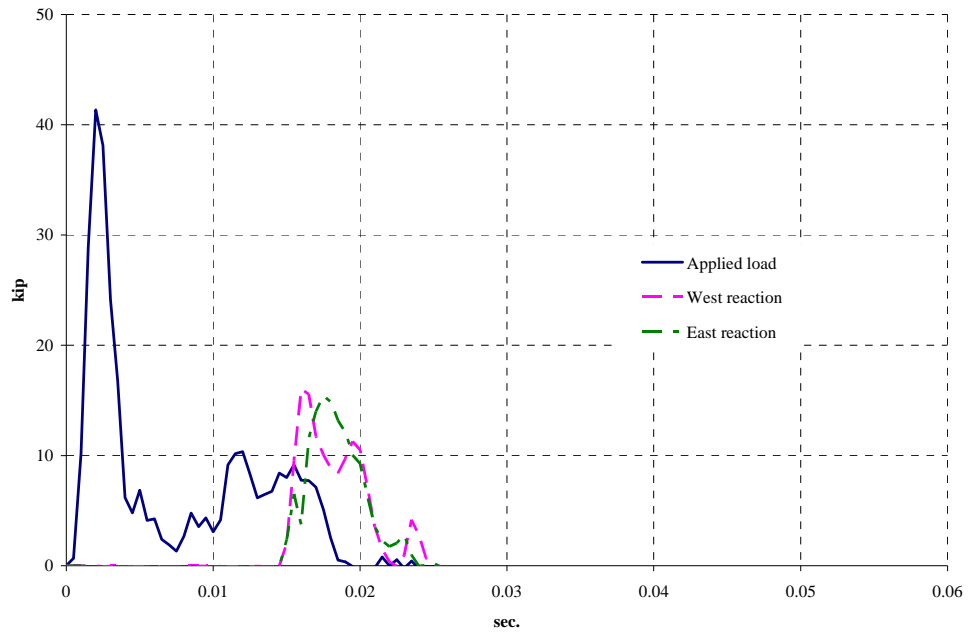
Figure 3.95 Measured applied load and reactions, B-BH-A-6S

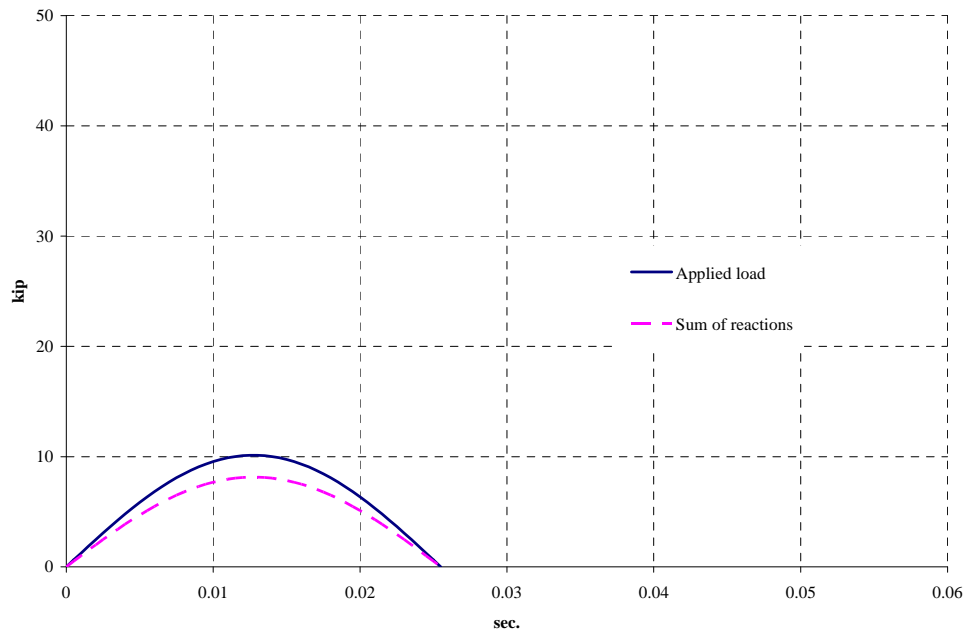
The normalized applied load and sum of the reactions are shown in Figure 3.96. The peak normalized applied load was 10.1 kip and sum of the reactions was 8.2 kip (80 % of the peak normalized applied load). The calculated static strength of B-BH-A-6S was 11.1 kip and the peak normalized applied load was 91 % of the static strength.

Figure 3.96 Normalized applied load and sum of reactions, B-BH-A-6S

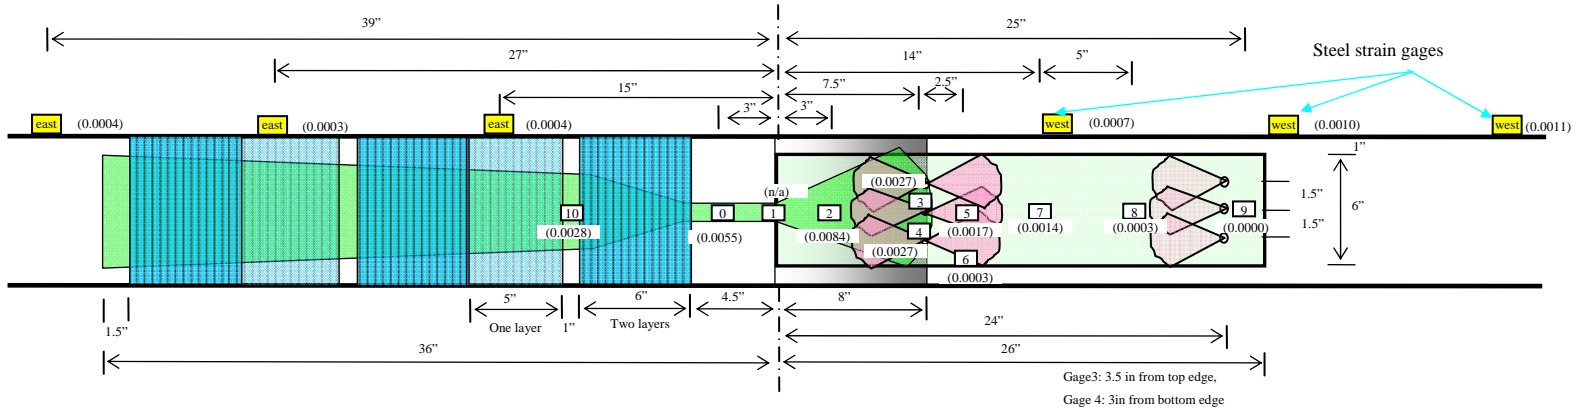
The maximum strain measured in the #6 bars in B-BH-A-6S was 0.0011 which was about 50 % of yield of the steel reinforcement.

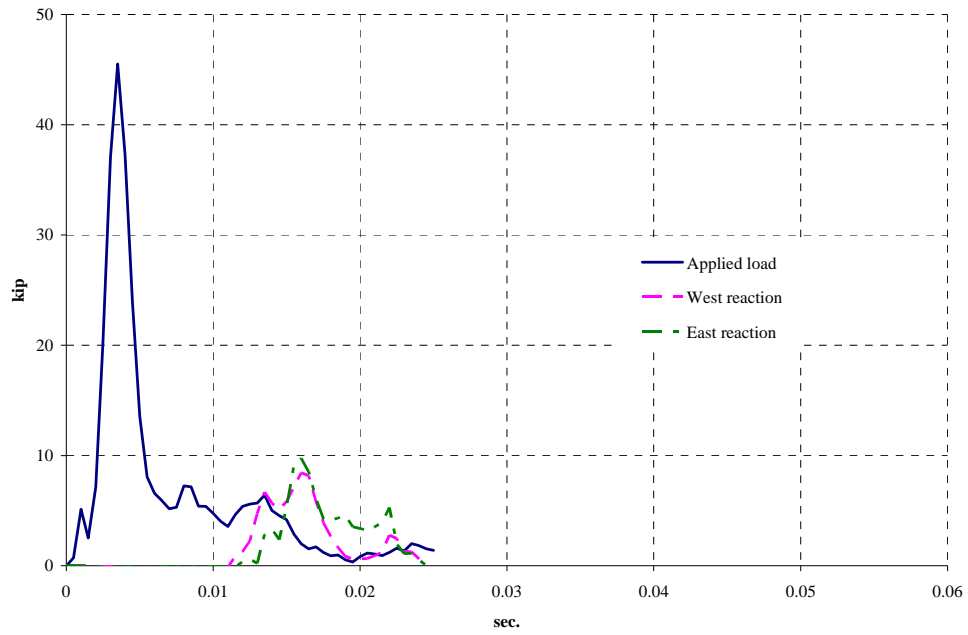
Figure 3.101 Measured applied load and reactions, B-BH-U-6S

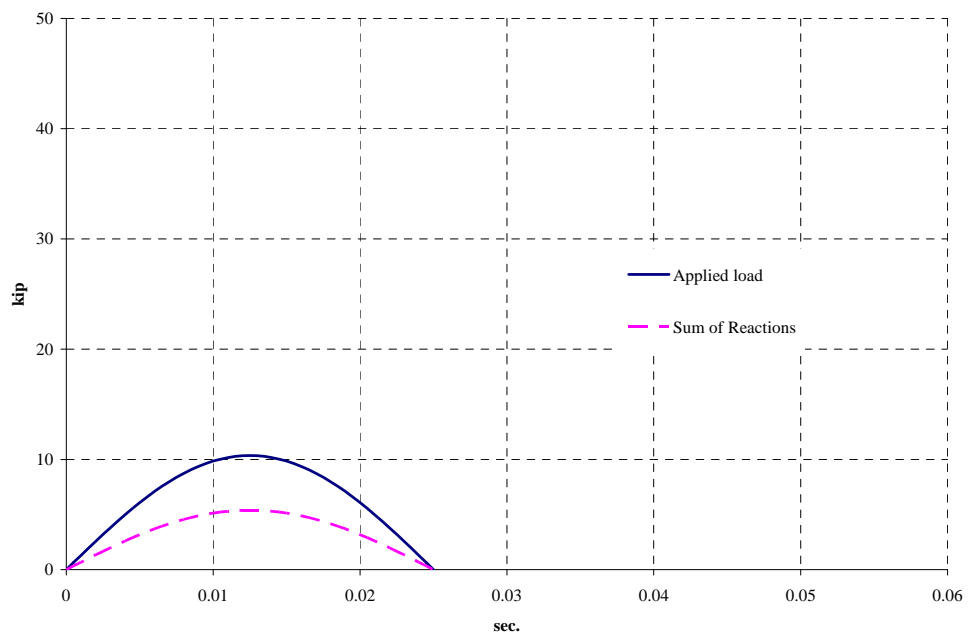
Figure 3.102 Normalized applied load and sum of reactions, B-BH-U-6S

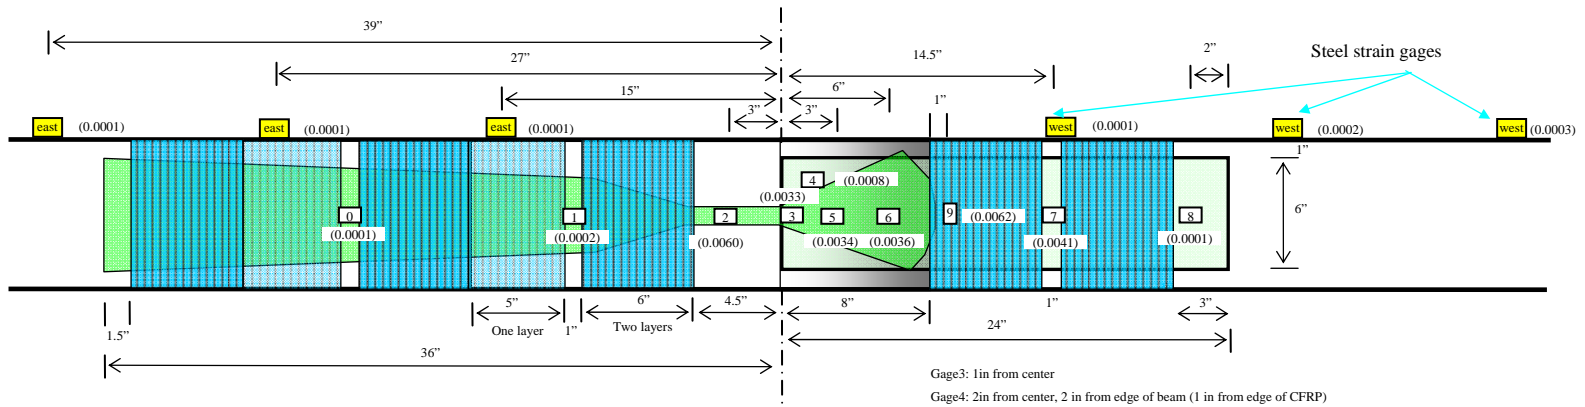
The maximum strain measured in the #6 bars in B-BH-U-6S was 0.0003 which was about 15 % of yield of the steel reinforcement.
