**Use of CFRP to Provide Continuity in Existing Reinforced Concrete
Members Subjected to Extreme Loads**

Dissertation

The University of Texas at Austin

August 2008

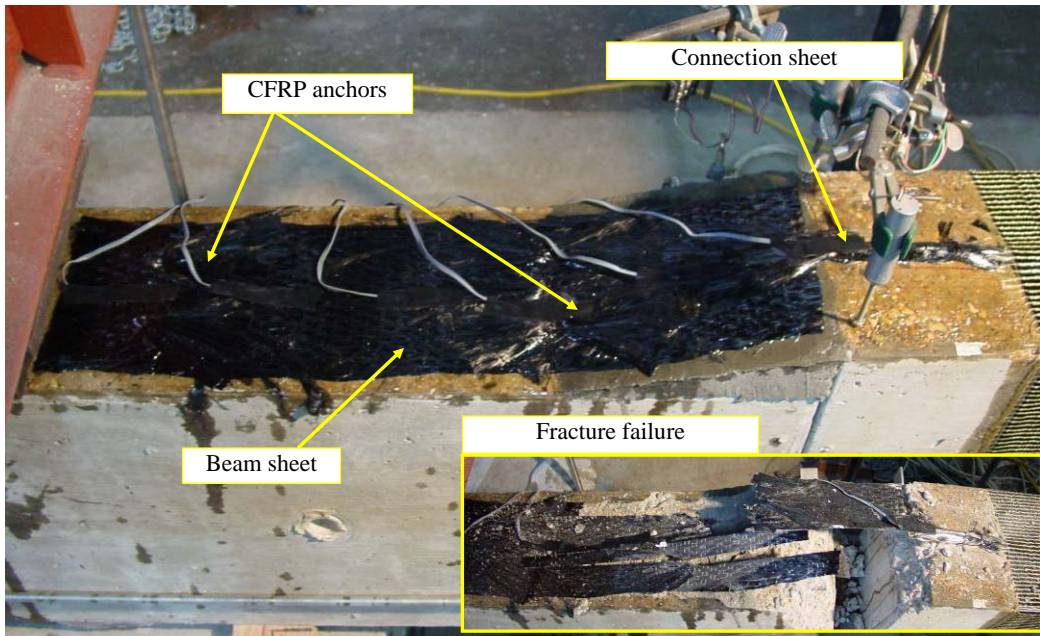
Figure 3.105 *Static test, CFRP sheet and anchors, 105 % of the ultimate strength
(Orton, 2007)*

In the beams with a height transition (B-BH-A-6G and B-BH-U-6G), the effectiveness of different anchorage methods (CFRP anchor or CFRP U-wrap) on dynamic performance of CFRP was examined. The only difference between these two beams was type of anchorage. Both beams failed by fracture of the CFRP sheet and the CFRP sheet reached the ultimate tensile strength. These results showed that the anchorage methods used to reach ultimate strength under static loading performed similarly under dynamic loading. As shown in Figure 3.105 and Figure 3.106, beams with the anchorage using the anchors or U-wraps failed by CFRP fracture under static loading.

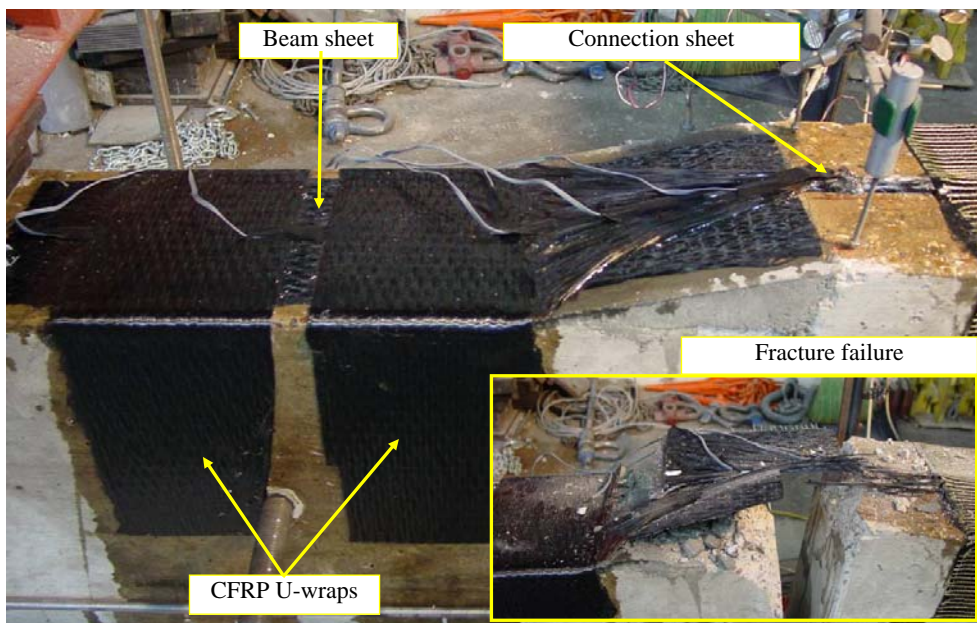
Figure 3.106 *Static test, CFRP sheet and U-wraps, 89 % of the ultimate strength
(Orton, 2007)*

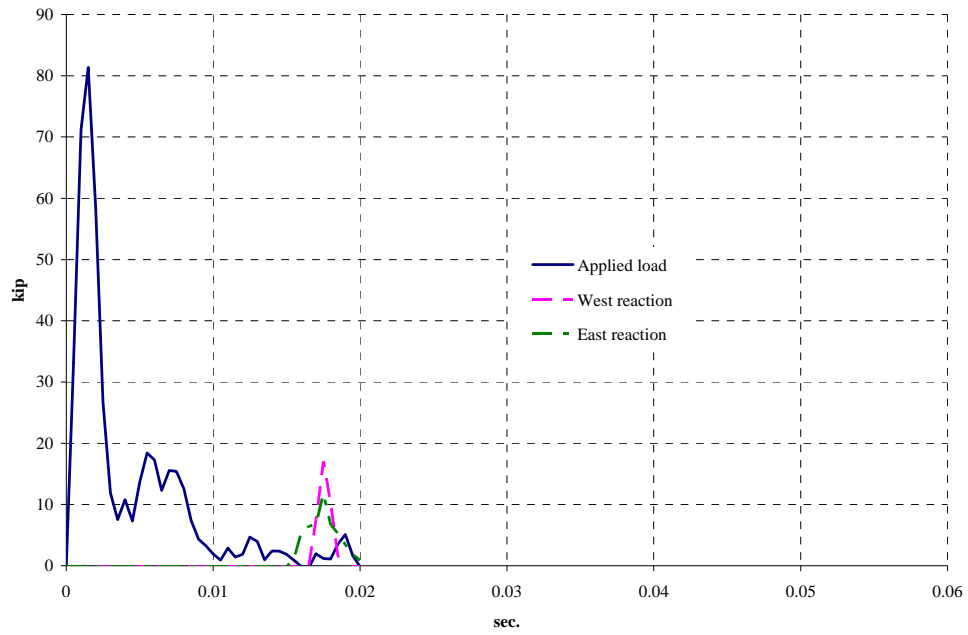
Figure 3.109 Measured applied load and reactions, A-S-A-6G

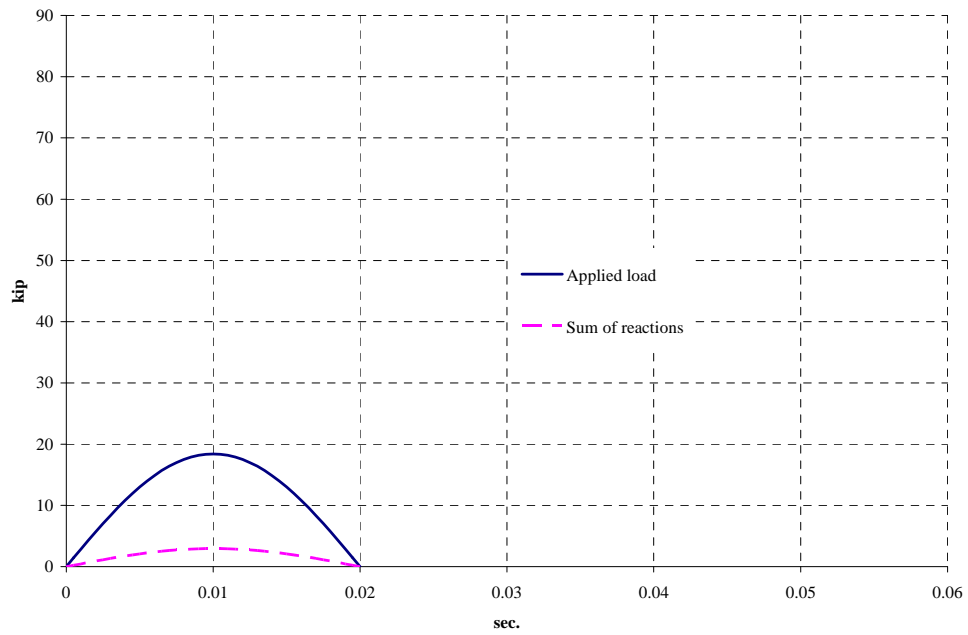
Figure 3.110 Normalized applied load and sum of reactions, A-S-A-6G

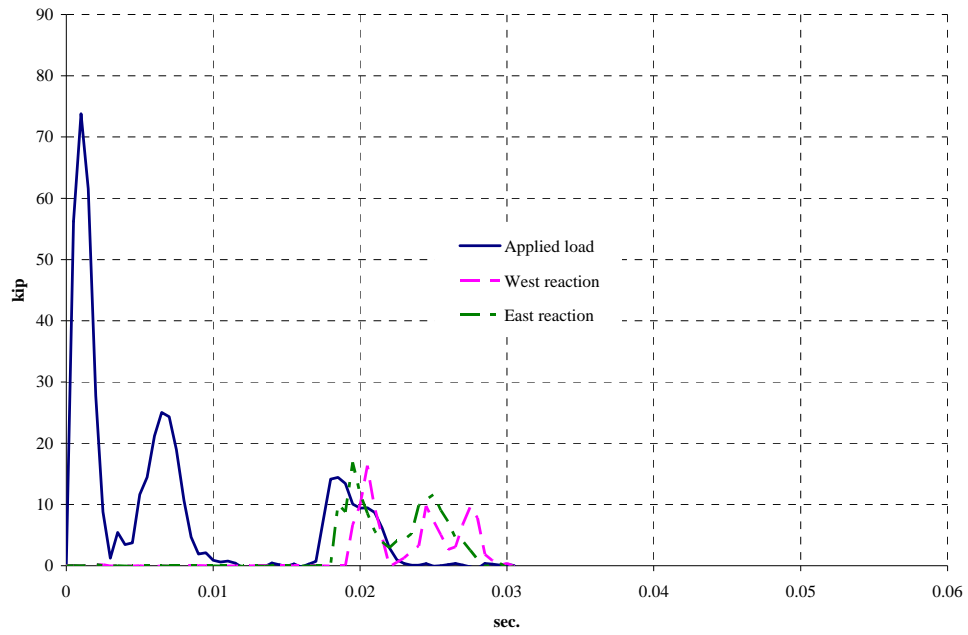
Figure 3.115 Measured applied load and reactions, A-S-AU-2S

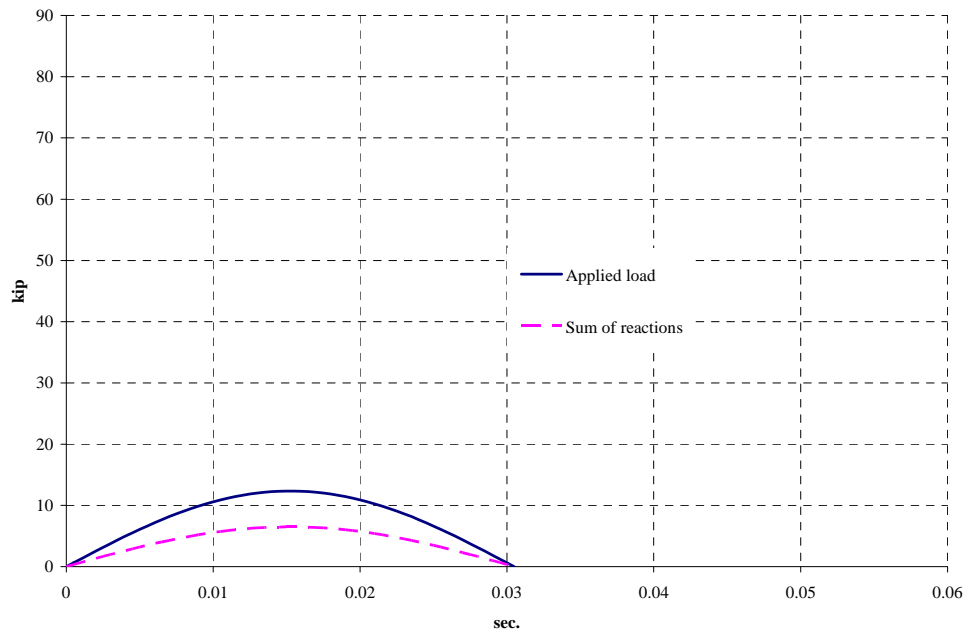
Figure 3.116 Normalized applied load and sum of reactions, A-S-AU-2S

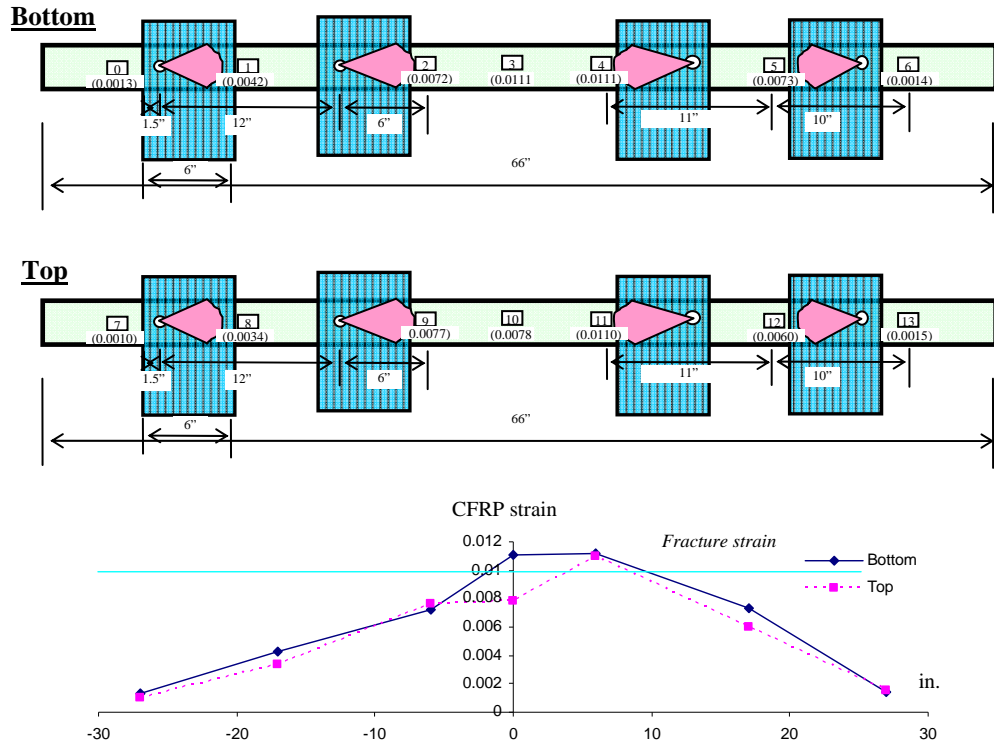
Strain gages were not installed in the #6 bars in this beam.

Figure 3.117 Location of strain gages and distribution of strain in CFRP, A-S-AU-2S

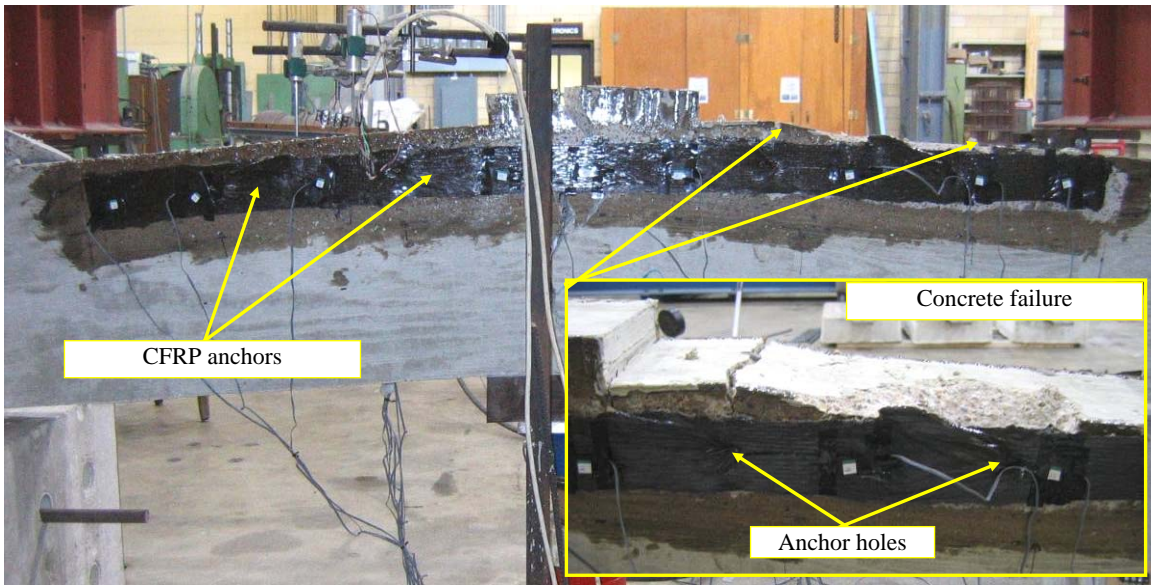
Figure 3.119 Static test, CFRP anchors, 81 % of the ultimate strength (Kim, 2006)

Two specimens (A-S-A-6G and A-S-AU-2S) were tested with the side face strengthening. The failure mode of both specimens was fracture of the CFRP sheets, and this failure mode indicated that the ultimate strength of the CFRP sheets was realized in both specimens. The failure mode of A-S-A-6G under dynamic loading was different from that under static loading (concrete failure near the anchor holes, Figure 3.119) while the failure mode of A-S-AU-2S was the same as that under static loading (fracture of the CFRP sheet, Figure 3.120). In similar tests under static loading (Kim, 2006), the compressive strength was 3,500 psi. Because of the low compressive strength, the specimen loaded statically exhibited a failure in the concrete while the comparison specimen with 6,000 psi concrete failed by fracture of the CFRP sheet under dynamic loading. In the case where the anchors only were used, the compressive strength of the concrete might affect the performance of the specimen. However, if a combination of the CFRP anchors and U-wraps was used, the ultimate strength of CFRP strength was realized in both static and dynamic loading conditions regardless of the compressive strength of the concrete. These results indicated that anchors combined with U-wraps were effective in anchoring the CFRP sheets applied to the side faces of reinforced concrete beams.

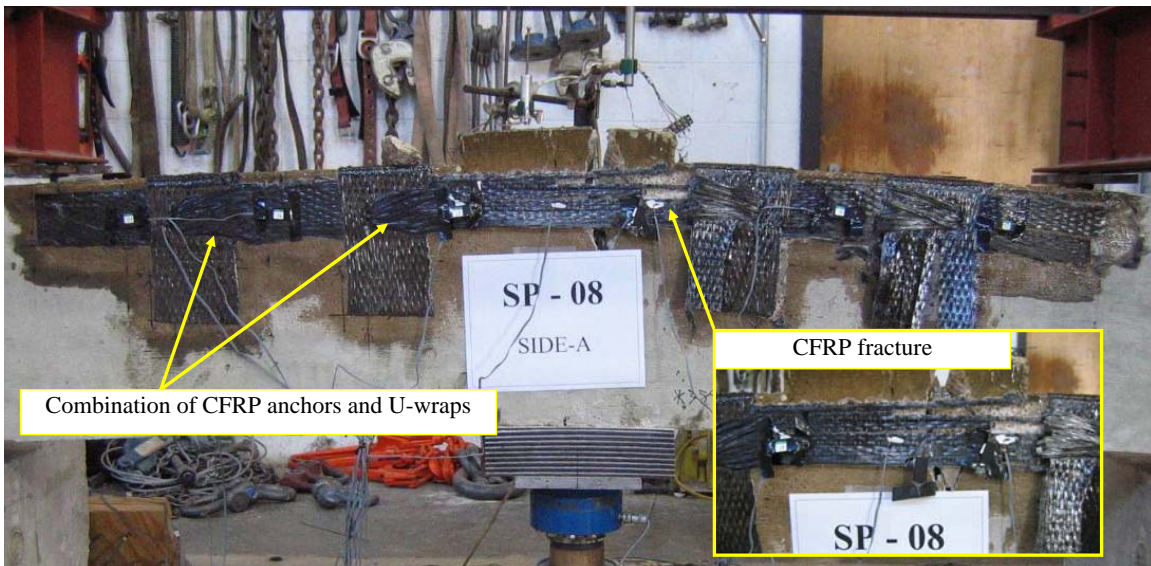
Figure 3.120 Static test, a combination of CFRP anchors and U-wraps, 100 % of the ultimate strength (Kim, 2006)

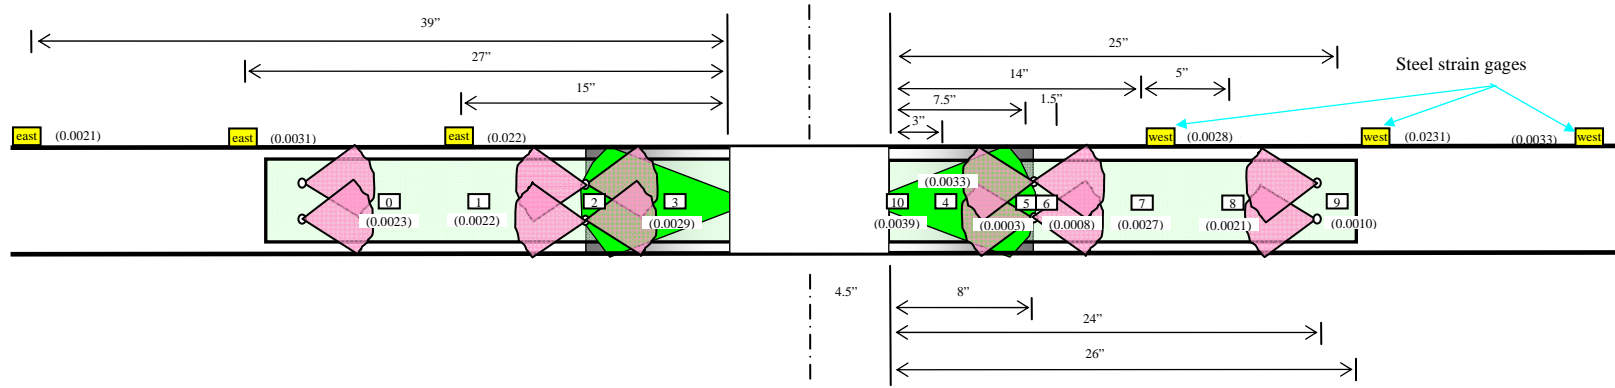
The responses of gage 10 at different drop heights are shown in Figure 3.130. The initial values of strain in the tests except the first test, 2 in. drop height, were not zero because of the previous impacts. The peak strain increased as the drop height increased.

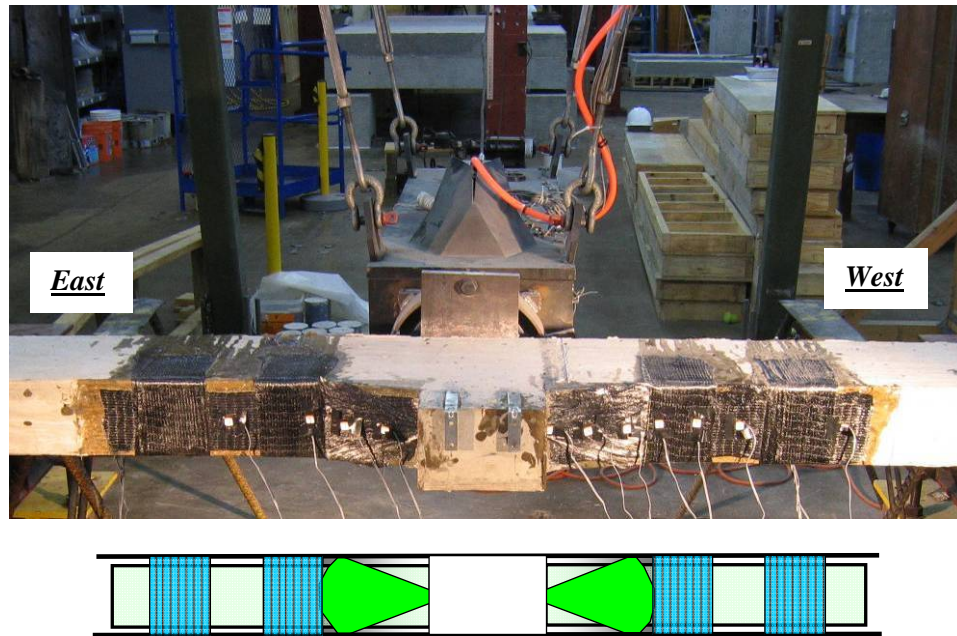
C-BC-U-6G was a Type C beam and CFRP was applied through the column at the bottom face. This beam had one layer of the beam sheet on the east and west side, and the sheet was anchored using the CFRP U-wraps. The connection sheet connected the beam sheets through the column hole and was lap spliced with the beam sheets on the transition ramps. The difference between this beam and C-BC-A-6G-01 was type of anchorage. The surface of the bottom face was ground. The measured compressive strength of the concrete was 6,000 psi. Configuration of the beam is shown in Figure 3.144.

Figure 3.144 Configuration of , C-BC-U-6G

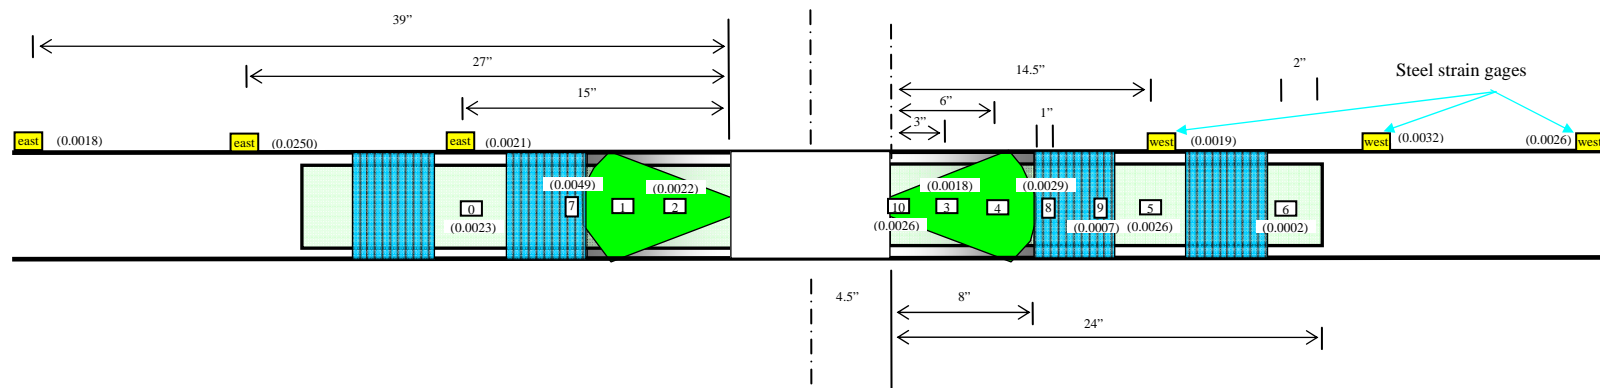
The response of gage 10 at different drop heights is shown in Figure 3.153. This gage was installed on the connection sheet. The initial values of strain in the tests except the first test, a 2 in. drop height, were not zero because of the previous impacts. The peak strain increased as the drop height increased. The response of gage 7, installed in the U-wrap at different drop heights is shown in Figure 3.154. The peak strain increased as the drop height increased and the maximum strain measured in the CFRP U-wrap was larger than that in the CFRP sheets.

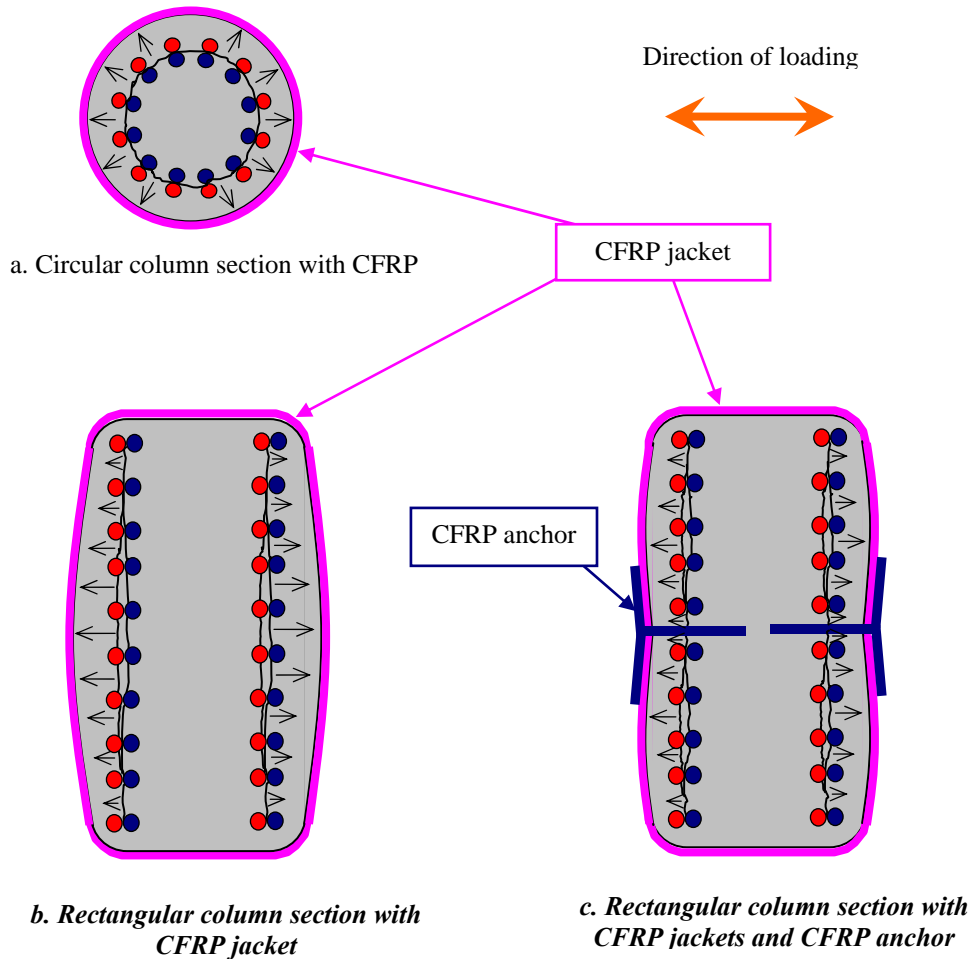
However, CFRP jacketing of square and rectangular reinforced concrete columns (Figure 4.3-b) is not as efficient as it is for circular columns (Figure 4.3-a) because CFRP jackets can not confine a rectangular section as effectively as a circular section. Except for lap splices located at the corners of a square or rectangular column, splitting caused by lap splices of bars away from the corner will not be restrained by the CFRP jacketing. The effectiveness of CFRP jacketing in rectangular columns could be improved using CFRP anchors (Figure 4.3-c). The CFRP anchors cross the splitting crack that develops at the lap splices located away from a corner.

Figure 4.3 Confinement effect of CFRP jackets and CFRP anchors

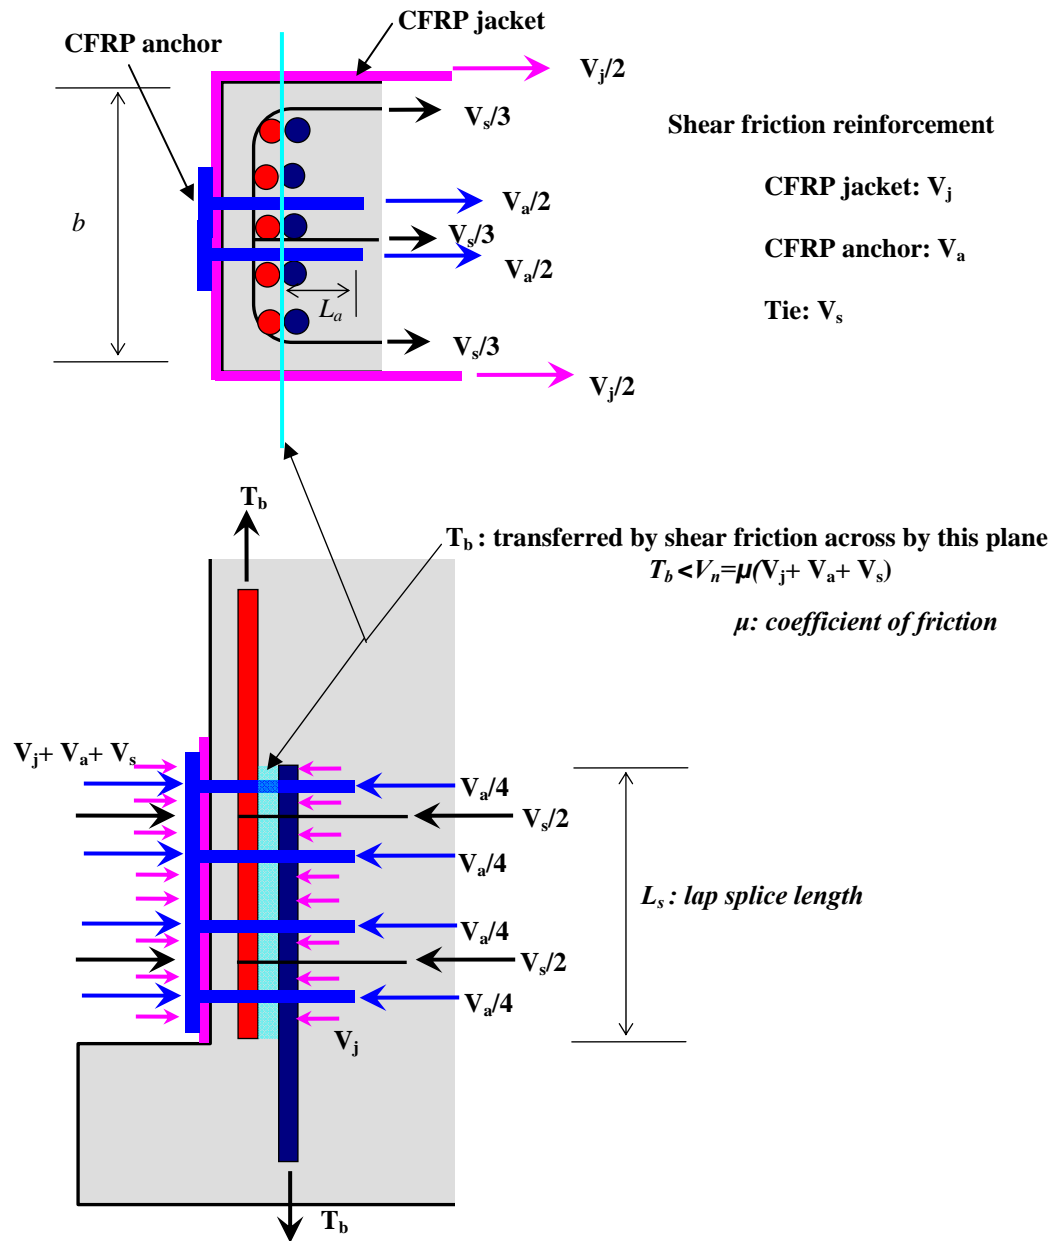
CFRP materials for rehabilitation of 2-A-S8-M and the west side of 3-B-S10-M were initially designed using shear friction as shown in Figure 4.11.

Figure 4.11 Shear friction mechanism, 3-B-S10-M

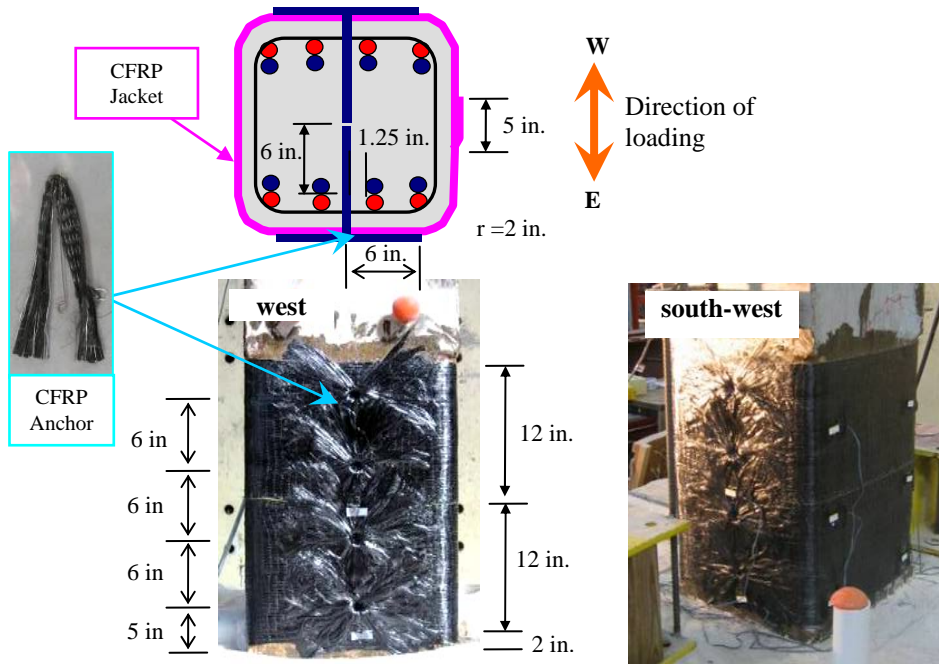
CFRP anchors consist of a roll of CFRP material inserted into a 9 in. deep hole drilled into the concrete. The inserted depth of the CFRP anchor from the expected plane of splitting cracking was 6 in. The inserted depth of the anchor holes in all the other columns was the same as 2-A-S8-M. The CFRP protruding from the hole was splayed out in a 6 in. radius over the CFRP jacket. The anchors were installed at the center of the column so at least one side of every lap spliced longitudinal bars was next to CFRP anchors or column ties. Four anchors were installed in both the damaged and undamaged sides of 2-A-S8-M (at 5 in., 11 in., 17 in. and 23 in. from the top of the footing). Clear spacing between the CFRP anchor and a lap splice bars was 1.25 in.

Figure 4.17 Layout of the CFRP jackets and CFRP anchors, 2-A-S8-M

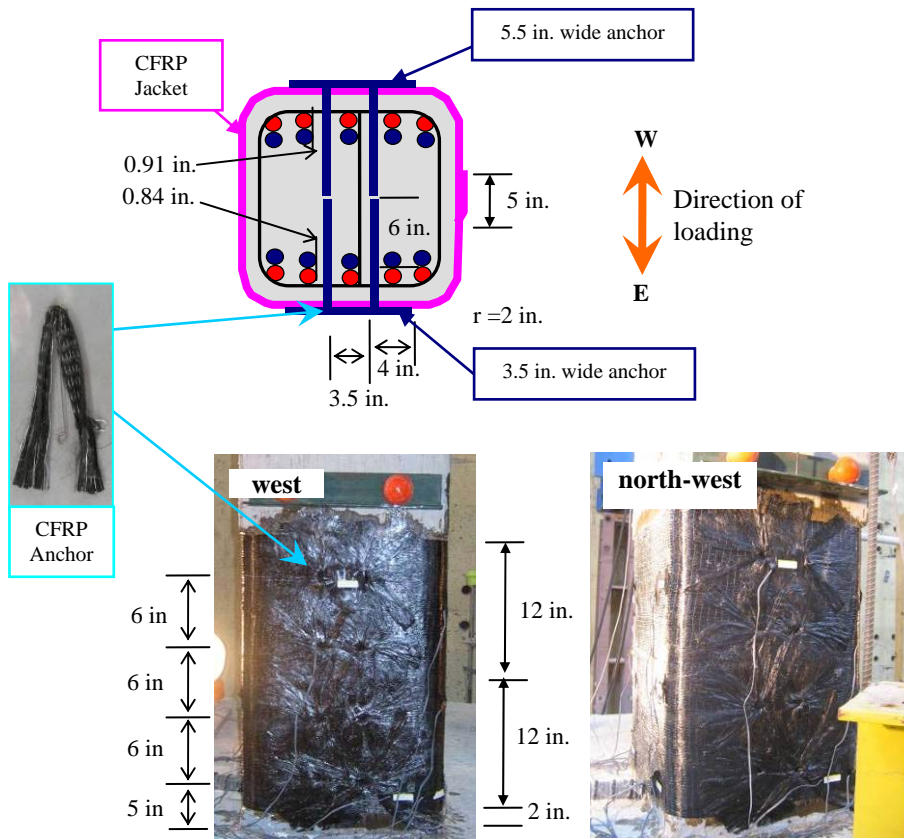
The width of a CFRP sheet used in fabricating an anchor was 5.5 in. on the west face (damaged) and 3.5 in. on the east face (undamaged). The width of the CFRP anchors on the west face was 44 in. (5.5 in. x 8 pc) and on the east face was 28 in. (3.5 in x 8 pc). Total width of CFRP across the plane of splitting was 92 in. on the west face (CFRP jacket: 24 in. x 2 sides; CFRP anchor: 44 in.) and 76 in. (CFRP jacket: 24 in. x 2 sides; CFRP anchor: 28 in.) on the east face. The width of CFRP anchors on the west face was selected using the shear- friction mechanism and that on the east face was selected to provide the same width of CFRP anchors to 3-B-S10-M as 2-A-S8-M. The design method of deciding the width of the CFRP anchors on the west face is discussed in Section 4.2.3.

Figure 4.20 Layout of the CFRP jackets and CFRP anchors, 3-B-S10-M

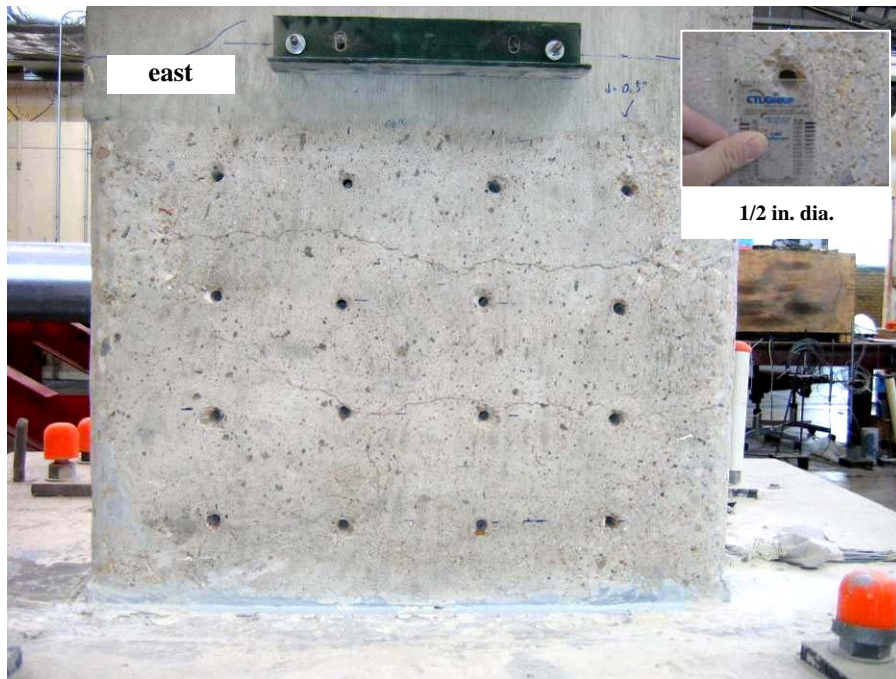
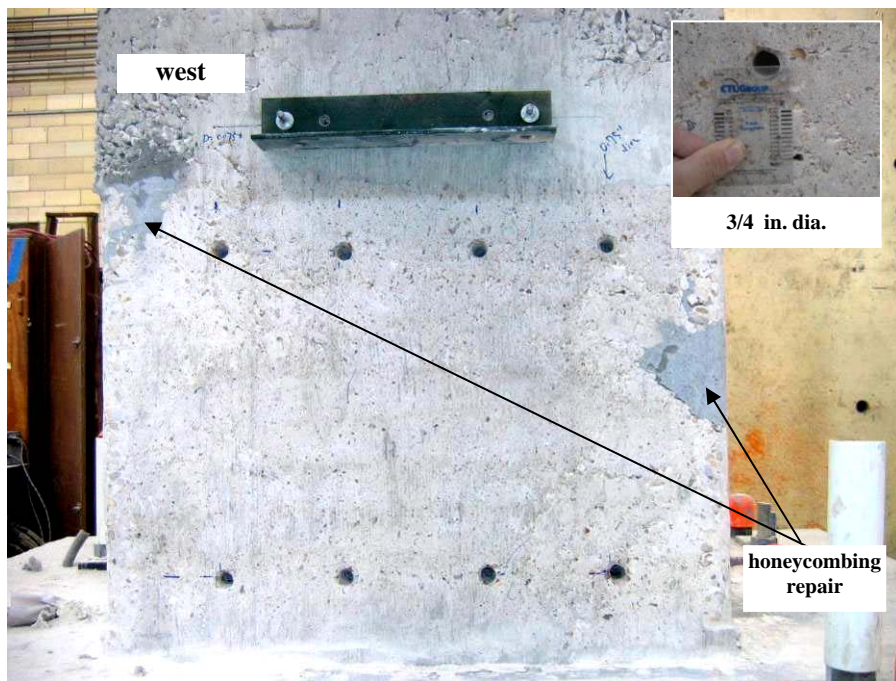
Some honeycombing occurred in 4-C-R20-M due to lack of vibration during casting. The honeycombing in the lap spliced region was repaired using a patching polymer mortar (Tyfo® P from FYFE Co. LLC) after removing all loose materials. The surface of 4-C-R20-M after the repair is shown in Figure 4.21.

Figure 4.21 Anchor holes in 4-C-R20-M

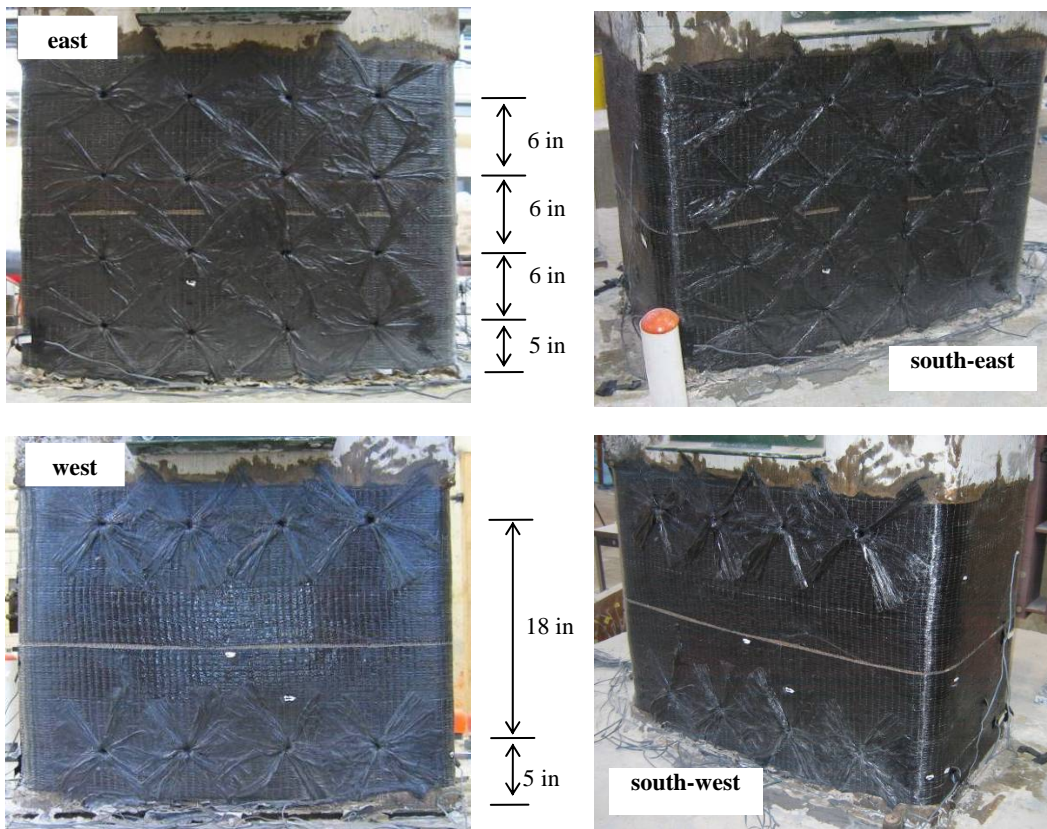
The width of CFRP was selected based on the test results of the west face of 3-B-S10-M. Four 3.5 in. or two 7 in. anchors were placed in a column of CFRP anchors so the total width of CFRP material in the anchors next to a lap spliced bars was 14 in.

Figure 4.22 Layout of the CFRP jackets and CFRP anchors, 4-C-R20-M

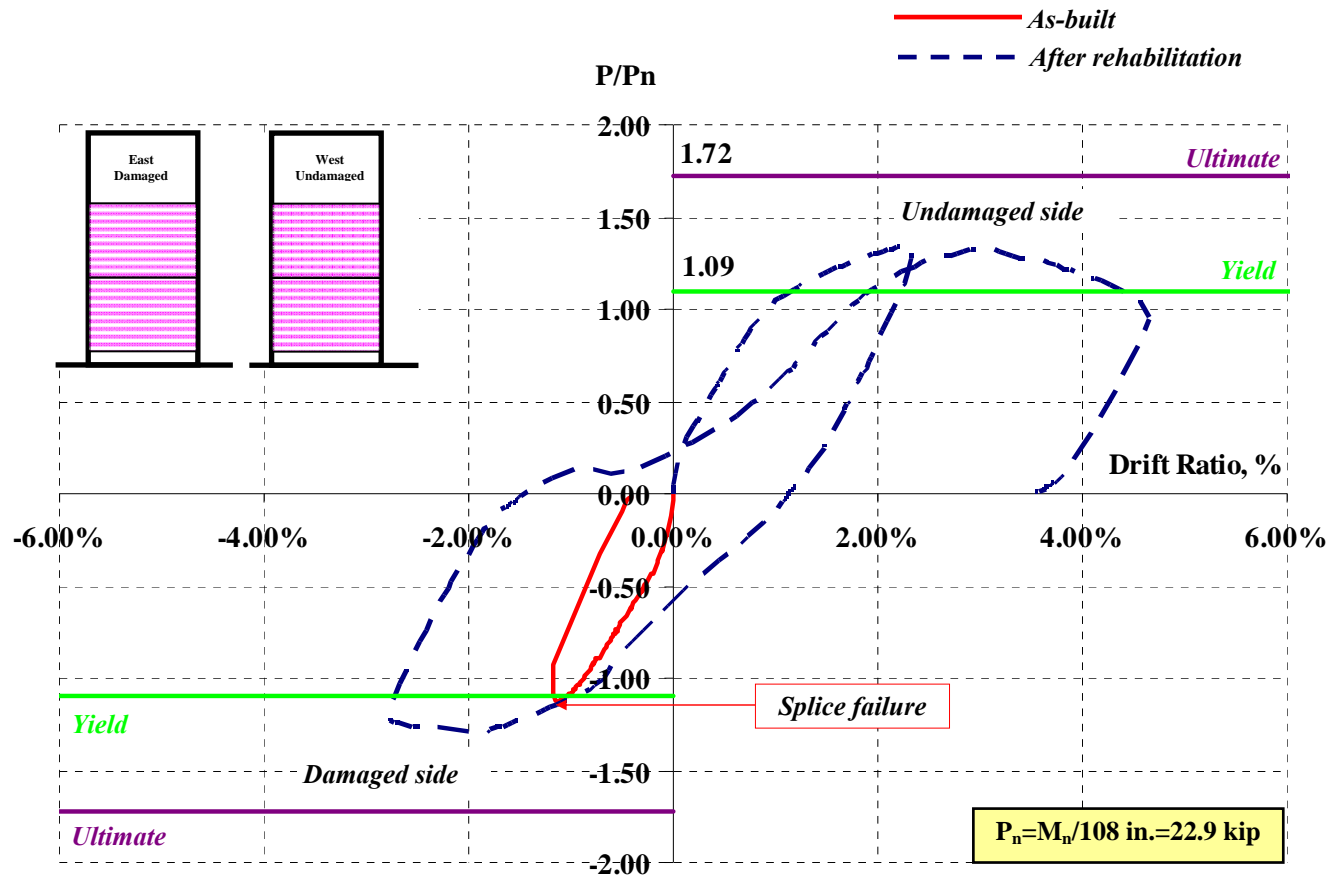
strength increased by 13 % for the damaged side and by 18% for the undamaged side after rehabilitation compared with the as-built strength of this column. The drift ratio of 1-A-S8-M as-built was 1.1 % at the maximum load. The drift ratio corresponding to the peak strength was 1.9 % in the damaged side and 2.3 % in the undamaged side after rehabilitation. In both directions, there was a gradual reduction in strength beyond the peak load up to the stroke limit of the load actuator.

Figure 4.28 Drift ratio vs normalized lateral load, 1-A-S8-M

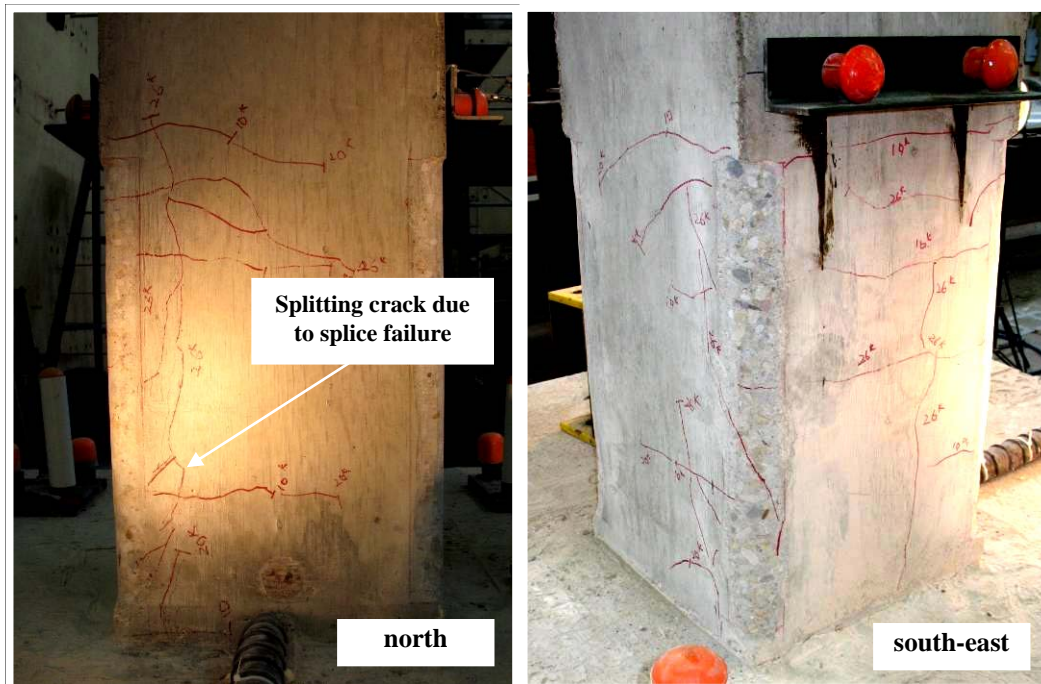
The failure mode of 1-A-S8-M as-built was a brittle splice failure (Figure 4.29). A sudden drop of load was observed at the peak load during the test of this column as-built (Figure 4.28). The use of the CFRP jackets effectively confined lap splices and changed the failure mode of 1-A-S8-M from a brittle splice failure to yielding of tension steel indicated by measured strains in the steel reinforcement presented in the next section.

Figure 4.29 *Splice failure of 1-A-S8-M, before rehabilitation*

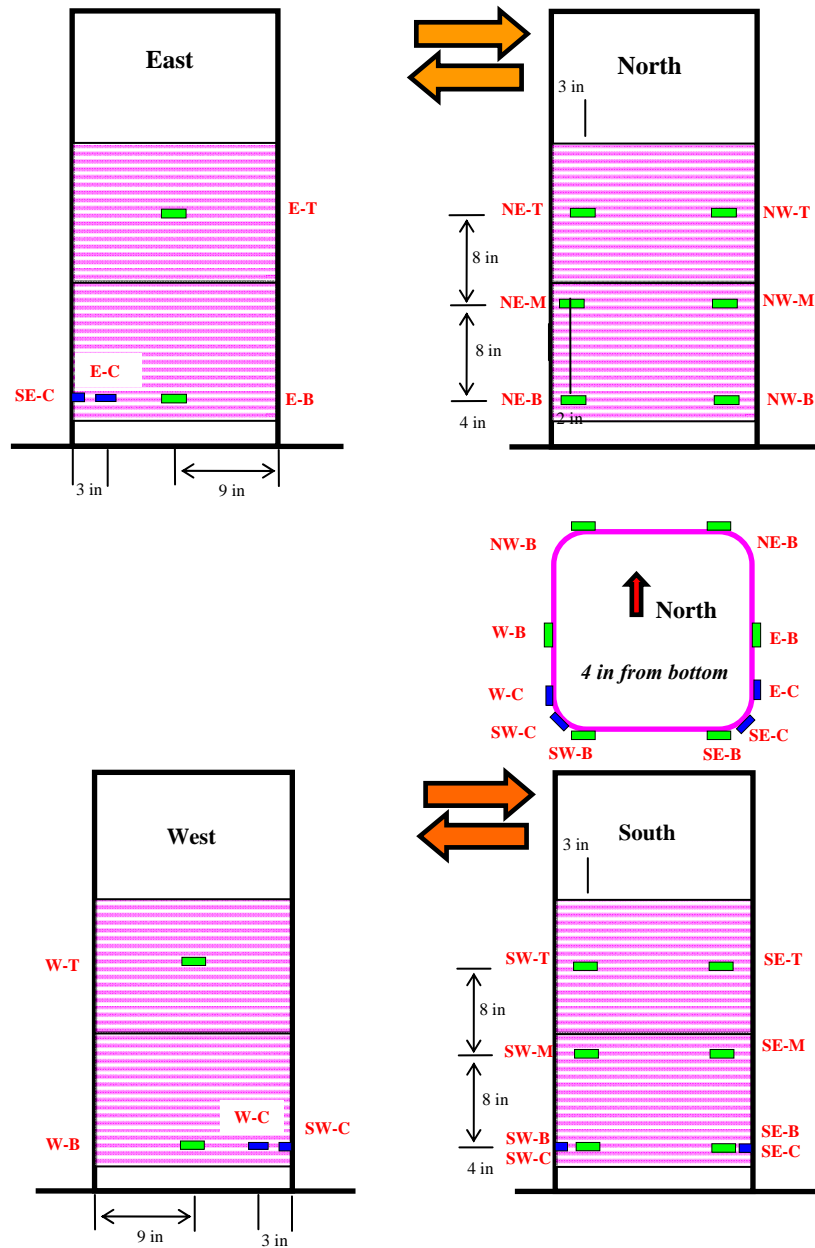
Figure 4.34 Layout of CFRP strain gages, 1-A-S8-M

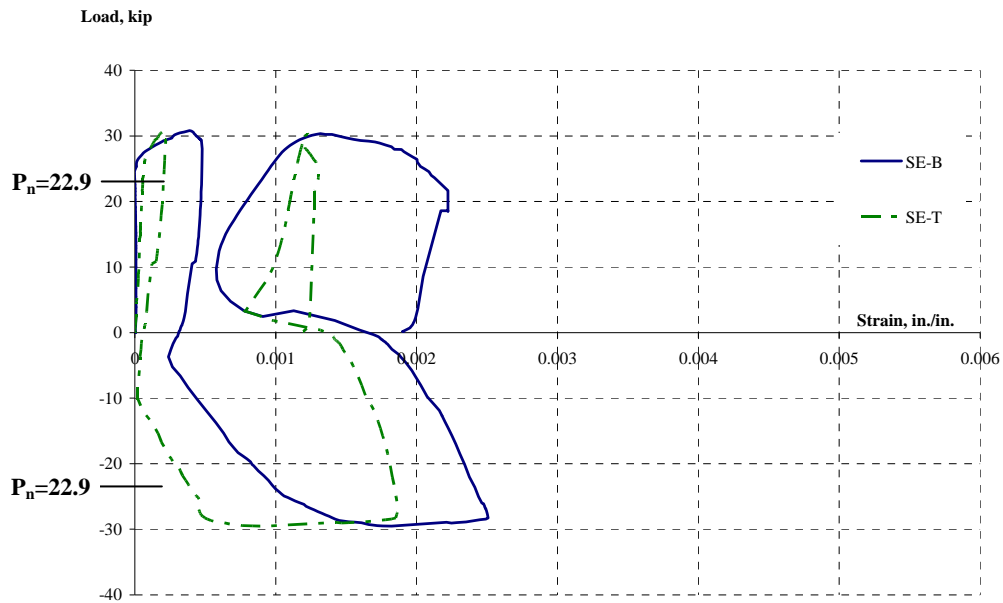
Figure 4.35 CFRP strains at location of splitting cracking, south-east, 1-A-S8-M

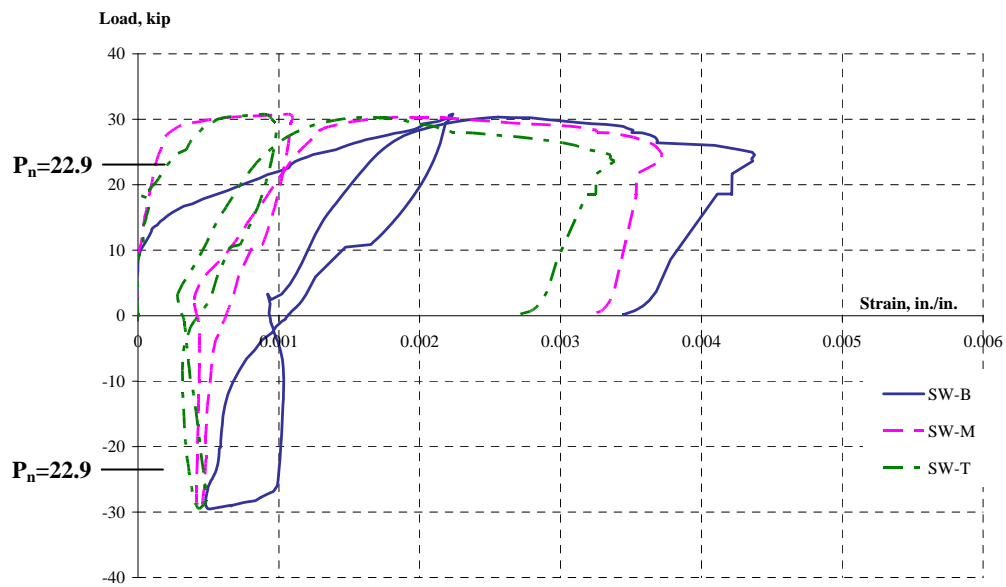
Figure 4.36 CFRP strains at location of splitting cracking, south-west, 1-A-S8-M

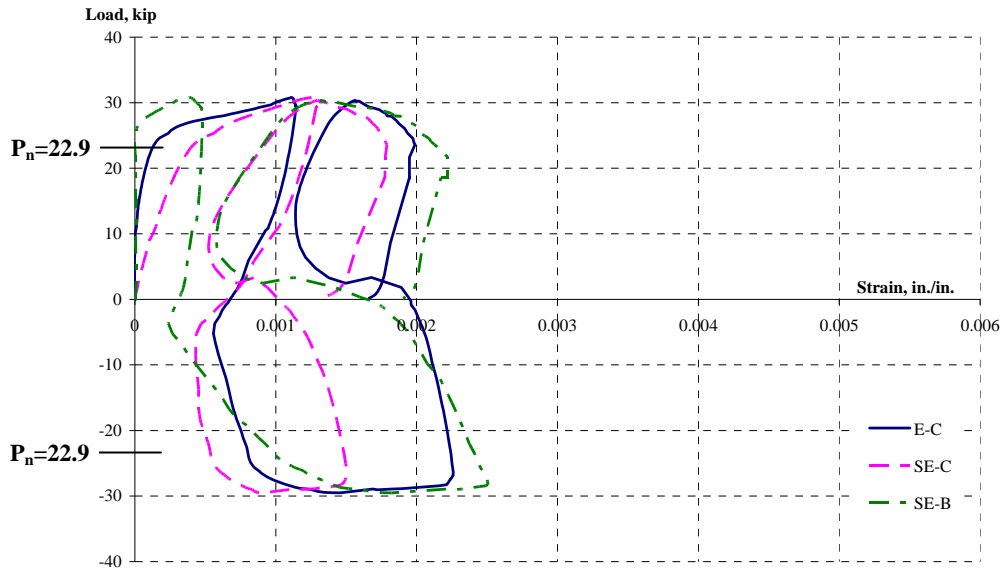
Figure 4.37 CFRP strains at south-east corner, 1-A-S8-M

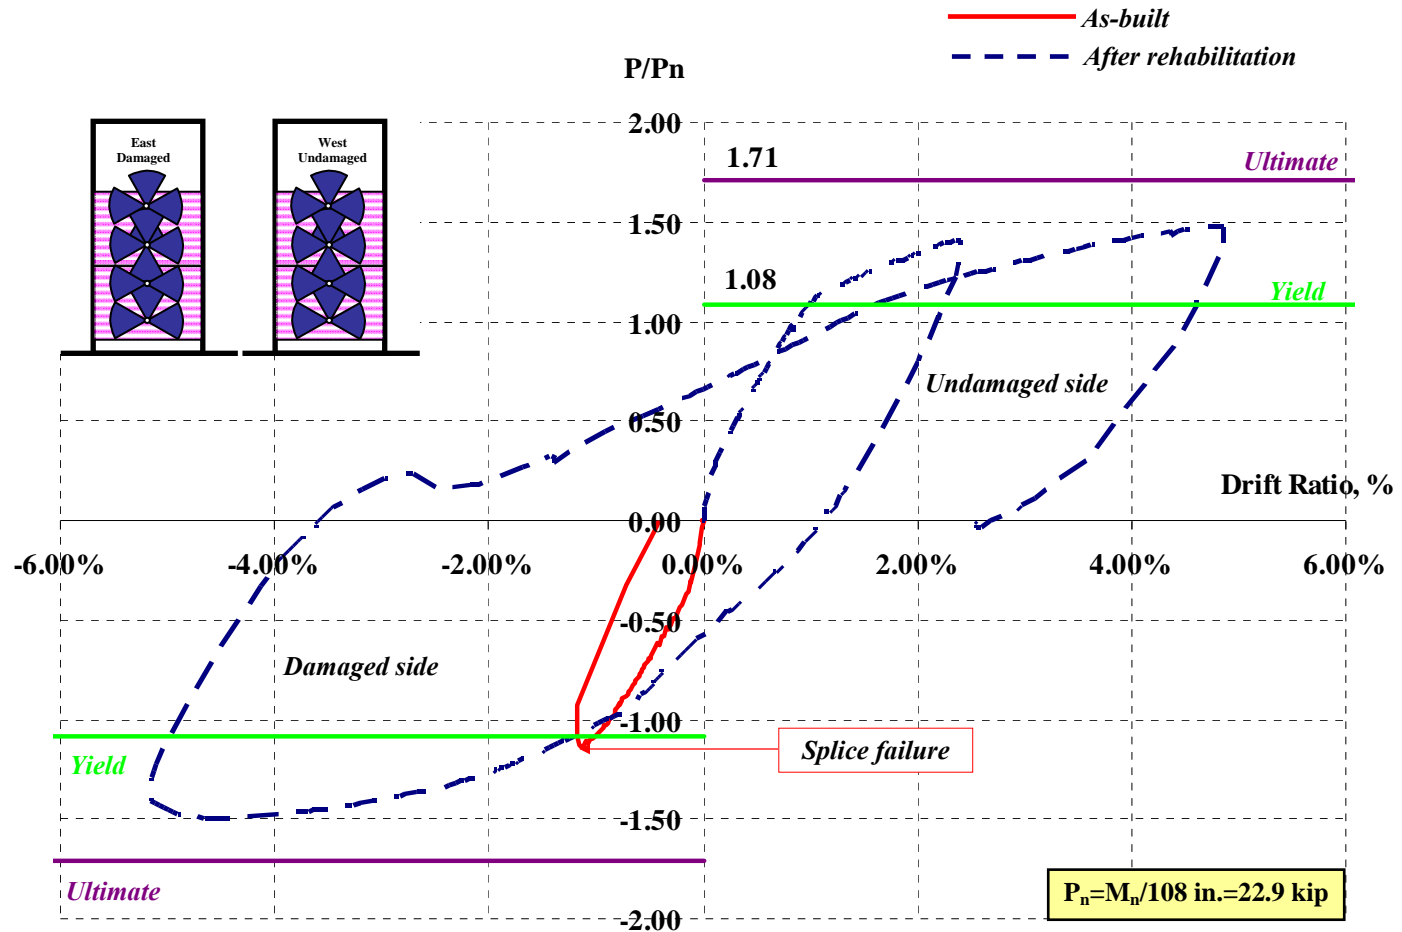
Figure 4.39 Drift ratio vs normalized lateral load, 2-A-S8-M

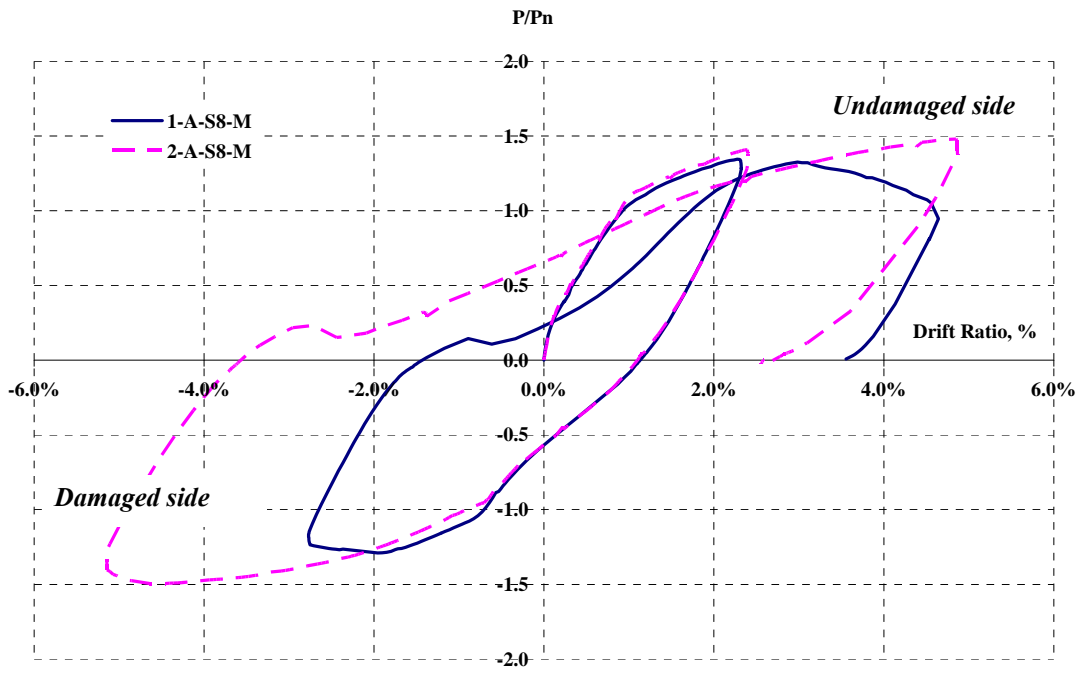
Figure 4.48 Response of 1-A-S8-M and 2-A-S8-M after rehabilitation
