**Use of CFRP to Provide Continuity in Existing Reinforced Concrete
Members Subjected to Extreme Loads**

Dissertation

The University of Texas at Austin

August 2008

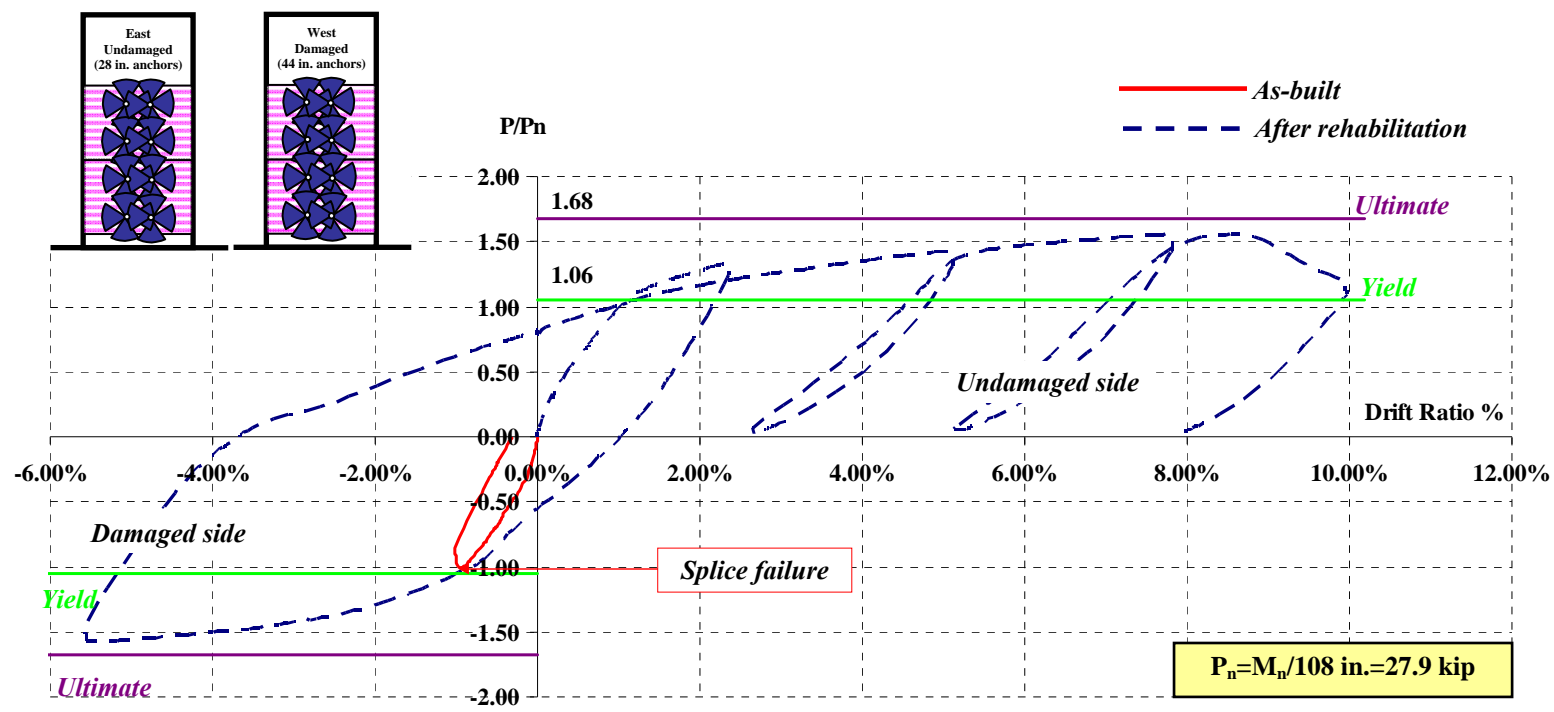
Figure 4.50 Drift ratio vs normalized lateral load, 3-B-S10-M

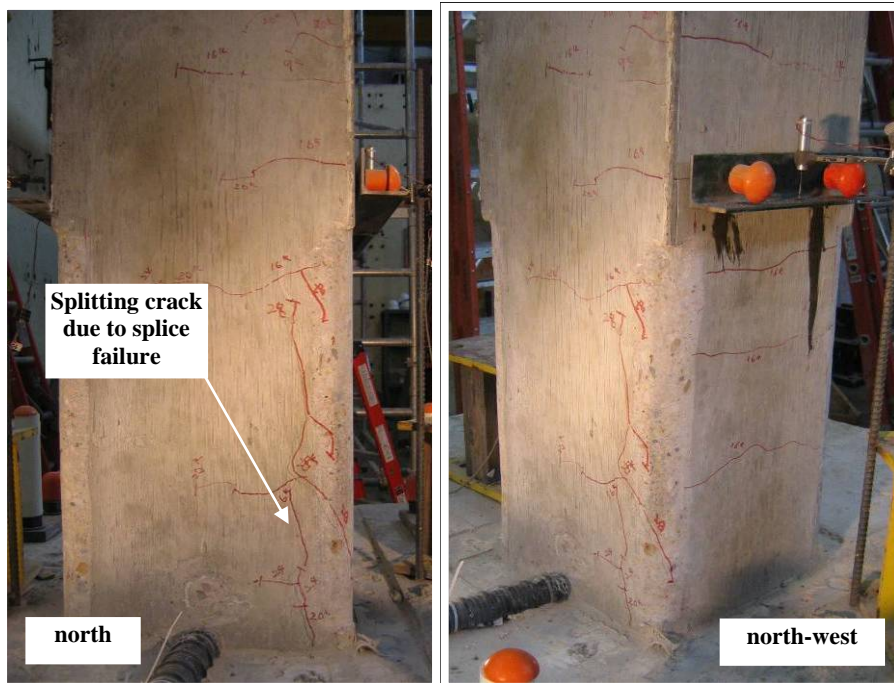
Figure 4.51 *Splice failure of 3-B-S10-M before rehabilitation*

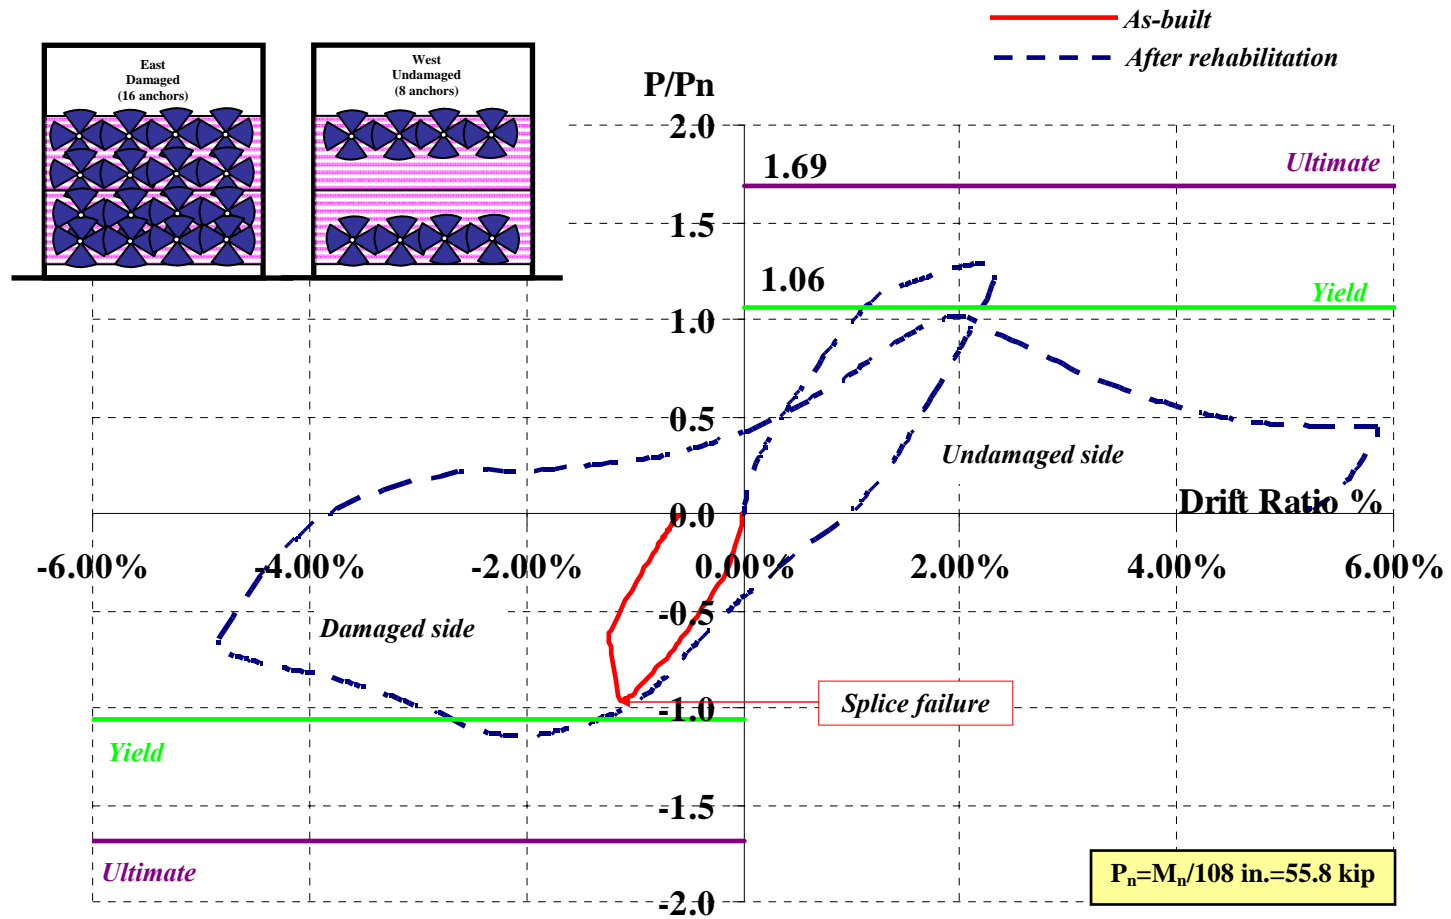
Figure 4.61 Drift ratio vs normalized lateral load, 4-C-R20-M

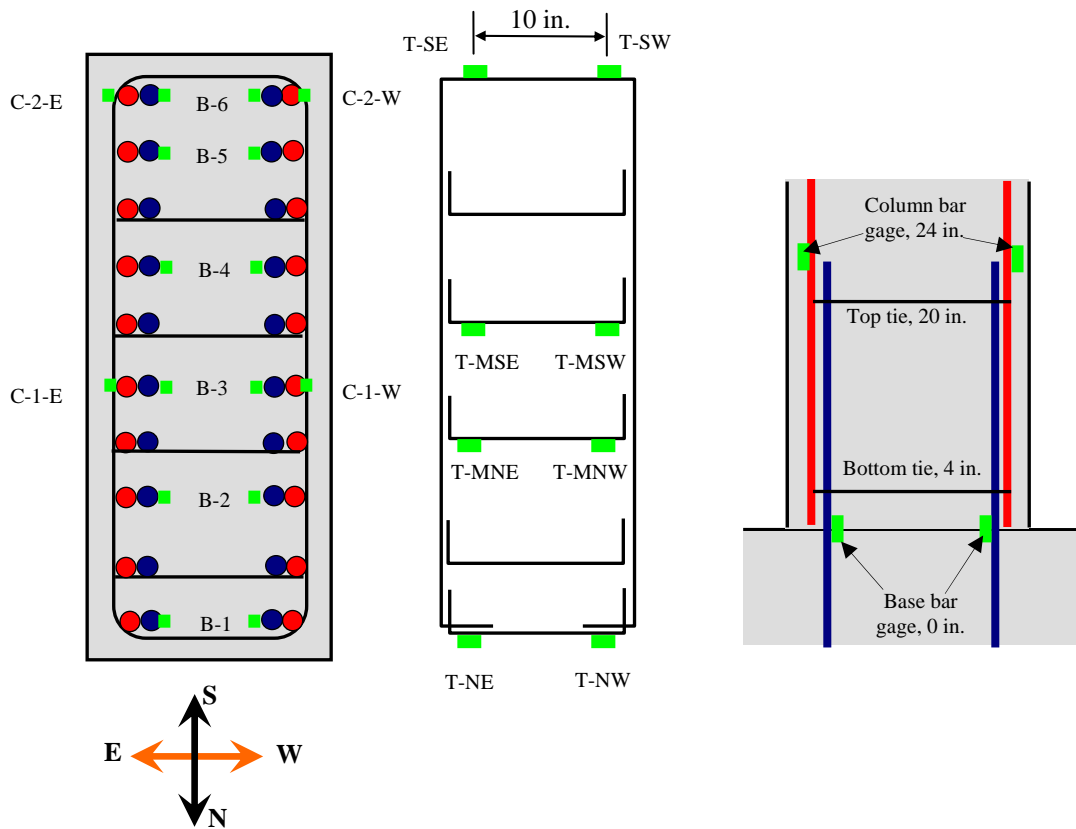
- **Base bar gages (B - # - Direction):** at the top of the footing
- **Column bar gages (C - # - Direction):** 24 in. from the top of the footing
- **Tie bar gages (T-Top or Bottom- Direction):**
 - Top-tie** at 20 in. from the top of the footing
 - Bottom-tie** at 4 in. from the top of the footing

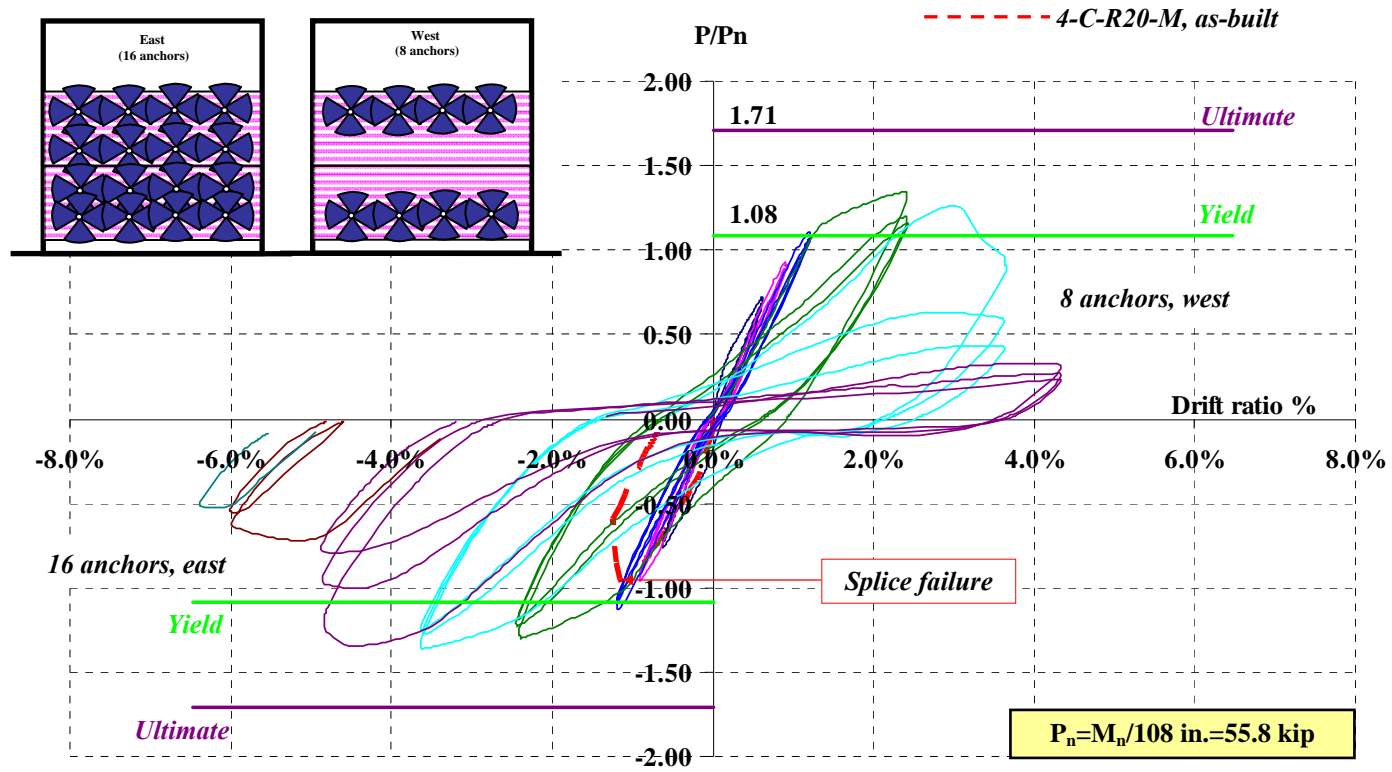
Figure 4.67 Drift ratio vs normalized lateral load, 5-C-R20-C

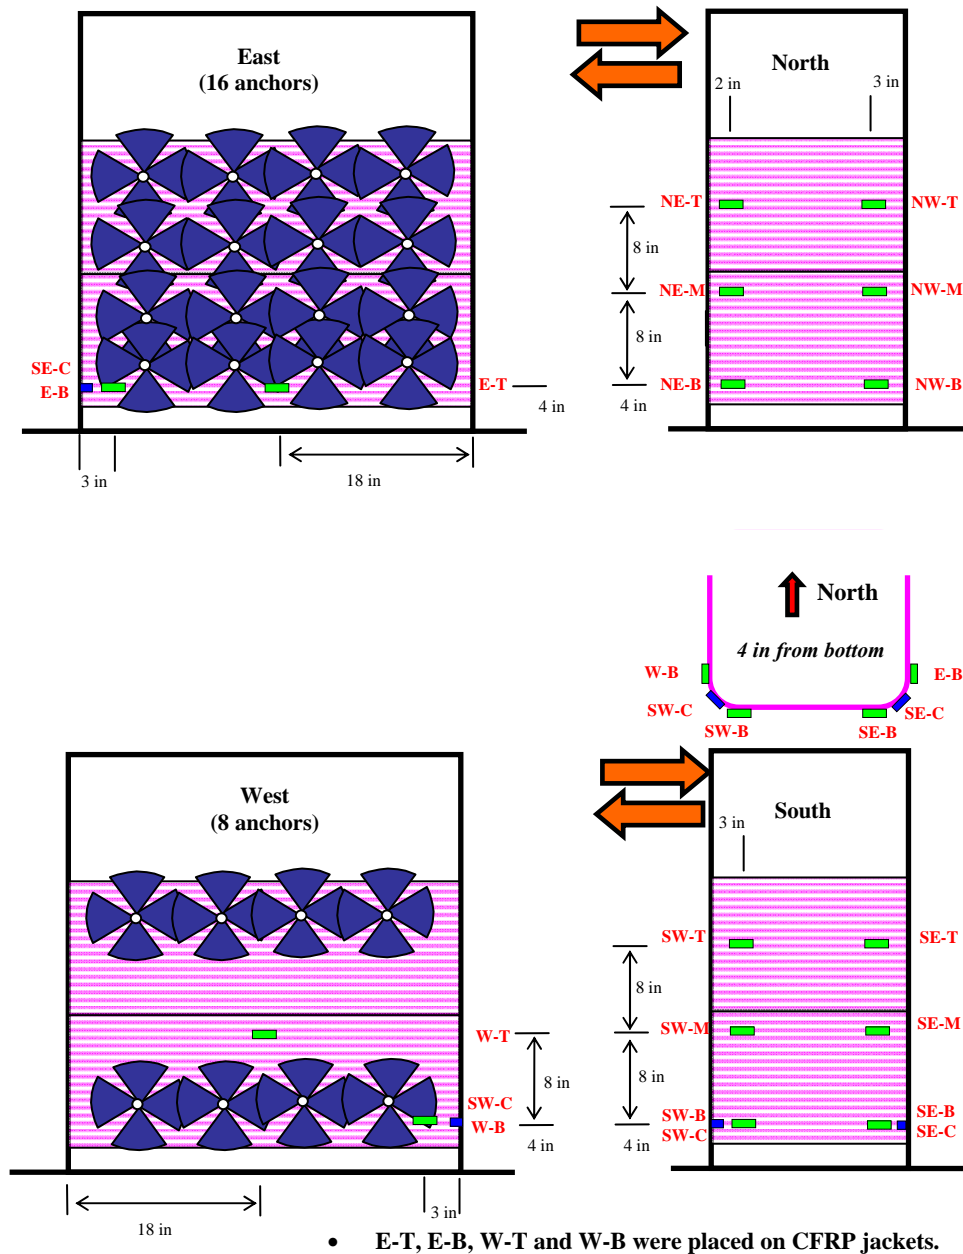
Figure 4.72 Layout of CFRP strain gages, 5-C-R20-C

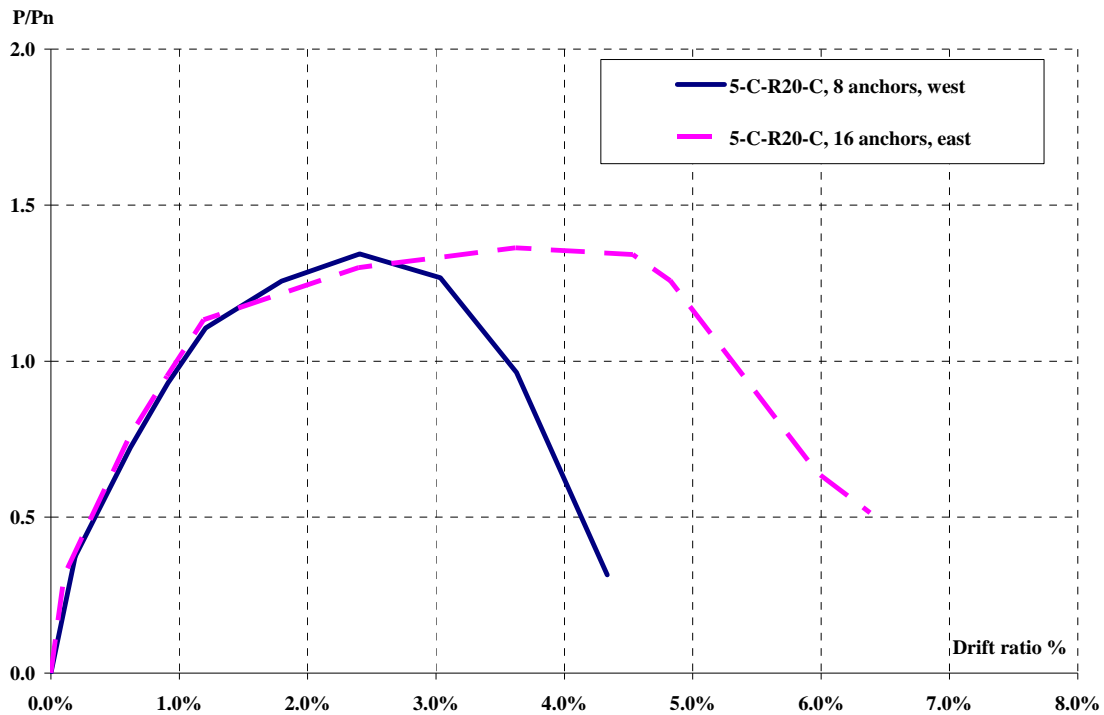
Figure 4.77 Envelope of cyclic response, 5-C-R20-C

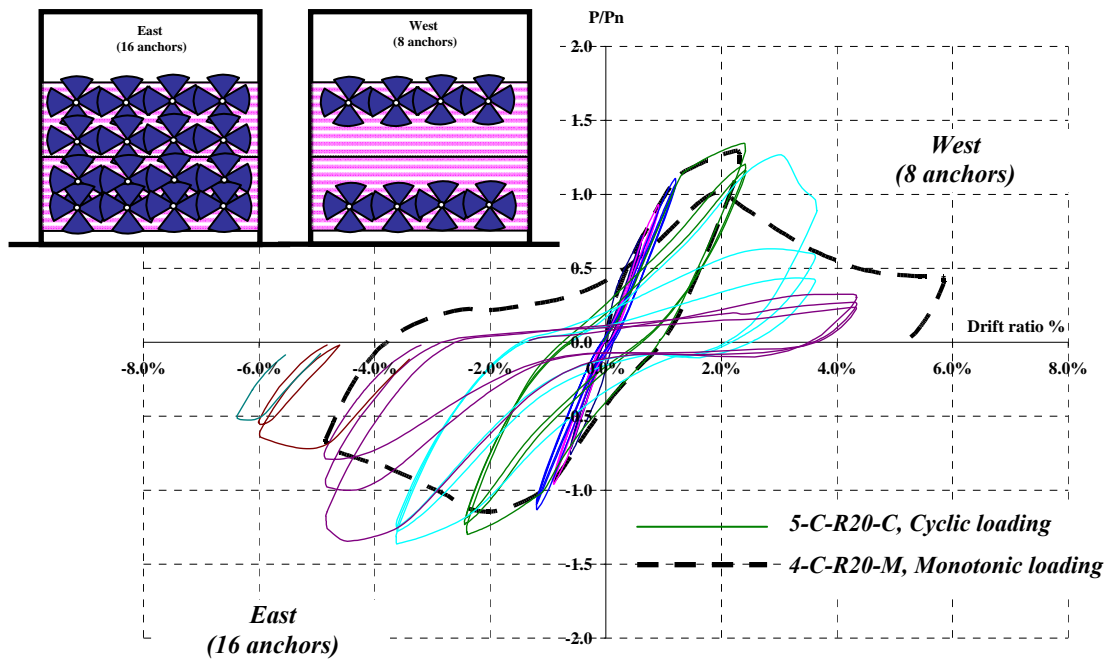
Figure 4.78 Drift ratio vs normalized lateral load, 4-C-R20-M and 5-C-R20-C

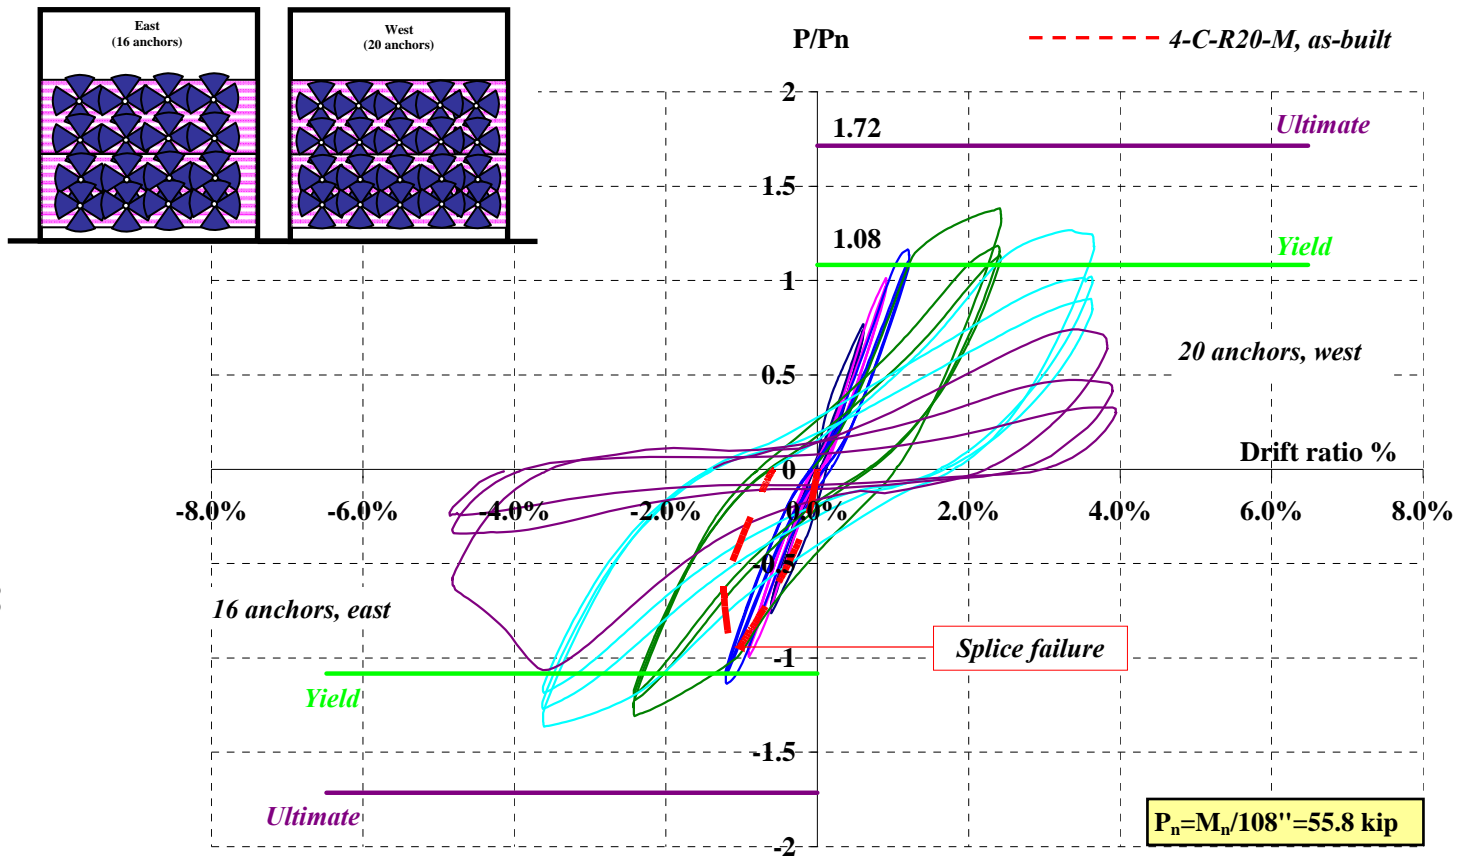
Figure 4.79 Drift ratio vs normalized lateral load, 6-C-R20-C

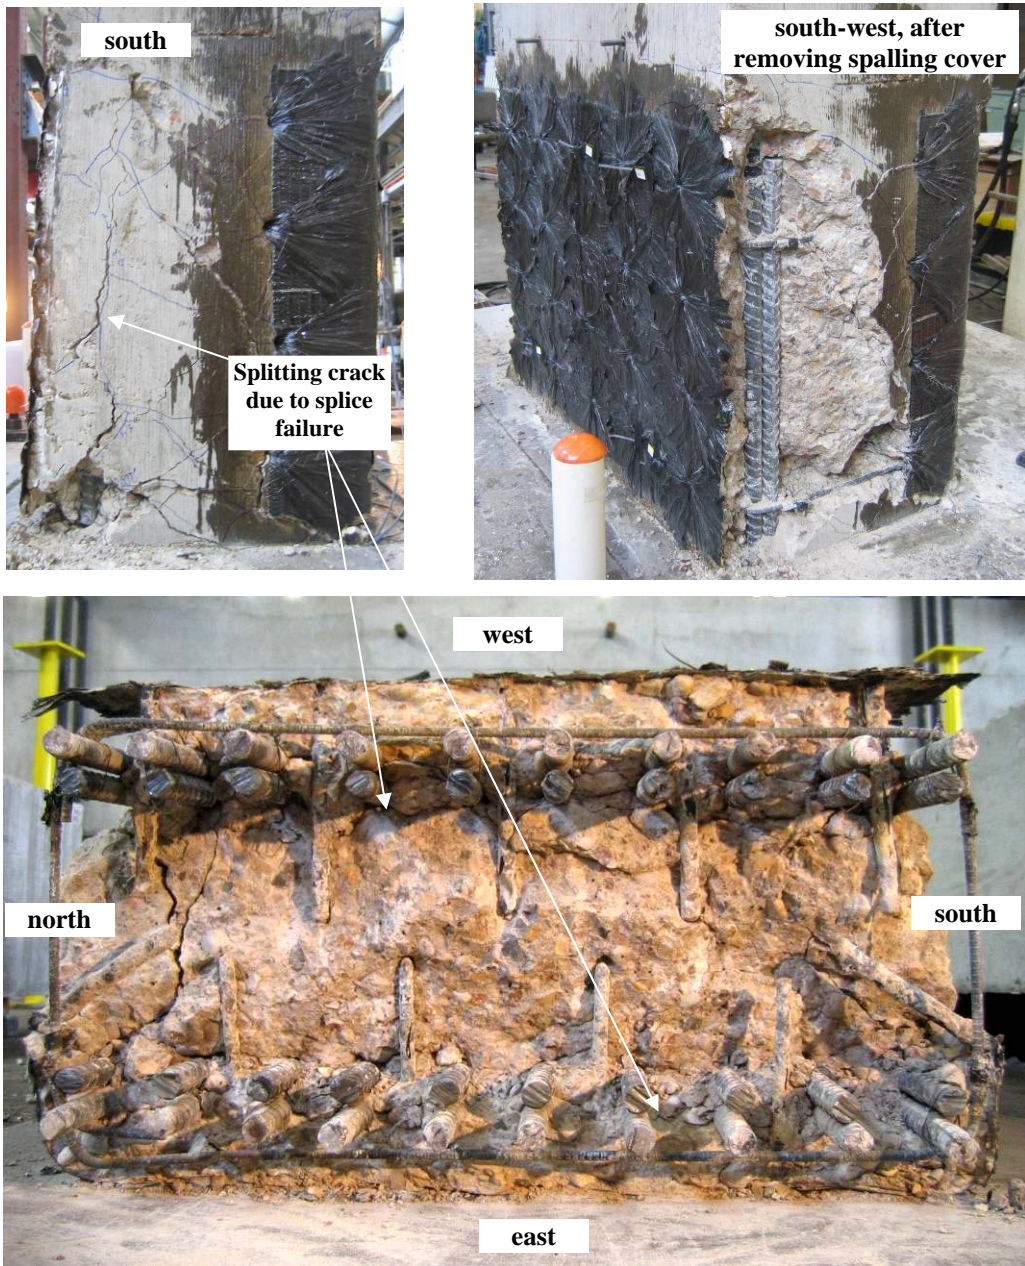
Figure 4.80 *Splice failure of 6-C-R20-C*

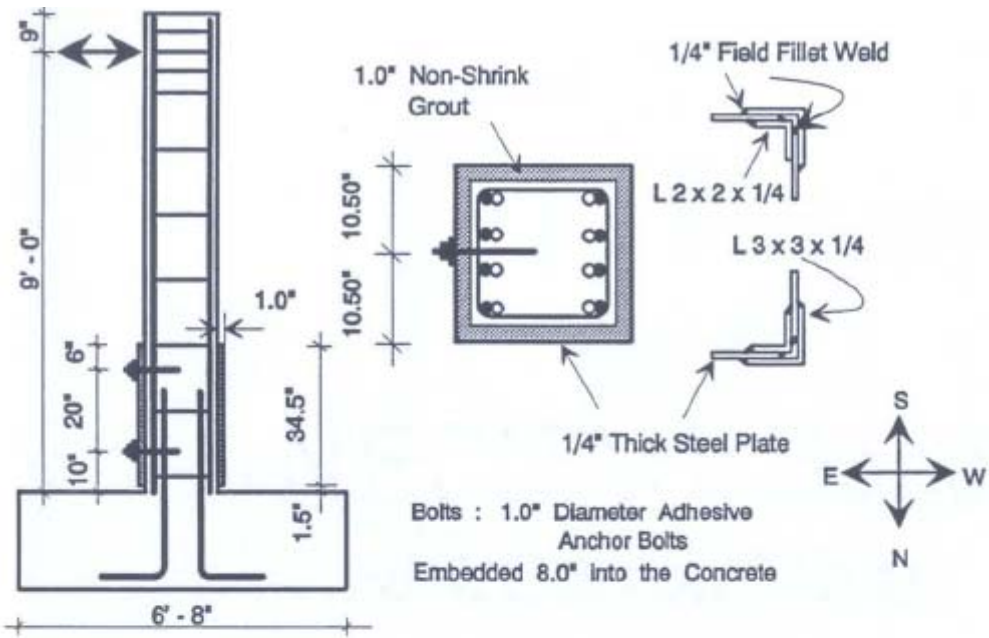
(a) Details of Column FC17

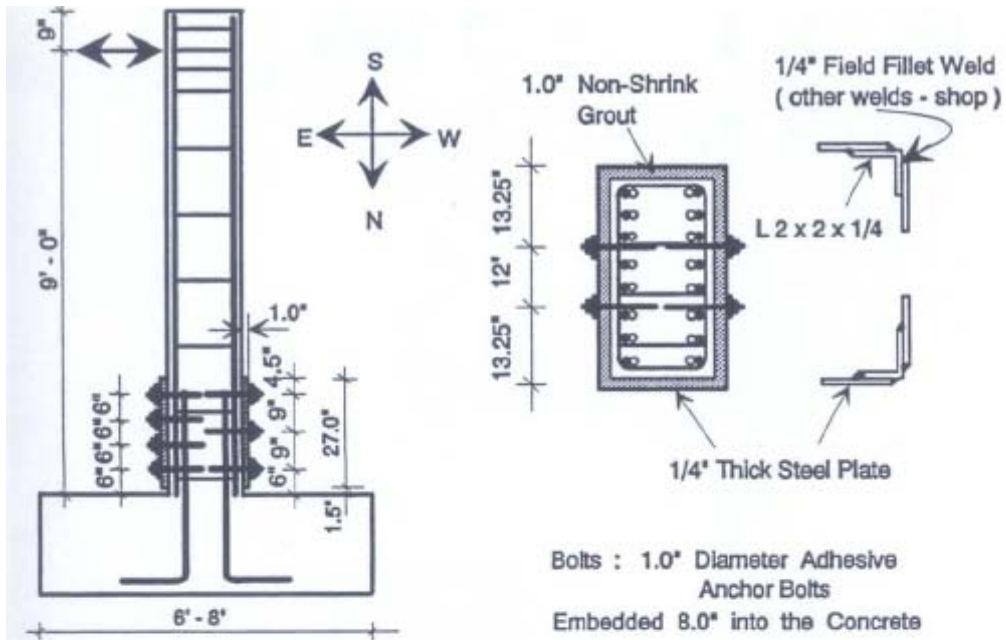
(a) Details of Column FC11
