**Shear Strengthening of Reinforced Concrete Beams with Carbon Fiber  
Reinforced Polymer (CFRP) and Improved Anchor Details**

**Thesis**

The University of Texas at Austin

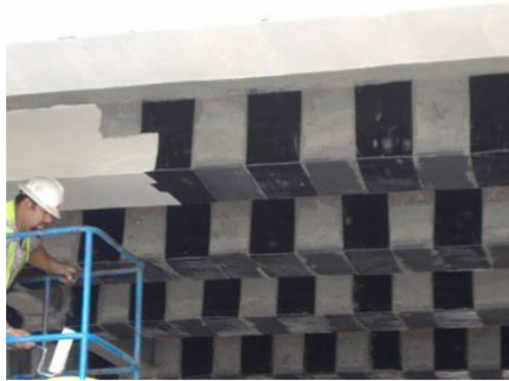
*Figure 2-4 CFRP used in flexural strengthening (Yang, 2007)*

CFRP sheets can be installed in all types of structural applications including but not limited to flexural strengthening (Figure 2-4), shear strengthening (Figure 2-5) and axial confinement (Figure 2-6) applications (Khalifa, Alkhrdaji, Nanni, & Lansburg,

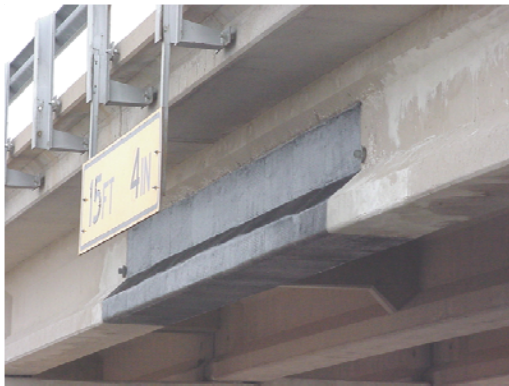
*Figure 2-5 CFRP used in shear strengthening (Yang, 2007)*

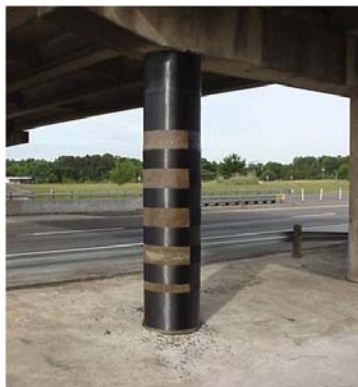
*Figure 2-6 CFRP used in an axial confinement application (Yang, 2007)*

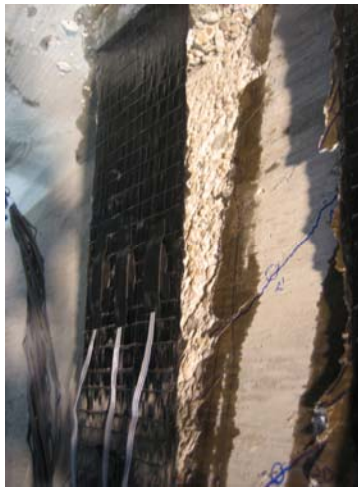
***Figure 2-12 An experimentally debonded CFRP strip***

One of the key factors that effects the bond strength between the concrete and CFRP is the concrete compressive strength. Debonding almost always occurs in the concrete at a small distance away from the concrete/CFRP interface. When debonding occurs, some concrete is still adhered to the CFRP. Because the failure actually occurs in the concrete, it is obvious that the concrete compressive strength of the beam plays a key role in the overall strength of the system (Chen & Teng, FRP Debonding, 2003). Figure 2-12 illustrates this concept clearly. The debonded strip has pulled some of the concrete substrate away from the beam.

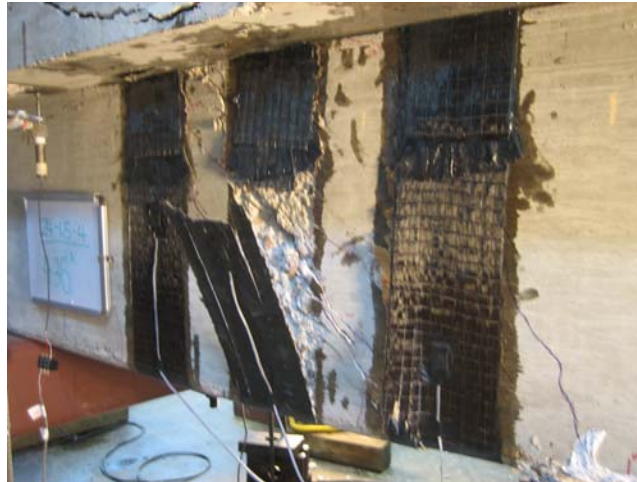
*Figure 2-13 Rupture of a CFRP strip*

When a concrete beam strengthened in shear with CFRP strips fails by CFRP rupture, the most highly stressed strip will fracture first. Once this strip has fractured, it loses its ability to resist tensile force and the beam redistributes the force to neighboring CFRP strips. These strips then, in turn, become highly stressed and fracture as well.

Redistribution occurs again until each strip crossing the main shear crack ruptures, causing the beam to fail (Teng, Lam, & Chen, 2004). A photo of an experimentally tested specimen failing by CFRP rupture is presented in Figure 2-13.

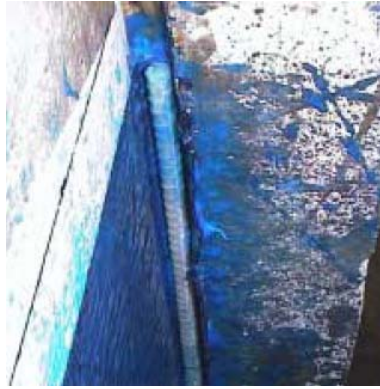
*Figure 2-25 Glass FRP rod used to anchor a CFRP sheet a concrete beam (Khalifa, Alkhrdaji, Nanni, & Lansburg, 1999)*

Another form of anchorage being studied at the Missouri Institute of Science and Technology (formerly the University of Missouri-Rolla) is the U-anchor system as depicted in Figure 2-24. The CFRP U-Anchor system (Khalifa, Alkhrdaji, Nanni, & Lansburg, 1999). To construct this anchorage system, a groove is cut into the concrete element at the intersection between the web and flange. The groove is coated with the adhesive epoxy material recommended by the manufacturer of the CFRP laminates. The CFRP sheet is then installed onto the surface of the beam and a glass FRP rod is used to insert the CFRP sheet into the preformed groove as seen in Figure 2-25. This rod also

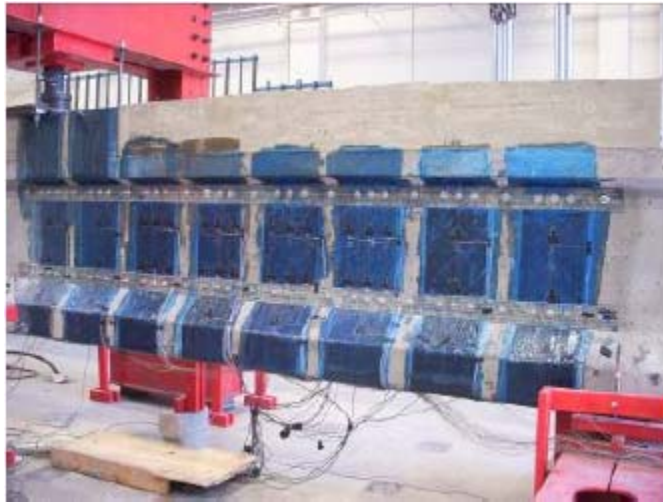
**Figure 2-26 Continuous CFRP plates used to anchor CFRP sheets (Ortega, Belarbi, & Bae, 2009)**

As seen in Figure 2-26 and Figure 2-27, the anchorage system consisted of continuous CFRP plates bonded to the CFRP strips with epoxy and securely anchored to the concrete with wedge anchors and steel bolts. A CFRP plate was placed near the ends of the CFRP strips in an effort to prevent debonding from occurring. A second CFRP plate was installed close to the reentrant corner of the specimen to prevent the debonding associated with the strips' high tendency to debond at reentrant corners when an axial tension load is applied to the strip.

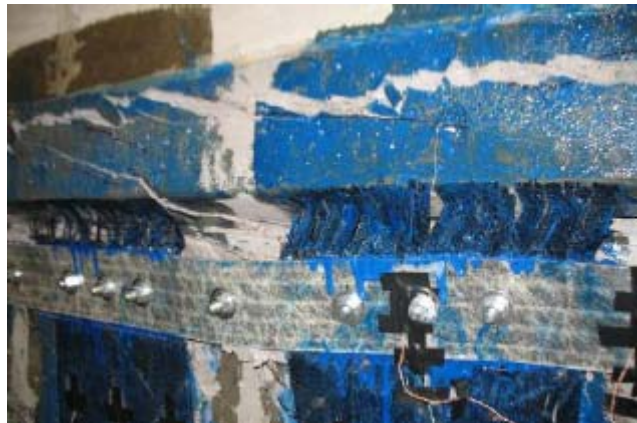
***Figure 2-28 Buckling of the continuous CFRP plate observed at failure (Ortega, Belarbi, & Bae, 2009)***

This method of anchorage proved to be ineffective due to the tendency of the continuous CFRP plate to buckle (Figure 2-28). Short embedment lengths of the wedge anchors and steel bolts caused them to pull out from the concrete. Because these wedge anchors and bolts were no longer able to keep the CFRP strips adhered to the beam, severe debonding occurred. Therefore, a new method of anchorage was developed by Ortega et al. (2009) consisting of discontinuous CFRP plates.

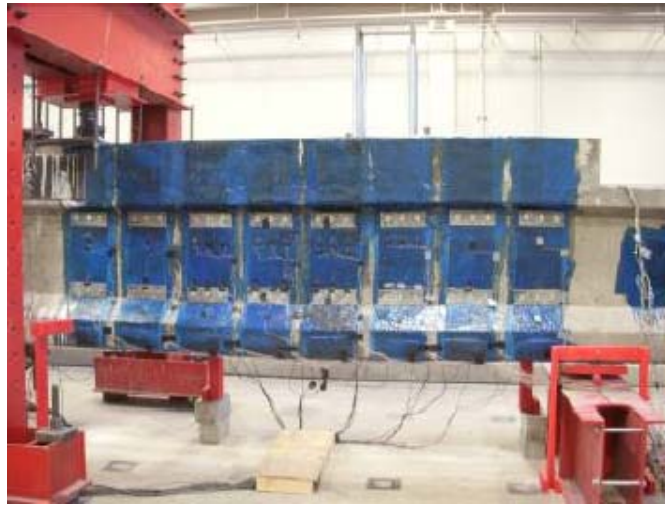
**Figure 2-29 Discontinuous CFRP plates used to anchor CFRP sheets (Ortega, Belarbi, & Bae, 2009)**

The discontinuous CFRP plate anchorage system is constructed in much the same way as the continuous plate system. The only difference is that discontinuous CFRP plates are installed on each CFRP strip (Figure 2-29 and Figure 2-30) rather than one continuous CFRP strip adhering to all of the CFRP strips. Also, longer embedment lengths of the concrete wedge anchors and steel bolts were utilized in an effort to prevent pullout failures from occurring.

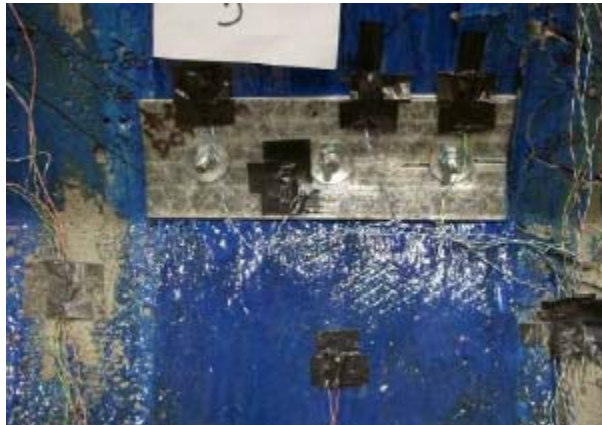
*Figure 2-31 A CFRP strip that has slipped out of the discontinuous anchorage (Ortega, Belarbi, & Bae, 2009)*

The discontinuous system performed much better than the continuous system. The concrete specimen did not fail until it was loaded to a much higher shear load; however, an interesting failure mode was observed. As seen in Figure 2-31, the CFRP strips slipped out of the anchorage provided by the discontinuous CFRP plates at failure. The CFRP strip might slip from the anchorage device at a load lower than the ultimate failure load. Since this was an undesirable mode of failure, Ortega et al. (2009) developed a modified anchor bolt system.

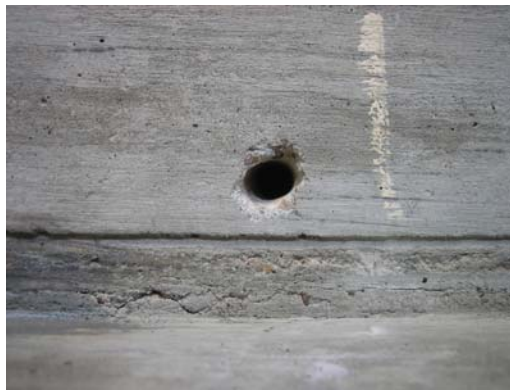
*Figure 2-35 Anchor hole drilled into the side of a concrete specimen*

The first step requires drilling a hole into the concrete beam as seen in Figure 2-35. Özdemir (2005) determined that there is a certain embedment depth of the CFRP anchors beyond which the capacity of the CFRP anchors no longer increases. As the embedment depth increases, the average bond strength along the surface of the drilled hole decreases. This implies that the stress distribution along the depth of the drilled hole is not uniform (Ozbakkaloglu & Saatcioglu, 2009). Therefore, it is usually acceptable to embed the anchor deep enough into the concrete specimen so that the capacity of the CFRP anchor is not diminished (Orton, Jirsa, & Bayrak, 2008).

Another concern relating to the drilled anchor hole is the rough concrete edge that is formed around the lip of the drilled hole. As seen in Figure 2-35, a sharp, rough edge can create stress concentrations in the anchor. These stress concentrations can cause the anchor to rupture, initiating a premature failure of the entire CFRP system. Therefore, proper rounding of the rough edge around the drilled anchor hole is the next step in the installation of CFRP anchors.

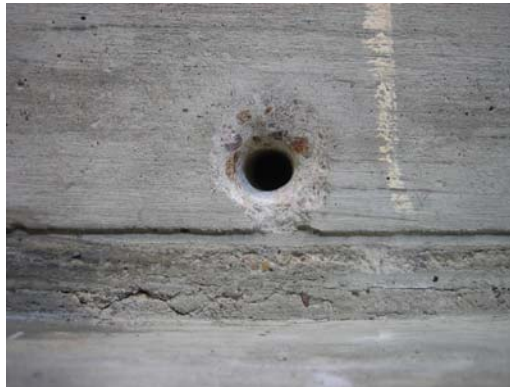
***Figure 2-36 Anchor hole rounded with appropriate radius***

Rounding the edge of the drilled hole (Figure 2-36) lessens the stress concentrations in the CFRP anchor produced at the opening of the hole. Kobayashi et al. (2001) rounded each anchor hole to a radius of 20-mm in their study of CFRP anchors. ACI 440.2R-08 recommends that all 90 degree corners be rounded to a radius of 0.5-in.; however, in a study by Morphy (1999), it was recommended that the radius of the bend located at the opening of the anchor hole be at least four times greater than the anchor diameter. This means that for a 3/8-in. anchor diameter, the opening of the anchor hole requires a rounded radius of 1.5-in. (Orton, 2007).

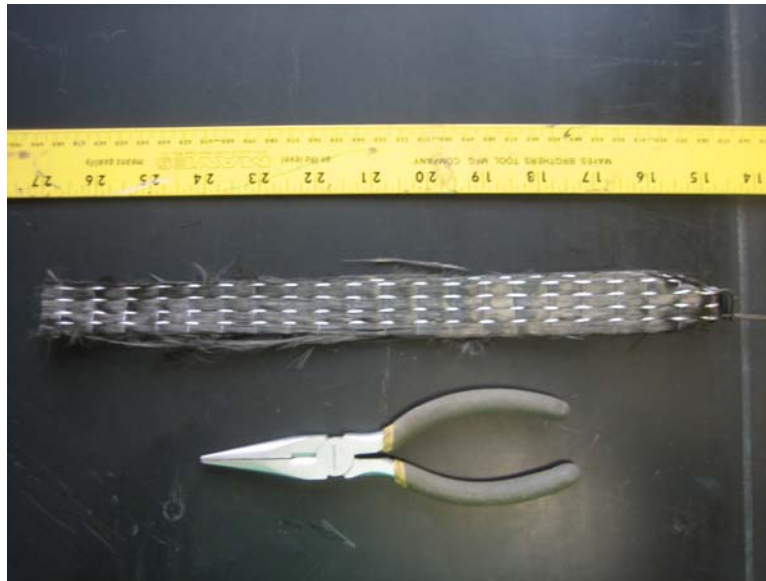
***Figure 2-38 CFRP strip folded in half and clasped with a rebar tie***

The total length of the CFRP strip used to create the CFRP anchor can then be calculated as twice the sum of the embedment depth and the required geometric length of the anchorage fan. To make installation of the CFRP anchor easier, this strip of CFRP fabric is folded in half (Figure 2-38) and therefore the required length of the anchor must be doubled. Because the ends of the CFRP strip are folded together, the width of the CFRP strip used to create the anchor only needs to be half the required width.

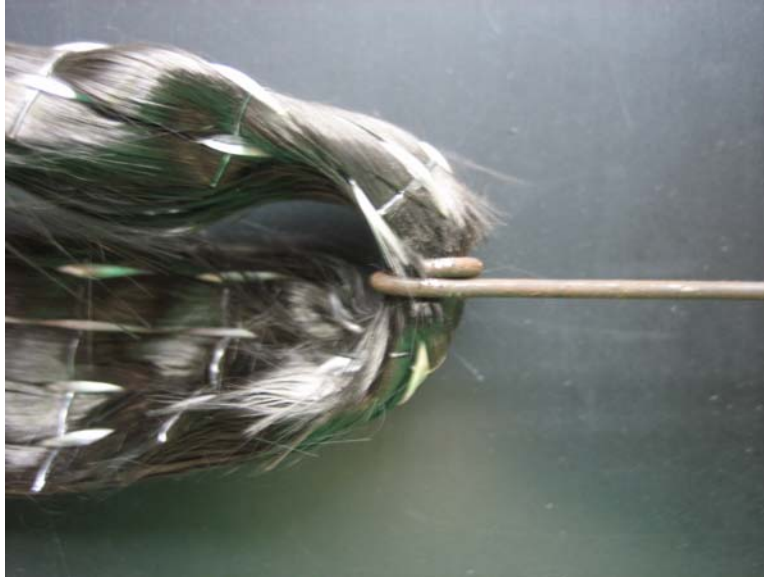
*Figure 2-39 A close up view of the rebar tie clasp*

Once the length and width of the anchor is selected, the CFRP strip can then be cut from the original roll of the CFRP fabric. A rebar tie is used to clasp the strip at its midpoint (Figure 2-39). The rebar tie serves as an installation tool offering the installer

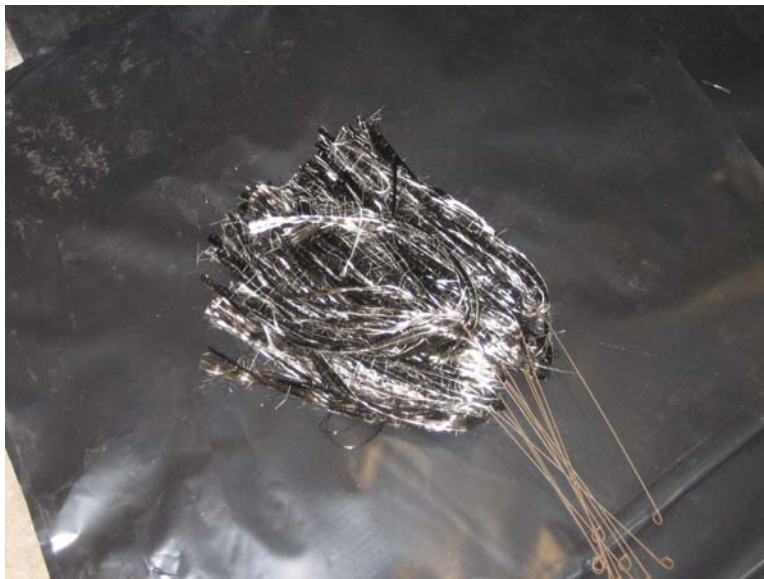
*Figure 2-40 A pile of CFRP anchors*

leverage in inserting the anchor into the drilled hole. Once folded in half, the ends of the anchor are frayed (Figure 2-40), which allows the CFRP materials located within the portion of anchorage fan to be spread out.

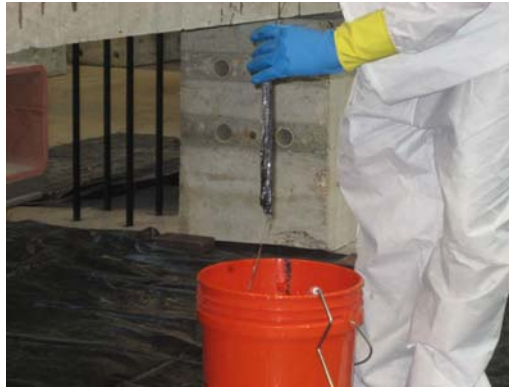
***Figure 2-41 Impregnation of the CFRP anchor with high strength structural epoxy***

The first step in installation is the impregnation of the anchors with a high strength structural epoxy (Figure 2-41). This can be done effectively by submersing the CFRP anchor into a bucket of epoxy and squeezing the strands to force epoxy into the anchor.

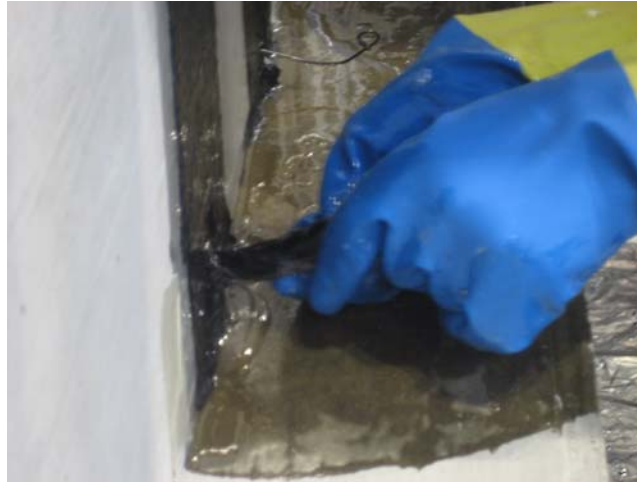
***Figure 2-42 Insertion of the CFRP anchor***

Once impregnated with the structural epoxy, the CFRP anchor is ready to be inserted into the predrilled hole. The rebar tie that was used to clasp the anchor together is used to push the saturated anchor into the predrilled hole. Figure 2-42 and Figure 2-43 display the proper procedure for inserting the CFRP anchor into the concrete specimen.

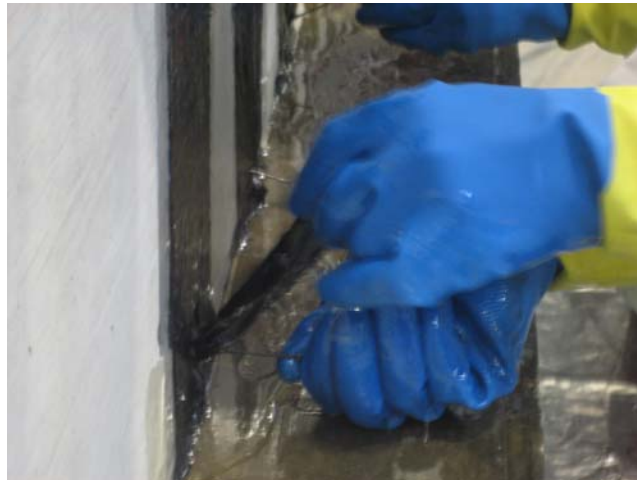
***Figure 2-43 Using a rebar tie to properly insert the CFRP anchor into a predrilled hole.***

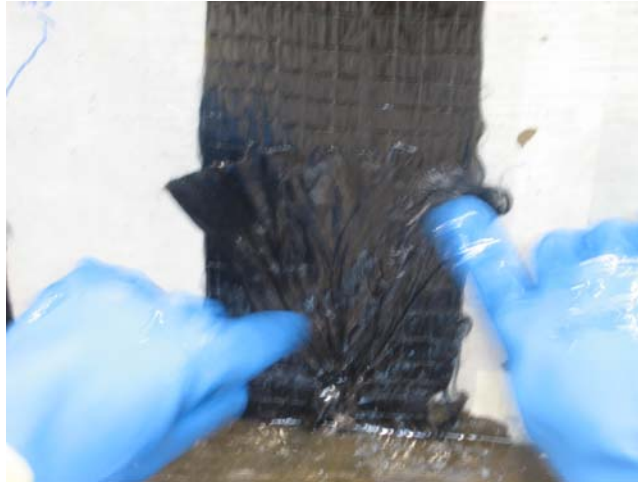
***Figure 2-44 Construction of CFRP anchorage fan***

When the CFRP anchor is fully inserted into the hole, the anchor fan can be spread out by hand (Figure 2-44). When discrete strips of CFRP fabric are installed on the concrete surface, the anchorage fan should extend past the edges of the CFRP strip by approximately 0.5-in. in order to insure that every carbon fiber strand of the anchor intersects a fiber from the main CFRP strip. Figure 2-45 shows a completed installation of the CFRP anchors.

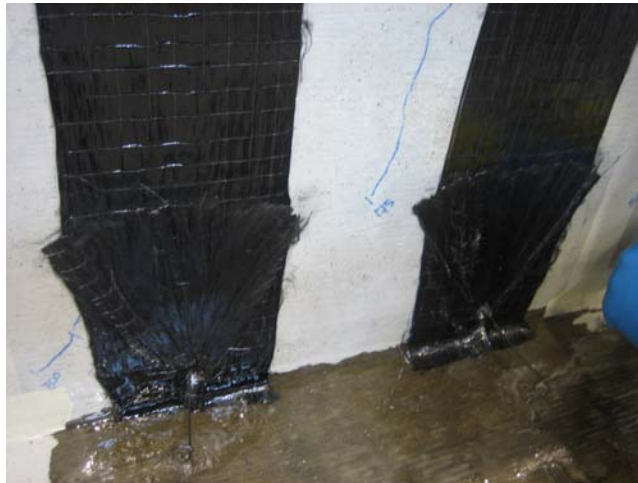
***Figure 2-45 Completed installation of CFRP anchors***

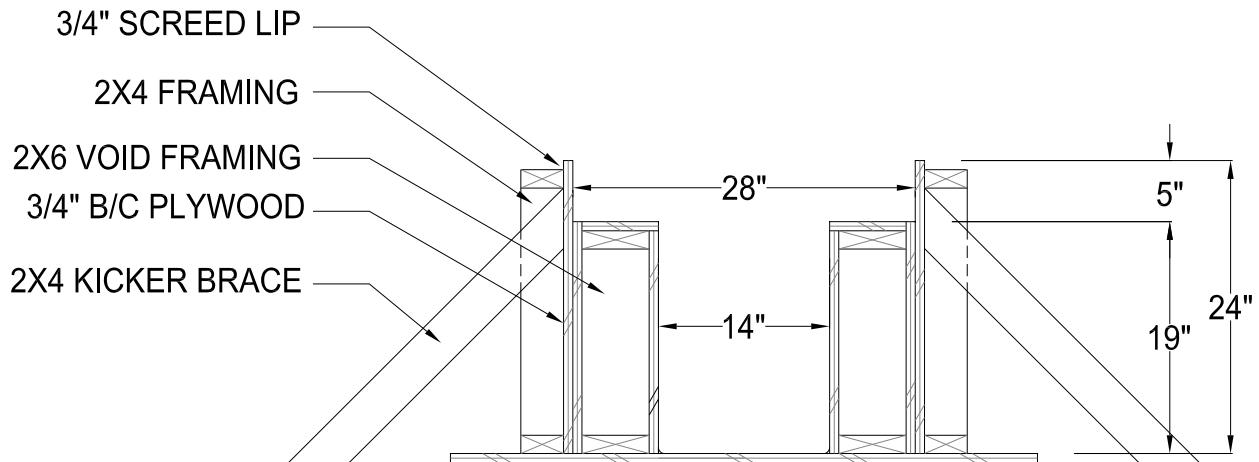
*Figure 3-2 Schematic cross section of the specimens' formwork*

Because six test specimens were to be constructed, it was determined that high quality wood formwork using plywood with a dense surface would be used to limit any deterioration due to overuse. A cross section of the form work is presented in Figure 3-2.

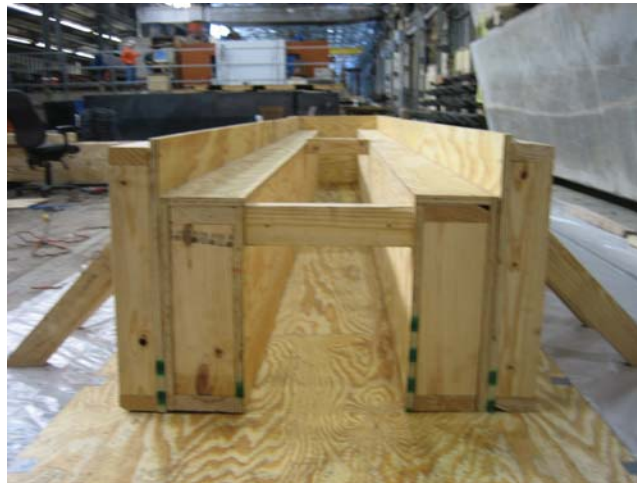
*Figure 3-3 Cross section of wood formwork as constructed*

All 2x6 framing, faced with plywood, created the 7-in. by 19-in. block outs of the T-section. The 2x4 framing formed the outer edge of the flange with a 0.75-in. screed lip along the top most surface of the concrete specimen. This lip provided an area for loose aggregate to fall while a screed leveled the surface of the specimens. Well oiled, higher grade B/C plywood was used to form all the surfaces of the concrete beams in order to limit excessive wear and tear on the forms due to multiple uses. In Figure 3-3, an image of the wood formwork during construction is shown.

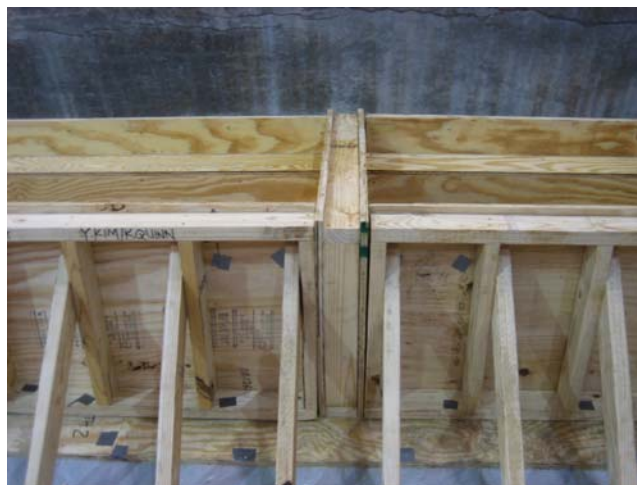
*Figure 3-5 Lateral kicker braces and internal form divider*

To restrain the lateral hydrostatic force applied to the forms by the freshly placed concrete, 2x4 kicker braces were spaced intermittently along the sides of the formwork. The kicker braces can be seen in Figure 3-5.

in this, allowing a 28-ft. long set of formwork to be constructed encompassing both a 12-ft. long and a 16-ft. long specimen separated by a divider. A view of the completed 28-ft. long formwork for two separate concrete specimens is shown in Figure 3-4 and the divider is shown in Figure 3-5.

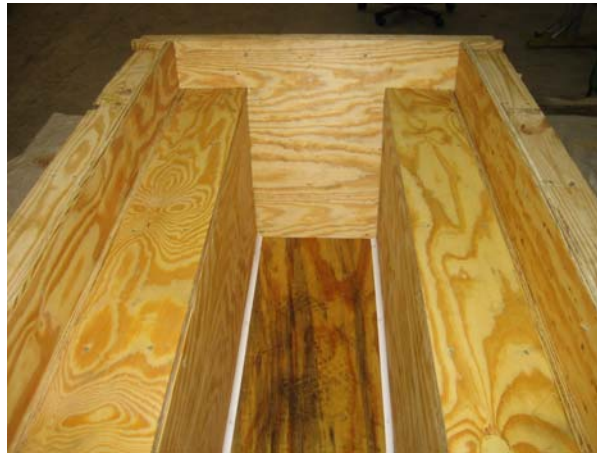
*Figure 3-6 Chamfer strips provided at 90 degree corners to provide a sufficiently rounded corner for CFRP materials*

As discussed previously (2.3.2), sharp corners will develop large stress concentrations in any applied CFRP laminates, causing the laminates to fail prematurely due to CFRP rupture failure. It is common practice to round these sharp edges to a minimum radius of 0.5-in. (ACI 440.2R-08, 2008).

However, rounding long lengths of these corners can take large amounts of time. Therefore, chamfer strips were installed along each of the 90 degree corners to develop a rounded edge with a radius of 0.5-in. (Figure 3-6). The chamfer strips consisted of decorative molding purchased at a local hardware store. The molding was ripped to the appropriate dimensions using a standard band saw.

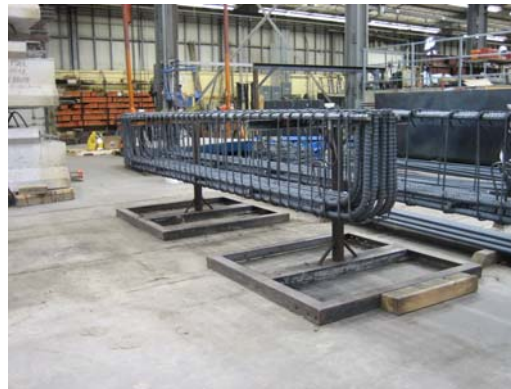
**Figure 3-8 12-ft. steel reinforcing cage with stirrups spaced at 4-in. for deep beam test specimen**

ACI 318-08 requires that all beams classified as deep beam specimens (shear span-to-depth ratio of less than two) maintain a maximum spacing of transverse reinforcement equal to one-fifth of the beam's effective depth ( $d/5$ ). Because the constructed specimens had an effective depth of nearly 20-in., transverse reinforcement was spaced at 4-in. on-center and is shown in Figure 3-8.

cross section showing the longitudinal reinforcing steel is presented in Figure 3-7 and Figure 3-8 shows the longitudinal steel placed in the steel reinforcing cage.

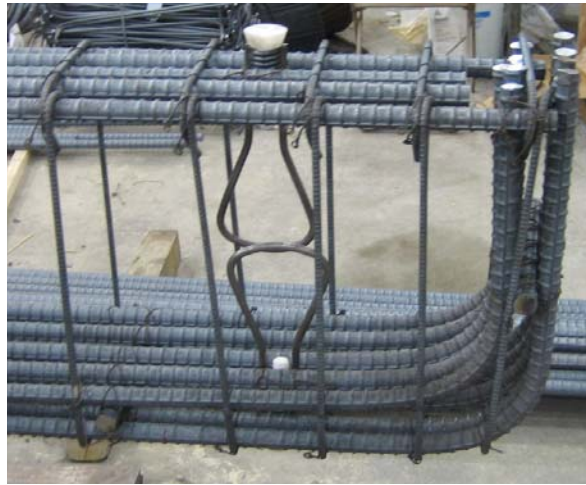
*Figure 3-9 Lifting inserts provided near the ends of each specimen*

Due to the fact that the test specimens were to be cast in a location different from where they were to be tested, consideration had to be given to transportation of the specimens through the research laboratory. Steel lifting inserts were provided near the ends of each specimen as shown in Figure 3-9.

Additional consideration had to be given to the orientation of the specimens during testing. As will be discussed further in 3.2.1, load was to be applied along the top surface of the T-beam flange, but the test specimens were required to be loaded from the ground up. Because of this, it was required to flip the concrete specimens upside down before inserting them into the loading test setup. In order to place the specimens in their test positions, it was necessary to install a second lifting insert along the bottom surface of the beam's web, in line with the inserts previously described to provide a lifting point to rotate the beams as will be discussed in 3.2.1.

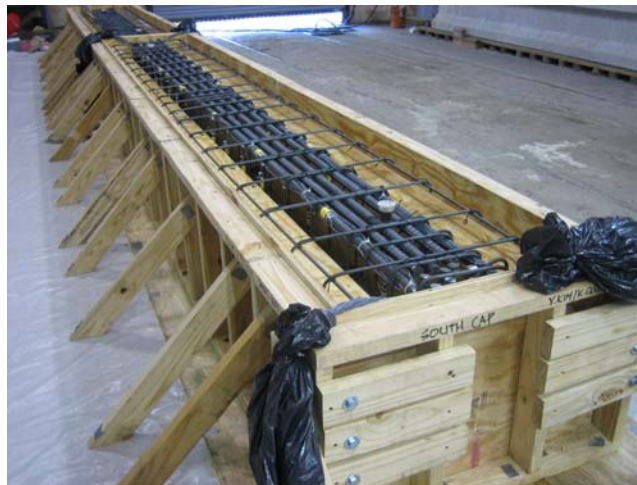
*Figure 3-10 A completed reinforcing cage with slab reinforcement installed*

The completed reinforcing cages were placed in the formwork (Figure 3-14) with reinforcing chairs to maintain a minimum concrete cover of 1.5-in on all reinforcement. Reinforcement (slab steel) for the flange of the T-beam specimens consisted of #3 bars with spacing equal to that of the transverse reinforcement.

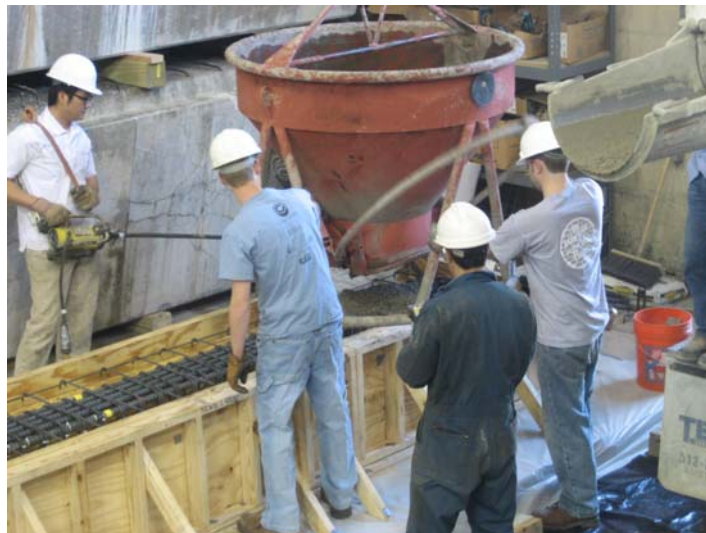
*Figure 3-12 Placing concrete within the formwork*

A concrete bucket (having a volume of 1 cubic yard) was used to move concrete from the delivery truck to the forms (Figure 3-12). This allowed the concrete to be placed in three lifts. The first lift covered only the tensile reinforcement at the bottom of the forms. The second filled the web of the specimens and finally, the third lift completed placement of the flange portion of the beam. Each lift of concrete was vibrated to ensure that all voids were filled in the closely spaced reinforcing cage (Figure 3-13).

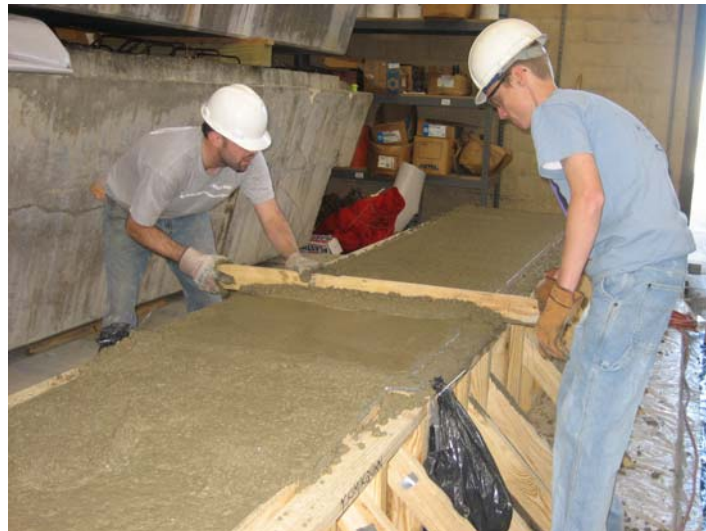
***Figure 3-14 Screeding the top surface of the beams***

The top surface of the concrete was screeded and leveled with trowels (Figure 3-14).

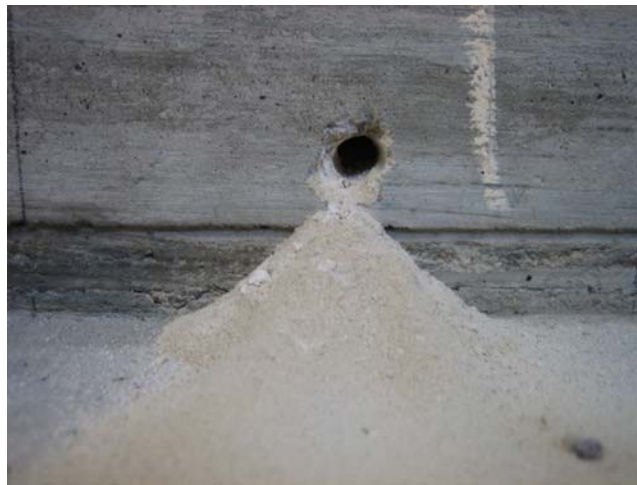
***Figure 3-15 A hole is drilled into the concrete specimen***

Drilling the hole into the concrete specimen is the first step (Figure 3-15). A standard hammer drill is used to abrasively bore into the concrete specimen. It is recommended that a new drill bit be used when drilling these holes. Old, dull and worn bits will chip excessive amounts of concrete away from the edge of the anchorage hole, creating locations of high stress in the CFRP anchor.

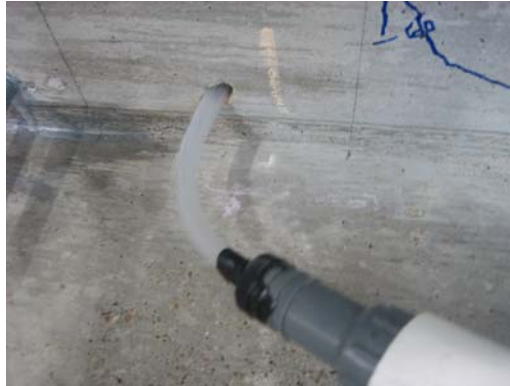
***Figure 3-16 Removing debris from the anchorage hole***

A vacuum cleaner with an adapted nozzle (designed to fit into the anchorage hole) quickly and effectively removed all debris from the anchorage hole, as shown in Figure 3-16. Removing debris from the anchorage hole using negative vacuum pressure as compared to using positive air pressure (such as with compressed air) was employed for

several reasons. First, it was noticed in previous studies that a small amount of oil residue remained on the surface of the concrete after compressed air was used to remove debris from the concrete anchorage hole. This small amount of oil might hinder the bond strength between the CFRP anchor and anchorage hole.

Another reason supporting the use of vacuum pressure as compared to compressed air is that compressed air is an abrasive technique that might dislodge portions of the concrete aggregate into the anchorage hole. This dislodged aggregate can block the anchorage hole, preventing the insertion of the CFRP anchor. Therefore, it is recommended that if at all possible, negative vacuum pressure should be used to clear the hole of any debris.

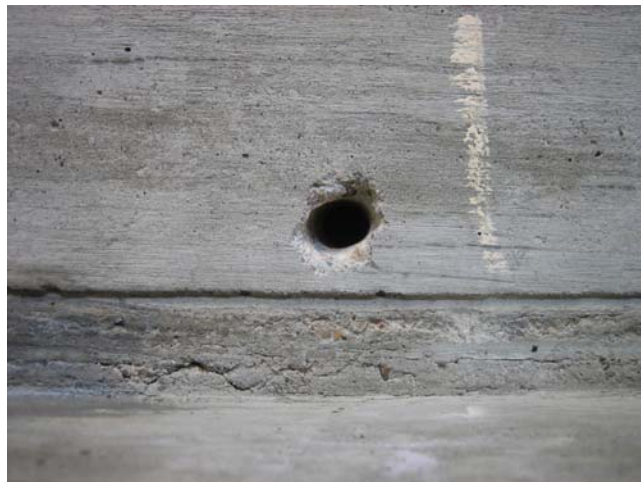
***Figure 3-17 Drilled and cleared anchorage hole***

A freshly drilled anchorage hole that has been cleared of all debris is shown in Figure 3-17. It can be seen in this image that the edge of the concrete hole is rough. This rough edge can easily produce areas of high stress in the CFRP anchor. Therefore, an abrasive masonry bit was used to round the edge of all anchorage holes to a radius of 0.25-in. to 0.5-in. depending on the particular anchorage detail being studied. The anchorage holes need only be rounded to the required radius along the edge that contacts the anchorage fan. Because one-way CFRP anchors were used in all cases associated with this research project, the anchorage holes were only rounded along one side of the hole, as shown in Figure 3-18.

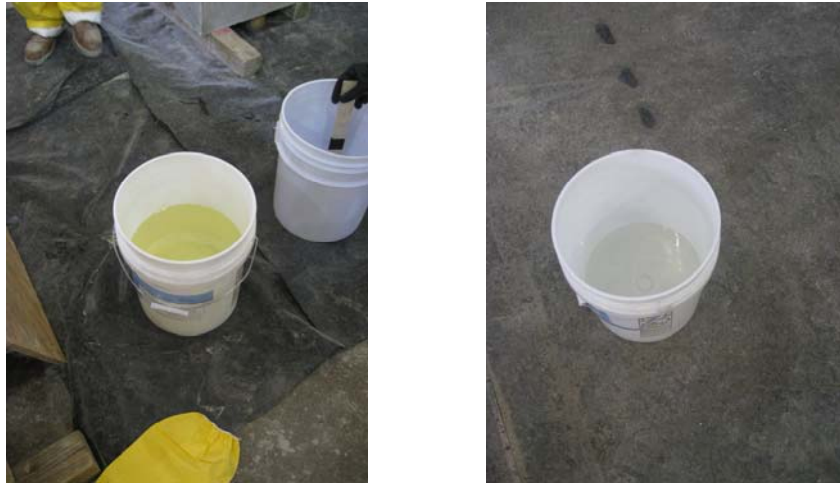
***Figure 3-19 Two components of the high strength structural epoxy – the resin (left) and hardener (right)***

The procedure begins by measuring specific volumes of the two epoxy components (Figure 3-19). One component consists of a high strength resin while the other component is a chemical hardener which reacts with the resin, causing the epoxy to set. Vapors from one component can react with the second component, causing portions of the material to begin setting up. This causes the overall strength of the epoxy to decrease. Therefore, it is important to keep the two components separate until they are ready for use.

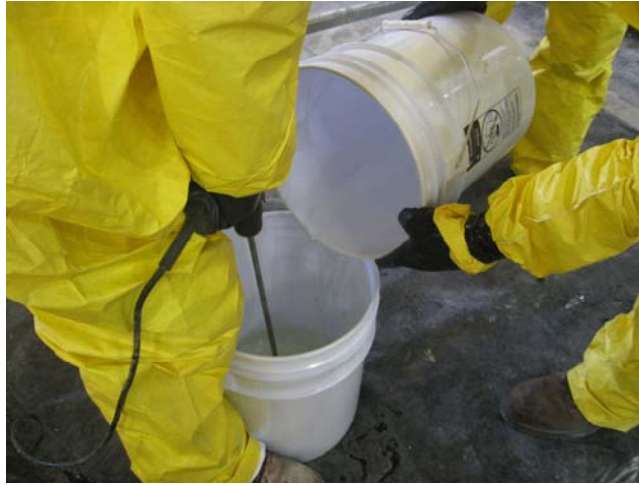
***Figure 3-20 Mixing the two components of the epoxy together***

Once the proper proportions of the two components are obtained, they are poured together and mixed thoroughly with an electric mixer, as shown in Figure 3-20.

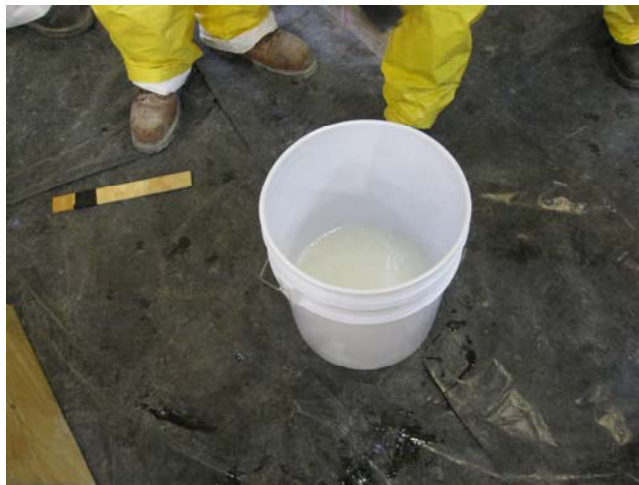
***Figure 3-21 Completed high strength structural epoxy***

As the two components mix together, air is churned into the mixture. This causes the initial epoxy mixture to become opaque as many tiny air bubbles are suspended in the solution (Figure 3-21). These air bubbles are temporary as they will slowly dissipate to the surface.

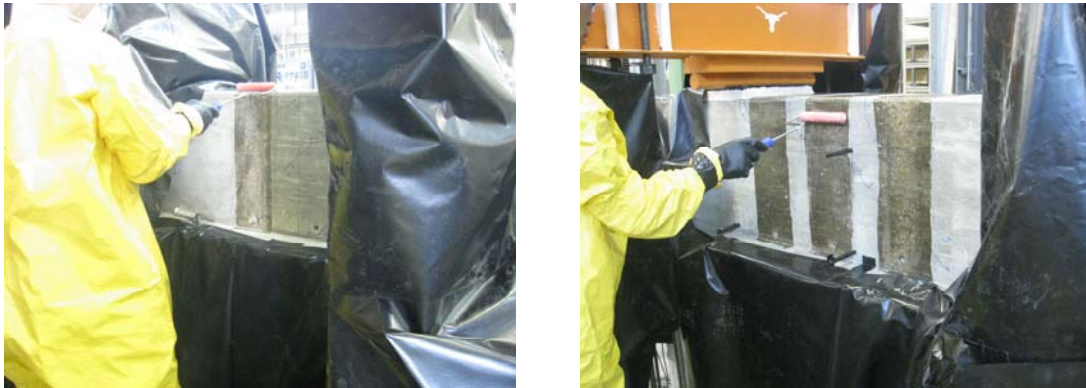
***Figure 3-22 Wetting the surface of the concrete specimen***

The next step in the procedure places some of the high strength structural epoxy onto the surface of the concrete specimen. This step is known as wetting the surface. Using a small nap paint roller, a small amount of epoxy is applied to the surface of the concrete (Figure 3-22). This allows epoxy to fill holes and other minor surface

depressions in the concrete. The surface must first be coated with epoxy where carbon fiber materials are to be installed.

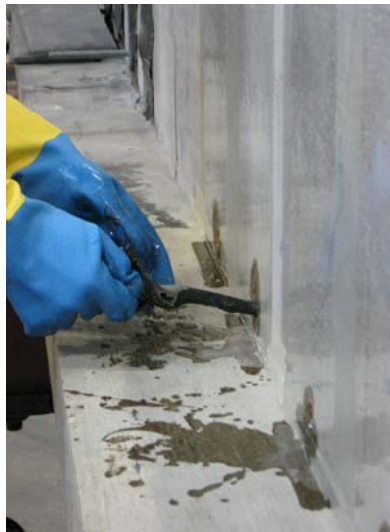
***Figure 3-23 Wetting the drilled anchor hole with epoxy***

The inner surface of the prepared anchor holes must be coated as well. This surface is wet with epoxy using a swab made of a small amount of carbon fiber fabric bundled together with a rebar tie (Figure 3-23). Lining the hole with a layer of epoxy helps to fill any voids along the surface of the hole created by the abrasive drilling procedure described in 3.1.5.1.

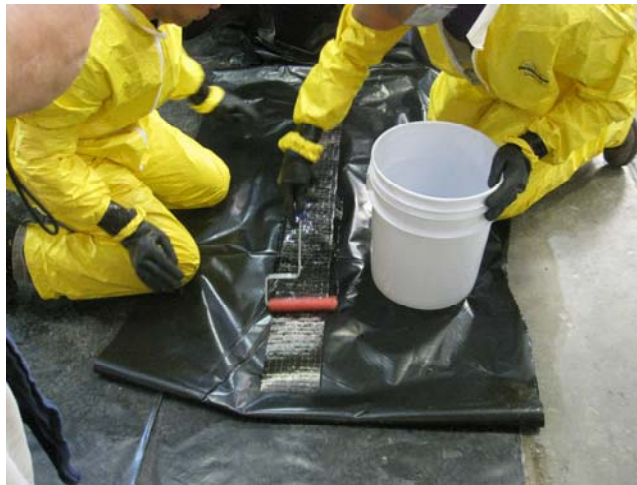
***Figure 3-24 Impregnating the carbon fiber sheets with epoxy***

During the wet lay-up procedure, the CFRP sheets are laid on the ground on a clean sheet of heavy duty plastic. Using the same roller that was used to wet the surface of the beam, epoxy is firmly pressed into the carbon fiber sheets (Figure 3-24). The sheet is flipped over and epoxy is again forced into the CFRP sheet from the opposite side.

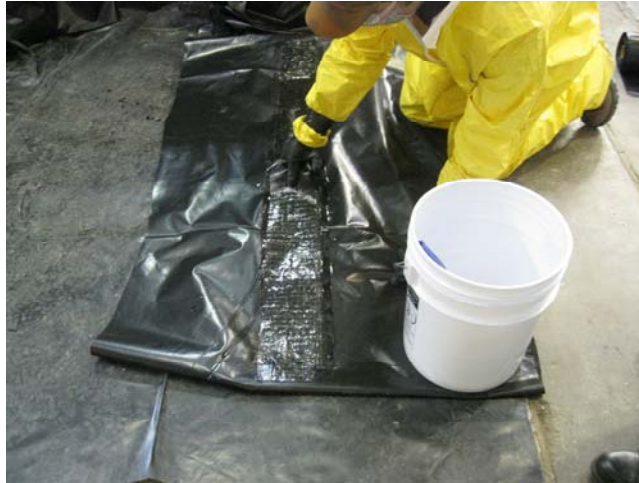
***Figure 3-25 Folding the impregnated sheets in half for ease of handling***

Once impregnated, the sheet is ready to be installed onto the surface of the beam. Handling a large sheet that has been saturated with epoxy is difficult. Therefore, the sheet is folded in half before handling (Figure 3-25). This allows one person to carry a single sheet.

The sheets are then lifted and applied to the surface of the concrete. This step requires at least two people (one on each side of the beam's web) to install the CFRP laminates. It is important to note that in the images presented within this report, CFRP sheets were applied downward due to the test specimens being inverted during experimental testing (Refer to 3.2.1). In practice, the CFRP sheets would be installed overhead.

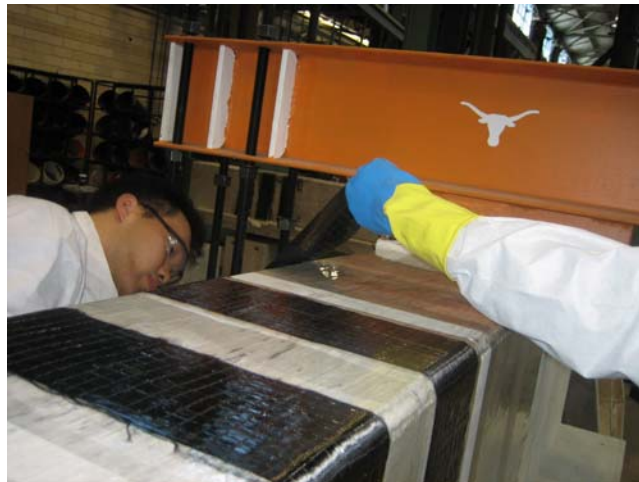
***Figure 3-26 Placing the CFRP sheet onto the surface of the beam***

To align the sheet on the beam efficiently, one end of the carbon fiber sheet is lined up in its correct position; then, the free end of the sheet is laid along the surface, as shown in Figure 3-26 and Figure 3-27.

Installing the CFRP sheets in this manner allows any air that may be trapped by the sheet to escape, eliminating most of the air bubbles beneath the sheets. Any additional air pockets that remain beneath the CFRP sheets are removed using a simple bondo knife, as seen in Figure 3-28.

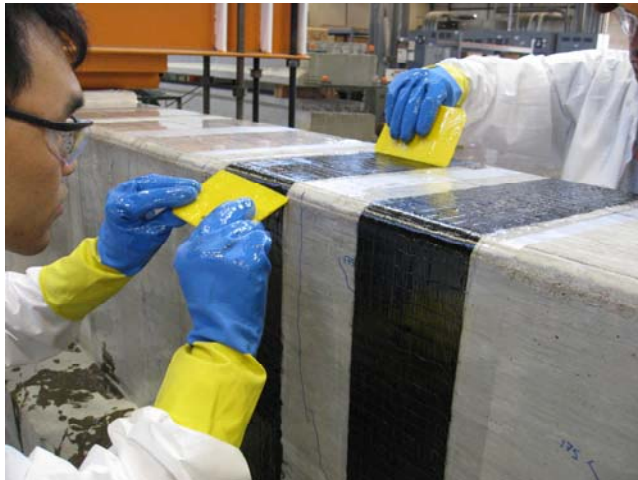
*Figure 3-28 Removing excess epoxy from the installed CFRP strip*

Firm pressure is applied to the sheet with the bondo knife as it is guided along the length of the CFRP strip to force all air and excess epoxy out from beneath the CFRP strip, producing a high quality, flush finish of the CFRP materials to the concrete substrate.

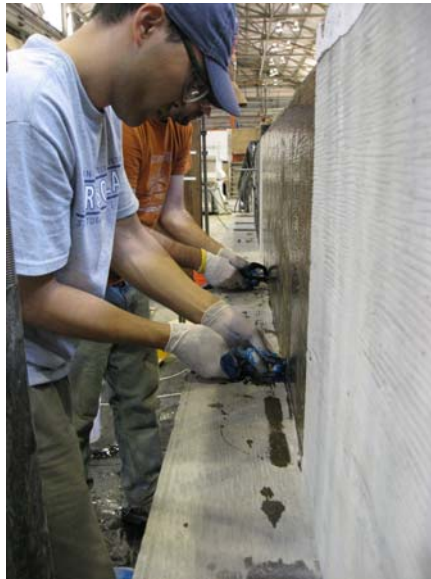
***Figure 3-33 Wetting the surface of the CFRP anchor holes***

Once all surfaces have been primed, a two part structural epoxy is mixed and used to wet the surface of the beam, identical to the procedure described in 3.1.5.2. Just as with the wet lay-up procedure, the anchor holes are wet with epoxy using a small swab of CFRP material (Figure 3-33). In order to provide enough epoxy to impregnate the carbon fiber laminates while on the surface of the beam, a generous amount of structural epoxy is used to wet the surface of the concrete beam.

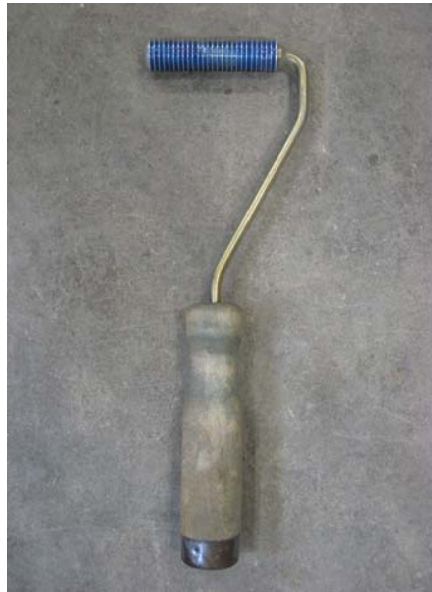
***Figure 3-34 Serrated roller used to impregnate the CFRP strips***

The second major difference exists between the wet lay-up and dry lay-up procedures in how the CFRP strips are impregnated with the epoxy. First, a dry strip of carbon fiber fabric is laid on the freshly wet surface. Then, a serrated roller (Figure 3-34) is vigorously rolled over the installed CFRP strip (Figure 3-35). This special tool forces epoxy to the exposed surface of the CFRP strip or sheet. This effectively impregnates the carbon fiber material with the epoxy. Because the sharp edges of the serrated roller are run in the direction of the carbon fibers, the vigorous procedure does not damage the system or reduce the strength of the carbon fiber laminates.

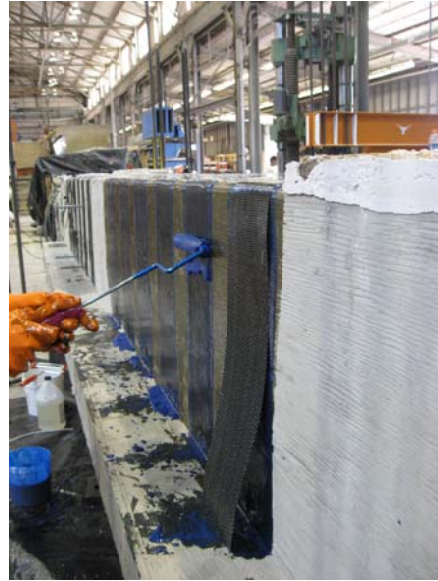
*Figure 3-36 Sealing the CFRP laminates with epoxy*

After the fibers have been impregnated, another application of the high strength structural epoxy is rolled over the CFRP strips (Figure 3-36). This effectively seals the system and allows the epoxy to fully saturate the carbon fiber materials. A completed installation of a CFRP system using the dry lay-up procedure is shown in Figure 3-37.

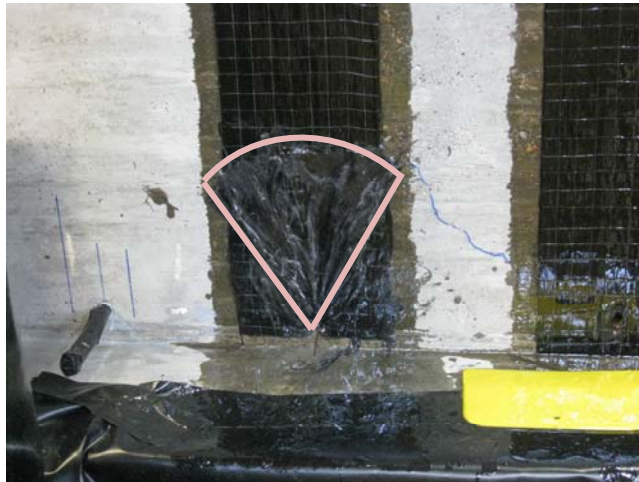
***Figure 3-39 Completed CFRP anchor utilizing the anchorage detail developed by Kim, 2008***

To construct the anchor, a strip of CFRP material was cut to the necessary dimensions (as dictated in 2.8.1) and bundled together using a standard rebar tie. The key portion of the anchor was inserted 6-in. into the concrete beam, providing a minimum of 4-in. embedment into the concrete core. The remaining 6-in. of the CFRP anchor was then utilized as the anchorage fan. The anchor fan was distributed over an angle of 60 degrees to completely cover the CFRP strip and provide an overlap of 0.5-in on either side of the strip. A schematic diagram of this particular anchorage detail can be found in Figure 3-38 and an image of the as-built detail can be seen in Figure 3-39.

As stated previously, the main benefit in using CFRP anchors as compared to some other mechanical anchorage system is that the material used in the anchorage system is the same as the material used to strengthen then beam. However, a slight problem was encountered when installing an anchorage system using Material A-1. This material was coated with a chemical substance that increased the stiffness of the physical CFRP sheet. The additional stiffness greatly increased the workability associated with the material when saturated with epoxy. But, the increased stiffness also made bundling the material together to create the anchor extremely difficult. The bundled anchor was too large to be inserted into the anchorage hole as designed per the recommendations presented in 2.8.1. Thus, a different material (Material A-2) produced by the same manufacturer was used to create all anchors associated with the installation of Material A-1.

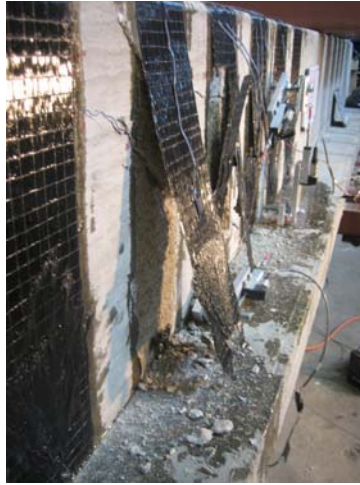
***Figure 3-40 Rupture of the CFRP anchor near the anchor hole opening***

Although this detail performed fairly well in experimental studies, it was noticed that many of the failures associated with this detail occurred due to fracture of the anchor at a location near the opening of the anchor hole before the CFRP strip reached its ultimate strain (Figure 3-40). This indicated that stress concentrations large enough to fracture a CFRP anchor were developed at the opening of the CFRP anchor hole. At this

location, all shear forces are transferred between the concrete and CFRP. Therefore, this location is crucial to the overall strength of the system.

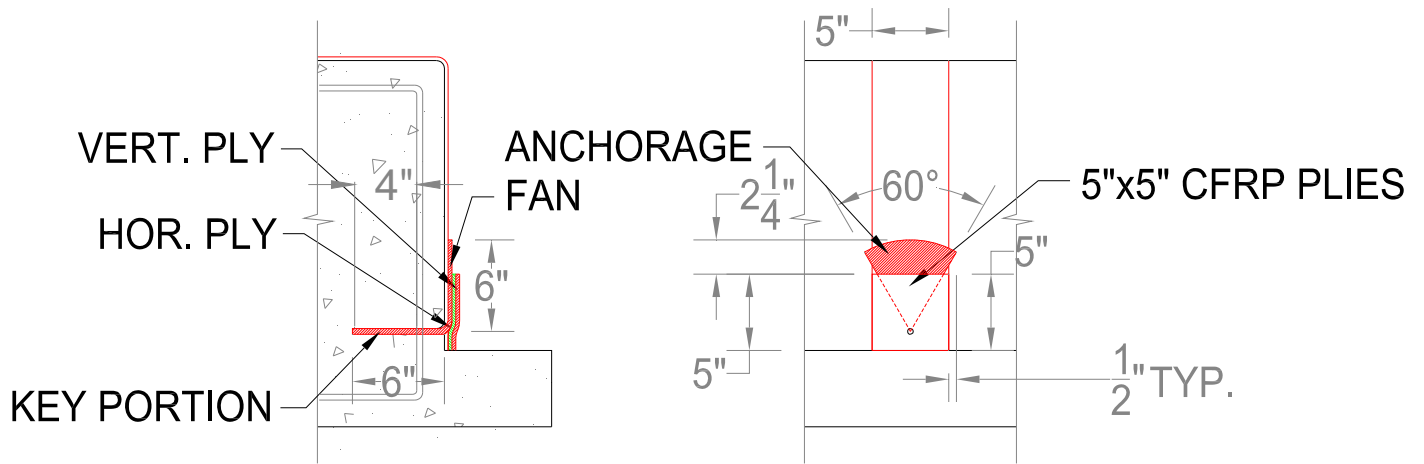
***Figure 3-42 New anchorage detail developed to relieve high stresses at opening of anchorage hole***

Also, the amount of material contained within the anchor was increased from 1.5 to 2 times the amount of material contained within the CFRP strip and the bend radius at the opening of the anchorage hole was increased from 0.25-in. to 0.5-in. The increase in the amount of material contained within the anchor was intended to provide additional strength to the key portion of the anchor that could be utilized if the anchor experienced high stress concentrations at the opening of the anchorage fan. The increase in bend radius at the opening of the anchorage hole was also intended to help reduce stress concentrations developed at this crucial location in the CFRP anchor. A schematic diagram of this particular anchorage detail can be seen in Figure 3-42 and the as-built detail can be seen in Figure 3-43.

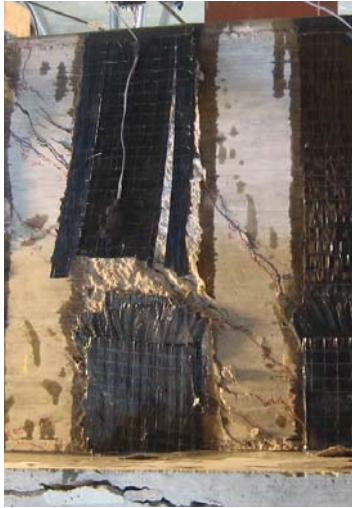
*Figure 3-44 Failure of CFRP strip with new anchorage detail installed*

The modified detail performed very well in experimental studies. In some instances, the anchor fractured at the opening in the CFRP anchor hole, but only after the CFRP strips obtained a tensile strain much higher than the manufacturer reported values in Table 3-2. In most instances, failure was reached due to fracture of the CFRP strips with the CFRP anchors remaining relatively undamaged (Figure 3-44). It is apparent from Figure 3-44 that the modified CFRP anchor performed fairly well.

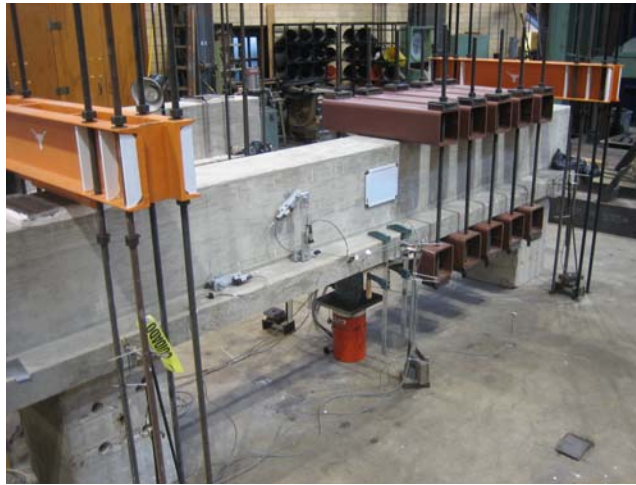
**Figure 3-46 Aerial view of the low capacity test setup**

elevation view of the 16-ft., low capacity test setup is presented in Figure 3-45 and an image of the as-built test setup is presented in Figure 3-46.

The high strength bolt groups were spaced on a 4-ft by 4-ft grid along the lab floor. A schematic plan view of the loading setup is presented in Figure 3-47. This allowed the test setup to be easily adapted to the different specimen lengths. For all 12-ft. test specimens, the test setup consisted of two back-to-back channel supports spaced eight feet apart. For the 16-ft. specimens, the back-to-back channels were moved an additional four feet apart to accommodate the longer length, as seen in Figure 3-46.
