**Shear Strengthening of Reinforced Concrete Beams with Carbon Fiber  
Reinforced Polymer (CFRP) and Improved Anchor Details**

**Thesis**

The University of Texas at Austin

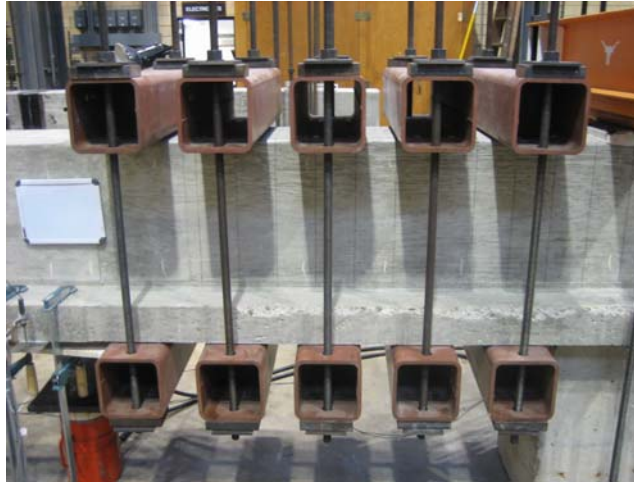
***Figure 3-48 HSS 8x8x1/2" steel tubes used as external clamps during testing***

Therefore, a clamping system of HSS 8x8x1/2" tubes (Figure 3-48) was designed to provide a system of external prestressing forces that would help reduce the tendency for the longer span of the concrete specimen to crack, prohibiting the internal stirrups from yielding. Additionally, after the short shear span was loaded to failure, the same clamps were used to provide external reinforcement to the failed region of the beam during the second test on the specimen. This allowed the structurally sound end of the specimen to experience a shear failure during testing while the previously failed region of the beam continued to resist the high shears associated with the applied failure load.

The clamps consisted of two HSS 8x8x1/2" sections, held together with two, 1" diameter high strength all-thread steel rods. Small hydraulic rams were used to prestress each of the high strength rods to a force of 30-kips (Figure 3-49). Thus, each external clamp was able to provide 60-kips of clamping force to the test specimens.

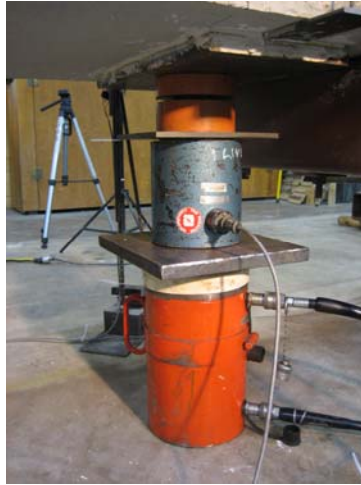
***Figure 3-51 Hydraulic loading ram, load cell and spherical head***

All load associated with the low capacity test setup was applied from the ground at a single point along the beam in an upward direction. Load was applied using a system that included a hydraulic loading ram, a load cell, a spherical head and a number of plates placed intermittently between these components. Figure 3-51 displays a typical setup of the mechanism used to apply load to the test specimens.

Load was applied to the concrete members by a 300-kip capacity hydraulic ram with a 10-in. stroke. In some instances, a single 300-kip capacity ram was insufficient to produce a shear failure in the test specimen. Therefore, a second ram, identical to the first, was used in conjunction with the first to provide a loading capacity of 600-kips (Figure 3-52). The applied load was monitored using a 400-kip load cell that can be seen in Figure 3-51 and Figure 3-52.

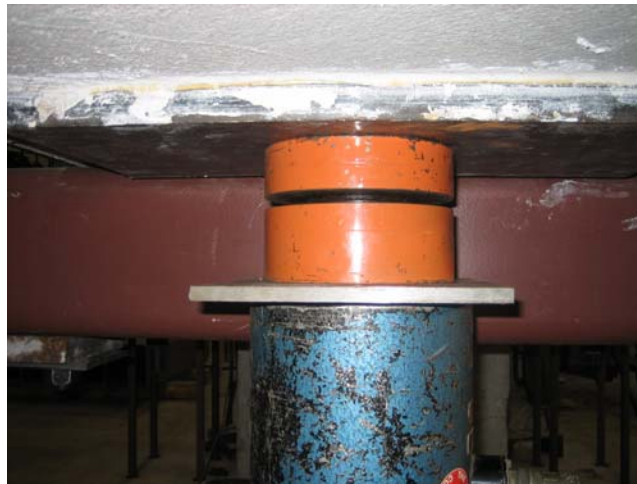
*Figure 3-53 Spherical head*

Because load was applied in an upward direction, the bearing plate was difficult to install. A mechanical lifting device along with several clamps was used to hold the plate. Hydrostone was used to develop uniform contact between the concrete surface and the bearing plate. A spherical head (Figure 3-53) was also utilized to ensure proper alignment of the bearing plate relative to the concrete surface during testing.

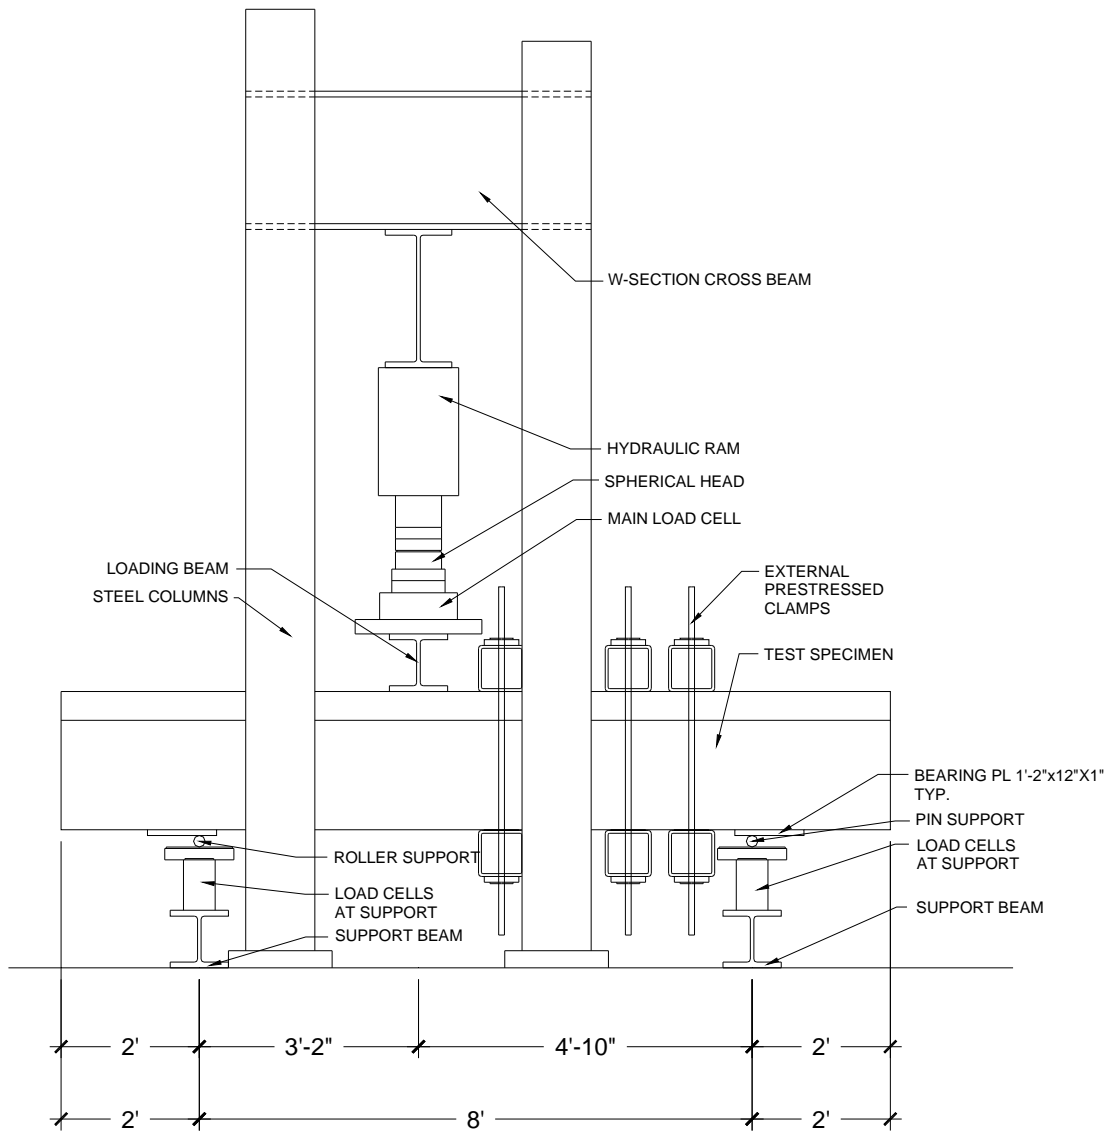
**Figure 3-54 Elevation view of high capacity test setup**

A large steel W-section was suspended from two channels spanning between the columns. The W-section supported a 600-kip capacity hydraulic loading ram which allowed the test specimens to be loaded in a downward direction and the beam did not have to be rotated.

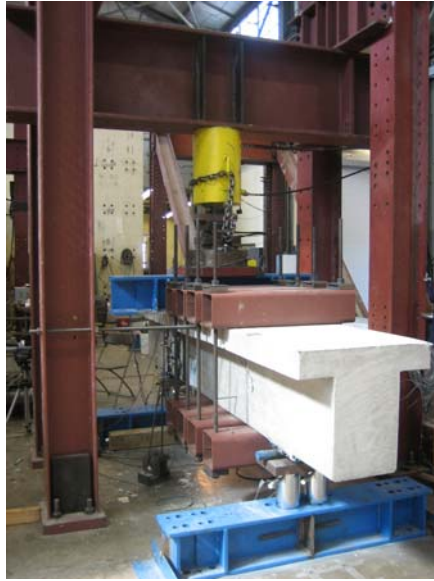
*Figure 3-55 As-built high capacity setup*

In Figure 3-54, an elevation view of the high capacity test setup is shown and a photo of the as-built test setup is shown in Figure 3-55. The high capacity setup was used to conduct tests on two specimens in the deep beam series (shear span-to-depth equal to 1.5). Again, as seen in Figure 3-55, the external clamps (described in 3.2.1.1) were utilized to help prevent a premature shear failure of one of the specimen's test regions.

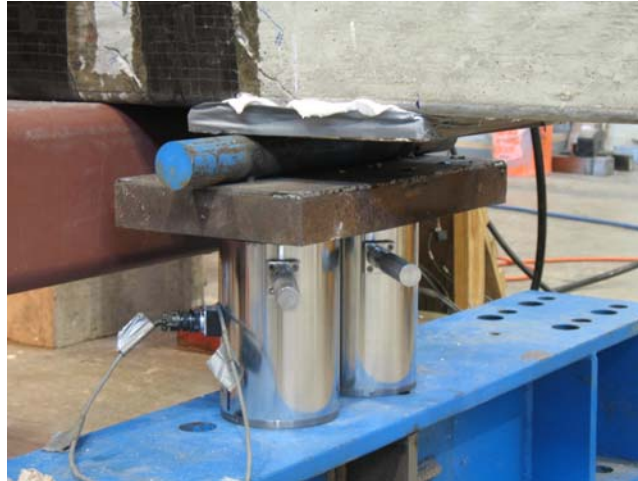
*Figure 3-57 Additional load cells located at each support*

Four additional 500-kips capacity load cells were also used in the high capacity load setup. Two of these load cells were located at each support, as shown in Figure 3-57. During testing, these additional load cells monitored reactions at the supports and could be used to determine if the beam was subjected to torsion during testing.

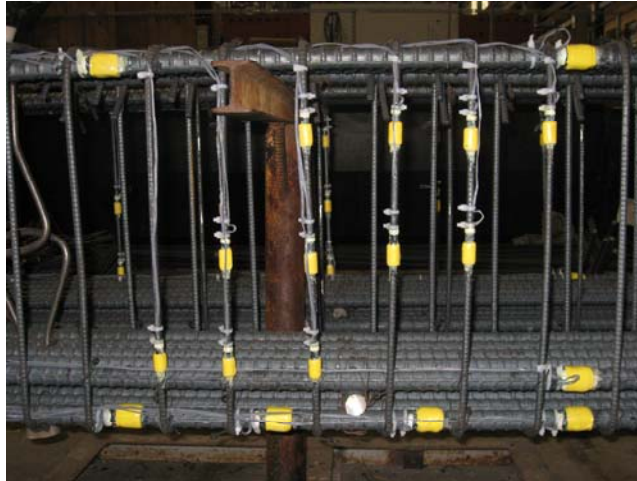
***Figure 3-58 Rubber pads served as mechanical protection for the gauges***

Gauges consisted of a standard electrical resistance gauge adhered to the surface of the reinforcing steel. Because the gauges were to be installed prior to concrete placement, a wax coating was placed on all of the gauges to ensure that the gauges were appropriately waterproofed. Also, because mechanical vibrators could come in close proximity to the steel gauges, the yellow rubber pads shown in Figure 3-58 were placed around the gauges to provide mechanical protection against vibration.

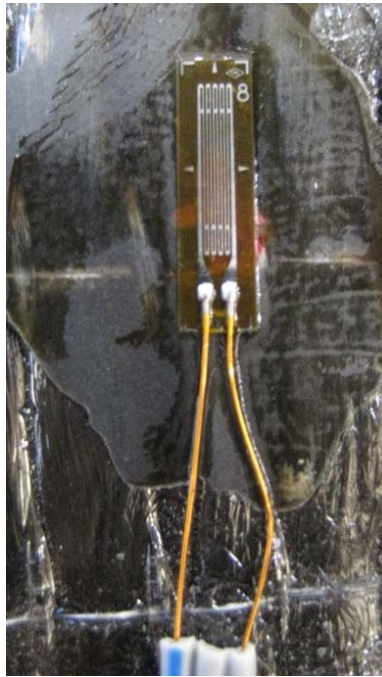
*Figure 3-63 Electrical resistor CFRP strain gauge (Pham, 2009)*

The CFRP gauges, again, consisted of a standard electrical resistor. A typical CFRP strain gauge is pictured in Figure 3-63. To provide a flat surface for the gauge to adhere to, a two part composite material was applied over the CFRP laminates. Once cured, the composite provided a smooth surface on which to apply the CFRP strain gauges. The smooth composite surface can be seen in Figure 3-63.

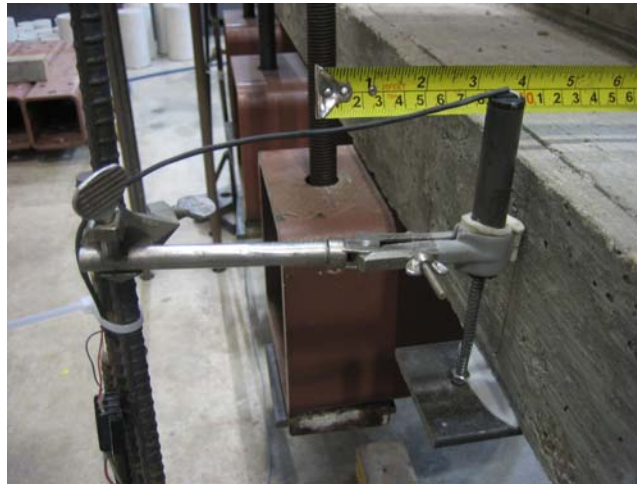
*Figure 3-69 Typical LVDT setup*

When the low capacity test setup was employed to test a concrete beam, a total of six LVDTs were used to monitor the displacements of critical locations along the test specimen during experimental testing. Figure 3-69 displays the typical LVDT used to monitor experimental displacement. The plunger of the LVDT was allowed to rest on a steel plate that was adhered to the concrete specimen with a high strength concrete epoxy.

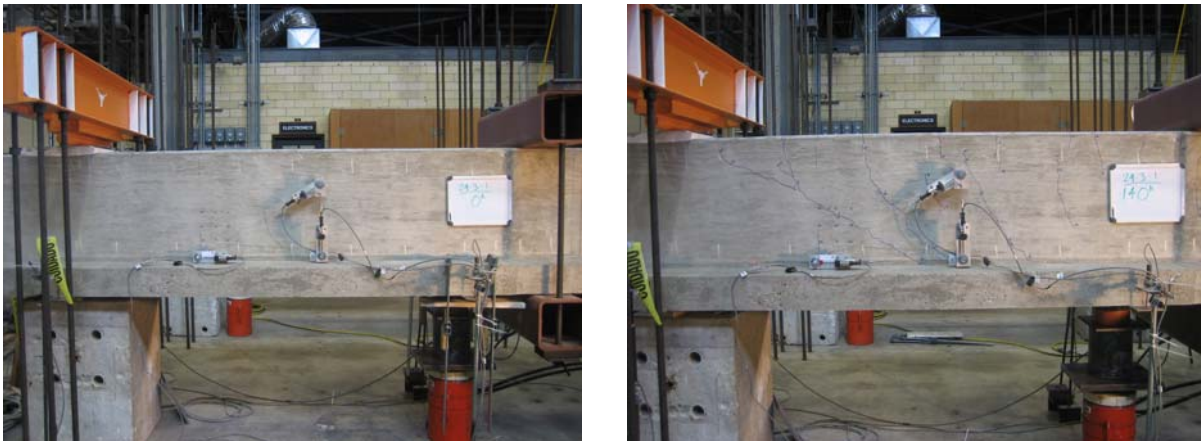
*Figure 4-3 24-3-1 before (left) and after (right) loading*

In the first test, 24-3-1, the specimen was loaded until strain gauges placed on the internal shear reinforcement indicated yielding. Yielding occurred at an applied shear load of 73-kips in strain gauge 24-3-1-4CR. Photos of test specimen before and after loading are presented in Figure 4-3. Concrete cracks observed during testing have been marked in blue. A sketch of the cracking observed during testing of 24-3-1 is presented in Figure 4-4.

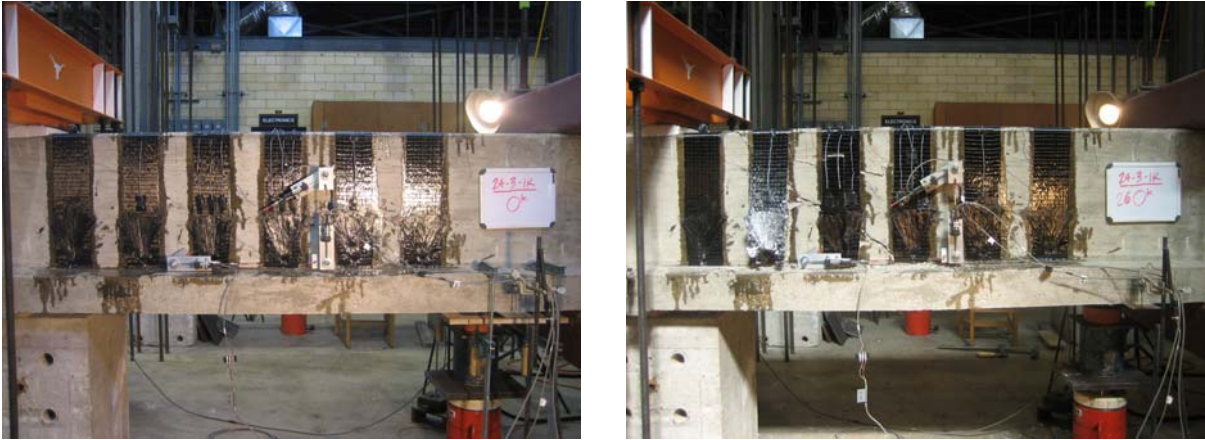
**Figure 4-5 24-3-1R before (left) and after (right) loading**

The maximum shear load applied to specimen 24-3-1R was 151-kips. Photos of the test specimen before and during loading are presented in Figure 4-5. Concrete cracks observed during testing have been marked in red. A sketch of the cracking observed during testing of 24-3-1R is presented in Figure 4-6.

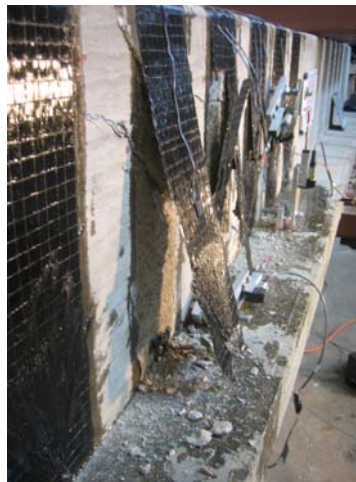
***Figure 4-8 CFRP anchor failure observed during 24-3-1R***

Failure of the specimen was initiated by a combination of rupture of the CFRP strips and the CFRP anchors. A portion of one of the CFRP strips initially fractured and was separated from the concrete substrate in an explosive manner. Figure 4-7 shows the detached portion of the first CFRP strip that failed. The shear force resisted by the failed strip was redistributed to the neighboring CFRP strips, which quickly failed due to rupture of the CFRP anchors. Figure 4-8 shows a CFRP anchorage failure more clearly.

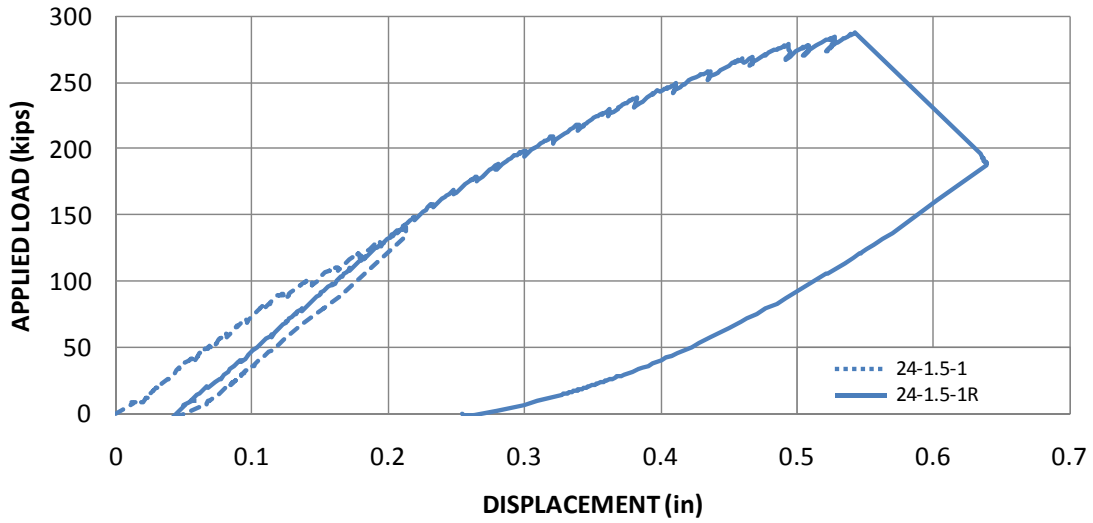
**Figure 4-9 Load-displacement response of 24-3-1/1R series**

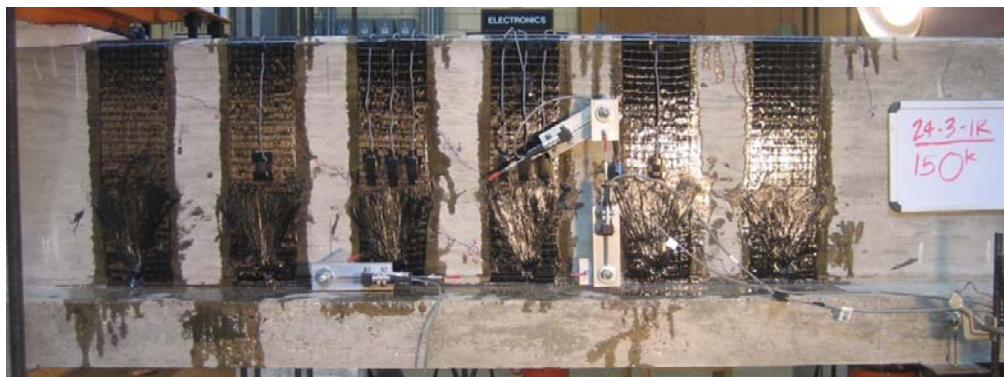
*Figure 4-11 24-3-1R at 150-kips applied load (79-kips applied shear)*

The strain values recorded in the CFRP and steel at various stages during testing are presented in Figures 4-11 through 4-14. The strain values shown are the maximum values recorded in the materials at given distances from the location of applied load. As applied load increased, some strain gauges malfunctioned and were deemed unreliable. In these instances, the maximum reliable strain reading is plotted on the graph and dashed lines are used to connect the data point to the neighboring values.

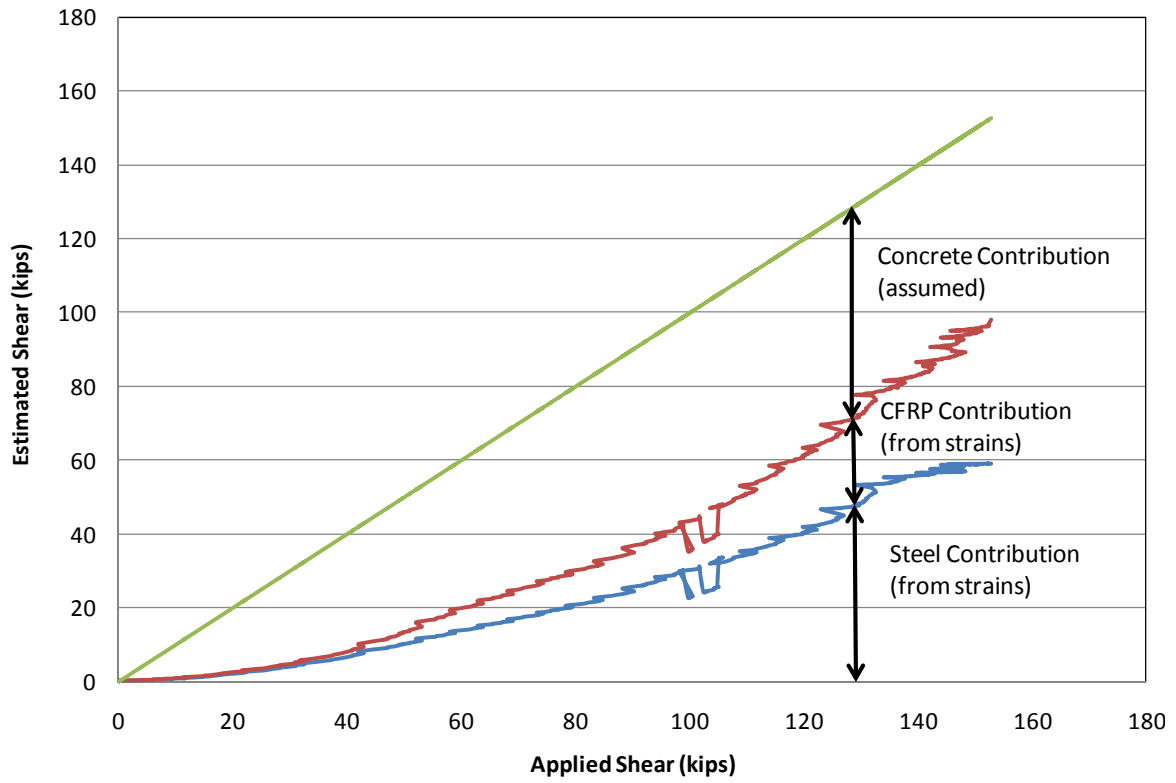
**Figure 4-16 Estimated shear carried by concrete, CFRP and steel (test 24-3-1R)**

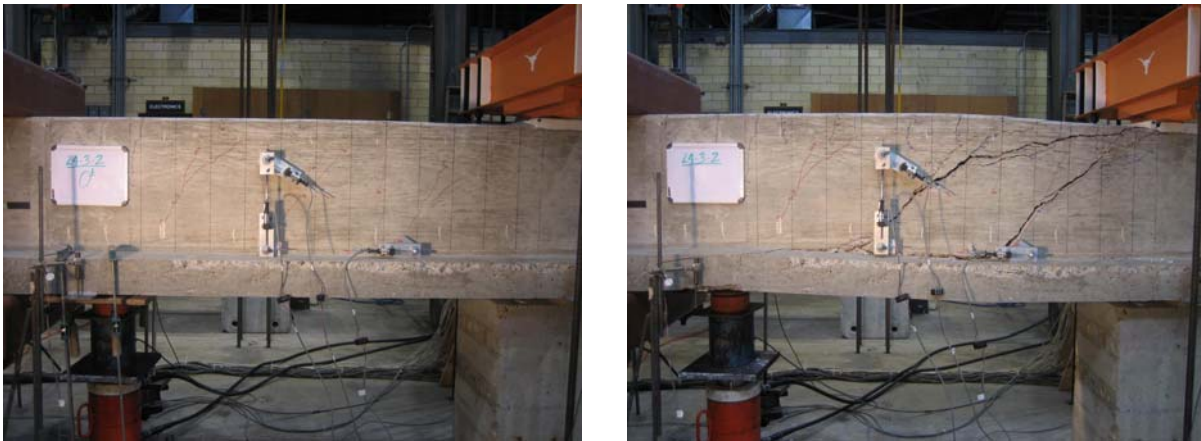
*Figure 4-17 24-3-2 before (left) and after (right) loading*

Shear failure occurred at a shear of 105-kips. Photos of the test specimen before loading and after failure are shown in Figure 4-17. Concrete cracks observed during testing have been marked in blue. A sketch of the cracking observed during testing of 24-3-2 is presented in Figure 4-18.

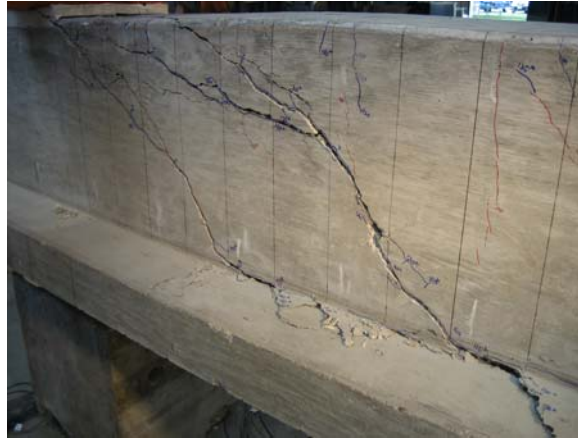
***Figure 4-19 Large cracking observed during 24-3-2***

As seen in Figure 4-19, large cracks formed in the concrete member. The complete load-displacement response of 24-3-2 observed during testing is provided in Figure 4-20. The curve seen in Figure 4-20 lacks an unloading portion because the mountings for the transducers monitoring displacement were damaged at failure. Shear deformation is plotted in Figure 4-21.

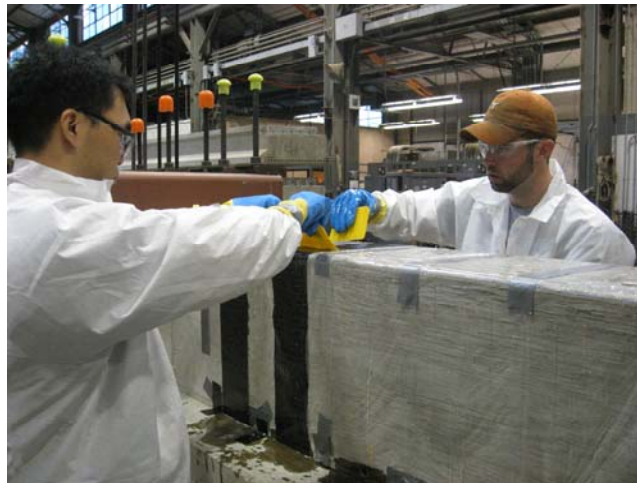
***Figure 4-26 Clear plastic wrap used to eliminate bond in test 24-3-3***

To eliminate bond between the CFRP and concrete substrate, a clear plastic wrap was taped to the surface of the concrete before installation of the CFRP. A photo of the clear plastic wrap taped to the specimen during installation of the carbon fiber strips is shown in Figure 4-26. Installation of the CFRP strips in this manner proved to be difficult. Because the clear plastic wrap was not adhered to the concrete, large gaps between the CFRP and concrete substrate were created.

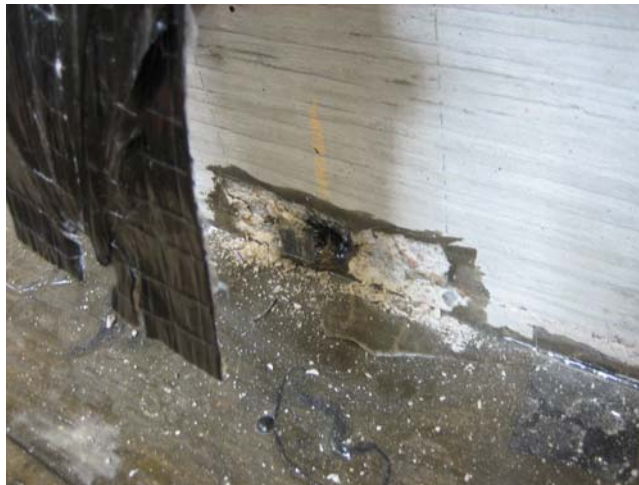
**Figure 4-30 Premature CFRP anchor rupture, test 24-3-3**

An example of a CFRP anchor failure can be seen in Figure 4-30. Rupture of the CFRP anchors occurred at a relatively low load. Therefore, it can be assumed that the poor installation of the CFRP laminates can be blamed for the poor performance of the strengthening scheme. A CFRP strip that failed due to premature rupture of the CFRP anchor is shown in Figure 4-31. As can be seen in Figure 4-31, the clear plastic wrap was effective in eliminating all bond between the CFRP and concrete.

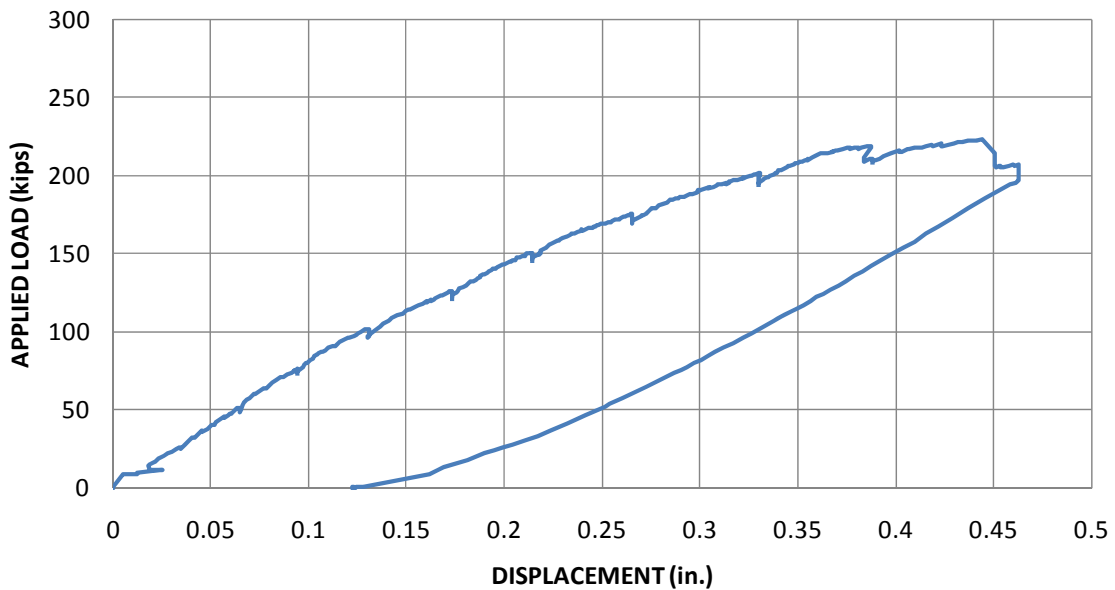
**Figure 4-32 Load-displacement response, test 24-3-3**

Shear failure occurred suddenly as shown in Figure 4-32. A small drop in applied load along with a small increase in total displacement was observed after the maximum load was applied to the specimen. The CFRP anchors ruptured at a lower applied load than expected. Shear deformation is plotted in Figure 4-33.

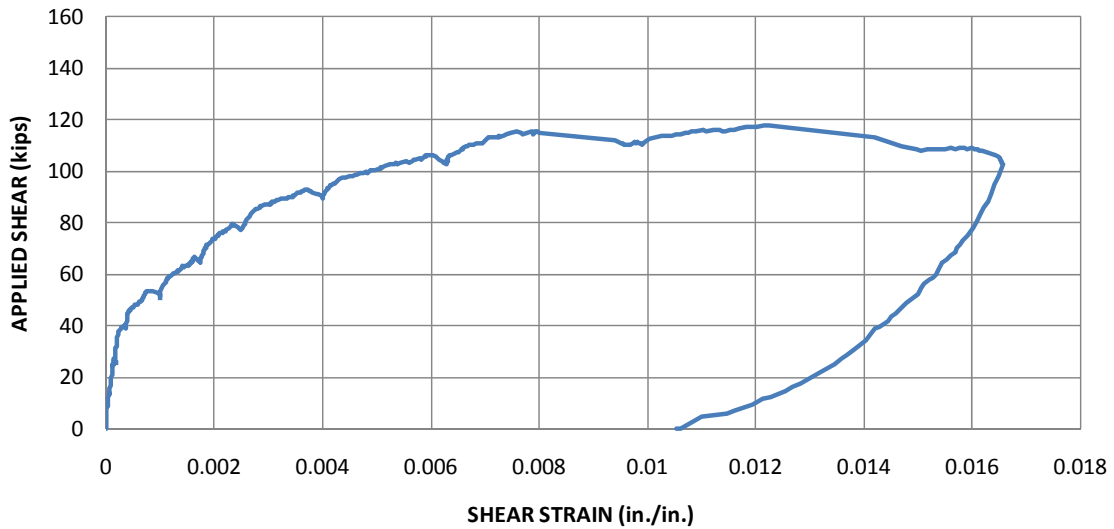
**Figure 4-33 Shear deformation plot, test 24-3-3**

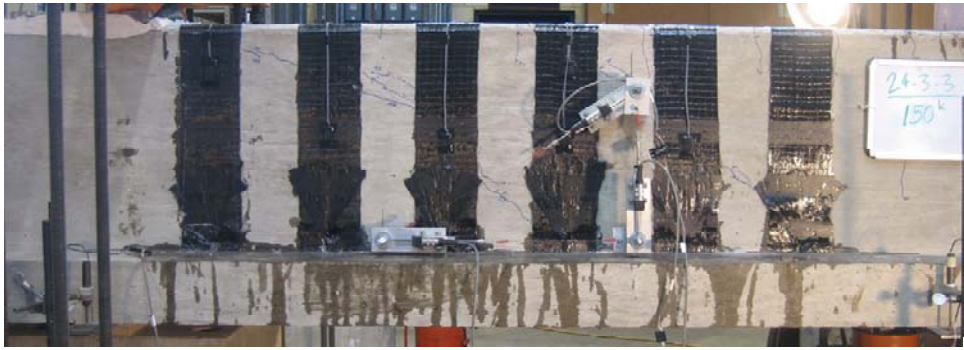
*Figure 4-34 24-3-3 at 150-kips applied load (79-kips applied shear)*

The strain values recorded in the CFRP and steel at various stages during testing are presented in Figures 4-34 through 4-36. Photos of the specimen at the loading stage associated with the recorded strain values are also presented in Figures 4-34 through 4-36.

Strains in the steel stirrups were monitored during testing with several strain gauges. Initial yielding of the steel stirrups was reported at an applied shear load of 83-kips. Strains were also monitored in the CFRP sheets. The maximum reported CFRP strain during test 24-3-3 was 0.0087. The strain value reported was lower than the manufacturer reported ultimate tensile strain value of 0.0105 which is evidence that failure was due to premature CFRP rupture due to the use of the plastic wrap.

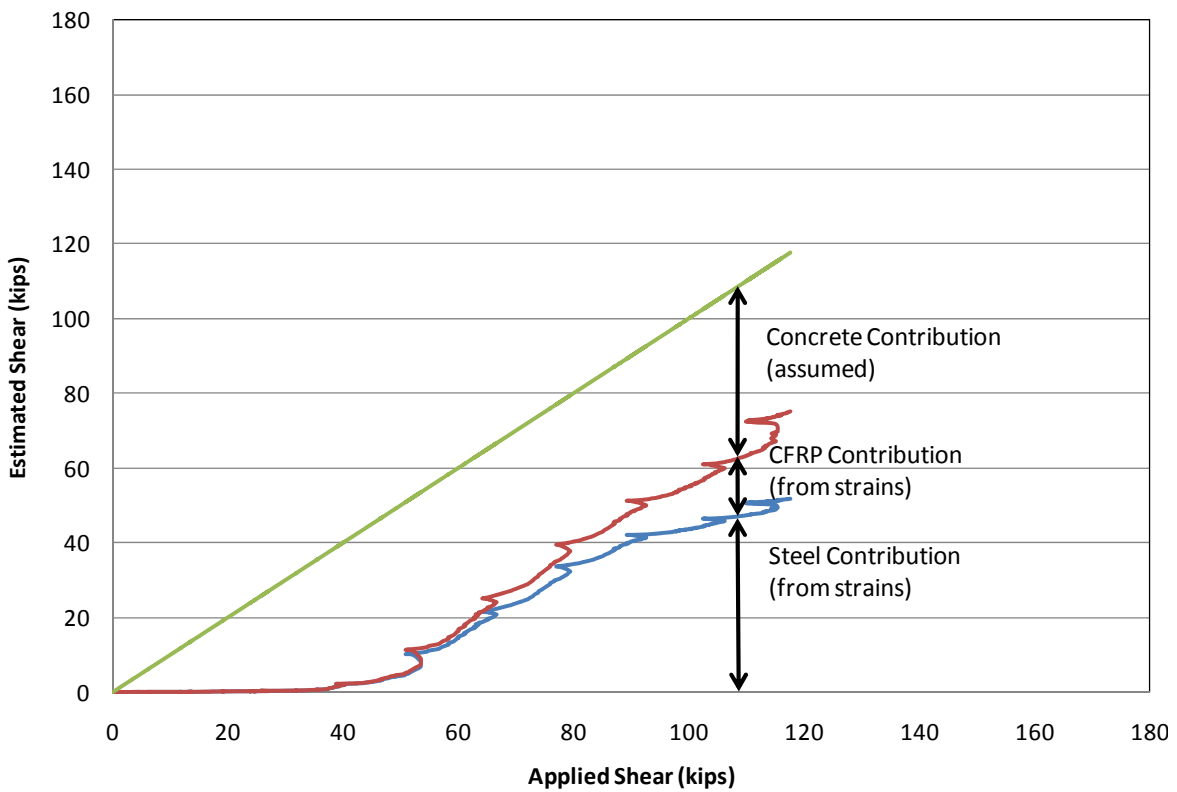
**Figure 4-38 Estimated forces experienced by concrete, CFRP and steel during 24-3-3**

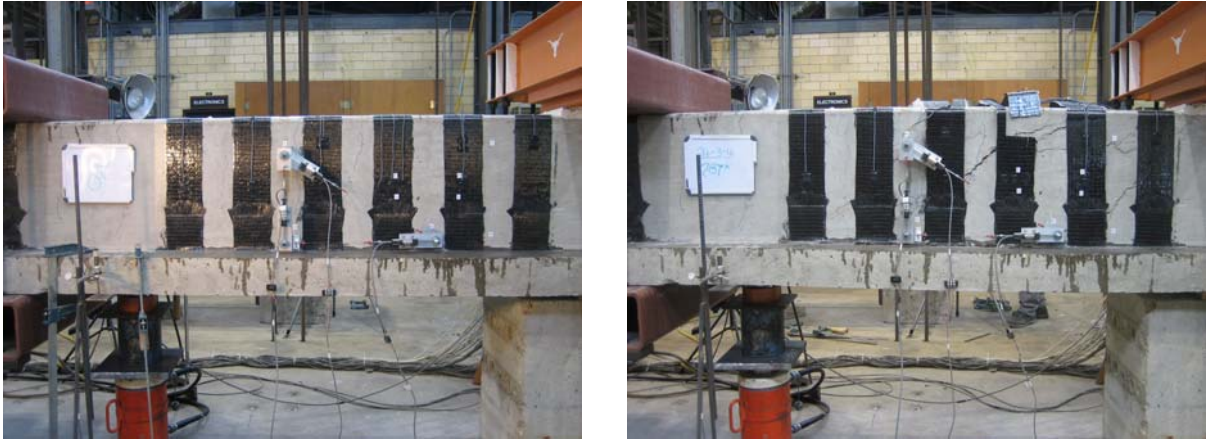
*Figure 4-40 24-3-4 before (left) and after (right) loading*

Shear failure occurred in 24-3-4 at a shear of 151-kips. Shear failure was initiated by rupture of the CFRP strips. Photos of the test specimen before loading and after failure are displayed in Figure 4-40. Concrete cracks observed during testing have been marked in red. A sketch of the cracking observed during testing of 24-3-4 is presented in Figure 4-42.

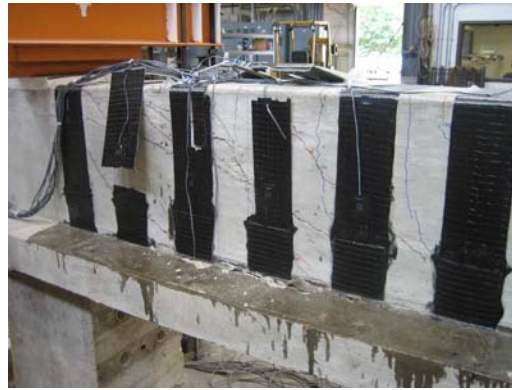
*Figure 4-41 Rupture of CFRP strips, test 24-3-4*

Shear failure of the specimen was initiated by rupture of the CFRP strips (Figure 4-41). CFRP anchor failure was not observed at any point during testing. Large cracks were observed in the specimen at failure. Large strains were developed in the CFRP. The CFRP anchorage detail (as described in 3.1.5.4.2) allowed the CFRP strips to experience large strains without rupturing the CFRP anchors.

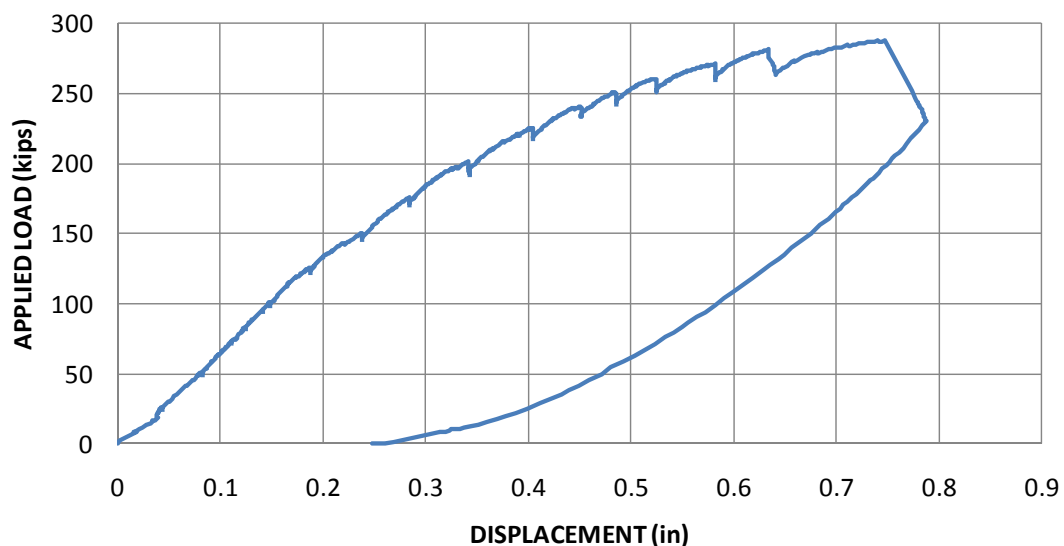
**Figure 4-43 Load-displacement response, test 24-3-4**

A sudden shear failure was observed in 24-3-4 as indicated in Figure 4-43. A large decrease in applied load along with a small increase in displacement was observed after the peak load was reached. There was no spalling of concrete when the strips failed because bond between the CFRP and concrete was effectively removed using the clear plastic shelf liner discussed earlier. The maximum load applied to 24-3-4 equaled the maximum load applied to 24-3-1R in which the CFRP strips were bonded to the concrete substrate. Shear deformation is plotted in Figure 4-44.

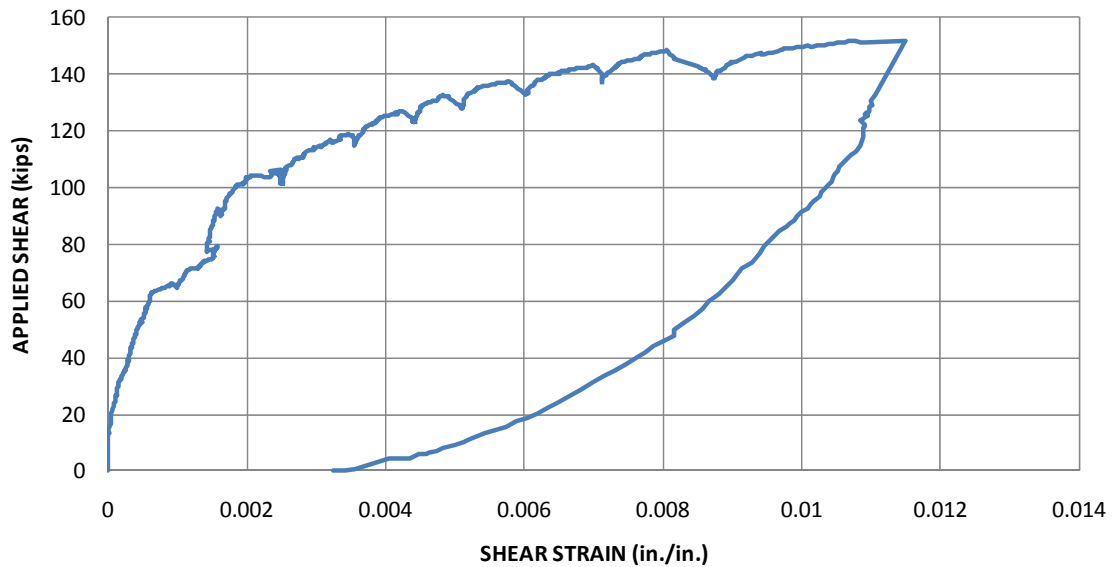
**Figure 4-44 Shear deformation plot, test 24-3-4**

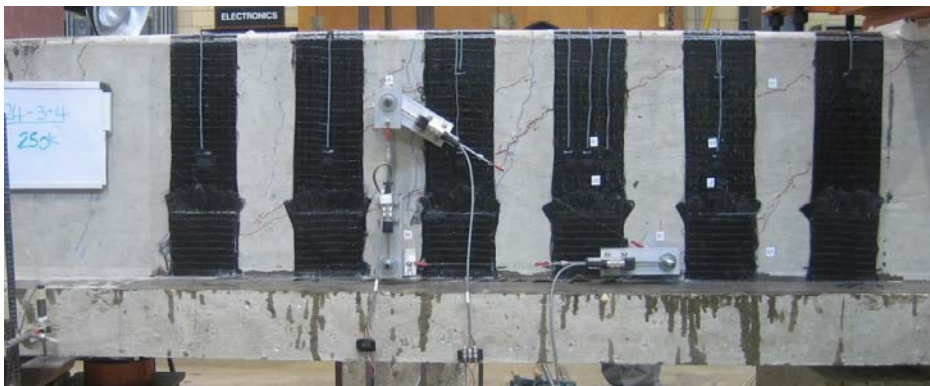
*Figure 4-47 24-3-4 at 250-kips applied load (132-kips applied shear)*

Strains in the steel stirrups were monitored during testing with several strain gauges. Initial yielding of the steel stirrups was reported at an applied shear load of 103-kips. Strains were also monitored in the CFRP sheets. The maximum reported CFRP strain during test 24-3-4 was 0.0126. The high strain value was recorded at a location of fracture in one of the CFRP strips and was higher than the manufacturer reported ultimate tensile strain value of 0.0105.

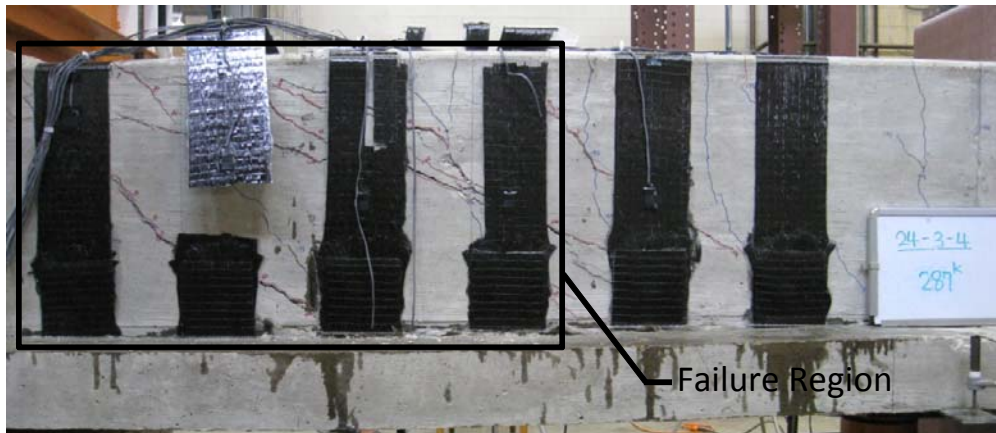
*Figure 4-49 Failure region of 24-3-4 (east)*

The shear forces resisted by the CFRP, transverse steel and concrete were estimated using the measured strains in the failure region (Figure 4-49). The estimated shear forces resisted by each material are presented in Figure 4-50. Because the CFRP strips were not adhered to the surface of the beam, the strains in the CFRP strips were able to be distributed over their entire length. Therefore, the CFRP contribution to shear resistance was small until the stirrups yielded (at about 105-kips), allowing the CFRP to resist more of the shear force.

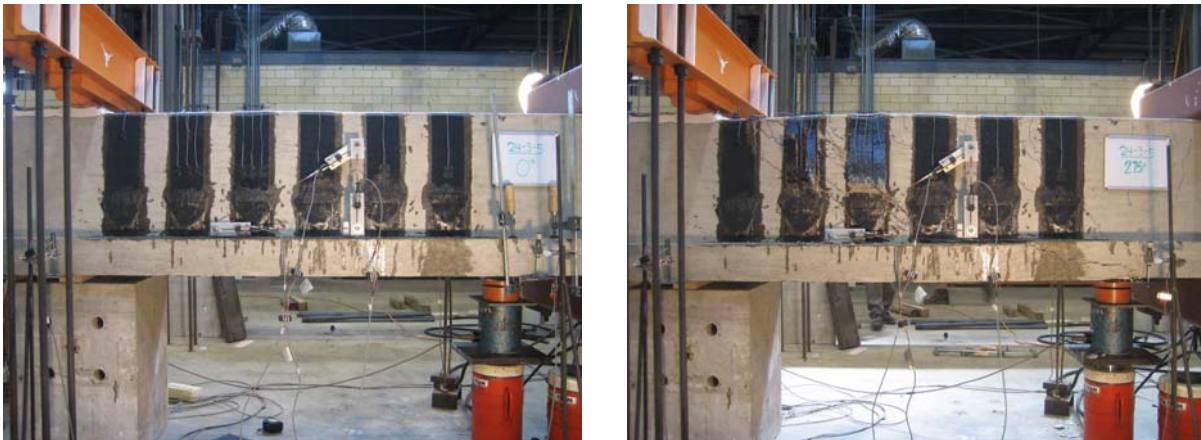
*Figure 4-51 24-3-5 before (left) and after (right) loading*

Shear failure occurred in 24-3-5 at a shear of 145-kips. Shear failure was initiated by rupture of the CFRP strips. Photos of the test specimen before loading and after failure are displayed in Figure 4-51. Concrete cracks observed during testing have been marked in blue. A sketch of the cracking observed during testing of 24-3-5 is presented in Figure 4-52.

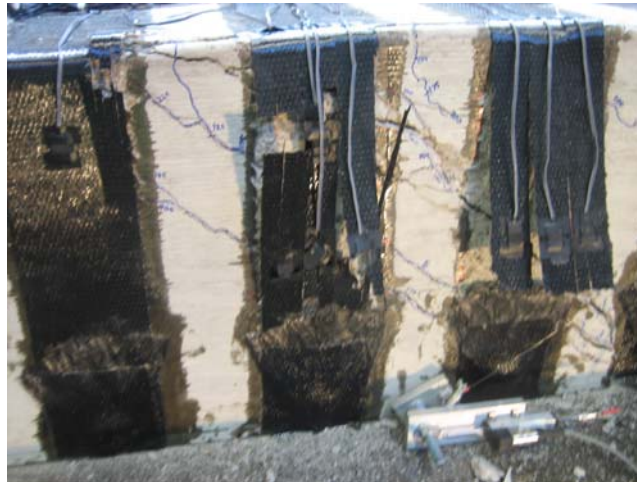
**Figure 4-53 Rupture of CFRP strips, test 24-3-5**

Shear failure of the specimen followed rupture of the CFRP strips (Figure 4-53). No CFRP anchor failures were occurred. Large cracks were observed in the specimen at failure and were accompanied by large strains in the CFRP.

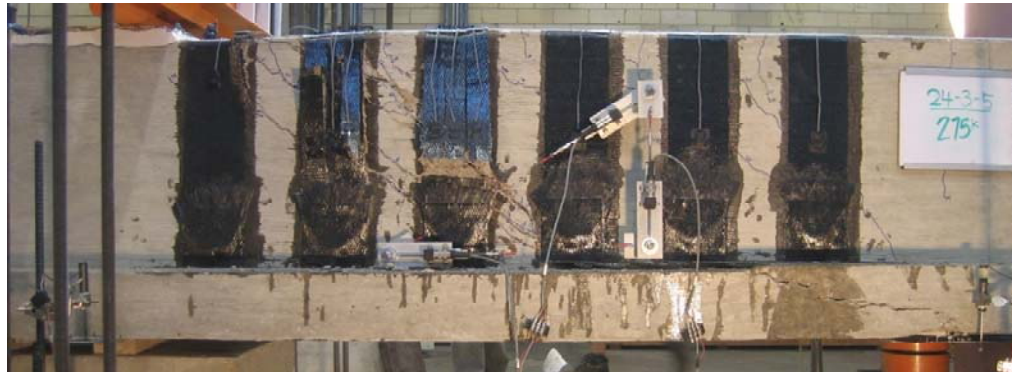
**Figure 4-59 24-3-4 at 275-kips applied load (145-kips applied shear)**

fracture in one of the CFRP strips and was higher than the manufacturer reported ultimate tensile strain value of 0.01.

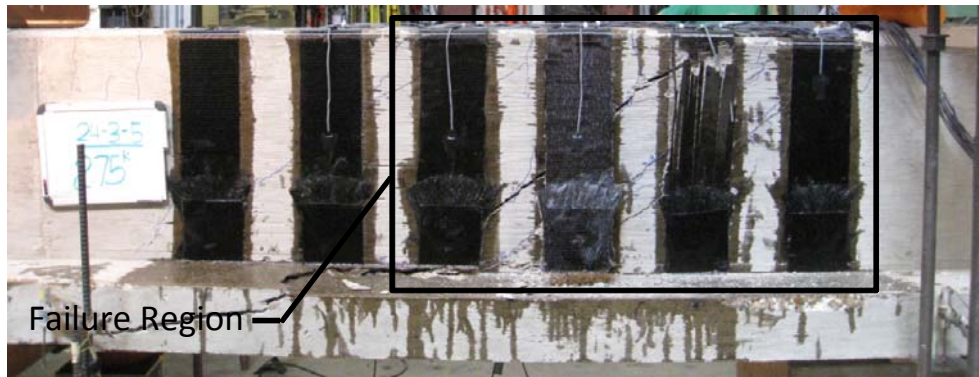
**Figure 4-60 Failure region of 24-3-5 (east)**

The estimated shear forces resisted by the CFRP, transverse steel and concrete for the failure region shown in Figure 4-60 are plotted in Figure 4-61.

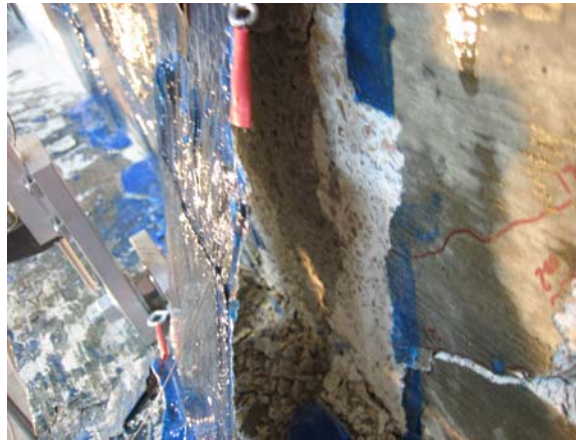
*Figure 4-64 CFRP anchor rupture, test 24-3-6*

As load increased, large cracks formed in the concrete. Because material C had large deformation capacity (ultimate tensile strain of 0.0167), the cracks opened more than the previous tests. Eventually, the cracks became so large that concrete aggregate interlock may have been significantly weakened. Shear had to be resisted mainly by the CFRP and transverse steel. The sudden increase in load on the CFRP resulted in rupture of the CFRP anchors. A photo of one of the ruptured CFRP anchors is shown in Figure 4-64.

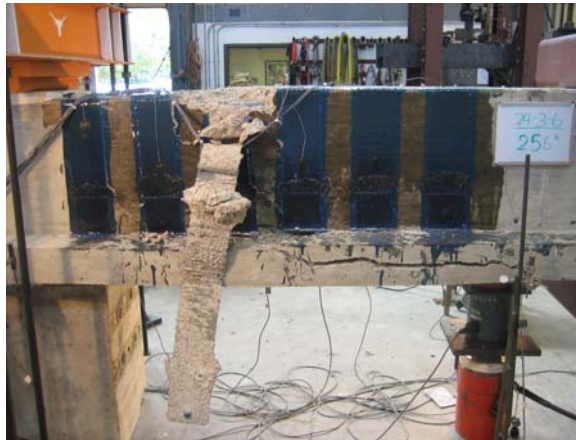
*Figure 4-65 CFRP strip removed from the concrete specimen, test 24-3-6*

When the CFRP anchor ruptured, it deflected violently outward along with a large segment of concrete cover over the longitudinal steel. Photos of this explosive failure are shown in Figure 4-65 and Figure 4-66.

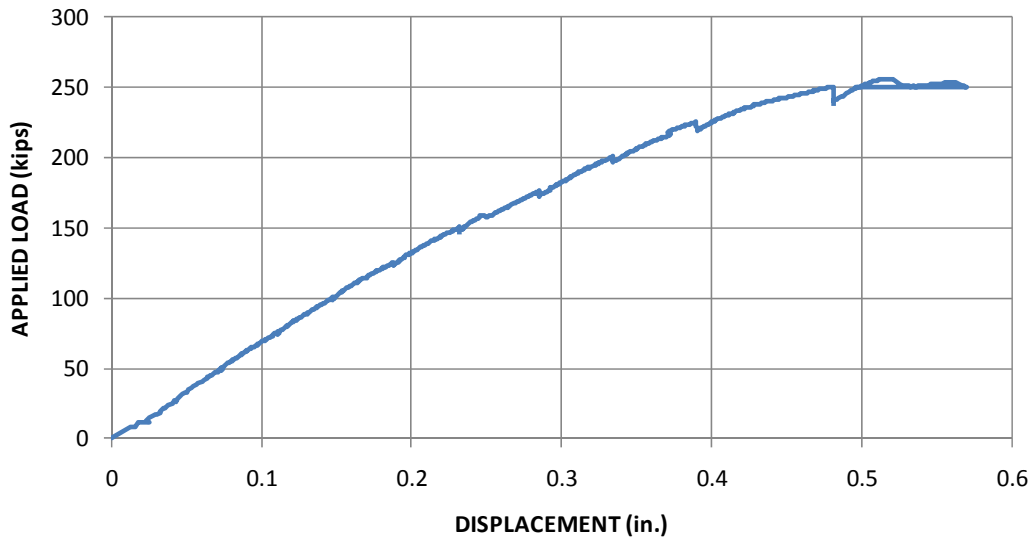
**Figure 4-67 Load-displacement response, test 24-3-6**

The load-displacement response of 24-3-6 is presented in Figure 4-67. The curve seen in Figure 4-67 lacks an unloading portion because the mountings of the transducers monitoring displacement were damaged at failure. Shear deformation is plotted in Figure 4-68. As the CFRP strip that failed separated from the specimen, it severed one of the transducer leads for the shear deformation instrumentation. Therefore, the plot is terminated at that point.

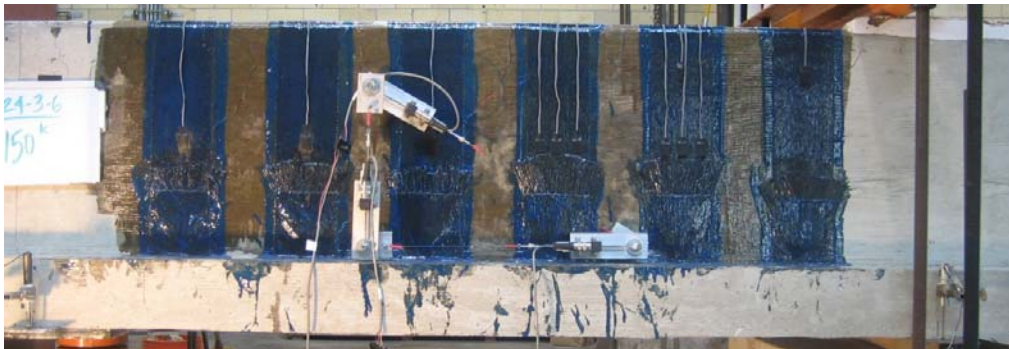
*Figure 4-69 24-3-6 at 150-kips applied load (79-kips applied shear)*

The strain values recorded in the CFRP and steel and photos of the specimen are presented in Figures 4-69 through 4-71.

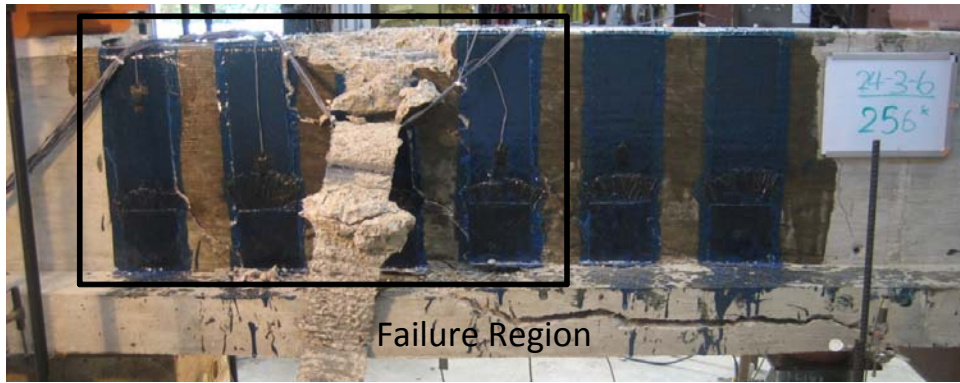
**Figure 4-72 Failure region of 24-3-6**

The estimated shear forces resisted by the CFRP, transverse steel and concrete are plotted in Figure 4-73 for the failure region shown in Figure 4-72. As seen in Figure 4-73, the concrete contribution to the overall shear strength of the member was reduced at failure. This observation led to the belief that failure was likely associated with some loss of concrete aggregate interlock.

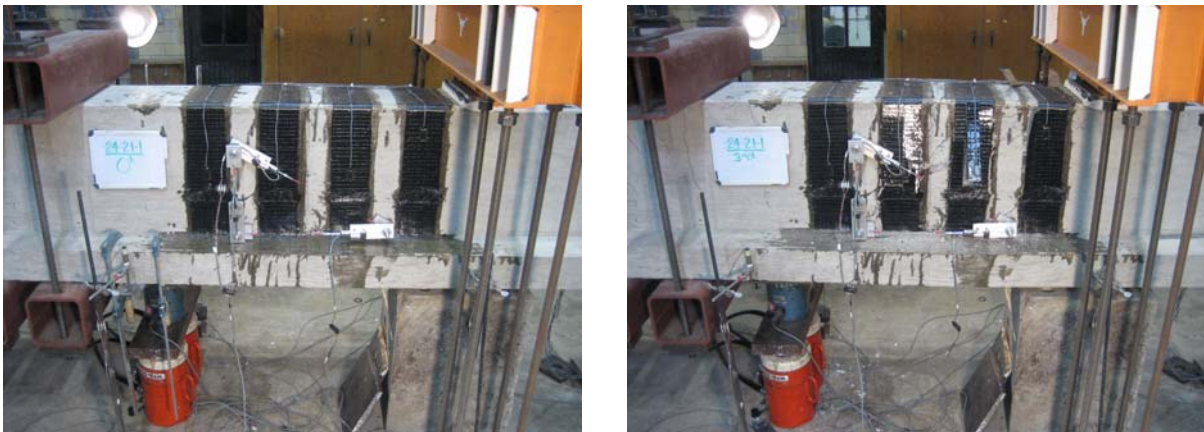
*Figure 4-75 24-2.1-1 before (left) and after (right) loading*

Shear failure occurred in 24-2.1-1 at a shear of 170-kips. Shear failure occurred due to a combination of CFRP rupture and CFRP anchor failure. Photos of the test specimen before loading and after failure are shown in Figure 4-75. Concrete cracks

observed during testing have been marked in blue. A sketch of the cracking observed during 24-2.1-1 is presented in Figure 4-76.
