**Shear Strengthening of Reinforced Concrete Beams with Carbon Fiber  
Reinforced Polymer (CFRP) and Improved Anchor Details**

**Thesis**

The University of Texas at Austin

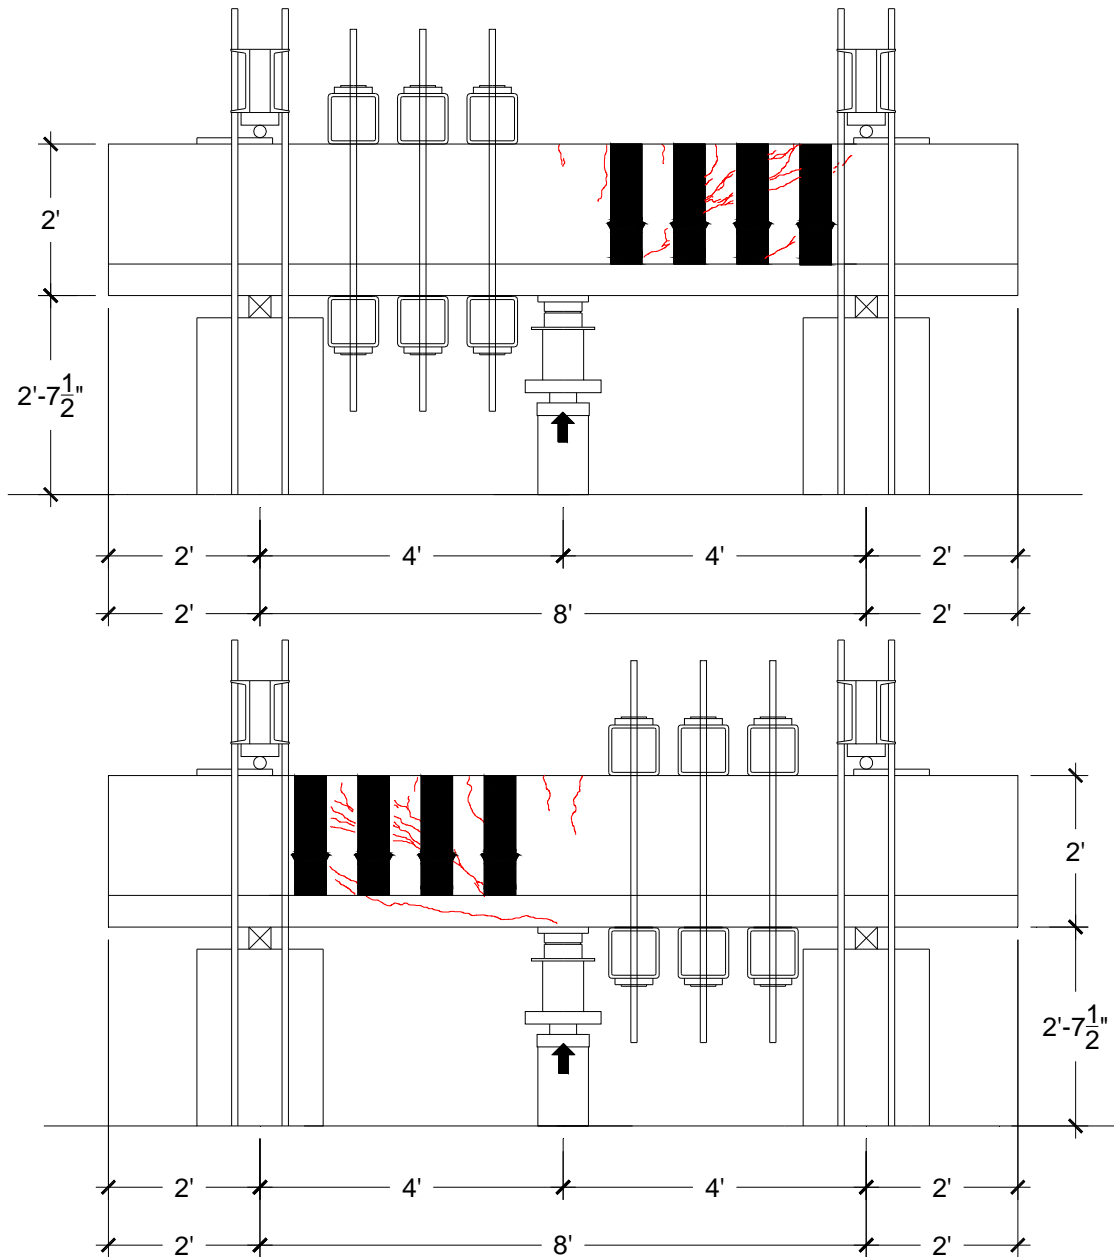
**Figure 4-76 Sketch of cracking observed during 24-2.1-1 west (top) and east (bottom)**

observed during testing have been marked in blue. A sketch of the cracking observed during 24-2.1-1 is presented in Figure 4-76.

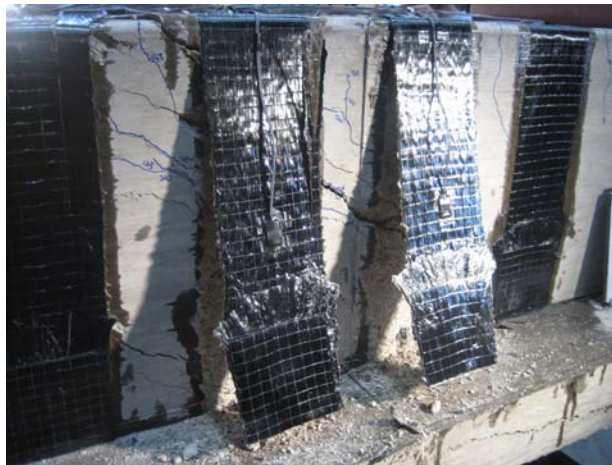
*Figure 4-77 CFRP anchorage failure observed during 24-2.1-1*

Failure of the specimen was initiated by rupture of the CFRP strips. After the first strip ruptured, shear force carried by the strip was redistributed to adjacent CFRP strips. The overload experienced by these strips caused a dramatic failure to occur at the location of the CFRP anchors. Several anchors ruptured at the sheet/concrete interface, allowing the CFRP strips to pull away from the surface of the beam (Figure 4-77 and Figure 4-78). The anchors fractured because they were unable to resist the additional force; however, it is noted that the anchors were able to develop strains higher than the manufacturer reported ultimate values in the CFRP strips before ultimate failure of the specimen.

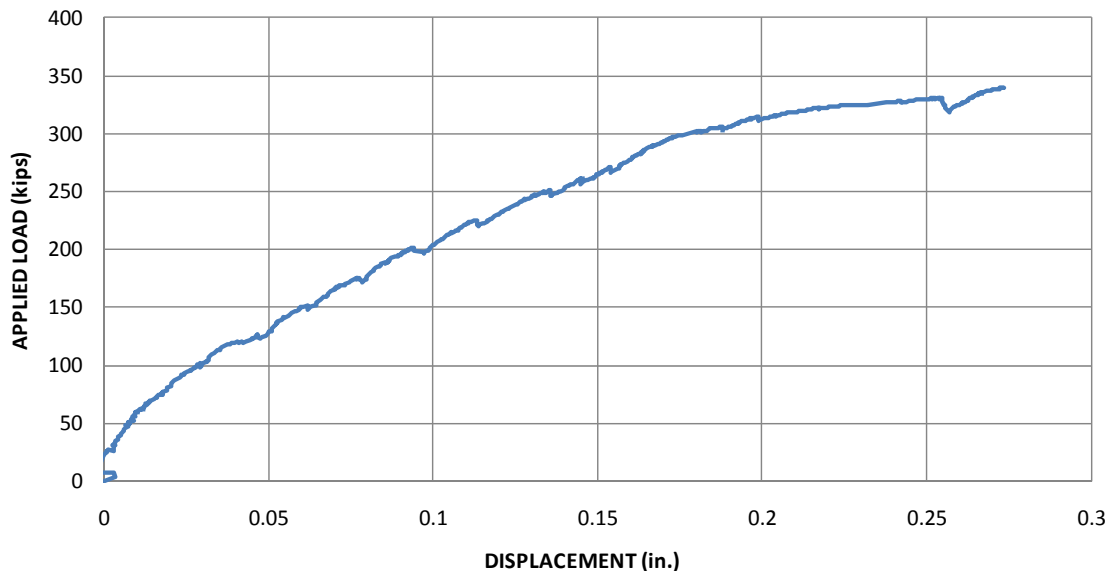
***Figure 4-79 Load-displacement response, test 24-2.1-1***

The shear failure observed in 24-2.1-1 was sudden and violent. As the CFRP strips and some of the CFRP anchors ruptured, large cracks formed in the specimen. Concrete spalled outward from the specimen in an explosive manner. The complete load-displacement response of 24-2.1-1 is presented in Figure 4-79. No unloading portion is shown because the mountings for the transducers monitoring displacement were damaged at failure. Shear deformation (as described in 3.3.3.2) of 24-2.1-1 is plotted in Figure 4-80.

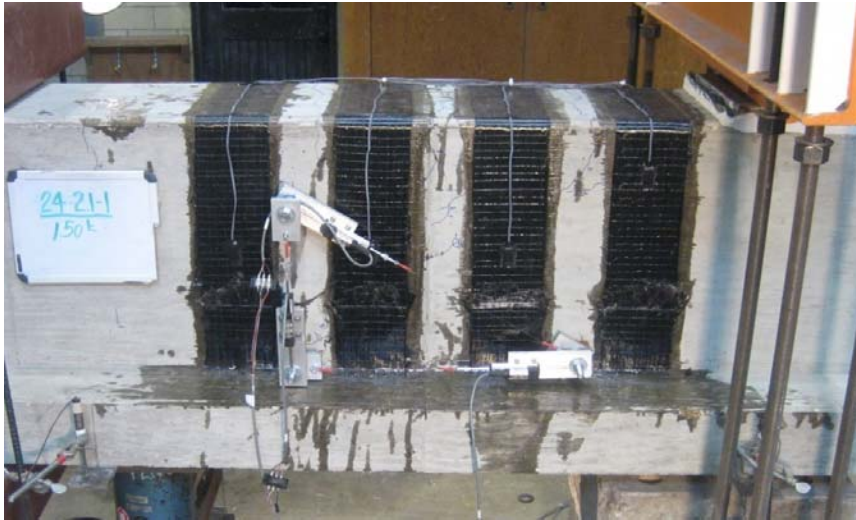
**Figure 4-81 24-2.1-1 at 150-kips applied load (75-kips applied shear)**

The strain values recorded in the CFRP and steel at various stages during testing are presented in Figures 4-81 through 4-84. The strain values shown are the maximum values recorded at given distances from the location of applied load. As applied load increased, some strain gauges malfunctioned and were deemed unreliable. In these instances, the maximum reliable strain reading is plotted on the graph and dashed lines are used to connect the data point to the neighboring values.

Photos of the specimen at the loading stage associated with the recorded strain values are also presented in Figures 4-81 through 4-84. The photos, in relation to the recorded strain values, provide a comparison of numerical data to physical observations noted during testing.

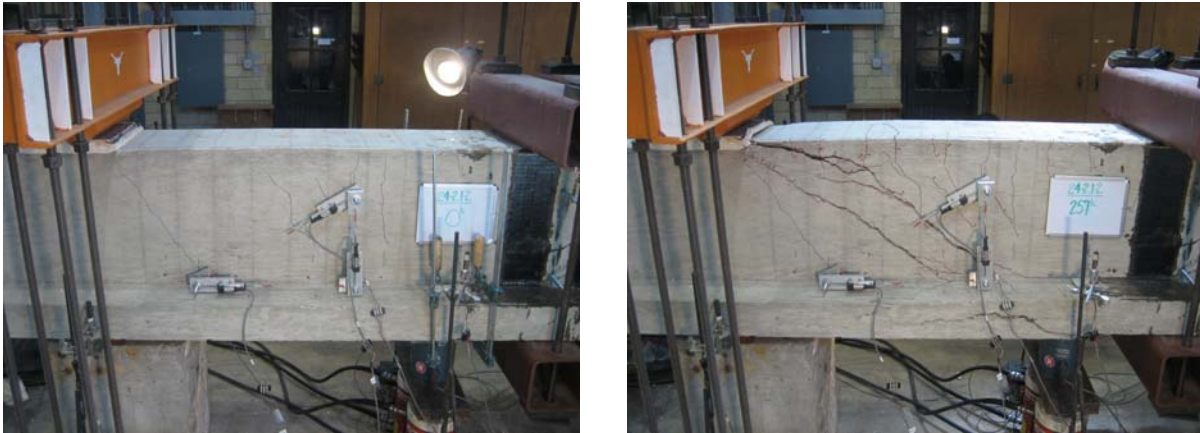
**Figure 4-87** 24-2.1-2 before (left) and after (right) loading

Shear failure occurred in 24-2.1-2 at a shear of 129-kips. Shear failure occurred in a sectional mode of failure. Photos of the test specimen before loading and after failure are presented in Figure 4-87. Concrete cracks observed during testing have been marked in red. A sketch of the cracking observed during testing of 24-2.1-2 is presented in Figure 4-88.

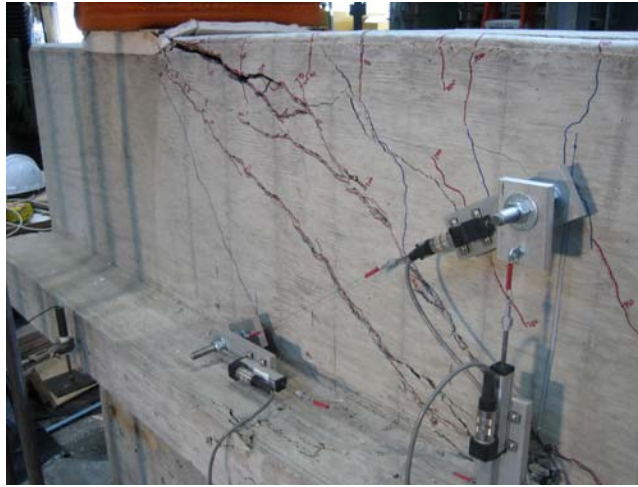
*Figure 4-89 Cracking observed in 24-2.1-2*

As seen in Figure 4-89, large cracks formed in the concrete member and failure was controlled by a shear mode of failure rather than crushing of a concrete strut.

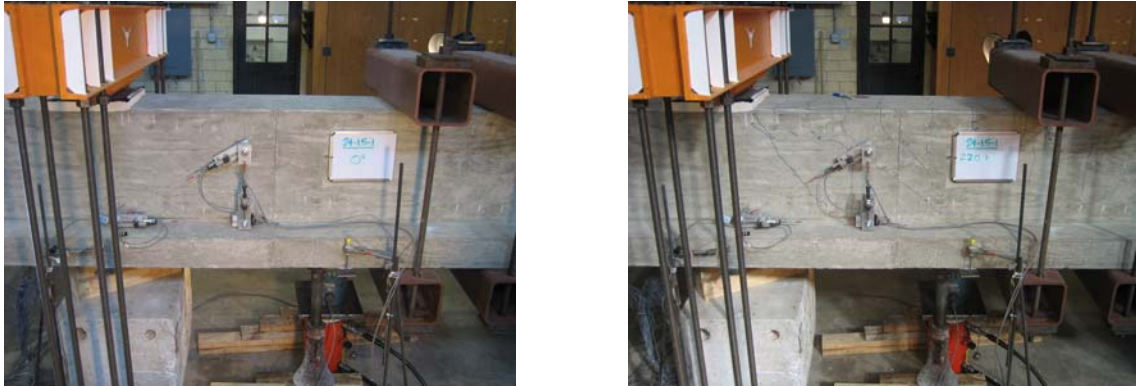
**Figure 4-93 24-1.5-1 before (left) and after (right) loading**

In the first test, 24-1.5-1, the specimen was loaded until strain gauges placed on the internal shear reinforcement indicated yielding. Yielding occurred at an applied shear load of 131-kips in strain gauge 24-1.5-1-3ER. Figure 4-93 shows the condition of the

test specimen before and after loading. Concrete cracks observed during testing have been marked in blue. The maximum concrete crack width observed was 0.018-in at an applied shear of 130-kips. A sketch of the cracking observed during 24-1.5-1 is presented in Figure 4-94.

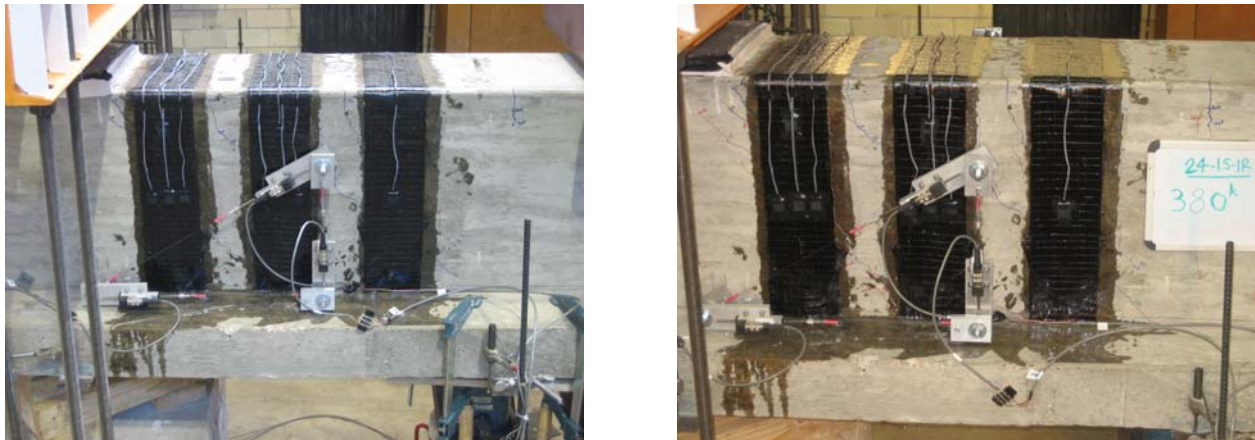
***Figure 4-95 24-1.5-1R before (left) and during (right) loading***

The maximum load applied to specimen 24-1.5-1R was 400-kips; however, the specimen did not fail. The applied load of 400-kips corresponded to an applied shear load of 240-kips, the maximum shear load that could be applied using the low-capacity test setup. Images of the test specimen before and during loading are shown in Figure 4-95. Concrete cracks observed during testing have been marked in red. The maximum concrete crack width observed during testing was 0.06-in. A sketch of the cracking observed during testing of 24-1.5-1R is presented in Figure 4-96.

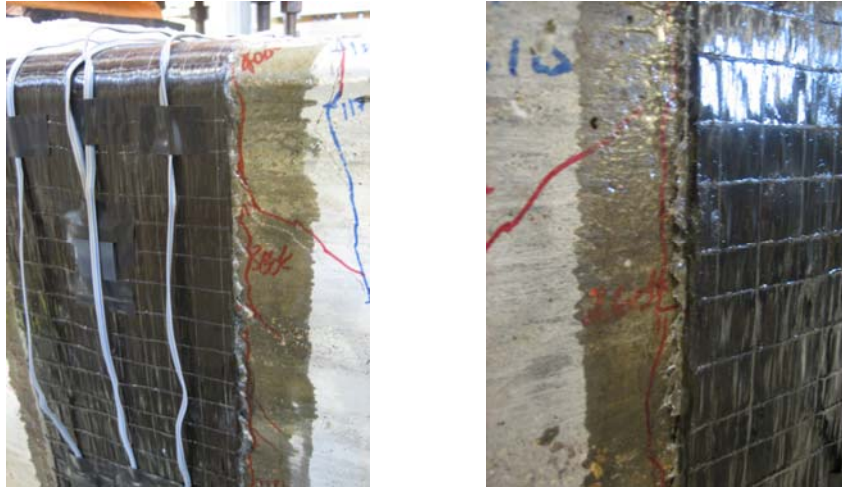
*Figure 4-97 Observed debonding during test 24-1.5-1R*

While loading, audible popping and cracking were heard as the CFRP laminates began to debond from the concrete substrate. During testing, the maximum strain in the CFRP sheets was 0.0039 in strain gauge 24-1.5-1R-F1C.1. Also, concrete began to spall

on the east and west sides of the test specimen. Some of the debonding observed during testing is displayed in Figure 4-97.

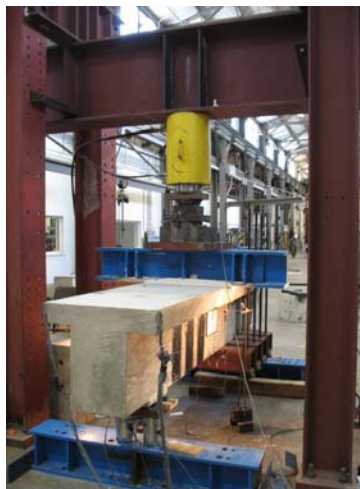
*Figure 4-98 24-1.5-1R2 placed within the high capacity test setup*

The test specimen was placed in the high-capacity test setup (Figure 4-98) to load the specimen to failure.

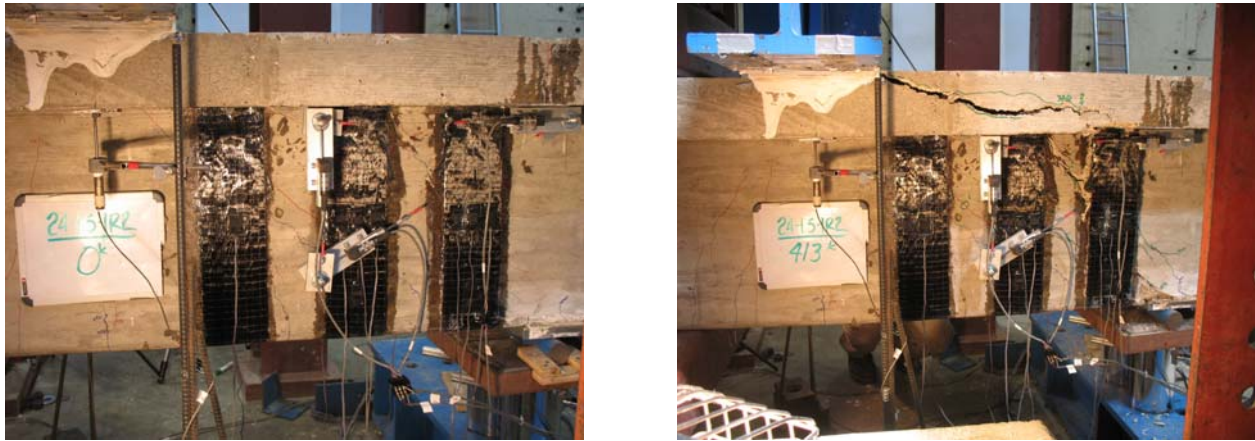
**Figure 4-99** 24-1.5-1R2 before (left) and after (right) loading

Shear failure occurred in 24-1.5-1R2 at an applied shear of 252-kips. Shear failure occurred due to crushing of the concrete strut that formed between the point of applied load and the support. The condition of the test specimen before loading and after failure is shown in Figure 4-99. Concrete cracks observed during testing have been

marked in green. A sketch of the cracking observed during testing of 24-1.5-1R2 is presented in Figure 4-100.

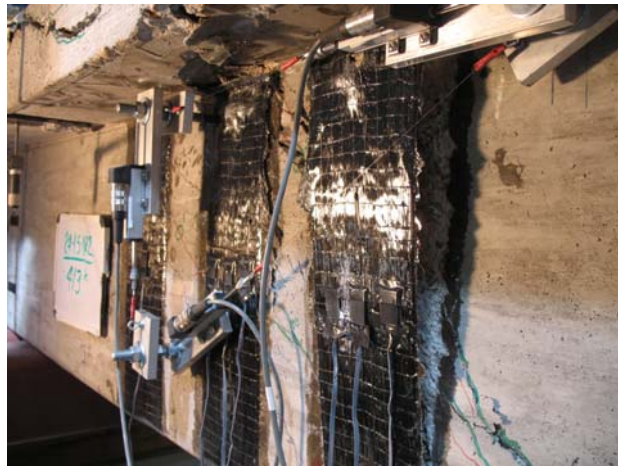
reinforcement crossing the steep crack. As the deformation of the specimen increased, a failure mechanism began to form which engaged the remaining CFRP strips and steel stirrups. However, the ultimate capacity was reached when concrete crushed along the direct strut that formed between the point of applied load and the support. None of the CFRP strips experienced rupture, but some of the anchors fractured near the opening of their anchorage holes as seen in Figure 4-101. The final condition of the failed specimen is shown in Figure 4-102.

***Figure 4-101 Anchorage failure of 24-1.5-1R2 (west side)***

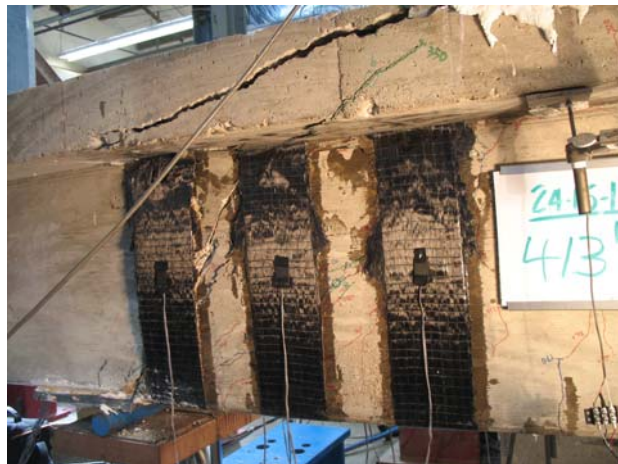
***Figure 4-102 Observed failure of 24-1.5-1R2 (east side)***

The failure of 24-1.5-1R2 was not experienced suddenly or without warning. The applied load increased to its maximum value, and then decreased as the deformation

increased. This observed behavior provided substantial evidence that the overall shear failure of the beam was governed by a concrete crushing mechanism. The low concrete strength and sufficient confinement of the concrete strut that formed between the point of applied load and support prevented a sudden failure from occurring. A complete load-displacement response of all three tests conducted on the test specimen is presented in Figure 4-103. A large decrease in member stiffness was observed between 24-1.5-1R and 24-1.5-1R2. After 24-1.5-1R and before 24-1.5-1R2 were completed, a separate test was conducted on the opposite end of the member (24-1.5-2) which reduced the stiffness observed during 24-1.5-1R2. The intermittent unloading and reloading curves for 24-1.5-1R resulted from a malfunctioning hydraulic valve that required the specimen to be completely unloaded in order to be properly repaired.

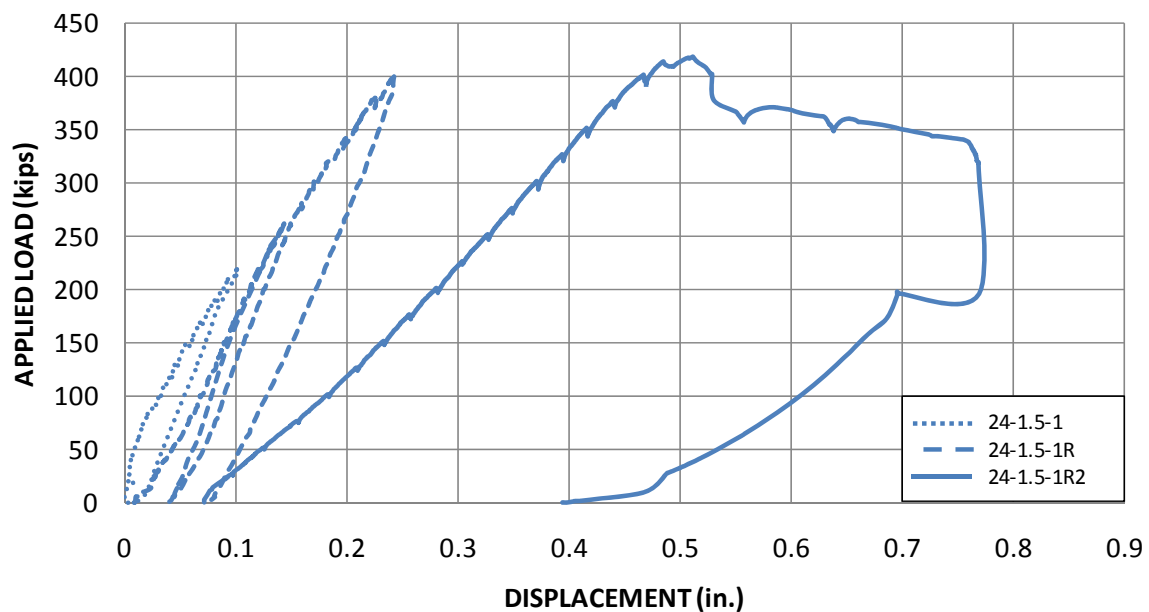
**Figure 4-103 Load-displacement response of 24-1.5-1/1R/1R2 series**

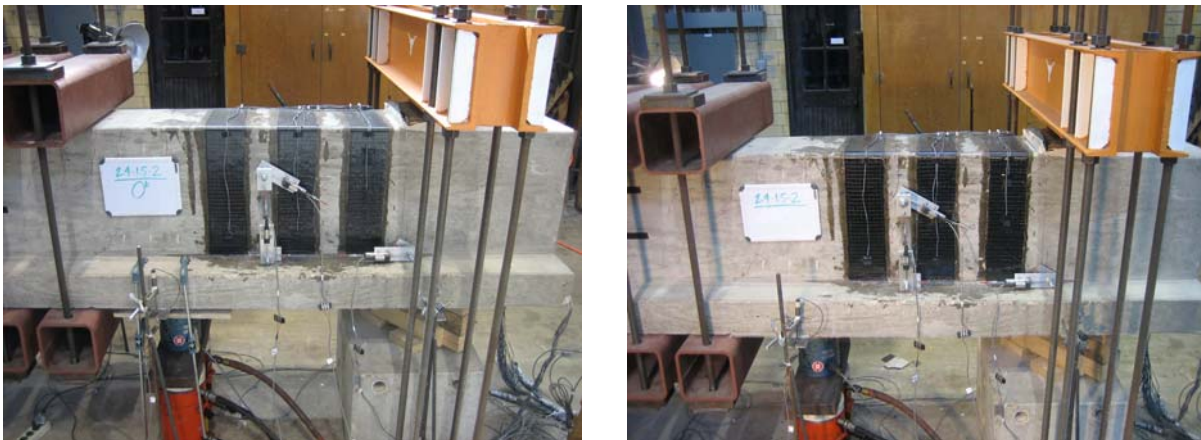
Shear failure occurred at an applied shear load of 254-kips. Shear failure occurred due to crushing of the concrete strut that formed between the point of applied load and the support. Photos of the test specimen before loading and after failure are shown in Figure 4-104. Concrete cracks observed during testing have been marked in blue. A sketch of the cracking observed during testing of 24-1.5-2 is presented in Figure 4-105.

*Figure 4-104 24-1.5-1R2 before (left) and after (right) loading*

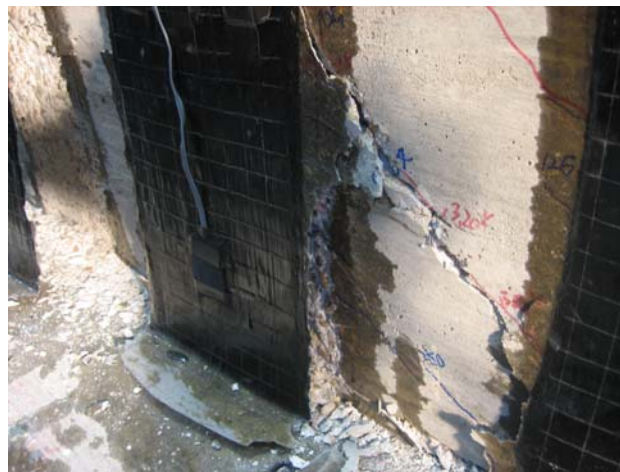
Failure of the specimen was not controlled by debonding of the CFRP strips. Rather, the ultimate failure of the specimen was controlled by crushing of the concrete. The CFRP strips did debond from the surface of the concrete; however, complete debonding of the strips from the surface occurred after the maximum load was applied to the specimen. Photos of the debonding that occurred during testing are shown in Figure 4-106 and Figure 4-107.

**Figure 4-106 Observed debonding during 24-1.5-2**

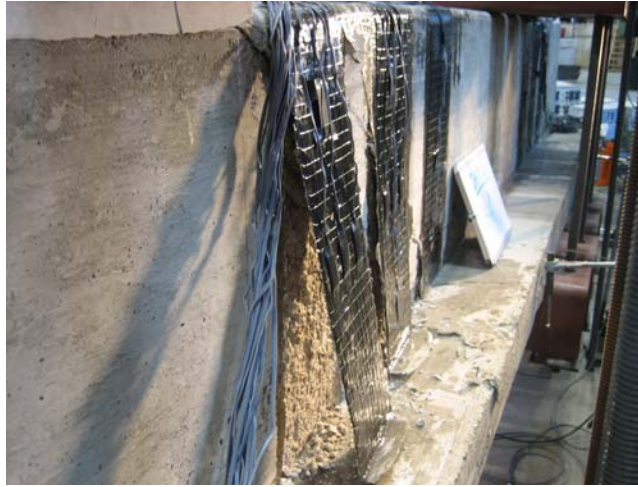
**Figure 4-107** *Debonding of CFRP strips during 24-1.5-2*

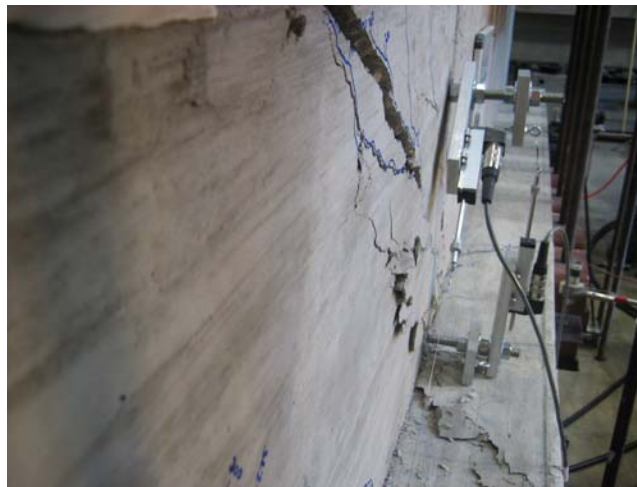
Failure of the specimen was controlled by crushing of the concrete. As load increased, concrete spalled from the surface and cracks became very large. Concrete bulged outward along the web of the specimen, as seen in Figure 4-111. The large shear crack that formed in the specimen at failure is shown in Figure 4-112.

***Figure 4-111 Bulging of concrete observed during 24-1.5-3 (west)***

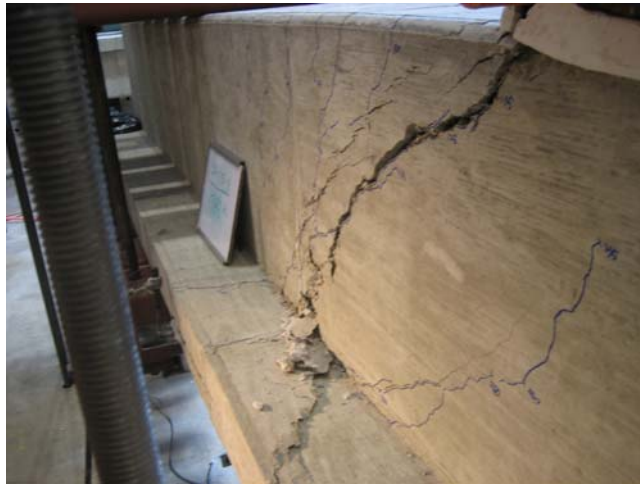
**Figure 4-112 Failure observed during 24-1.5-3**

The failure of 24-1.5-3 was not sudden or without warning. The applied load reached maximum, then decreased. The overall capacity of the specimen was controlled by the compressive strength of the concrete. Figure 4-113 provides the complete load-displacement response of 24-1.5-2 observed during testing.

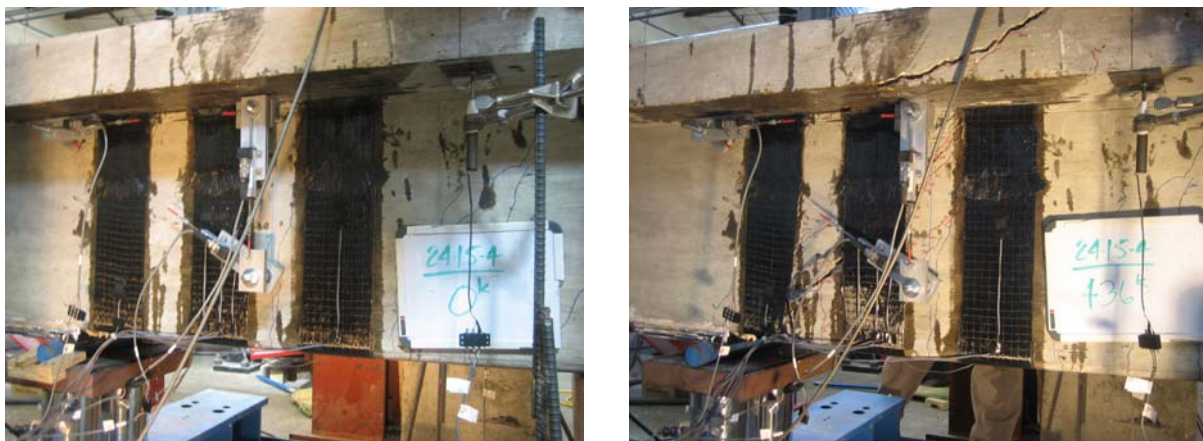
Shear failure occurred in 24-1.5-4 at an applied shear of 264-kips. Shear failure occurred shortly after one of the applied CFRP strips ruptured. Photos of the test specimen before loading and after failure are displayed in Figure 4-114. Concrete cracks observed during testing have been marked in red. A sketch of the cracking observed during testing of 24-1.5-4 is presented in Figure 4-115.

*Figure 4-114 24-1.5-3 before (left) and after (right) loading*

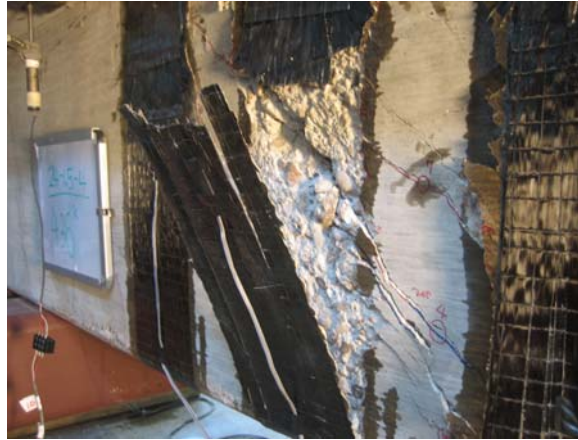
Failure of the specimen was controlled by rupture of the CFRP strips. The CFRP anchors did not fail and allowed the CFRP strips to reach full capacity. The ruptured CFRP strip that led to failure of the specimen is shown in Figure 4-117.

**Figure 4-117 Rupture of a CFRP strip during 24-1.5-4**

Because failure of the specimen was controlled by the rupture of the CFRP strips, a dramatic and sudden failure was observed. As the applied load approached its maximum value, one of the CFRP strips fractured. The value of the applied load dropped suddenly to a value of 359-kips as shown in Figure 4-118. Then, shortly thereafter, another CFRP strip splintered along the length of the strip and the beam failed.

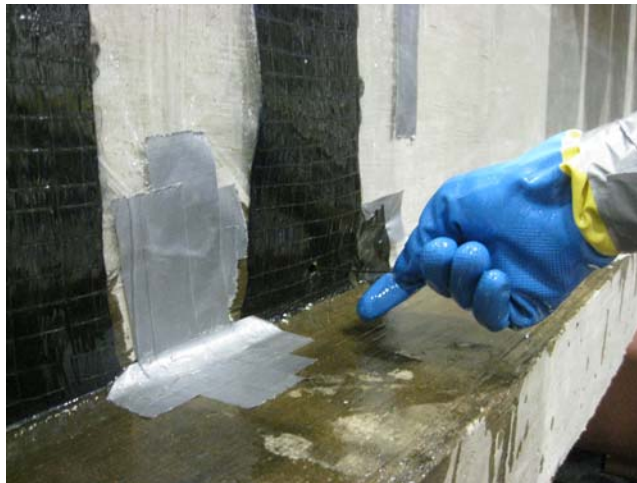
Installation of the CFRP strips in this manner proved to be difficult. Because the clear plastic wrap was not adhered to the concrete, it was able to hang freely away from the surface of the beam. Therefore, during installation, large gaps between the CFRP and concrete substrate were created, as shown in Figure 5-4 and Figure 5-5.

***Figure 5-4 Large gaps between the CFRP and concrete during CFRP installation of 24-3-3***

The poor installation of the CFRP laminates had a dramatic effect on the overall capacity of the member. In many instances, the voids seen in Figure 5-4 and Figure 5-5 formed near the edges of the CFRP strips because the CFRP anchor pinned the center of

the strips to the concrete member and created a direct load path to the anchorage hole. Therefore, as the applied load increased, stresses were not uniform across the width of the strip (refer to 5.1.4.1). Stress concentrations developed in the middle region of the strip and eventually caused the anchor to rupture at the location of the anchorage hole.

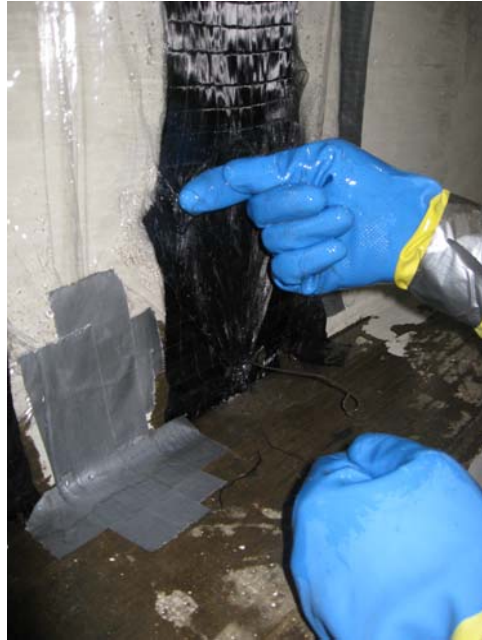
*Figure 5-5 Gaps observed near the edges of the CFRP strips (24-3-3)*

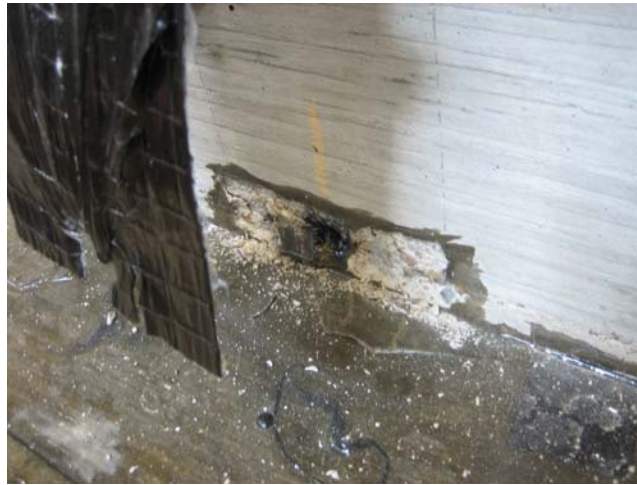
Shear failure occurred in 24-3-3 at an applied load of 118-kips. Many of the CFRP anchors ruptured at a relatively low load, causing the beam to fail. CFRP anchor rupture can be seen in Figure 5-6. The shear at failure was only 12% higher than the shear at failure of the control specimen (24-3-2, refer to 4.2.2); however, the poor quality of construction proved to be the cause of the inadequate performance.

**Figure 5-6 Premature CFRP anchor failure (24-3-3)**

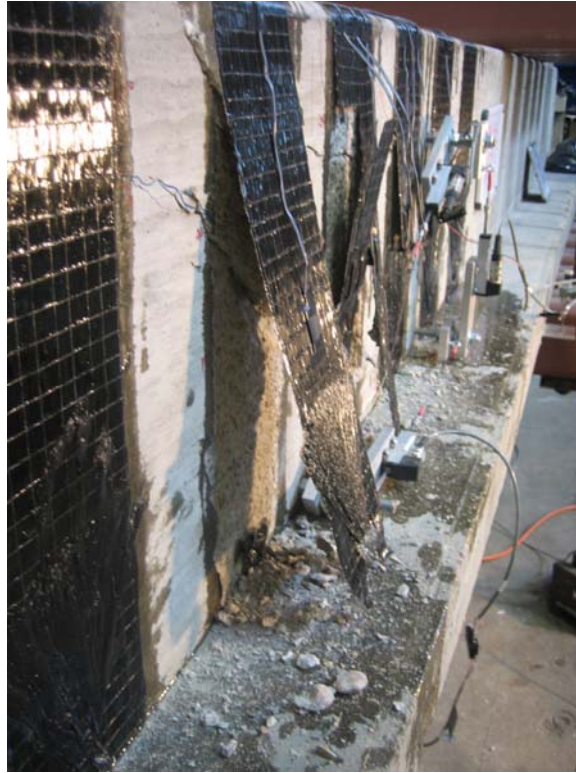
Although the anchors performed fairly well, many CFRP anchor rupture failures were observed when this detail was implemented during testing. Two examples of this type of failure are shown in Figure 5-11 and Figure 5-12. Because the shear force carried by each individual anchor was funneled into a single point, large stress concentrations accumulated near the base of the anchorage fan. Without an appropriate amount of CFRP material to resist the increase in stress, premature failure due to rupture of the CFRP anchors was inevitable.

*Figure 5-11 Anchor rupture associated with 24-3-1R*

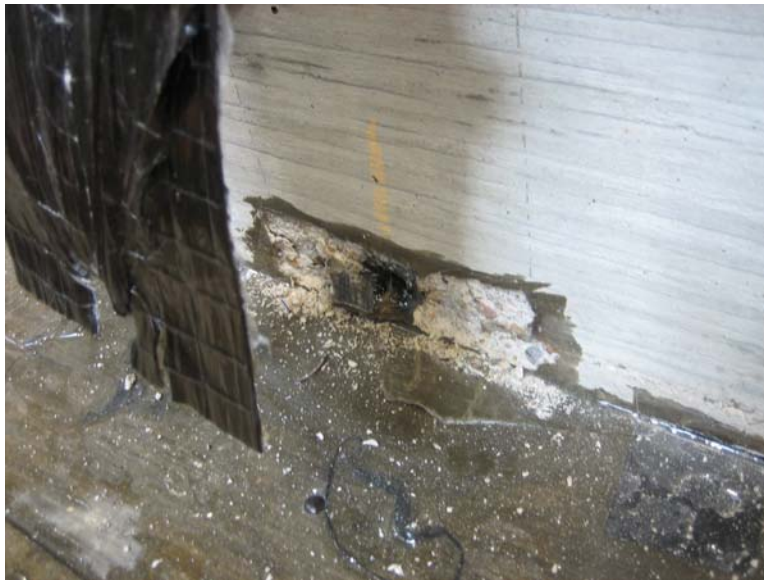
*Figure 5-12 Anchor rupture associated with 24-3-3*

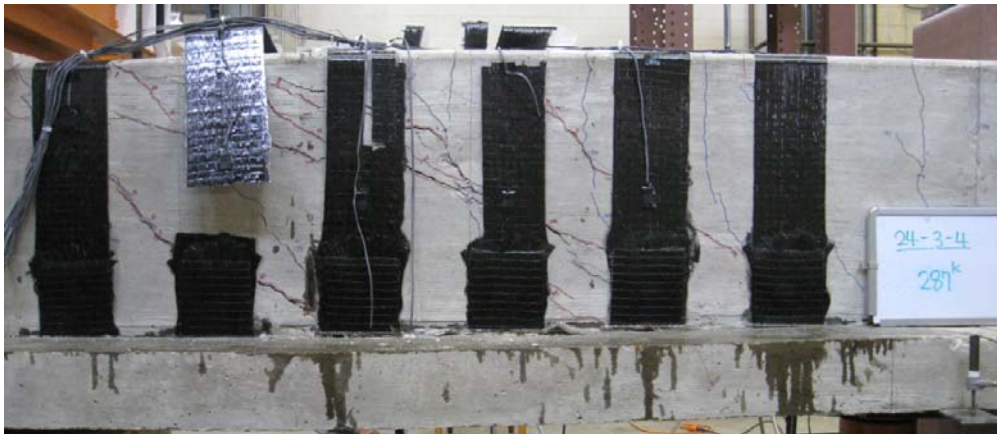
The new anchorage detail performed very well during testing. The modified CFRP anchor allowed the CFRP strips to reach their ultimate tensile capacities without experiencing premature CFRP anchor rupture. Photos of the CFRP rupture failure obtained with the use of the improved anchorage detail are shown in Figure 5-14 and Figure 5-15. As can be seen, many of the anchors remained undamaged at failure.

*Figure 5-14 CFRP rupture failure observed during 24-3-4*

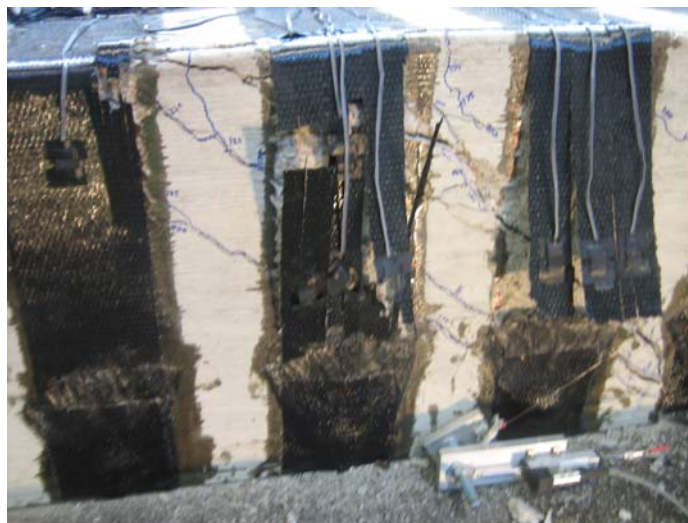
*Figure 5-15 CFRP rupture failure observed during 24-3-5*

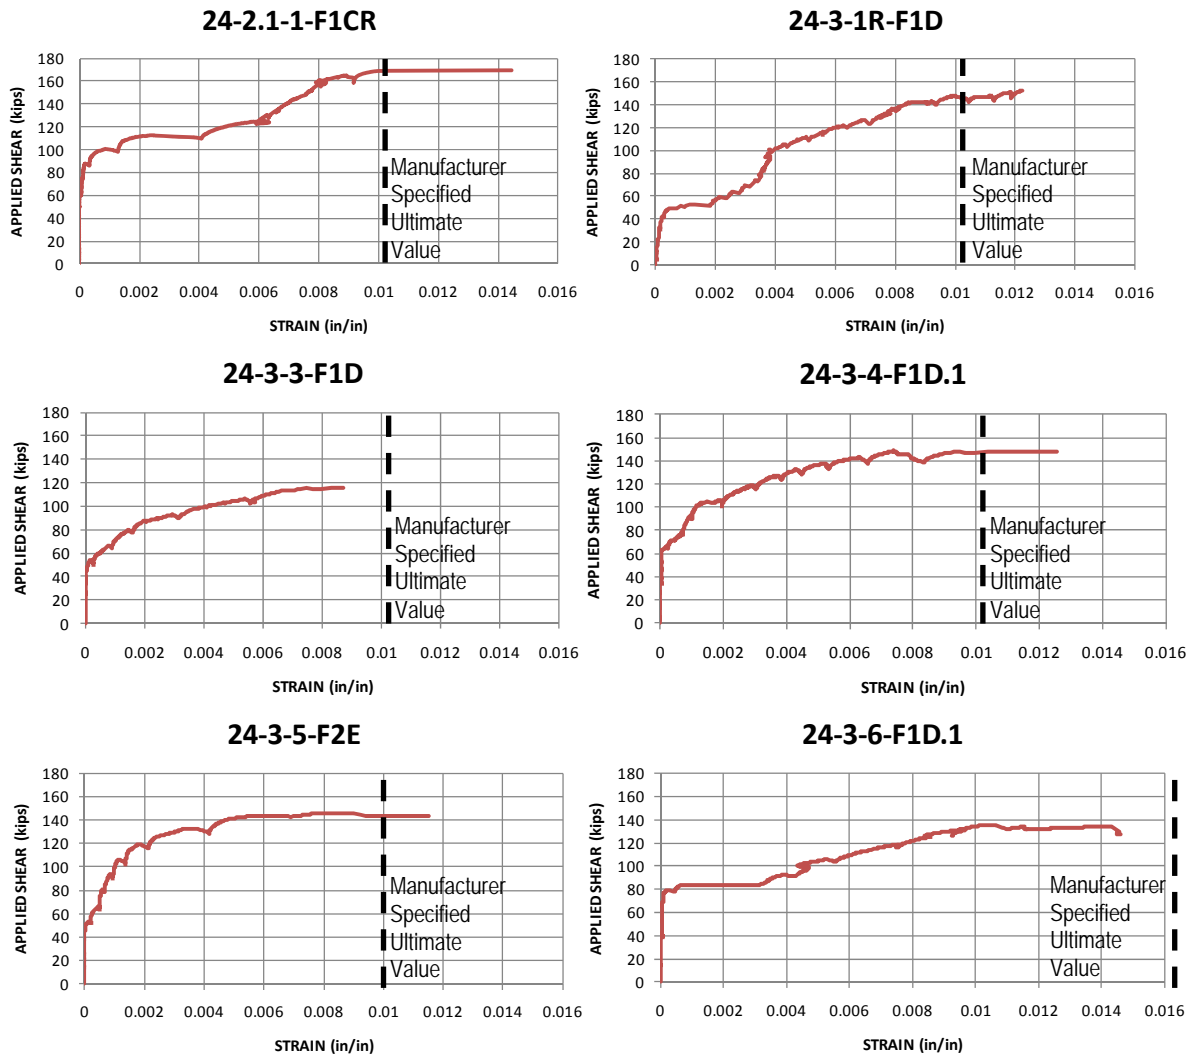
**Figure 5-17 Strain-applied shear plots of CFRP strain gauges reporting maximum strains during testing**

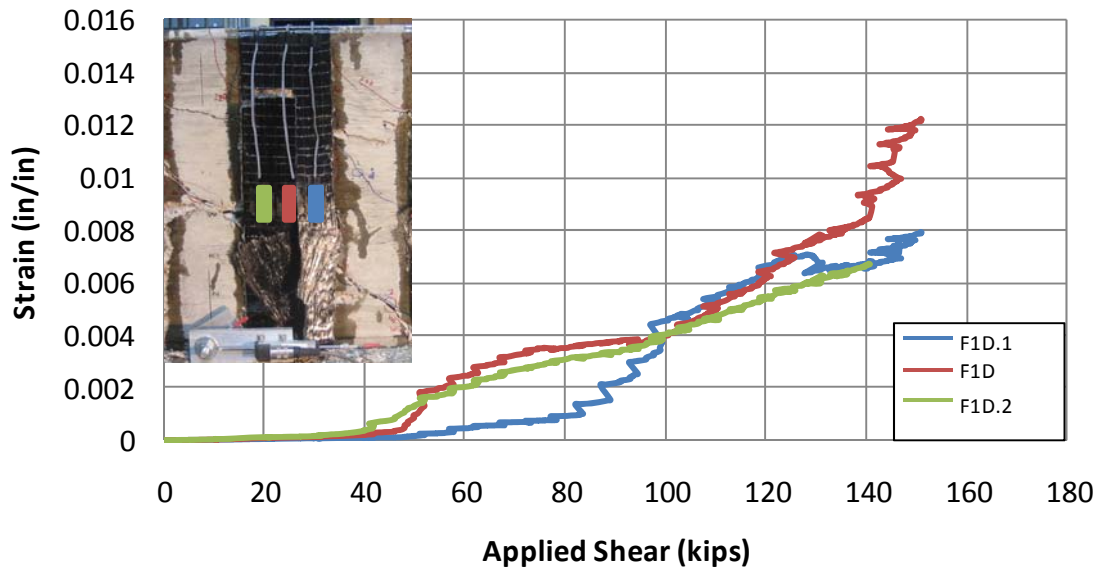
*Figure 5-20 Parabolic CFRP strain distribution observed in Strip D, test 24-3-1R*

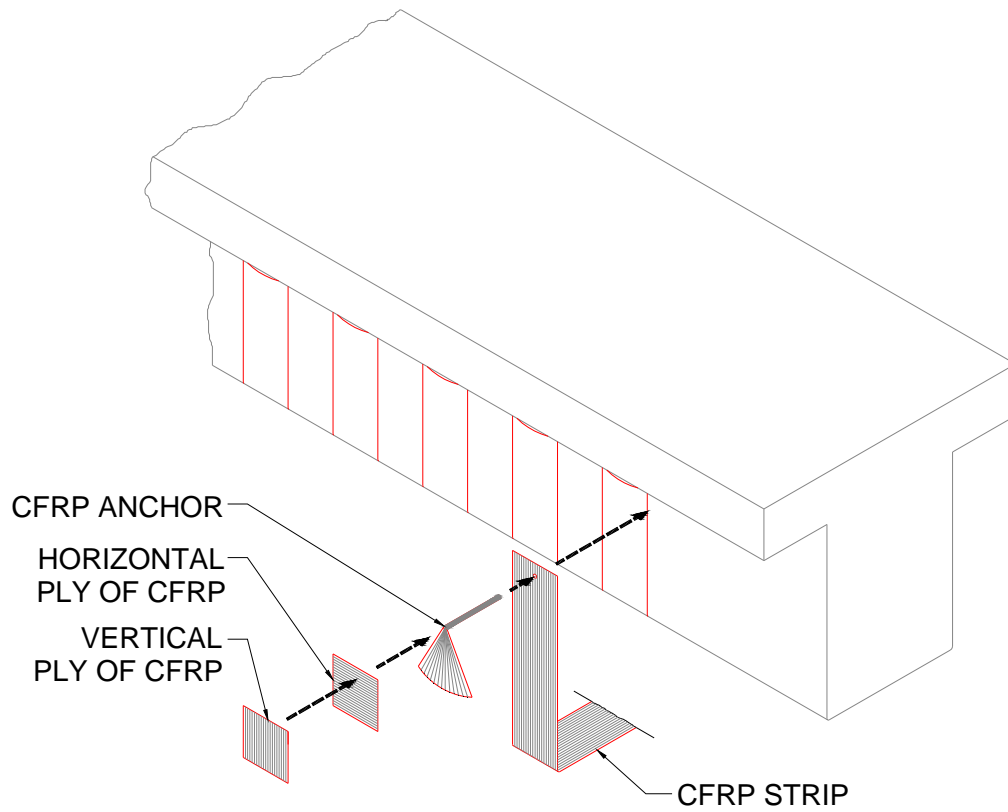
**Figure 5-29 Isometric view of CFRP anchor installation**
