**PERFORMANCE OF REINFORCING STEEL COATED
WITH A HIGH RATIO ZINC SILICATE**

THESIS

The University of Texas at Austin

December 1992

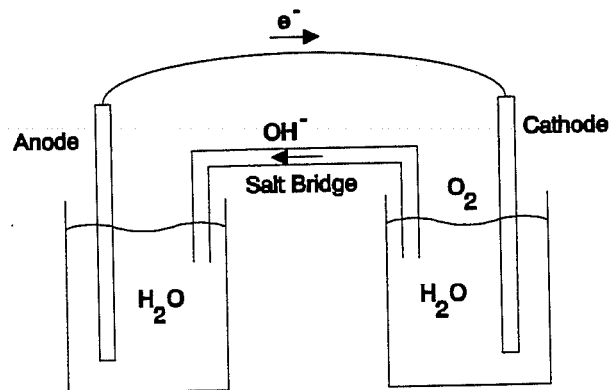
Figure 1.1: Electrochemical Corrosion

Corrosion of reinforcement is an electrochemical process and is shown schematically in Figure 1.1. An electrical connection carries electrons from the anode to the cathode

while anions are carried in the reverse direction through a salt bridge. The basic reactions for the cathode and anode are also given in the figure. Corrosion can occur in the presence of oxygen and water, but steel is normally protected by an oxide film that exists on the surface. Chlorides, however, can assist and accelerate the

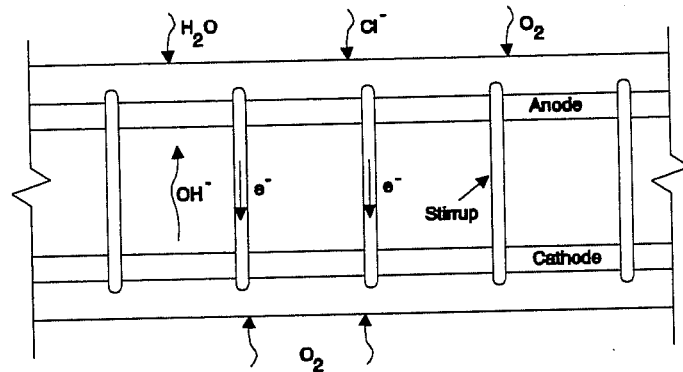
Figure 1.3: Macrocell Corrosion

electrical connection is achieved by stirrups which connect the mats together for the transfer of electrons. The salt bridge is formed by the moist concrete which is

called the electrolyte. Water, oxygen, and chlorides from deicing salts are sufficient ingredients for corrosion to initiate.

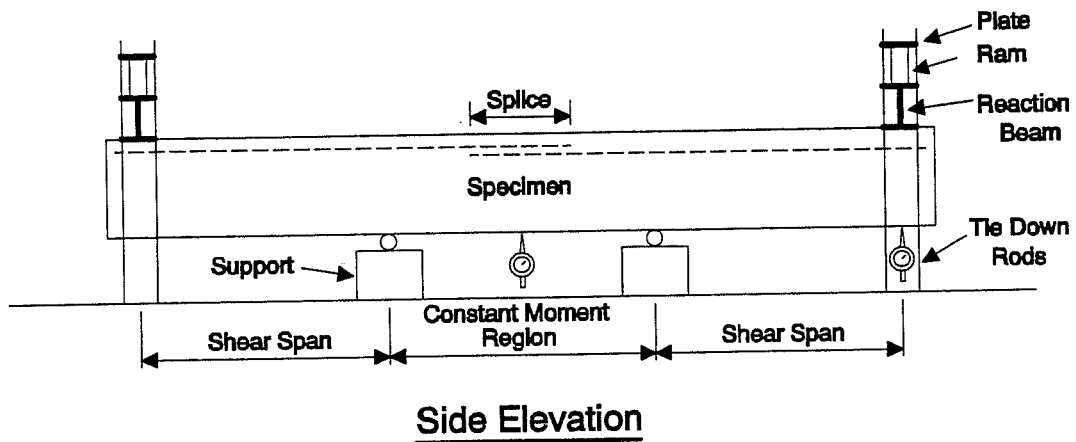
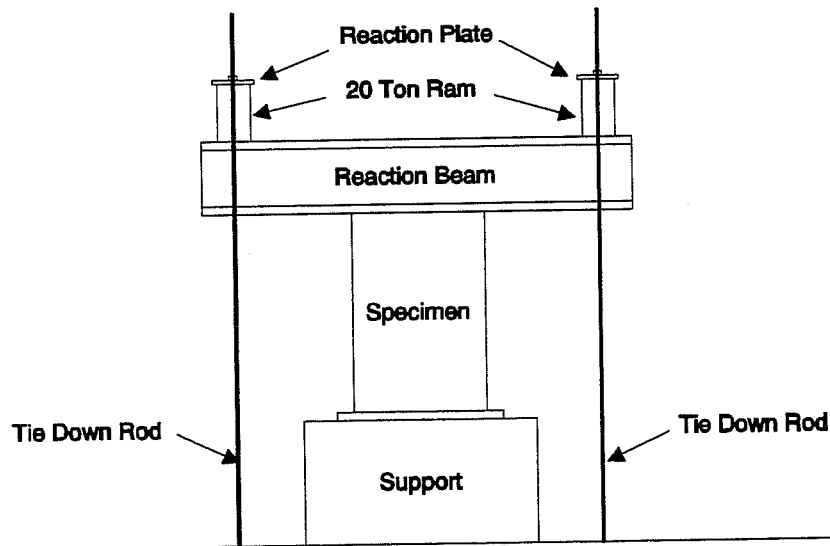
Figure 2.1: Loading System

Beams were designed to permit comparisons with previous tests^[17] performed for determining bond strength of epoxy coated reinforcing bars. The loading system was designed to produce a constant moment region in the center portion of the specimen where the splice is located (Figure 2.1). The test arrangement provides the most severe condition on the lap splice since the total tension in the reinforcement is constant across the entire constant moment region. The specimens were tested in negative bending for the convenience of observation and for the ease in measuring the crack widths during testing.

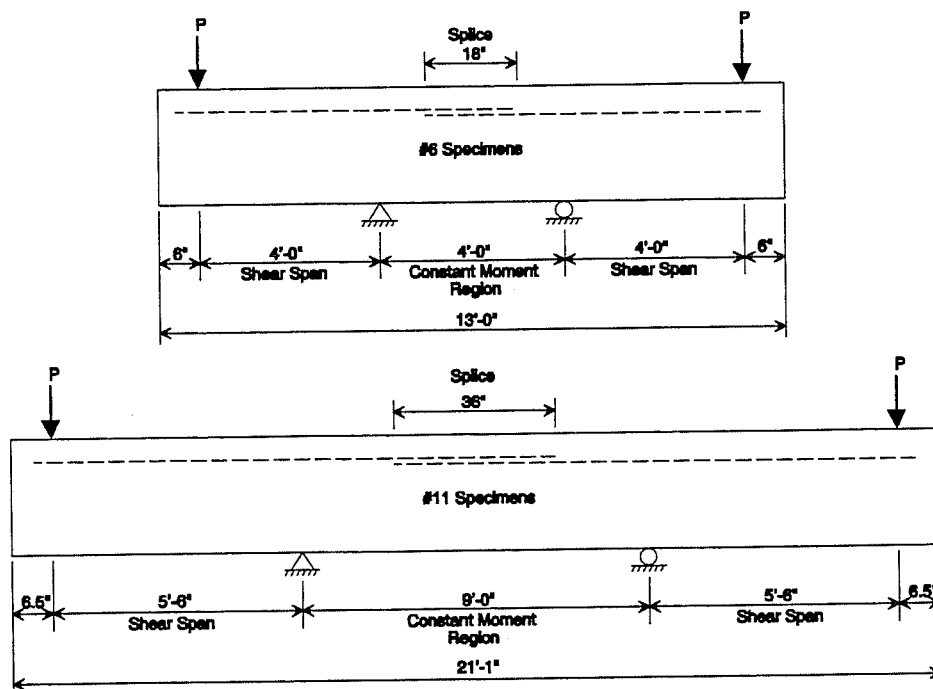
Figure 2.2: Beam Dimensions

To satisfy the constraints mentioned above, the specimens with #6 bars were designed with a 4 ft. constant moment region and a 12 ft. span between loading points. Six inches were added to each end to accommodate the loading beam. The total beam length was 13 ft. as shown in Figure 2.2. The

specimens with #11 bars were designed with a 9 ft. constant moment region and a 20 ft. span between loading points. In order to accommodate the loading beam, 6.5 inches were added to each end. The total beam length was 21 ft. - 1 in. as shown in Figure 2.2.

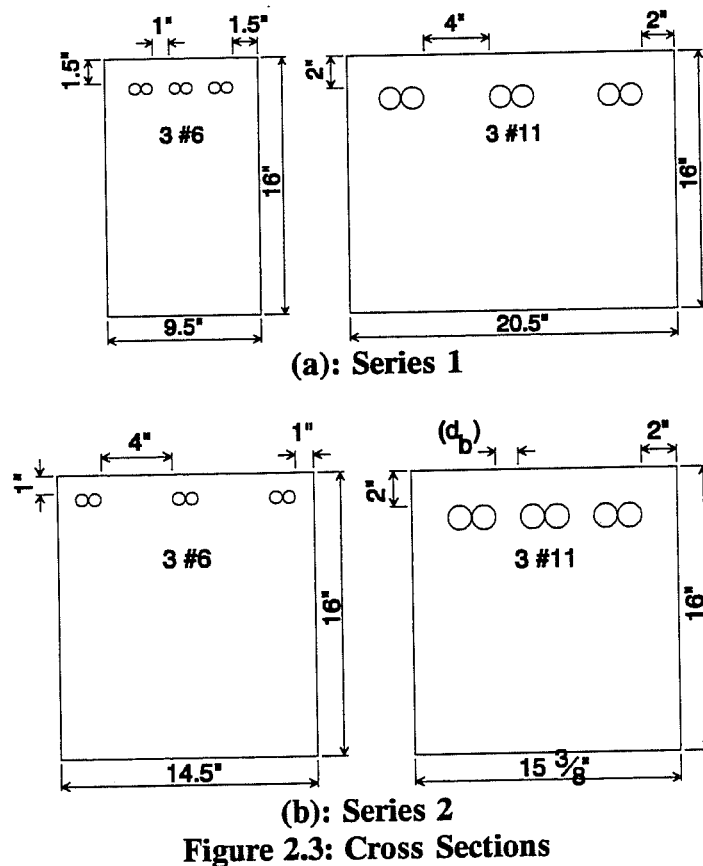
The beam cross-sections are shown in Figure 2.3. The total beam depth for all specimens was 16 inches. This dimension was used to allow the reinforcement to be cast in the top position (more than 12 inches of fresh

concrete cast in the member below the reinforcement). The beam depth also corresponds to that used in previous tests.^[17] The actual cover and spacing

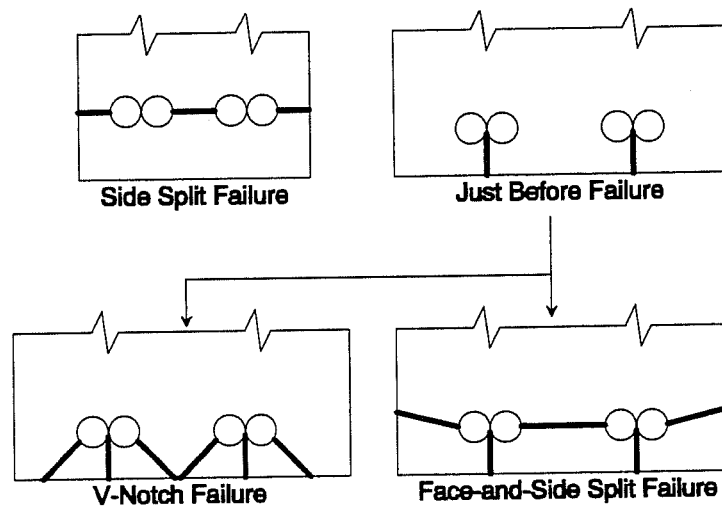
Figure 2.4: Splitting Failure Modes

The width of the specimens was determined by the selected cover and spacing dimensions. For the #11 specimens, the cover was set at 2 inches which corresponds with the minimum cover required by ACI 318-89^[1] for concrete exposed to earth or weather and with the recommendations for corrosive environments. In addition, the cover corresponds with AASHTO^[2] requirements. The clear separation was varied for the two series of tests. Series 1 included a 4 inch spacing since this dimension will produce either a side split failure or a face and side split failure (Figure 2.4).^[14] In Series 2, a one bar diameter (d_b) spacing was used since this is the minimum spacing allowed by the ACI code.

For the #6 specimens, the cover was decreased to ensure that the splice would fail before reaching yield. Series 1 included a 1.5 inch cover with a 1 inch spacing. The spacing is the minimum allowed by the ACI code and the

cover corresponds with the minimum cover for concrete not exposed to weather or in contact with ground. In the Series 2 tests, the cover was further reduced to 1 inch to study the effects of a small cover and wide spacing between bars which would be more likely to fail in face splitting.

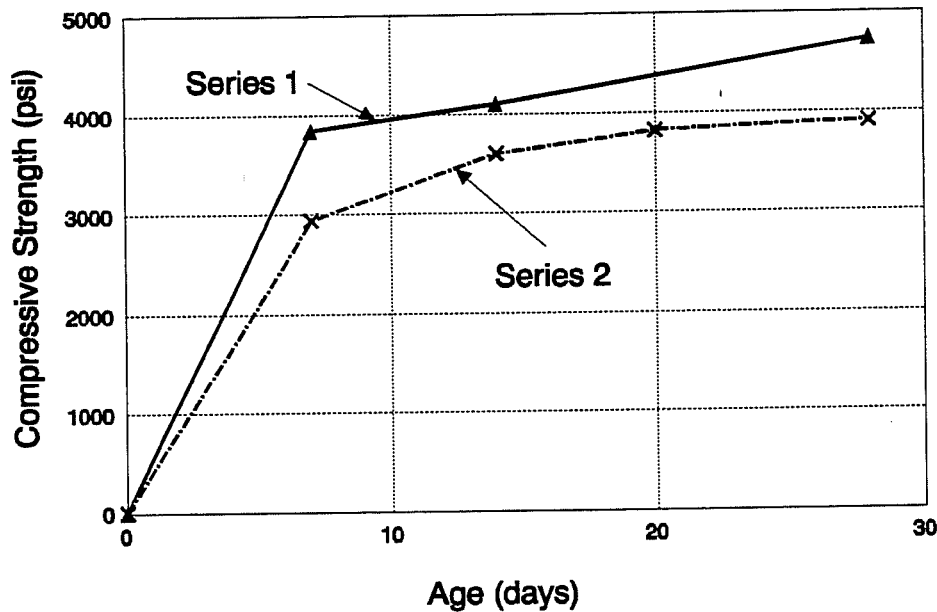
Figure 2.5: Concrete Strength Gain

cylinders were used to determine average compressive strengths. The strength gain curves of both series of specimens are given in Figure 2.5.

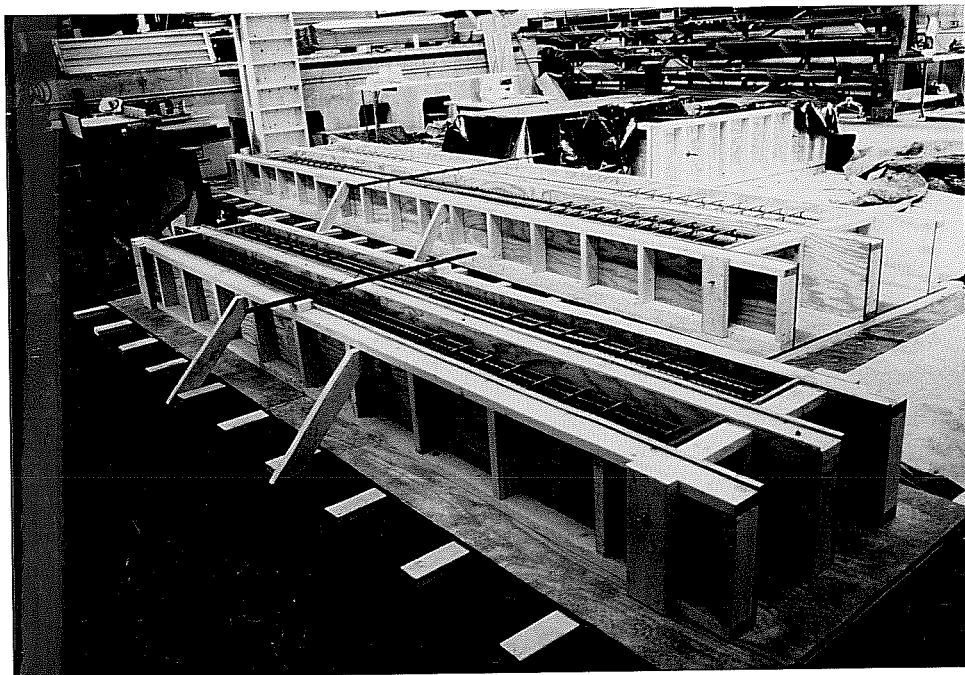
Figure 2.6: Formwork

The formwork was designed so that two companion specimens could be built side by side to ensure that both specimens were constructed and cast using the same procedures. Two sets of forms were constructed to accommodate two #6 specimens and two #11 specimens and to allow all beams of one series to be cast together. The formwork is shown in Figure 2.6.

The forms were constructed with a plywood base of sufficient width that the different width beams of Series 1 and Series 2 could be accommodated. A center divider was fastened to the base with threaded rods that were placed through the center and secured by nuts. The outside forms were attached to

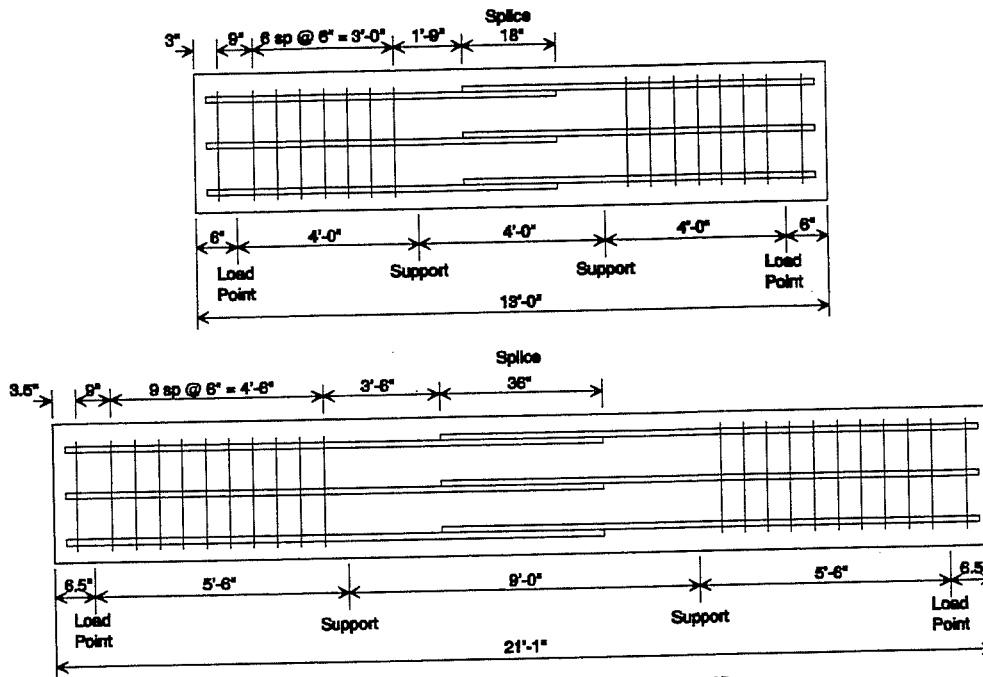
Figure 2.7: Reinforcement Details

Closed stirrups were used in the shear span to prevent a shear failure during testing. No stirrups, however, were used in the splice region in order to eliminate the influence of transverse reinforcement on bond strength. Transverse reinforcement in the splice region increases bond strength when a splitting mode of failure controls. Steel reinforcement details are shown in Figure 2.7. Two #3 bars were used as bottom steel for the entire length of all specimens to help hold the cages together and maintain the steel dimensions in the forms.

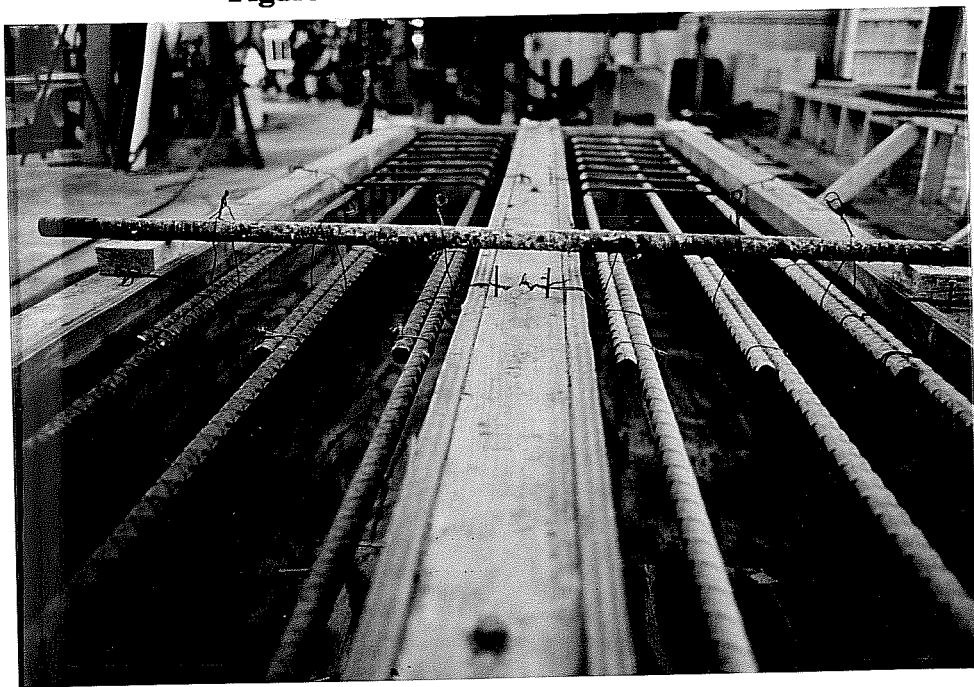
Figure 2.8: Splice Support Rod

Since stirrups were not used in the splice region, the bars needed to be held in place by a rod placed across the width of the forms as shown in Figure 2.8. Tie wires were used to hold the splices in position. This procedure permitted adjustment of cover and spacing dimensions to achieve the values selected in design.

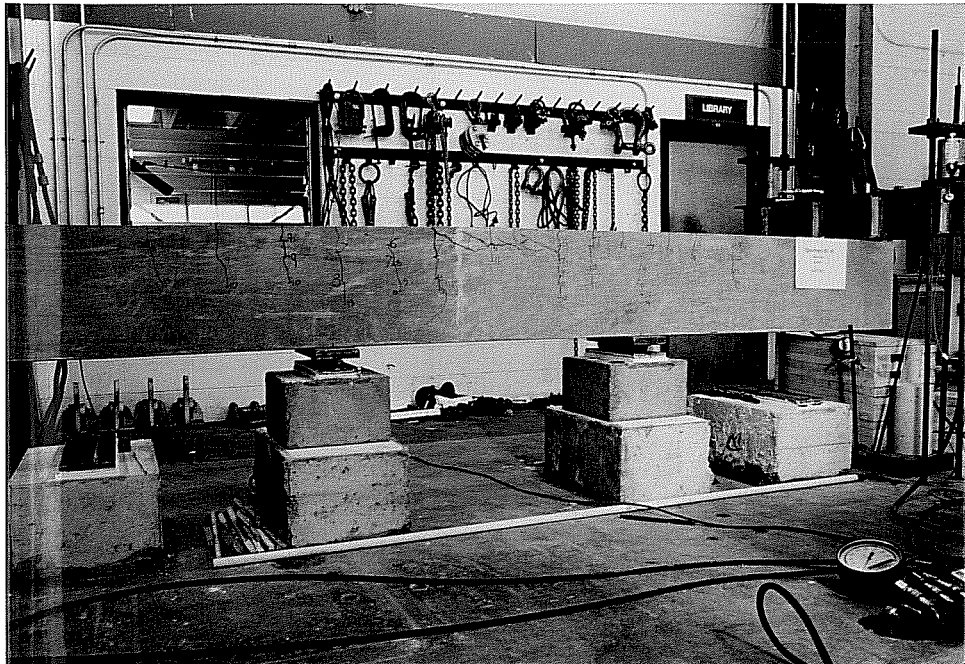
Figure 2.12: #6 Testing Setup

The testing setup was designed to load down on the beams at the ends producing a constant moment region in the center. The beams were supported by concrete blocks that were grouted to the reaction floor. At the reaction points, rods were placed between two steel plates which distributed the reactions to the concrete and avoided localized crushing. The bottom plates were attached to the concrete base with hydrostone while the upper

plates were seated between the beam and the rod without any grouting. At one support, the rod was welded to the bottom plate to simulate a pin connection while at the other support, the rod was free to simulate a roller.

At each load stage, the load was read along with the deflections at the middle of the beam and under the loading point. Deflections were read with 0.001 inch dial gages for Series 1 specimens while a 0.0001 inch digital displacement gage was used for Series 2 specimens. The cracks were marked and crack widths were measured at several locations with a crack comparator. Cracks located between the support and the end of the splice were measured at one specific location along the crack. Cracks were measured at the ends of the lap splices.

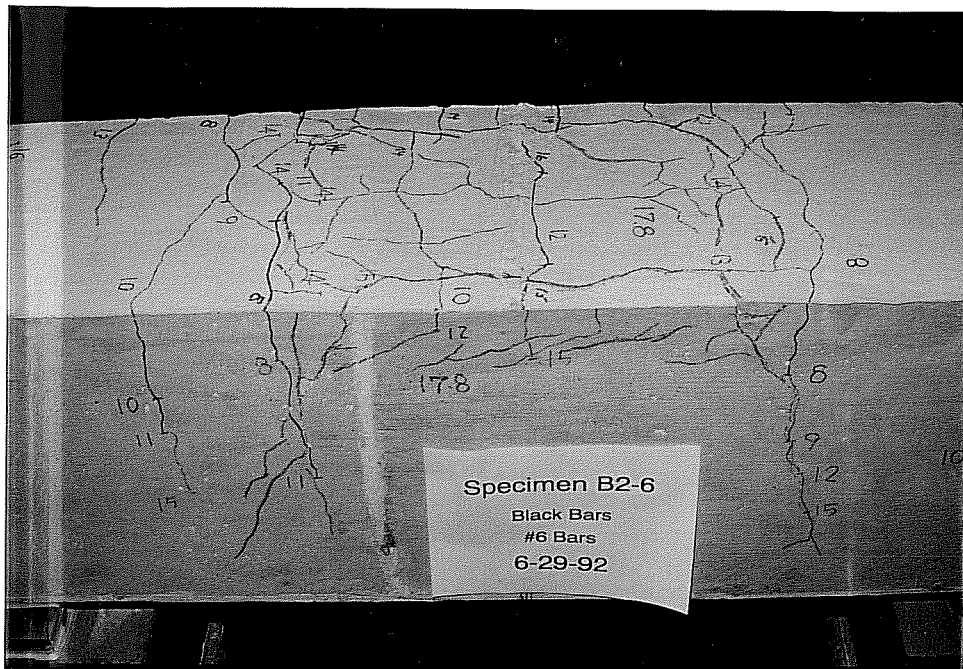
Figure 3.1: Extensive Splitting Cracks

In all tests, the failure was sudden and without much warning which is typical of an unconfined lap splice failure. In a few tests, small longitudinal splitting cracks were evident on the surface over the bars which indicated that failure was near. In most cases, however, only flexural cracks were evident immediately before failure. The extensive spitting cracks shown in Figure 3.1 were visible only after failure. The brittle nature of the failure is evident in Figure 3.2 where cover splitting and the collapse of the beam ends can be seen.

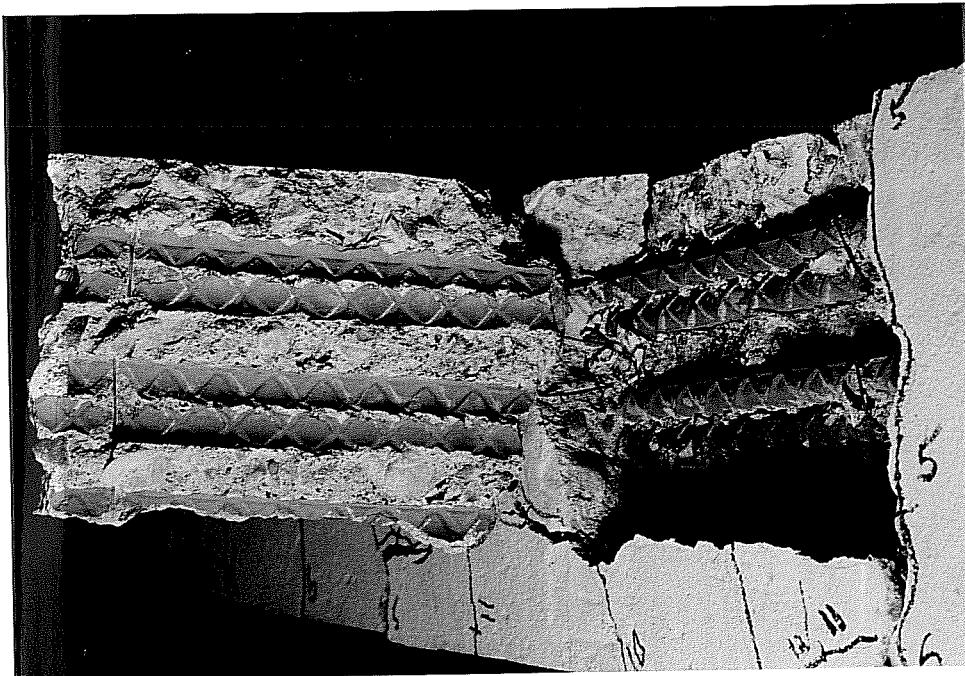
Figure 3.4: Coating Attached to Concrete

Upon removal of the cover from the coated bars, it was noticed that the bar coating was attached to the concrete cover and very little appeared to be adhering to the bar (Figure 3.4). Several small spots, however, did not adhere to the concrete. The concrete in these spots was discolored; the concrete was darker in color in these locations appearing that the concrete was chemically altered at the coating-concrete interface.

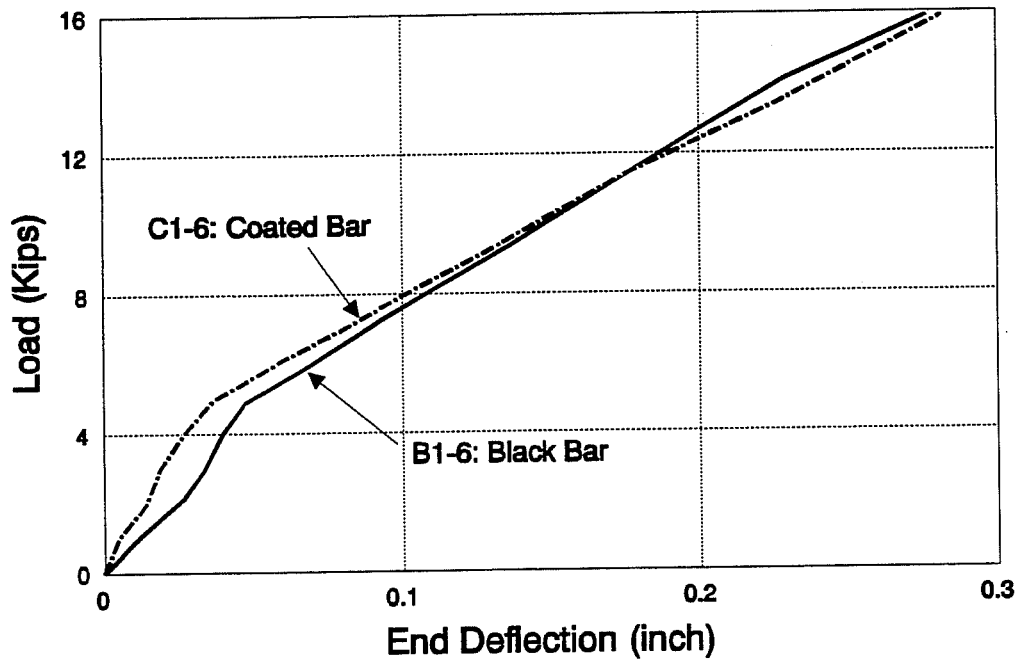
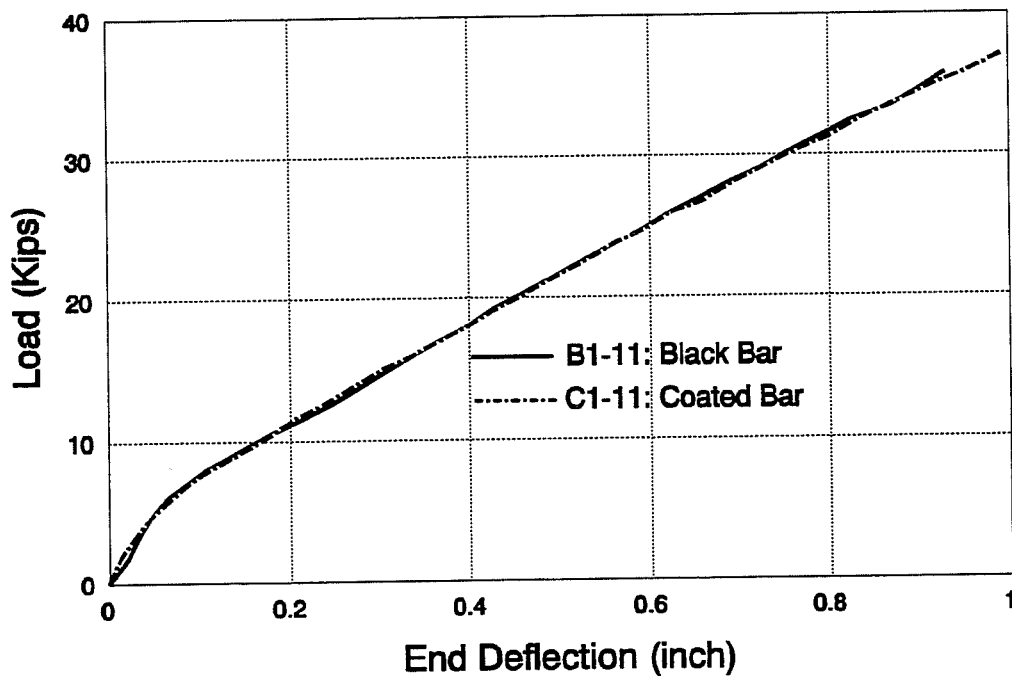
Figure 3.5: Series 1 Splice Tests

The stiffness of beams containing coated bars is compared to that of beams containing uncoated bars to determine whether the coating influences the beam stiffness. The comparison is made by plotting end load versus end deflection of a companion set of beams. As evident in Figures 3.5

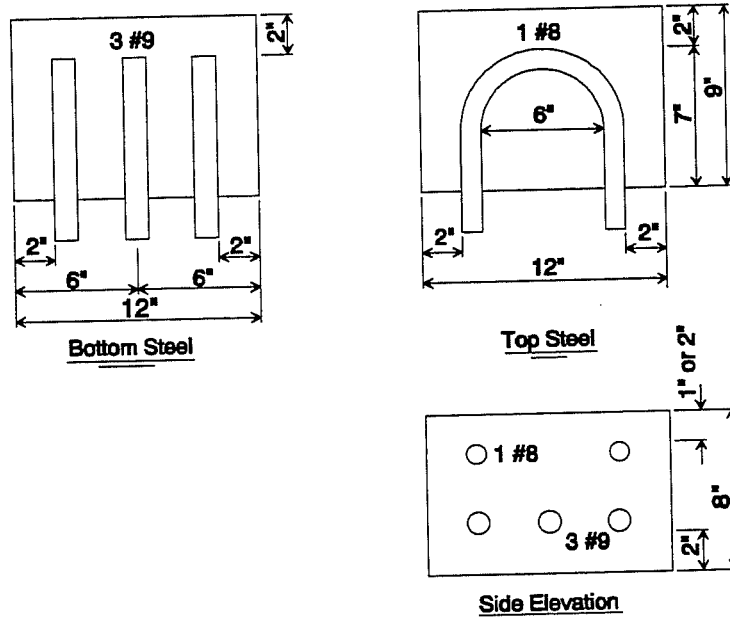
Figure 4.1: Macrocell Details

Macrocell action is created by setting up a galvanic cell. The corrosion circuit is shown in Figure 4.2. Chloride (NaCl) solution is ponded on top of

the specimen which supplies both water and chloride ions for the electrochemical cell. A steel bar is welded to the three bars in the bottom mat for electrical continuity. The circuit is completed by attaching a 100 ohm resistor between the top and bottom mats of reinforcement. The current is determined by measuring the voltage across the resistor which is the potential difference between the top and

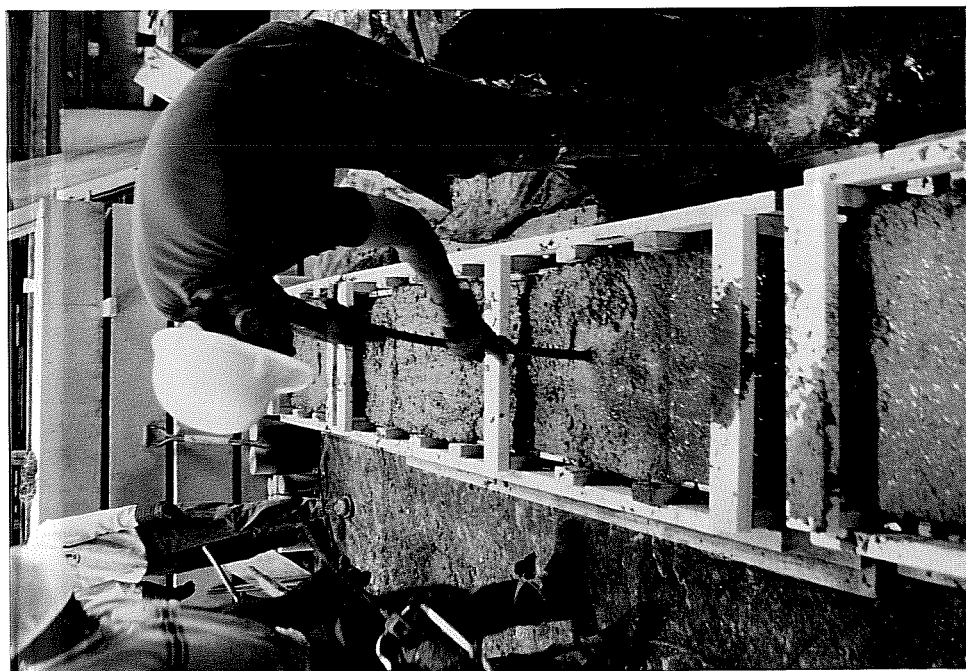
Figure 4.8: Casting

All specimens were cast as shown in Figure 4.8. The concrete was placed in one lift and consolidated using internal vibrators inserted only at the back sides of specimens to ensure that the steel was not shifted or damaged. During placement, chloride penetration specimens and cylinders were also cast. The specimens were screeded immediately after casting and trowelled shortly after. Plastic sheeting was placed to maintain the moisture. All forms and cylinder molds were removed at the same time approximately four weeks after casting.

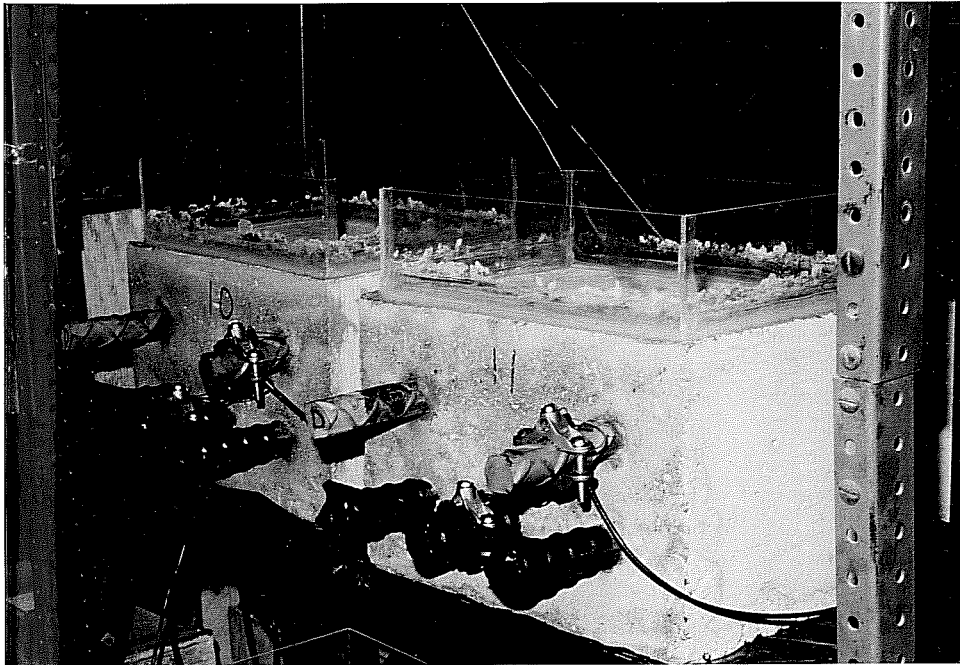
Figure 4.9: Completed Macrocell Specimens

wires as shown in Figure 4.9. Finally, oil was applied to the exposed bars to prevent corrosion outside of the specimen.

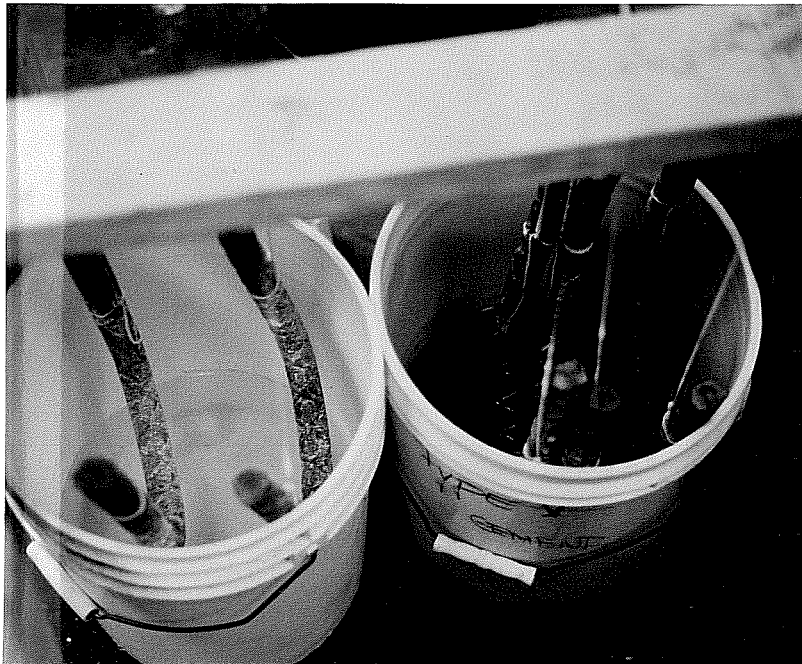
Figure 4.10: Air Exposure Specimens

The air exposure tests were maintained in a one week cycle. The specimens are shown in Figure 4.10. The bars were dipped in buckets containing a 3.5 percent salt solution for 4 days. The specimens were then removed for 3 days of air drying to complete the cycle. Visual observations were made periodically to monitor the corrosion.

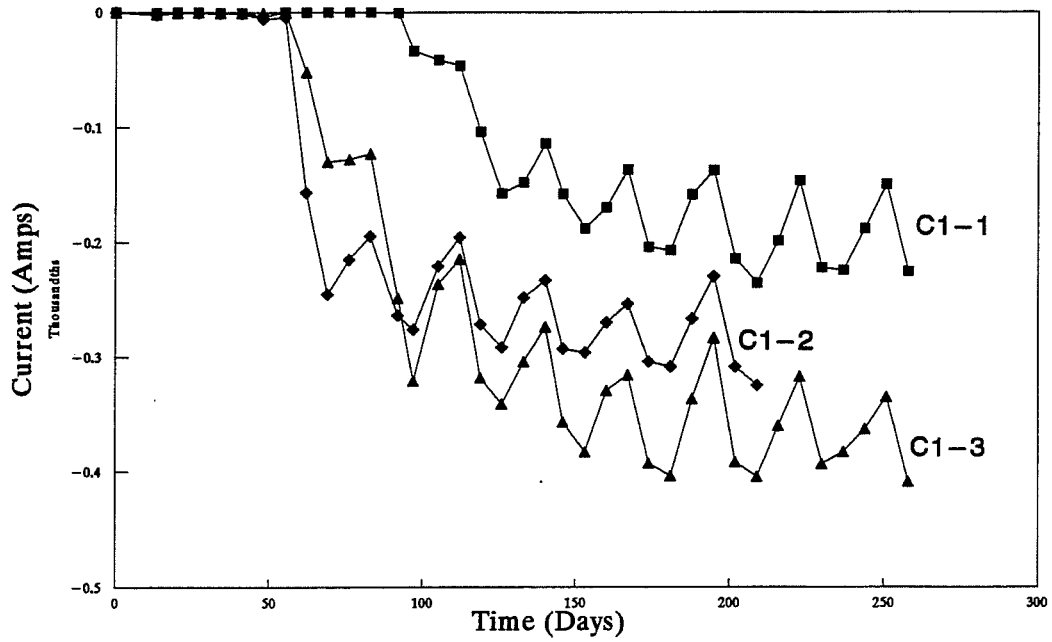
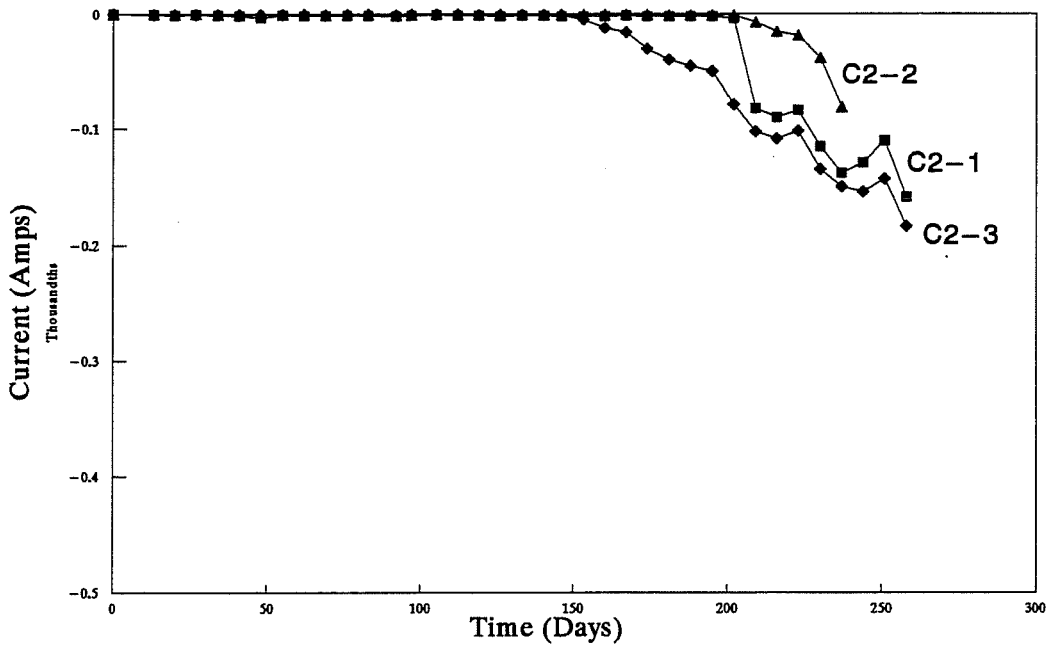
Figure 5.2: Macrocell Tests - Coated Bars

Specimen C2-3 was selected for study since corrosion activity was evident for only 35 days according to the current measurements. This specimen, therefore, would indicate if the current indicated cathodic protection or

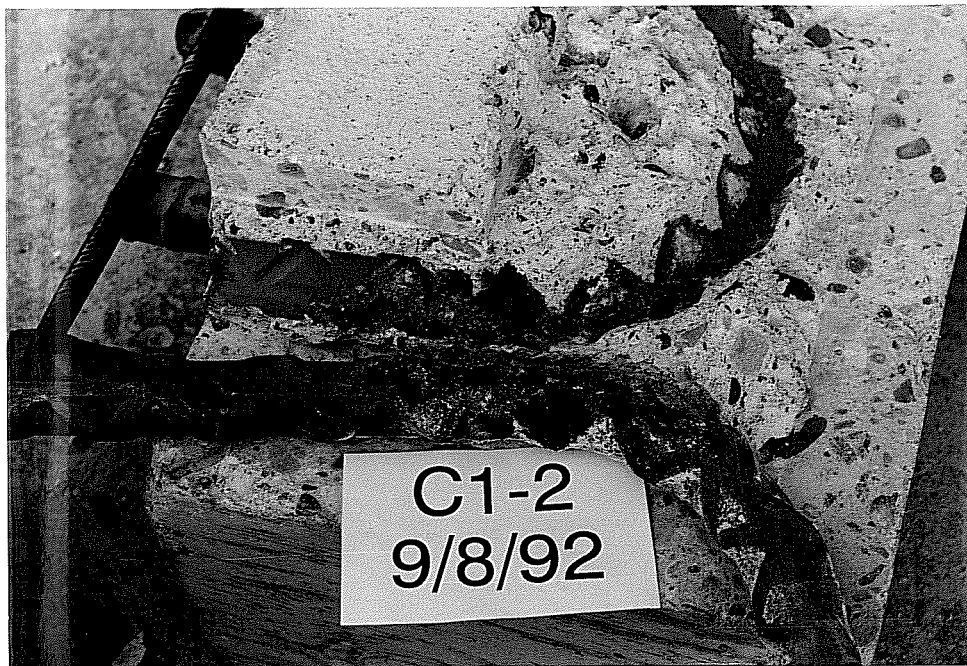
Figure 5.3: Specimen C1-2

Specimen C1-2 (Figure 5.3) showed corrosion over an extensive area of the bar extending from the beginning of the bend for several inches into the bent region of the bar. The corroded area was on the resistor side of the bar and extended on both the top and bottom. The most severe corrosion occurred on the bottom surface as shown. A blackish corrosion product was present immediately after removing the concrete which changed to a reddish-brown color after exposure to air. Several days after the bar was removed, small spots of rust were evident in the entire bent region of the bar. The corrosion was not intense, but was apparent as small specks in the region where the coating flaked due to fabrication. Upon removal of the corrosion product from the severely corroded region, pitting was also noted. The chloride content at the level of the steel was found to be 0.20 percent by weight of concrete.

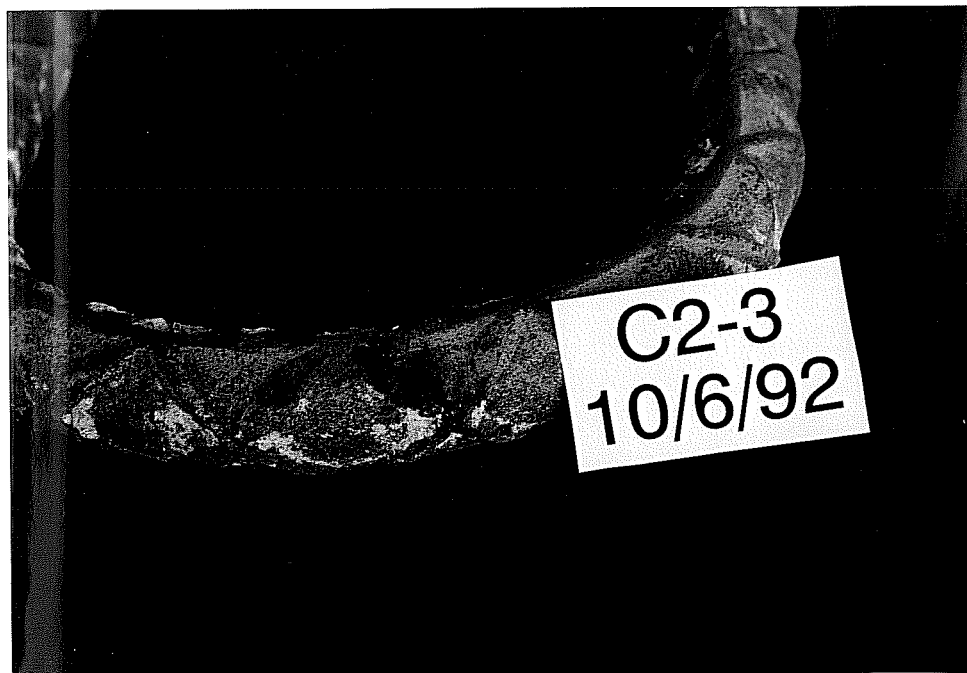
Figure 5.4: Specimen C2-3

corrosion of steel. The bar had corrosion on the top from the neutral axis to the outside diameter of the bend as shown in Figure 5.4. The relatively small spot appeared in the middle of the bent region. The corrosion product was blackish and turned reddish-brown after air exposure. No corrosion was found along the entire bent region due to flaked coating as was found with Specimen C1-2. The chloride content at the level of the steel was found to be 0.04 percent by weight of concrete.

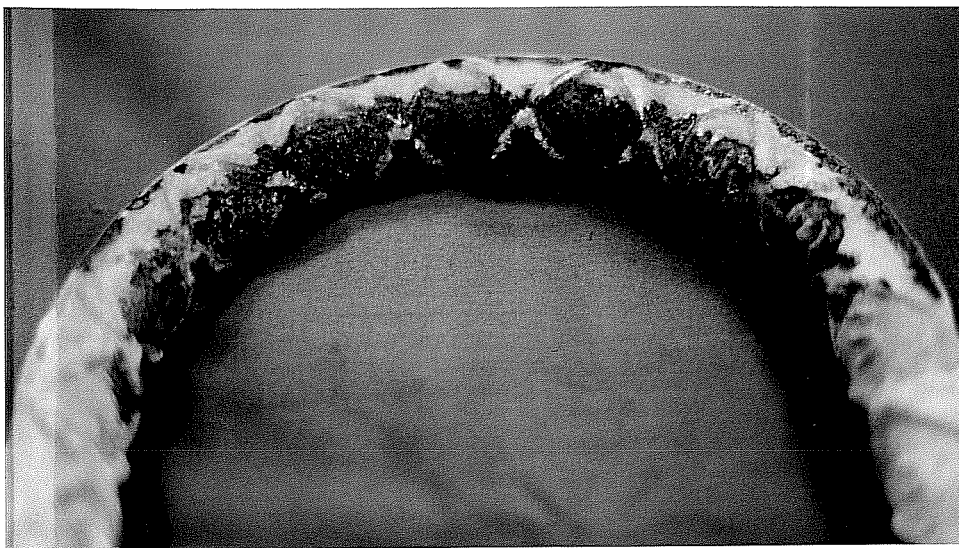
Figure 5.5: Air Exposure Tests - Coated Bar

Severe corrosion occurred on all air exposure specimens in the bent region of the bar as shown in Figure 5.5.

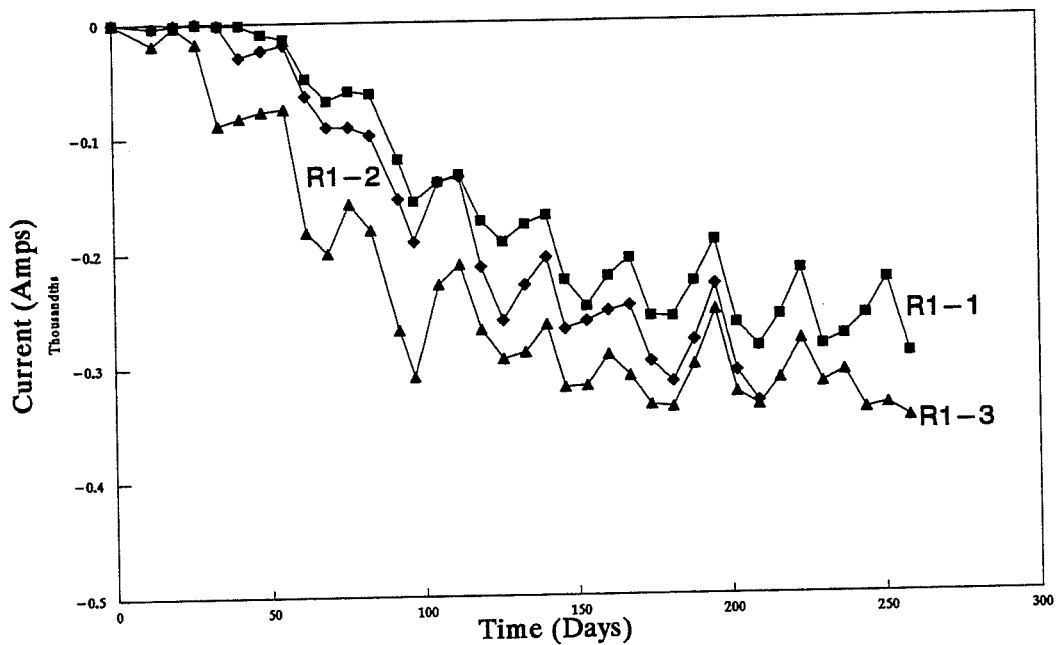
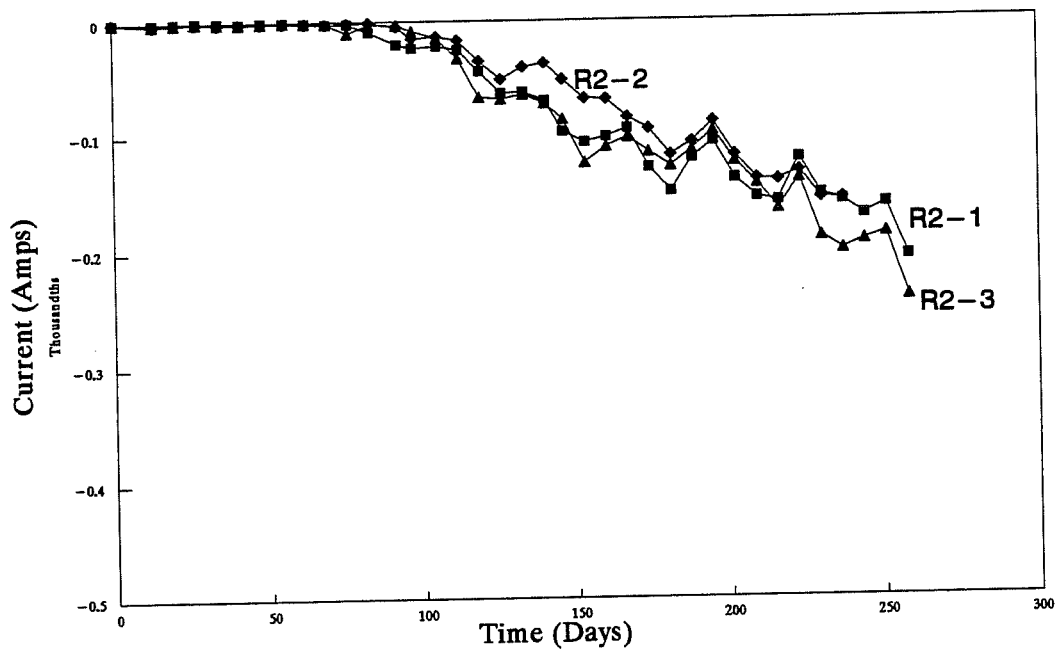
The results of the recoated bar tests are presented in Figure 5.6. By comparing the results with the control specimens, it is apparent that the coating did not affect the time to corrosion. An autopsy was performed on

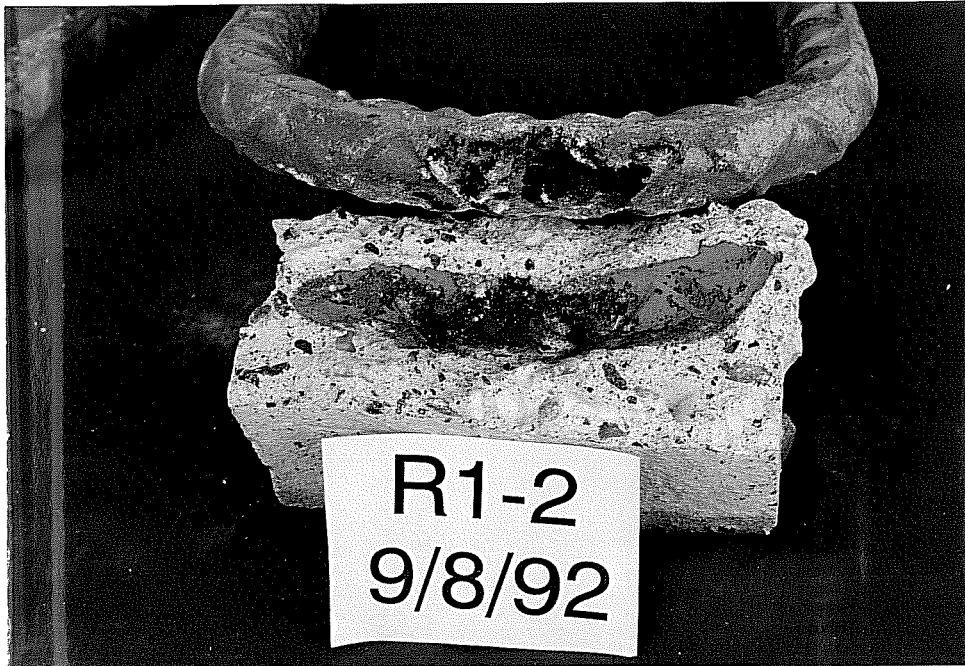
Figure 5.7: Specimen R1-2

Specimen R1-2 showed extensive corrosion on the middle of the outside diameter of the bend as shown in Figure 5.7. Corrosion was also evident on the inside diameter of the bend but was not as intense. The corrosion product was blackish upon removal of the bar and converted to reddish-brown with exposure to air. The chloride content at the level of the steel was found to be 0.29 percent by weight of concrete.

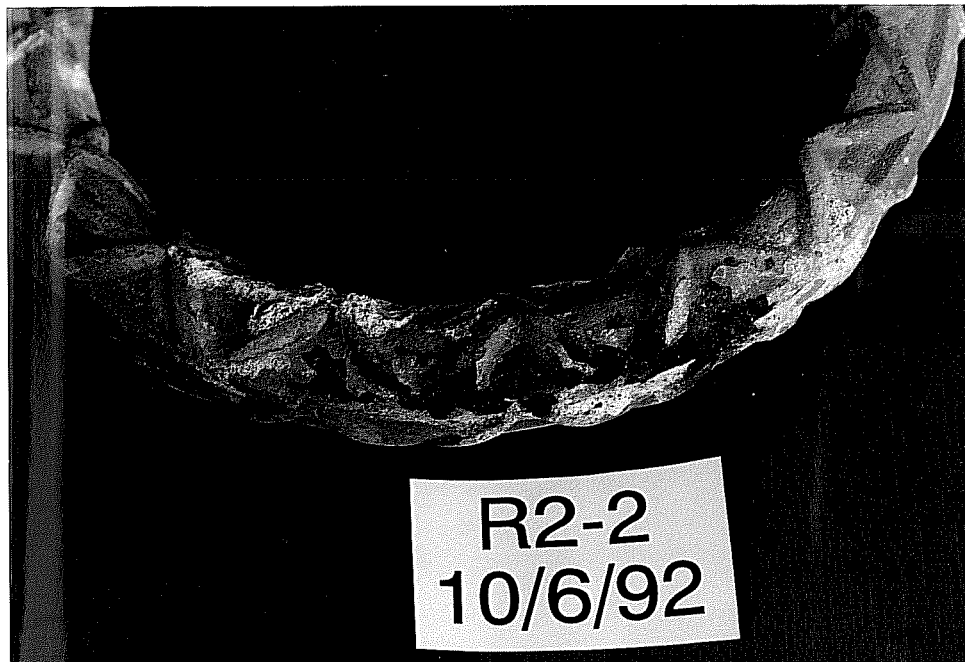
Figure 5.8: Specimen R2-2

Specimen R2-2 (Figure 5.8) also showed extensive corrosion on the middle region of the outside diameter of the bend. The corrosion was spread over a larger area than R1-2, but was not as intense. The corrosion product appeared blackish and blackish-grey in less attacked spots. A reddish-brown product was evident in small spots upon removal and was seen over most of the corroded area after exposure to air. The chloride content at the level of the steel was found to be 0.16 percent by weight of concrete.

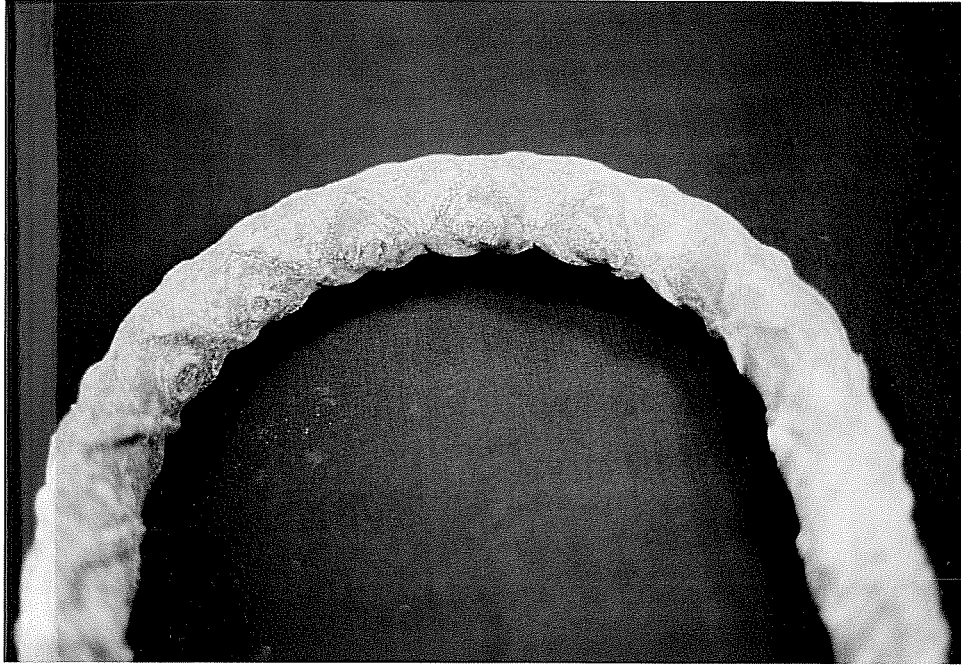
Figure 5.9: Air Exposure Tests - Recoated Bar

No corrosion damage has been observed on the air exposure specimens as shown in Figure 5.9.

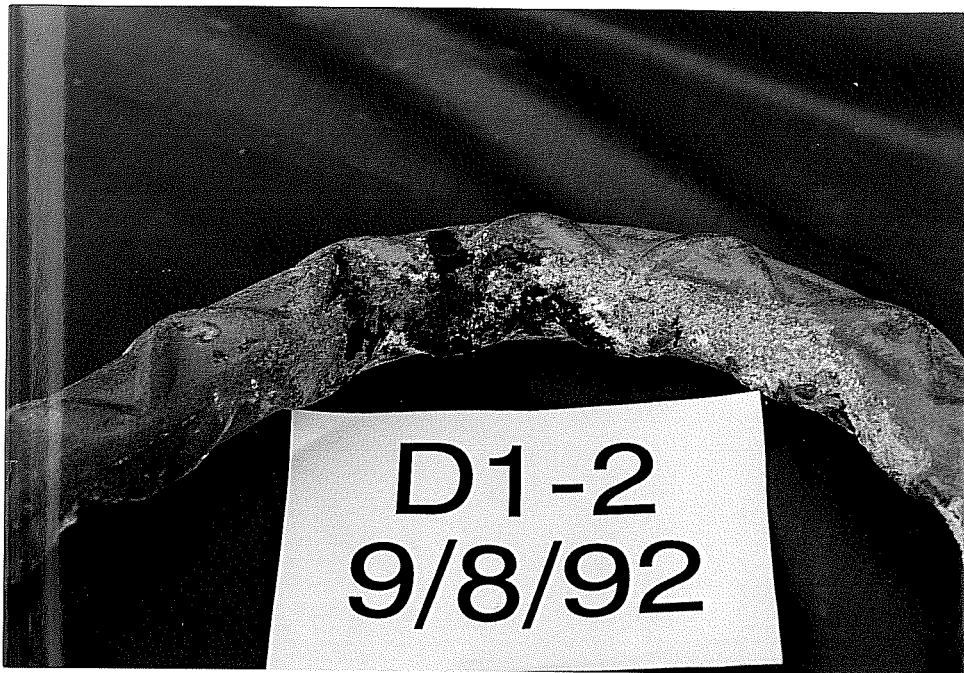
Figure 5.11: Specimen D1-2

Specimen D1-2 (Figure 5.11) showed severe corrosion on the inside diameter of the bend on the resistor side. In addition, another corrosion site was located at the middle of the inside diameter of the bend. The corrosion

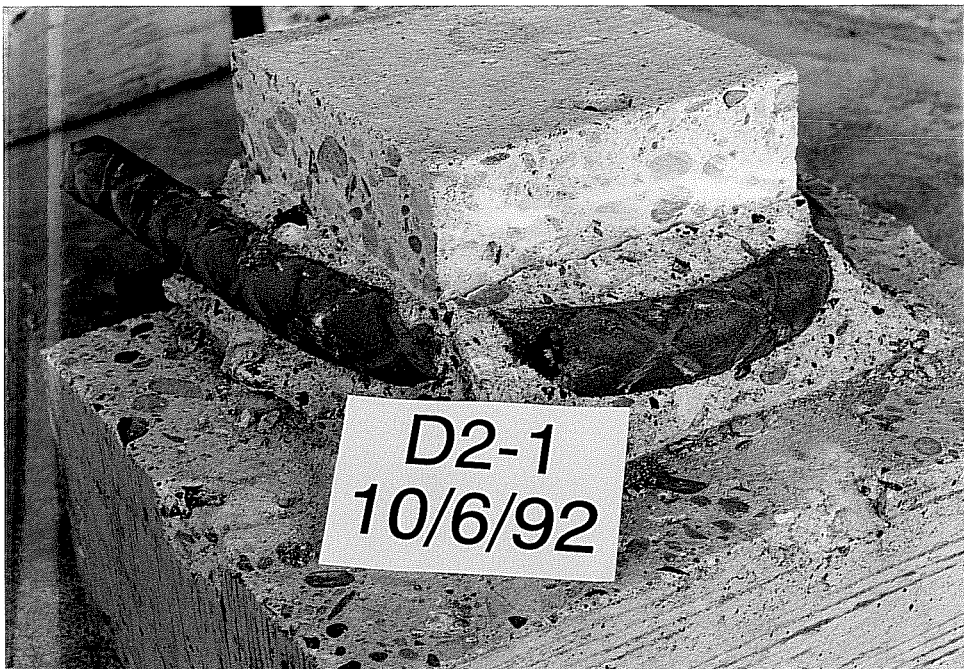
Figure 5.12: Specimen D2-1

Specimen D2-1 had three different corrosion sites all on the resistor side of the bar that are shown in Figure 5.12. One small corrosion spot was evident at the beginning of the bend. Another small spot was located on the middle of the outside diameter of the bend. The most severe corrosion was found in between these locations. Corrosion was evident on both the inside and outside diameters of the bend in this location. The corrosion product was blackish in all locations and converted to reddish-brown after air exposure.
