**PERFORMANCE OF REINFORCING STEEL COATED
WITH A HIGH RATIO ZINC SILICATE**

THESIS

The University of Texas at Austin

December 1992

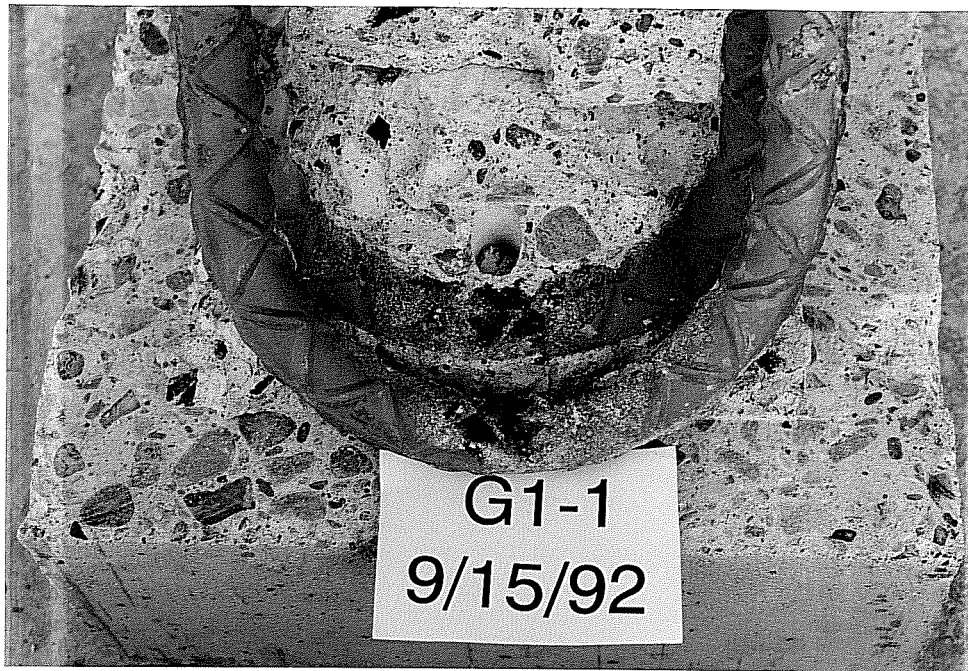
Figure 5.14: Specimen G1-1

Specimen G1-1 showed severe corrosion on the bottom in the middle of the bent region as shown in Figure 5.14. Further corrosion was evident on the top of the bar from the middle of the bar continuing for several inches on the resistor side of the bend. The corrosion product was blackish upon opening the specimen and converted to reddish-brown after air exposure. The chloride content at the level of the steel was found to be 0.36 percent by weight of concrete.

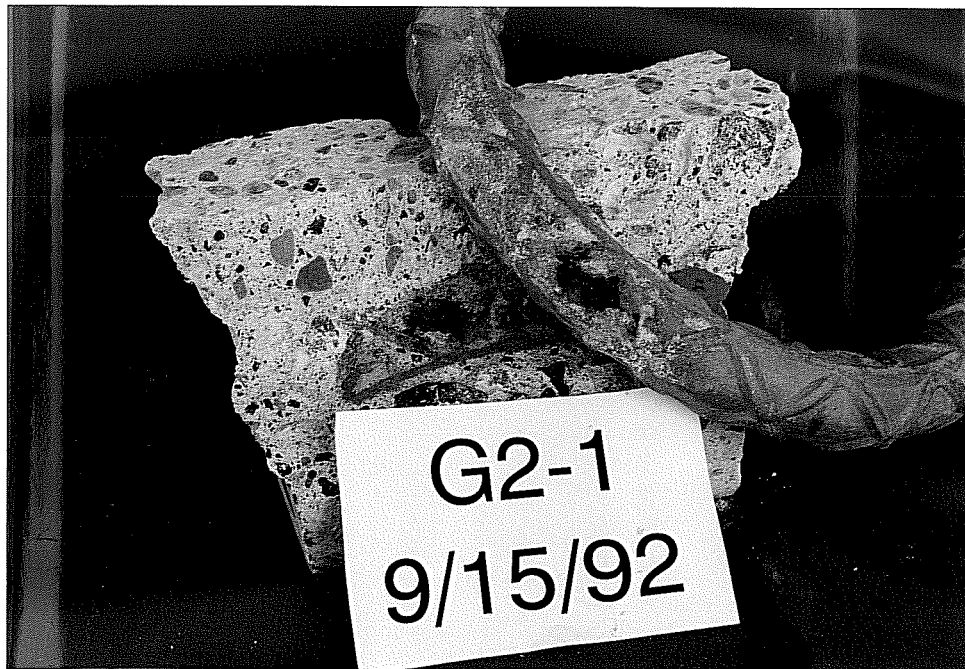
Figure 5.15: Specimen G2-1

Specimen G2-1 (Figure 5.15) showed corrosion only in one 3/4 inch spot on the outside diameter in the middle of the bend. The corrosion product was black and converted to reddish-brown after air exposure. The chloride content at the level of the steel was found to be 0.09 percent by weight of concrete.

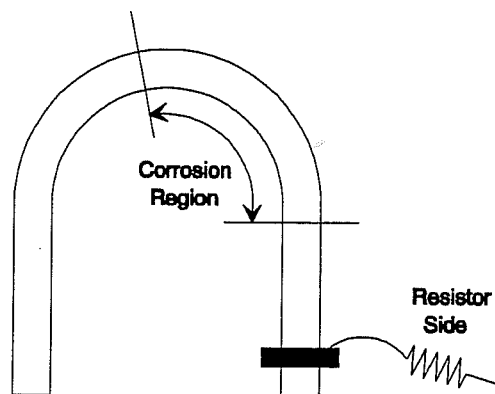
Figure 5.16: Corrosion Locations

The corrosion may have initiated in the bent region since the steel in this part of the bar has been yielded. Yielded steel is more susceptible to corrosion than non-yielded steel since yielding changes metallurgical properties. Another possibility is that the bent region of all bars except those denoted as "coated" contained new coating from the recoating process while the straight region contained the original coating. There could be a
