**Zero-skew bridge deck behavior  
at expansion joints**

**Thesis**

The University of Texas at Austin

**August 2003**

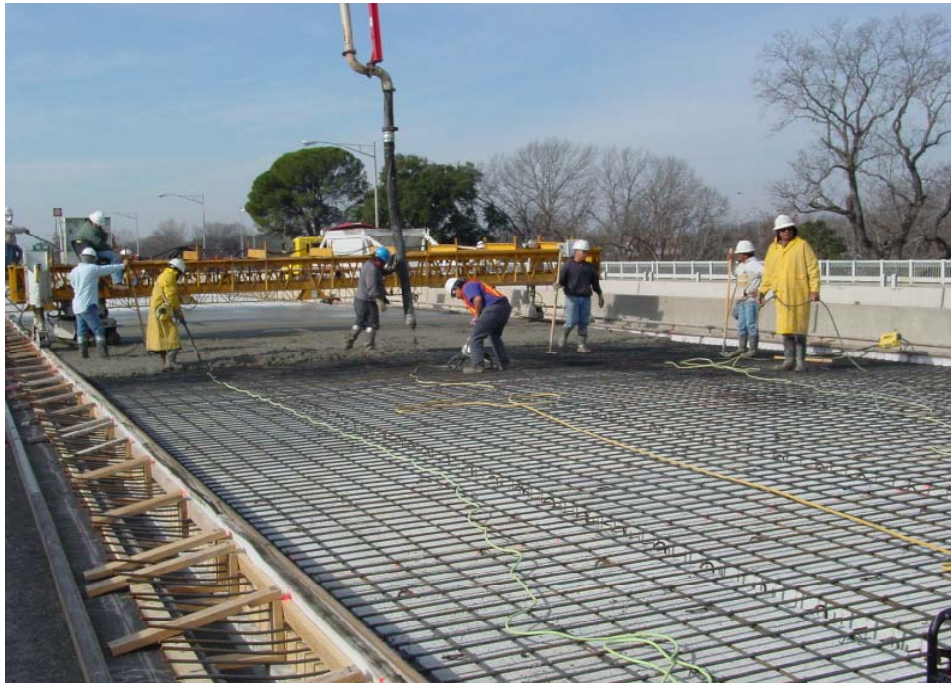
*Figure 1-6: Placing of concrete in the field*

The concrete was placed using a concrete pump with a boom that reached across the deck and vibrated to eliminate voids. A movable screed riding on temporary rails was used to finish the fresh concrete (Figure 1-6). Finally, construction workers bull floated the deck for a final finish. The process was continuous, allowing long lengths of deck to be placed efficiently.

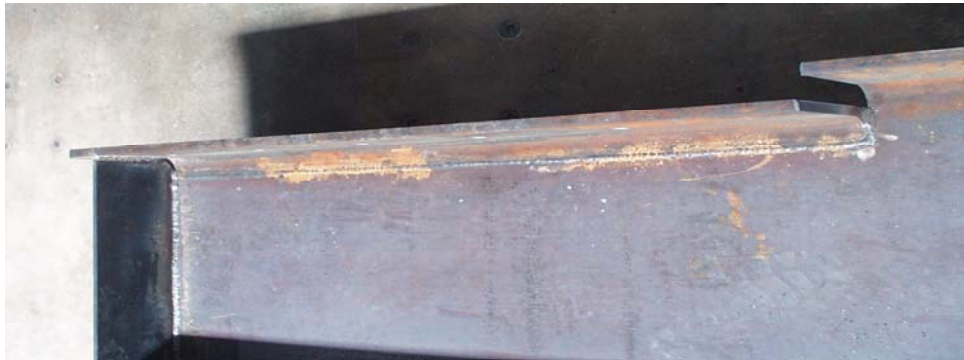
***Figure 4-1: Girder flange drop down***

It was necessary to elevate the bridge deck in order to inspect the bottom of the specimen for cracking during load tests. Four-foot tall by two-foot diameter concrete columns were cast to support the girders. The girders had to be specially fabricated to permit the IBTS detail's two-inch deep thickened edge. A four-foot length of the top flange was cut off, and then a two-inch deep piece of web was removed. Lastly, the top flange was reconnected to the girder with a full-penetration weld (Figure 4-1). Full-depth web stiffeners were welded at the centerline of the supports and the top flange was punched to fit the shear studs.

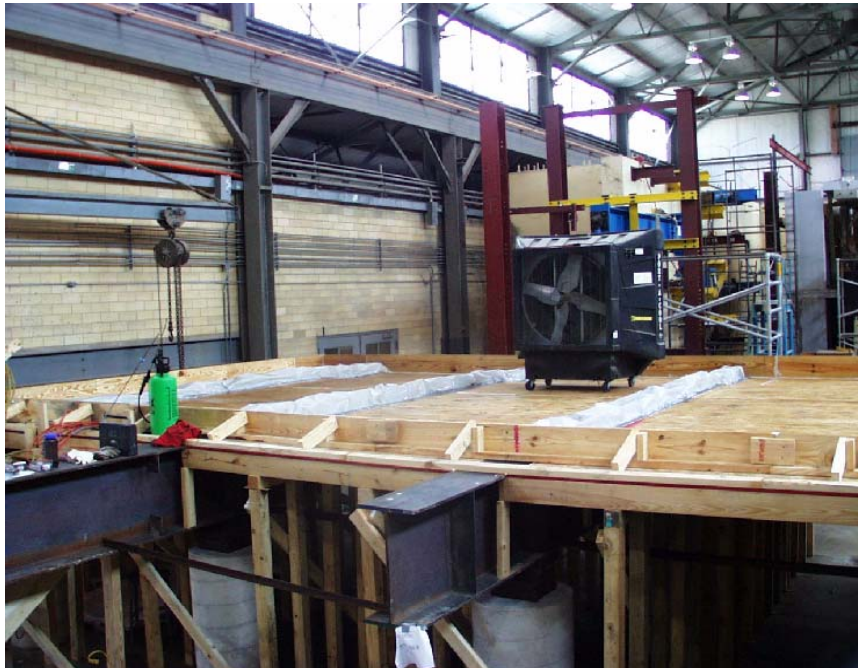
*Figure 4-2: Finished formwork*

Once the girders were erected on the columns and laterally braced for stability, elevated formwork was built using four-foot by eight-foot panels. The panels were made up of  $\frac{3}{4}$ -inch thick plywood supported by 2x6 stringers at 16-inches on center. The panels were propped up by 4x4 posts as well as 2x4's wedged between the bottom flange of the girder and the 2x6 stringers.

In order to provide a shear connection between the girders and the formwork (necessary for the overhang forms), metal clips were fabricated that linked the shear studs to the panels. Edge boards, which formed the sides of the deck, were diagonally braced to the lower formwork. Gaps in the forms were sealed with caulking and the forms were oiled to allow easier removal from the hardened concrete after casting (Figure 4-2). The reinforcing steel, both instrumented and bare, was then placed, chaired and tied. Block-outs, made of PVC pipe, were located in the bridge deck to allow loading rods to pass through the specimen. Prior to placing the concrete, the exact location of all strain gauges was recorded and their wires were routed out of the specimen.

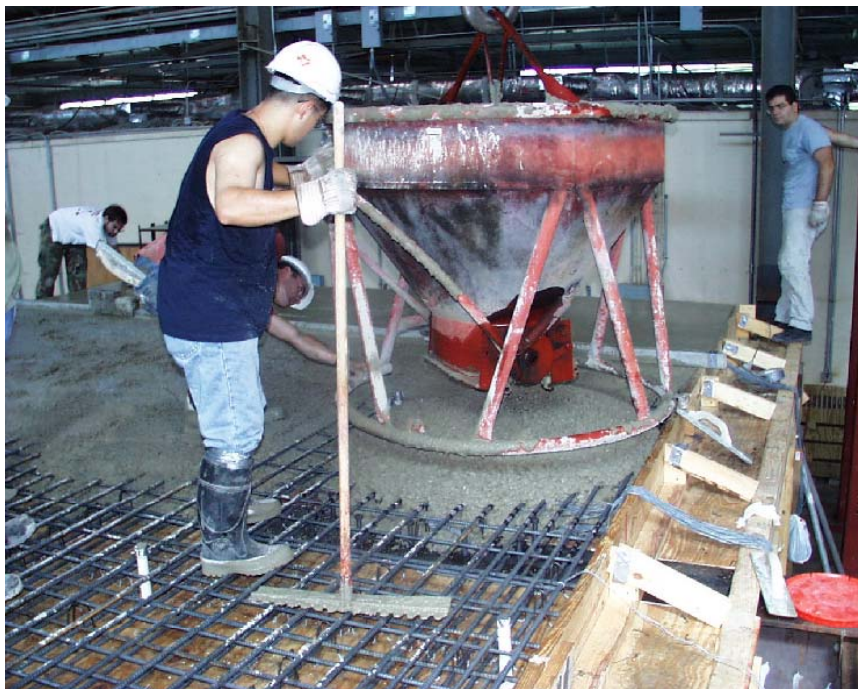
*Figure 4-3: Placing concrete*

Approximately sixteen cubic yards of concrete was placed on July 25, 2002 at Ferguson Structural Engineering Laboratory with help from fellow graduate students and lab technicians (Figure 4-3). The wet concrete was transported within the lab with a bottom-drop bucket hoisted by a crane. Then the

concrete was vibrated to eliminate voids in the specimen. A vibrating, aluminum screed was used to level the top surface of the bridge deck. Finally, the bridge deck was bull-floated and hand-finished to create a smooth, flat surface. The specimen was cured for seven days by placing saturated strips of burlap, covered by plastic sheeting to reduce evaporation, over the entire surface of the deck. After 28 days, the forms were stripped and block-outs removed.

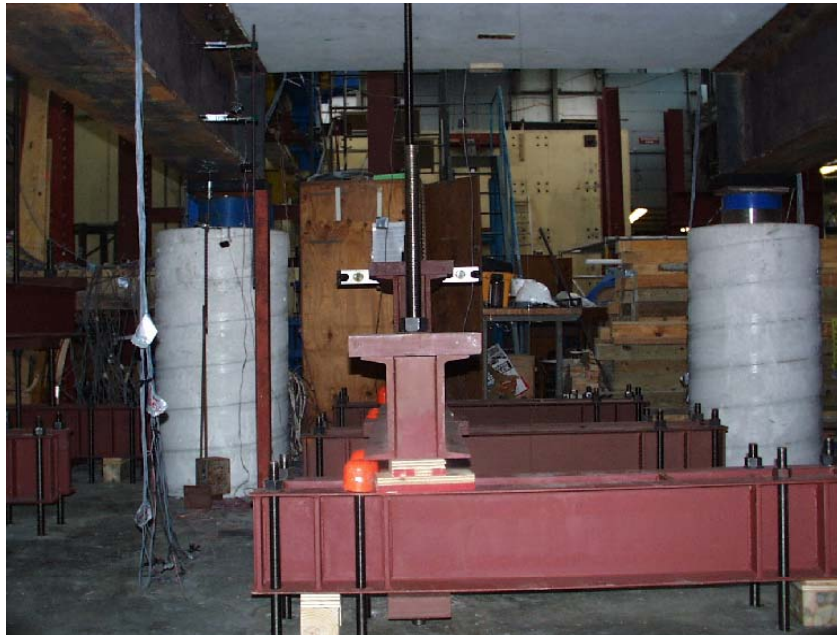
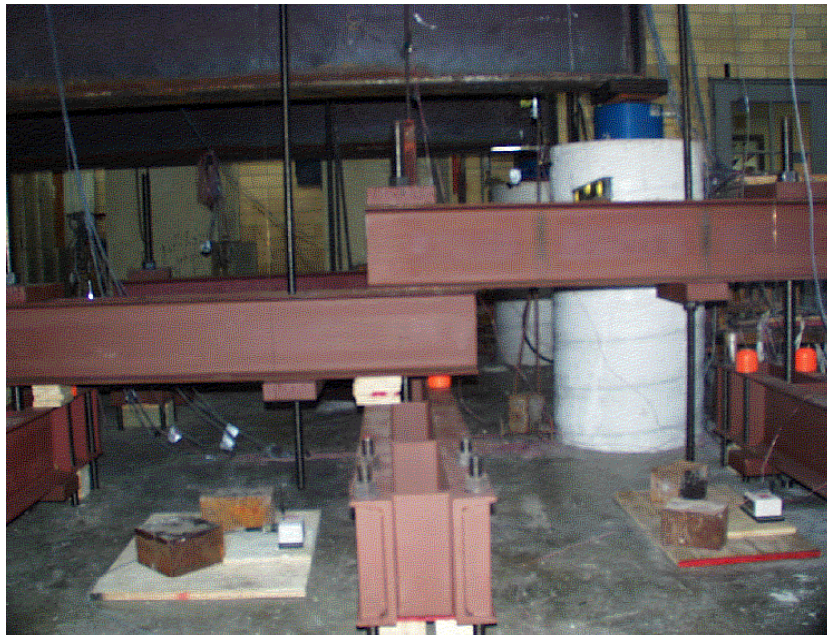
*(i) Facing south (same view as Figure 4-4)*

*(ii) Facing east (perpendicular to view in Figure 4-4)*

**Figure 4-5: Pictures of load frame**

The test specimen was built on the Ferguson strong floor in order to allow application of the vehicle loads. Loading the bridge deck from above, with a reaction frame, was not feasible because of the large area of the test specimen and the need to move the load frame often. A compact, reconfigurable load frame was designed and built which could fit underneath the test specimen and be moved with hand trucks (Figure 4-4).

For the load arms, C10 X 20 channels were connected back-to-back with plate spacers to allow loading through their center-of-gravity. The lower load arm flanges were drilled to match the strong floor bolt pattern and stiffened adjacent to the holes. The upper load arm was connected to two lower load arms by a threaded rod, which was prestressed prior to performing a test in order to eliminate rotation of the arm due to minor imperfections. The load rod was routed through the loading assembly on top of the bridge deck and attached to the upper load arm underneath the deck (Figure 4-5, i and ii). Six lower load arms and four upper load arms were built, enabling the application of up to four tire loads at any location under the deck.

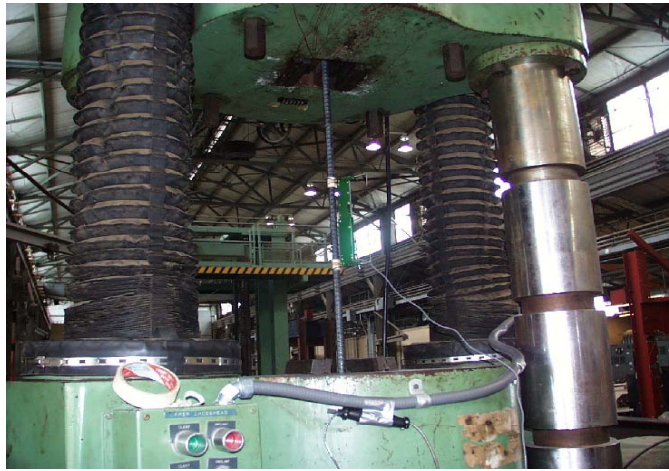
*Figure 4-14: Rebar tension test*

The reinforcing steel used in the specimen came from two different heats. Two specimens from each heat were tested in tension. An extensometer was used to determine strains (Figure 4-14) and the applied load was measured by the built-in load cells in the test machine. After converting the load measurements to stresses, stress versus strain plots were created. Figure 4-15 and Figure 4-16 each show a close agreement between the two tests and a yield plateau above 60ksi for all tests. The average modulus of elasticity for heats 1 and 2 were 30600ksi and 31300ksi, respectively.

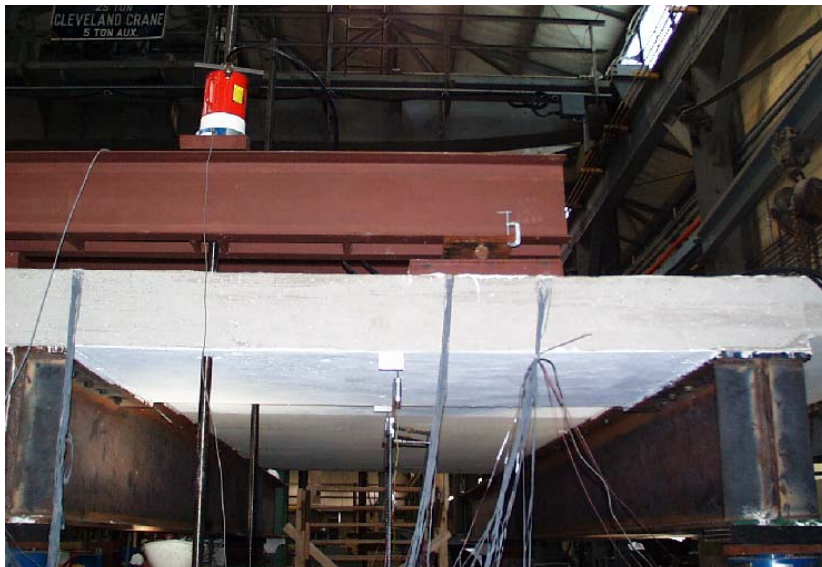
*Figure 5-2: Axle loading used to maximize positive moment*

In order to maximize the positive moment, an axle made of back-to-back C12X25 channels was loaded through its mid-length by a hydraulic ram connected to the load rod (Figure 5-2). Roller supports were placed between the axle and the load plates to ensure uniform loading of the plates, simulating tire loads. Tandem, truck axle-front and truck axle-back loading configurations were applied at the HS-25 load level (Table 5-1).

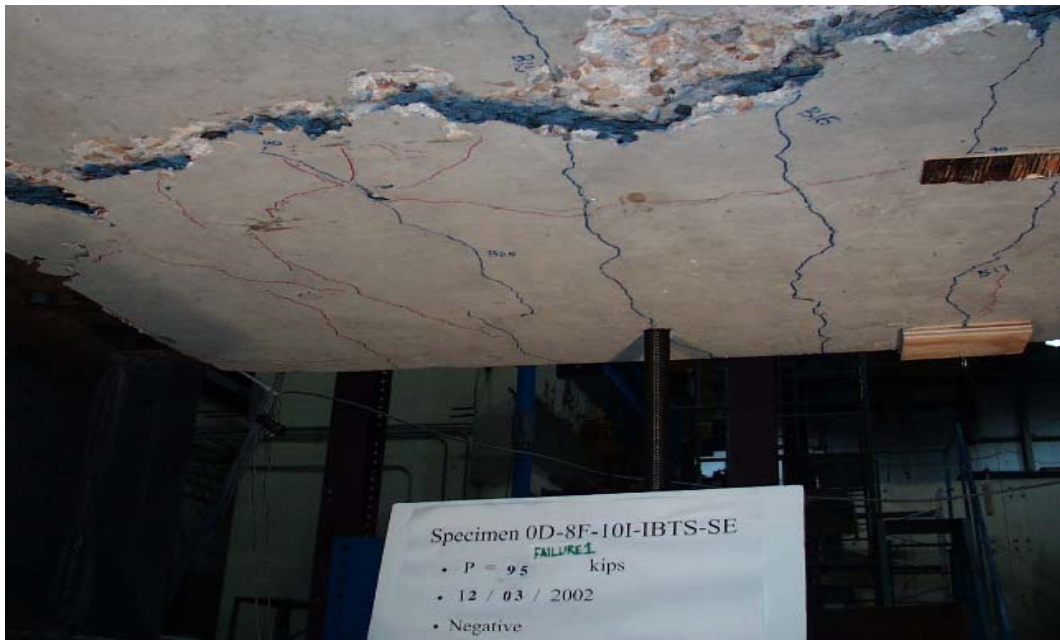
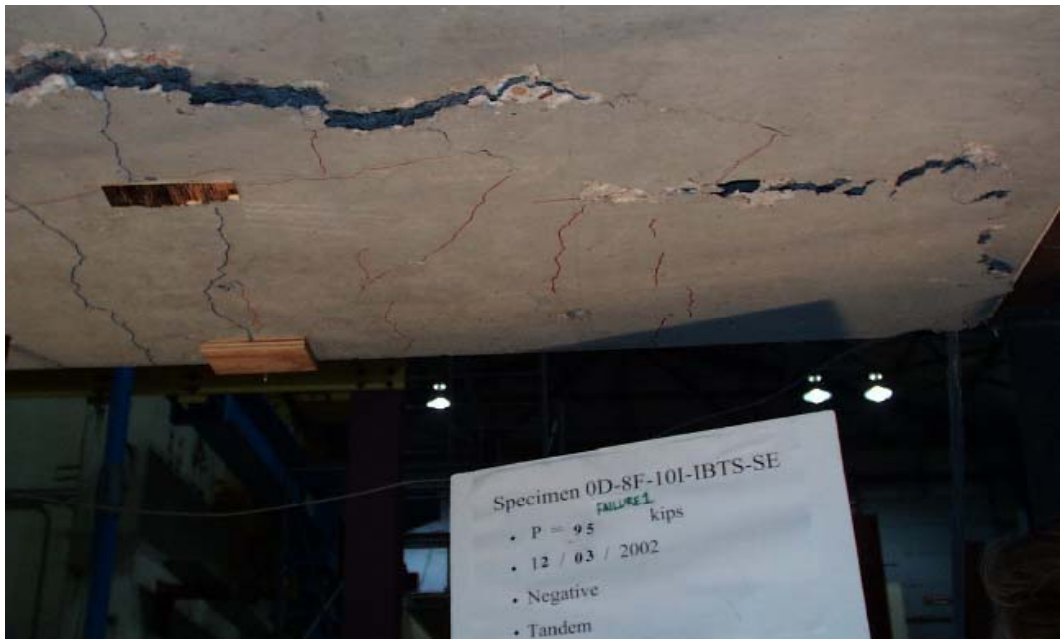
Failure of the test area was due to punching at the tire closest to the edge in the interior span of the bridge deck. After failure occurred, pictures of the failure surface were taken (Figure 5-15 through Figure 5-17). The bottom failure involved a large area of the bridge deck (Figure 5-15). The inside edge of the failure crack ran parallel to the deck edge, about 2 ½ feet into the deck, except at the west girder where it curved toward the edge of the deck.

*(i) East side of interior span, facing south*

*(ii) West side of interior span, facing south*

**Figure 5-15: Interior span failure at bottom of deck**

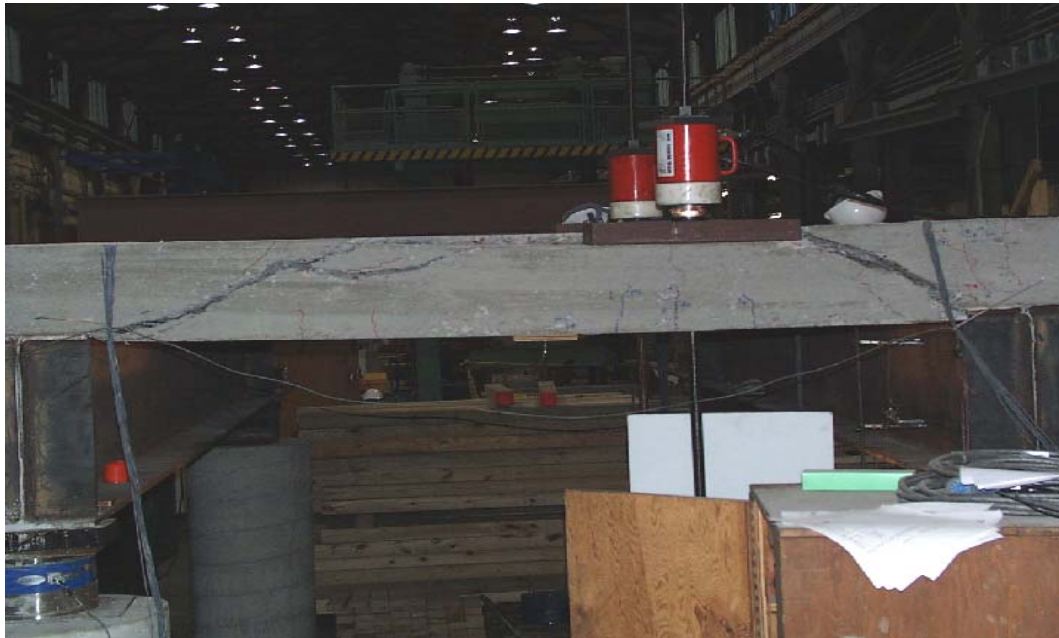
***Figure 5-16: Interior span failure at side of deck, interior span, facing north***

Figure 5-16 shows the failure surface on the side of the deck. Major failure cracks extended from the edges of the load plate to the girder flanges. The failure surface on each side of the load plate formed at different angles in order to reach the girders. The major failure crack on the west side of the load plate branched near the top of the deck, resulting in two main cracks.

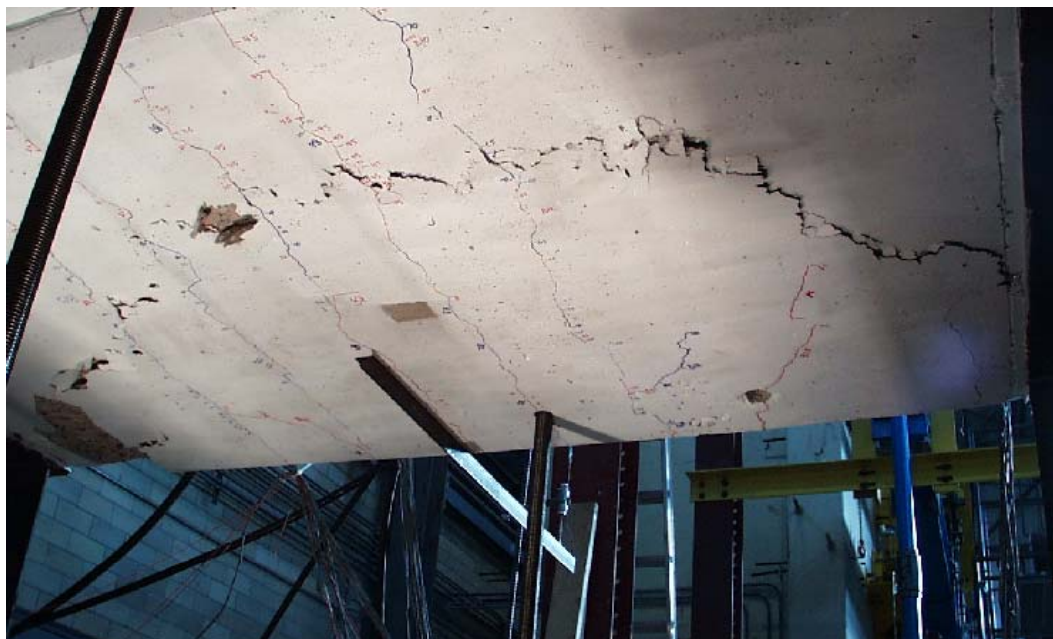
The bottom failure surface was closer to elliptical around the load plate than the interior span failure (Figure 5-32). The side cracks once again extended from the load plate to the girders (Figure 5-33). The top failure surface was different from the interior span failure, with the major failure cracks occurring further from the edge of the load plate (Figure 5-34).

***Figure 5-32: Exterior span failure at bottom of deck, facing south***

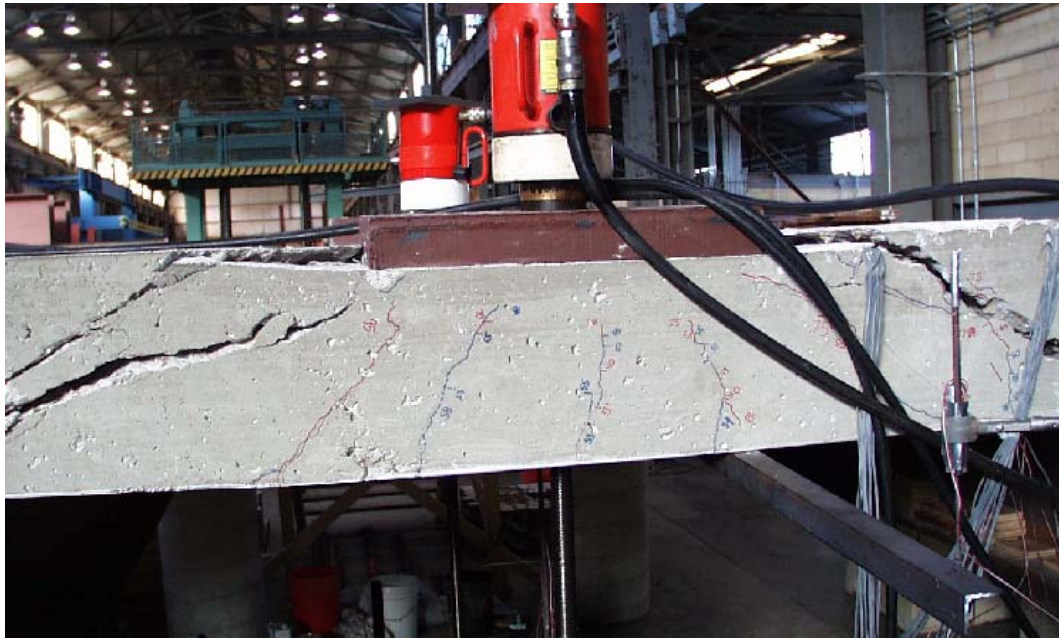
*Figure 5-33: Exterior span failure at side of deck, facing north*

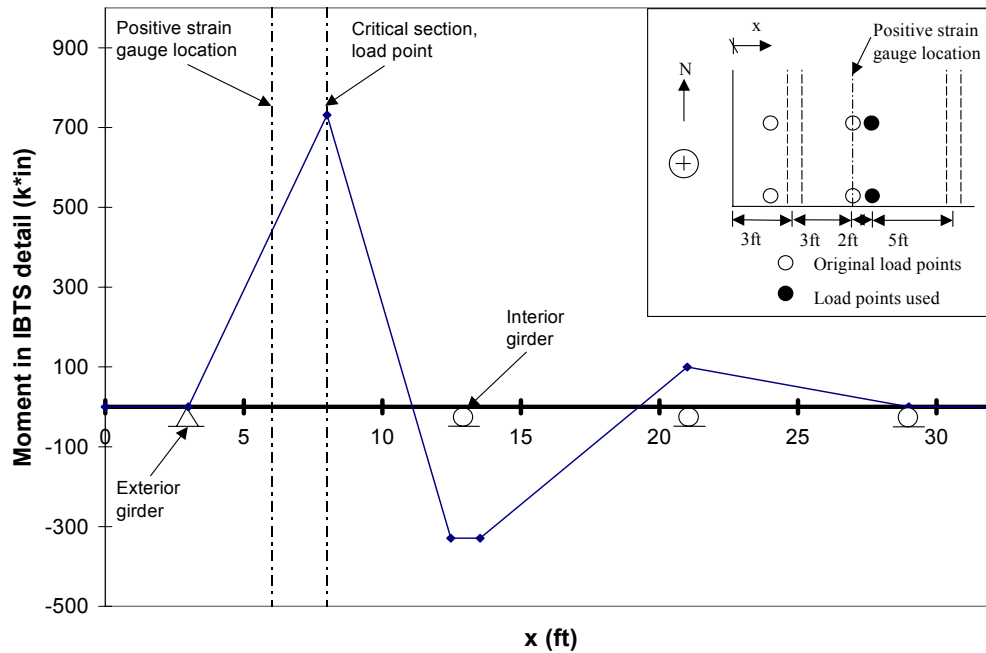
The loading to maximize negative moment could not be applied since the interior span of the south edge was damaged. Based on influence lines presented in Figure 4.7, the loading to maximize positive moment places a tire one-foot from the centerline of the interior girder. This tire's load will go directly into the supporting girder and not significantly affect the bridge deck behavior. Therefore, it was only necessary to apply one tire load per axle. Since the

**Figure 5-35: Critical section shift due to loading location change**

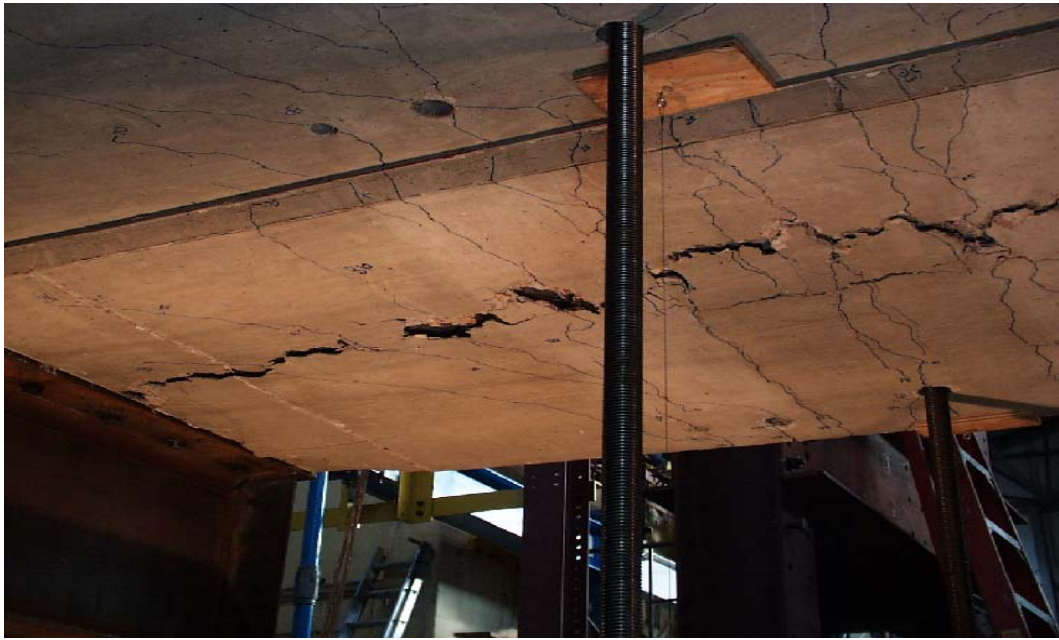
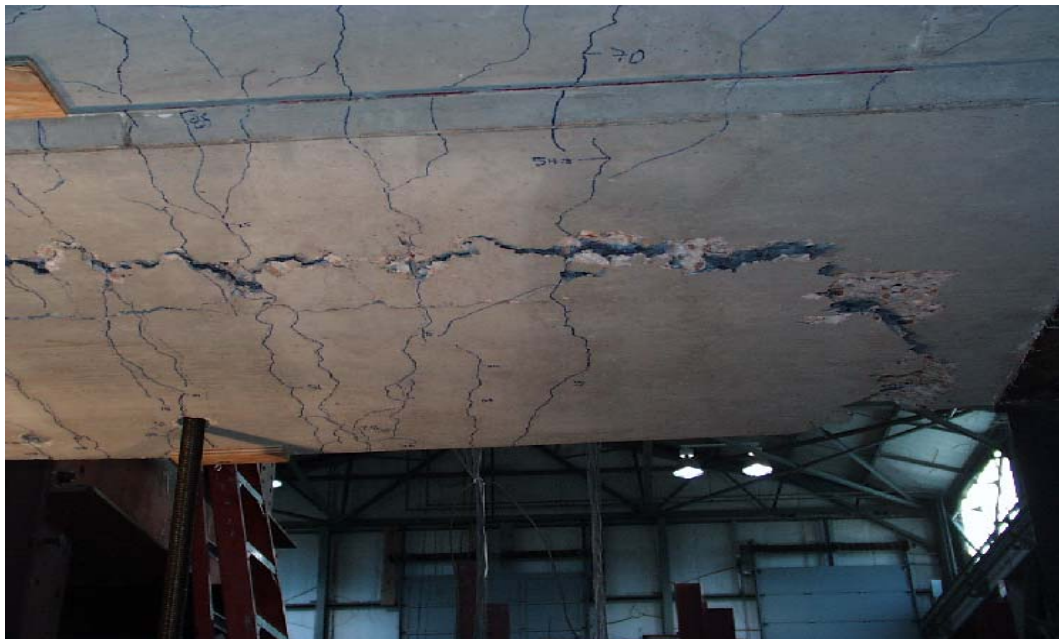
*(i) East side of test span, facing south*

*(ii) West side of test span, facing south*

**Figure 5-43: Southwest test area failure pictures at bottom of deck**

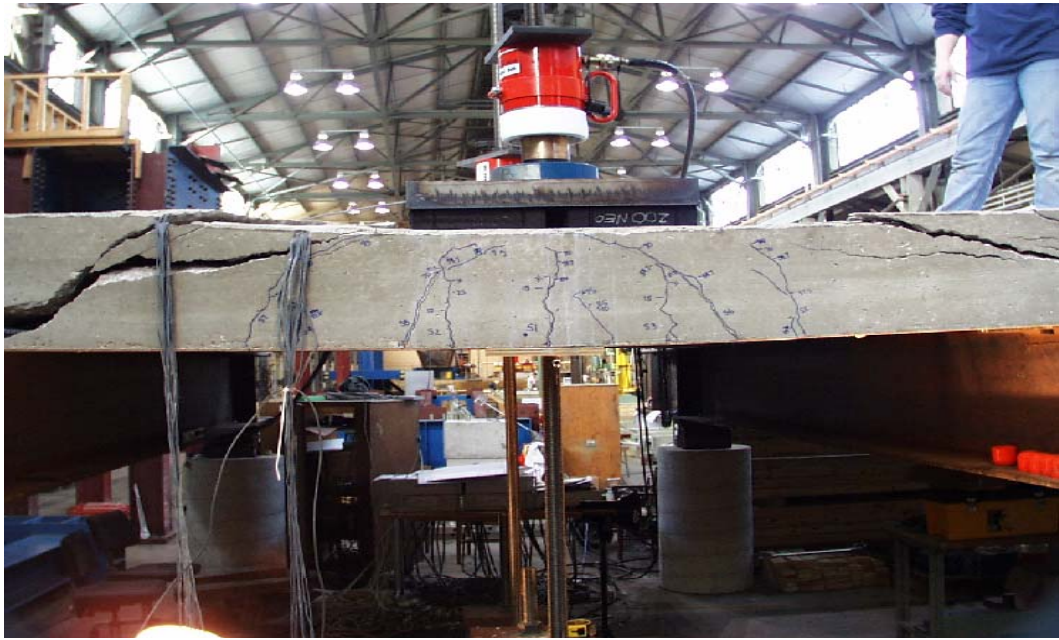
*Figure 5-44: Southwest test area failure picture at side of deck, facing north*

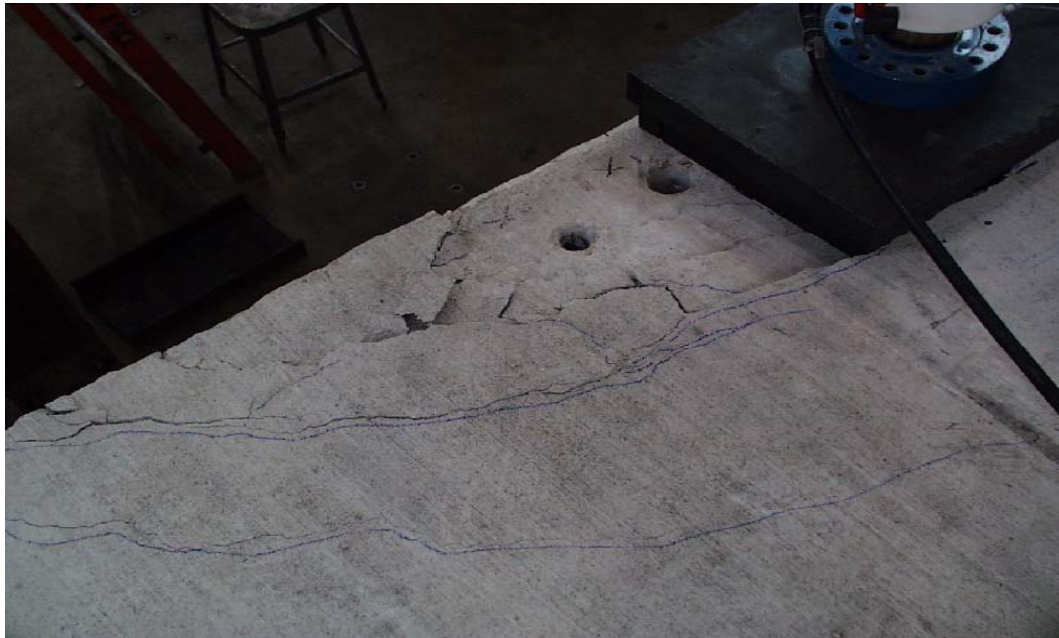
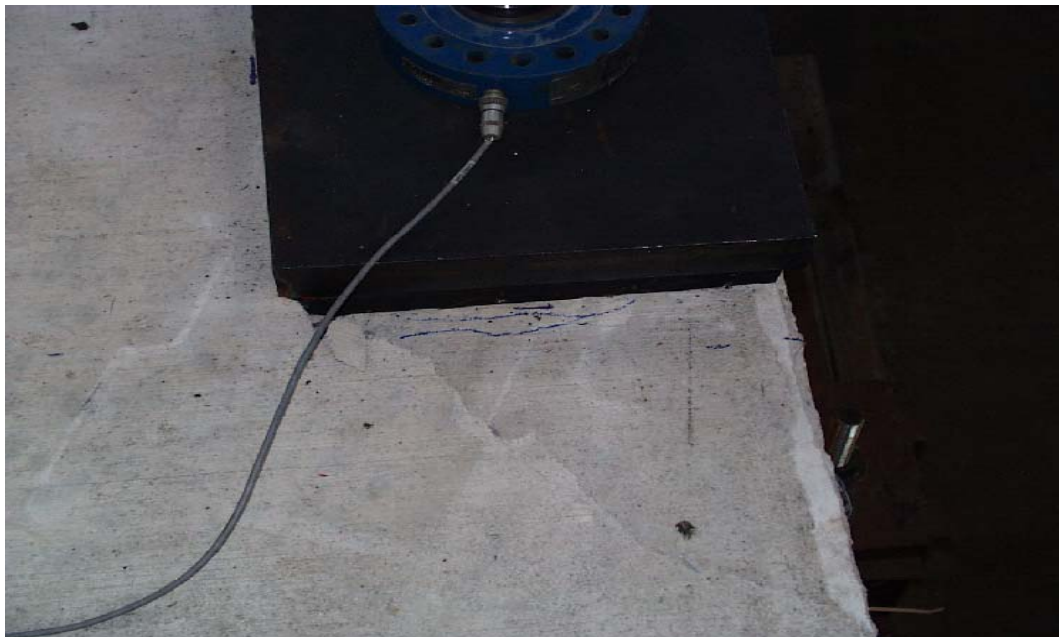
The failure surface extended diagonally from the north side of the load plate to deck edge (Figure 5-45). The failure surface was again flush along the north side of the load plate.

*(i) East side of interior span, facing south*

*(ii) West side of test span, facing east*

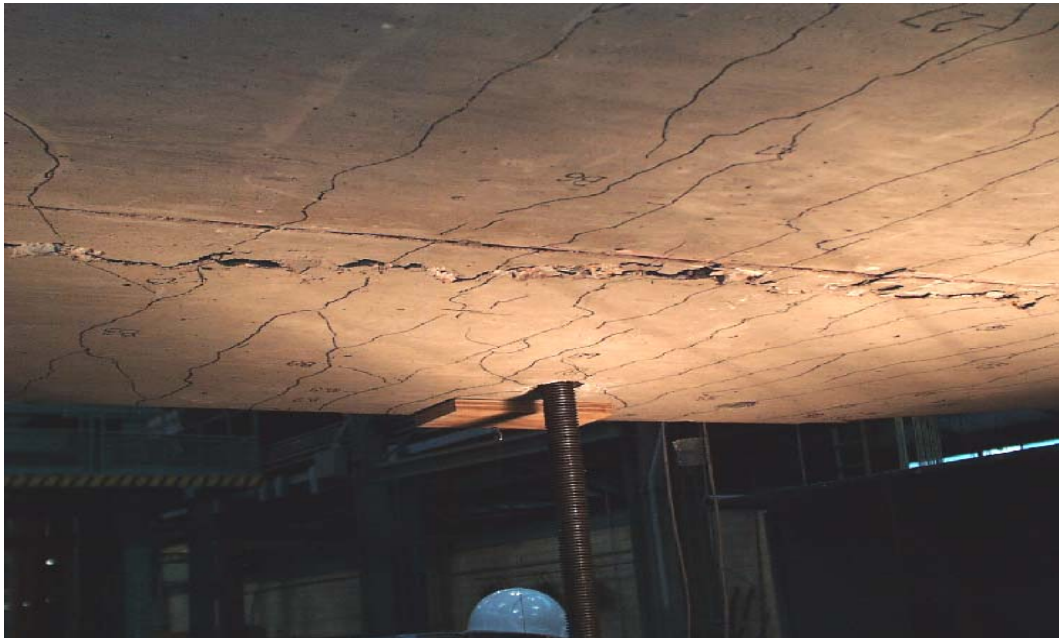
The northwest test area failed due to punching of the edge tire at a load of 81kips (5.2xHS-25 or 6.5xHS-20) per tire. Figure 5-54 shows the underside of the bridge deck and the extent of the failure surface. The bottom surface of the punching cone was similar to the ones observed in other test areas in that it ran parallel to the edge of the deck near midspan and curved toward the deck edge at the girders. Inclined shear cracks on both sides of the loading plate can be seen in Figure 5-55. Some of the wide shear cracks on the west side of the load plate extended to the girder flange. On the east side, however, the shear cracks formed at a steeper angle and did not reach the girder. Some of the shear cracks that are mapped in Figure 5-53 (iii) widened and contributed to the formation of the punching cone at failure. The failure surface on the top of the deck followed the back of the loading plate on the south side and moved slightly away from the sides of the loading plate towards the edge (Figure 5-56). In addition, wide cracks encircling the load plate formed at failure.

*Figure 5-54: Northwest test area failure at bottom of deck, facing north*

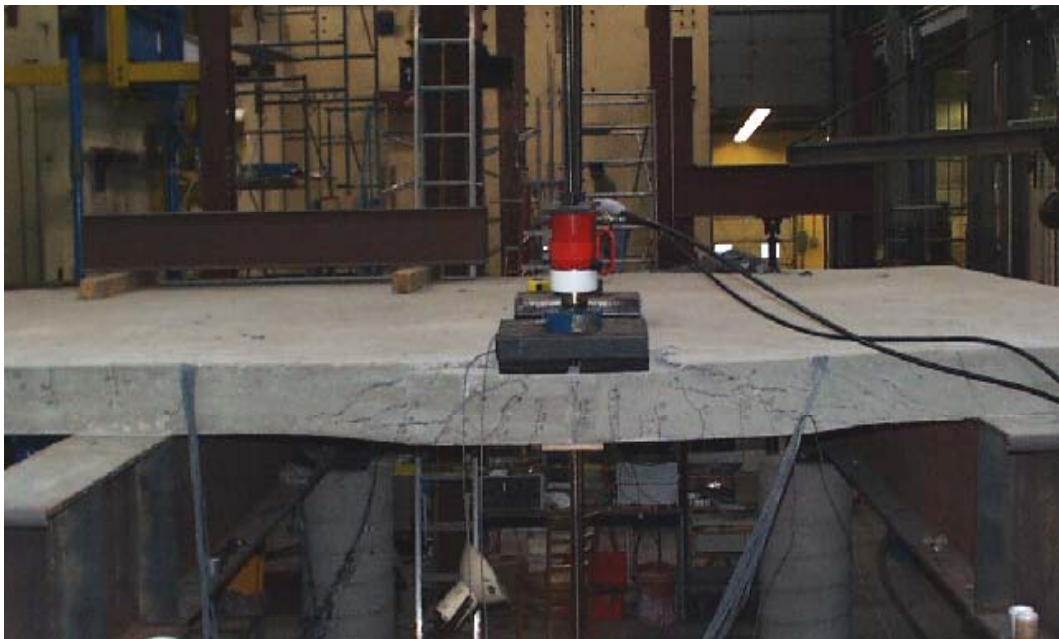
*Figure 5-55: Northwest test area failure picture at side of deck, facing south*

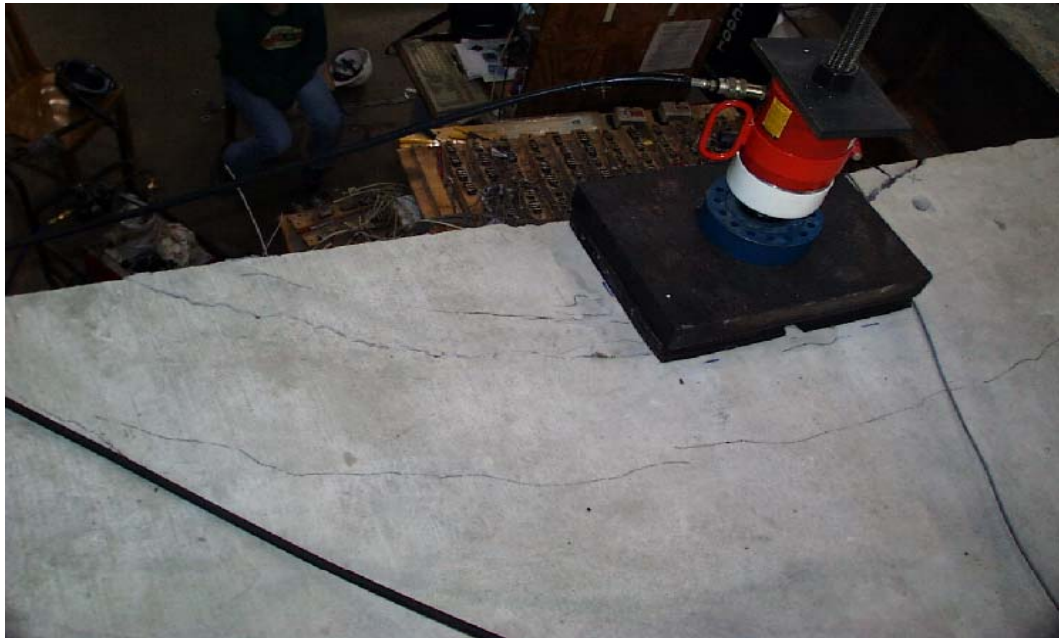
*Figure 5-56: Northwest test area failure at top of deck, facing north*

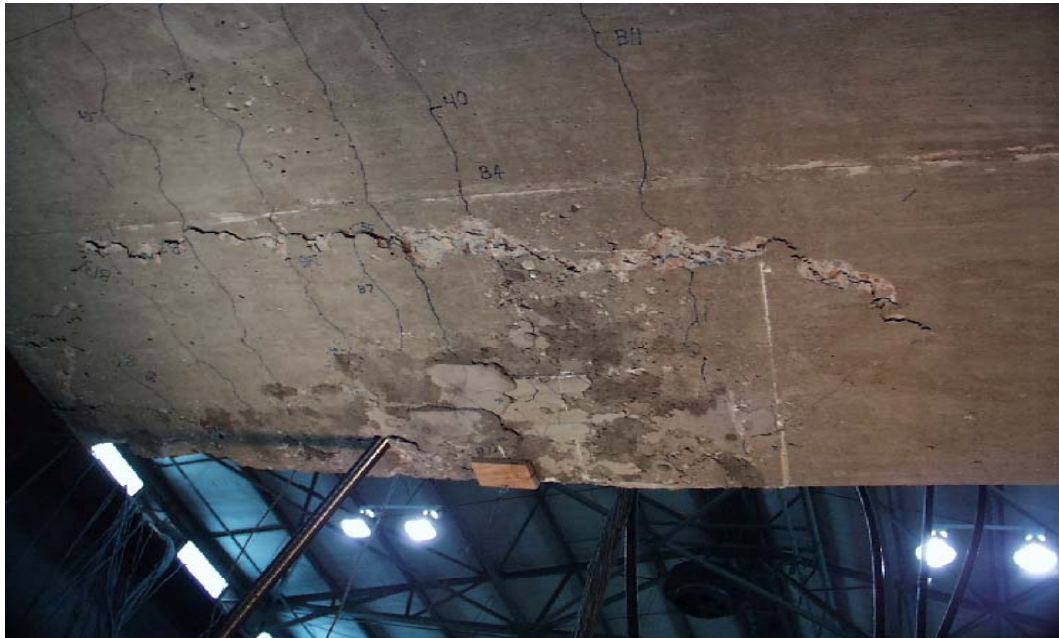
The northeast test area failed in punching shear at the edge-most tire in the exterior span at an applied load of 76kips (4.9xHS-25) per tire. The bridge deck specimen contained voids at the bottom of the deck in the exterior span due to insufficient vibration of the concrete during casting. Grout was injected into the voids as shown in Figure 5-65. The voids caused little difference in the flexural behavior of the specimen as they were in the tensile zone of the section. In addition, the voids did not affect the punching shear capacity significantly. However, it is believed that the concrete contribution to punching shear strength was slightly lower in the exterior span in comparison to that in the interior span. Hence, a punching shear failure was experienced in the exterior span. The failure surface again formed parallel to the edge of the deck and curved towards the deck edge near the girders.

***Figure 5-65: Exterior span failure at the bottom of the deck***

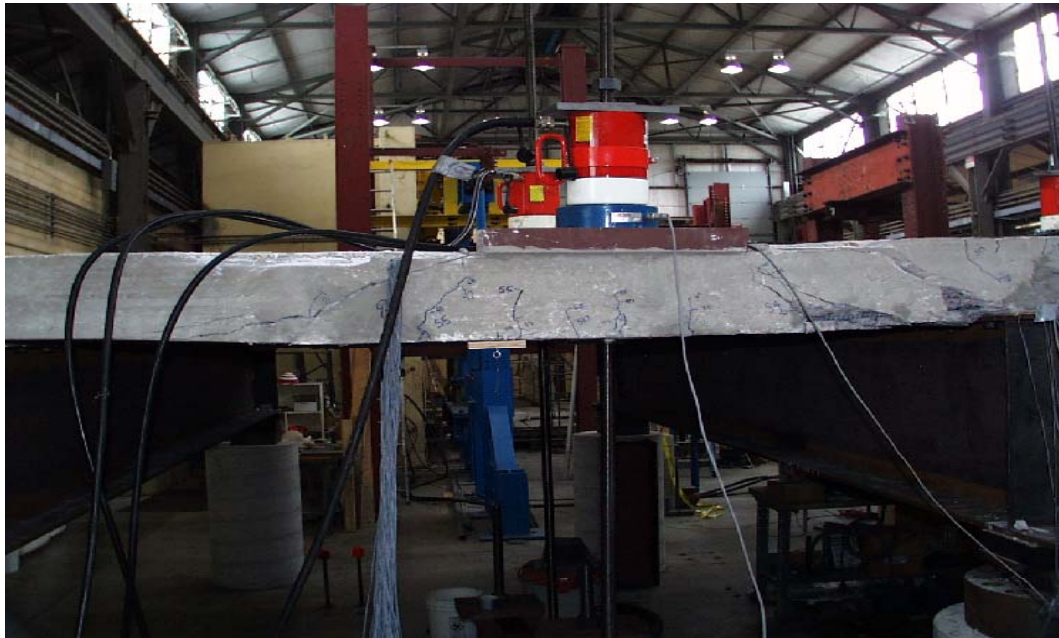
At the side of the deck, the major shear cracks on the west side of the load plate extended to the interior girder (Figure 5-66). The shear cracks on the east side of the load plate opened less and did not reach the exterior girder. The failure surface formed where no previous shear cracks had occurred. The failure surface at the top of the bridge deck formed flush along the interior edge of the load plate (Figure 5-67). Wedges of concrete at the sides of the load plate broke away.

*Figure 5-66: Exterior span failure at the side of the deck, interior span, facing south*

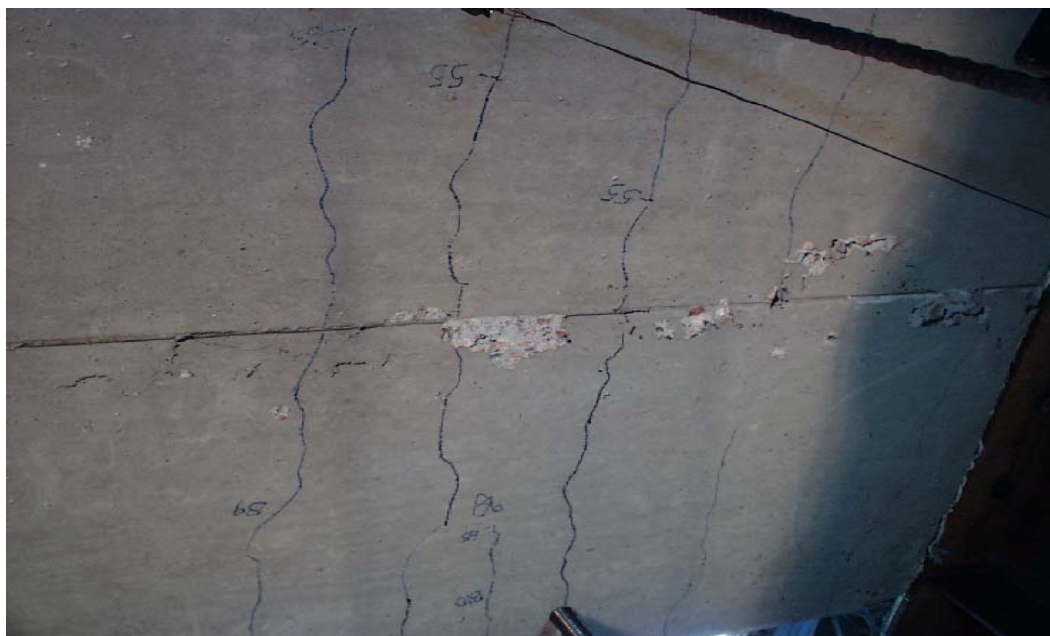
**Figure 5-80: Interior span failure at bottom of deck, facing south**

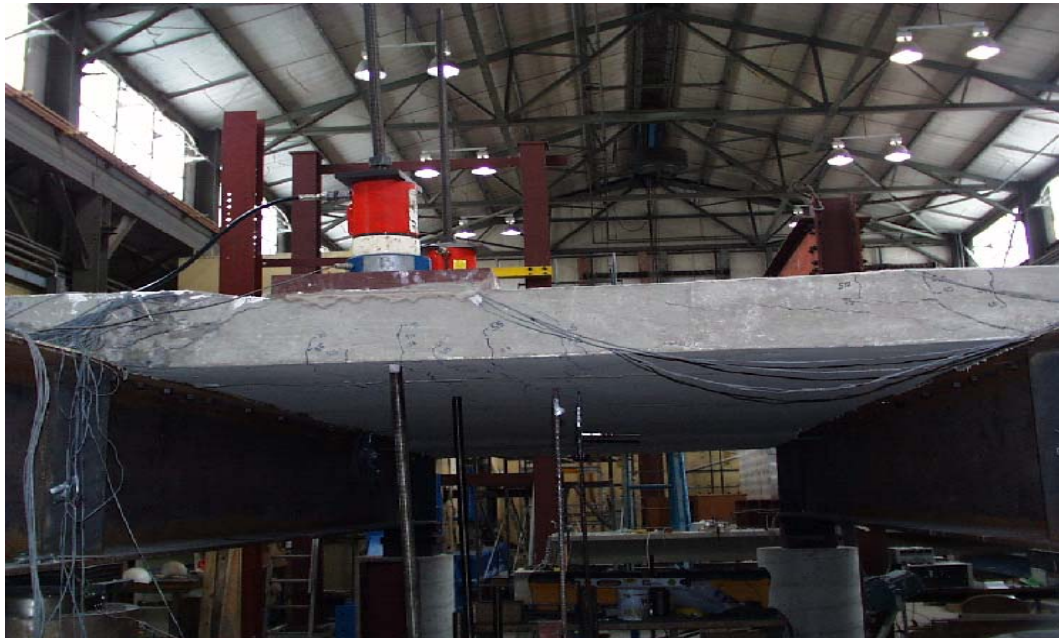
At the side of the deck, the shear cracks on the east side of the load plate were wide and extended to the flange of the girder (Figure 5-81). The shear cracks on the west side of the load plate were not as wide and they were shallow-angled (approximately 20°-30°) crack extending to the girder flange. The shear cracks during loading to failure formed at locations where no previous cracking had occurred. The failure surface at the top of the deck formed close around the east side of the load plate but ran adjacent to the deck edge on the west side of the load plate (Figure 5-82).

*Figure 5-81: Interior span failure at side of deck, facing south*

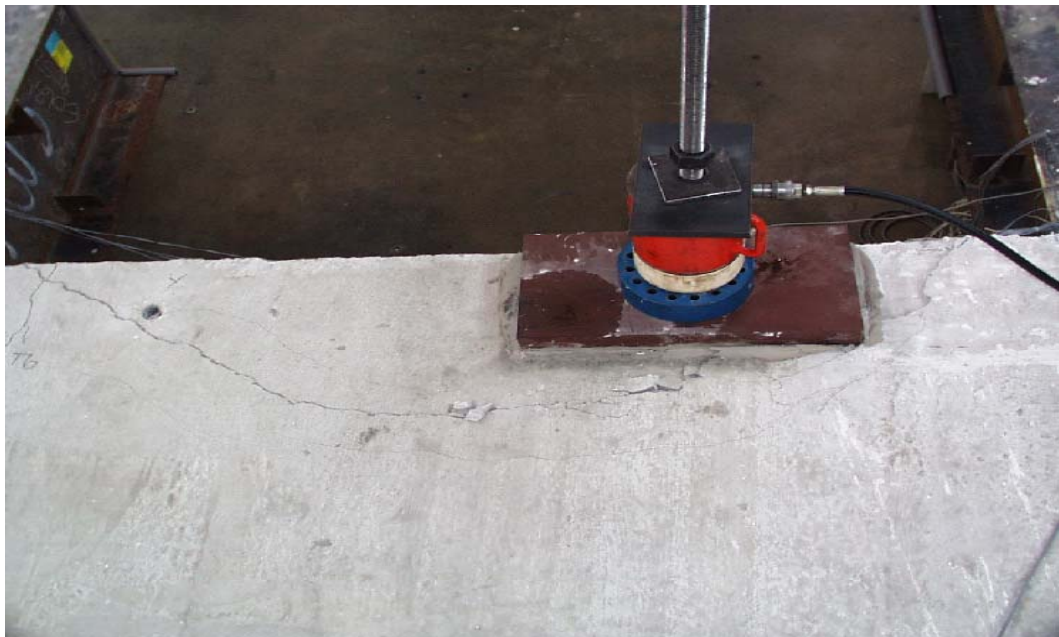
*Figure 5-82: Interior span failure at top of deck, facing north*
