**Investigation of Factors Affecting  
Web Fractures in Shear Links**

**Pedro Gálvez, BCE**

**Thesis**

The University of Texas at Austin

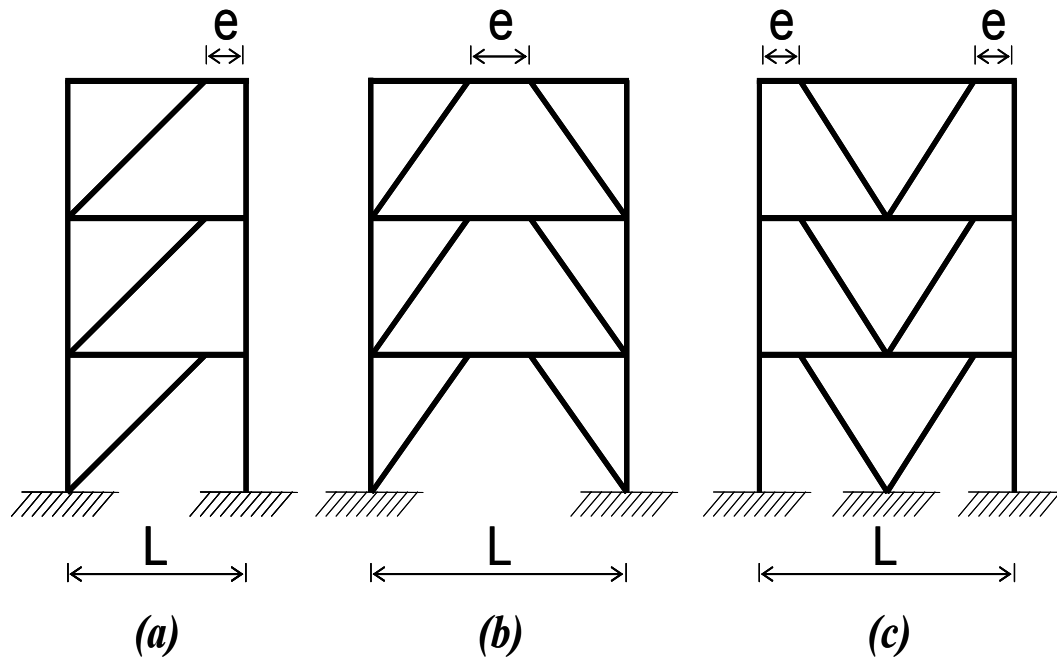
**Figure 1.1 Examples of eccentrically braced frames (EBF)**

Eccentrically braced frames (EBF) are seismic lateral force resisting systems that combine the ductility of moment resisting frames with the elastic stiffness of concentrically braced frames. EBF's are particularly ductile because the yielding takes place at the link elements in the frame. The plastic deformations in the frame will take place in the link while the rest of the the frame will remain elastic. Figure 1.1 shows three different arrangements of links in EBF's. Link lengths are denoted by the letter "e."

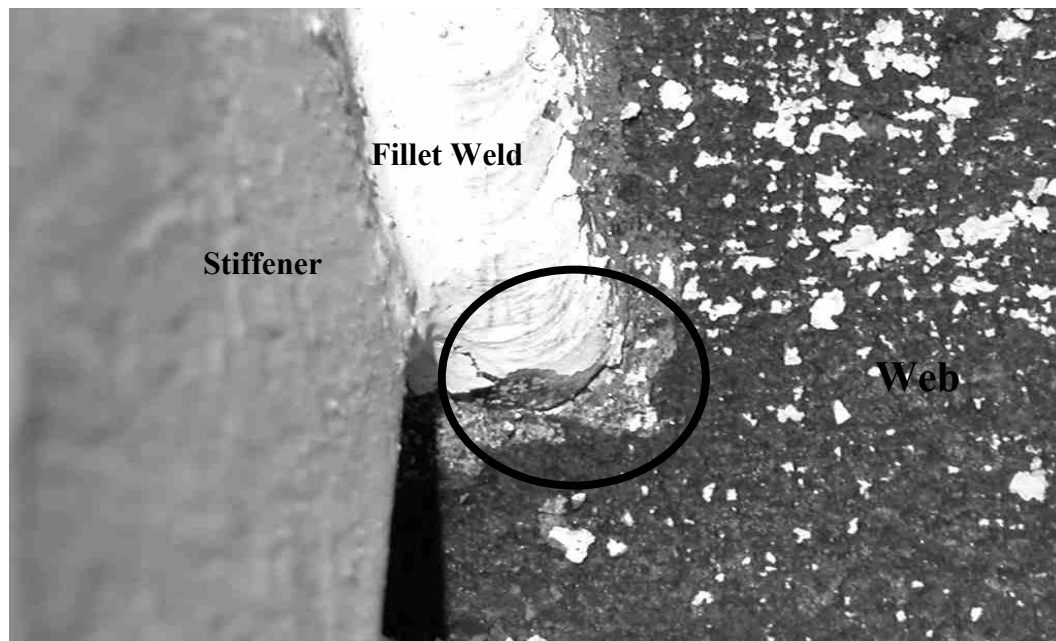
***Figure 1.2 Crack observed at the toe of the weld in one of the stiffeners of a shear link tested by Arce (2002).***

Under cyclic loading tests, Arce (2002) observed frequent occurrences of premature fractures in the web of links. These fractures initiated at the termination of fillet welds connecting stiffeners to the link web, at the top and bottom of stiffeners. The fractures then normally propagated horizontally, running parallel to the flanges and ultimately causing failure of the specimens. Shear yielding links ( $e \leq 1.6M_p/V_p$ ) seemed to be especially affected by this problem. Further, these fractures typically occurred prior to web buckling, and in many cases, before the link achieved the required plastic rotation of 0.08 radian. These fractures, originating at the top and bottom of the stiffeners in the links, were not reported in earlier EBF research conducted in the 1980s. The photo in Figure 1.2 shows an example of the cracks in the web of a shear link observed by Arce. Arce attempted to prevent these web fractures by moving the stiffener weld termination further away from the k-area of the link section. The objective was to reduce the stress concentration at the end of the stiffener induced when the stiffener termination is too close to the flange. The purpose was also to move the weld termination away from the k-area of the W-Shape link section, where

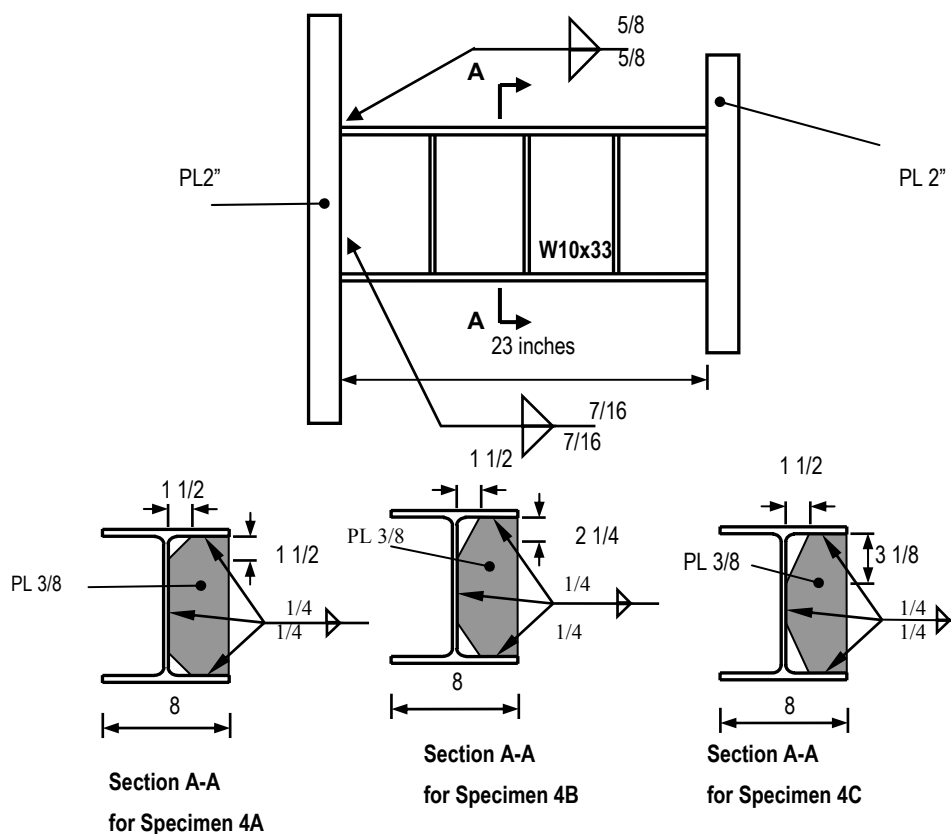
**Figure 1.3 Welding detailing on link stiffeners in specimens 4A, 4B and 4C tested by Arce (2002)**

It was found that by increasing the distance between the termination of the stiffener weld and the flange, the inelastic rotation in the specimens was improved. The results showed that by moving the welding away from the k-line web fractures could be delayed, but not prevented. Based on these results, Arce recommends terminating the stiffener welds a distance of at least five times the link web thickness from the k-line of the section.

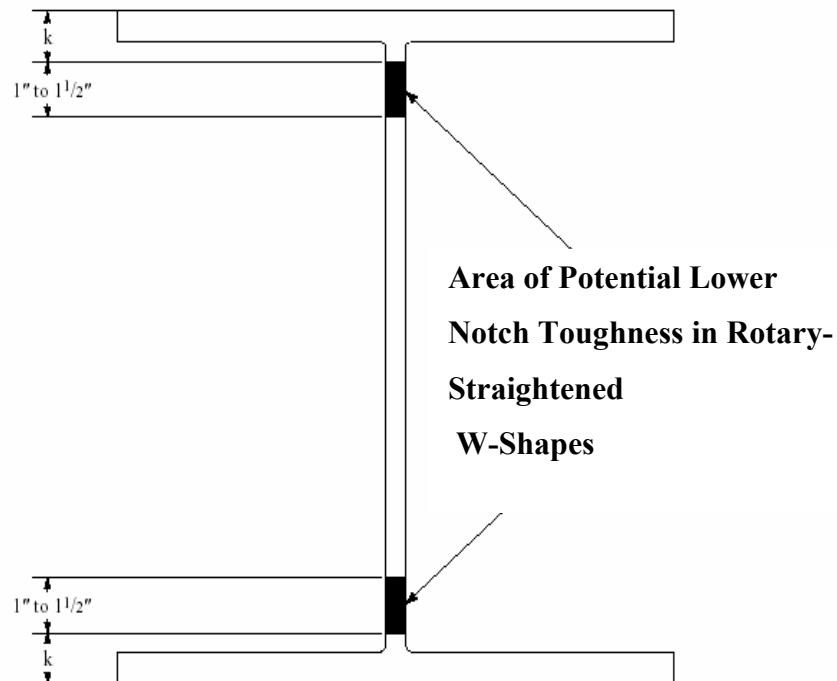
*Figure 1.4 “k” Area as shown in the 2002 AISC Seismic Provisions*

The k-area of rolled wide-flange shapes is defined as the region “extending from mid-point of the radius of the fillet from the flange into the web, approximately 1 to 1-1/2 inches beyond the point of tangency between the fillets and web” (section 3.3.2.3, FEMA-350). Figure 1.4 shows the k-area in a typical wide flange beam. This area is characterized by lower toughness and higher hardness, as compared to properties in other areas of the wide-flange cross-section. It is suspected that these properties might make the k-area prone to fracture when welds are placed in this region.

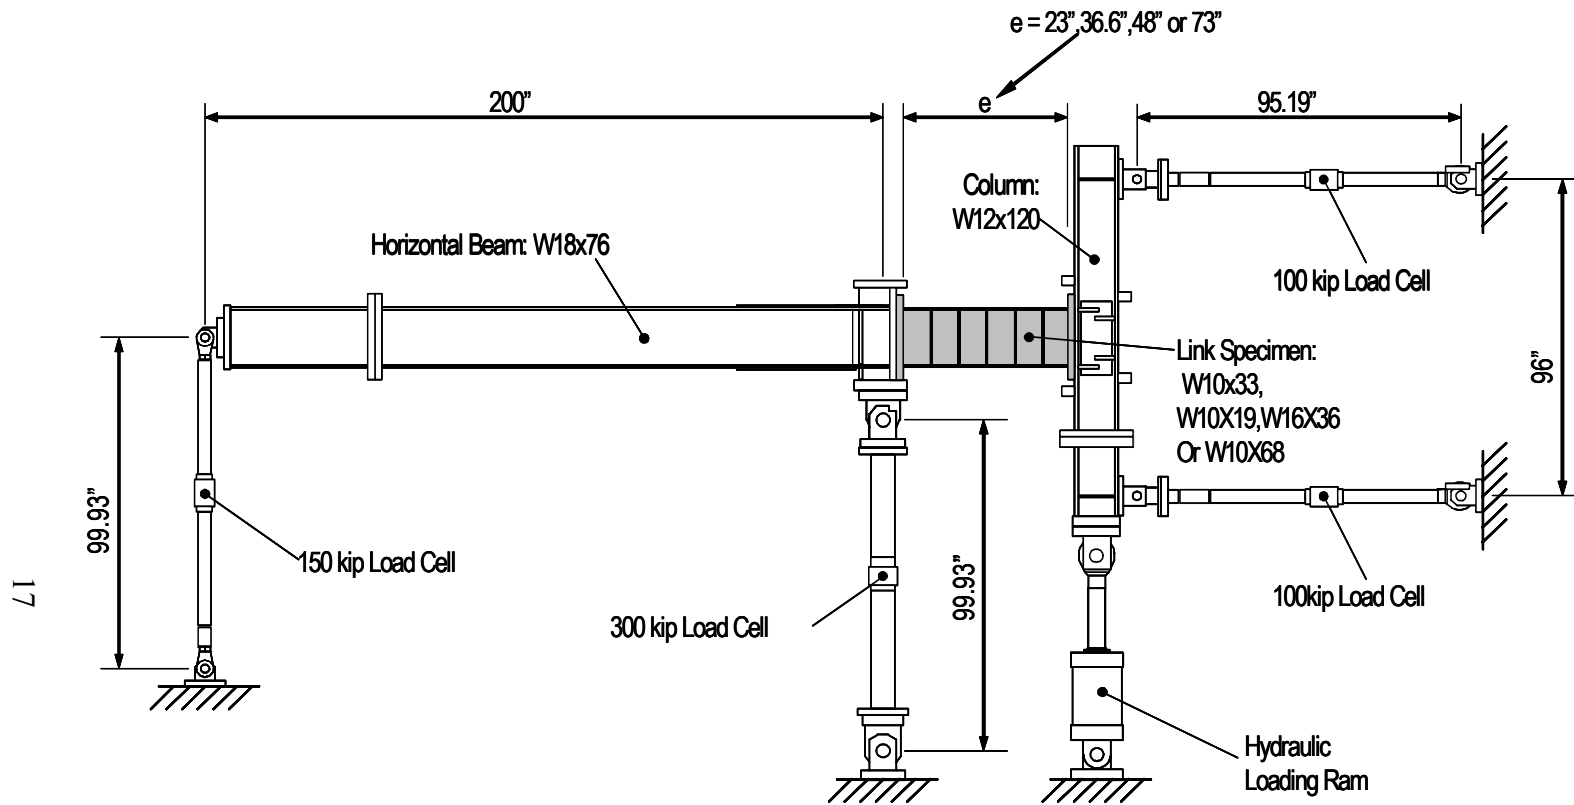
*Figure 2.1 Details and dimensions of the test setup*

The test setup was previously designed and built by Okazaki (2004) and Arce (2002) for investigations on the experimental performance of links and link-to-column connections. It was originally designed to accommodate links with lengths ranging from 23” up to 73”. The shaded region shown in Figure 2.1 is the link specimen, and is the portion of the test setup which is changed for each experiment. For the investigation reported herein, all specimens were built with a link length of 23-inches. A link specimen placed in the test setup is subjected to constant shear throughout its length and to reverse curvature bending. The moment introduced at the south end of the link (column end of link) in the elastic range of behavior is larger than the moment at the north end (Beam end of link), similar to the elastic moments developed in the link of a typical single diagonal EBF. Figure 2.2 compares the distribution of forces in a single EBF and the test setup.

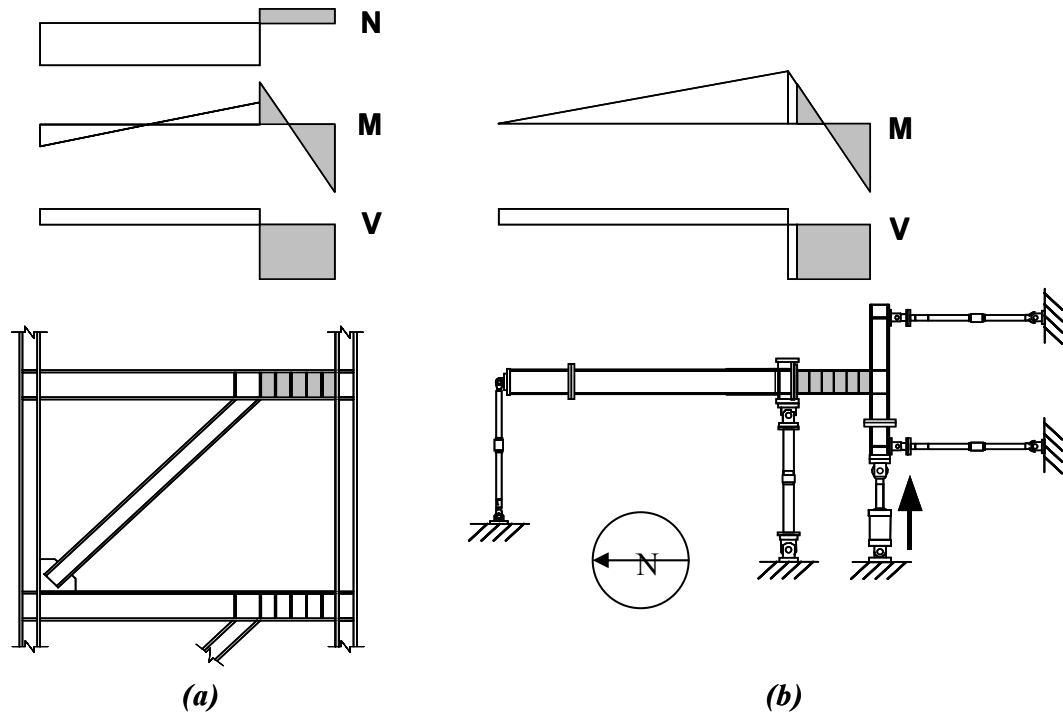
**Figure 2.2 Force distributions in (a) typical single diagonal EBF and (b) in the test setup**

The setup is designed so that axial forces introduced in the link can be considered negligible. Link rotation was achieved by quasi-statically displacing the W12X120 column segment of the test setup, until a target rotation was achieved as required by the loading protocol. The ends of the link specimens were welded to 2" thick end plates which were then bolted on to the beam and the column segment of the test setup using eight 1 1/4" A490 bolts at each side. In addition, a fastening mechanism was in place to prevent the plates from slipping under shear loading.

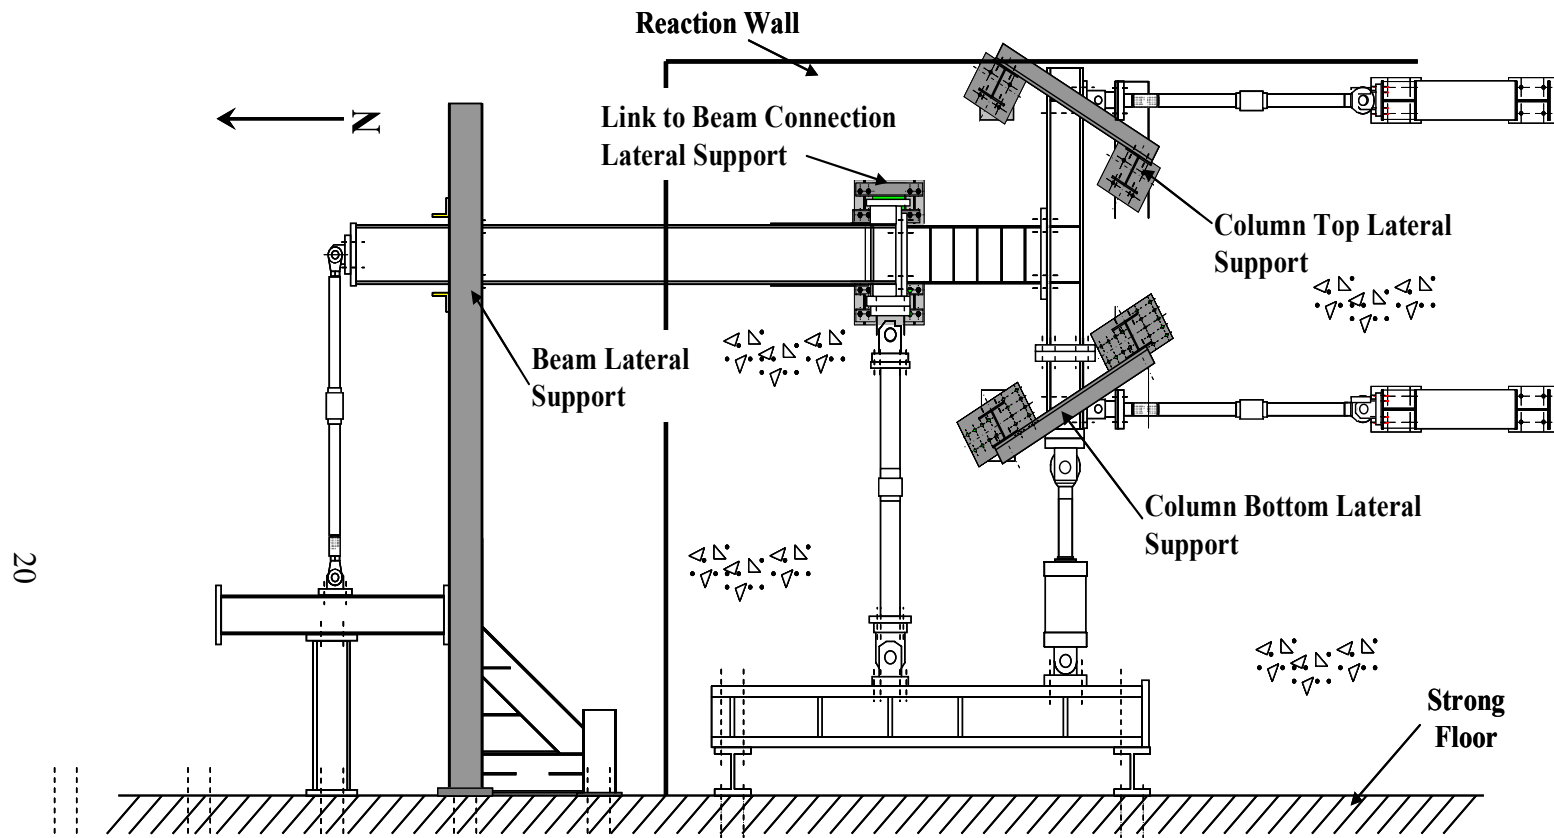
Figure 2.3 Lateral support system

Figure 2.3 presents the detailing of the bracing used to prevent out-of plane movement of the test setup. The frame was provided with a support system to provide lateral stability throughout the testing process. Lateral support was provided at four points in the frame as shown in the figure. The bracing system was designed so that it would not interfere with the free in-plane movement of the system. Contact surfaces between the lateral braces and the test frame were coated with Teflon to minimize friction associated with in-plane movement.

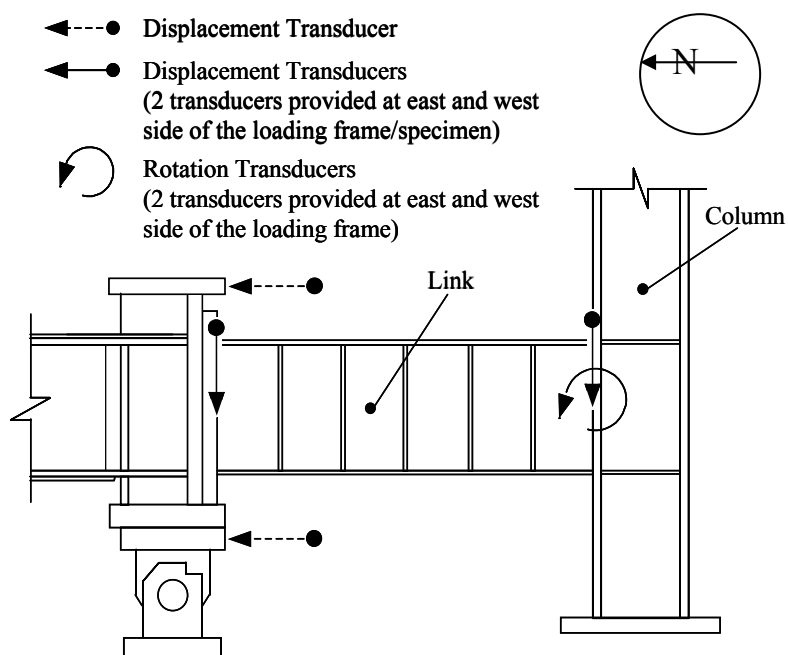
*Figure 2.4 Location of transducers used to monitor the link displacement*

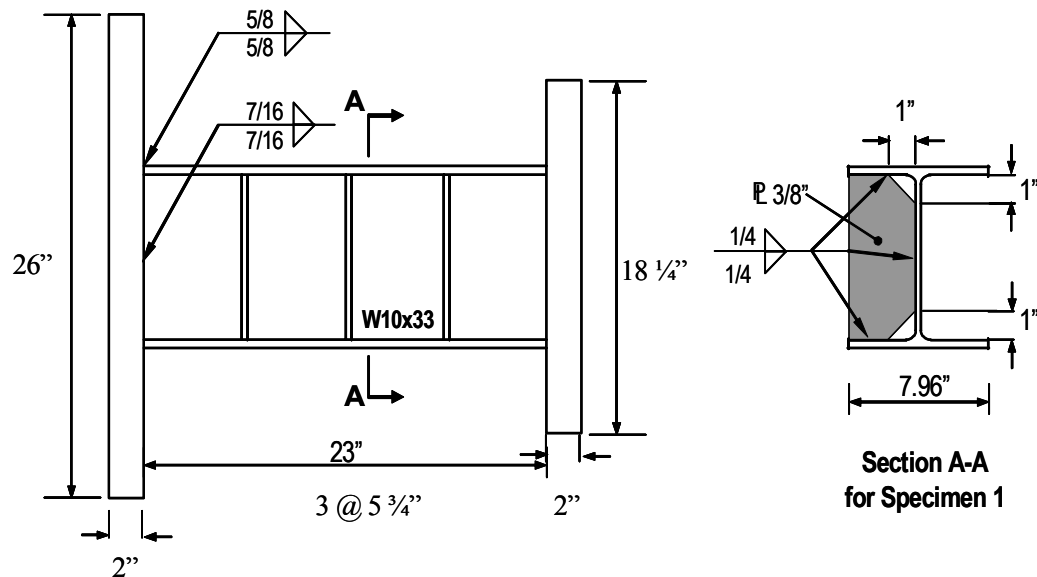
**Figure 2.5 Welding and stiffener details for Specimen 1**

the fillet welds joining the stiffeners to the link web would be terminated 1.4- inches away from the outer face of each flange, as previously shown in Figures 2.5 to 2.14.

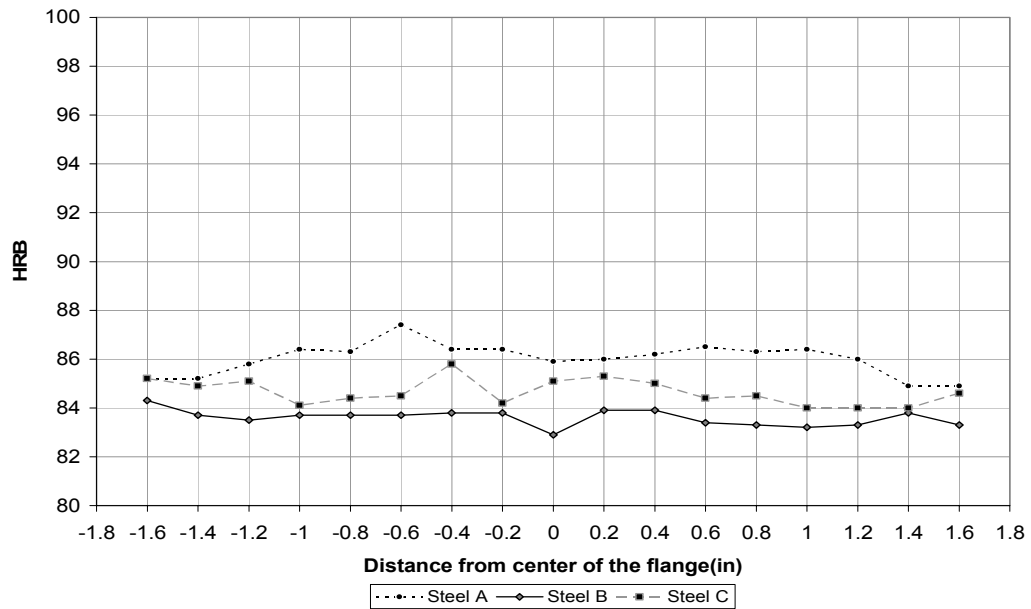
**Figure 2.15** *Hardness results at the center line of the flange for Mills A, B and C. (zero distance is the center line of the web of the section)*

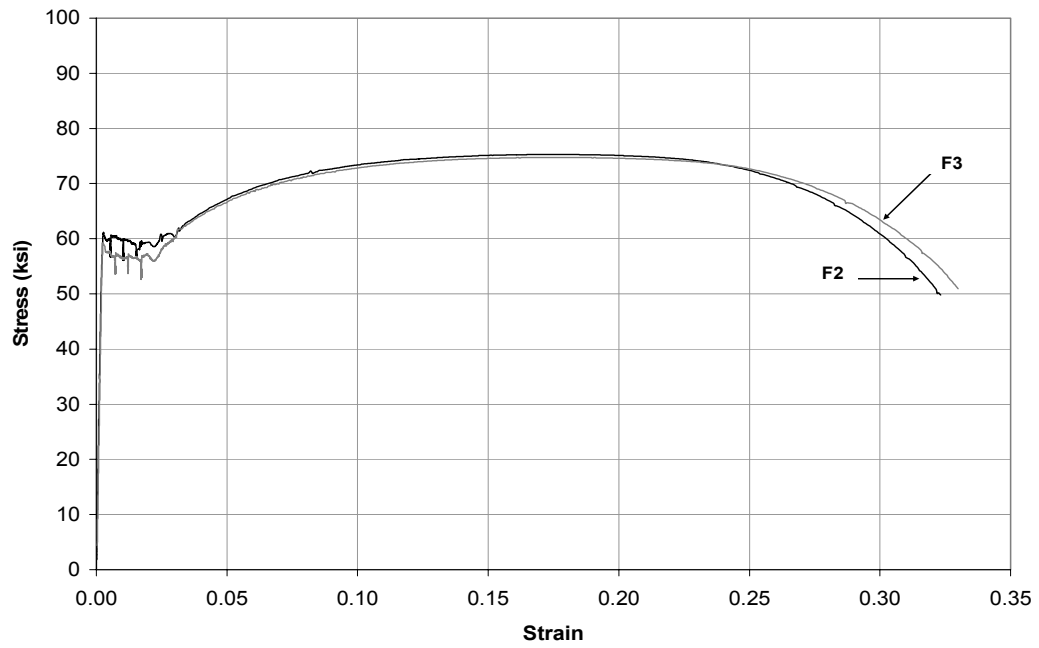
*Figure 2.20 Tensile test results for F2 and F3 from steel B*

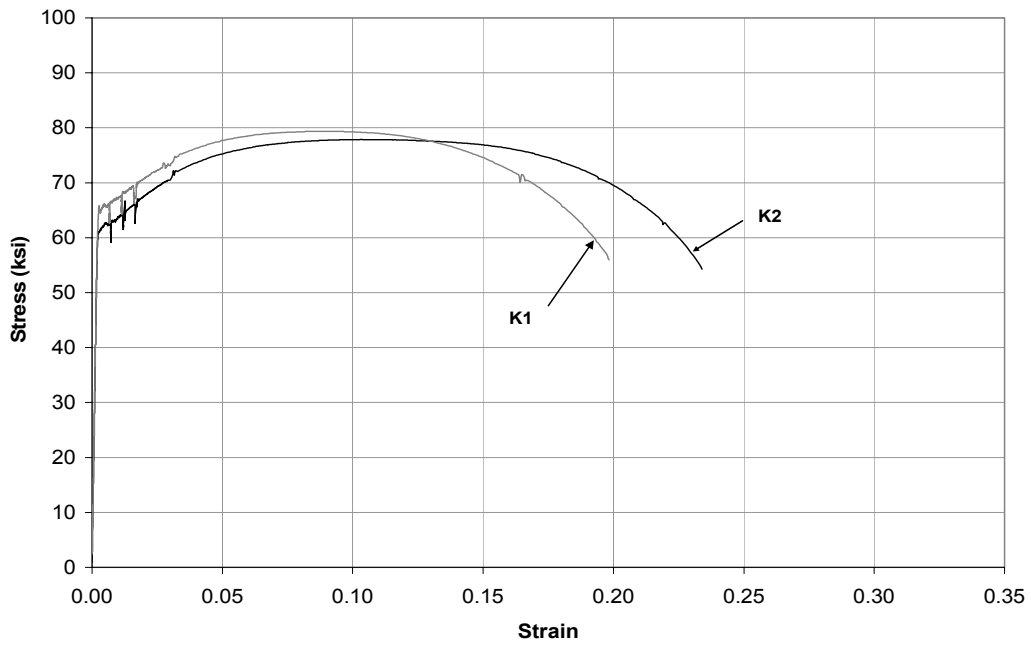
*Figure 2.24 Tensile test results for coupons K1 and K2 from steel B*

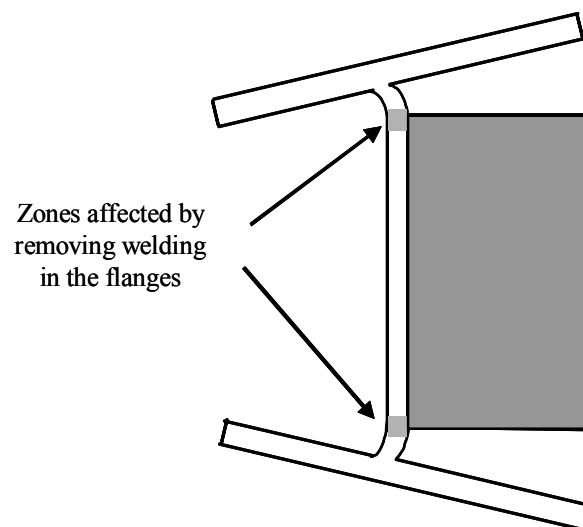
***Figure 3.71 Failure mode experienced by Specimen 7***

This specimen achieved a total plastic rotation  $\gamma_p = \pm 0.05$  radian. The data suggest that by eliminating the fillet weld joining the stiffeners to the flanges, the web is allowed to buckle as shown in Figure 3.71, resulting in a less desirable type of failure. As illustrated in this figure, the link flanges appeared to rotate in this specimen, likely causing significantly larger stress concentrations at the stiffener to web weld terminations. It is not clear why the link flanges had a tendency to rotate, but such rotation was observed in the specimen. Welding the stiffeners to the flanges apparently restrains link flange rotation. Overall, Specimen 7 with stiffeners welded to the web only showed poor performance.

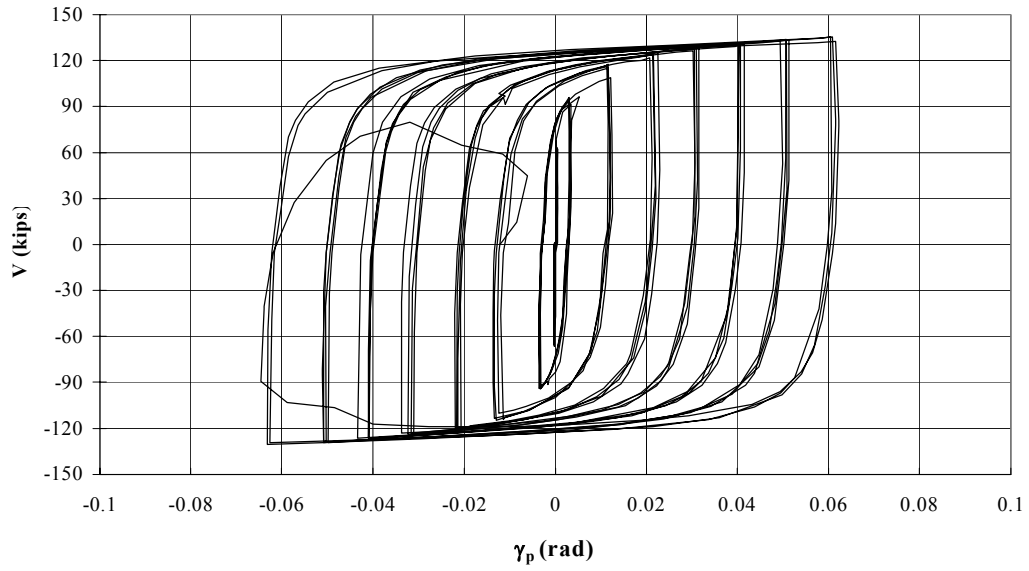
***Figure 3.1 Link shear vs. plastic rotation angle for Specimen 1***

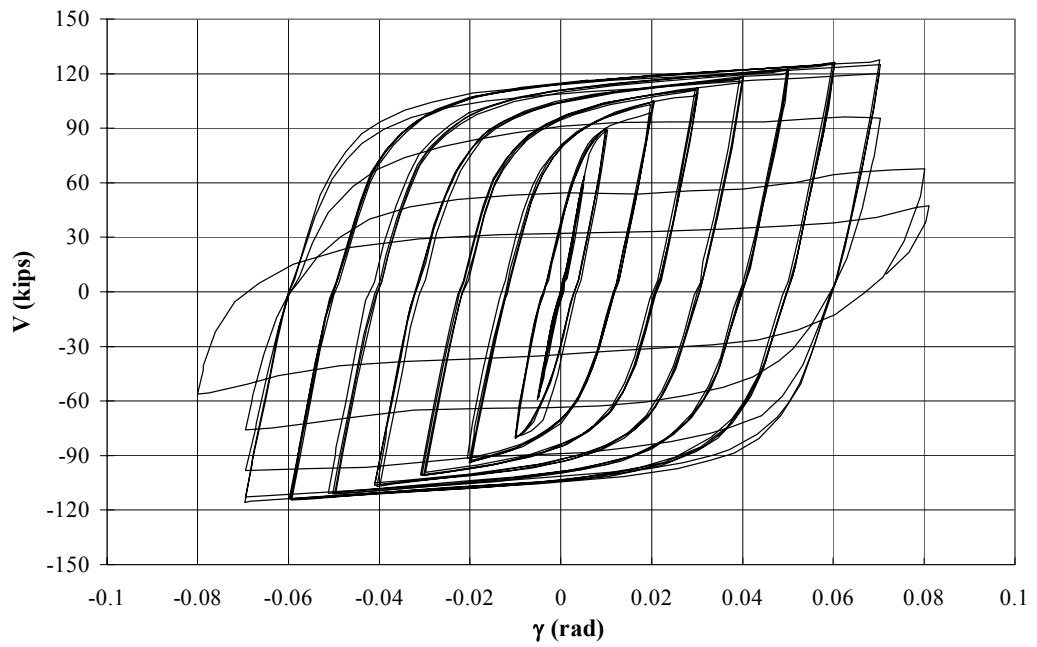
**Figure 3.8 Link shear vs. total rotation angle for Specimen 4**

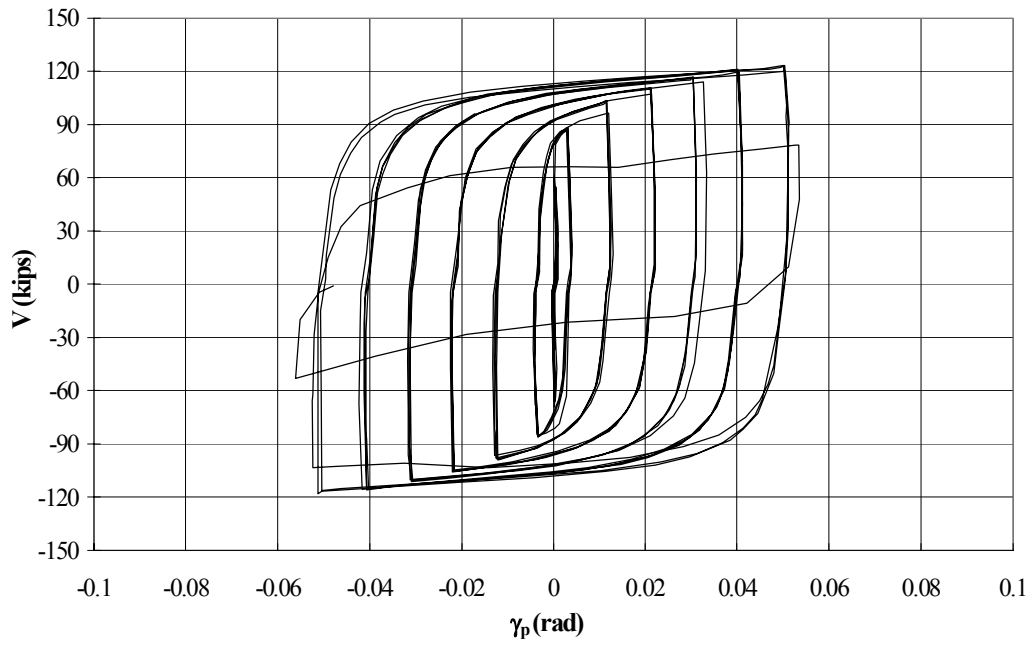
**Figure 3.11 Link shear vs. plastic rotation angle for Specimen 6**

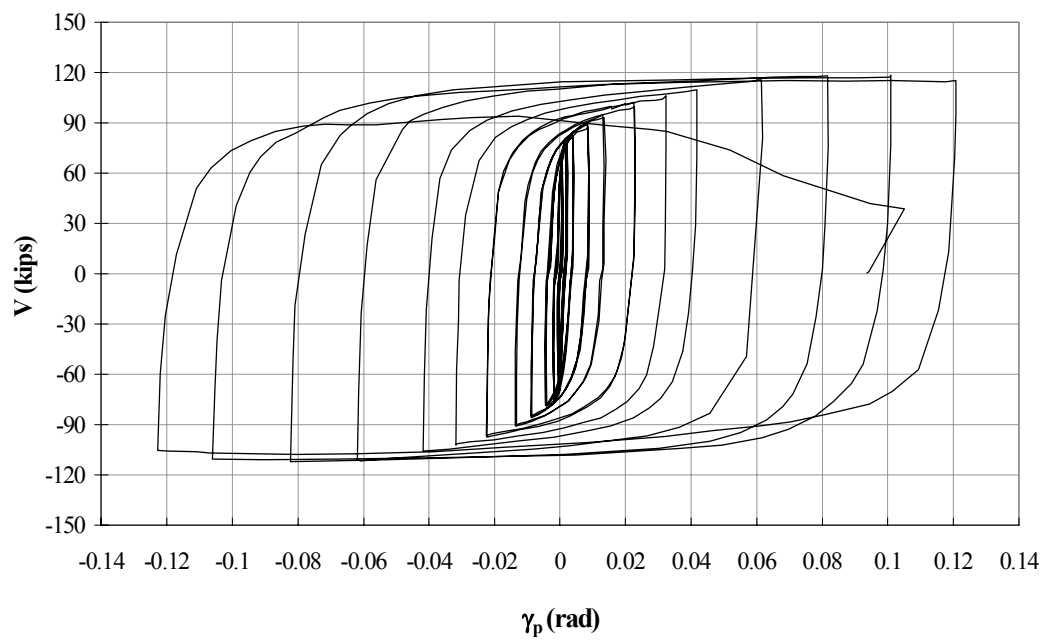
**Figure 3.15 Link shear vs. plastic rotation angle for Specimen 8**

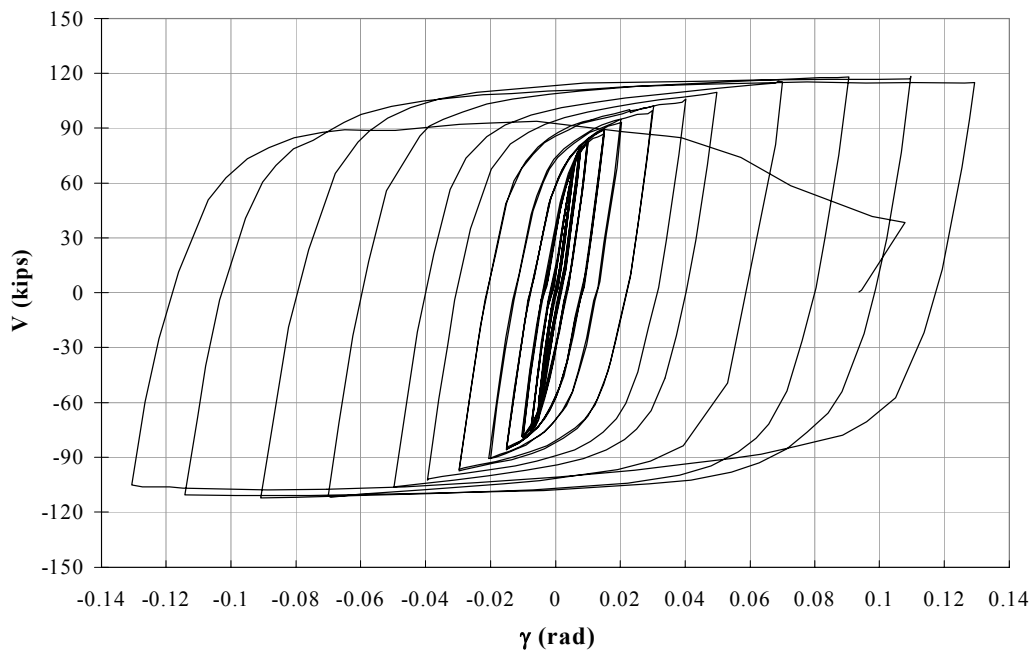
**Figure 3.16 Link shear vs. total rotation angle for Specimen 8**

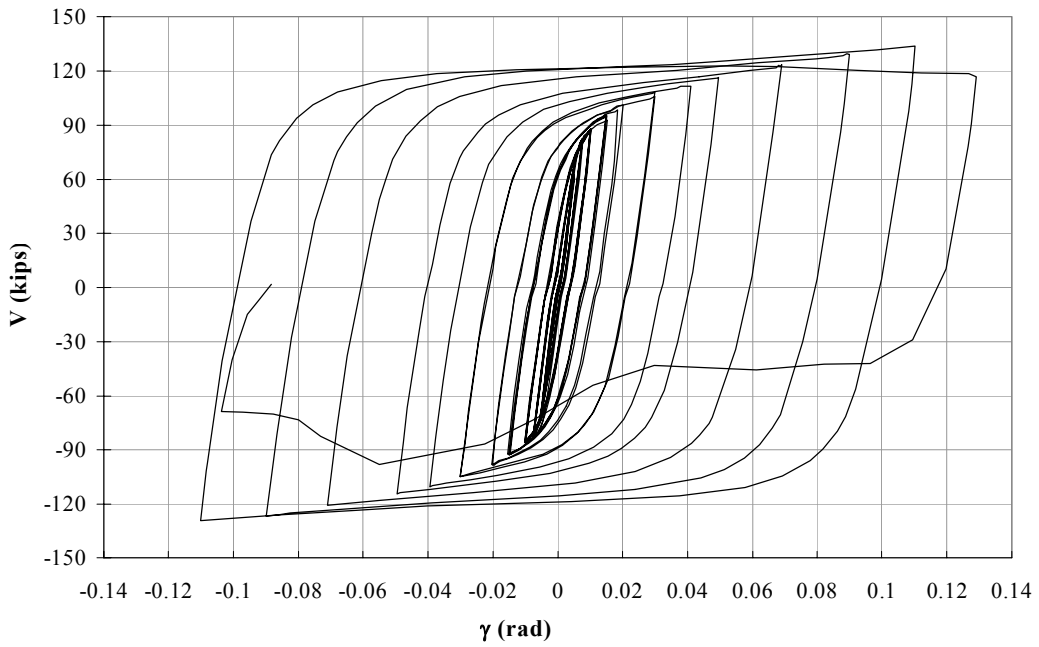
**Figure 3.18 Link shear vs. total rotation angle for Specimen 9**

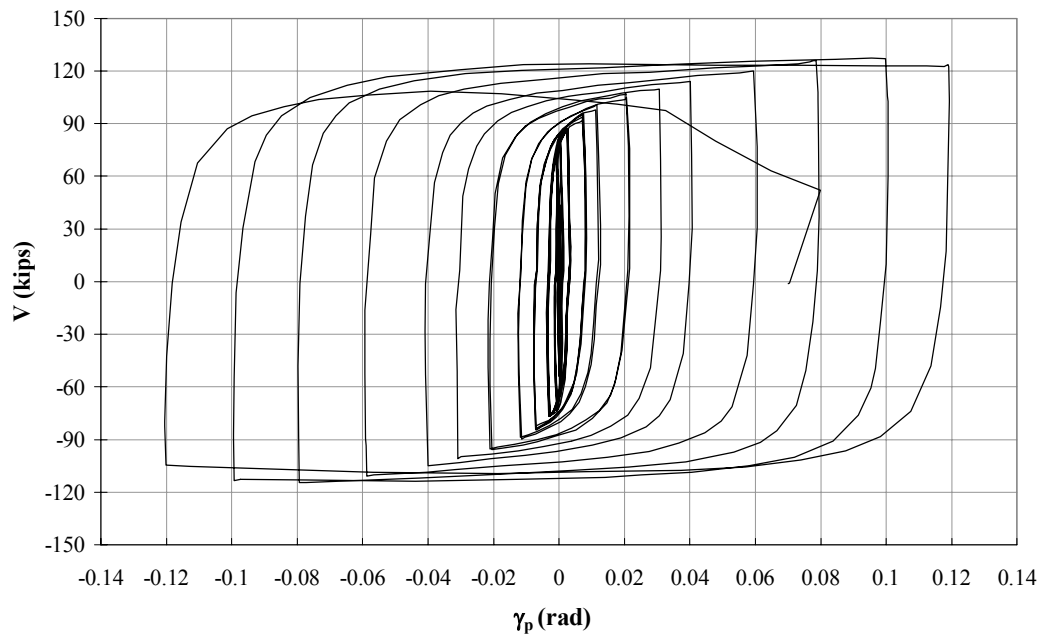
**Figure 3.19** Link shear vs. plastic rotation angle for Specimen 10

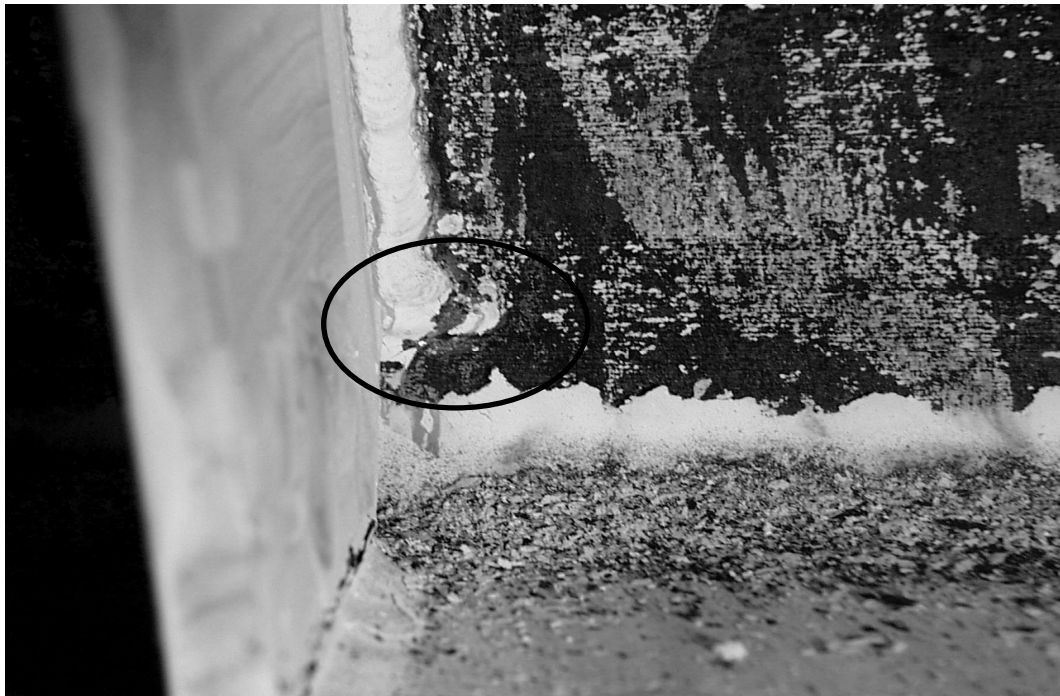
*Figure 3.22 Specimen 1: Crack observed at the toe of the welding of the far north stiffener during the fourth cycle of load step 8 ( $\gamma = -0.06$  radian)*

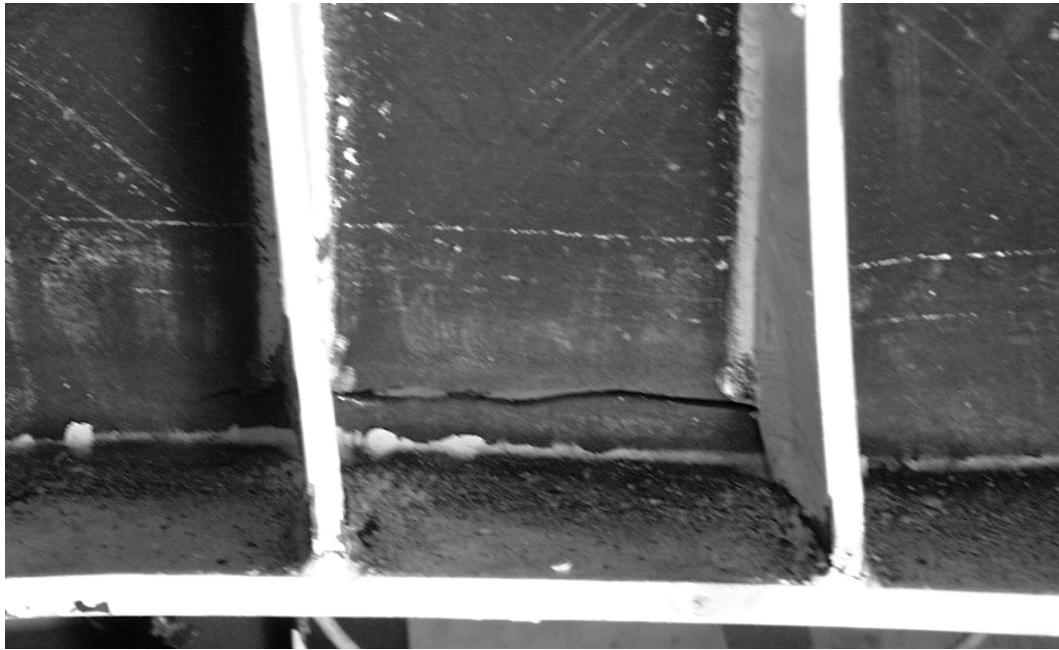
*Figure 3.23 Specimen 1: Horizontal crack after completing the second cycle of load step 9 ( $\gamma = +0.07$  radian)*

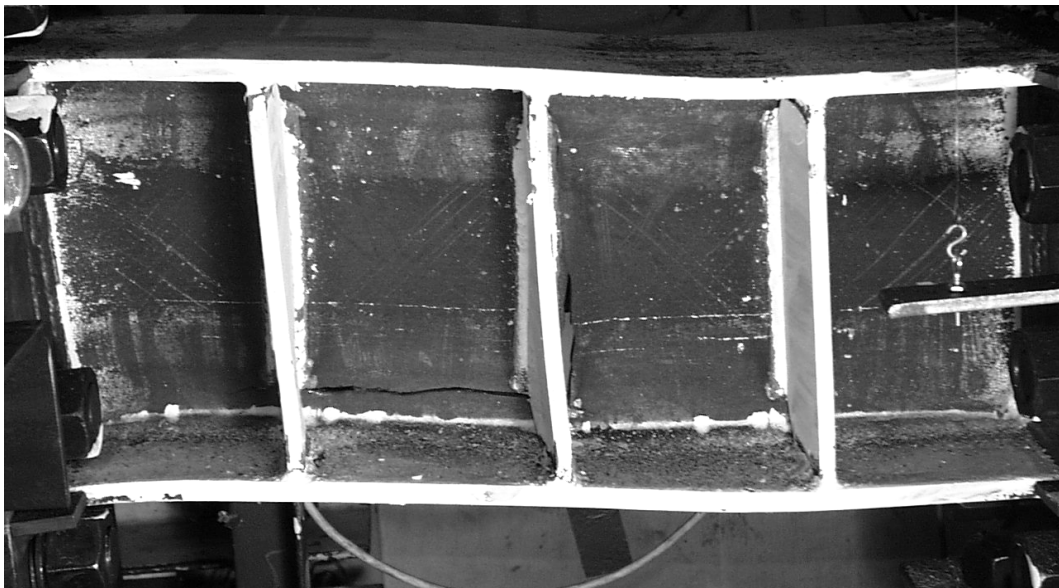
*Figure 3.24 Specimen 1: Horizontal and vertical crack observed after the third cycle of load step 9 ( $\gamma = +0.07$  radian)*

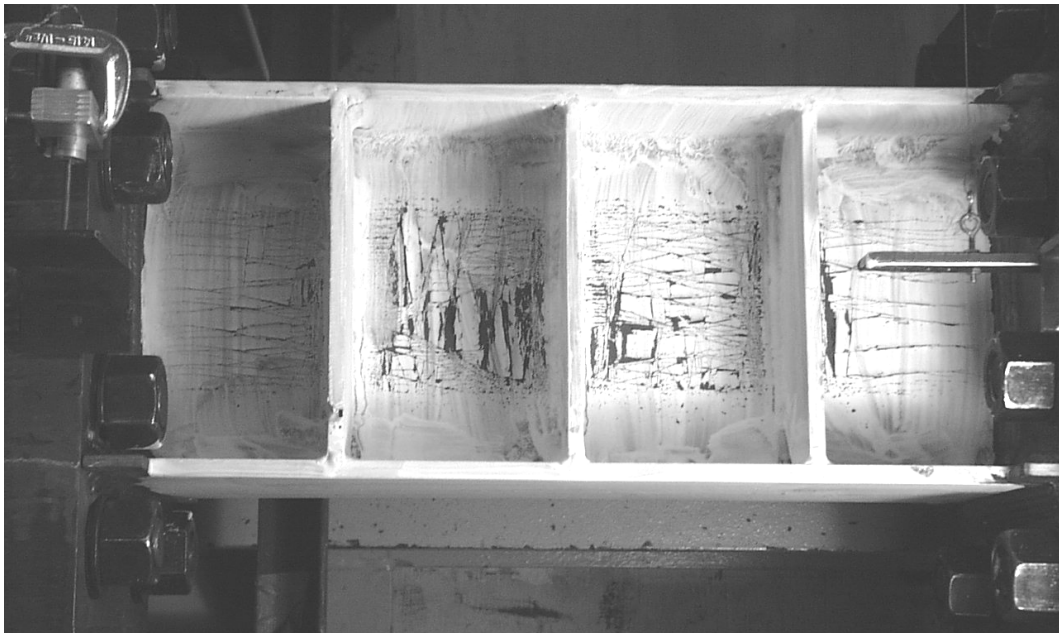
*Figure 3.26 Specimen 2: Web yielding after the first cycle of load step 3  
( $\gamma = +0.01$  radian)*

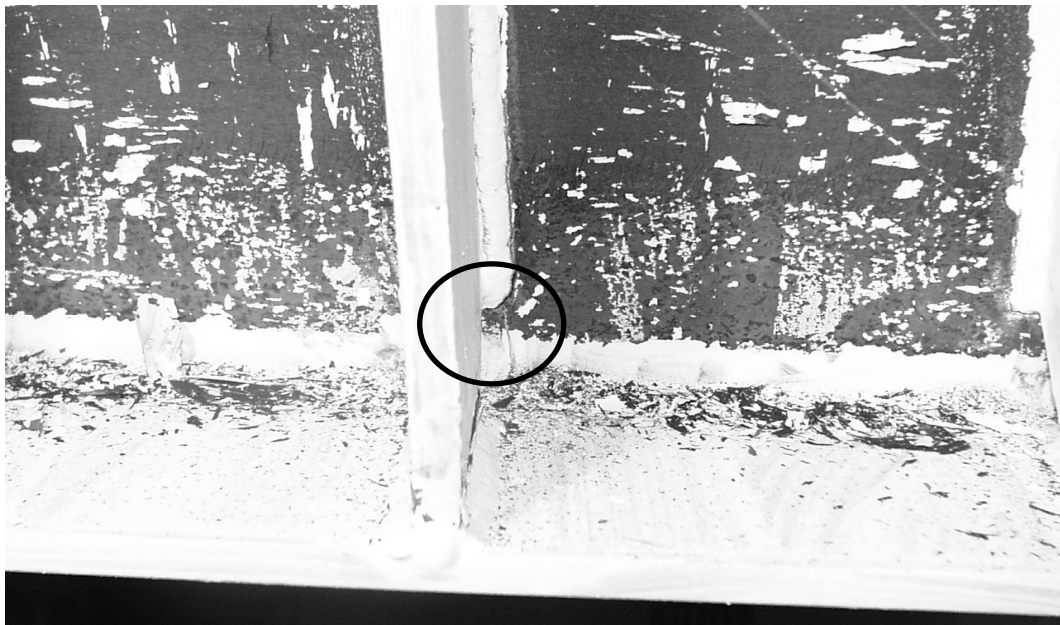
*Figure 3.27 Specimen2: First crack observed at the bottom of the center stiffener after the fourth cycle of load step 6 ( $\gamma = +0.04$  radian)*

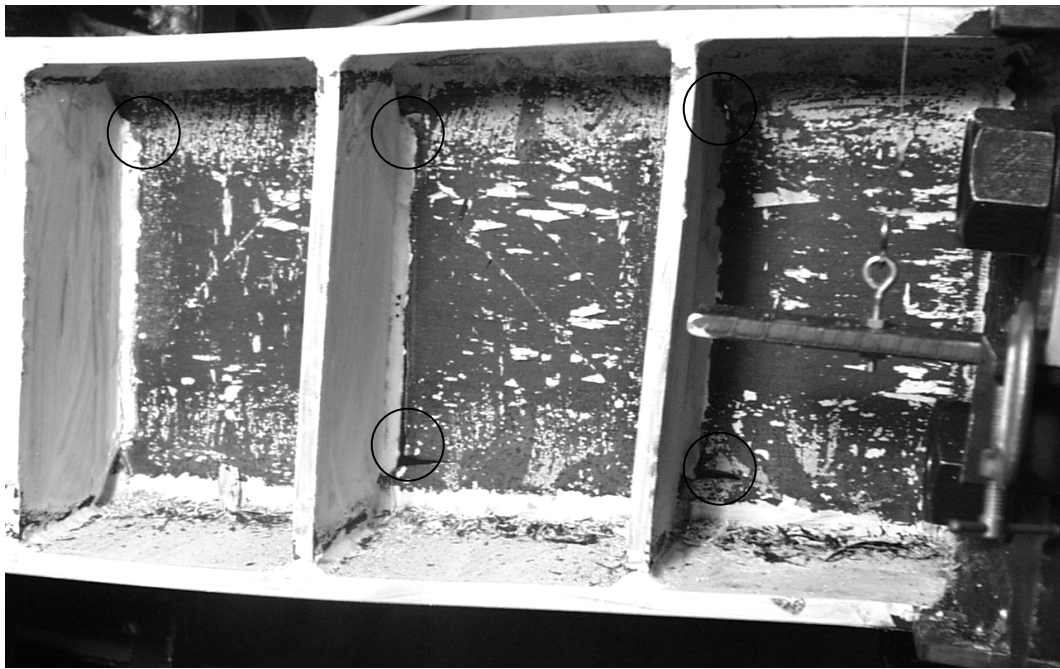
*Figure 3.28 Specimen 2: Cracks at the termination of the welds of the stiffeners after the second cycle of load step 9 ( $\gamma = -0.07$  radian)*

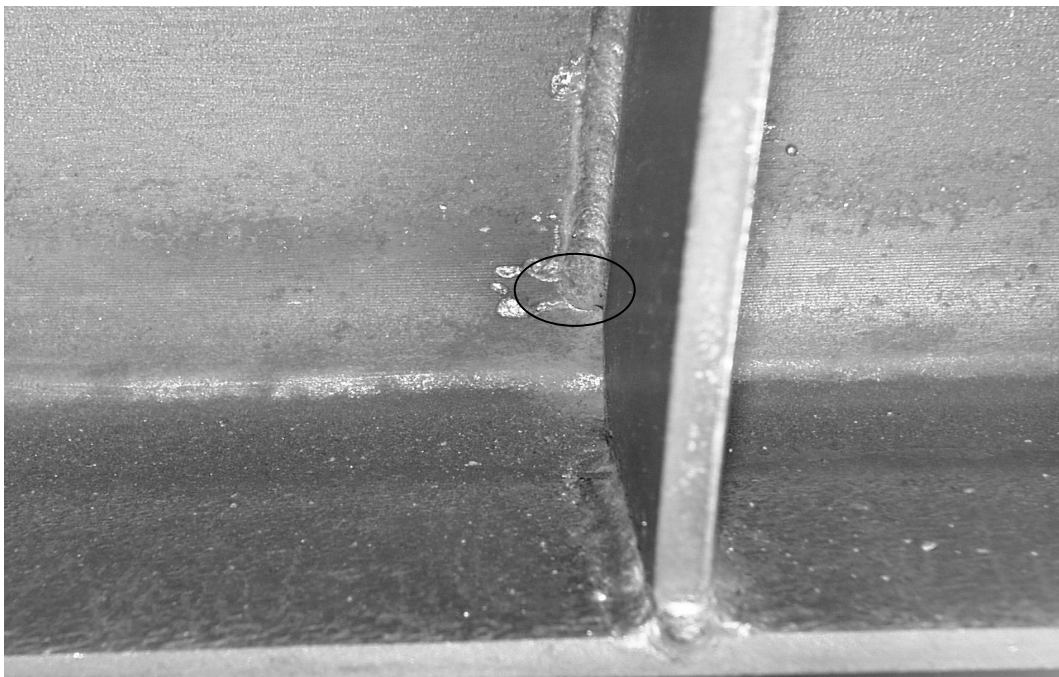
*Figure 3.30 Specimen 3: Crack at the termination of the welding at the north stiffener after the fourth cycle of load step 8 ( $\gamma = -0.06$  radian)*

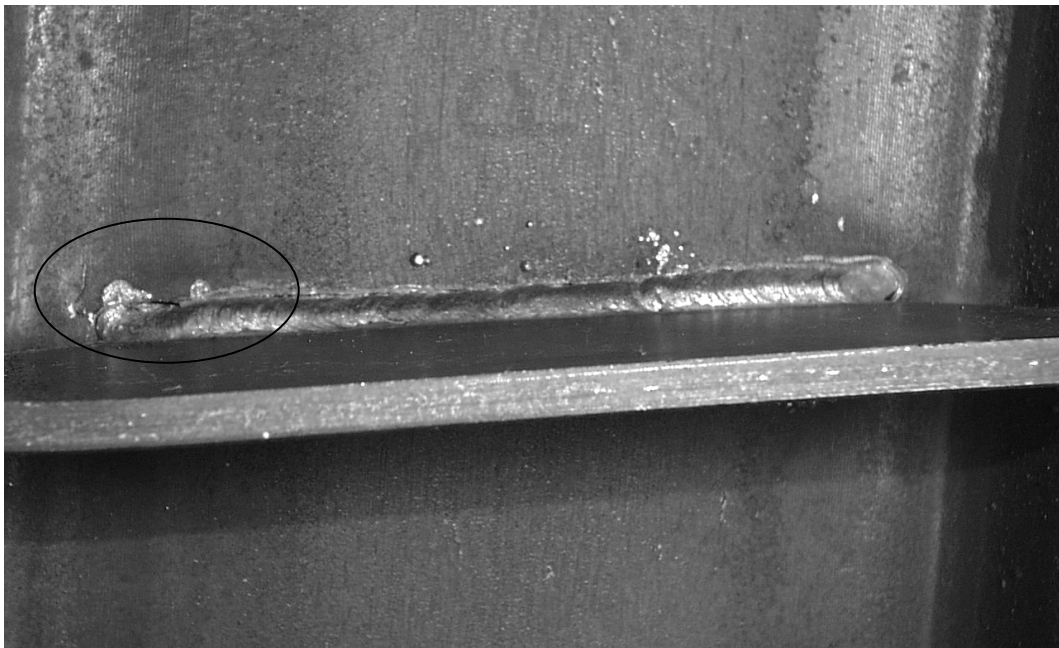
*Figure 3.32 Specimen 3: Crack at the center stiffener during the first cycle of load step 10 ( $\gamma = + 0.08$  radian)*

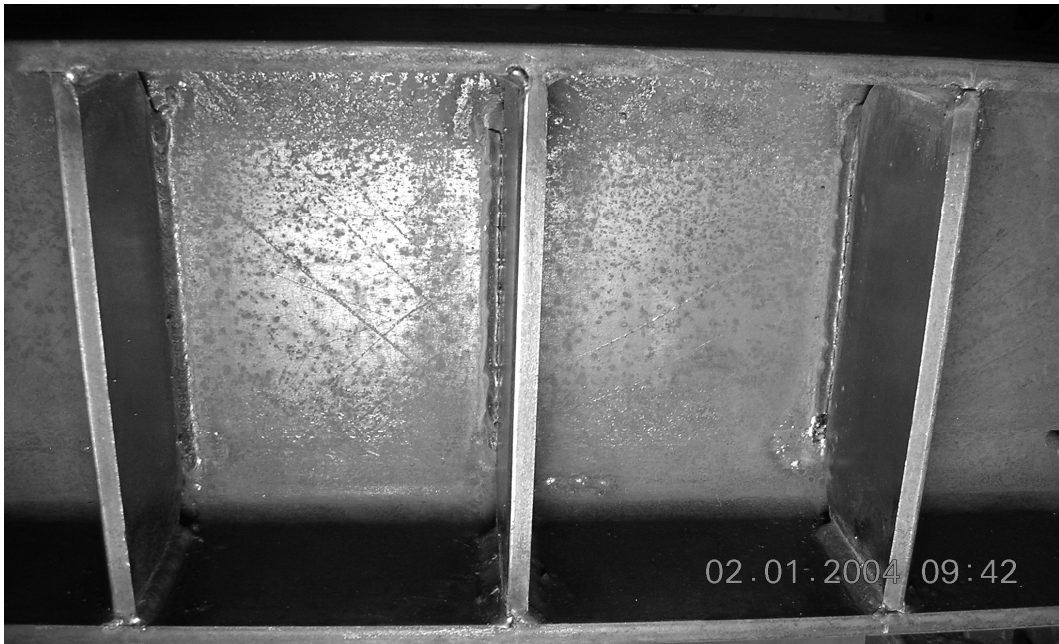
*Figure 3.34 Specimen 4: Web yielding observed at an early stage after the third cycle of load step 2 ( $\gamma = \pm 0.005$  radian)*
