**Investigation of Factors Affecting  
Web Fractures in Shear Links**

**Pedro Gálvez, BCE**

**Thesis**

The University of Texas at Austin

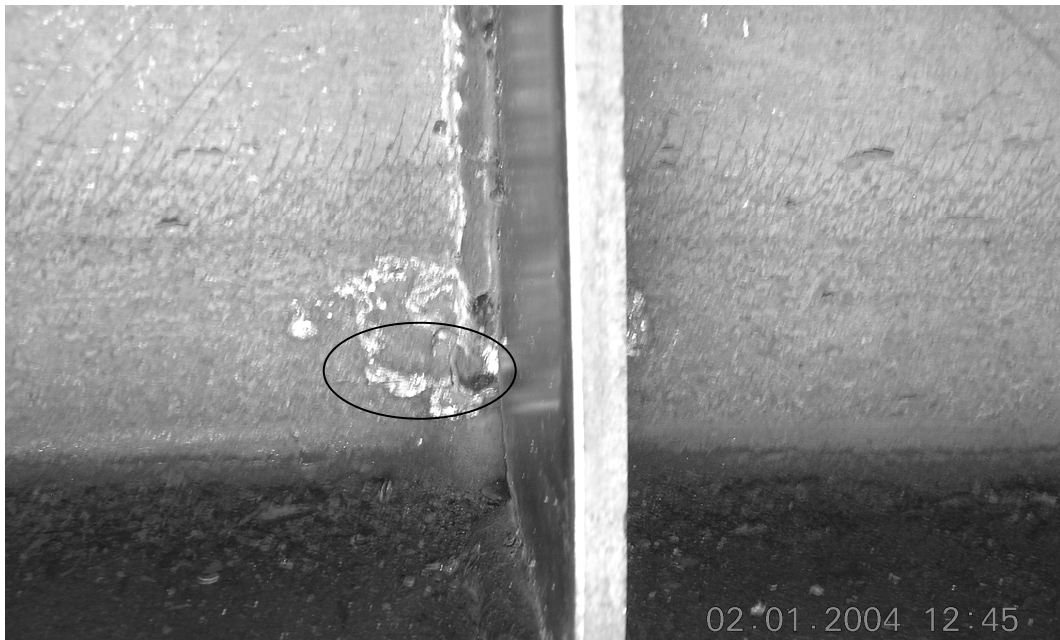
*Figure 3.35 Specimen 4: Crack observed after the fourth cycle of load step 8 ( $\gamma = -0.06$  radian)*

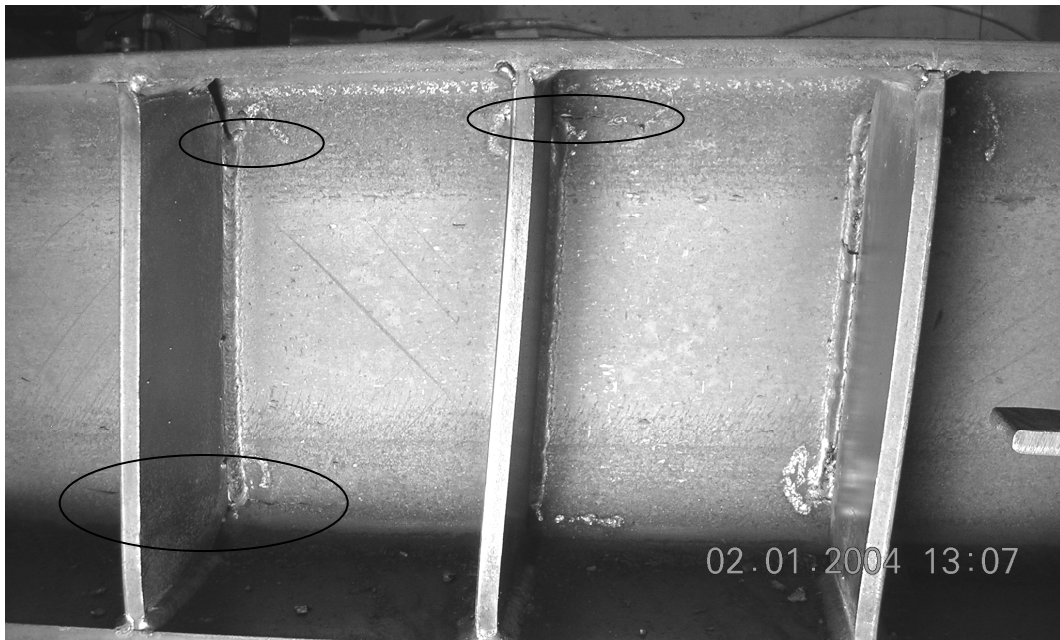
*Figure 3.36 Specimen 4: Cracks observed after the second cycle of Load step 9 ( $\gamma = +0.07$  radian)*

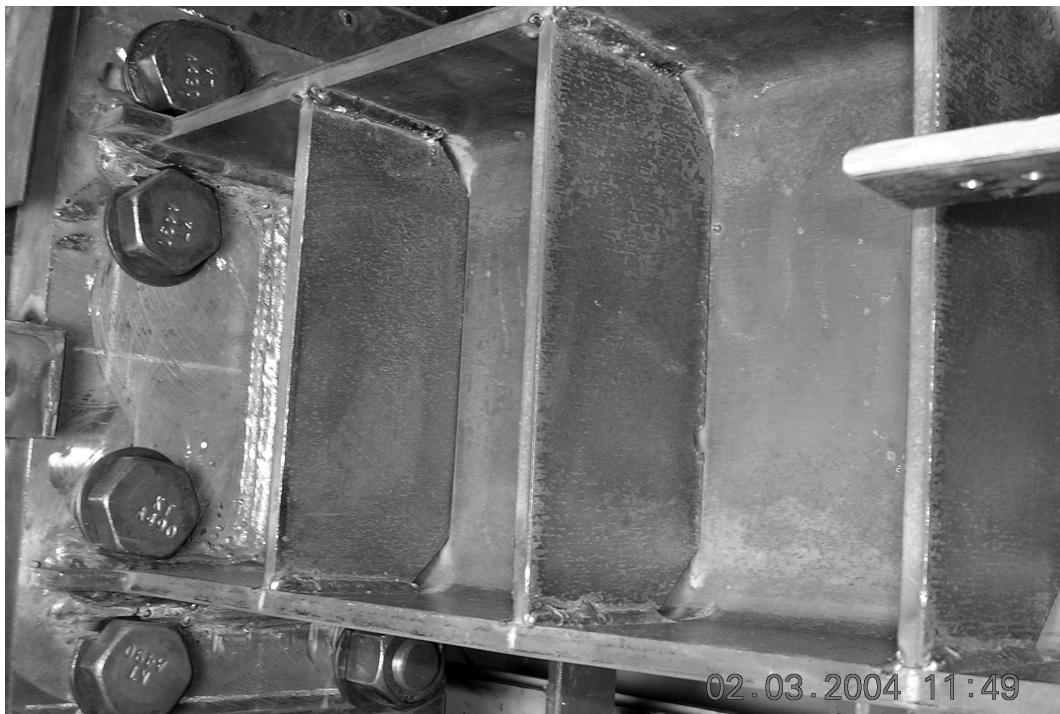
*Figure 3.38 Specimen 5: Before testing*

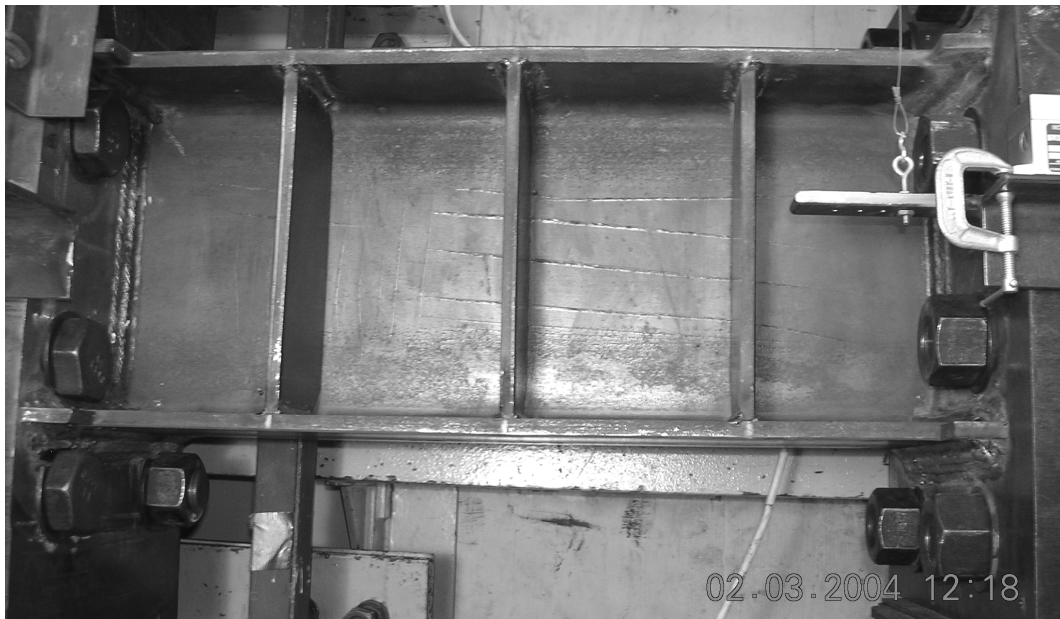
**Figure 3.39 Specimen 5: Web yielding after completion of the first cycle of load step 3 ( $\gamma = \pm 0.01$  radian)**

In this specimen, web yielding was observed at the end of the second cycle of load step 2 ( $\gamma = -0.005$  radian). Previous specimens with stiffeners welded to the web showed diagonal and then horizontal and vertical yield lines at early stages when the web was yielding. Specimen 5, on the other hand, showed only horizontal and vertical yield lines in the web. Figure 3.39 illustrates the horizontal yield lines observed after completing the first cycle of load step 3 ( $\gamma = 0.01$  radian). Unlike the earlier specimens with stiffeners welded to the web, signs of web buckling appeared in Specimen 5 during load step 6 ( $\gamma = -0.04$  radian). Web yielding increased during the following cycles. However, no cracks

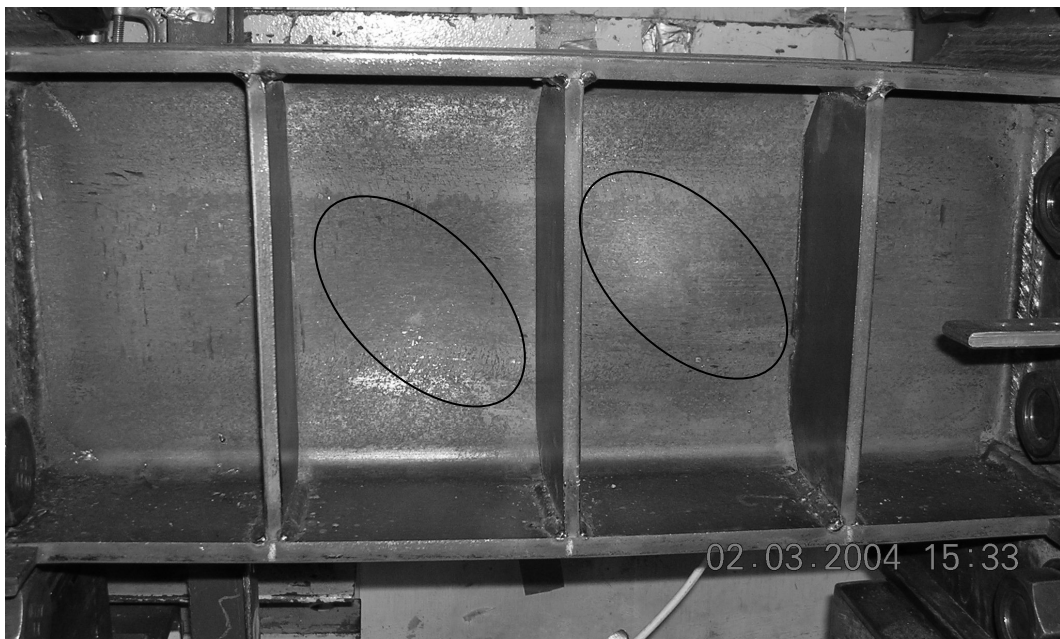
**Figure 3.40 Specimen 5: Web buckling observed during the first cycle of load step 9 ( $\gamma = +0.07$  radian)**

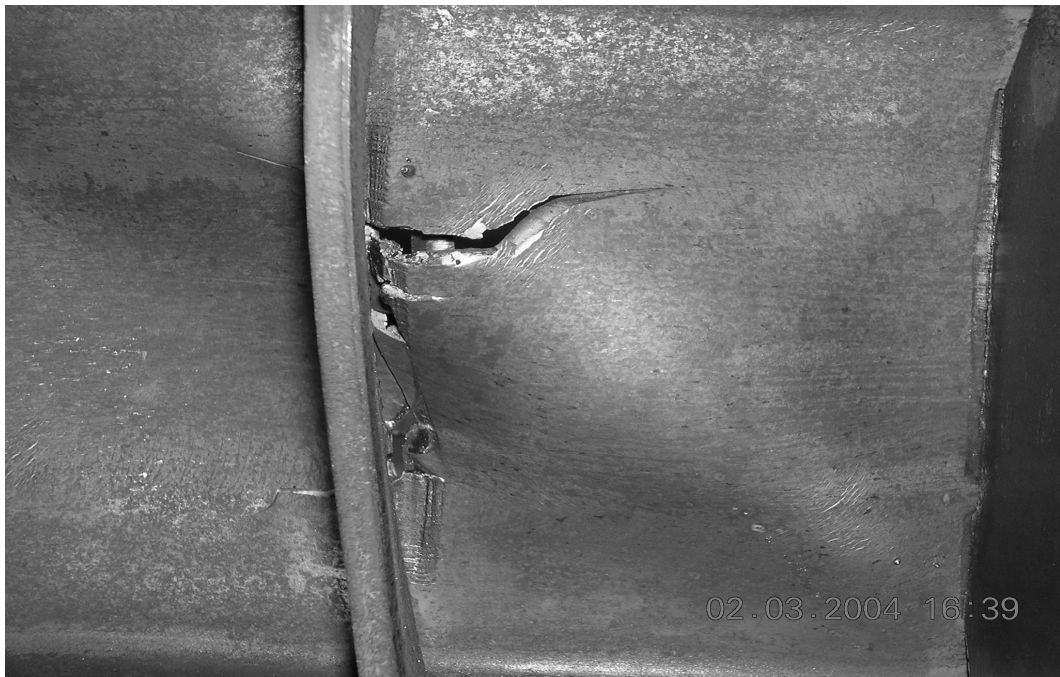
*Figure 3.41 Specimen 5: Closer look at the crack formed behind the center stiffener after testing*

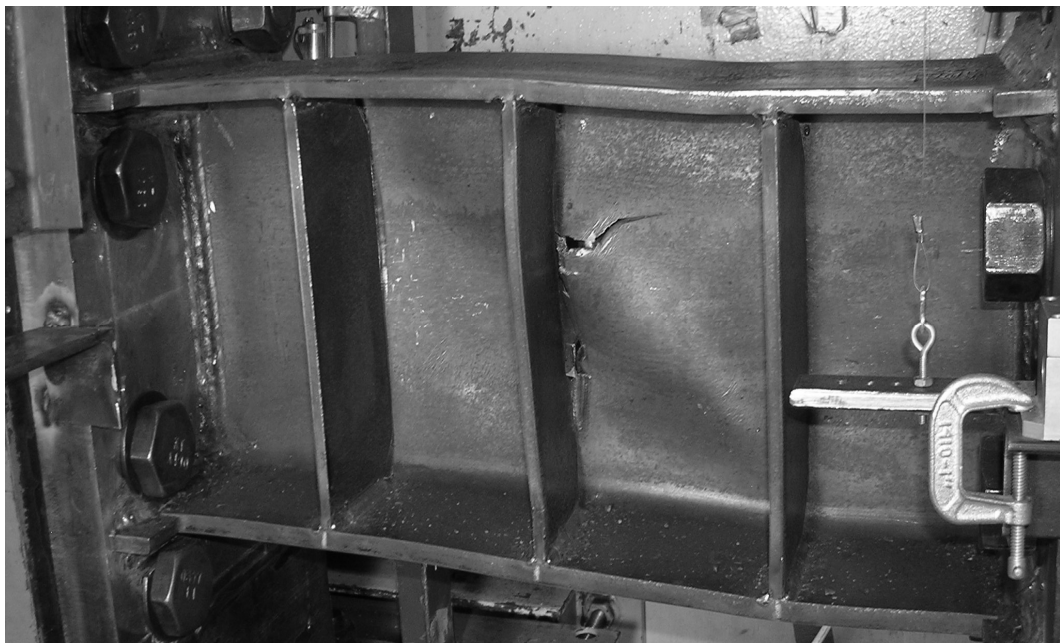
*Figure 3.42 Specimen 5: After testing*

A small crack was observed at approximately mid-depth of the web, behind the center stiffener. It appeared that this crack was created by the rubbing of the stiffener against the web. As the test continued, this crack continued to grow. During the second cycle of load step 10 ( $\gamma = +0.08$  radian) the load carrying capacity of the link started to decrease. Finally, the link suffered substantial strength degradation due to growth of the cracks behind the center stiffener. Figure 3.41 shows the crack behind the center stiffener at the end of the test and Figure 3.42 presents an overall view of the link after testing. This specimen performed better than Specimen 4 by reaching a plastic rotation angle  $\gamma_p = \pm 0.07$  radian.

was thought to be adequate to avoid severe web buckling at an early stage during the test. Specimen 5 not only reached higher plastic rotation than Specimens 2 and 4, but it did not experience web fractures in the k-area. The fractures observed in this specimen appeared at the center of the web. There is a possibility that the web fracture shown in Figure 3.41 might have been initiated by a cut produced by the center stiffeners due to the rubbing of the stiffeners and the center of the web. These results suggest that web fractures in the k-area were prevented by not welding stiffeners to the web. Overall, the results of Specimen 5 are very promising.

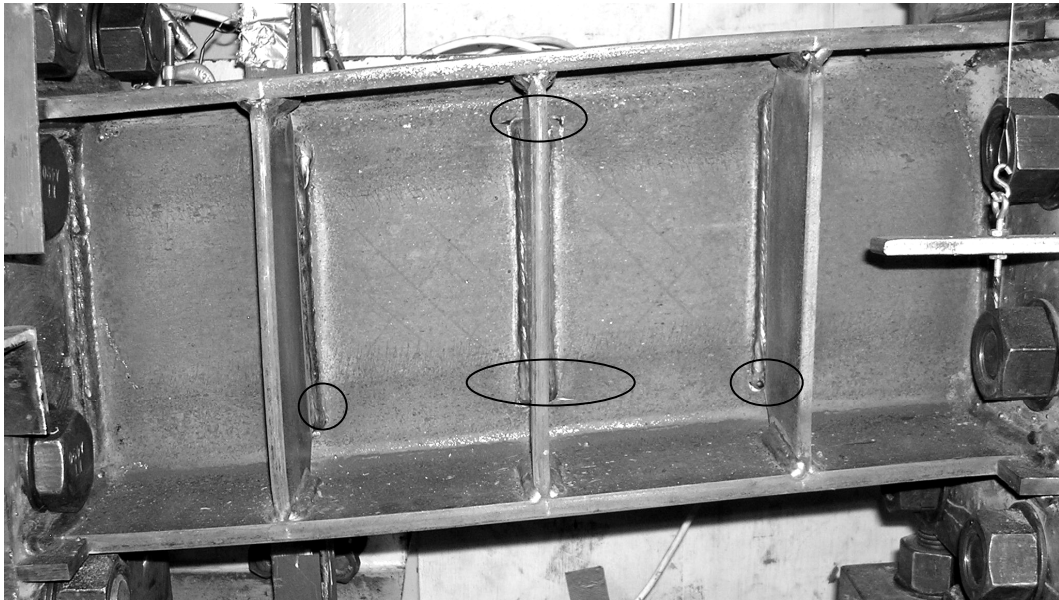
*Figure 3.43 Specimen 6: Cracks observed at the termination of the fillet welds after the first half of the third cycle of load step 8 ( $\gamma = +0.06$  radian)*

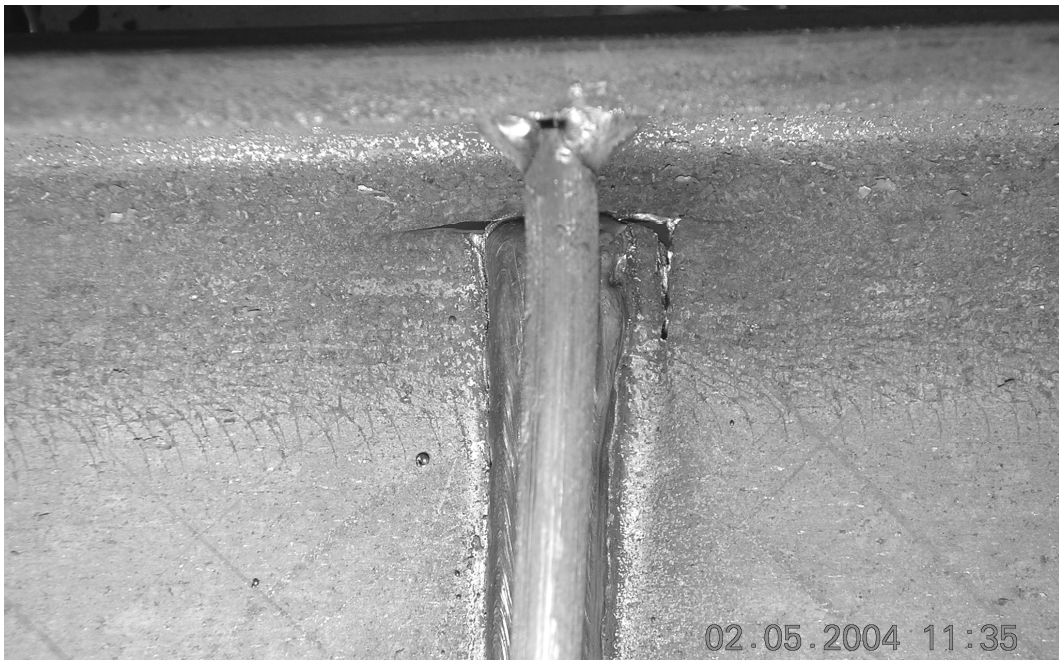
*Figure 3.44 Specimen 6: Crack at the top of the center stiffener during the first Half of the third cycle of load step 8 ( $\gamma = -0.06$  radian)*

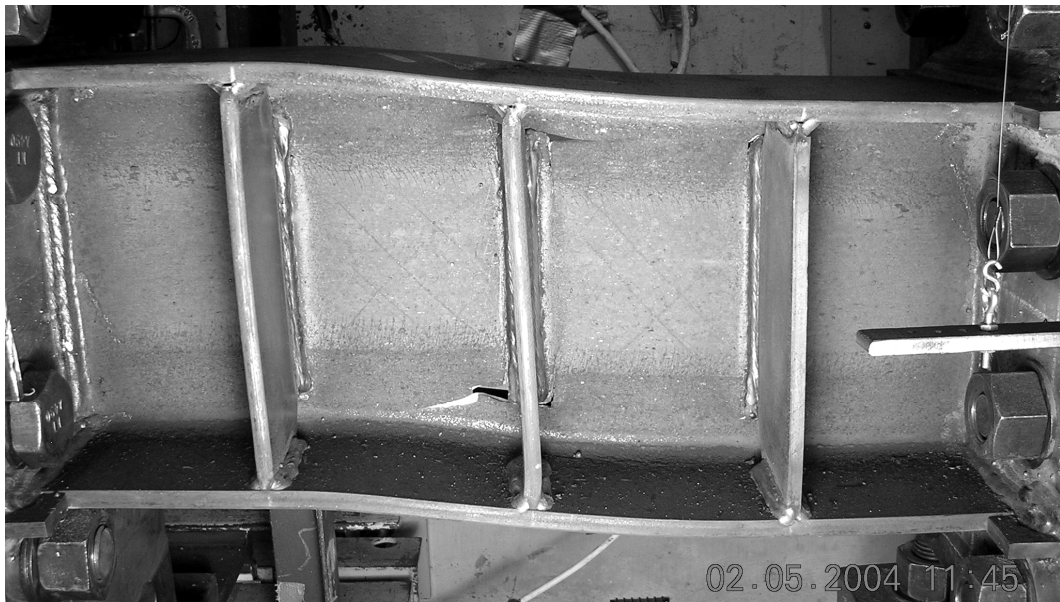
*Figure 3.45 Specimen 6: Cracks running parallel to the flanges during the second half of the third cycle of load step 8 ( $\gamma = -0.06$  radian)*

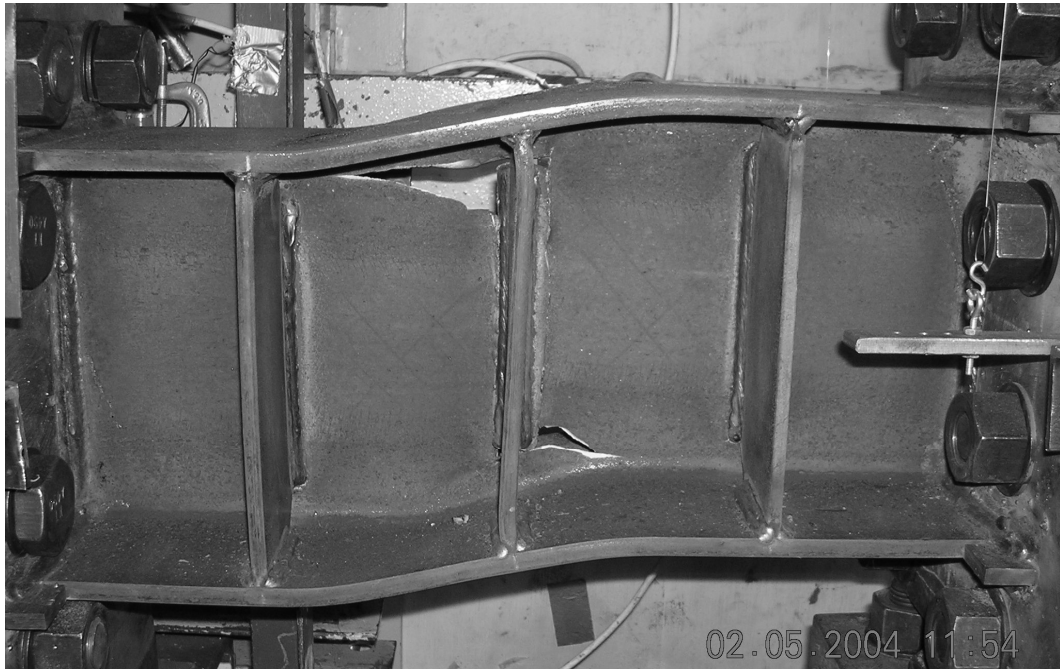
*Figure 3.46 Specimen 6: After testing*

stiffener after completing two cycles in load step 8 ( $\gamma = \pm 0.06$  radian). During the third cycle of load step 8 ( $\gamma = -0.06$  radian) the horizontal cracks propagated further and the specimen suffered severe strength degradation during the following cycle. Finally, the test was terminated at the end of the fourth cycle of load step 6, ( $\gamma = -0.06$  radian). Figure 3.46 shows the specimen after testing. Note that these cracks are similar to those observed in previous specimens. This specimen reached a plastic rotation of  $\gamma_p = \pm 0.05$  radian.

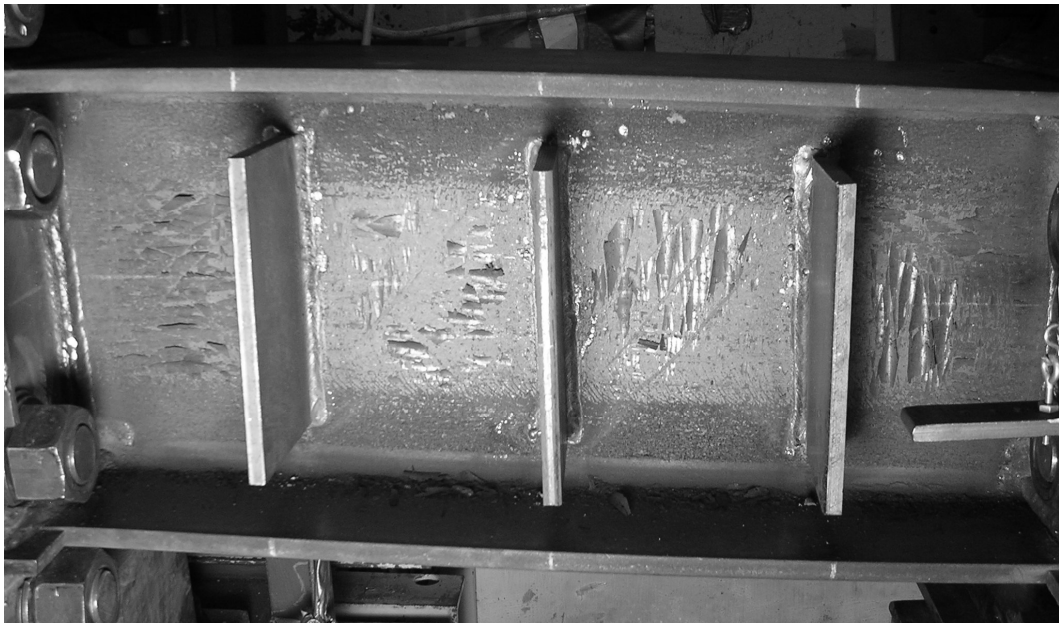
*Figure 3.48 Specimen 7: Web yielding observed during the fourth cycle of load step 6 ( $\gamma = -0.04$  radian)*

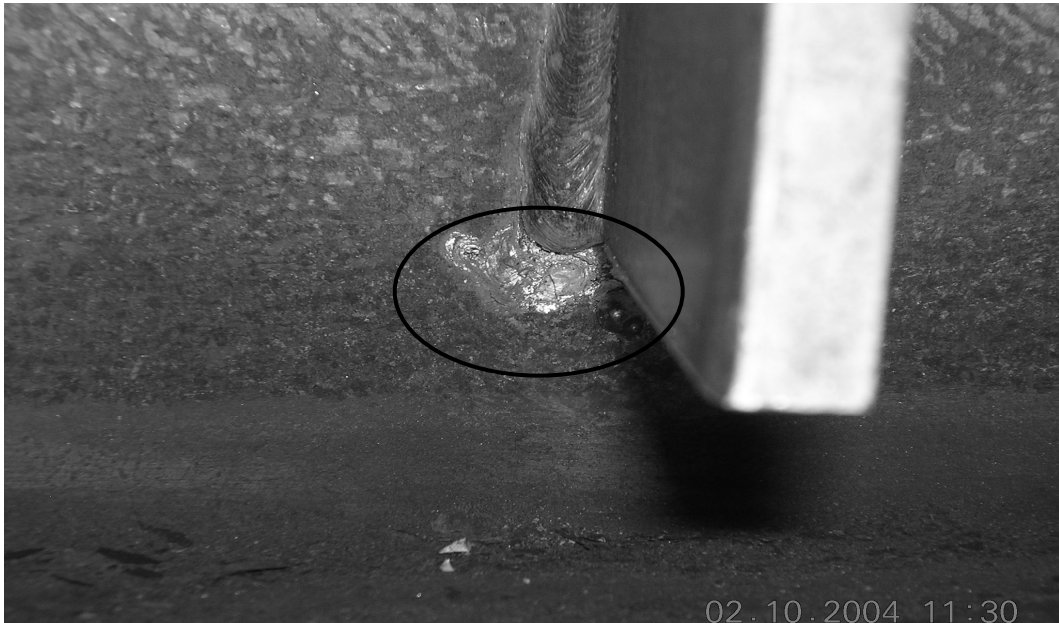
*Figure 3.49 Specimen 7: Crack observed at the bottom of the north stiffener after the fourth cycle of load step 7 ( $\gamma = -0.05$  radian)*

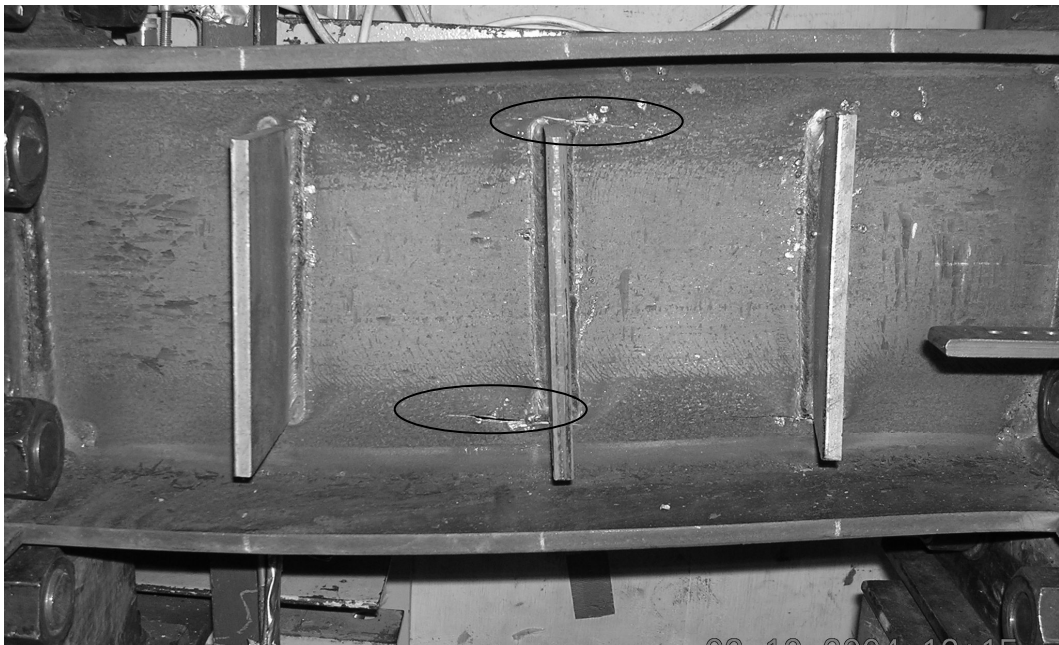
*Figure 3.50 Specimen 7: Horizontal cracks observed during the first half of the third cycle of load step 8 ( $\gamma = +0.06$  radian)*

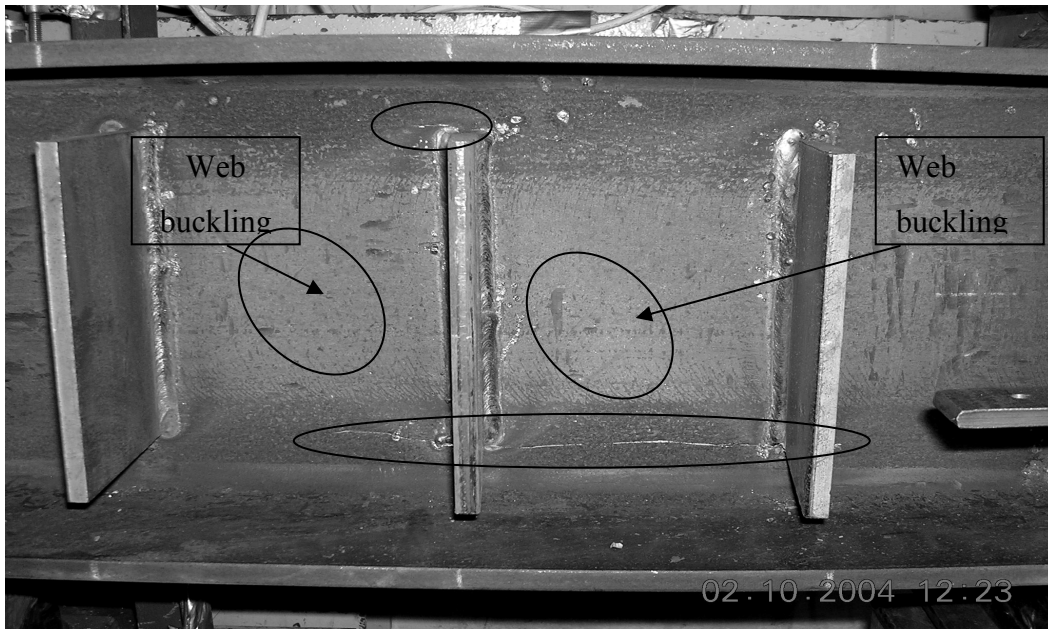
*Figure 3.51 Specimen 7: Horizontal crack observed during the second half of the third cycle of load step 8 ( $\gamma = -0.06$  radian)*

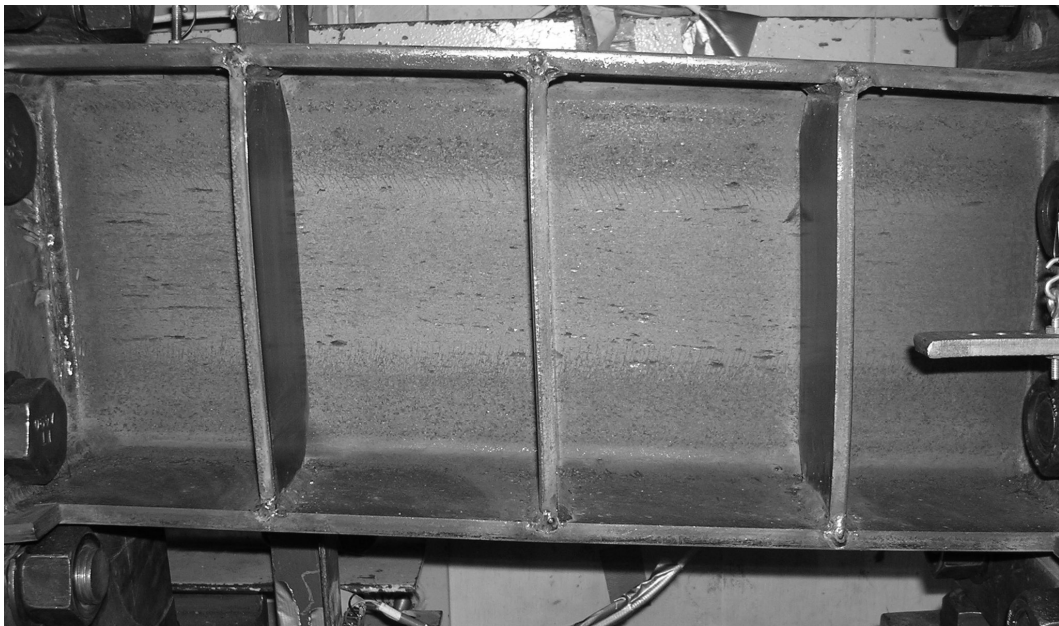
*Figure 3.54 Specimen 8: No mill scale observed at the center of the web after the second cycle of load step 7( $\gamma = 0.003$  radian)*

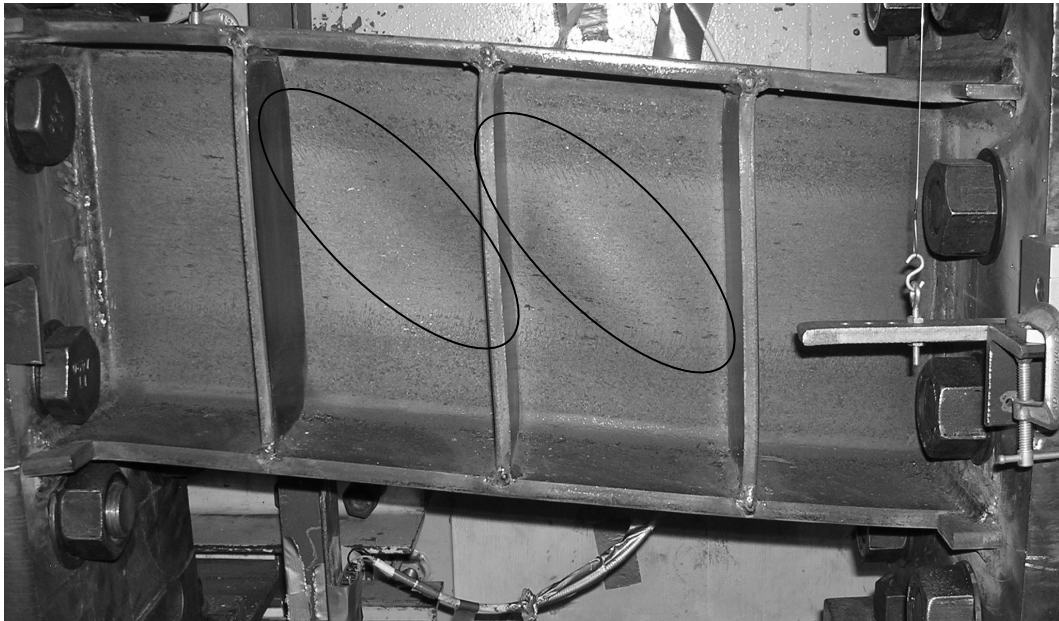
*Figure 3.55 Specimen 8: Web buckling during the first cycle of load step 11 ( $\gamma = -0.09$  radian)*

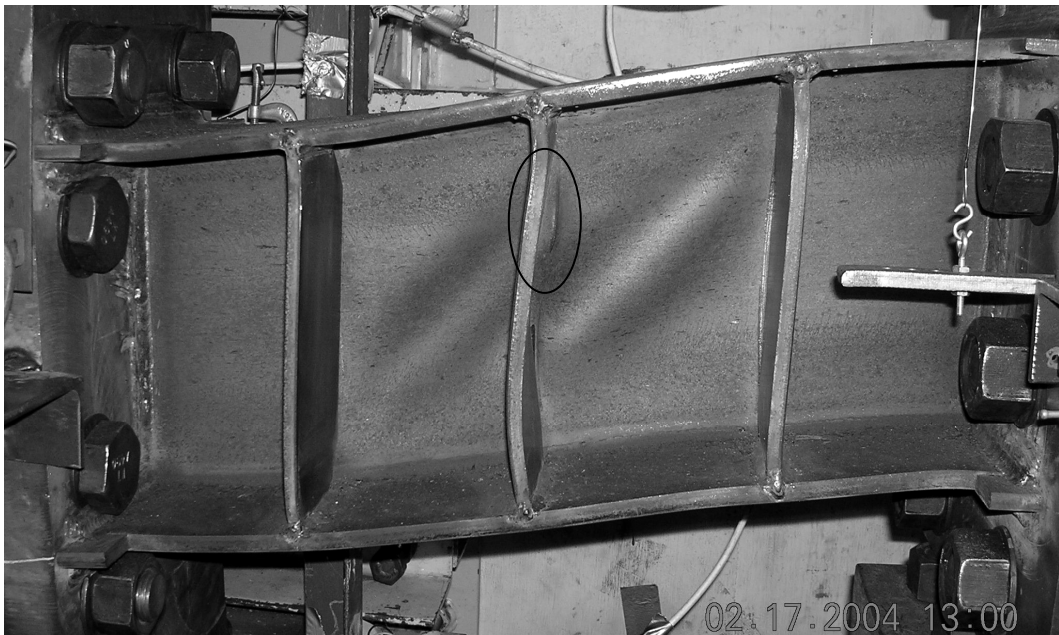
*Figure 3.56 Specimen 8: Web damage due to the rubbing of the center stiffener during the first cycle of load step 13*

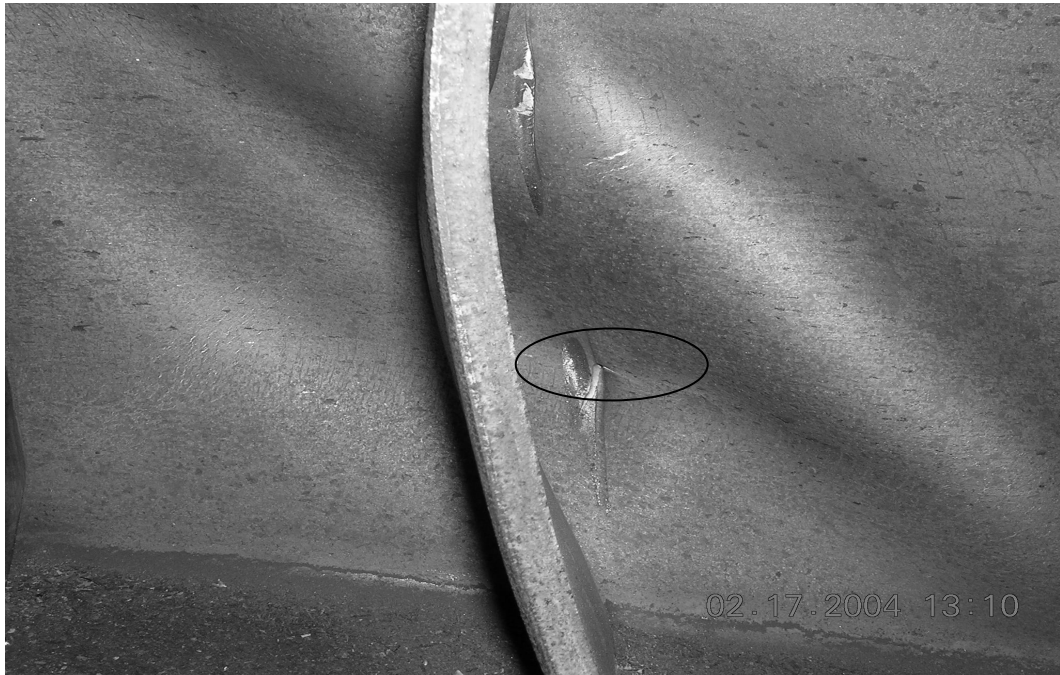
***Figure 3.57 Specimen 8: Crack initiated in the damaged region of the web during the first half of the first cycle of load step 13( $\gamma = +0.13$  radian)***

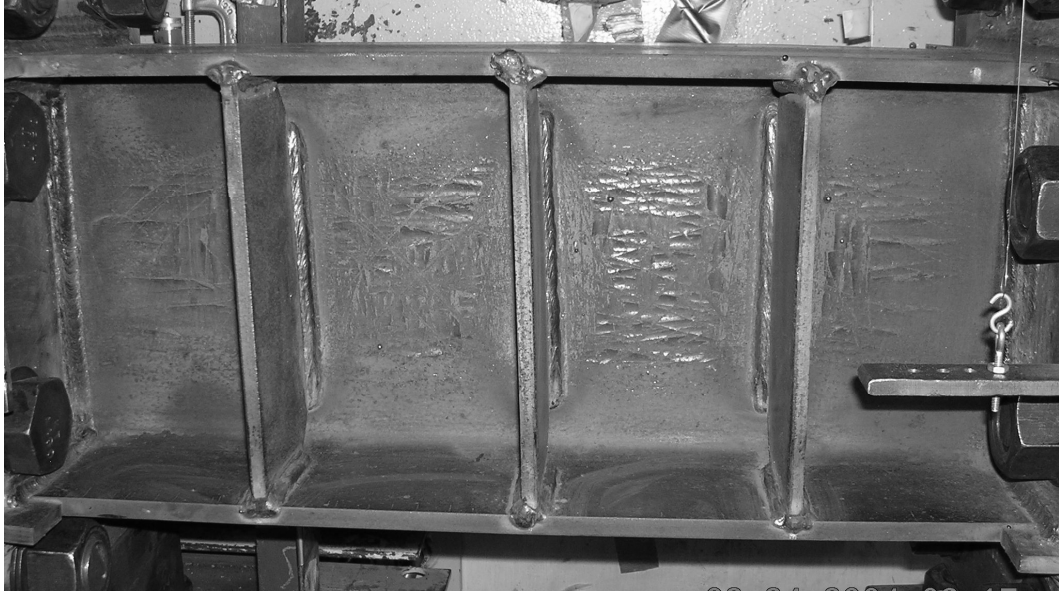
*Figure 3.59 Specimen 9: Web yielding during the sixth cycle of load step 4 ( $\gamma = -0.01$  radian)*

Web yielding was noted first after completing the sixth cycle of load step 2 ( $\gamma = -0.005$  radian). Figure 3.59 shows the flaking of the mill scale after the sixth cycle of load step 4 ( $\gamma = -0.01$  radian). Cracks were not visible in the specimen until the first cycle of load step 9 ( $\gamma = -0.05$  radian) when a small crack was detected at the termination of the weld at the top of the south stiffener. During the following cycle another crack appeared at the termination of the fillet weld joining the web to the top part of the center stiffener. After completing the first cycle of load step 10 ( $\gamma = -0.07$  radian), a crack was observed at the bottom of the north stiffener. Figure 3.60 shows the cracks at the ends of all stiffeners

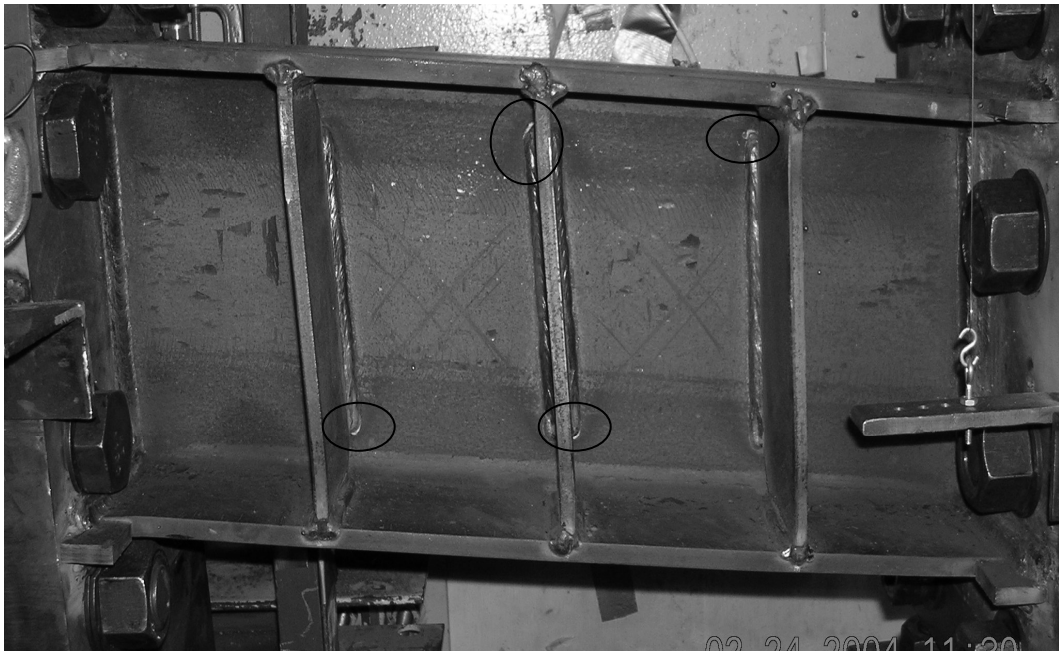
*Figure 3.60 Specimen 9: Cracks observed after the first cycle of load step 11 ( $\gamma = -0.09$  radian)*

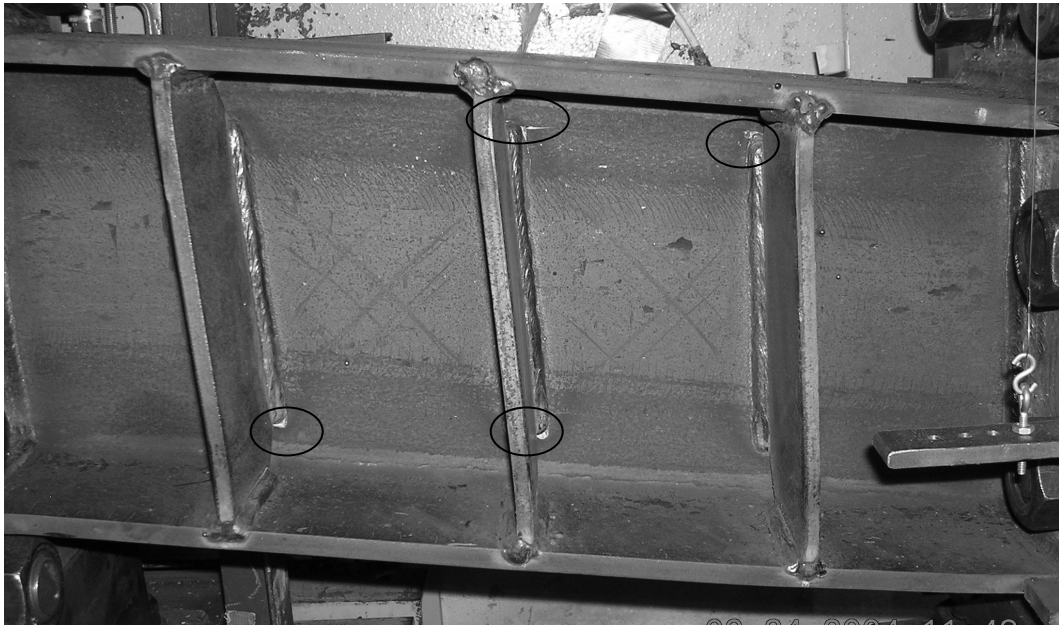
*Figure 3.61 Specimen 9: Cracks observed during the first cycle of load step 12 ( $\gamma= 0.11$  radian)*

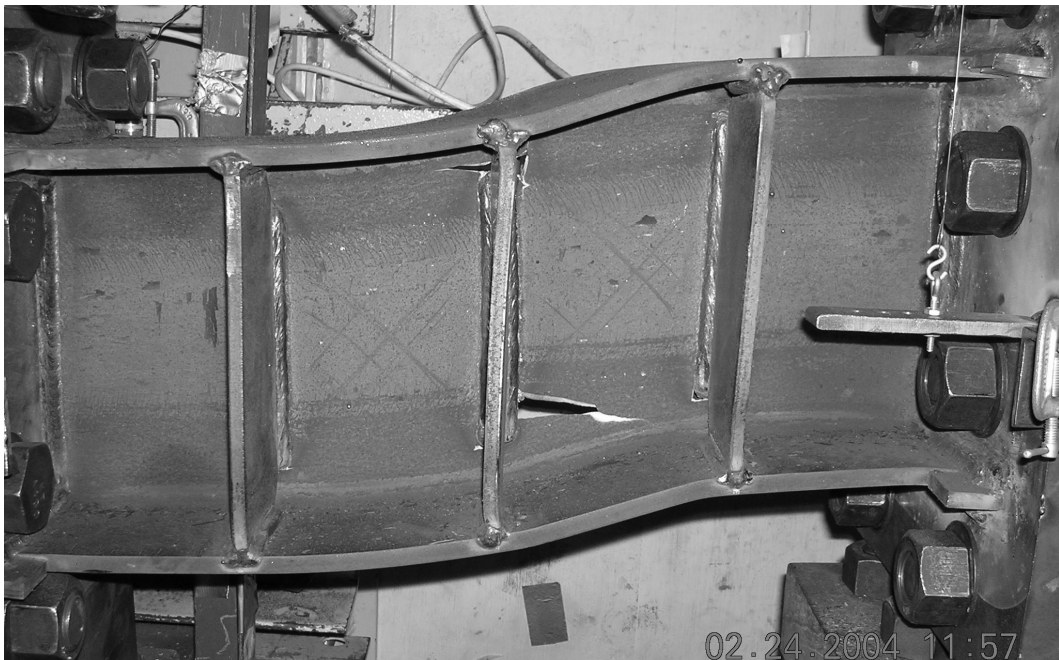
*Figure 3.62 Specimen 9: Cracks during the first cycle of load step 13 ( $\gamma= -0.13$  radian)*

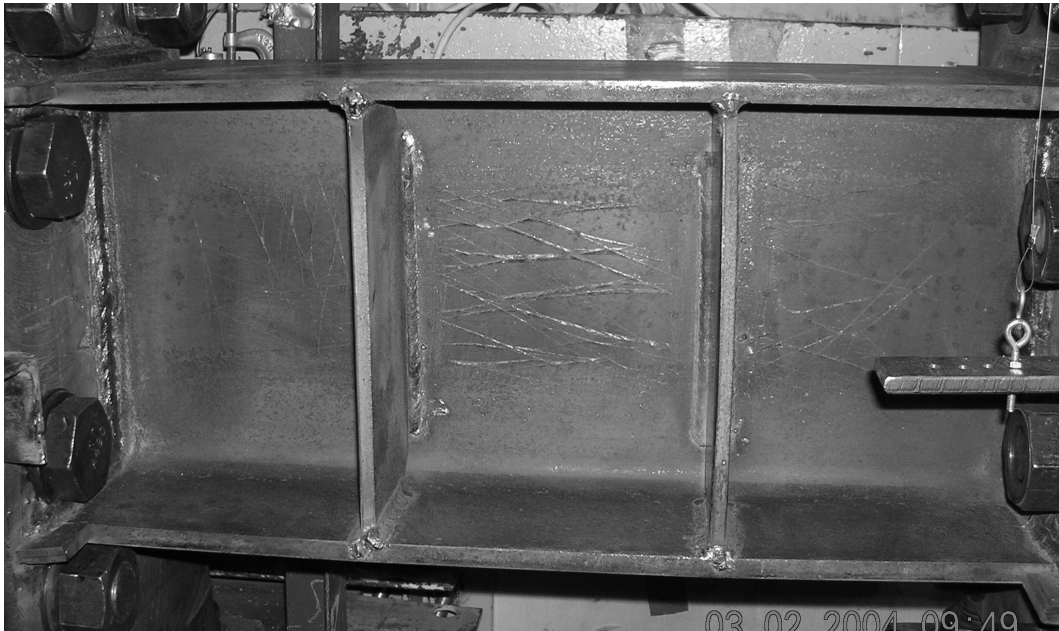
**Figure 3.65 Specimen 10: Web yielding observed after the fourth cycle of load step 3 ( $\gamma = 0.0075$  radian)**

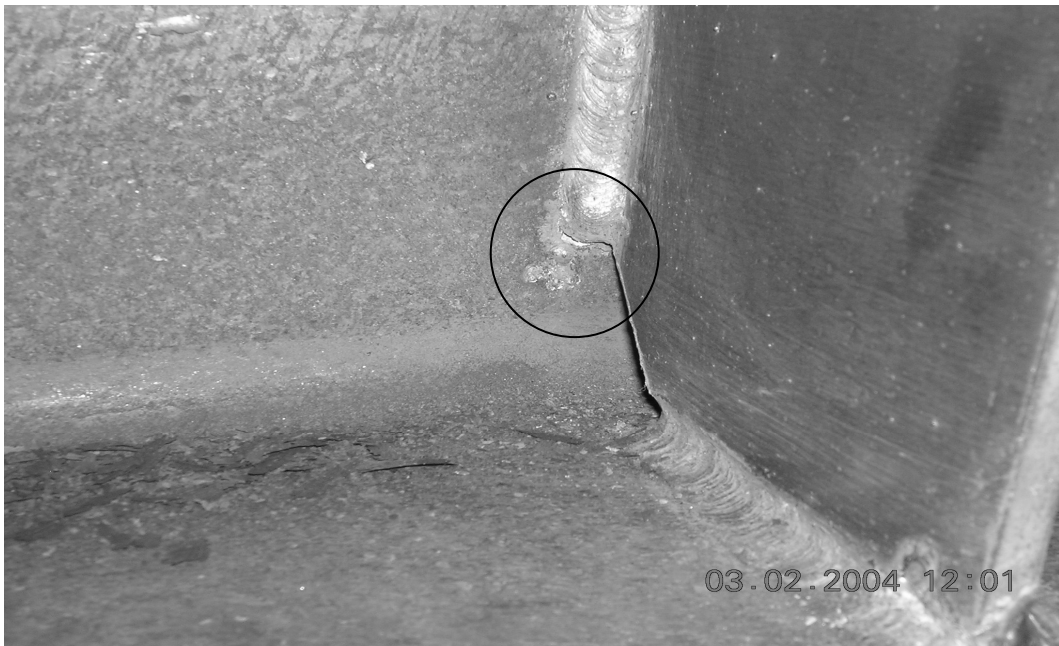
**Figure 3.66 Specimen 10: Crack observed at the bottom of the north stiffener after the first cycle of load step 11 ( $\gamma = +0.09$  radian)**

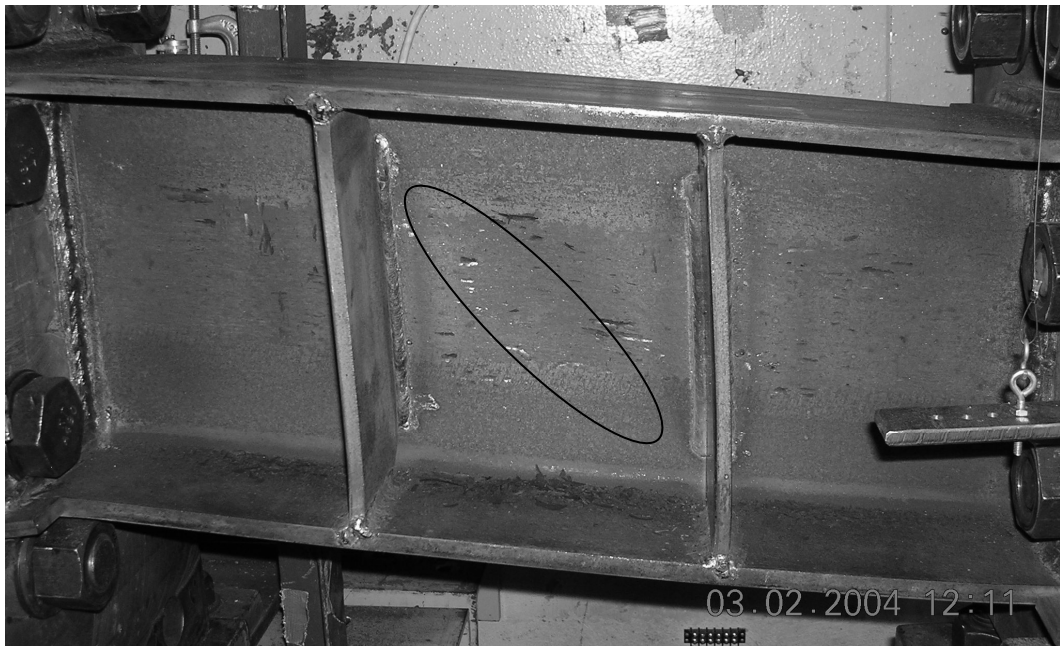
**Figure 3.67 Specimen 10: Web buckling observed after the first cycle of load step 11 ( $\gamma = -0.09$  radian)**

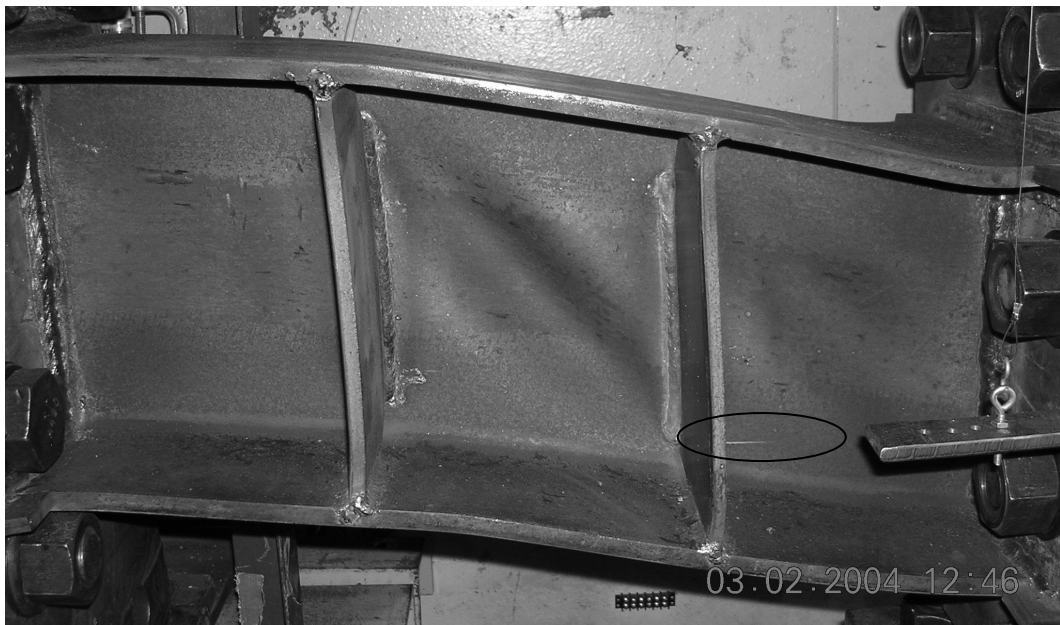
**Figure 3.68 Specimen 10: Web buckling and cracks observed after the first cycle of load step 13 ( $\gamma = -0.13$  radian)**

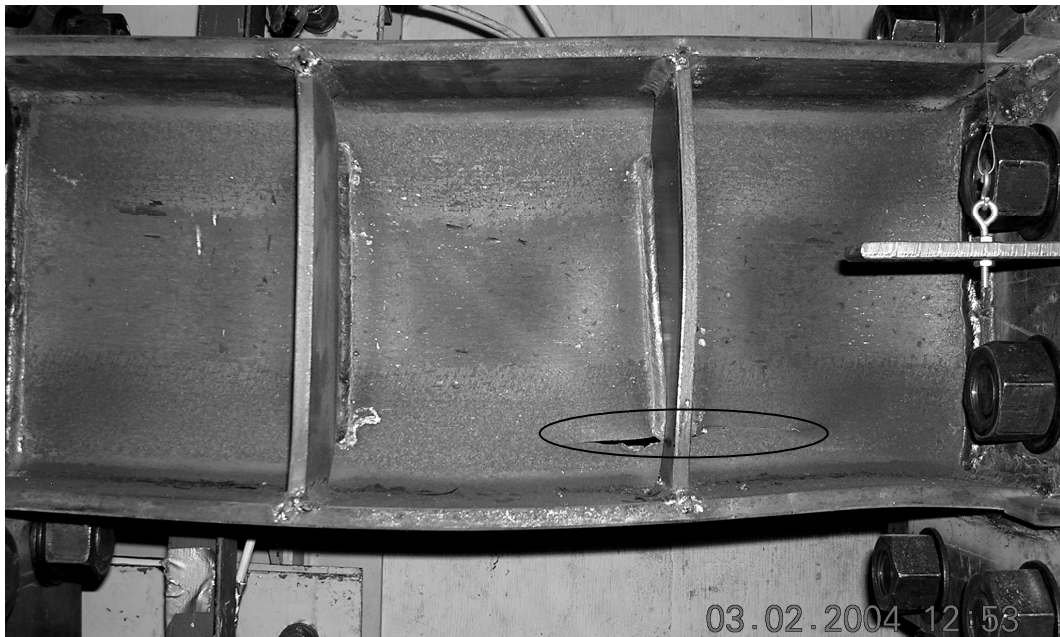
*Figure 3.69 Horizontal crack observed at the web during the first cycle of load step 14 ( $\gamma = -0.15$  radian)*

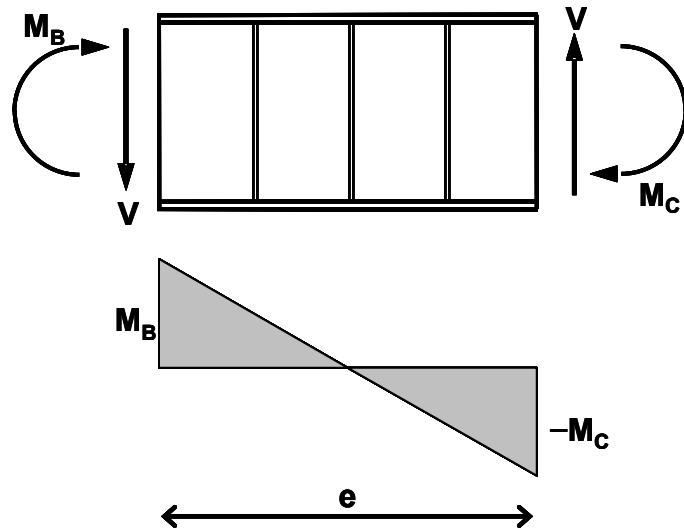
*Figure 4.1 Sign convention used for link end force resultants*

In this section, data on the moment measured at both ends of the link are presented. The sign convention adopted for the calculation of resultants at the end of the links is shown in Figure 4.1. The moment on the column side is denoted as  $M_C$  and the moment on the beam side of the link is denoted as  $M_B$ . The dotted line shown on each of Figures 4.2 to 4.11 represents the condition where  $M_C$  equals  $M_B$ .

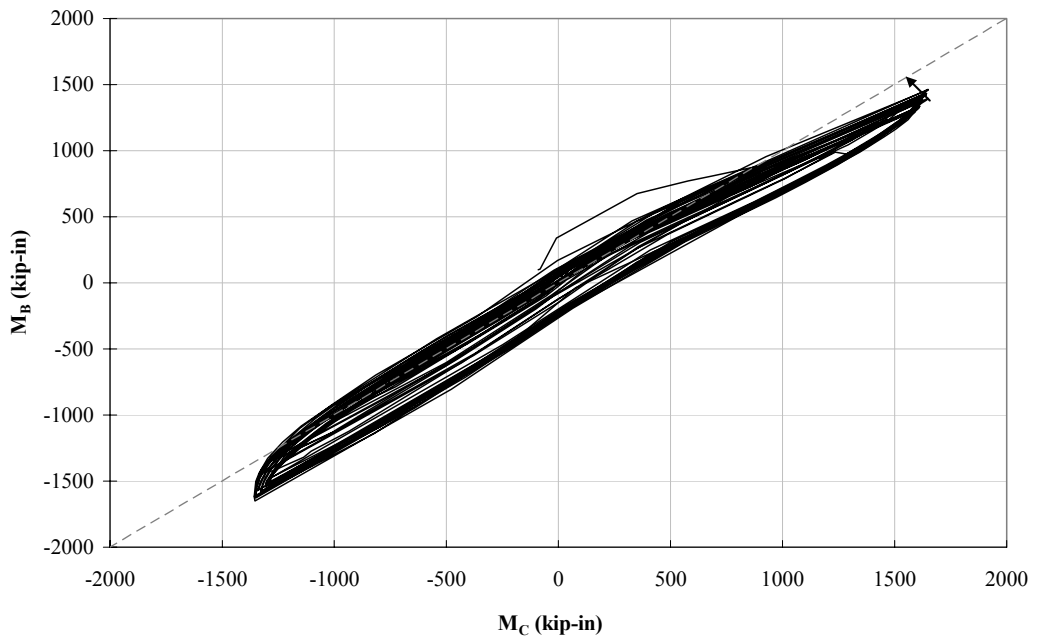
***Figure 4.2 Link end moment relationship of Specimen 1***

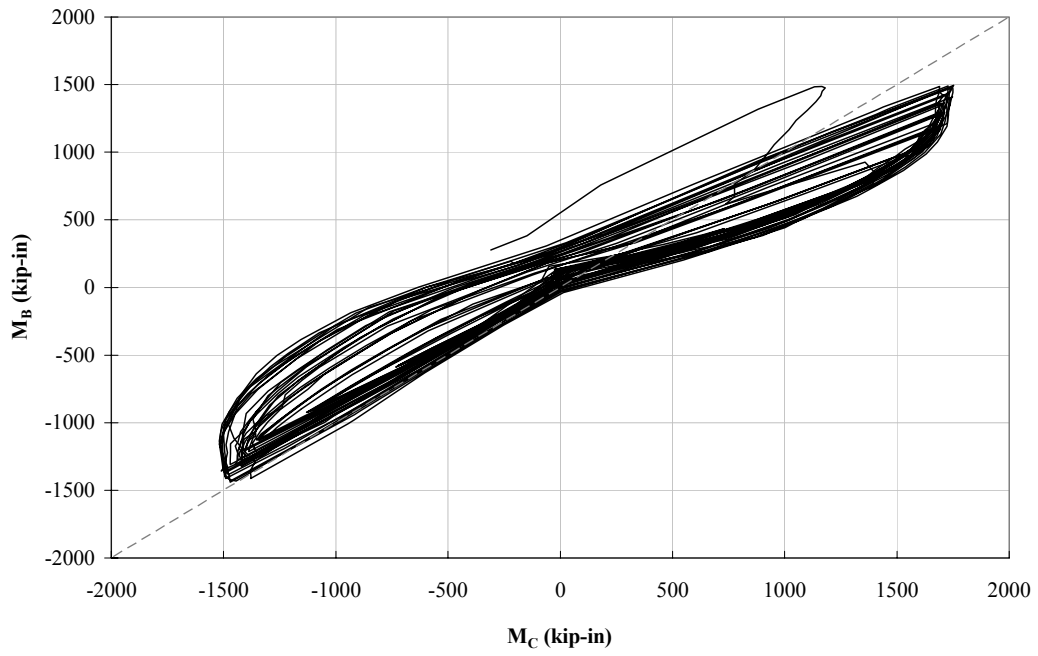
*Figure 4.4 Link end moment relationship of Specimen 3*
