**Investigation of Factors Affecting  
Web Fractures in Shear Links**

**Pedro Gálvez, BCE**

**Thesis**

The University of Texas at Austin

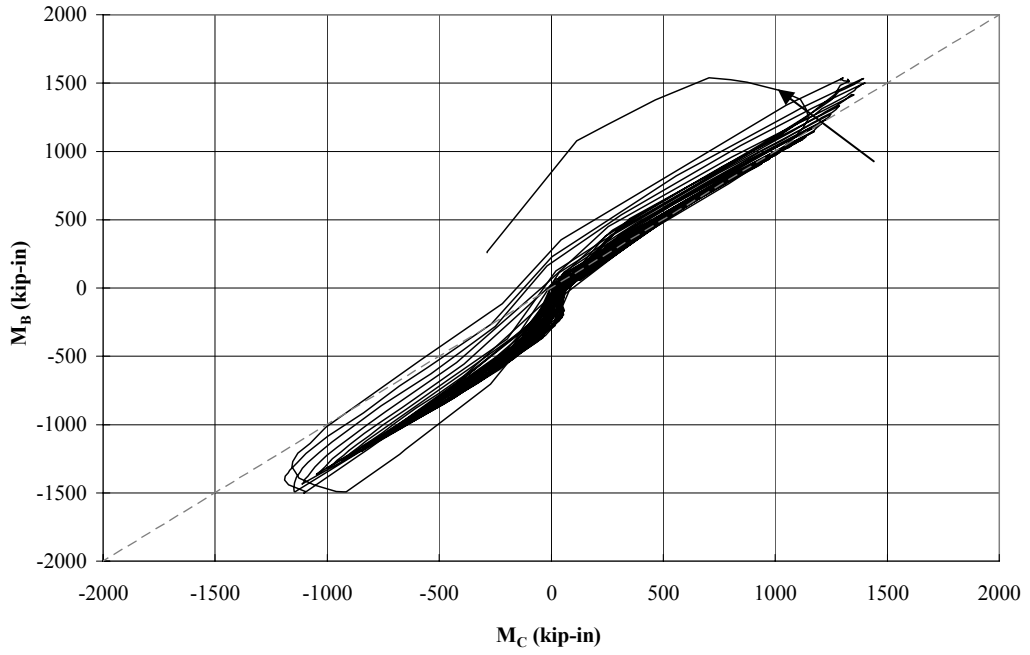
**Figure 4.11 Link end moment relationship of specimen 10**

In Figure 4.11 for Specimen 10, the arrow points where the link started to exhibit irregular behavior. This coincides with the severe load degradation due to the propagation of the vertical crack at the welds of the center stiffener in the specimen. This behavior was also observed in the other specimens. Figures 4.2 to 4.11 also show an offset of the response with respect to the origin. This phenomenon was also observed by Arce (2002). It is believed that this phenomenon is the result of the movement of the clevises as the various reaction points of the test setup pass through zero force.
